Seismic Retrofitting Guidelines for the Conservation of Doctrinal Chapels on the Oyón Highlands in Peru

Patricia Navarro Grau, Julio Vargas Neumann, and Maribel Beas

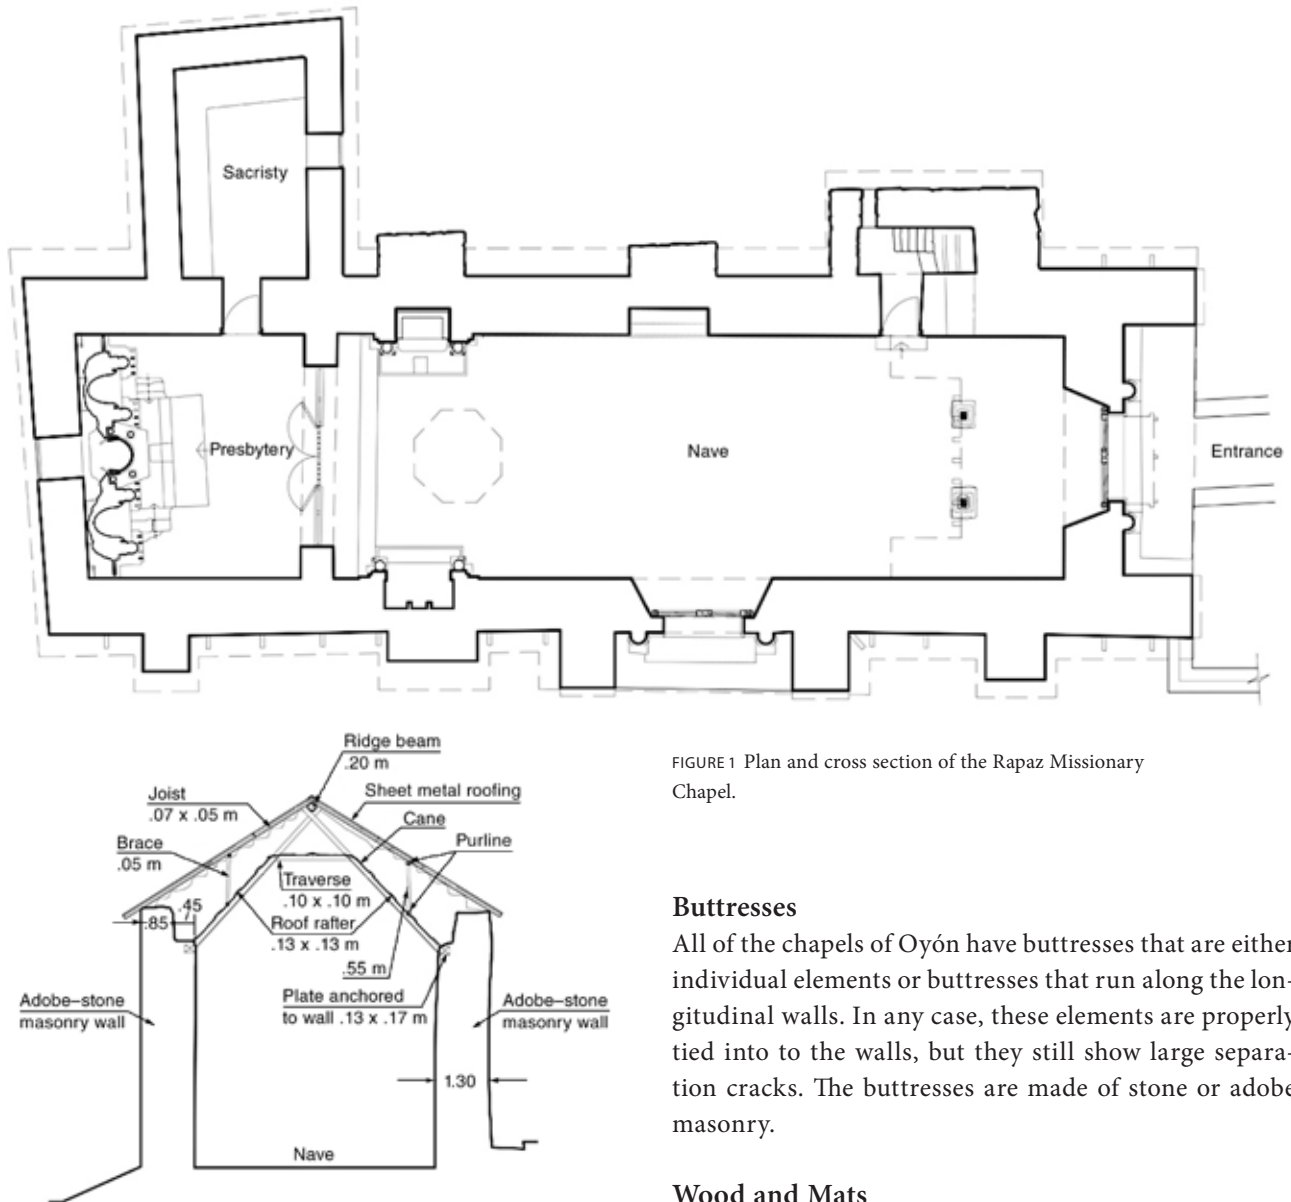
The typical configuration of a chapel consists of a single nave ending at the presbytery and an adjacent sacristy. These areas form an L-shaped floor plan, which is irregular and asymmetrical (fig. 1). The walls are generally constructed of adobe or mixed masonry. The roof is a lightweight wooden truss structure.

FIGURE 1 Plan and cross section of the Rapaz Missionary Chapel.

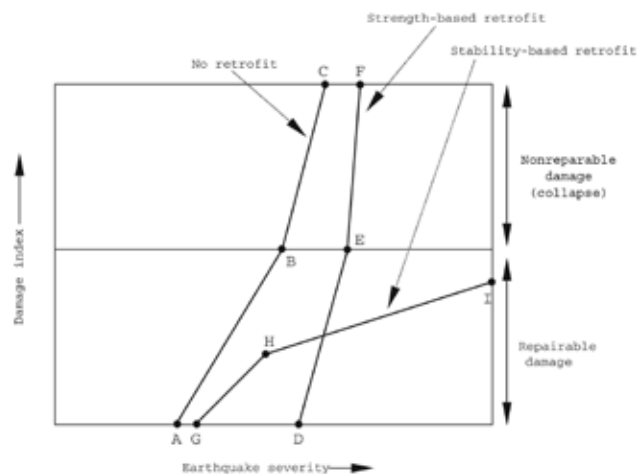
FIGURE 5 Damage-progression index versus earthquake severity for unretrofitted structures (ABC) and for strength-based (DEF) and stability-based (GHI) retrofitted structures. In the stability-based retrofit, cracks and displacement are controlled; this prevents collapse and allows for future repair. (From Tolles, Kimbro, and Ginell 2002, 45, fig. 4.1.)

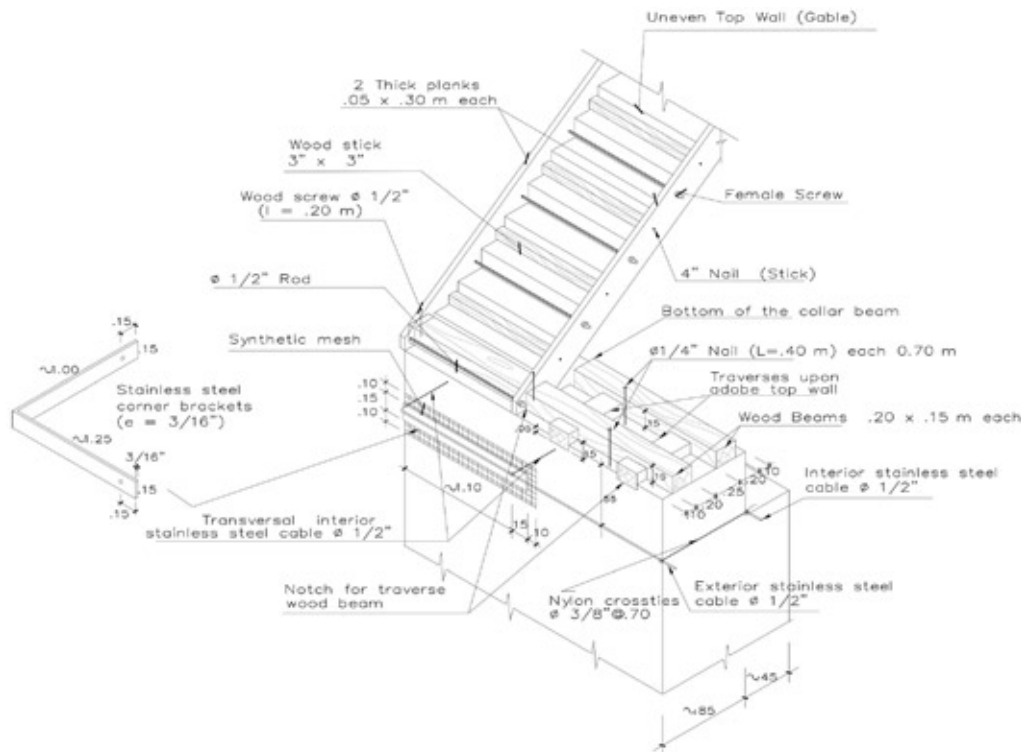
FIGURE 6 Design of a minimal intervention reinforcement for the Church of Rapaz (detail of upper corner).

preservation of human life and cultural heritage. The way to achieve this is to apply a series of redundant reinforcements to the structure, providing alternate paths for the distribution of earthquake-induced forces. These reinforcements are meant to confine the walls, preventing greater displacements of damaged walls. This design ensures the continuity and connection of cracked elements (Tolles, Kimbro, and Ginell 2002).

On behalf of these goals, the following structural interventions have been decided upon (fig. 6).

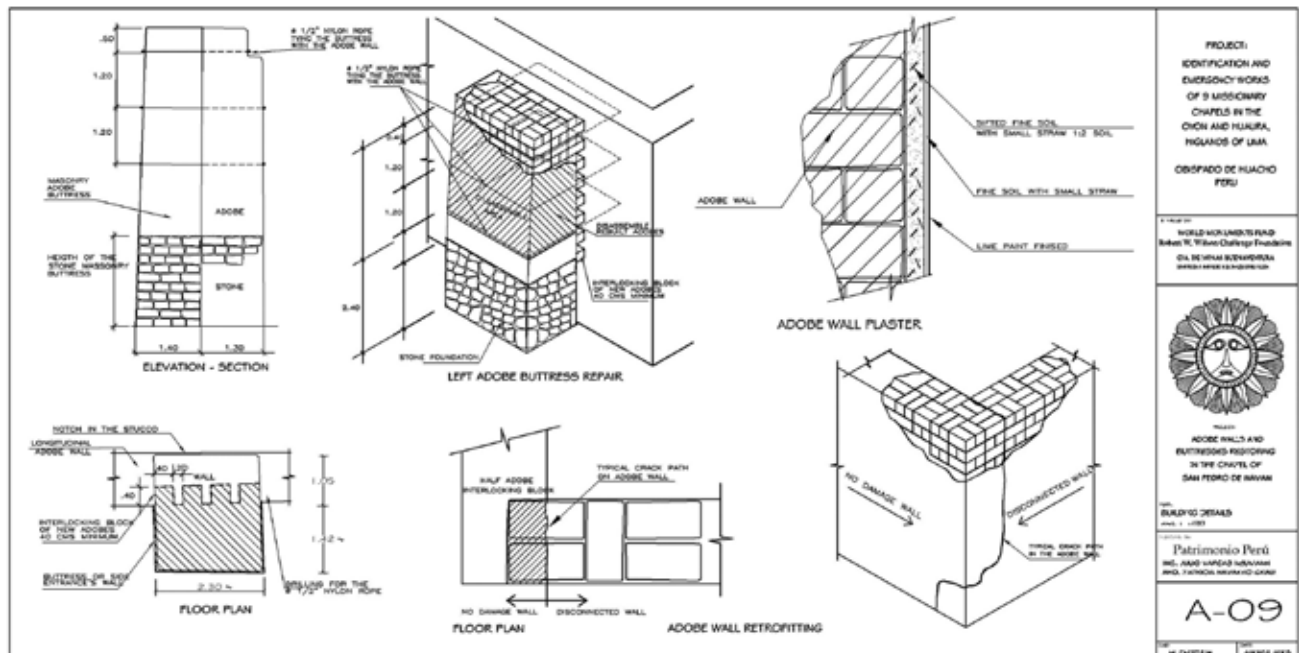
FIGURE 9 Retrofit design details, San Pedro de Navan.

The San Pedro de Navan Chapel was one of the most damaged and unstable chapels in the area. We designed several restoration details (fig. 9), relying on engineer Julio Vargas Neumann’s expertise. Additionally, with the help of the community’s people, we were able to work on the following tasks relating to crack repair:
