Evolving Methodology in Seismic Retrofit: Stabilizing the Las Flores Adobe

John M. Barrow, Douglas Porter, Stephen Farneth, and E. Leroy Tolles

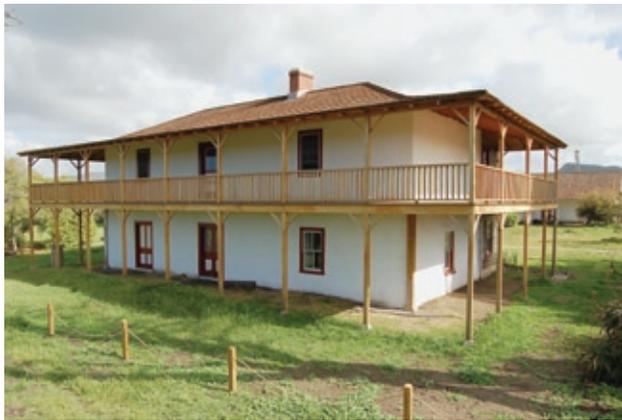
FIGURES 1A AND 1B The Las Flores complex with a ranch house (main house) consisting of the two-story Monterey block (a) and the Hacienda block, which is the long, low section connecting the Monterey block on the left and the carriage house on the right (b).
