*Report on the partial re-excavation
of the Laetoli hominid trackway, Site G*

February 2011

The Getty Conservation Institute

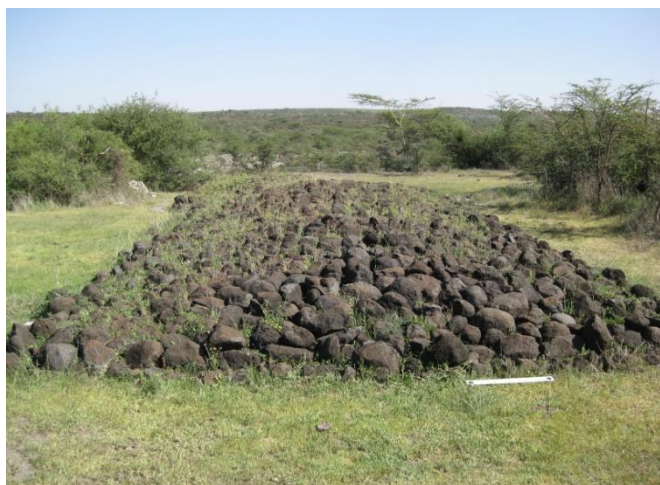
The reburial mound prior to removal of boulders

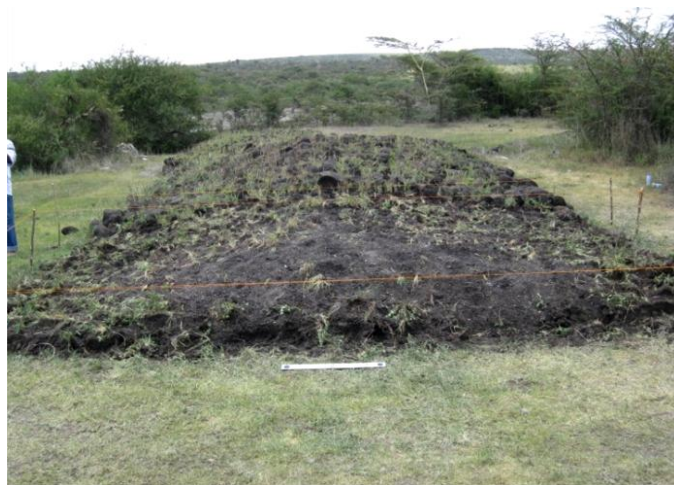
The reburial mound after removal of boulders from the southern 4 meters

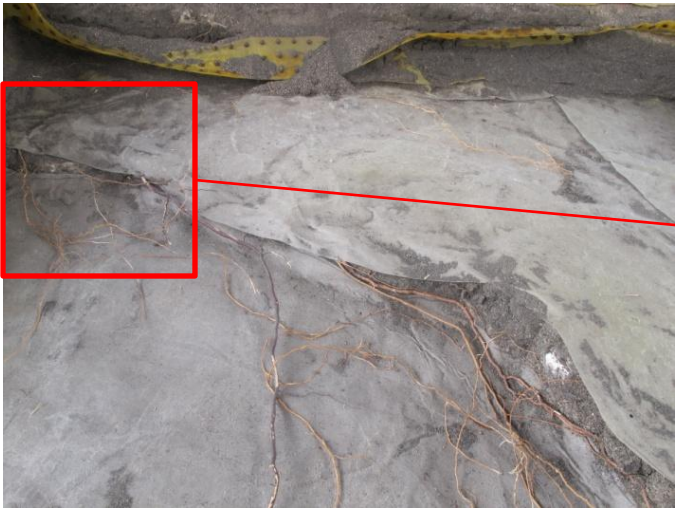
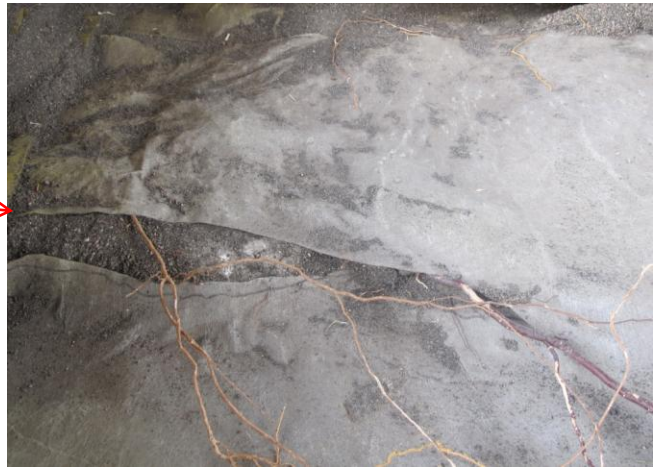
Roots running above geotextile along the Augite Biotite scarp. Roots found easy access below geotextile where 2 pieces of geotextile met at the top of the Augite Biotite scarp.

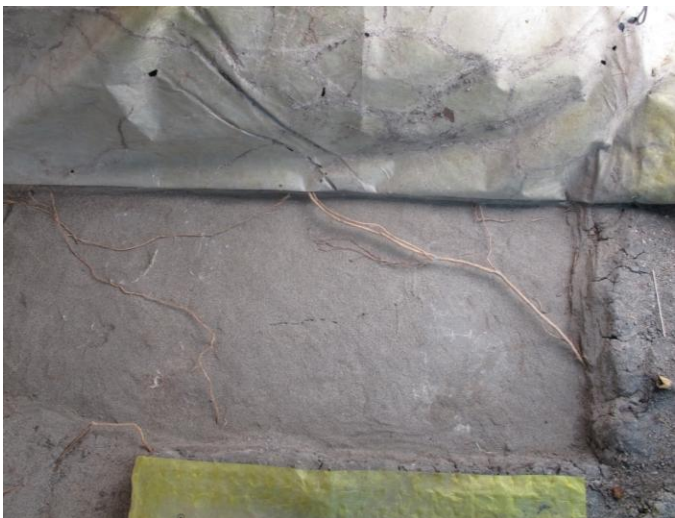
Geotextile pulled back to reveal Layer 1. Roots growing between geotextile and surface of Layer 1 emanate from east and south 1979 baulk.

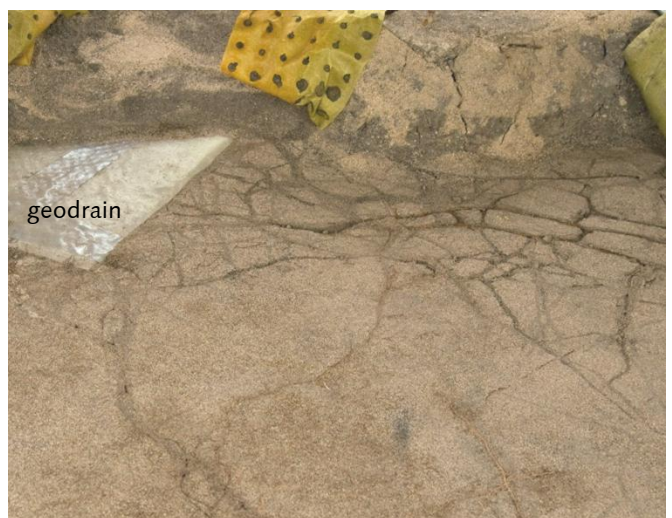
Impressions of dead roots in Layer 1 with evidence of termite activity in damp fill near the geodrain drain in the 1979 west trench.

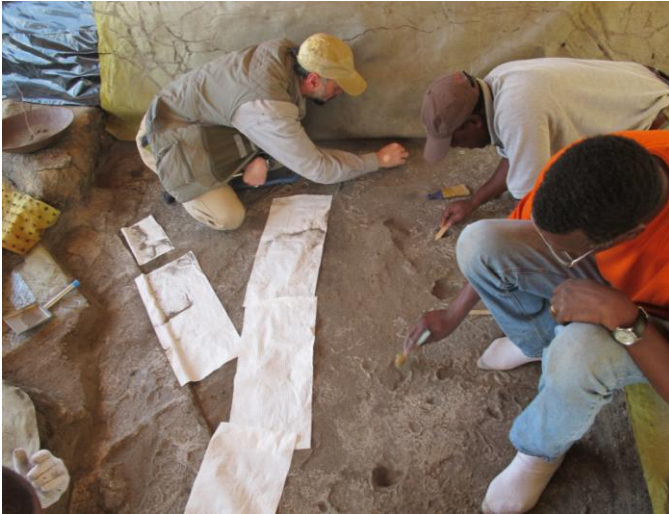
Removing Layer 1 from surface of tuff. Absorbent paper on prints and tuff that were subject to water infiltration from rain.

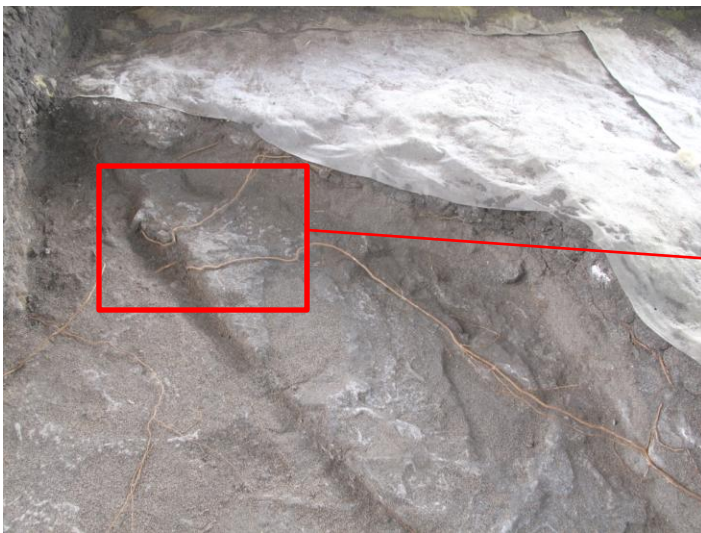
Roots penetrating tuff at edge of Fault 1. Root penetration in conjunction with excavation dislodged a piece of the tuff.

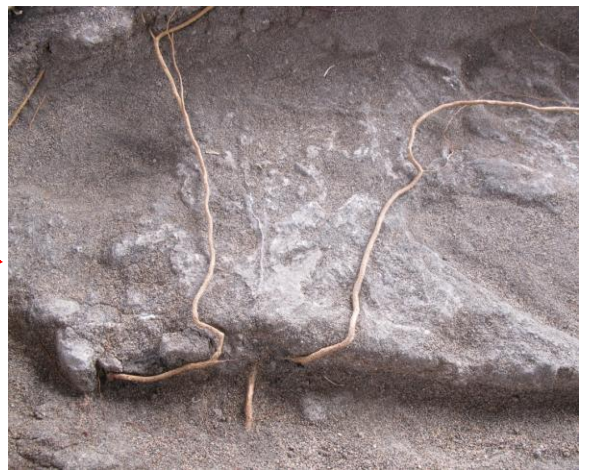
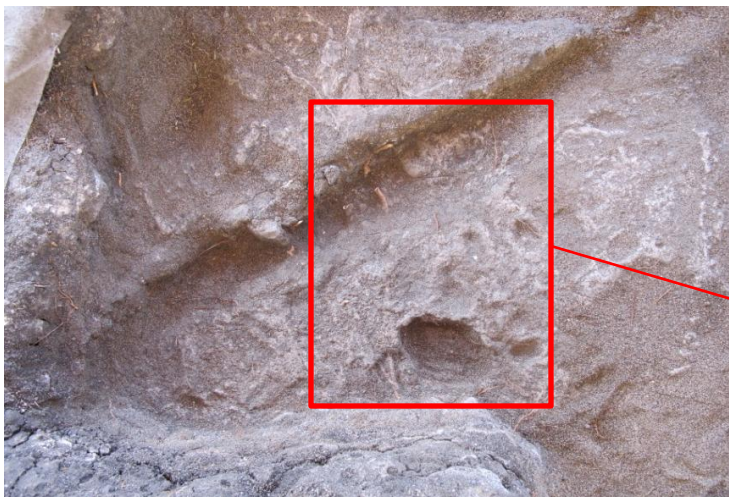
Roots at edge of Fault 1 after cutting; one can follow the root eastward (dashed line) into the unexcavated 1979 trench wall.

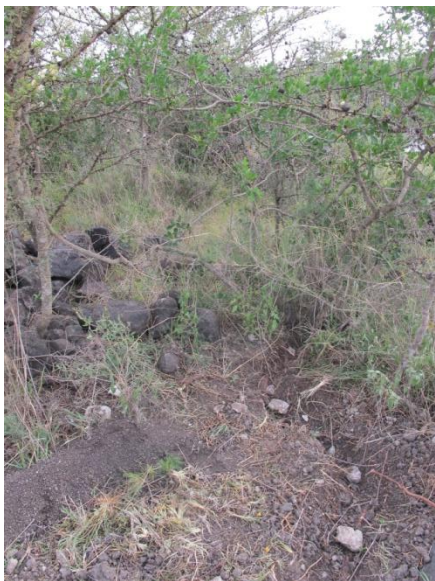
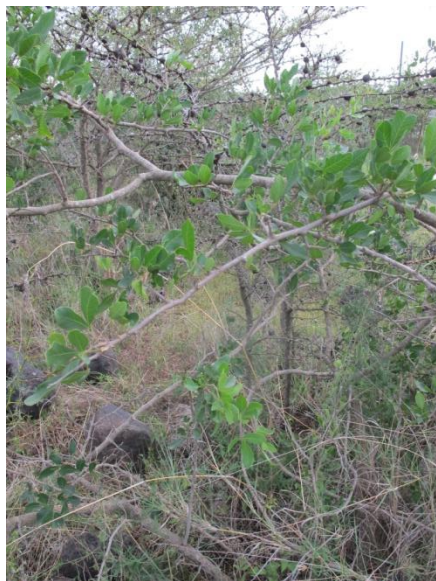
Unidentified tree (likely *Balanites sp.*), growing amidst *Acacia drepanolobium*, was responsible for the lateral roots that entered the mound from the east.

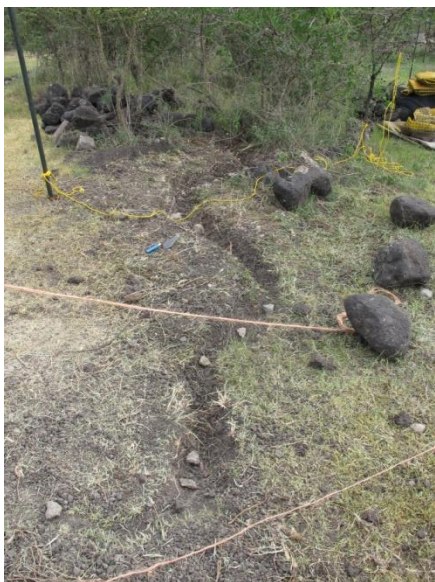
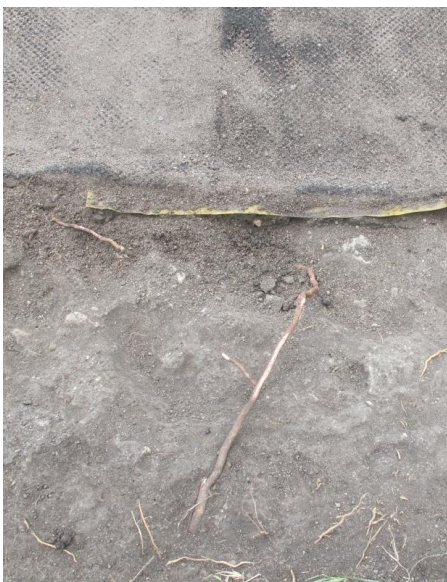
The main root from this tree was traced (far left) traveling 8.3 m to the edge of the trench where it can be seen penetrating unexcavated 1979 ground surface, near Biobarrier 2 (left), to emerge from the 1979 trench wall.

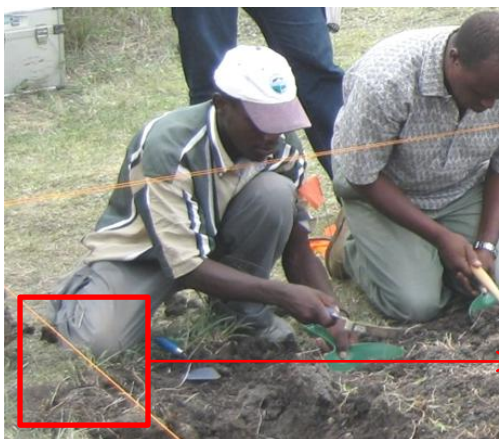
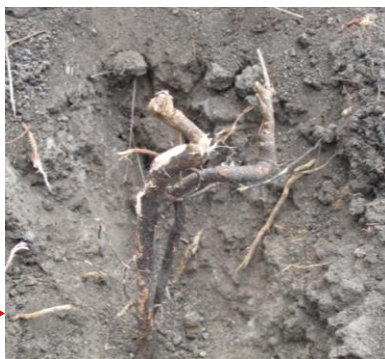
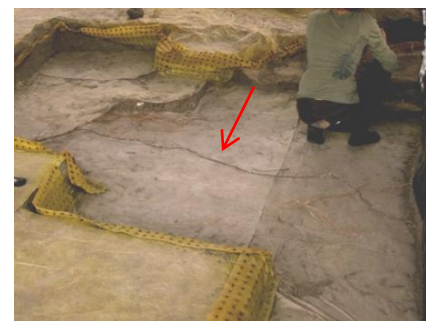
Live, unidentified tree stump (probably *Acacia drepanolobium*) in the SE corner of reburial mound (visible far left during removal of Layer 5). A root running N-S above the geotextile from the SE part of the trench (far right photo) may emanate from this cut tree stump.

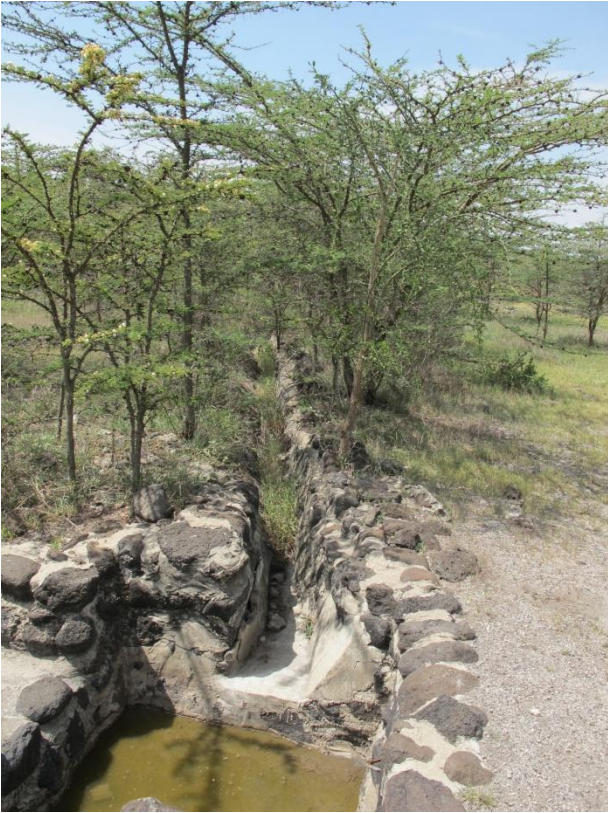
Extensive growth of acacia trees adjacent to drainage channel, which is clogged with vegetation. Catchment sump in foreground.

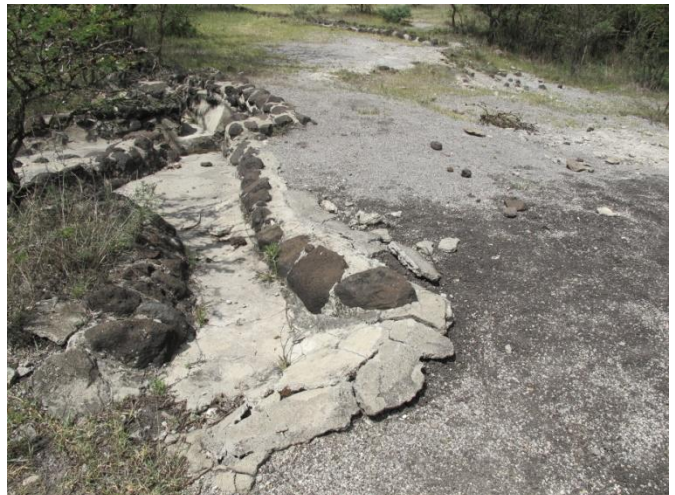
Cement inlet apron on east drainage channel is breaking up.

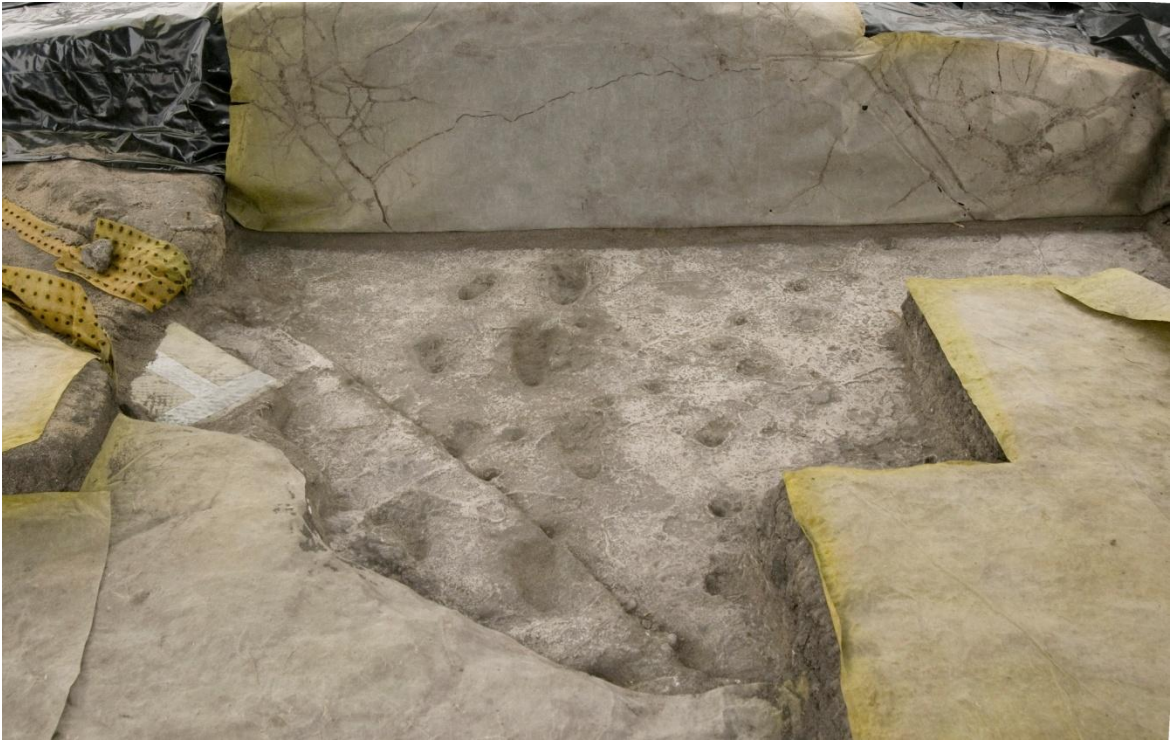
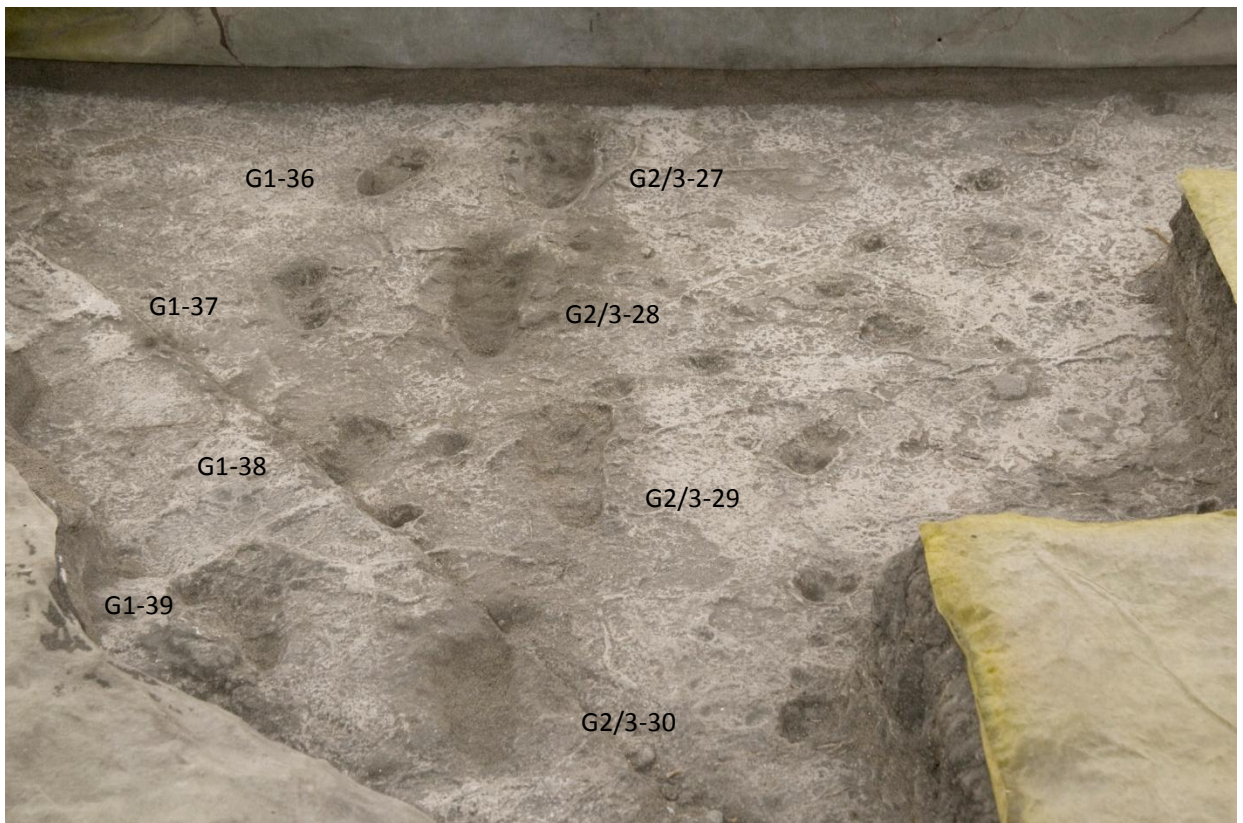
Embedding of sand particles and growth of hair roots in the Bedacryl layer (consolidant used on the prints in 1979) and the tuff obscured details on the floor of the prints. Bedacryl, noted as a problem in 1995, continues to be problematic. It darkens the prints and their immediate surround and has likely trapped moisture in the prints.

3.50 meter section of southern trackway after re-excitation in February 2011. Eight footprints and numerous hipparion prints were exposed. The prints were not cleaned to the same level as in 1995 due to lack of time required to remove adherent and embedded fine particles from the floor of the prints. Dark color in the prints and the 'halos' around them is due to Bedacryl applied in 1979. Geotextiles remain in situ on the unexcavated surfaces in photo.

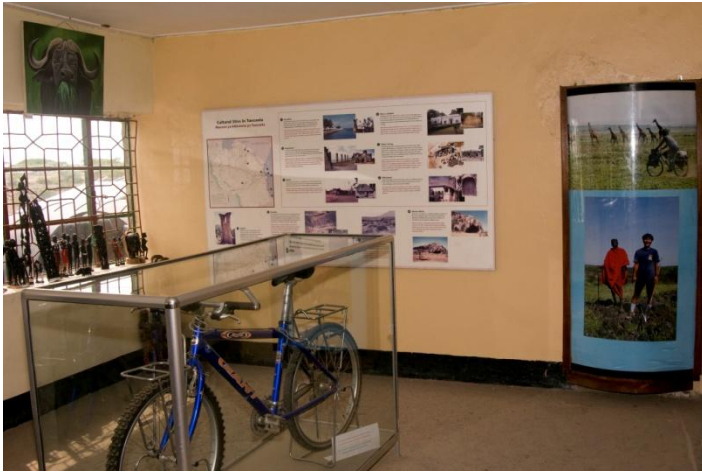
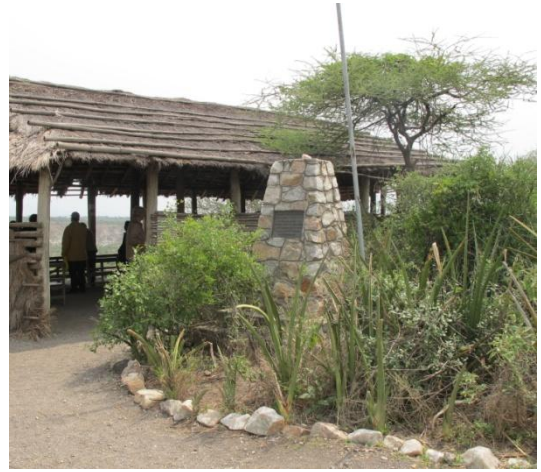
Irrelevant additions in the Orientation room at Olduvai (bicycle and 2 large panels) and 2m high stone memorials erected at the Olduvai Museum (right) and at the site of Laetoli by a Japanese cyclist undermine the integrity of the exhibit.

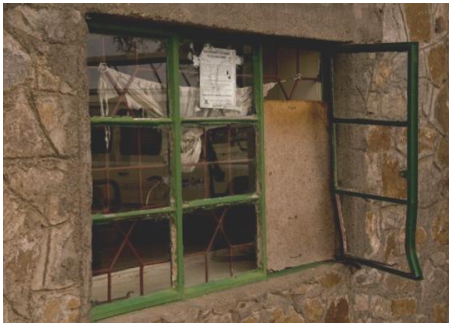
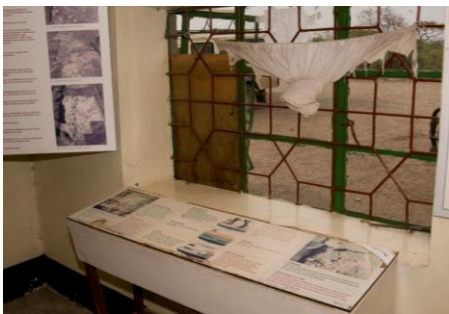
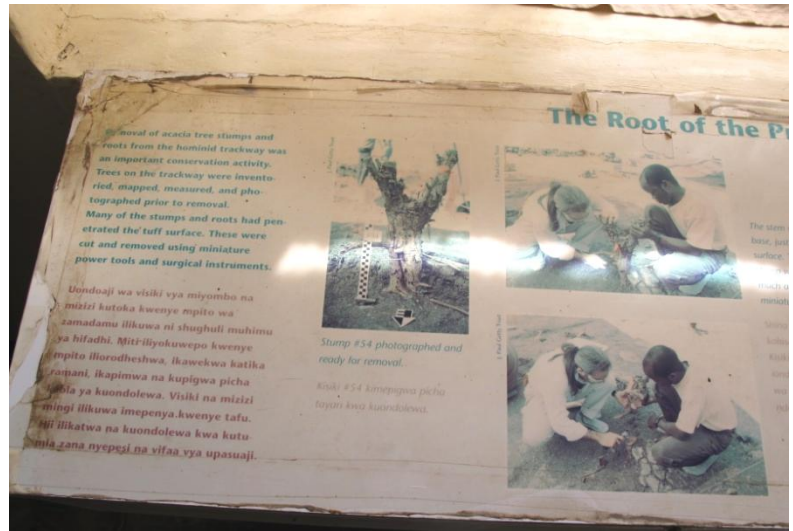
Windows and exterior gutters are broken allowing water to enter. This has damaged two panels.

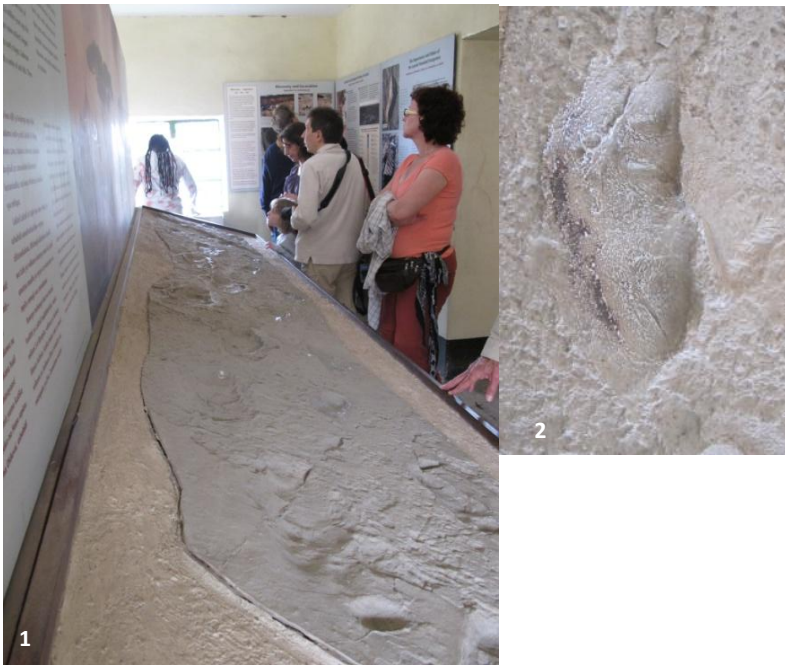
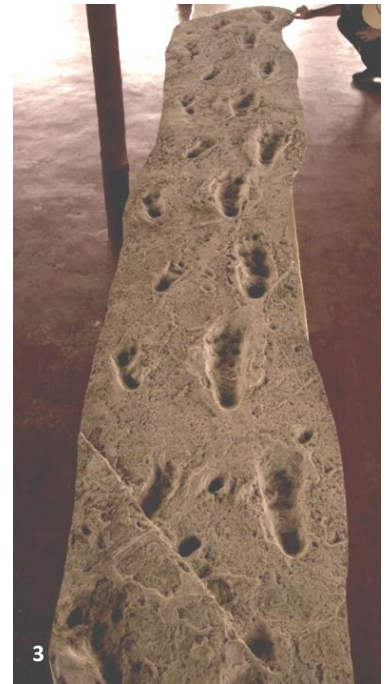
Replica cast of southern trackway in Olduvai exhibit (1). Touching of prints by visitors has deposited oils from hands and removed some of the patination (2). The impact of touching is mainly superficial; the cast could be cleaned and repatinated. The master epoxy cast made in 1995 (3), which is now the only replicable cast of the trackway as excavated in 1979, was transported from its permanent storage in Dar es Salaam to the temporary exhibit hall at the Laetoli site in 2009.

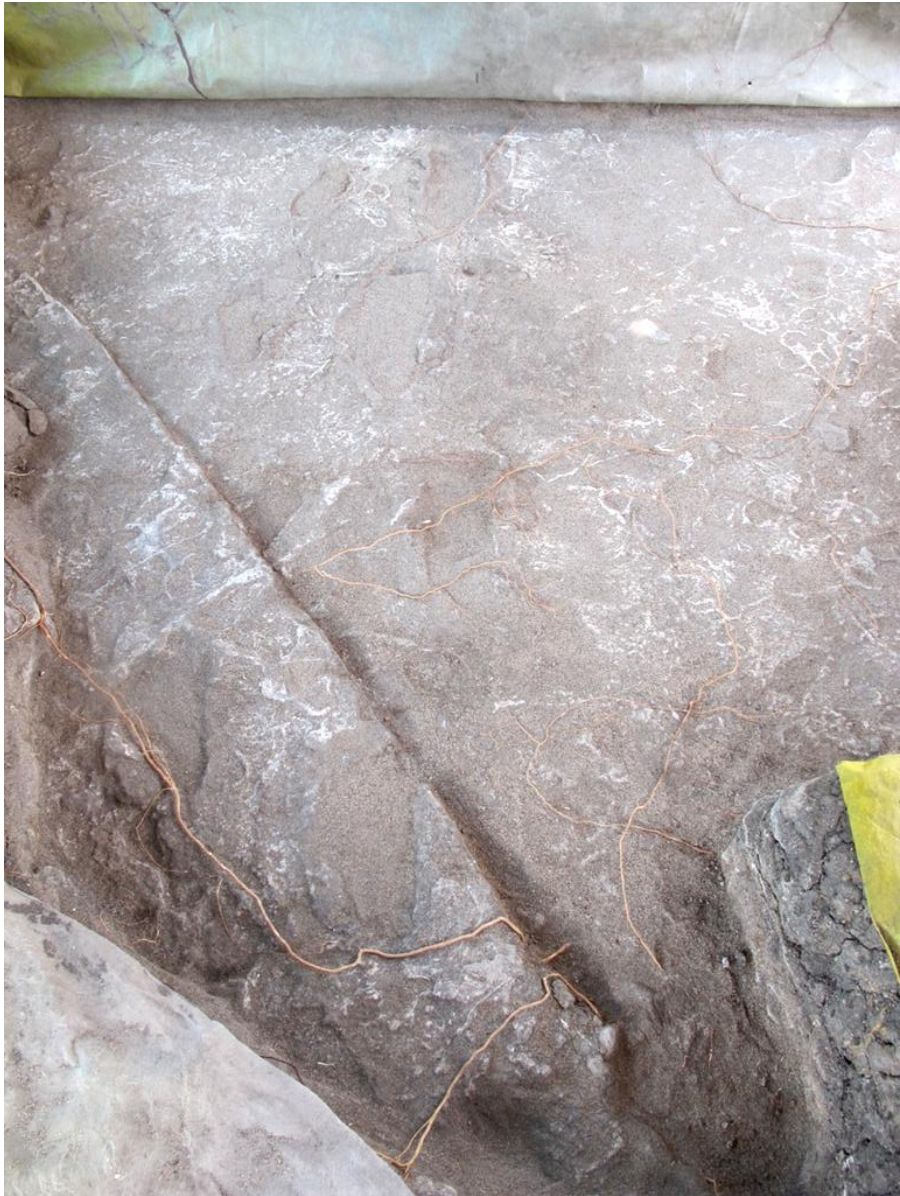
Detached/loose tuff: A small piece of tuff on the edge of Fault 1 was detached from root penetration.

Trackway before final cleaning of tuff surface and with fill still in prints. Roots growing in Layer 1 are visible on the surface and penetrating tuff at the edge of Fault 1.

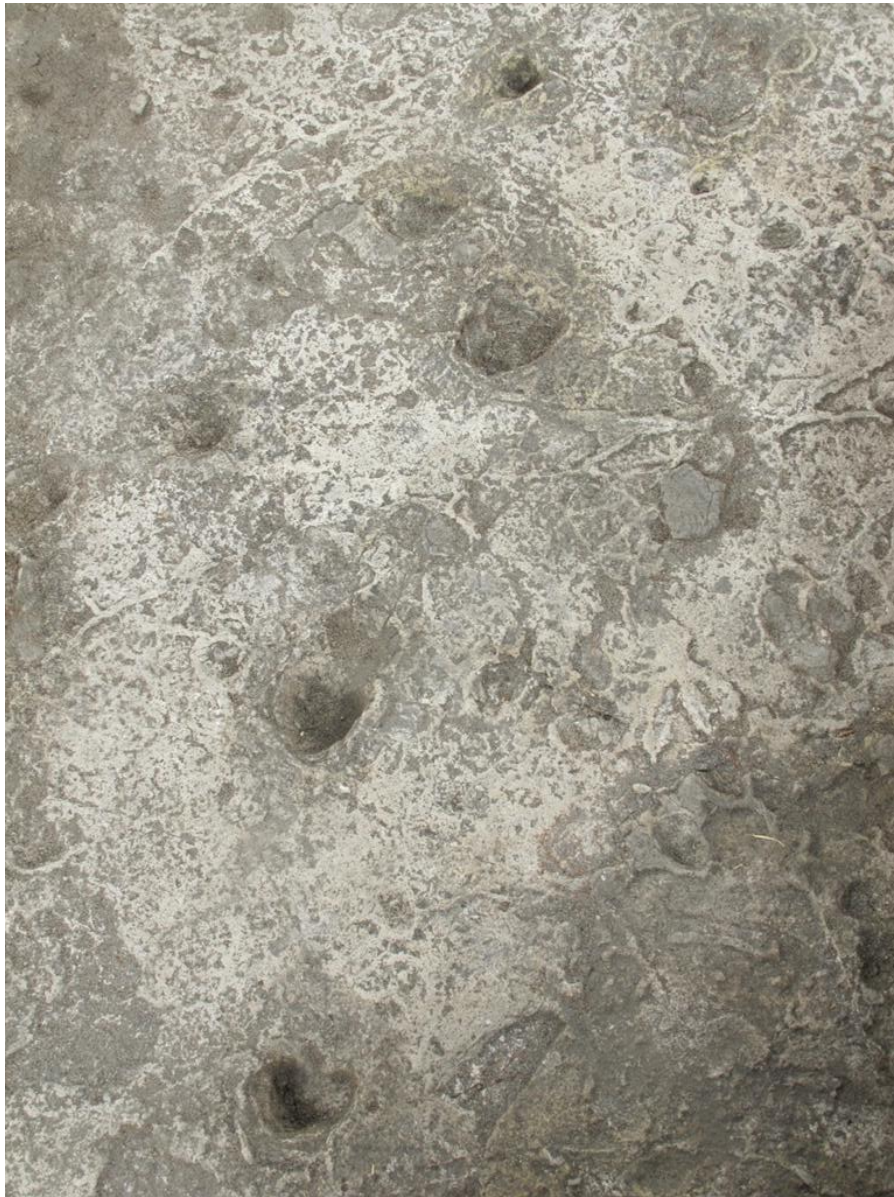
As in 1995, in 2011 Bedacryl was distinctly visible as darkening and yellowing of the tuff. Yellowing is most obvious where Bedacryl extends beyond margins of prints (hominid and hipparion) creating the halo effect. In three of the 2011 re-excavated prints Bedacryl was noted in 1995 as having been thickly applied (G1-37, G2/3-27, G2/3-29). In all re-excavated prints deterioration (cracking, blistering or loss) of the Bedacryl was recorded in 1995. In 2011 the prints were not sufficiently cleaned to determine if the Bedacryl layer was further deteriorating. It is also probable that it may be trapping moisture thus promoting natural chemical processes of weathering of the tuff and encouraging penetration of root hairs attracted to the moisture.

Footprint Tuff with hipparion prints, east of hominid trail.
Bedacryl darkening and halo around hipparion prints is visible.

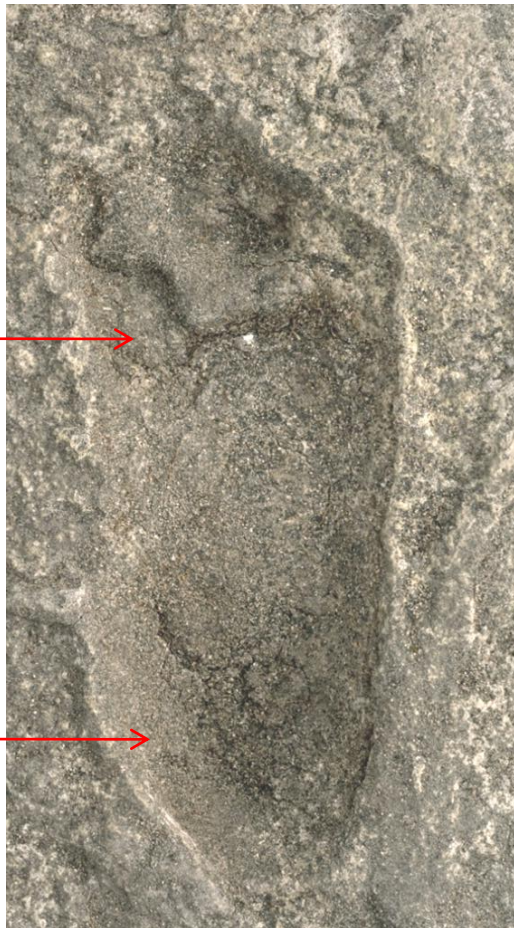
Cracking along fossil burrows

Cracking in heel of print

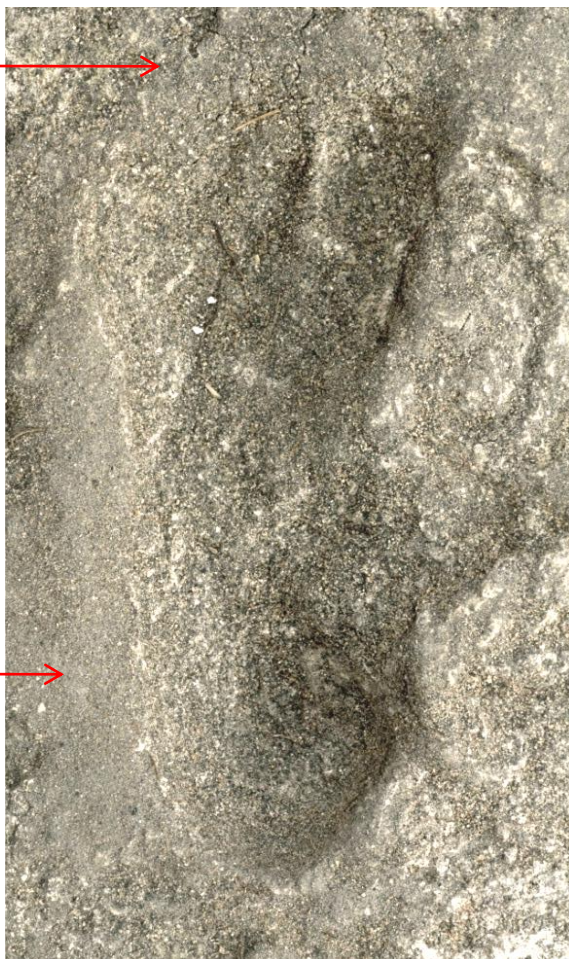
Cracking
outside lateral
margin

Adhered fines
outside
posterior
margin

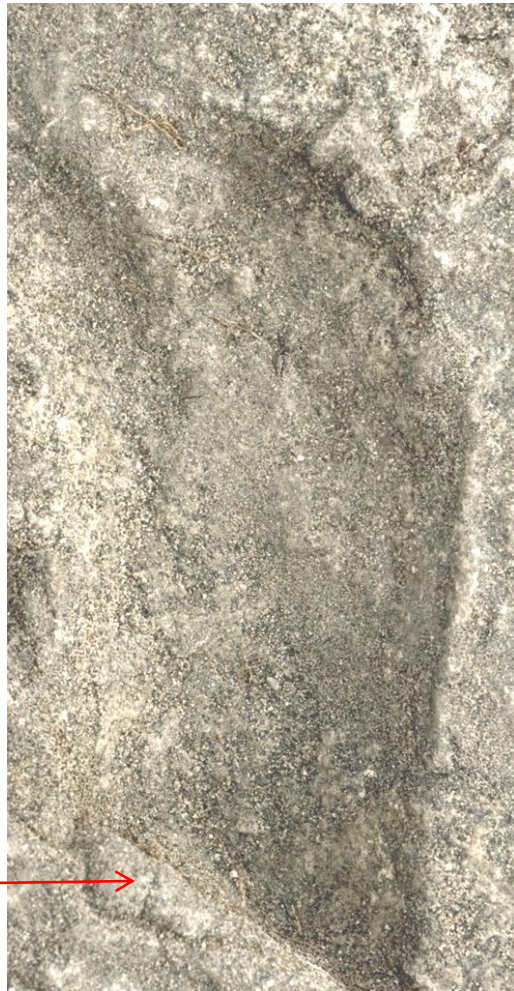
Crack on fault

1995 Condition**General condition:** Minor alteration/Good. [Minor alteration/Good]**Tuff Conditions:****Weathering:** Slight weathering of tuff at the point where the fault intersected the print.**Cracking:** Fine surficial cracks at the fault intersection (not visible in photograph). [Slightly raised tuff at fault line has a new crack perpendicular to the fault line]**Losses:** Minor abrasion of tuff surface outside posterior print margin; appears to be an old loss.**Detached/loose tuff:** none**Powdering:** none**Other:** none**Conditions related to 1978-79 [1995] Interventions:****Bedacryl:** Bedacryl covered the print and surrounding tuff surface. Patches of deteriorated Bedacryl on floor of print. [Bedacryl visible as darkening on floor of print and yellow halo around print.]**Embedding:** Severe embedding of fine particles in the area of weathered tuff and along medial margin; slight embedding on the remainder of the print surface. [Minor embedding and adherence of sand grains on floor of print and outside lateral margin]**Silicone:** Traces of silicone outside print margin.**Excavation tool marks:** Tool marks visible outside medial margin near fault line.**Inventory number on tuff:** 1979 label ("1-38") visible on tuff surface. [Number visible]**Other:** none**Root damage:** Root penetrated the wall of the fault where it intersected the print, but did not go directly into the floor of print. Rootlets on surface of print. [A few rootlets in anterior part penetrating tuff and cracks]**Insect activity:** none**1995 [2011] Interventions****Consolidation/stabilization:** none**Fills:** none**Reattachment:** none**Root treatment:** Surface roots removed. [Fine rootlets and hair roots penetrating Bedacryl layer or tuff not removed]**Other:** none**Comparison with 1978-79 Cast/Photograph**Comparison with the 1979 cast and photos showed distinct loss of resolution of features on the print surface due to Bedacryl and embedding of fine particles covering the surface of the print. Tool marks visible in the cast on the floor of the print were obscured *in situ*.**Notes**

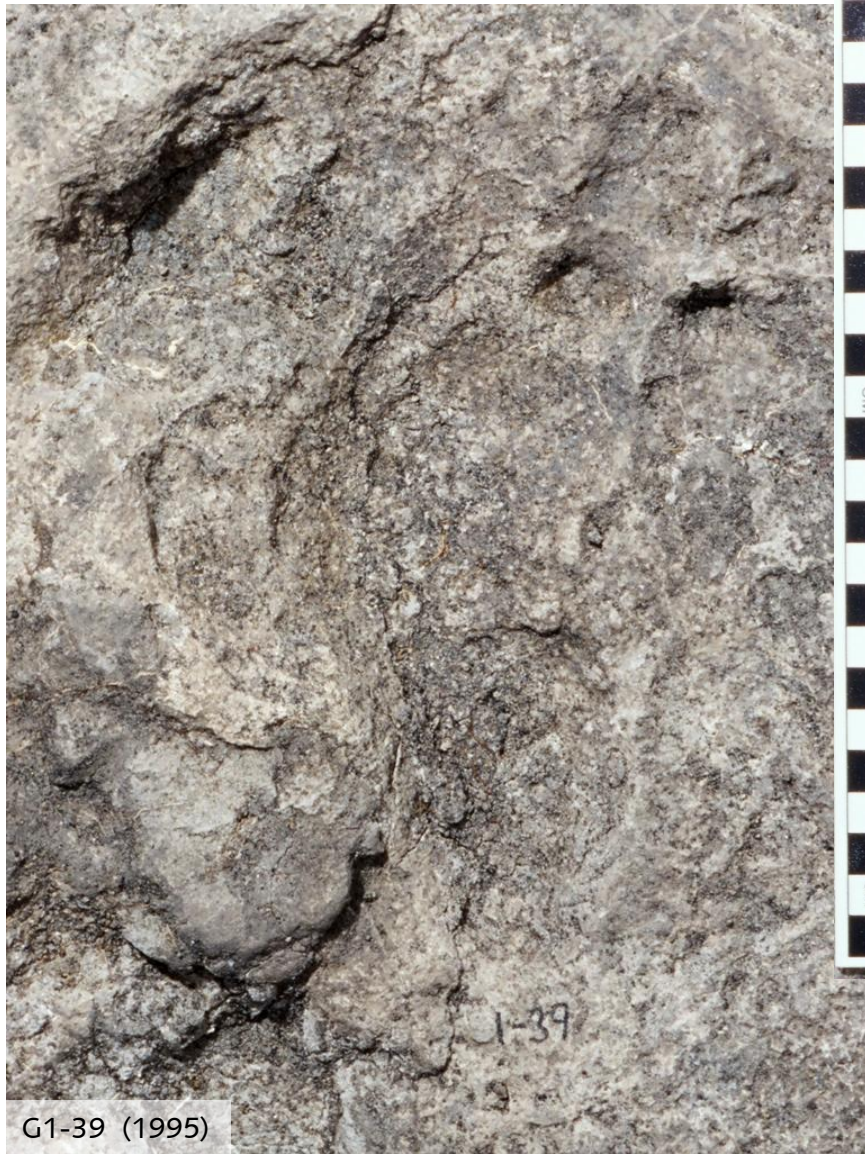
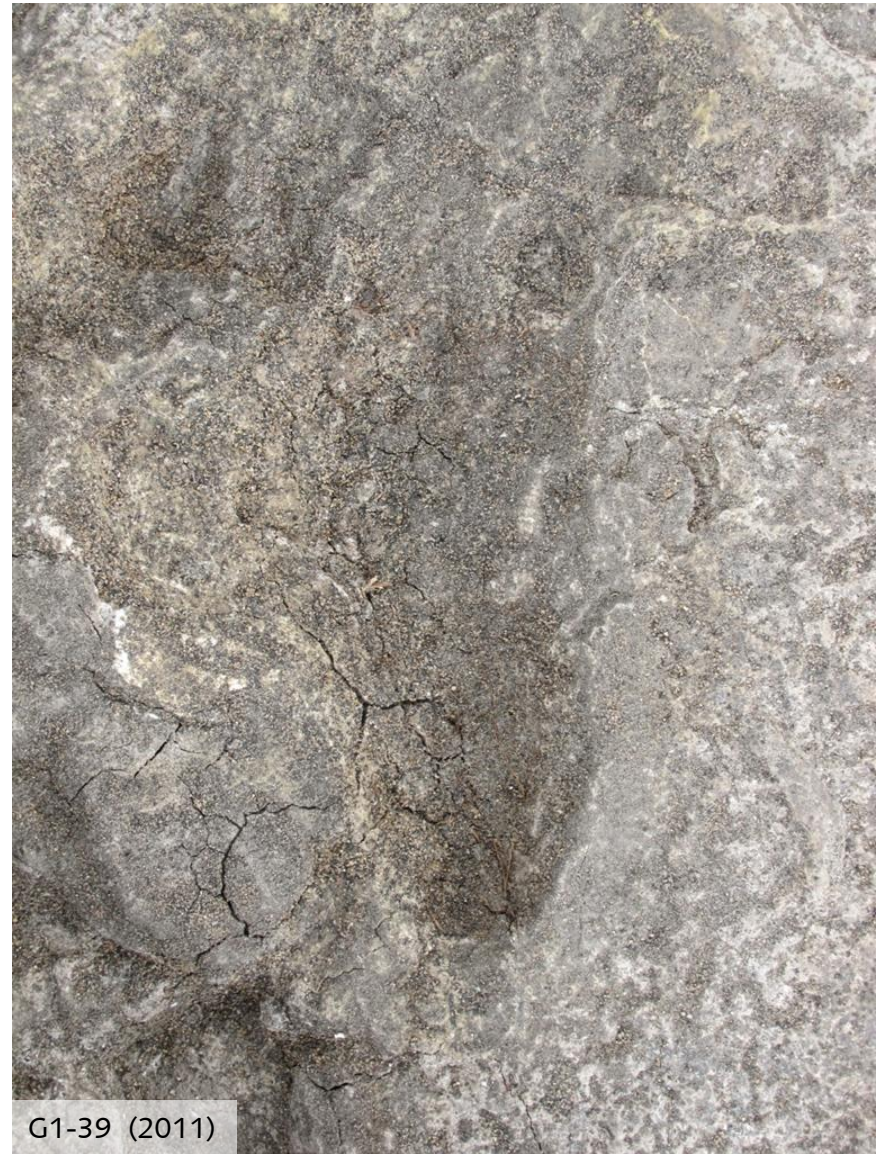
Comparative photos of G1-39 in 1995 and 2011

Weathering/cracking: Distinct areas of cracking were evident in and around prints, especially outside the margin of print G1-39. The areas of cracking correspond to incipient cracking and/or

<p>1995 Condition General condition: Minor alteration/Good. [Moderate alteration/Fair]</p> <p>Tuff Conditions: Weathering: Slight weathering of the tuff along the lateral margin of print. Cracking: none. [Incipient cracking visible on the island of tuff west of the heel in 1995 has widened and cracks have propagated. Cracking in the heel and lateral margin of the print occur principally in the same area where weathering and cracking of Bedacryl layer were noted in 1995. Cracks were free of sand grains indicating opening occurred as a result of drying from re-excavation.] Losses: Minor loss of tuff outside margin of great toe and lateral margin of print. Detached/loose: none Powdering: none Other:</p> <p>Condition Related to 1978-79 [1995] Interventions: Bedacryl: Bedacryl covered the surface of the print and surrounding tuff. It was slightly deteriorated along the lateral print margin with numerous hairline cracks in Bedacryl layer, and outside the anterior margin. [Bedacryl visible as darkening on floor of print and distinct yellow halo around print] Embedding: Slight embedding noted in Bedacryl layer (not shown on graphic). [Moderate embedding and adhered sand grains] Silicone: Minor traces of silicone outside print margins. Excavation tool marks: none Inventory number on tuff: 1979 label ("1-39") visible on tuff surface. [Number partially visible] Other:</p> <p>Root damage: Rootlets, less than 1mm diameter, weaved in and out of the Bedacryl layer and a few penetrated the tuff along the lateral side, forming a root mat in the lateral heel portion. [Rootlets and hair roots penetrated tuff and cracks in heel and arch area]</p> <p>Insect activity: none</p>

Close-up of the heel of G1-39 in 1995 and 2011. Incipient cracking on raised island of tuff and weathering along lateral margin and floor of heel, visible in 1995 and 1979 photos, increased and propagated on re-excavation and drying in 2011.

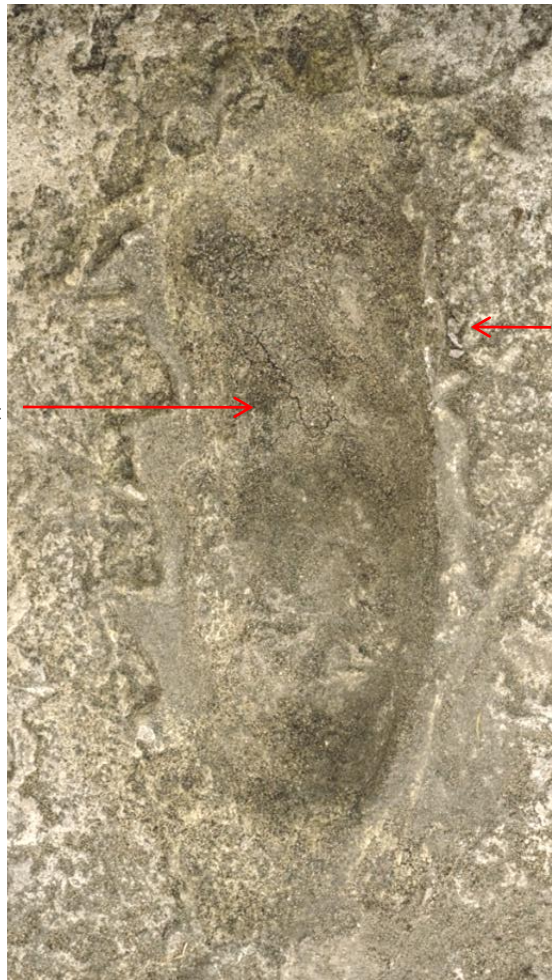
Mechanical damage: The 2011 re-excavation resulted in mechanical damage from excavation to the fossil termite burrow on print G2/3-27.

Cracking in anterior part of print

Mechanical damage

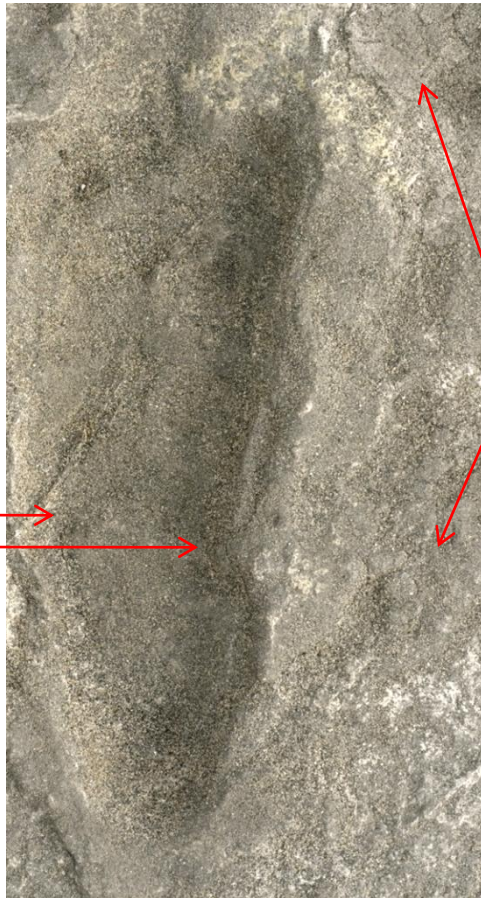
Incipient cracking on margins

Cracking on tuff surface

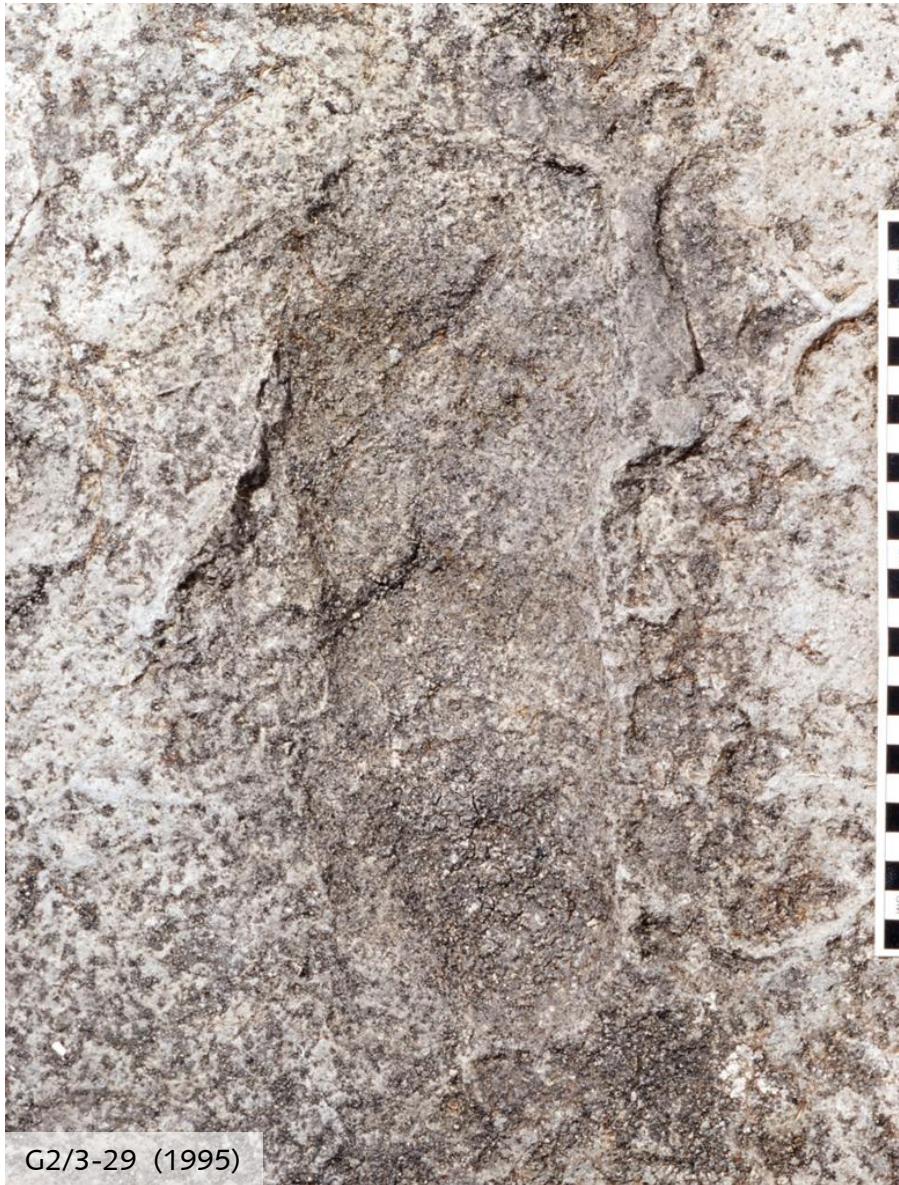
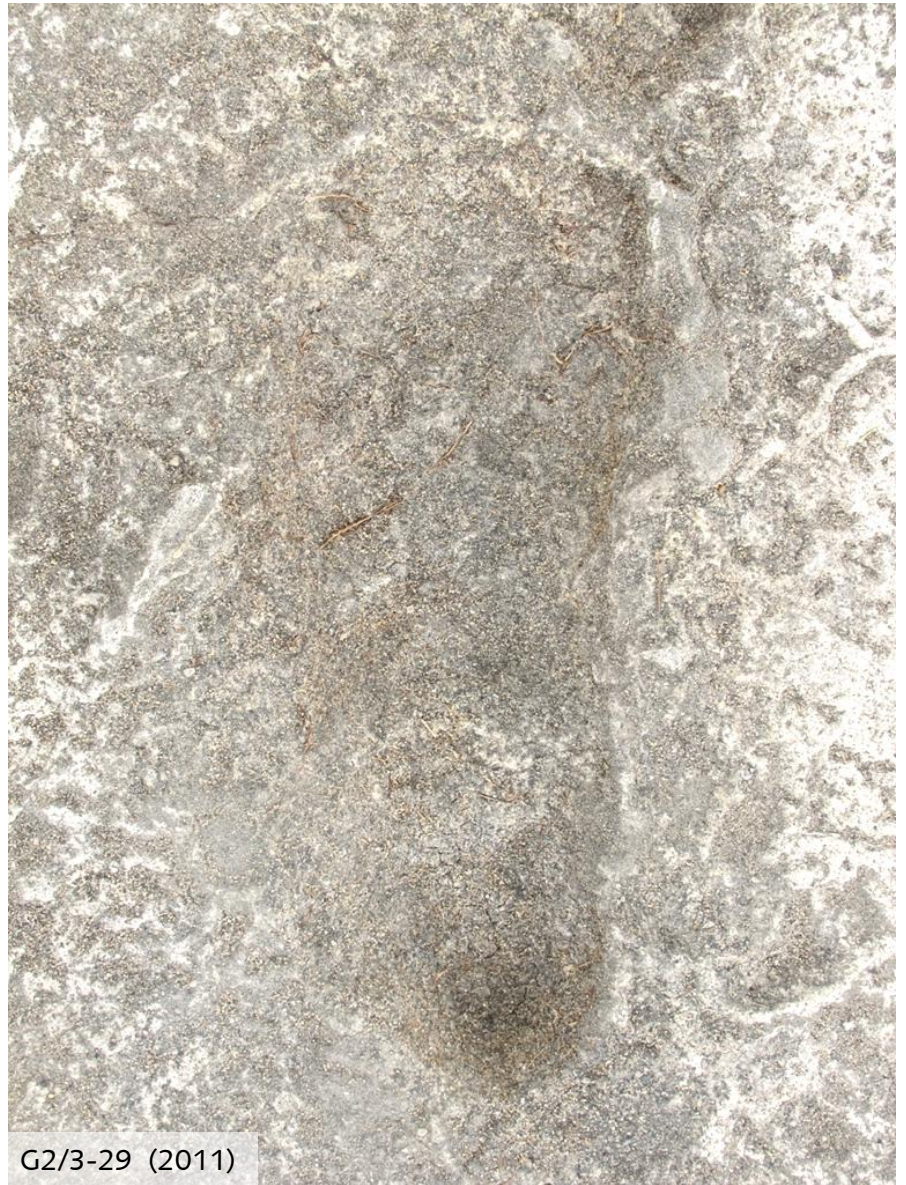
Comparative photos of G2/3-29 in 1995 and 2011

Root damage: Numerous rootlets on surface only. [Hair roots penetrate tuff and/or Bedacryl layer on floor of print. One rootlet runs across anterior portion of print weaving in and out of tuff]
Insect activity: none
1996 Interventions Consolidation/stabilization: none Fills: none Reattachment: Loose fragment of tuff outside anterior margin reattached with Paraloid B-72 [®] Root treatment: Surface rootlets removed. [Penetrating hair roots were not removed] Other: none
Comparison with 1978-79 Cast/Photograph Comparison with 1979 cast and photos showed loss of resolution on floor of the prints. Fine features, including tool marks clearly evident in the posterior portion of the cast, were obscured due to the thick layer of Bedacryl and fine particles of overburden embedded in the coating. Although consistently applied to all the well-preserved 1979 prints, no inventory number was visible <i>in situ</i> , nor could it be ascertained on the available photos.

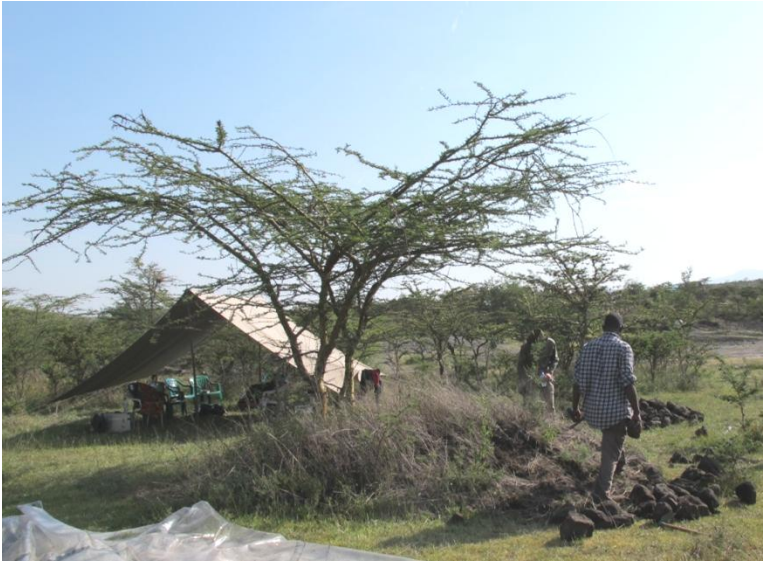
The buried monitoring trench as it appeared before re-excitation in 2011. The *Acacia seyal* had grown far larger than the other *Acacia drepanolobium* around the trench.

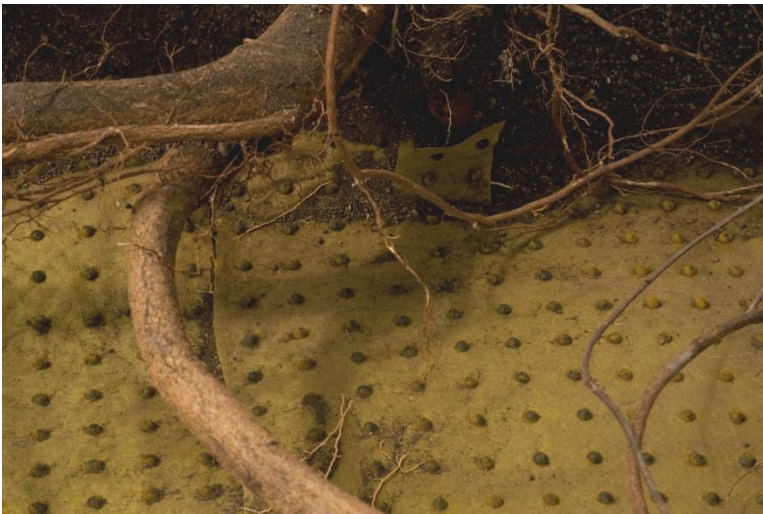
Roots of the *Acacia seyal* are seen growing and spreading just above the Biobarrier, avoiding contact with it.

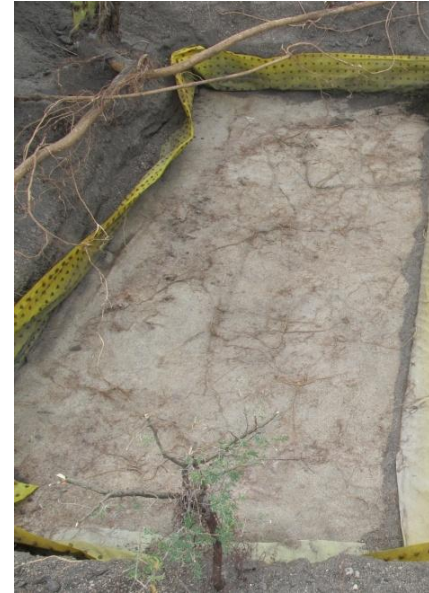
As in the trackway reburial, roots are entering the trench laterally through gaps and tend to follow the surface of the geotextile, as seen here.
