*Report on the partial re-excavation
of the Laetoli hominid trackway, Site G*

February 2011

The Getty Conservation Institute

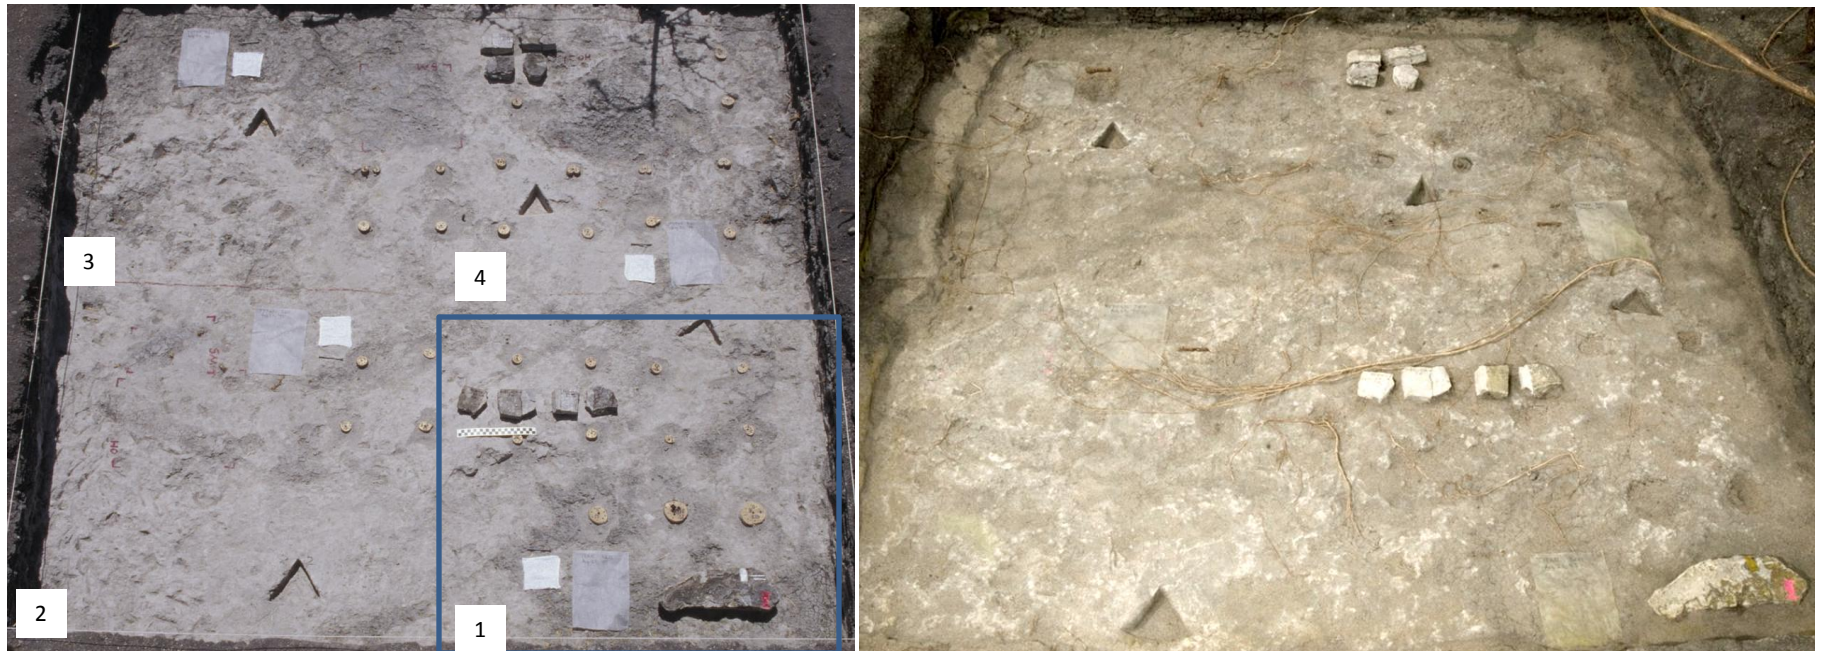
The floor of the trench showed reticulated cracking. This had been noted already in 1995 and again in 1997, and ascribed to drying out of the clay-rich tuff upon (re-)excavation. In the area excavated in 1997 cracking was more pronounced in 2011; as seen on the trackway itself, incipient cracking or weathering in 1995 increased or had propagated. The network of cracks could be seen most clearly on removal of the pieces of geotextile that had been laid on the floor. Around the geotextile, cracks were essentially invisible because of infilling with the first layer.

Monitoring trench floor with objects as laid out in 1995 (left) and as re-excavated in 2011 (right). Quadrant 1 (in box left) was excavated in 1997.

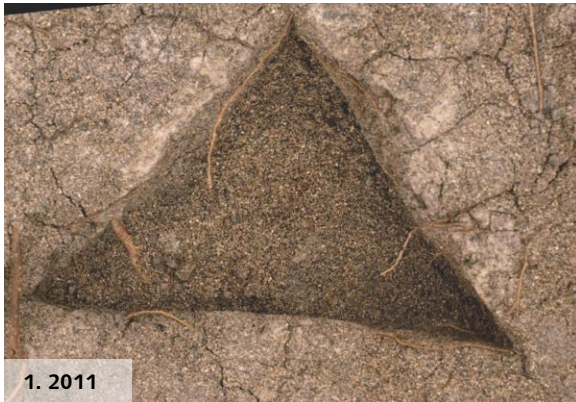
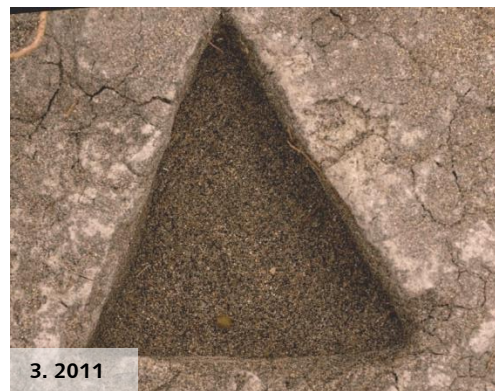
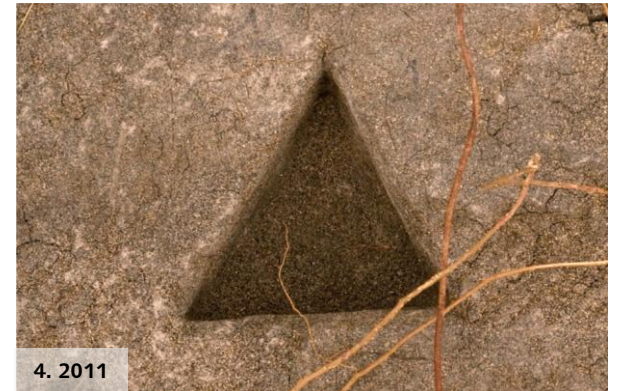
Monitoring triangles 1,3 and 4. Cracking of tuff has increased since 1995. The form, edges and score marks are little changed but obscured by embedding.
