# Seismic Retrofitting Project Modeling of Prototype Buildings

## Research Report

Paulo B. Lourenço, Federica Greco,  
Alberto Barontini, Maria Pia Ciocci,  
and Giorgos Karanikoloudis

THE GETTY CONSERVATION INSTITUTE  
LOS ANGELES  
TECMINHO – UNIVERSITY OF MINHO  
GUIMARÃES, PORTUGAL

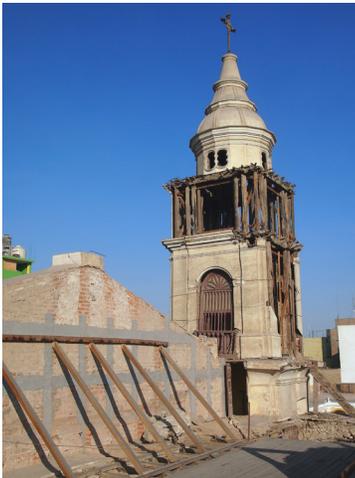
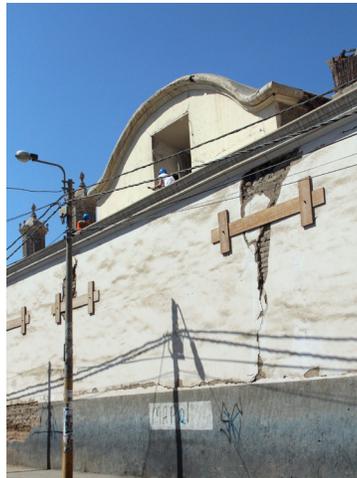
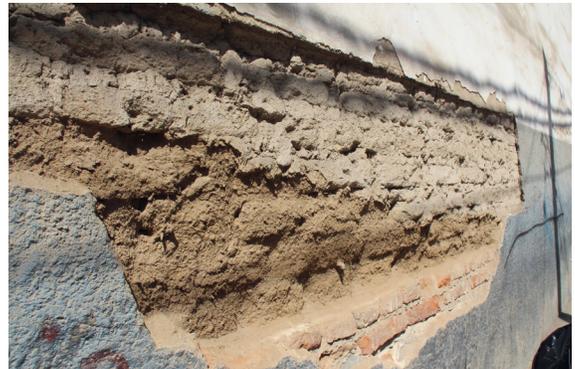
**FIGURES 2.9A–C.**  
Photos of the masonry envelope of the cathedral, showing (a) southern bell tower; (b) northern lateral wall; (c) detail of the northern lateral wall, showing the different masonries.

Both lateral walls are constructed of adobe masonry, with a slenderness ratio of approximately 3.35 (see fig. 2.9b). The northern lateral wall, which faces the street, rests over a 0.90-m-high fired-brick masonry base course on top of a 0.40 m rubble stone masonry wall (see fig. 2.9c). The height of the base course in the southern lateral wall is 0.60 m, while the rubble stone wall is 0.48 m deep. A series of adobe piers, connected to the lateral walls by fired-brick connections, supports the beams of the internal timber structure (Cancino and Lardinois 2012).

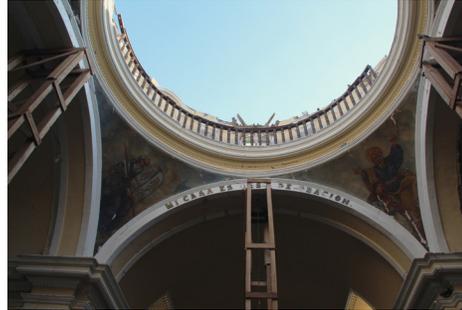
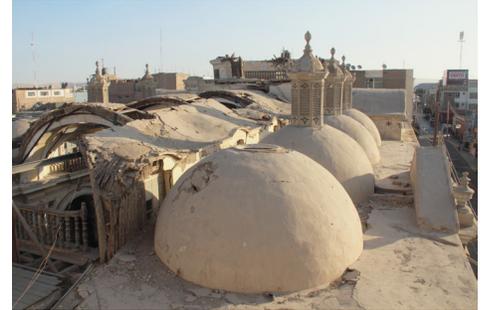
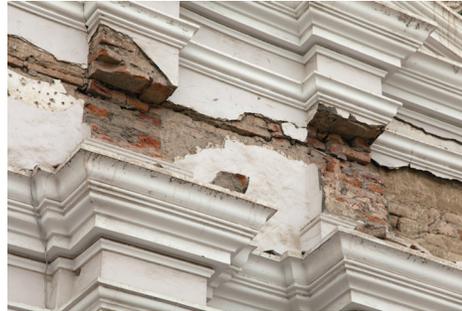
**FIGURES 2.13A–D.**

Historically, the Ica Cathedral has suffered heavy damage, mainly due to the large number of earthquakes that have affected this area. Partial collapses from the 2007 Pisco earthquake (fig. 2.12), which were later aggravated by another seismic event in 2009, have led to the cathedral not being currently in use. Collapses of the interior timber frame of the cathedral are mostly in the roof structure, namely the central dome, the barrel vaults covering the main nave, and the roof over one of the bays near the southern aisle (figs. 2.13a–d). In addition, extensive cracking, displacements, loss of connection between structural members, and other damages are observed throughout the interior and the roof structure. A rocking mechanism of the pillars was observed during the 2007 Pisco earthquake with loss

Photos of the current damage to the cathedral, showing (a) collapse of the central dome; (b) partial collapses of the roofing system; (c) cracks separating the pediment from the lower part (photo: Scott S. Warren for the GCI, 2011); (d) horizontal and vertical cracks in the northern wall.

of connection between the pillars and their base, and between the pillars and the timber structure above. However, failure of the beams at the top of the lunettes is thought to be the main reason for the collapse of the roofing system (Cancino and Lardinois 2012).

Cracking, loss of connection, and out-of-plane deformations can be observed also in the masonry envelope, particularly in the main facade and the northern wall. The main facade is characterized by horizontal cracks between the pediment and the lower part (see fig. 2.13c). Extensive damage is present also at the connection of the bell towers with the front facade and lateral walls. The northern lateral wall presents horizontal cracks at the interface of the different types of masonry, as well as vertical cracks at the connection with the internal timber structure (see fig. 2.13d) (Cancino and Lardinois 2012).

observed in situ (see chapter 2, figs. 2.12, 2.13a–d). In addition, separation cracks are seen between the lateral wall and the chapel at the northwestern corner of the building.

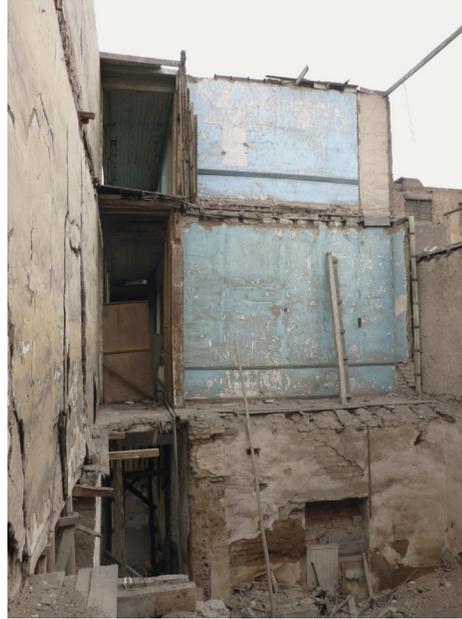
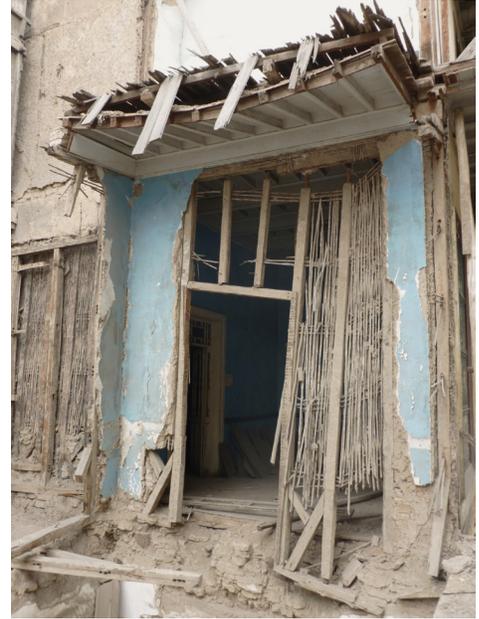
**FIGURES 2.23A, 2.23B.**  
 Photos showing collapsed area in Hotel El Comercio: (a) northwest view; (b) southeast view.

The lack of maintenance led to localized damage in the quincha panels, including cracks, plaster detachment, and exposure of the internal wood structure to deterioration. The section between the two patios, adjacent to the two-story *casona*, has collapsed (figs. 2.23a, 2.23b; see fig. 2.21). Humidity due to improperly installed plumbing or improper site drainage was likely the cause of localized damage in the adobe.
