# 建筑 and 建筑构件 状况评估

## Condition Assessment of Architecture and Architectural Elements

### HUICHENG HALL: CONDITION ASSESSMENT

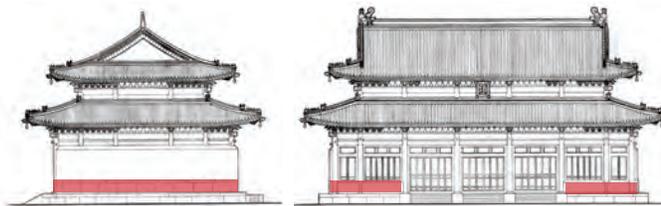
会乘殿，北槛墙，内部，盐霜  
Huicheng Hall, N Sill wall, Interior Efflorescence

The interior surface of the sill wall is largely occluded by built-in wooden sutra shelves. However, the visible N wall has extensive efflorescence, apparently matching exterior areas of salt-related damage.

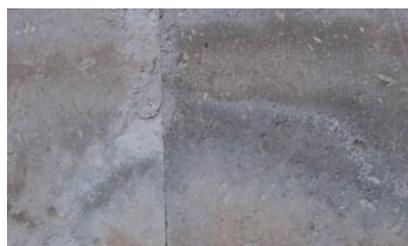
会乘殿，北立面，槛墙，盐霜  
Huicheng Hall, N Facade, sill wall Efflorescence

The sill wall suffers predominantly from basal erosion, staining, and surface deposits (e.g. paint, bird droppings). Vertical joints are frequently open on all facades, allowing for the entrance of moisture into the building fabric. Salt-fretting and resulting surface loss is widespread on the N facade, and present to a far lesser degree on the exterior S wall. S and W facades have areas of parallel hairline crack propagation. Cement interventions are also present in small areas around the building. Localized partial loss, usually at corners or edges of stone blocks, is also present, but not a major concern.

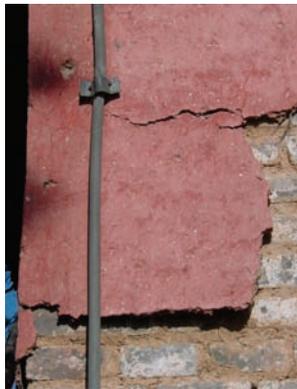
会乘殿，西立面，抹灰缺失、空鼓、开裂  
Huicheng Hall, W Facade  
Stucco loss, detachment, and cracking

Red-colored stucco, composed of two independent layers, has been applied as a coating to the brick masonry. General conditions present throughout the stucco include cracking, mechanical damage (gouging), incised graffiti, staining and surface deposits. Large areas of detachment and adjacent loss are present on the W facade, which is the worst area and in need of stabilization to avoid further loss. The E facade exhibits long vertical cracks emanating downward from one column head, related to column movement further explained in the structural assessment. Small holes of 0.5cm to 1cm in diameter can be seen on all facades and have been determined to be caused by small pellets used as projectiles, still present within the holes in many cases. Insects have moved into many of these holes and contribute to surface deposits (e.g. spider webs) in some cases. Differential staining from water runoff and windborne dust/dirt collection is apparent in a dull and dirty surface along the upper 1m of the stucco, below the eaves, on all facades where present.

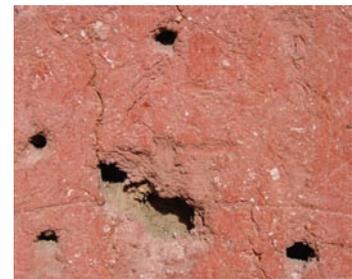
会乘殿，西立面，抹灰机械损伤  
Huicheng Hall, W Facade  
Stucco mechanical damage

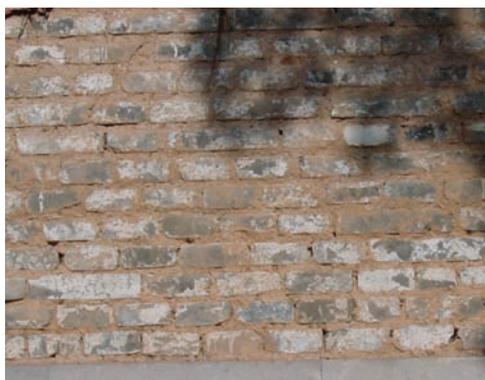
Brick masonry laid with what appears to be a lime-modified earthen mortar (no analysis has been carried out) and grey fired bricks sits atop the sill wall at either end of the N facade and all along the E and W facades. Large areas of stucco loss on the W facade allowed for limited inspection of the masonry, which appears to be in good condition, with only some minor leaching of mortar and resulting brick staining. Long, thin hemp ropes hang from various points within the mortar joints, traditionally used as a method for keying the stucco during application. The stability of the masonry is also sound, though some movement and cracking may have occurred on the E facade due to movement of one of the columns. Monitoring and crack measurement should be implemented to determine if this movement is active.

会乘殿，西立面，砖墙  
Huicheng Hall, W Facade, brick masonry

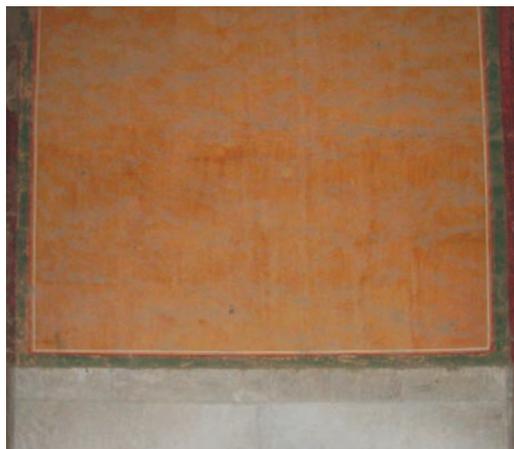
会乘殿，北立面，内部，抹灰表面堆积  
Huicheng Hall, N wall, interior  
Plaster surface deposit

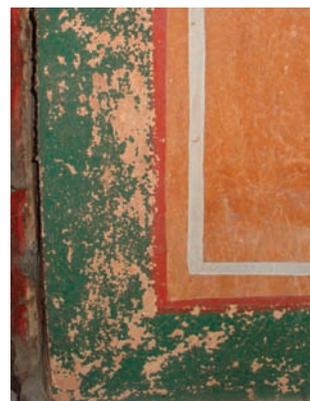
render seems to be a different technique than that of the architectural red paint (*youshi*) and *caihua*, as both plaster and paint seem to be applied in much thinner layers with beaten fiber in the plaster often visible through the paint layer. The green borders exhibit the most deterioration, in the form of cracking and resulting lifting and loss of the paint layer. Other colors are largely intact and seemingly stable.

会乘殿，北立面，内部  
抹灰病害  
Huicheng Hall, N wall,  
Interior  
Paint loss and cracking

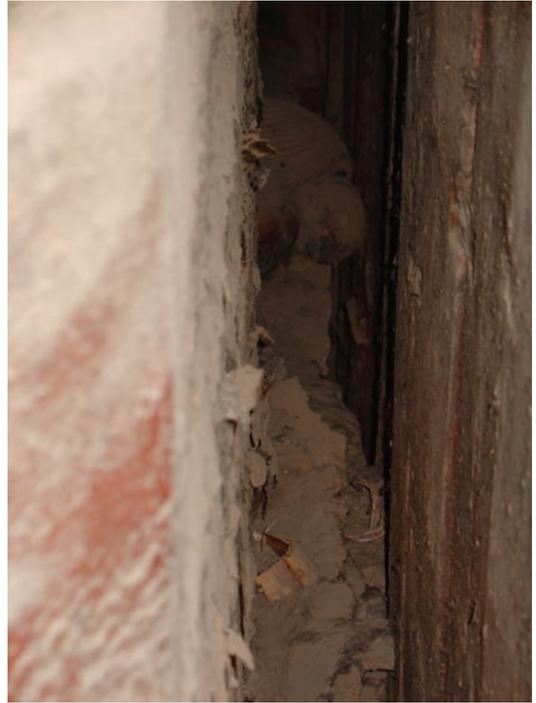
The S side of the partition wall, which serves as the backdrop for the altar and central statuary, has almost no extant plaster, such that the bare wood panels are easily observed. A large amount of intact plaster has fallen onto the floor and can be seen in the small space between the stone plinth statuary base and the partition wall. On the N side of the wall, the majority of painted plaster has also been lost. On the E

会乘殿，内部，木板照壁脱落的地仗  
Huicheng Hall, Interior  
Partition wall fallen plaster

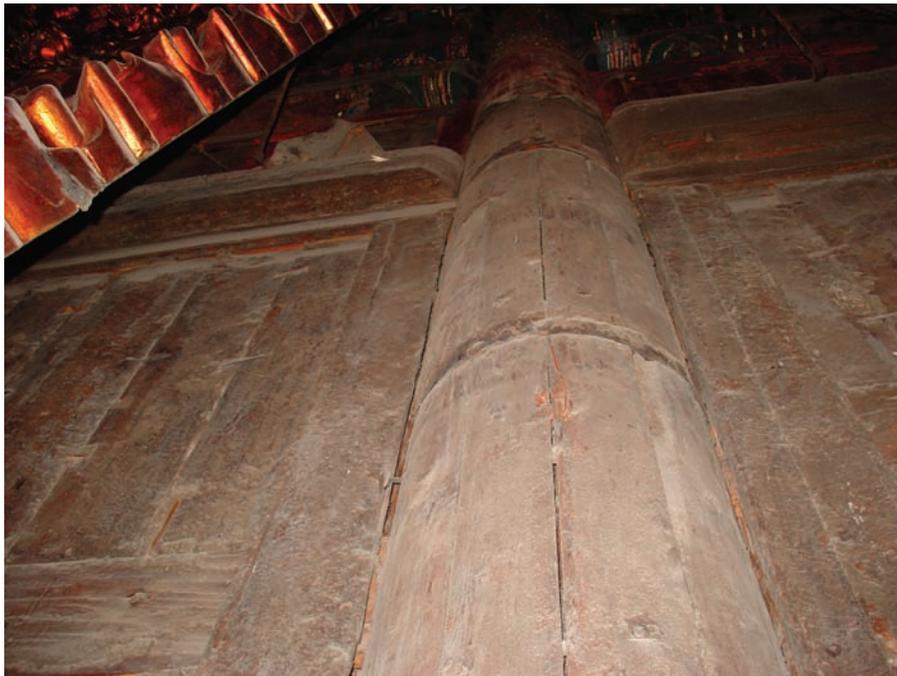
会乘殿，内部，木板照壁地仗脱落  
Huicheng Hall, Interior  
Partition wall plaster loss

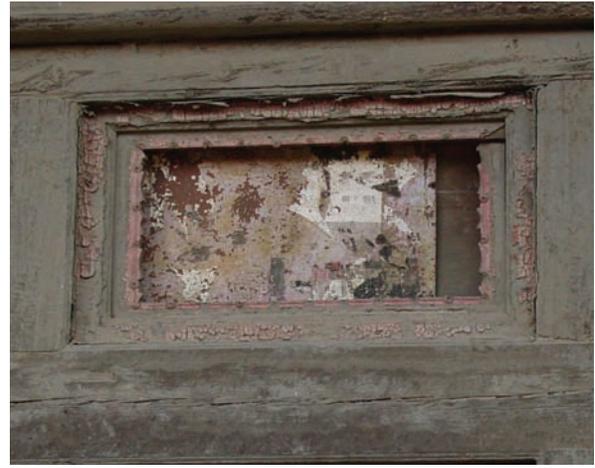
会乘殿，北立面，横批窗缺失  
Huicheng Hall, N Facade, Loss of transom lattice

Sill windows often have preferential erosion of their horizontal components (i.e. wooden frame members), presumably due to precipitation accumulating and being absorbed in those areas. Sill and transom windows have cracks and splintering on both facades, with a few cracks of up to 2cm or more in width. Integrity of latticework varies, though transom windows seem to have more extant historic fabric than sill windows and doors. As with painted plaster, the N facade exhibits greater loss of lattice pieces than the S, with fewer repairs. On the N facade, there is loss of one entire lattice. Some bronze fittings are extant on the sill windows, but most have been lost.

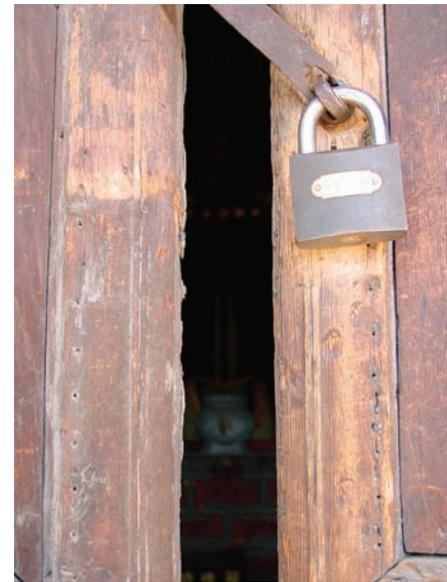
会乘殿，南立面，门铜配件缺失  
Huicheng Hall, S Facade  
Loss of bronze fittings

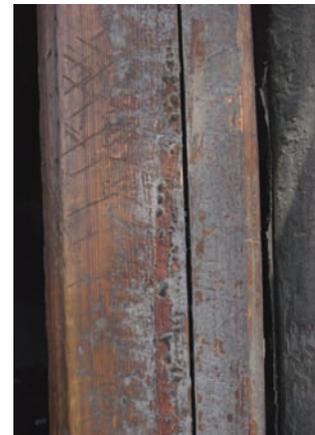
The wooden panel doors are highly decorative, with intricately carved baffleboards and highly refined latticework. The doors were once plastered and painted, with cast bronze fittings placed around the frames. Extant painted plaster is visible in a number of locations, particularly on and around the baffleboards, while the bronze fittings still run along the edges of the doors on the S facade. Intact painted plaster may also be found underneath extant bronze fittings. Inner edges of doors often have patterns of cut marks and scratches, probably used for keying of plaster.

会乘殿，南立面  
门内面边切割  
Huicheng Hall, S Facade  
Cutmarks on door

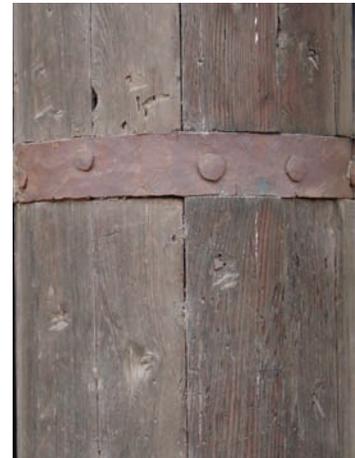
会乘殿，北立面，  
柱子铁箍和木头退色  
Huicheng Hall, N Facade  
Column hoop and  
greying of wood

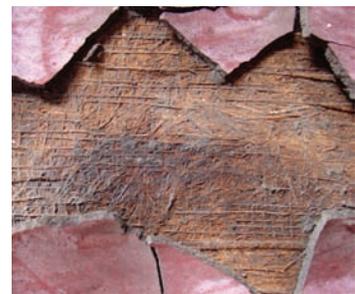
会乘殿，柱子  
地仗和油饰脱落后，暴露出下面的纤维层和地仗。  
Huicheng Hall, column  
Paint and plaster loss, revealing underlying fiber  
and plaster

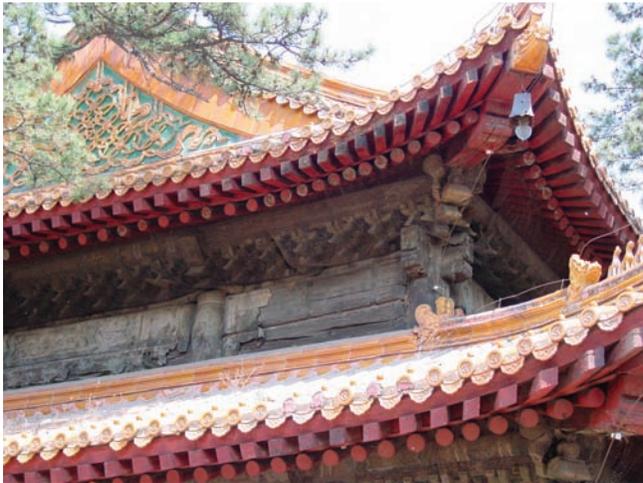
屋顶的出檐部分为椽子构成，它们支持着屋面与屋瓦。椽子还包括一些特殊的形式，如檐椽、翼角椽和飞椽。会乘殿的椽子除了少数的翼角椽之外，其它所有椽子在上世纪50年代修屋顶的时候都被更换过了。这些新近换过的椽子都涂了一层薄的红漆，情况良好。目前可见到干裂、少数的开裂、末端油漆脱落等现象。

会乘殿，西立面，椽子  
Huicheng Hall, W Facade  
Rafters

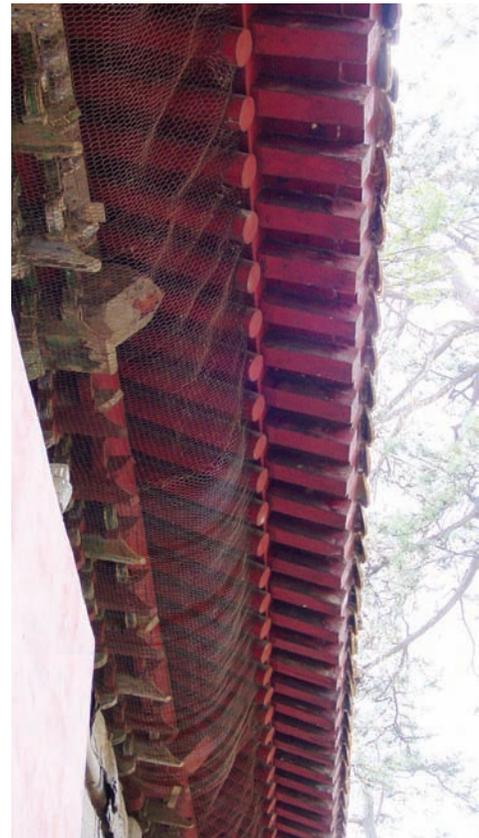
会乘殿，北立面，椽子  
Huicheng Hall, N Facade  
Rafters

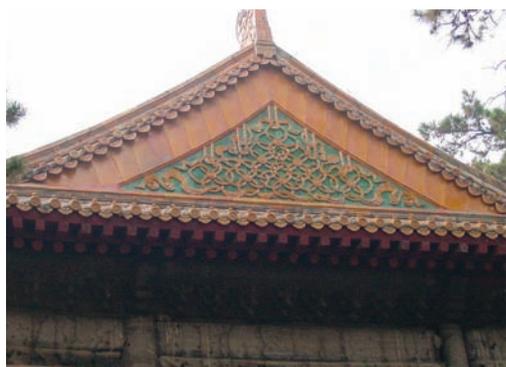
The large flat glazed tiles on the W gable show large cracks and, in at least five cases, have resulted in complete splitting or breaking of the tile. The roof ridge shows advanced glaze loss and some staining from lightning rod attachments and, perhaps, biological growth. Glazed animals (*chuiji shou*) suffer loss and partial loss on the N facade lower eave. Many of the tile nail caps are loose/displaced or lost.

会乘殿，东立面，小红山的琉璃  
Huicheng Hall, E Facade  
Gable

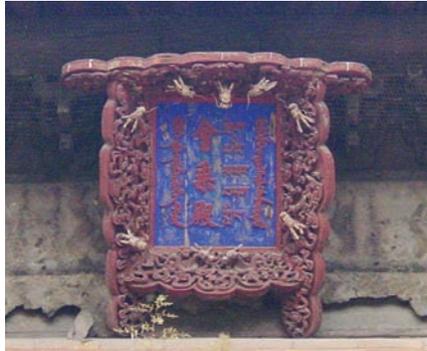
会乘殿，南立面，匾  
Huicheng Hall, S Facade  
Plaque

The name plaque which sits above the main entrance, on the upper eave, is still intact with some cracking and loss of elements and surface decoration evident.

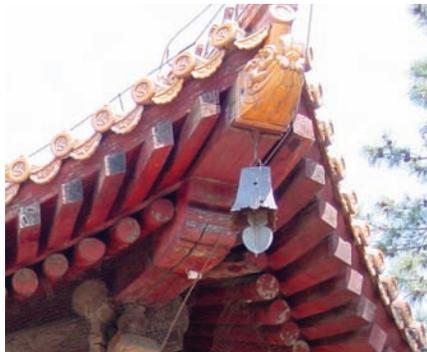
Metal bells hang from the corners of each of the eaves. Limited access did not allow for close inspection of the bells, though they are all present and seem intact from ground inspection.

会乘殿，上檐西南角，风铎  
Huicheng Hall, Upper eave, SW corner  
Bell

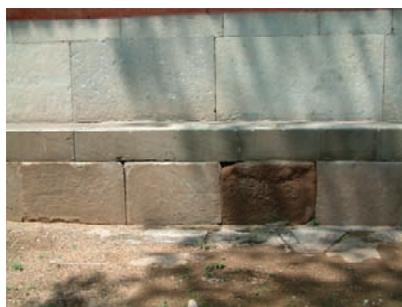
In the past, refuse collected around the base resulting in the inability of rainwater to drain away. This caused the rammed earth inside the platform to become saturated with water and the outer stones of the platform to move out of plane. The protrusion of the foundation stones on the west is also due to the absorption of rainwater.

1、台基东侧，外鼓台帮  
Platform, E side, protrusion of stones

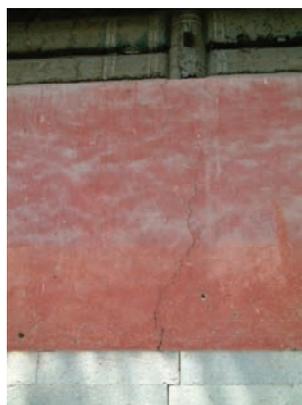
东侧中部墙体沿着檐柱纵向裂缝一道（照片2）。

Vertical stucco cracking is present along the length of one column on the eastern side of the wall (See Fig. 2). This cracking is caused by the rotting of the wooden column and the resulting cracking of surrounding brick masonry; rubbish accumulated on the outside of the wall for a long period of time not enabling the water to drain away after rainfall which caused the earth layer at the foot of the wall to become saturated

thereby resulting in the damage seen.

2、东山墙，开裂墙体  
E side, Gable wall, cracking

经柱网超平，未发现内部柱子下沉，内部柱子糟朽几率较小；后一种原因概率较大。由于现在淤土、杂物已经清除，且墙体开裂缝隙较小，建议做观测点，对裂缝情况进行监测，根据监测结果再做修缮方案。

The central part of the columns do not show signs of differential settlement. There is minimal rotting in columns. Debris has now been removed and the cracking in the walls is also minimal. Monitoring of cracks is recommended, as well as drafting of a repair plan to be implemented after monitoring.

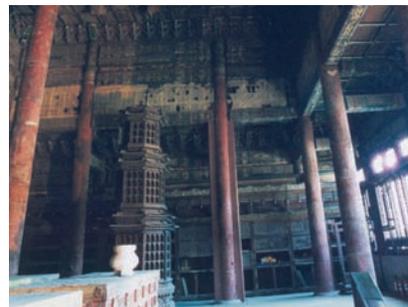
上檐东侧与西侧相比，角柱高度基本持平，东侧两金柱比西侧两金柱约低80毫米，因而升起幅度相对较大。从室内观察：该金柱后加抱柱两根，上部梁枋劈裂下沉；加抱柱后，构架已经稳定（照片3）。

The corner columns on the east side of the upper eaves are basically the same height with the two principal columns being 80mm lower than those on the western side. This has caused considerable raising. Observations from within the hall show that the principal column has been wrapped with two pieces of wood and that the upper beam ties have cracked and subsided. After being supported by two external wood columns the framework has been stabilized (Fig. 3).

3、室内，后加抱柱  
Interior column shoring

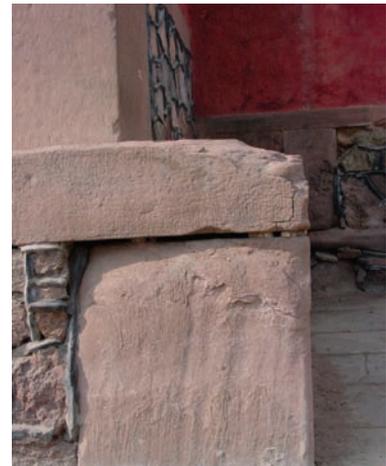
In general, the red sandstone of the platform exhibits erosion, particularly at the edges and corners of blocks. Many of these blocks also suffer from flaking and scaling, which seem to be the primary mechanisms of surface material loss. Surface deposits, staining, and efflorescence are localized throughout the large sandstone blocks of the entire platform. On the N facade, deposits of a cementitious material (perhaps mortar used in roof repairs), rest on the surface of the horizontal top members. The SE corner shows the most severe erosion, which has also resulted in a significant level difference between the SE and SW corners.

山门, 台基东南角  
被侵蚀的角部  
Shanmen, SE Platform corner  
Eroded corners

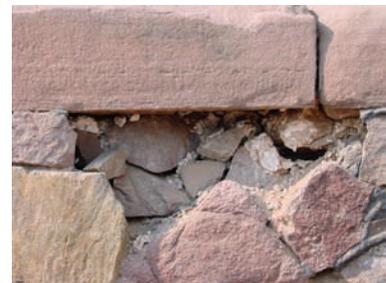
The rubble masonry suffers from localized loss of stone and some minor surface erosion of the stone. Later repointing interventions using cementitious mortar are aesthetically inappropriate and may be contributing to efflorescence and certain conditions in the sandstone, though no analysis of the mortar or efflorescing salts has been undertaken to verify this. The N side of the W wall has extensive loss of rubble masonry and severe erosion of sandstone coping.

山门, 南立面, 台基  
毛石缺失  
Shanmen, S Facade, platform  
Loss of rubble fill

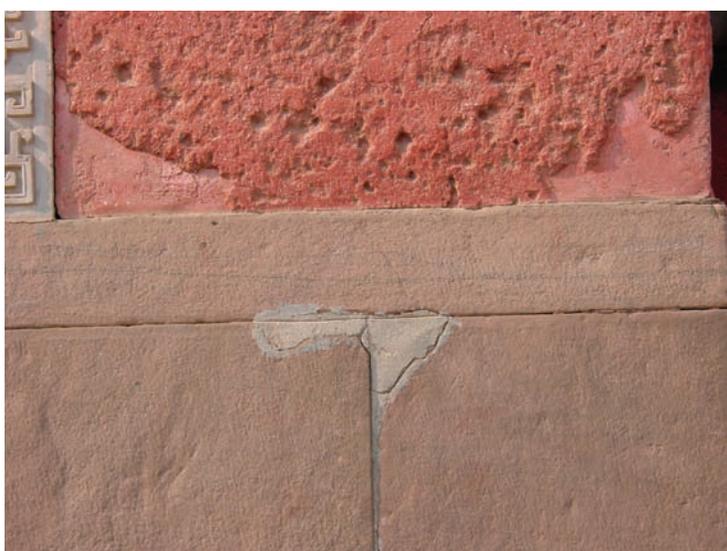
山门，南立面，下碱  
水泥填充

Shanmen, S Facade, sill wall  
Cement infill

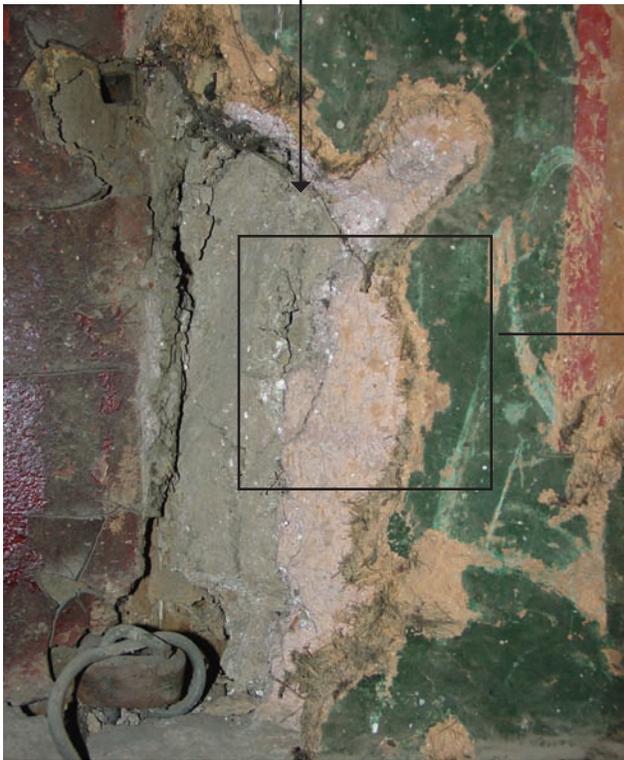
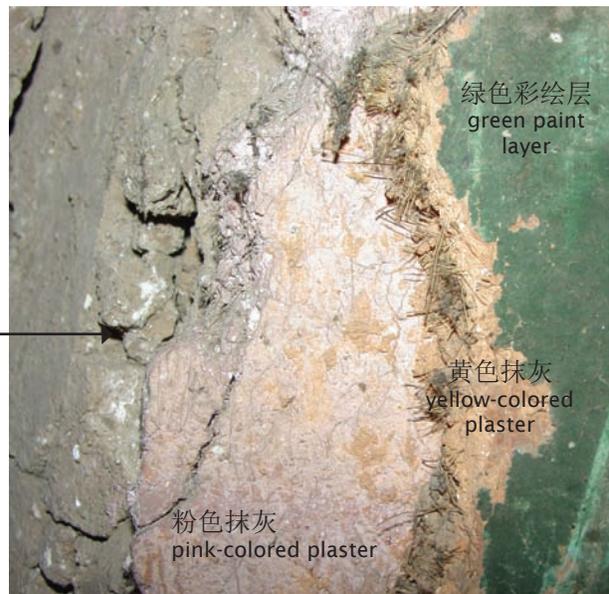
In each bay of Shanmen, above the stone sill wall, the interior walls are decorated with a solid yellow-colored plaster with a white/red/green framed border decoration. Though the interior plaster was not analyzed during this investigation, the stratigraphy from visual inspection shows a pink plaster, similar in appearance to the exterior stucco, followed by a high-fiber content, yellow hued earthen plaster, followed by the paint layer.

抹灰缺失部位的细部放大表现出的抹灰层理结构  
Details of area of loss showing plaster stratigraphy

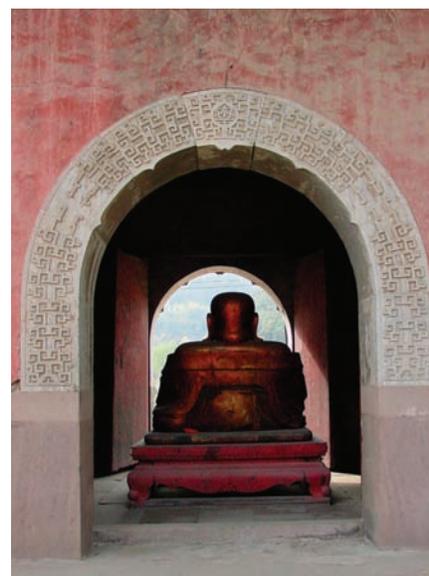
The surface of the stone is largely in good condition, with little erosion or loss of definition of the carvings. In general, the conditions present are staining and surface deposits, which affect all the stone elements. The window in the W bay on the N facade shows displacement of its keystone, as does the door surround on the N facade. The soffits of both door surrounds exhibit staining and surface deposits, seemingly from a coating reminiscent of tung oil. On the W side of the S facade door surround soffit is a crack with adjacent scaling and flaking.

山门，北立面，雕刻的券门  
Shanmen, N Facade  
Carved door surround

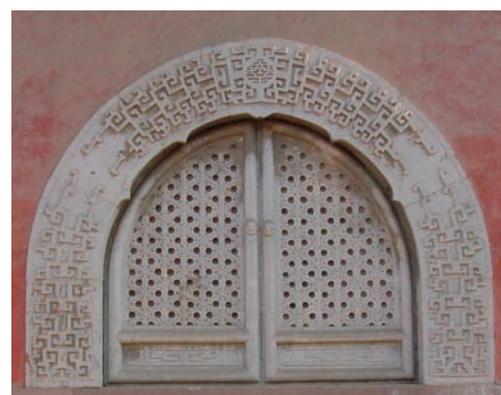
山门，北立面，雕刻的盲窗  
Shanmen, N Facade, carved blind window

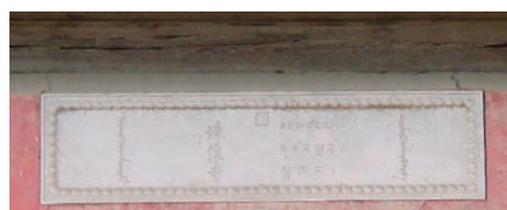
山门，南立面，雕刻的石匾  
Shanmen, S Facade, carved stone plaque

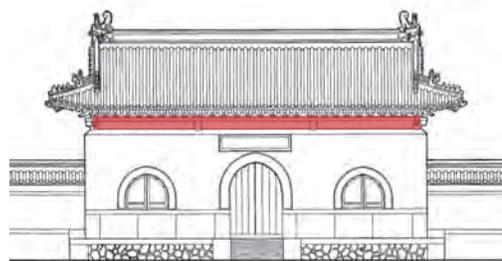
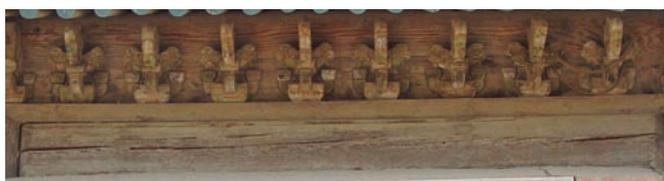
Where visible, the wood of the architraves is cracked, but does not seem to pose any structural problems requiring replacement. E and W facades have intact painted plaster, while the N and S facades have some intact plaster and exposure, with certain bays being completely exposed. The flat tie beam exhibits warping in all bays of the N facade.

山门，南立面，额枋和平板枋  
木质暴露、开裂  
Shanmen, S Facade, architrave and flat tie-beam  
Exposed wood, cracking

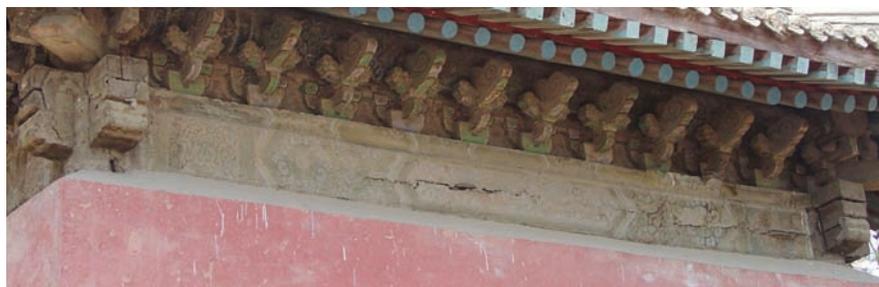
山门，东立面，额枋和平板枋  
Shanmen, E Facade  
Architrave and flat tie-beam

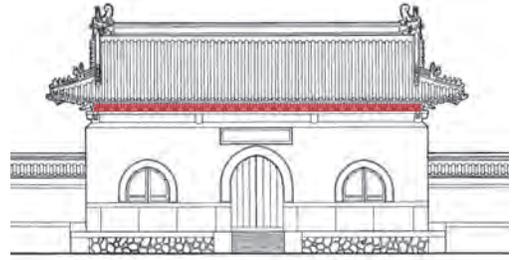
Paint is largely extant on brackets, though purlins have lost much of their painted plaster covering. At least one purlin on the N facade center bay has been replaced.

山门，北立面，东角，斗拱、挑檐檩、檐椽、飞椽  
木质暴露、开裂  
Shanmen, N Facade, E corner  
Brackets, purlins, rafters, flying rafters  
Exposed wood, cracking

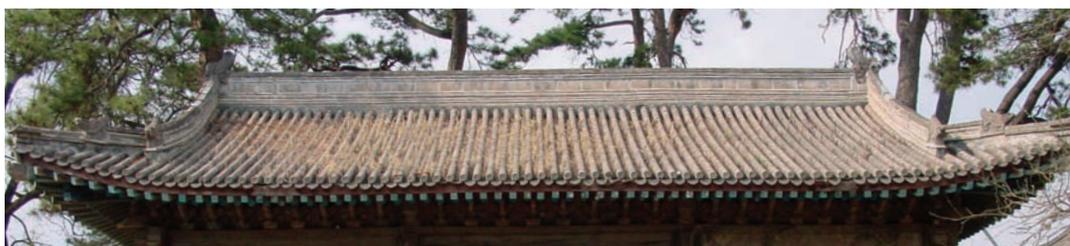
由于从地面上只能对屋顶状况作有限度地观察，因此没有详细的资料。目前可见的最严重的情形是杂草的生长，北面特别密集。北面房檐上有附近树木刮落的枝子和叶子。屋檐四周的瓦当有局部的破损。

山门，南立面，屋顶  
植物生长  
Shanmen, S Facade, roof  
Biological growth

It bears noting that the site has an annual campaign of roof plant removal for historic buildings. Closer investigation of tile and roof elements may most conveniently be undertaken at that time.

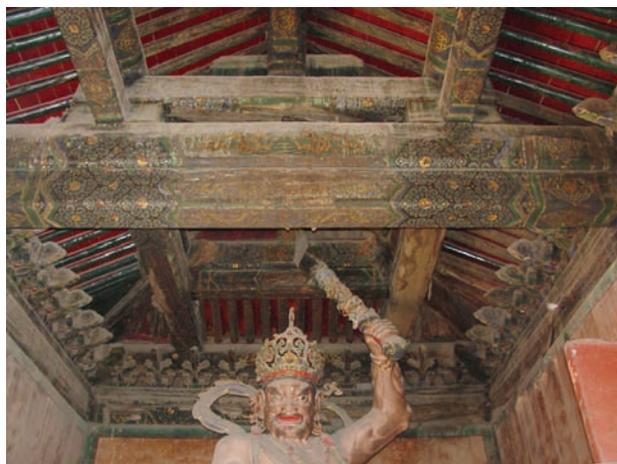
1、山门梁架结构  
Structural wood frame

The overall structure of Shanmen is relatively stable. There has been some subsidence at the southeastern corner of the building. Further surveying is required to determine whether this problem will continue to develop in the future. The elements that have deteriorated in the structure have not caused any structural damage to the building.

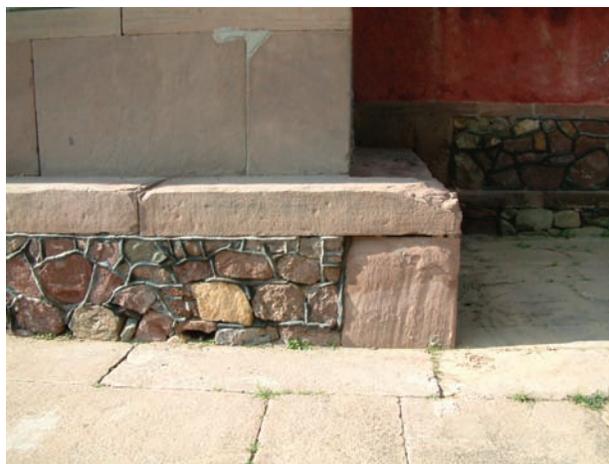
殊像寺山门整体结构相对稳定，东南角部出现下沉，下沉是否加剧，需进一步观测，现存破坏尚未形成结构性破坏。

2、山门东南角部台基  
Platform, SE corner

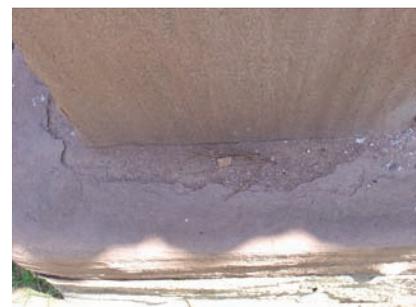
钟楼，西立面，台基上  
台基上有鳞片状与粉末状剥落  
Bell Tower, W Facade, platform top  
Scaling and powdering

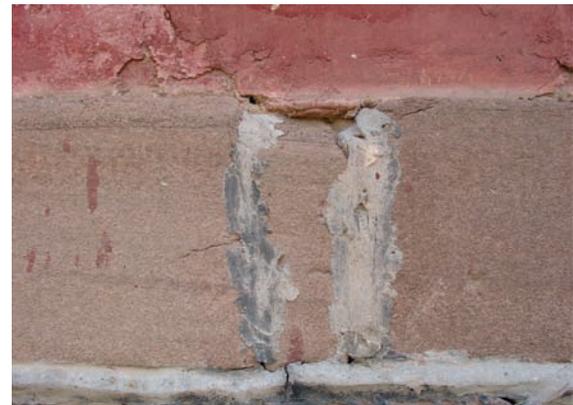
钟楼，西墙，不和谐的人工干预  
Bell Tower, W Facade, sill wall  
Incompatible intervention

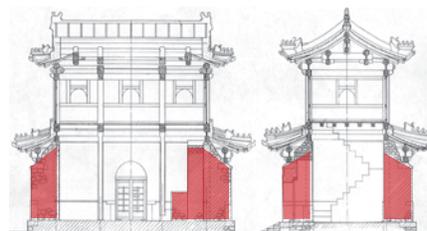
钟楼，西立面，抹灰修护  
Bell Tower, W Facade, plaster repair

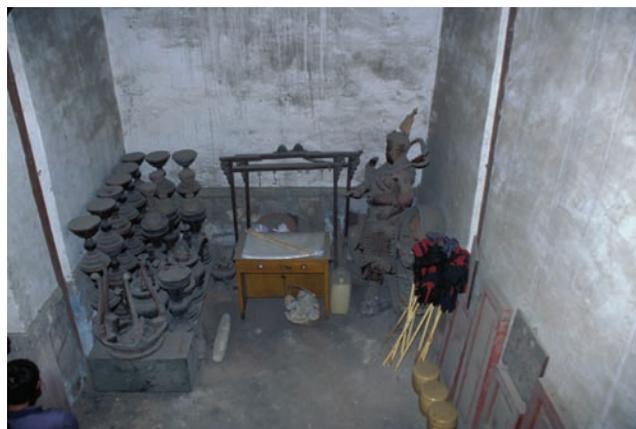
钟楼内部，墙面与储存在内的物品  
Bell Tower, Interior  
View of stored items and plaster

清楚。由于空气中的灰尘和污垢的积累，墙面呈灰色，并有局部的机械损伤。目前两座建筑均改为仓库，内墙抹灰将面临着进一步的恶化（钟楼内存储塑像和陈设物，鼓楼存储煤炭）。

Interior plaster is white in color and of an unknown composition, as no careful observation or analysis has been undertaken. In both buildings, the plaster is greying from accumulation of airborne dirt and dust. Localized mechanical damage is evident and the plaster is at further risk from the use of these buildings as storage (statuary and furniture in the Bell Tower and coal in the Drum Tower).

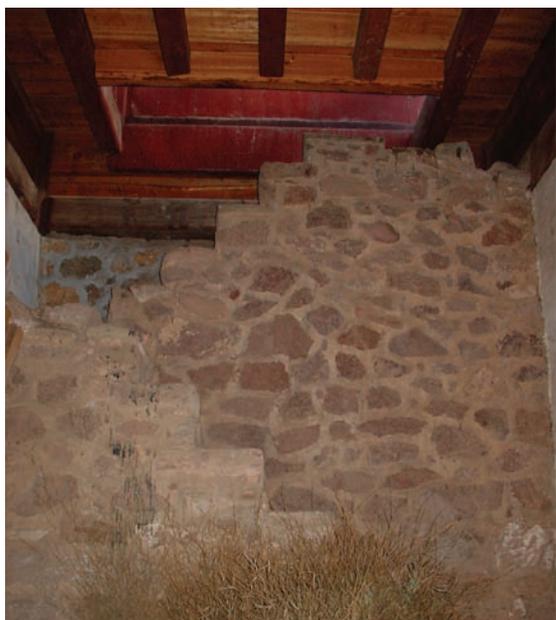
两座建筑的南立面内墙建都有通往二楼的半弯型自支撑式楼梯，楼梯由虎皮毛石砌筑，状况良好，看起来好像是原件（两座建筑的二楼原置钟、鼓各一面，鼓现已不存）。两座楼梯存在少量的开裂，表面堆积（修复二楼时所掉下来的材料），以及部分地方有水泥补修和勾缝。钟楼楼梯旁边的砖石作墙（即南立面墙和东、西立面墙的南端）没有抹灰，因而可以看到水泥勾缝的虎皮毛石。

Built into the S interior wall in each of the structures is a stone rubble masonry half-turn stair that allows access to the upper level housing the bell and drum (no longer extant), respectively. The self-supporting stairs are in good condition and seem original to the buildings. Both show some minor localized cracking, surface deposits from spillage of intervention materials used on the upper floor during work and some cementitious patching and repointing. The masonry walls adjacent to the stairs, i.e. S wall and S ends of the W and E walls, in the Bell tower are unplastered and reveal a rubble masonry with cementitious repointing.

钟楼内部，南面墙梯  
Bell Tower, Interior, S wall stair

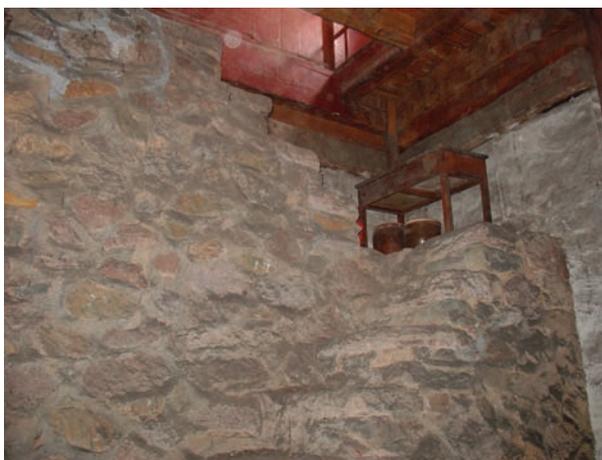
鼓楼内部，南面墙阶梯  
Drum Tower, Interior, S wall stair

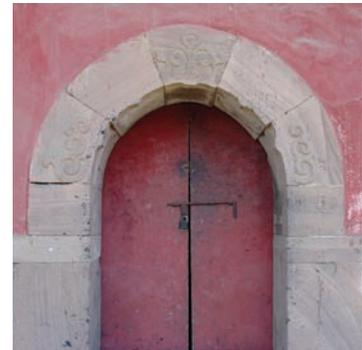
券门及其砖石作组合的结构一般说来是稳定的，保存状态良好。最突出的问题为溅落在表面的油漆痕迹，钟楼的券门还有煤留下的污渍。楔型拱石已勾过缝，钟楼的拱心石接缝南端和旁边的楔型拱石用水泥修补过。鼓楼券门的两个拱脚以及钟楼券门北面的拱脚都出现外闪。钟楼的拱心石有一条贯穿整个拱心石裂缝，这条裂痕的深度不明。

In general, the arches and their composite masonry are structurally stable and in a good state of preservation. The most prevalent conditions relate to surface deposits from dripped paint and, in the Drum Tower, from coal. Some repointing of voussoirs is evident and the Bell Tower keystone has a cementitious patch that covers its joint to the south and a portion of the adjacent voussoir. A slight outward movement from the wall is present in both springers in the Drum Tower and in the N springer of the Bell Tower entrance. A horizontal crack is present across the width of the keystone in the Drum tower, though it is unclear whether this crack continues through the thickness of the stone.

鼓楼，东面墙入口的污斑，表面的沉淀物，裂缝  
Drum Tower, E Facade, Entryway  
Staining, surface deposits,  
cracking

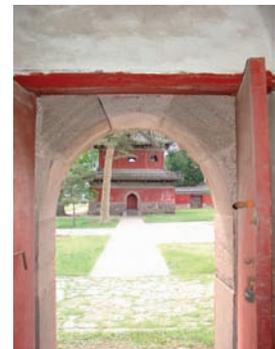
钟楼入口内面  
Bell Tower, Entryway interior

我们对两座建筑的门扇了解不多。门扇为木质，上有一层地仗，红漆油饰。门扇有经常开关的痕迹，大面积的机械损伤导致了油漆的局部脱落。门扇的年代不详。

Little is known about the doors, which are of wood and painted red over a preparatory plaster. They bear the signs of heavy use, primarily widespread mechanical damage resulting in localized loss of paint. The date of these doors is unknown.

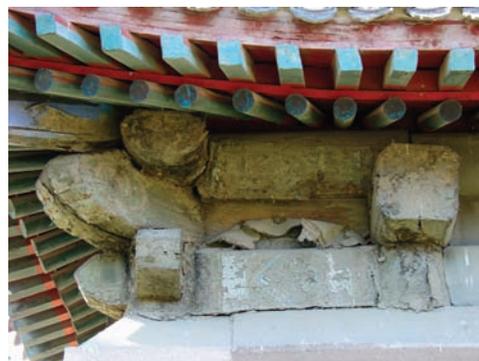
钟楼下檐额枋西南、西北角仍然保存原来的彩画，这是确定结构木件为清代的依据。额枋的其他构件上有一层地仗，额枋地仗表面上普遍存在水污痕迹和局部开裂等现象。钟楼上层支柱的红漆已出现大面积开裂和脆弱性。

Extant painted decoration is present only on the Bell Tower lower eave architrave NW and SW corners and provides evidence for extant Qing structural members. The remaining architrave members in both buildings are coated with a mud plaster. Prevalent surface conditions include water staining and localized cracking of plaster on architraves. Red paint on the upper level columns shows extensive cracking and friability in the Bell Tower.

钟楼，南面墙，西拐角残存彩画  
Bell Tower, S Facade, W corner  
Extant painted decoration

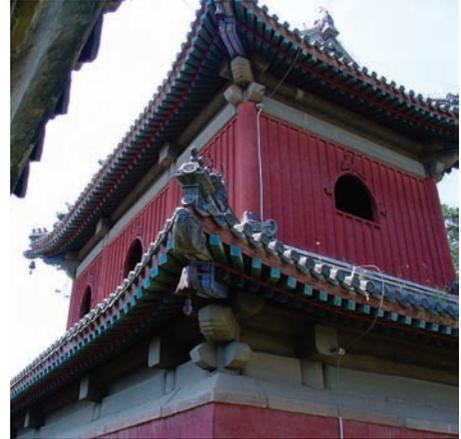
上个世纪八十年代初钟、鼓楼的屋檐和屋顶构件在进行修复时被更换过。据文献记录，所有椽飞望板、屋顶板、屋檐及剪边瓦均属于这个时期。经过观察之后，我们确定了上、下檐状况良好，屋顶构件很完整。两座楼屋檐和屋面的瓦片，尤其是瓦当及创兽，出现少量的破裂。悬挂在檐角的铃铛均在，但出现了锈蚀。钟、鼓楼的檐上和屋顶上都有植物生长。

Eave and roof elements were largely replaced as part of the early 1980s campaign of interventions on the Bell and Drum towers. According to records, all flying rafters, roof boarding, eave and tile edging date to that period. On inspection, the upper and lower eaves appear to be in good condition, with all roofing members intact. Eaves and roofs of both buildings only show minimal tile breakage and loss, particularly of end tiles and hip corner animals. All corner eave bells are present, though showing signs of oxidation. Evidence of plant growth is present on the eaves and roof of both the Bell and Drum towers.

钟楼，东北角，上层与下层屋檐的构架  
Bell Tower, NE corner  
Upper and Lower eave framing

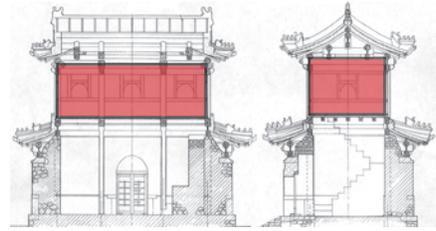
上层楼外侧木板上的油漆已出现大规模的开裂及部分脱落。两座楼内都有燕子窝，地板上有大量的鸟粪，屋梁上有污点。

The exterior paint on the wood paneling exhibits widespread cracking and some resulting loss. Use of the interior for nesting of swallows has resulted in large amounts of droppings on the floor and staining of roof beams in both buildings.

鼓楼，东立面上层，漆的裂缝及脱落。  
Drum Tower, N Facade, Upper level  
Paint cracking and loss

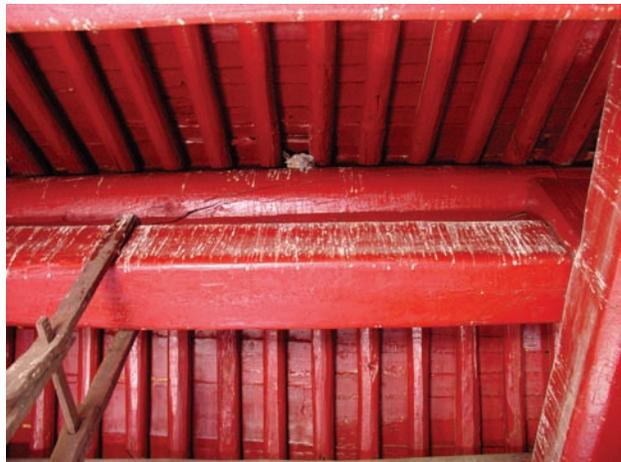
钟楼，上层屋梁上鸟的排泄物与鸟窝  
Bell Tower, Upper Chamber  
Deposits from bird droppings, with visible nest

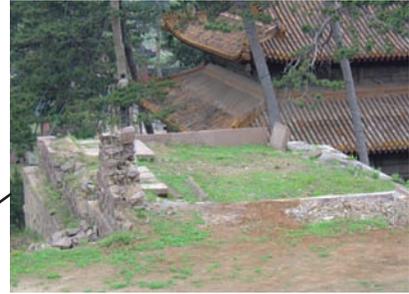
云来殿址，从东北边看  
 Yunlai Hall, from NE

尽管这些基址遗存的数量有限，到处都可以看到后期干预的痕迹；这些干预很可能是加固工程的一部分。最常见的干预工程包括：更换榻板、腰线石、有水泥和石灰补块，通常在槛墙里或墙上。新的榻板、腰线石和填充物因其位置、材料很容易就能看出来（譬如青砂岩），在某些情况下，这些干预工程挡住或占据了支柱的原始位置，因此，可以确定它们不是该建筑的原始构件。云来殿基址就是重新利用不恰当的一个特殊实例：为了修复宝相阁，在云来殿的地基附近修建了一个石砌的石灰池，破坏了该殿的地基。

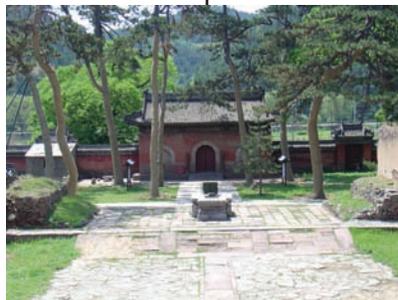
总体来讲，这些基址的大部分地上建筑已不存在，留下的部分多少不一。其保存状态和维护情况似乎与其所在的位置有关，寺内南半部较大的建筑（配殿）保存了较多的建筑原件，其设置也比保存较少的、位于北部的小殿堂更易理解。这些基址常常保留着墙体中部的砂岩陡板和腰线石，或在原址，或已位移和失落。位移和失落的石材多为植物生长所致。配殿内大部分的砖石作、铺地石及柱顶石或已缺失，或埋在地里。天王殿的情况独特，其铺地石不但保存下来，且较完整。遗憾的是，这些铺地石出现了严重的表层剥落和分解，以至造成表面脱落。车辆的来往加速了石材的损坏进程。但是寺院后面的配殿大都保存了殿内原有的须弥座，同时，与会乘殿以南的较大的配殿相比，所有这些小配殿都至少保留了部分的毛石槛墙以及部分山墙，山墙墙体上的抹灰也有部分存留。在这些基址里，天王殿保留了最多的历史建件部分，包括基本完整的西山墙和内外墙上的抹灰。

天王殿址，前景，朝南看  
 Tianwang Hall remains, in foreground,  
 looking S

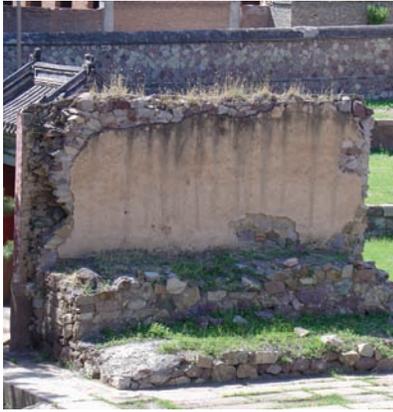
天王殿址，残存的西墙和抹灰  
Tianwang Hall, extant W wall with plaster

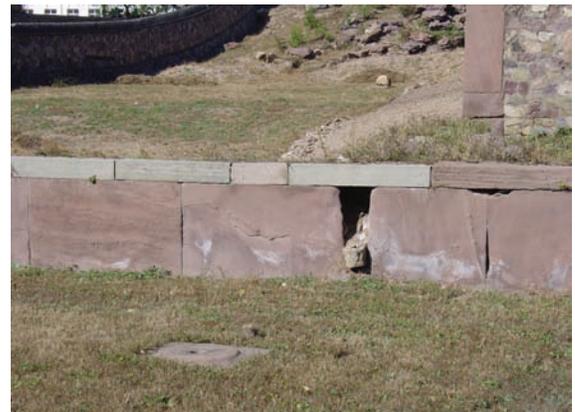
演梵堂址，北下碱墙和干预工程使用的石材，前景为柱顶石  
Yanfan Hall, N sill wall with intervention stone, column base in foreground

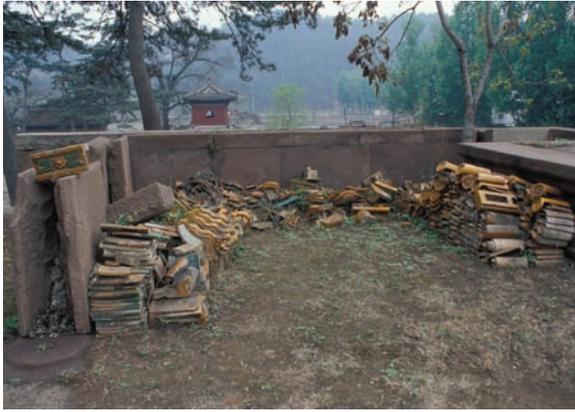
面月殿址，堆积的瓦  
Mianyue Hall, stacked tile

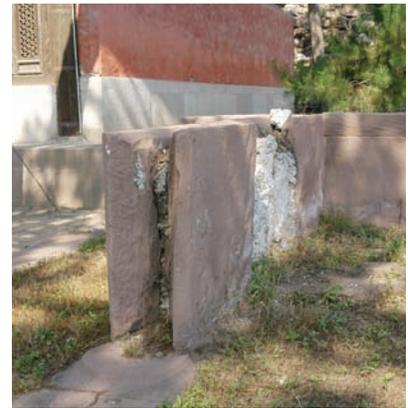
指峰殿址，立砌红砂岩和白灰膏  
Zhifeng Hall, red sandstone ashlar  
with white mortar

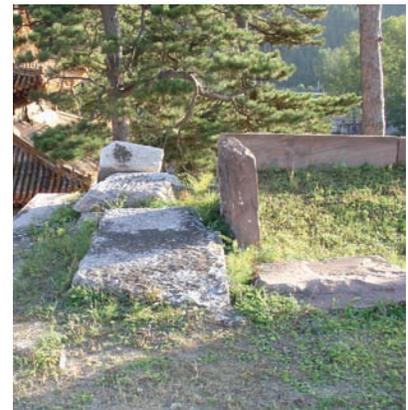
雪净殿址，位移条石  
Xuejing Hall, fallen ashlar blocks

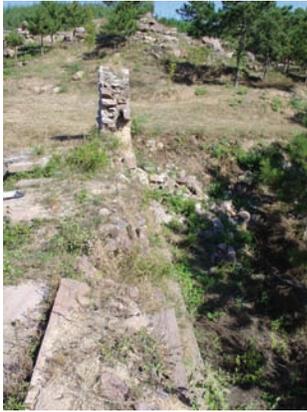
云来殿址，东侧尚存的毛石墙  
Yunlai Hall, E extant portion  
of rubble masonry wall

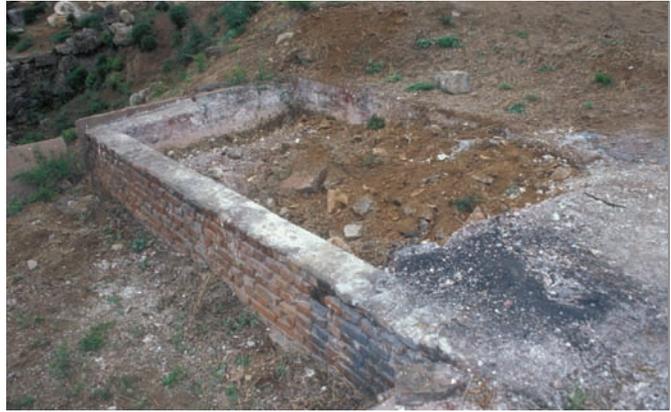
Despite the limited amount of extant fabric in most of these ruins, later interventions, presumably part of stabilization efforts, are visible throughout. Common interventions include replacement of sill wall stringers, and introduction of cementitious and lime fills and caps, usually in or on the sill walls. New stringers and fills are often easily identified because of their location and material (for example, the whitish-green sandstone); in some cases these interventions block or fill the historic location of columns, evidence that they are not original to the buildings. Yunlai Hall has a unique example of inappropriate reuse: a lime pit dug into its foundation and enforced with brick masonry for the restoration work of Baoxiang Pavilion.

云来殿址，石灰池（后来干预的工程）  
Yunlai Hall, lime pit (later intervention)

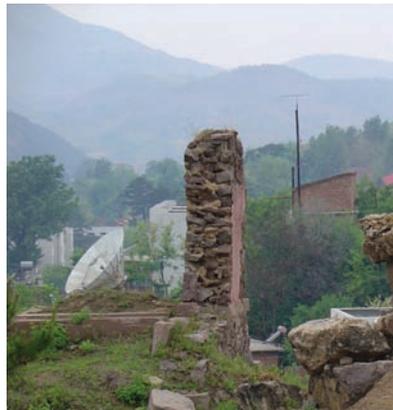
慧喜殿址，南侧尚存的部分毛石墙  
Huixi Hall, N side extant portion of  
rubble wall

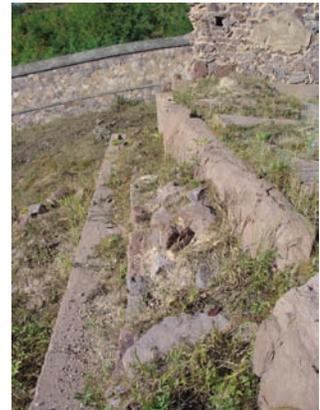
慧喜殿址，西侧，台基和槛墙残存的部分  
Huixi Hall, W side, platform  
and extant portion of sill wall

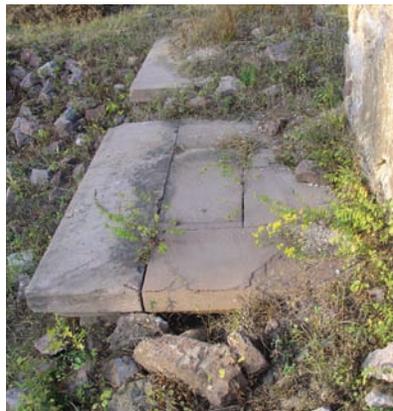
吉晖殿址，残存的红砂岩须弥座  
Jihui Hall, extant red sandstone  
*sumeru* pedestals

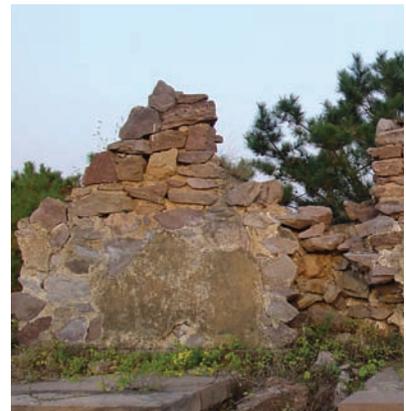
吉晖殿址，残存的毛石墙的部分  
Jihui Hall, extant portion of rubble  
wall

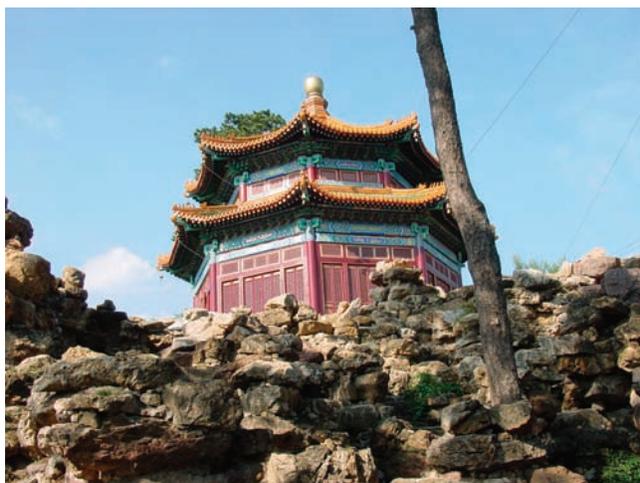
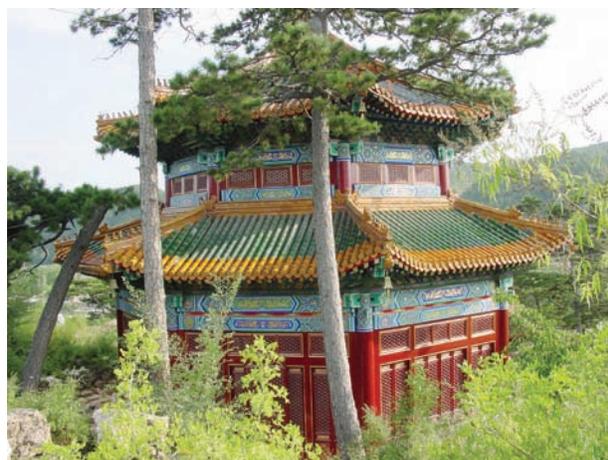
宝相阁在1997年—2002年进行了修复（详见卷一，《殊像寺干预史》附件2）。修复使用了部分原有落架保护大木（主要是梁枋、柱子），斗拱旧件主要用在东西南北四个正面，角梁、檩条、椽飞、装修及全部瓦件均为后补配。阁内重新塑造的文殊像利用了旧有的塑像残块，并且修补了石质须弥座；须弥座台面万字串枝西蕃莲多为后来按原样雕刻修补。修复过的建筑石基已经出现裂缝与表面粉化，地仗与画层出现裂缝，漆已变色，窗子的玻璃已破碎。

Baoliang Pavilion was restored from 1997 to 2002 (see a restoration report in Vol. 1, *History of Interventions*, Appendix 2). Some of the original wooden frame components were reused (e.g. beams, columns) and old bracket components were used on the primary facades (east, west, north, and south); corner beams, purlins, and rafters were repaired and all tiles were replaced. The statuary was restored (incorporating the few extant pieces); the stone pedestal was repaired and carved in the original pattern. The restored building already exhibits cracking and surface powdering of its stone foundation, plaster and paint cracking, paint color change, and breakage of window glass.

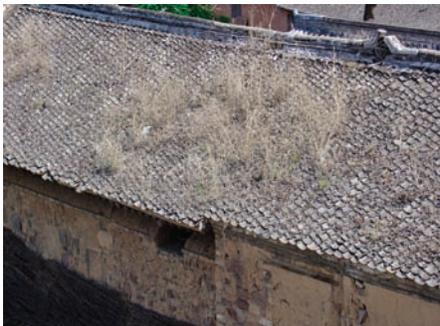
僧房，屋顶上植物生长  
Monks' quarters, plant growth on roof

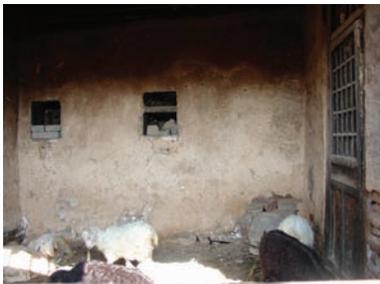
僧房，室内，墙面抹灰，目前为牲口圈  
Monks' quarters, interior, extant plaster and barn use

现存僧房为殊像寺内喇嘛居址的唯一实例。该房破旧不堪；为一座面宽五间，进深一间，毛石砌墙的建筑。由于该房冬天用作牲口圈，因而面临着极大的危险。目前难以确定该建筑的完整性，仅就肉眼观察，可以看到东墙上明显的水泥勾缝，以及遍布整座建筑的后期干预工程使用的现代红砖。该房内墙上有抹灰，内外均有木门，对其年代没有做进一步的考察。

The monks' quarters represent the only extant example of what would have originally been a number of buildings meant to house the lamas resident at Shuxiang Temple. The rubble masonry five-bay wide by one-bay deep structure is currently in a serious state of disrepair and remains at great risk, given its frequent use as a barn for animals during the winter. It is difficult to determine the degree of integrity of the structure, given visible cementitious mortar infills on the E facade and modern red-colored fired brick interventions throughout the building. An extant interior earthen plaster is visible, as are wooden doors on the interior and exterior, but no investigation into the composition or age of these materials has been carried out.

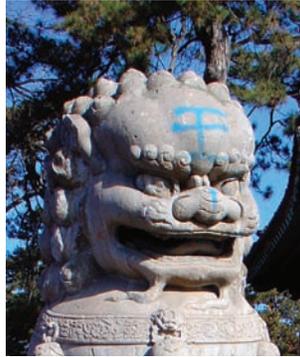
西侧石狮子，涂写  
West stone lion, graffito

山门前东西两边各有一雄一雌、用鸚鵡岩雕刻的石狮子。狮子蹲坐在须弥座上，保存基本完整。须弥座下部可见风化及剥蚀痕迹，并有多处裂隙；石狮头部表面多处开裂，部分缺失；一前额上有胡乱的涂写。狮身及须弥座有多处的机械损伤。现设有金属保护栏杆。

A pair of tuff lions, one male and one female, sits in front of Shanmen, each on a stylized *sumeru* pedestal, in relatively good condition. The pedestals exhibit erosion and cracking; the heads show surface cracking and partial loss; one of the lions bears a graffito on its forehead. Both the bodies and bases show mechanical damage. Currently, there is a metal fence protecting each lion.

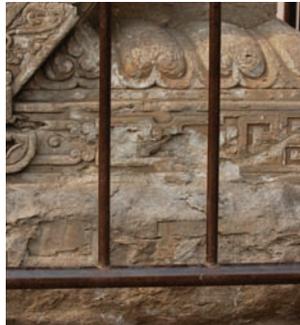
东侧石狮子，东侧面  
East stone lion, east side

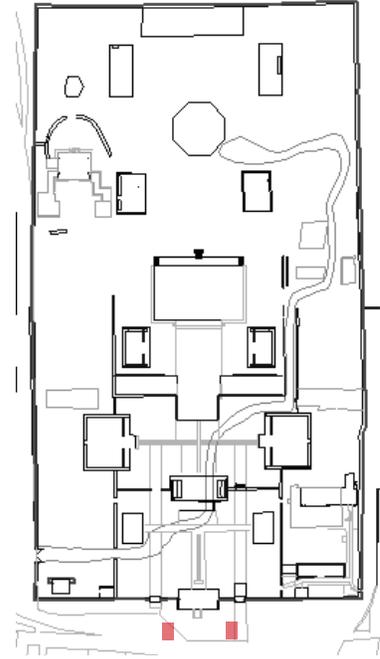
石狮子，须弥座，侵蚀、开裂  
Stone lion, *sumeru* pedestal  
Erosion, cracking

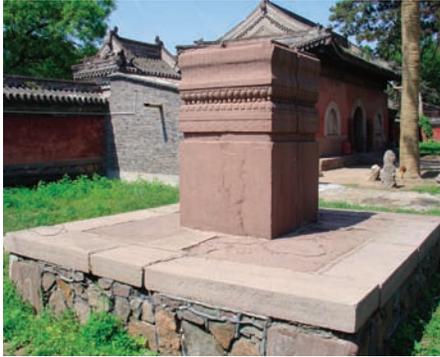
第一进院落，东幢杆座  
First Courtyard, E banner pole base

第一进院落的幢杆座保存完整，外表局部风化，幢杆已不存。

The banner pole bases in Courtyard 1 are generally in good condition, with some surface erosion. The banner poles are no longer extant.

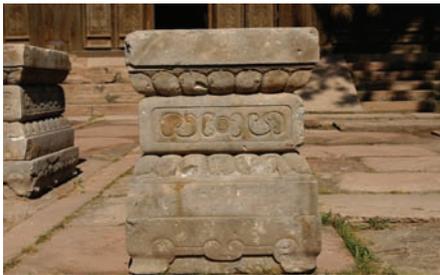
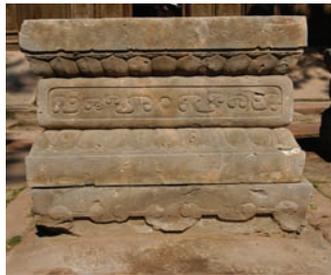
会乘殿前，供奉  
Huicheng Hall, front terrace, altar

会乘殿前有五座石供奉，边缘破损，并有侵蚀和部分缺失。

In front of Huicheng Hall are five carved tuff stone altars, often with edge damage, erosion, and partial loss.

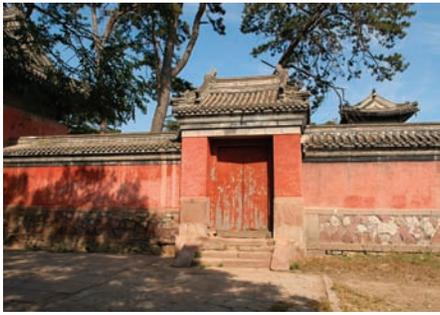
围墙，东南便门  
Perimeter wall, SE side gate

山门、天王殿两侧的墙体上各对称设有2座便门，门基、下碱用条石砌筑，毛石上身外饰红灰，青砖屋檐、灰瓦歇山屋顶，实榻板门。以上诸项在1982年进行了修缮。现围墙保存完好，有污迹，并有抹灰开裂。外面的便门长期关闭，已不使用。

The walls on either side of Shanmen and Tianwang Hall have side gates, the platform and base wall of which are constructed of ashlars, with rubble masonry above, covered with red-colored stucco, and grey brick courses and eaves with grey tile. These were also restored in 1982. The walls are generally in good condition, but exhibit some staining and plaster cracking. The external gates are not used and remain closed.

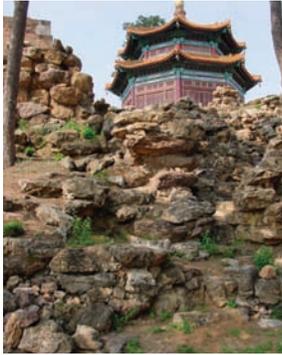
宝相阁前假山，南侧  
Rockery in front of Baoxiang Pavilion, S side

主要存在于会乘殿护坡墙前、会乘殿后、宝相阁四周及香林室院内。假山主要用当地产的不规则沉积岩、火山岩、砂岩等叠砌，以宝相阁前的假山最为珍贵，有山洞、登山道路等与四周建筑相通。此处假山基本上保存了原状，但叠石多处松动不稳，局部被用水泥砂浆修补过。其它的假山多仍被土覆盖，未作考古清理，情况不明。见卷一，《殊像寺简述》，附件3。

The rockeries are located in front of the retaining wall of Huicheng Hall, behind Huicheng Hall, all around Baoxiang Pavilion and in the Xianglin Complex. The rockery is made from irregularly shaped pieces of sedimentary rock, volcanic rock and sandstone, which have been stacked. The outstanding rockery in the temple complex is the one in front of Baoxiang Pavilion. There are culverts and pathways throughout the rockery that link up on the four sides of the building. This rockery has been largely preserved in its entirety, however some of the rocks have become loose and are no longer stable. Certain areas have been repaired using cement. Most of the other rockeries are now largely buried and there has been no archaeological investigation to determine their exact perimeters. See Vol. 1, *Description of Shuxiang Temple*, Appendix 3 for more information on the rockeries.

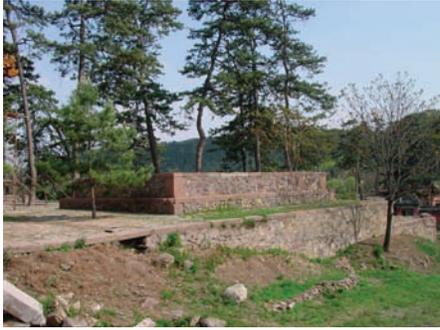
月台护坡墙，西侧  
Terrace retaining wall, W side

毛石砌筑勾缝，顶部压面条石，并设有石质挑头。原压面石以上有带顶的石砌女墙，现仅存个别转角、端部石构件。护坡墙目前保存较好，无明显破损，但由于顶面防水失效，雨水渗入台面从墙上部渗出，墙体膨胀造成破坏。有些部位有新加的灰泥与石块。

The retaining walls are constructed of rubble masonry with raised mortar. The top of each wall is finished in ashlar with carved stone scuppers. The original top surface has a small stone parapet of which only portions of the corner and end stones are extant. The retaining wall is in good condition with few signs of deterioration. However, the surface coping is no longer completely effective in preventing moisture infiltration and parts of the wall show resulting swelling. There are areas of modern intervention mortar and stone replacement.

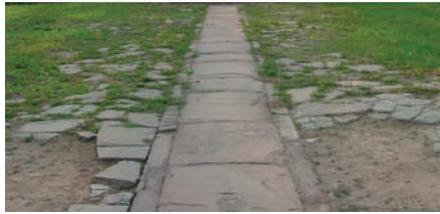
演梵堂前铺墁  
Paving in front of Yanfan Hall

寺院中间的院落原有种类不同的砂岩铺墁。会乘殿前的月台、第一进和第二进院落用规则块石铺墁，其它部位片石铺墁（冰裂纹）。因为石材种类不同，所以墁地片石有不同程度的分解或开裂，石缝间杂草丛生。第一进院落道路近期重新铺墁，水泥砂浆勾缝了。山门前地面为红砂岩条石铺墁，保存尚可，但机动车辆通行停放对地面造成损害。

The courtyards were originally paved with sandstone of different varieties. The terrace in front of Huicheng Hall, Courtyard 1, and Courtyard 2 were paved with regularly set square stone, with areas of crazy paving. Given the variety of stones used and the type of paving, differing degrees of disintegration and cracking of the pavement are evident. Plant growth (grass) is also often present in spaces between pavers. Courtyard 1 was repaved in 2002 using white sand and cement. The pavement made from red sandstone ashlar in front of Shanmen is well preserved, though portions have been subjected to vehicular traffic and show related deterioration.

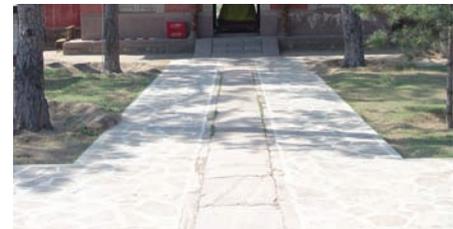
第一进院落铺墁，新铺的冰裂纹铺墁  
First Courtyard Paving, new crazy paving
