附件1：名词图解

APPENDIX 1: VISUAL GLOSSARY

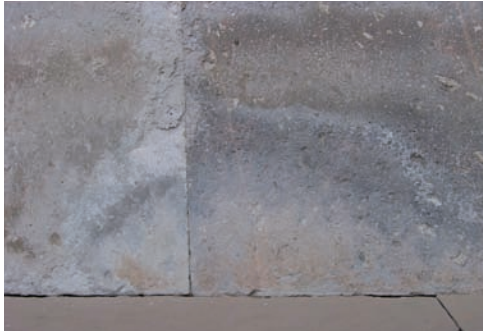
会乘殿，室外东北槛墙
鸚鵡岩
盐霜凝结
Huicheng Hall,
NE Exterior sill wall
Tuff (*yingwuyan*)
Salt efflorescence

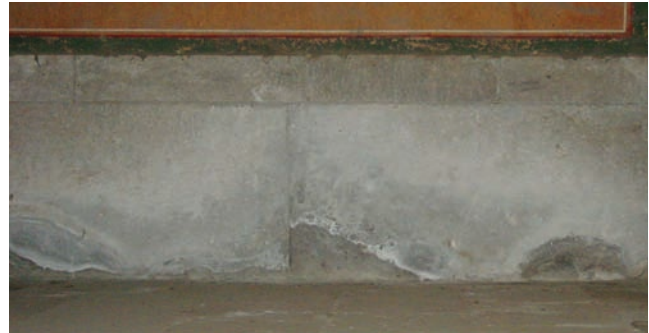
会乘殿，室内东北角槛墙
鸚鵡岩
盐霜凝结
Huicheng Hall, NE Interior sill wall
Tuff (*yingwuyan*)
Salt efflorescence

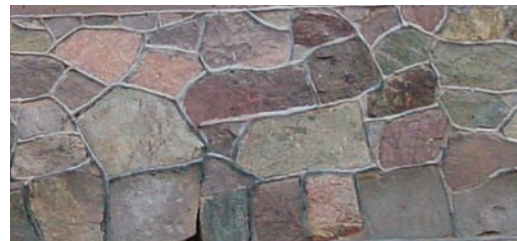
围墙，南立面
虎皮石墙
使用水泥做不和谐的重新勾缝
Perimeter Wall, S Facade
Rubble "tiger skin" masonry
Incompatible repointing with cement

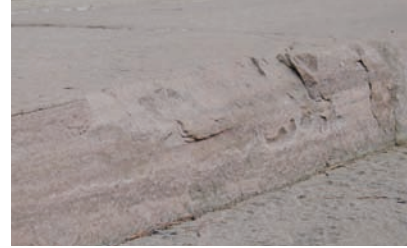
会乘殿，台基北侧踏步
红砂岩
侵蚀造成部分石材缺失

Huicheng Hall, N Platform step
Red Sandstone
Partial loss of stone, with erosion

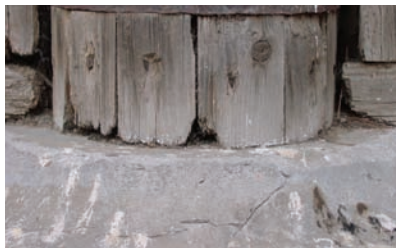
会乘殿，北立面
鸚鵡岩
鸟粪
Huicheng Hall,
N Facade
Tuff (*yingwuyan*)
Bird droppings

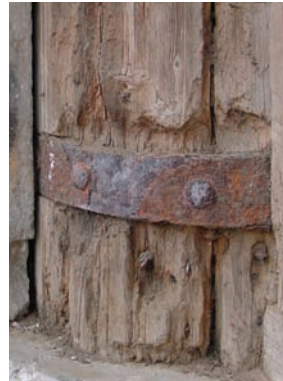
会乘殿，北立面
柱脚
腐朽
Huicheng Hall, N facade
Base of Column
Erosion

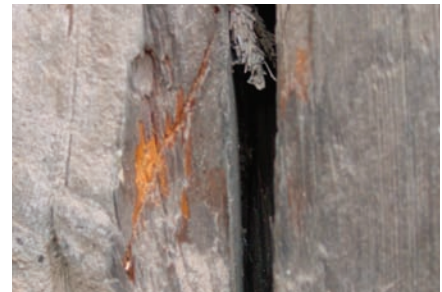
会乘殿，北立面
抱框及门扇
凿口痕迹及蚀洞
Huicheng Hall, N Facade
Enclosure frame and door
Gouge marks and scoring

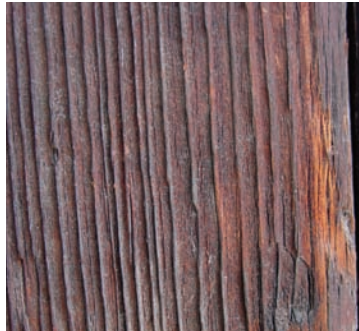
会乘殿，南立面
纹理凸起
Huicheng Hall, S Facade
Raised Grain

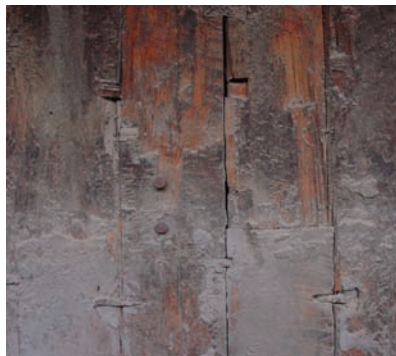
会乘殿，室内，北廊
扇面墙
表面堆积（大片地仗脱落后的
少部分地仗遗存）
Huicheng Hall,
Interior,
N corridor
Wood panel wall
Surface deposit (remnant
plaster after significant
plaster loss)

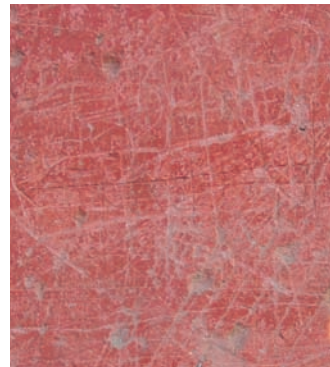
会乘殿，西立面
红色抹灰
涂写及凿痕
Huicheng Hall,
W Facade
Red-colored stucco
Graffiti and gouging

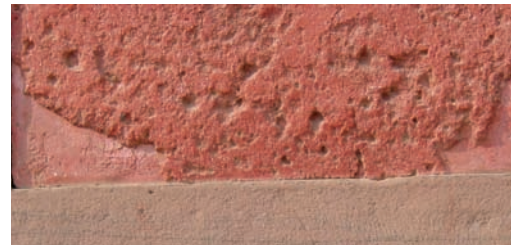
山门，南立面
红色抹灰
不和谐的新加抹灰

Shanmen, S Facade
Red-colored stucco
Incompatible replastering

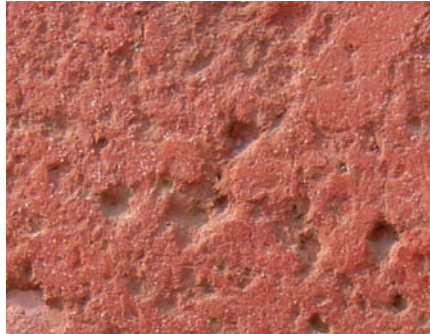
山门，室外南
红色抹灰
孔状脱落及凿痕

Shanmen, S Exterior
Red-colored stucco
Pitting and gouging

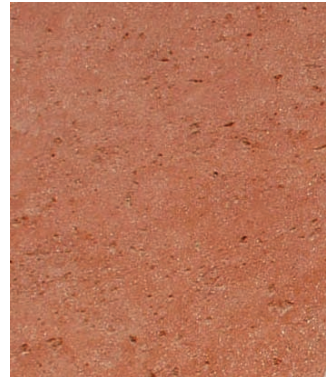
山门，室外南
红色抹灰
孔状脱落及凿痕

Shanmen, S Exterior
Red-colored stucco
Pitting and gouging

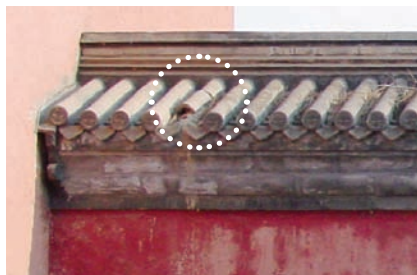
围墙，山门西侧
顶瓦
一片瓦位移

Enclosure wall, W of Shanmen
Roof tile
Displacement of one tile

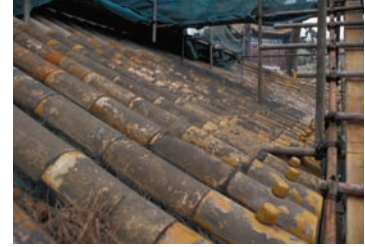
会乘殿，东立面
下檐
琉璃瓦
脱釉
Huicheng Hall,
E facade
Lower eave
Glazed tile
Loss of glaze
