# 彩绘相关构件专有词汇图释

Due to limited access the condition assessment of the interior polychrome painting (*caihua*) was conducted as a brief visual inspection from the ground. Comprehensive photographic documentation and a detailed condition assessment are recommended to build upon this initial survey.

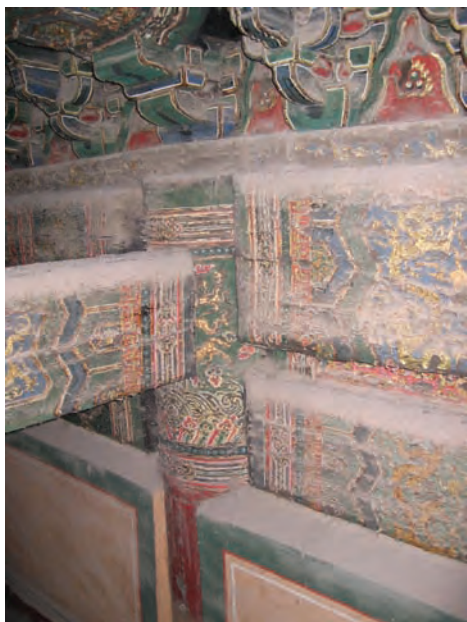
In general, the condition of the interior painted decoration is far better than the exterior. Though there are surface conditions, including flaking, cracking of the paint layer and areas of loss, the paintings maintain much of their original character. Despite a thick layer of dust, the interior *caihua* pattern is often still legible.

The interior painted decoration does not appear to exhibit the same extent of detachment and loss as the exterior (though this was difficult to assess from ground level). Overall, most of the decoration still survives though there are areas where the painting is starting to split horizontally along the middle of the beams. This is usually an indication that the painting is beginning to detach from the underlying wood support.

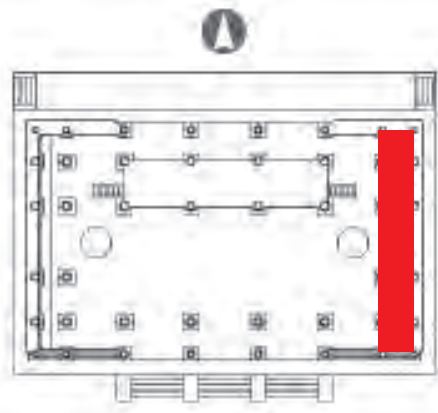
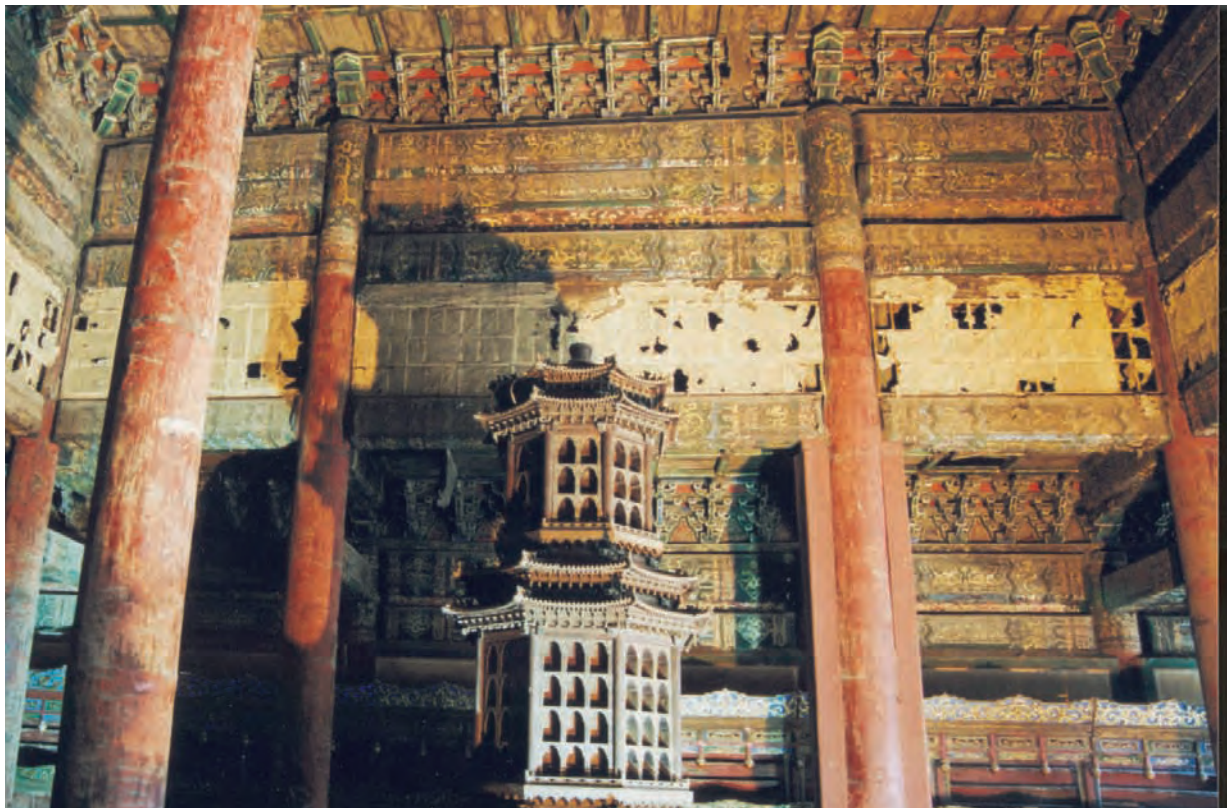
东壁的彩画几乎完全保存下来，但是额枋上局部出现水平开裂的迹象。在上檐局部的地方彩画出现空鼓与凸起，但是在下檐彩画一般状况良好。

The painting on the east wall survives almost in its entirety but is showing signs of horizontal tearing on some areas of the architraves. The painting on the upper register exhibits areas of detachment and bulging while the painting on the lower register appears to be in generally good condition.

东壁彩画全景。

Overall view of the east wall decoration.

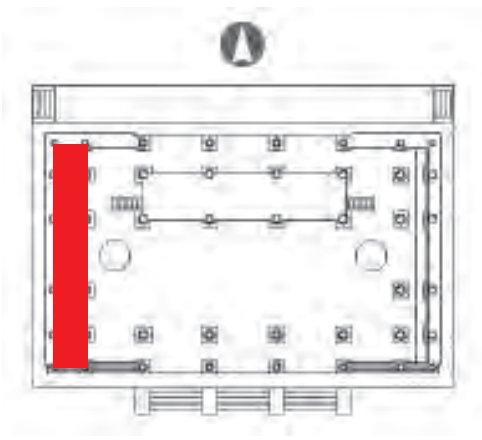
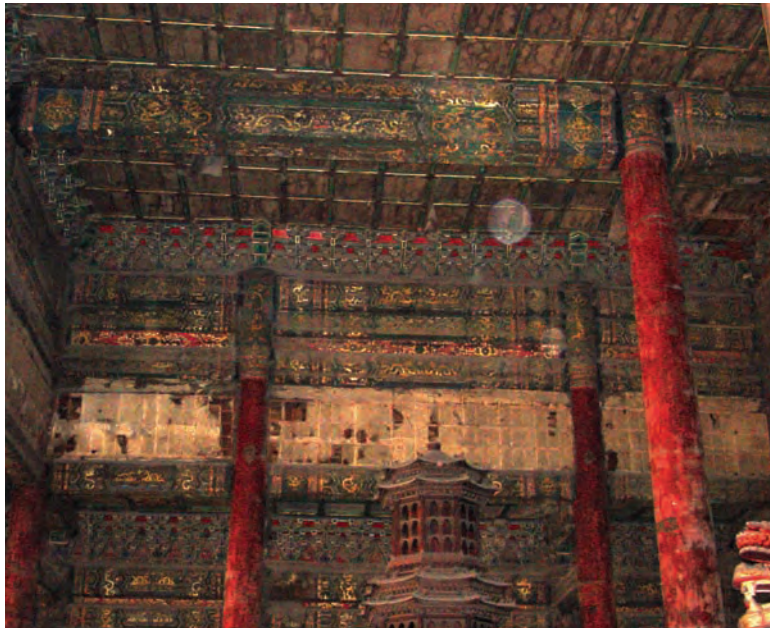
西壁彩画有多处的空鼓与脱落。西壁最南端的彩画的状况最严重，有撕裂，空鼓与大面积脱落的情形。在西壁第三间与第二间的部位也可以看到类似的情形，但是没有那么严重。

The west wall has areas of detachment and loss of painting. The condition of the painted decoration in the first bay is the most serious with tearing of the painting, detachment and large areas of loss. Similar conditions, but less severe, are visible on the second and third bays.

西壁装饰全景。

Overall view of the west wall decoration.

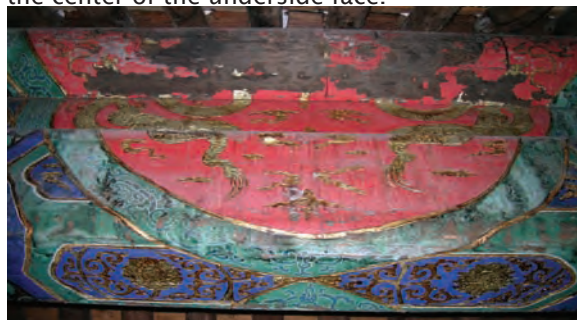
红底金龙袱子纹饰  
Wrapper pattern (*fuzi*) with golden dragons on a red background.

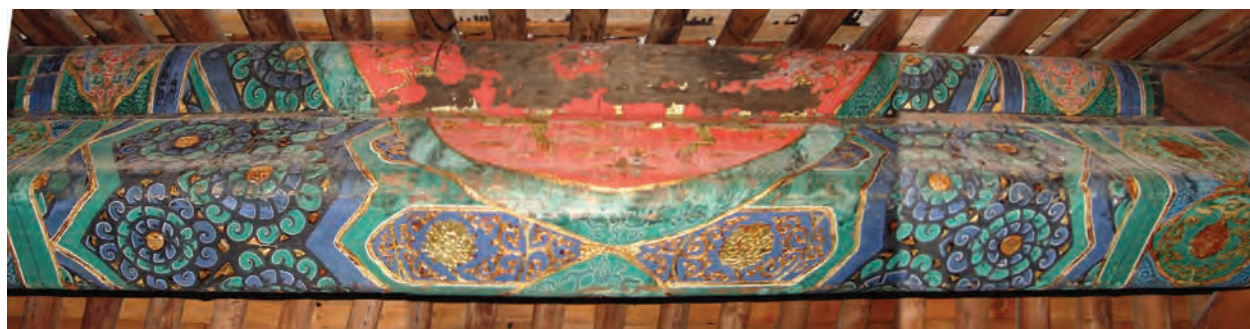
总的来说，脊檩彩画的状况要比其他室内彩画要好。这可能是因为脊檩彩画所在的封闭空间(封隔在天花板上)提供了较稳定的小环境。彩画本身的单皮灰结构也与底下的木基层结合较好(相较其他室内的多层地仗结构)。彩画表面有颜料层脱落，污垢和少量的沥粉起甲。主要的病害有脊檩部位的彩画脱落，木基层的开裂和大片的水渍。

In general, the ridge purlin is in better condition than the rest of the interior caihua. This may be in part because of the enclosed condition (sealed above the ceiling panels in the roof space), providing a relatively stable environment. The single layer plaster also adheres better to the wood support than the multi-layer plaster generally used elsewhere. There are some surface conditions such as loss of the paint layer, staining and a small amount of flaking of the raised decoration. The main forms of deterioration are paint loss, found primarily in the wrapper area of the upper beam, horizontal cracks through the wooden support, and large areas of water stains.

北面构件的合成照片

Photo montage of the north face of the purlin.

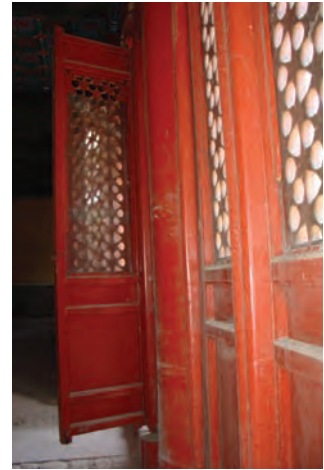
普仁寺重新油漆的门扇。  
Restored architectural  
paint on the doors  
at Puren Temple.

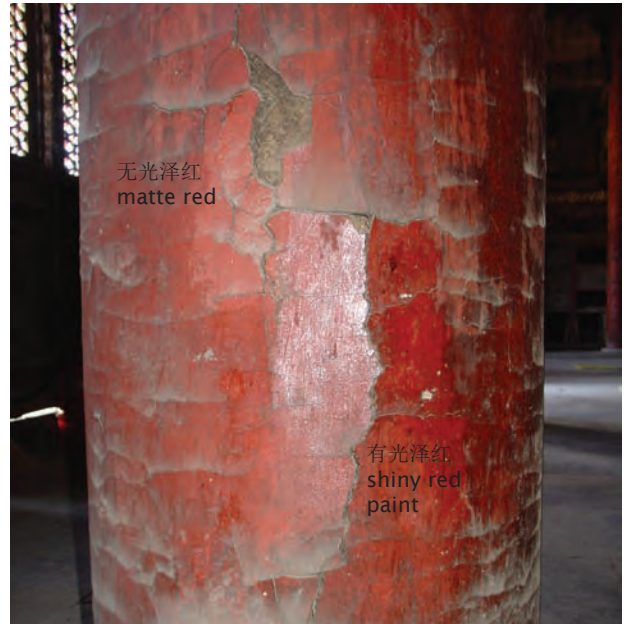
会乘殿西南角重漆的柱子。

Column in the southwest corner of Huicheng Hall.
