Area reference	Object number	Object name or title
11		Stairs from ground to 1st floor corridor Sael/canal room, 14 steps
Object category		provenance
Stairs		built in this house

most recent assessment:	assessor:
8/14/2006	GCI/ICN

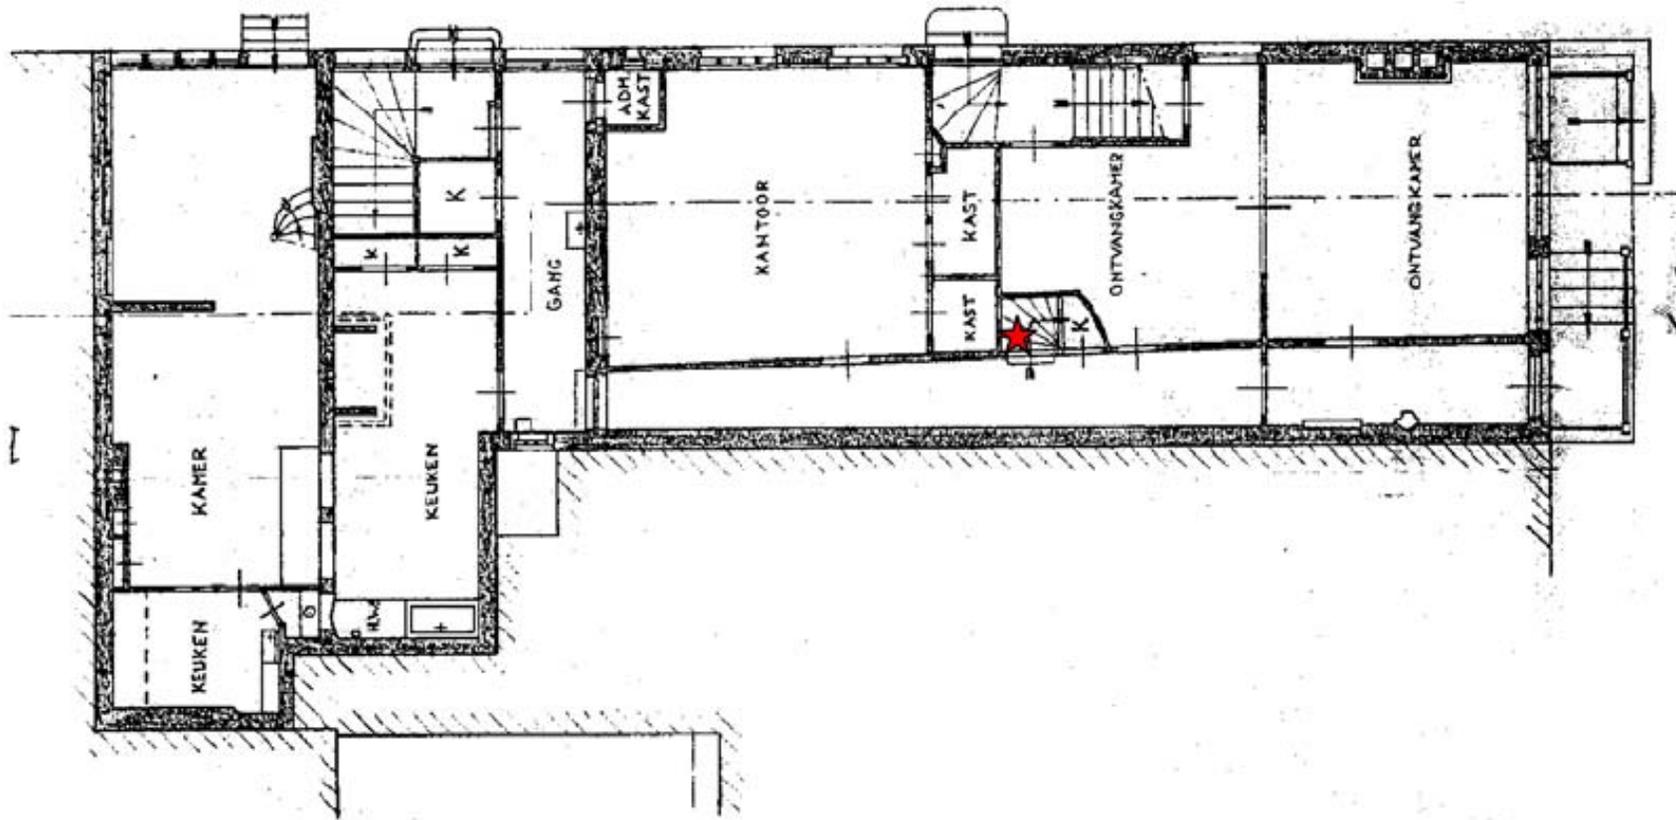
Location of the stairs on the ground floor

description of damage:
 2 turning points visible. Abrasion top step from 31-20 mm, 1st step 31-18/20 mm, 3rd step 31-16 mm (turning point).

comments
 In 2002 they were closed to the public and were taken out of the normal museum routing, because of the extensive abrasion of the steps. These stairs have since only been in use during weddings, and only by the bride.

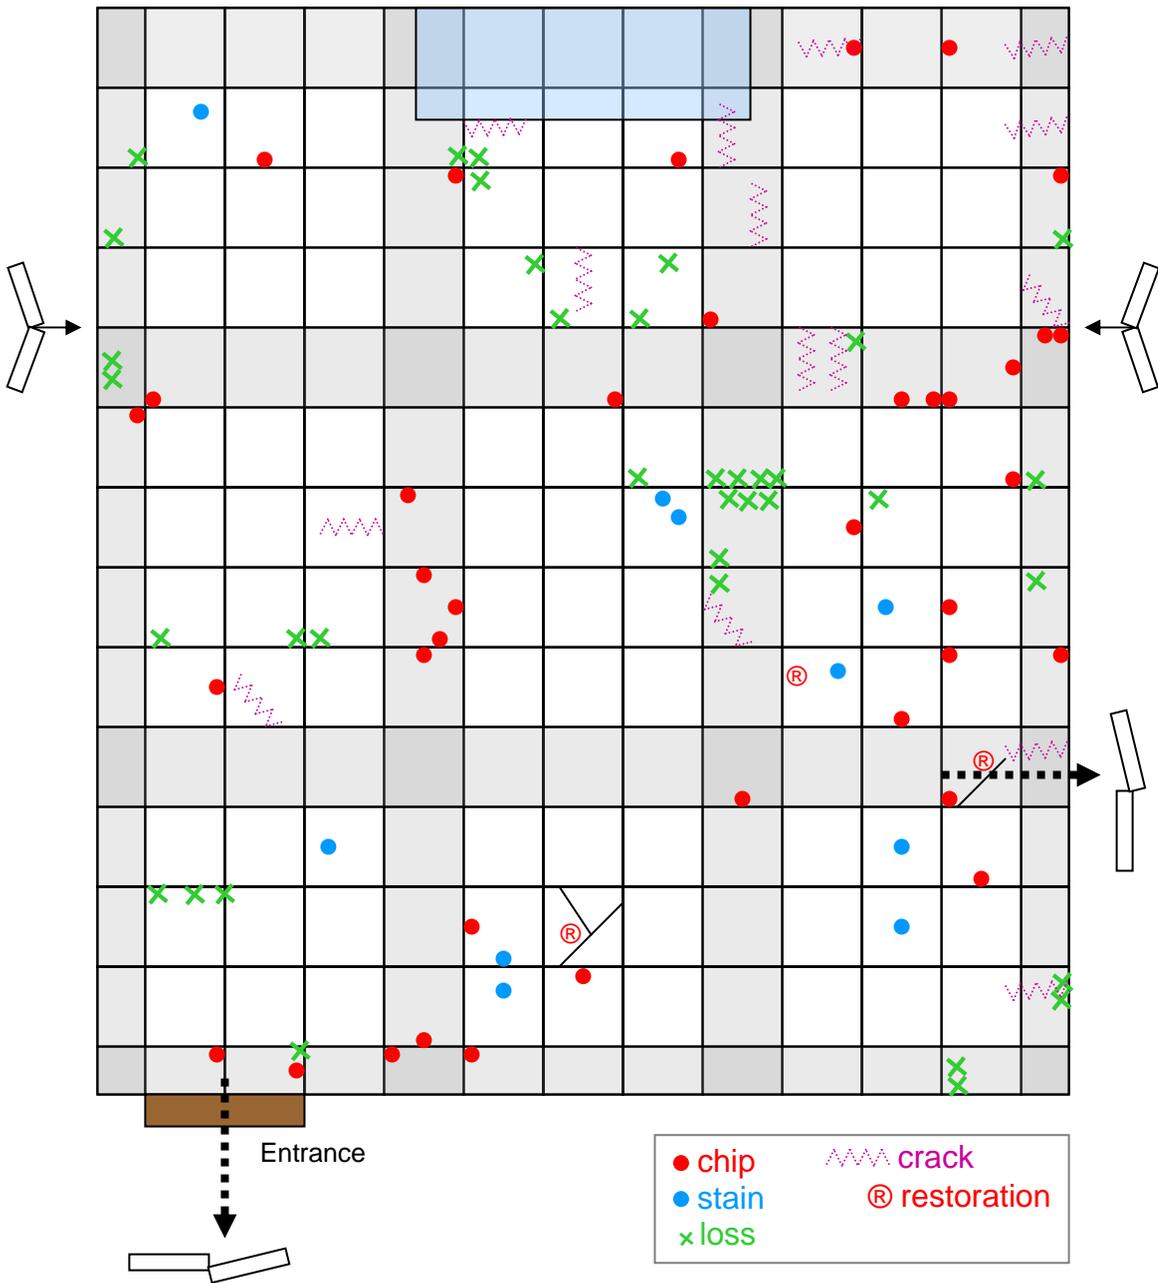
The stone floor in the sael

Chipping of edges, loss of corners. Some previous restorations, cracks, fractures through tiles (NB: natural veins can be mistaken for cracks). Deformation of floor - slanting towards the alley. Some stains. Compression of shell bed causing stress.

Floor has been interfered with during installation of central heating. Floor moves when people walk over it, but its flexible construction is made to deal with this. Maintenance of shell bed is important to prevent damage.

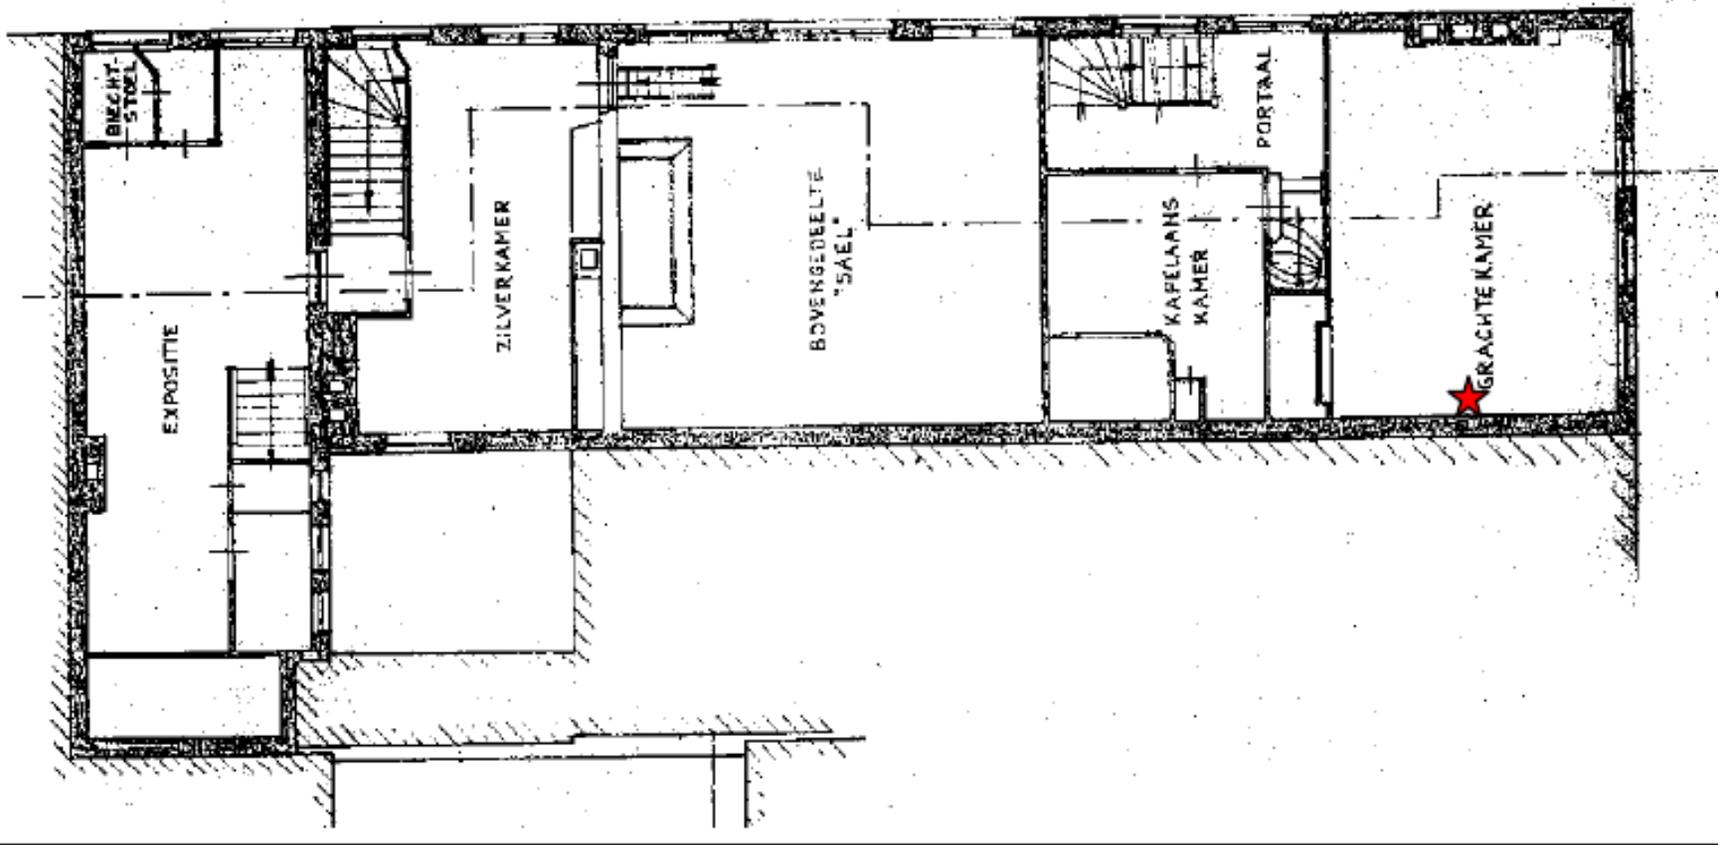
Location of cabinet in Canal Room

Oak wood shrunk, veneer extends for several mm. Minor cracks in oak wood and veneer. Small area of paint loss in right door, inside (possibly corresponding with joint between planks). Dents and scratch marks on bol feet. Dust deposition.

comments	most recent assessment:	assessor:
The canal room is the first room in the tour and is noticeable more dusty then the rest of the house.	8/14/2006	GCI/ICN

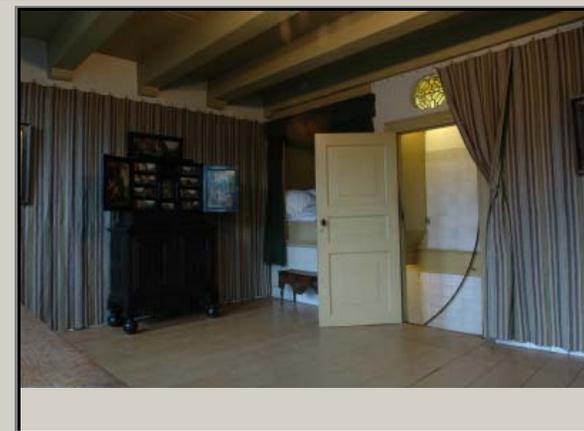
comments	most recent assessment:	assessor:
live adult moths are flying around, probably nesting in the woolen curtains.

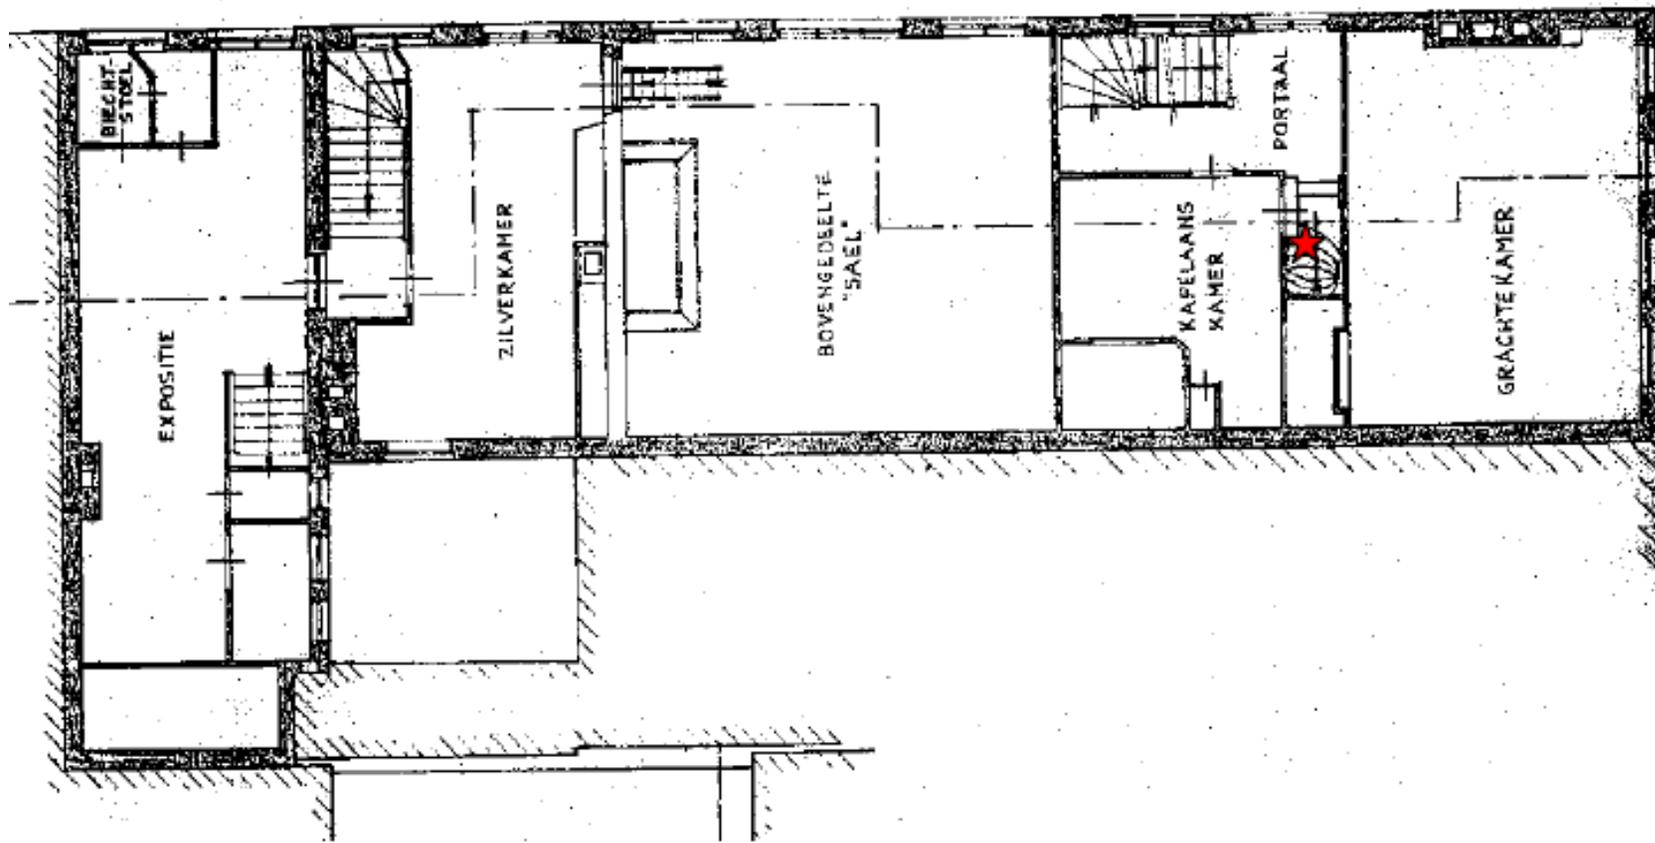
Location of the stairs on the first floor

description of damage: Abrasion of steps, especially in the middle part towards the front of the step. Abrasion 2nd step from 62-52 mm, 6th step 64-58 mm, top 2 steps both 3 mm loss.	visible damage 1	visible damage 4	visible damage 7:
	abrasion		
	visible damage 2	visible damage 5	visible damage 8:
	deformation		
	visible damage 3	visible damage 6:

comments	most recent assessment:	assessor:
It is unclear if the 2 steps to the chaplain's room were ever part of the museum routing in the past but they have not been used for some time now, as this room is closed off for visitation.	8/14/2006	GCI/ICN

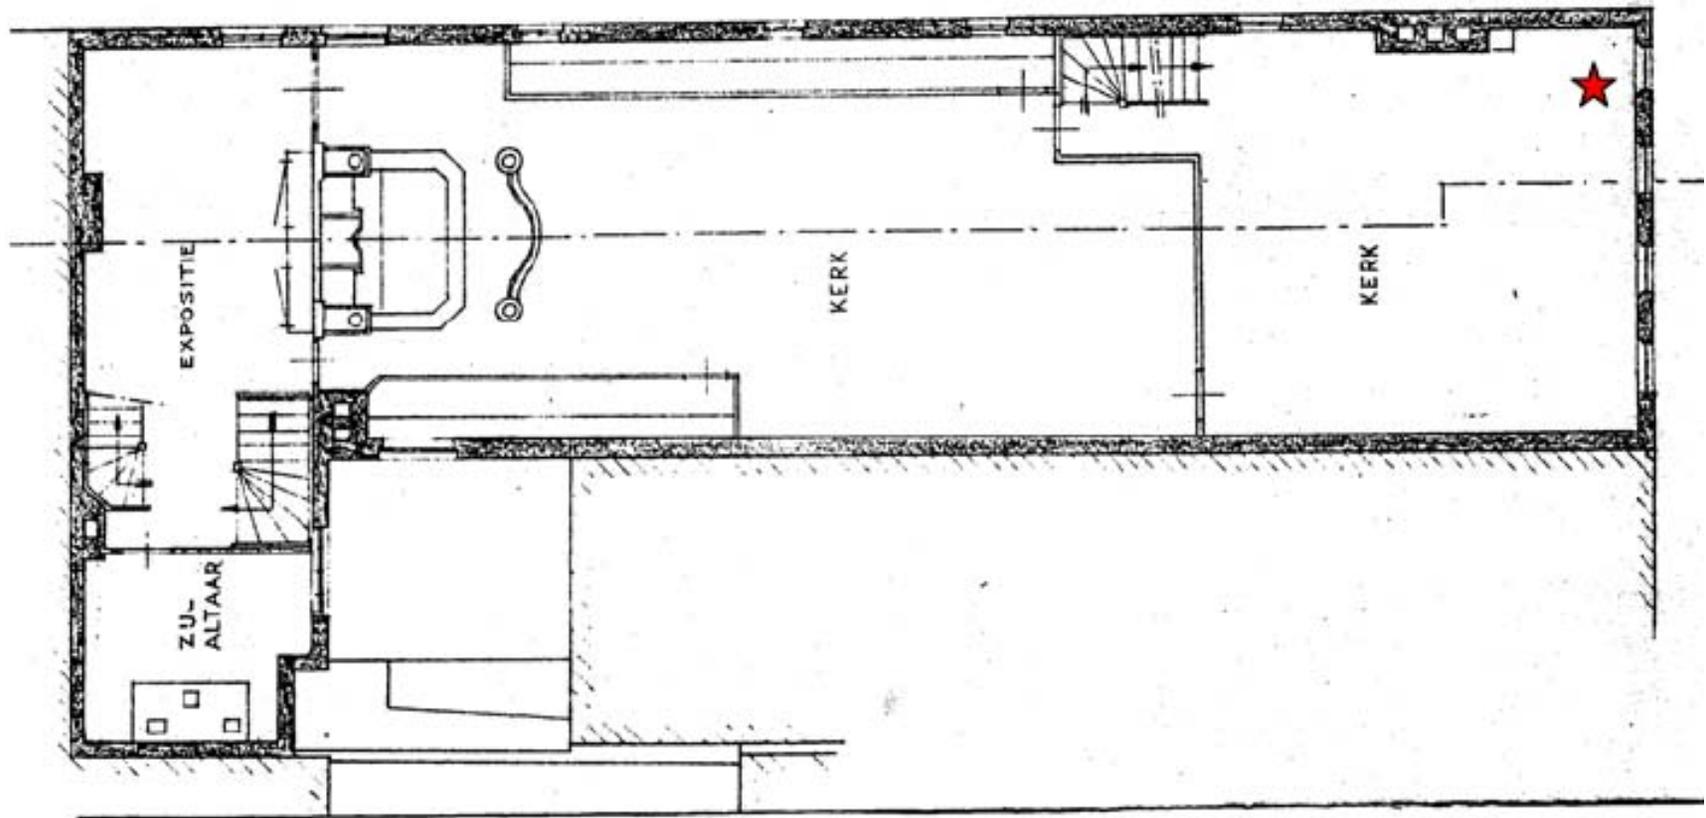
Location of statue in church

description of damage: Wood severely cracked, loss of paint and some ground layer, loss of wood in base, dust deposition (in folds), staining on lower part, old repairs using infills in different colour, evidence of woodborers' activity (inactive), abrasion of protruding parts.	visible damage 1	visible damage 4	visible damage 7:		
	crack	staining			
	visible damage 2	visible damage 5	visible damage 8:		
	flaking/delaminating	loss			
	visible damage 3	visible damage 6:			
	soiling	abrasion			
damage caused by 1	damage caused by 2	damage caused by 3	damage caused by 4	damage caused by 5	damage caused by 6:
PF 3/9 inherent stress	PF 2/3 maintenance/repai	PF 3/3 handling	Cont 3/1 dust	Cont 2/3 cleaning spills	Pests 2/2 insects

comments	most recent assessment:	assessor:
Statue is placed in front of S facing window, underneath which is a radiator. In between radiator and statue is a humidifier, set @ 50%.	8/14/2006	GCI/ICN

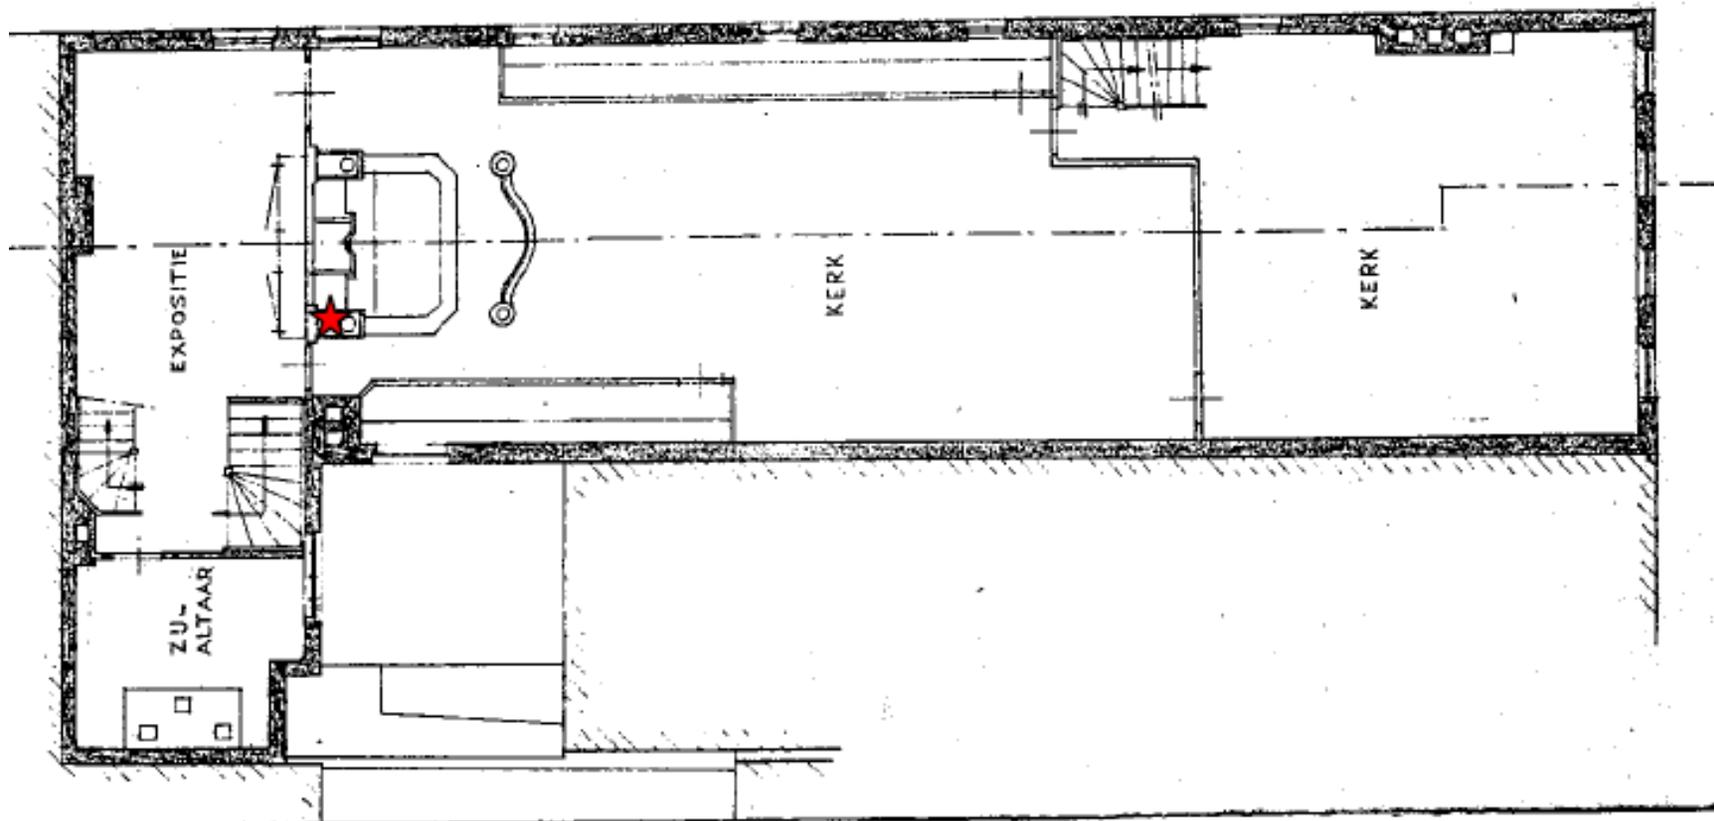
Position of the pulpit cupboard behind the altar in the church

comments	most recent assessment:	assessor:
Because the pulpit is considered fragile, it is seldom shown. It is however assessed that the cupboard is the most fragile part, followed by the mechanics. The pulpit itself is robust and in good condition.	8/14/2006	GCI/ICN

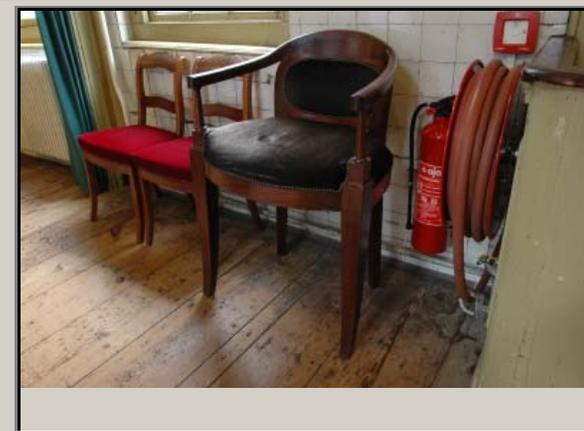
description of damage:
 2 tears in seat (torn on weak area, though considerable force was necessary - possibly heavy person sitting down), loss of veneer on front of seat, slight abrasion, greasy stains on arms, scratches, dents and small stains on legs. Minor light damage.

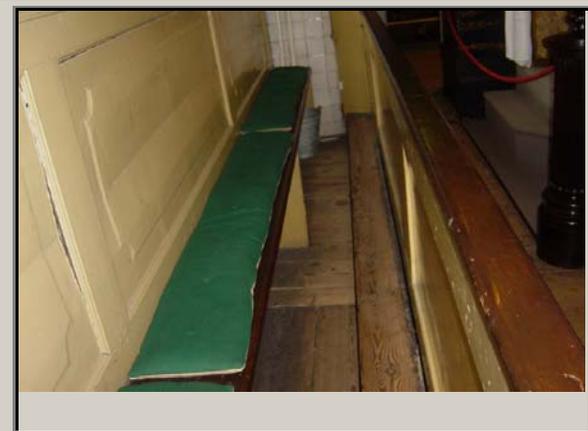
comments	most recent assessment:	assessor:
The other choir bench does not have the damage to the back - it is wider.	8/14/2006	GCI/ICN

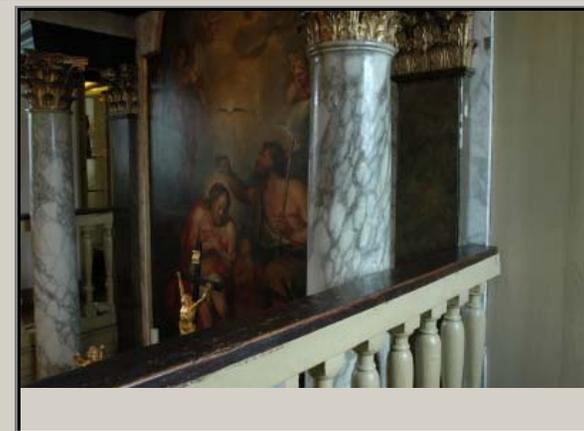
description of damage:
 Craquelure in horizontal ring formation. Chipped paint, paint loss (picking by visitors). Small areas from acanthus leaves broken off/lost. Darker, yellowish appearance where varnished. Previous restorations visible.

visible damage 1	visible damage 4	visible damage 7:			
crazed/craquele	discolouration				
visible damage 2	visible damage 5	visible damage 8:			
chip					
visible damage 3	visible damage 6:				
loss					
damage caused by 1	damage caused by 2	damage caused by 3	damage caused by 4	damage caused by 5	damage caused by 6:
PF 3/9 inherent stress	PF 2/4 use/touching	Cont 3/5 greasy deposit fro	Cont 2/4 object treatment

comments	most recent assessment:	assessor:
Varnish has been applied over old craquelure as protection layer.	8/14/2006	GCI/ICN

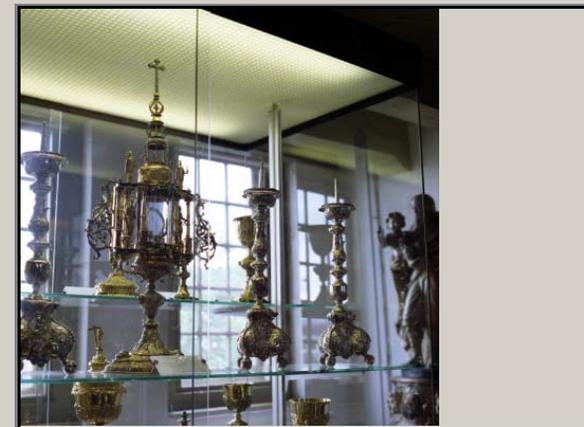
Area reference	Object number	Object name or title
30		showcase with gold and silver liturgical objects
Object category		provenance
Lithurgical objects

visible damage 1
displacement

damage caused by 1	damage caused by 2	damage caused by 3	damage caused by 4	damage caused by 5	damage caused by 6:
PF 3/2 continous vibration

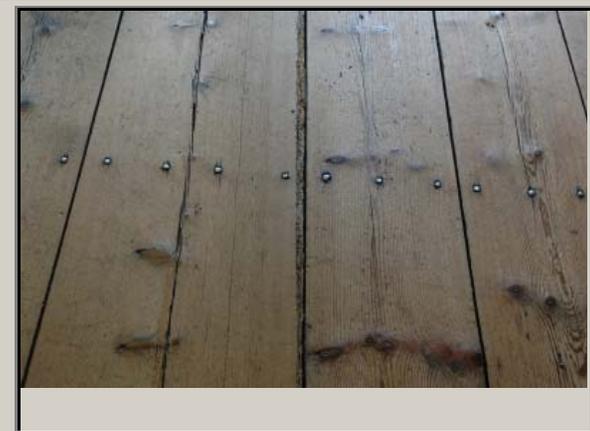
visible damage 1
abrasion

visible damage 2
chip

visible damage 3
deformation

visible damage 4
staining

visible damage 5
soiling

damage caused by 1	damage caused by 2	damage caused by 3
PF 3/5 abrasion	PF 3/8 frequent use	PF 3/9 inherent stress

comments
When replacing or repairing floor parts in the past, the springs were mechanically broken and may now be missing.

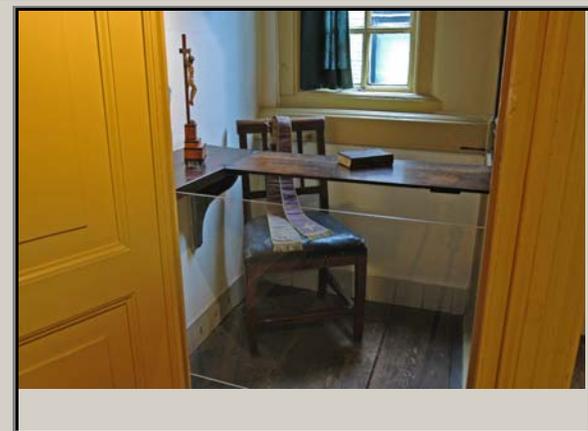
Area reference	Object number	Object name or title
38		Built in confessional with velvet covered stool, waxed linen chair, folding desk, painting, crucifix.
Object category		provenance
Architectural element

Silk stole faded, paint loss on walls, window frame and door post. Stool is sometimes kneeled upon, but no visible damage.

damage caused by 1	damage caused by 2	damage caused by 3
LUV 2 exposure to high int	PF 2/4 use/touching

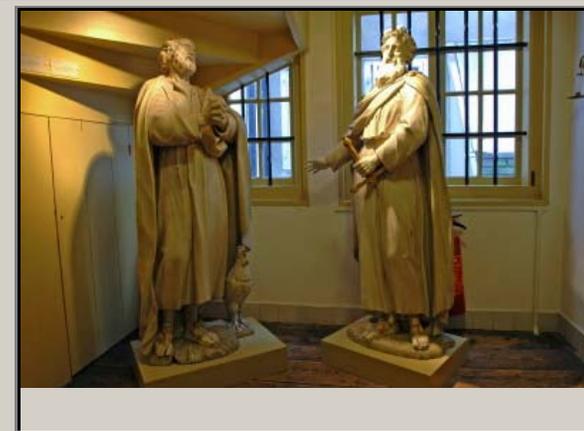
description of damage:
Some loss of paint and ground layer, some construction cracks, dust deposition (in folds), paint drops, evidence of woodborers' activity (inactive). Peter: keys are lost. Paul: abrasion of protruding parts.

damage caused by 1	damage caused by 2	damage caused by 3
PF 3/9 inherent stress	PF 2/3 maintenance/repai	PF 3/3 handling

damage caused by 4
Cont 3/1 dust

damage caused by 5
Cont 2/1 building work

damage caused by 6:
Pests 2/2 insects

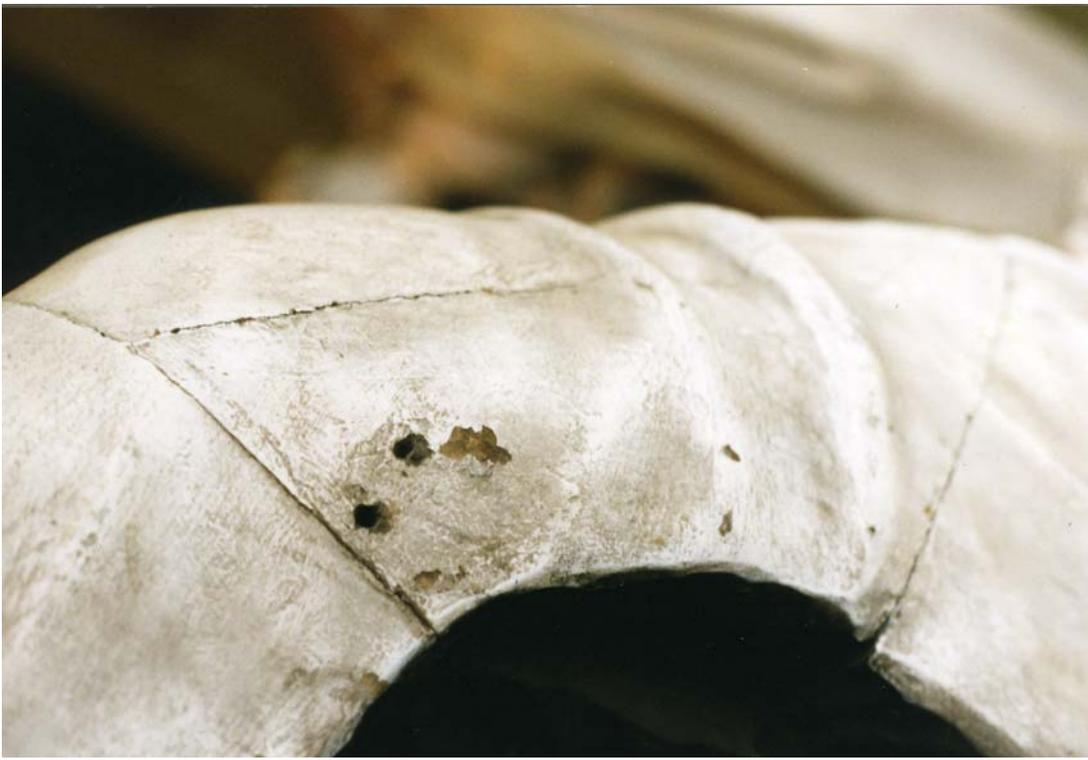
Paul_right_shoulder_18_03_1997.jpg

- Cracks are related to construction, especially crack over right upper arm
- triangular piece is missing from the base near the right foot
- blisters in paint on right leg, that could burst eventually
- some flaking paint

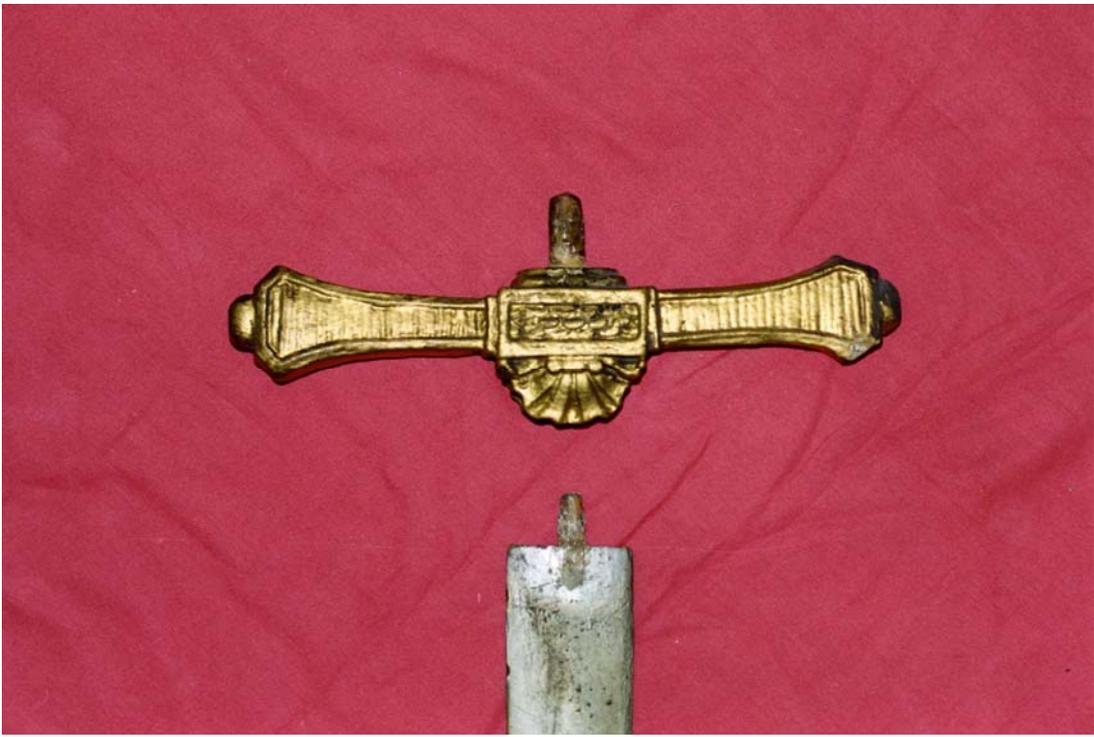
Sword_Paul_14_05_2002.jpg

Blade of sword is loose (abrasion) Direct action.
 Part of finger on righthand is missing
 Some flaking paint
 JUNE 2003: LOOSE PAINT FIXED WITH GELATIN
 PRETREATMENT OF ALCOHOL/WATER 50:50
 APPLICATION BRUSH / INJECTION NEEDLE

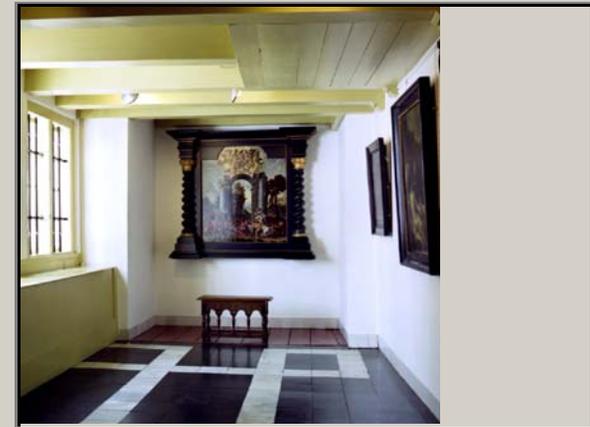
Area reference	Object number	Object name or title
42		White Italian marble and black Belgium hard stone tiled floor. Landing near staircase and part of floor on SW side painted wood.
Object category		provenance
Floors		Built in this house.

Chipping of edges, loss of corners. Some cracks, fractures through tiles. Compression of shell bed causing stress. Wooden landing above stairs severe abrasion (of wood and paint) and deformation. See also stairs (area reference 43)

damage caused by 1	damage caused by 2	damage caused by 3
PF 3/8 frequent use	PF 3/2 continous vibration	PF 3/9 inherent stress

Floor moves when people walk over it, but its flexible construction is made to deal with this. Maintenance of shell bed is important to prevent damage. Surface area of stone 9 m2, of wood 8 m2. Compare abrasion of paint on both wooden surfaces!

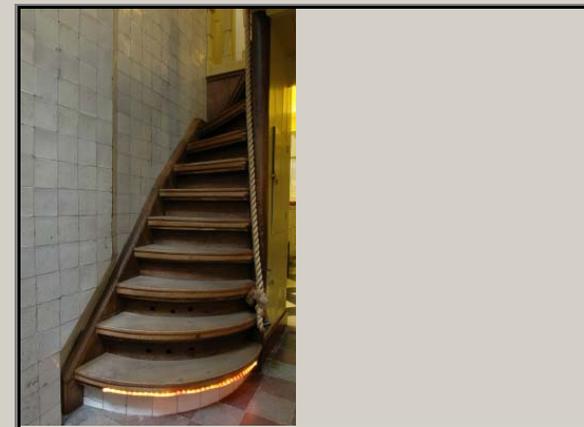
Area reference	Object number	Object name or title
43		Stairs in the back of the house, from 17th C. kitchen to 1st floor, 11 steps, thick rope as hand rail.
Object category		provenance
Stairs and landing

description of damage:
Landing is deformed and severely abraded (9.5 mm difference with first step) - turning point. Grime on pole from handling. Previous metal chain as railing caused dents in pole of stair.

damage caused by 1	damage caused by 2	damage caused by 3
PF 3/8 frequent use	PF 3/3 handling	Cont 3/5 greasy deposit from touching

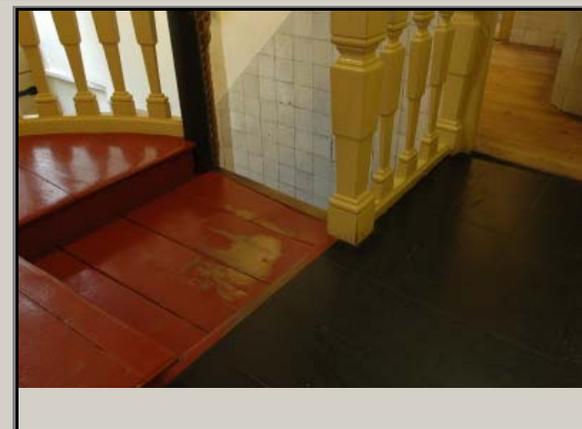
Area reference	Object number	Object name or title
43		Balustrade around landing of stairs in the back of the house, from 17th C. kitchen to 1st floor.
Object category		provenance
Furniture		unknown

description of damage:
Extreme built of grime on railing of balustrade and paint completely abraded away. Denting at bottom plint.

damage caused by 1	damage caused by 2	damage caused by 3
PF 3/8 frequent use	PF 3/3 handling	Cont 3/5 greasy deposit from kitchen

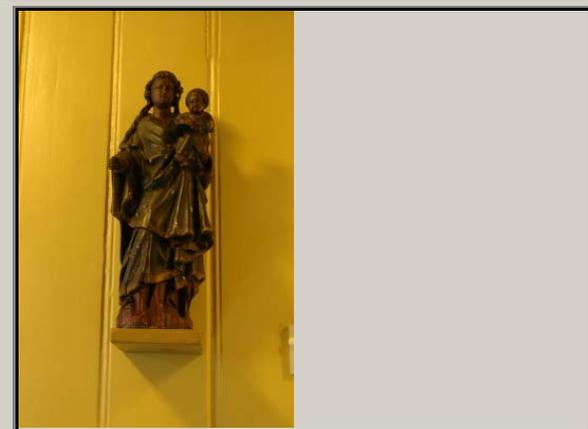
Area reference	Object number	Object name or title
48		Maria and child
Object category		provenance
Sculpture		since 1889 in museum. Stolen in Feb 1957, bought back in Nov 1957.

previous treatment	maintenance	overall condition
1976 and 1981 examined by CL. In 1981 coloured infills (?). In 1997 flaking paint is fixated. Areas of paint loss after 1981 show white ground layer.		unstable presentable
