## 8 Condition assessment

### 9.1.1 Comments with regard to the current condition of the building

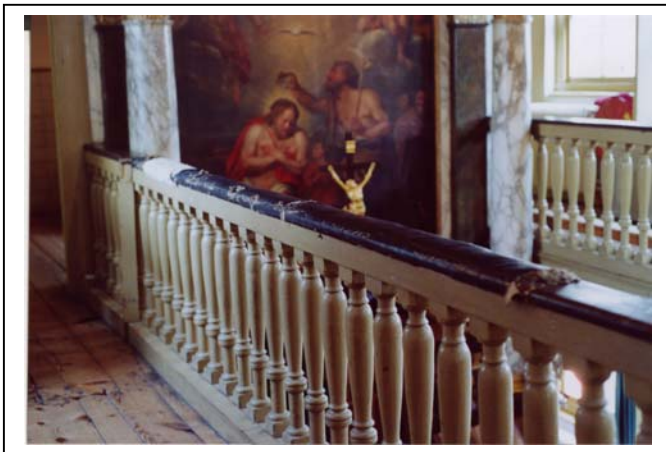
In 2005, the piece of leather and stuffing on the railing of the balustrade on the first gallery was removed. This was very badly damaged (by use?) and the exact purpose of the upholstery was unknown. This upholstery may be reinstated during the planned restoration of the church.

View of balustrade on 1<sup>st</sup> gallery with the leather upholstery still in place (photo: museum Our Lord in the Attic)

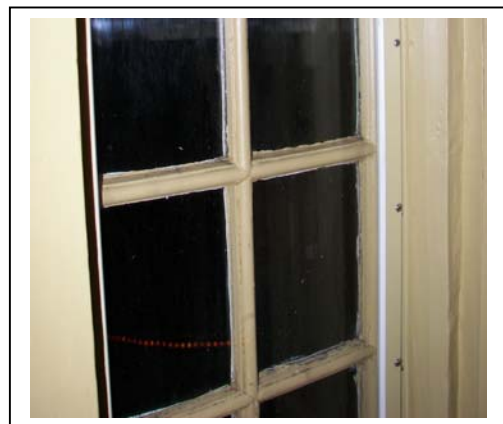
In winter, there is often condensation on the inside of the windows, resulting in rapid decay of the windowsills.

Damage to window sills, accelerated by  
condensation (photo: Paul Ryan)

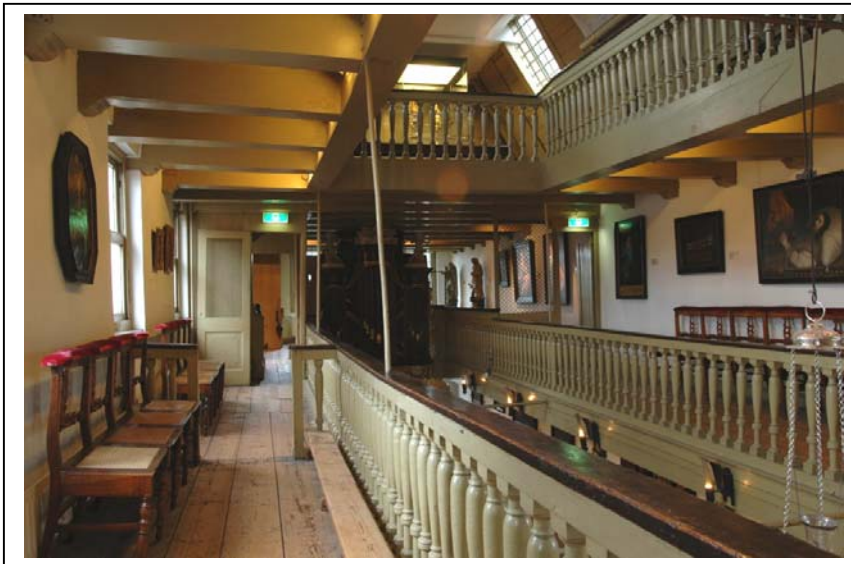
View of the 1<sup>st</sup> and  
2<sup>nd</sup> gallery  
(photo: Paul Ryan)

The flexing of the galleries by their own weight and when loaded with people is mitigated by the vertical tension rods. However the galleries are slightly dipping closer to the altar. One rod (near the altar, on the SW side) was broken (first noticed in the 1970's and not repaired until 2001). At this point the SW 1<sup>st</sup> gallery is sagging more, which could be an indirect result of this damage. The gallery on the opposite side also has a bend, but to a much lesser extent.

There is obviously some movement in the SW 1<sup>st</sup> gallery – the plaster underneath is crumbling away and there is damage to the beam heads.

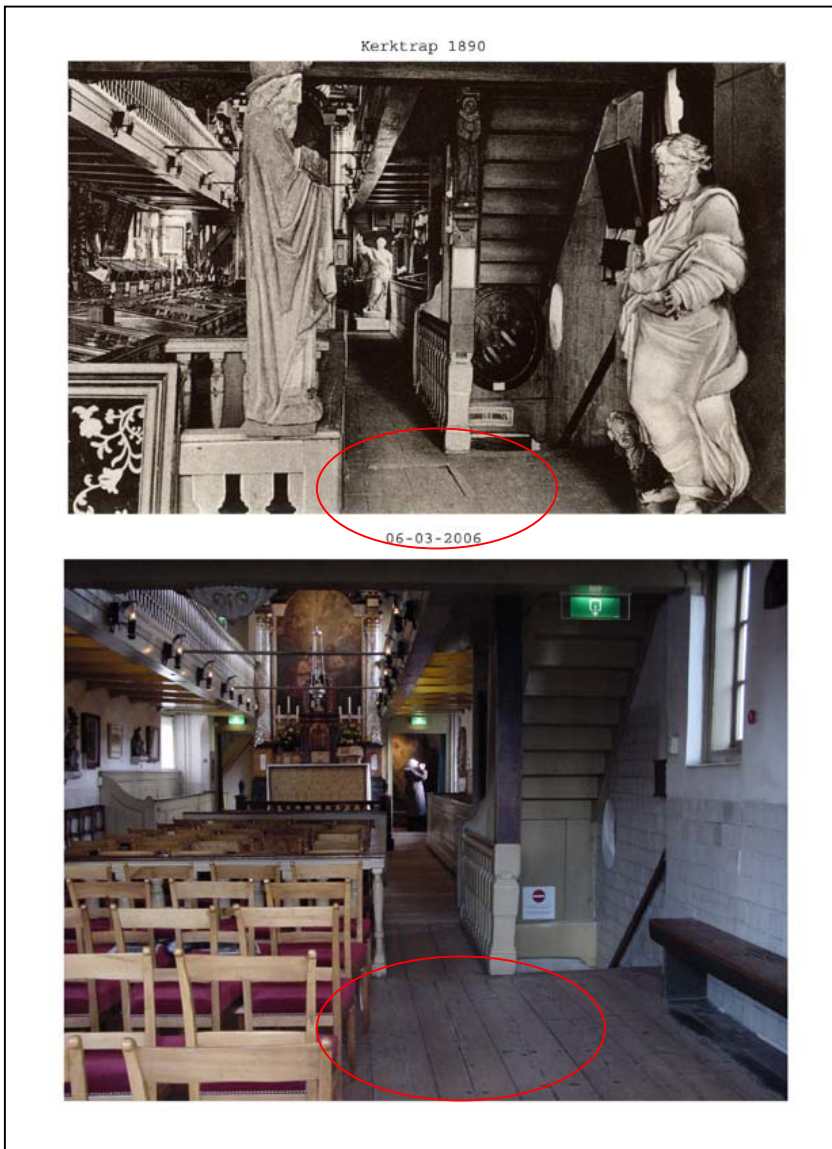
It can be seen from old photographs from the church that some planks were placed elsewhere.

Comparison studies by Marjolein Versluijs (Reinwardt intern with ICN 2006), showing that floorboards next to the steps have been replaced. (source: ICN)

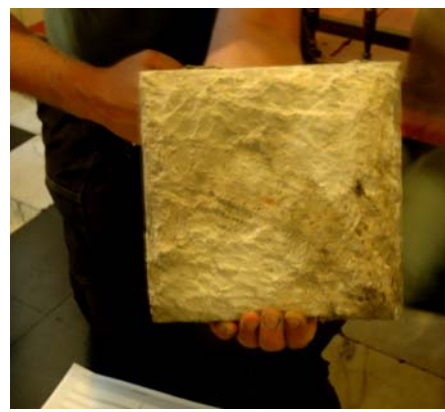
A marble slate being lifted to show  
structure underneath

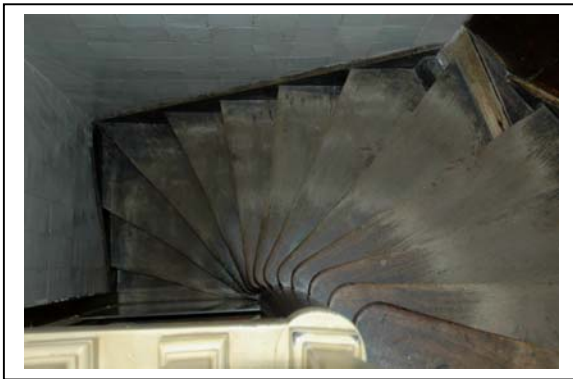
Damage: severe abrasion of steps, especially in the wider part of the triangular shaped steps.

The 17<sup>th</sup> century stairs as seen from the first floor down.

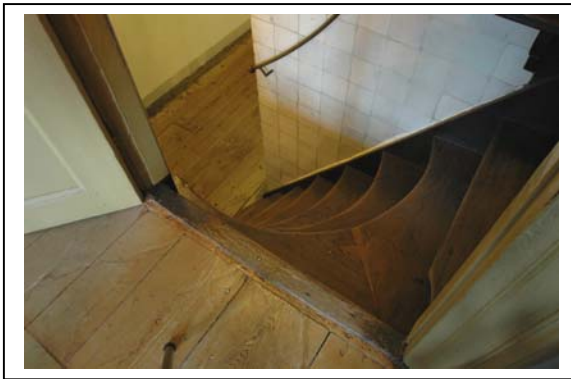
Damage: abrasion of steps, especially in the middle part towards the front of the step.

The 17<sup>th</sup> century stairs as seen from the Canal room. (photos: Paul Ryan)

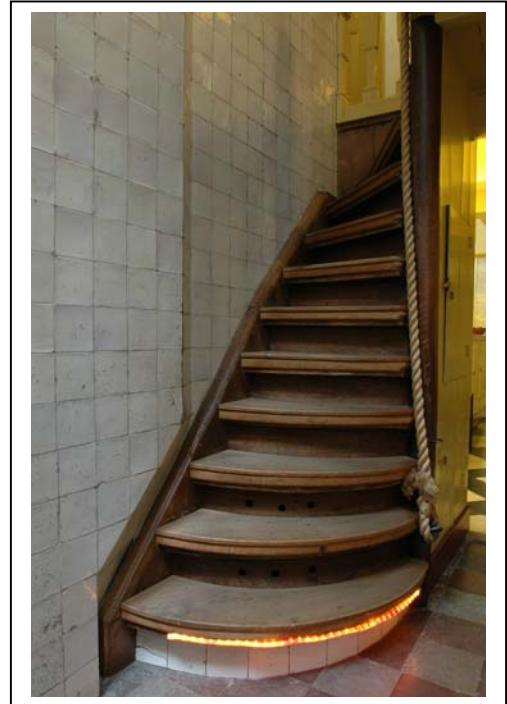
17<sup>th</sup> Century stairs  
(photo: Paul Ryan)

Damage: minor abrasion of steps, especially in the middle part towards the front of the step.

Damage (continued): the top of the stairs is dipping and the floor plank closest to the stairs is severely flexing when stepped upon. The red paint is abraded away in the area where one turns ones feet to enter the Leeuwenberg Room. The brown paint on the railing of the balustrade is largely worn away and in areas there is a thick layer of accumulated grime (from hands). As this layer is also brown, it is difficult to distinguish between paint and grime.

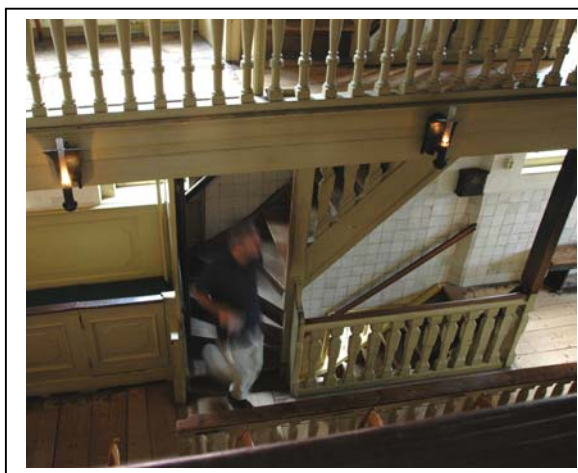
Stairs in the Church

Damage: minor abrasion of steps, especially in the middle part towards the front of the step. Abrasion and grime deposition on railing and posts.

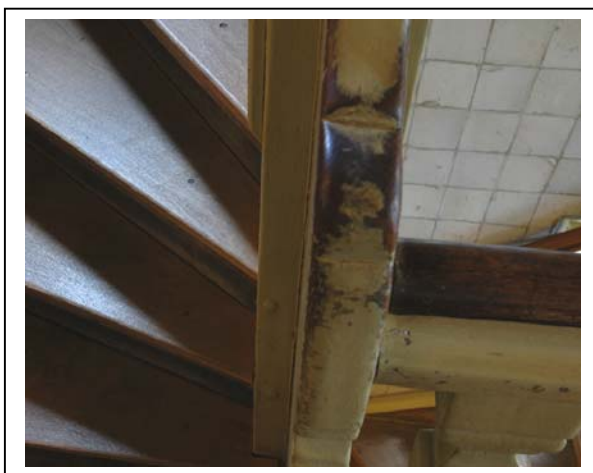
Detail of railing (photos: Paul Ryan)

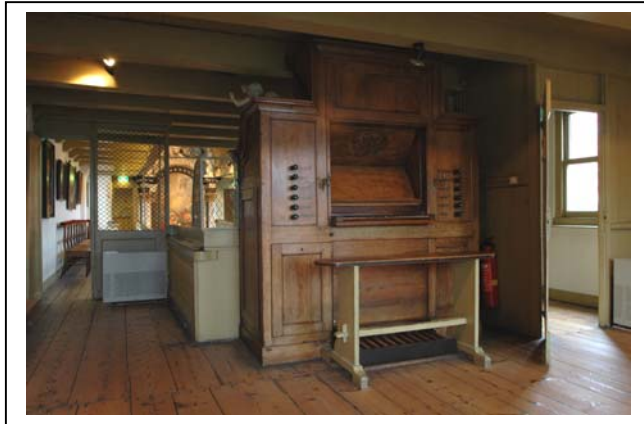
The Organ on the 1<sup>st</sup> gallery  
(photo: Paul Ryan)

The organ is still being played. When played, the balustrade on the first gallery resonates at certain pitches. It is not unlikely that certain building elements and consequently objects attached to these also resonate – some statues in this area are known to ‘walk’

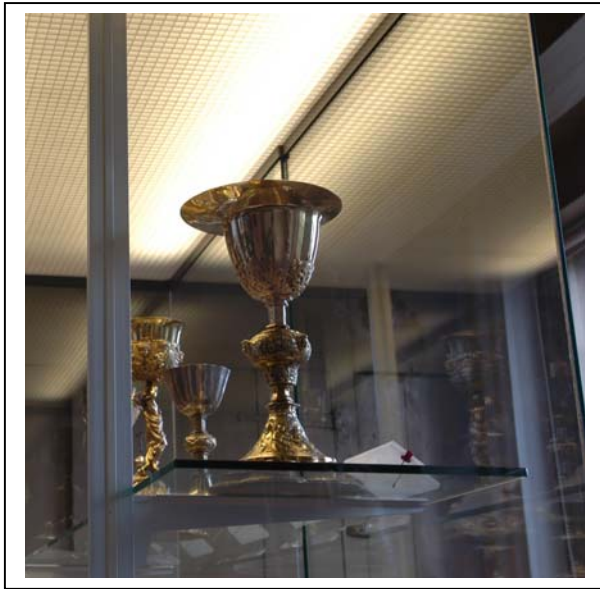
However it is difficult to distinguish if the movement of some objects is more related to the organ being played or to visitor movement, or even outside traffic. The silver objects in the showcase behind the organ are also displaced over time. It is more obvious that visitor movement, causing flexing of the floor, is the main causative factor here. The showcase is unbalanced and the objects within rock when the visitors walk in this area.

Chalice in the showcase on the 1<sup>st</sup> gallery, showing displacement of the cover by visitor induced vibrations. (photo: Paul Ryan)

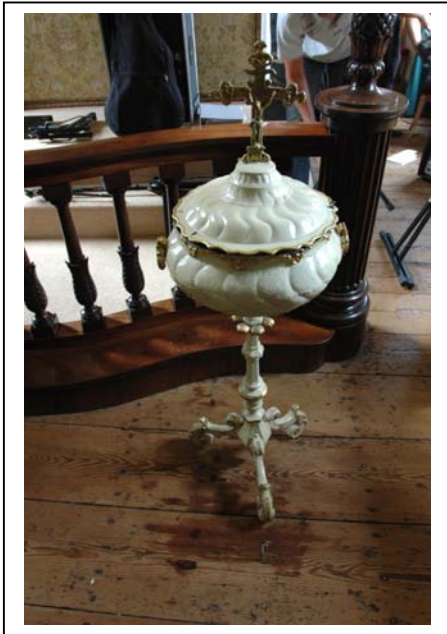
Detail of the water stains caused during baptism.

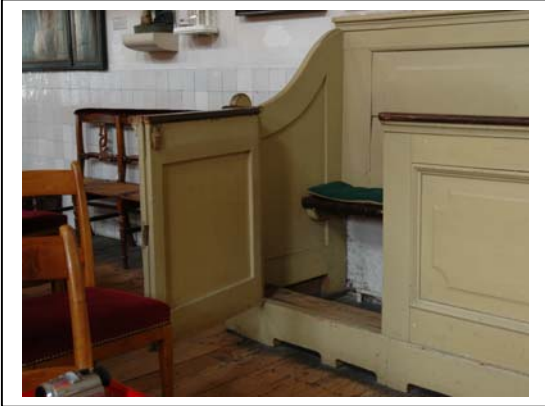
Bench for dignitaries on SW wall  
(photos: Paul Ryan)

The fixed wooden benches for dignitaries on either sides of the church (placed around 1737) are not commonly used, but are still in use during events. The bench on the SW wall is shorter and narrower than the one on the opposite wall. Both benches show many signs of use: the wood is deformed and the balustrades are unstable from people pressing against them. There is paint loss, butches and scratches from direct contact with people. The SW bench is especially unstable and the back seat of the bench is dislodged by people pressing their backs against it. This bench is also at a narrow pathway on the left hand side of the altar.

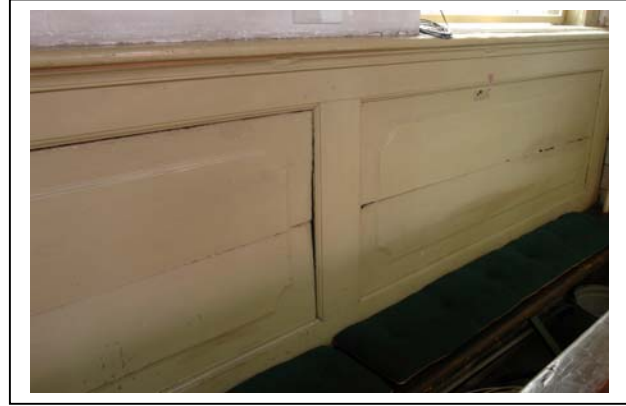
Detail of the dislodged back

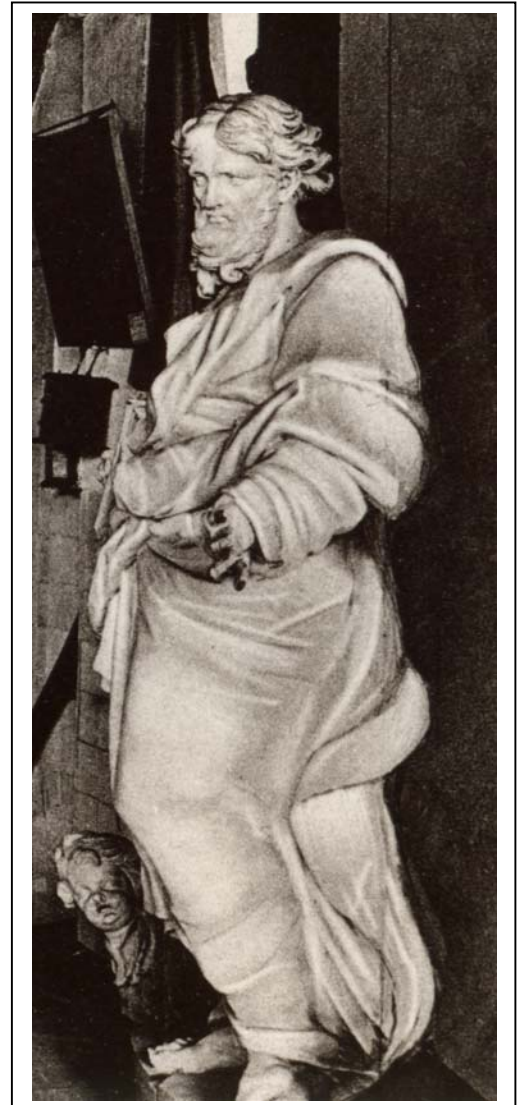
The current location of the statue is difficult, right in front of a humidifier, central heating and south-facing window. The wood responds to the climates changes present but because of the major cracks, this does not appear to result in a tension built-up within the statue. This could explain why no further damage is noticed.

Although the object is vulnerable to damage caused by visitors touching it, there is no visual proof that this is happening. The statue is in a fragile, but stable condition. Treatment of the statue to consolidate the paint and make it more presentable will only be successful if its surrounding conditions are changed. This can most effectively be achieved by placing the statue somewhere else in the museum where more stable conditions exist.

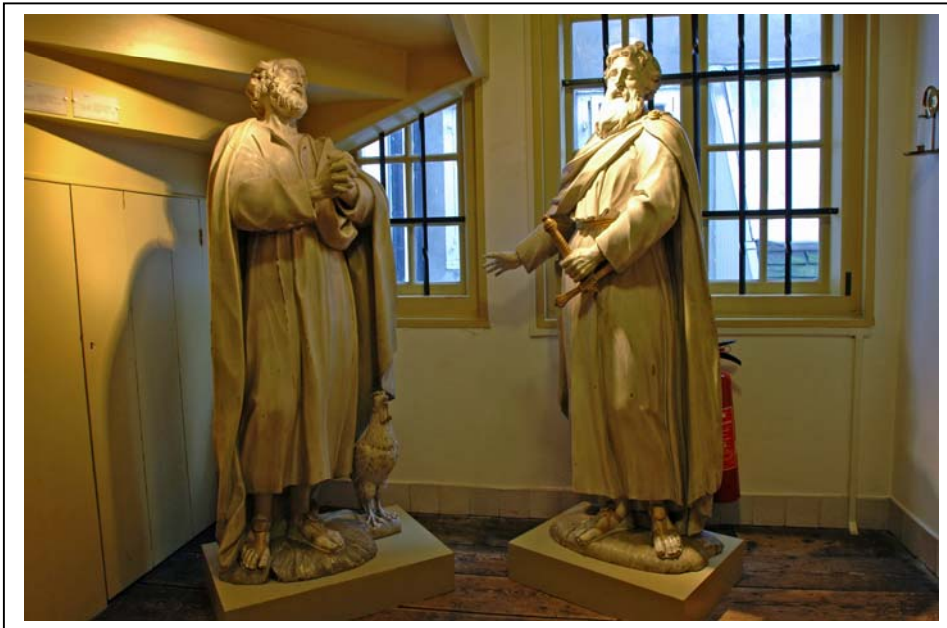
St..Peter and St. Paul in the former confessional (photo: Paul Ryan)

Damage: St. Peter was investigated more closely: St. Peter's keys are missing. Most of the damage is concentrated to the bottom part of the statue (loss of wood, cracks, etc.). The paint layer is crazed and appears locally to be pushed upwards. Minor loss of paint and ground. Some abrasion on protruding areas, dust deposition and discoloration due to dirt, small paint stains (from previous decorating work, possibly before entering the collection). Old insect damage. Since the last condition assessment there has been some minor loss of paint on one of the cracks in the shoulder.

Observations: the statue's condition appears stable since the last treatment, with only minor paint loss on one crack. The paint crazing and uplifting could be a result of the response to climate fluctuations. The shrinkage of the wood is minor and has not resulted in major cracks. Some damage, such as abrasion and dirt, can be directly related to visitors touching the objects. The damage, mainly to the bottom part of the statues, is related to the annual move of these statues. The museum should reconsider moving these statues regularly – if moving them is absolutely necessary, more appropriate moving equipment will have to be used.

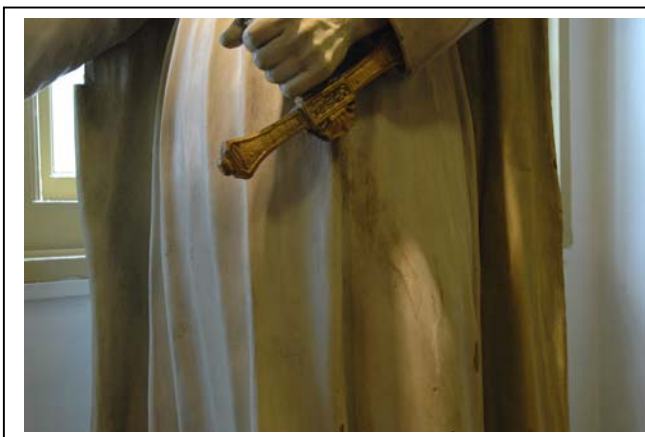
Recently, St. Paul's sword was removed by the curator, in anticipation of possible loss or damage. The sword was loose and visitors were known to touch it, hence the abrasion marks on the robe of St. Paul.

Detail of abrasion near the sword of St. Paul.  
(photos: Paul Ryan)

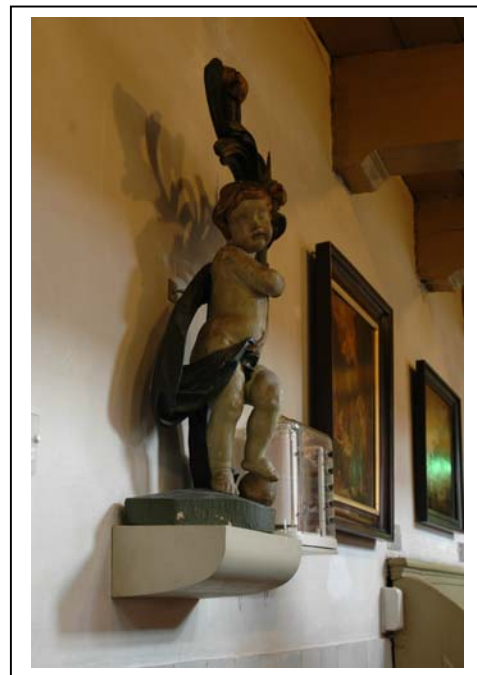
Damage: paint layer is cracked, local paint loss, local paint and ground layer loss, dust deposition and discoloration due to dirt, few water stains, old insect damage.

Observations: Since the last treatment there has been a fair amount of paint loss, which can easily be distinguished from older paint loss (now tinted gray) as it exposes the white ground layer. The object is unstable. There are several contributing factors to this paint loss. Most important are: an inadequate binding of paint to ground layer; fluctuating climatic conditions causing stress in the surface layers; recent handling in calamity.

The perception that the recent water incident stained the wall behind the statue could easily be misinterpreted, but this staining was caused by a previous leakage and was already there in 2004 (photographic evidence). The statue may therefore have been exposed to damp or wet conditions prior to this incident.

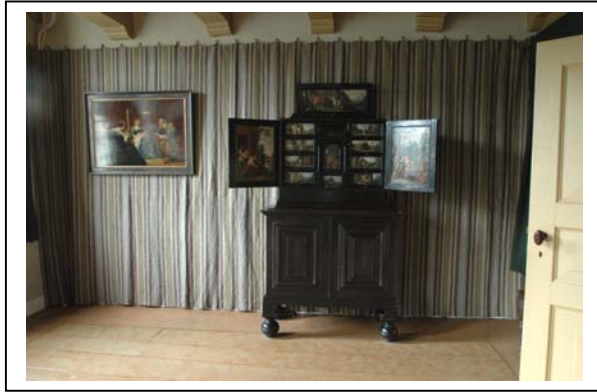
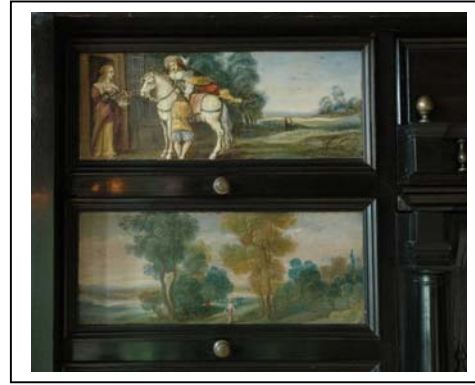
Previous treatment: the painted panel of the top left hand drawer was stolen – all other drawers are now fixed in place using screws at the back and the missing panel was reconstructed. There is a clumsy repair at the bottom of the cupboard where elements have been fixed with nails.

Cabinet in the room and detail of reconstructed stolen panel (photos: Paul Ryan)

Damage: abrasion of protruding parts, veneer is locally split and it extends minimally from the surface. There is a small crack in one of painted doors with minimal paint loss. Damage at ball feet caused by bumping (feet or vacuum cleaner?). The cabinet is dusty, even though it was dusted a few days before the assessment.

Observations: this object is free standing and is inviting to people to touch. This occurs on a regular basis and has, in the past, resulted in a theft. The fact that all drawers are now fixed in place by screws at the back has changed the functionality of the cabinet, but does not appear to result in stress. The small splits in and extension of the veneer is a common damage type and relates to the difference in shrinkage of the main wood and the veneer over time. This makes the veneer more vulnerable, as it can easily break off when dusting or handling the object. The fact that that is not the case can be seen as a sign that cleaning is carried out with care. The abrasion seen on the protruding parts is most likely caused by cleaning over the years. Fluctuating climatic conditions are a contributing factor to the veneer splitting, caused by the difference in shrinkage of the main wood and the veneer (different types of wood, cut in different directions). The crack in the door panel is most likely a result of fluctuating RH. The paint loss appears fairly recent and is expected to slowly continue along the same line in the panel, if current fluctuations persist. This could also occur in other similar areas.

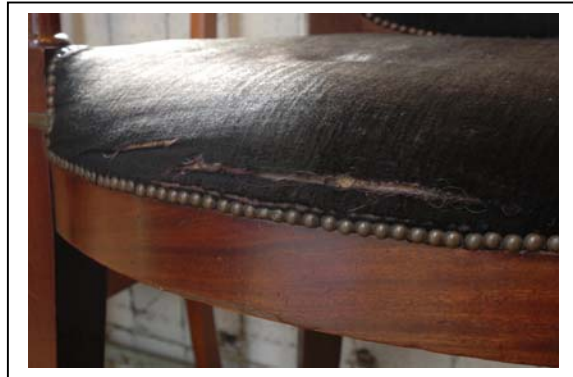
Damage: grime built-up on the armrests. Scratching, denting and some water stains on the legs. Some abrasion of the upholstery and a couple of large tears in the upholstery fabric on the front edge of the seat. Severe dust deposition on the reverse side of the chair.

Detail of tear in seat (photos: GCI)

Observations: this chair is occasionally used – it is the chair of Sinterklaas (refer to 3.2.3). However, it is known that visitors occasionally sit on the chair, because it is in line with two other chairs that are not museum objects. This is obviously confusing to the public. There is no barrier or cord to indicate that this chair is not for normal use. The tear in the fabric of the seat is possibly accidental tearing of an already weakened part in the fabric. If left untreated the tear will rapidly grow and a larger area will be affected – whenever somebody sits on the seat, the tension on the tear causes it to rip further. Other than that, visitors are attracted to touch and poke such areas of damage.

The museum will have to decide the importance of this chair in its current condition and weigh this against the value of the chair in use for Sinterklaas. This will establish if the chair should be conserved or reupholstered. The dust deposition on the reverse side of the chair is a sign of lack of cleaning. The frequency of cleaning the parts that are out of sight should be increased. These pockets of dust are ideal breeding grounds for insects.

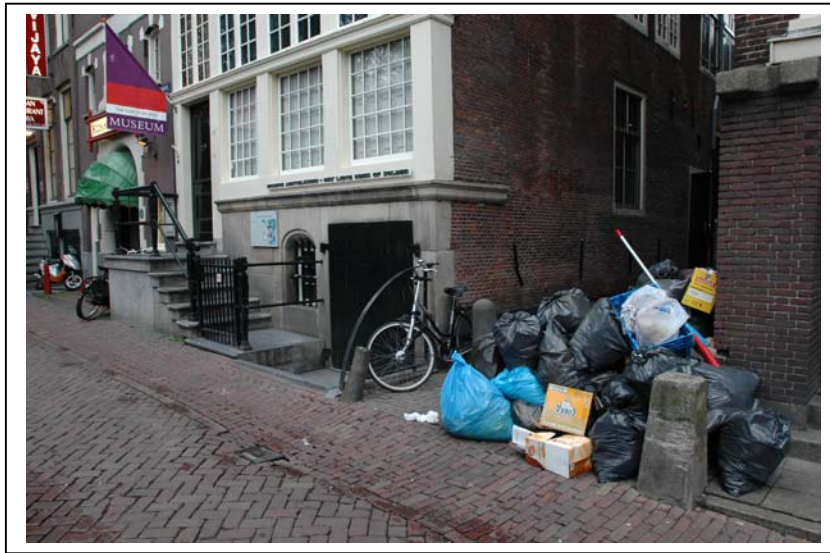
Pile of rubbish waiting to be collected by the council. (photo: Paul Ryan)

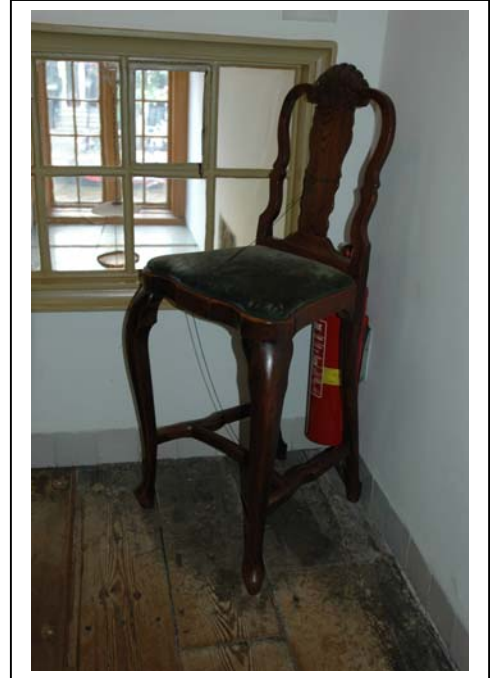
- There is a no smoking policy in the museum and church and the use of candles is forbidden.
- There is frequent contact with the local fire brigade, as the building is open to the public and organizes events. The fire officials have set maximum numbers of occupants for the church and other rooms in the building (refer to 6.3).
- Rooms are equipped with portable fire extinguishers and there are water hoses in the church and all floors. Some of the staff members are instructed to handle this equipment and they are also trained on a regular basis in providing first aid.
- The fire extinguishers are sometimes difficult to reach because of objects placed near or in front of them.

Chair placed in front of fire extinguisher  
(photo: GCI)

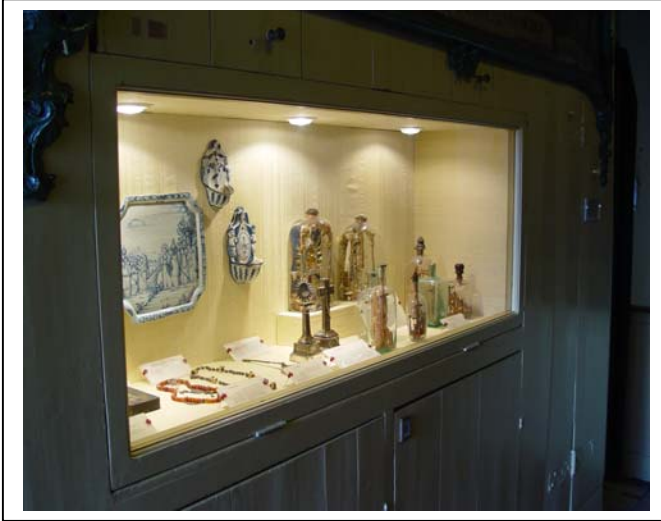
The temperature in the showcases, which are lit from the inside, rises drastically within the first hour. For the 'Varia showcase' behind the altar, the temperature increases by 7 °C within the first hour and there is a 10 °C difference between the day and night situation. The cupboard with the vestments is closed and keeps a fairly stable but low indoor temperature, with a high relative humidity of 68–70%.

Varia showcase behind the altar  
(photo: ICN)

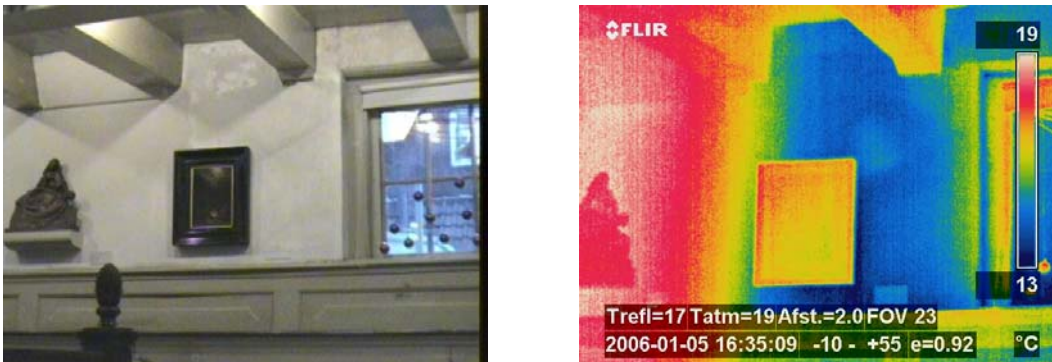
The south west wall in Church, partly and outer wall and inner wall (photos: TU/E)

Above figures show a panel painting on an outer wall in early May 2005. The temperature difference between front and back of the panel was 3 °C, corresponding to approximately 10–15% RH difference. The reverse of the painting absorbs and desorbs moisture much faster than the obverse. This might eventually contribute to warping of the individual planks of the panel.
