# **FIRST PRESBYTERIAN CHURCH OF STAMFORD, CT CONSERVATION MANAGEMENT PLAN**

**FINAL REPORT**

October 16, 2017

# **First Presbyterian Church Conservation Management Plan**

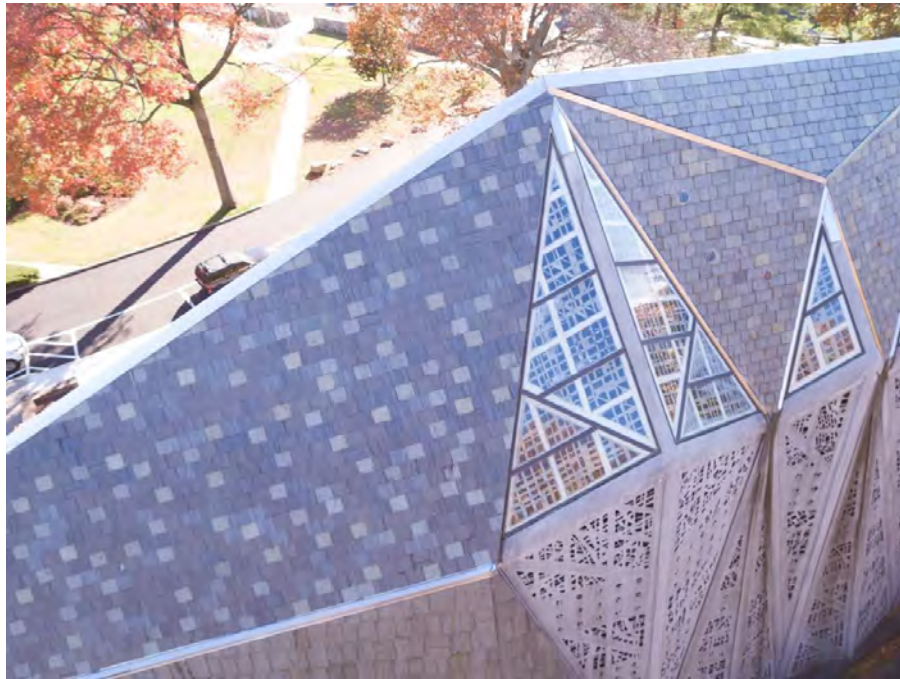
Above: Aerial image of the east elevation (narthex), panel E1, showing replacement *dalle de verre* in epoxy matrix.

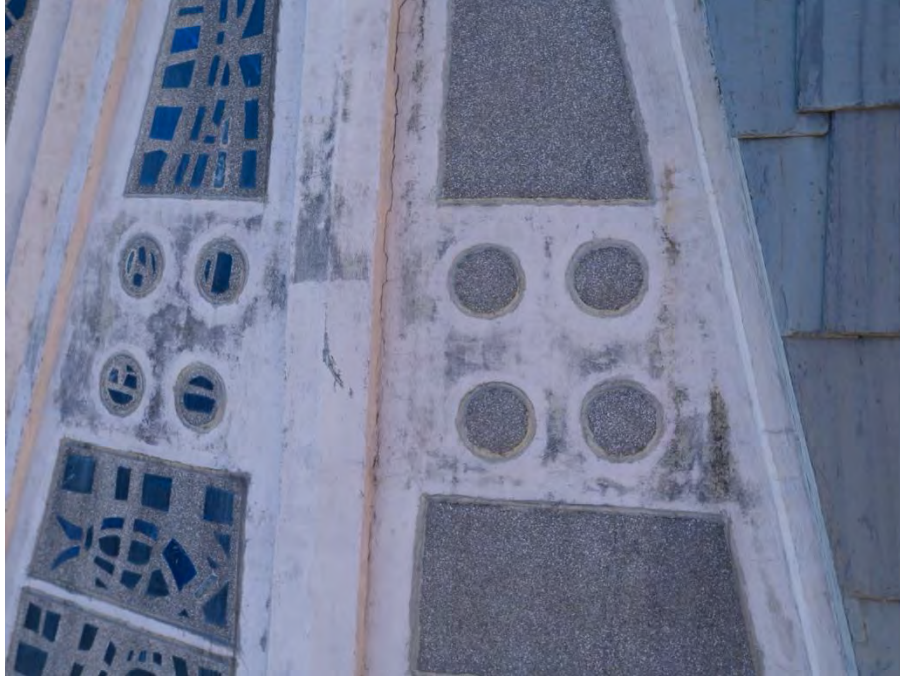
Below: Aerial image of the north elevation (nave), between panels N21 and N20, showing condition of roof slate, original *dalle de verre* in concrete matrix with secondary glazing, and *dalle de verre* portals.

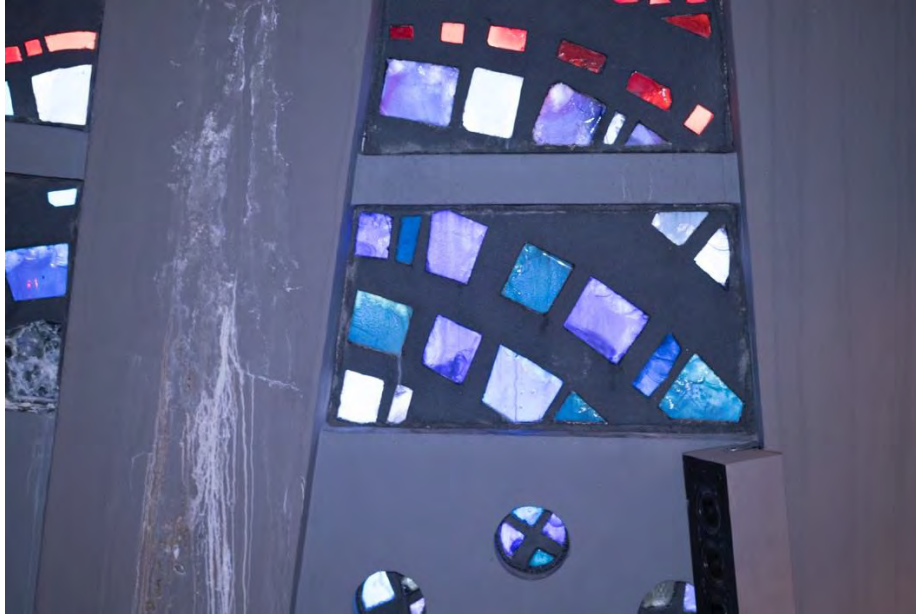
Below: Interior image of the north elevation (nave), panel N9C, showing condition of the original *dalle de verre* in concrete matrix, original suspended lights in foreground. Photo by Propellerheads, November 2016.

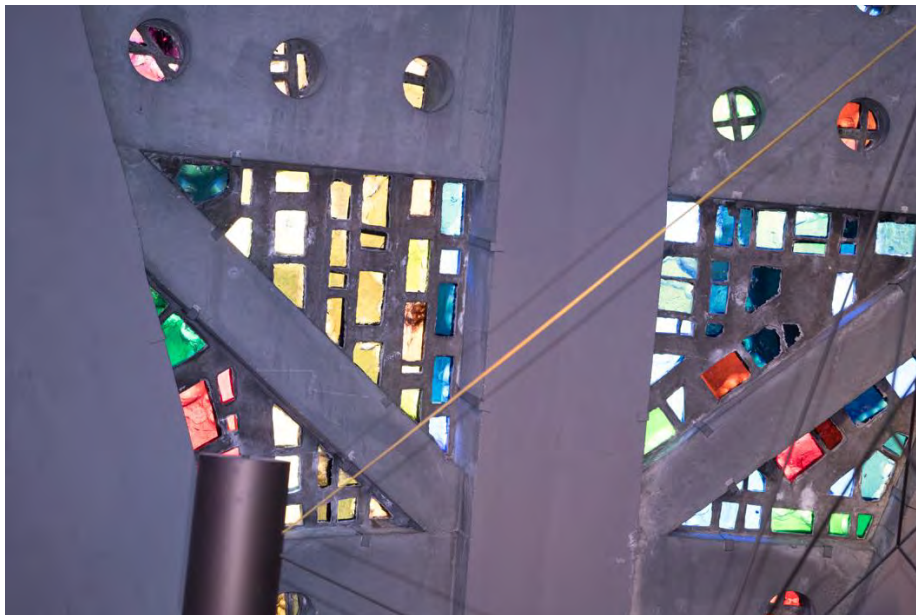
Above: Interior image of the east elevation (narthex), panels E5 and E6, showing condition of the replacement *dalle de verre* in epoxy matrix and condition of the poured-in-place concrete. Photo by Propellerheads, November 2016.

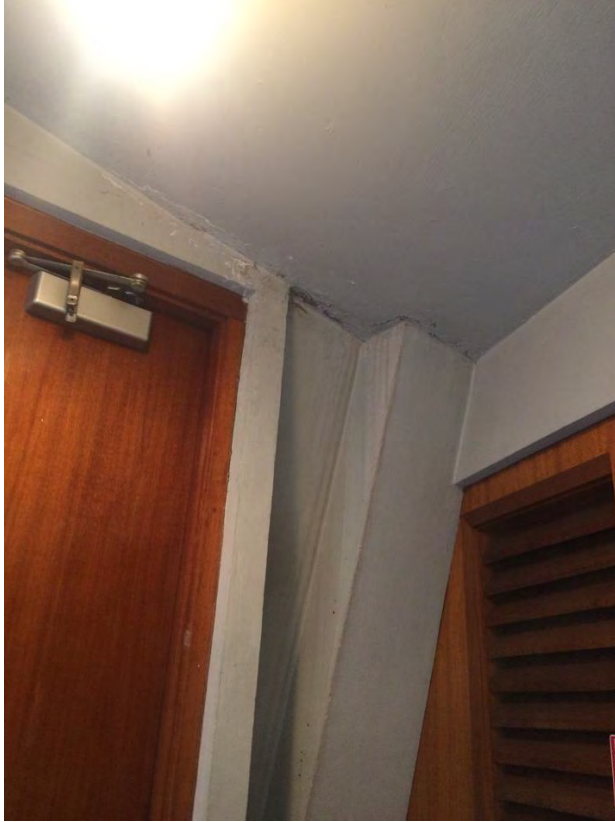
The Sanctuary's interior shows evidence of extensive water damage. In the south, north, and east elevations, there is damage in the form of efflorescence, peeling paint, different degrees of concrete spalling, rebar corrosion, flaking, and cracking of glass *dalles*. Water damage on the interior is evident throughout the inclined precast panels, but appears to be especially severe on the cast-in-place ribs along the roof line and at the ribs connecting the precast panels, as well as at the cast-in-place concrete base (Appendix 4: Figures 16 and 17). Water infiltration is also apparent at the interior of both entrances at the south façade, resulting in flaking and peeling paint, mold stains, cracking, and spalling concrete (Appendix 4: Figures 18 and 19).

Figure 18 (above left): Conditions at interior entrance (SE Narthex).  
Photo by Prudon & Partners.

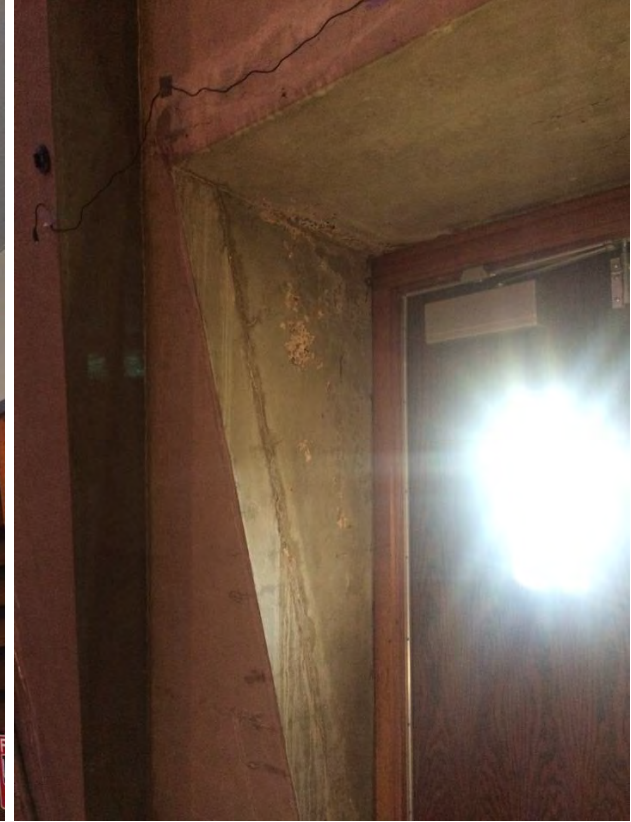
Figure 19 (above right): Conditions at interior entrance (SW Nave).  
Photo by Prudon & Partners.

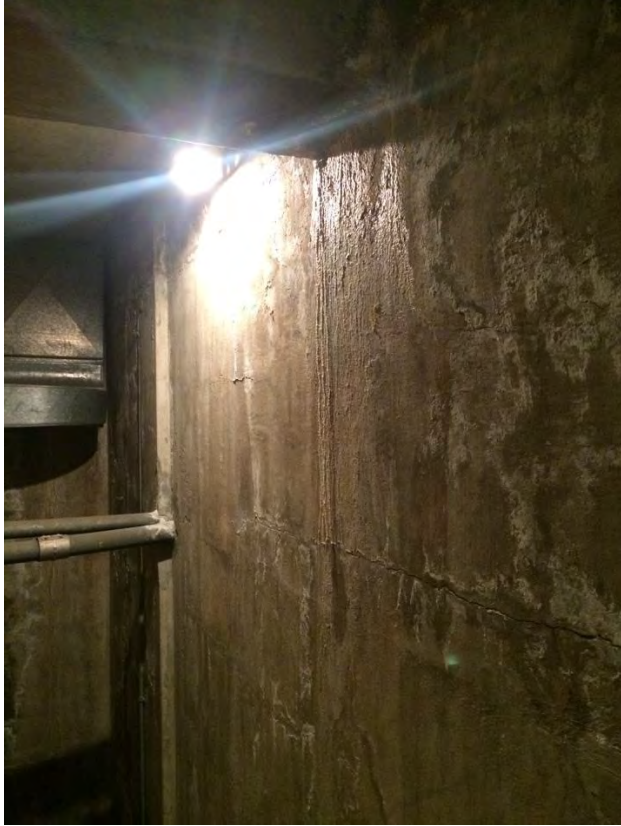
Wet conditions and efflorescence exist at the interior of the foundation wall along the stairs to the fan room (Appendix 4: Figure 20), indicating water infiltration from the main entrance landing above. The landing and stairs are cracked at various locations (Appendix 4: Figure 21).

Figure 20 (above left): Conditions at foundation wall.  
Photo by Prudon & Partners.

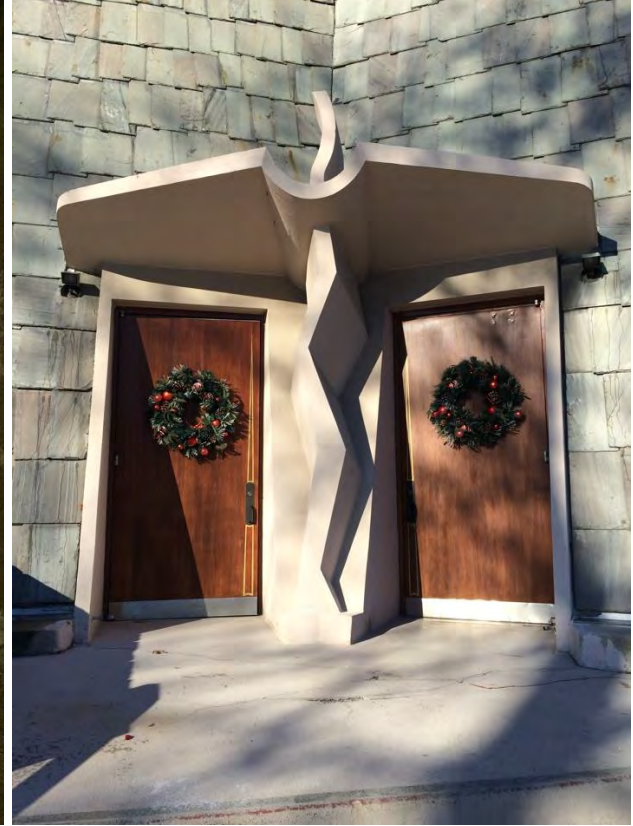
Figure 21 (above right): Conditions at entry landing.  
Photo by Prudon & Partners.

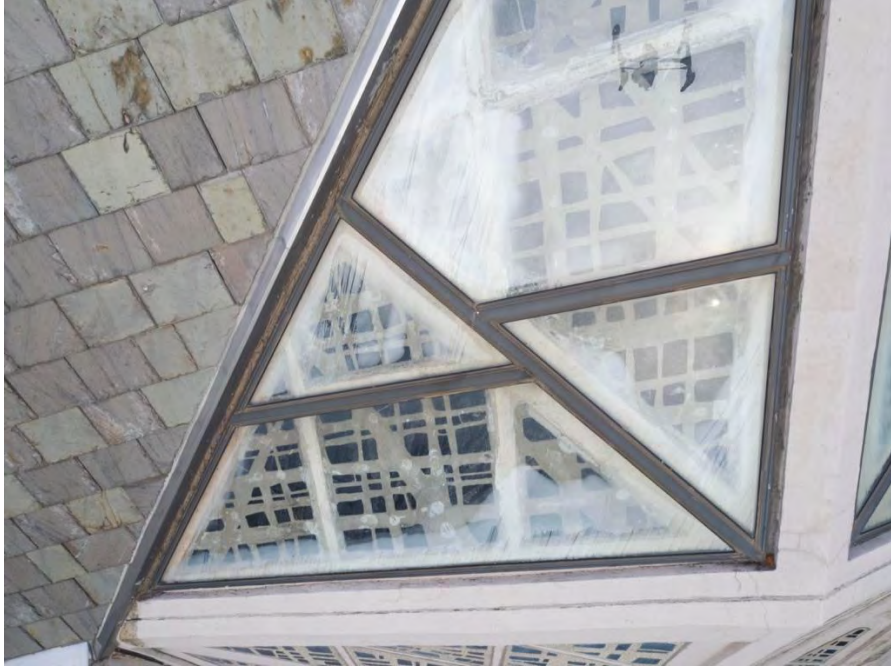
The aerial photos show condensation under the protective glazing over the *dalle de verre* skylights (Appendix 4: Figure 22). The condition at the the roof panels appear to be less severe than the condition of the slanted walls, but the congregants report that fragments of glass occasionally fall into the space from the skylight panels, despite the wire mesh under the skylight *dalle de verre* panels.<sup>373</sup>

Figure 22 (above): Condensation at roof panel secondary glazing.  
Photo by Propellerheads.

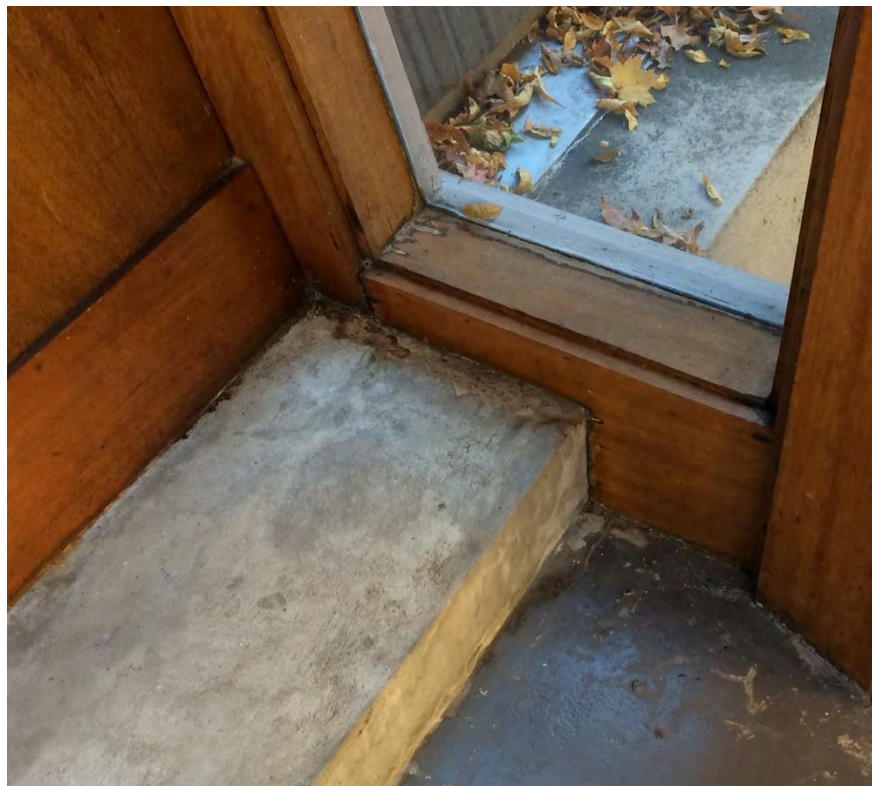
Water infiltration from the roof is not cause for concern in the corridor. There is, however, some infiltration at the walls where the corridor roof meets the north wall of the Sanctuary (Appendix 4: Figure 23). The glass of the window wall is single pane, and there is no climate control in the corridor as a result the water damage may be attributed to condensation (Appendix 4: Figure 24).

Figure 23 (below): Conditions at connecting link and north facade.  
Photo by Prudon & Partners.

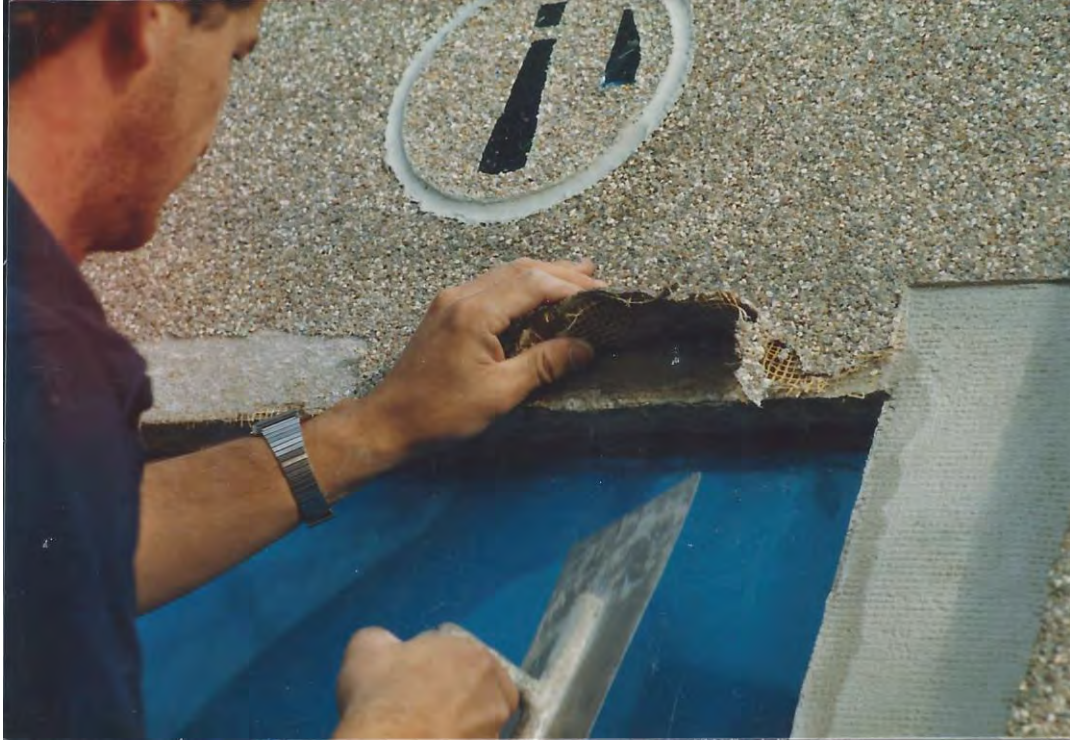
applied to repair the concrete and a cementitious product furnished by the STO Company was utilized. The application included a glass fiber mesh (Appendix 4: Figure 35).<sup>303</sup>

Figure 35 (above): Removing STO coating.  
Source: Rohlf Archive.

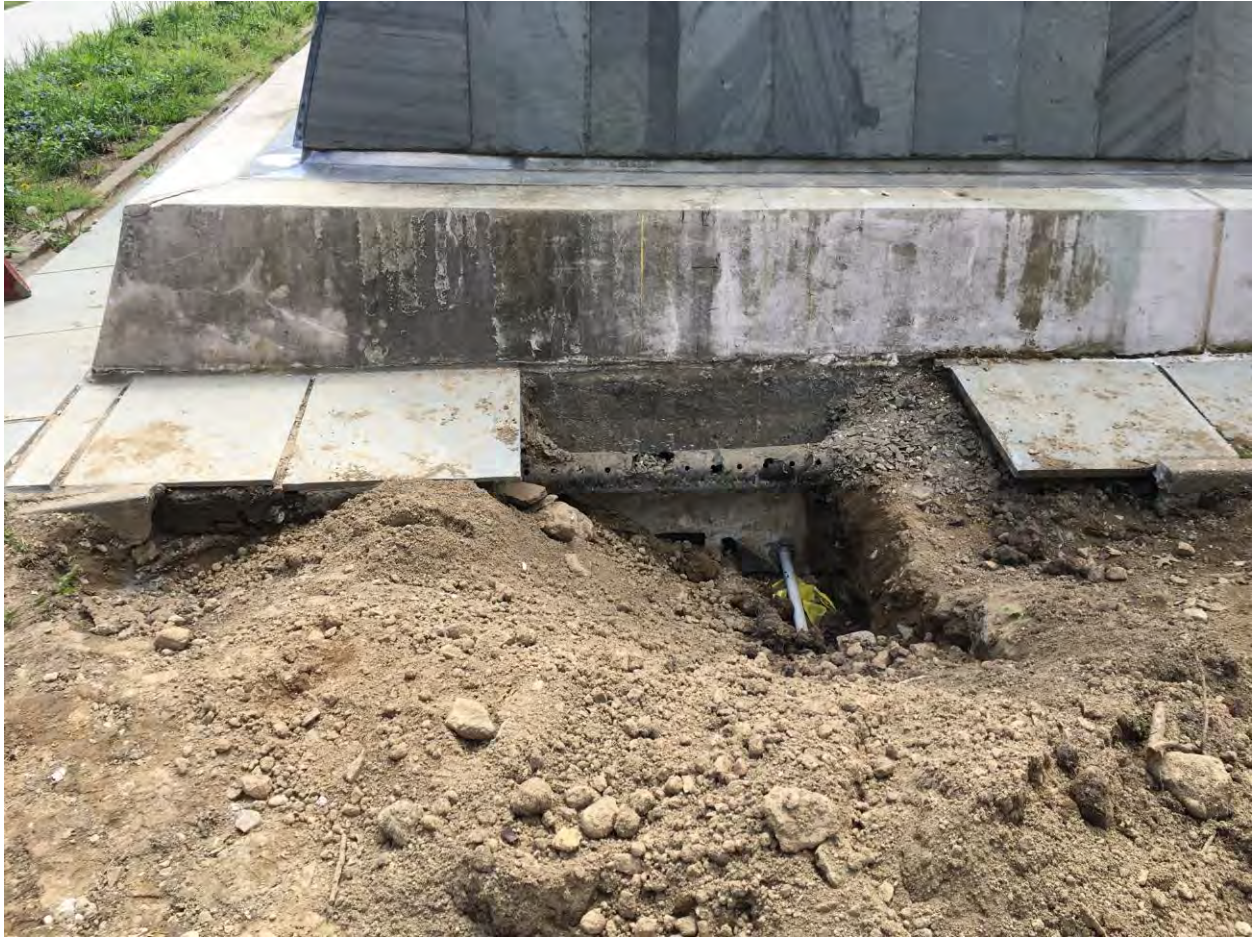
Figure 43: Exposed defunct foundation drain (northeast). Photo by Prudon and Partners.  
5/02/2017

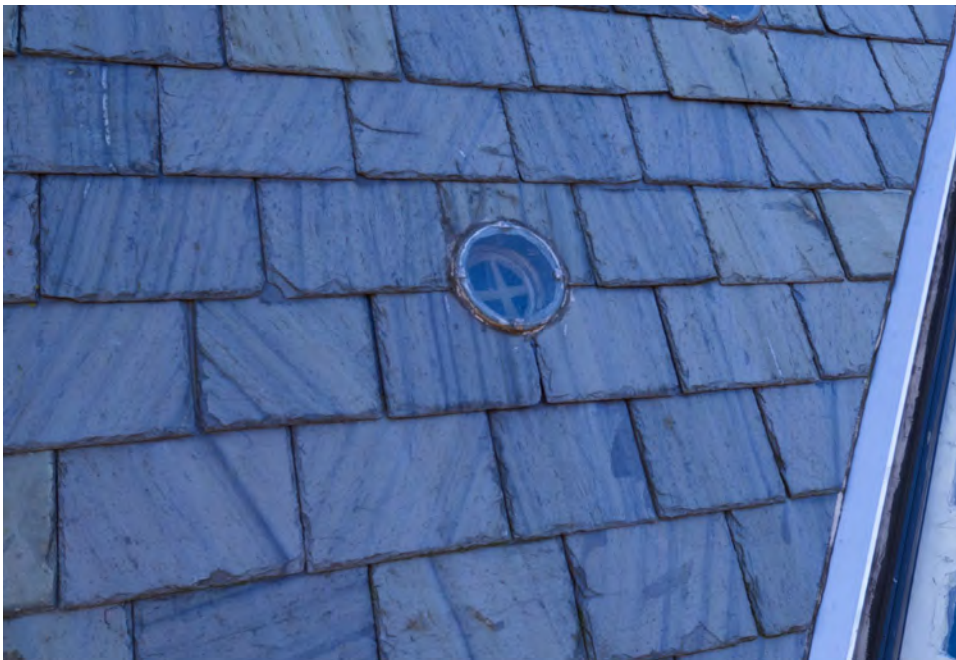
Figure A10. Typical existing portal window with protective glazing, installed in area of roofing slate. Sealant at the perimeter of the protective glazing typically appears to be deteriorated.

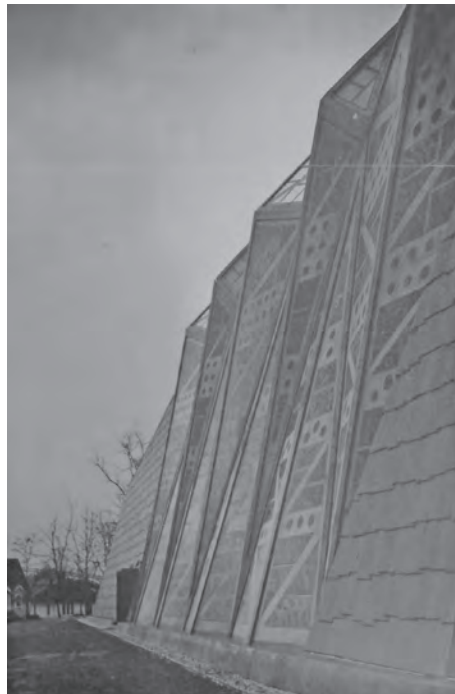
Figure A12. Archival image of completed Sanctuary showing protective glazing panels at skyward facing dalle de verre. "A Brilliant Canopy for Worship," Architectural Forum, April 1958, 107.

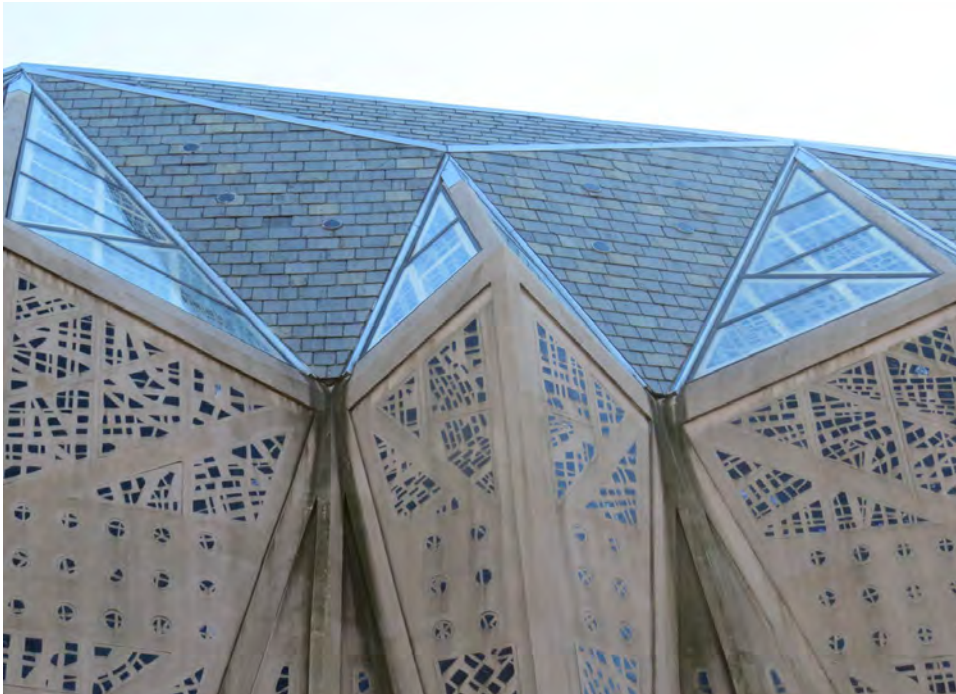
Figure A13. Existing aluminum framed protective glazing on the north elevation showing that the frames do not fully coincide with the pre-cast concrete and dalle de verre patterns. The pre-cast concrete below the glass exhibits a previously applied waterproofing coating.

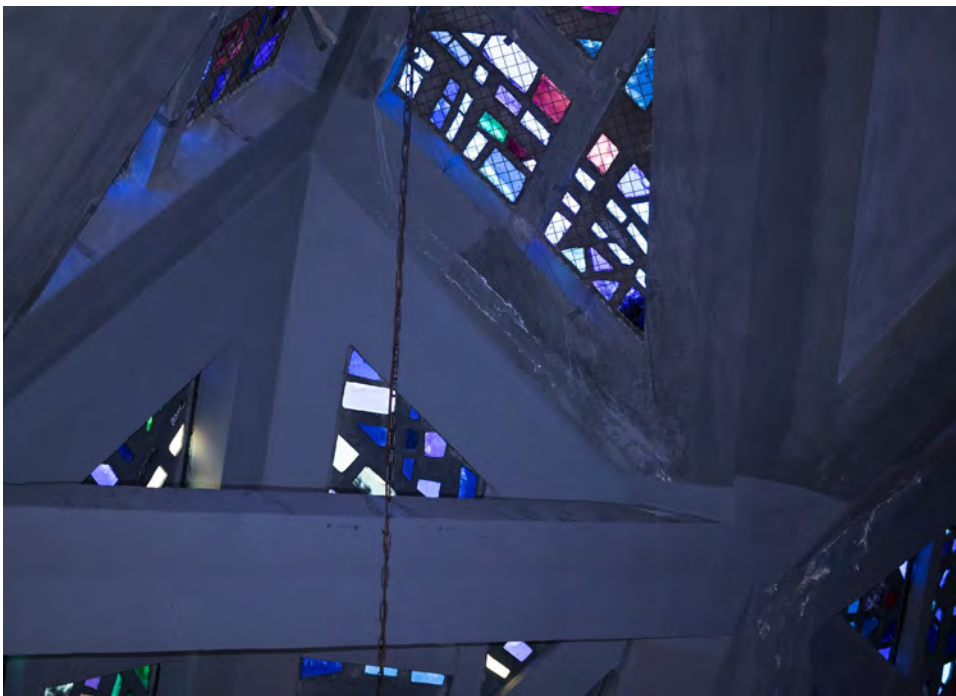
Figure A22. Interior work was not performed above the roofline in 1986. The interior painting stops at this level, as shown here.

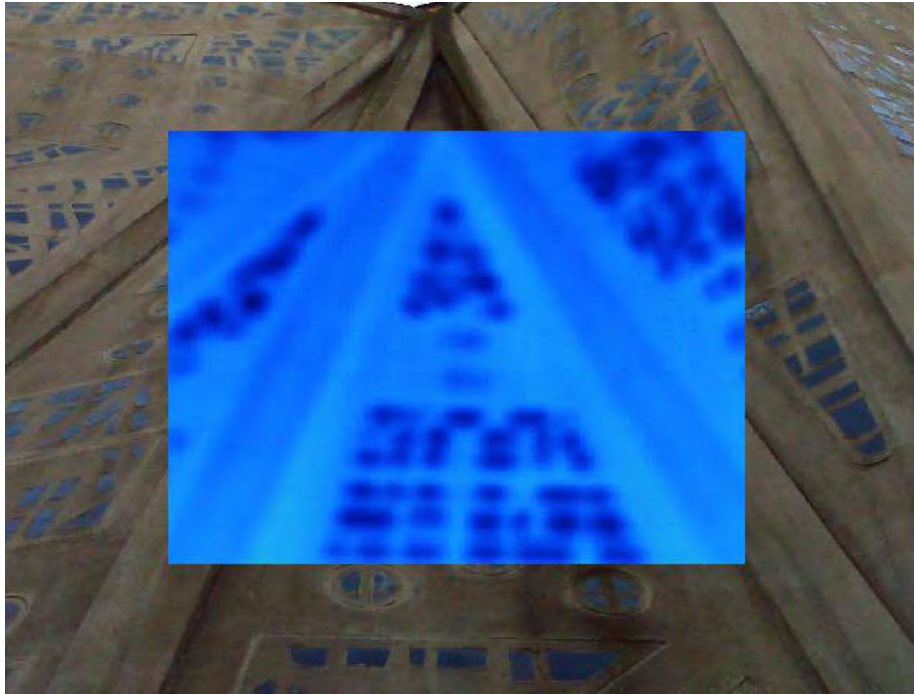
Figure A23. Thermogram of exterior north elevation in January 2017. Thermogram processed to show range of temperatures 45 (Blue) -100 (Red). The temperatures of the materials on this elevation were substantially cooler than those on the south (Figures A24 and A25).

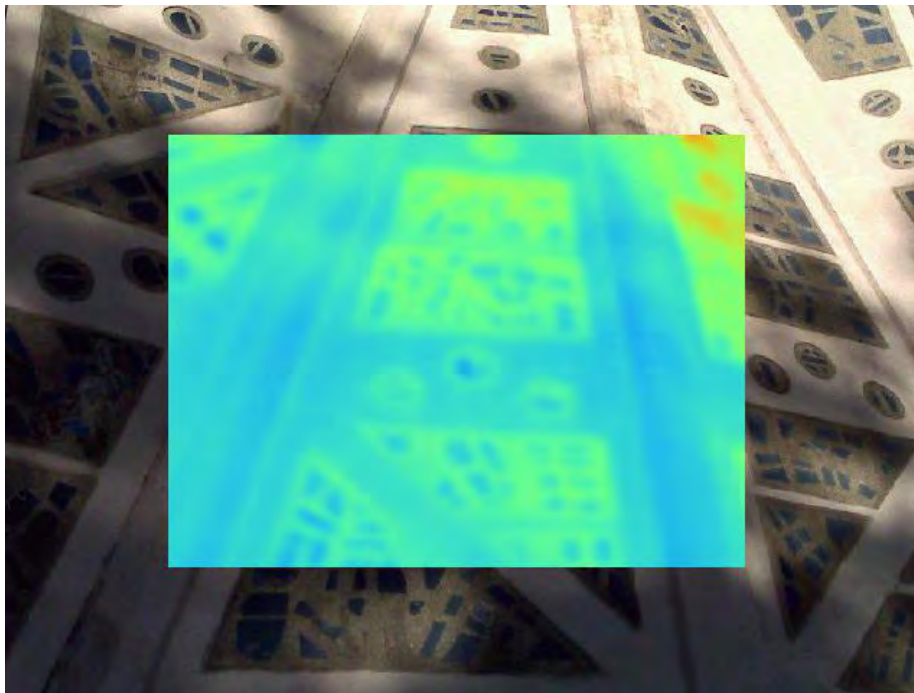
Figure A24. Thermogram of materials in the shade at the west end of the south elevation in January 2017. Thermogram processed to show range of temperatures 45 (Blue) -100 (Red). The temperatures of the materials on this elevation were substantially warmer than those on the north (Figure A23).

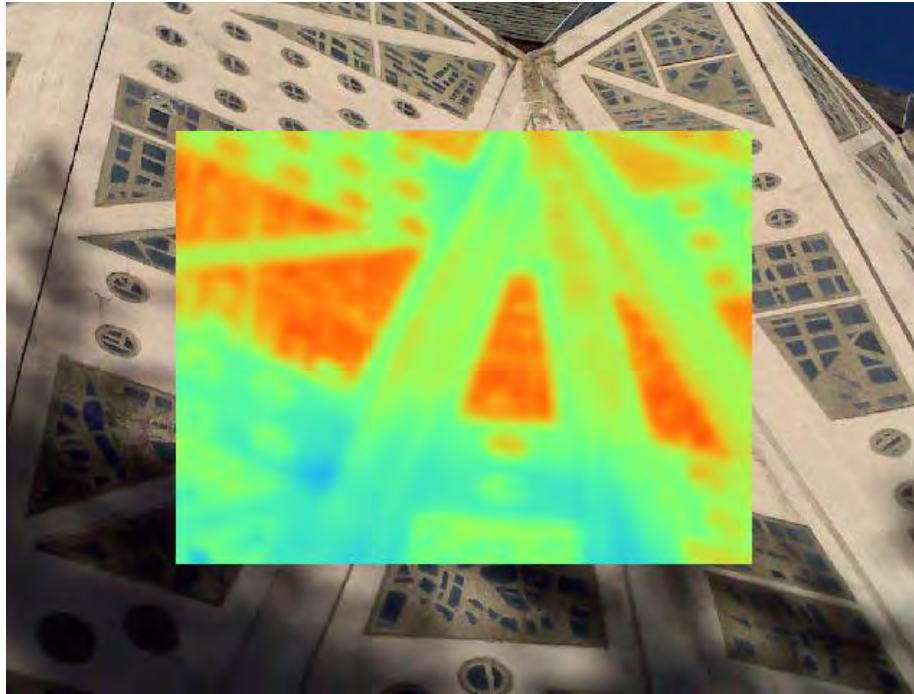
Figure A25. Thermogram of an area in direct sunlight at the east end of the south elevation in January 2017. Thermogram processed to show range of temperatures 45 (Blue) -100 (Red). The temperatures of the materials on this elevation were substantially warmer than those on the north (Figure A23). The dalle de verre exhibits greater heat gain and loss and more stresses.

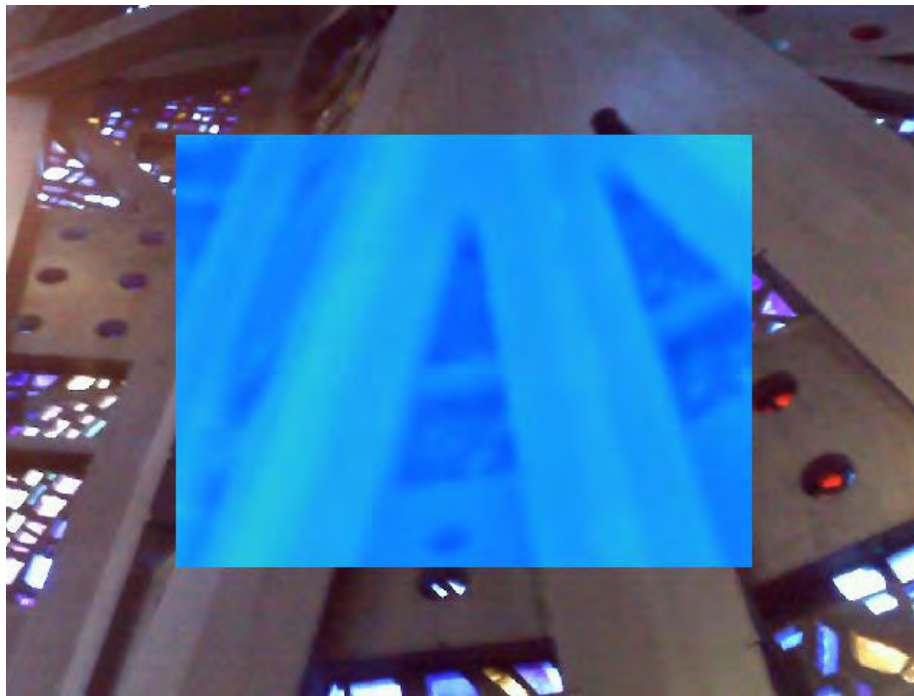
Figure A26. Thermogram of interior north elevation in January 2017. Thermogram processed to show range of temperatures 55 (Blue) -100 (Red). The temperatures of the materials on this elevation were substantially cooler than those on the interior of the south (Figure A27).

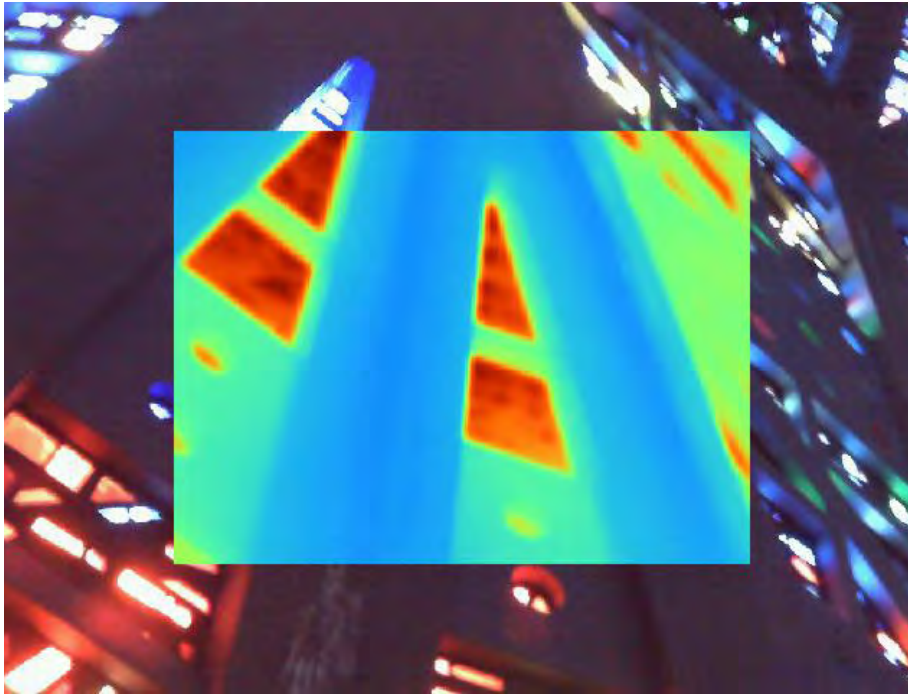
Figure A27. Thermogram of interior south elevation in January 2017. Thermogram processed to show range of temperatures 55 (Blue) -100 (Red). The temperatures of the materials on this elevation were substantially warmer than those on the interior of the north (Figure A26). The dalle de verre exhibits greater heat gain and loss and more stresses.

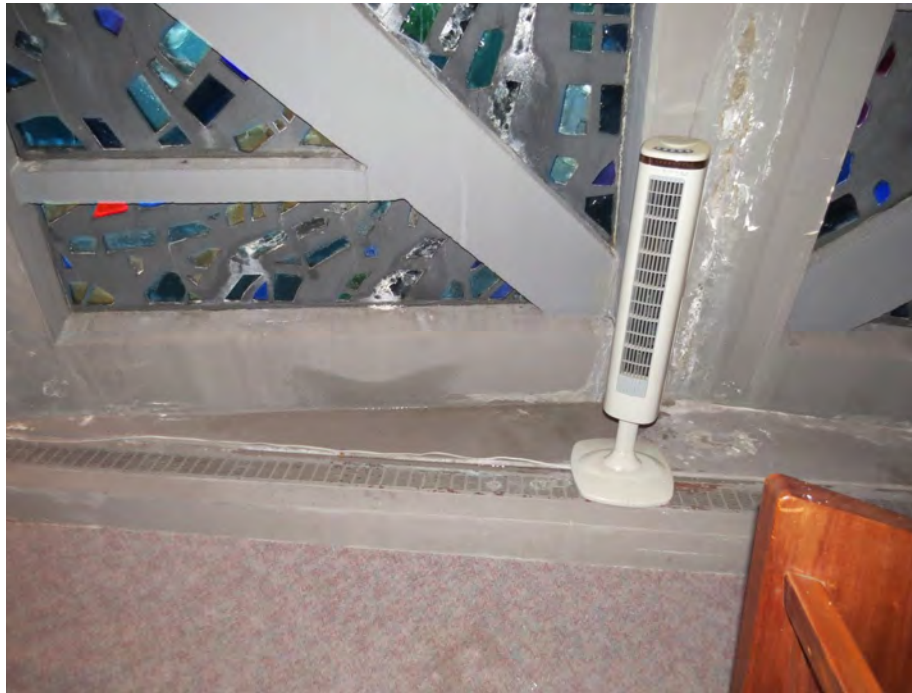
- Pooling water was noted at the interior base of the south wall, as was carpet damage (Figure A30). Water infiltration primarily originates from deteriorated sealant at the exterior perimeter of the dalle de verre panels and at the exterior intersection of pre-cast concrete panels and cast-in-place concrete framework.

Figure A30. Water pooling at the base of the south elevation during a heavy rain in October 2016.

- Further assess the existing conditions of the various flashing materials and provide new flashings if necessary.
- Clean all slate free of general soil and biological growth using a biocide.
- Replace loose, missing, and deteriorated slate with new slate matching the original.
- Replace all exterior sealant between the pre-cast concrete panels and at the perimeter of the original dalle de verre panels following the removal of concrete coatings.
- Remove planting directly adjacent to the base in north courtyard.
- Install drainage system to separate the building and landscape at the west and north elevations, including in the north courtyard, to direct water away from building.
- Redirect downspouts away from the base of the Sanctuary.

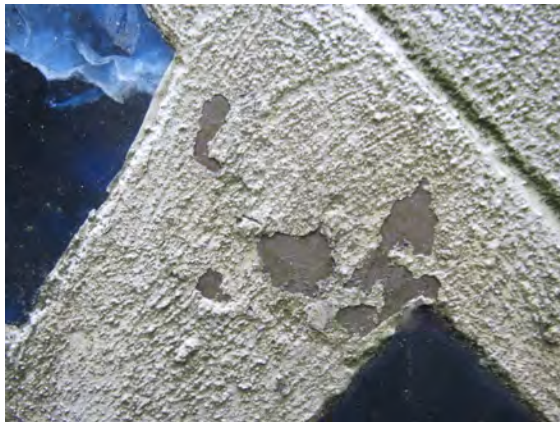
**PHOTO LOCATION** North Façade

Deteriorated coating on the north elevation, exposing concrete below and allowing for water penetration into the concrete. In some areas, the deteriorated coating traps water, resulting in damage to the underlying masonry and glass.

- I A Deteriorated Elastomeric Coating, General Atmospheric Soil, and Biological Growth on Exterior Concrete

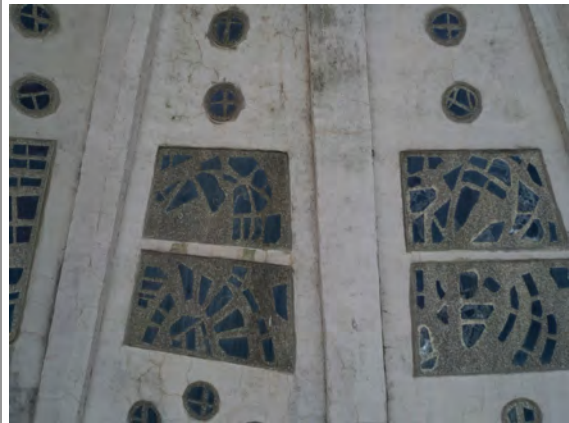
**PHOTO LOCATION** South Façade

Extensive cracks in the deteriorated coating on the concrete substrate.

- 2 A Network Crack(s) in Concrete Coating

Further investigation required to determine the extent that the cracks propagate from the substrate. Removal all coatings and survey concrete. Provide necessary concrete repairs and new waterproof coating.

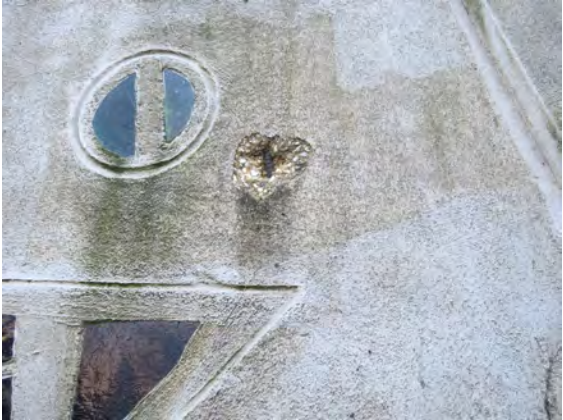
<p>Spalled concrete and exposed steel reinforcement in pre-cast panel N3. The rebar is approximately 3/4" in diameter and located approximately 3/4" below the concrete surface.</p> <p><b>CONDITION(S)</b></p> <p>3 A Spalled Exterior Concrete with Exposed Ferrous Reinforcement</p> <p><b>RECOMMENDATION(S)</b></p> <p>Remove unsound concrete. Clean exposed reinforcing bar and coat with corrosion inhibitor. Provide concrete patch(es).</p>	<p><b>ELEMENT(S)</b> Framework, Pre-cast Panel, Southwest and Northwest Door Surrounds, Entrance Canopy, Base</p> <p><b>MATERIAL(S)</b> Concrete</p> <p><b>LOCATION(S)</b> Sanctuary Façade</p> <p><b>ELEVATION(S)/SURFACE(S)</b> East, North, South</p> <p><b>PHOTO LOCATION</b> East Façade</p>

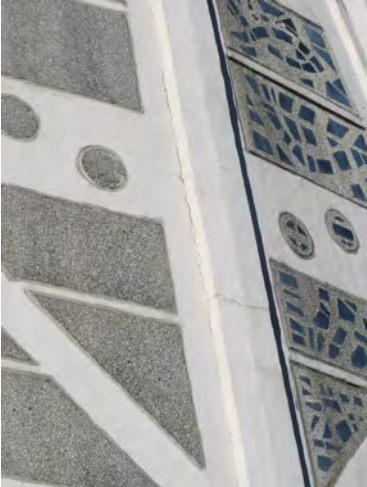
<p>Horizontal crack visible in concrete coating on the cast-in-place framework. The extent that such cracks in the concrete coating project from the substrate is not known. Some repairs are assumed necessary.</p> <p><b>CONDITION(S)</b></p> <p>4 A Crack(s) in Exterior Concrete</p> <p><b>RECOMMENDATION(S)</b></p> <p>Remove all coatings. Review cracks and perform sounding survey. Remove unsound concrete. Clean exposed reinforcing bar and coat with corrosion inhibitor. Provide concrete patch(es)</p>

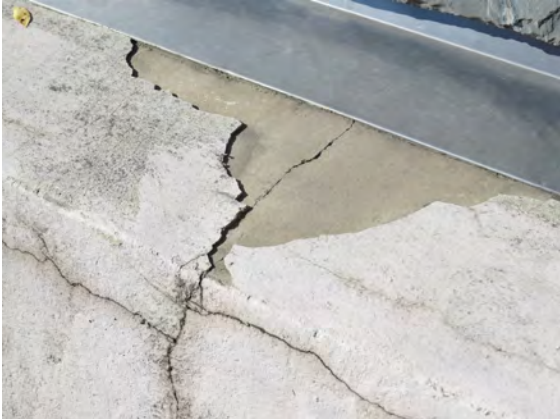
<p>Delaminating coating and crack in base. Cracks are visible in the concrete base on all elevations. Similar conditions were previously addressed in multiple restoration campaigns.</p> <p><b>CONDITION(S)</b></p> <p>5 A Crack(s) in Exterior Concrete Base</p> <p><b>RECOMMENDATION(S)</b></p> <p>Further investigation required. Remove deteriorated coatings and patching materials for further review of concrete substrate. Perform additional testing to determine source of cracking.</p>	<p><b>ELEMENT(S)</b> Stairs</p> <p><b>MATERIAL(S)</b> Concrete</p> <p><b>LOCATION(S)</b> Sanctuary Façade</p> <p><b>ELEVATION(S)/SURFACE(S)</b> South</p> <p><b>PHOTO LOCATION</b> Southwest Entrance</p>

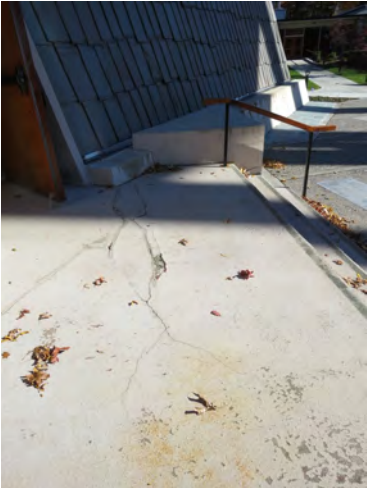
<p>Cracks in stairs at Narthex entrance. Condition requires review by a structural engineer.</p> <p><b>CONDITION(S)</b></p> <p>6 A Cracks in Concrete Stairs</p> <p><b>RECOMMENDATION(S)</b></p> <p>Further investigation required. Engineer to review cause of cracking.</p>

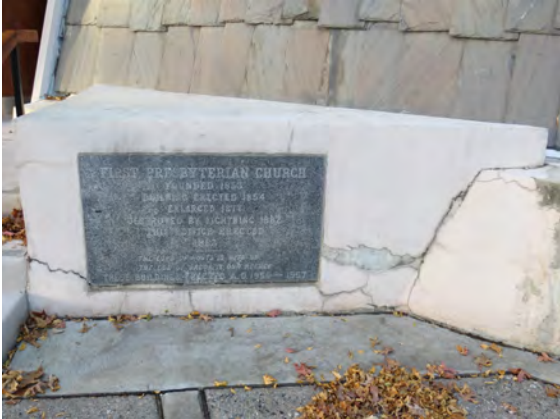
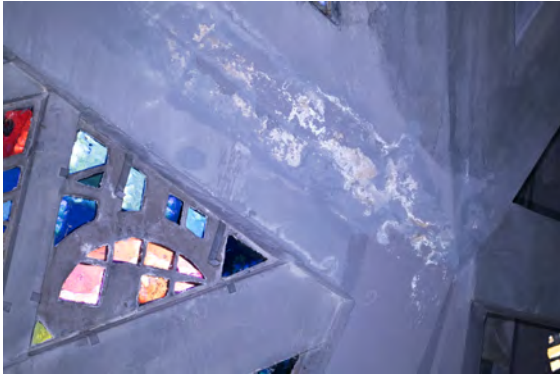
<p>Significant cracks and deteriorated sealant at the stairs and granite plaque of the Narthex entrance. These were previously identified for repair during the 2003-2007 Waterproofing Campaign.</p> <p><b>CONDITION(S)</b></p> <p>7 A Cracks and Deteriorated Sealant Around Granite Plaque</p> <p><b>RECOMMENDATION(S)</b></p> <p>Further investigation required. Engineer to review cause of cracking.</p>	<p>Water infiltration is common at the corners of pre-cast panels, along the roof ridge on both the north and south elevations.</p> <p><b>CONDITION(S)</b></p> <p>8 A Water Infiltration Typical at Corners of Pre-Cast Panels Along the Roof Ridge and at the Valleys Where the Wall Panels Meet</p> <p><b>RECOMMENDATION(S)</b></p> <p>Determine and eliminate source of water infiltration. Vacuum efflorescence from concrete, strip deteriorated paint from surface of concrete, remove all salts using poultice, and provide concrete repairs as necessary.</p>

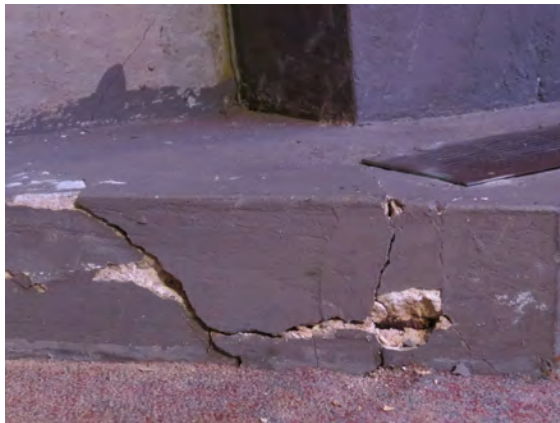
Spalled concrete over steel reinforcement in the concrete base near the door to the Choir room on the north elevation. Small spalls over corroding steel are also visible in the cast-in-place framework of the walls.

9 A Spalled Interior Concrete with Exposed Ferrous Reinforcement

Remove unsound concrete. Clean exposed reinforcing bar and coat with corrosion inhibitor. Provide concrete patch(es).

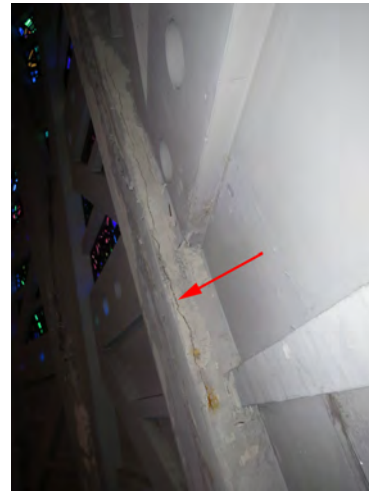
Large crack parallel to the face of the cast-in-place concrete framework in the Narthex. The ferrous stains along the crack indicate rusting reinforcement.

10 A Crack(s) and Impending Spall(s) in Concrete

Remove unsound concrete and patching material from interior surfaces. Clean exposed reinforcing bar and coat with corrosion inhibitor. Provide concrete patch(es).

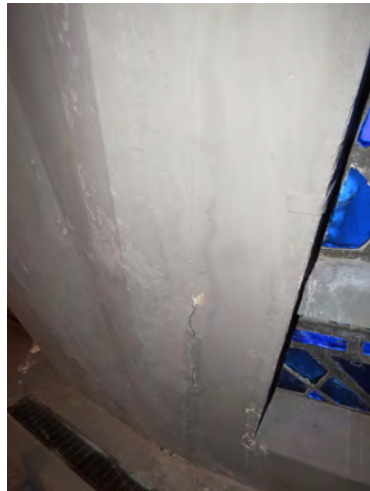
Typical vertical crack at the interior, where pre-cast panels abut cast-in-place concrete framework.

11 A Vertical Cracks at the Interior Where Pre-cast Panels Intersect the Cast-in-Place Framework

Further investigation required. Remove deteriorated coatings and patching materials for further review by engineer.

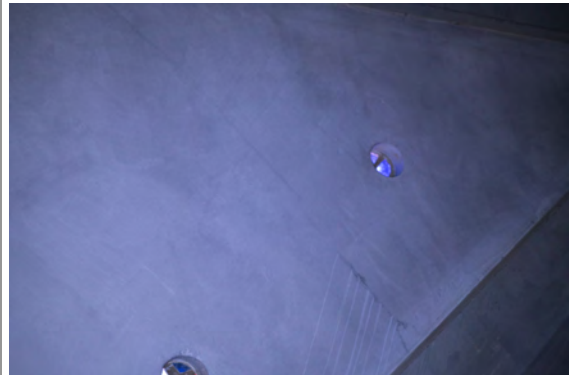
Water infiltration through crack in pre-cast ceiling panel between Panels N26 and N27. The exterior of this panel is covered with slate. It has not been determined if this is an active leak or if it was resolved by the 2005 waterproof campaign.

12 A Crack(s) in Precast Panels

Determine and eliminate source of water infiltration. Repair crack with grout injection crack repair.

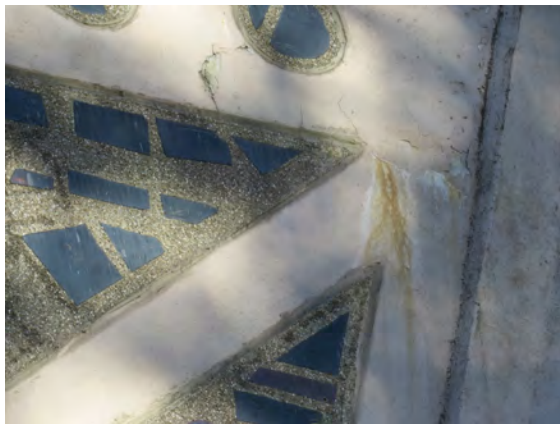
Efflorescence on the exterior concrete. Also note the cracks and ferrous stains visible in this image.

Remove all coatings. Remove all salts using poultice and provide concrete repairs as necessary.

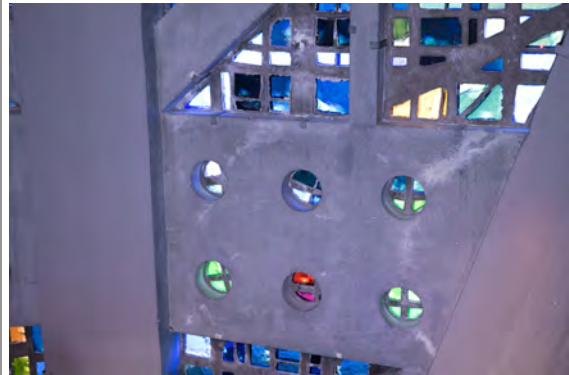
Typical thin efflorescence visible on the pre-cast panels comprising the north wall of the nave.

Determine and eliminate source of water infiltration. Vacuum efflorescence from concrete and remove all salts using poultice.

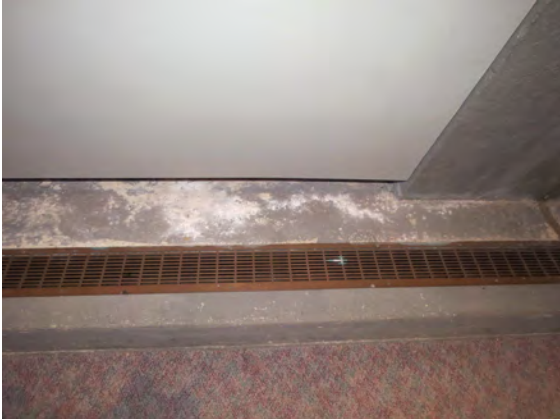
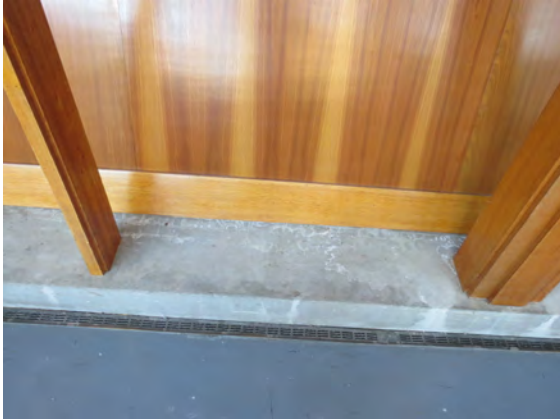
<p>Efflorescence visible on the interior concrete base below the acoustical panels on the North elevation. See Condition 4B for view of concrete on the other side of interior wall.</p> <p><b>CONDITION(S)</b></p> <p>3 B Efflorescence at Interior Concrete Base in Nave</p> <p><b>RECOMMENDATION(S)</b></p> <p>Determine and eliminate source of water infiltration. Vacuum efflorescence from concrete and remove all salts using poultice.</p>	<p>Efflorescence visible on the interior concrete base in the North Passage. See Condition 3B for view of concrete on the other side of interior wall.</p> <p><b>CONDITION(S)</b></p> <p>4 B Efflorescence at Interior Concrete Base in North Passageway</p> <p><b>RECOMMENDATION(S)</b></p> <p>Determine and eliminate source of water infiltration. Vacuum efflorescence from concrete and remove all salts using poultice.</p>

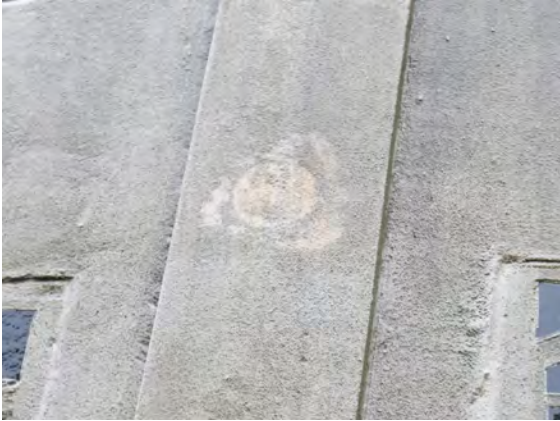
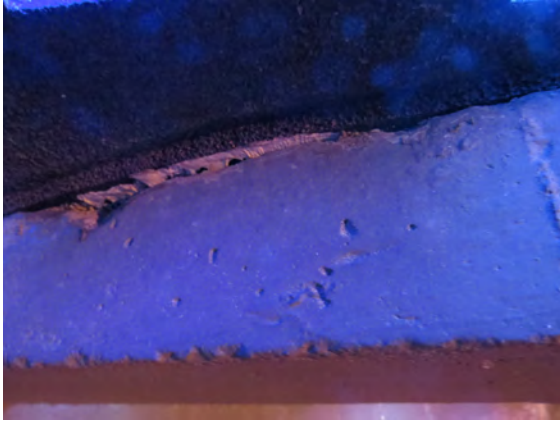
<p>Previous exterior patch on the north elevation. The shape of the patch suggests a previous core location.</p> <p><b>CONDITION(S)</b></p> <p>5 B Previous Exterior Patch(es) in Concrete</p> <p><b>RECOMMENDATION(S)</b></p> <p>Remove previous deteriorated or non-matching repair(s) and provide new concrete patch(es) matching adjacent concrete.</p>	<p>Edge spalls visible along interior of pre-cast concrete panels. This may have resulted from the removal and replacement of the dalle de verre in the 1980s. Also note the exposed and loose flexible foam expansion joint filler.</p> <p><b>CONDITION(S)</b></p> <p>6 B Shallow Spall(s) in Interior Concrete (No Exposed Ferrous Reinforcement)</p> <p><b>RECOMMENDATION(S)</b></p> <p>Remove only unsound concrete and provide concrete patch(es) at deep losses.</p>

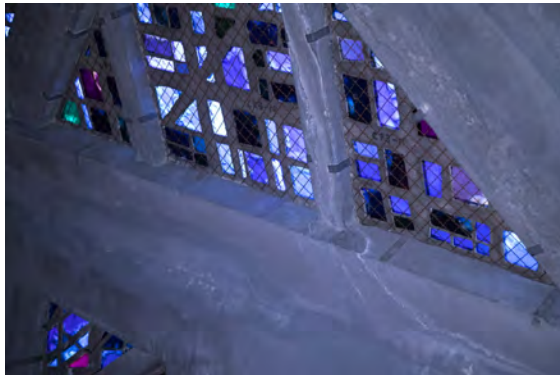
Water infiltration stains on the concrete.

1 C Water Stains and General Atmospheric Soil on Interior Concrete. Heavy Soiling at Skyward Facing Surfaces of Concrete.

Determine and eliminate source of water infiltration. Vacuum heavy dust from skyward facing surfaces, and clean concrete.

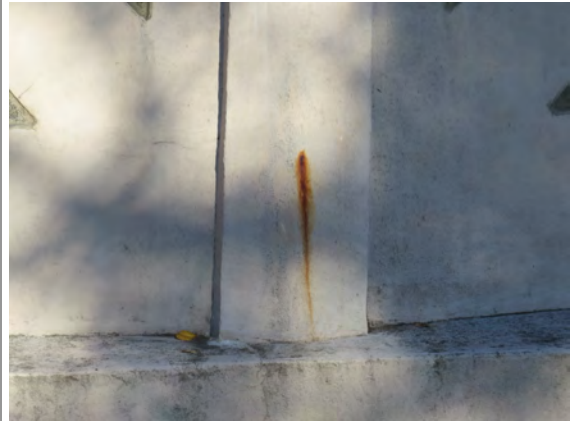
Typical ferrous stain telegraphing through the existing coating.

2 C Ferrous Stains on Concrete

Remove all coatings. Remove ferrous stains using a chemical cleaner in a poultice and pressurized water rinsing.

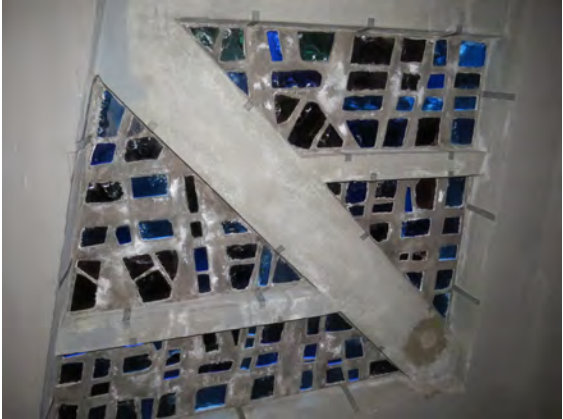
<p>Previous patch near the base of pre-cast panel N11. The shape of the patch suggests it was a core sample location during a previous building investigation. Note the efflorescence on the original dalle de verre panels visible in this image.</p> <p><b>CONDITION(S)</b></p> <p>3 C Previous Nonmatching/Inappropriate Interior Patch(es) in Concrete</p> <p><b>RECOMMENDATION(S)</b></p> <p>Remove previous repair(s) and provide new concrete patch(es) matching adjacent concrete.</p>	<p><b>ELEMENT(S)</b> Framework, Pre-cast Panel</p> <p><b>MATERIAL(S)</b> Concrete</p> <p><b>LOCATION(S)</b> Nave, Narthex</p> <p><b>ELEVATION(S)/SURFACE(S)</b> East, North, South</p> <p><b>PHOTO LOCATION</b> Interior East Wall</p>
