# **FIRST PRESBYTERIAN CHURCH OF STAMFORD, CT CONSERVATION MANAGEMENT PLAN**

**FINAL REPORT**

October 16, 2017

# **First Presbyterian Church Conservation Management Plan**

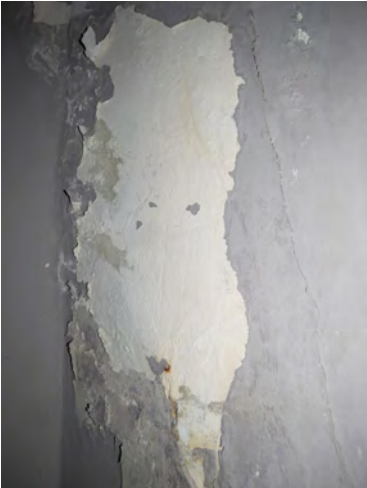
<p>Deteriorated paint revealing a skim coat finishes applied to the interior concrete. Also note the small area of ferrous stains visible at the bottom center of this image, where embedded reinforcement is rusting.</p> <p><b>CONDITION(S)</b></p> <p>4 C Previous Plaster Patch Repair(s) in Concrete</p> <p><b>RECOMMENDATION(S)</b></p> <p>Remove all coatings. Remove existing inappropriate patch material. Clean exposed reinforcing bar and coat with corrosion inhibitor. Provide concrete patch(es).</p>

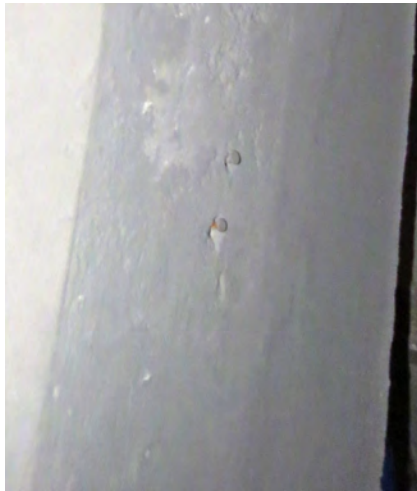
Isolated abandoned anchors in concrete.

Remove Conduit(s)/Wire(s)/Anchor(s) and provide cementitious patch repair.

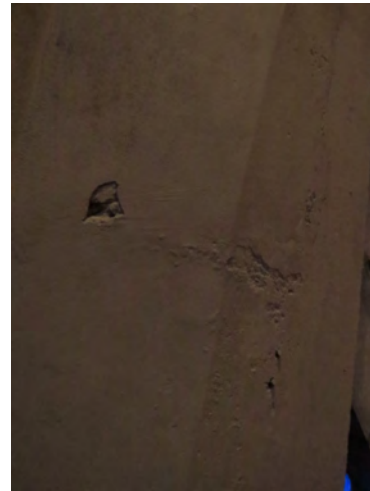
Typical pitting on interior concrete framework surface.

No Restoration Work is Recommended

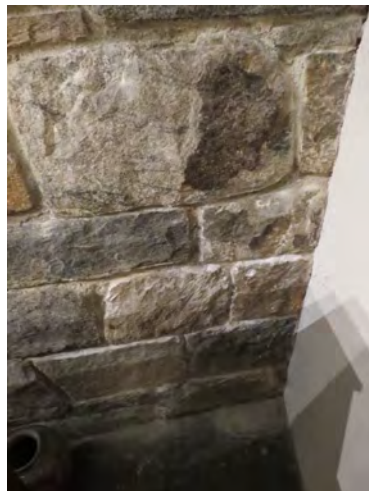
Efflorescence on the interior field stone at the bottom of exterior wall on east elevation of Chapel.

Determine and eliminate source of water infiltration. Vacuum efflorescence from stone and remove all salts using poultice.

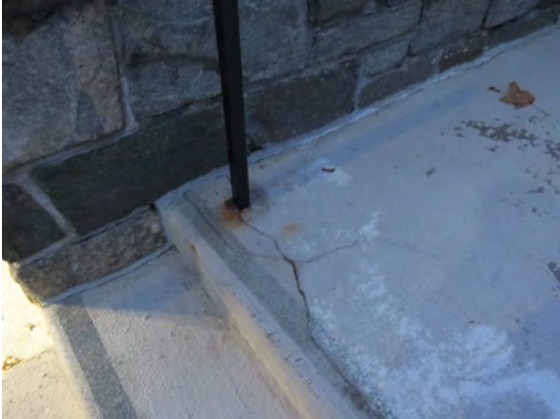
<p>Corrosion and deteriorated concrete at base of ferrous metal rail post.</p> <p><b>CONDITION(S)</b></p> <p>1 B Corroding Base of Handrail</p> <p><b>RECOMMENDATION(S)</b></p> <p>Remove railing, strip paint, and remove corrosion. Prepare, prime, and paint. Reinstall railing with lead around rail bases in lieu of sealant.</p>	<p><b>ELEMENT(S)</b> Louvers</p> <p><b>MATERIAL(S)</b> Sheet Metal</p> <p><b>LOCATION(S)</b> Sanctuary Façade <b>ELEVATION(S)/SURFACE(S)</b> North, West</p> <p><b>PHOTO LOCATION</b> West Façade</p>

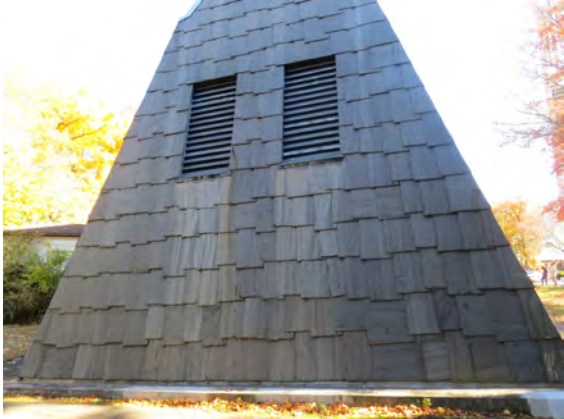
<p>Louvers on west elevation leading to organ loft. Louvers are also located on east end of the north elevation.</p> <p><b>CONDITION(S)</b></p> <p>2 B Deteriorated Finish on Exterior Louvers</p> <p><b>RECOMMENDATION(S)</b></p> <p>Prepare surface of louvers and provide new coating.</p>

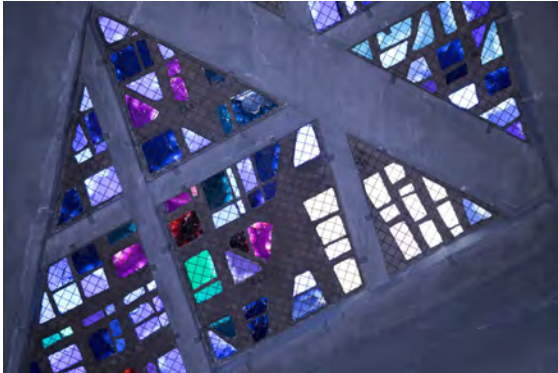
Typical wire installed under skyward facing dalle de verre panels during the building's original construction. It is assumed that this wire was installed to comply with skylight construction codes.

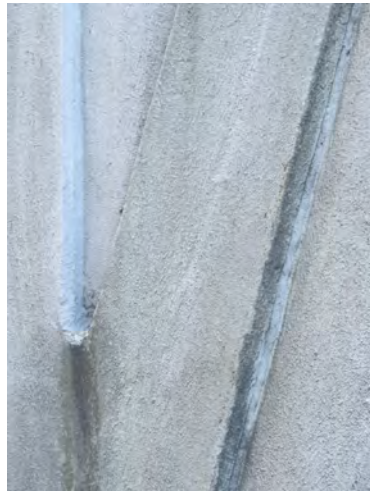
Typical failing sealant between the pre-cast and cast-in-place concrete on the north elevation.

- I A Failing/Deteriorated/Missing Sealant Between Pre-cast Concrete and Cast-in-Place Concrete

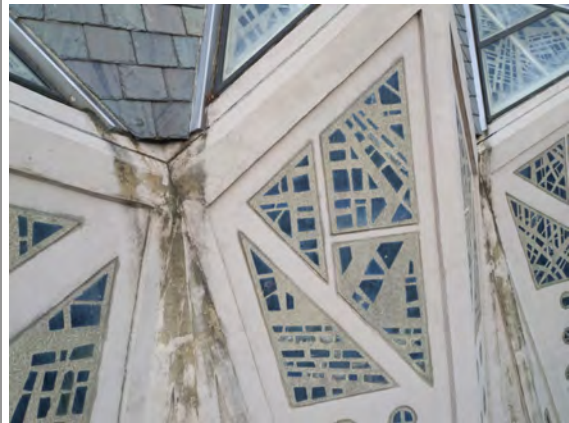
Reglet installed at roof line during 1980s restoration campaign. The sealant and concrete coatings are typically deteriorated at the valley where the roof and wall panels connect. See Condition 8A for typical interior damage in these areas.

- 2 A Deteriorated Sealant in Reglet at Exterior of South and East Elevations

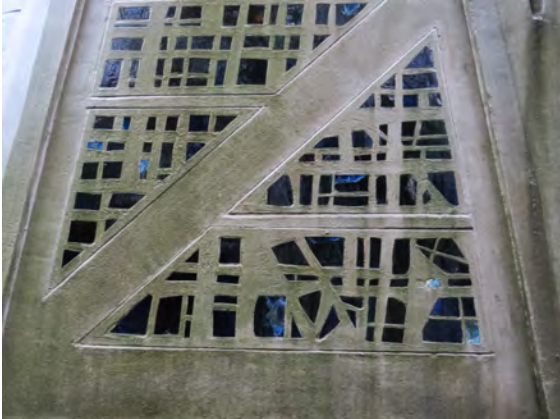
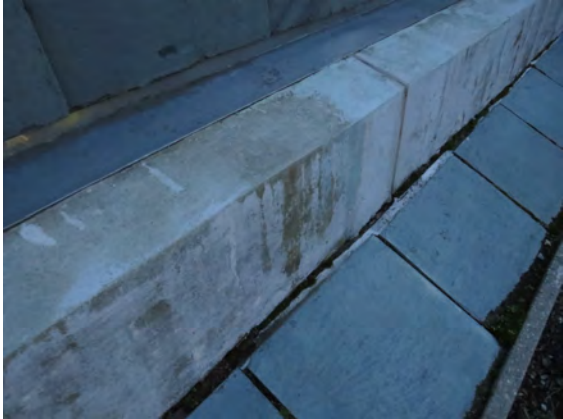
<p>The deteriorated coating on the north elevation was also installed over the sealant at the perimeter of the dalle de verre panels and larger pre-cast panels. It additionally laps onto the glass. Archival research suggests it was applied in the 1990s.</p> <p><b>CONDITION(S)</b></p> <p>3 A Deteriorated Coating Over Sealant at Perimeter of Panels</p> <p><b>RECOMMENDATION(S)</b></p> <p>Remove all coatings. Provide new sealant around all panels on the north elevation.</p>	<p>Deteriorated sealant in the joint at the base of the east end of north elevation. Biological growth is present in joint and on concrete base. The existing construction varies slightly from 1980s construction detail included as Figure C8 in Appendix C.</p> <p><b>CONDITION(S)</b></p> <p>4 A Failing/Deteriorated/Missing Sealant at Base of Building</p> <p><b>RECOMMENDATION(S)</b></p> <p>Provide new sealant.</p>

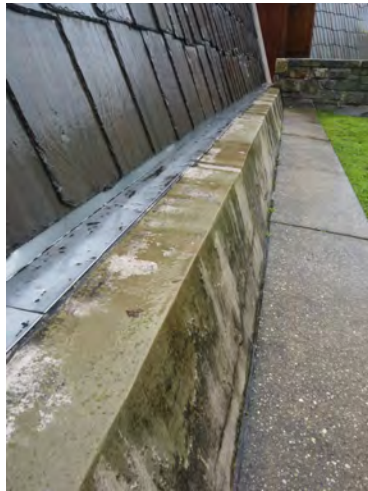
Typical deteriorated sealant at the flashing along the base of the building. Also note the typical biological growth visible on the concrete base.

- 5 A Failing/Deteriorated/Missing Sealant At Flashing of Concrete Base

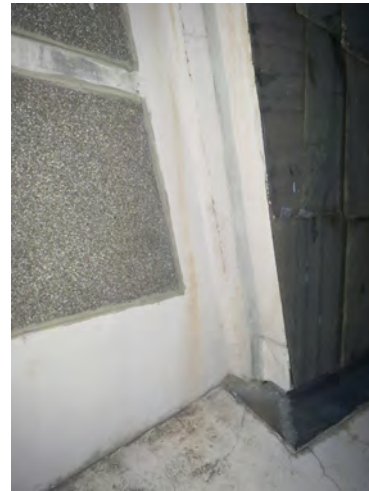
Deteriorated sealant at the juncture of flashing and concrete.

- 6 A Failing/Deteriorated/Missing Sealant at Flashing/Counter Flashing

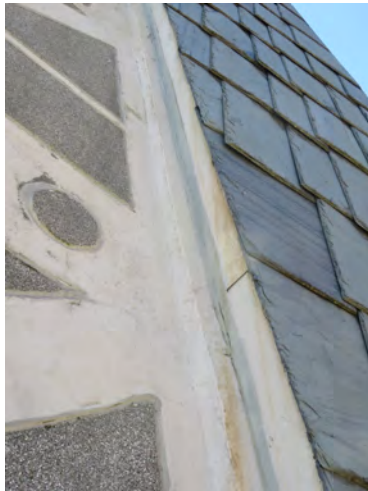
The coating found on the concrete was also applied the flashing between the concrete and slate on the east elevation.

7 A Deteriorated Coating on Flashing

Remove all coatings from existing flashing. Review condition of underlying flashing and repair or replace where necessary.

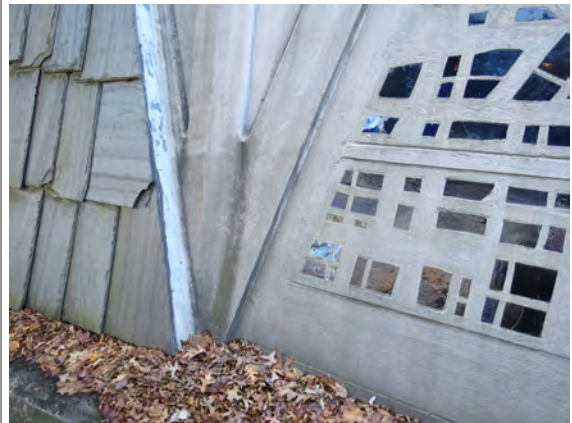
Lead coated copper flashing is still visible at isolated areas of the building, such as at this connection of the slate and concrete on the north elevation.

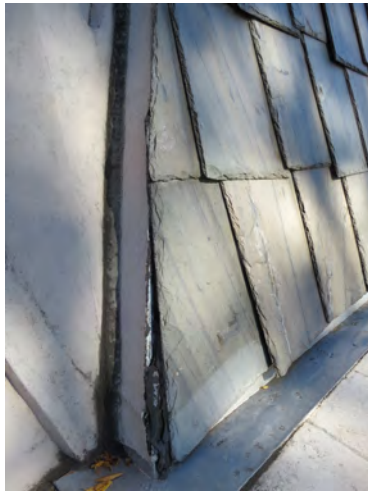
Deteriorated waterproofing material at the edge of the slate on the south elevation.

- 9 A Deteriorated Waterproofing at Perimeter of Slate

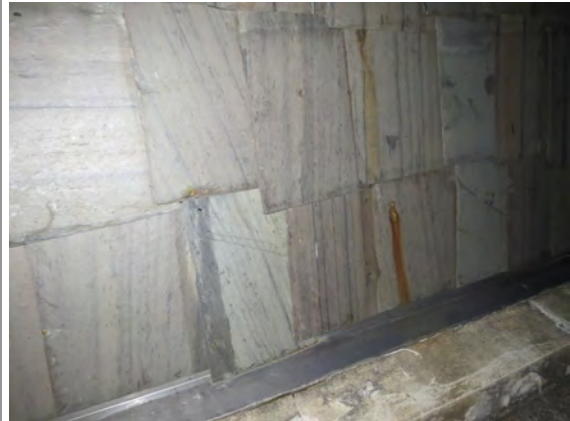
Isolated loose slate shingle on south elevation.

- 10 A Loose Slate Shingles

Remove, salvage, and reinstall loose slate shingles. Provide new to matching existing where shingles are damaged.

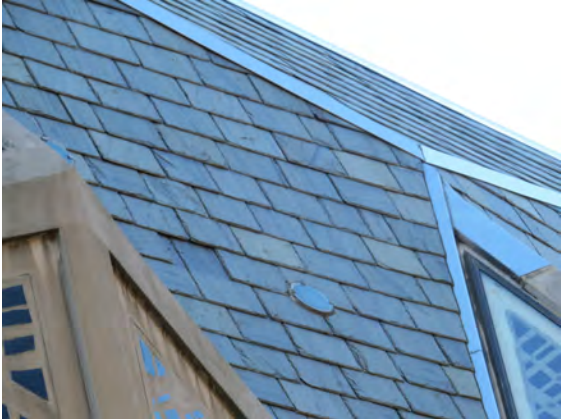
<p>Typical isolated missing slate shingle.</p> <p><b>CONDITION(S)</b></p> <p>11 A Missing Slate Shingles</p> <p><b>RECOMMENDATION(S)</b></p> <p>Provide new slate shingles to replace missing slate shingles.</p>	<p><b>ELEMENT(S)</b> Roofing/Exterior Cladding</p> <p><b>MATERIAL(S)</b> Shingle (Slate)</p> <p><b>LOCATION(S)</b> Sanctuary Façade</p> <p><b>ELEVATION(S)/SURFACE(S)</b> All</p> <p><b>PHOTO LOCATION</b> South Façade</p>

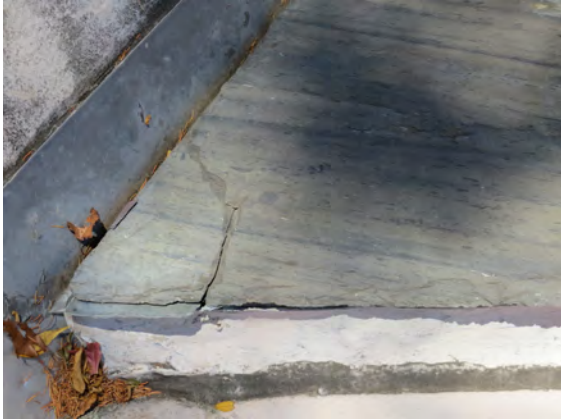
<p>Typical isolated cracked slate.</p> <p><b>CONDITION(S)</b></p> <p>12 A Cracked Slate</p> <p><b>RECOMMENDATION(S)</b></p> <p>Provide new slate shingles to replace broken slate shingles.</p>
--	---

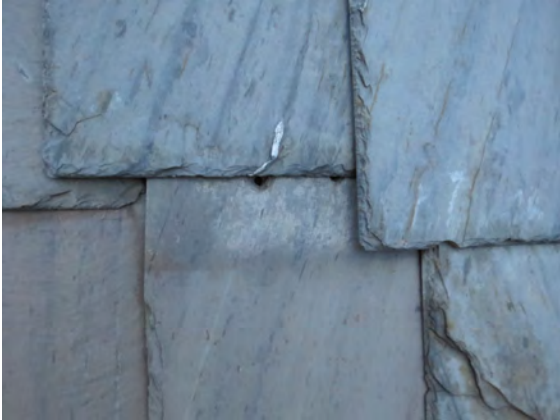
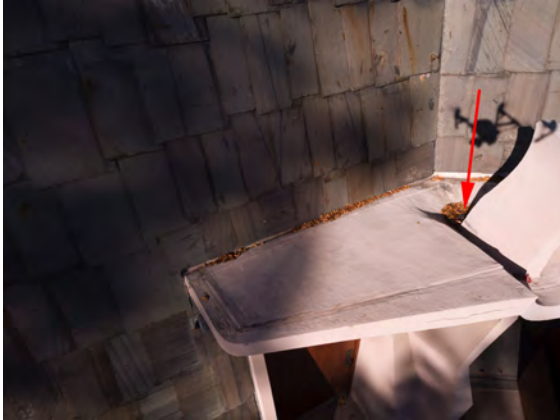
<p>Missing anchor in slate at the center of the image. Also note the previously repaired slate visible directly above the missing anchor.</p> <p><b>CONDITION(S)</b></p> <p>13 A Missing Anchors/Corroding Ferrous Nails in Slate Roof</p> <p><b>RECOMMENDATION(S)</b></p> <p>Replace fasteners with new stainless steel or copper fasteners.</p>	<p>Archival research suggests the existing coating on this canopy was applied during the 1990s. Repairs to the flashing were reportedly performed in 2005 to address water infiltration and damage to the interior concrete. The red arrow identifies the drain.</p> <p><b>CONDITION(S)</b></p> <p>14 A Deteriorated Coating and Debris in Drain</p> <p><b>RECOMMENDATION(S)</b></p> <p>Clean and inspect drain. Remove existing coating and examine condition of underlying concrete. Provide concrete patching and crack repairs as necessary. Provide new waterproofing coating.</p>

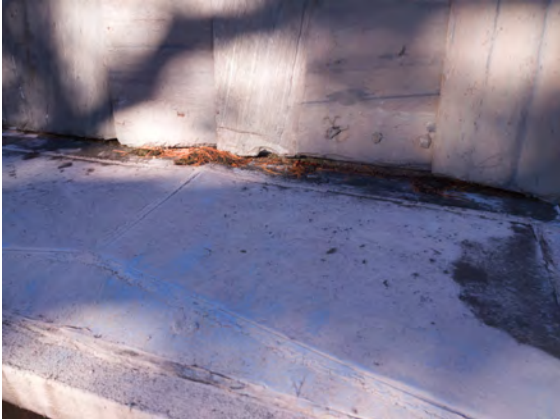
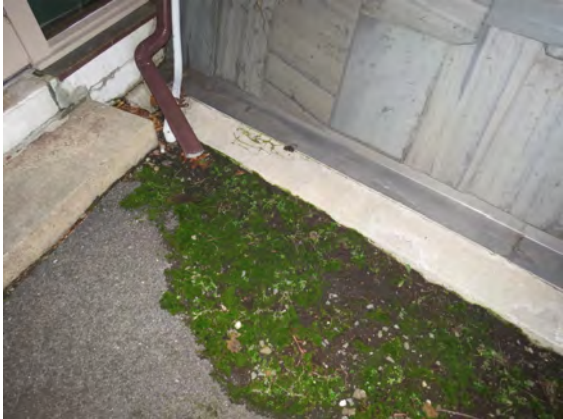
<p>Weathered roof coating over the southwest entrance. This metal roof was scheduled for replacement as part of the work in 2005, but it appears to have been coated instead. The interior concrete at the soffit of the entrance exhibits impending spalls.</p> <p><b>CONDITION(S)</b></p> <p>I 5 A Deteriorated Roofing Coating</p> <p><b>RECOMMENDATION(S)</b></p> <p>Further investigation required. Remove existing coating and examine condition of underlying metal roof.</p>	<p>Drainage from Choir Room roof is directed to the base of Sanctuary, promoting moisture penetration into the concrete.</p> <p><b>CONDITION(S)</b></p> <p>I B Drainage from Adjacent Roof Directed to Base of Sanctuary</p> <p><b>RECOMMENDATION(S)</b></p> <p>Redirect drainage away from base of Sanctuary. Install proper drainage system to separate landscaping from façade.</p>

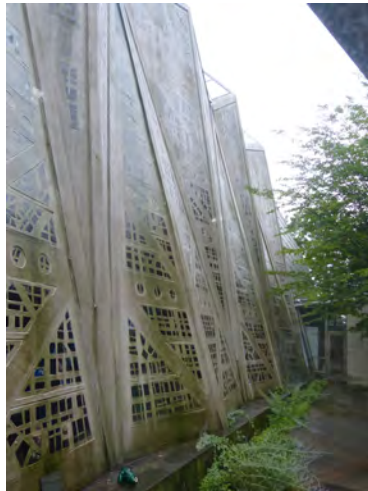
Plantings adjacent to the base of the Sanctuary in the north courtyard.

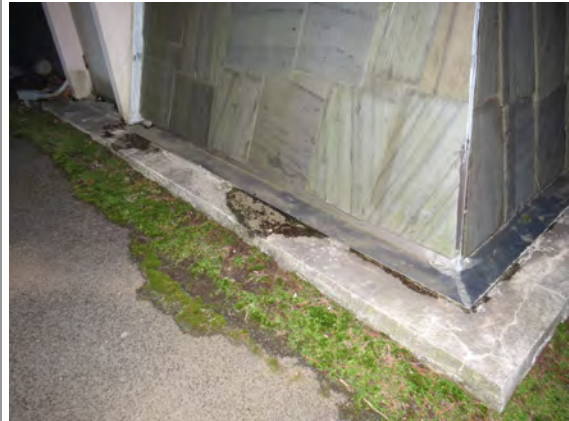
Grass adjacent to concrete base at the northwest corner of the Sanctuary.

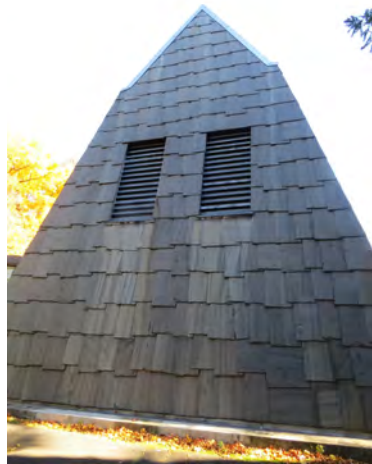
Typical soil and biological growth on slate.

Clean slate surfaces using chemical cleaner designed to remove biological growth. Further investigation required to determine the type of staining below the metal louvers.

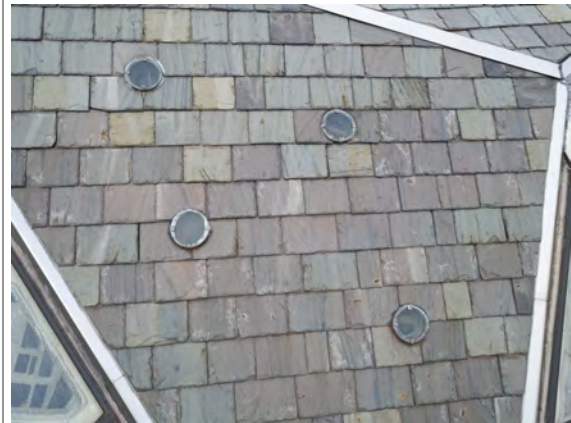
Typical efflorescence visible on isolated slate.

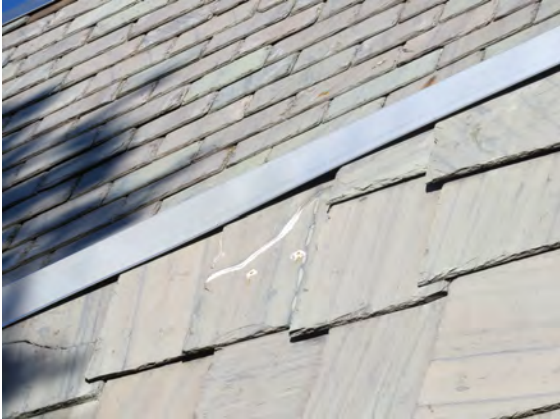
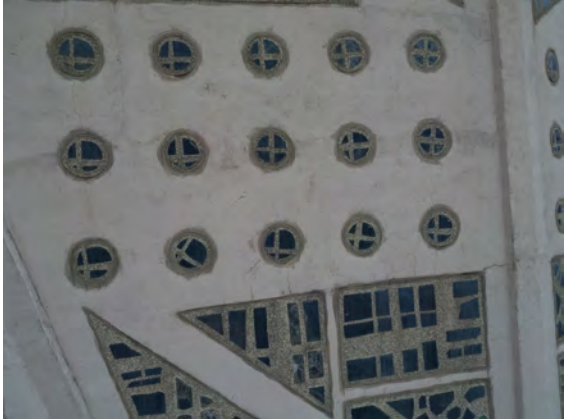
<p>Isolated slate appear to have been repaired with various materials.</p> <p><b>CONDITION(S)</b></p> <p>6 B Previously Repaired Slate</p> <p><b>RECOMMENDATION(S)</b></p> <p>Provide new slate shingles to replace broken slate shingles.</p>	<p>Sealant smears around panels installed on the south elevation. Also note the cracks in the concrete and coating in this area.</p> <p><b>CONDITION(S)</b></p> <p>I C Sealant Smears on Adjacent Concrete and Dalle de Verre</p> <p><b>RECOMMENDATION(S)</b></p> <p>Overall recommendation for dalle de panels with an epoxy matrix includes fabrication and installation of new dalle de verre panels.</p>

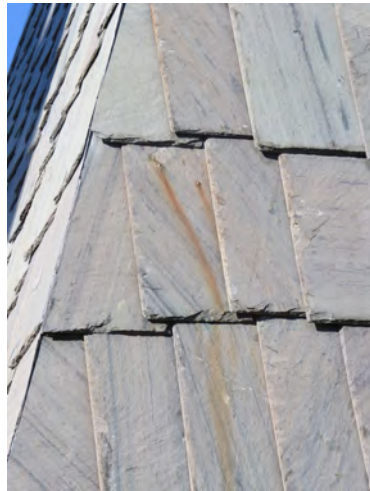
Typical ferrous stains from inclusions in the slate.

2 C Ferrous Stains on Slate Roof

Remove ferrous stains using a chemical cleaner in a poultice and pressurized water rinsing.

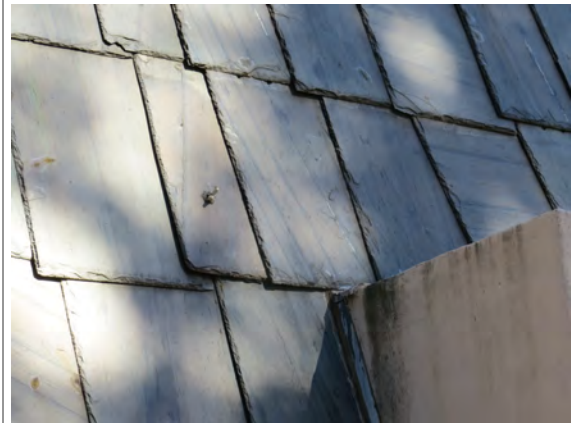
The 2005 water infiltration report noted that the fixtures in this location were water logged. They appear to have been subsequently removed.

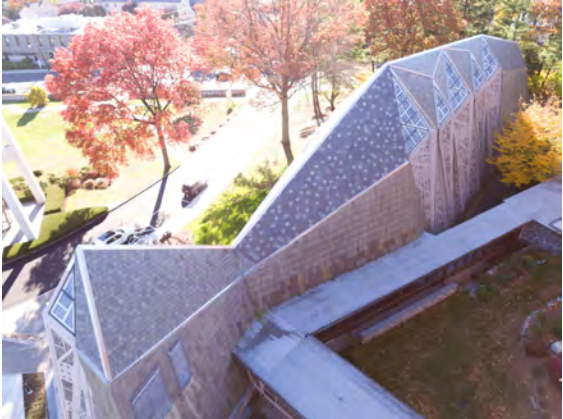
<p>Non-matching replacement slate is visible in this image above the roofline of the north passage and at the roof portions above the Nave (although not above the concrete panels).</p> <p><b>CONDITION(S)</b></p> <p>4 C Previous Non-Matching Replacement Slate</p> <p><b>RECOMMENDATION(S)</b></p> <p>No Restoration Work is Recommended</p>	<p><b>ELEMENT(S)</b> Roofing/Exterior Cladding</p> <p><b>MATERIAL(S)</b> Shingle (Slate)</p> <p><b>LOCATION(S)</b> Sanctuary Façade</p> <p><b>ELEVATION(S)/SURFACE(S)</b> All</p> <p><b>PHOTO LOCATION</b> South Façade</p>

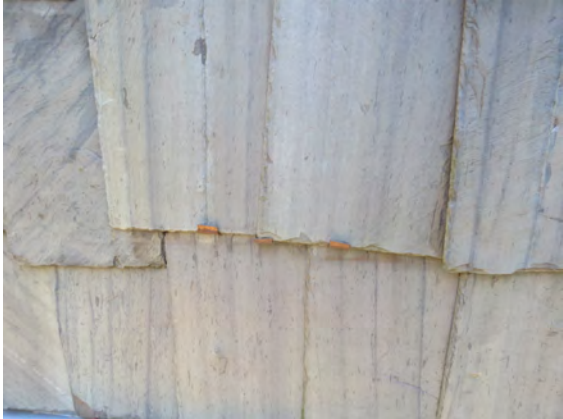
<p>Isolated slate are supported by visible clips.</p> <p><b>CONDITION(S)</b></p> <p>5 C Previously Reinstalled Slate with Exposed Anchors</p> <p><b>RECOMMENDATION(S)</b></p> <p>No Restoration Work is Recommended</p>

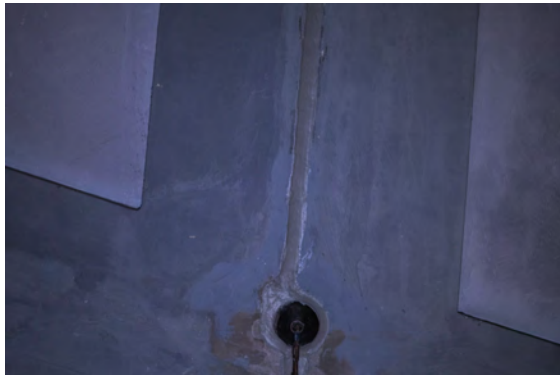
Existing control joint, running north to south in the framework, just west of the Choir Loft.

No Restoration Work is Recommended

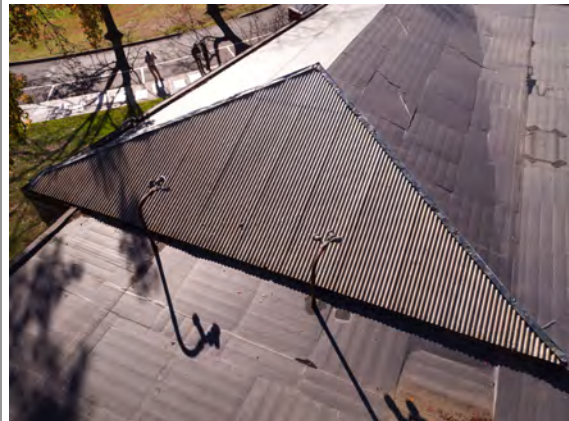
Roofing protection over chapel dalle de verre. Archival drawings identify it as Corrulux, which was a corrugated, translucent plastic panel with fiber glass reinforcement.

7 C Existing Stained Glass Protection Panel

No Restoration Work is Recommended

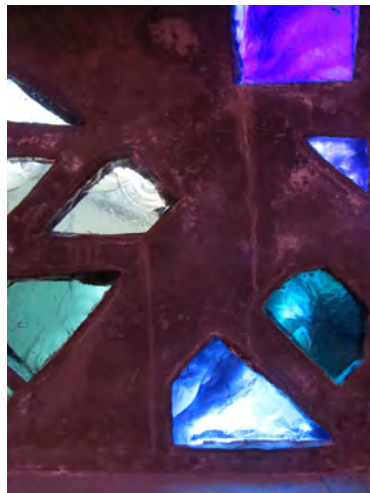
Typical stains resulting from water infiltration through hairline separation between the dalles and concrete matrix.

- I A Water Infiltration at Perimeter of Dalle(s) in Concrete Matrix

Provide protective glazing on the north elevation over all original dalle de verre. Recommendation also intended to address glass deterioration on this elevation.

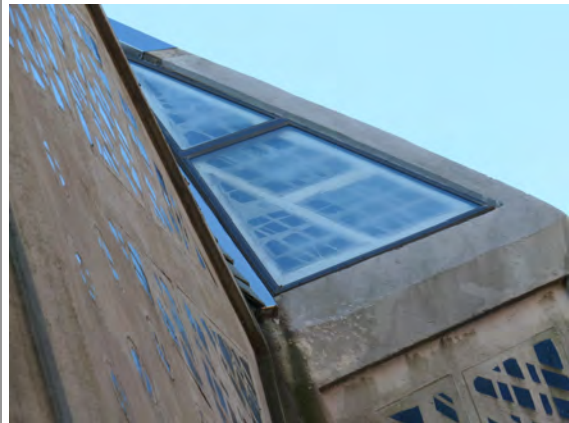
Typical protective glazing units on the north. Similar units are installed above the roofline on the south and east elevations. They do not appear to be vented, resulting in condensation on the glass and potential water infiltration through panels below.

- 2 A Condensation Visible Within Protective Glazing. Signs of water infiltration visible on interior concrete.

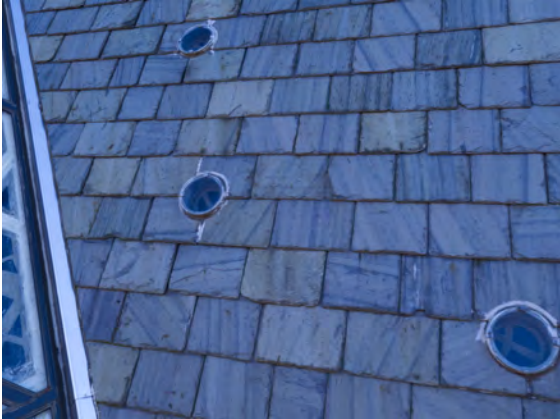
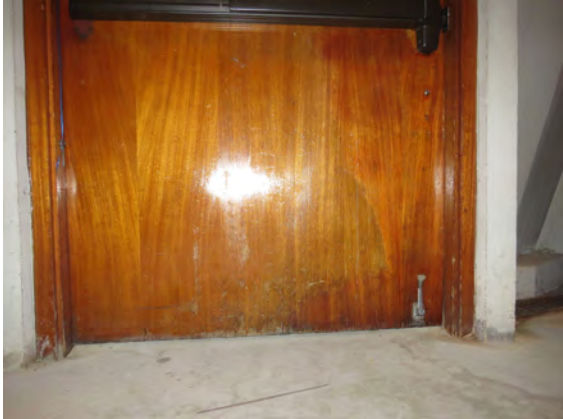
<p>Typical deteriorated and inconsistent sealant application around the protective glazing over the roof portal windows. The 2005 details of the protective glazing show no venting.</p> <p><b>CONDITION(S)</b></p> <p>3 A Deteriorated Sealant at Protective Glazing Over Portholes. Glazing is Not Vented.</p> <p><b>RECOMMENDATION(S)</b></p> <p>Provide new vented protective glazing.</p>	<p>Typical deterioration at Narthex door. The finish is abraded and exhibits water stains. Abandoned anchors are visible and holes are visible from previously removed hardware.</p> <p><b>CONDITION(S)</b></p> <p>I B Deteriorated Finish and Abandoned Anchor Holes</p> <p><b>RECOMMENDATION(S)</b></p> <p>Strip existing finish. Provide dutchmen and patch repairs as necessary. Provide new clear finish.</p>

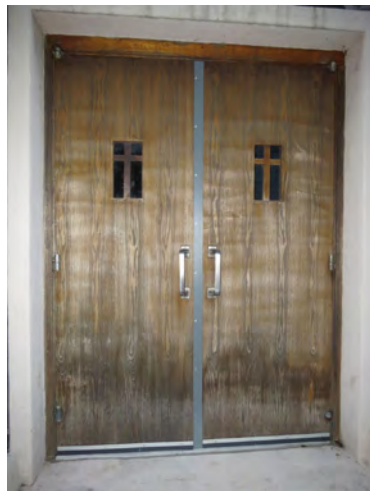
Deteriorated finish and wood veneer at southwest entrance door.

- 2 B Deteriorated Wood Finish and Delaminating Veneer Door and Wood Frame

Strip existing finish. Restore delaminating veneer and replace missing section of veneer. Provide dutchmen and patch repairs as necessary. Provide new clear finish. Alternate: replace door with new matching historic design.

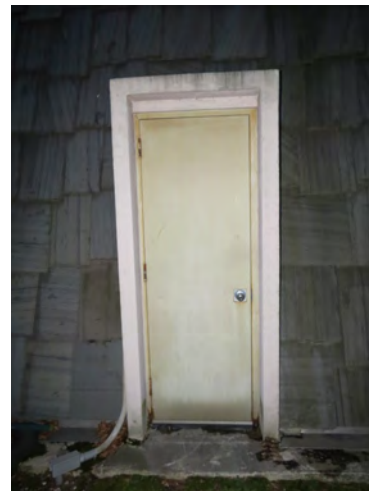
Exterior of door at west end of north elevation. The door leads to the pit under the original organ loft.

- 3 B Deteriorated Finish and Corrosion

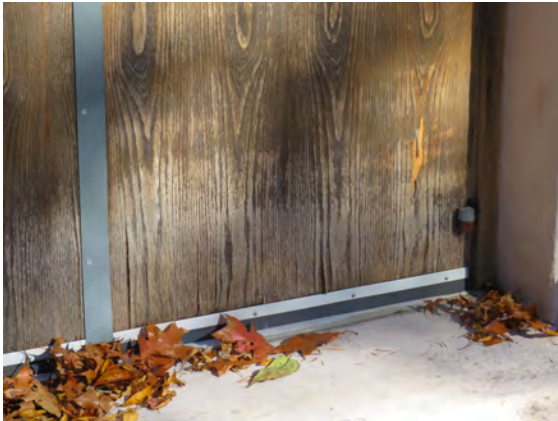
Typical corroding hinge and deteriorated veneer on the southwest entrance door.

- 4 B Missing, Inappropriate, Damaged Door Hardware, and/or Deteriorated Finishes on Hardware

Return hardware to first class operating condition and refinishing to match original appearance at each door. Replace missing components.

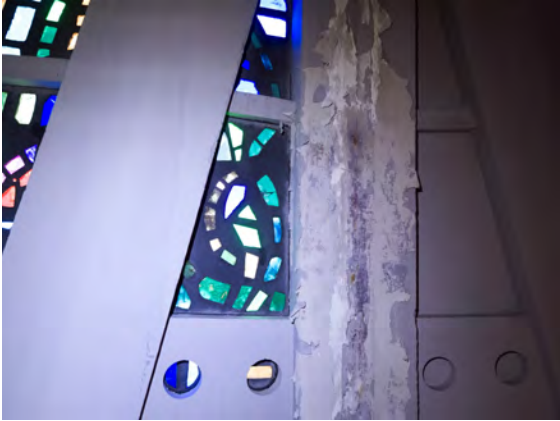
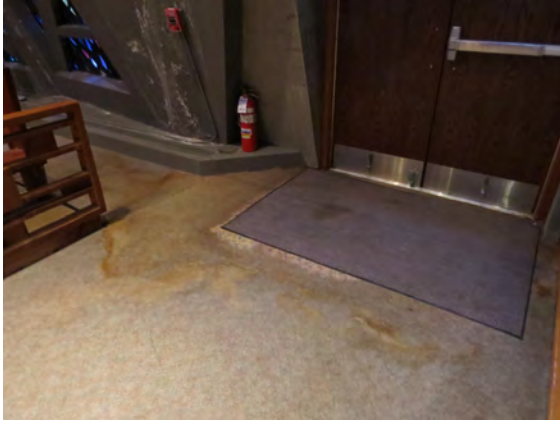
<p>Significant water damage on the east elevation and small areas of exposed corroding steel reinforcement.</p> <p><b>CONDITION(S)</b></p> <p>I B Flaking/Peeling Paint, Water Stains, and General Atmospheric Soil on Interior Concrete. Heavy Soiling at Skyward Facing Surfaces of Concrete.</p> <p><b>RECOMMENDATION(S)</b></p> <p>Vacuum heavy dust from skyward facing surfaces. Strip all coatings from all surfaces to sound finish. Repaint with breathable mineral coating.</p>	<p>Water damaged carpet near southwest entrance. Water damage is visible on the concrete door surround. It is undetermined if the damage here is from water ingress around or underneath the door.</p> <p><b>CONDITION(S)</b></p> <p>2 B Water Stained Carpet</p> <p><b>RECOMMENDATION(S)</b></p> <p>Determine and eliminate source of water infiltration. Further recommendations not in building envelope restoration scope.</p>

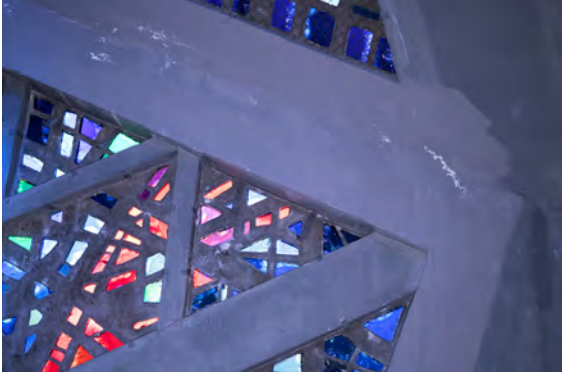
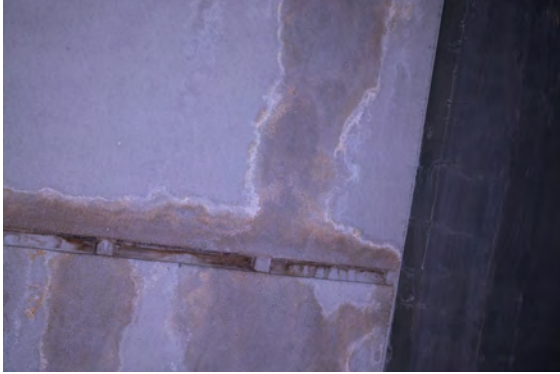
<p>The concrete framework at the center of the Nave was previously repainted up to the roofline on both the north and south elevations. The pre-cast concrete panels on the south were also painted; the pre-cast panels on the north were not painted.</p> <p><b>CONDITION(S)</b></p> <p>1 C Inconsistently Painted Concrete</p> <p><b>RECOMMENDATION(S)</b></p> <p>Strip all coatings from all surfaces to sound finish. Repaint with breathable mineral coating.</p>	<p>Acoustical panels on north and south elevations of Nave, near the Choir Loft exhibit isolated areas of water damage. The stains appear similar to photos in a 2005 conditions assessment, suggesting damage has not progressed since the roof repairs.</p> <p><b>CONDITION(S)</b></p> <p>2 C Water Damaged Acoustical Panels</p> <p><b>RECOMMENDATION(S)</b></p> <p>Determine and eliminate source of water infiltration. Further recommendations not in building envelope restoration scope.</p>

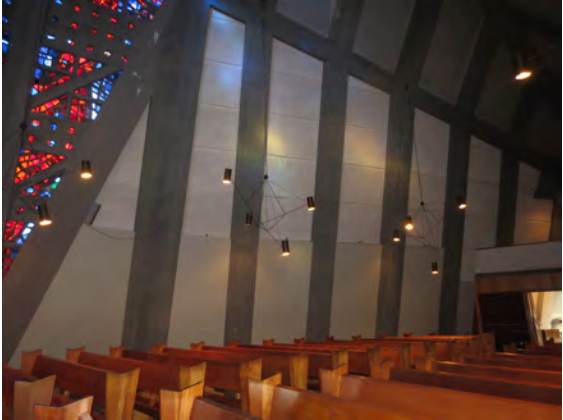
<p>Panels installed at the base of north and south elevations, over previously installed acoustical panels that stretch the full height of the Nave. Conditions behind the surface of these more recently installed panels were not accessible for review.</p> <p><b>CONDITION(S)</b></p> <p>3 C Panels Installed to Height of Approximately 12 Feet</p> <p><b>RECOMMENDATION(S)</b></p> <p>Further investigation required. Remove more recently installed panels to allow for review of underlying conditions requiring treatment. Evaluate appropriateness of existing materials and design and consider potential replacement materials.</p>	<p><b>ELEMENT(S)</b> Framework</p> <p><b>MATERIAL(S)</b> Wood</p> <p><b>LOCATION(S)</b> Chapel</p> <p><b>ELEVATION(S)/SURFACE(S)</b> East</p> <p><b>PHOTO LOCATION</b> Interior East Wall</p>

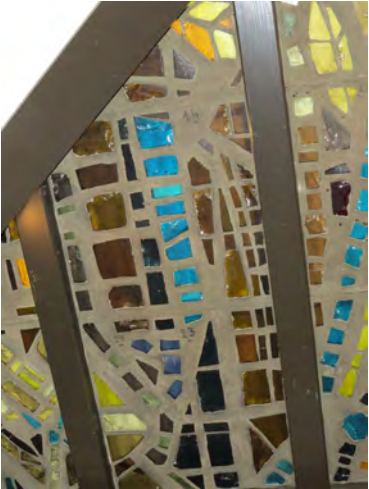
<p>The frame for the dalle de verre in the chapel is identified as wood on the archival drawings. It is painted brown, which contrasts with the original light color finish visible in archival images.</p> <p><b>CONDITION(S)</b></p> <p>4 C Sound Painted Wood</p> <p><b>RECOMMENDATION(S)</b></p> <p>Perform finishes analysis to determine original finish on wood.</p>

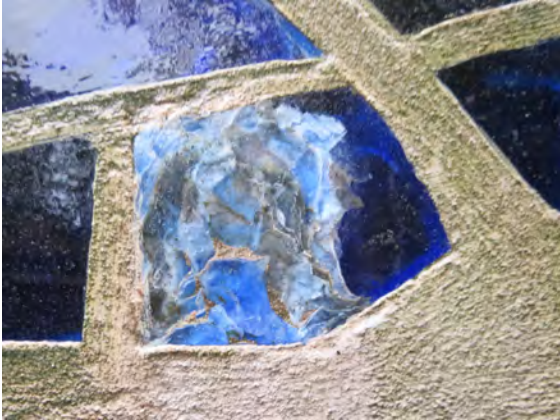
<p>Typical delaminating glass. Heavy soiling and biological growth is visible in the foliations. Some of the foliations appear to have been filled with mortar. These materials result in discoloration of the glass from the interior.</p> <p><b>CONDITION(S)</b></p> <p>I A Delaminating Dalle(s) in Concrete Dalle de Verre</p> <p><b>RECOMMENDATION(S)</b></p> <p>Carefully clean soil and biological growth from glass. Following installation of protective glazing stabilize interior surfaces of dalles. Work to be performed by an experienced conservator.</p>	<p><b>ELEMENT(S)</b> Dalle de Verre</p> <p><b>MATERIAL(S)</b> Glass Dalle(s), Pre-Cast Concrete</p> <p><b>LOCATION(S)</b> Nave</p> <p><b>ELEVATION(S)/SURFACE(S)</b> North</p> <p><b>PHOTO LOCATION</b> Interior North Wall</p>

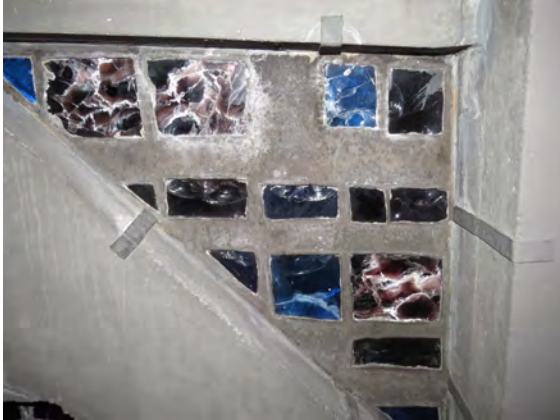
<p>Efflorescence visible on delaminated glass and on the concrete matrix on the north elevation.</p> <p><b>CONDITION(S)</b></p> <p>2 A Efflorescence on Glass and Concrete in Dalle de Verre</p> <p><b>RECOMMENDATION(S)</b></p> <p>Carefully vacuum efflorescence from concrete and glass. Carefully rinse salts from glass and remove all salts from adjacent concrete using a poultice. Work to be performed by an experienced conservator.</p>

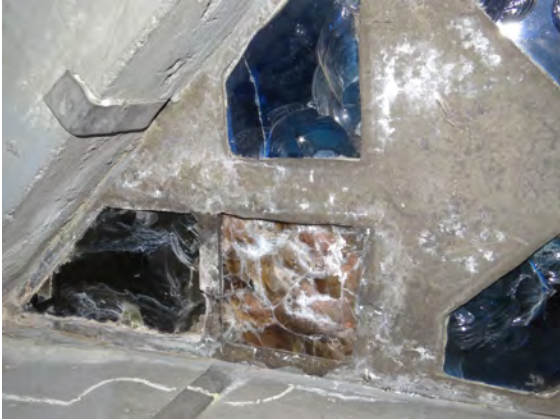
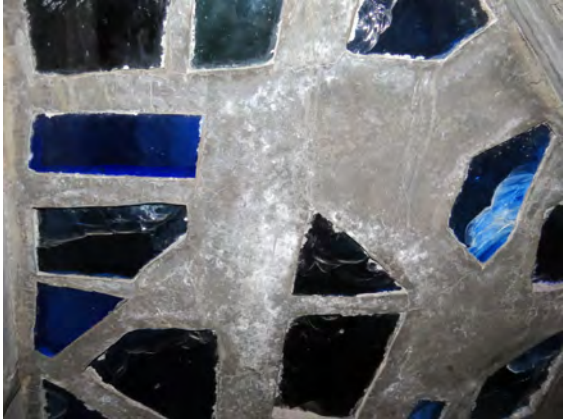
<p>Isolated crack in glass dalle at the top of image. This condition occurs less frequently than the delamination of the glass seen in the dalle at the bottom center of the image.</p> <p><b>CONDITION(S)</b></p> <p>3 A Cracked Dalle(s) in Concrete Dalle de Verre</p> <p><b>RECOMMENDATION(S)</b></p> <p>Provide adhesive injection repairs at cracks that threaten to destabilize glass.</p>	<p>Typical cracks in the concrete matrix. Some cracks are apparent on the exterior, but most are too fine to telegraph through the existing coating.</p> <p><b>CONDITION(S)</b></p> <p>4 A Crack(s) in Concrete at Dalle de Verre</p> <p><b>RECOMMENDATION(S)</b></p> <p>Remove all coatings. Review cracks and provide crack repairs on the north elevation that threaten to destabilize glass or allow light penetration.</p>

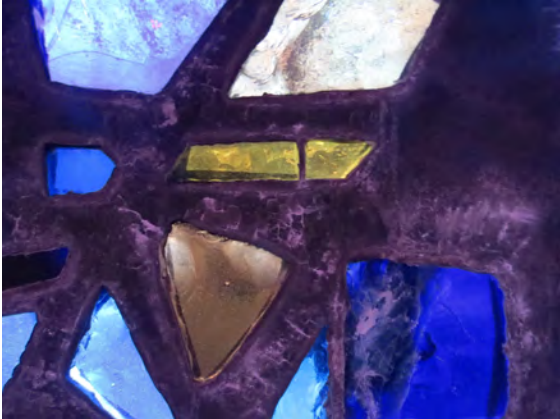
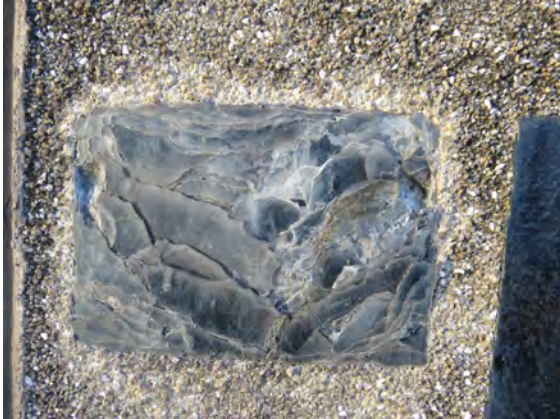
<p>Network surface cracks, typical at interior of dalle de verre concrete matrix exhibiting efflorescence.</p> <p><b>CONDITION(S)</b></p> <p>5 A Network Crack(s) in Concrete Matrix</p> <p><b>RECOMMENDATION(S)</b></p> <p>Further investigation required. Remove all coatings from concrete to determine extent of cracking in substrate. Repair concrete as necessary and provide new coating.</p>	<p>Typical delaminating glass. Heavy soiling and biological growth is visible in the foliations, resulting in discoloration of the glass from the interior.</p> <p><b>CONDITION(S)</b></p> <p>6 A Delaminating Dalle(s) in Epoxy Dalle de Verre</p> <p><b>RECOMMENDATION(S)</b></p> <p>Overall recommendation for dalle de panels with an epoxy matrix includes fabrication and installation of new dalle de verre panels.</p>

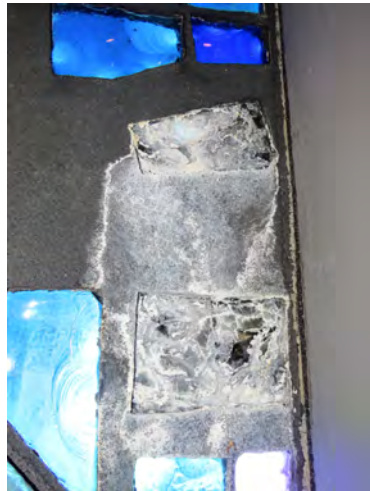
Heavy efflorescence on the glass and epoxy dalle de verre at the base of pre-cast panel S15.

Overall recommendation for dalle de panels with an epoxy matrix includes fabrication and installation of new dalle de verre panels.

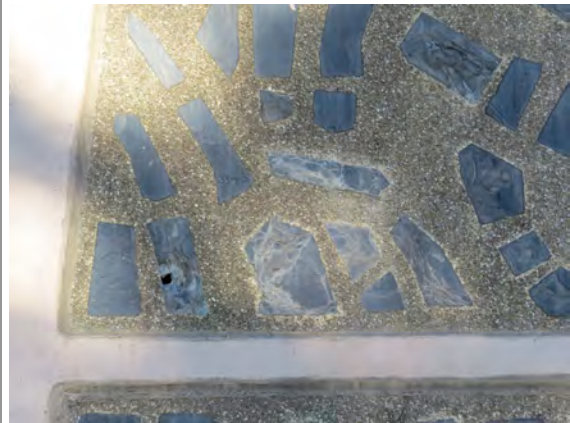
Hole in glass dalle in epoxy dalle de verre panel.

Overall recommendation for dalle de panels with an epoxy matrix includes fabrication and installation of new dalle de verre panels.

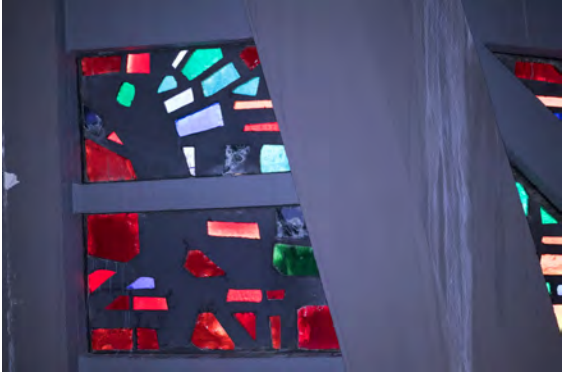
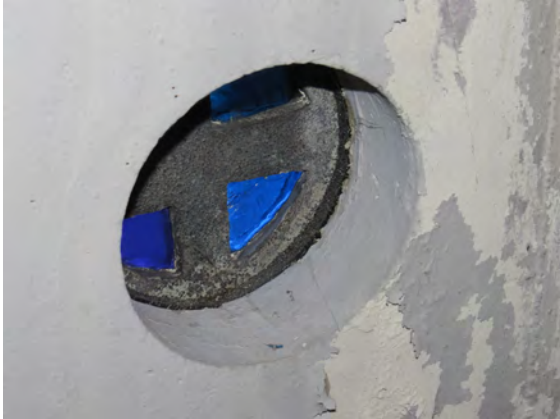
<p>Cracks radiating from dalles in the epoxy matrix are generally to fine to perceive, except when water infiltration makes them more visible.</p> <p><b>CONDITION(S)</b></p> <p>9 A Crack(s) in Epoxy at Dalle de Verre</p> <p><b>RECOMMENDATION(S)</b></p> <p>Overall recommendation for dalle de panels with an epoxy matrix includes fabrication and installation of new dalle de verre panels.</p>	<p>Sealant was specified in the construction documents from the 1980s, but is not installed. The perimeter of panels is therefore a common source of water infiltration on the east and south facades.</p> <p><b>CONDITION(S)</b></p> <p>10 A No Interior Sealant at Perimeter of Dalle de Verre</p> <p><b>RECOMMENDATION(S)</b></p> <p>Overall recommendation for dalle de panels with an epoxy matrix includes fabrication and installation of new dalle de verre panels.</p>

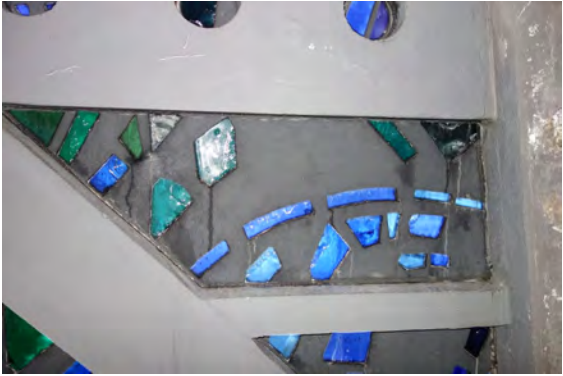
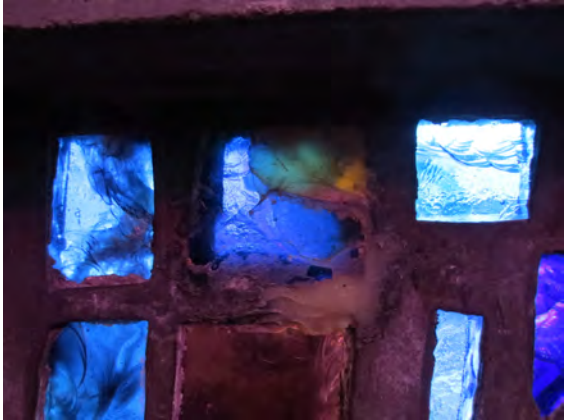
<p>Typical water stains as a result of moisture infiltration through hairline separation between dalle and matrix. Note that no loose dalles were detected at the accessible areas.</p> <p><b>CONDITION(S)</b></p> <p>I I A Water Infiltration at Perimeter of Dalle(s) in Epoxy Matrix</p> <p><b>RECOMMENDATION(S)</b></p> <p>Overall recommendation for dalle de panels with an epoxy matrix includes fabrication and installation of new dalle de verre panels.</p>	<p>Previous repair to the interior of glass and concrete at a dalle-de-verre panel near the base of pre-cast panel N4. The repair material is brittle and disfiguring to the glass. In other locations, cementitious mortar was used to patch glass.</p> <p><b>CONDITION(S)</b></p> <p>I B Previous Inappropriate Dalle/Matrix Repair in Concrete Panel</p> <p><b>RECOMMENDATION(S)</b></p> <p>Remove patching material and review underlying condition. Where a glass dalle is destabilized or there is a significant hole in the dalle, replace with a new dalle matching the original.</p>

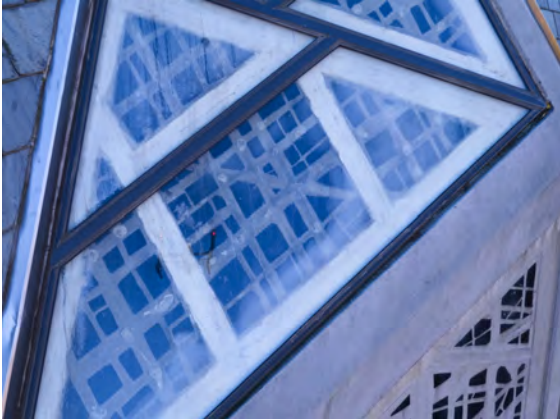
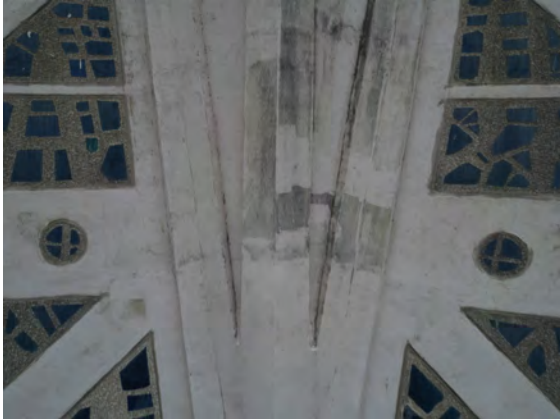
<p>Residue is visible on the skyward facing dalle de verre; this appears to be from adhesives previously used to attach plexiglass protection. The pre-cast concrete within the protective glazing also exhibits a white waterproofing coating.</p> <p><b>CONDITION(S)</b></p> <p>2 B Residue on Dalle de Verre and Unidentified Coating on Skyward Facing Surfaces Within Protective Glazing</p> <p><b>RECOMMENDATION(S)</b></p> <p>Remove all residue and coatings from dalle de verre and pre-cast panels in advance of installing new recommended protective glazing.</p>	<p>Biological growth visible on the uncoated epoxy dalle de verre on the south and east elevations. Differential growth is visible on patching material in the pre-cast concrete and</p> <p><b>CONDITION(S)</b></p> <p>3 B General Atmospheric Soil and Biological Growth on Epoxy Dalle de Verre</p> <p><b>RECOMMENDATION(S)</b></p> <p>Overall recommendation for dalle de panels with an epoxy matrix includes fabrication and installation of new dalle de verre panels.</p>

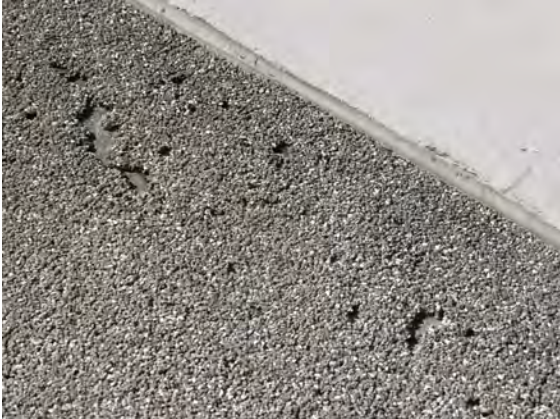
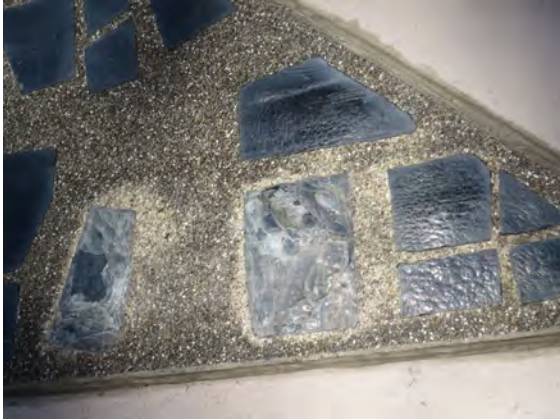
<p>Disaggregation of the panel surface was noted on the panels on the east elevation. The deterioration was notably worse at the south end of this short elevation.</p> <p><b>CONDITION(S)</b></p> <p>4 B Friable Epoxy Matrix</p> <p><b>RECOMMENDATION(S)</b></p> <p>Overall recommendation for dalle de panels with an epoxy matrix includes fabrication and installation of new dalle de verre panels.</p>	<p>Typical discoloration of the exterior epoxy matrix adjacent to delaminating glass.</p> <p><b>CONDITION(S)</b></p> <p>5 B Discolored Epoxy at Perimeter of Deteriorated Glass</p> <p><b>RECOMMENDATION(S)</b></p> <p>Overall recommendation for dalle de panels with an epoxy matrix includes fabrication and installation of new dalle de verre panels.</p>

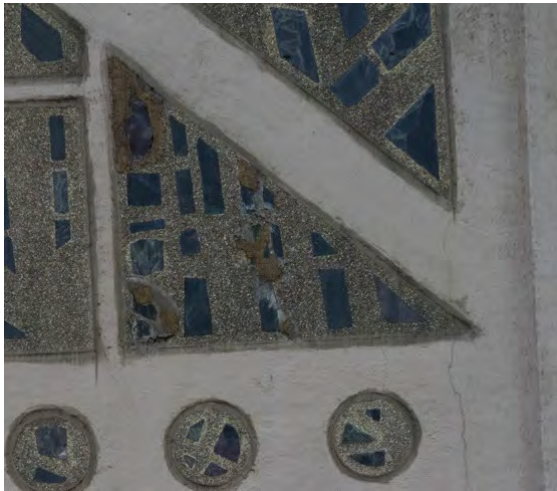
Rough mortar material appears to have been used to repair multiple locations in this triangular dalle de verre panel in pre-cast panel S9.

6 B Previous Inappropriate Dalle/Matrix Repair in Epoxy Panel

Overall recommendation for dalle de panels with an epoxy matrix includes fabrication and installation of new dalle de verre panels.

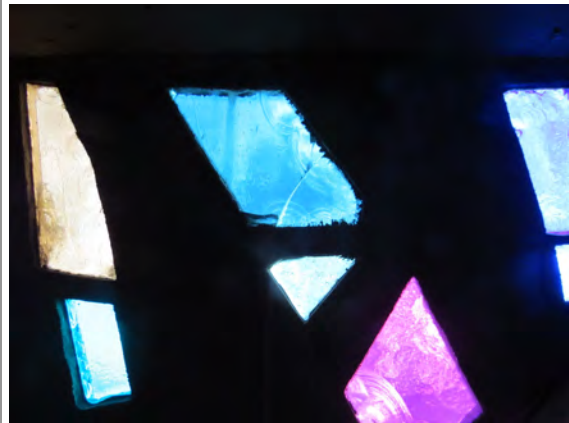
Isolate crack in glass dalle.

7 B Cracked Dalle(s) in Epoxy Dalle de Verre

Overall recommendation for dalle de panels with an epoxy matrix includes fabrication and installation of new dalle de verre panels.

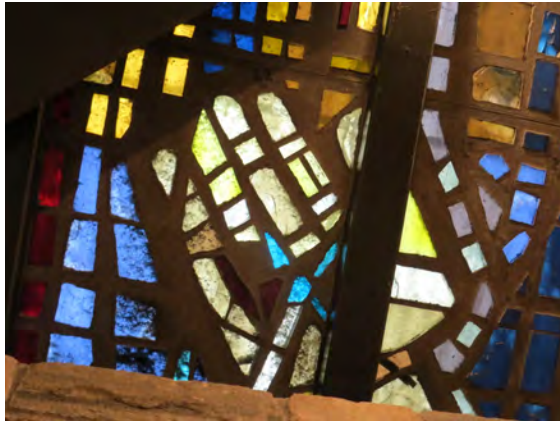
Heavy soiling on the top side of dalles in the Chapel.

Clean glass on north elevation with chemical cleaner designed specifically for glass in advance of installing recommended protective glazing.

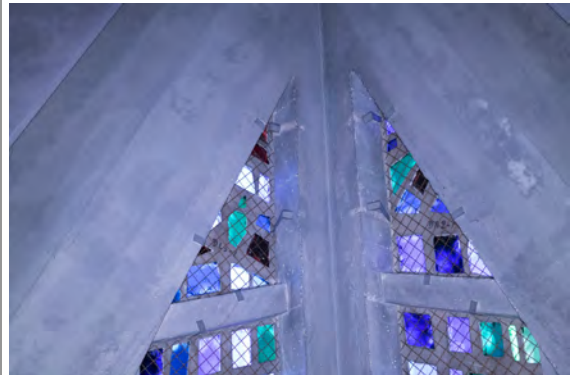
Displaced interior panel anchors visible throughout Nave and Narthex at original panels. There is no record of these panels having been previously removed.

2 C Loose/Displaced Panel Anchor at Concrete Dalle de Verre

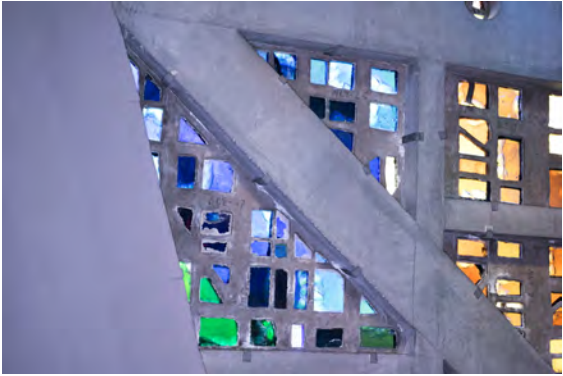
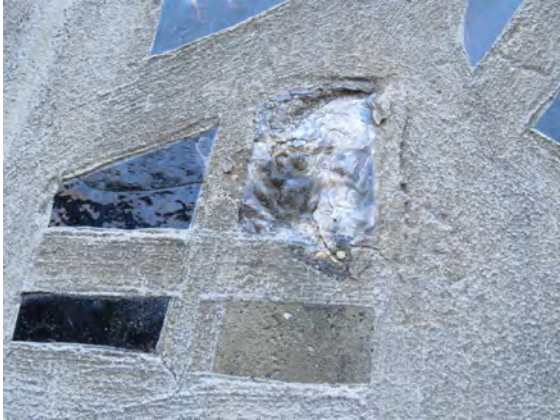
<p>Typical heavy dust accumulation at perimeter of dalles and in deep facets.</p> <p><b>CONDITION(S)</b></p> <p>3 C Heavy Soiling in Facets</p> <p><b>RECOMMENDATION(S)</b></p> <p>Vacuum all interior glass on north elevation. Clean all stable glass with glass cleaner after general cleaning performed at adjacent materials.</p>	<p>Possible previous cementitious patch repair at missing dalle. Two such patches were noted at the base of the north elevation. Other similar patches may be covered with the existing concrete coating.</p> <p><b>CONDITION(S)</b></p> <p>4 C Missing Glass</p> <p><b>RECOMMENDATION(S)</b></p> <p>Remove existing patch in concrete matrix and replace with new dalle matching the original where the original color of the glass can be determined through archival research.</p>
