# **FIRST PRESBYTERIAN CHURCH OF STAMFORD, CT CONSERVATION MANAGEMENT PLAN**

**FINAL REPORT**

October 16, 2017

# **First Presbyterian Church Conservation Management Plan**

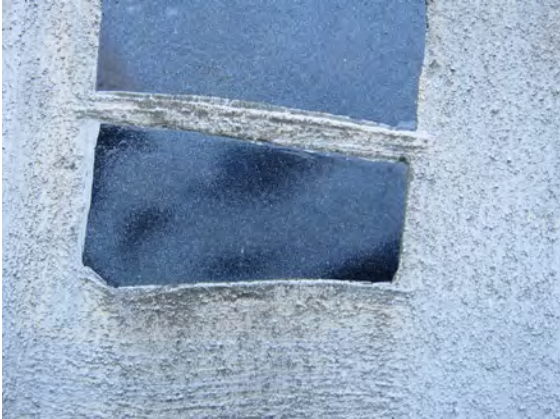
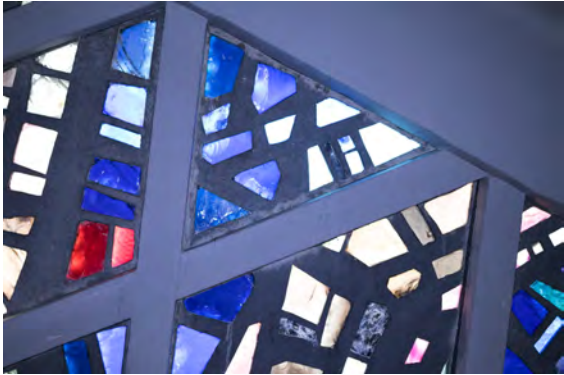
<p>Abraded glass in two dalle de verre panels at base of the pre-cast panel N12. This darkens the interior appearance of the glass. This may have resulted from a previous cleaning test using an abrasive material.</p> <p><b>CONDITION(S)</b></p> <p>5 C Abraded Glass in Panel</p> <p><b>RECOMMENDATION(S)</b></p> <p>No Restoration Work is Recommended</p>	<p>Water infiltration and damage at the perimeter of epoxy dalle-de-verre panels, where no sealant is installed.</p> <p><b>CONDITION(S)</b></p> <p>6 C Water Stains and General Atmospheric Soil on Epoxy Dalle de Verre</p> <p><b>RECOMMENDATION(S)</b></p> <p>Overall recommendation for dalle de panels with an epoxy matrix includes fabrication and installation of new dalle de verre panels.</p>

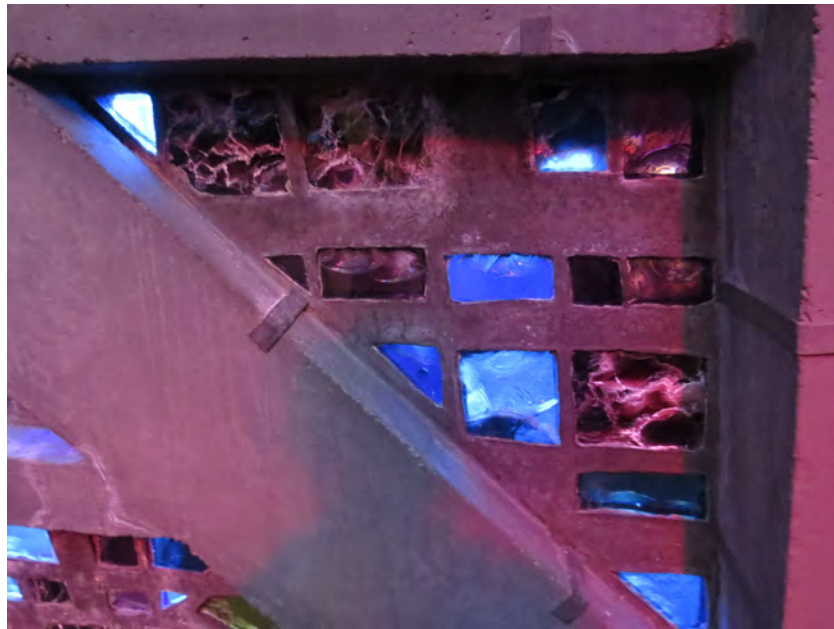
- 3 Sample location A in Figure I. Sampled deteriorated purple glass dalle near the base of pre-cast concrete panel N15.

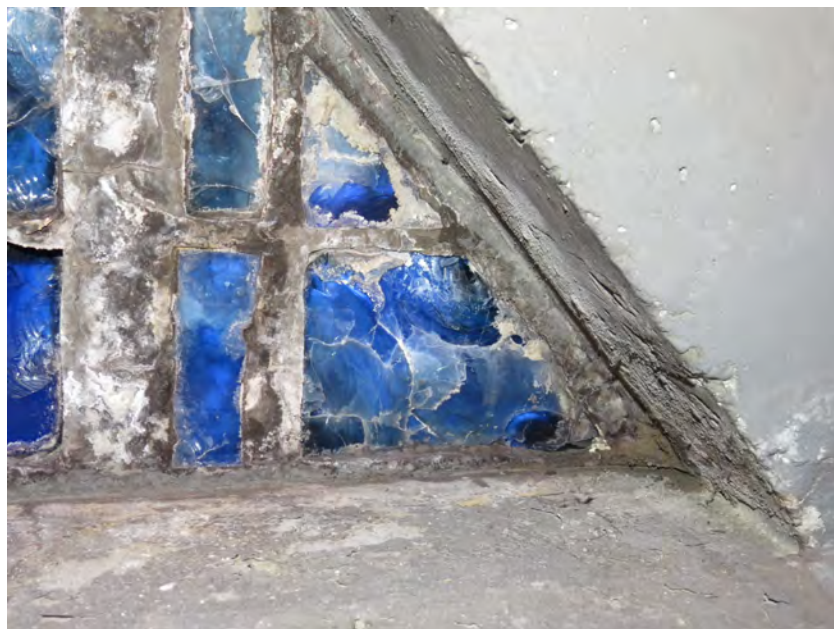
- 4 Sample location B in Figure I. Sampled deteriorated blue glass dalle near the base of pre-cast concrete panel N3 (Figure 4).

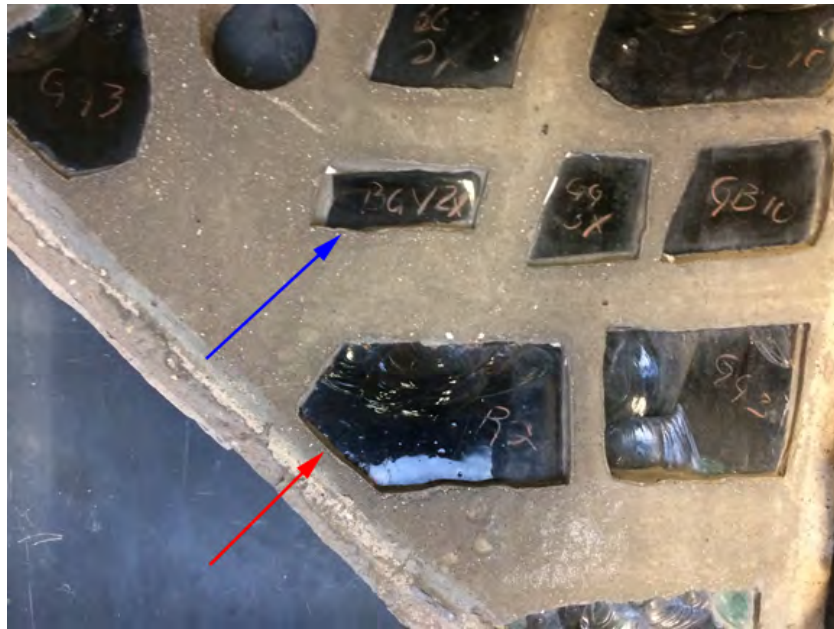
- 5 Salvaged panel where blue and red dalls were removed for testing (arrows indicated dalls tested; the color of the arrows corresponds to the glass colors). Panel was originally located in pre-cast panel S12, identified as sample locations C/D in Figure 2.

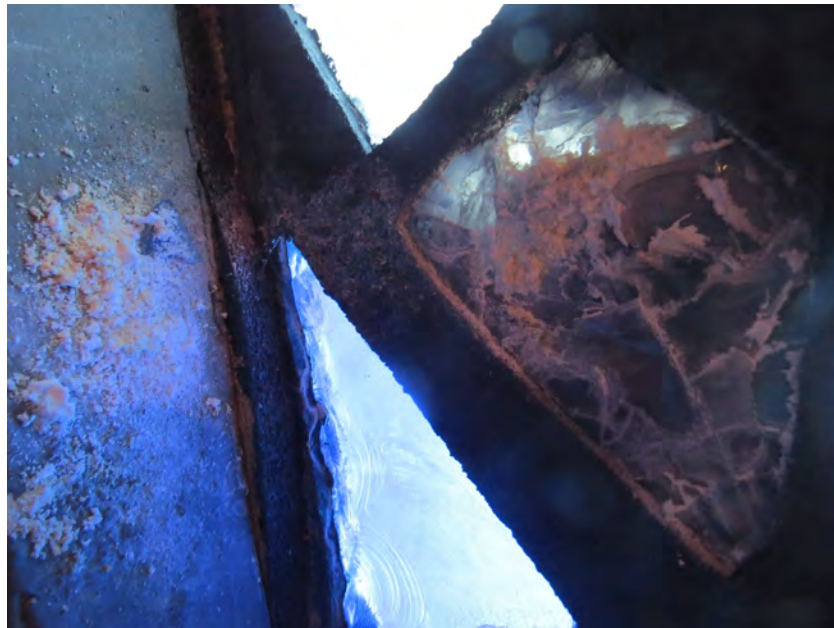
- 6 Sample location E in Figure 2. Sampled deteriorated purple glass dalle near the base of pre-cast concrete panel S12.

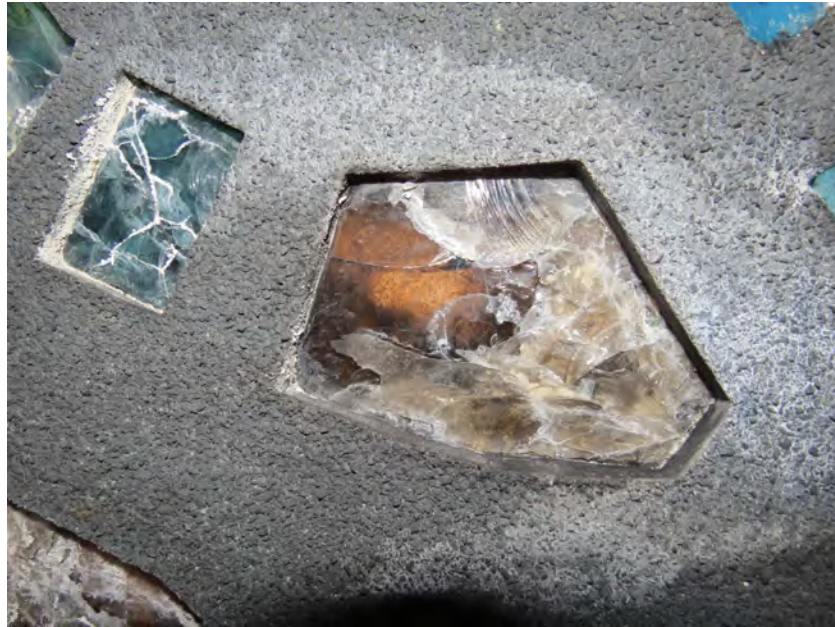
- 7 Sample location F in Figure 2. Sampled deteriorated orange glass dalle near the base of pre-cast concrete panel S4.

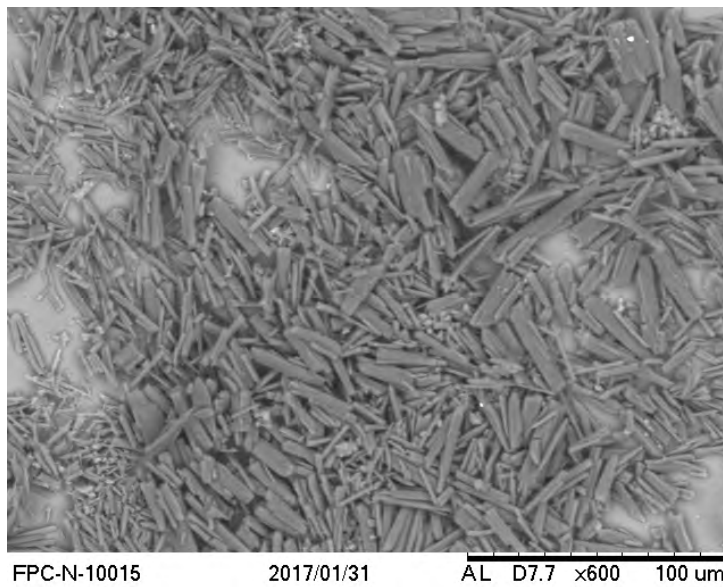
The significant fracturing of the glass and formation of sodium carbonate is consistent with a type of deterioration known as “glass disease” or “crizzling,” which results from an unstable glass composition. Because sodium and potassium oxides in glass are soluble in water, moisture combined with exposure to carbon dioxide causes the  $\text{Na}_2\text{O}$  and  $\text{K}_2\text{O}$  to convert to sodium or potassium carbonate, both of which are very hygroscopic, meaning they absorb or attract moisture in the air. As the sodium or potassium oxides form carbonates and leach out of the glass, a fragile and porous hydrated silica network is left behind.<sup>5</sup> During this process, the pH of the glass surface may rise greater than 10, which is high enough to dissolve the silica.<sup>6</sup> As a result of these reactions, the glass deterioration continues, resulting in crazing, cracks, flakes, pits, and as is the case at the Fish Church, a separation of the glass into layers.

- 8 Image showing the growth of sodium carbonate from the glass matrix at on Sample Sample A (deteriorated original glass).

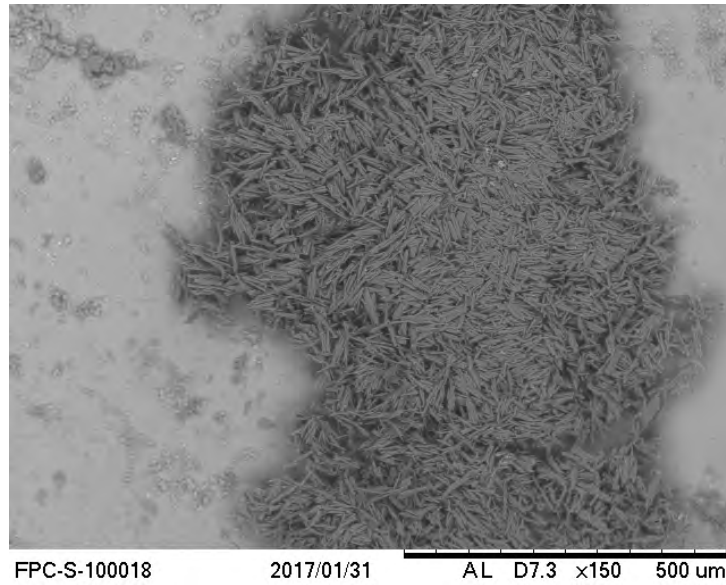
- 9 Image showing the growth of sodium carbonate from the glass matrix on E (deteriorated replacement glass).

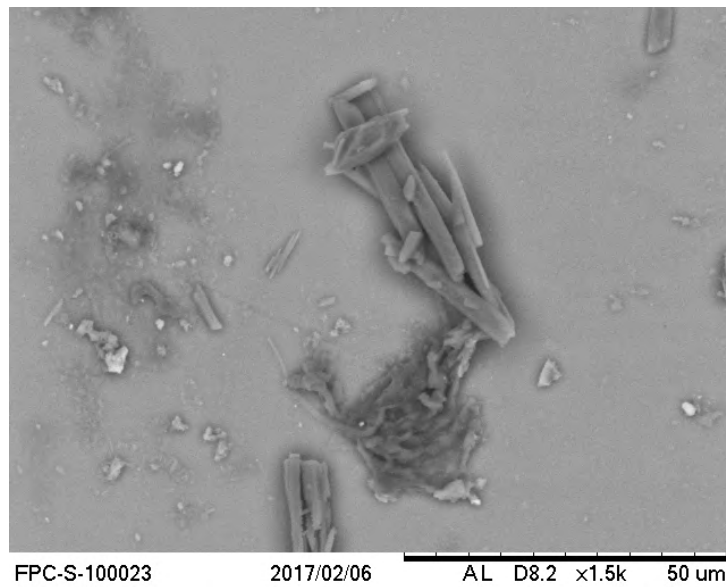
- 10 Image showing the growth of sodium carbonate from the glass matrix on Sample E (deteriorated replacement glass).

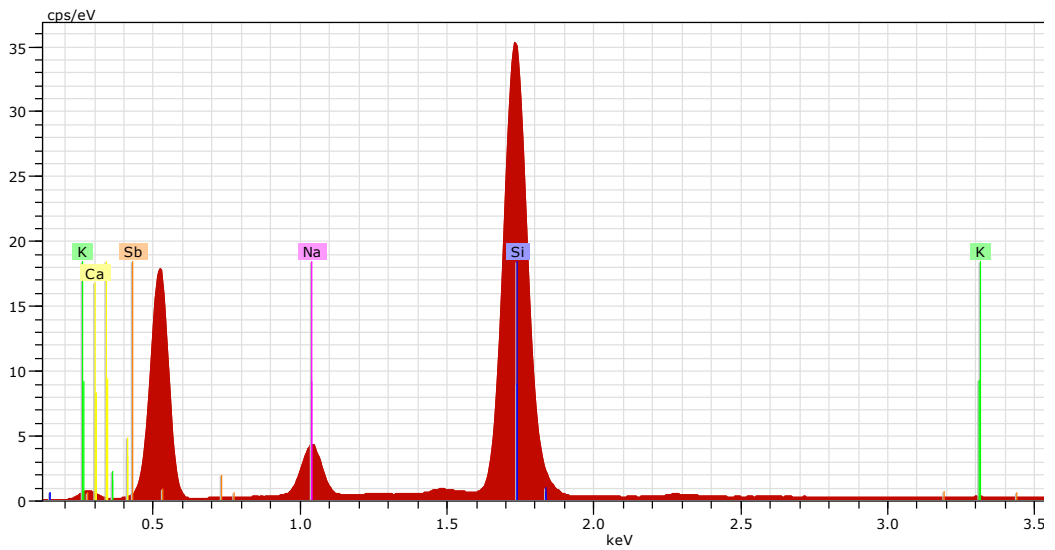
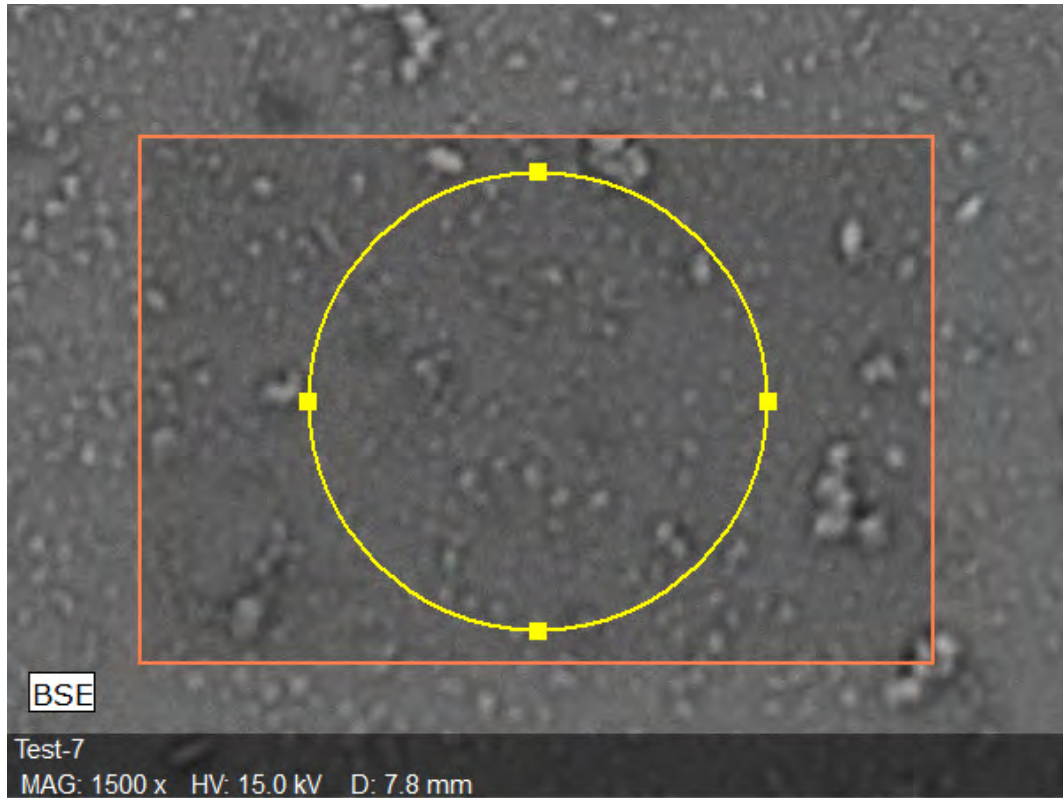
II Results from analysis of Sample A: Deterioated original purple glass.

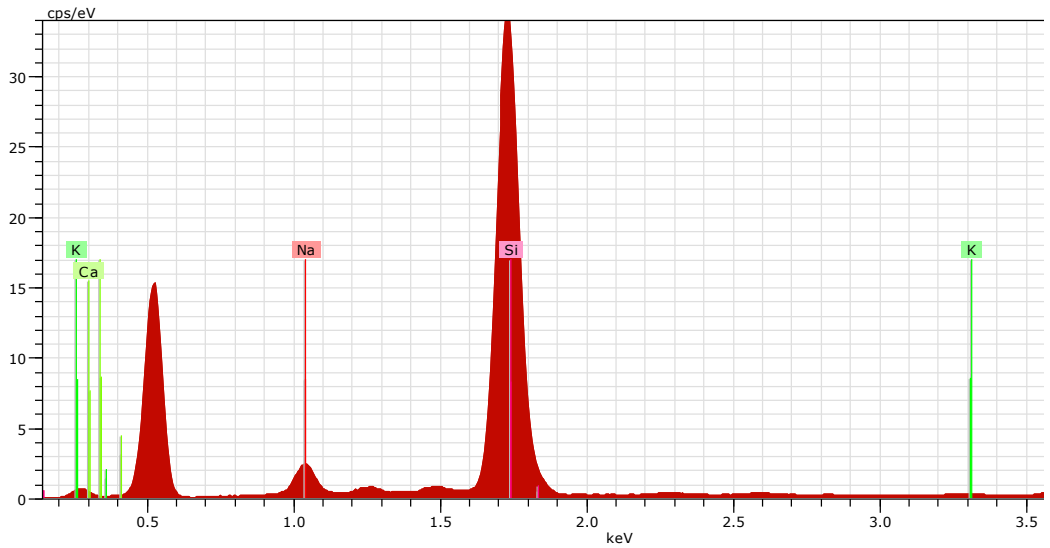
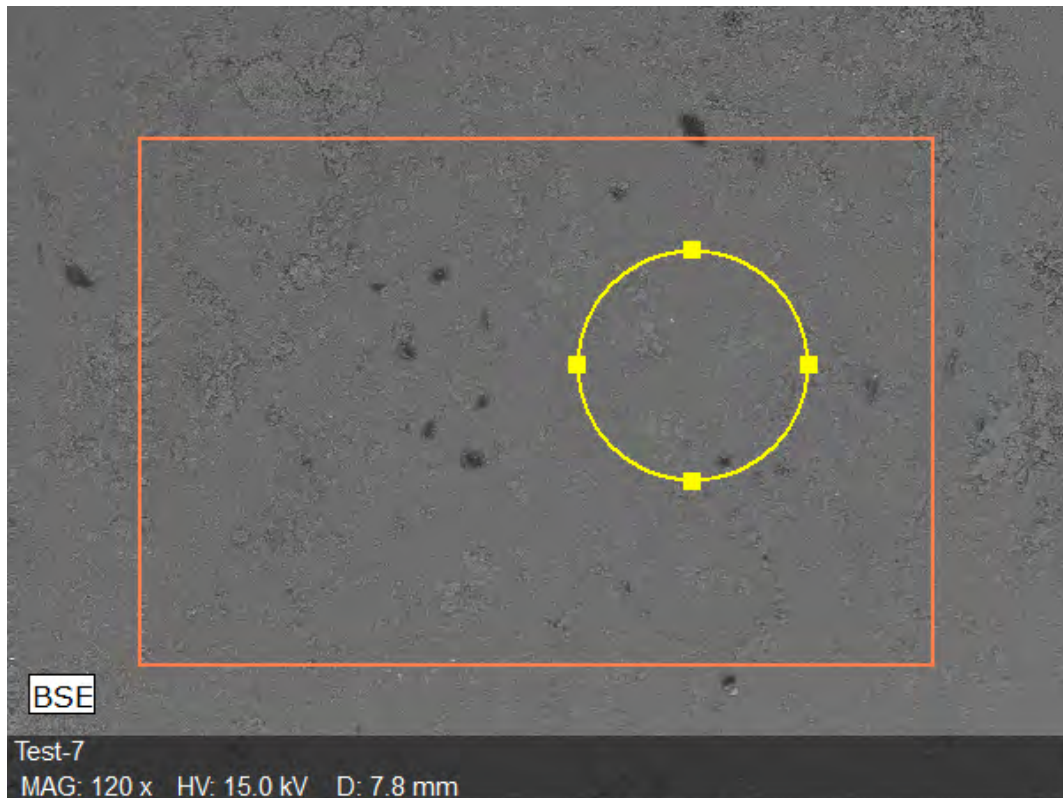
12 Results from analysis of Sample B: Deterioated original blue glass

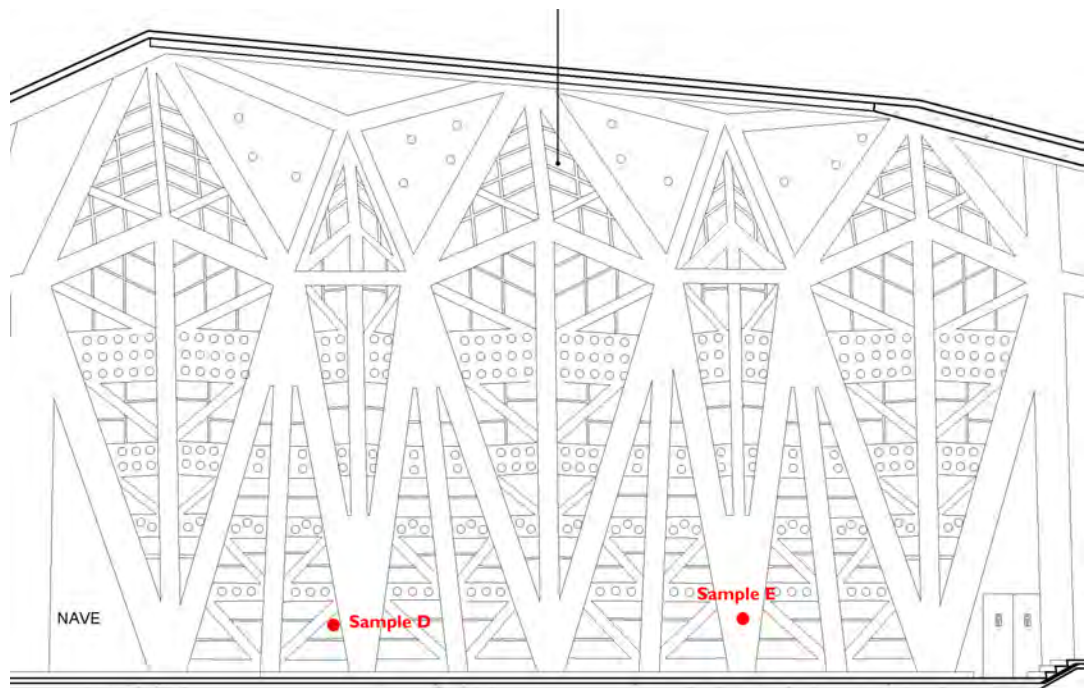
2 Sample locations on the interior of the south elevation.

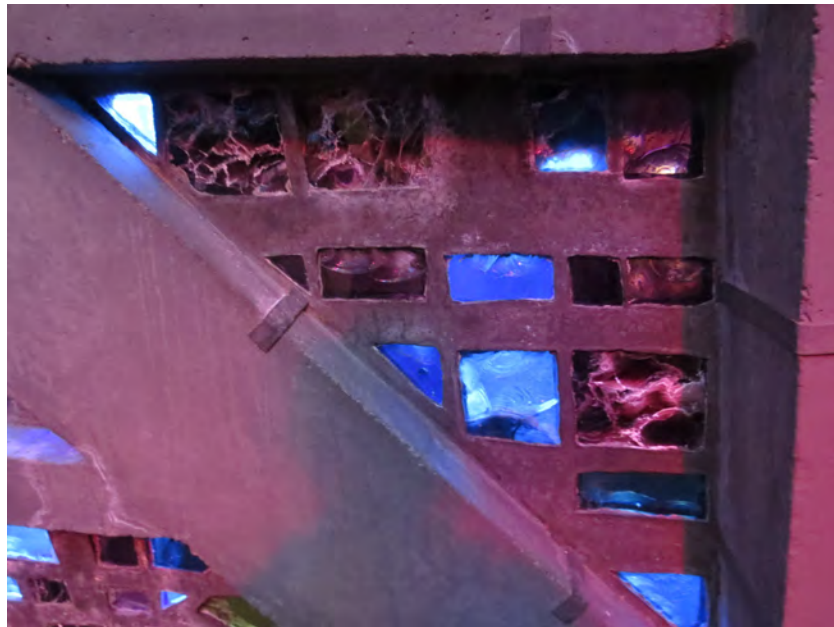
- A. Deteriorated glass in a dalle-de-verre panel near the base of pre-cast concrete panel N15 (Figure 3).
- B. Concrete matrix in a dalle-de-verre panel containing no deteriorated glass, near the base of pre-cast concrete panel N12 (Figure 4).
- C. Interior cast-in-place concrete base below the acoustical panels by the Choir Loft (Figure 5).

- 3 Sample location A in Figure I. Efflorescence removed from deteriorated glass in a dalle-  
de-verre panel near the base of pre-cast concrete panel N15.

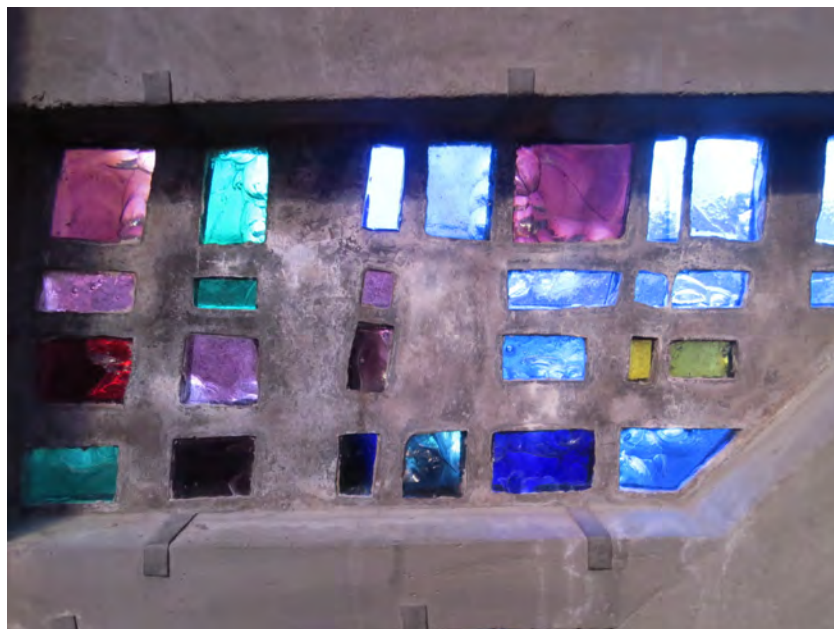
- 4 Sample location B in Figure I. Efflorescence removed from the concrete matrix in a dalle-  
de-verre panel near the base of pre-cast concrete panel N12. All glass in the panel  
appeared sound, free of cracks or delamination.

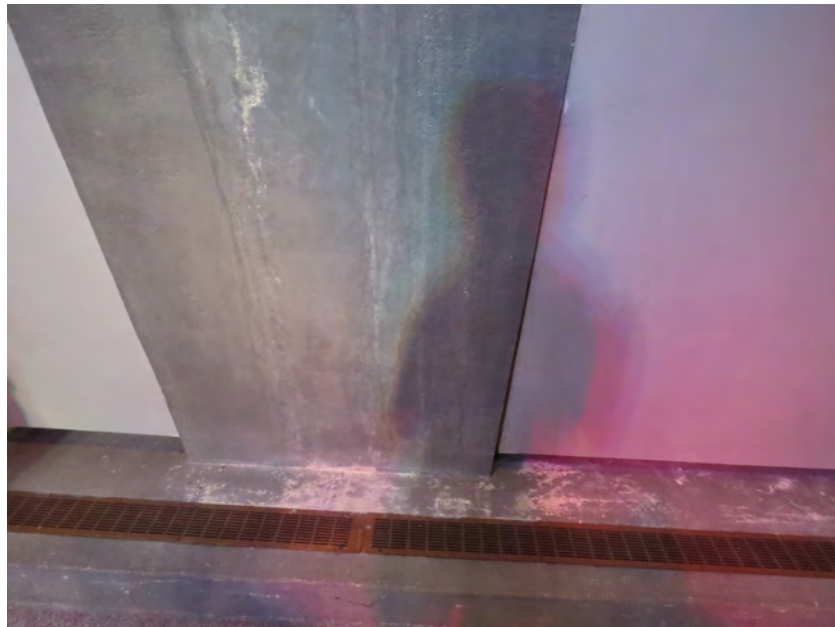
- 5 Sample location C in Figure 1. Efflorescence removed interior cast-in-place concrete base below the acoustical panels by the Choir Loft. Similar efflorescence was also visible on the portion of the base visible in the north passage.

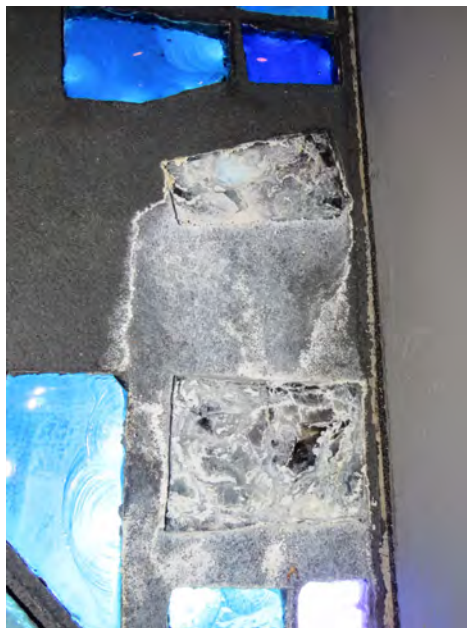
- D. Deteriorated glass in a dalle-de-verre panel near the base of pre-cast concrete panel S15 (Figure 6).
- E. Cast-in-place concrete exhibiting flaking and peeling paint, near the base of the building, between pre-cast concrete panels S3 and S4 (Figure 7).

- 6 Sample location D in Figure 2. Efflorescence removed from deteriorated glass and adjacent epoxy matrix material in a dalle-de-verre panel near the base of pre-cast concrete panel S15.

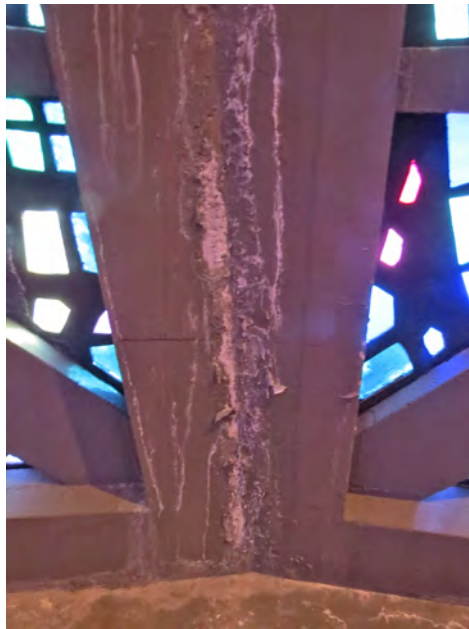
- 7 Sample location E in Figure 2. Efflorescence removed from cast-in-place concrete exhibiting flaking and peeling paint, near the base of the building, between pre-cast concrete panels S3 and S4

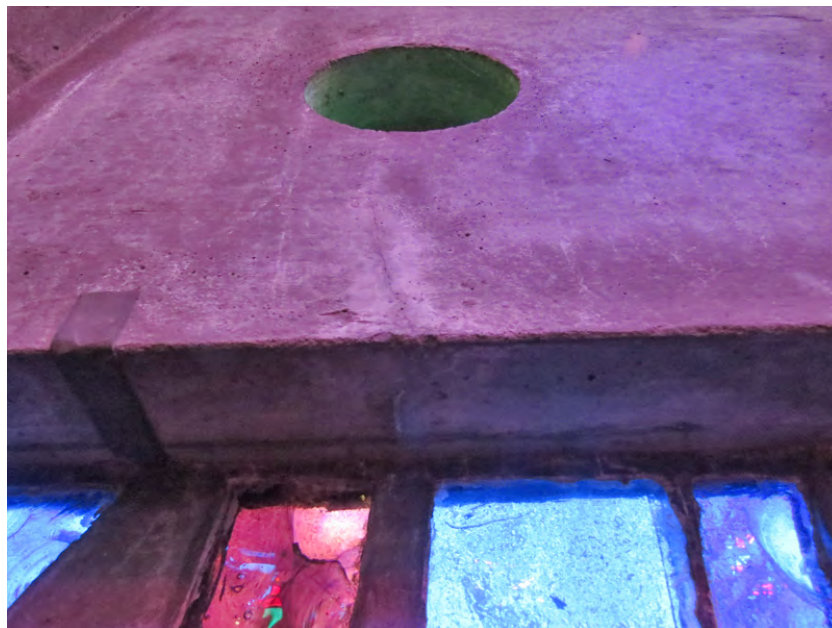
- 8 Typical efflorescence on pre-cast concrete panel on the north elevation. The surface deposition was too thin for bulk sampling of the material.

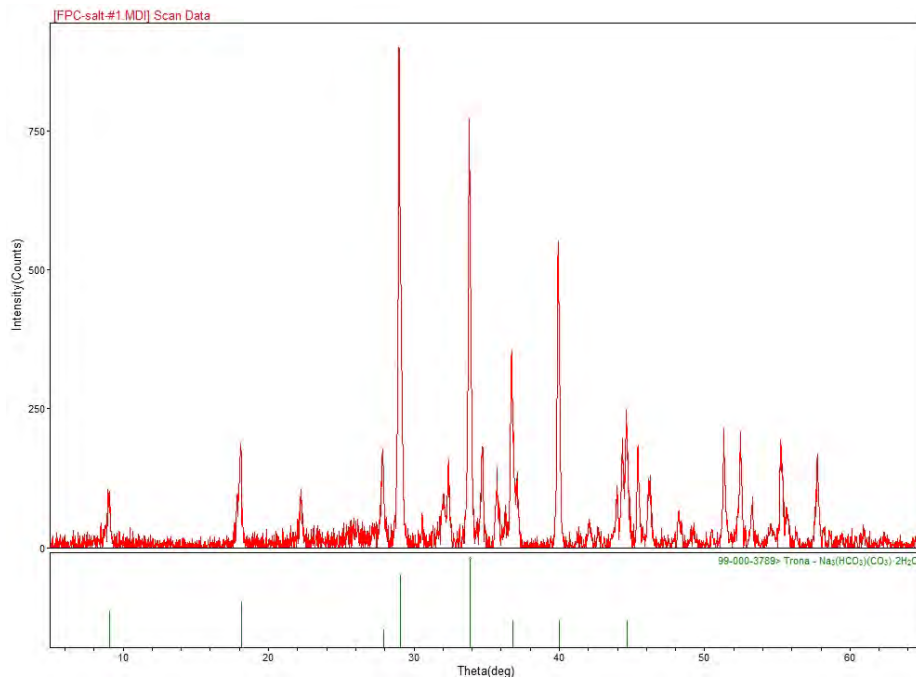
9 Diffractogram for Sample A – Salt on Glass in Concrete Dalle de Verre Panel. The primary phase identified is trona, which is sodium carbonate.

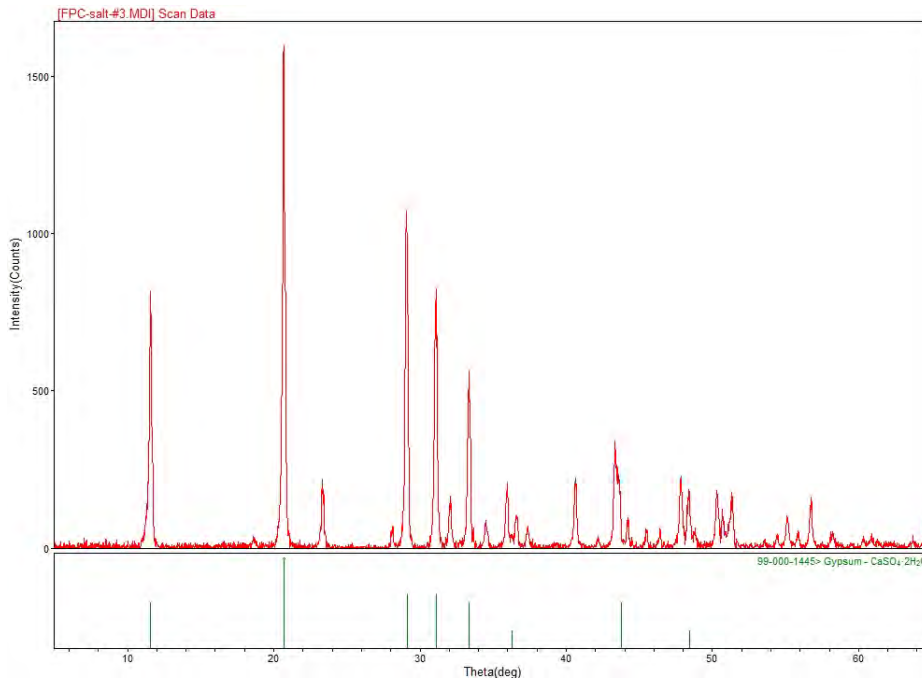
10 Diffractogram for Sample B – Salt on Concrete Dalle de Verre Matrix. The primary phase identified is gypsum, which is calcium sulfate.

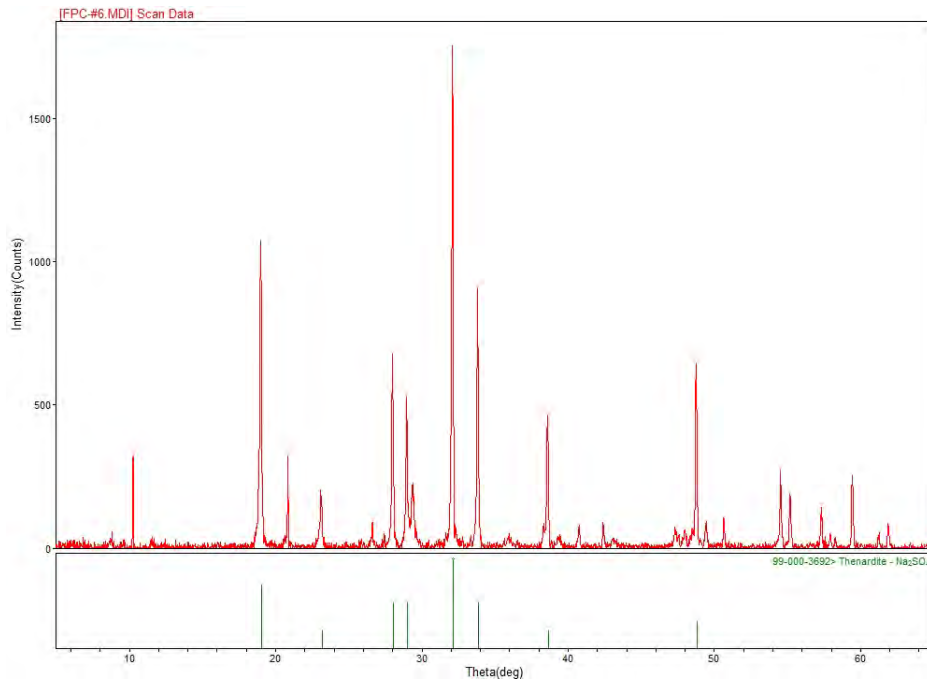
11 Diffractogram for Sample C – Salt on Cast-in-Place Concrete Base. The primary phase identified is thenardite, which is sodium sulfate.

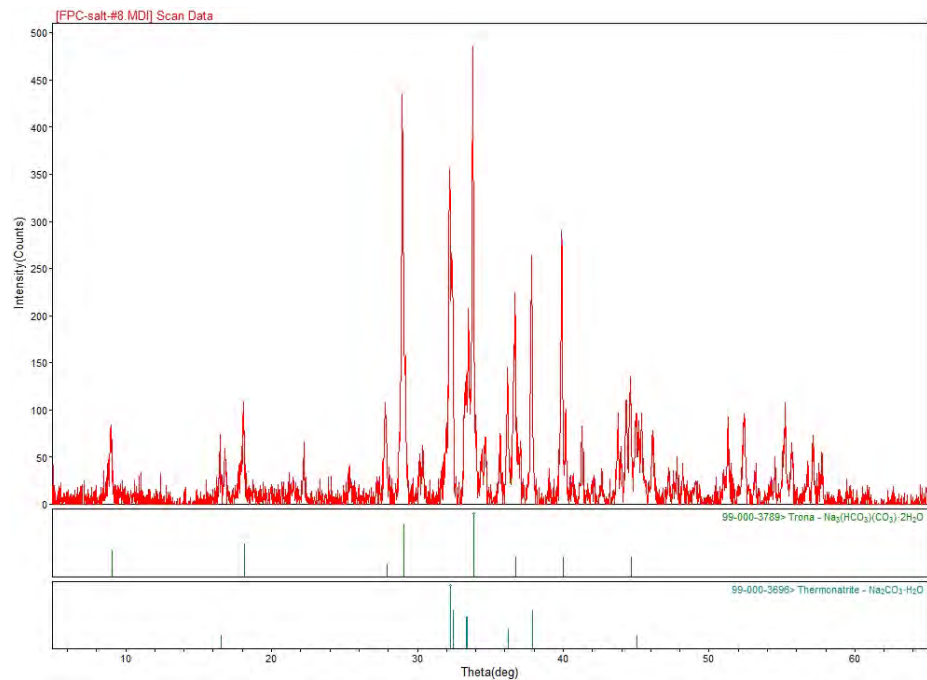
12 Diffractogram for Sample D – Salt on Glass in Epoxy Dalle de Verre Panel. The primary phases identified is trona (like Sample A) and thermonatrite, both of which are forms of sodium carbonate.

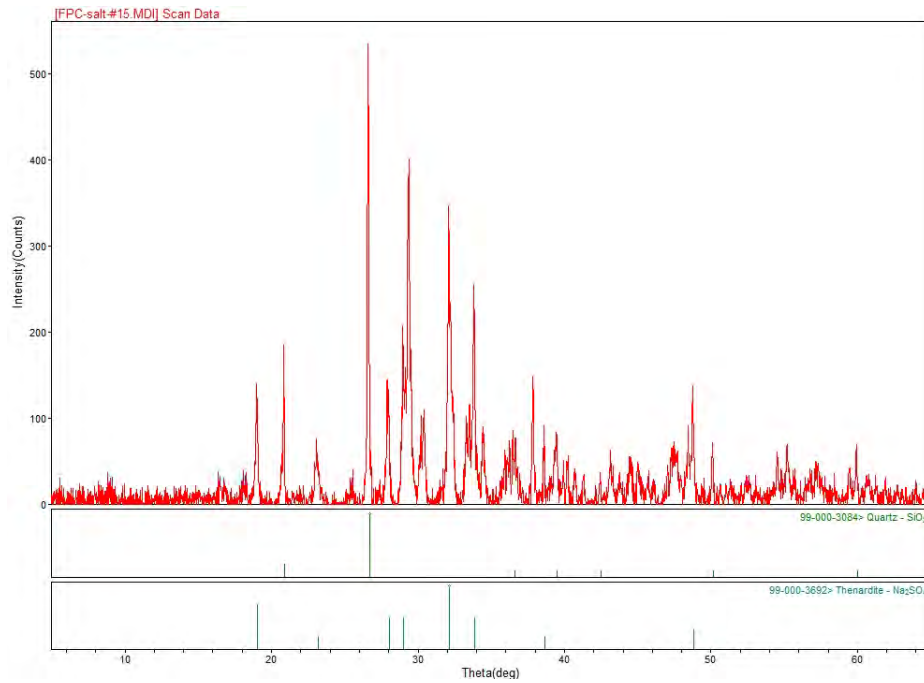
- 13 Diffractogram for Sample E – Salt on Cast-in-Place Concrete Framework. The primary phase identified is thenardite, which is sodium sulfate (like Sample C). The quartz identified during the analysis is not a component of the efflorescence; it was inadvertently sampled with the removal of the existing salt.

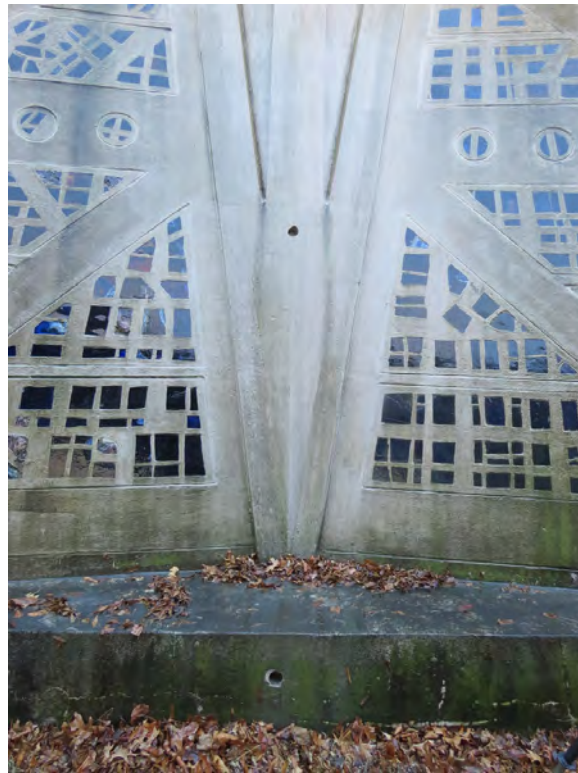
All sample areas appeared to have sound, original concrete. Sample #3 was taken approximately 5 inches below the horizontal shelf of the base and about 2 inches above an existing continuous crack in the vertical face of the base (Figure 4). No deterioration was noted adjacent to the other sample locations; however, all sample locations on the north elevation are coated with an elastomeric material, which may obscure nearby conditions.

- 4 Location of removed cores #1 and #3. Note that core #3 was taken approximately 2 inches above a continuous crack in the concrete base.

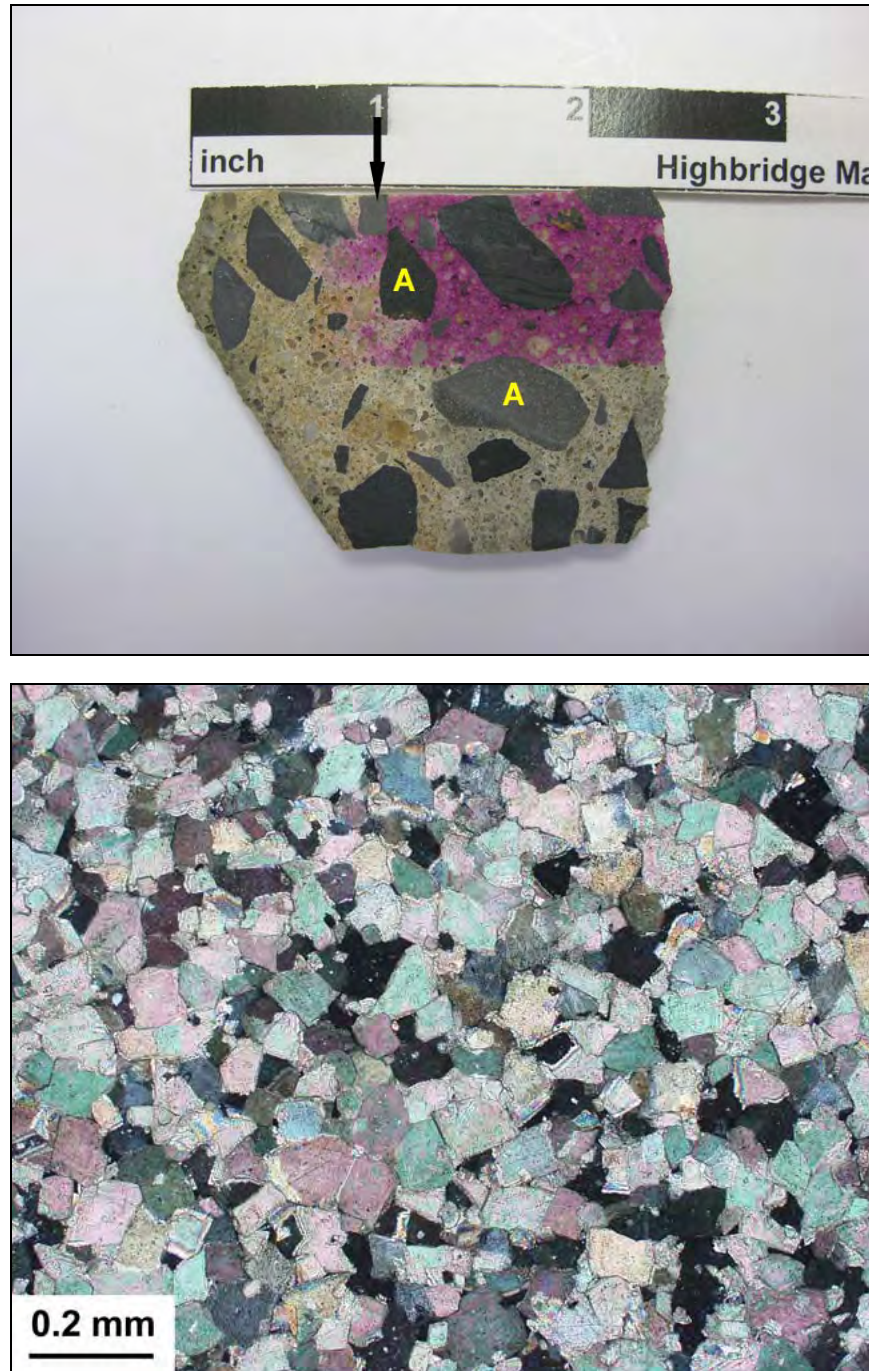
**Figure 2:** (Upper image) Photograph of the honed cross section of Core #1 with the outer surface oriented toward the left of the image. The crushed stone coarse aggregate (A) can be observed at this scale, though the sample is too small to accurately evaluate the size and distribution. Still, the stone appears to have a nominal top size at the 1/2" sieve. A No. 67 gradation profile is possible. The concentration of aggregate appears normal. A portion of the section is treated with a pH indicator solution. The pink color indicates that a high alkalinity is maintained below about 1" depth. The uncolored upper horizon coincides with the carbonation profile of the concrete. The depth of carbonation is a bit more than desirable at nearly one inch. Any steel reinforcement intersecting this zone could be at risk for depassivation. (Lower image) This XPL photomicrograph illustrates a typical microtexture within the coarse aggregate. The stone is a relatively pure, equigranular dolostone. The angular crystals all consist of dolomite. At this level of purity, the stone is not considered susceptible to alkali-silica reactions. However, dolostone of this character often contains inclusions of reactive chert or chalcedony. None are detected in this particular section.

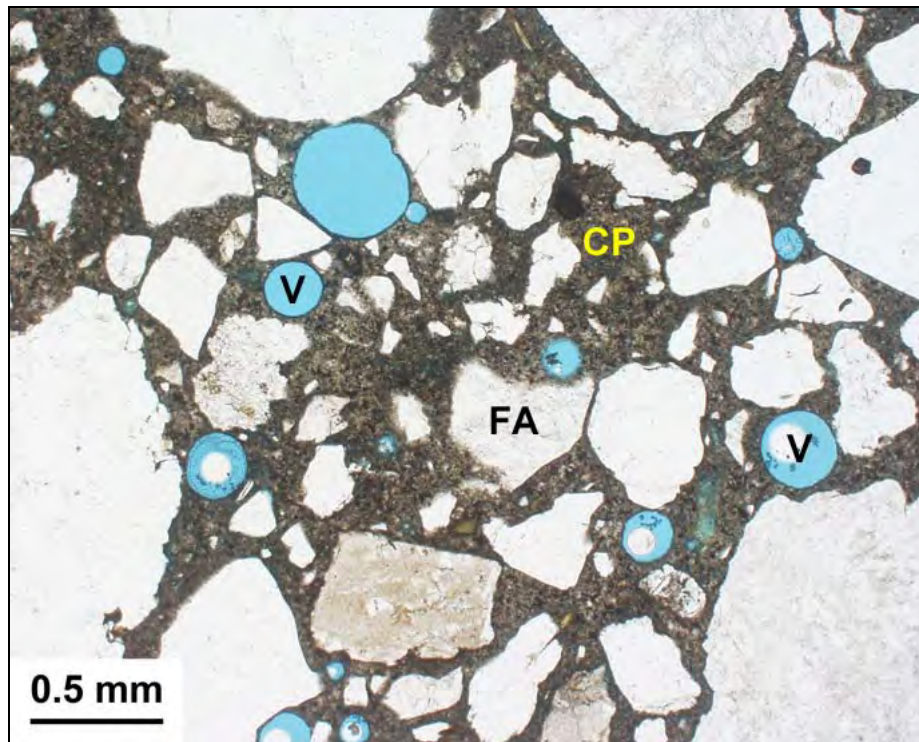
**Figure 3:** PPL photomicrograph illustrating the microstructure of the concrete in Core #1. The sample is impregnated with a low-viscosity, blue-dyed epoxy in order to highlight cracks, pores, and voids. The cement paste (CP) absorbs a moderate quantity of the dyed epoxy indicating a modest permeability. The microporosity suggests an original mix water content that was likely a little higher than desirable for concrete subject to exterior service but not necessarily excessive. Fine aggregate (FA) is evenly distributed throughout the matrix. The sand consists mostly of sharp-textured quartz grains. Air-voids (V) are present in moderate concentration. Though the abundance suggests intentional air-entrainment, there is a paucity of very fine void diameters. The air structure likely does not have the spacing factor or specific surface considered necessary for effective freeze-thaw resistance. This is not confirmed through an air-void analysis.

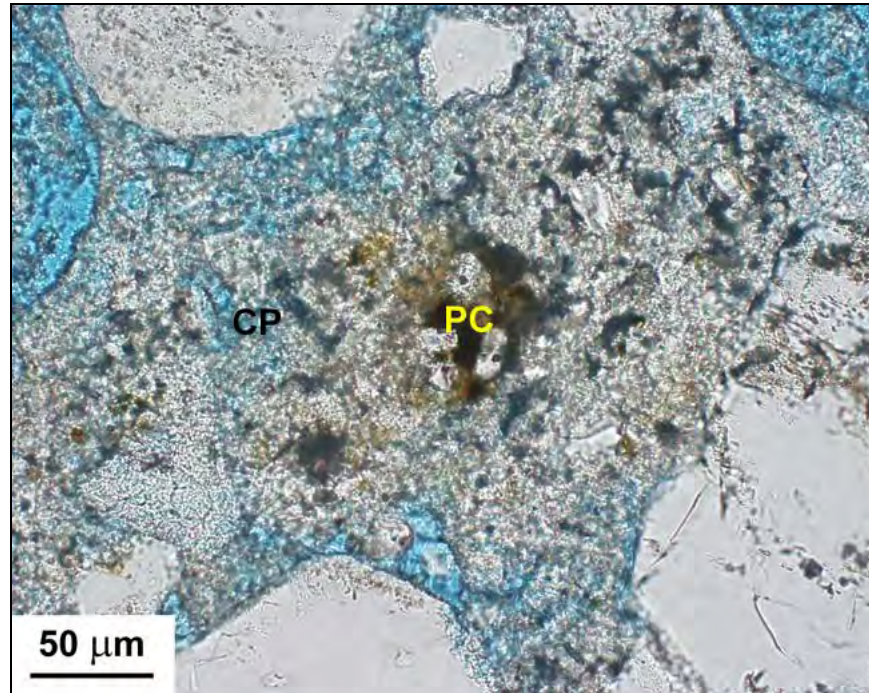
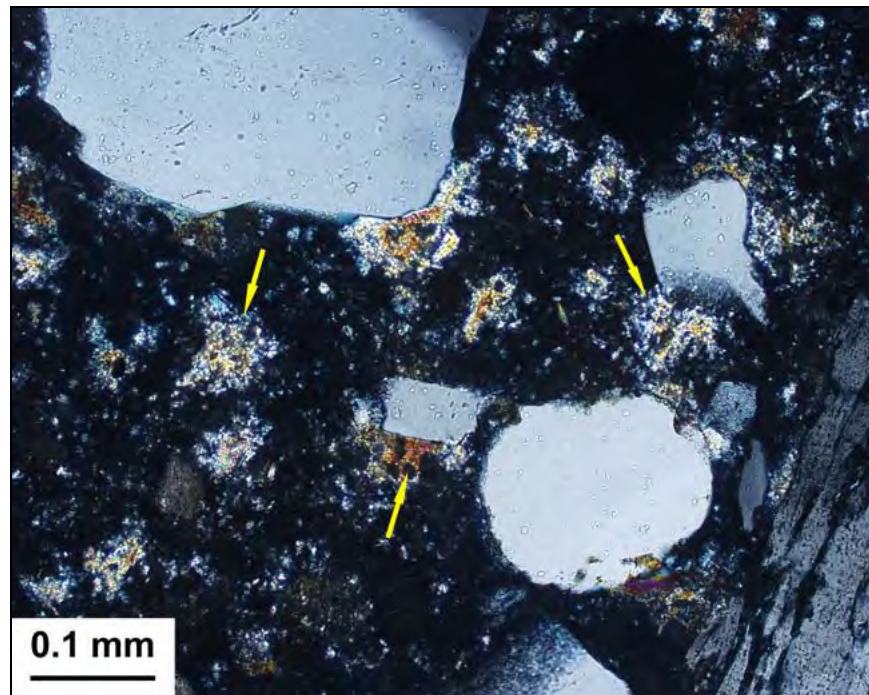
**Figure 4:** Photomicrographs illustrating the cement hydration characteristics for Core #1. (Upper PPL photomicrograph) Residual portland cement grains (PC) occur as fine agglomerates of former calcium silicate defined by a skeleton of brown-colored ferrite. The hydraulic calcium silicate once residing between these iron-bearing ferrite crystals is now fully consumed due to hydration. The adjacent cement paste (CP) is well-formed and has a moderate capillary porosity as indicated by the modest absorption of blue-dyed epoxy used in the sample preparation. (Lower XPL photomicrograph) The arrows illustrate medium-grained crystal masses of calcium hydroxide formed during the initial cement hydration. The non-compact morphologies are characteristic of water-cement ratios greater than approximately 0.40.

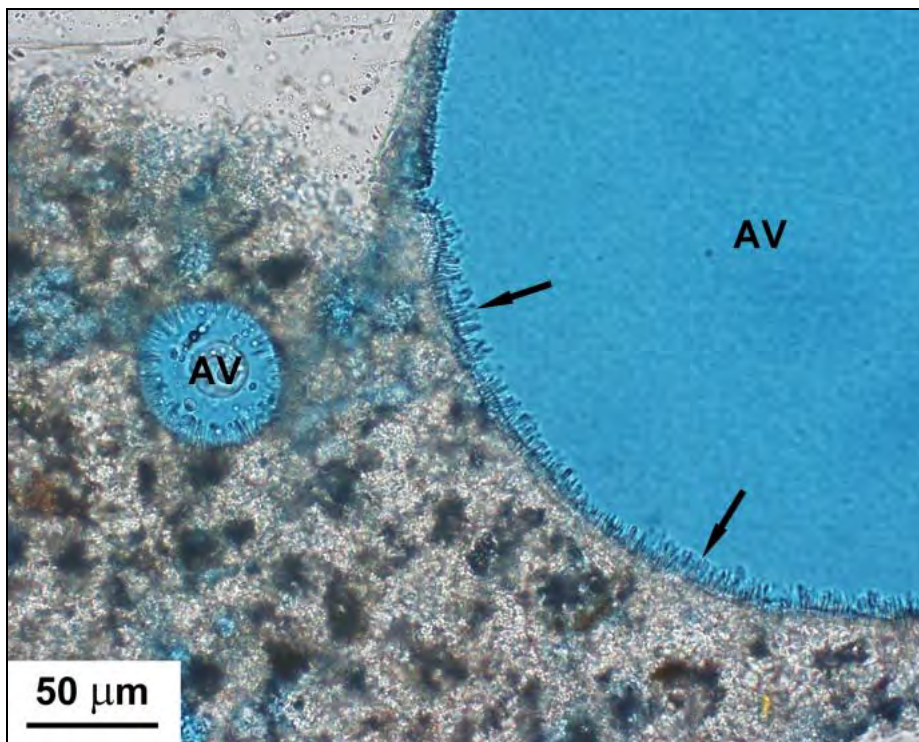
**Figure 5:** PPL photomicrographs. Air-voids (AV) are lined with exceptionally fine needles of secondary ettringite (arrows) wherever the cement paste is no carbonated. These are typical of even minor moisture fluxes and do not indicate any deleterious reactions within the concrete.

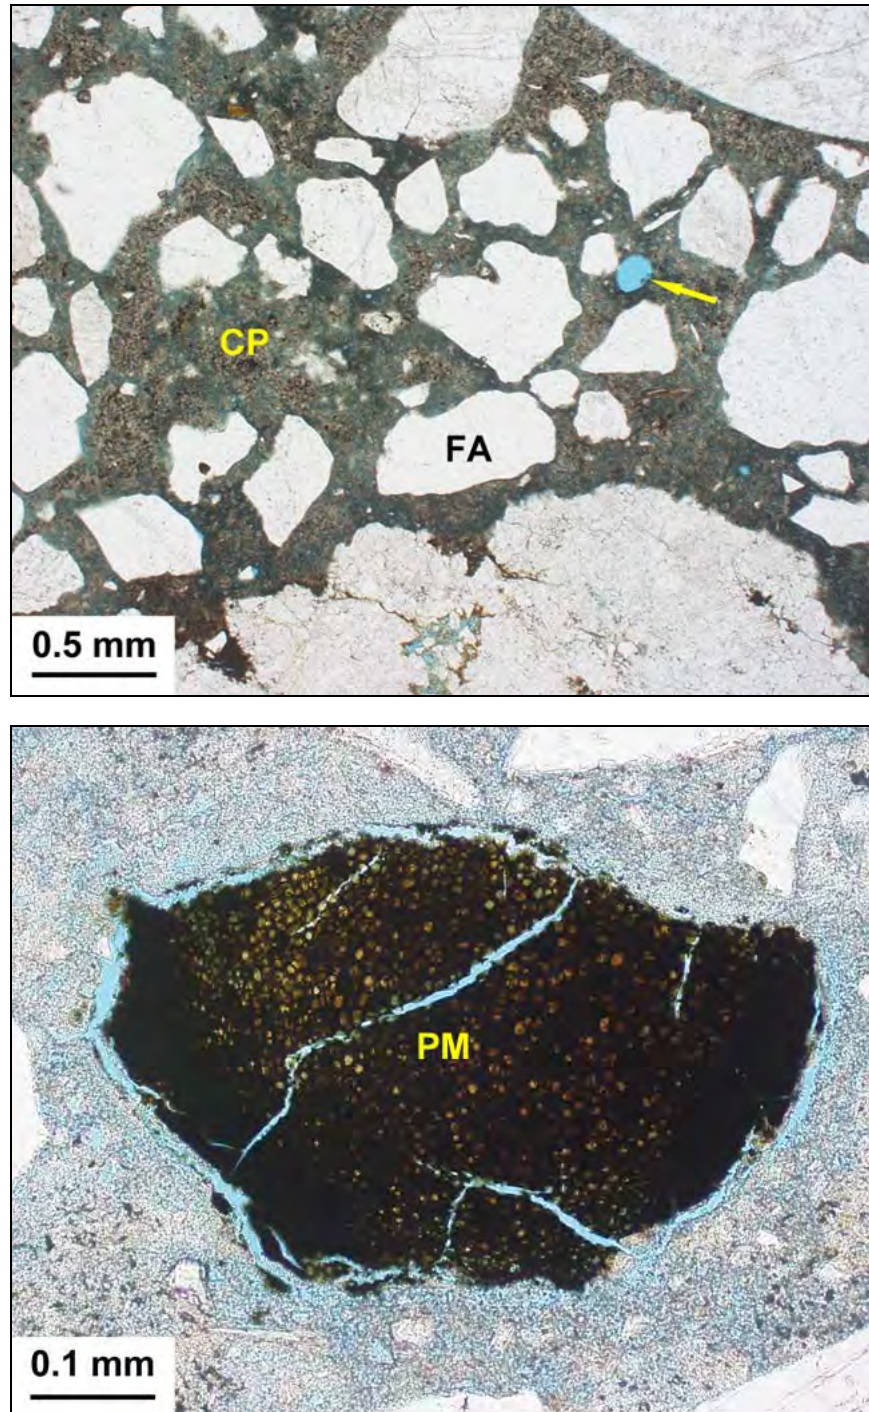
**Figure 3:** PPL photomicrographs of Core #2. (Upper image) The microstructure of the concrete is shown in this image. The sample is impregnated with a low-viscosity, blue-dyed epoxy in order to highlight cracks, pores, and voids. The cement paste (CP) strongly absorbs the dyed epoxy indicating a high permeability produced by a relatively high mix water content. The concrete is not considered water-resistant and this causes the material to be generally susceptible to a variety of distress mechanisms. Fine aggregate (FA) is evenly distributed throughout the matrix if a little sparse. The sand consists mostly of sharp-textured quartz grains. Air-voids are not at all abundant (arrow indicates an example). The concrete is not air-entrained and the very low content indicates a fresh concrete with moderately high slump. This is consistent with the higher water-cement ratio estimated from the hydration properties of the cement paste. (Lower image) Trace amounts of plant matter (PM) are interpreted to have been introduced with the fine aggregate. The organic contaminants are not considered excessive.
