# **FIRST PRESBYTERIAN CHURCH OF STAMFORD, CT CONSERVATION MANAGEMENT PLAN**

**FINAL REPORT**

October 16, 2017

# **First Presbyterian Church Conservation Management Plan**

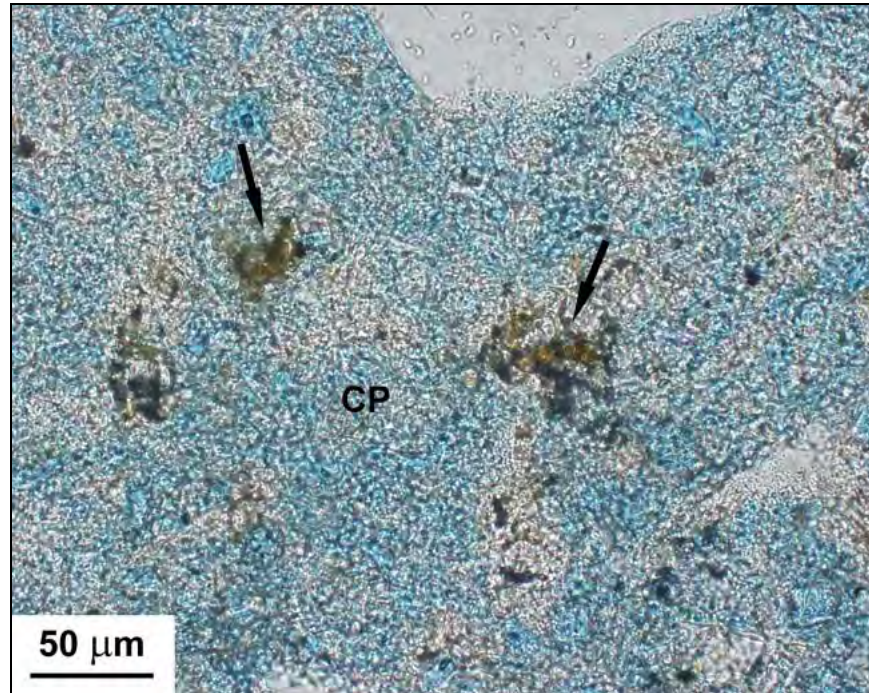
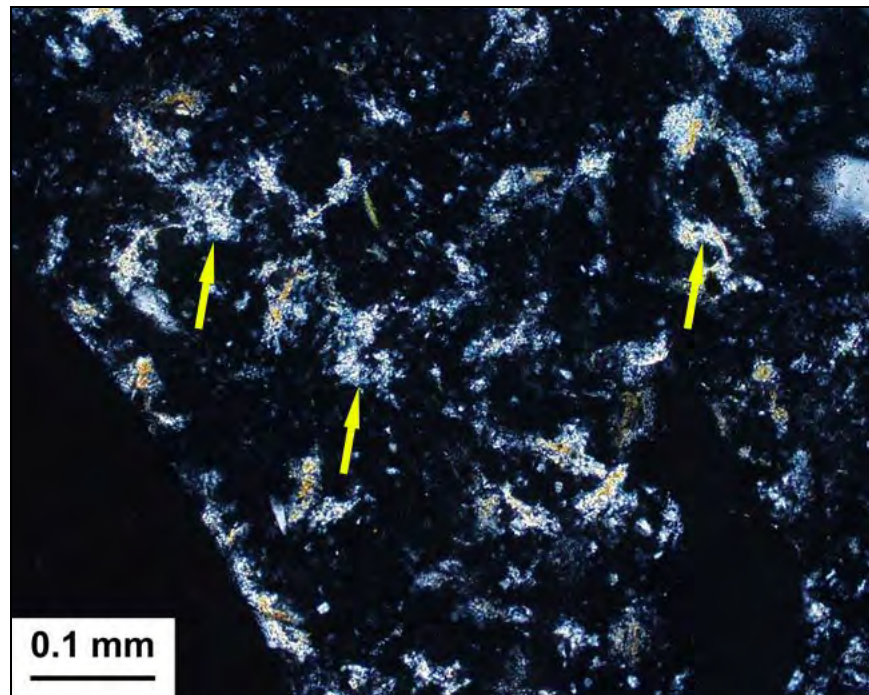
**Figure 4:** Photomicrographs illustrating the cement hydration characteristics in Core #2. (Upper PPL photomicrograph) The arrows indicate flakes of iron-bearing ferrite that just barely define the shapes of original calcium silicate agglomerates. These are residual portland cement grains that are extremely hydrated. The degree of hydration is consistent with a higher water content. The surrounding cement paste (CP) is uniform but rather sparse and this is also indicative of a more fluid mixture. Note the strong absorption of blue-dyed epoxy used in the sample preparation. These micropores, now filled with the epoxy, were once sites of evaporable mix water. (Lower XPL image) The arrows illustrate coarser-grained crystal masses of calcium hydroxide formed during the initial cement hydration. The abundance and non-compact morphologies are characteristic of a higher water-cement ratio.

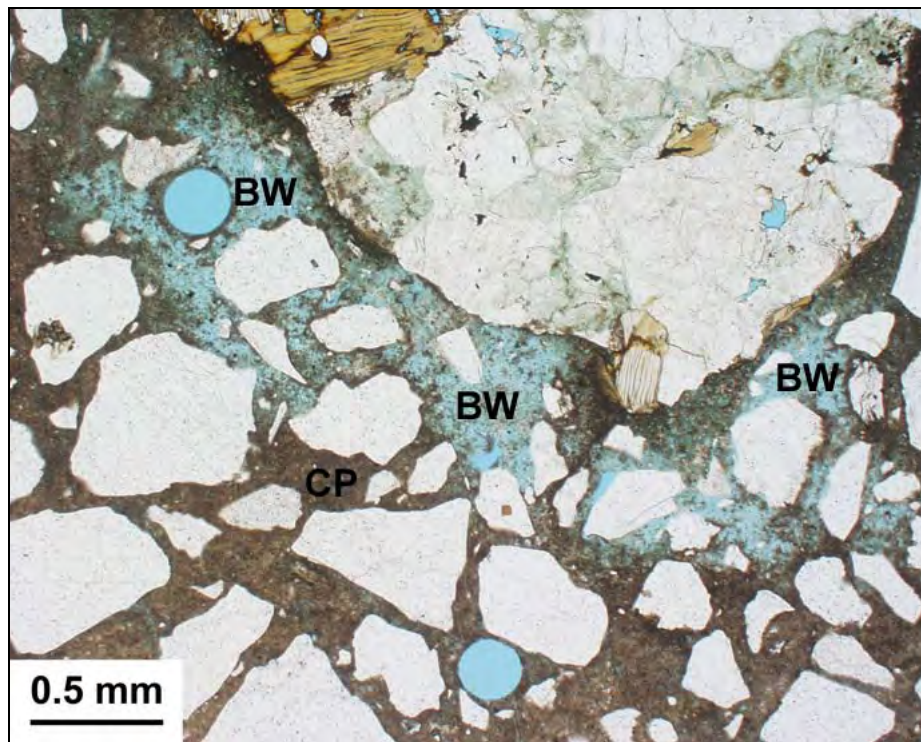
**Figure 5:** PPL photomicrograph of Core #2. The band of paste with increased microporosity is a bleed water channel (BW). Note the increased absorption of blue-dyed epoxy relative to the adjacent cement paste (CP). A few of these channels are noted close to the formed surface. However, there is no entrapment of bleed water as discrete voids below coarse aggregate grains. The features are considered relatively minor.

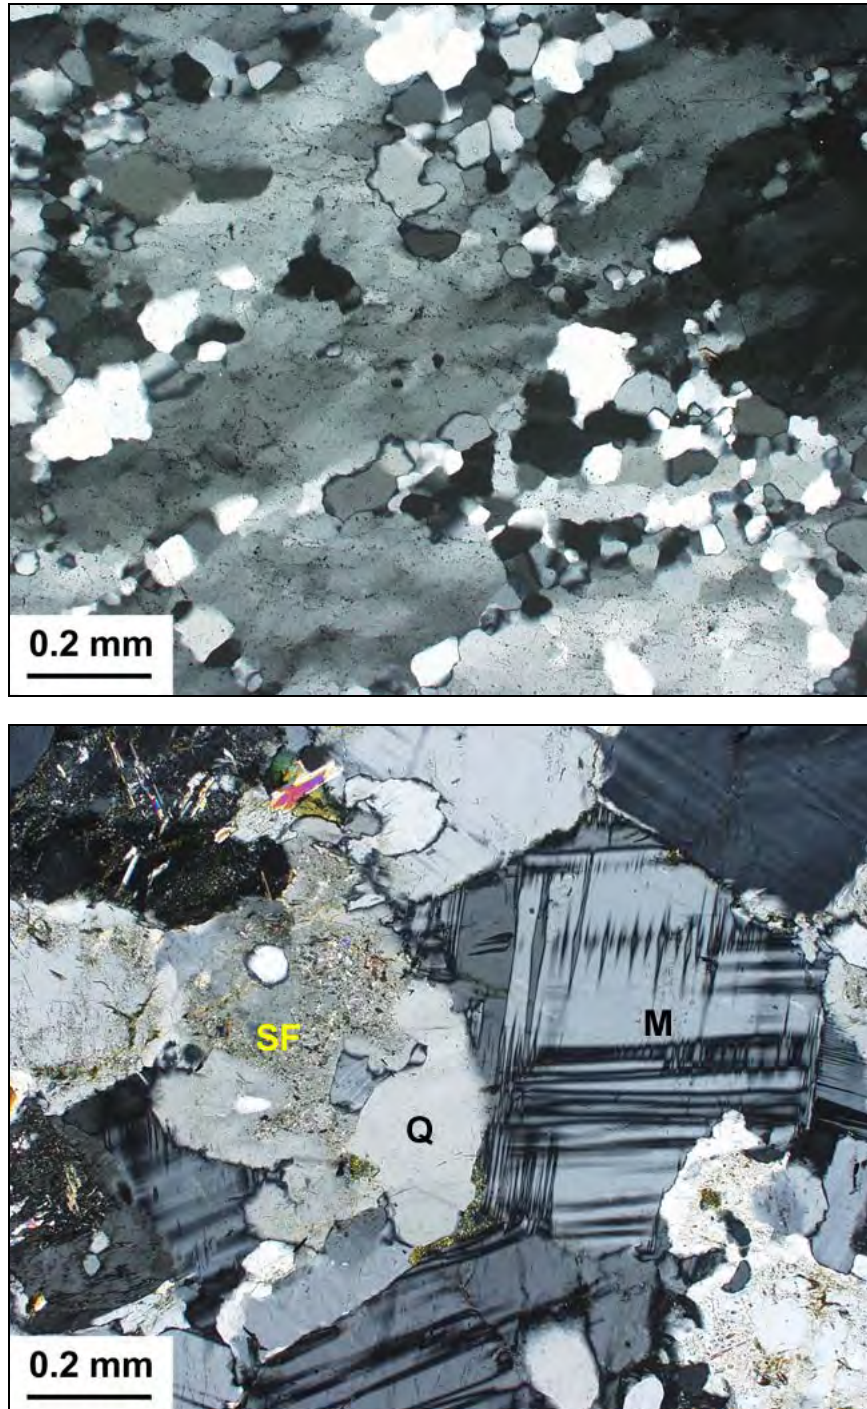
**Figure 2:** XPL photomicrographs illustrating some more common grain types in the coarse aggregate. (Upper image) The mosaic of grays and whites represents deformed quartz crystals in a strained quartzite. This type of rock comprises the largest percentage of the gravel and is known to be slowly alkali-silica reactive. (Lower image) Granite is a minor constituent. The grain shown here includes microcline (M), sodic feldspar (SF), and quartz (Q) along with several minor accessory minerals.

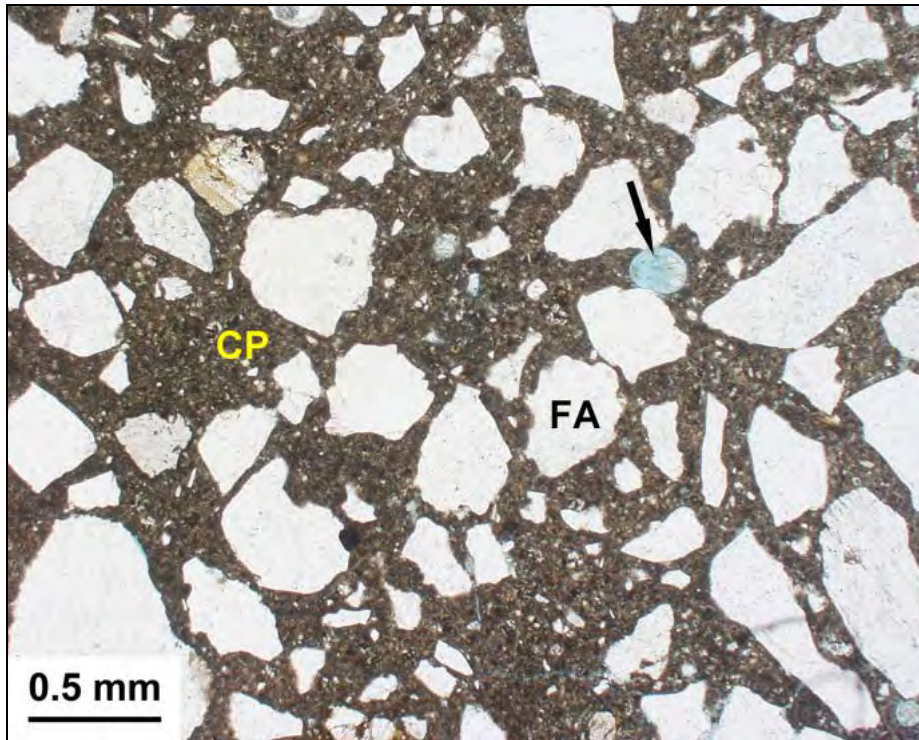
**Figure 3:** PPL photomicrograph illustrating the microstructure of the concrete in Core #3. The sample is impregnated with a low-viscosity, blue-dyed epoxy in order to highlight cracks, pores, and voids. The cement paste (CP) absorbs very little of the dyed epoxy. This shows that the matrix has a rather low permeability and is expected to be reasonably water-resistant and generally durable. The lower microporosity is the result of a moderately low water-cement ratio when originally mixed. Fine aggregate (FA) is evenly distributed throughout the matrix if a little sparse. The sand consists mostly of sharp-textured quartz grains. The arrow indicates a fine air-void. This particular region is not an especially good representation of the air content throughout the core. In many areas, air contents are as high as 3% by volume even though there is no entrained-air structure. The "bubbly" quality is indicative of a lower slump when fresh. Nevertheless, the concrete is well compacted without any segregations.

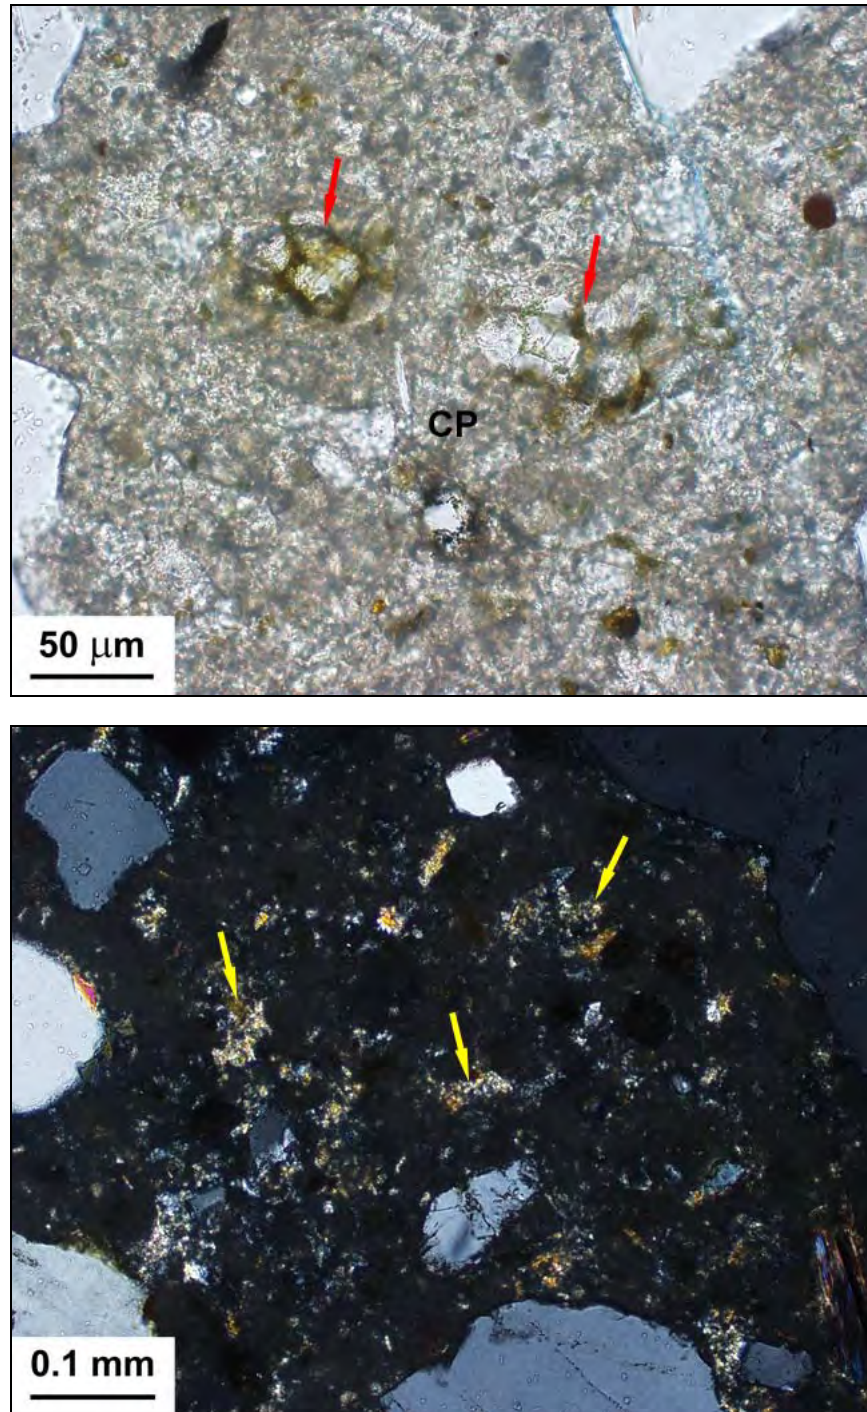
**Figure 4:** Photomicrographs illustrating the cement hydration characteristics in Core #3. (Upper PPL photomicrograph) Residual portland cement grains (arrows) occur as fine agglomerates of former calcium silicate defined by a skeleton of brown-colored ferrite. Much of the hydraulic calcium silicate once residing between these iron-bearing ferrite crystals is now fully consumed due to hydration. Still, the hydrated cement grains are present in moderate concentration. The adjacent cement paste (CP) is well-formed and has a moderately low capillary porosity as indicated by the very minimal absorption of blue-dyed epoxy used in the sample preparation. These features are indicative of a moderately low mix water content. (Lower XPL photomicrograph) The arrows illustrate finer-grained crystal masses of calcium hydroxide formed during the initial cement hydration. The non-compact morphologies are characteristic of water-cement ratios greater than approximately 0.40. However, the relatively low abundance suggests that the ratio was not much higher than this.

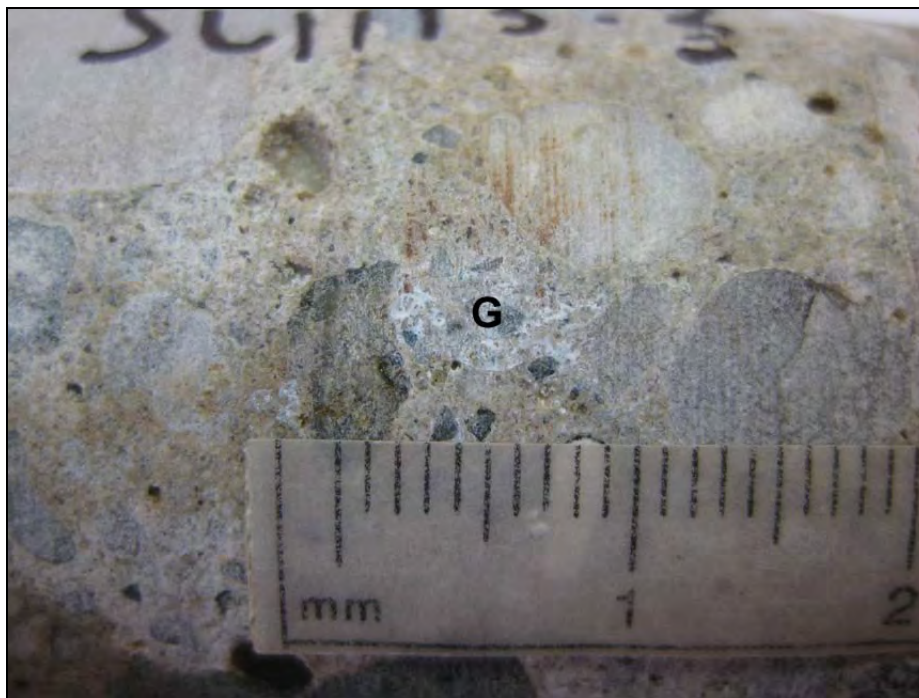
**Figure 6:** The side of the core sample is shown before further preparation. A few small exudates of gel (G) were observed along the surface when the sample was received. As in Core #2 (Highbridge Report SL1113-02), these exudates show that some unexpanded gel is present in the micropores of the concrete and this likely represents innocuous reactions that have occurred very slowly over the service life of the concrete. No cracking of any kind is associated with these incipient reactions.

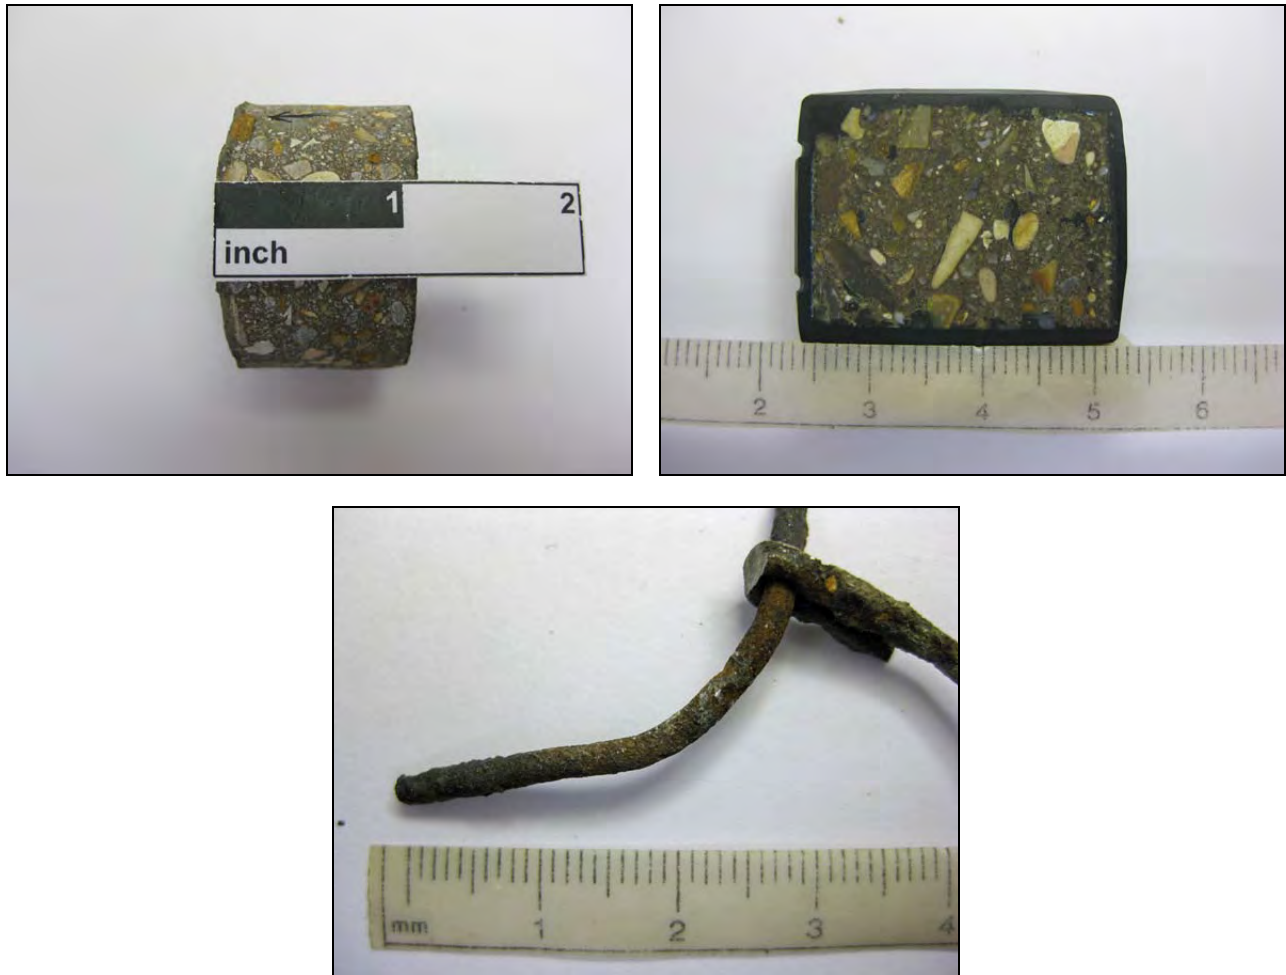
**Figure 1:** (Upper left) Photograph of Core #1. The sample is shown in side view with its outer surface oriented toward the left. (Upper right) A honed cross section of the dalle de verre is shown. Again, the outer surfaces is oriented toward the left of the image. The numbered units on the scale bar are in centimeters. The binder has a rich brown color typical of aluminite cements with high iron contents. The aggregate is coarse-grained and evenly distributed throughout the thickness. (Lower image) Wire reinforcement is embedded within the core. Note that some moderate corrosion product is evident along the wire. Corrosion of embedded metals could be one possible reason for any cracking noted in the dalle de verre. This is not confirmed in this analysis.

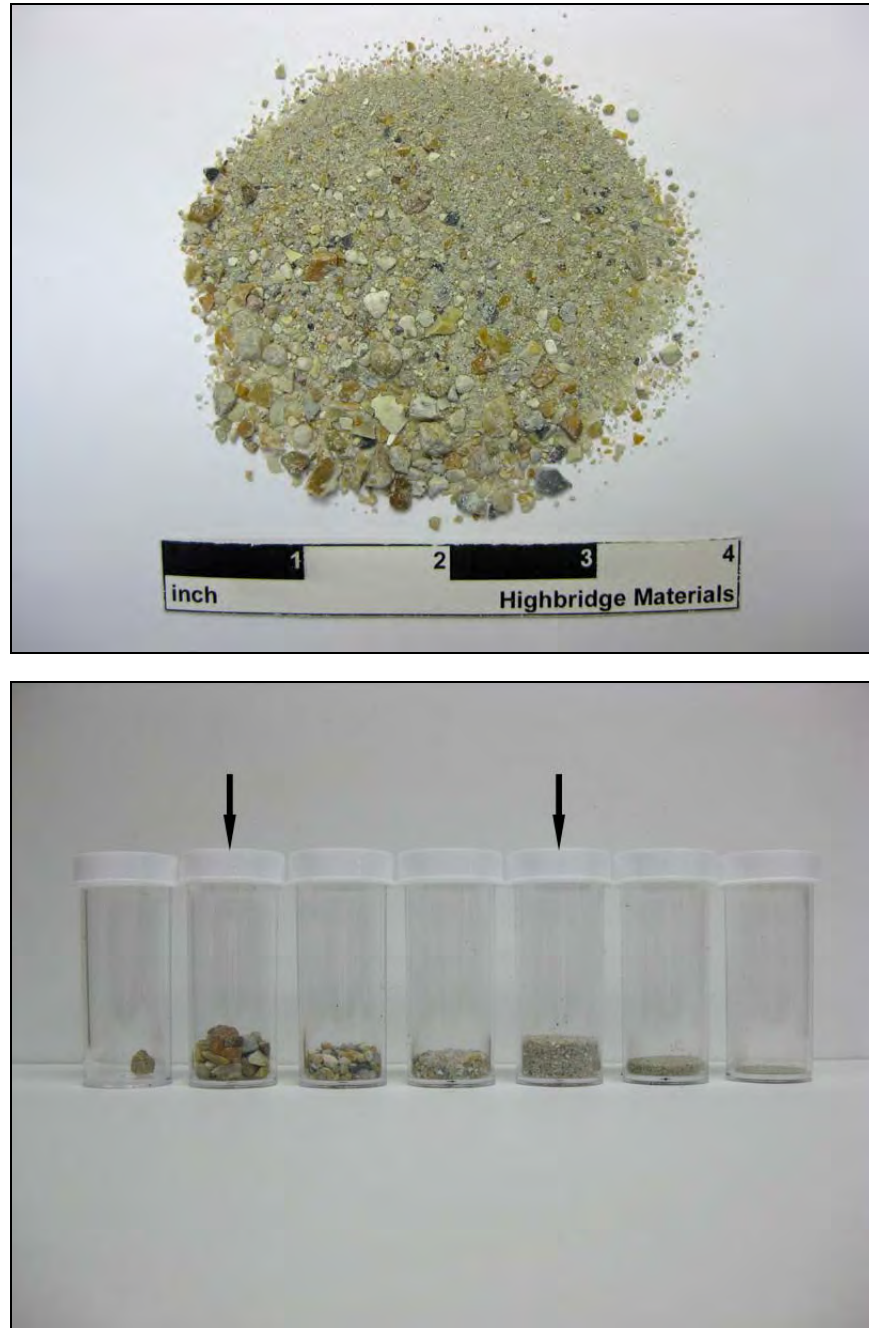
**Figure 2:** Photographs of the sand extracted from the mortar through acid digestion. The 85% of the aggregate that is siliceous in composition is recovered. The remaining 15% consists of acid-soluble limestone and this fraction was necessarily lost in the processing. (Upper image) The total extraction is shown. Note that there is a buff-colored background color produced by relatively pure quartz in the finer fractions. The coarse fraction is dominated by crushed chert. The iron-rich chert tends to be orange in color. (Lower image) The extraction is shown after gradation through a standard sieve stack. There is a bimodal distribution indicative of the separate additions of chert and quartz. The limestone would have been more evenly distributed throughout the full profile had it not dissolved. The left arrow indicates the peak in the chert gradation found between the No. 4 and No. 8 sieves. The peak in the quartz fraction is found between the No. 30 and No. 50 sieves and this is shown by the right arrow.

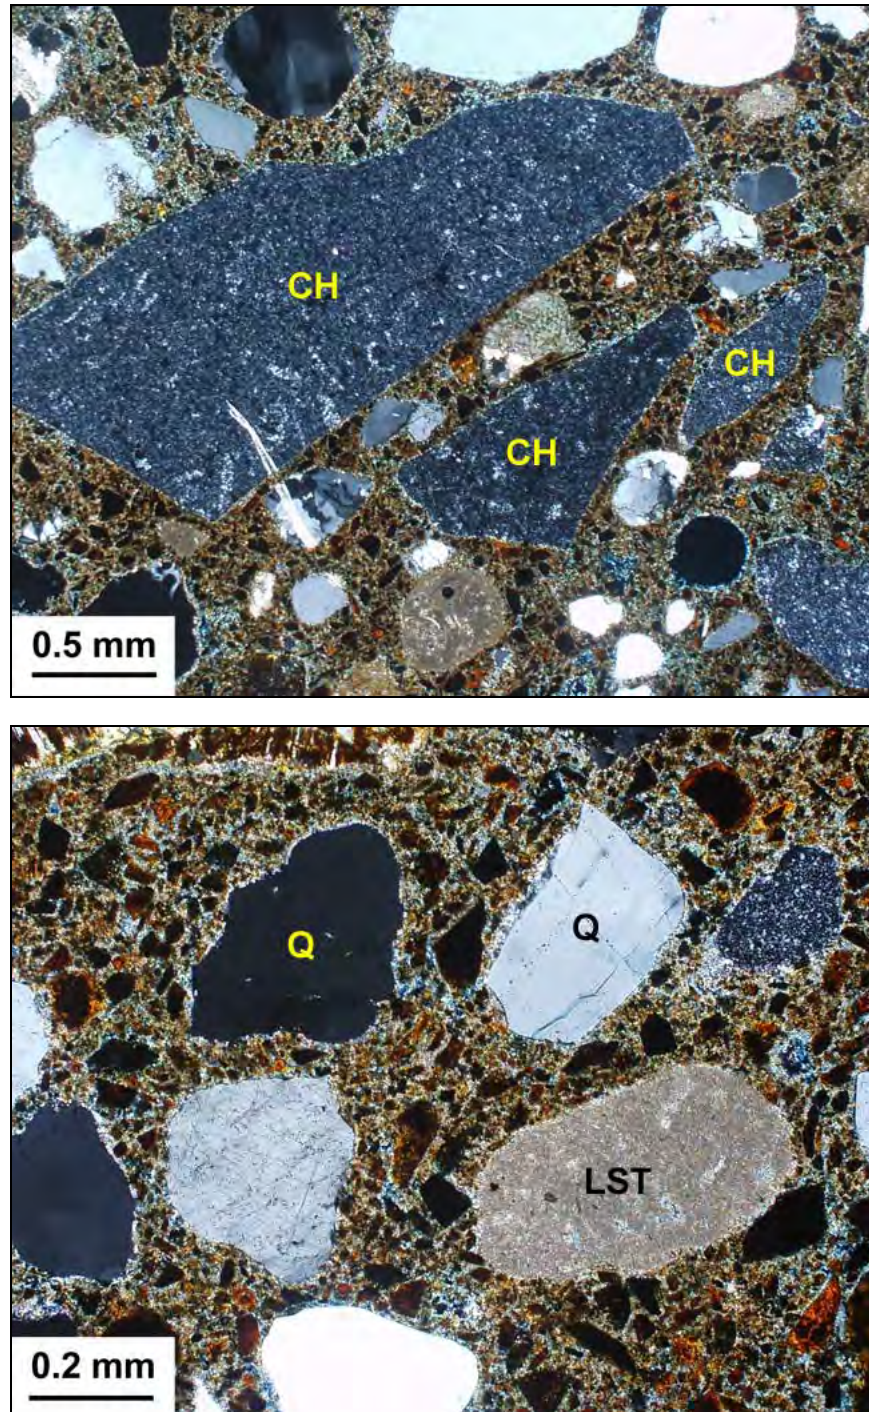
**Figure 3:** XPL photomicrographs illustrating the various major components of the sand. (Upper image) Chert (CH) has a uniform internal texture. Grains are angular and sometimes shard-like. The cryptocrystalline quartz can be highly reactive in portland cement-based materials. It is not considered a threat in the aluminate-based matrix. (Lower image) Quartz (Q) is abundant and somewhat narrowly graded. The grains are equidimensional and more often soft-textured. Limestone (LST) is present at about 15% of the total aggregate. Most is a fine-grained micrite such as the one shown here. Limestone particles tend to be rounded.

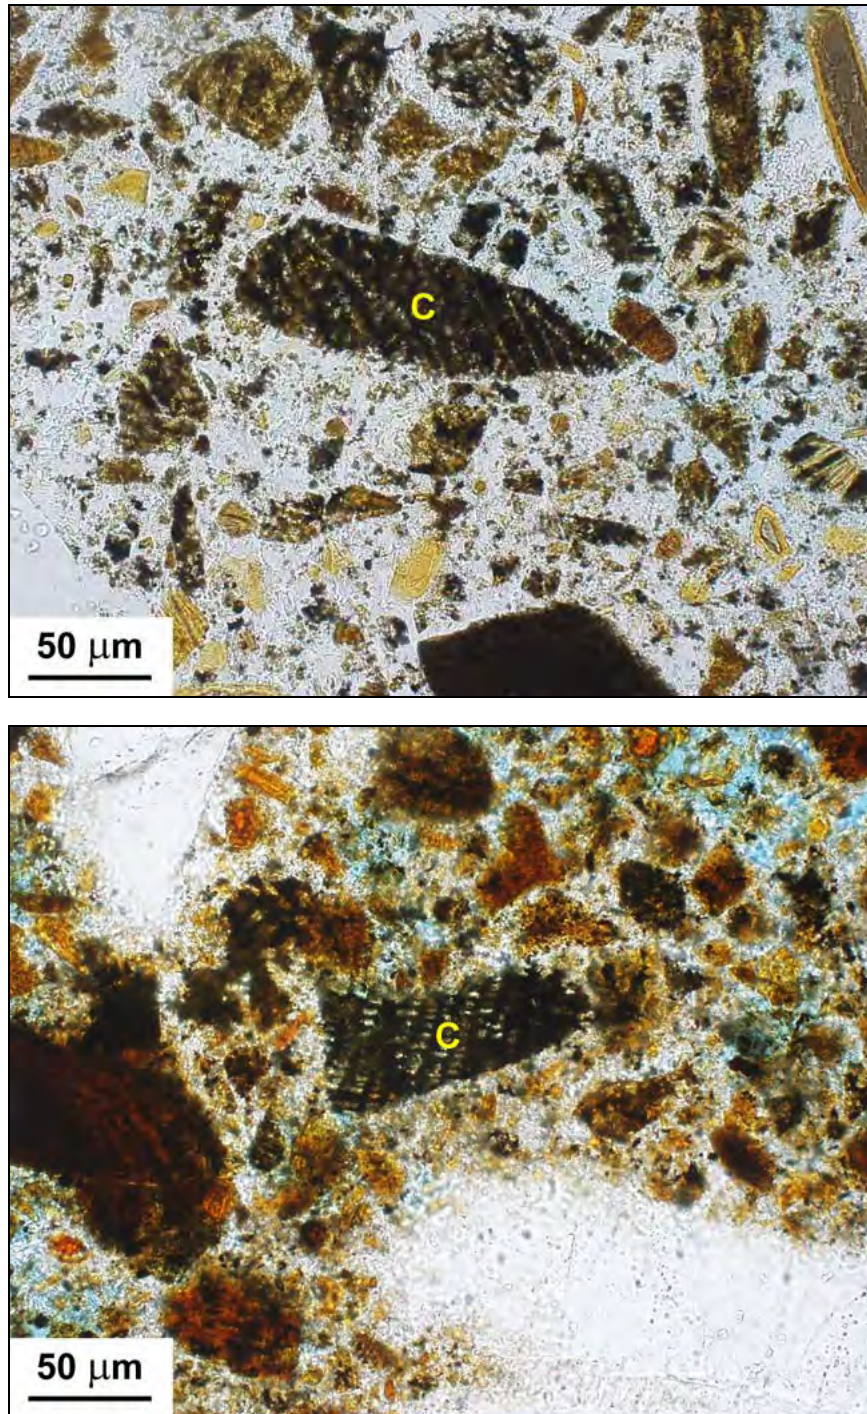
**Figure 5:** PPL photomicrographs illustrating examples of the aluminite cement texture. Many cement residuals (C) have bands of dark-colored ferrite separated by voids where CA (hydraulic calcium aluminite) once resided. The upper grain displays a "cross-hatch" texture while the lower exhibits a "weave" texture. It is possible that these are different orientations of the same type of structure.

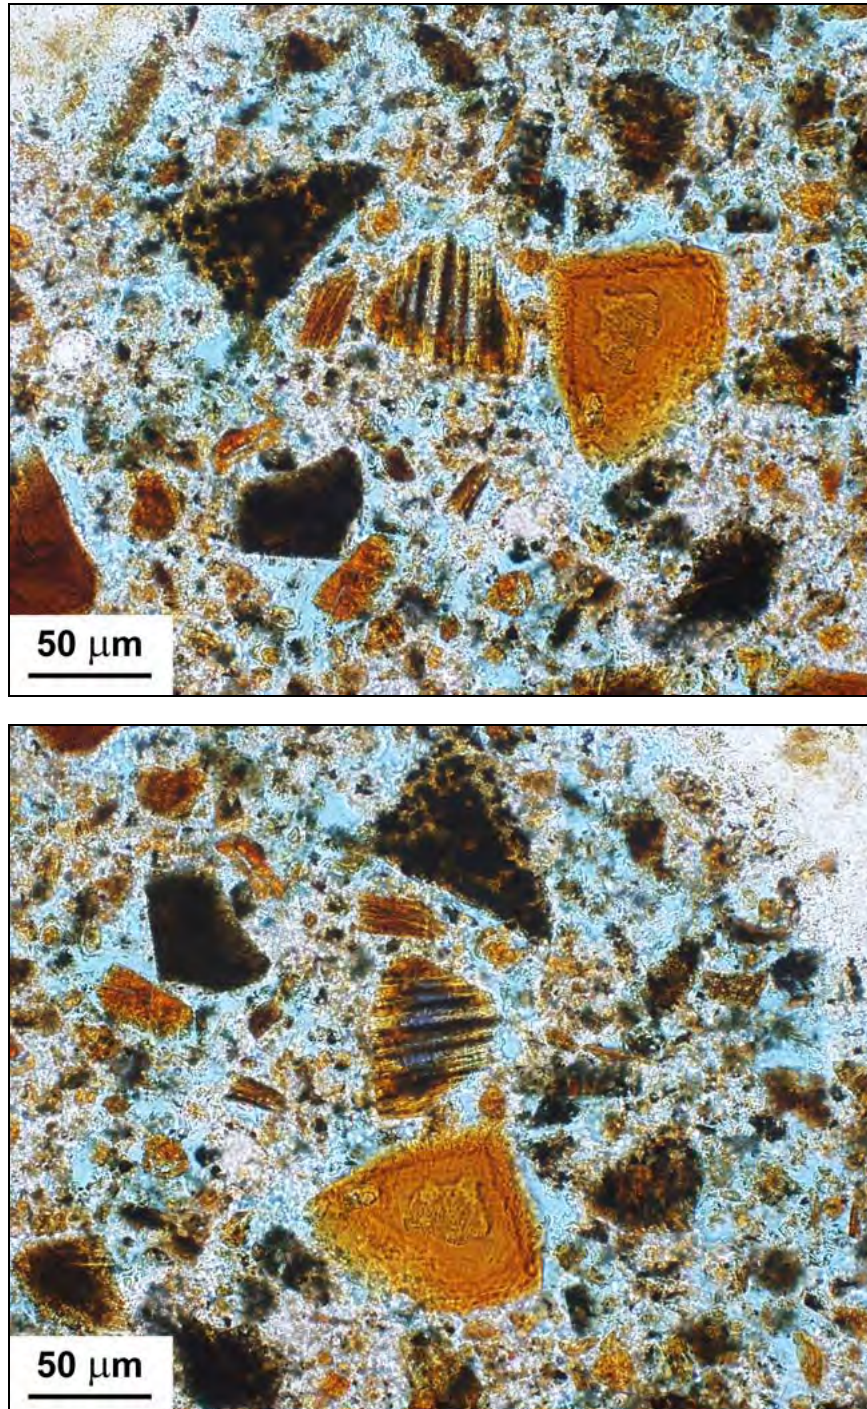
**Figure 6:** PPL photomicrographs of the same region taken at different orientations under plane polarized light. In the upper image, the striped grain in the center contains dark ferrite bands and lighter-colored interstitial bands. In the lower image, the thin section is rotated 90°. The light-colored area has turned a rich blue color. The difference in color upon rotation is a property called "pleochroism" and is a characteristic of an aluminate mineral called "pleochroite". Pleochroite is diagnostic of aluminate cements in general.

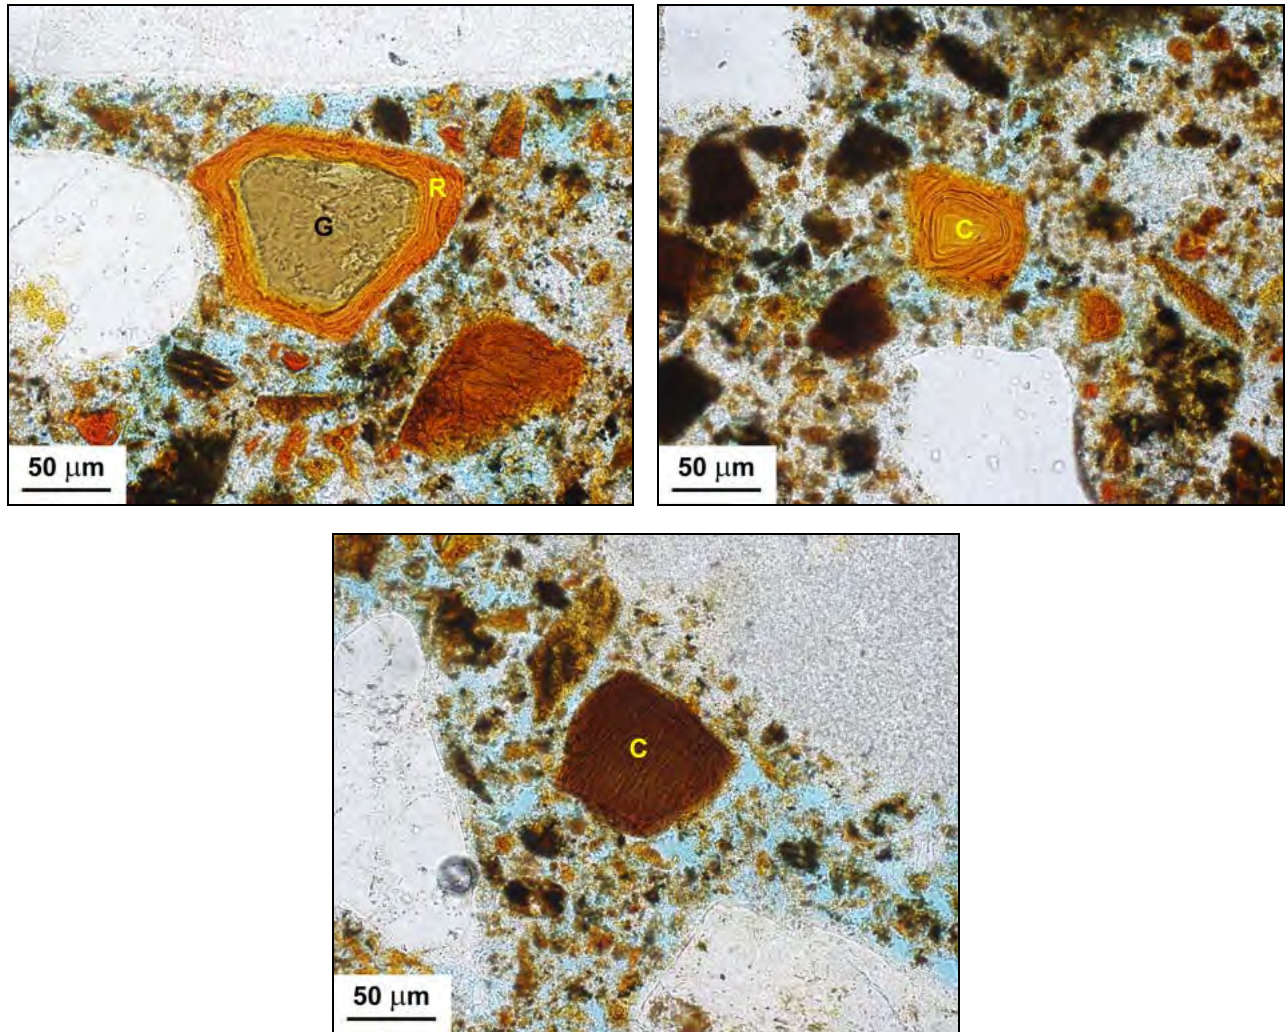
**Figure 7:** PPL photomicrographs illustrating other cement particles in the dalle de verre. In the upper left image, a brownish glass (G) is surrounded by an orange reaction rim (R) containing concentric rings. In the upper right, a similar cement grain (C) lacks the glass phase in the core. Glasses are known to be present in Ciment Fondu though the quantity observed in this sample seems higher than expected. Still, it does not appear that the glass is a separate addition. The cement grain in the lower image has a similar orange color but has a "feathery" internal texture. It is not known if these grains are associated with the glasses.

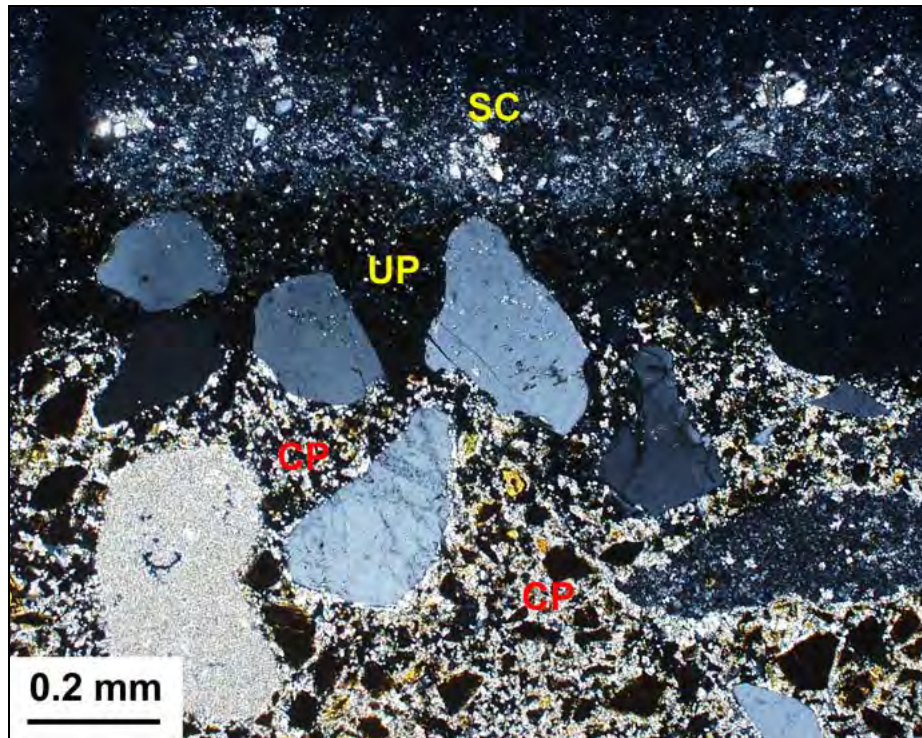
**Figure 8:** XPL photomicrograph. The outer surface of the dalle de verre panel is shown in cross section. Most of the material consists of a carbonated cement paste (CP) that appears brightly colored under crossed polars. The carbonation reaction may result in depassivation of any embedded steel. There is a thin veneer of uncarbonated paste (UP) along the outermost surface. The client reports that some type of sealant application may have been applied early in the history of the material. This could explain the lack of carbonation in this region. Finally, a thin cementitious skim coat (SC) was applied over the outer surface masking any original finish texture that may have been present. It is assumed that this skim coat was applied at a later date.

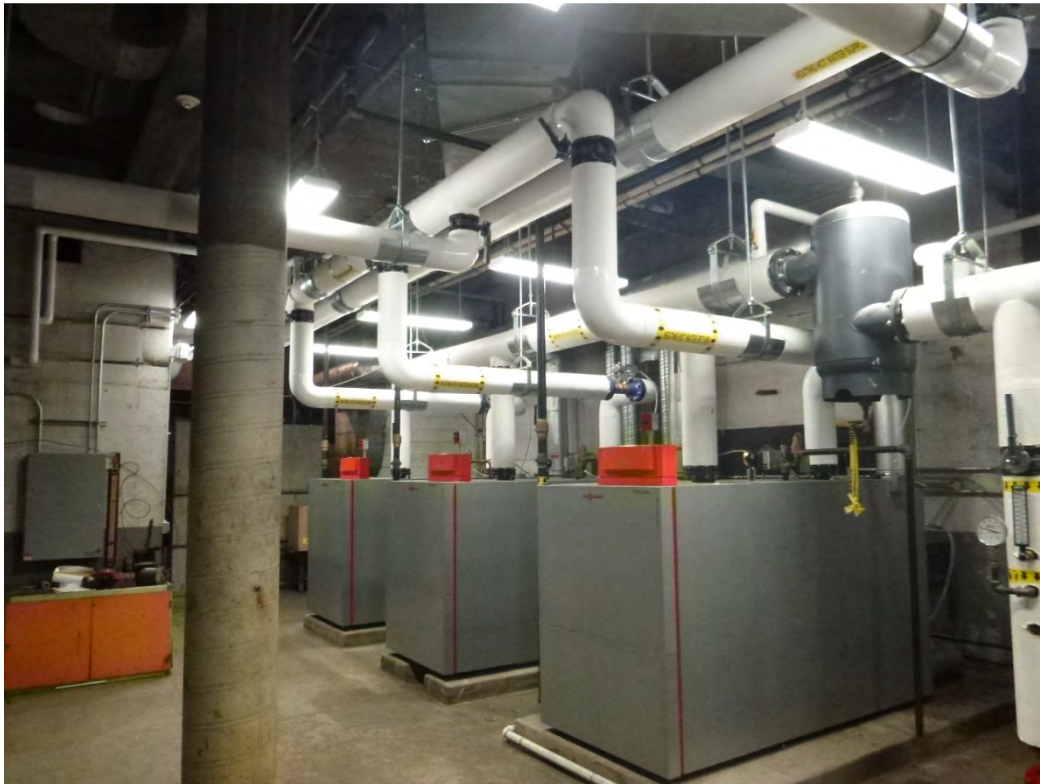
Picture#1-Viessmann boilers

The boiler plant appears to be installed in 2016 and is in good working condition with no reported issues.

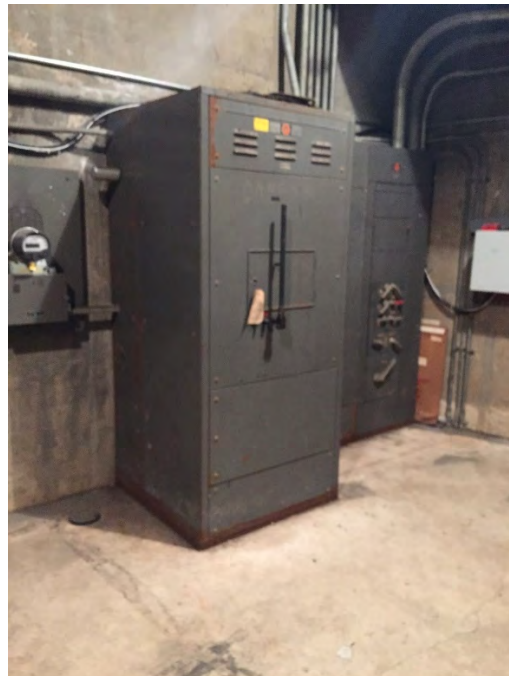
Picture#6-Main Switch

The original electrical service for the church building was initially installed in the mid 1950's of the last century and was not significantly upgraded within last years. The incoming service for the Complex is a 120/208 volt, 3 phase, 4 wire + ground service and is located in the cellar of the Parish House building. The service terminates in the main 1,200 Amp service switch fused at 1200 amp (see picture# 6). The main switch enclosure shows traces of rust at the bottom and on the sides.

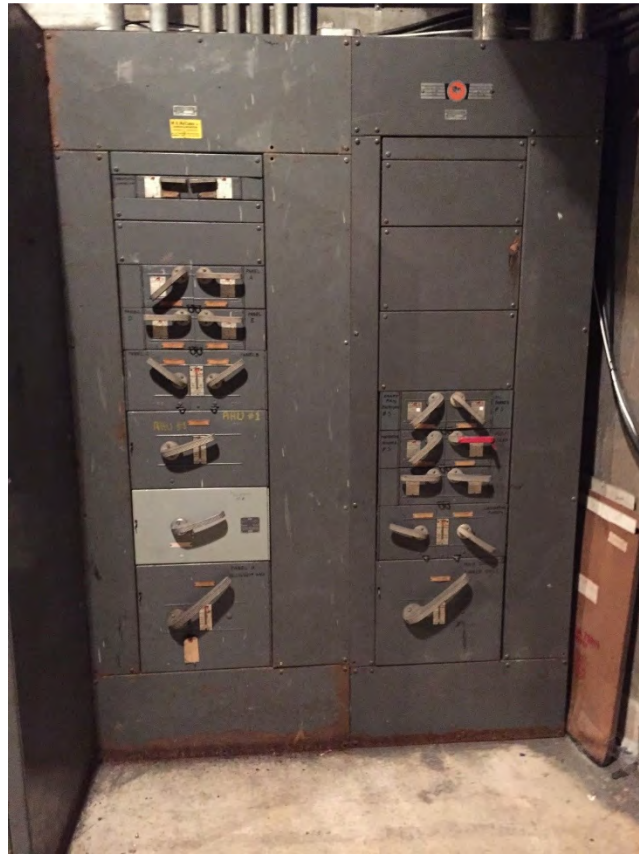
Picture#7-MDP

The existing main distribution board is in fair condition with traces of water damage at the bottom of the cabinet. (see picture#7).

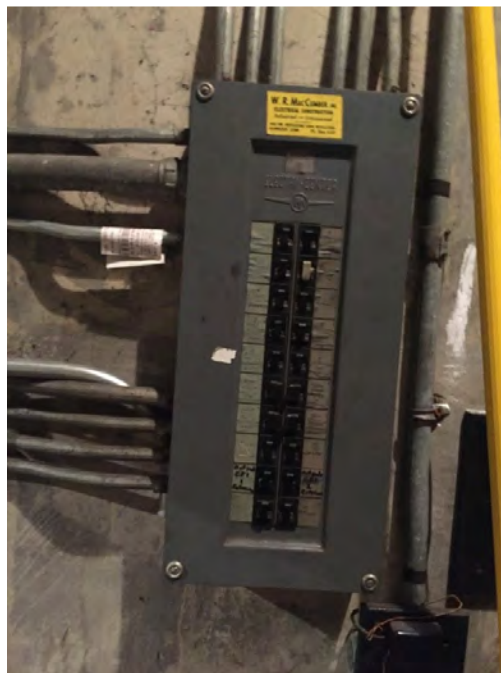
Picture#8-Panelboard

Some of the electrical panels and conduits are in fair condition and should be replaced soon. Existing panels are mostly old fashion circuit breaker type. The insulation on some wires is brittle and cracking. New electrical wiring, conduits, and panel boards are recommended (see picture #8).

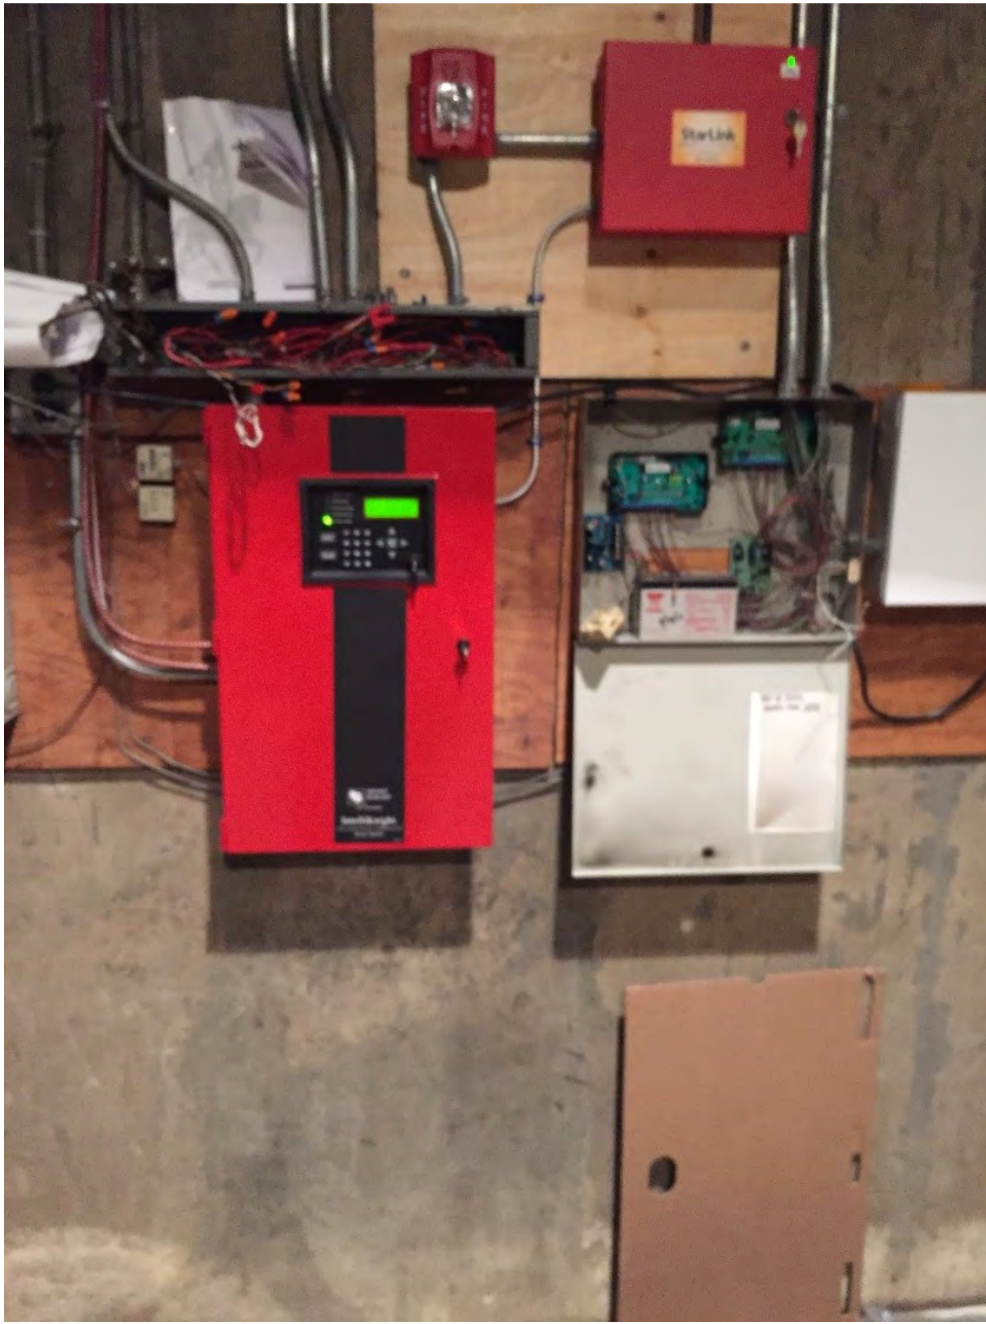
Picture#9-Fire Alarm System

The fire alarm system is a temporal-3 system; it has been recently upgraded throughout the building and is in the good working condition. The main fire alarm control panel is located in cellar adjacent to the main electrical distribution panel (see picture #9).
