Melnikov House

Research Report and Recommendations for a Conservation Plan

10 Krivoarbatsky Lane,
Moscow, Russia

August 2019

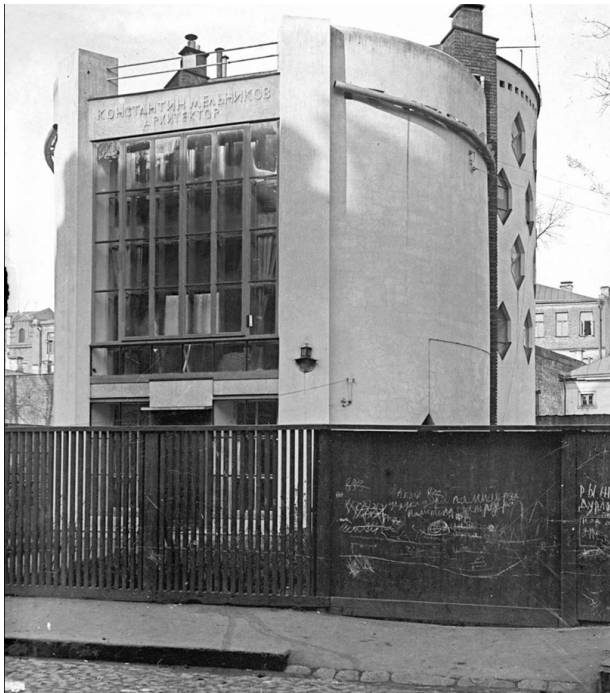
- The façade of the building is covered with a network of shrinkage, humidity and temperature-induced cracks.
- There are water stains on the façade under metal windowsills – probably because the metal sills do not project out enough over the wall, and their acute angle shape is not optimal. In general, it should be noted that the house tended toward this defect from the very beginning.
- There is a water stain on the façade, where the gutter is connected to the downspout – water misses the downspout and leaks down the wall.
- Vertical cracks intersect the inscription «Konstantin Melnikov Architect.» Interesting fact is that now they are almost in the same places.
- Dark stains of the exterior wall finish on the edge of the parapet. This initial defect is a consequence of the constant impact of precipitation (rain, snow) on the unprotected surface of the parapet.

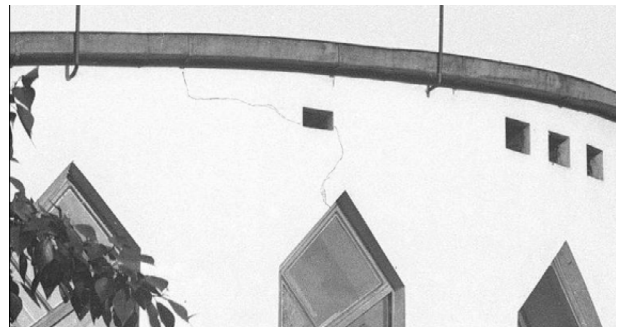
Enlarged fragment of the photo of the northwest façade. 1930s

There is a diagonal crack on the façade that goes from the roof level through the attic vent to the upper corner of the window. Nowadays, it also exists and it is continuous.

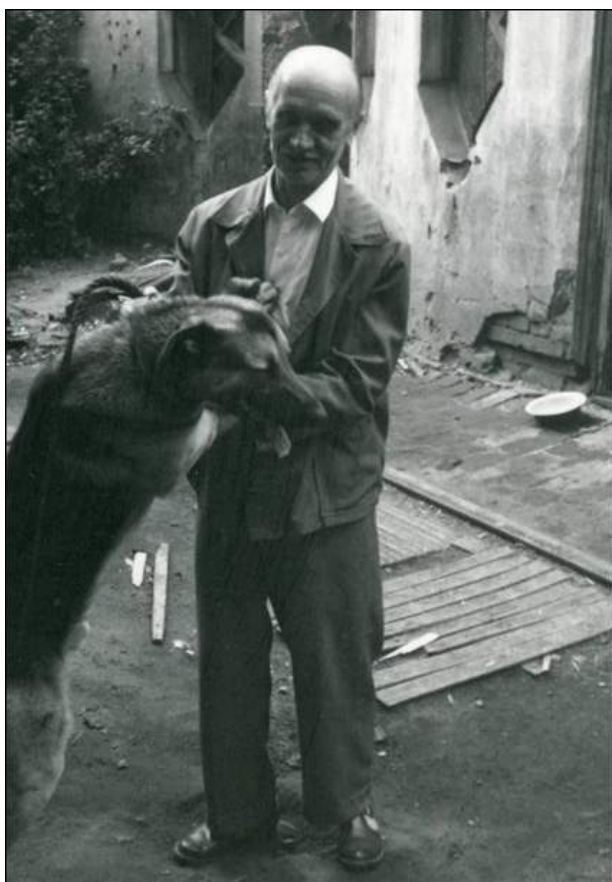
Physical deterioration of the building had been accumulating over the years. Finishing layers cracked, detached, crumbled (especially near the downspouts and on the foundation, and in this case, near the doghouse). The vegetation grew thicker, wet the façade, not allowing it to dry, the trees littered the downspouts and the roof with leaves. Without maintenance physical wear accelerated.

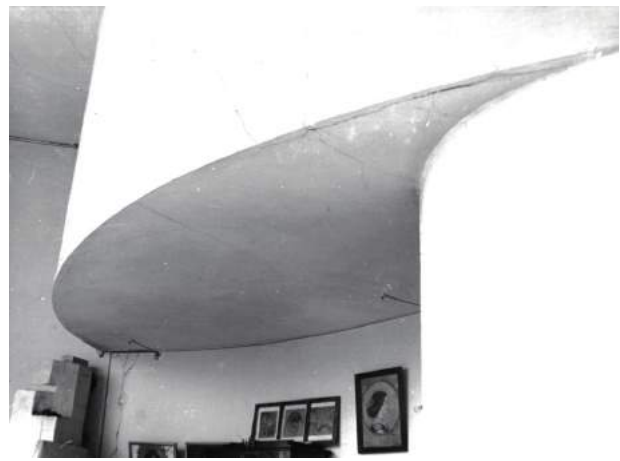
All the characteristic damage inside the building is clearly visible, which is to a certain extent noticeable nowadays and was evident during the operation of the House. These are cracks in the plaster layers of walls and ceilings, reflecting movements of the wood structures of the floor joists and partitions relatively to stone walls and each other, as well as deformations of the wood structures.

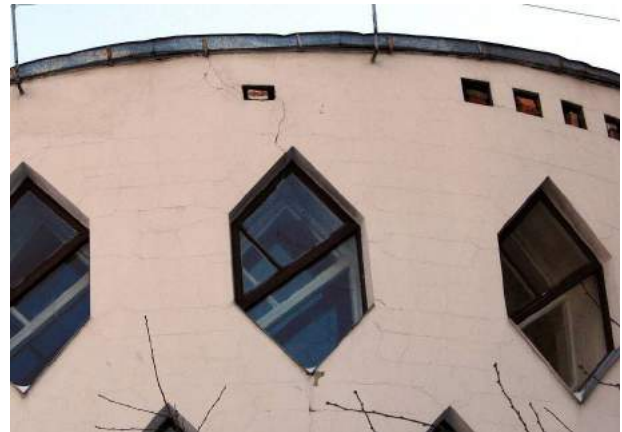
- Diagonal crack up to 0.3 mm wide stretches out from the top of the upper window to the attic vent

and further to the roof (the northwest façade). Inspection from inside the building showed that it is a through-wall crack. Originally it resulted from stress, afterwards it could expand from settlements (however, similar deformations were not found below this crack, it is just barely possible to point to a concentration of cracks 0.1 mm wide near that place).

Through-wall diagonal crack 0.3 mm wide. Northwest façade.

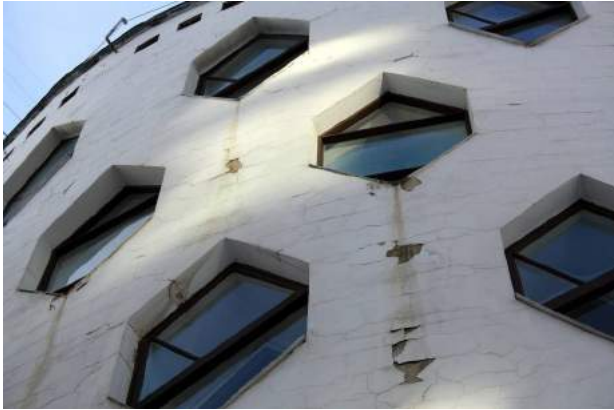
- Water stains under windowsills of all hexagonal windows. Consequently, the presence of more noticeable cracks there and a slight weakening of the plaster under the windowsills.

Water stains under windowsills, cracks, damage to the finish, traces of repairs. It is clearly visible that exterior windowsills differ in shape and width of their projection

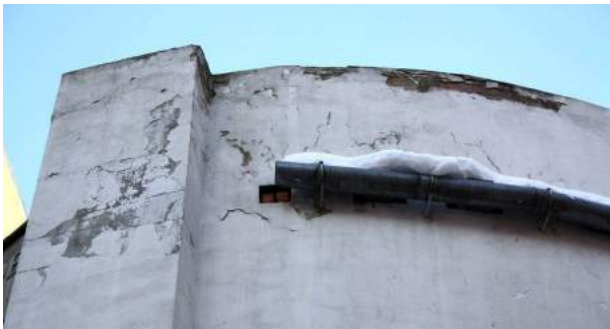
Damage to the masonry of the terrace walls owing to defrosting, loss of the plaster layer

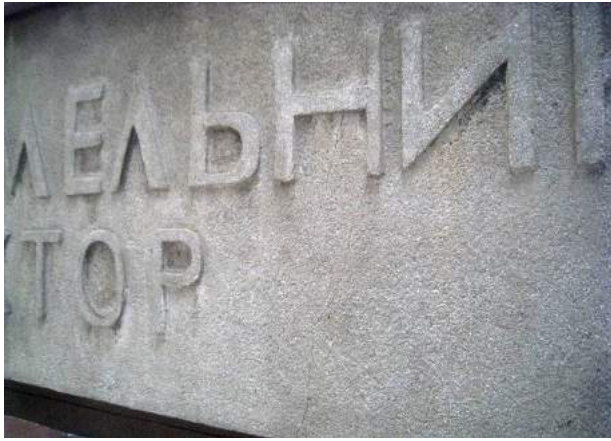
- The cracks in the glazing of the large window reflect deformations of its frames – warping and bending outwards.
- Vertical and near vertical cracks in the façade inscription “Konstantin Melnikov Architect” up to 0.2 mm wide. Presumably initially caused by stress, increased by weathering. There are also cracks in places where the inscription adjoins the walls of the terrace.

Crack in the façade inscription

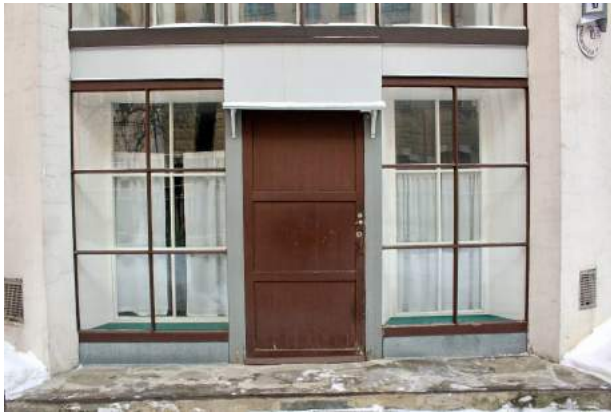
Cracks in the porch. Chinks and paint damage, warp of the entrance door boards

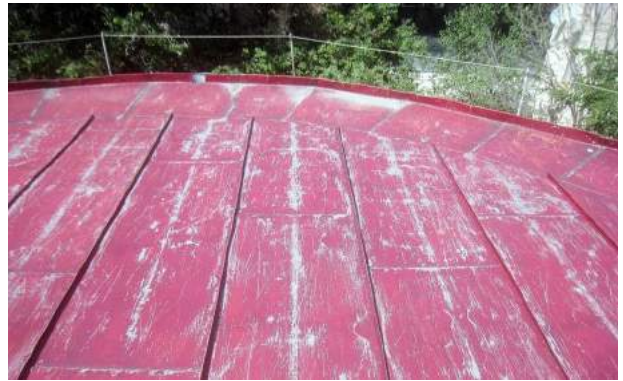
Water stagnation on the roof surface in two places near the edge and near the downspout of the northern façade. The reason is sagging of the spaced sheathing and roof structures.

Roof of the large cylinder. Traces of water stagnation near the downspout. Paint damage

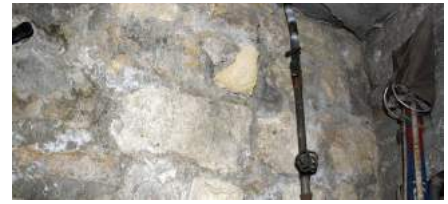
On the west and east exterior walls of the basement there are efflorescences. At the beginning of the inspection (February – March 2018), during the heating season, the walls had a dry surface. Efflorescences destroy masonry of the basement. Every day, traces of crumbling wall material (mortar and stone) were recorded on adjoining surfaces. After turning off the heating (April 2018), the surface of the exterior walls of the basement became wet and cool. The interior walls of the basement do not have such damage. Presumably the process is related to the humidity of the soil which is in contact with the wall from the outside.

Surface of the exterior walls of the basement. Traces of efflorescence on masonry

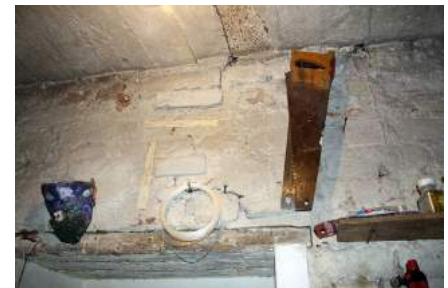
Crack in the brick wall of the basement, the wall remained from the former building. The crack width is 2.5 – 3 mm, it continues on the floor joists up to 2.5 mm wide between a joist and reinforced concrete filling

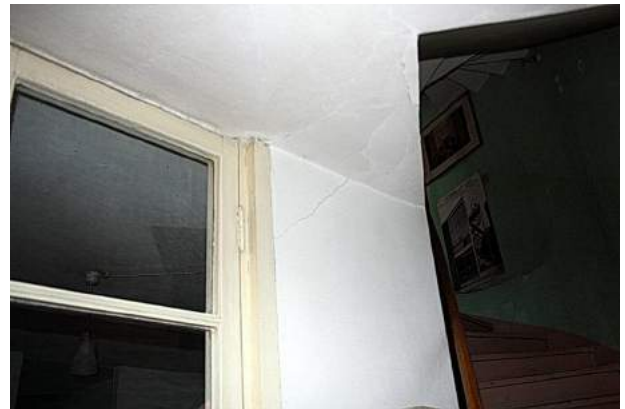
Cracks in the plaster layer of the wooden partition and ceiling

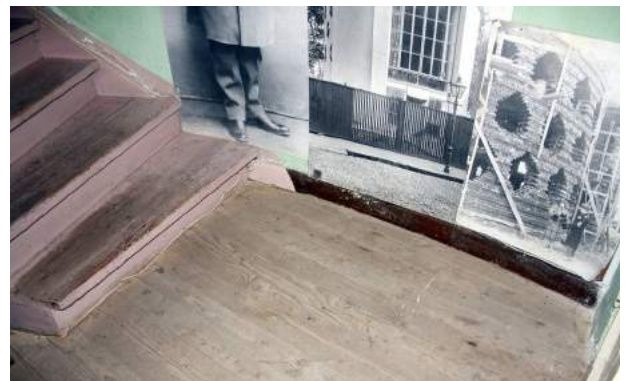
Physical deterioration of the stairs, there is a crack where the string meets the wall. Dirtying and loss of plaster layer

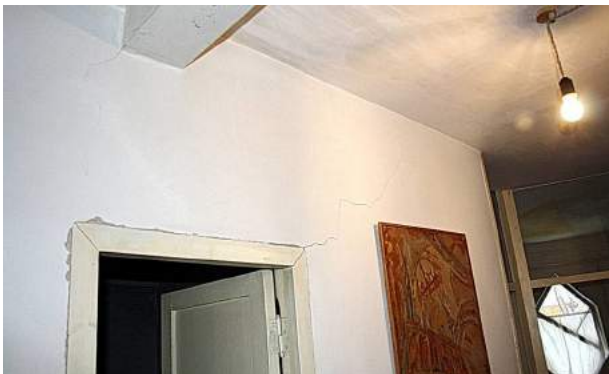
Cracks in the finishing layers of wooden partitions of considerable width, up to 2 mm. Their presence is observed on the large cylinder. They are oblique in orientation, have a settlement character, probably originated from the settlement of the foundations of partitions. The direction of the cracks indicates the deformation of the partitions towards the center of the large cylinder.

Settlement cracks in the partitions of the corridor of the large cylinder

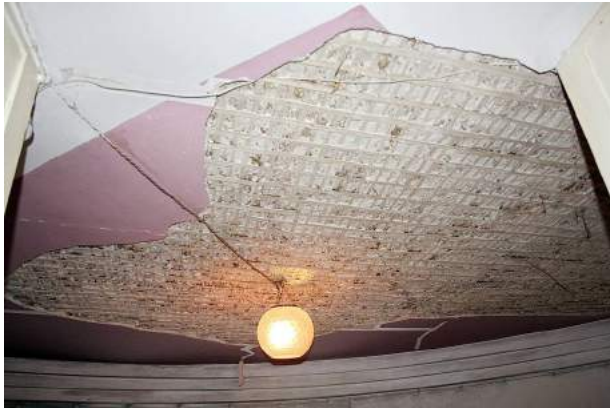
Falling away of the plaster layer from the ceiling with the exposure of lath and bast fiber fabric, which cover the bottom of the floor joists. It is about 50% of the ceiling surface of the room. As a result, the cracks in the ceiling finish have a much larger width than in other rooms (0.2-0.4 mm).

Falling away of the plaster layer from the ceiling, cracks in the rest parts

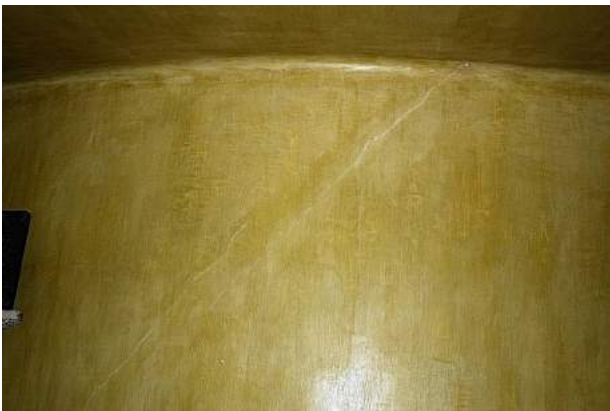
Diagonal cracks in the semicircular partition of the bedroom

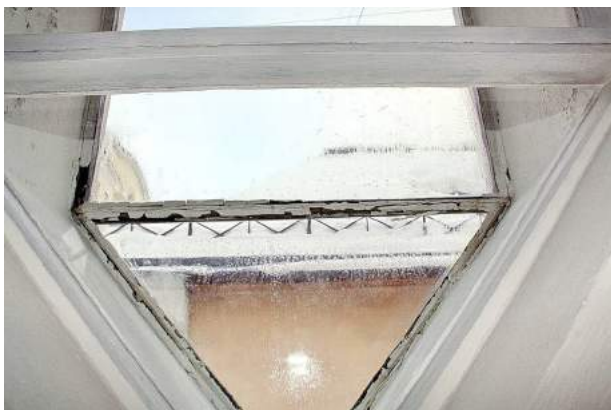
Condensation in the gap between the frames in the studio. Destruction of the finishing layers of the frames and the walls between the frames

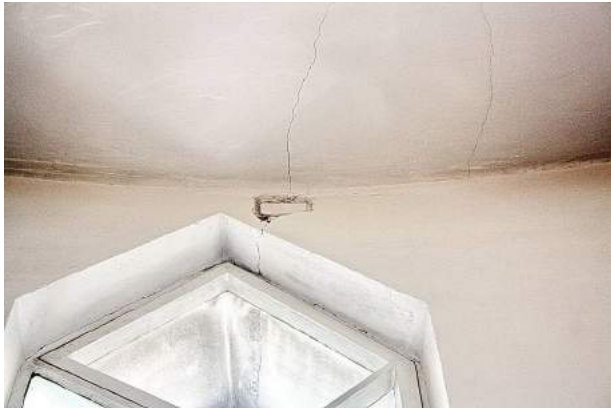
Through-wall diagonal crack under the upper window of the studio. Northwest wall

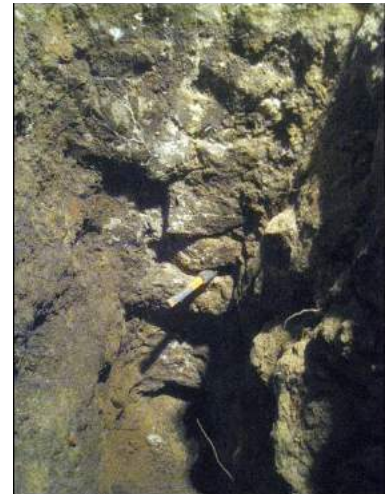
Pit 1. Lower footing. A chisel points out depth of the washed out mortar

2) The very foundations (constructed in 1927) have some minor defects, mainly as a result of washed-out mortar joints (two places in the northwest pit to a depth of 110 – 120 mm, the rest – to a shallower depth). According to the results of 2006, the foundation of the south wall also has defects in the form of a weak mortar of the foundation masonry (up to its absence).

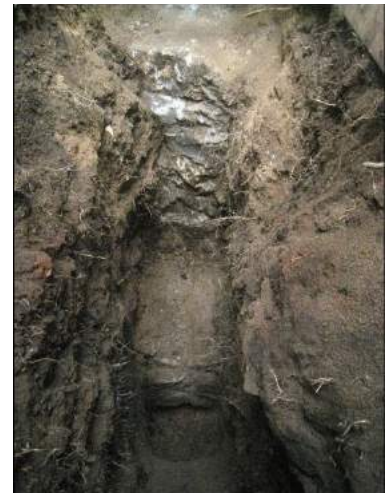
Pit 2. Lower footing

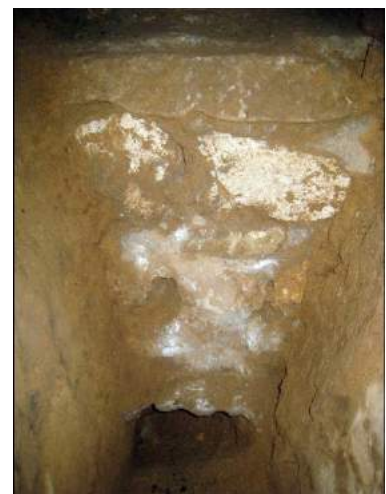
Pit 3. Lower footing

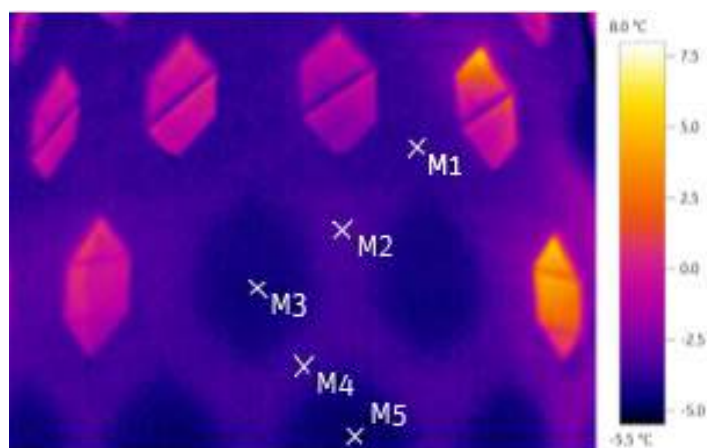
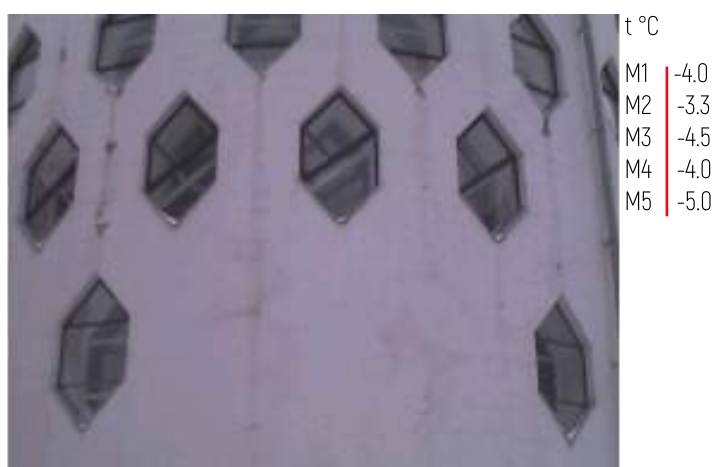
Thermal image. Fragment of the northwest façade

The cellular structure of the walls is clearly visible. The thermal protection of the filled up openings is shown. There is a fairly clear border on the intermediate floor between the first and the second levels – the bedroom is heated better. The temperature is much higher near the heating air duct (the rightmost windows).

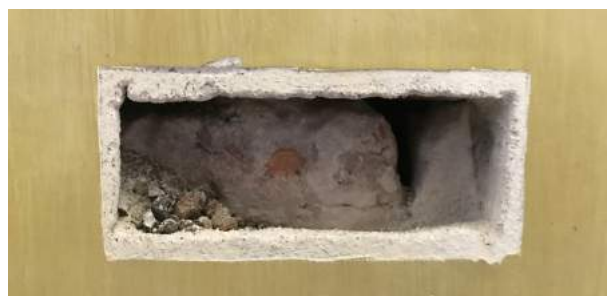
Opening B13

Location: the lower part of the northwest wall in the bedroom on the first floor in the large cylinder. Plaster layer is opened up to the brick masonry. The following samples were taken: light-yellow paint of the walls, plaster, masonry mortar of a bricked-up hexagonal aperture and its filling of sandy-clay mixture.

In the photo: a filling brick of the hexagonal aperture differs in color and size (some bricks were used for the second time, because they used to be a part of the previous building). The filling is not fastened to the main wall masonry. When attempting to drill the filling, the brick starts to move. Mortar of the filling is much weaker than the one of walls masonry.

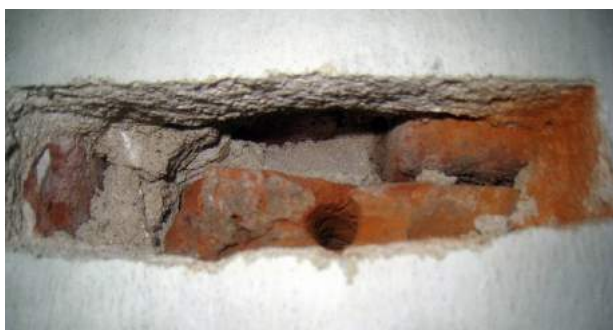
Opening B19

Location: semicircular lobby on the ground floor in the small cylinder on the east wall at the junction of the wall masonry to the bricking-up of the hexagonal aperture. Plaster layer is opened up to the brick masonry. The following samples were taken: plaster layer with paint, filling of the hexagonal aperture and masonry mortar.

In the photo: on the left – masonry of the wall, on the right – the bricking-up, which was made without brick shifting typical of the main brickwork.

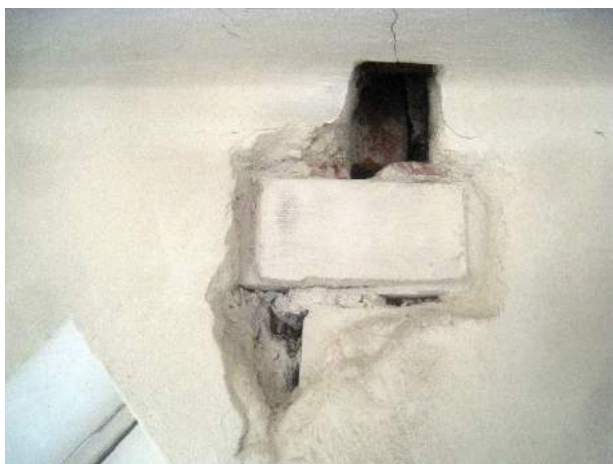
Opening B31

Location: under the ceiling in the studio on the second floor in the large cylinder to the left of the metal air-conditioning duct. Plaster layer of the wall was opened. The composition of the finish and the surface of the brick masonry were analyzed at the crack. A sample of the plaster with paint was taken.

In the photo: a through-wall crack passes along the head joint between bricks. There is no crack on the gypsum survey marker of the 2000s. The gap between the sheathing of the attic floor and the wall is seen above.

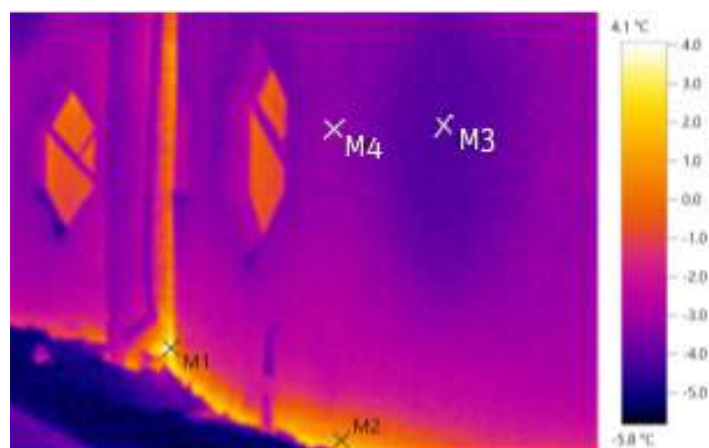
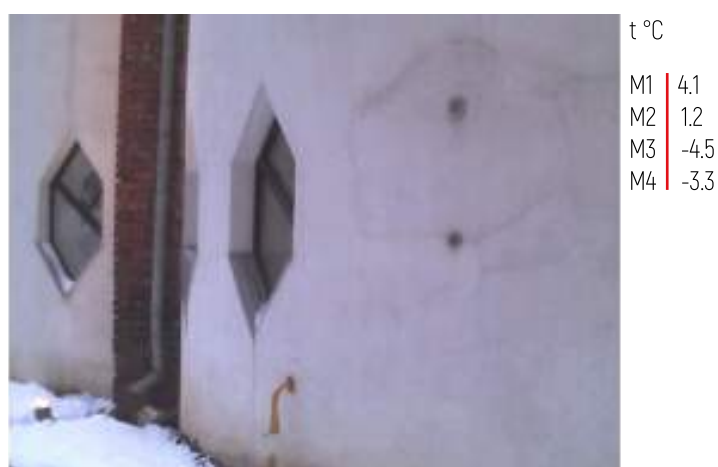
Thermal image. Fragment of the southwest façade

Heat loss at the bottom of the wall and along the brick chimney. Snow melts near the wall because of temperatures above 0°C.

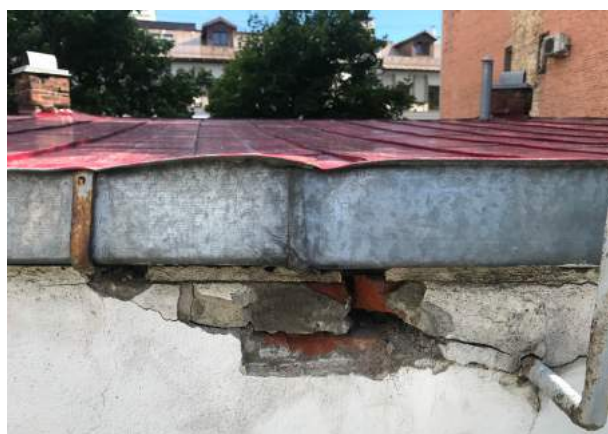
Opening F20

Location: the south façade of the small cylinder, at the bottom of the large window. Steel panels under the large window were opened, wooden planks of sheathing were removed. The structure of the intermediate floor corbels under the window and the state of the wooden structures were studied. Paint samples from the wooden sheathing, as well as mycological samples from the frame wood and the wood filling under the large window were taken.

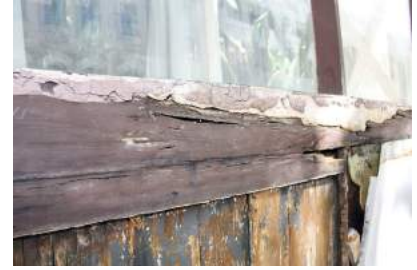
Rot on the lower frame of the large window (in some places it can be pierced with an awl), on the frame under the large window. Surface rot on the wooden filling of the frame under the large window.

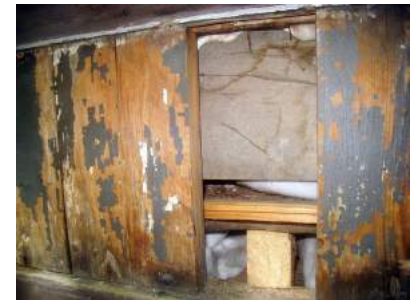
Filling under the large window. Below is a bar, to which the lining of the window of the ground floor is attached. There is a layer of roofing felt on top of the bar and further, between a rail and the joists of the intermediate floor. The bottom sheathing of the intermediate floor is made with a gap (due to the insertion of bars) with ribs and the front board, installed between the ribs. Thermal insulation with padding polyester was made in the 1990s. There are traces of moisture on the front board.

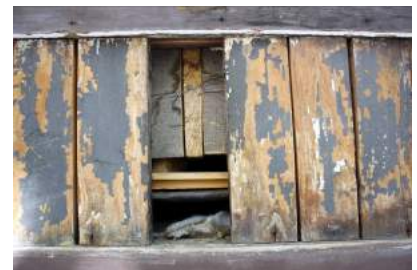
Opening of the frame filling under the large window. A visible end of a joist of the ground floor grid. Traces of the front board wetting. Traces of moistening of the filling planks and their surface rot.

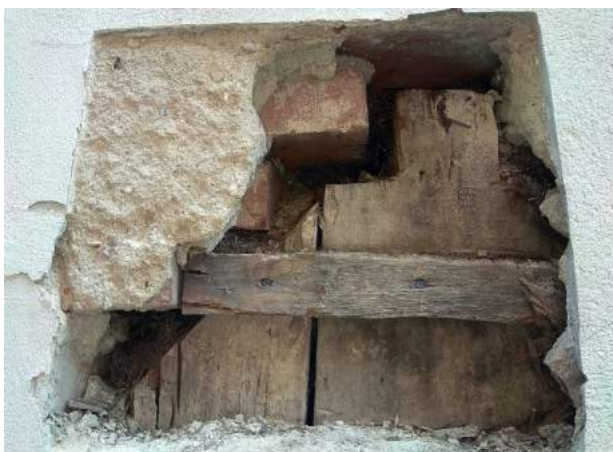
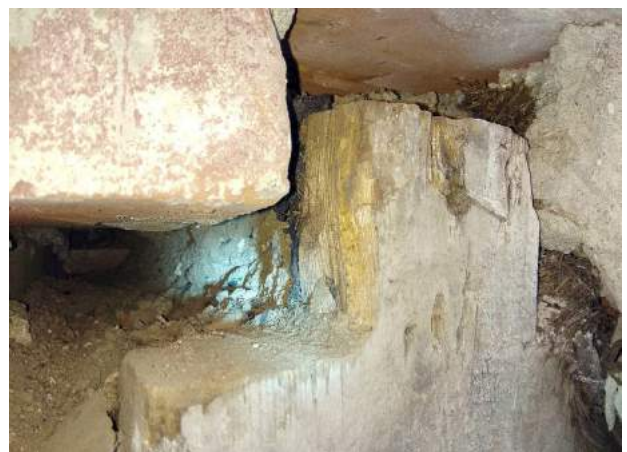
Rot on the edges of the wooden shield. Horizontal bar is loose as its connections lost strength. The tar paper layer lost its flexibility and became fragile. The layer of bast fiber fabric decayed (its remnants are visible on the right), therefore the adhesion of the plaster layer with the shield is lost.

In the background is a brickwork of the aperture from the side of the living room. A heterogeneous composition of the filling-up is also visible. The shield wood is affected by rot. Tar paper does not cover the perimeter tight, there are chinks along the filling-up contour.

After the examination, the filling-up was packed back into the aperture. The gaps between the shield and the brick walls were filled with tow fiber, the lath was restored and the aperture was plastered anew with the repair compound.

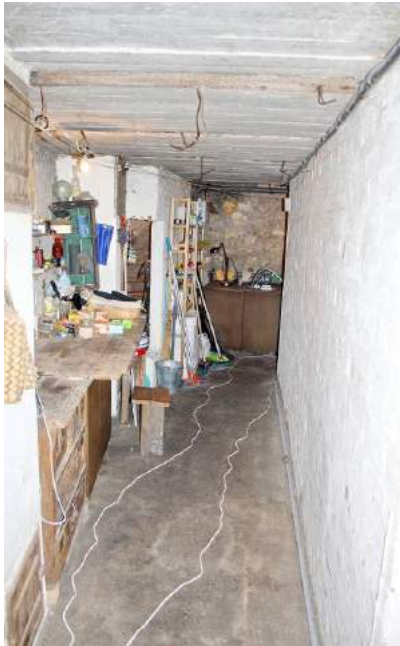
Basement, general view from east to west. Cable hooks made from reinforcing bars are visible under the ceiling. There are cracks in the floor.

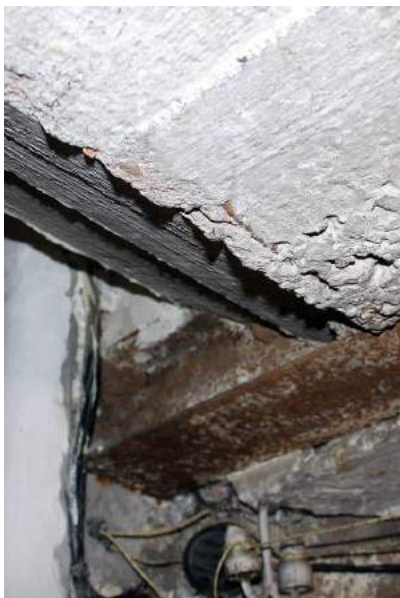
The eastmost beam of the intermediate floor rests on the wall. The beam corrosion, porous surface of concrete and corrosion of reinforcement.

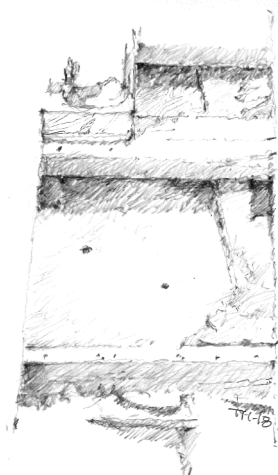
Ground floor. Opening in the toilet with a possible historic wall on the right side. T. Mustonen. 30.03.2018

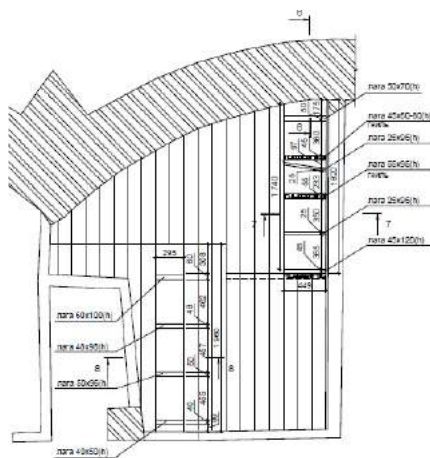
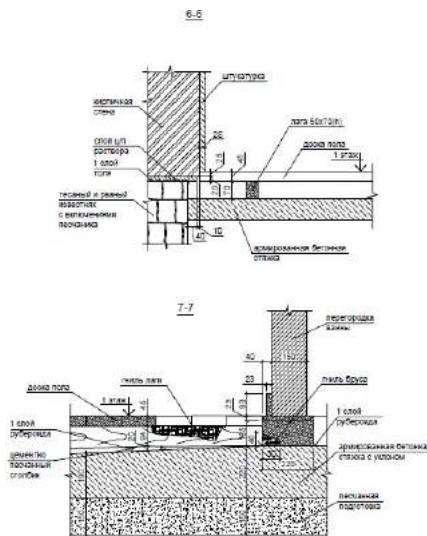
Opening B6. Bathroom. Ground floor

The boards are fastened with nails to battens (the nails are hammered on top, the boards are not grooved). In the opened area, the filling-up, the boards and the battens, the supporting part of the partition, the inclined screed under the floor, the foundation of the partition, the bottom of the brick wall of the large cylinder were examined.

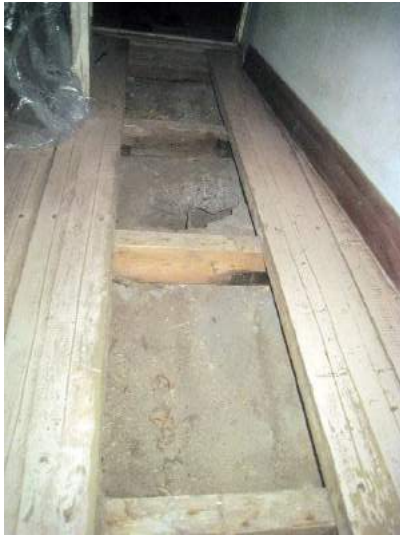
Place of the opening of the inclined reinforced concrete screed is seen between the battens.

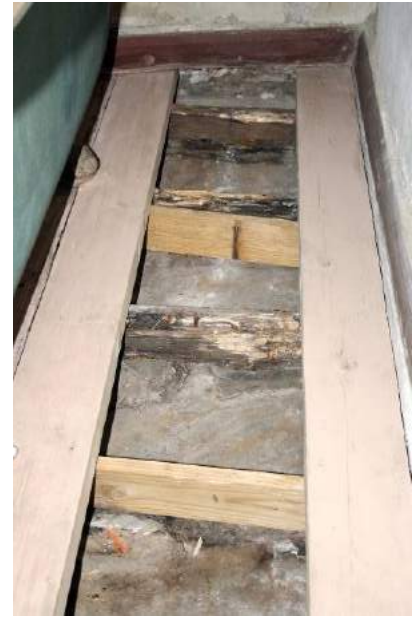
Opening behind the bath. Visible rotten battens and new battens, temporarily replacing them.

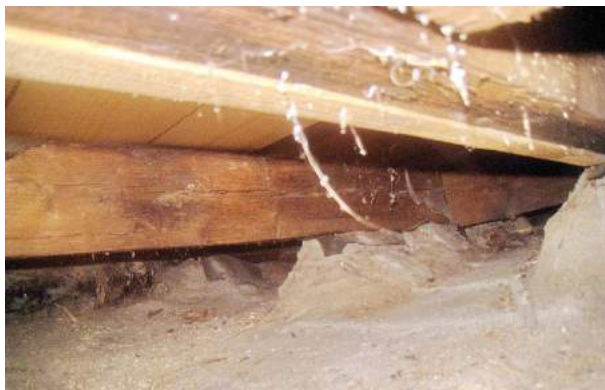
Inclined screed under the bathroom floor. The battens rest on the brick and mortar projections through the waterproofing pads. There are battens affected by rot.

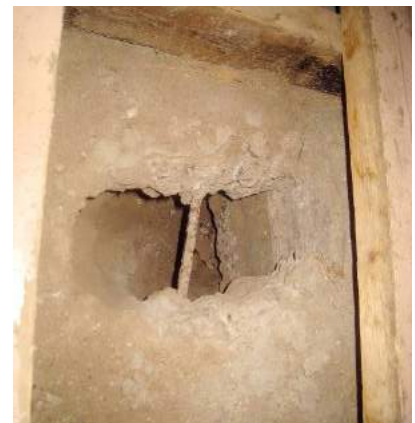
Opening of the inclined screed. The screed adjoins the reinforced concrete foundation of the partition, which partially extends on the brick wall of the basement, and at the same time is based on a sand pad.

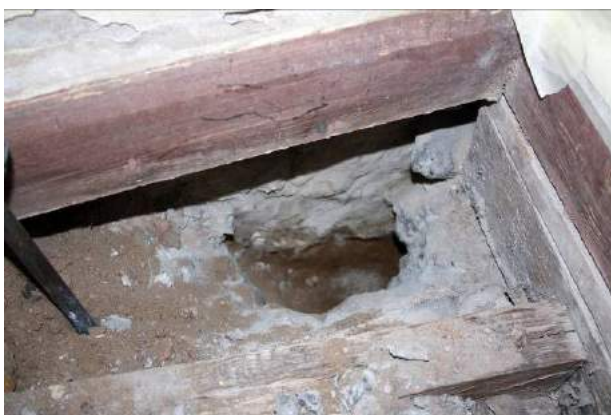
Opening of the inclined screed. The foundation of the partition between the children's room and the bathroom was not found. Visible loss of paint layers at the bottom of the wall.

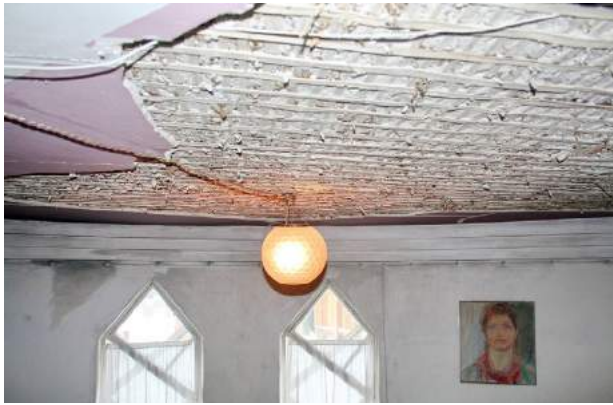
Dressing room on the ground level. Cracks in the ceiling, falling of the plaster layer. Parts of the remained plaster hang loose on the lath, bast fiber fabric and burlap, which cover the lower sheathing of the intermediate floor, and gradually crumble.

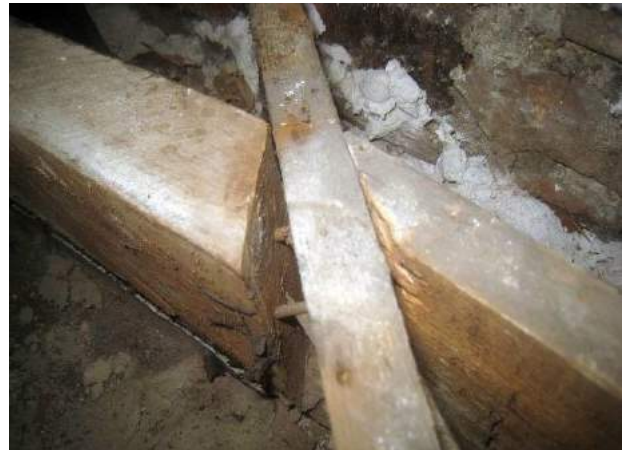
Inaccurately cut rim joist. Loosening of nailing.

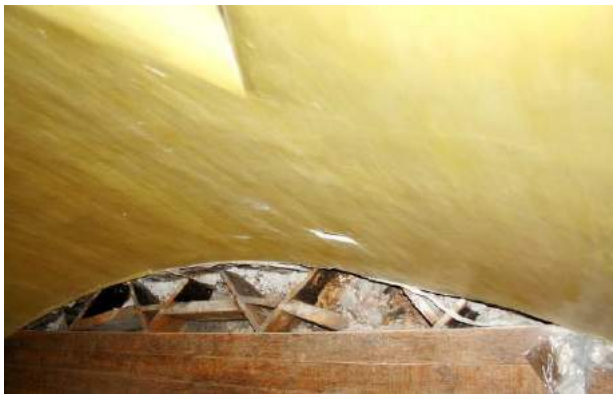
General view. Short rim joists are made of thinner boards. Rim joists are above the inner brick cornice of the ground floor wall.

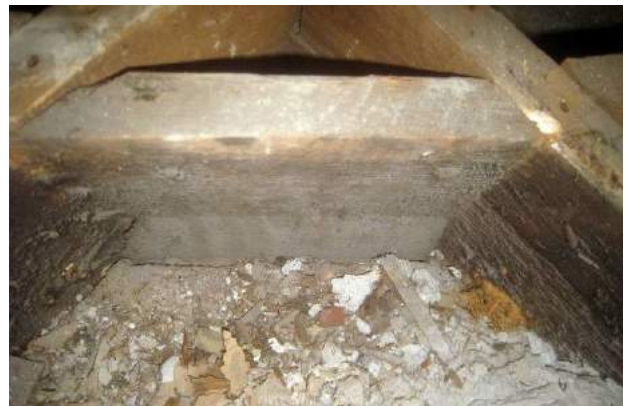
Thin rim joist is broken, probably because of the intermediate floor shift relative to the base.

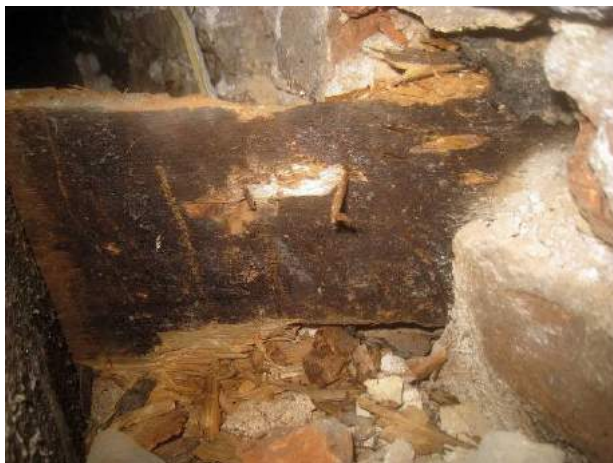
Separately the damage by rot of the intermediate floor of the ground level should be mentioned. It is especially evident in the bedroom – there is rot damage to the joist ends of the grid that extend beyond the rim joists (it is more typical of joists built-in the masonry walls). The floor openings in the living room revealed the rot damage to the supporting ends of the joists of the bearing grid of the small cylinder – but the damage is much smaller in size than the one to the intermediate floor of the large cylinder.

Damage by rot of the supporting ends of joists of the ground floor grid. The only joists damaged are those, that are built in the masonry of the walls. In the photo: the joist is mostly peeled off from weak wood.

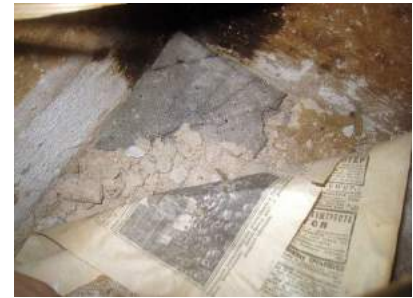
Opening of the filling. Tar paper layer on sheathing, mortar, two layers of newspapers with sand filling

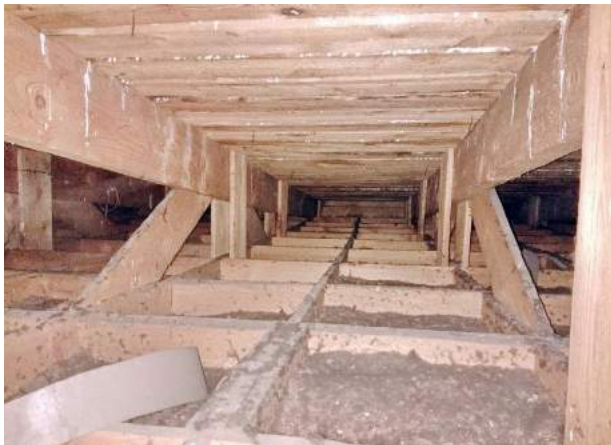
Roof of the large cylinder, general view of structures
 Unevenness of insulation in the cells of the attic floor, presence of construction debris (scraps of tinplate).

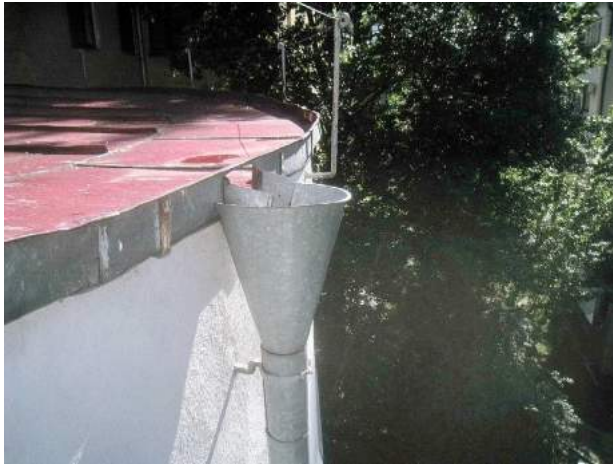
View of a downspout from the roof of the large cylinder. There are places of water stagnation on the surface of the roof. The painting layers of the metal enclosure and the holders of the standing seam metal roofing are damaged; there is initial stage of corrosion.

In general, the roof is in satisfactory condition, however, there are a number of defects that impede its normal operation. The following were detected: moisture seepage to the wall near the downspout, water stagnation on the roof surface due to deflections of the spaced sheathing and roof structures, local bending of the coating, standing seams, and mastic sealant failure.

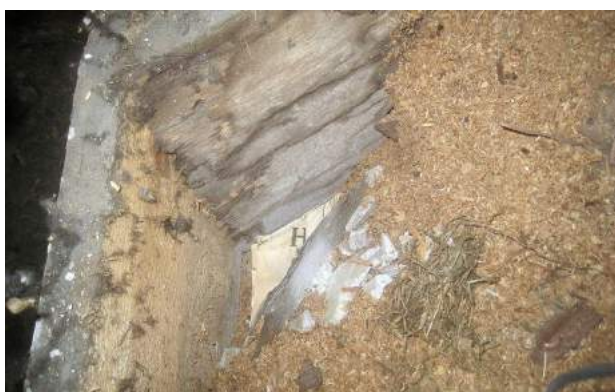
Attic floor filling. The original element is seen above – a rim joist with traces of moisture and more soft surface of wood.

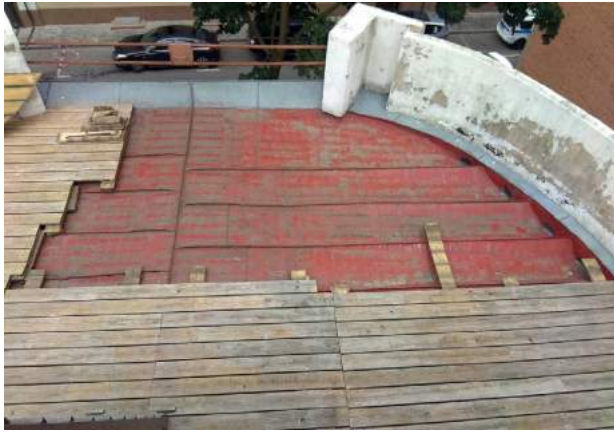
Roof of the small cylinder. Dirtiness of the roofing. The decking does not correspond to the author's design and the restoration project of the 1990s. Damage to the paint layers of the parapet.

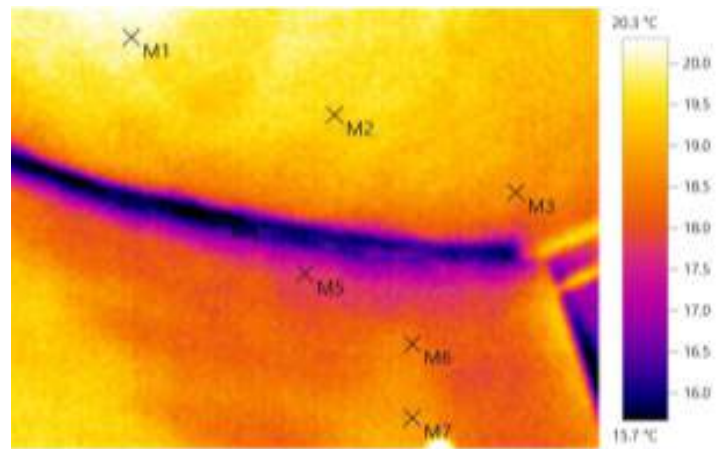
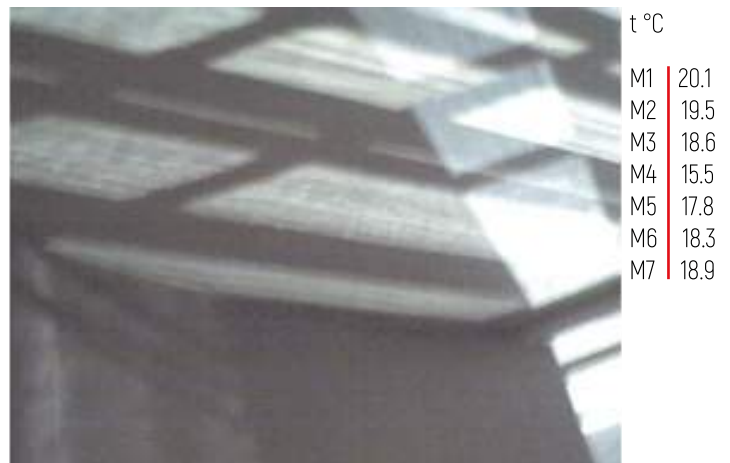
Thermal image. Fragment of the upper part of the southeast wall. 1st floor, the living room

Low temperature zone near the support area of the roof grid (along the edge of the ceiling). The temperature of the ceiling surface in the living room does not differ from the temperature of the ceiling surface in the studio.

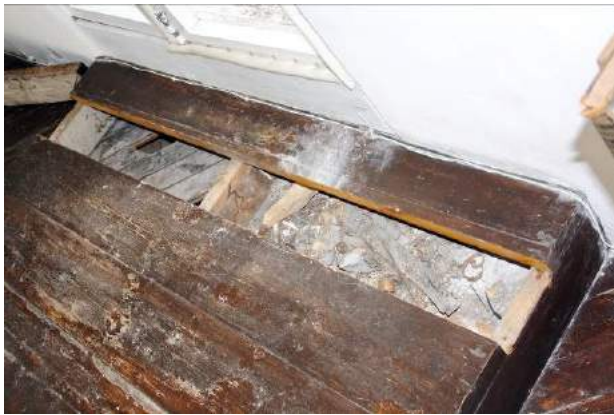
General view. Construction debris in the filling under the floor

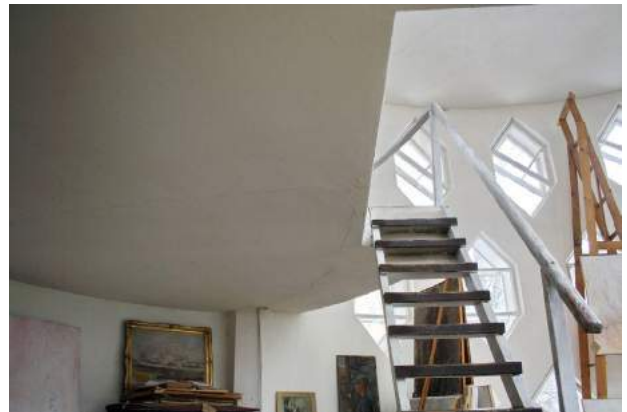
Second floor. Studio. Cracks in the finishing layers of the ceiling under the mezzanine. The stairs to the mezzanine don't have enough posts (insufficient rigidity of the handrail) and have severe wear of the treads

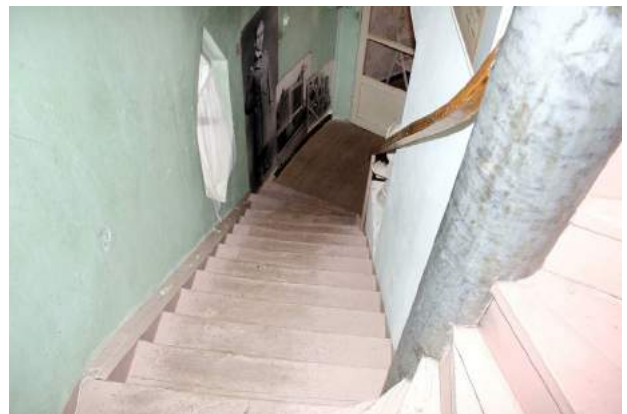
Main staircase between the ground and the first floors. Deflection and deterioration of steps in passing places, wear out of the paint layer, insufficient rigidity of the handrail

The stairs to the basement have defects mainly in the form of the coating detachment of treads and cracks in it. The main staircase has lots of cracks in the plaster layers; in some places the plaster layer has "void" sound when tapping, the paint layers have mechanical damage, the steps creak when walking, and have deterioration in passing places. The stairs to the mezzanine also have damage to the finishing layers, the deterioration of the wood steps in passing places. Steps and stringers of wooden staircases, as well as handrails have insufficient rigidity.

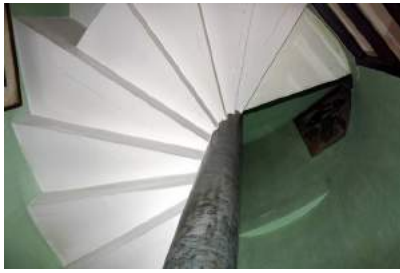
Main staircase between the first and second floors. Cracks in the plaster layers of the stairs and its cylindrical partition.

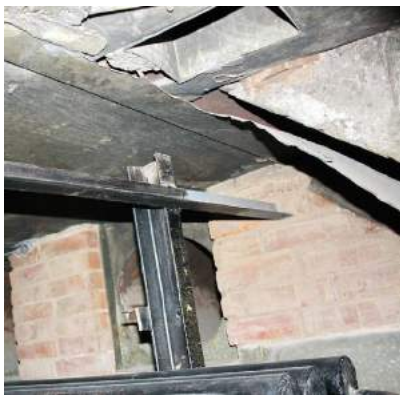
View inside the heater room. The reinforced concrete stairs are on the right side and the absence of thermal insulation of the stairs and ceiling (tinplate sheets) is clearly visible

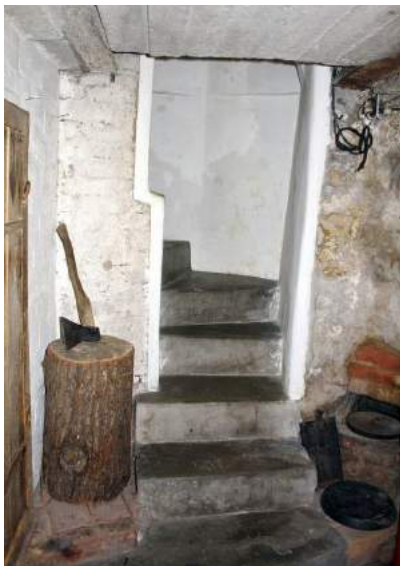
Basement, general view to the north. Cracks and detachment of the steps covering.

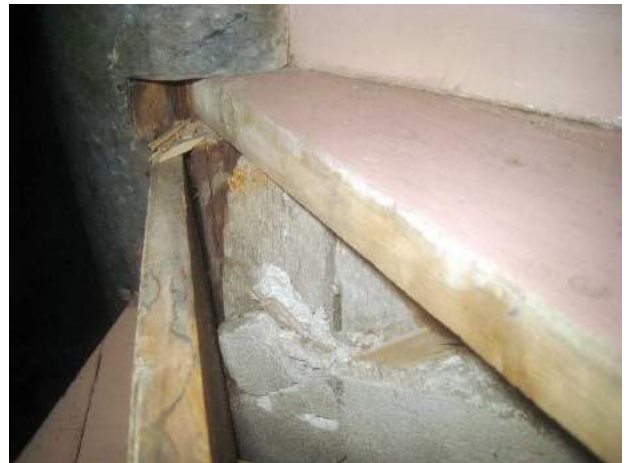
Central pillar supports the tread and the riser – leveling strips are left on the riser. The pillar has shrinkage cracks. A partition under the right side

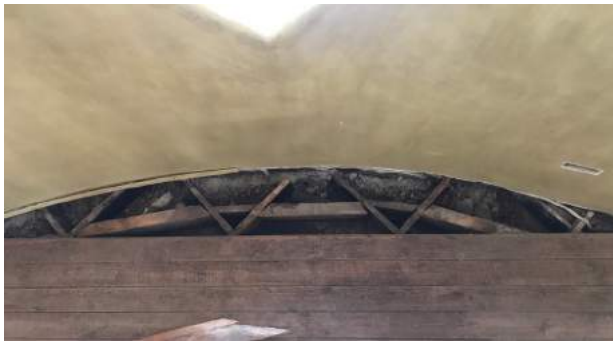
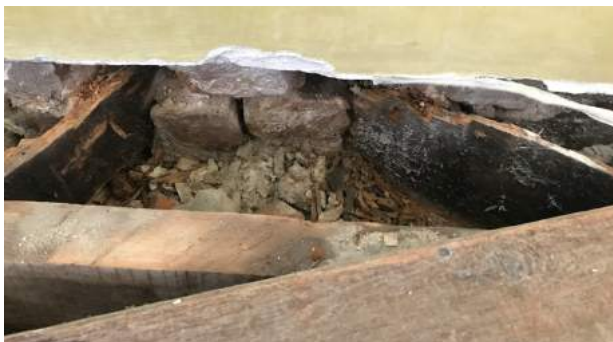
Inter-floor structures damaged by rot. Bedroom, 1st floor

- In the openings traces of vital activity of wood-decay fungi were found in the form of rot, however, viable fungi were not found.
- In the roof structures serious damage with a significant loss of strength (dangerous) was not fixed.

- External window frames have local areas of rot with a loss of strength. This implies either replacement or their repair in the affected places.
- Intermediate floors in the bedroom (between the ground floor and the first floor) as well as the lower part of the large window in the living room are most damaged by fungi places (CFU level 1500-2000 per dm² or higher). The wood of these intermediate floors has local areas of rot with a complete loss of strength, which implies entire or partial replacement of damaged parts of structures. It is recommended to replace or to treat the soundproof filling of the intermediate floor. New, replaced parts and old wooden structures should be treated with a bioprotective agent.

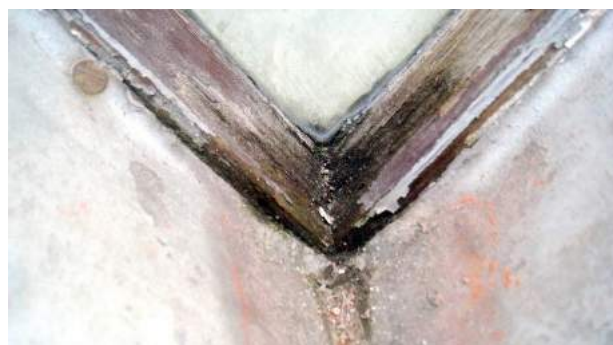
Bottom of the studio window (top row). Destruction of the paint layer, the wood is damaged by surface rot.

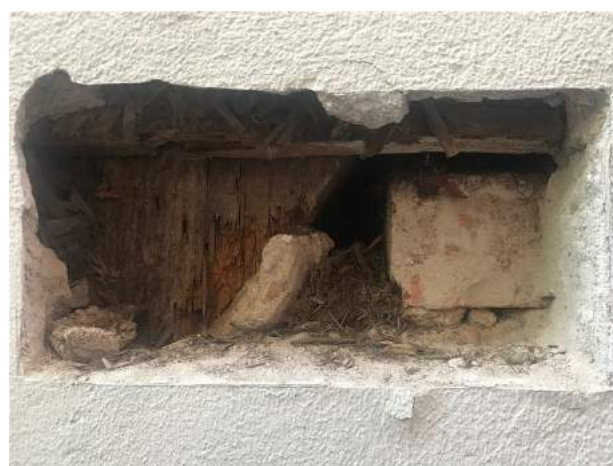
filled with insulation and locked in the course of construction in 1927 – 1929. The wood of the shields is dry but soft and rotten, and it is a potential source of microorganisms growth. One of the issues for future conservation project is to leave them as they are now (focusing on plaster strengthening) or to replace them with obvious loss of material authenticity. The insulation filling itself contains high level of fungi.

Rotten wooden shield covering hexagonal aperture in the outer brick wall. West façade of the small cylinder.

Preservation of biodeteriorated materials is possible by their conservation using chemical biocides or creating conditions that will prevent the growth of microorganisms. Recommendations are given about cleaning and treatment of particular wooden areas by biocides.

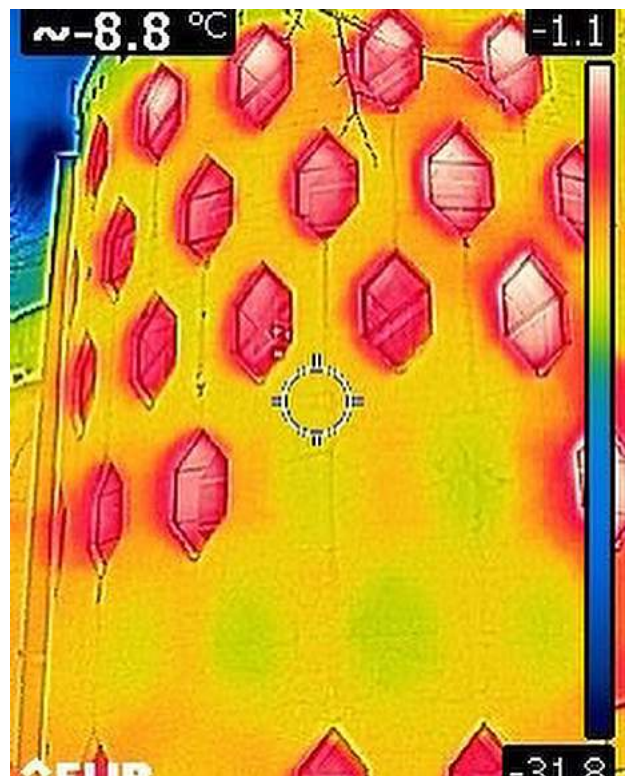
Thermal image of the northeast façade

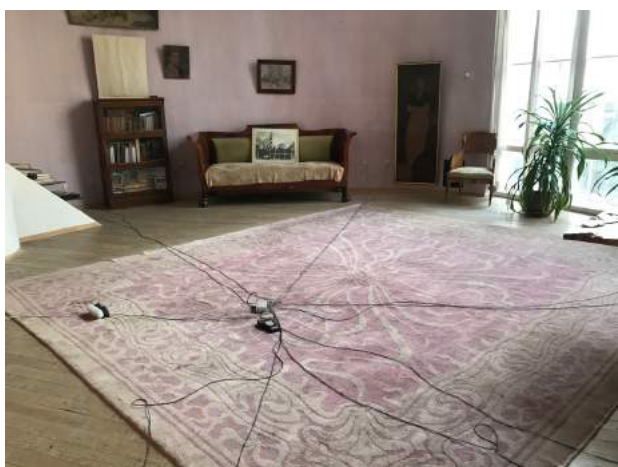
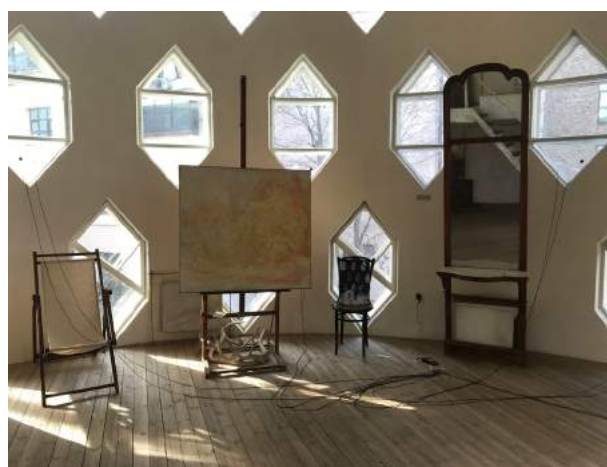
Thermal characteristics and heat losses via external walls, windows, doors and roof have been measured with sensors and thermal cameras.

Measuring of thermal properties of the walls and windows
