Melnikov House

Research Report and Recommendations for a Conservation Plan

10 Krivoarbatsky Lane,
Moscow, Russia

August 2019

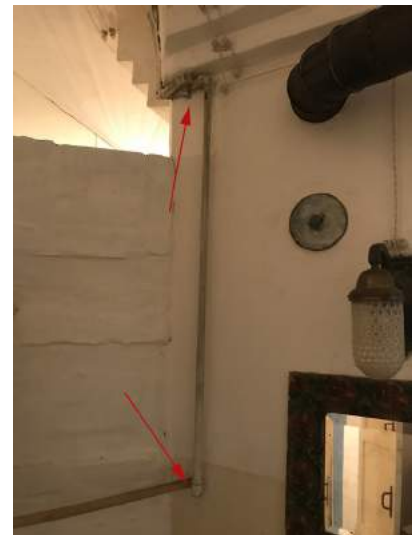
Fragments of non-functioning cold water pipes going into the studio on the second floor. Bathroom. Ground floor.

By request of the Museum, a possibility to use water supply pipes to provide tap water to the studio on the top level (not in use now) was checked by air pressure. Nevertheless, it is not recommended to use the existing original pipes (1929), built inside the walls, as they are not exploited for many decades and are obsolete and rusty.

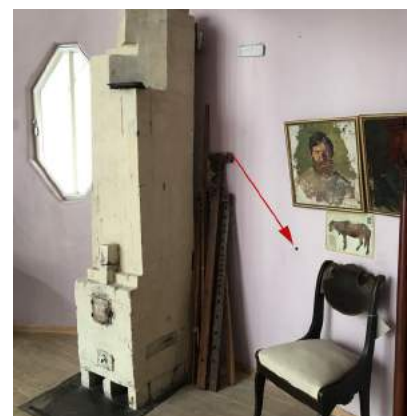
Exit point of the emergency water supply near the stove in the wall of the living-room. 1st floor

It was also found out that one of the two vertical risers has a horizontal branch (a copper pipe) 15 mm in diameter. It goes through the wall in the bedroom toward the stove in the living room on the first floor. Presumably this is the part of the standpipe (not in use now) built inside the interior wall. It was discovered as a historical evidence of the Second World War period (1944), when Melnikov designed and built a local heater ('suprematist stove') in the living room.

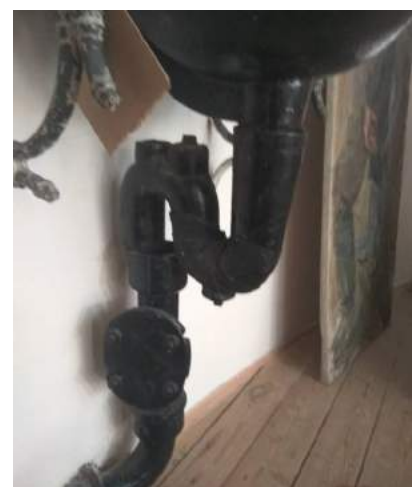
Iron cast trap with a visible disconnect. Studio. 2nd floor

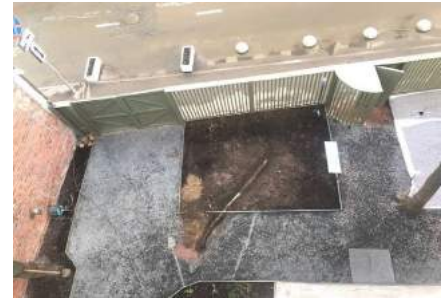
- 1) the line between the gate of the street fence and the corridor of the ground floor (mainly runs underground) has not functioned for decades, it also has disconnects in the basement and underground. A 5 meters long fragment of unused line of the 'air phone', going underground from the house to the entrance gate, was found during special excavation works in spring 2018.
- 2) the line, connecting the ground and the second floors, is in working condition and allows to transmit human speech. It is also currently used as a conduit for security alarm wires.

Excavated underground part of the 'air phone' going from the fence to the house

There is technical ability to restore the entire original acoustic phone system.

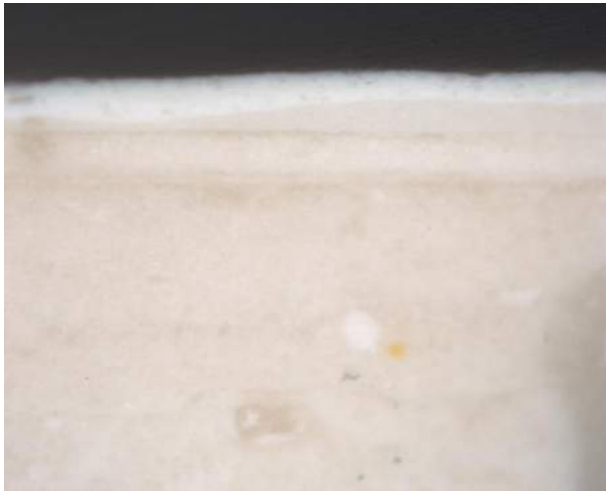
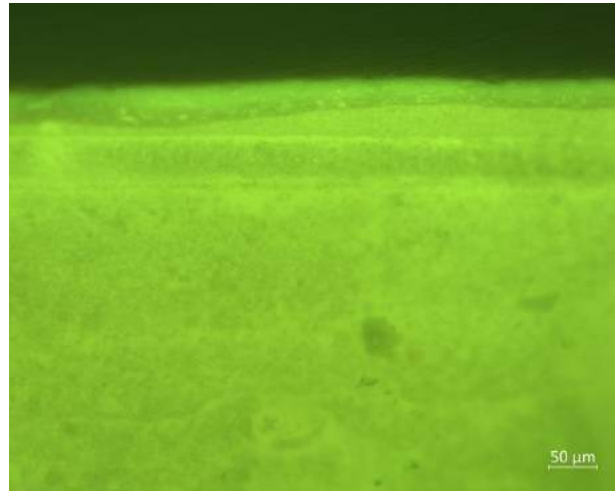
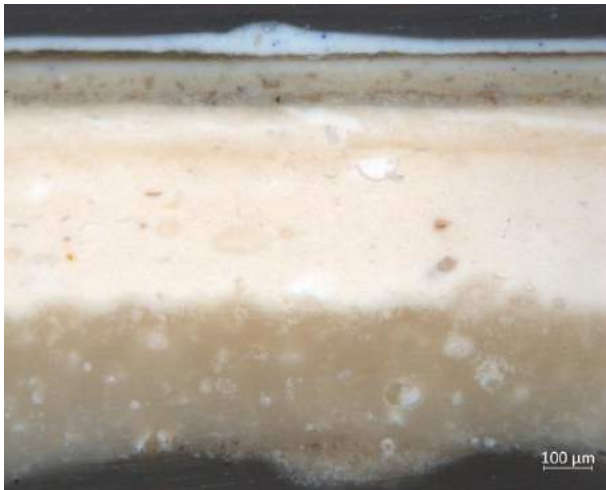
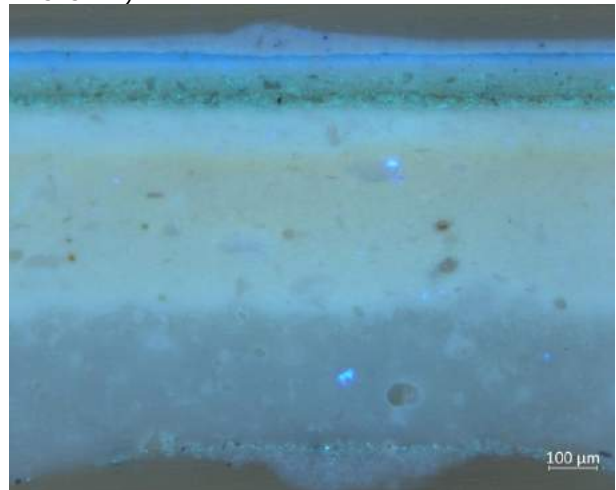
Sample number 19-051-1 (MHM 101) kitchen. dado of the wall behind the stove

On a small fragment of a plaster layer consisting of chalk a very thin light brown paint layer is visible, containing zinc white, chalk or gypsum and a little ochre (first finishing stage?). On this layer lies a thick brownish whitewash layer (carbonated lime) followed by a beige whitewash layer and a white whitewash layer. Each whitewash layer might have been a finish layer or applied together.

After some time a thin grey paint layer was applied, containing zinc white, chalk or gypsum, a little medium coarse barium sulphate and very little aluminium silicate, possibly an ochre. This layer probably was a finish layer. It is followed by a beige paint layer of zinc white, chalk or gypsum and medium coarse barium sulphate. This layer was applied as a finish layer.

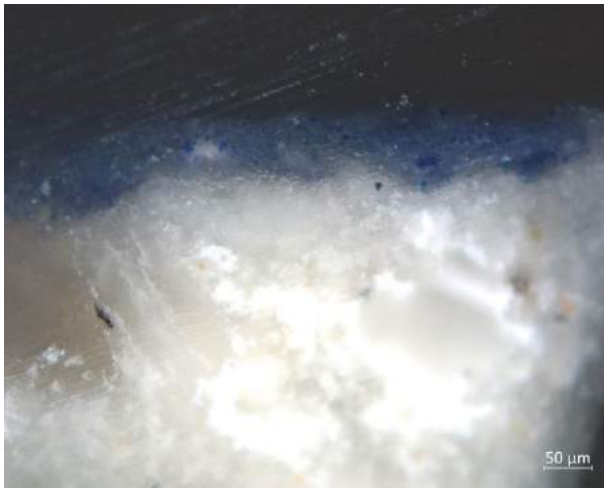
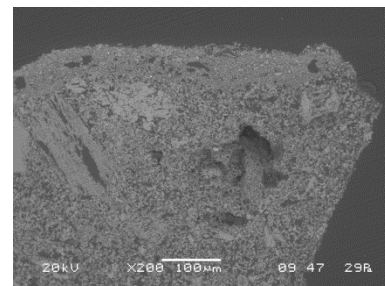
The original blue triangle in the boy's room was painted with a blue lime paint containing synthetic ultramarine blue on a white plaster layer, consisting of gypsum.

It was covered by a plaster layer (3) consisting of lime, sand and some clay minerals on which lies a greenish layer (4) of gypsum and probably a copper compound (although copper could not be detected in this layer). This is covered by a white or light blue layer (5) of gypsum with very little blue pigment. The greenish layer probably corresponds to the green plaster layer in the overpaint of the cylindrical yellow wall in the studio (sample number 19-051-13) and the copper containing plaster layer in sample 19-051-3 from the yellow triangle in the girl's room.

During the period 1948-1950 : 'In the summer the ground floor of the large cylinder is repaired. Walls and ceilings are treated with a copper sulphate solution and covered with fresh whitewash. In the children's rooms and toilet the ceilings and the yellow wall are repainted;' (Kuznetsov, 2017). This corresponds to the greenish layer (layer 4).

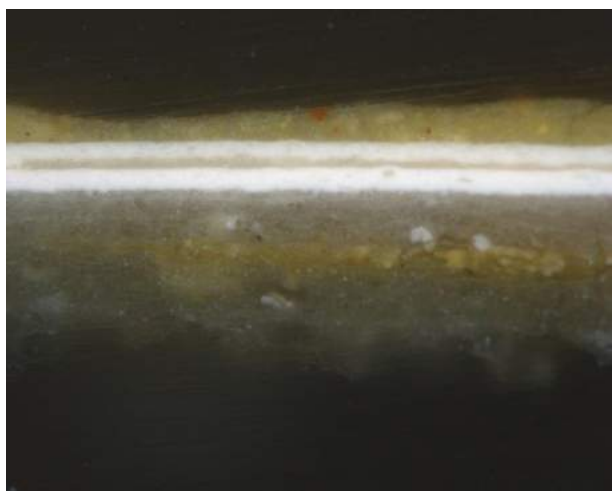
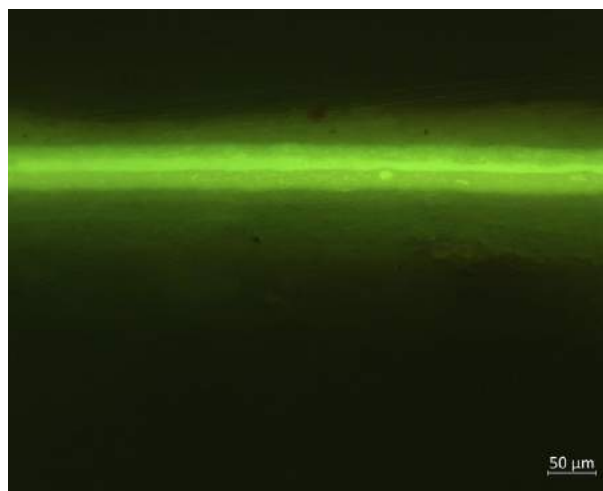
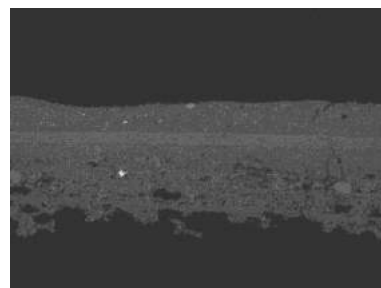
Sample number 19-051-3 (MHM 124) girl's room, yellow triangle on the ceiling

On a partially present plaster layer (1) lies a greyish, rather transparent, plaster layer (2), containing chalk and gypsum and a small amount of a copper compound. This probably gave this layer a light green appearance. This is covered with a yellow lime paint (3), probably containing an organic yellow on an aluminium containing substrate. The greyish, copper containing layer probably corresponds to the greenish layer (4) of the second finishing stage in the sample of the blue triangle (19-051-2) and the green copper containing layer in sample 19-051-13 from the cylindrical yellow wall in the studio. This indicates that paint layers of the original yellow triangle are not present in this sample. Maybe sampling has not been deep enough to incorporate the original yellow in the sample or the original was not present (anymore) at the sample location.

The yellow paint was overpainted with a greyish, rather transparent, lime layer (4), followed by a thin white paint layer (5), consisting of titanium dioxide, magnesium silicate (talc), chalk and some clay mineral. On this white paint layer a layer of ground paint consisting of chalk or lime and a fluorescing organic binder (6) was applied followed by a white paint layer (7) consisting of titanium dioxide, magnesium silicate (talc), chalk and some clay mineral, probably the same paint as paint layer 5. The currently visible yellow triangle was painted with a lime paint (8) containing yellow ochre.

During the period 1948-1950 : 'In the summer the ground floor of the large cylinder is repaired. Walls and ceilings are treated with a copper sulphate solution and covered with fresh whitewash. In the children's rooms and toilet the ceilings and the yellow wall are repainted; (Kuznetsov, 2017). This corresponds to the greyish, rather transparent, copper containing layer (layer 2). This means that the original yellow triangle is not present in this sample.

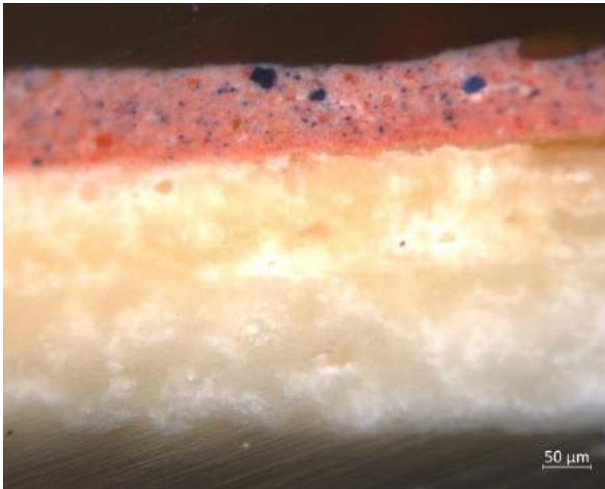
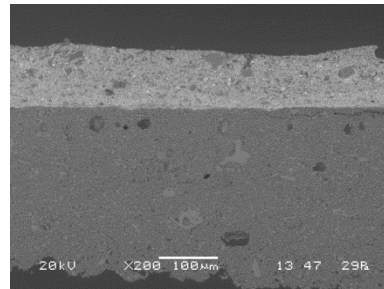
Sample number 19-051-4 (MHM 61) dressing room, red surface on ceiling

No traces of an older surface were observed on the plaster fragment that was available after part of the ceiling had collapsed.

On a yellowish white plaster layer lies a purplish red paint layer, consisting of zinc white, some chalk, an organic red pigment and synthetic ultramarine blue.

This can be confirmed by Interview [3]: in 2005: partially collapsed. Proposal: Repair

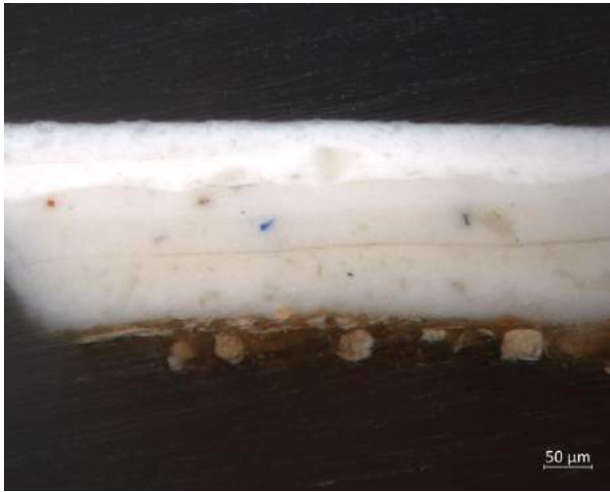
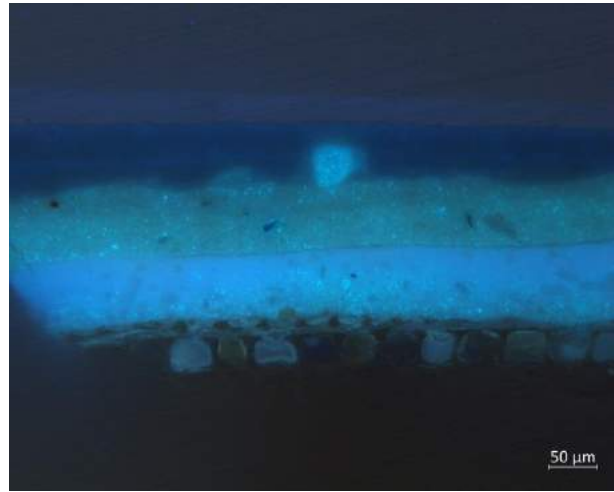
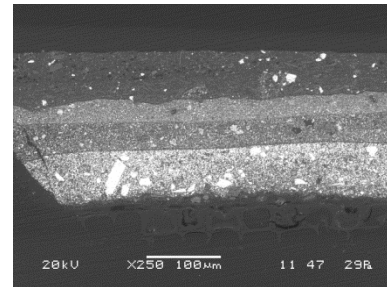
Sample number 19-051-5 (MHM118) dining room, window frame of inner window, interior side

The wooden window frame was first painted white with a white paint layer (1) containing zinc white, lead white and barium sulphate and a white paint layer (2) of lead white, zinc white and little barium sulphate.

This finish was overpainted with a greyish paint layer (3) containing zinc white and very little synthetic ultramarine blue, followed by a light greyish paint layer (4) consisting of zinc white.

These three phases correspond with the three phases in sample 19-051-16 and 19-051-18 of the windows in the bedroom.

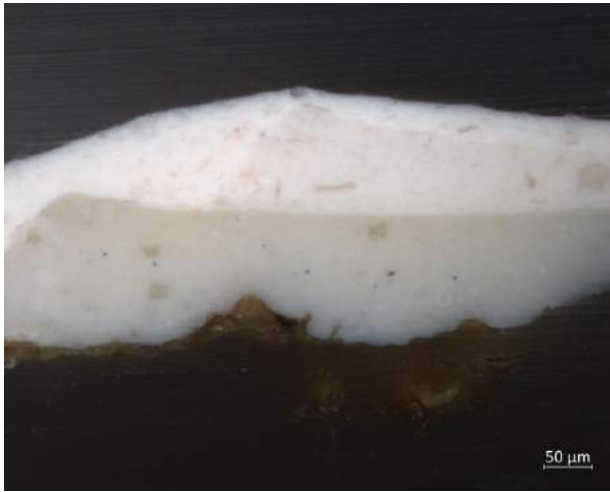
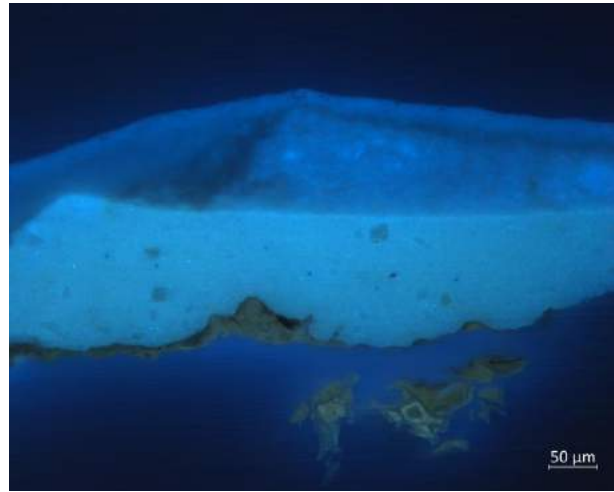
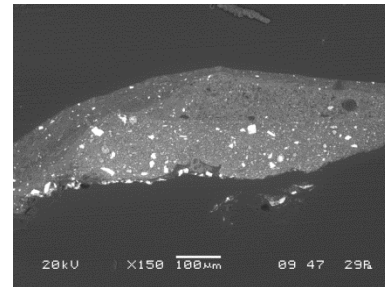
Sample number 19-051-6 (MHM134) dressing room, closet between dressing room and girl's room, right part

Between the wood of which a few cells are visible and the white paint layer traces of a yellow paint layer are visible containing coarse barium sulphate. The white paint layer consists of zinc white and some barium sulphate and probably very little synthetic ultramarine blue. It is of a similar composition as the paint of the second finish in sample 19-051-5 of the window frame in the dining room.

This finish was overpainted with a white ground paint consisting of chalk, titanium dioxide, magnesium silicate and quartz followed by a white finish layer containing titanium dioxide (rutile) and talc as filler.

Both interviews mention the yellow cupboard. Light ochre [3] is more likely, chrome is not.
 Interview Adamov [2]: Left (male) fitted cupboard. Paint. Colour: Yellow, chrome, comments: Not so bright.
 Interview [3]: in 1929 : Light ochre, oil paint ; in 2005: Painted with white enamel. Proposal: repaint

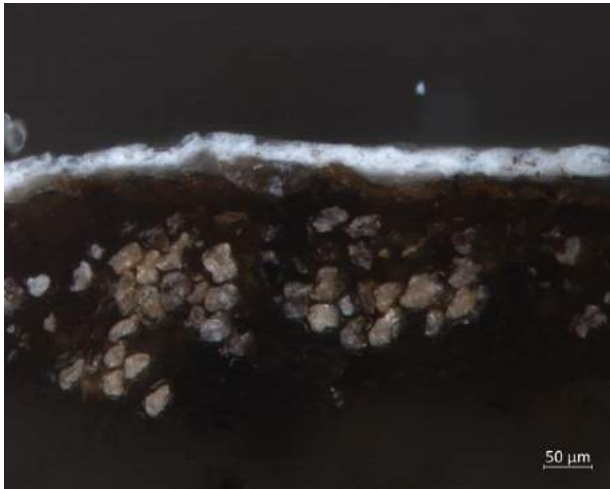
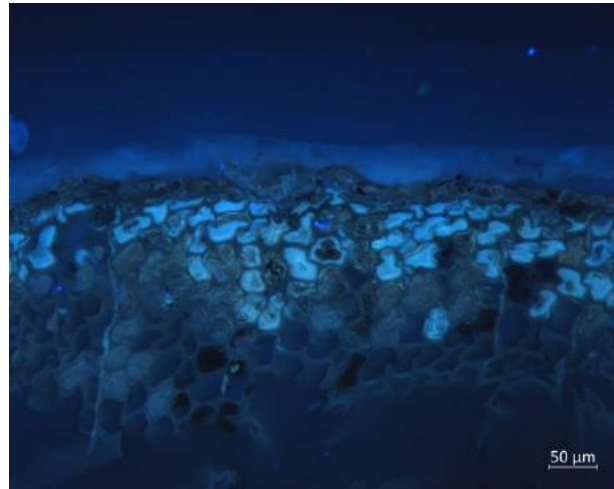
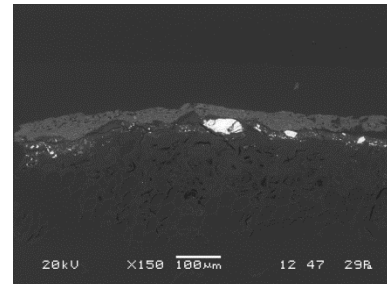
Sample number 19-051-7 (MHM145) living room, octagonal window, inner window, interior side

The window was initially painted with a brown paint layer containing brown ochre, some chalk and some rather coarse barium sulphate particles. This brown finish was later overpainted with a white paint layer containing magnesium silicates or dolomite and quartz and titanium dioxide.

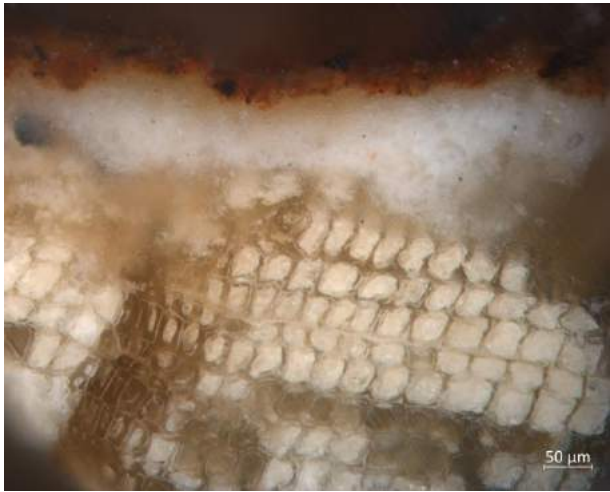
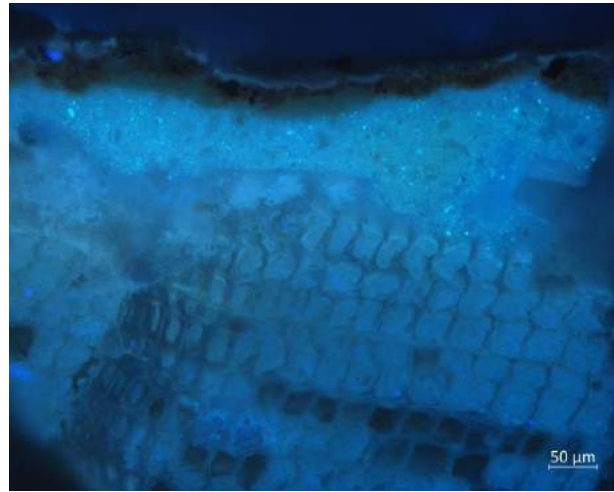
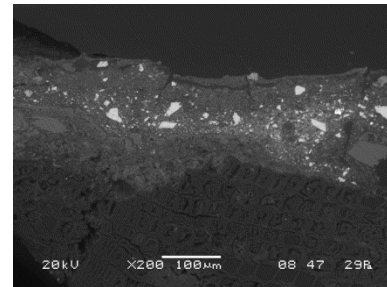
Sample number 19-051-8 (MHM147) living room, door frame to stairs

The wood of the door frame was primed with a white ground paint containing gypsum, followed by a white paint layer consisting of zinc white with little barium sulphate and chalk or gypsum. On this a red-brown paint layer was applied consisting of chalk and brown ochres. This layer was covered with a thin transparent and fluorescing varnish.

Especially the interview by Adamov conforms the analysis: Interview Adamov [2]: door into the living room, The door was painted so that the base coat showed through. The paint was more transparent, lighter, so that the base coat showed through. The thickness of the paint should be diluted with a touch of whitening. Colour: Brown, umbra. Comments: the colour was a lighter shade of brown, a lighter burnt umbra. The paint should be less graphic.

Interview [3]: in 1929 : Door : Burnt umber, light; in 2005: Dark paint Two glasses cracked.

Proposal:: Repaint

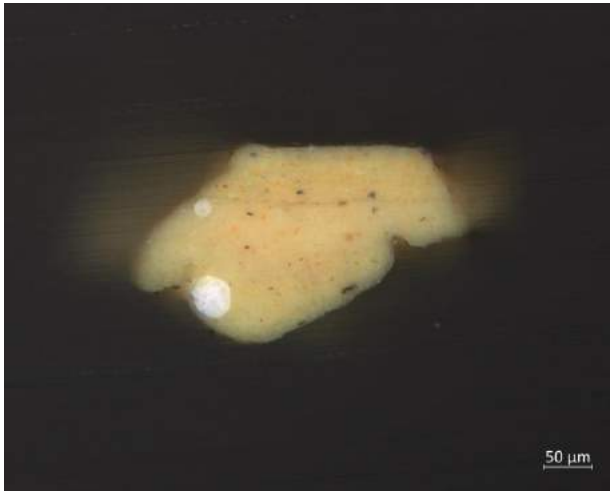
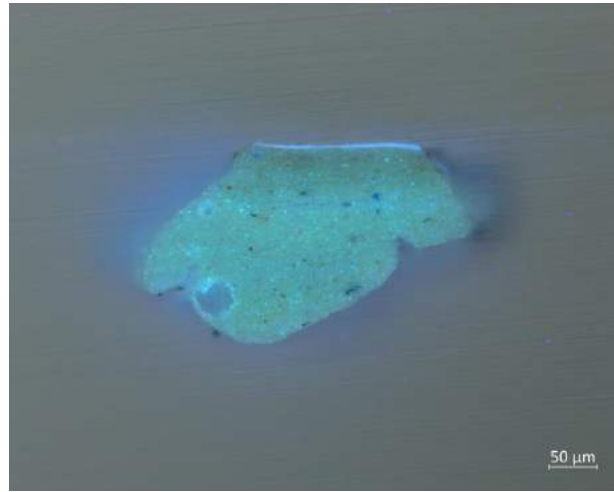
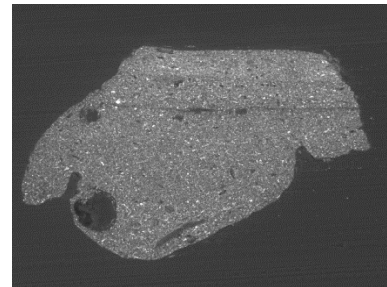
Sample number 19-051-9 (MHM162) painting of the bedroom by Viktor Melnikov, 'golden' finishing layer

The 'golden' finishing layer of the bedroom is depicted in the painting with three layers of yellow paint of similar composition, containing zinc white, little zinc yellow, and possibly an organic yellow pigment. The top layer is covered with a very thin fluorescing varnish.

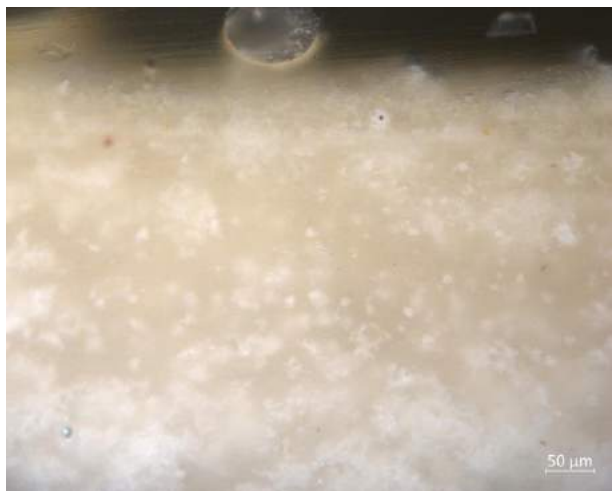
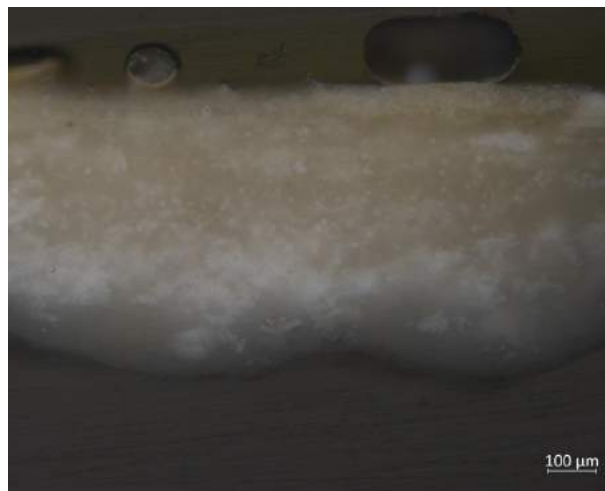
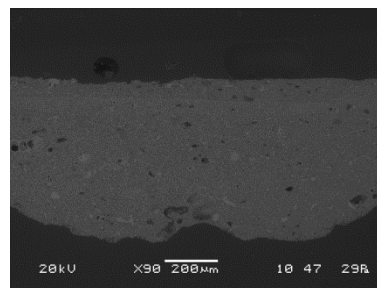
Sample number 19-051-10 (MHM171) bedroom, golden wall left from entrance, behind mirror

The yellow walls in the bedroom were painted with a lime paint on a lime plaster layer. Surprisingly, no yellow pigment was found in the finish layer. Microscopically, the layer does not appear yellow in cross section.

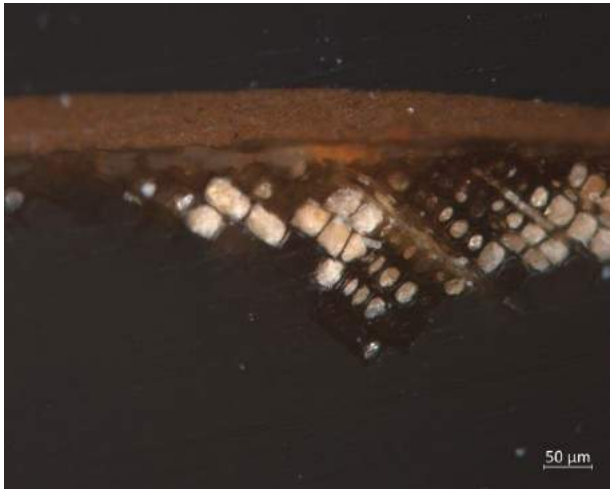
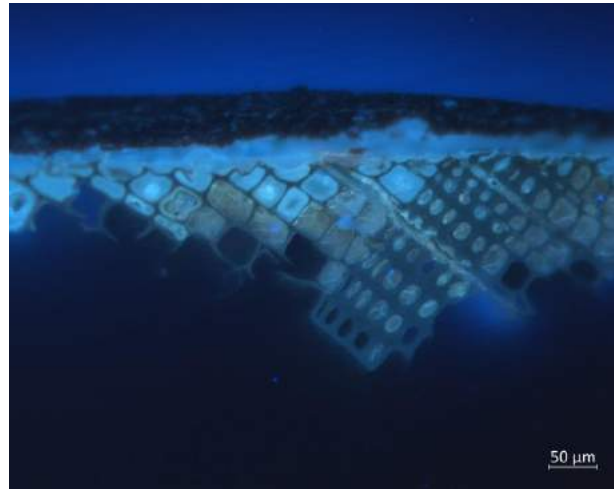
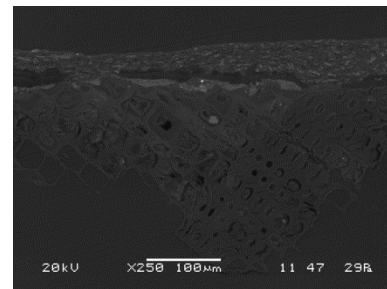
Sample number 19-051-11 (MHM173) exterior, window to the right of the entrance door

The window was originally painted with a thin layer of chalk and a little brown-red iron oxide and a transparent varnish, which fluoresces under UV-radiation. The structure of the wood was probably visible through these layers.

It was overpainted with a thick brown paint layer containing iron oxide brown, quartz and magnesium silicate as a filler.

Interview [3]: External curtain wall: frames, transom latches in 1929 : Coat of oil paint over oil varnish. Umber, light tone ; in 2005: Frames are cracked. Enamel paint colour has been changed.
Comments : Fit, clean and repaint the frames

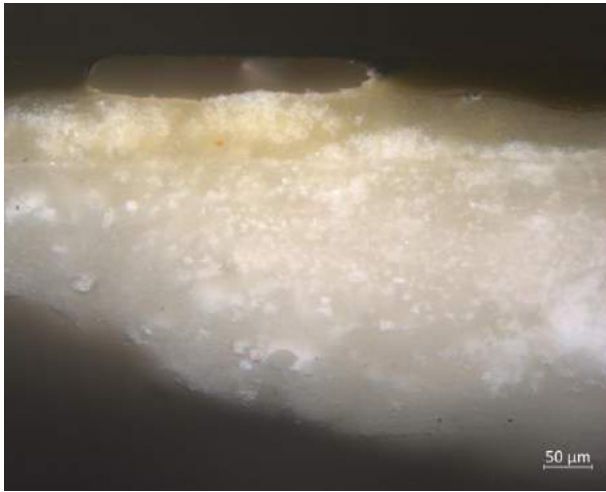
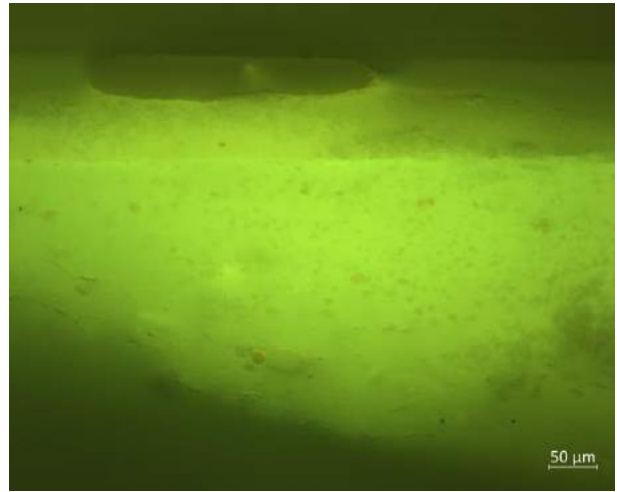
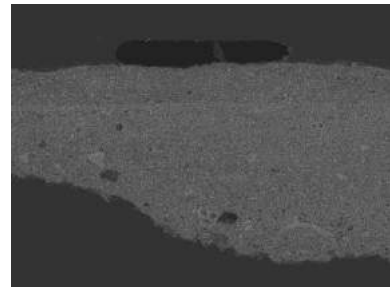
Sample number 19-051-12 (MHM172) bedroom, golden wall behind the sofa

The yellow walls in the bedroom were painted with a lime paint on a lime plaster layer. One particle of yellow ochre was encountered in the lime paint. The amount of yellow pigment is very low for the colour of the layer as observed with the naked eye.

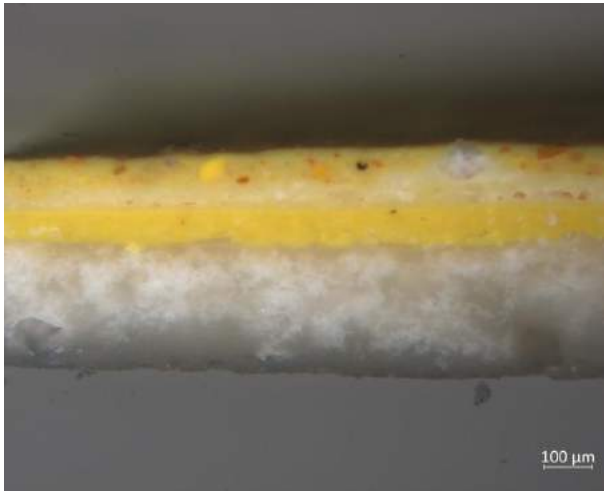
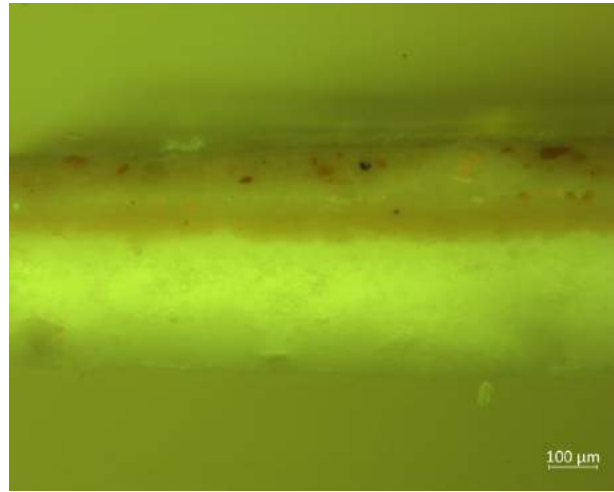
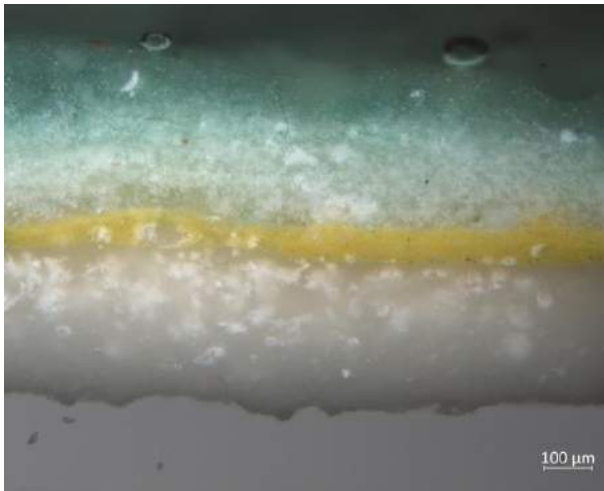
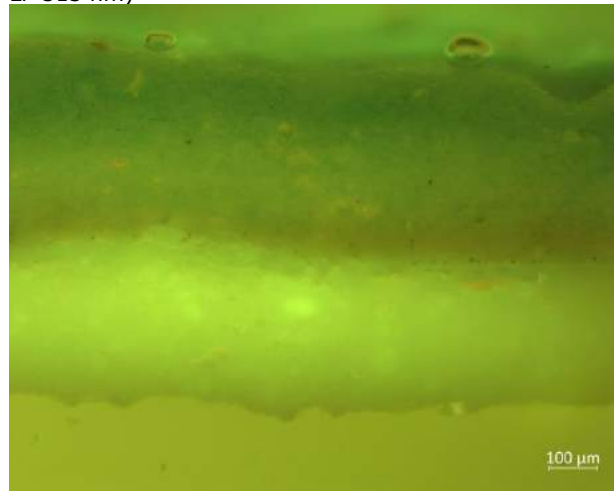
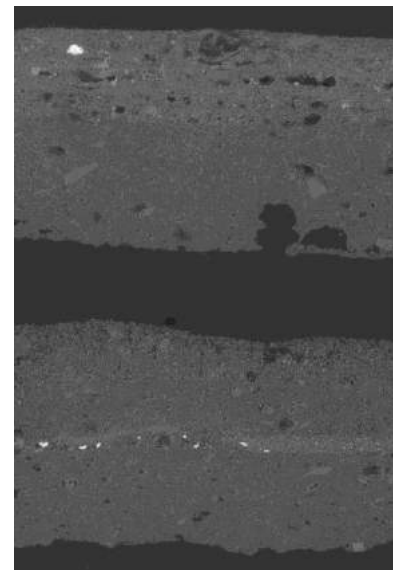
Sample number 19-051-13 (MHM163) studio, yellow cylindrical wall with green plaster under the paint layers

The wall was first painted yellow with a yellow paint layer, probably a lime paint, containing some barium sulphate and chrome yellow as the yellow pigment.

Subsequently the wall was covered with a thin white plaster or whitewash and a green plaster, which contains a green copper compound. A similar layer is also present on the ceiling in the girl's room on the first (ground) floor (sample number 19-051-3).

'During the period 1948-1950 : 'In the summer the ground floor of the large cylinder is repaired. Walls and ceilings are treated with a copper sulphate solution and covered with fresh whitewash. In the children's rooms and toilet the ceilings and the yellow wall are repainted; (Kuznetsov, 2017)
The green copper layer on the cylindrical wall would imply that the studio was treated with copper sulphate solution as well.

Interview Adamov [2]: Part of the cylinder of the stairwell. Paint a denser colour. Try to make heavier. Colour: Chrome yellow

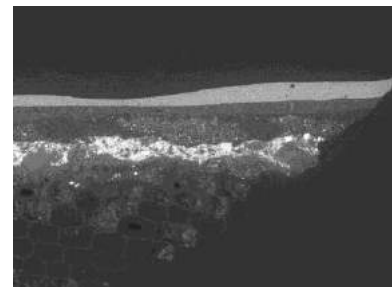
The post of the white balustrade was originally painted with a white ground layer containing chalk and a white finishing paint layer containing lead white, zinc white, some barium sulphate and little chalk.

It was overpainted with a single greyish white paint layer of zinc white and very little blue pigment. This layer is similar to the first overpaint of the interior window in the dining room.

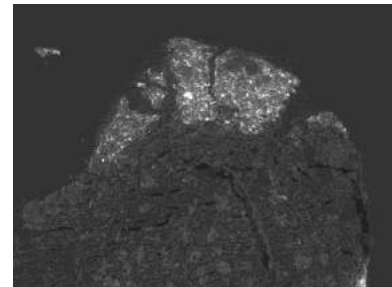
Sample number 19-051-15 (MHM167) studio, yellow balustrade of entresol, middle post

The yellow post of the balustrade was painted with a single yellow paint layer of cadmium yellow and some zinc white and probably some zinc yellow (zinc chromate).

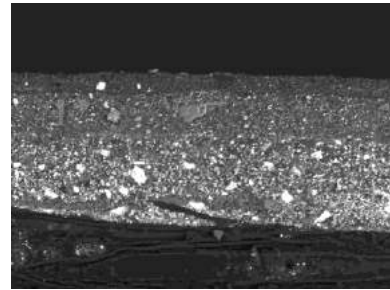
Sample number 19-051-16 (MHM30) bedroom, first window west, inner window, top window, interior side

The original finish of the window consisted of a single white paint layer containing zinc white, lead white, little barium sulphate and little chalk. This is similar to the first paint layer on the window in the dining room.

The second finish was also applied as a single grey paint layer, containing zinc white, gypsum, and some fine red and blue pigment.

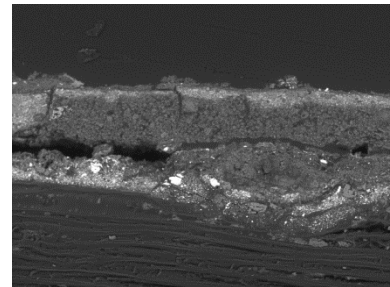
Sample number 19-051-17 (MHM36) bedroom, 1st window west, outer window, interior side

On the wood a damaged greyish white paint layer is present, consisting of zinc white and little gypsum. Similar paint layers are found in samples of the window in the dining room (sample 19-051-5) and the window in the bedroom (sample 19-05-16) as the first overpainting.

This was overpainted with a filler of gypsum, little zinc white and little ochre, a ground of chalk and a white paint layer containing zinc white, gypsum and aluminium silicate.

Comparison with samples 19-051-5 and 19-051-16 indicates that the first finish from 1929 is missing in this sample.

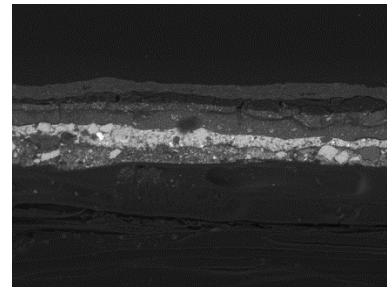
Sample number 19-051-18 (MHM38) bedroom, 2nd window west, inner window, interior side

The window originally was painted white with a white preparation paint layer containing zinc white, gypsum, little barium sulphate and very little lead white, followed by a white paint layer (finish layer) consisting of lead white, barium sulphate, zinc white and little silicate filler.

This white finish was overpainted with a white paint layer, consisting of zinc white with a very small amount of blue pigment. The next paint layer, consisting of zinc white and chalk, is probably a next overpainting. It is covered by a transparent organic layer.

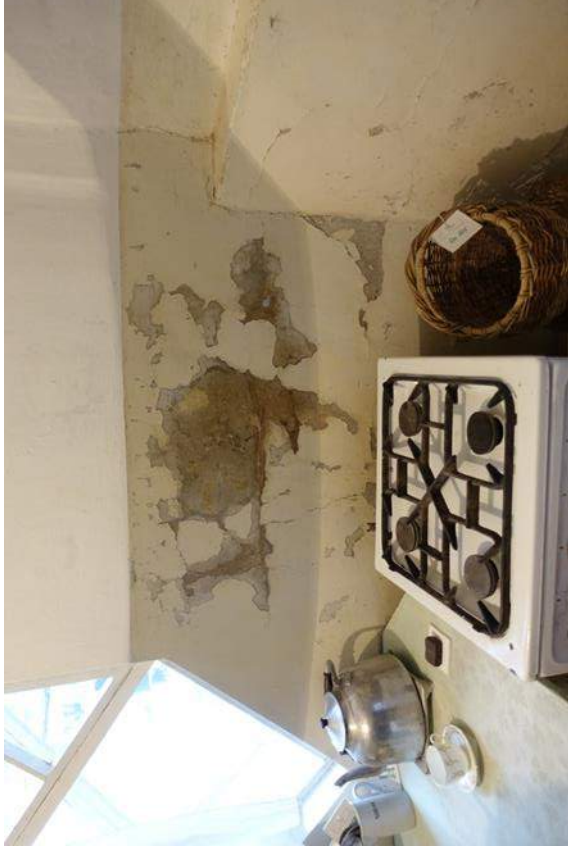
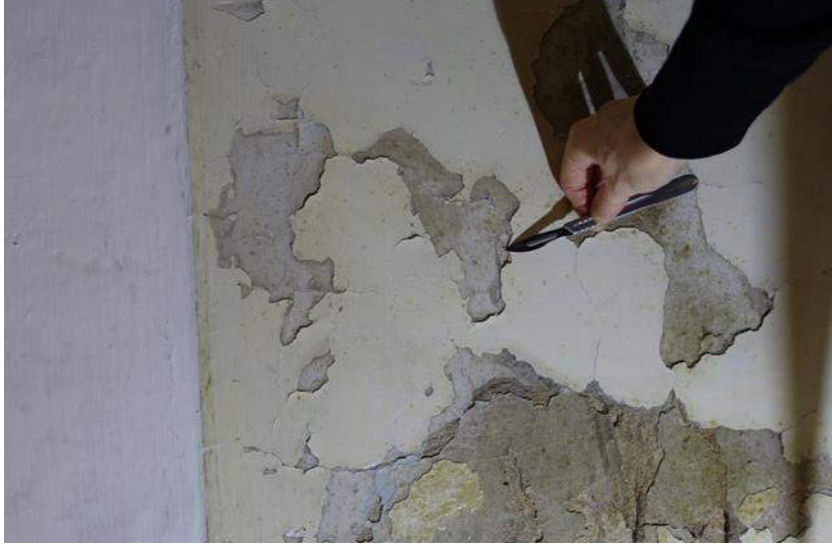
location MHM 101

1st floor_kitchen_dado of the wall behind the stove

It will be necessary to check the analyses in the Melnikov House. For example MHM 101, dado of the wall behind the stove in the kitchen, to understand the chronology of the damaged paint layers of the dado.

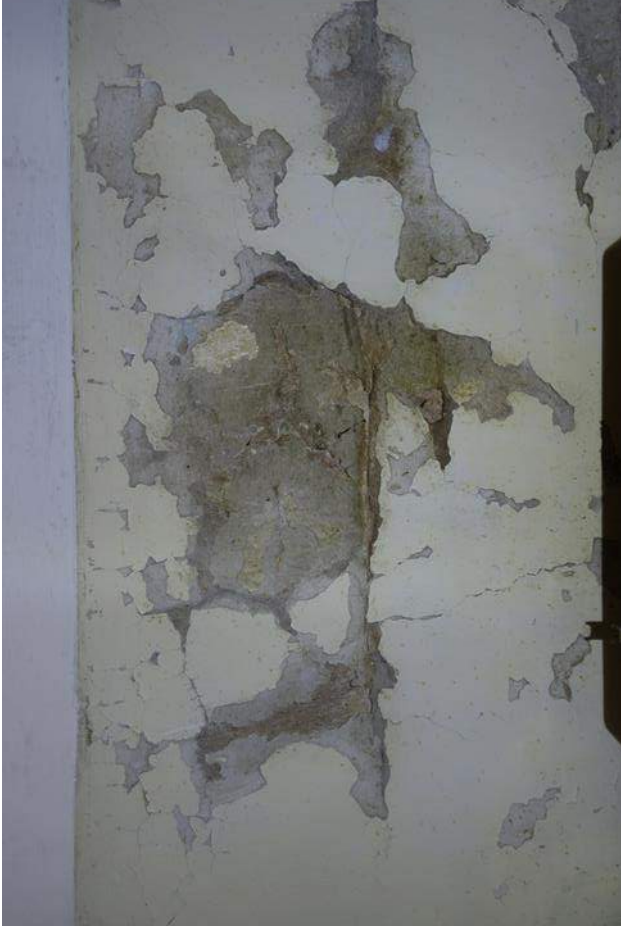
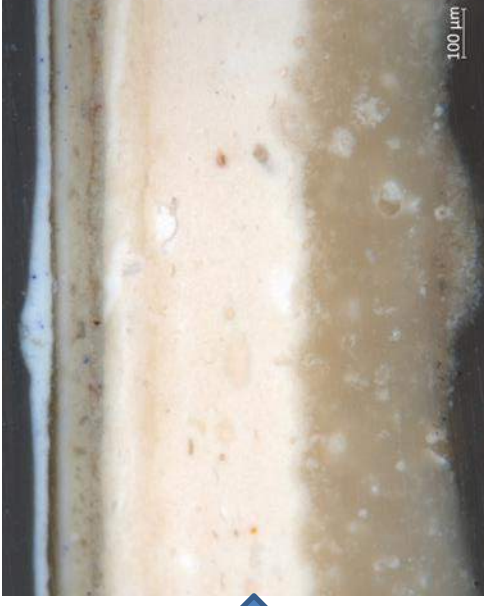
location MHM 101

1st floor_kitchen_dado of the wall behind the stove , next step

next step : to define the chronology of the top layers by relating the cross section with the traces in situ.

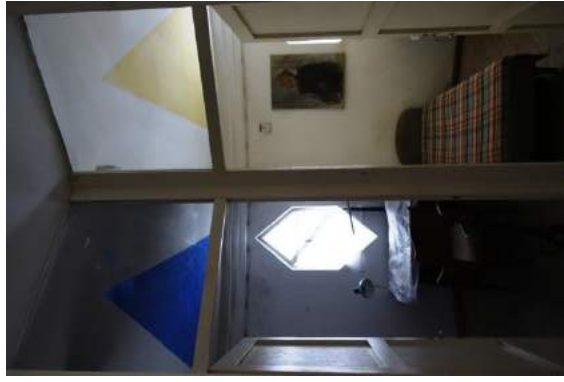
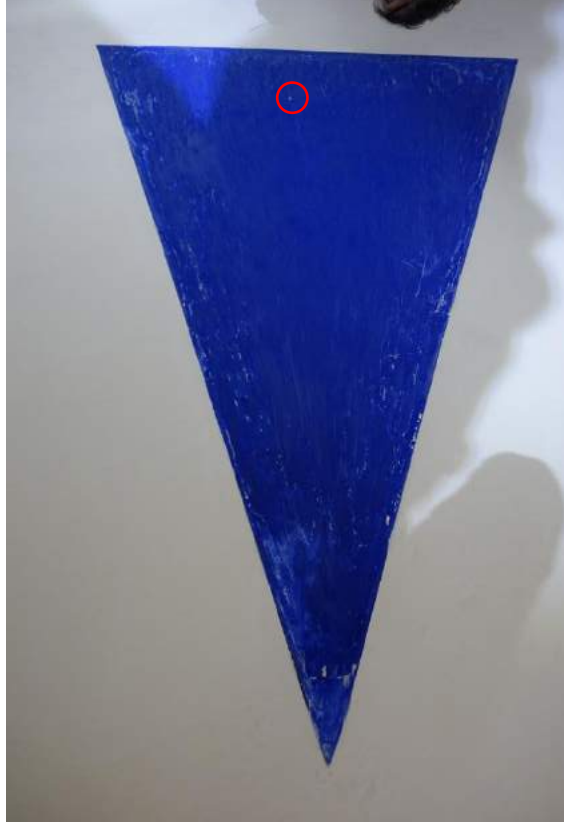
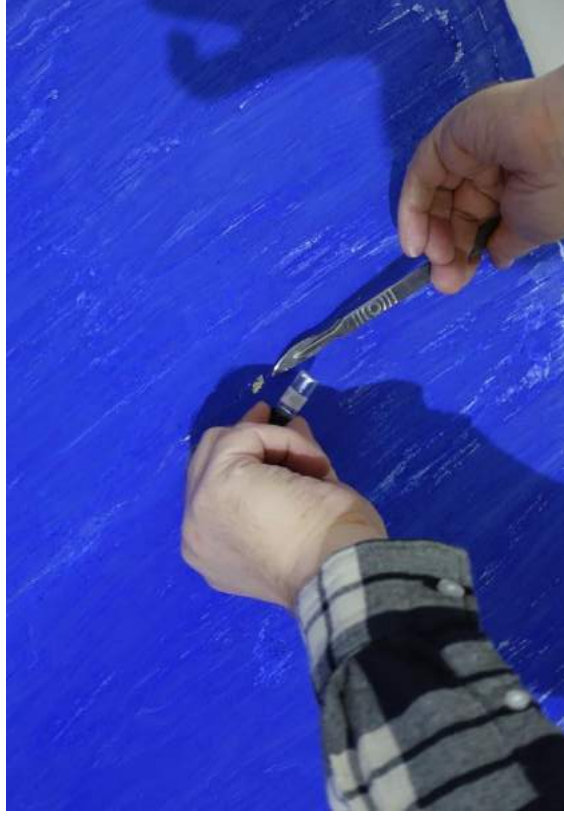
location MHM 122

1st floor_boy's room, blue triangle on the ceiling

research 1996: colour match of blue :
2 - ceiling in kid's room
(cobalt blue 1 part + chalk 0,5 part, #449)
Cobalt blue is not analysed in sample 19-051-2

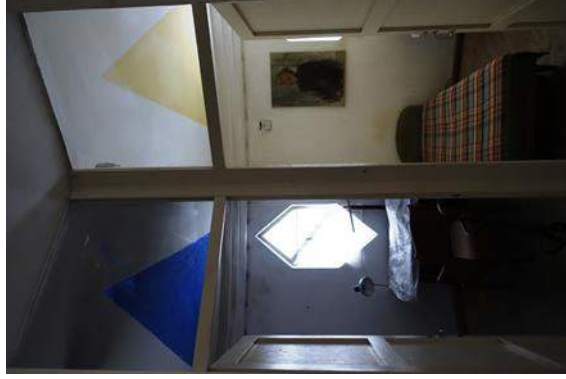
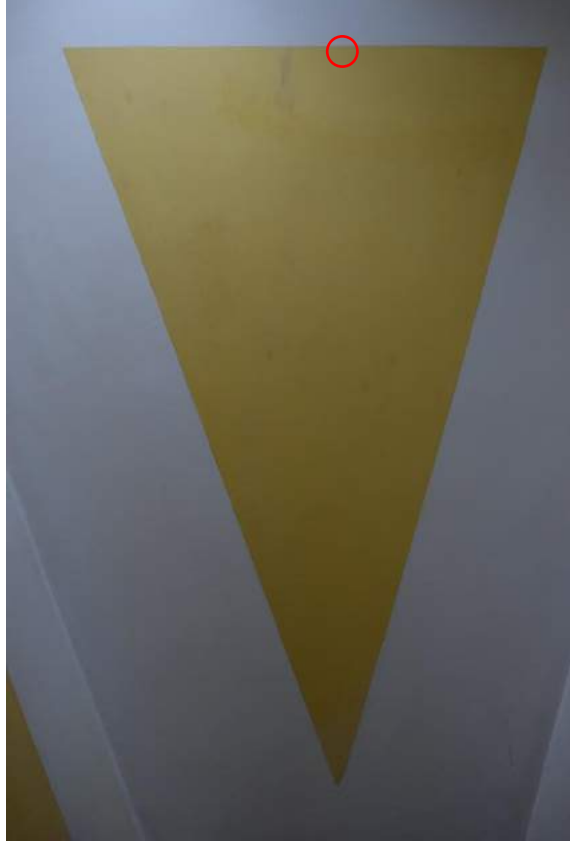
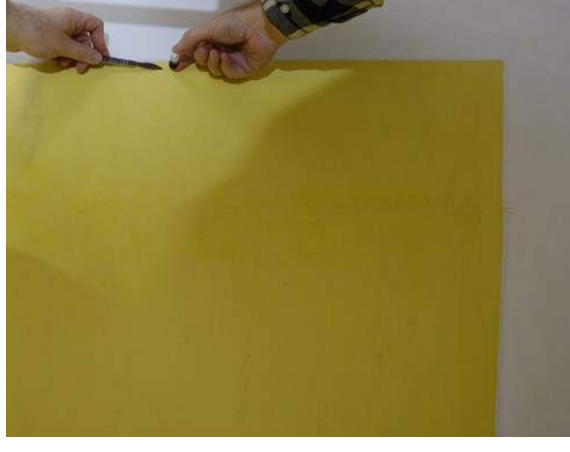
location MHM 124 (photo 2018)

1st floor_girl's room_yellow triangle on the ceiling

research 1996:
colour match of yellow :
1 - ceiling and wall in a kid's room
(yellow medium 1 part + chalk 16 parts, #411)
This might be possible in cross section 19-051-3

1996: stratigraphy of the yellow triangle :
green and white layers underneath the yellow

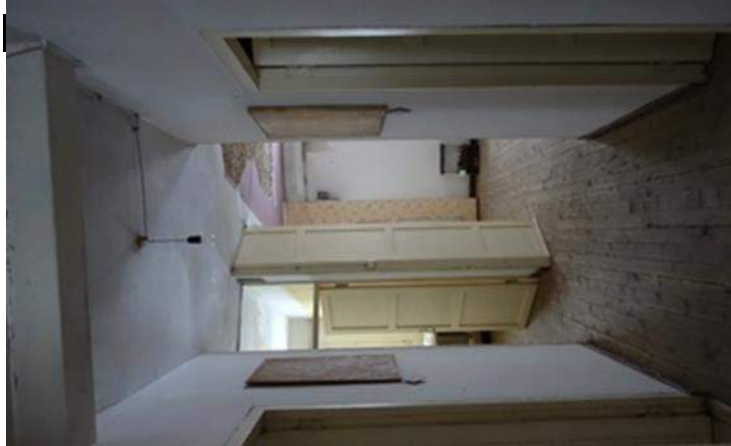
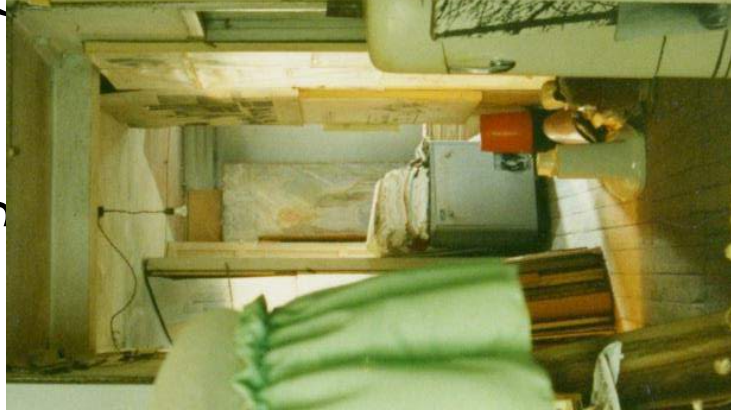
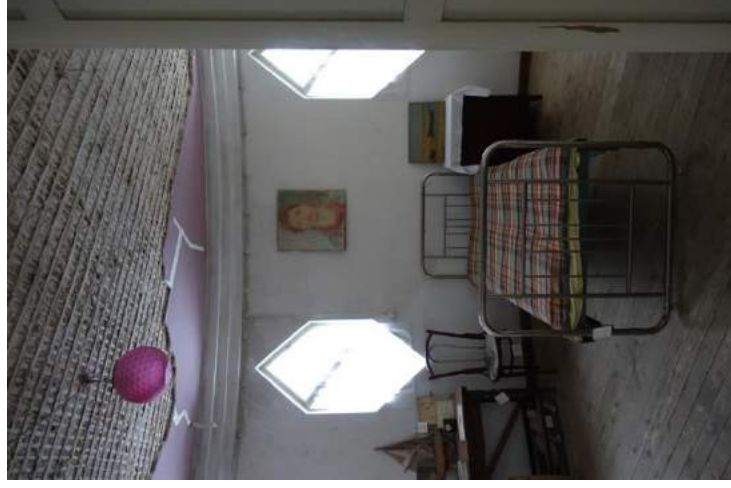
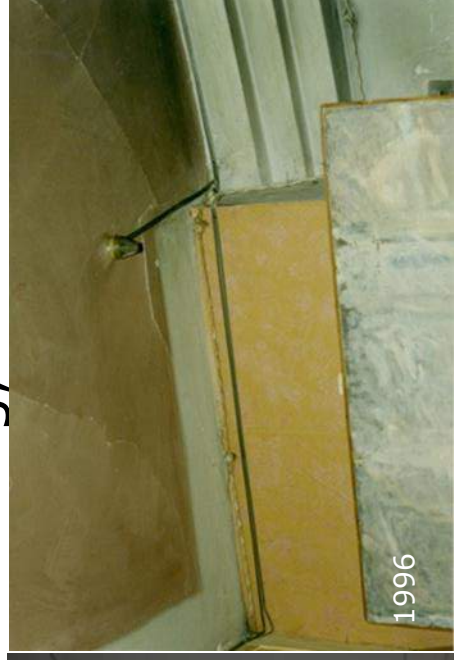
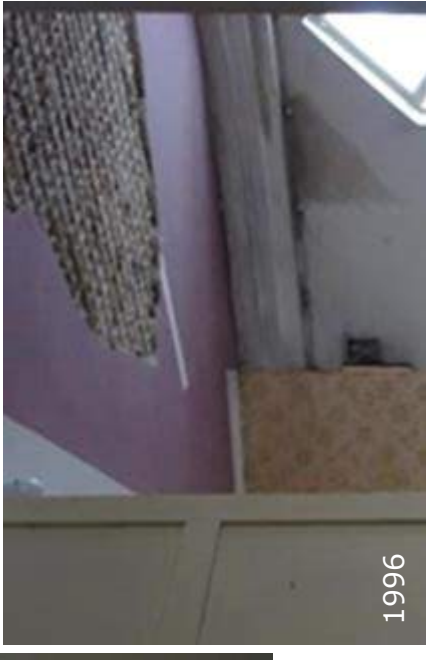
1996: stratigraphy of the red surface:
green en white layers underneath the red
2018,2019: completely reconstructed ceiling

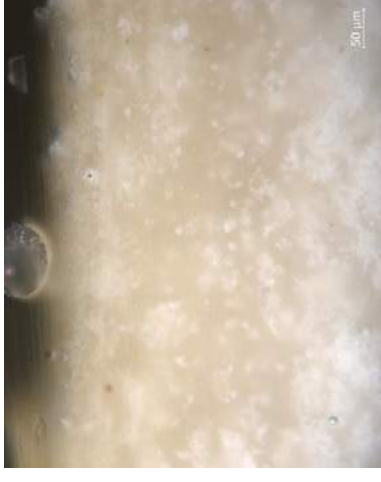
19-051-10 microphotograph of the paint cross section under incident polarized light : minimal yellow pigments

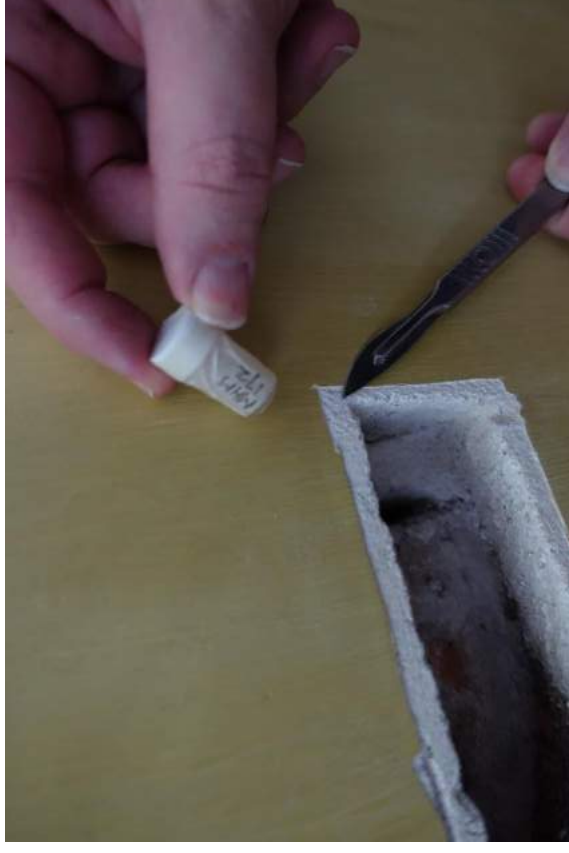
sample MHM 172 _ 19-051-12

19-051-12
microphotograph of
the paint cross
section under
incident polarized
light

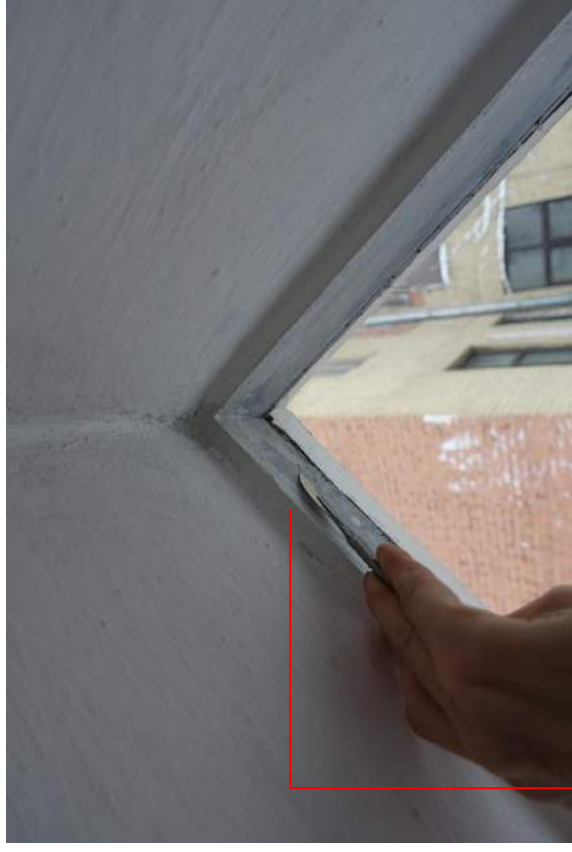
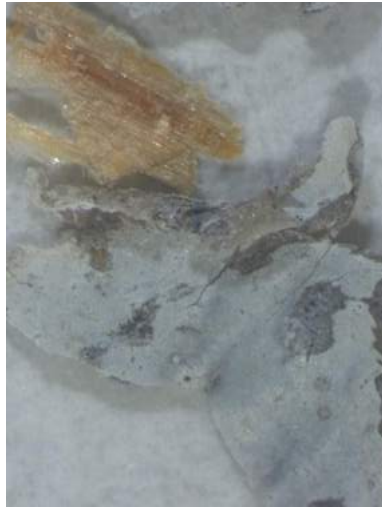
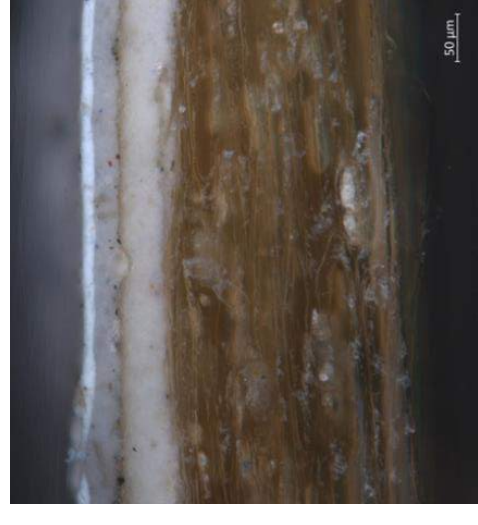
sample MHM 30 _ 19-051-16

19-051-16 microphotograph of the paint cross section under incident polarized light
