Melnikov House

Research Report and Recommendations for a Conservation Plan

10 Krivoarbatsky Lane,
Moscow, Russia

August 2019

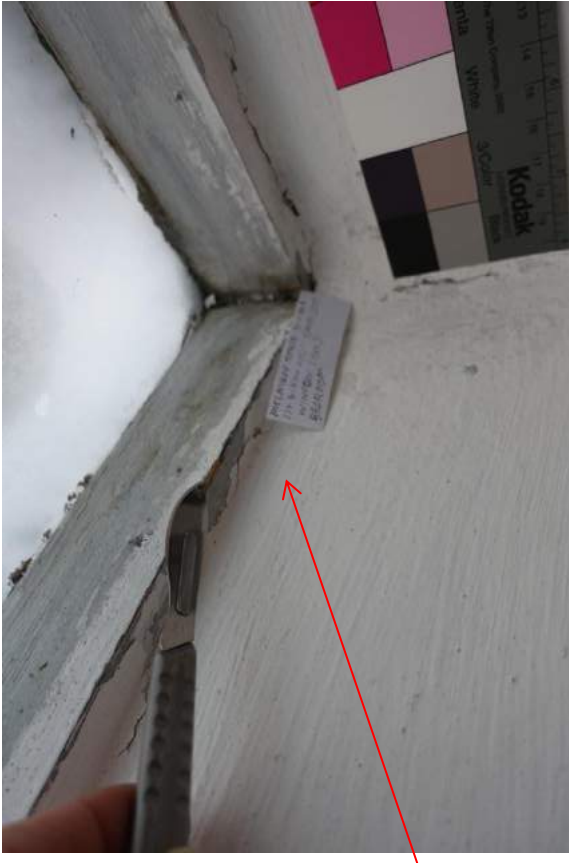
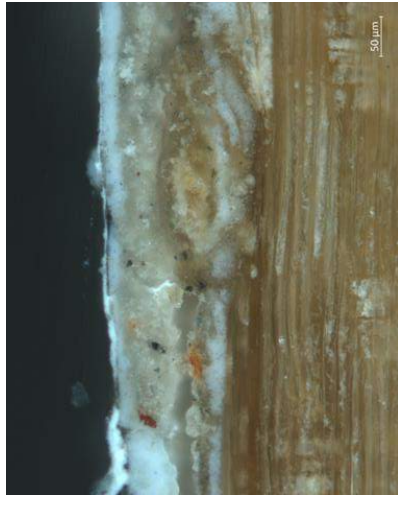
sample MHM 36 _ 19-051-17

19-051-17 microphotograph of the paint cross section under incident polarized light

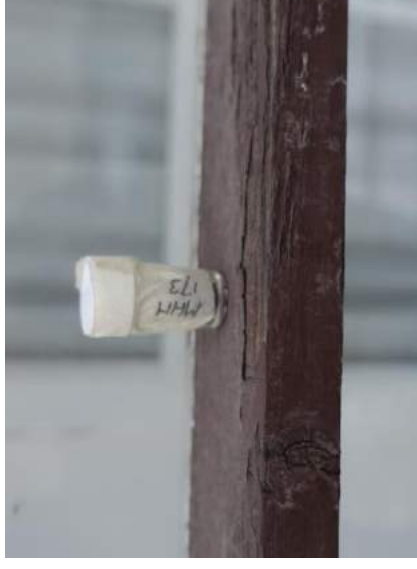
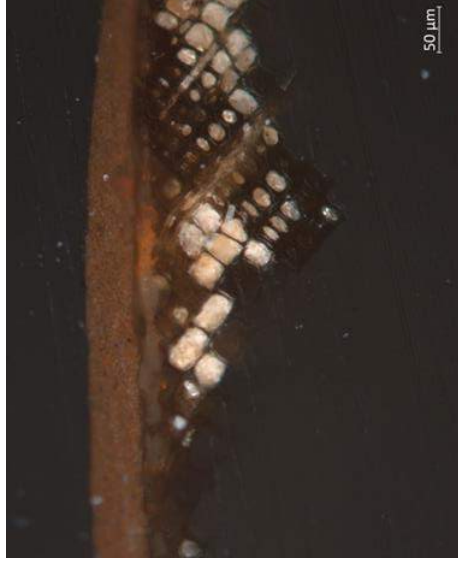
sample MHM 173 _ 19-051-11

On the wood a damaged greyish white paint layer is present, consisting of zinc white and little gypsum. Similar paint layers are found in samples of the window in the dining room (sample 19-051-5) and the window in the bedroom (sample 19-05-16) as the first overpainting.

Comparison with samples 19-051-5 and 19-051-16 indicates that the first finish from 1929 is missing in this sample.

19-051-11 microphotograph of the paint cross section under incident polarized light

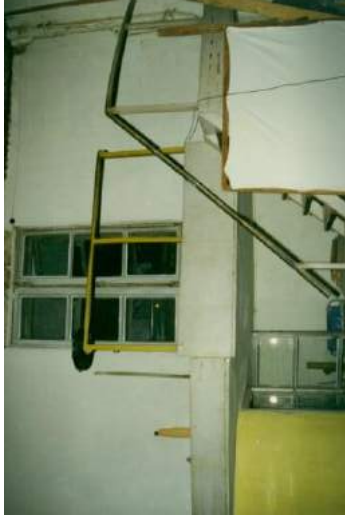
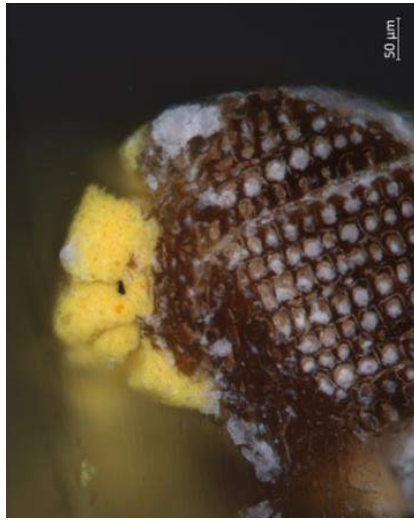
sample 19-051-15

19-051-15 microphotograph of the paint cross section under incident polarized light

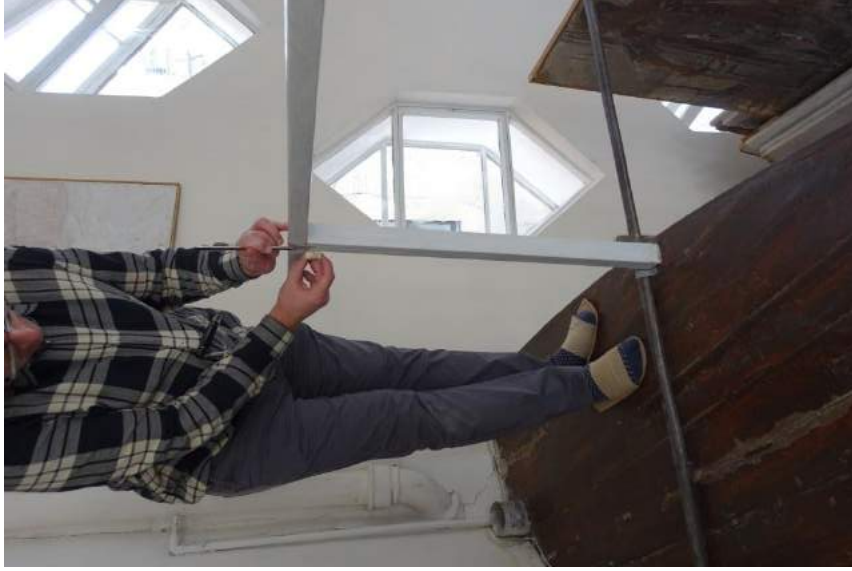
location MHM 166

3rd floor_studio, white balustrade of the entresol, white vertical post

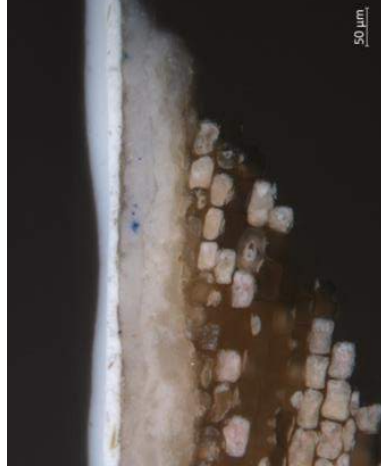
19-051-14
microphotograph
of the paint cross
section under
incident polarized
light
