FINAL REPORT July 2016

SAINT JOHN'S ABBEY CHURCH

CONSERVATION RESTORATION PRESERVATION

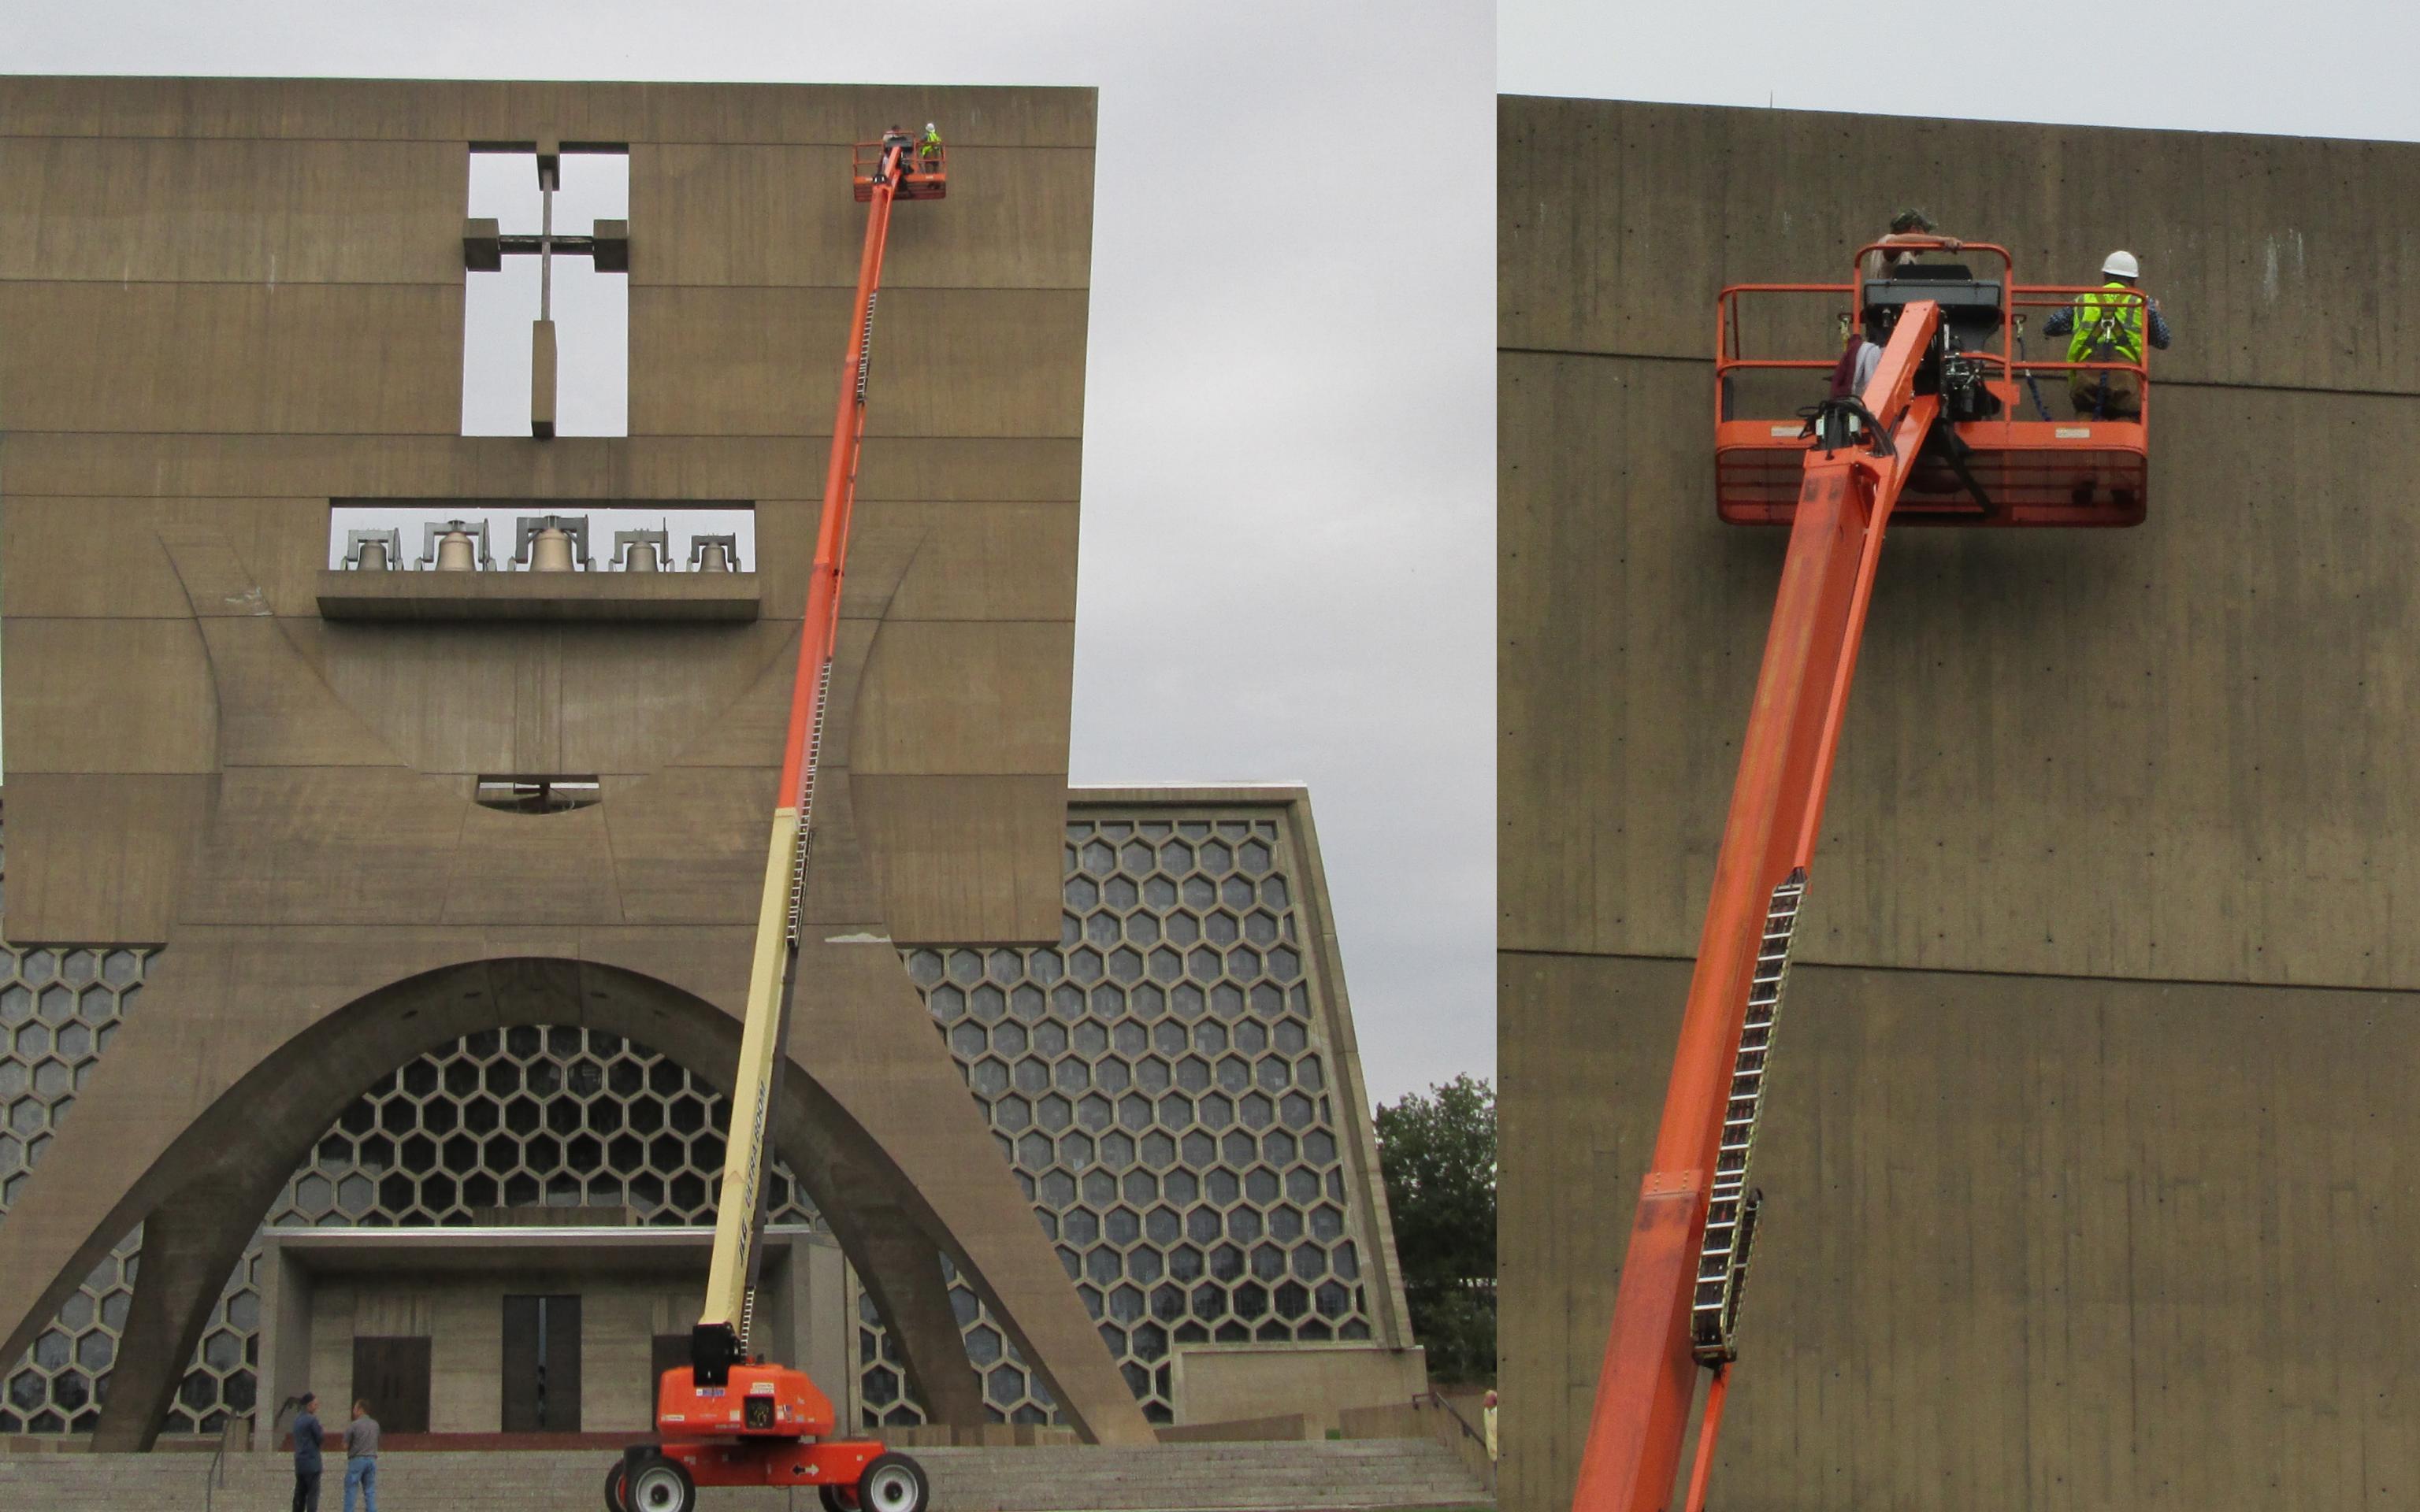
Discolored Areas at Repair Locations

Colored patches occur at the leg intersection to the banner face. Visual observations of the current conditions noted that the off-colored areas occur where the concrete had a higher level of honeycombing. These areas are in a location that would be considerably difficult to cast and the patch was likely placed at the time of original construction to repair the honeycombing. The patch surface color does not match the bulk of the concrete and is likely due to a difference in the material makeup of the patch material. Non-destructive sounding of the patch and edges indicate that the majority of the patches are sound with minor delaminations occurring at the edges.

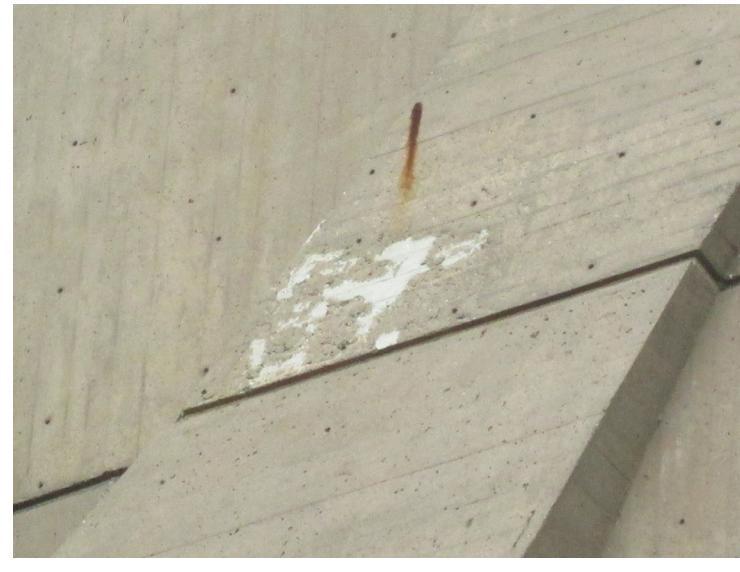
ABOVE Patching near the bell loggia concrete that does not match color and texture of original concrete

Remove poor patches and replace with new patch material compatible with original concrete. Provide waterproof solution to top surface of the banner.

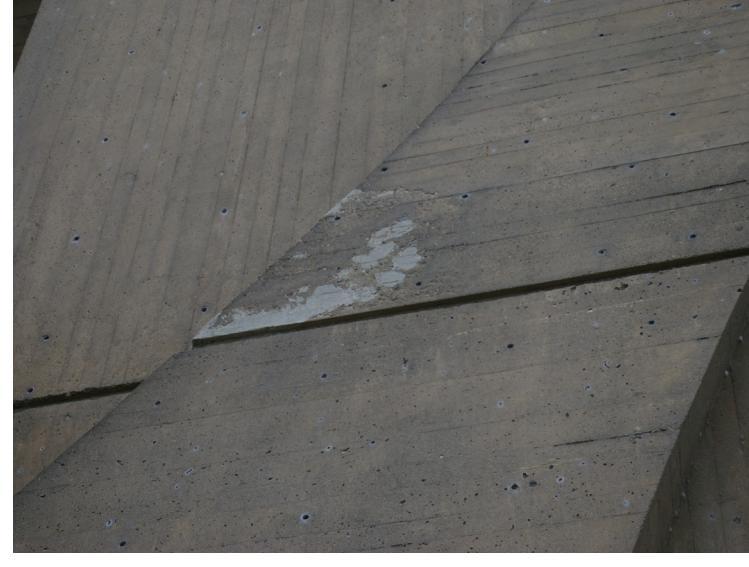
ABOVE Patching near the first reveal between the support arch and bell banner

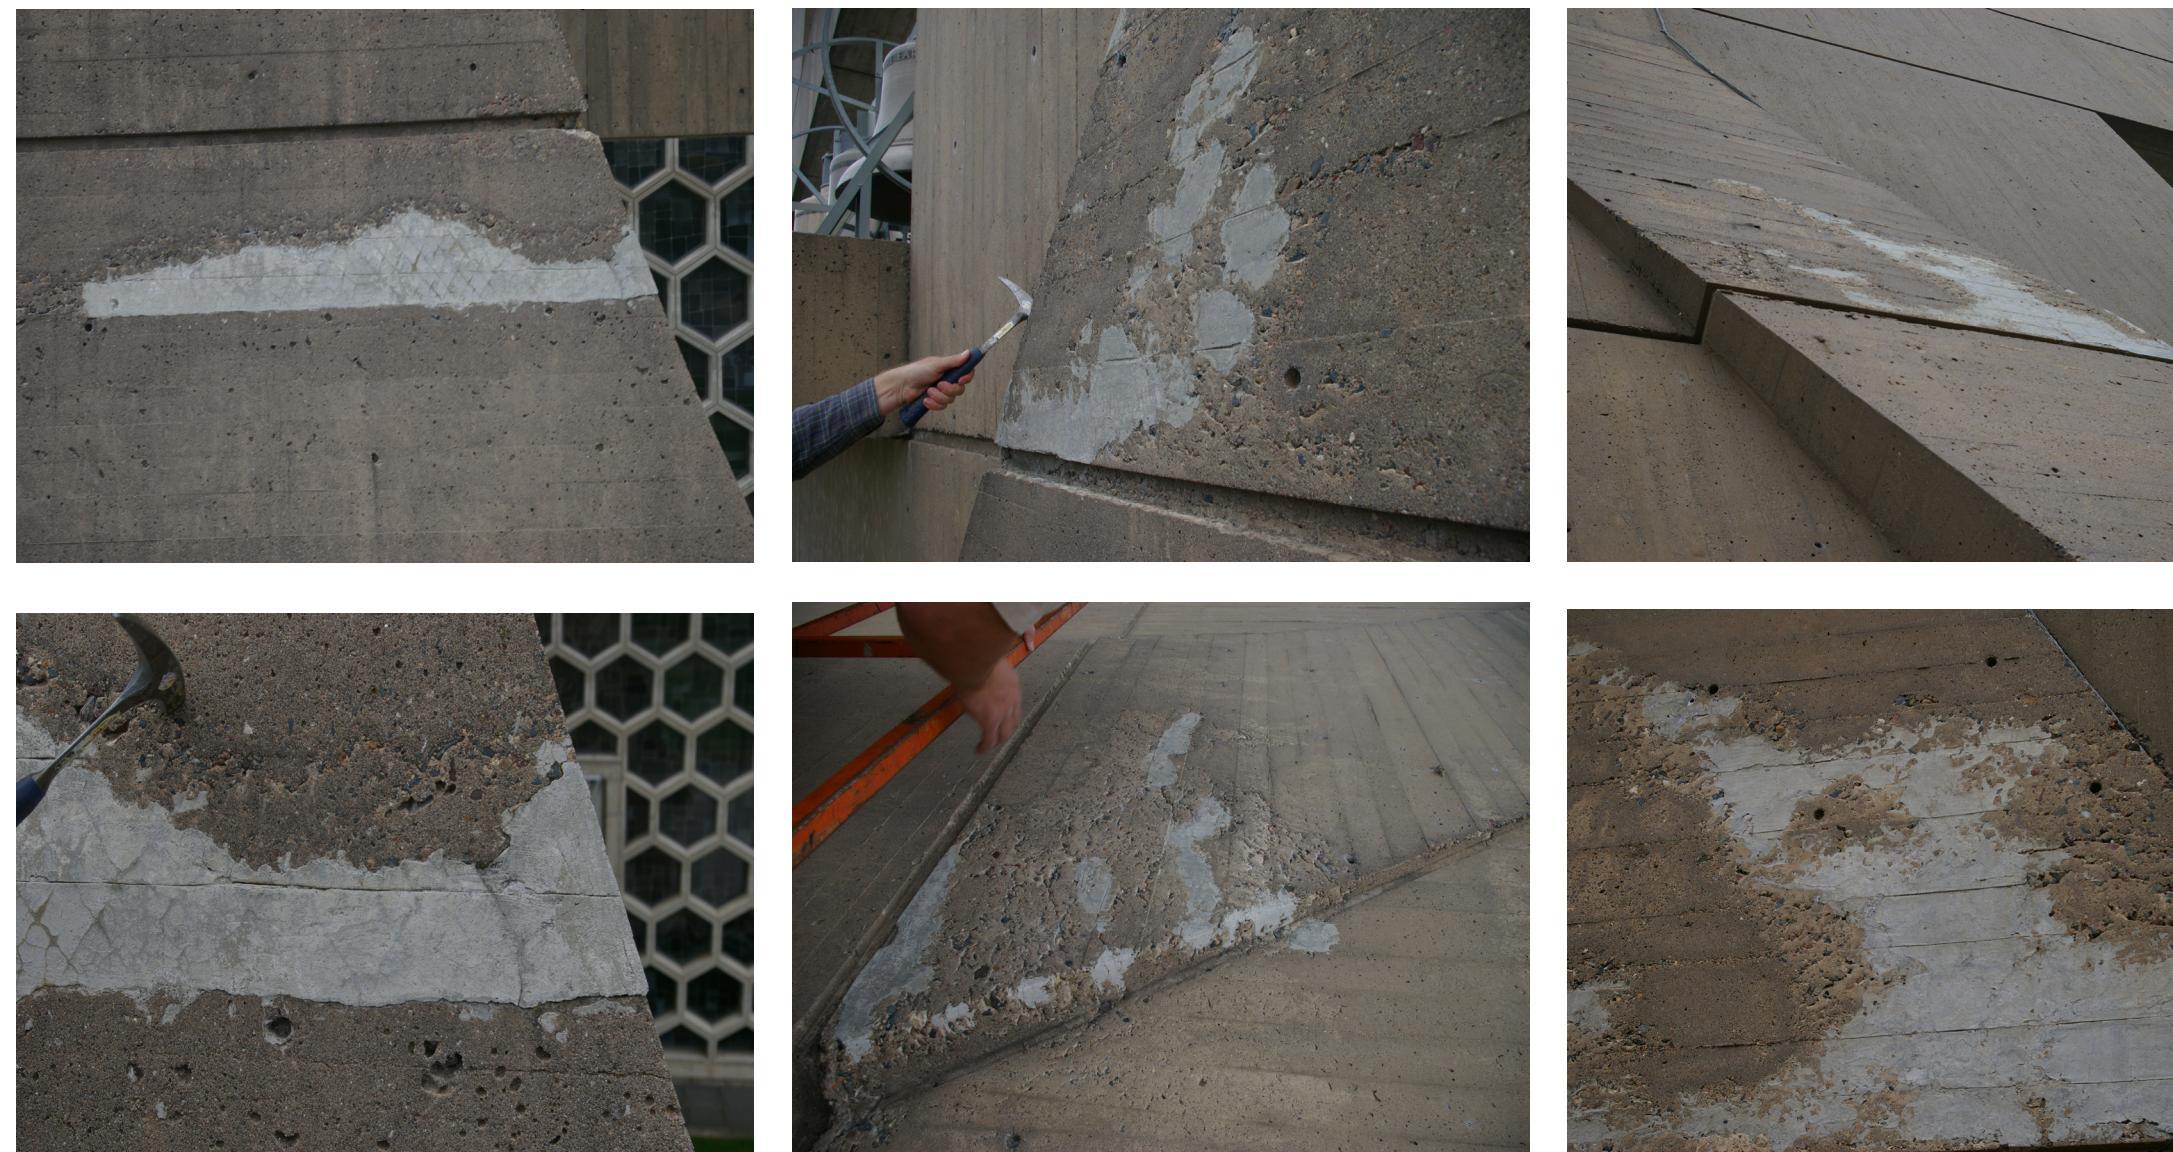
ABOVE Close ups of various patching efforts

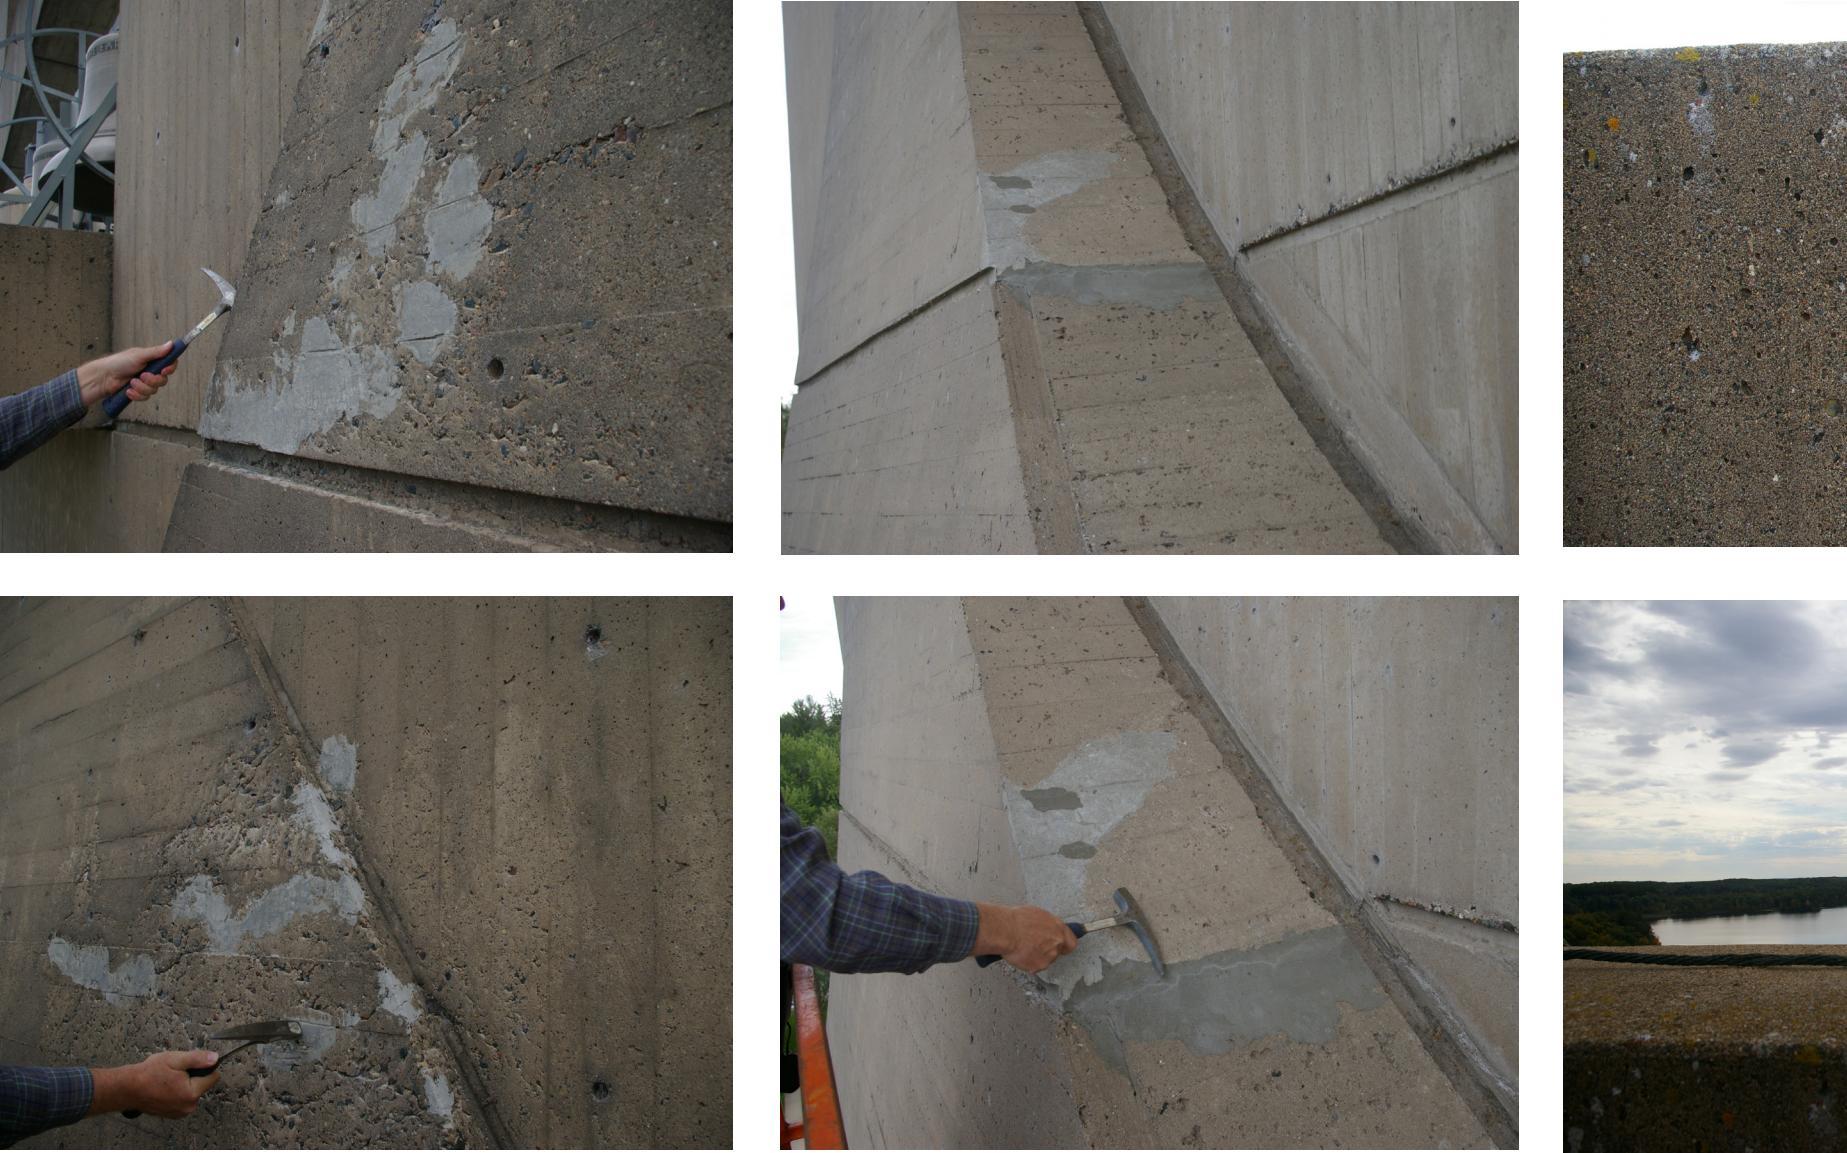
TOP AND LOWER LEFT FOUR Patching , including use of off-the shelf concrete patch mixtures, that does not match color and texture of the original concrete.

TOP RIGHT Rain is much more acidic (pH ~7.5) than the concrete paste. After exposure to rainfall over many years the surficial paste has etched away, revealing the fine aggregate particles present in the concrete.

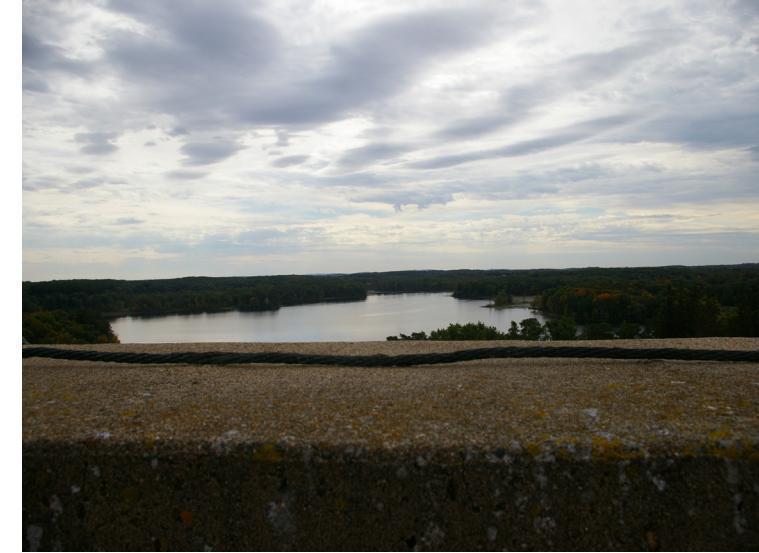
LOWER RIGHT Raw concrete top of the Banner allows moisture penetration of the upper face. A lighting protection leader rests on top.

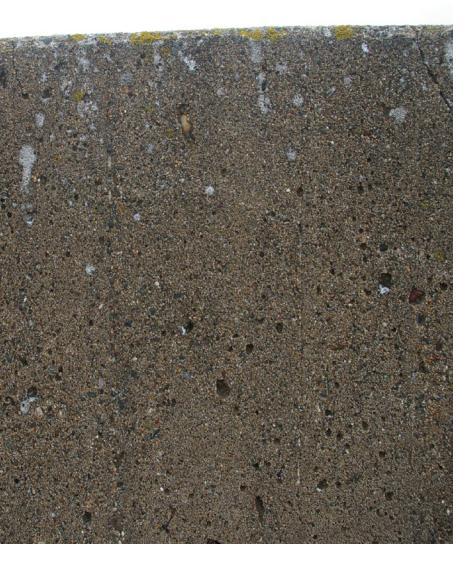
UPPER LEFT Detail of Surface texture of Banner with lichen growth. LOWER LEFT Close-up of lichen growth.

UPPER CENTER Spalling at reveal. LOWER CENTER Massive patch using off the shelf material incompatible with original concrete.

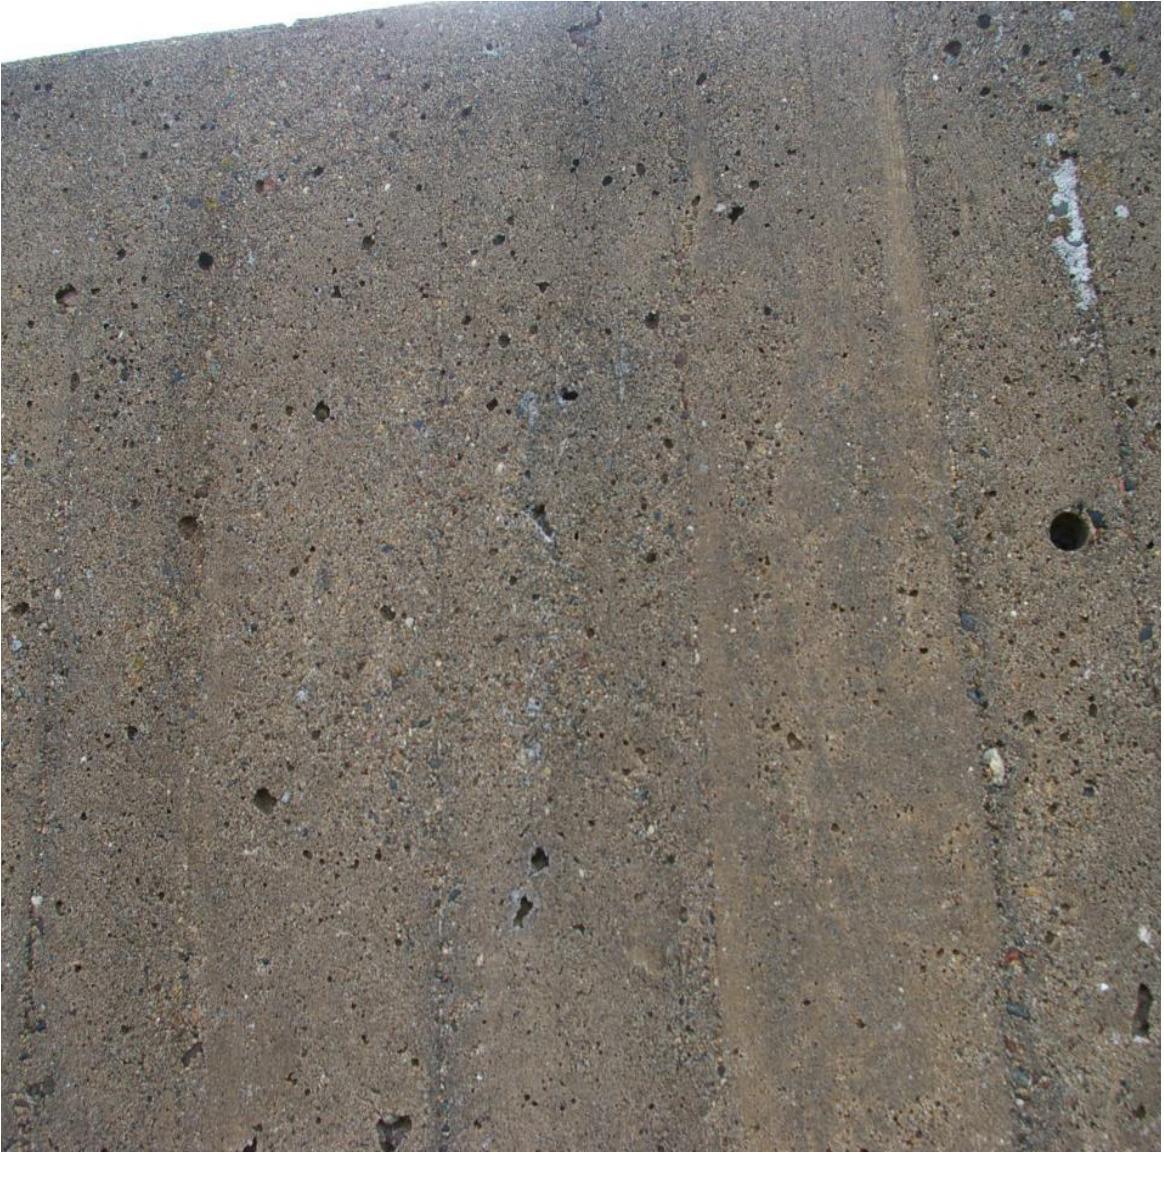
RIGHT Area at top of Banner where delaminations are detected. Note grey lichen, aggregate popouts and blockouts from form ties. These make the texture unique.

The entire top west corner concrete lift region of the banner has a number of intersecting surfaced cracked areas with subsurface delaminated concrete.

Delamination was noted on the upper right hand portion of the banner as seen from the south. This delamination was identified by hollow sounding areas when sounded using a hammer. Little or no signs of corrosion were noted on the vertical face, although some cracks and rust stains were noted.

The corrosion of reinforcing steel that has resulted in delamination on the banner is due to carbonation of the concrete. Carbonation, a reaction between carbon dioxide in the air and calcium in the concrete paste, reduces the pH below the point where the steel reinforcement becomes de-passivated. Carbonation will not occur in fully saturated concrete or in concrete that is dry; however carbonic acid, created by the solution of carbon dioxide gas from the atmosphere in water, will result in buildup of calcium carbonate.

One approach to repairing delamination would be to remove the concrete faces down to reinforcing and replacing it with new concrete. As removal and replacement presents significant aesthetic issues (color and texture would be impossible to match), a method of restoring both the integrity of the structure and the passivating conditions is proposed. This process, known as re-alkalinization, involves the perturbative movement of hydroxyl ions into the concrete under an impressed electric field.

5. In the localized area where delaminations were noted these are repaired by drilling pilot holes into the delaminated area from the top of the banner and applying a urethane bonding agent by gravity flow. Many such materials are optically clear and can be combined with the swarf from drilling to match the color of the concrete.

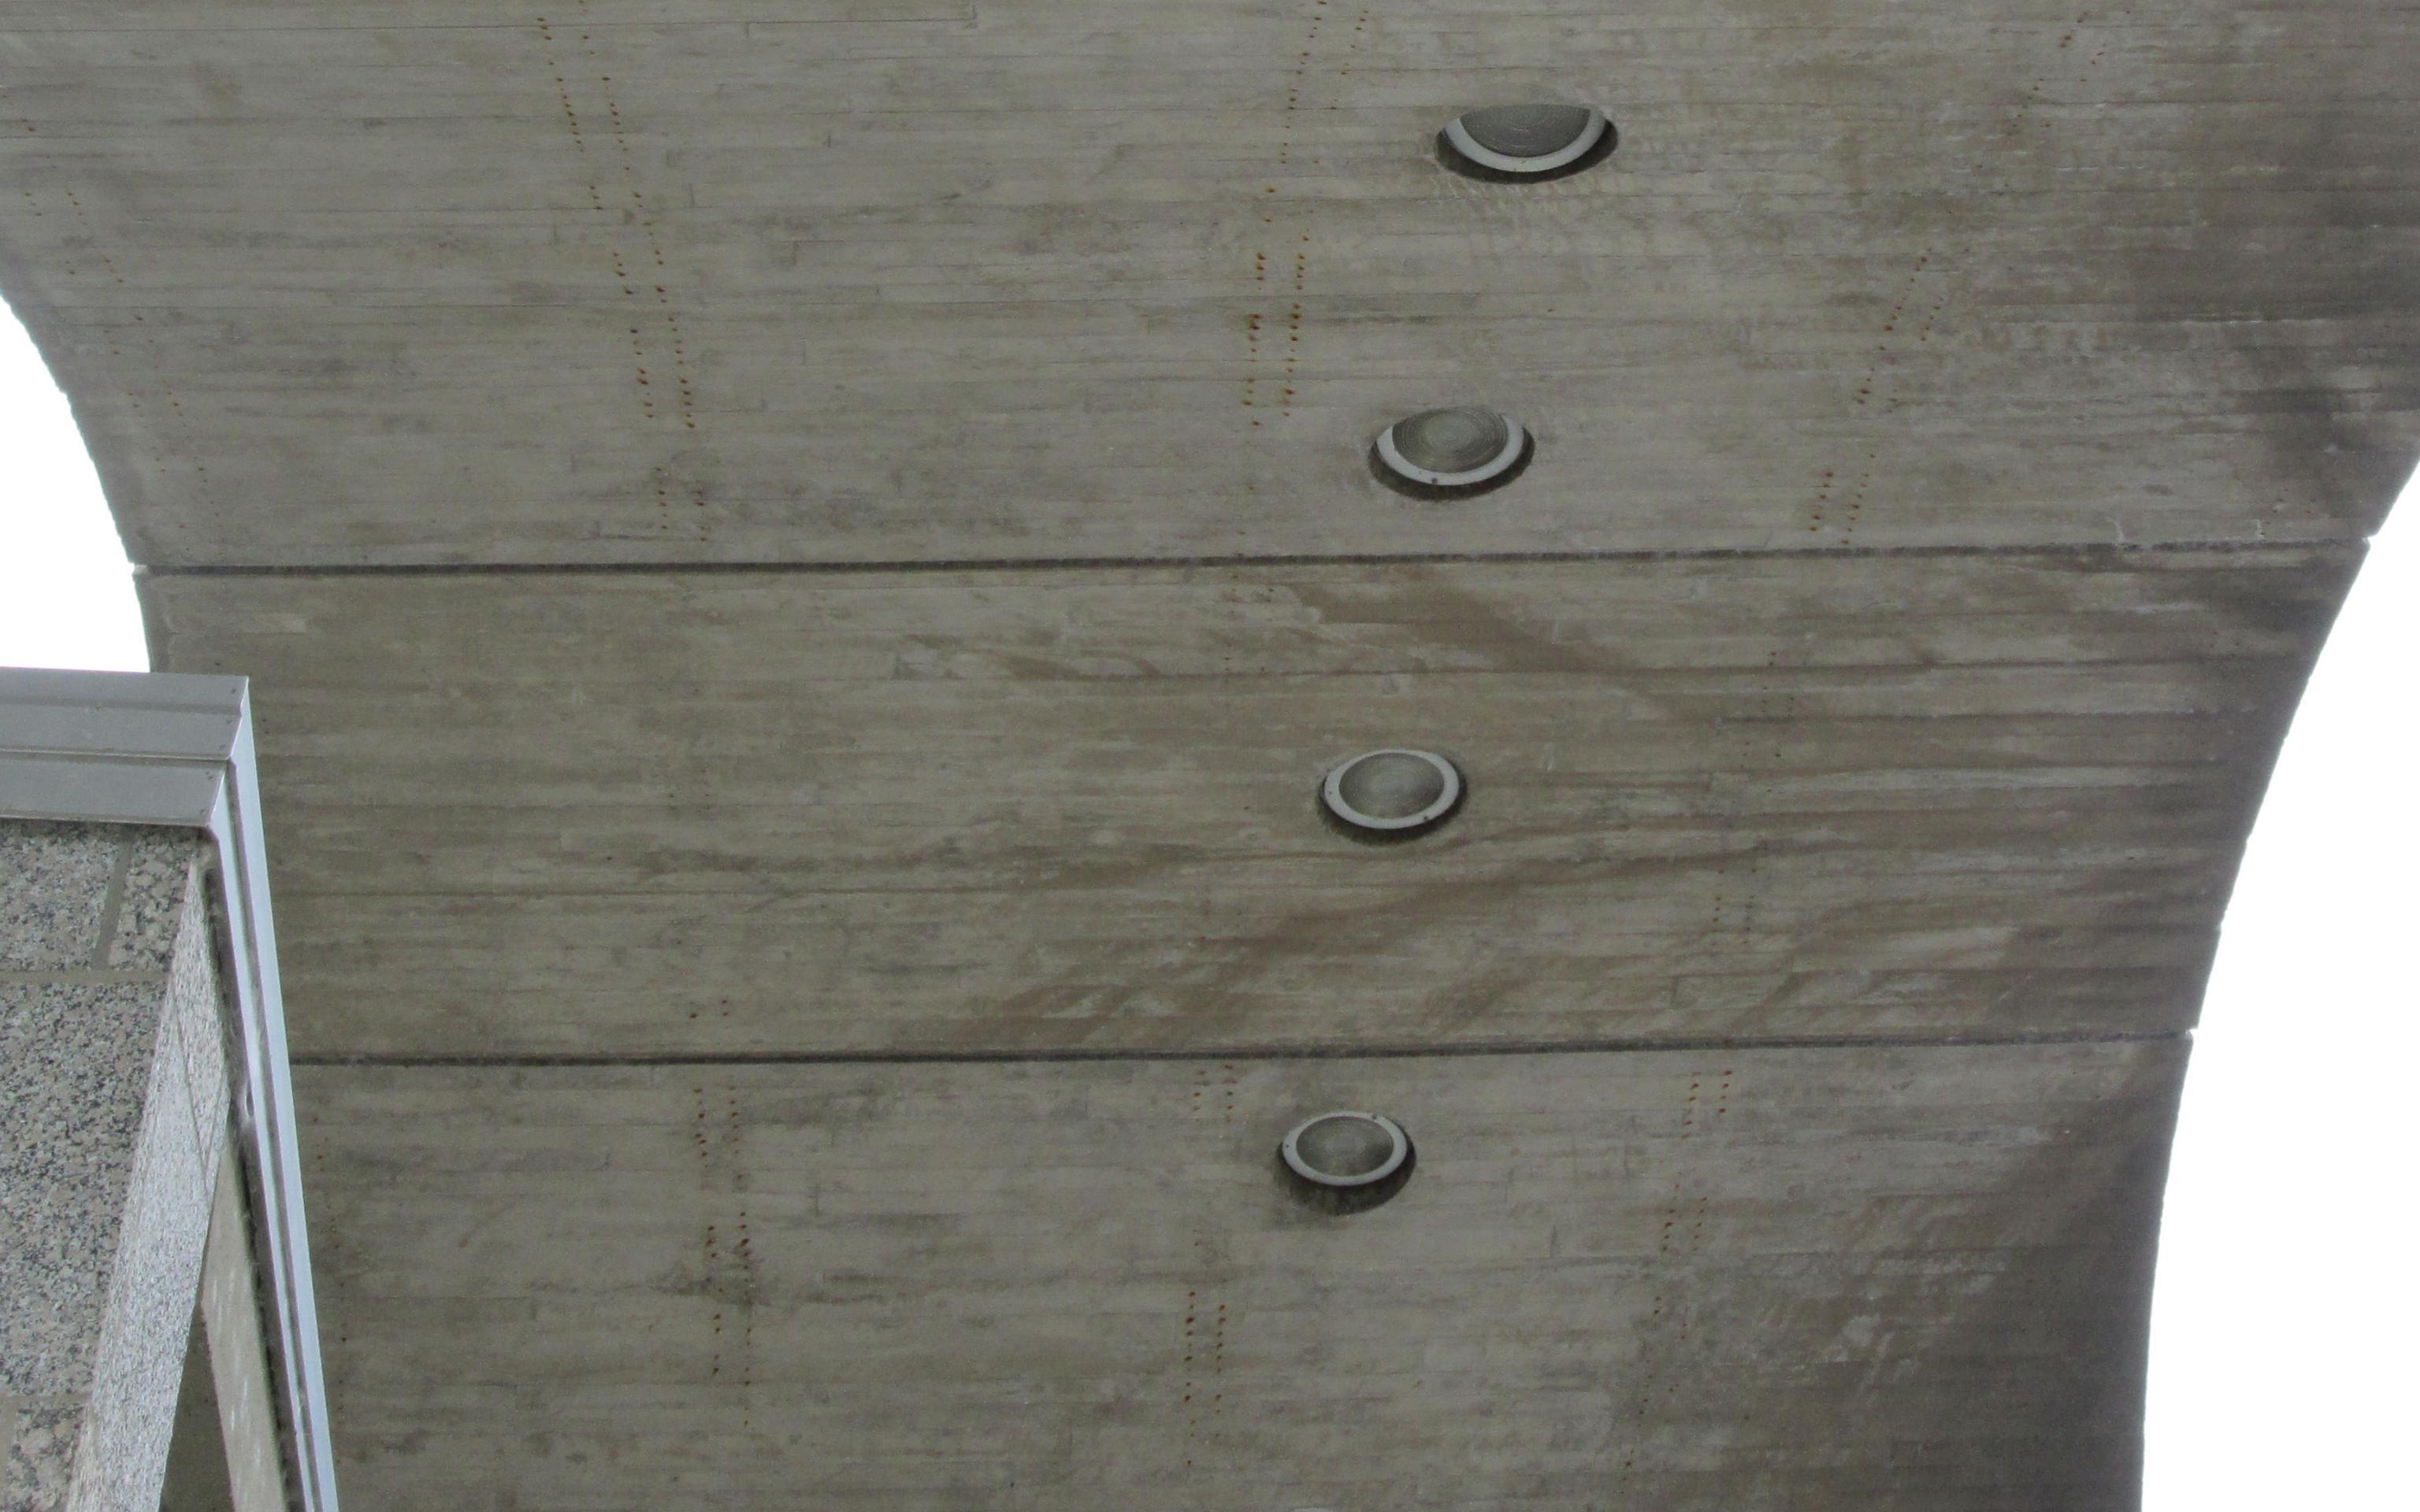
Iron oxide staining

A multitude of small repetitive rust stains on the underside of the arch intrados are clearly observable. The pattern and spacing is indicative of rebar chairs used to support the internal reinforcing steel. Oxidation of the metal chair legs has occurred resulting in the rust stains.

There are a small number of locations with other rust-colored stains. Each stain is typically in a vertical line emanating from a single spot location or a single spot stain. Stains of this appearance are likely the result of iron particle aggregate in the concrete mix rather than reinforcing steel misplacement. The combination of rust staining, spalling or delamination is more likely an indicator of reinforcing steel oxidation issues. Visual inspection did not indicate any observable spalling or delamination of the concrete at rust stain locations.

Options for removal and repair of the exposed reinforcing chair leg ends include precision drilling with micro-tools and introduction of a sealing product to infill the resulting surface cavity.

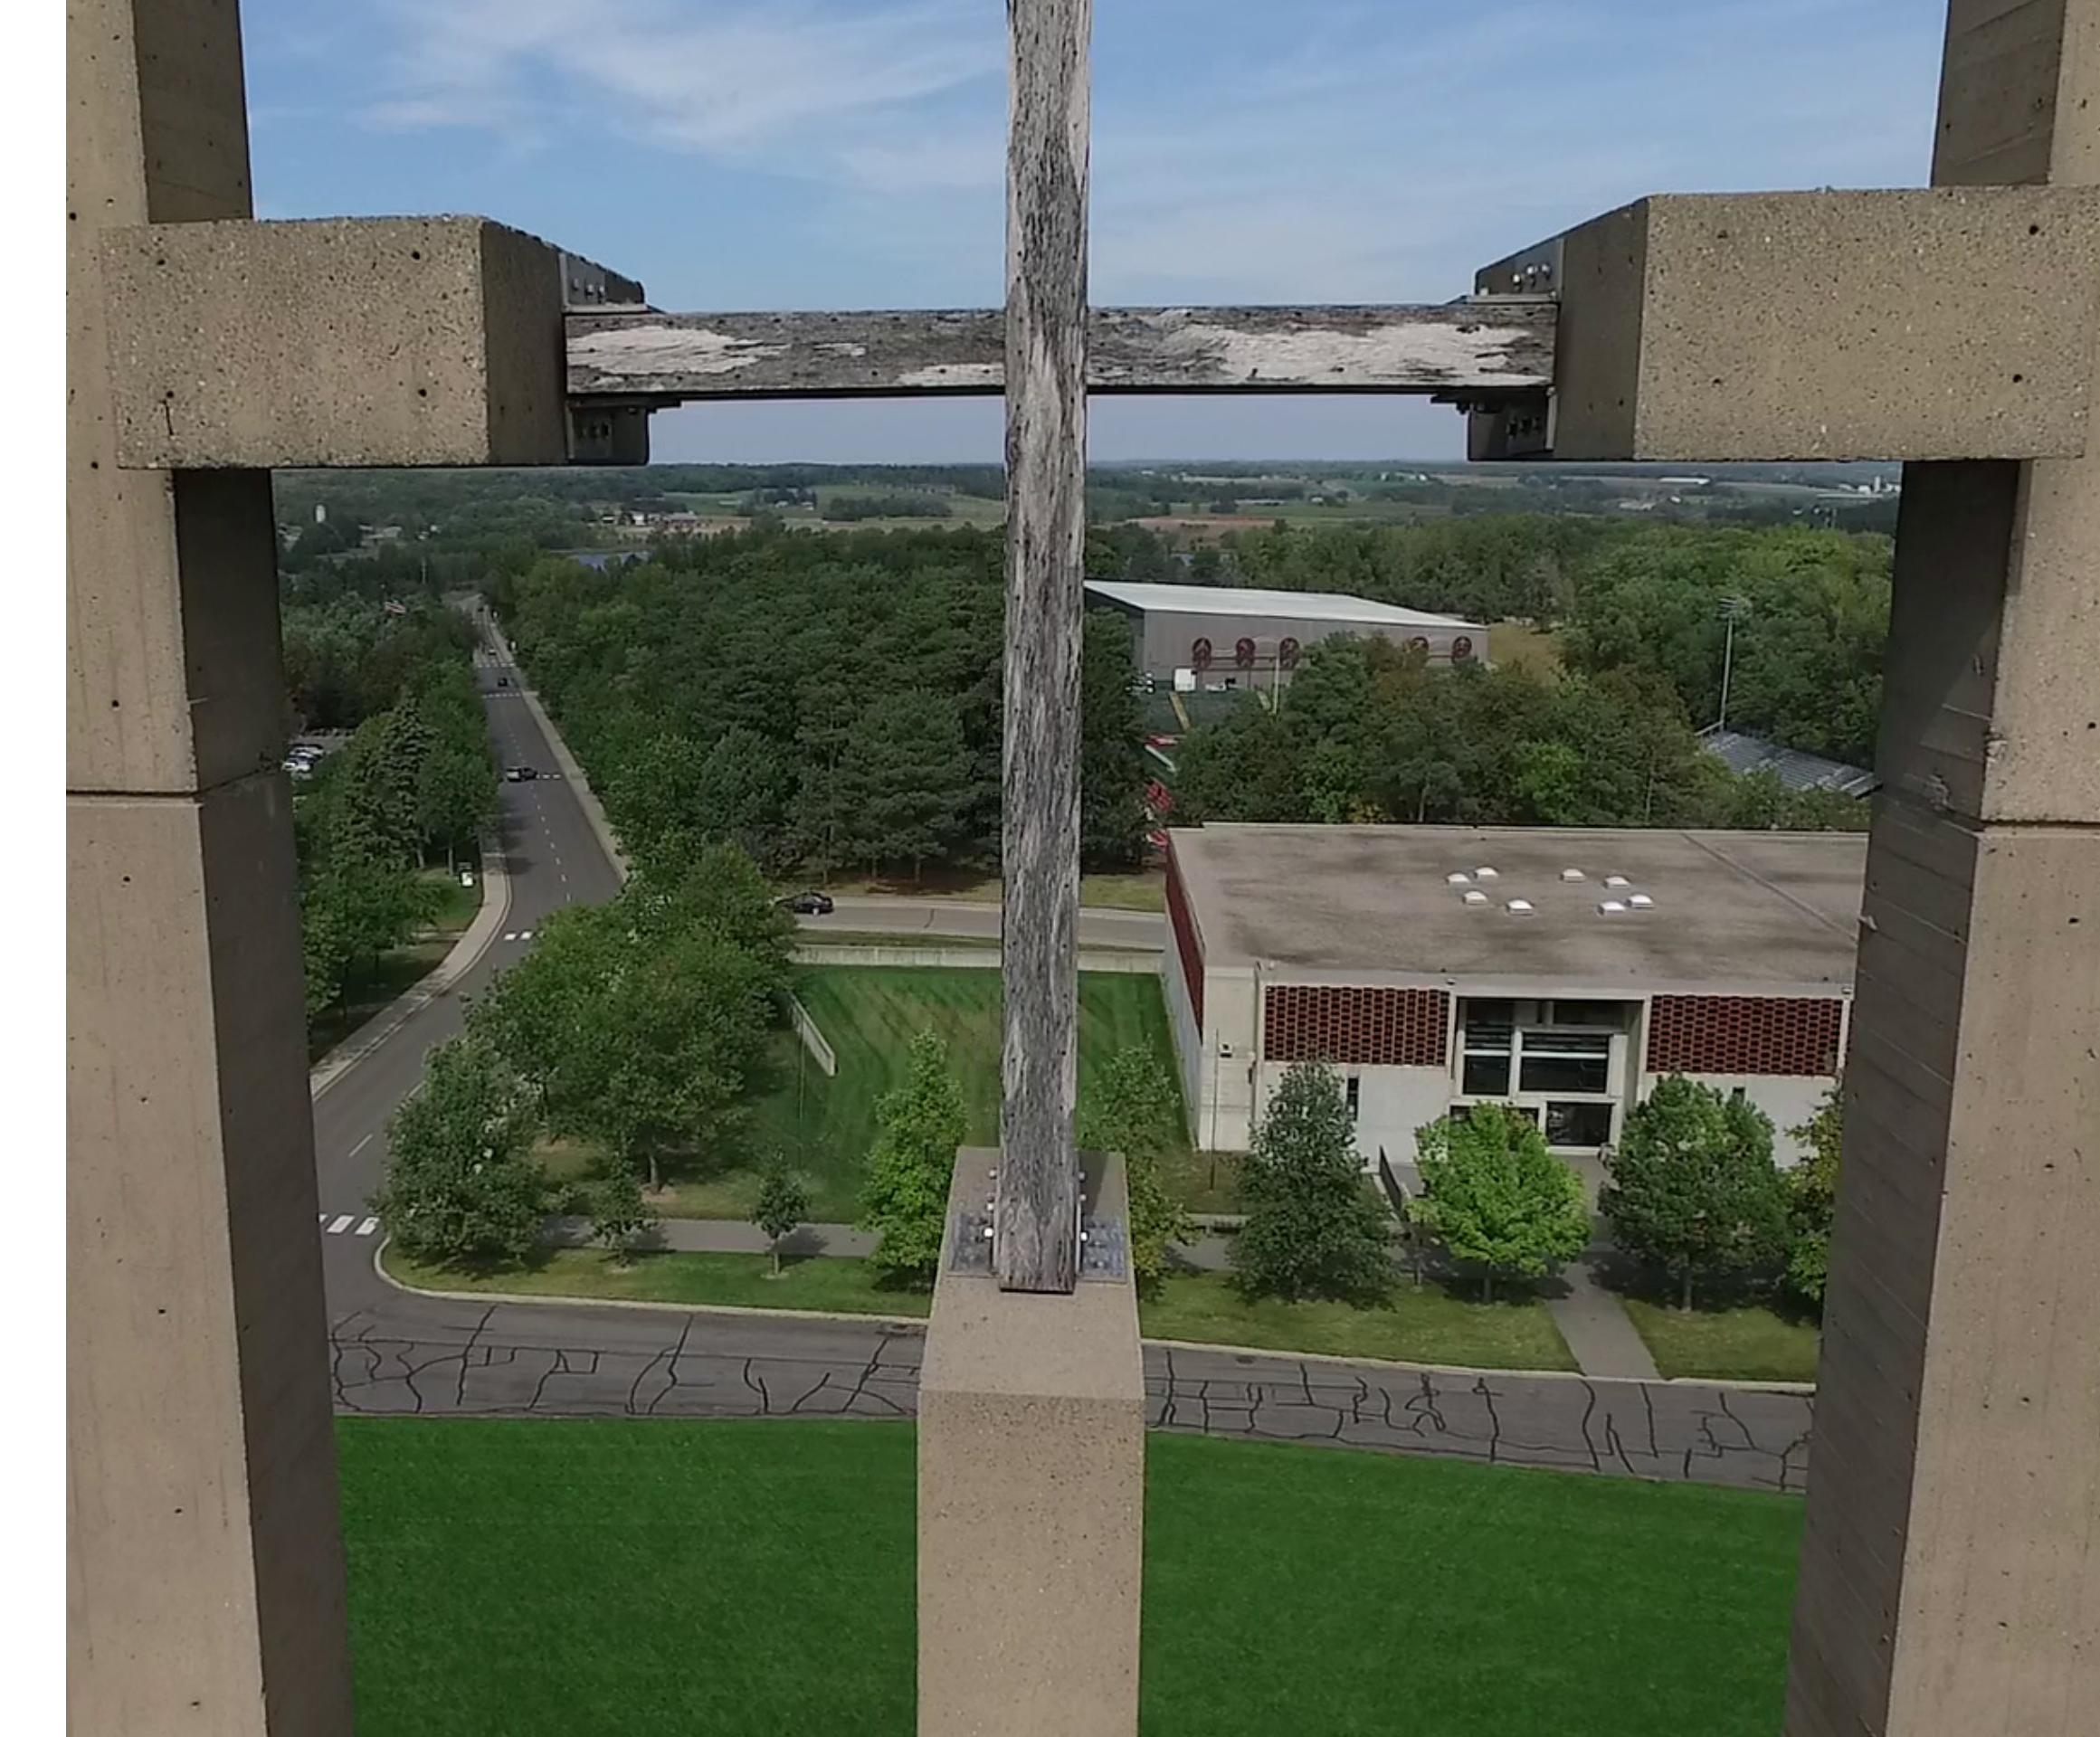
BELL BANNER CROSS

RIGHT Exposed to the elements, the wooden cross is replaced regularly.

Continue regular replacement of weathered wood components.
