FINAL REPORT July 2016

SAINT JOHN'S ABBEY CHURCH

CONSERVATION RESTORATION PRESERVATION

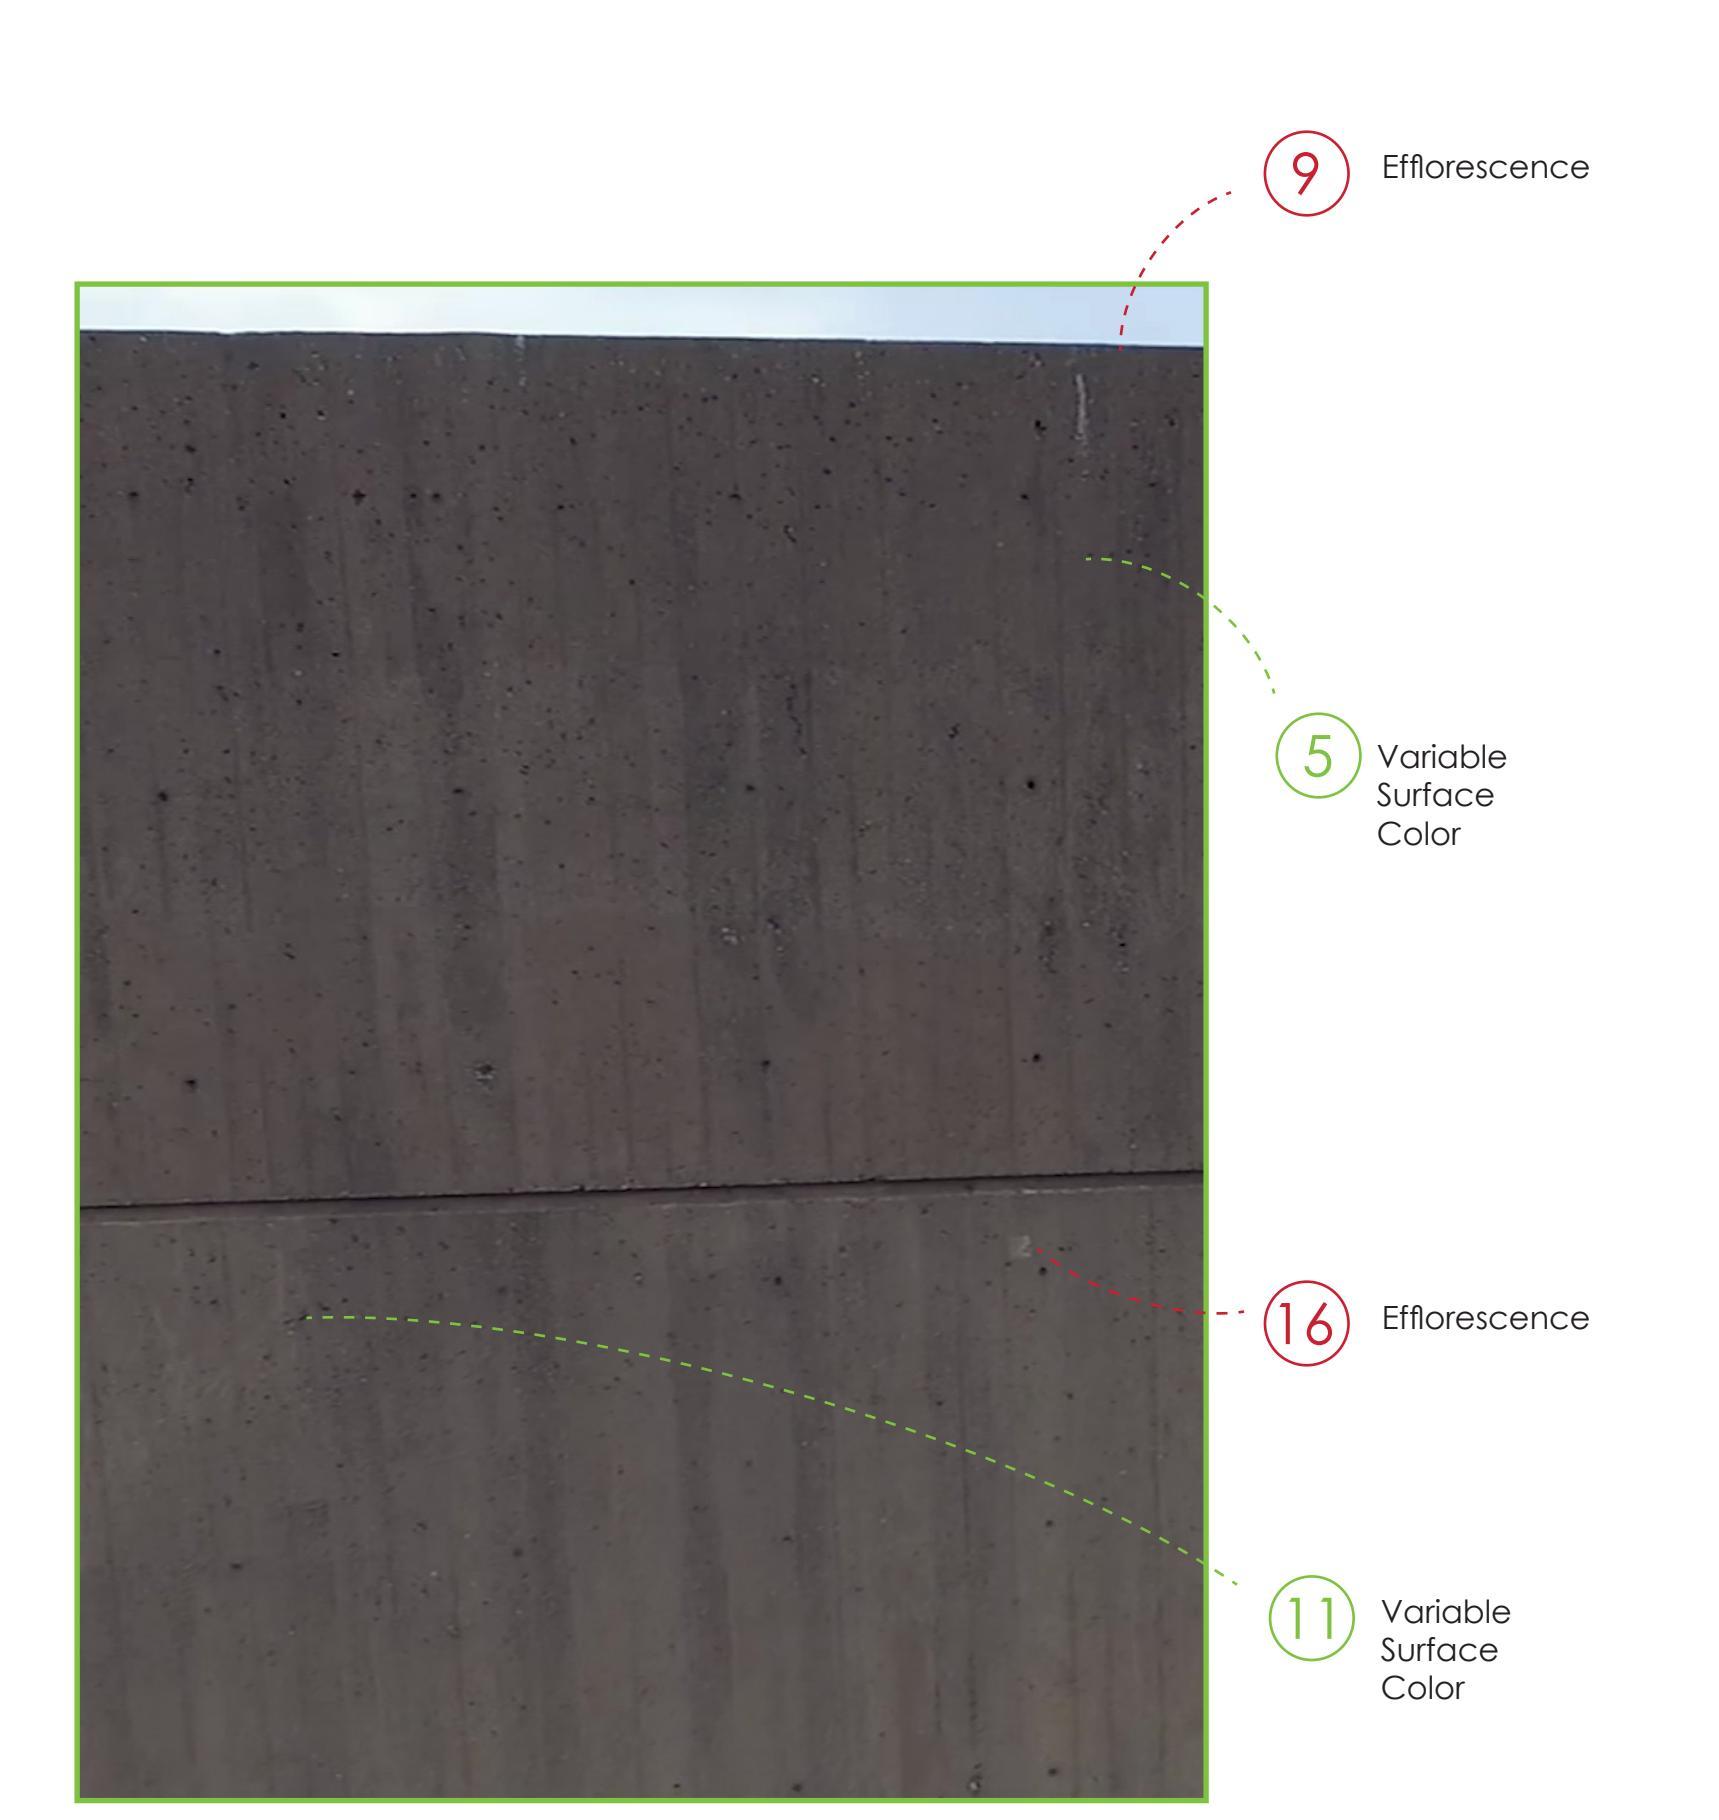
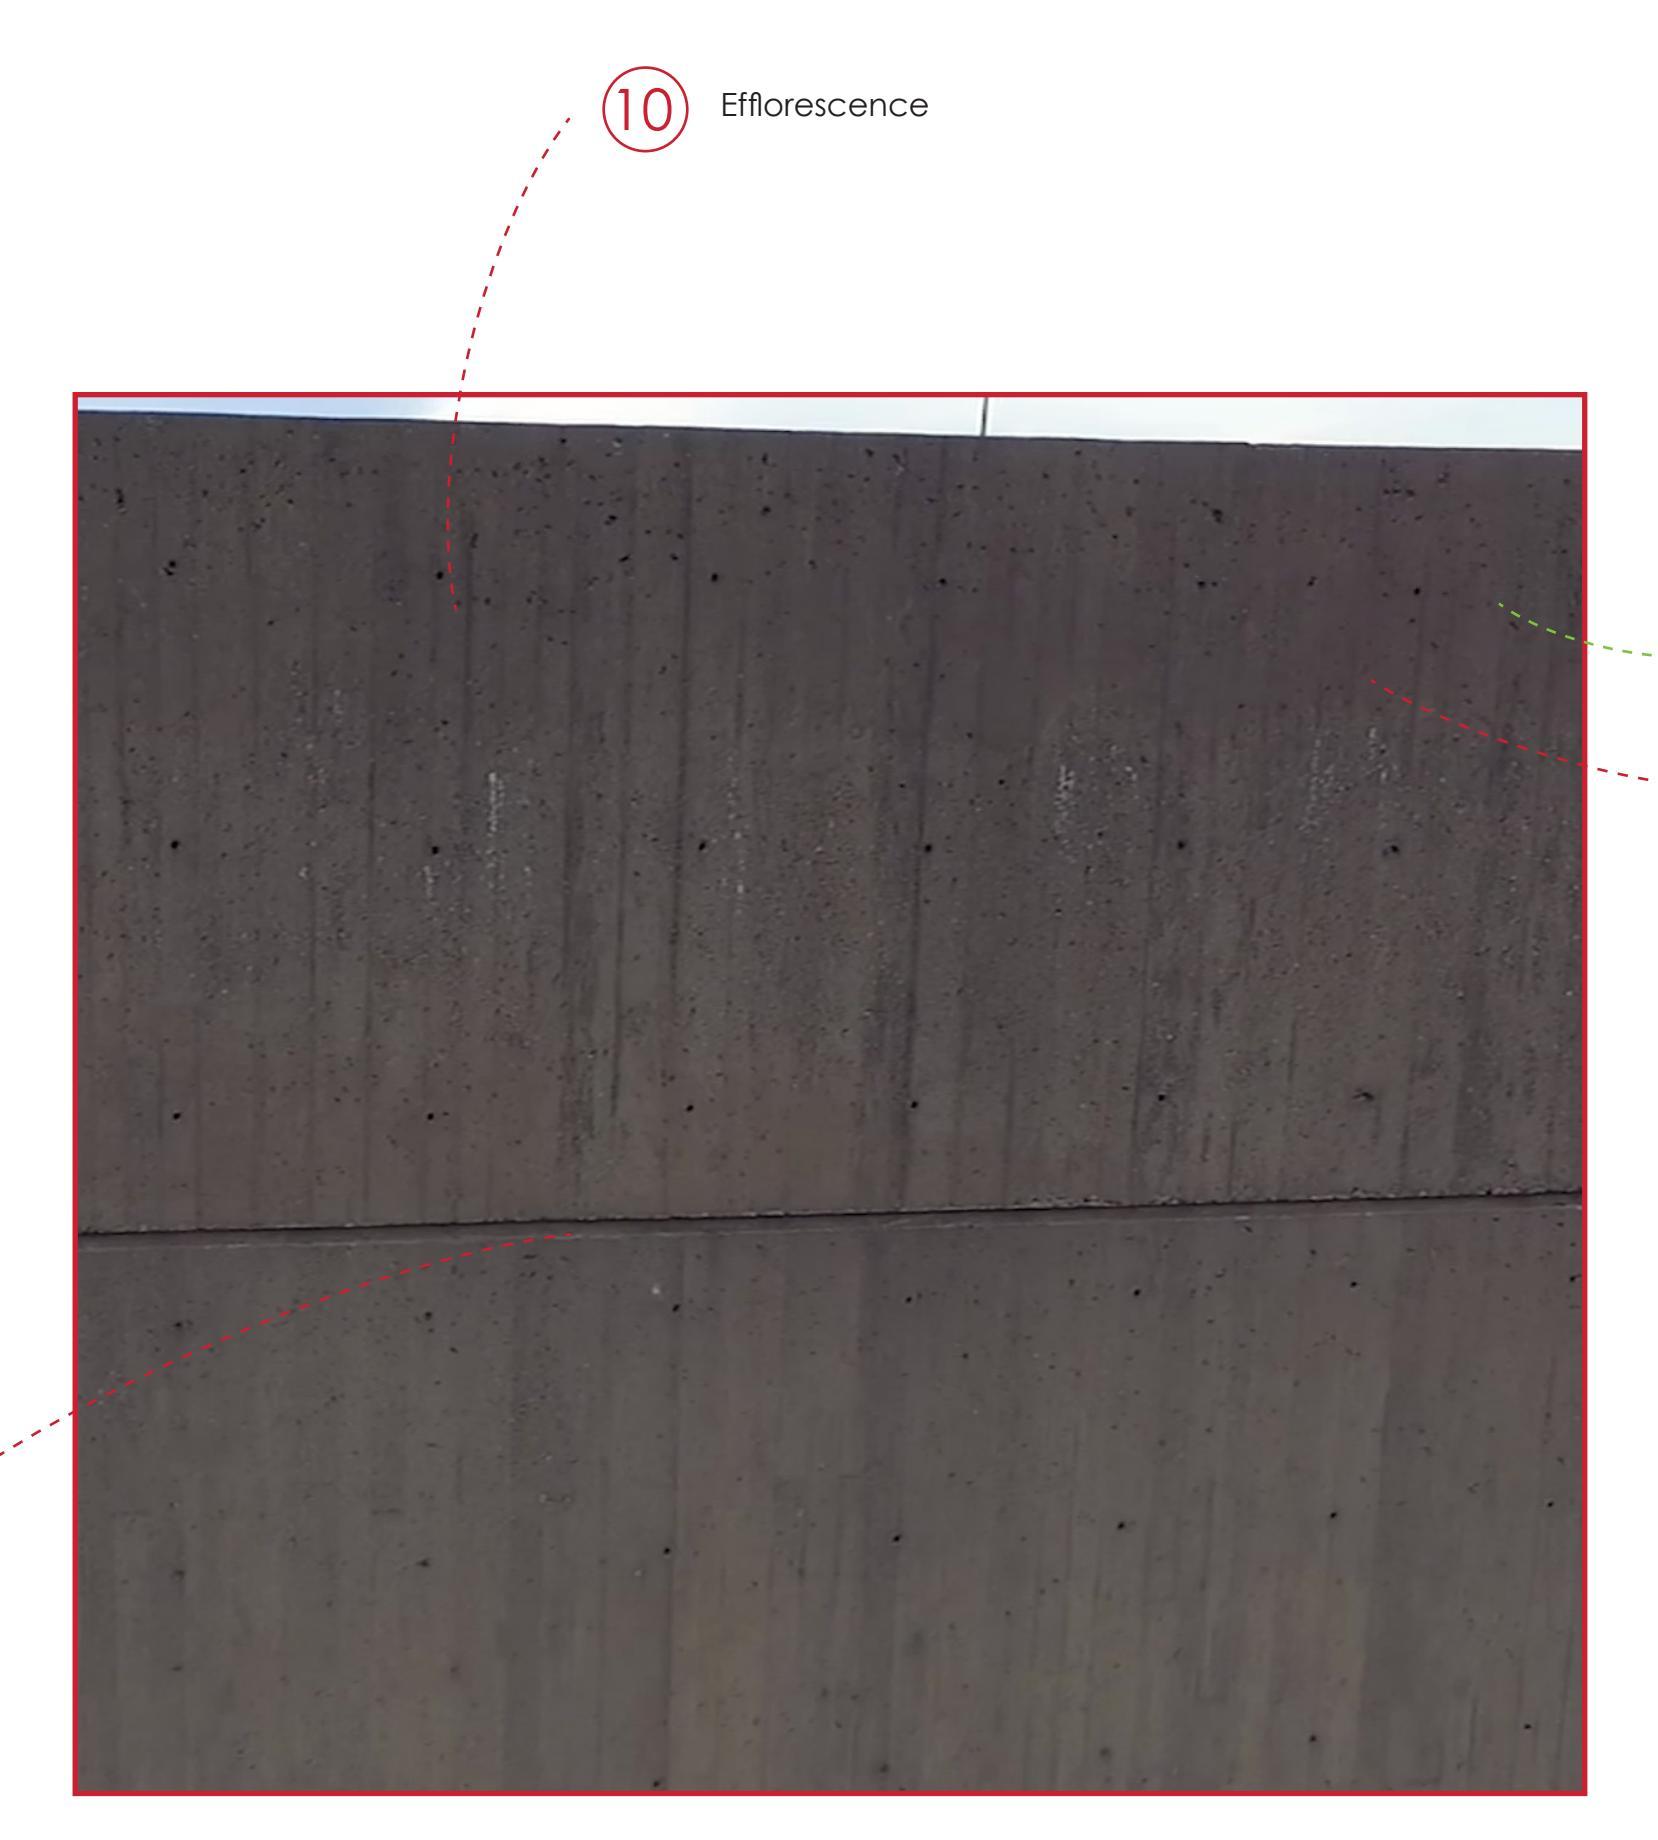
BELL BANNER NORTH ELEVATION

Efflorescence

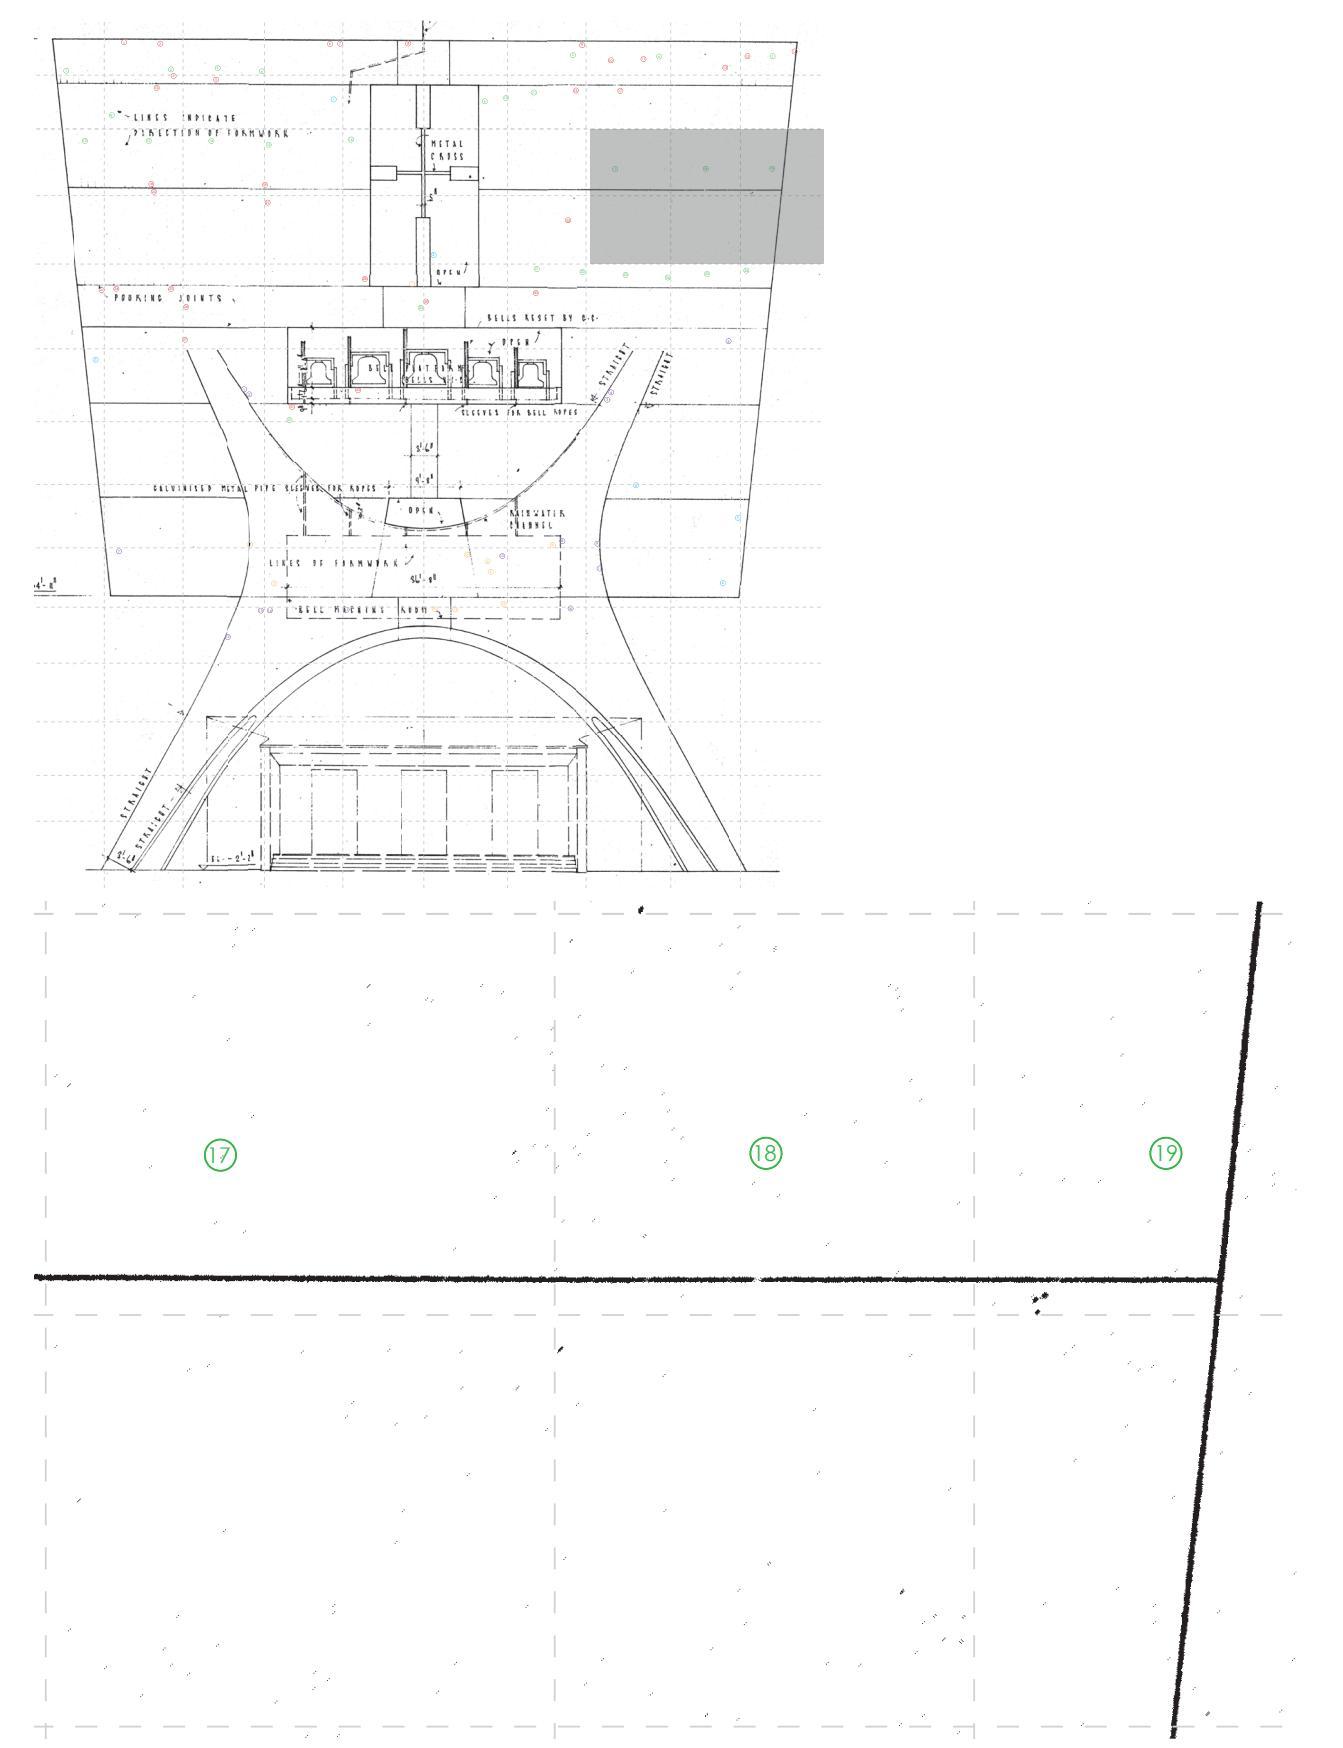
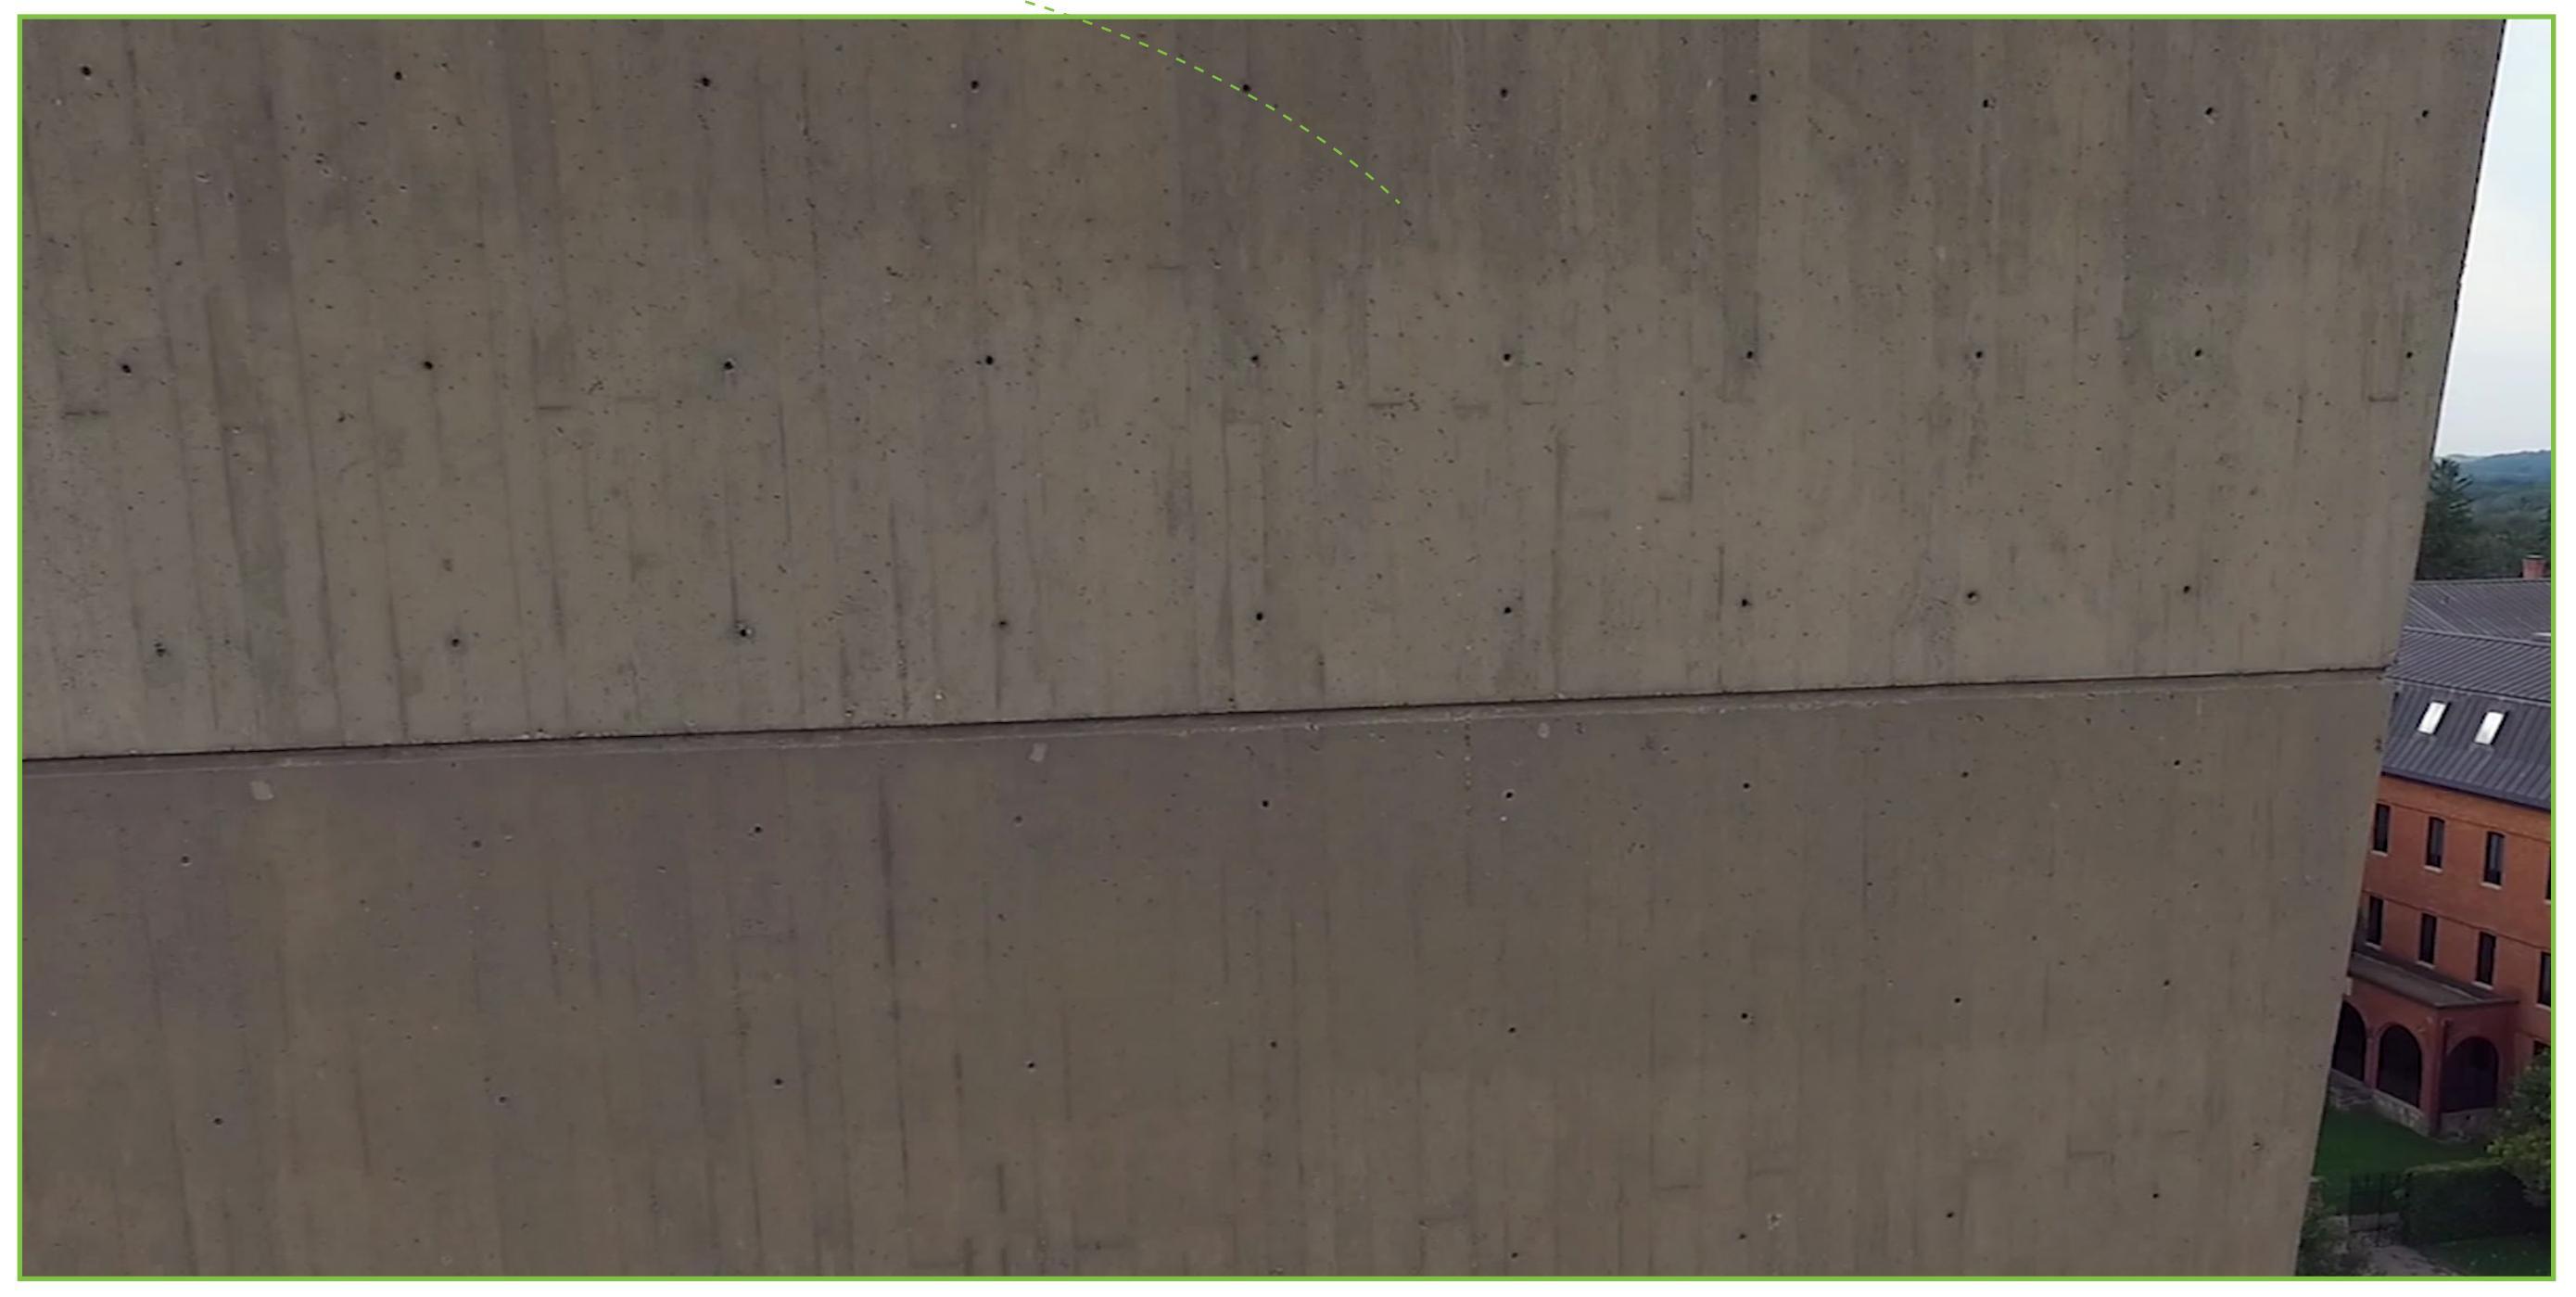
Rainwater washing down the faces of the Bell Banner and supports gives an understanding of how the variable surface coloring of the concrete has developed over the years, and demonstrates the effect of an unprotected top edge of the banner on moisture penetration, saturation and surface wash.

8 19 ı7 Variable Surface Color

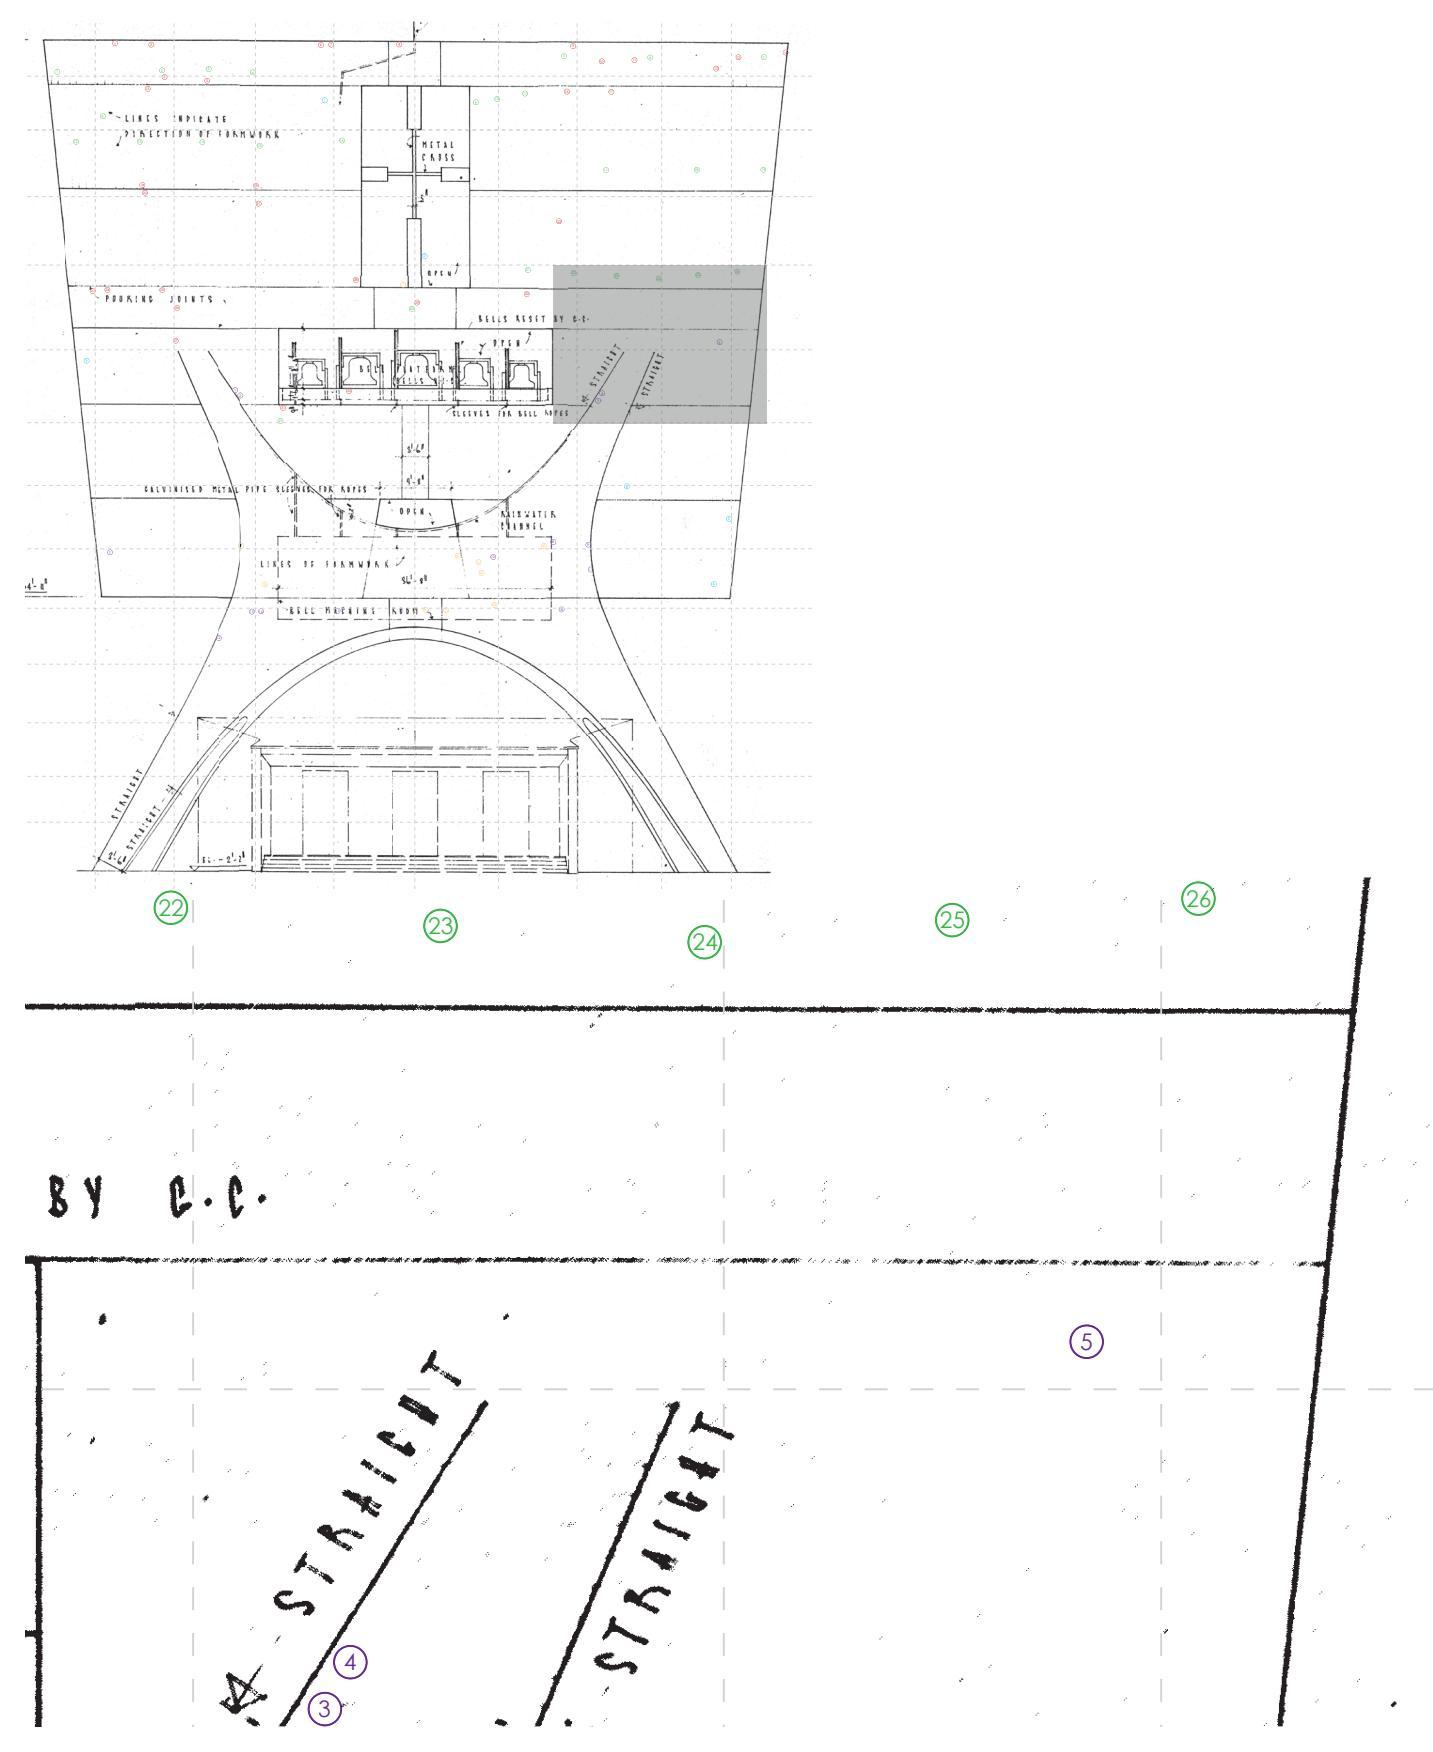
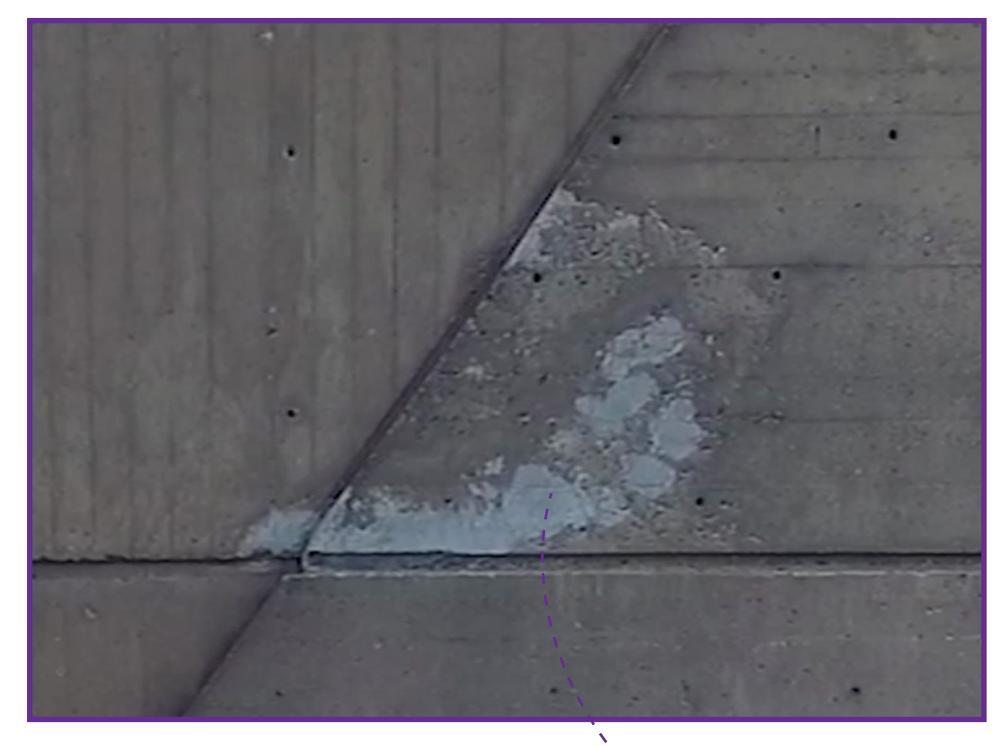
(20) Variable Surface Color

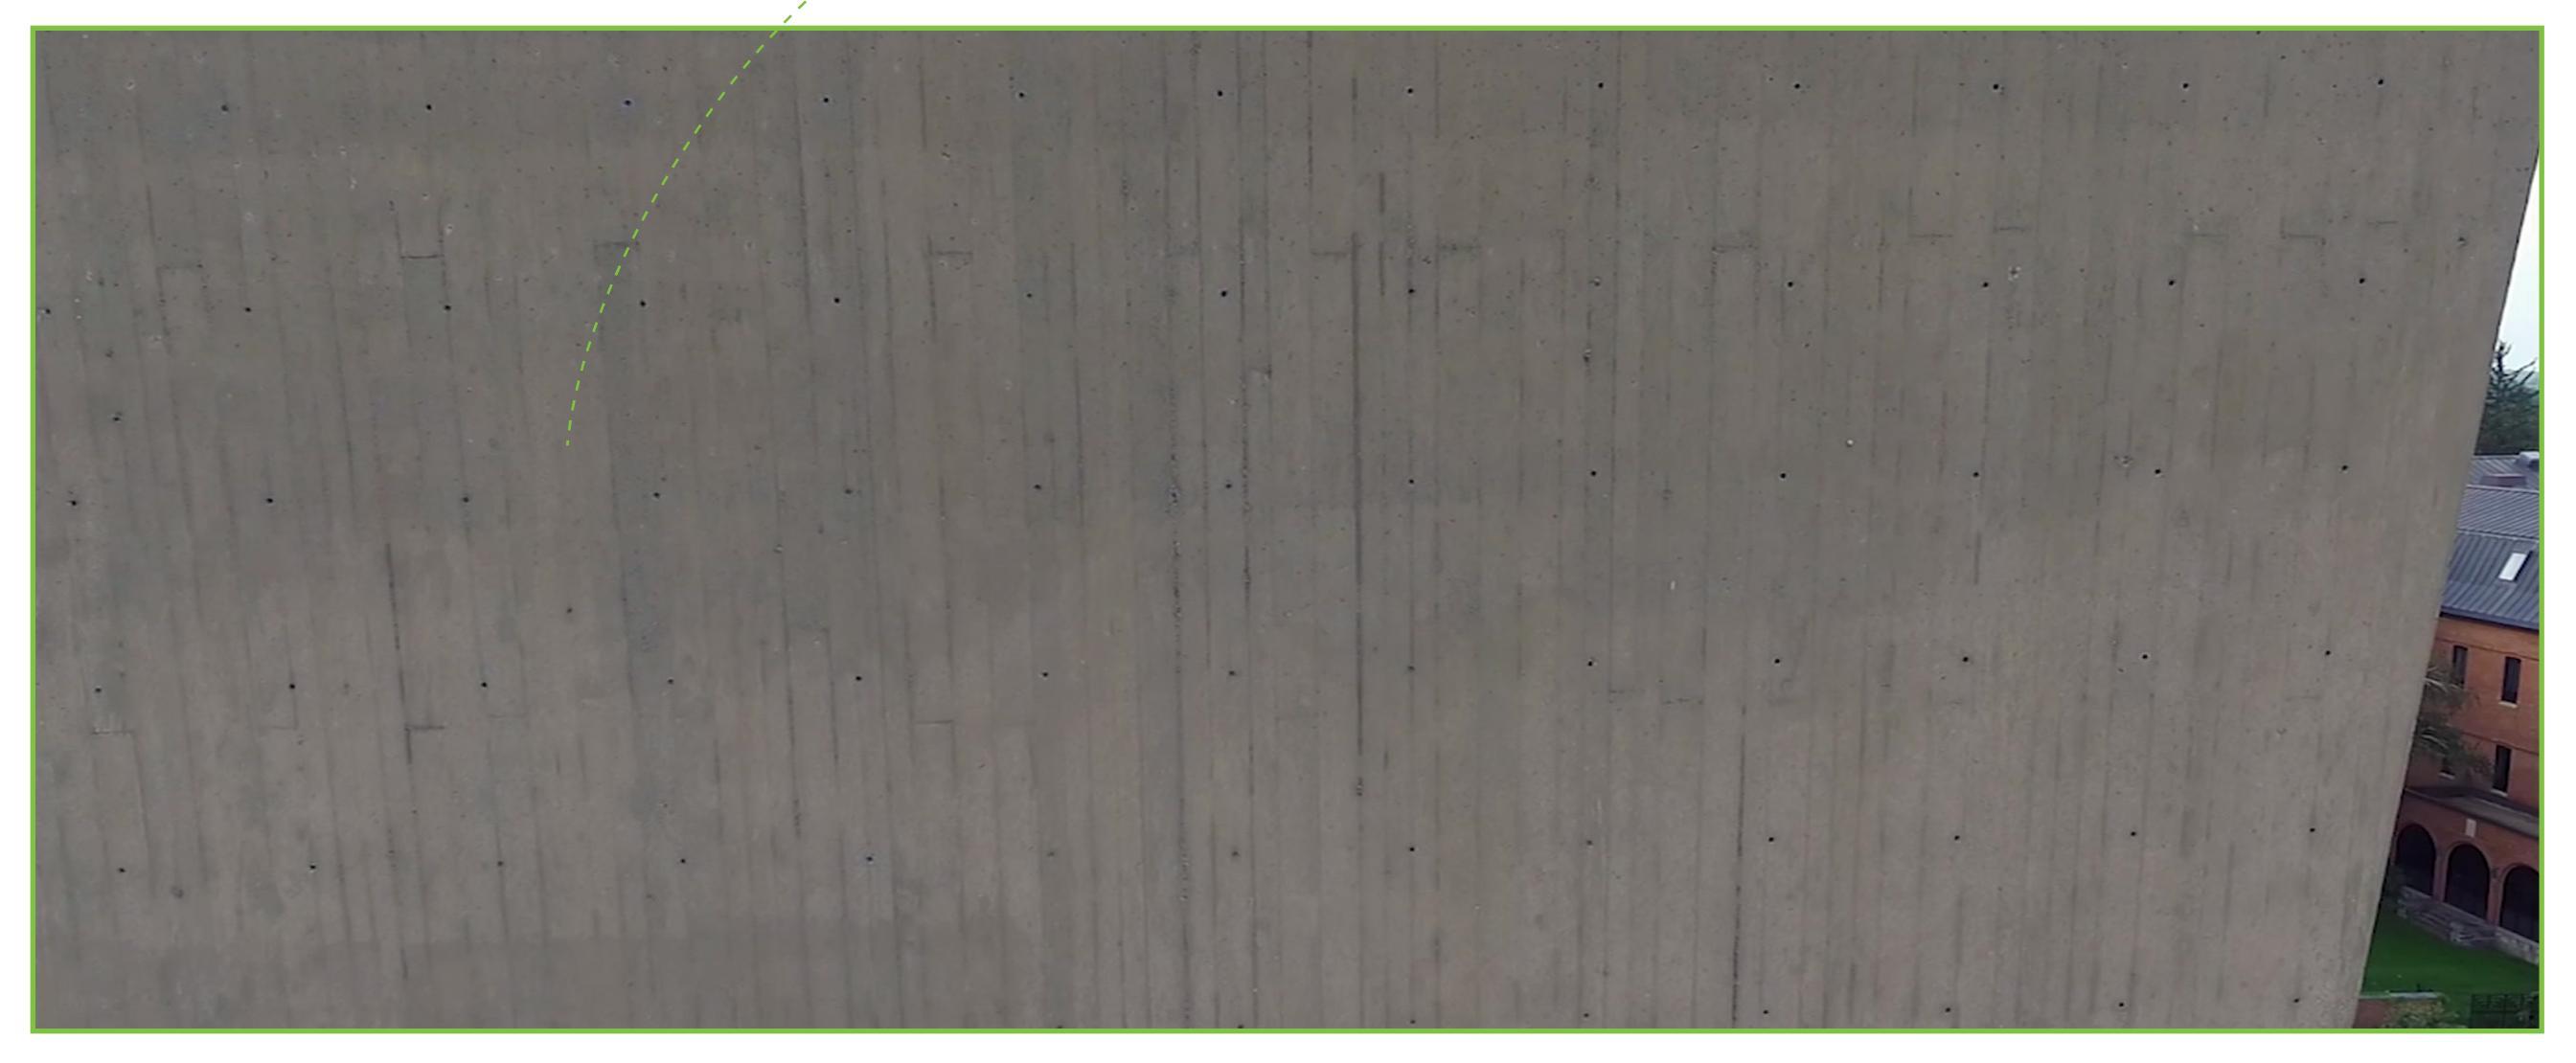
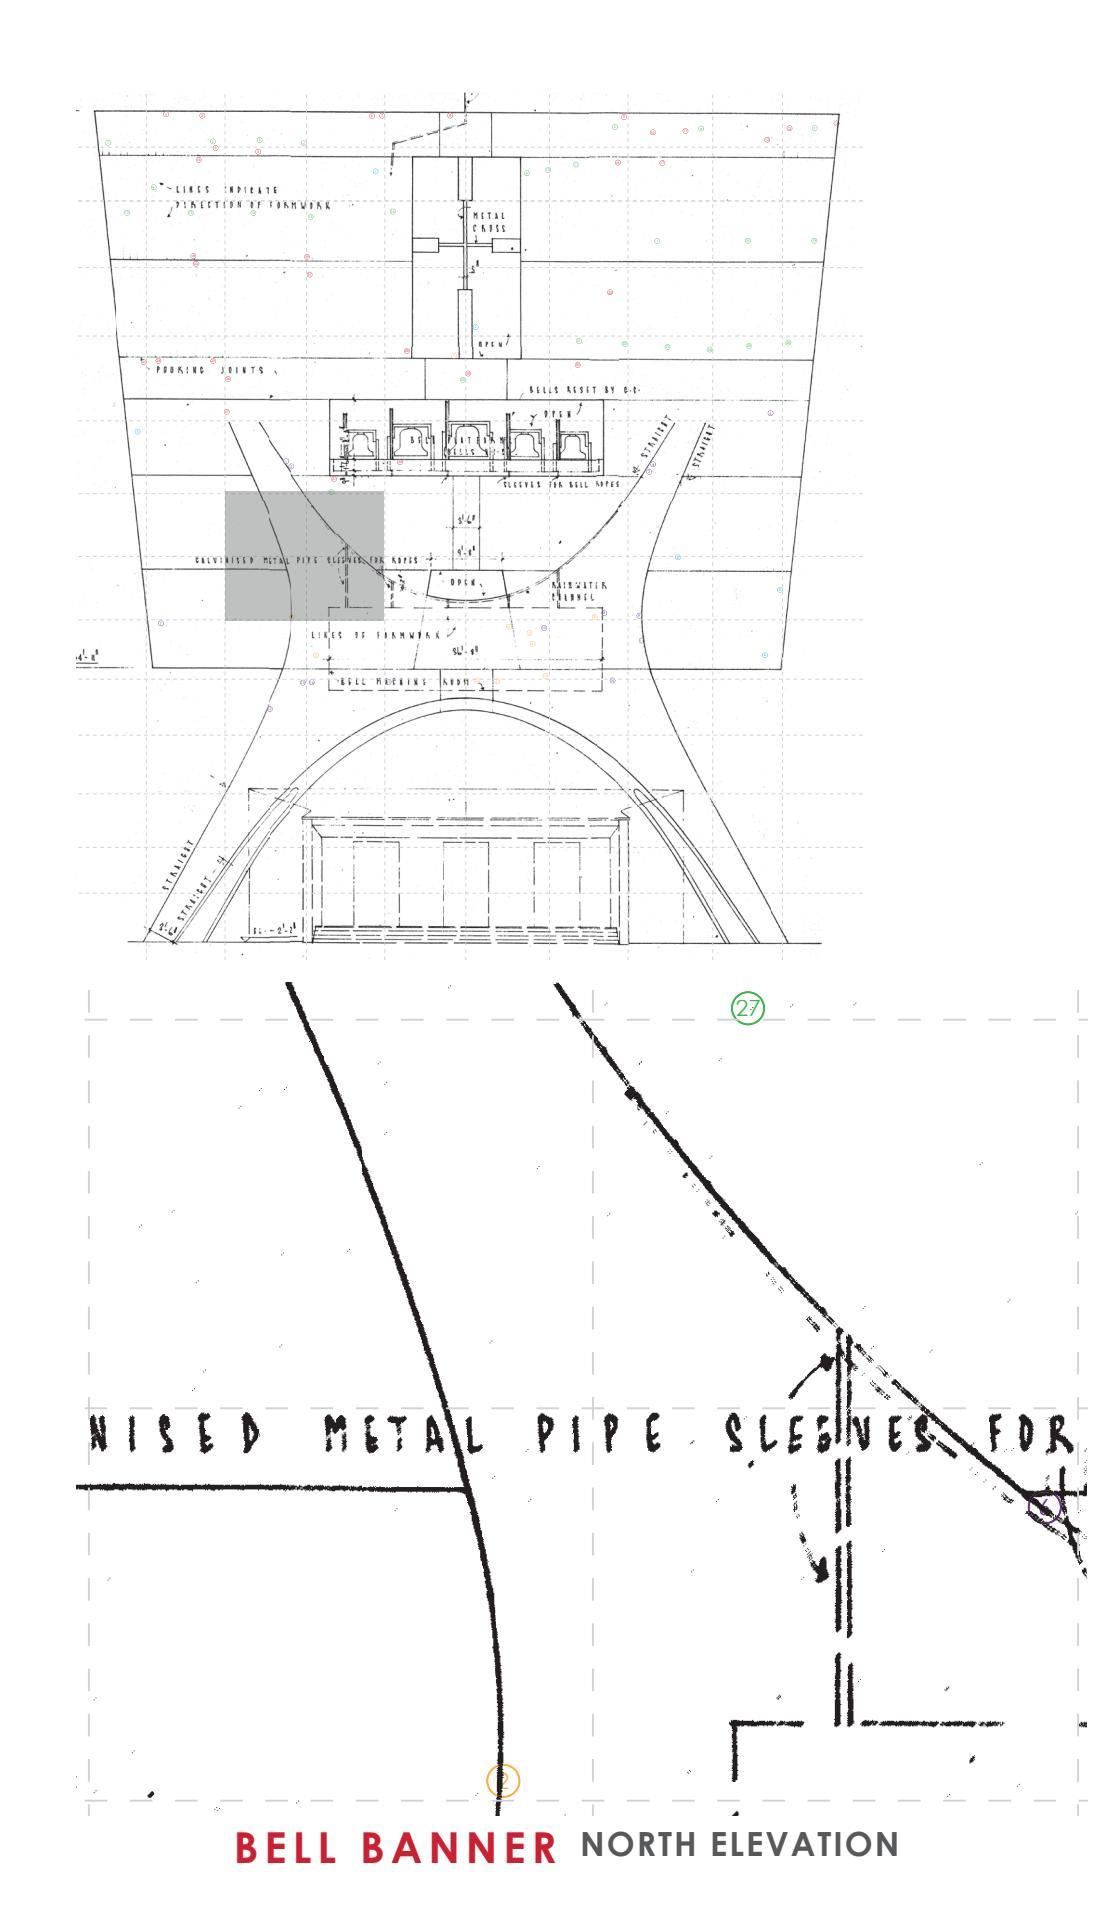
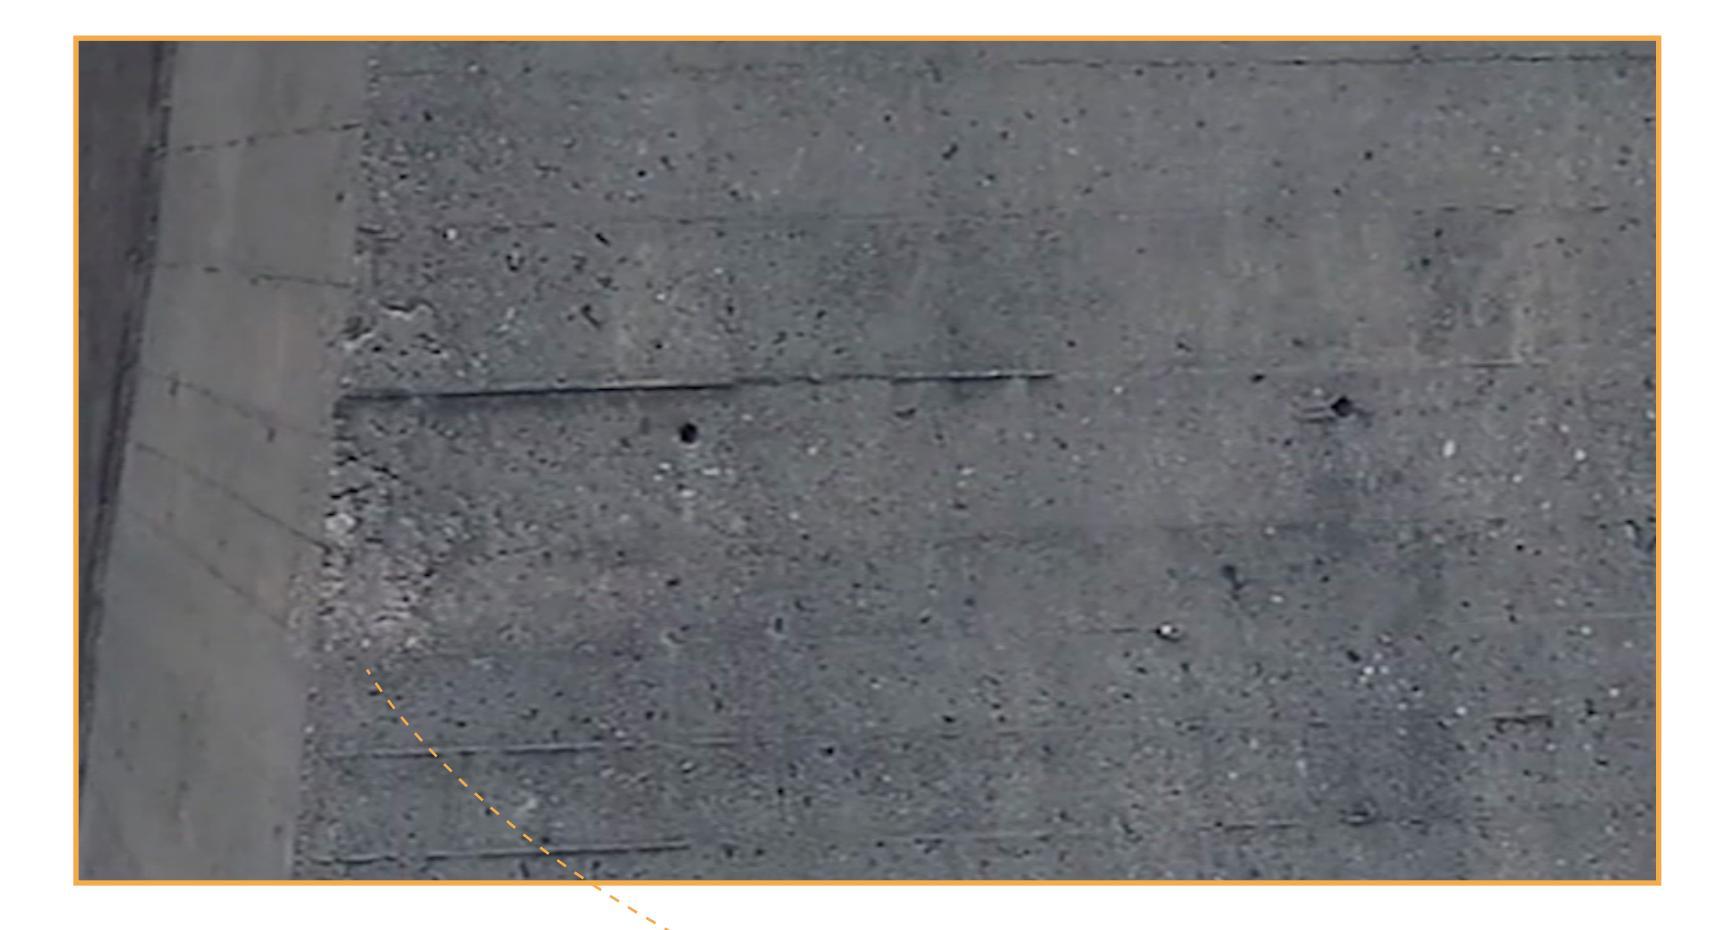
1(24) Variable Surface Color (25) (22)

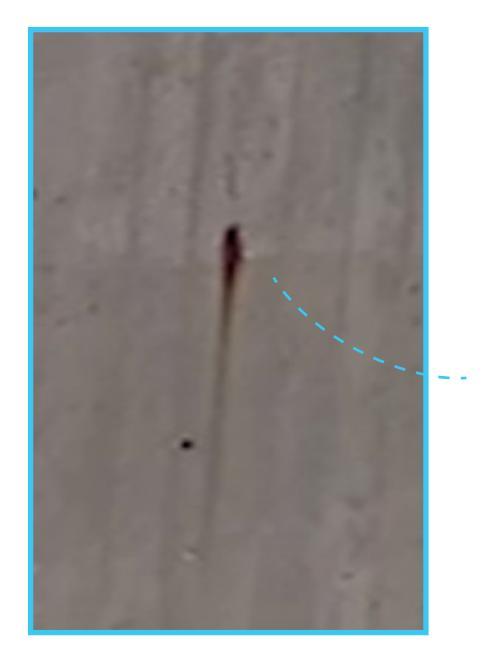
Iron Oxide Staining

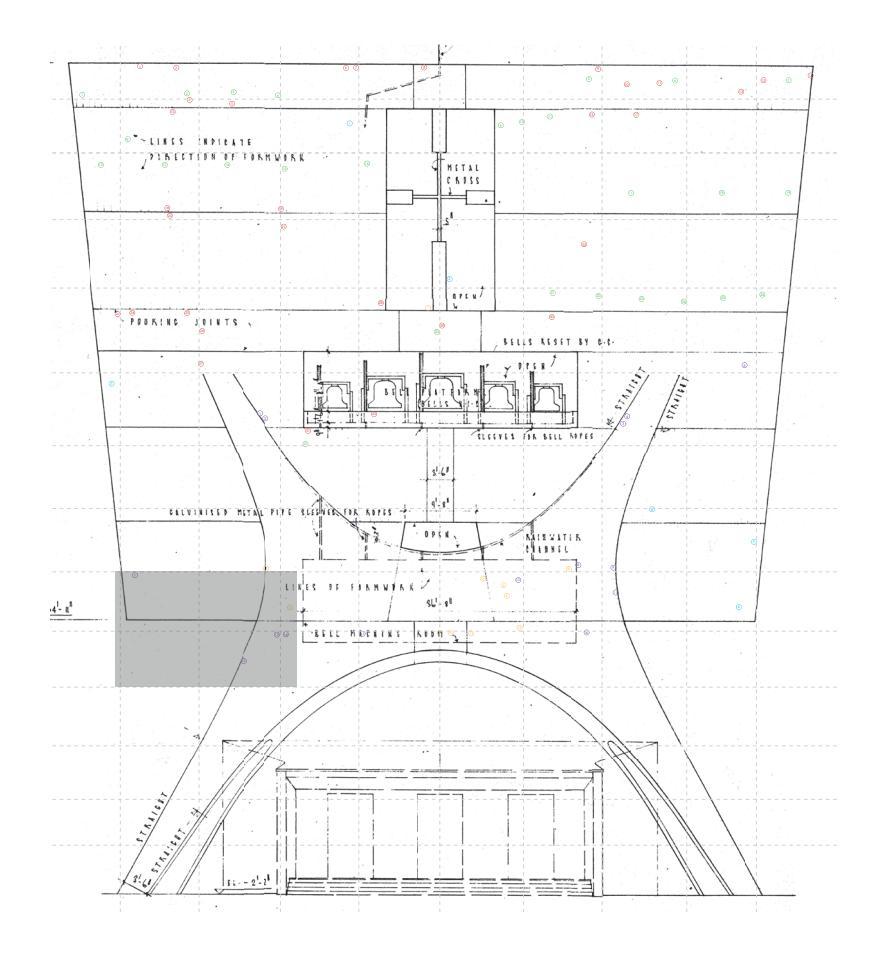
Spalling
