FINAL REPORT July 2016

SAINT JOHN'S ABBEY CHURCH

CONSERVATION RESTORATION PRESERVATION

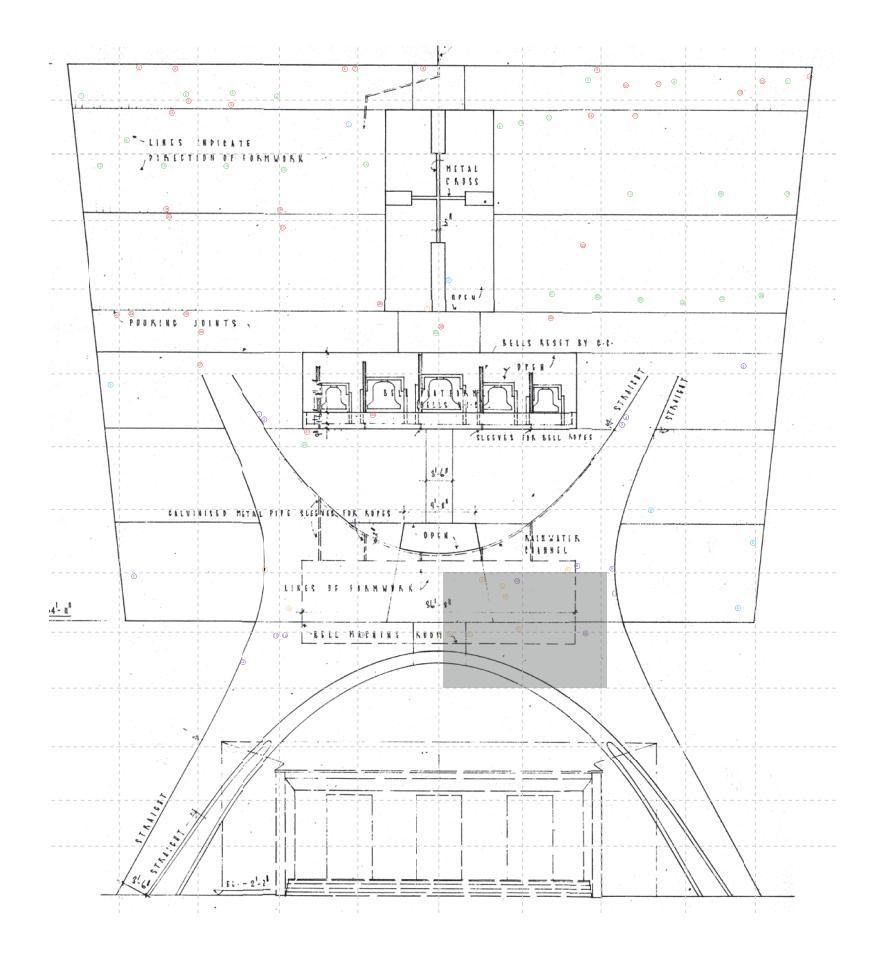
Spalling

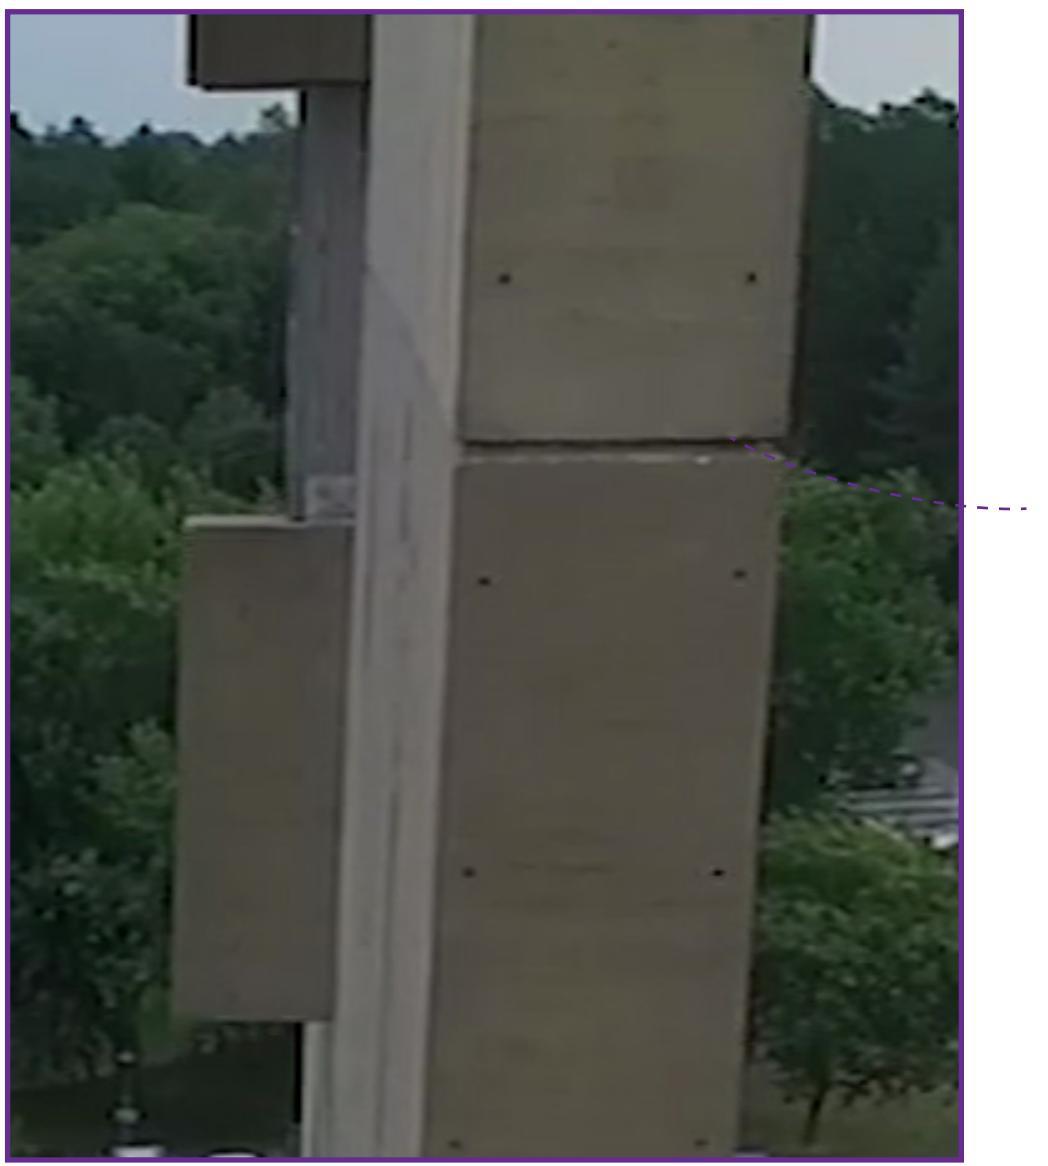
69

Chipping

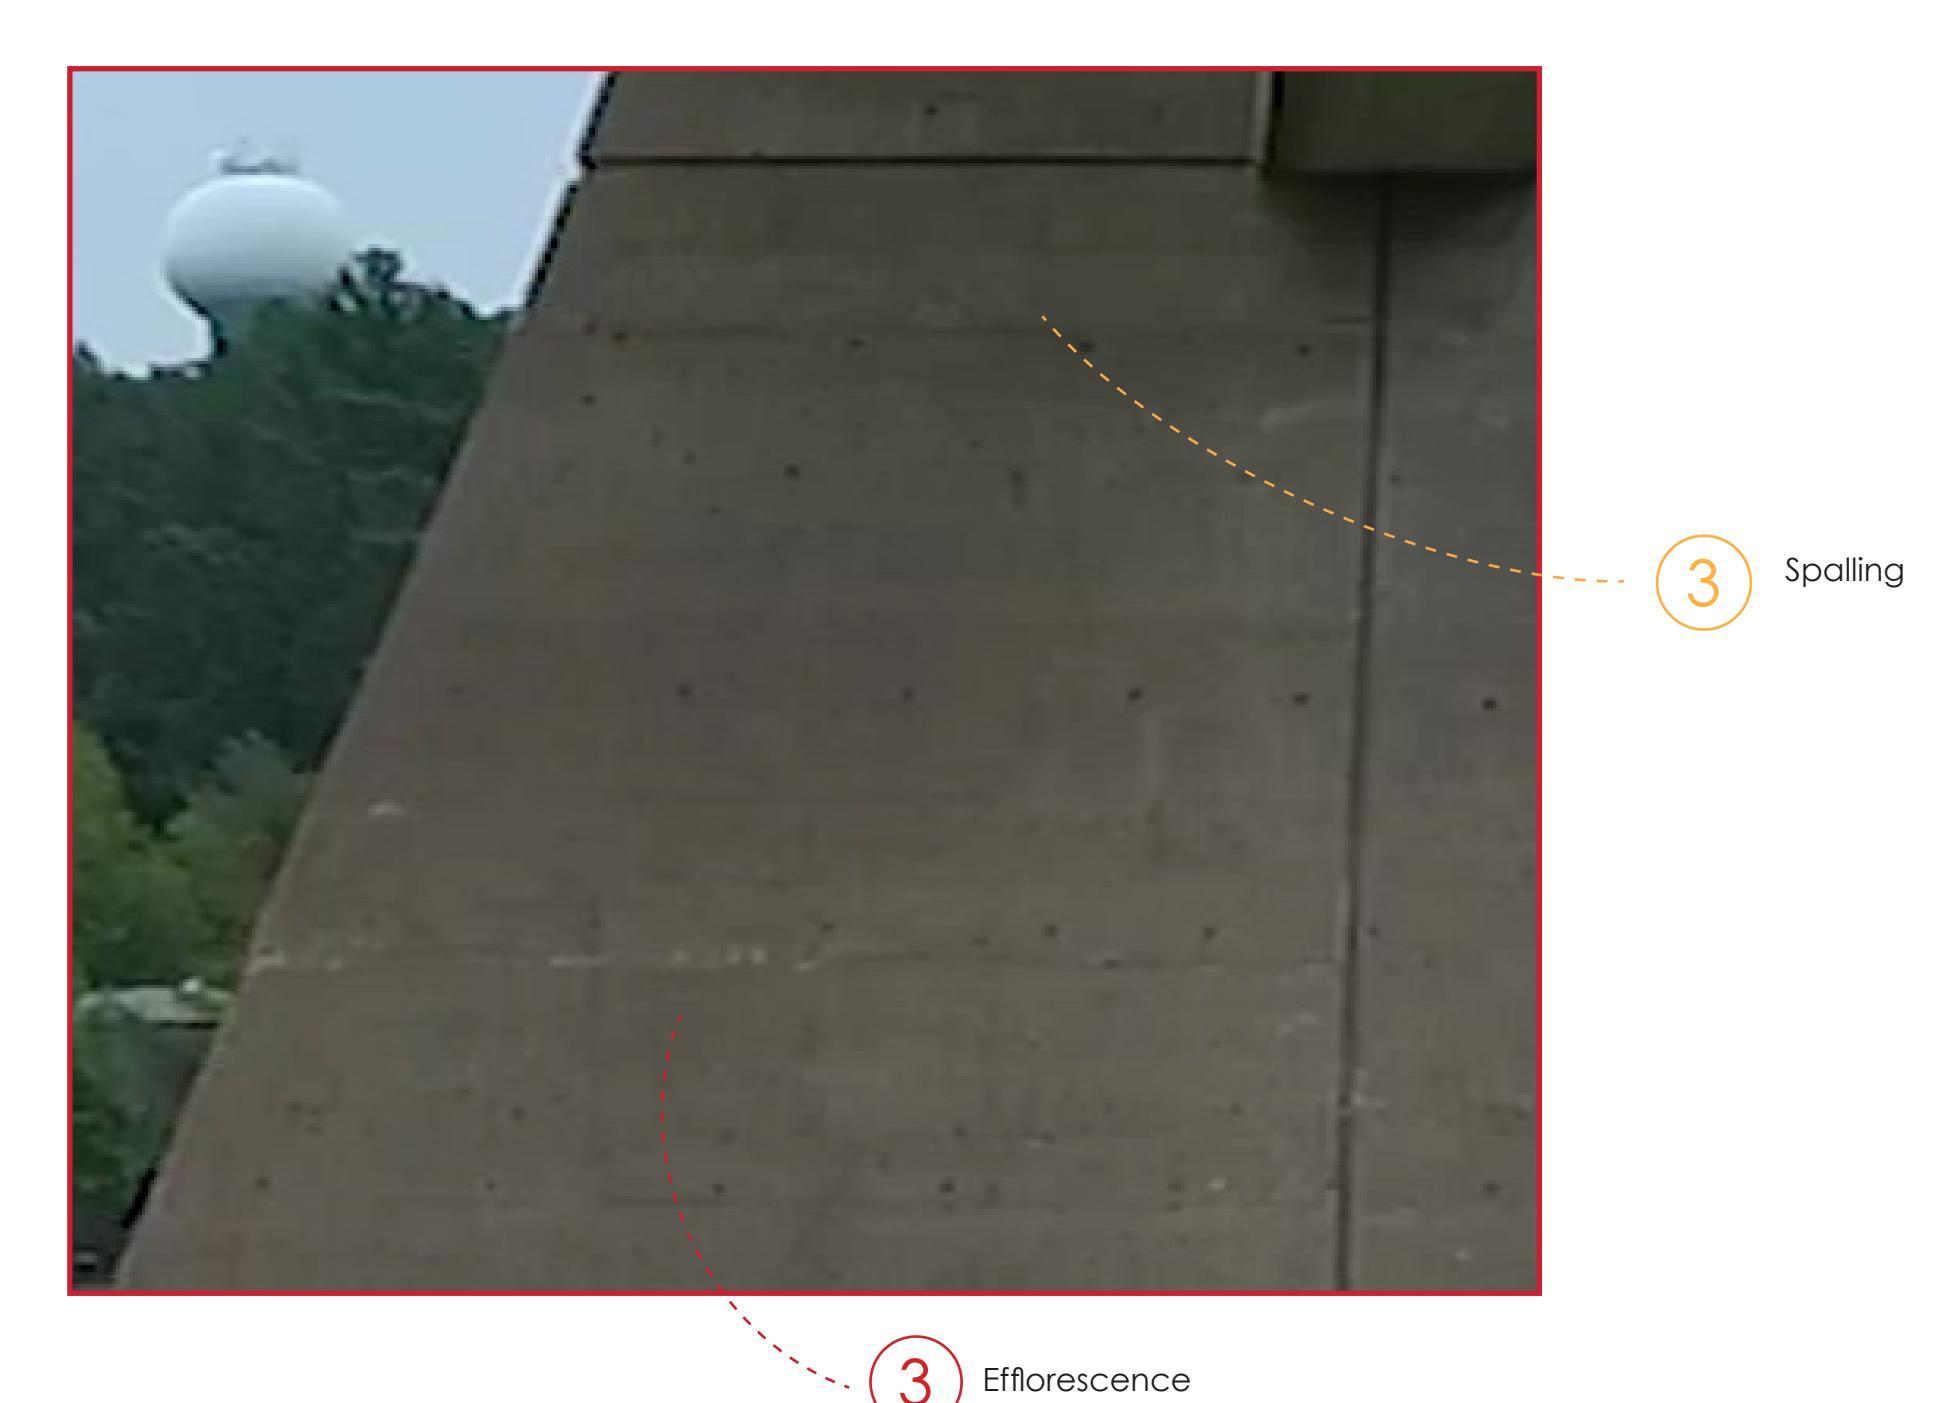
71

Efflorescence

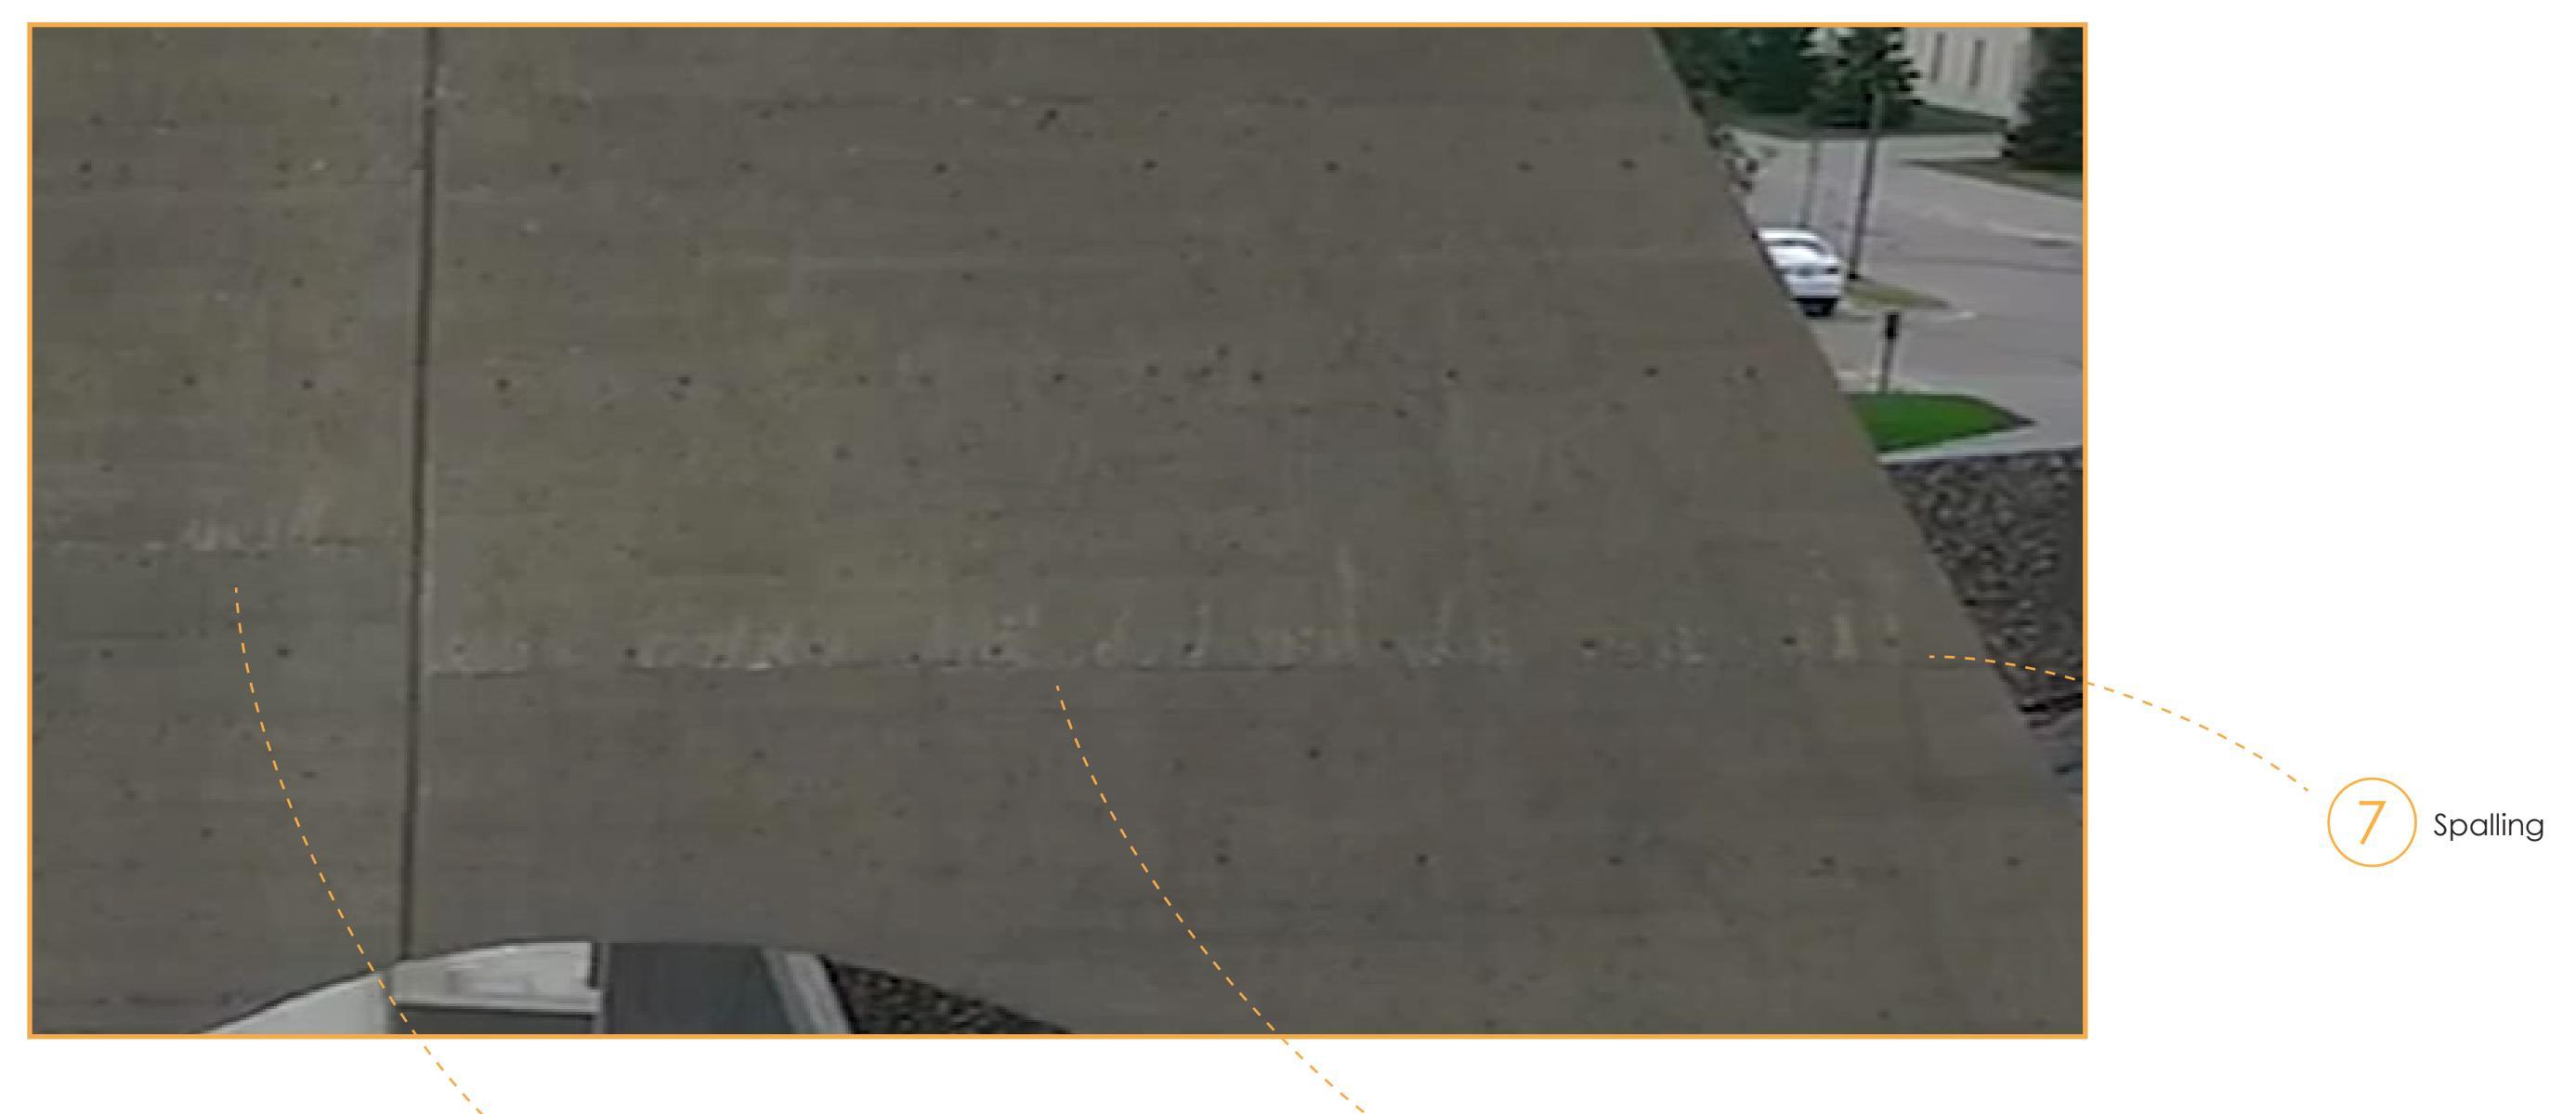
5 6 Spalling

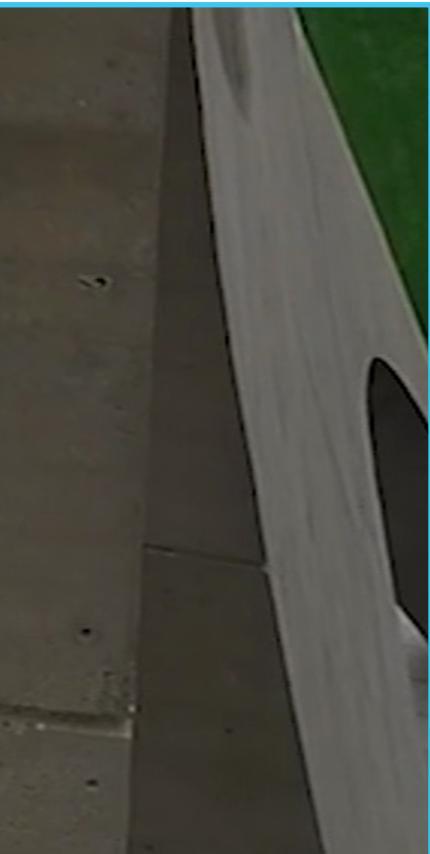
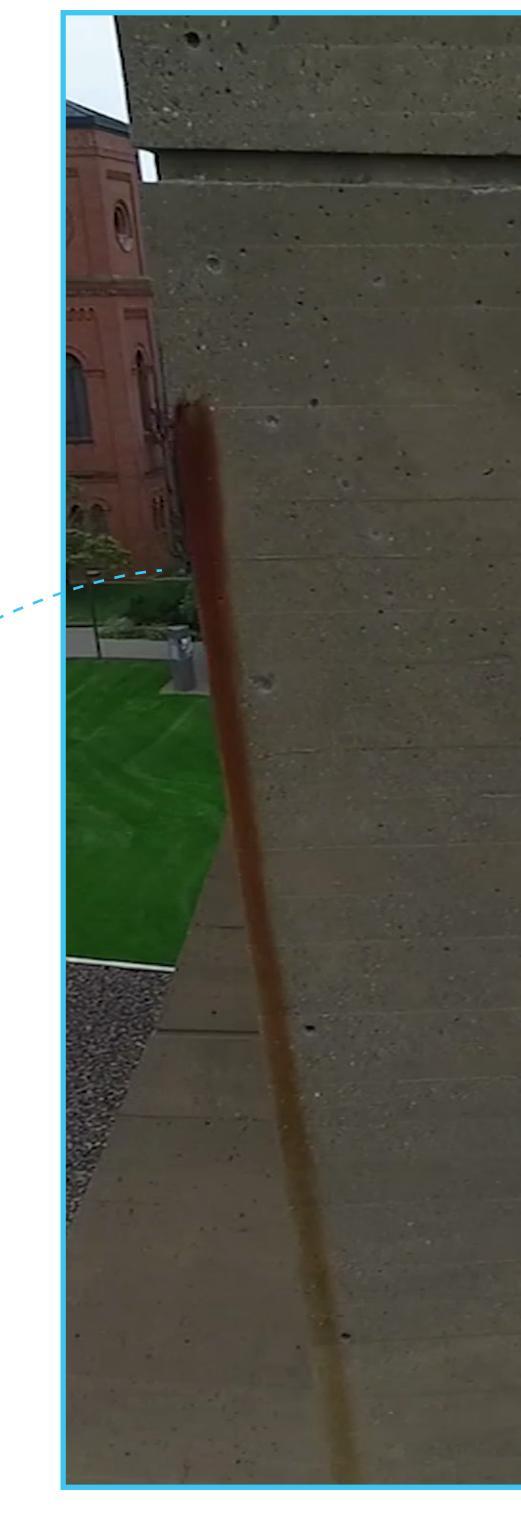
BELL BANNER EAST ELEVATION

Iron Oxide Staining (2)

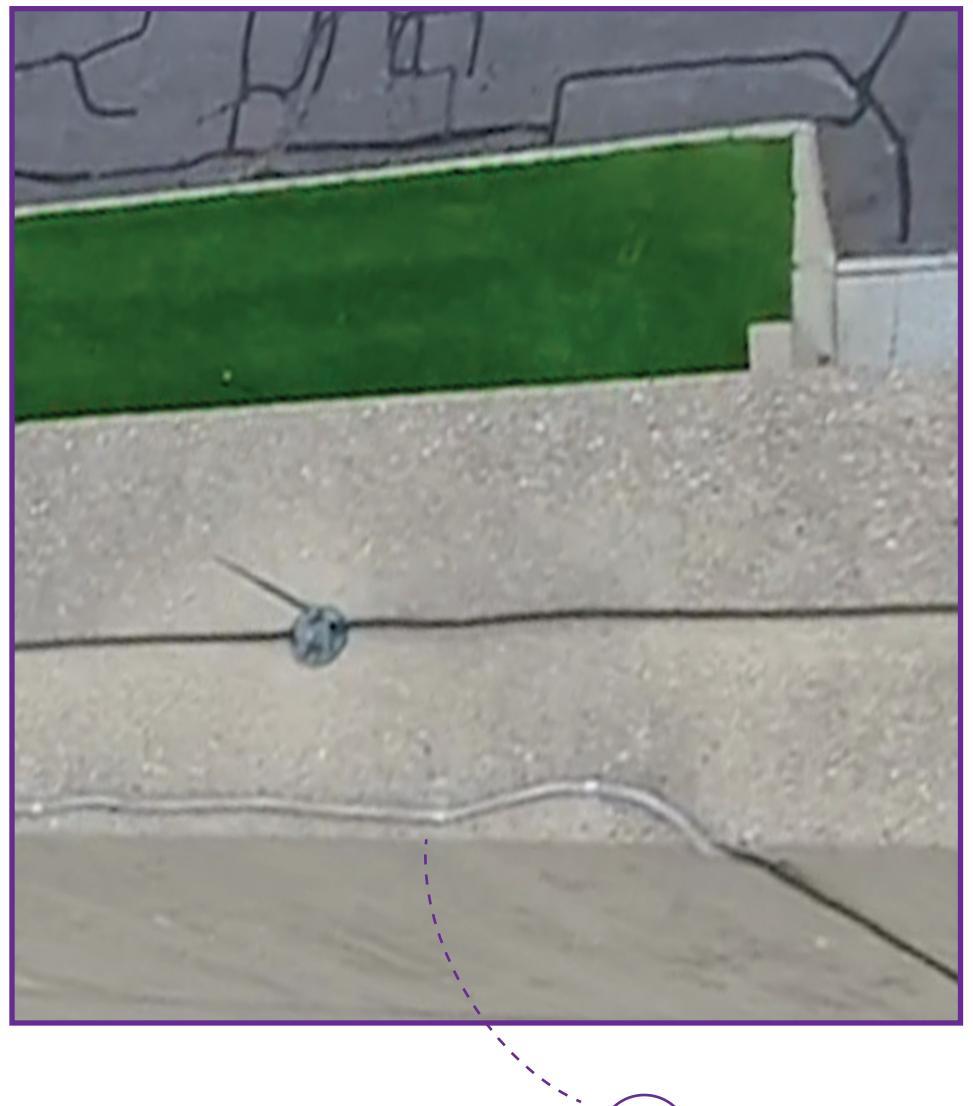
BELL BANNER TOP ELEVATION

Chipping

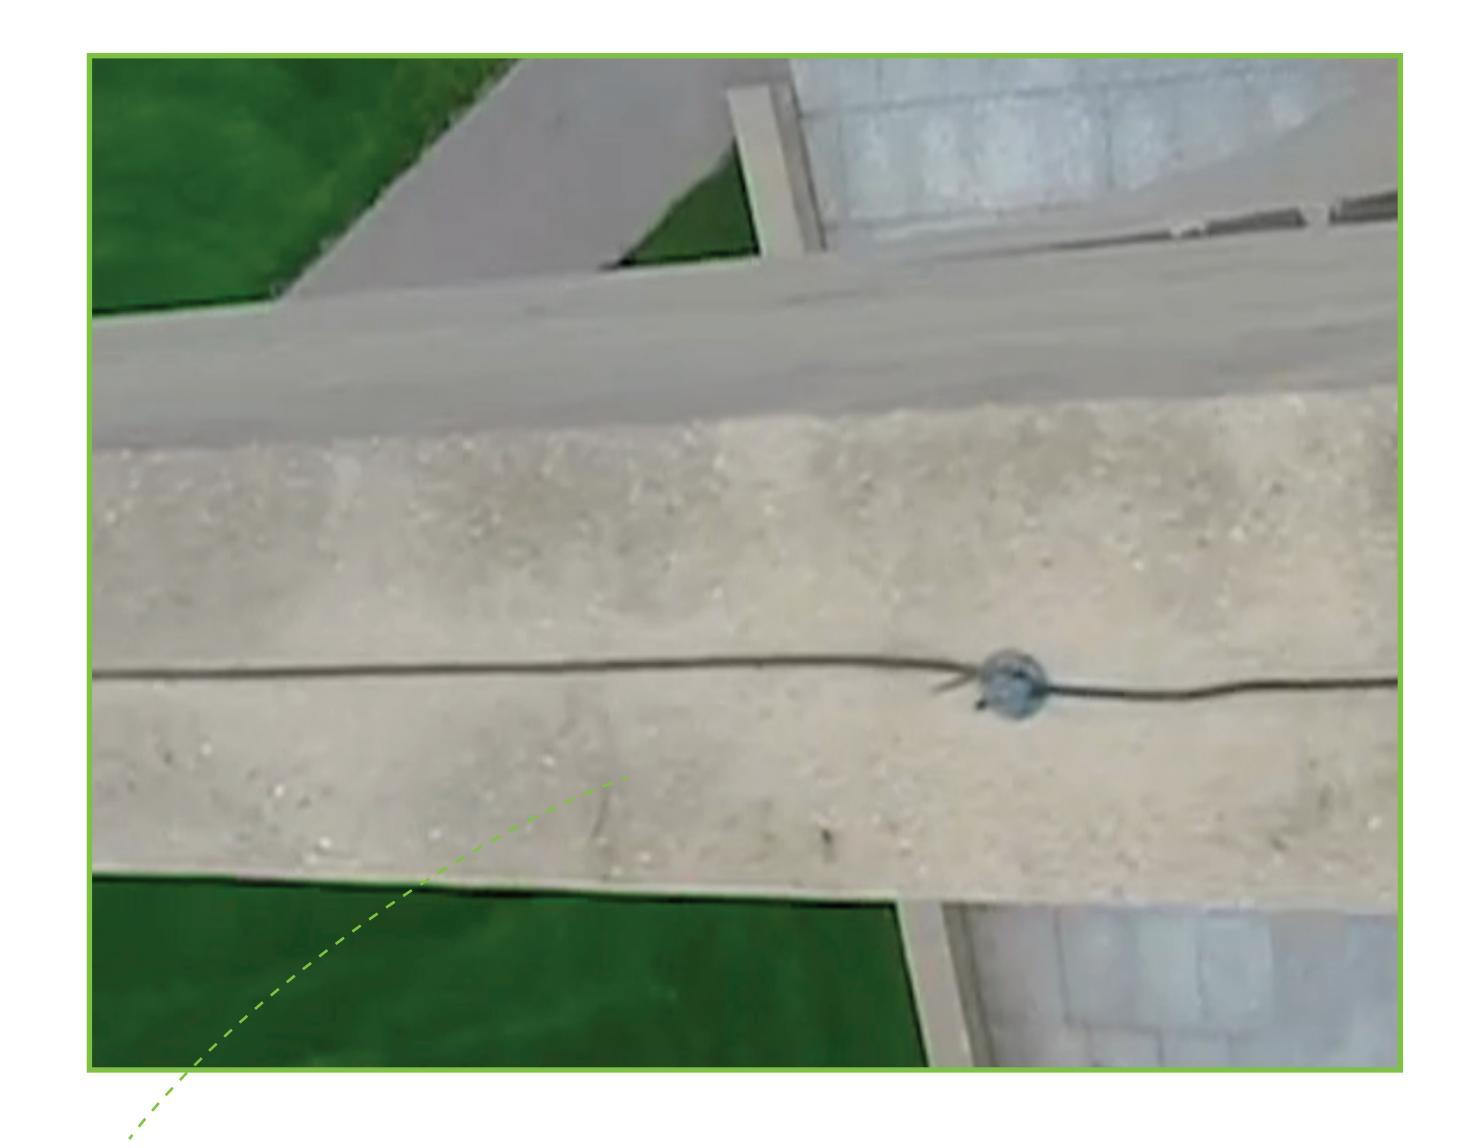
2 Exposed Cabling

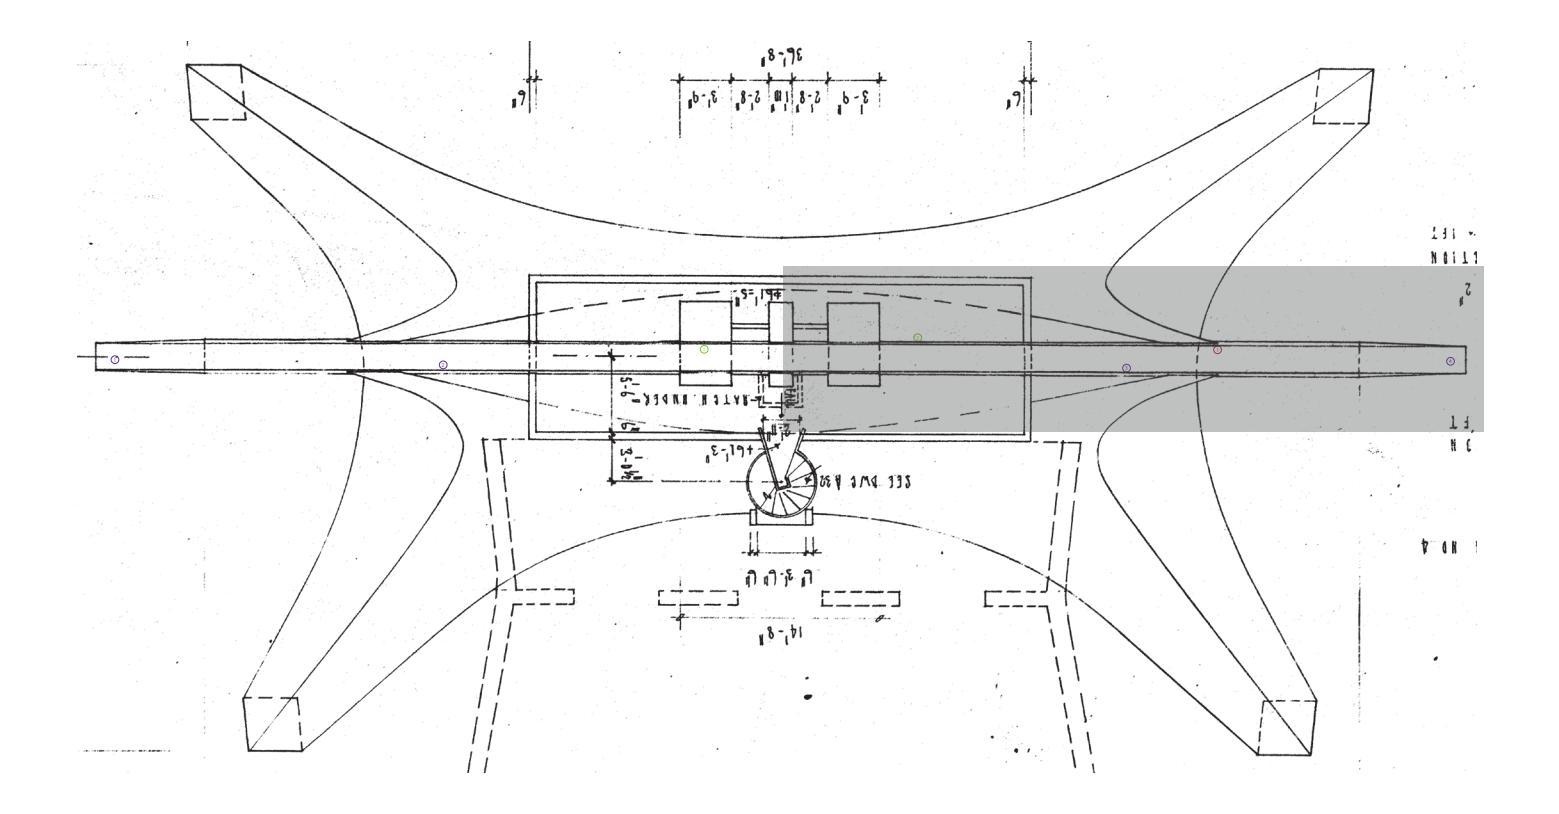
Variable Surface Color

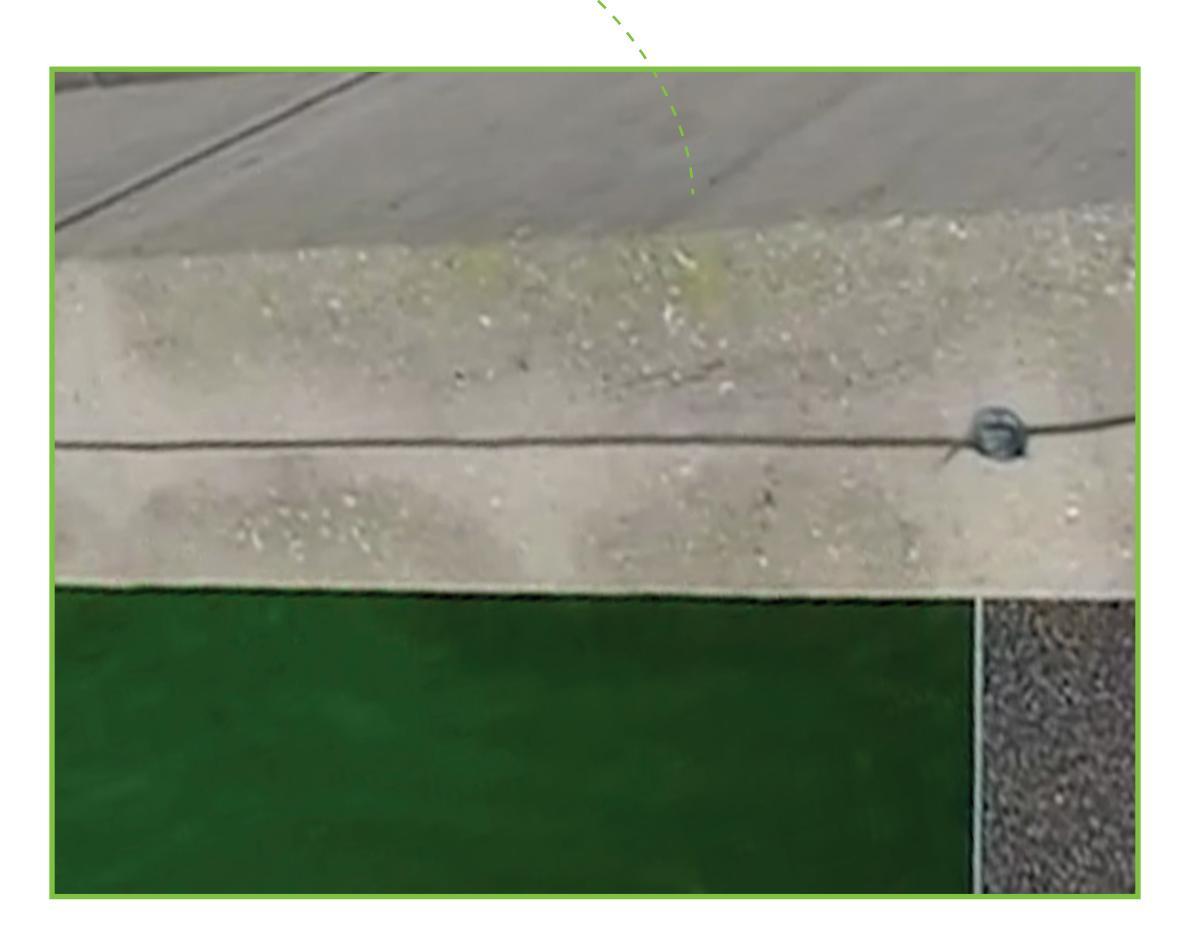
Variable Surface Color

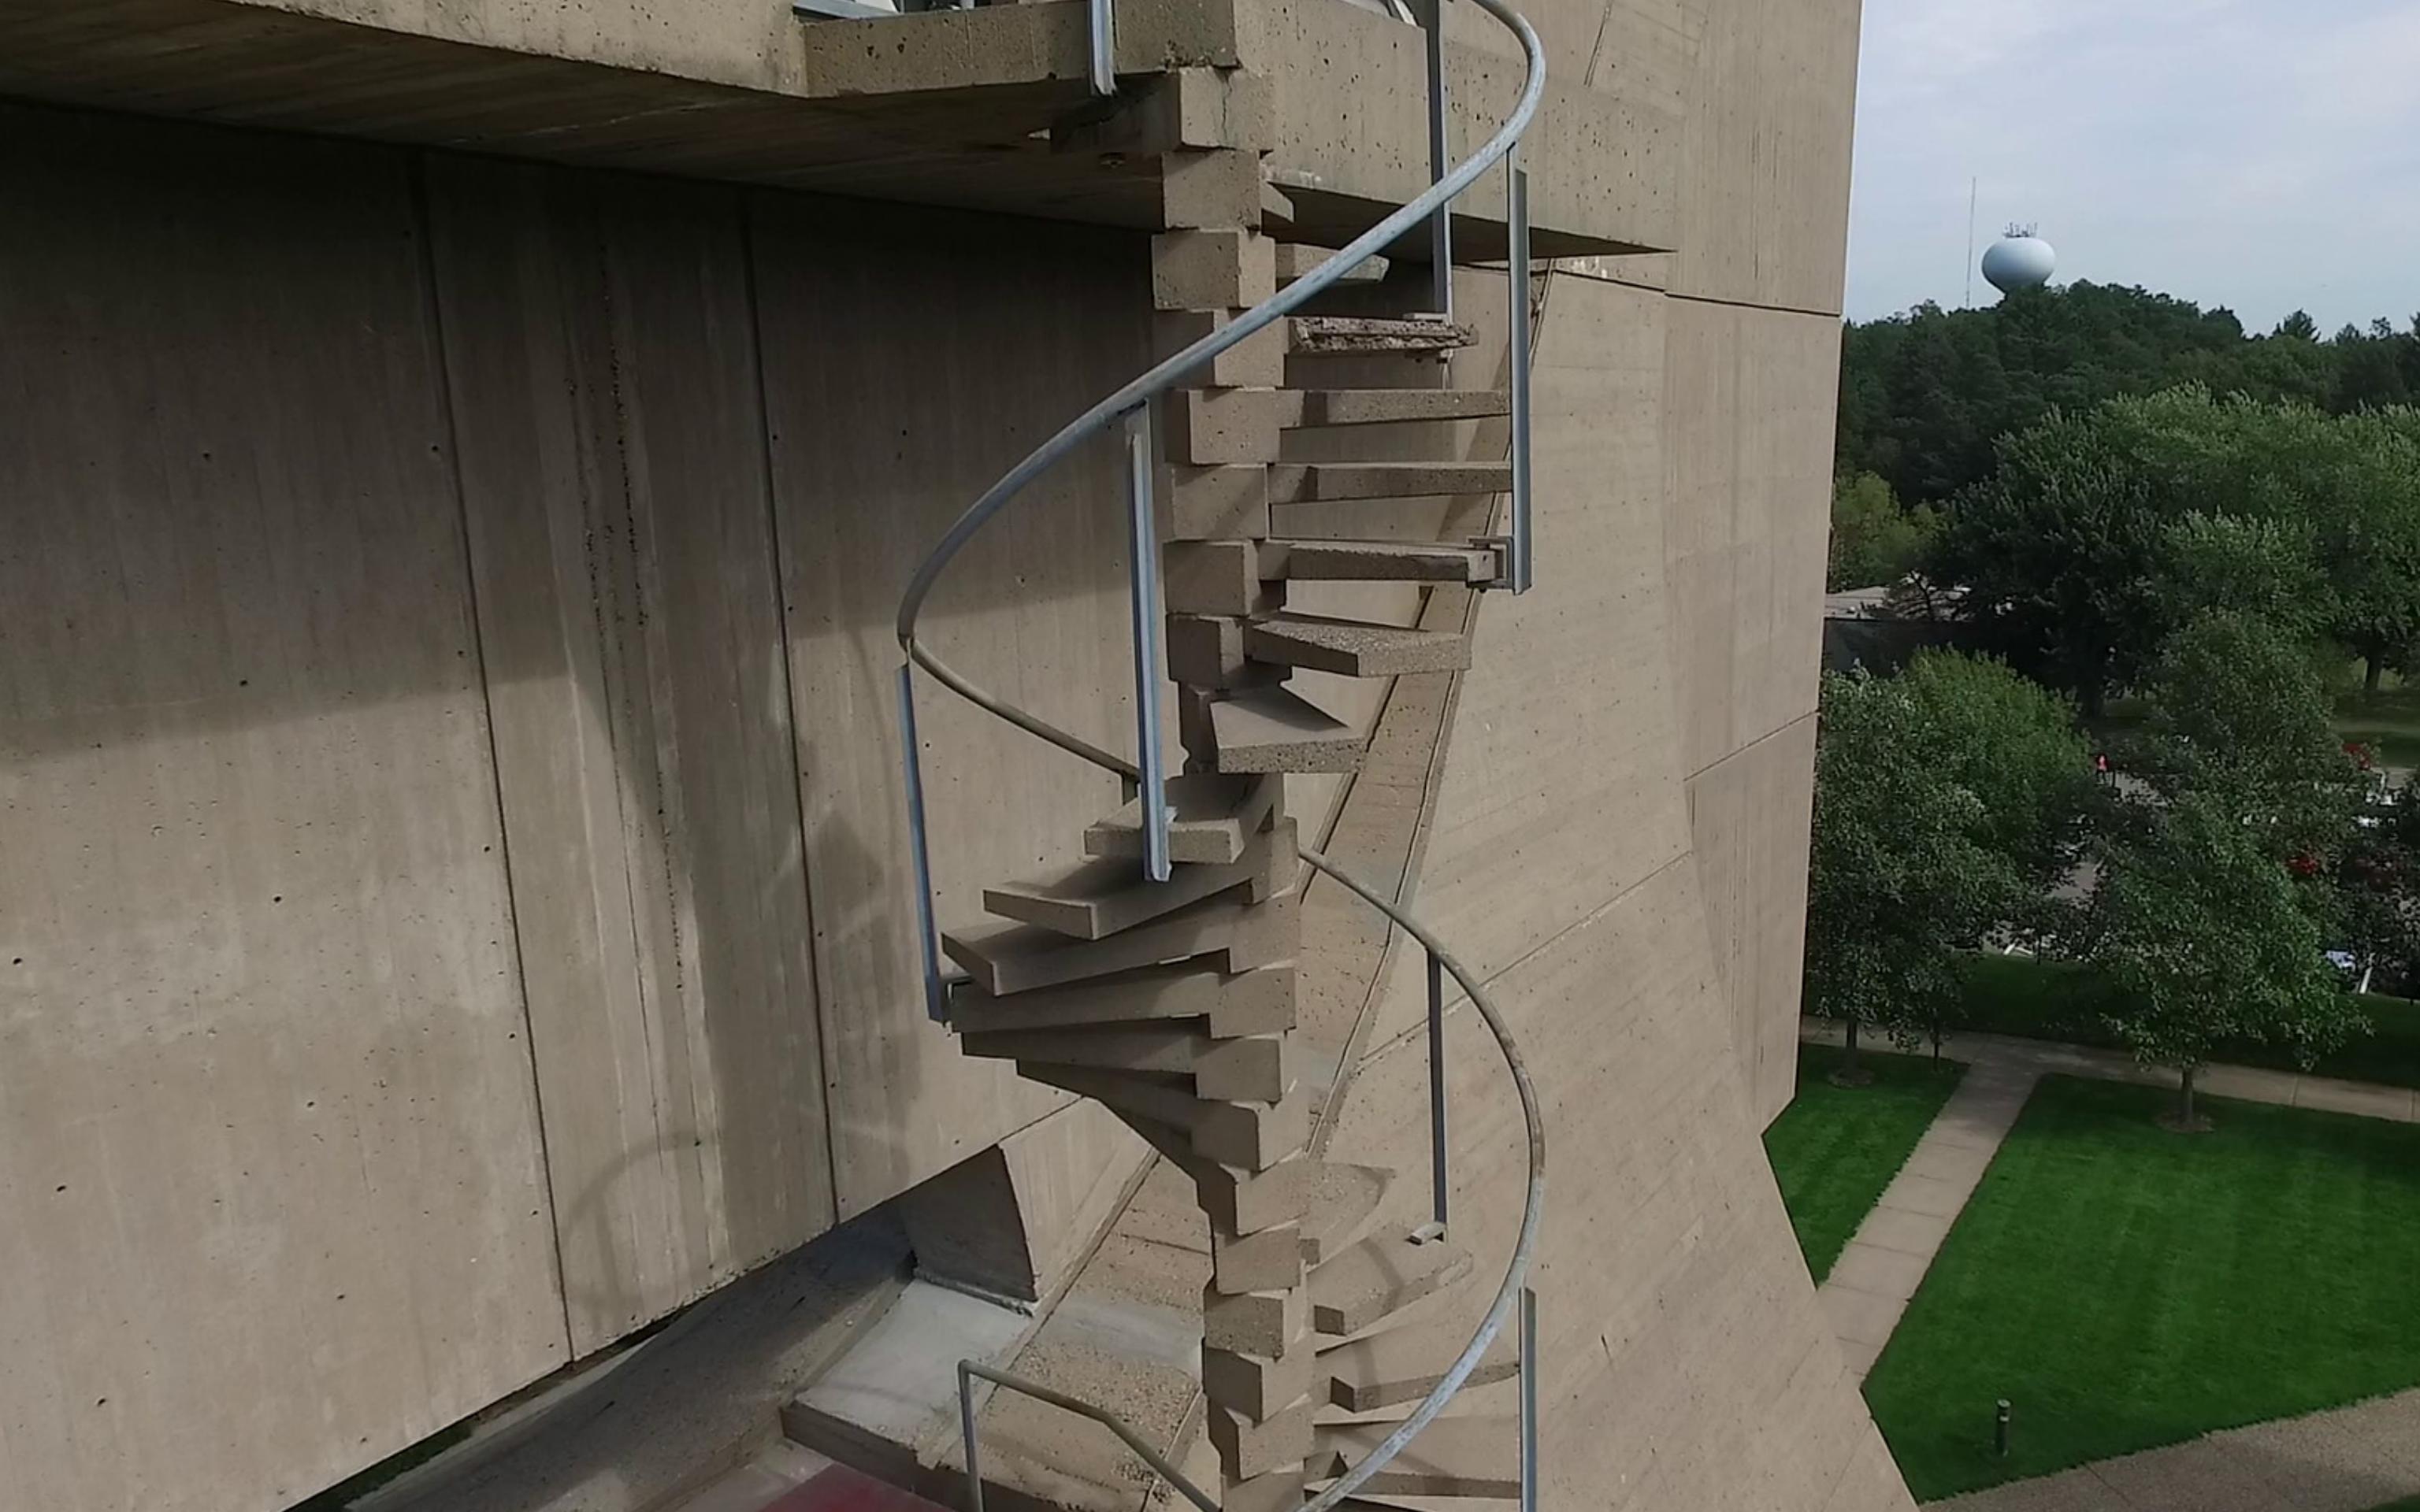
Exposed Cabling

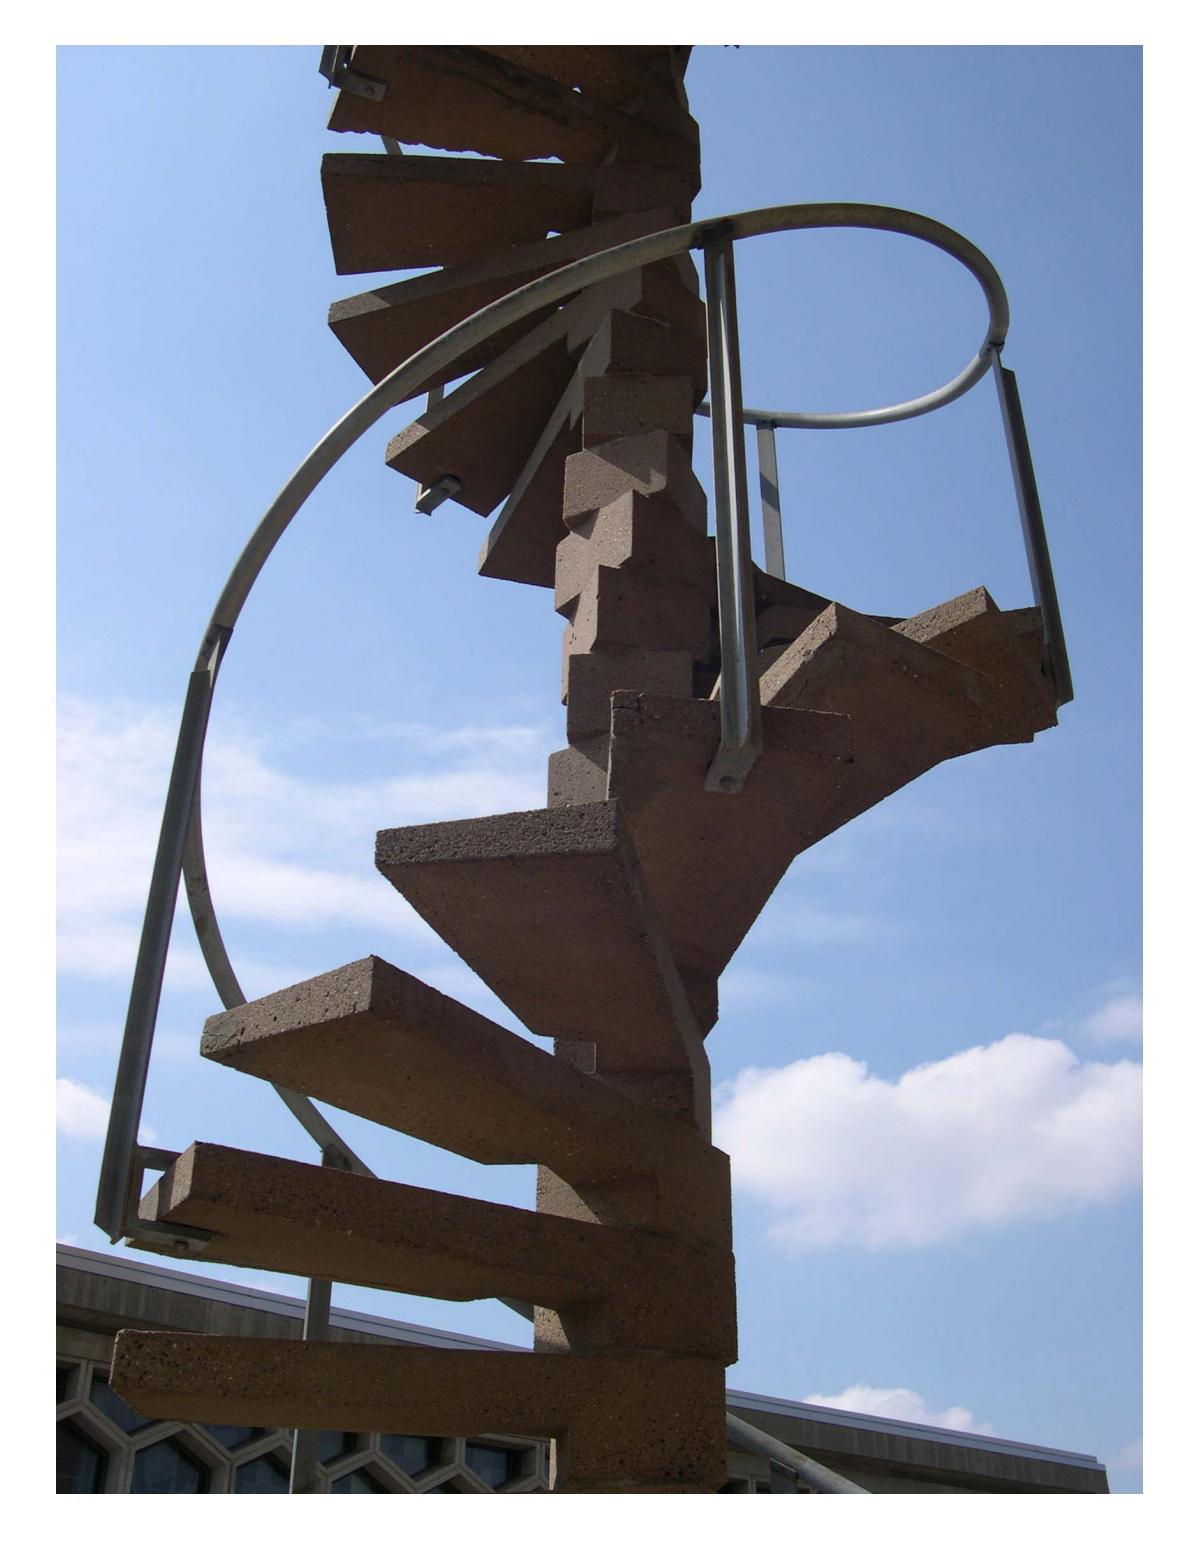
Photo 8 – April 2008 photo - The stair from the Bell Banner lower landing showing major cracking and spalling of the front face of tread.

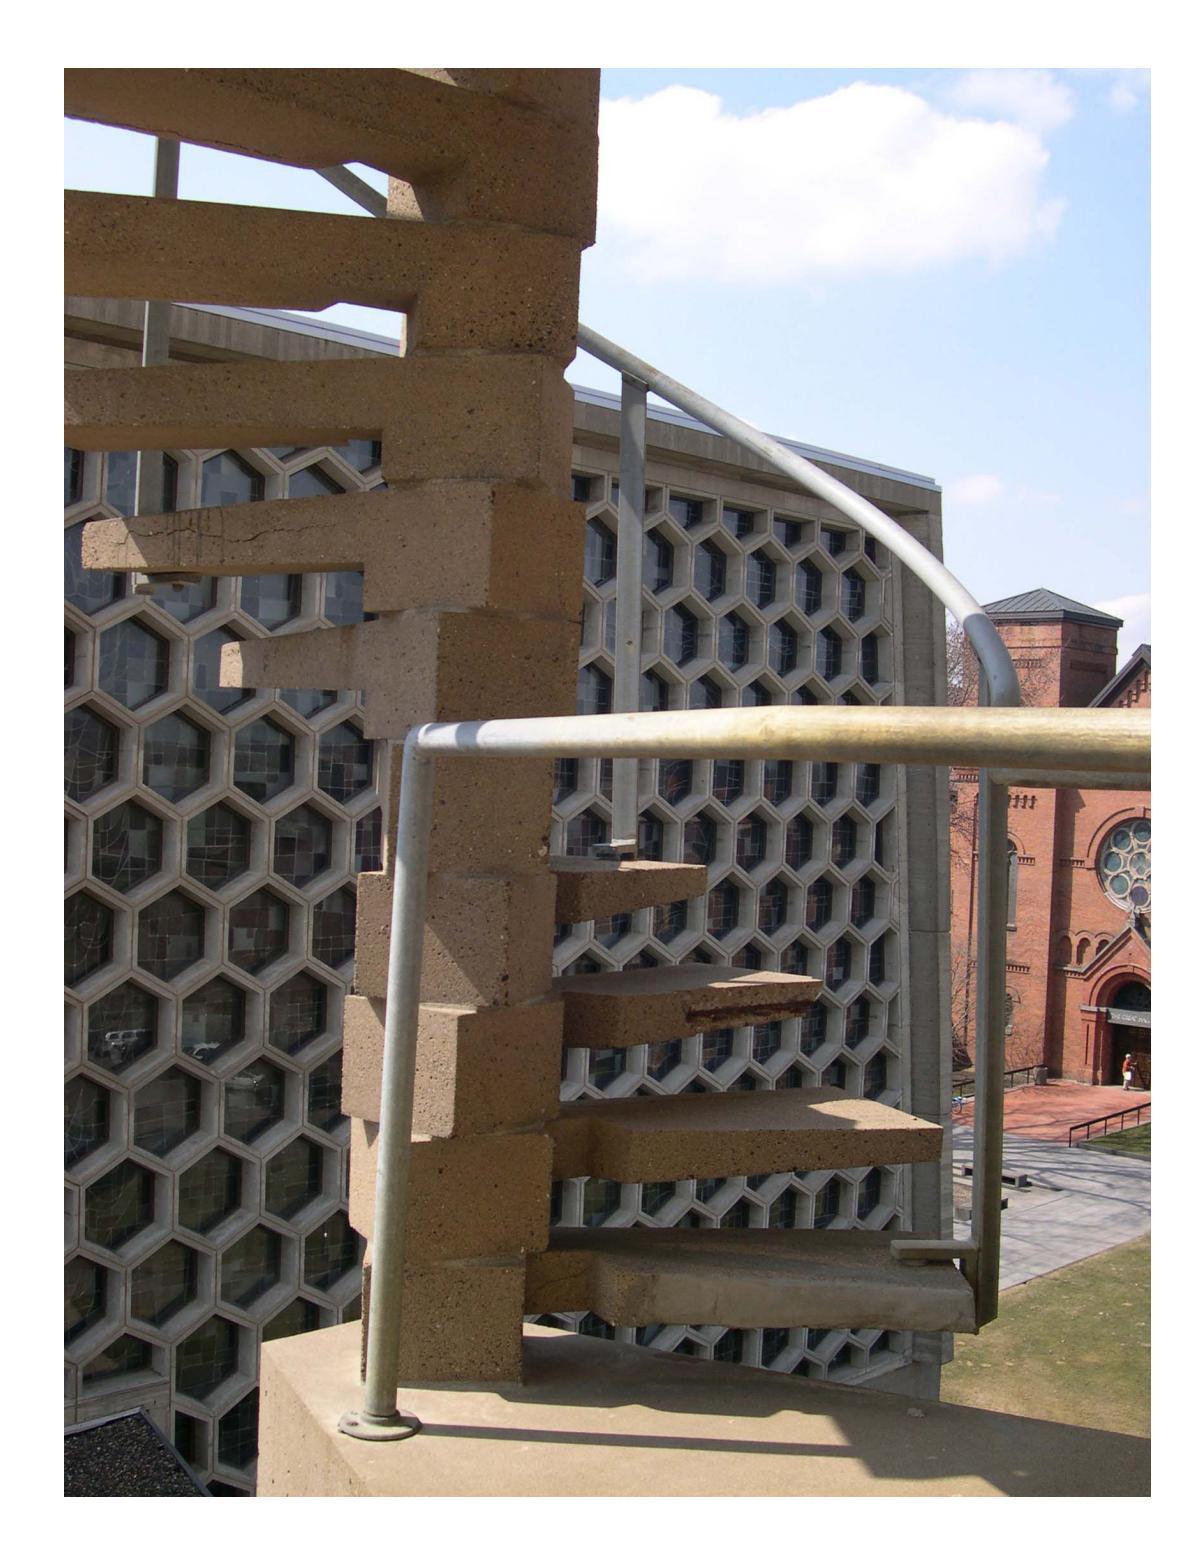
Photo 9 – April 2008 photo - The stair from the Bell Banner lower landing showing major cracking and spalling of the front face of tread.

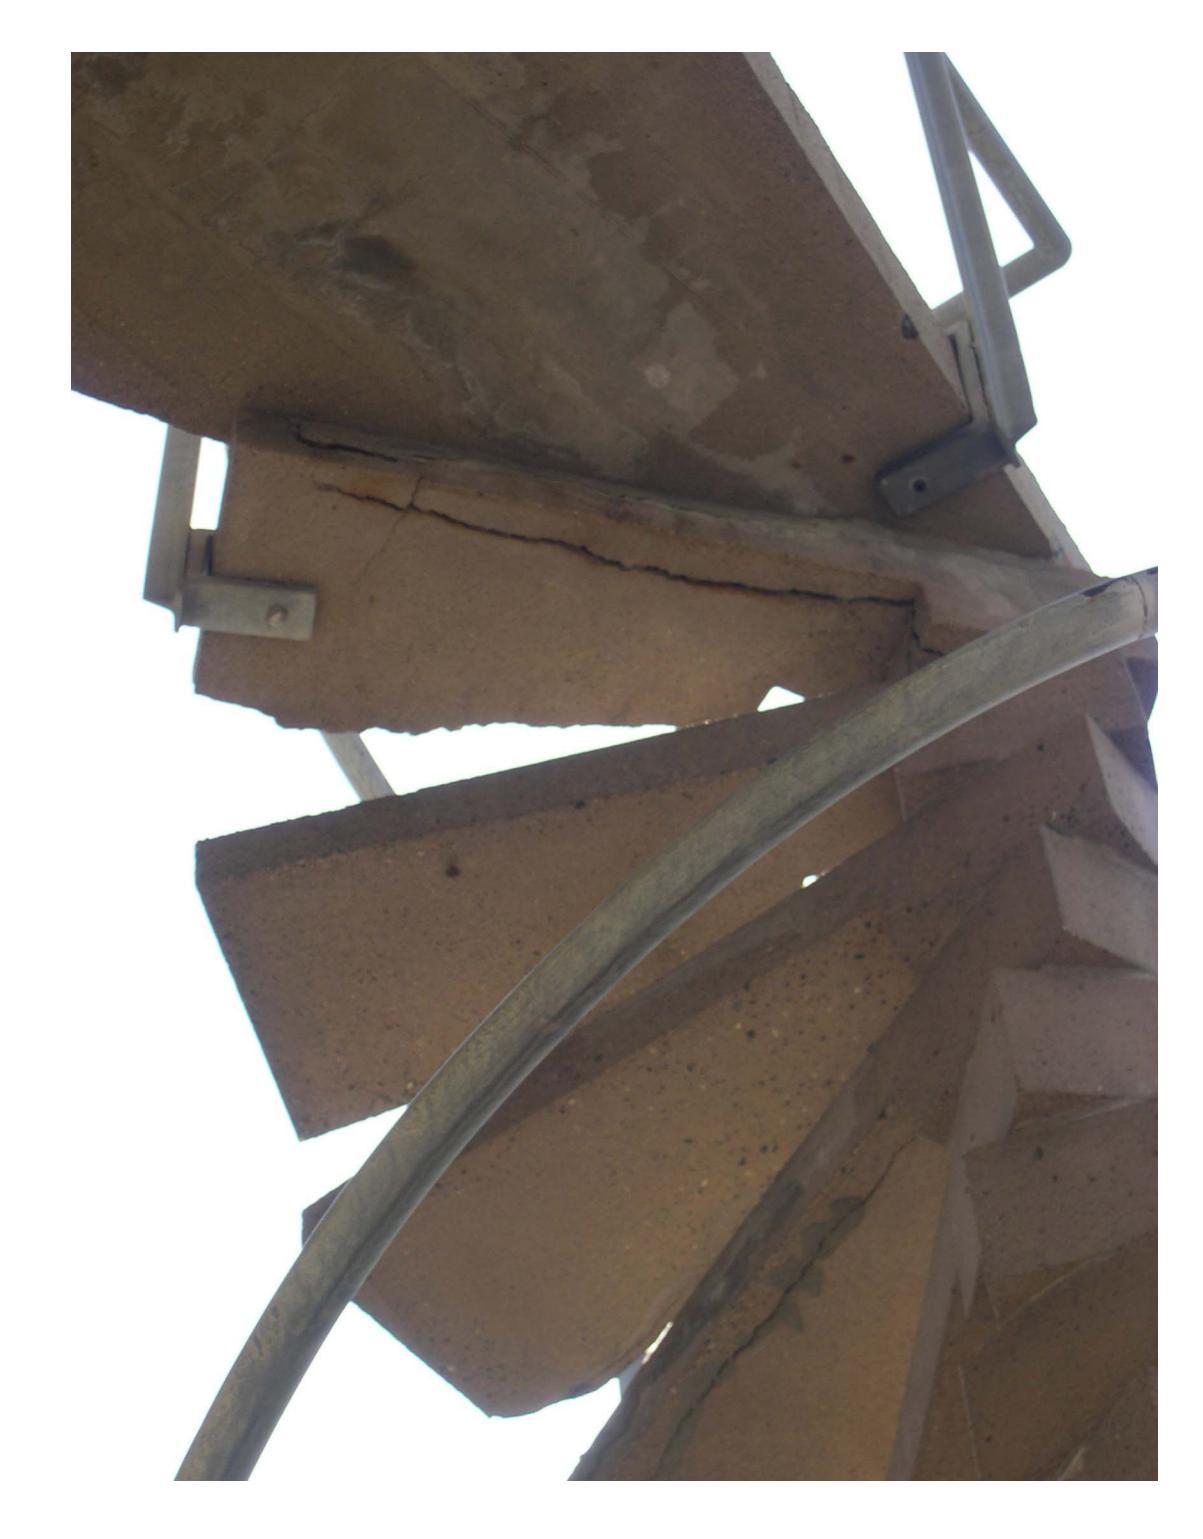
Photo 10 – April 2008 photo - The stair from the Bell Banner lower landing looking up at the upper landing - showing major cracking and spalling of the front face of tread.
