FINAL REPORT July 2016

SAINT JOHN'S ABBEY CHURCH

CONSERVATION RESTORATION PRESERVATION

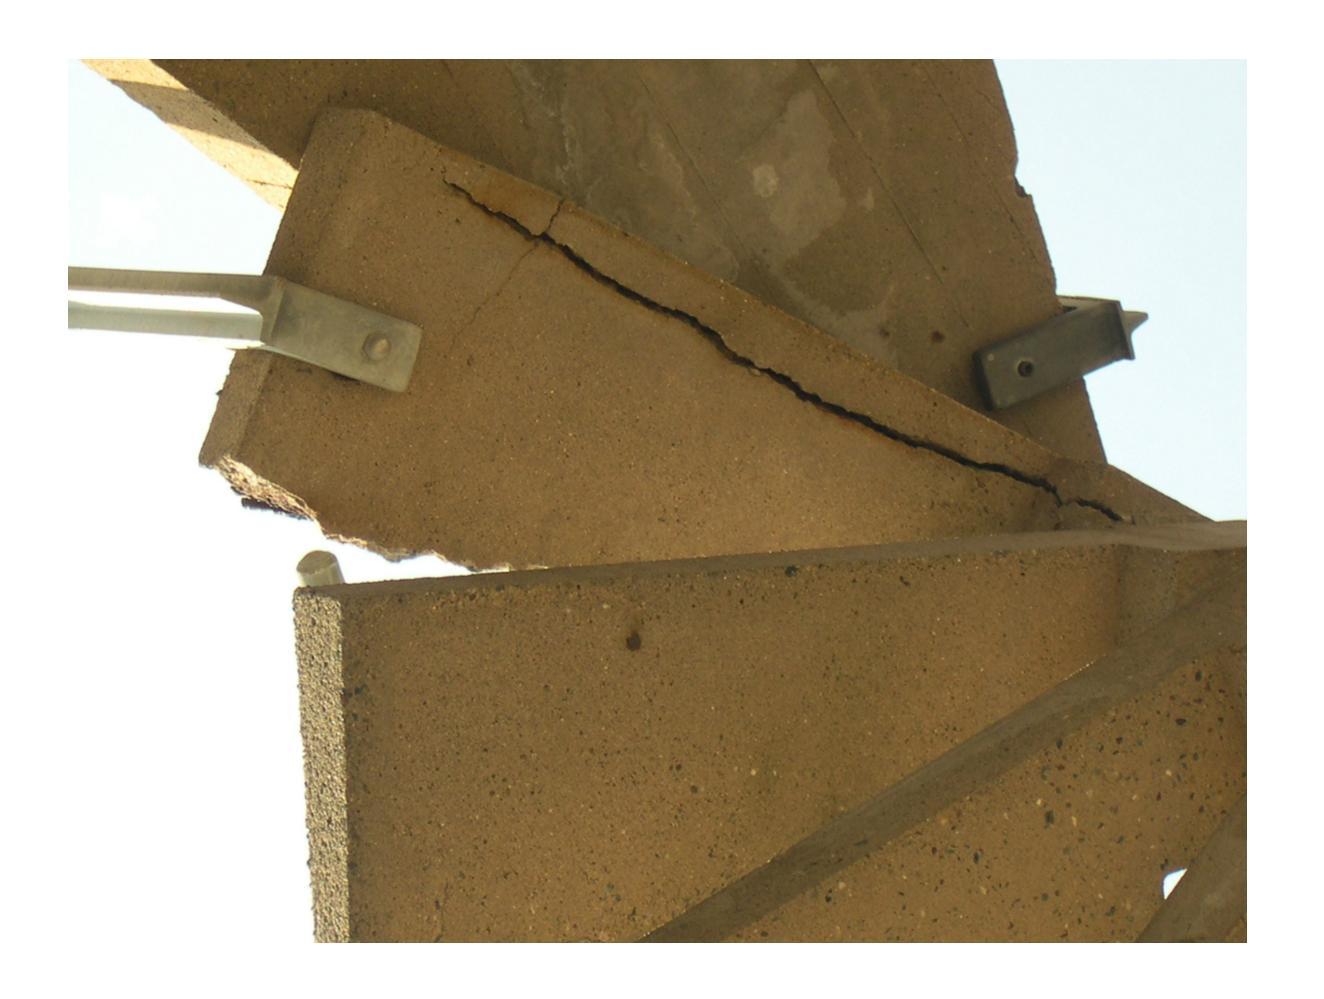
Photo 11 – April 2008 photo - The stair from the Bell Banner lower landing looking up - showing major cracking and spalling of the front face of tread.

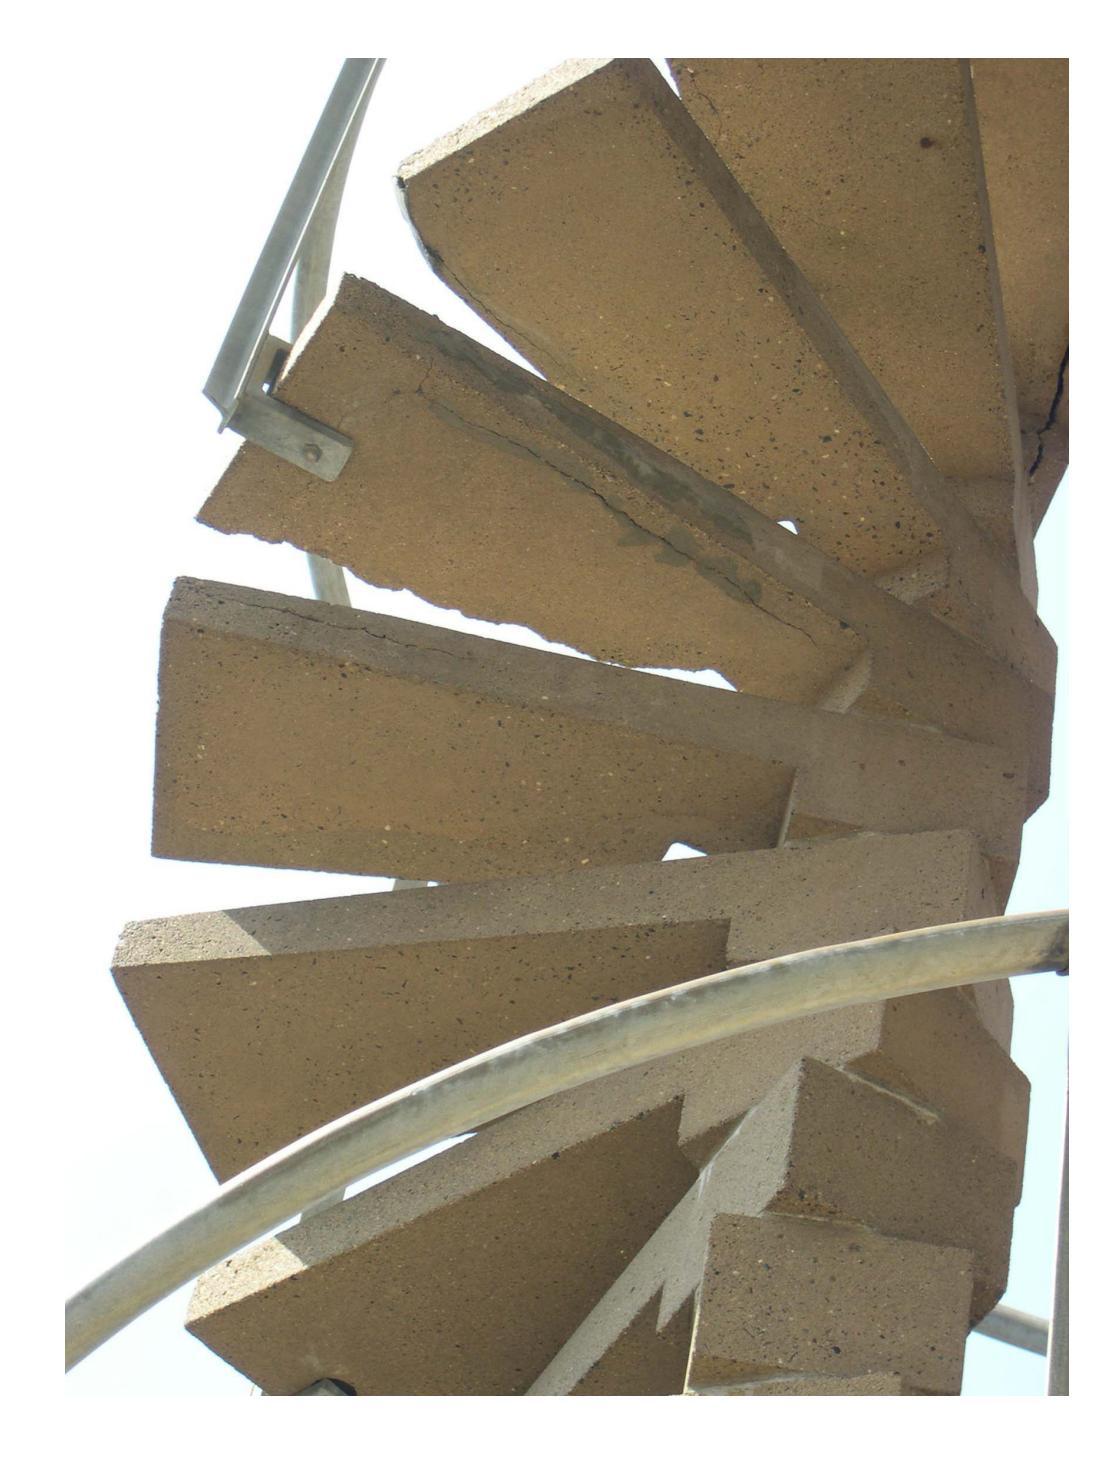
Photo 12 – April 2008 photo - The stair from the Bell Banner lower landing looking up - showing major cracking and spalling of the front face of tread.

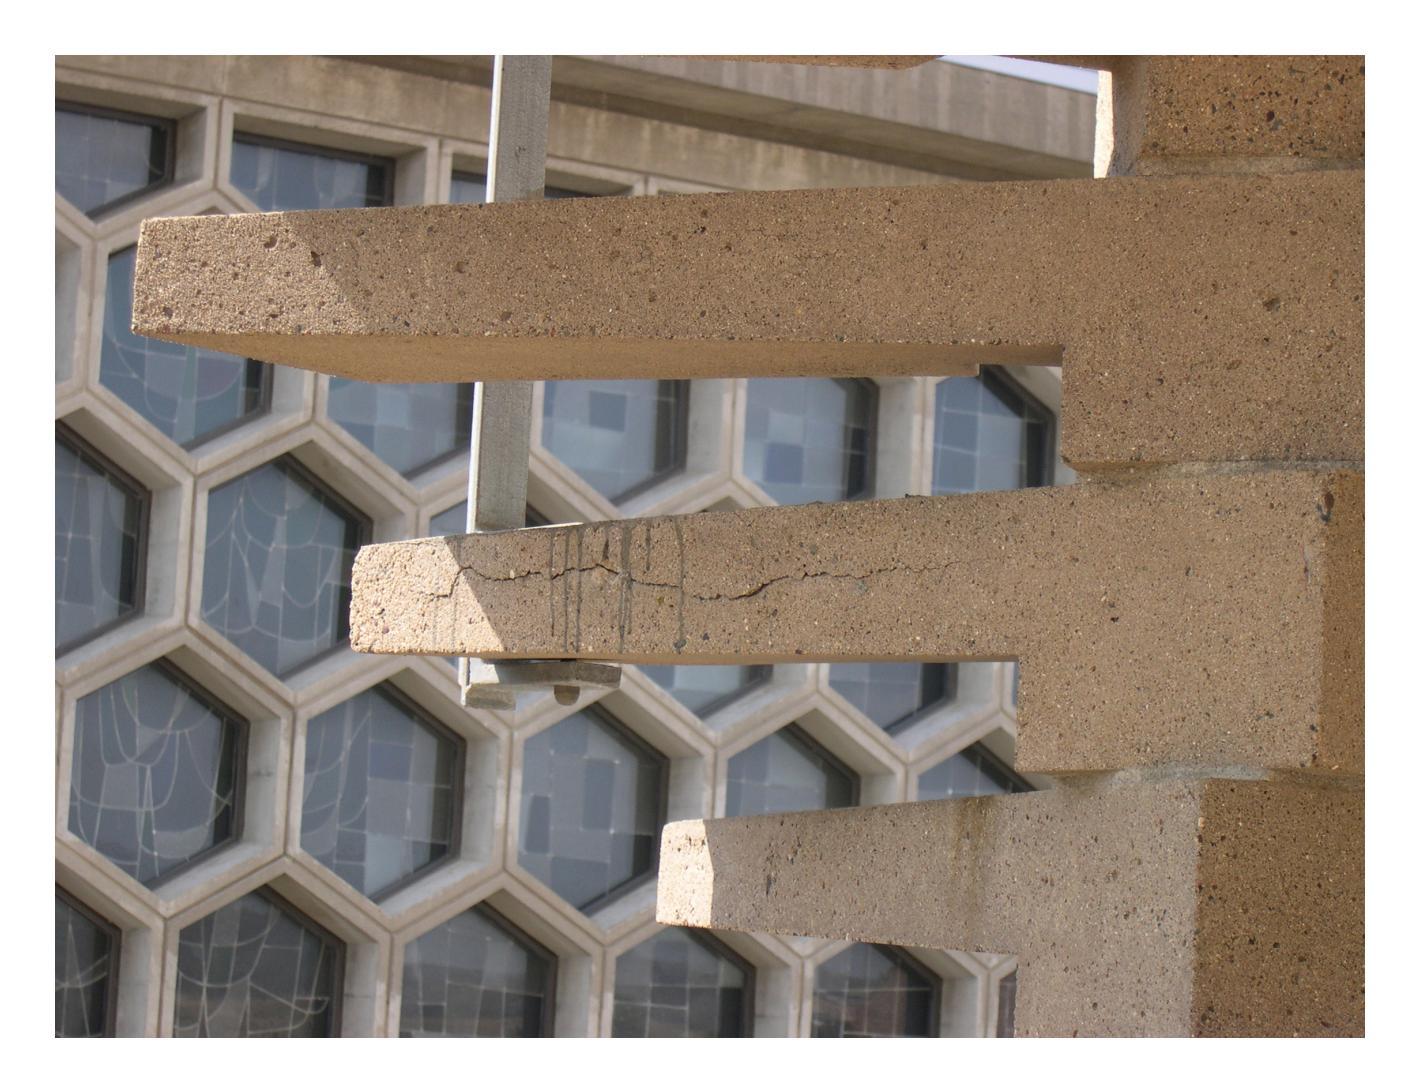
Photo 13 – April 2008 photo - The stair from the Bell Banner lower landing looking up - showing major cracking on rear of tread.

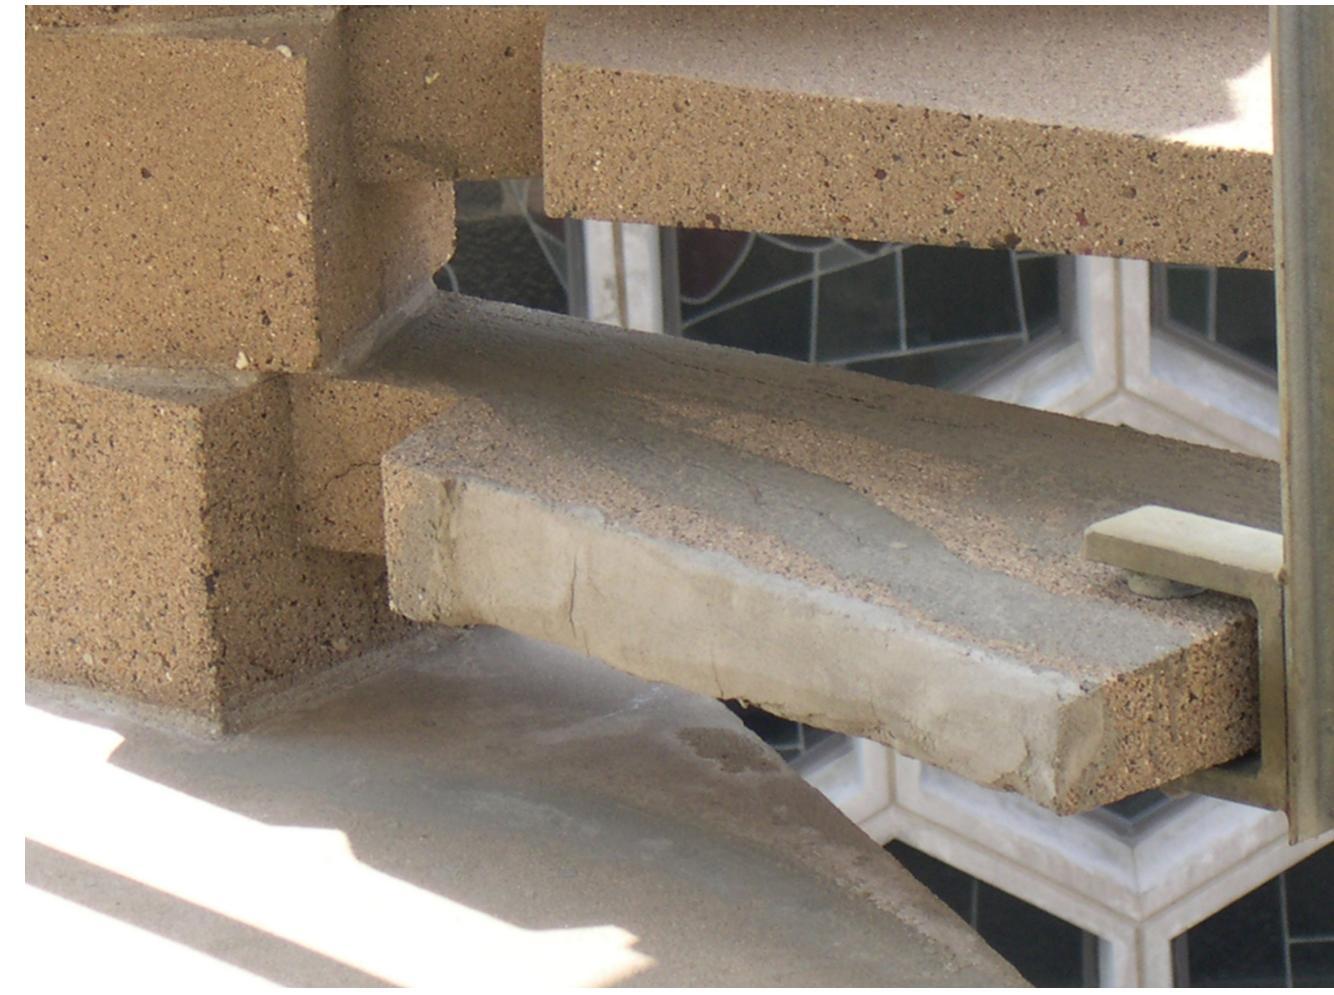
Photo 14 – April 2008 photo - The stair from the Bell Banner lower landing - showing concrete repair on front face of tread. Also showing there is a mortar joint between each tread as assumed from our review of the archive drawings.

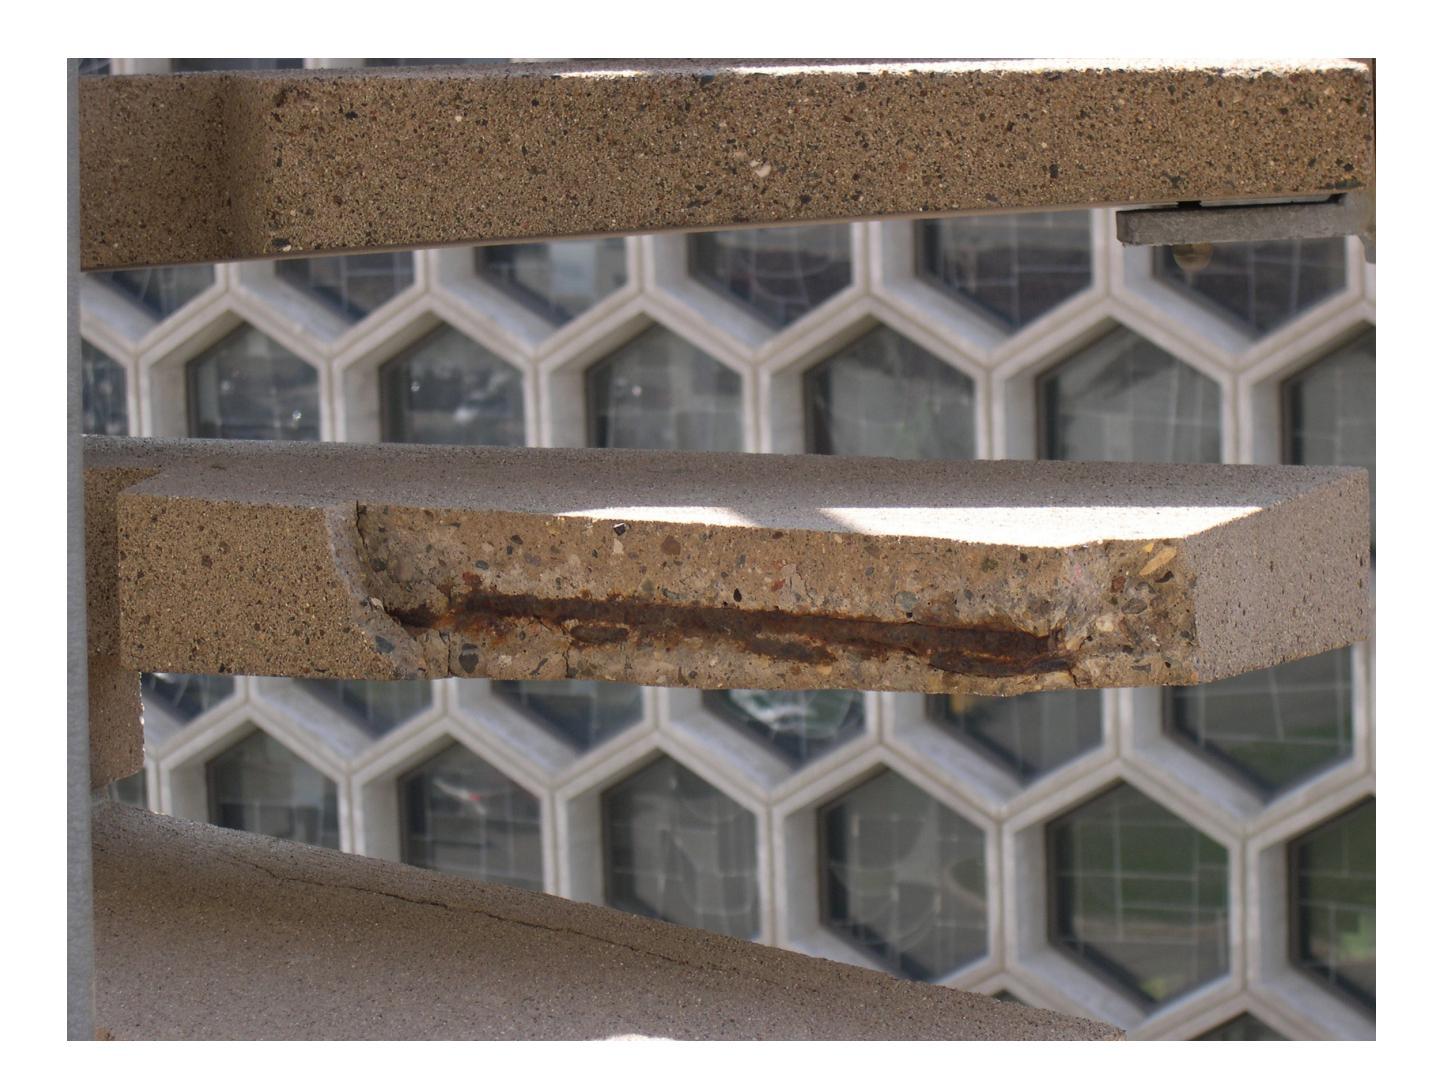
Photo 15 – April 2008 photo - The stair from the Bell Banner lower landing - showing concrete spalling on the front face of a tread and extensive reinforcement corrosion.

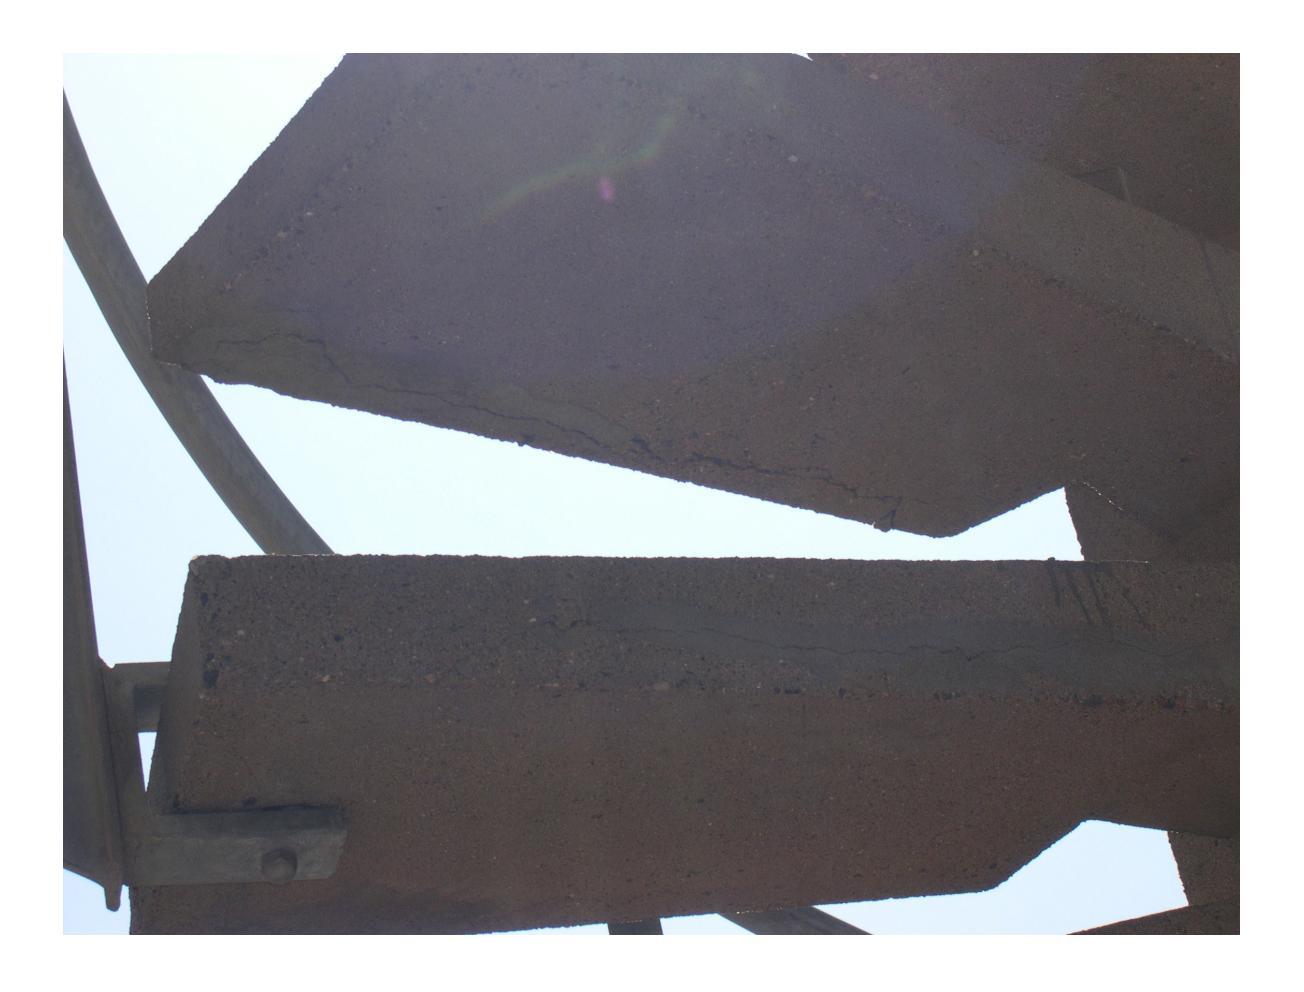
Photo 16 – April 2008 photo - The stair from the Bell Banner lower landing looking up - showing cracking on the front face of a tread.

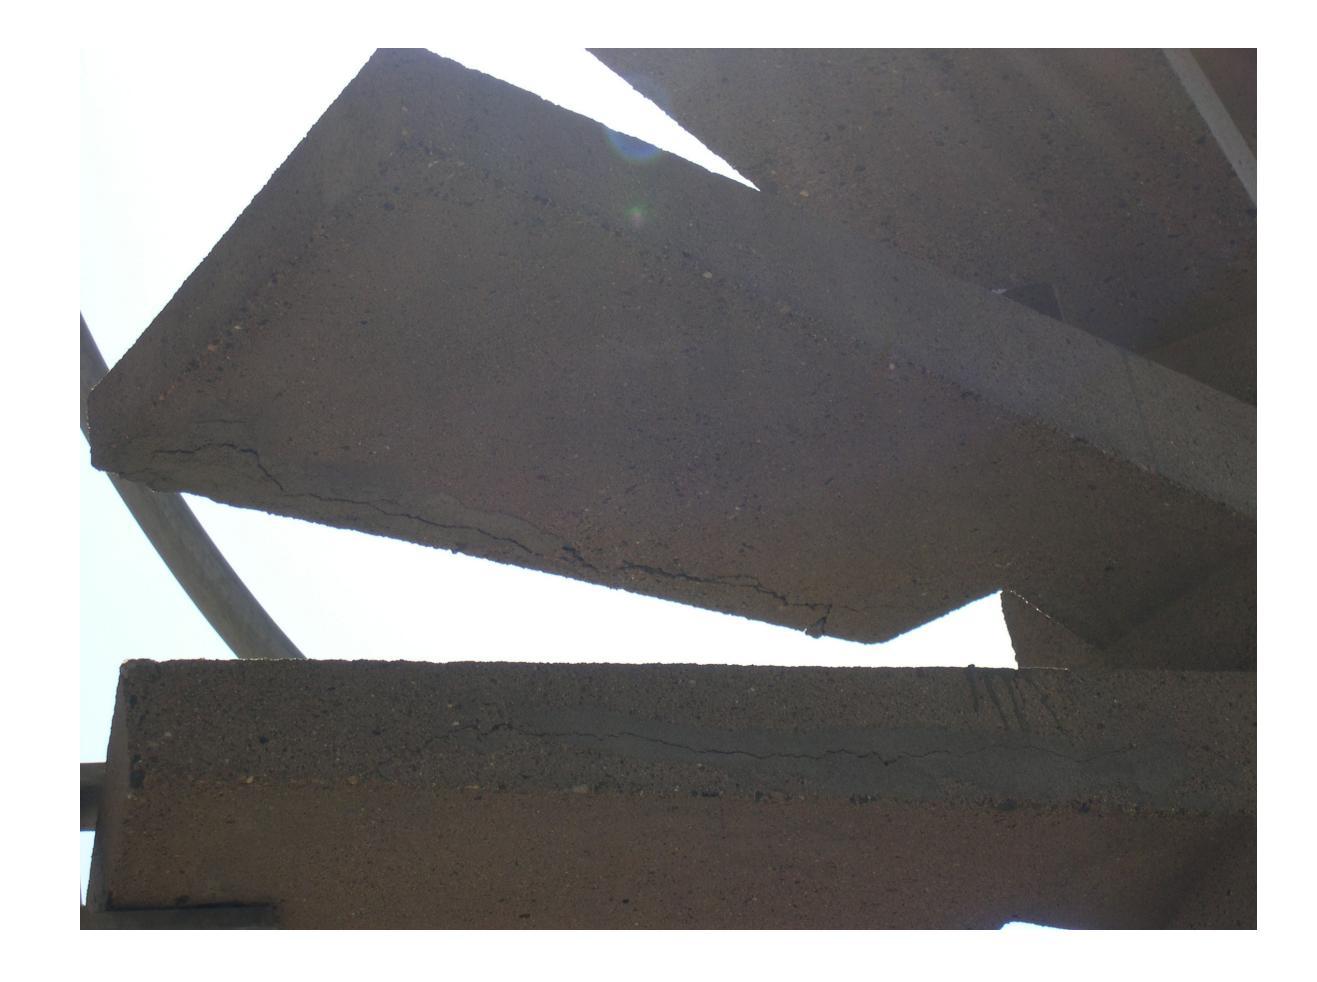
Photo 17 – April 2008 photo - The stair from the Bell Banner lower landing looking up - showing cracking on the front face of a tread and rear face of a lower tread.

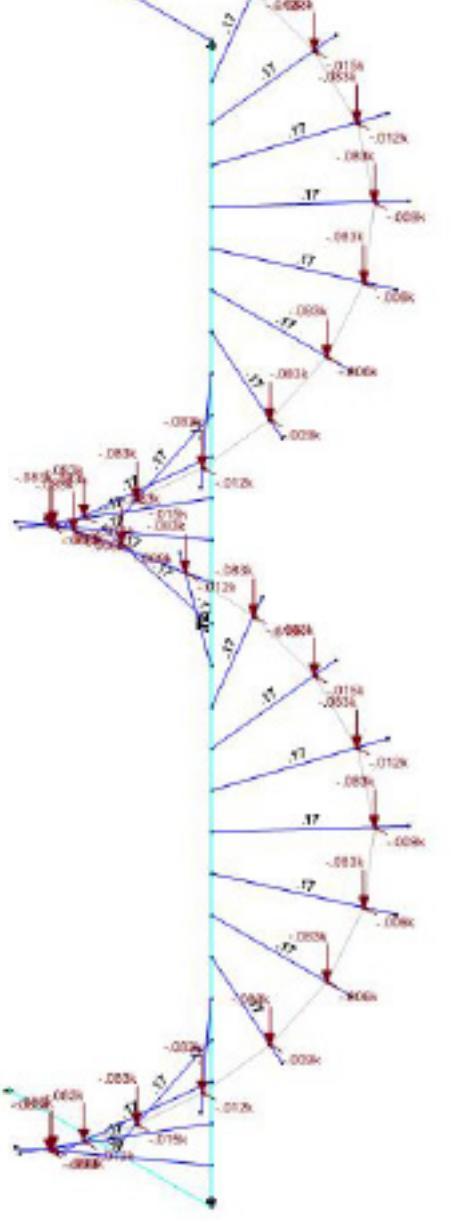
Under static load combinations (and per the Minnesota 2015 code – based on the IBC 2012 code) using a dead load self-weight of the concrete tread (at 145 pcf), a live load of 40psf for maintenance catwalk access (ASCE 7-10 Table 4-1. The live load was applied to the exposed portion of each tread as shown in Image 2, p.120), a snow load of 42psf and a laterally applied wind load of 35 psf, our analysis discovered a lateral maximum deflection of the central steel pipe column of 2", which is within the acceptable stress range of the pipe. This is a conservative analysis as it is unlikely that a full live load will be in place when there is an extreme snow or wind event. Refer to Image 3 (p.123) for the overall stair's deflected shape. The governing loads for stress in the pipe and the results of the code check are shown in Image 4(p.123).

Image 4 – Isometric view with upper and lower landing supports on the left of the image. This shows the maximum live loads on each tread. The numbers represent the stress in the members on a scale of Zero to One (with One being maximum allowed stress).

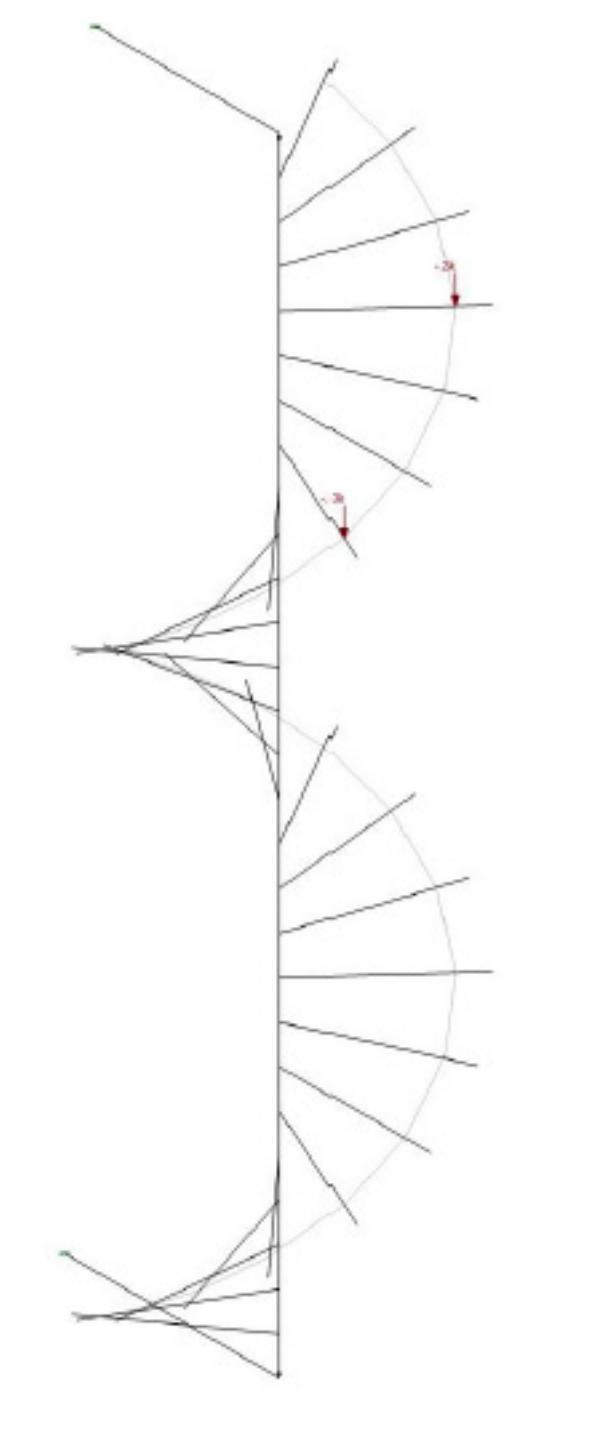
(limited by the closest people could be to each other). We ran this dynamic load configuration in conjunction with the dead load self-weight for an ascending or descending moving load on the stair and found the worst case condition shown in Image 5 (p.121). The governing loads for stress, due to concentrated load, in the pipe and the results of the code check are shown in Image 6 (p.122).

Image 5 – Isometric view with upper and lower landing supports on the left of the image. This shows the maximum concentrated dynamic moving live load combination on the stair.

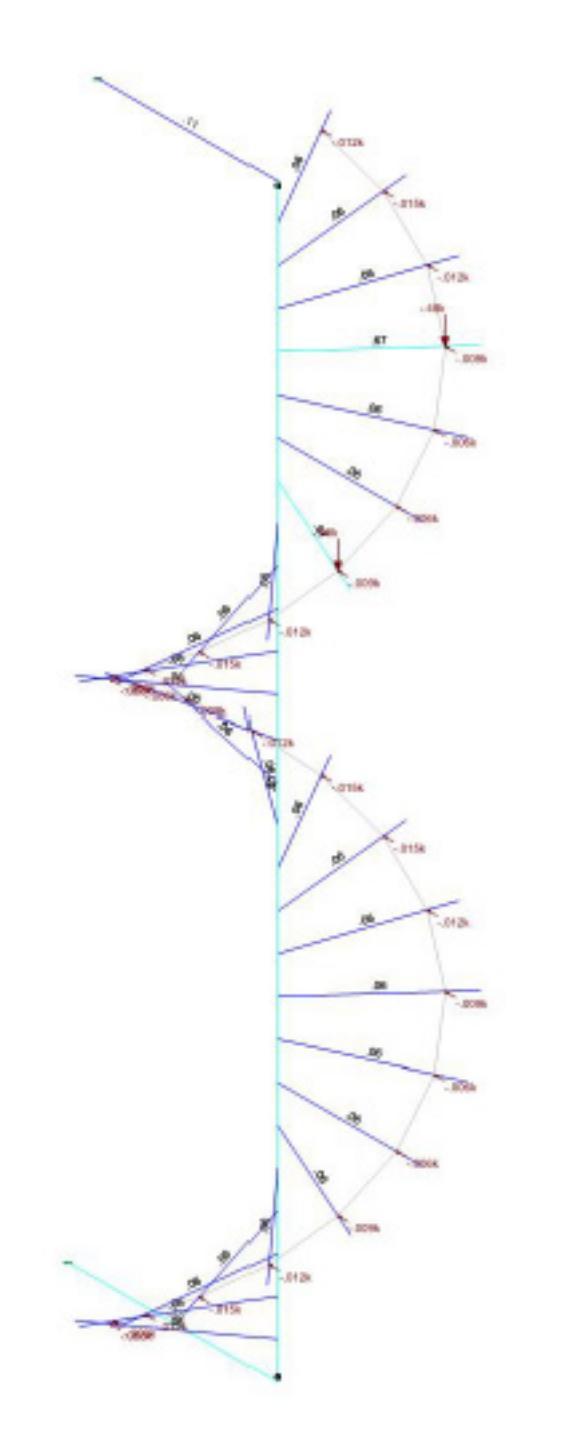
Image 6 – Isometric view with upper and lower landing supports on the left of the image. This shows the maximum concentrated dynamic moving live load combination on the stair. The numbers represent the stress in the members on a scale of Zero to One (with One being maximum allowed stress).

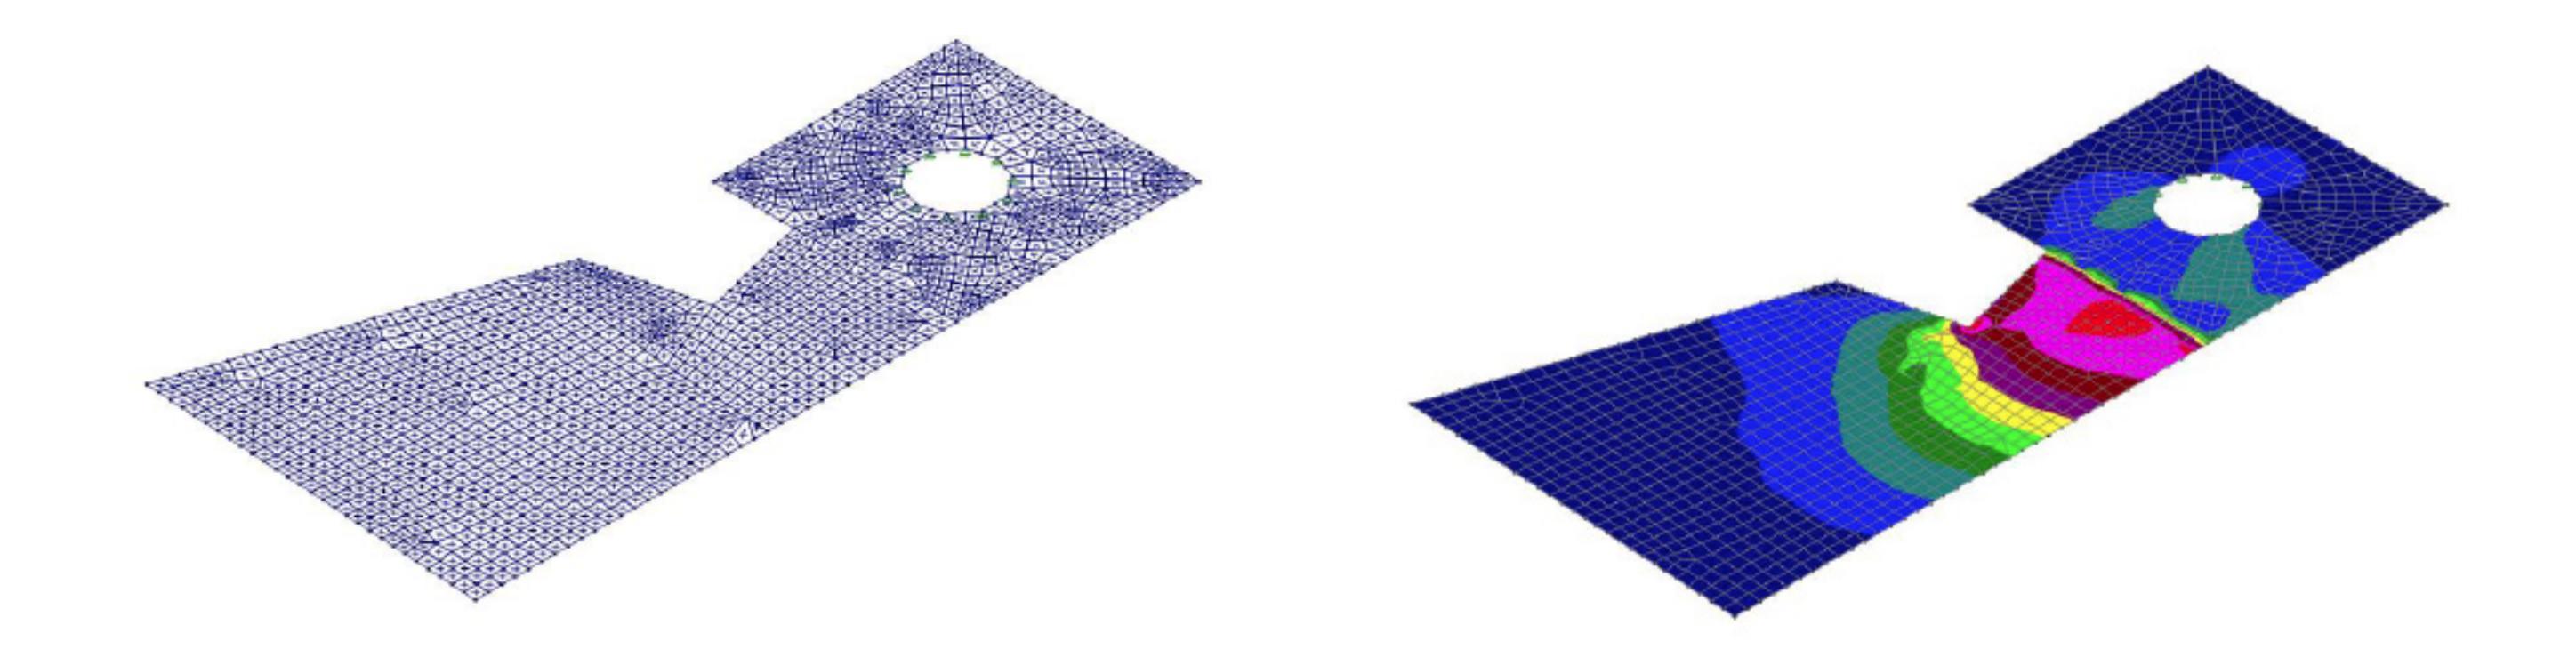
To analyze each individual tread two methods were employed. First the tread was minimally sized to be 2 3/4" deep by 5 1/4" wide (the narrowest section) by 2'-6" long and analyzed in Enercalc software. Minnesota 2015 (IBC 2012) load combinations were applied to this section to find that it is within code standards for deflection and stress. Please refer to Image 7 (p.122). Next the tread was modeled using Finite Element plate analysis in RISA-3D software. Please refer to Image 8 (p.123,left) for the Finite Element mesh used. This software provides bending stress contours in the tread under dead and live loads that will be used in the design of the replacement stair treads. Please refer to Image 9 for the results (p. 123, right).

Image 8 – Isometric view of stair tread modeled as a Finite Element plate element. This shows the Finite Element mesh used to model the intricate tread geometry. Image 9 – Isometric view of stair tread modeled as a Finite Element plate element. This shows the bending stress contours under dead and live load for the intricate tread geometry.

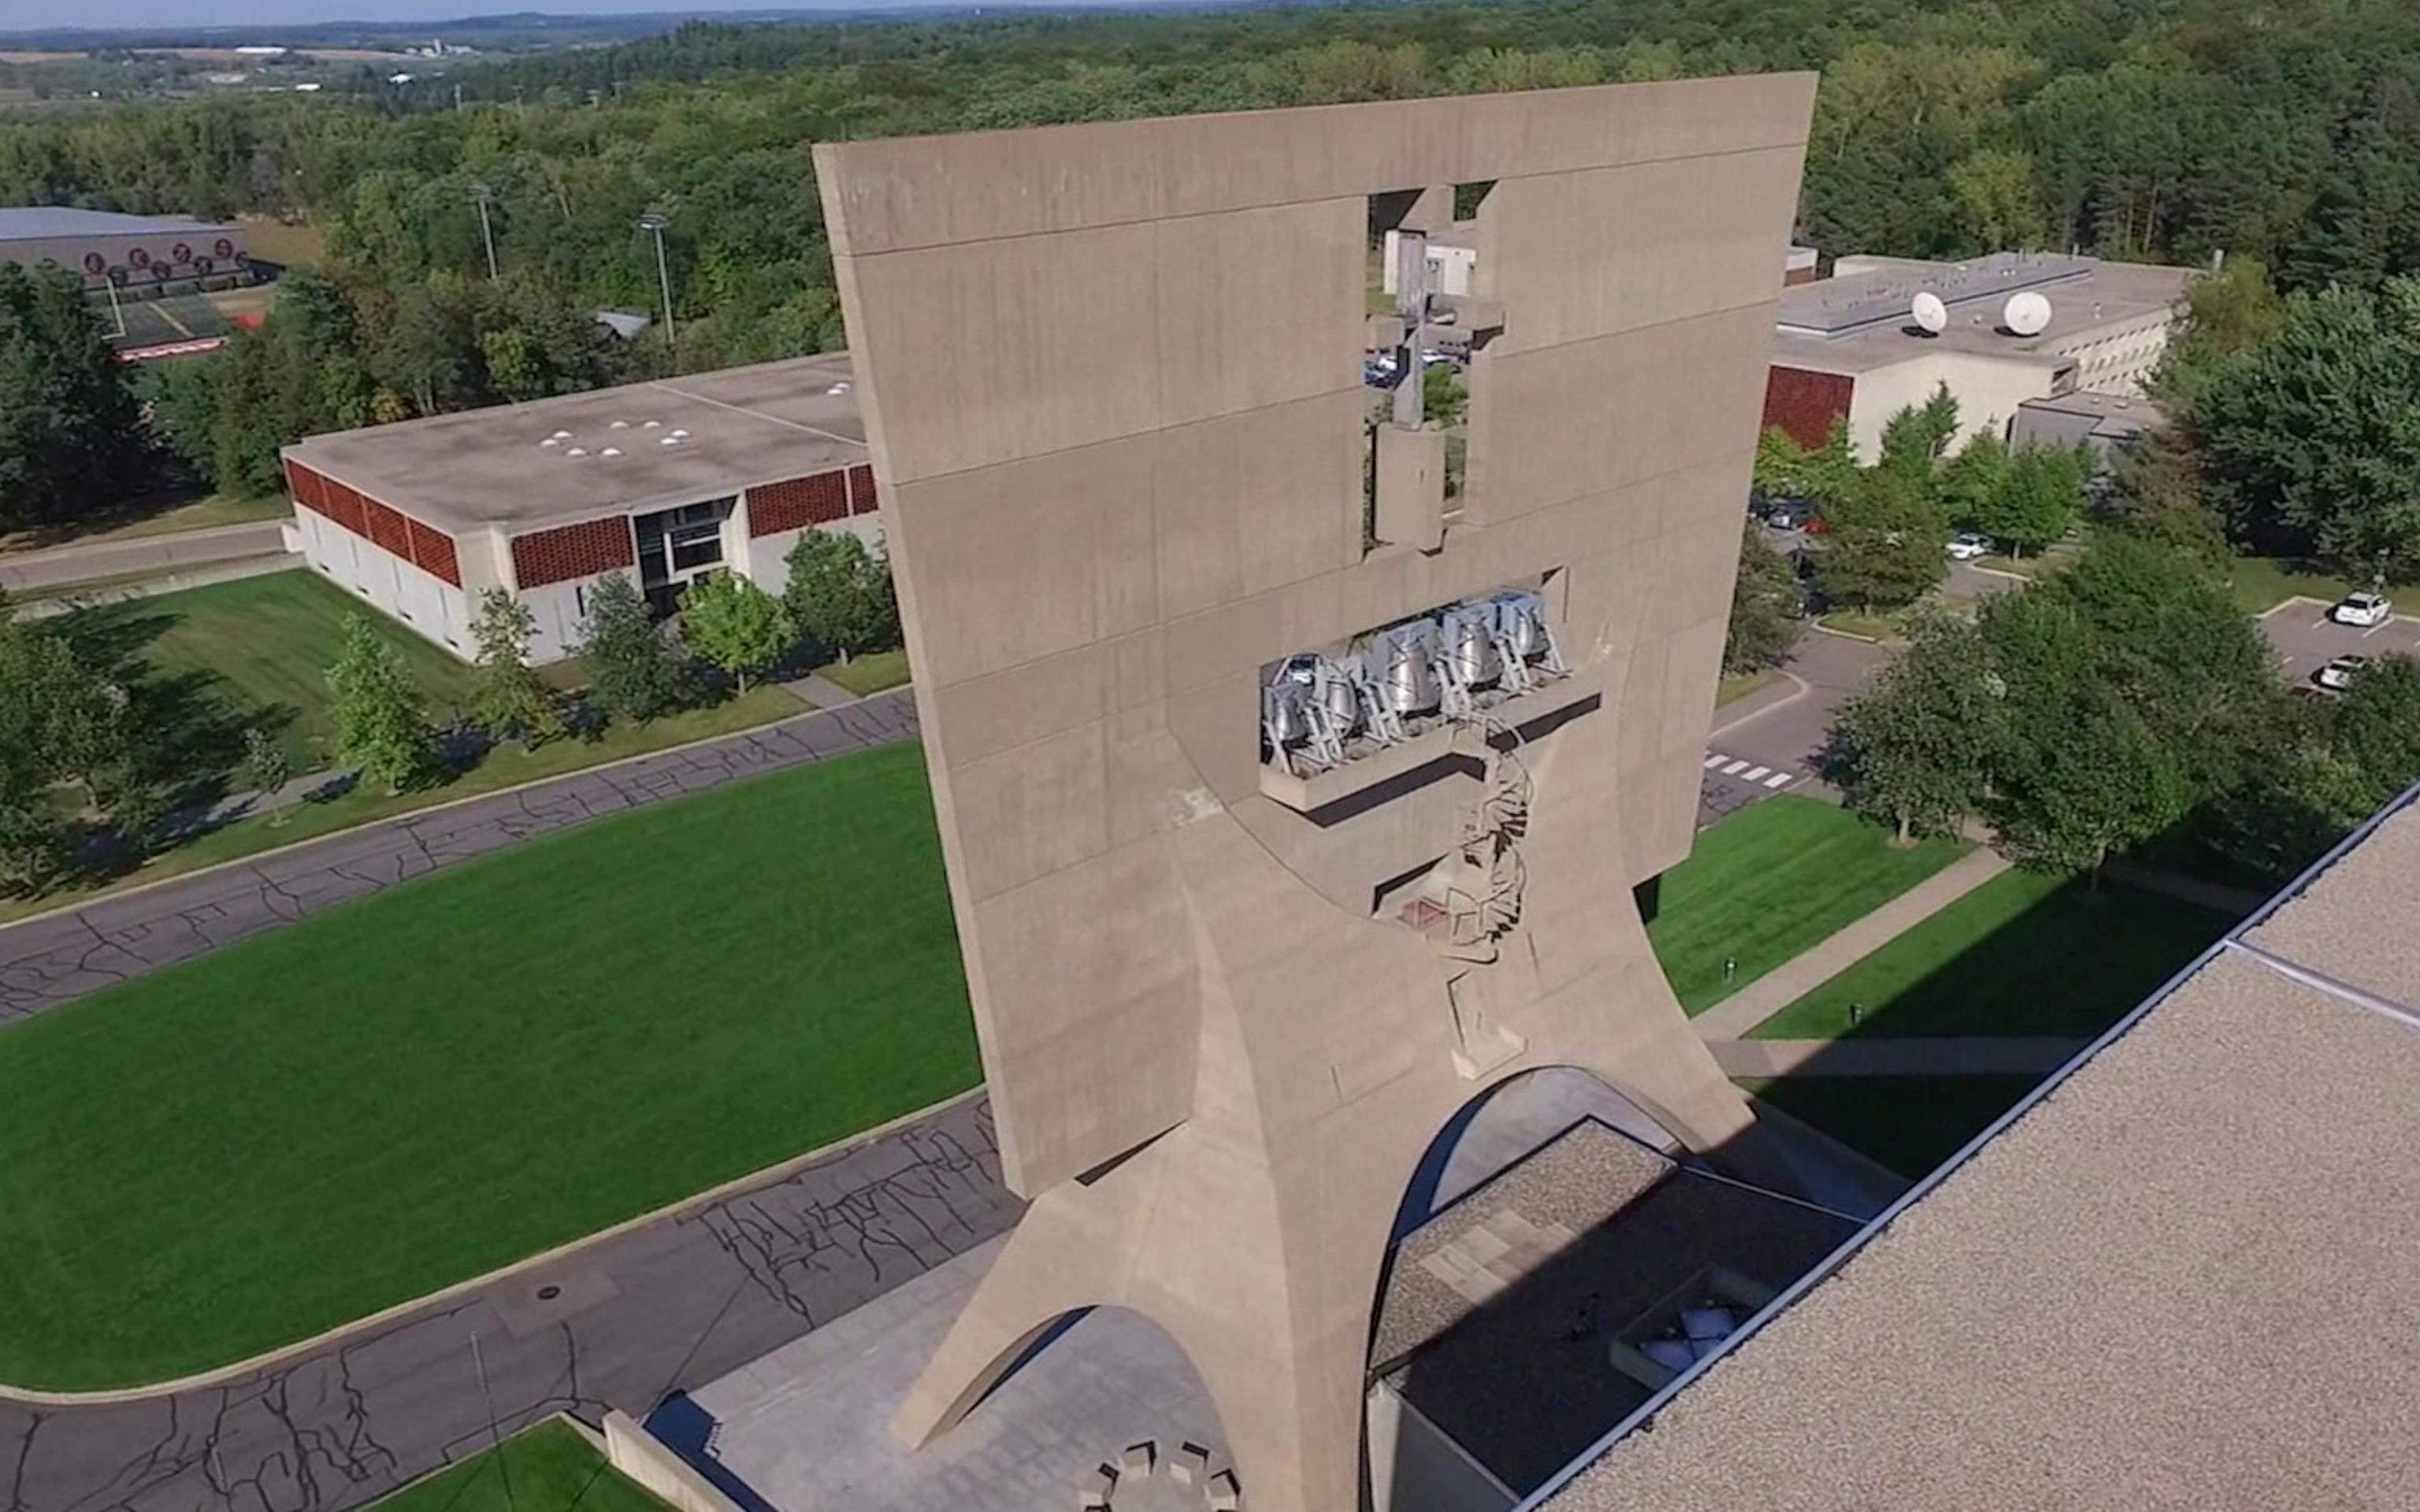
The existing plaza is paved with granite stone pavers. Each paver has dimensions of about 2-feet by 3- feet. Mr. Mike Guggenberger, Artistic Stone and Concrete, indicated the pavers experience continual movement, tipping, and occasionally crack. They all cause tripping hazards. The plaza is elevated about 3 feet above the drive and parking areas to the west, and is accessed with granite stairs.

Based on the penetration resistances, the existing fill soils appear to be poorly compacted. Based on the laboratory test results, they are also frost-susceptible.

Uncompacted fill soils can consolidate under loads or when they become saturated. The consolidation is typically not uniform. Frost-susceptible soils will heave when they become saturated and freeze.

To reduce the potential for settlement and frost heave, we recommend removing the existing fill soils and replacing them with nonfrost-susceptible sands. Recommendations are presented below in Section D.

We recommend removing the existing fill from below the pavers and steps. Based on the borings, excavation depths are expected to range from approximately 7 to 9 feet.

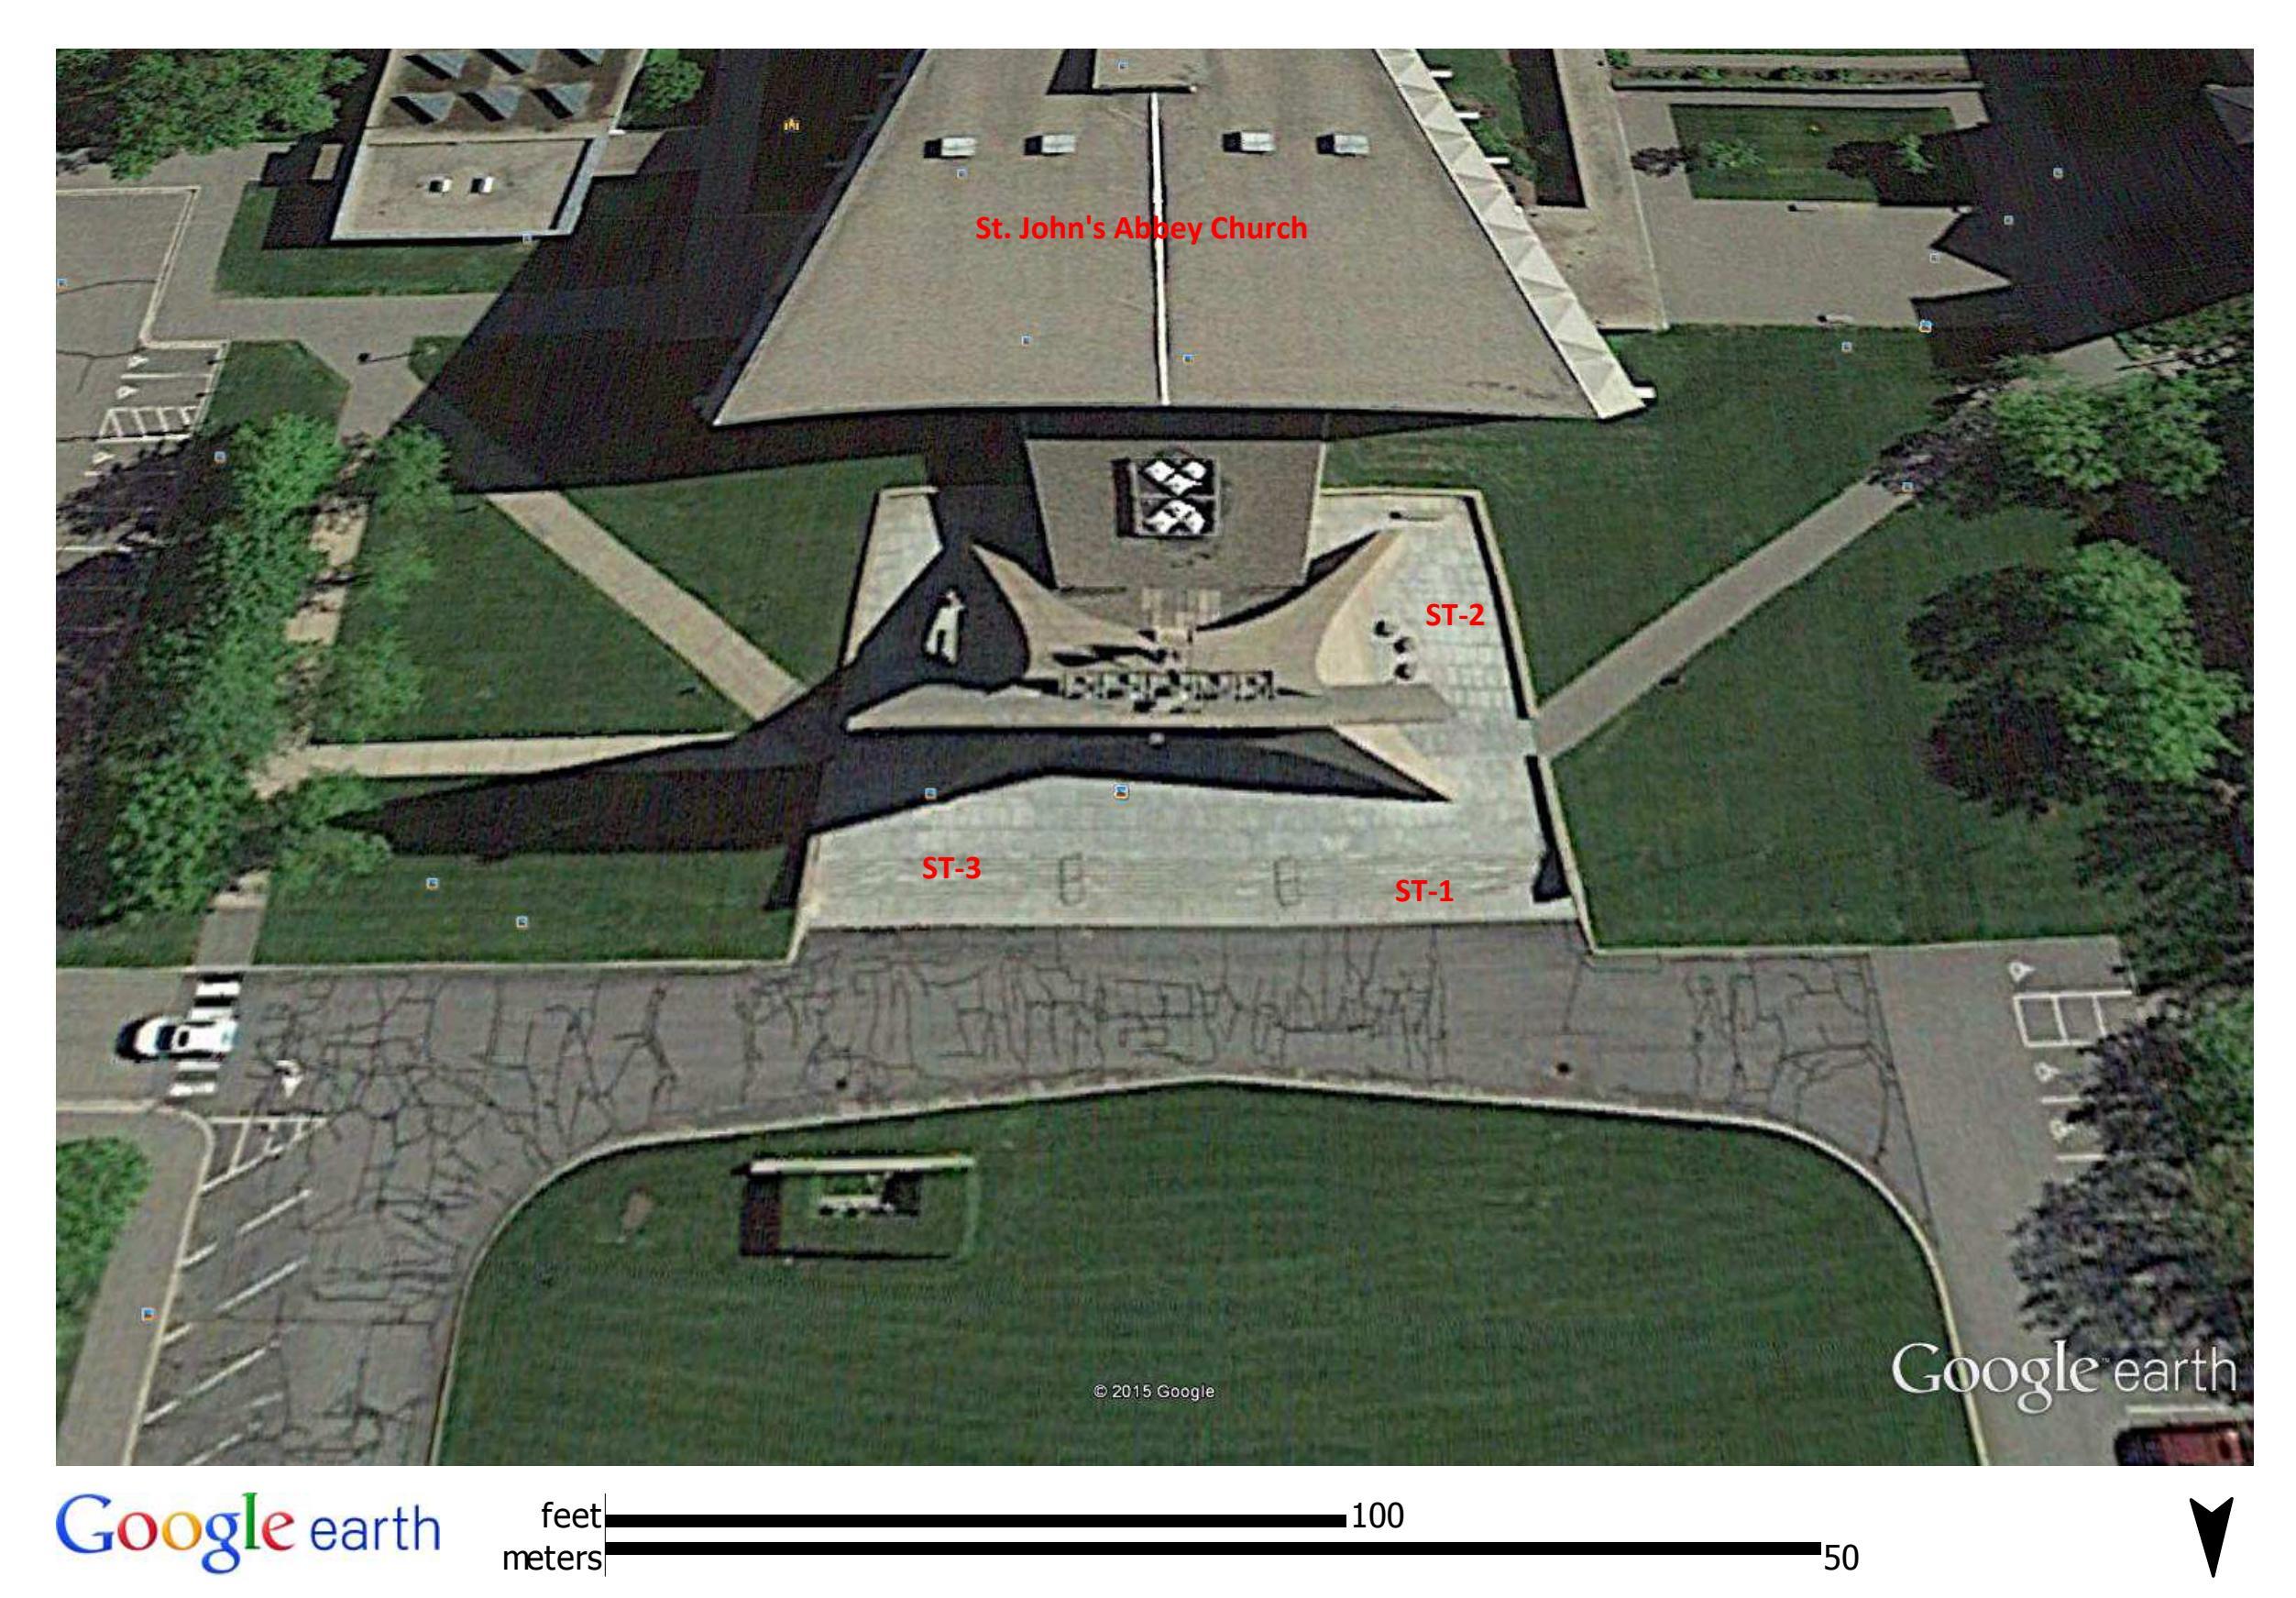
BELL BANNER GEOTECHNICAL

The general geologic profile at the site consists of 7 to 9 feet of existing fill soils underlain by silty sand and poorly graded sand. The existing fill soils generally consisted of clayey sand. Penetration resistances in the fills ranged from 1 to 8 blows per foot (BPF), indicating they were very soft to medium consistency and generally not very well compacted. Penetration resistances in the silty sand and sands ranged from 5 to 19 BPF, indicating they ranged from loose to medium dense.

⁻ Denotes approximate soil boring location
