FINAL REPORT July 2016

SAINT JOHN'S ABBEY CHURCH

CONSERVATION RESTORATION PRESERVATION

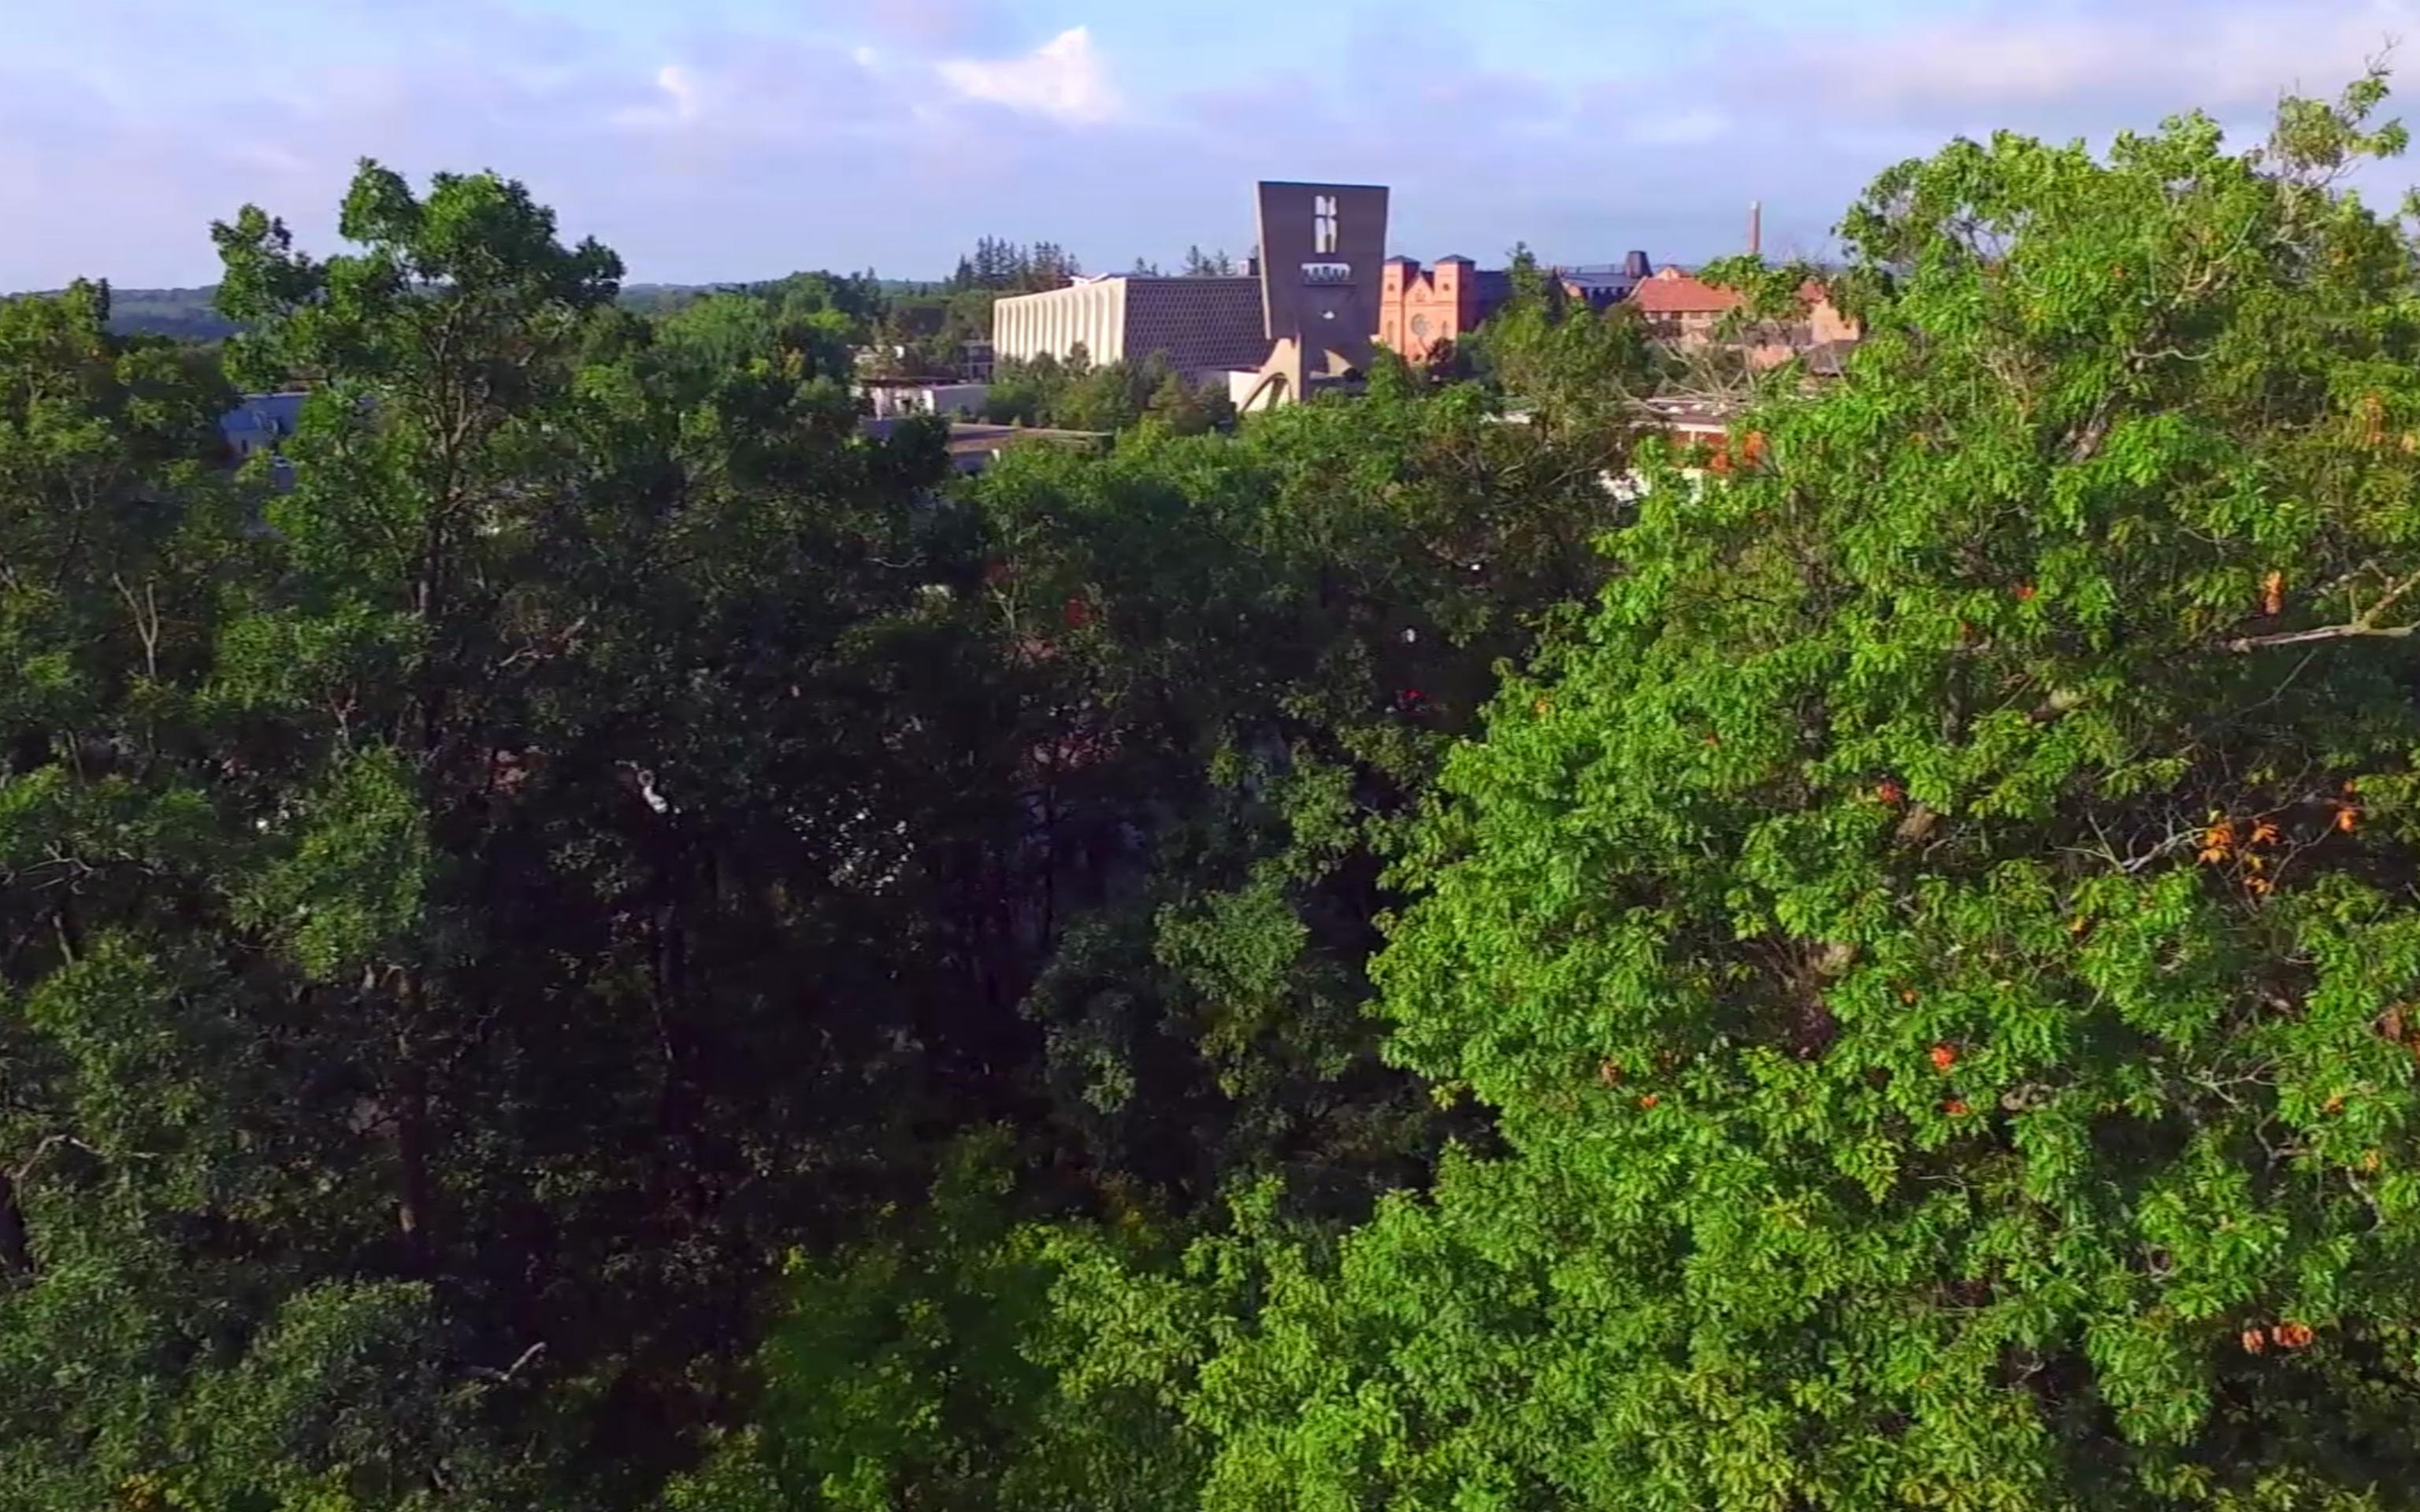
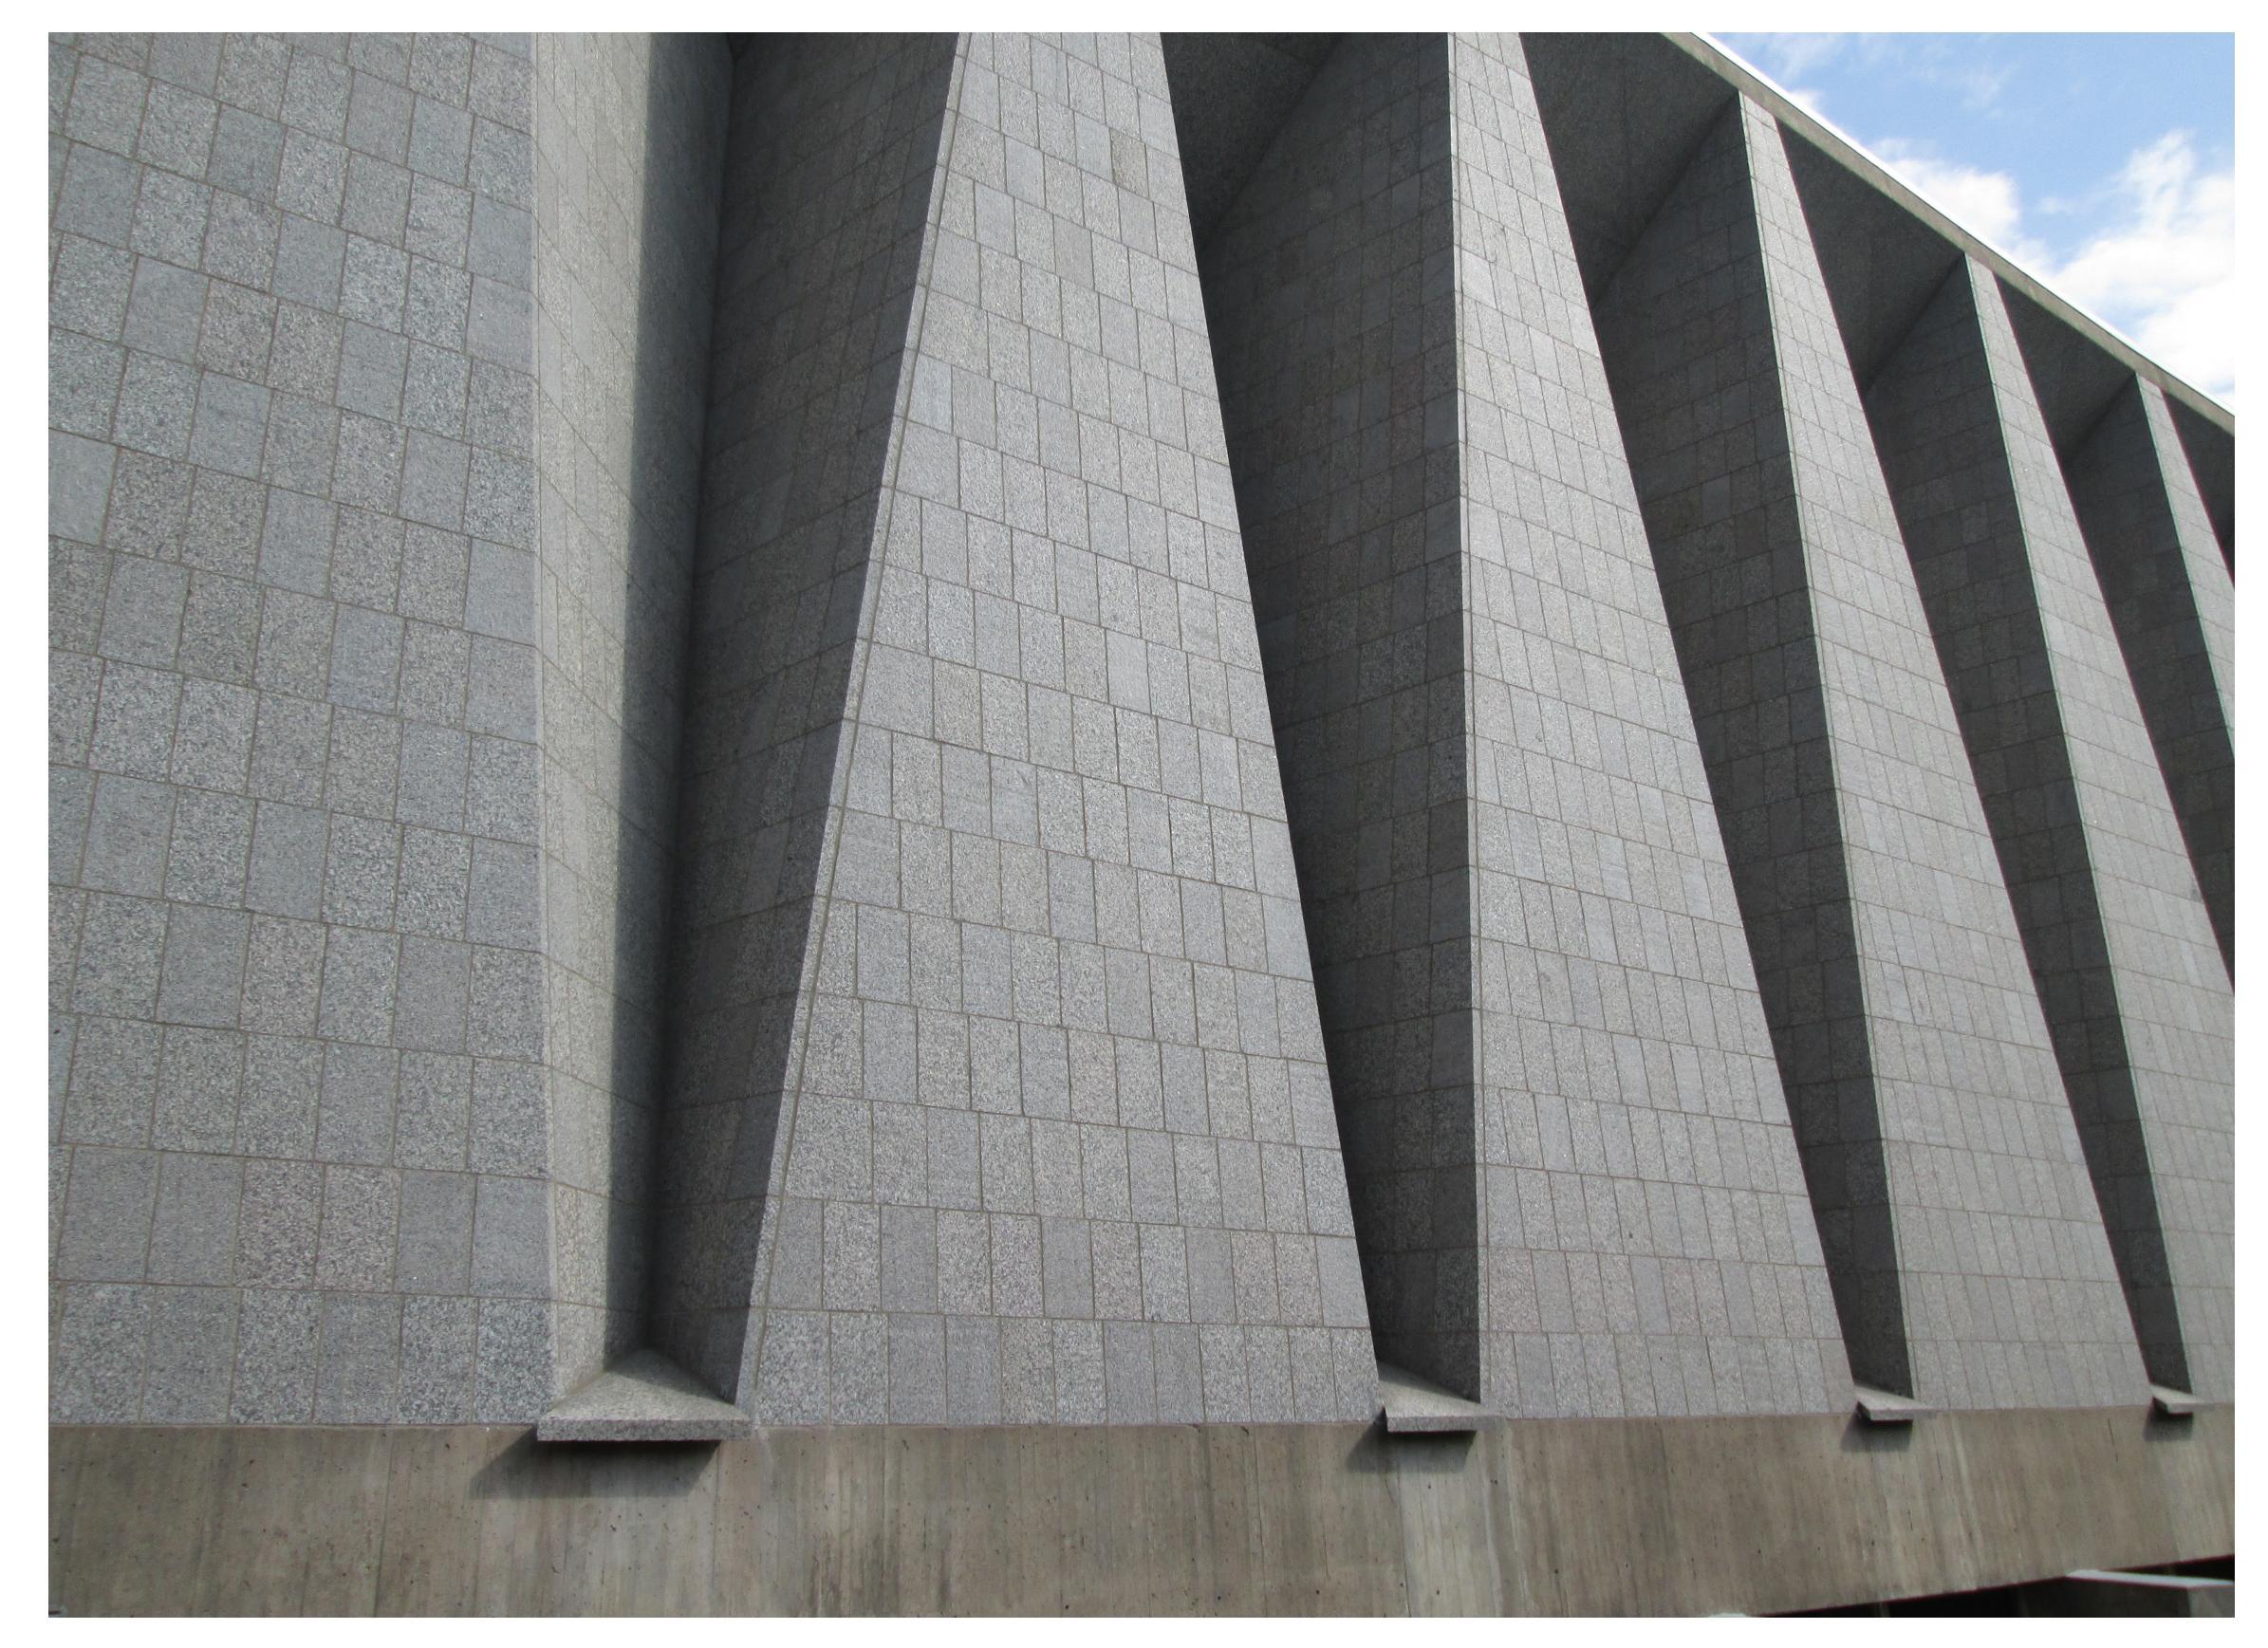
Exterior Wall Cladding

The exterior granite façade cladding mortar joints were tuckpointed in 2000. Vertical control joint sealants were replaced and additional vertical control joints were installed along the corners of the folded plate points during that same time. Visual observation of the current conditions noted no distress in the mortar joints or sealant control joints.

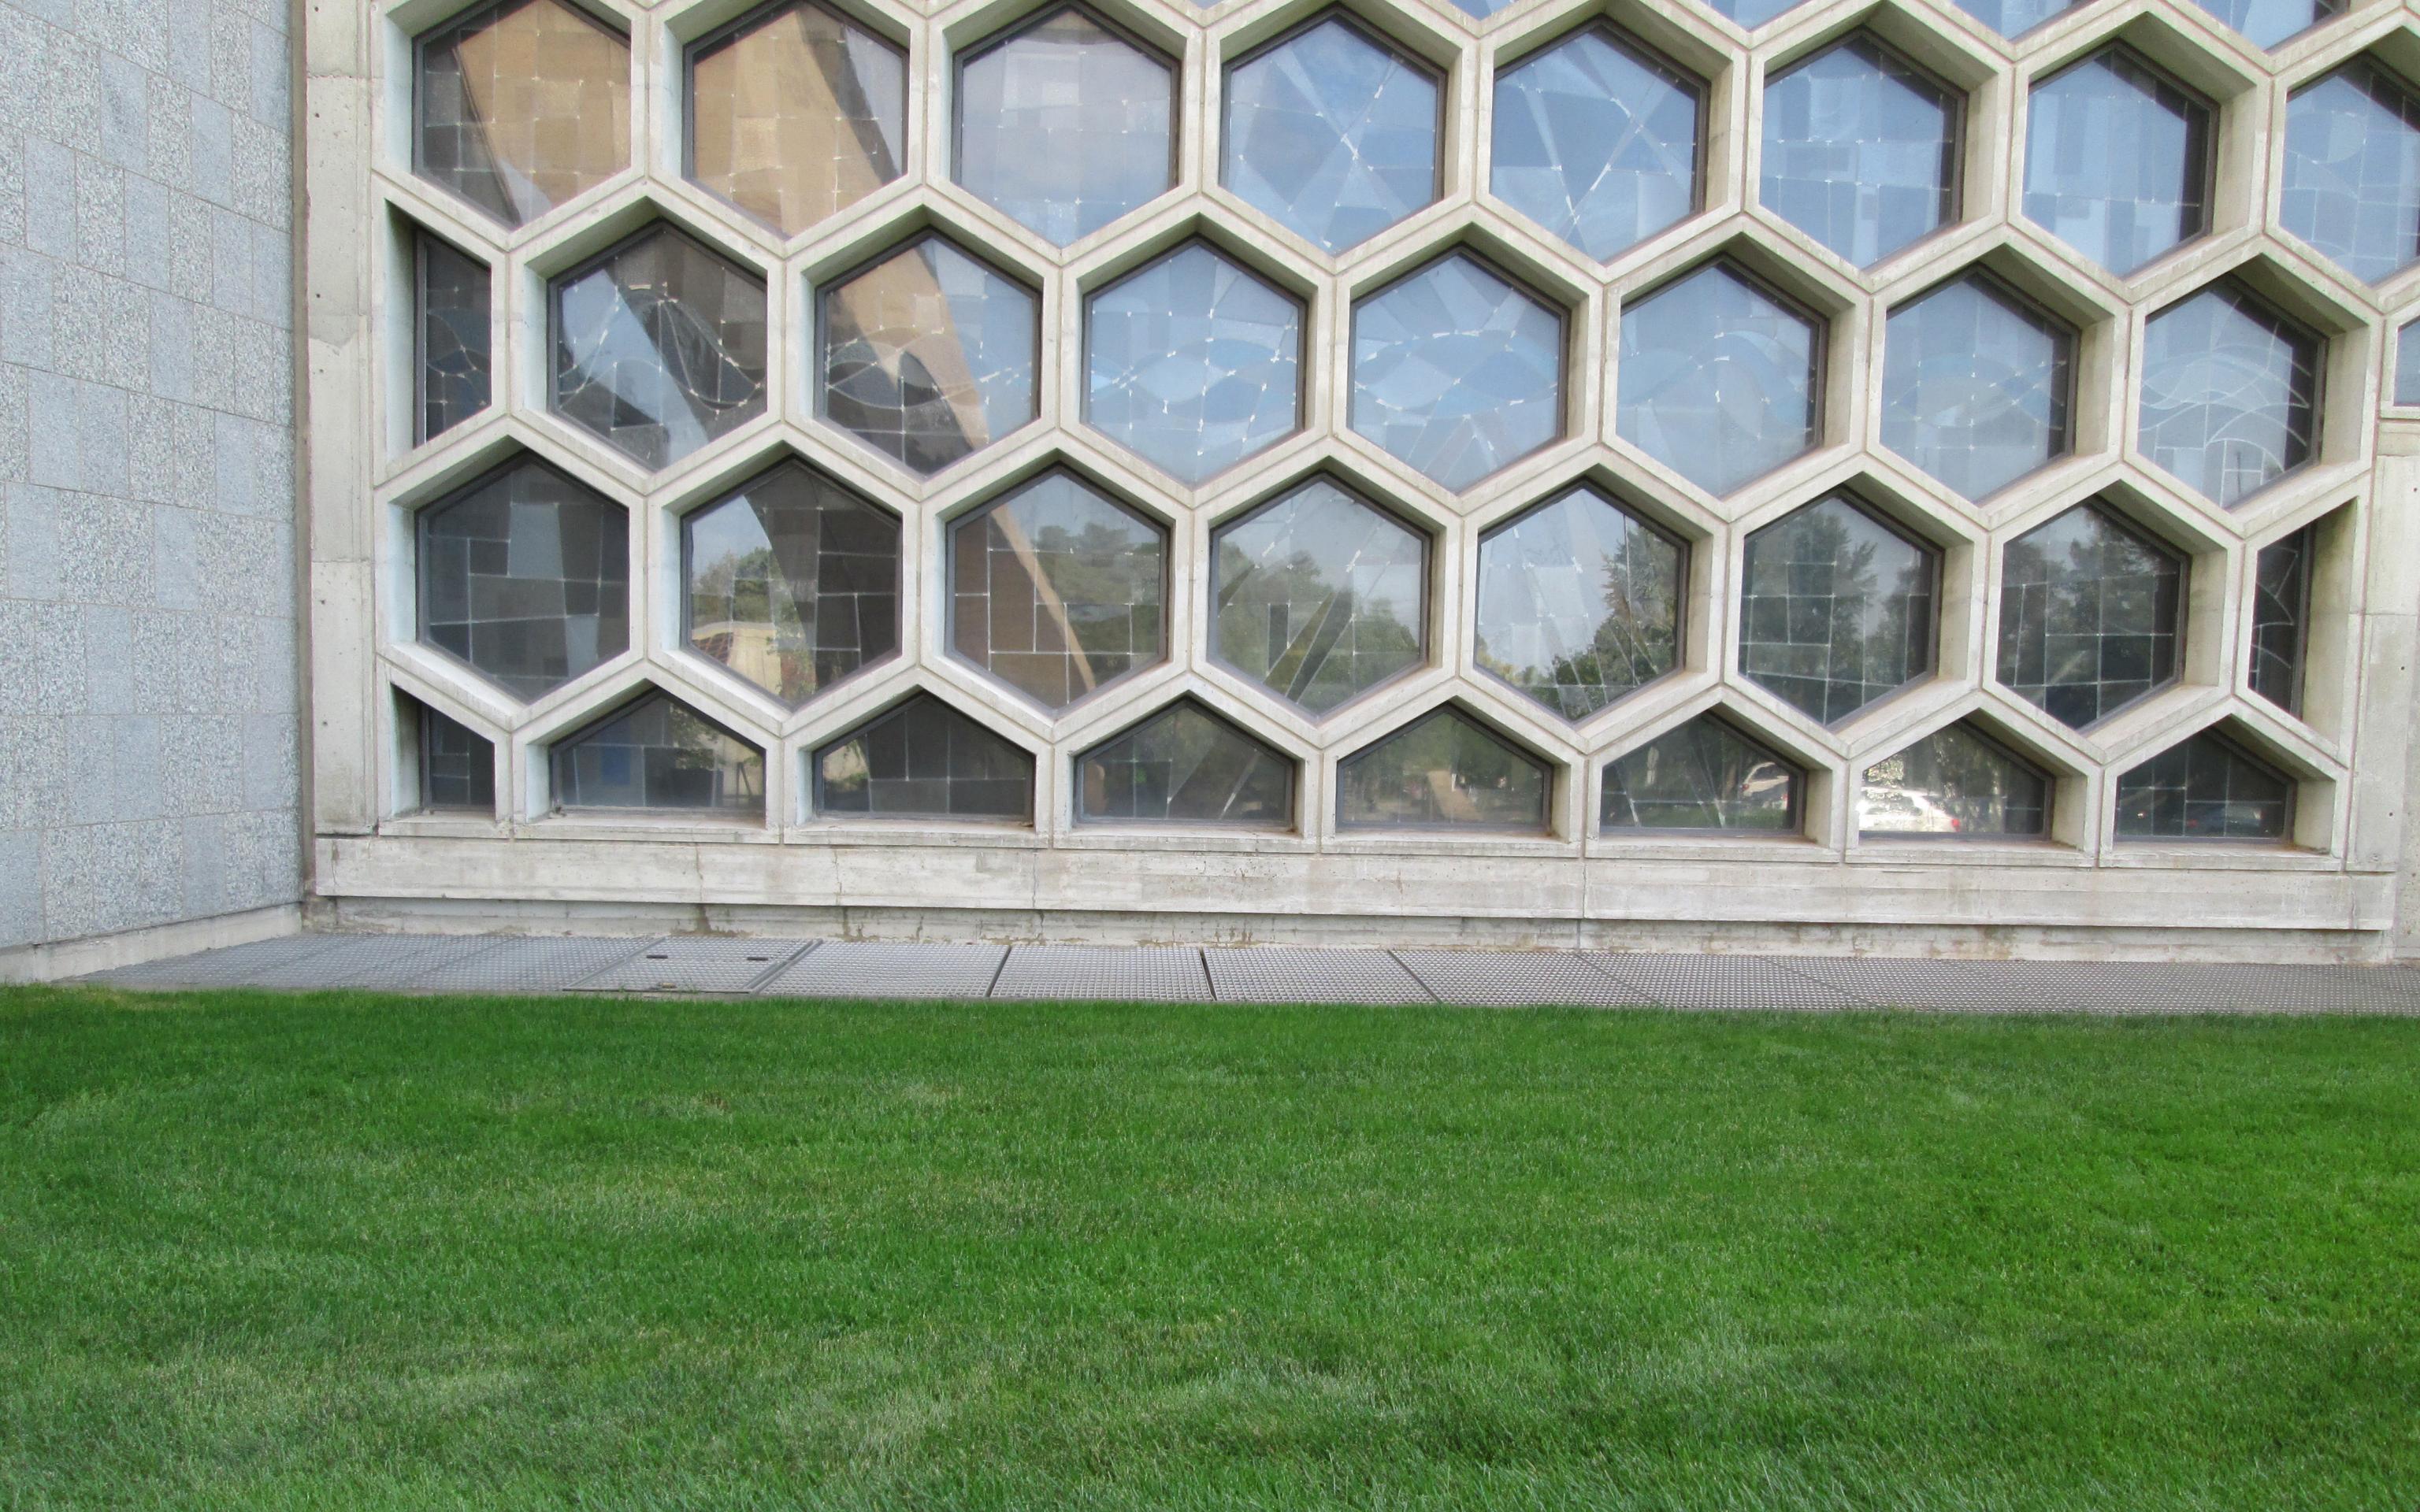
North Wall

The north wall concrete frames vertical control joint sealants were replaced in 2000. The polygonal concrete frames initial construction casting pattern resulted in a high number of horizontal construction joints. The flat surfaces of the frames appear to have a concrete rubbed finish.

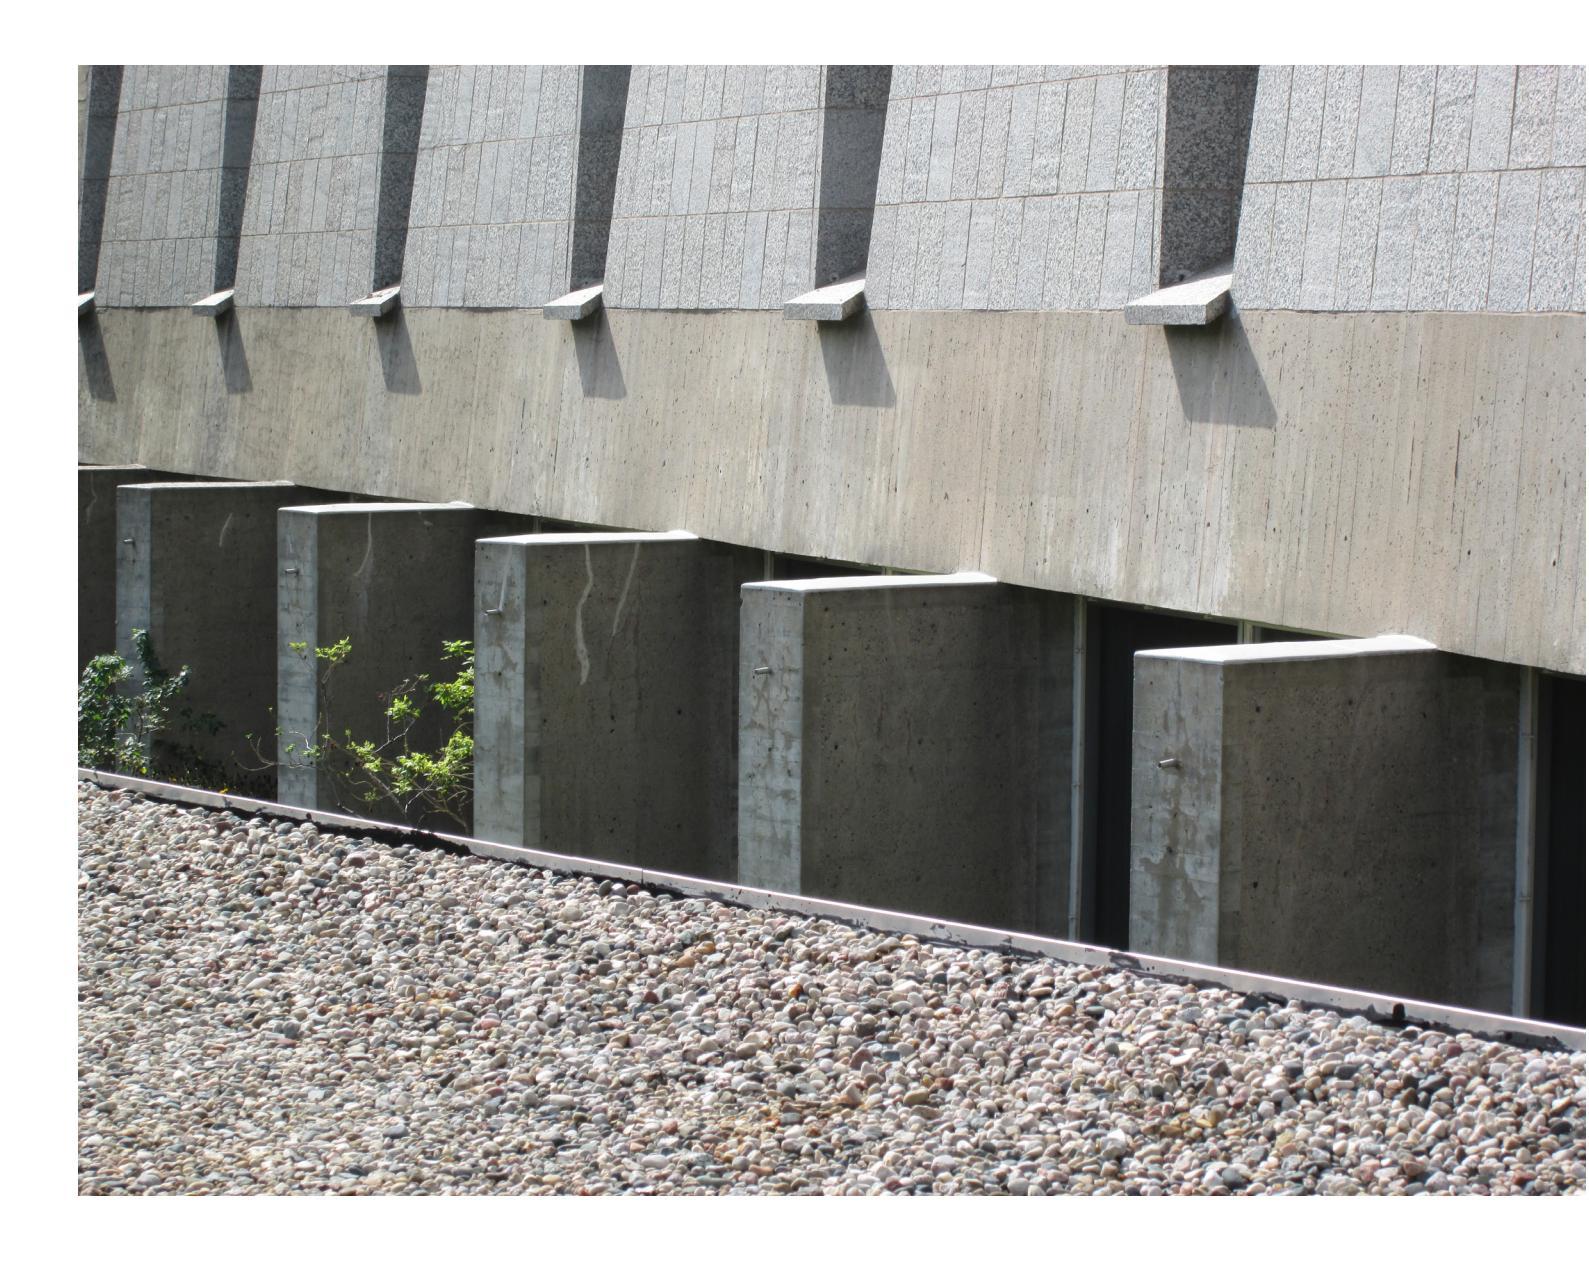
Buttresses

The buttress tops were repaired and the light fixture recesses capped and waterproofed. Visual observation of the current conditions noted micro cracking of the surface. Non-destructive sounding results of the areas indicate the concrete is sound.

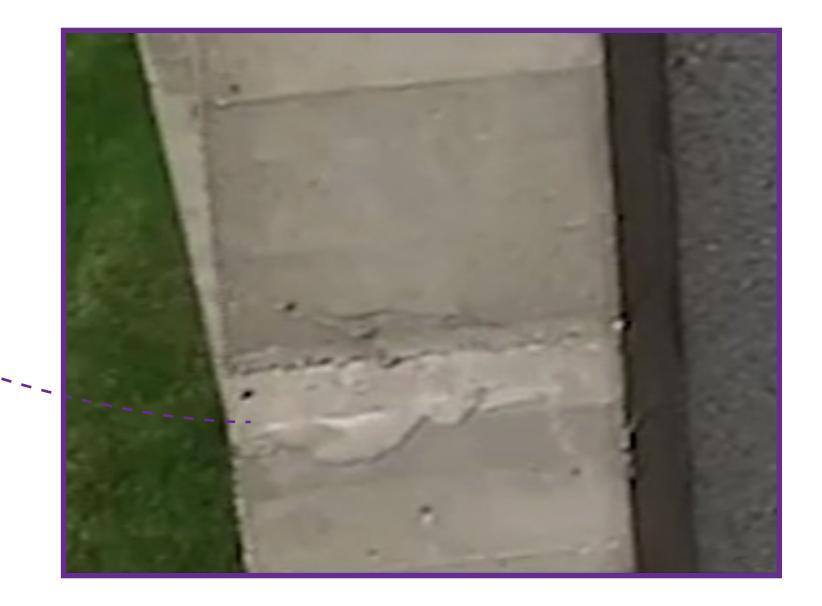
3 Spalling

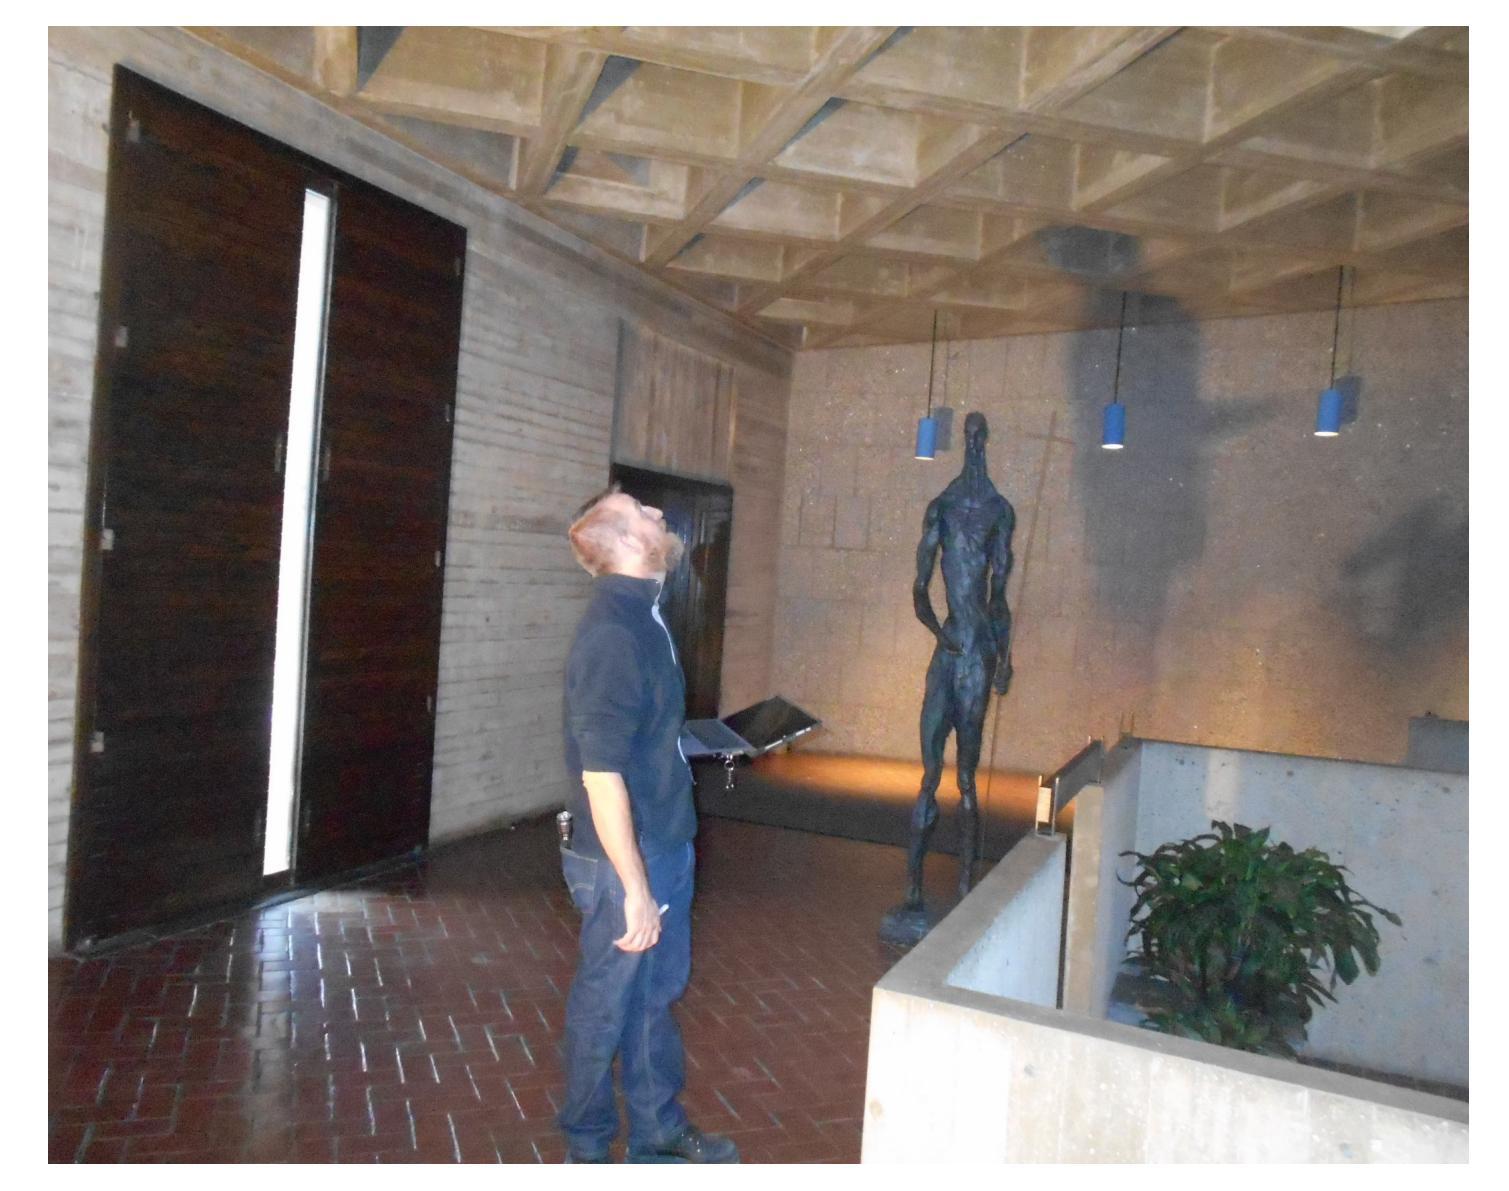
Atrium and Baptistry Roof Survey

The atrium roof structure consists of concrete pan and joist waffle ribs spanning the space. Minor hairline cracking was observed at a very small number of pan locations. Efflorescence or water staining was evident at a majority of the observed cracks. The assistant building and facility manager was not aware of any present roof leaks. The surfaces were dry at the time of observation. The cracking is not judged a structural concern.

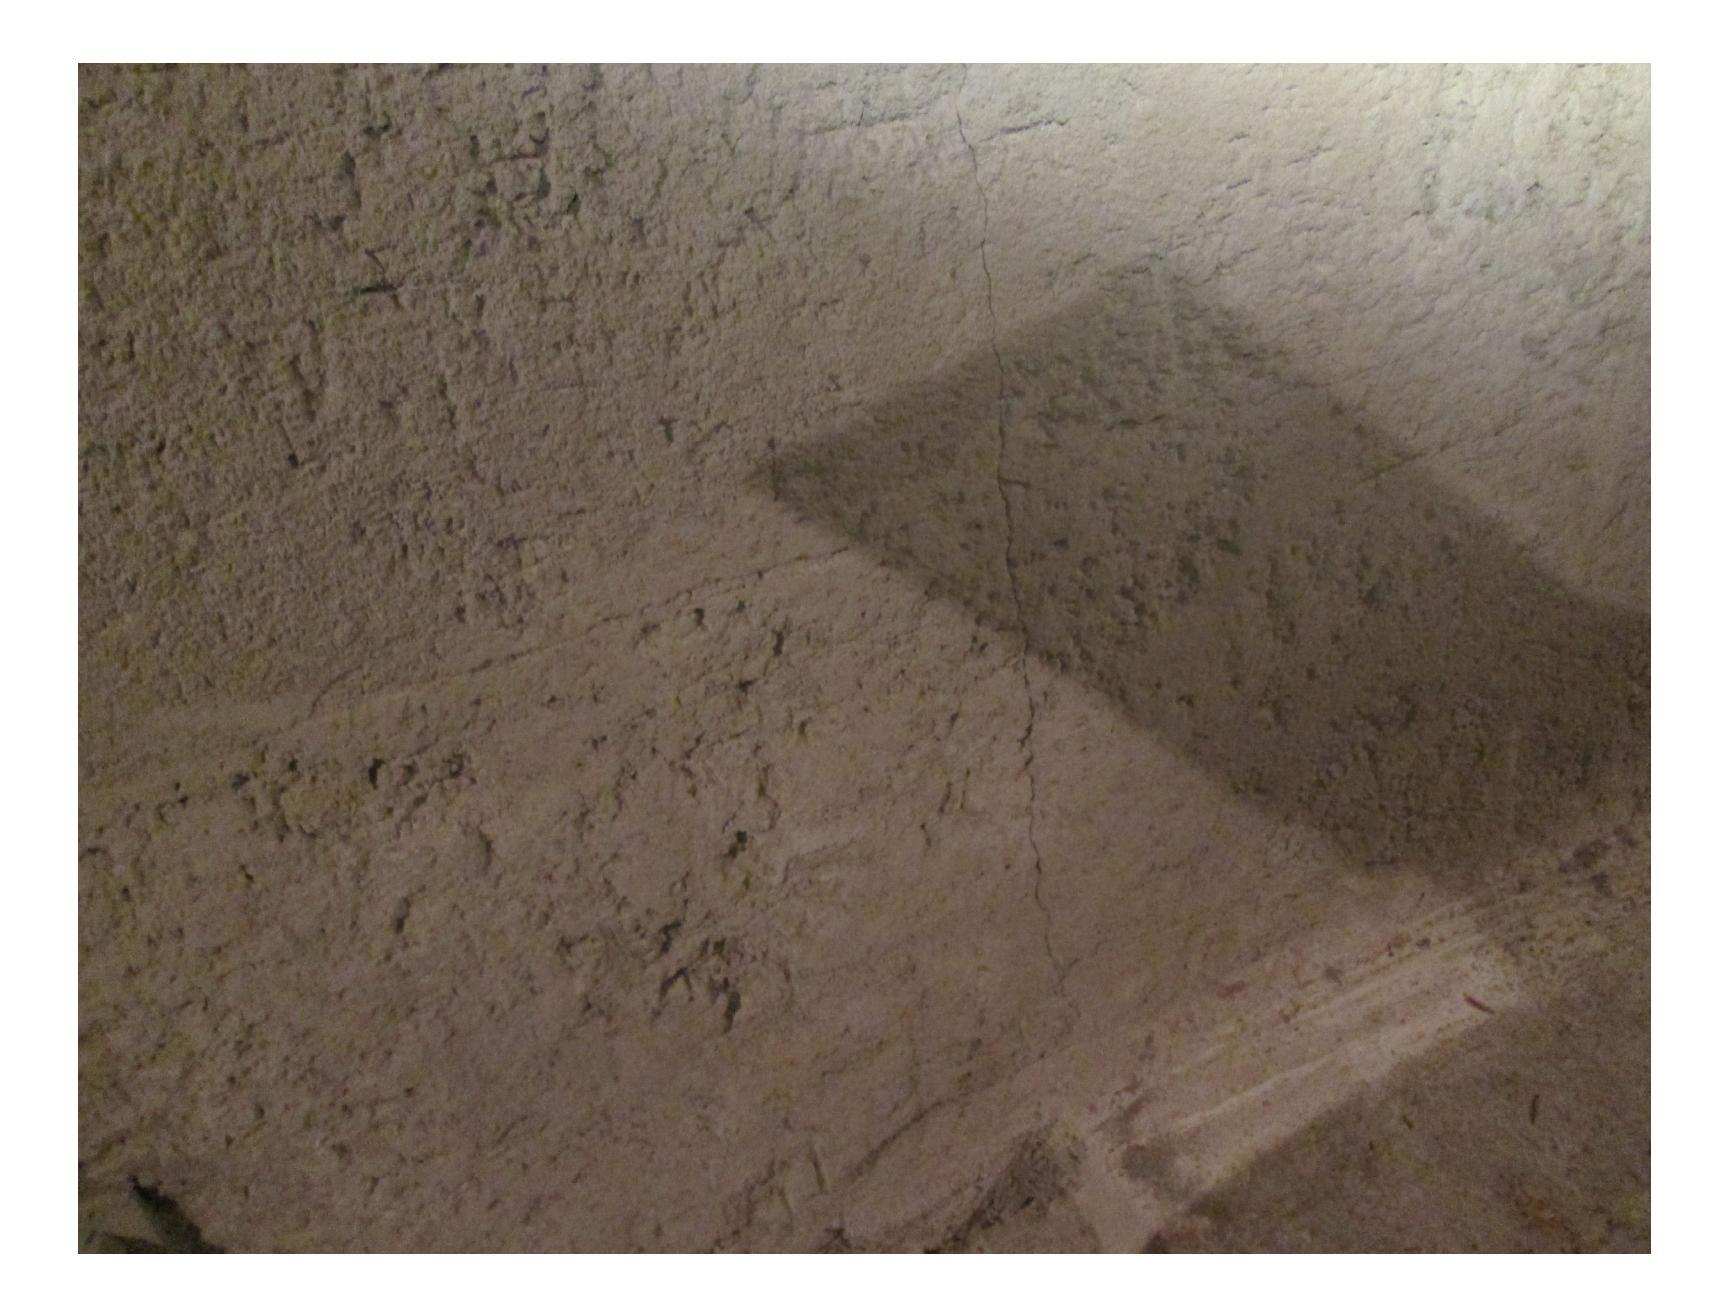
Sanctuary Folded Roof Plate Survey

The sanctuary roof structure consists of concrete folded plate "V" form ribs clear spanning the sanctuary space. The vertical sides of the plates have numerous lighting and ventilation openings. There is a concrete walkway bridge running north-south across the center with doorway openings for access to the ribs.

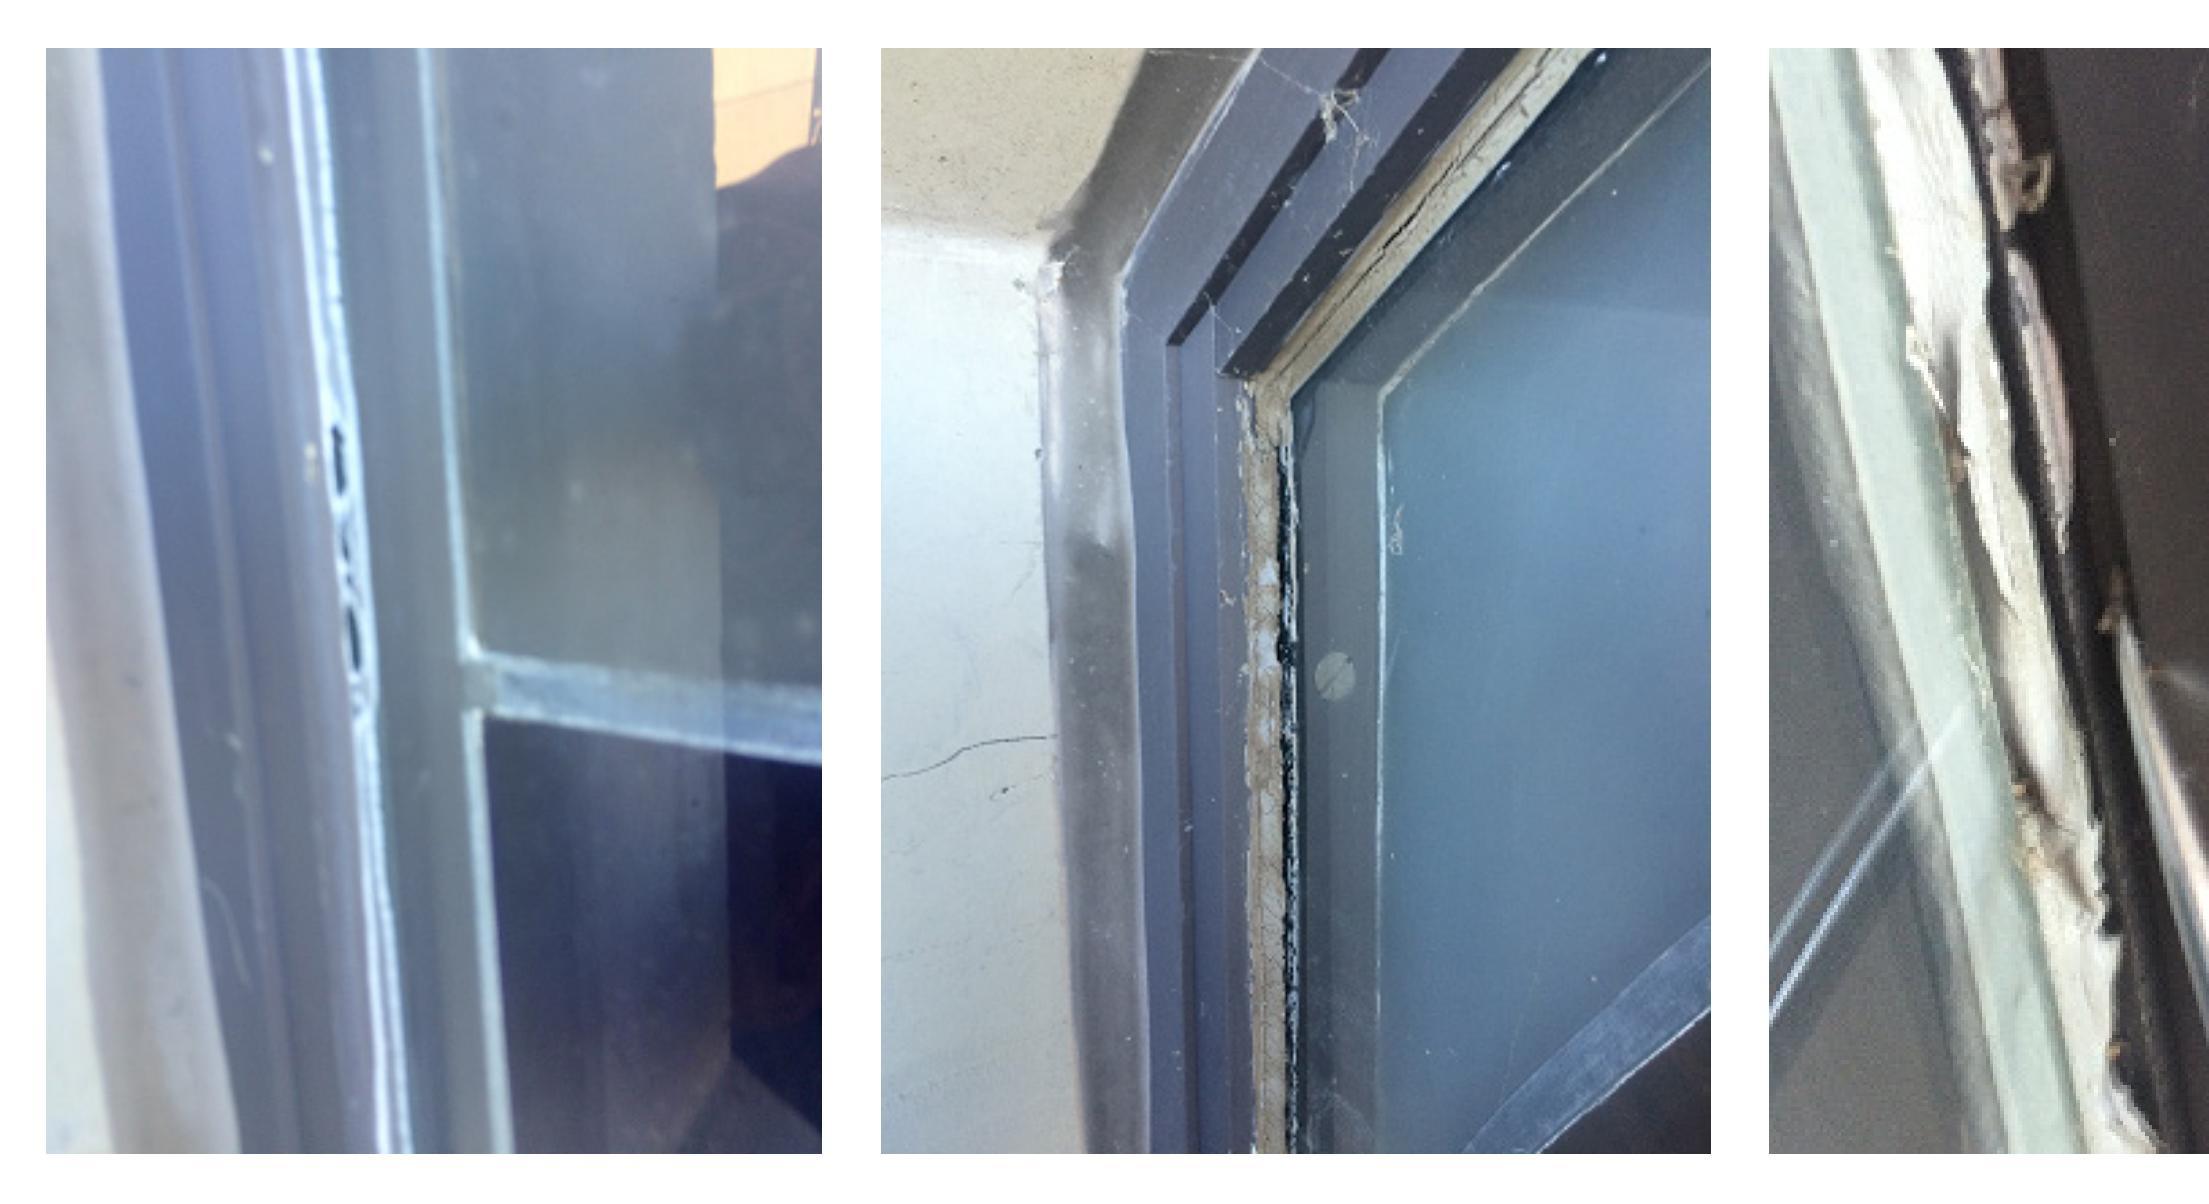
The original protective glazing was heel beaded, taped and cap beaded. The cap bead is deteriorating allowing moisture penetration. (See Photo # 104, 105). Photo (#123) shows the Heel Bead and the recess in the main frame for the leg of the offset glazing stops.

The new protective glass is to be heel beaded around the entire perimeter of the glass creating the critical moisture seal. Feathering of the heel bead sealant over the remaining exposed connection splice joint of the main frame members will be necessary to prevent moisture penetrating into the main frame cavity.
