FINAL REPORT July 2016

SAINT JOHN'S ABBEY CHURCH

CONSERVATION RESTORATION PRESERVATION

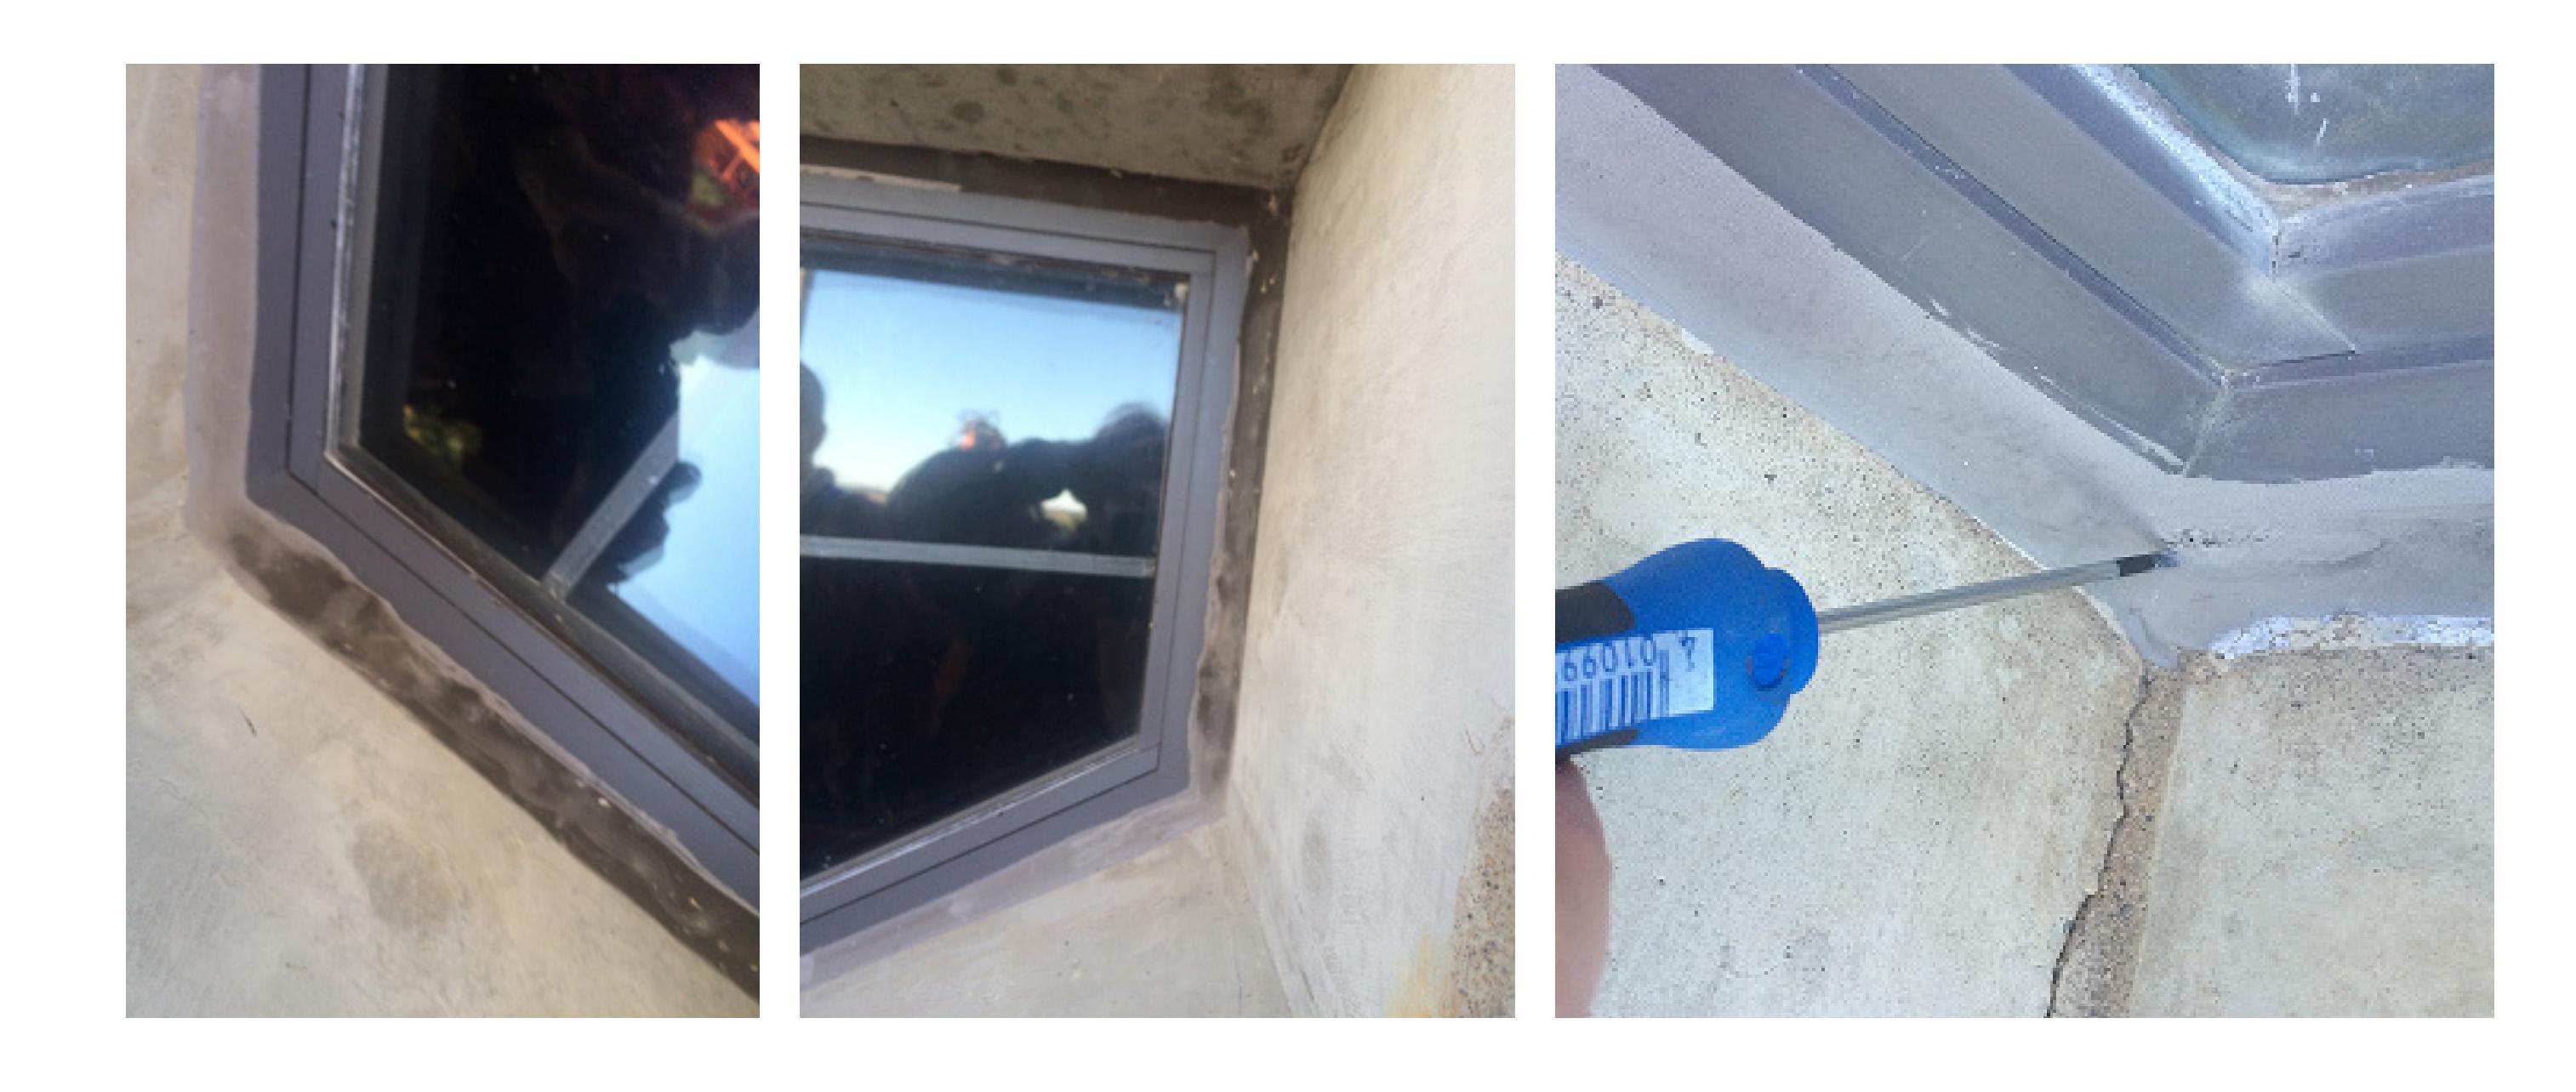
Improving the Protective Glazing

The existing glazing stops and recess location will not be able to be utilized with the implementation of high performance insulated glass do to the increase in the glazing thickness. Project specific custom extrusions will need to be created allowing the use of 7/8" (+-) thick insulated glass.

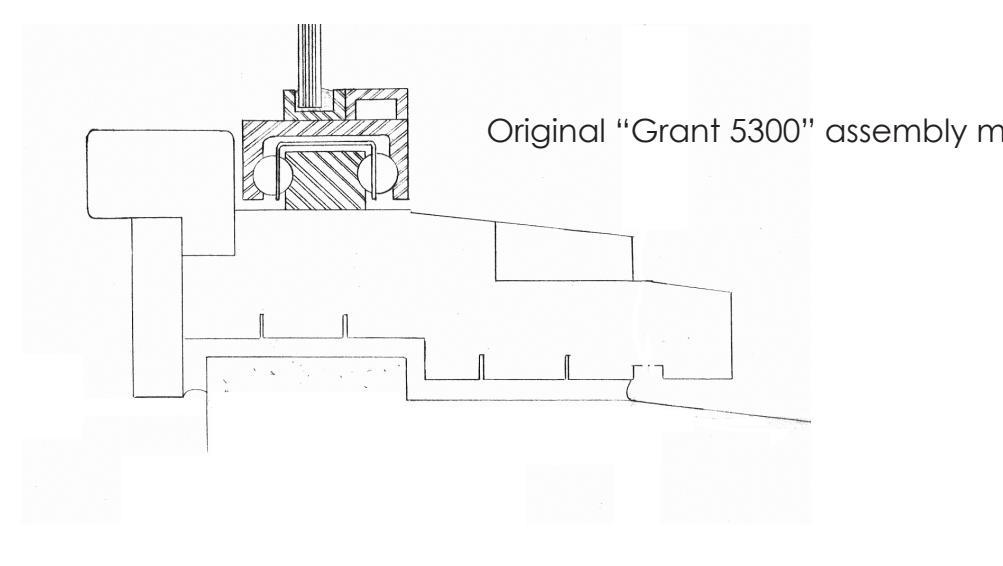
There are 20 operable windows, 10 on the east side and 10 on the west side of the Sanctuary. The openings vary in size from 8'4" to 16'0 wide x7'10" tall. The openings are all OX with one fixed glass panel and one sliding panel. The windows are constructed of custom wood designed specifically for the Abby Church. The sliding panel is set on an aluminum and stainless steel rolling track system by "Grant / Hetich". The original glass panels were ¹/₄" annealed (non tempered) clear polished plate glass.

In 1984 the ¹/₄" glass was replaced with 7/8" insulated glass consisting of (2) sheets of ¹/₄"glass separated by a 3/8" sealed air space. The weather stripping at the head, interlocks and jambs was improved. A brush sweep was added at the sill. Aluminum cladding was added at the sill to protect the wood and minimize maintenance.

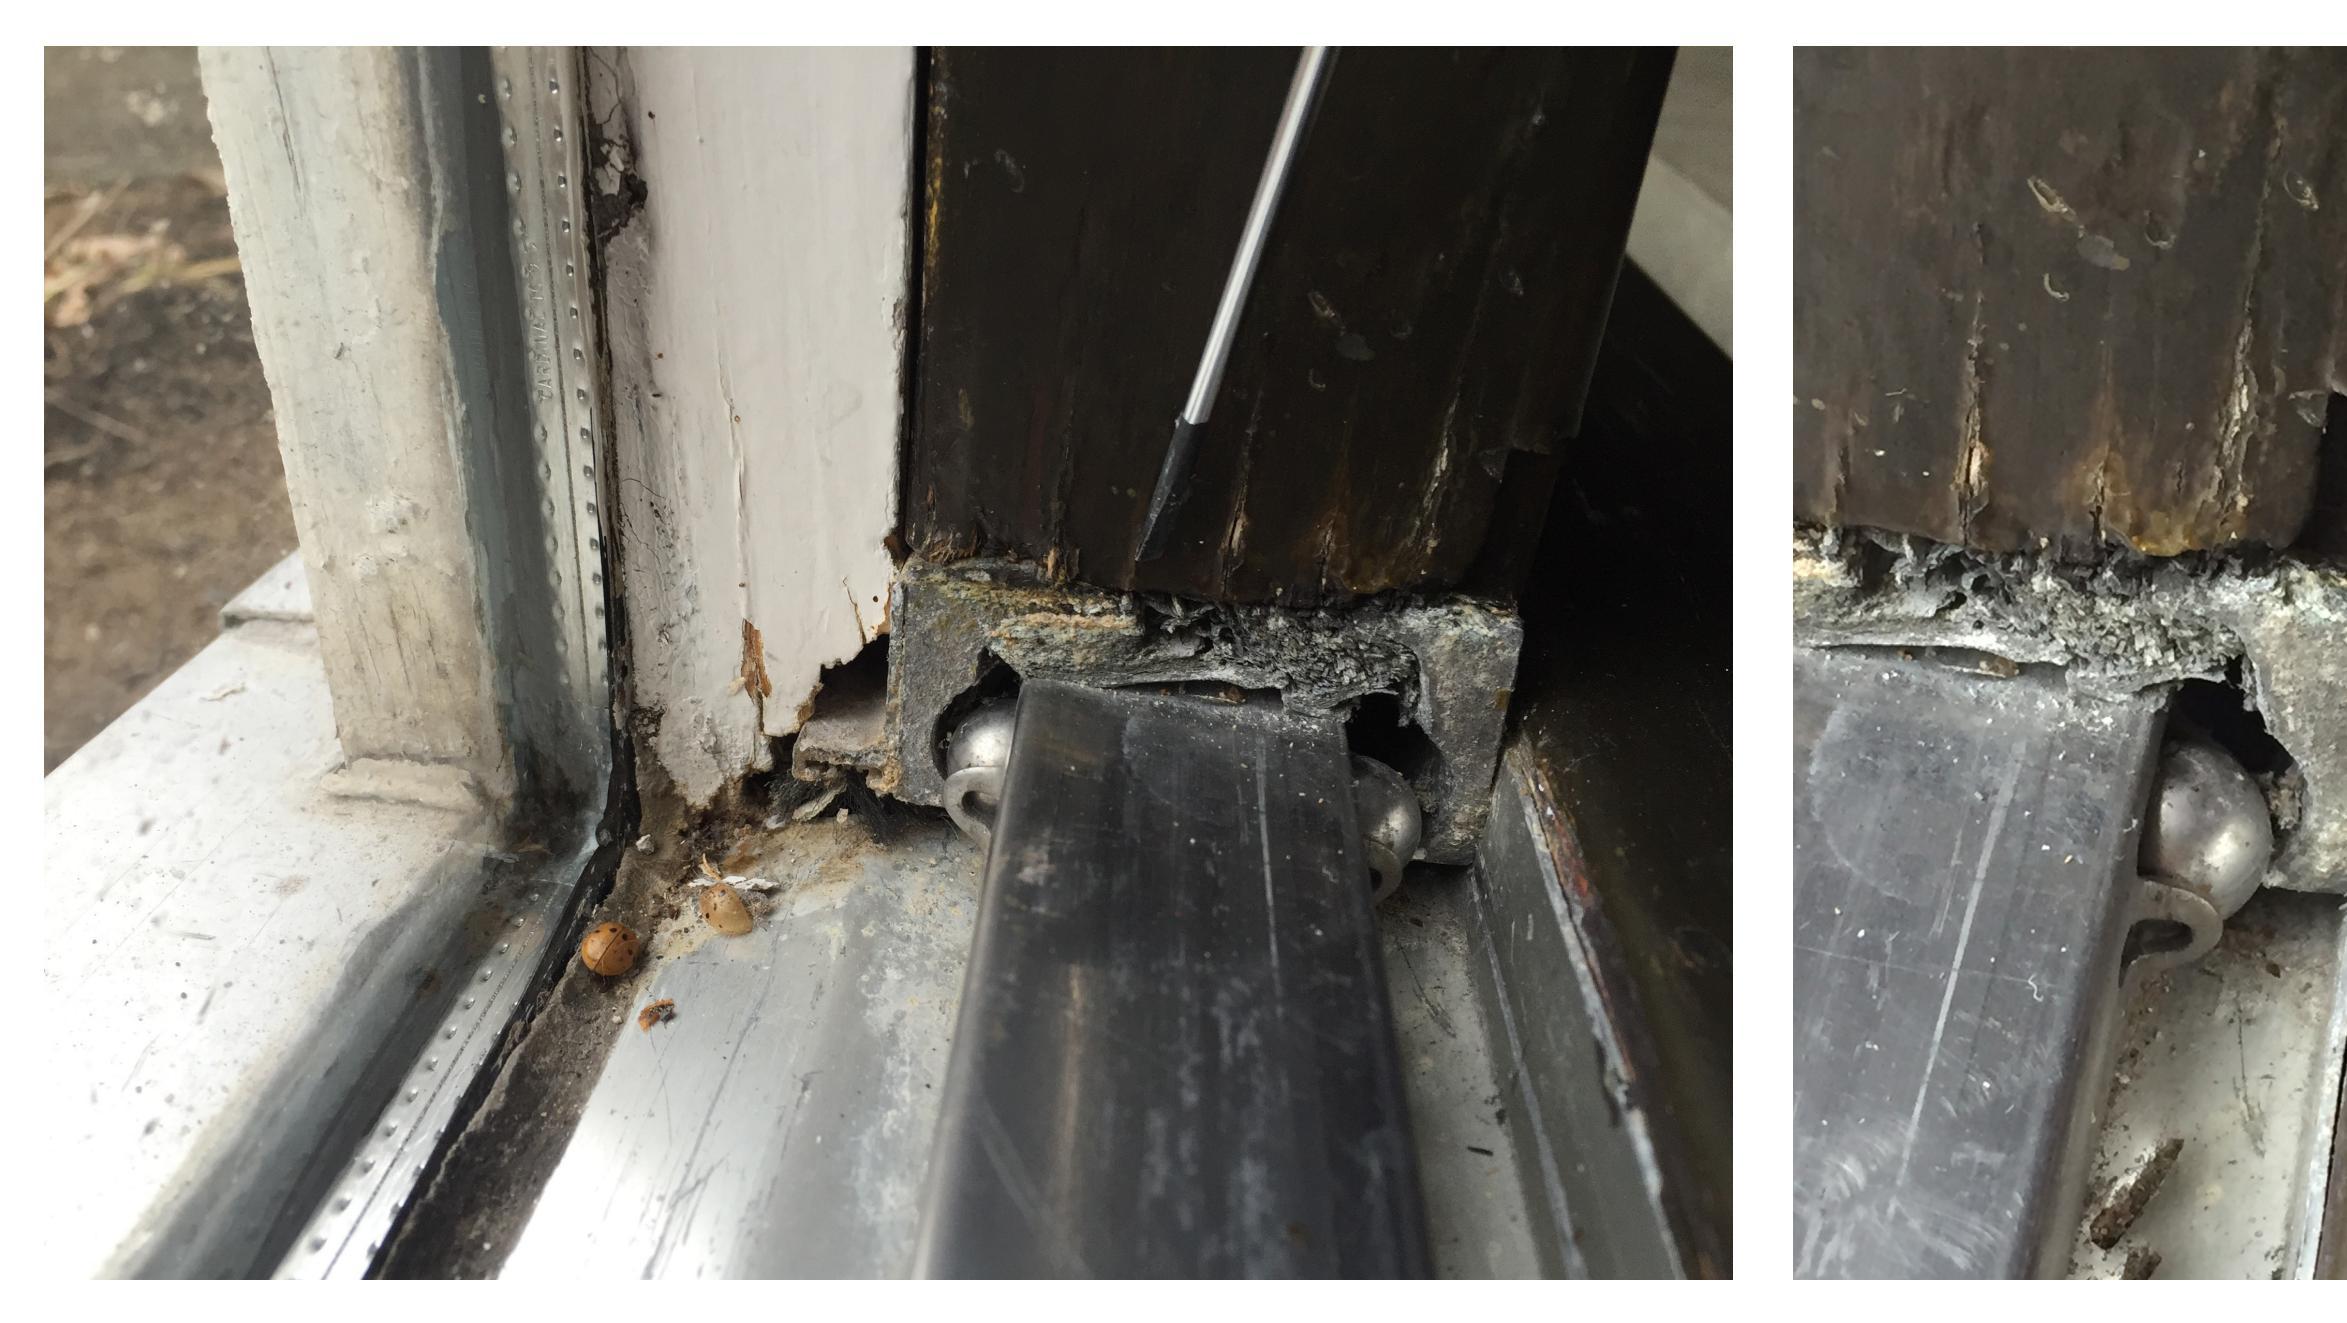
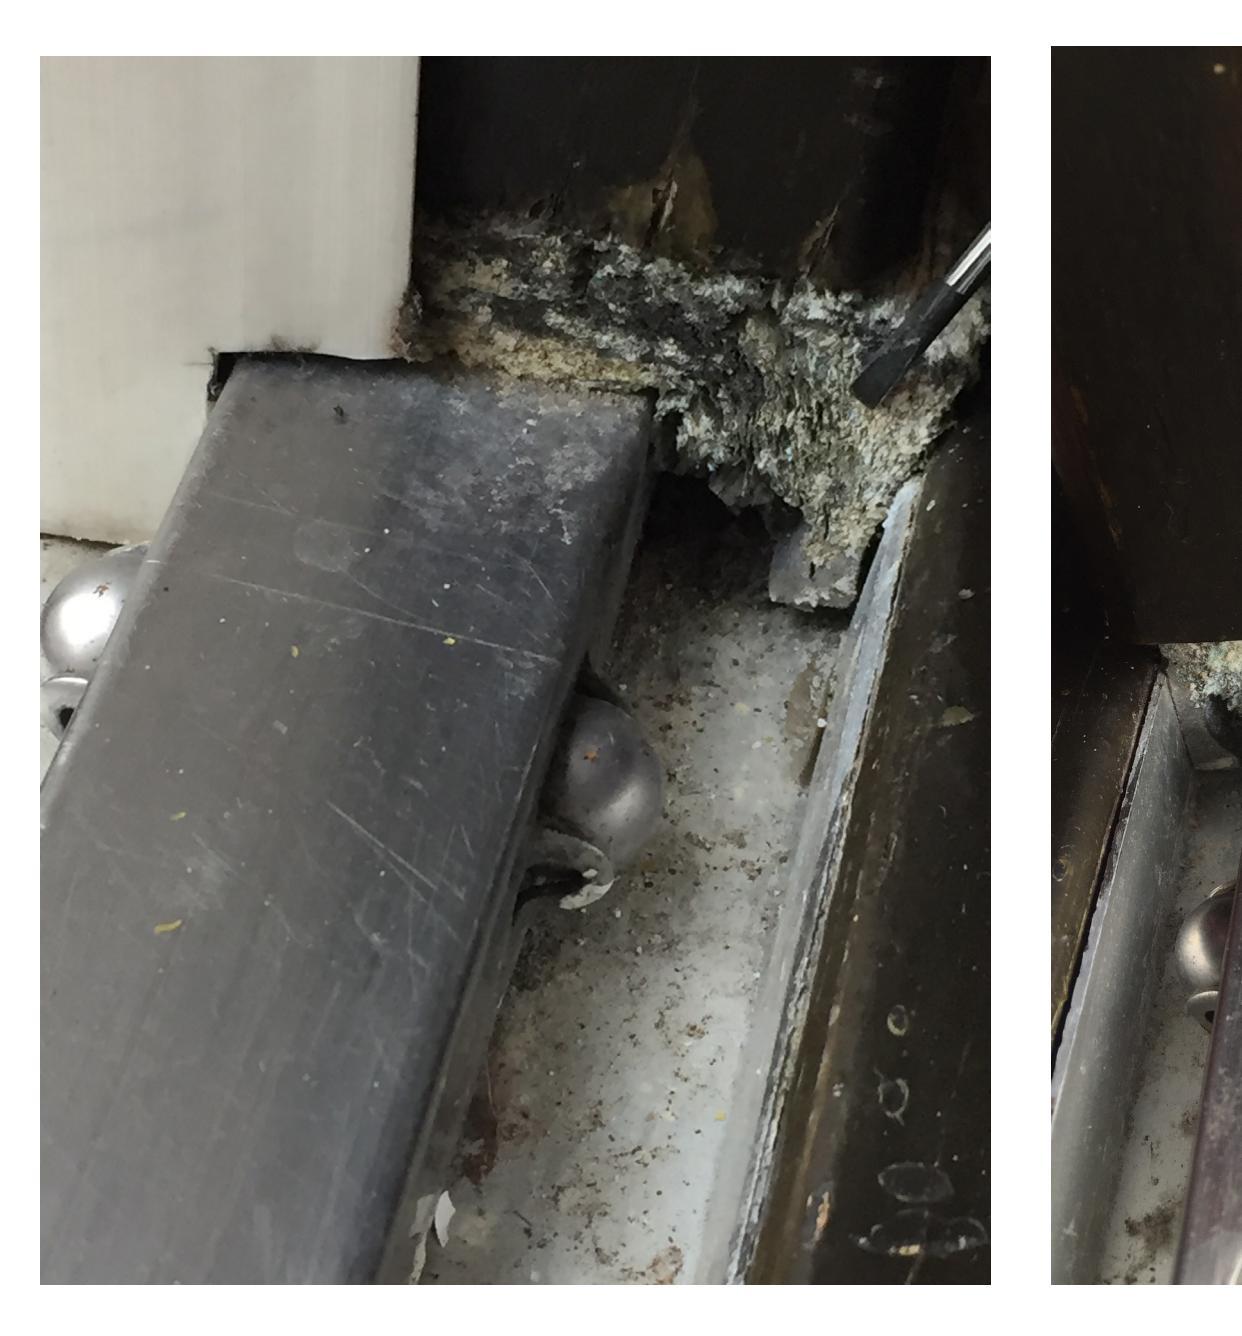
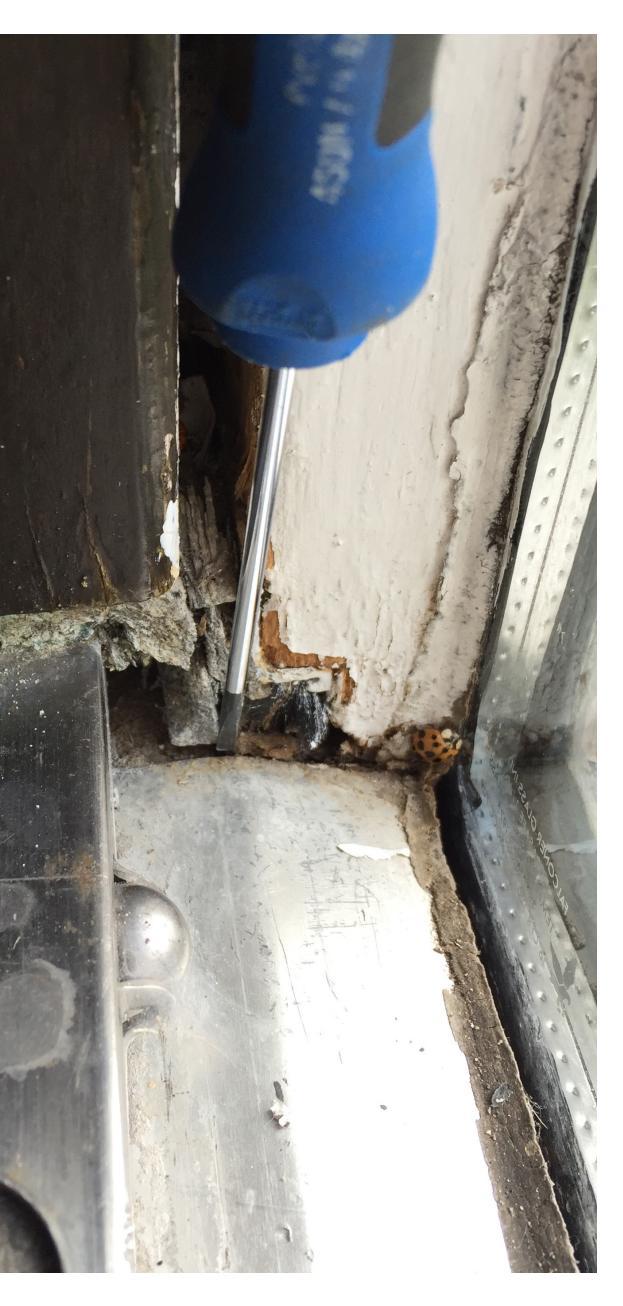
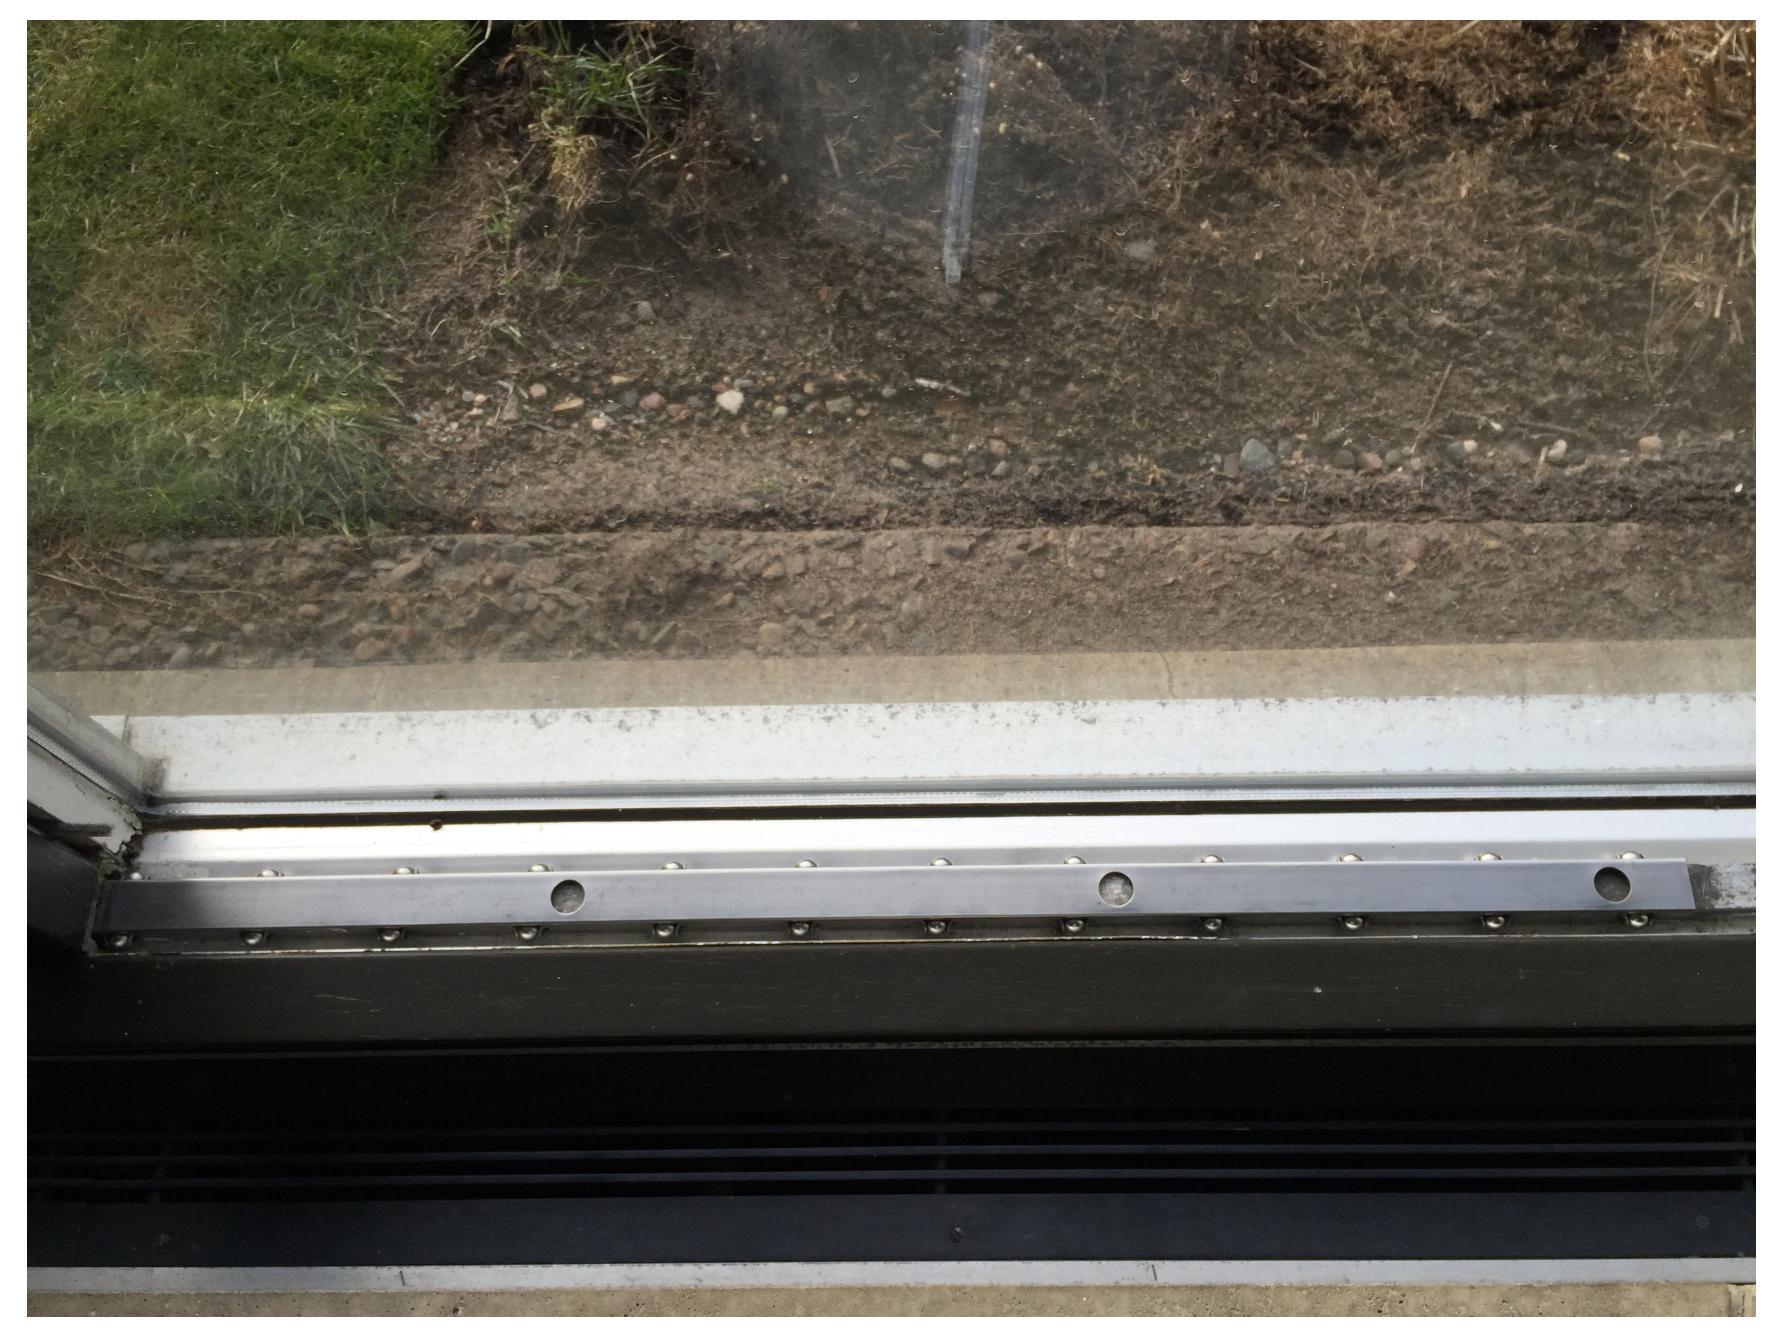
In 2015 not all the doors are functioning properly. Some are not opening, and the openings show signs of deterioration and need repair or replacement. The rolling systems extrusion supporting the sliding glass panels is the major cause of the sliding windows failure; it is collapsing and braking down, losing its structural integrity.

We are quite certain the original "Grant 5300" sliding track system is available and should be replaced.

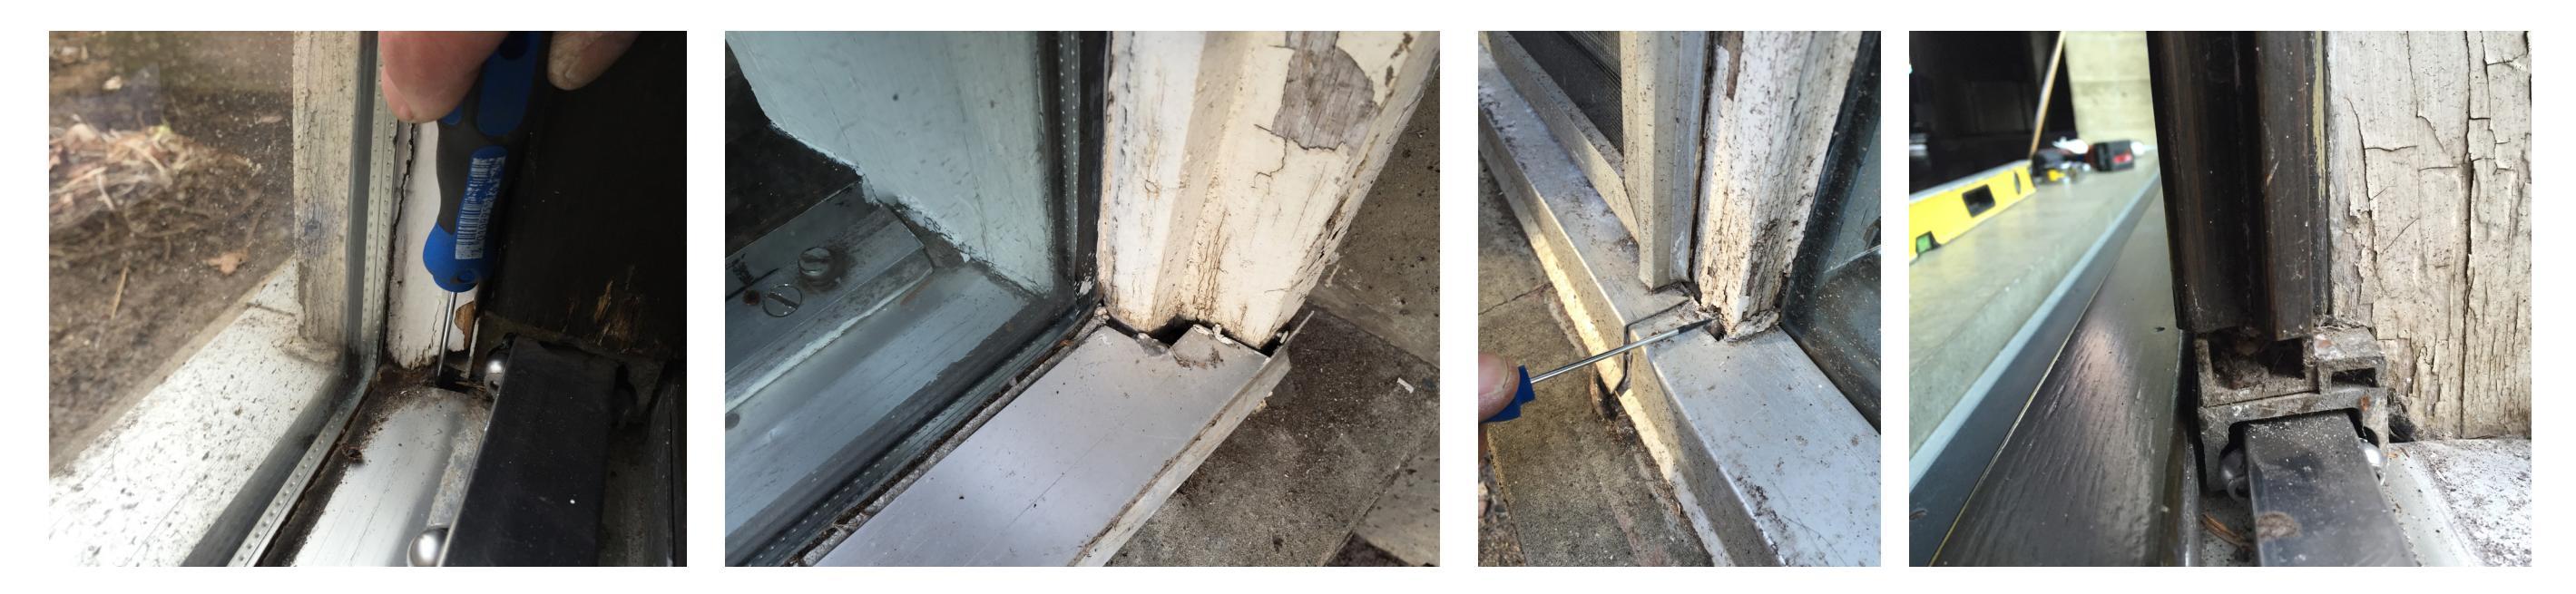
The stainless steel roller channel and the fixed bottom aluminum guide are in good condition and show minimal signs of deterioration.

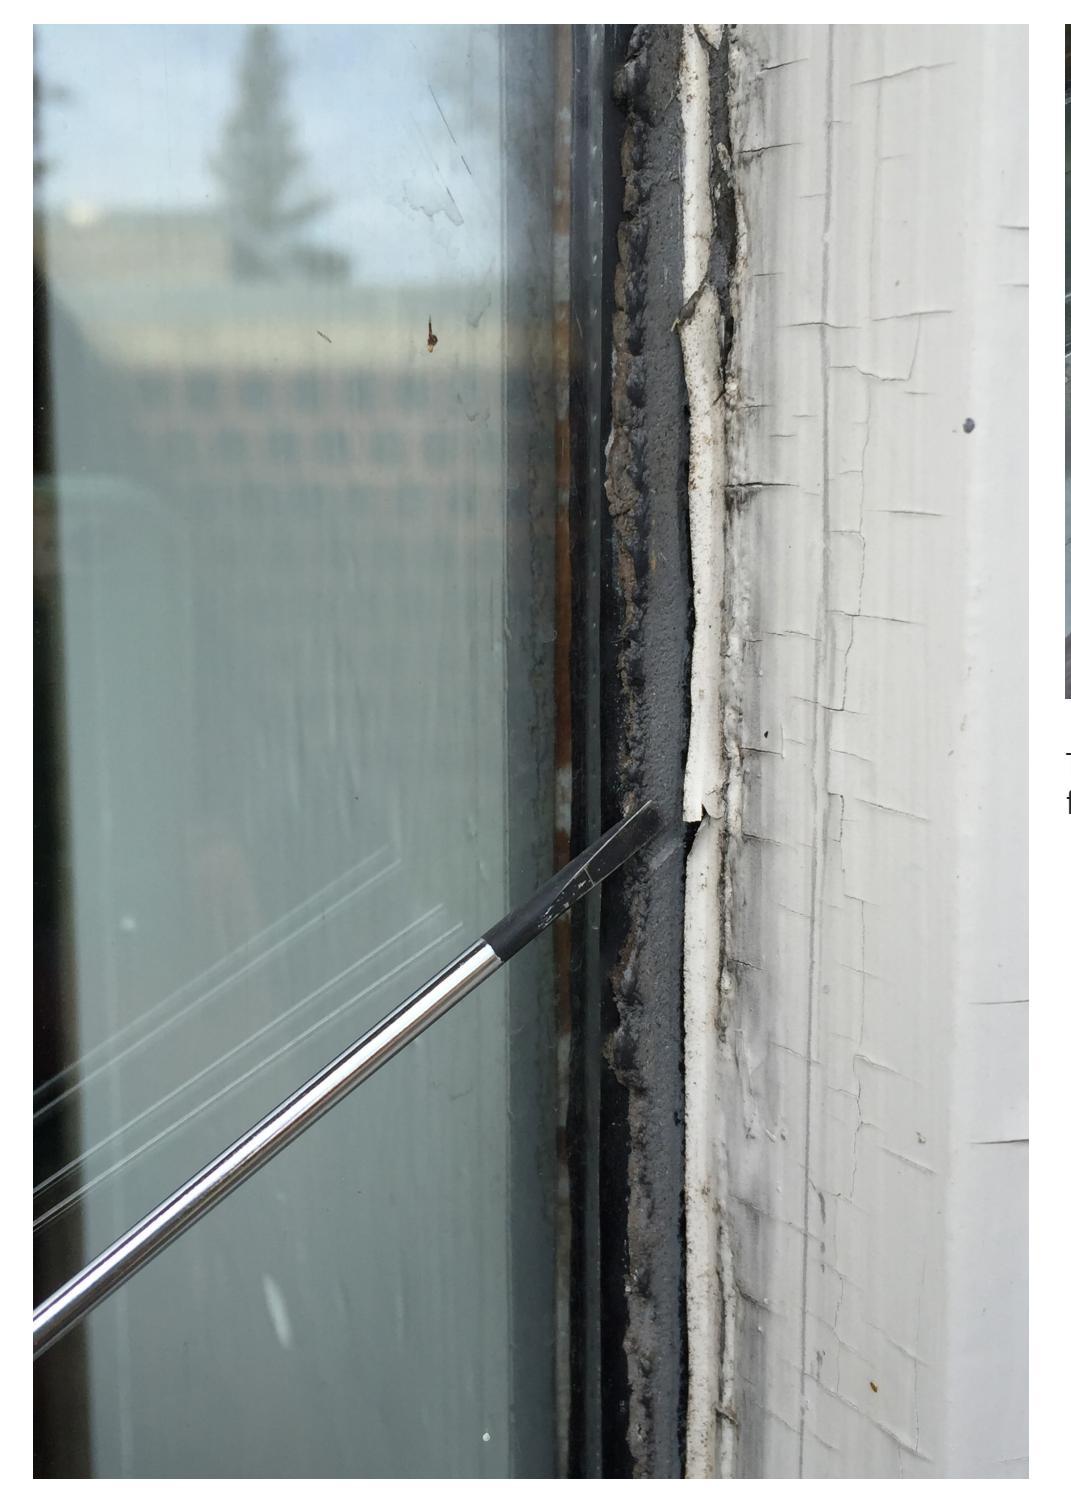
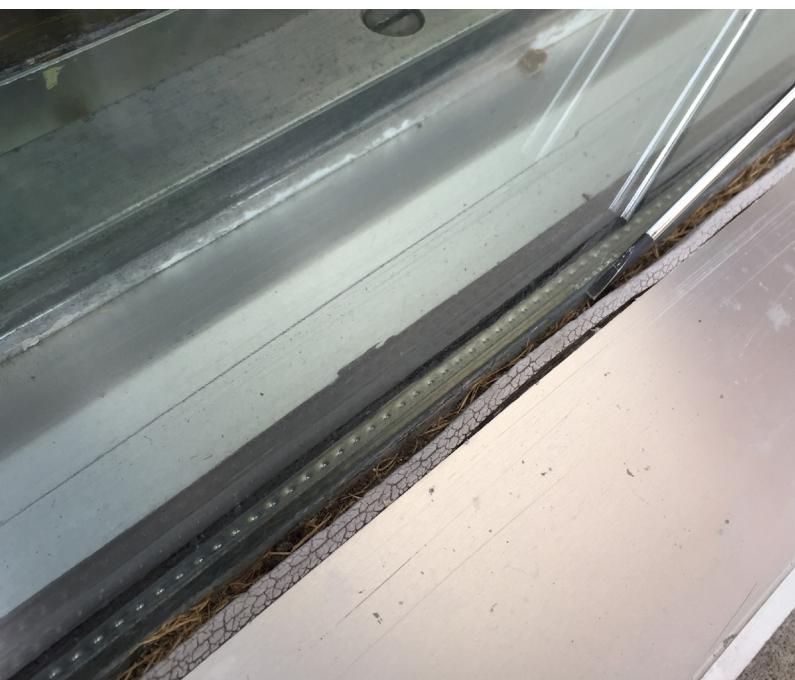
Wood Frame Deterioration

Sealant from the 1984 conversion has completely failed and in most locations is gone. Paint at the sill areas is in very poor condition. The critical seal area at the intersection of the vertical jambs and center mullions has failed and the wood in these areas is severely compromised.

Repair or replace the original damaged wood sills, jambs, and vertical mullions by a qualified craftsman.

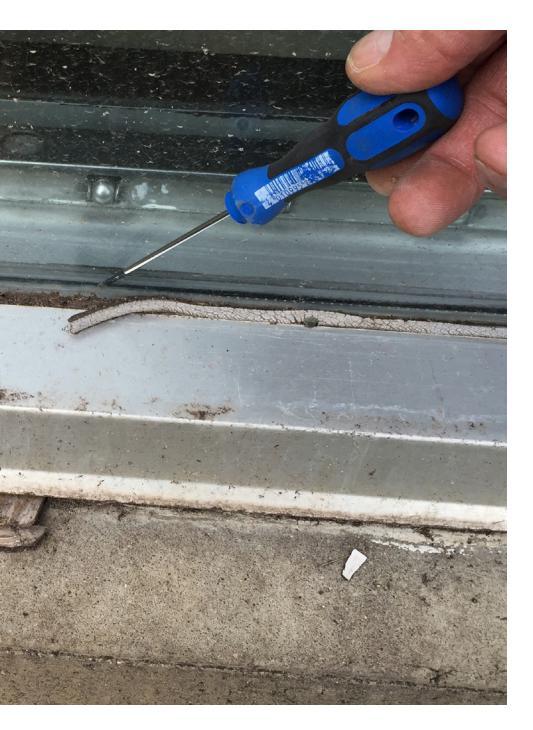
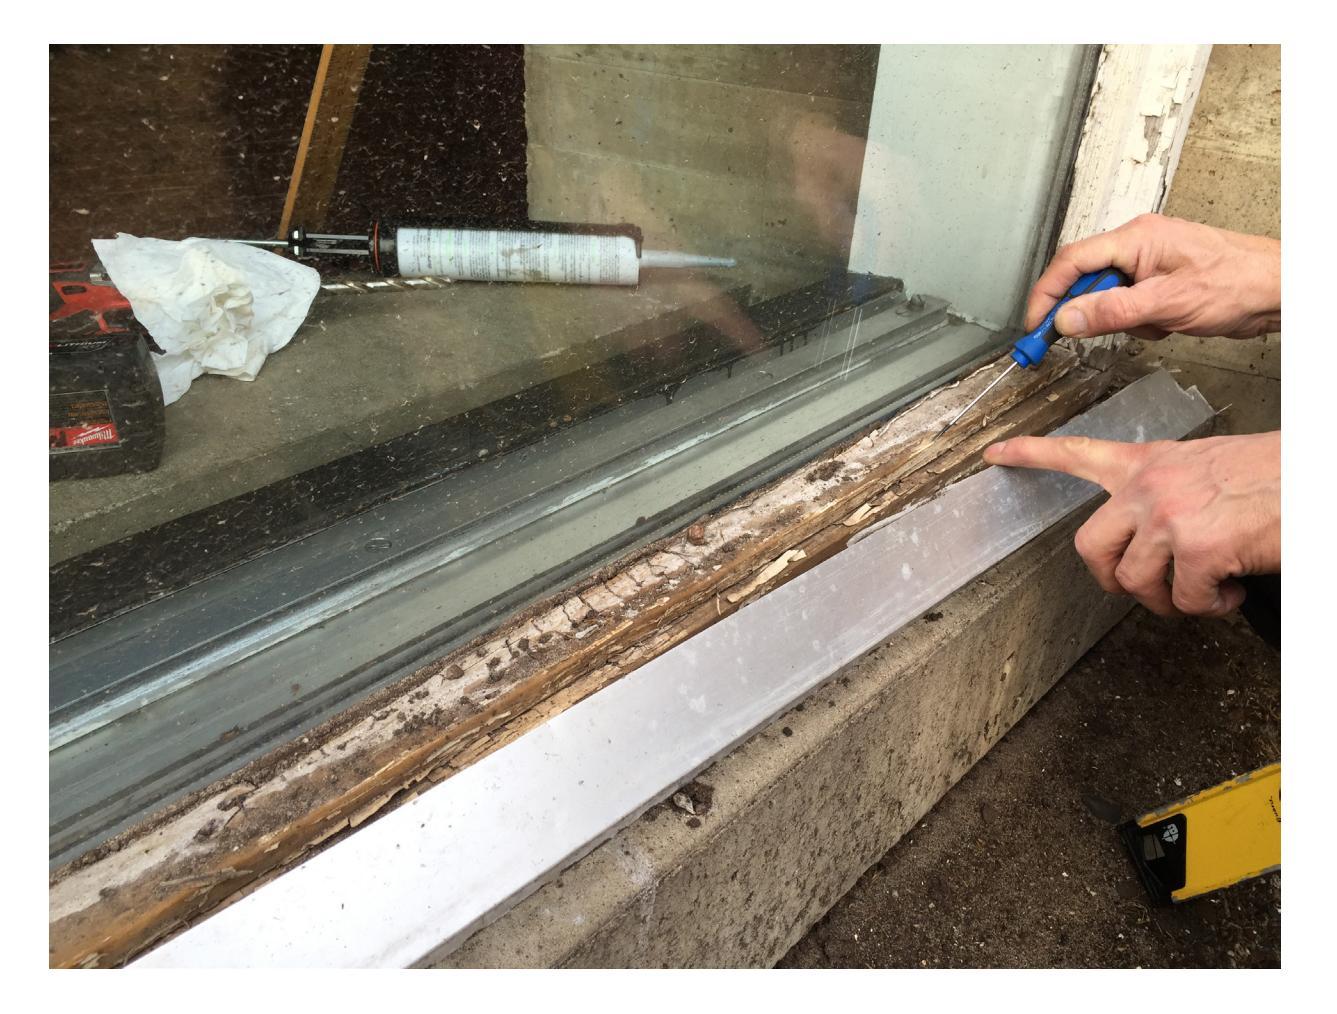
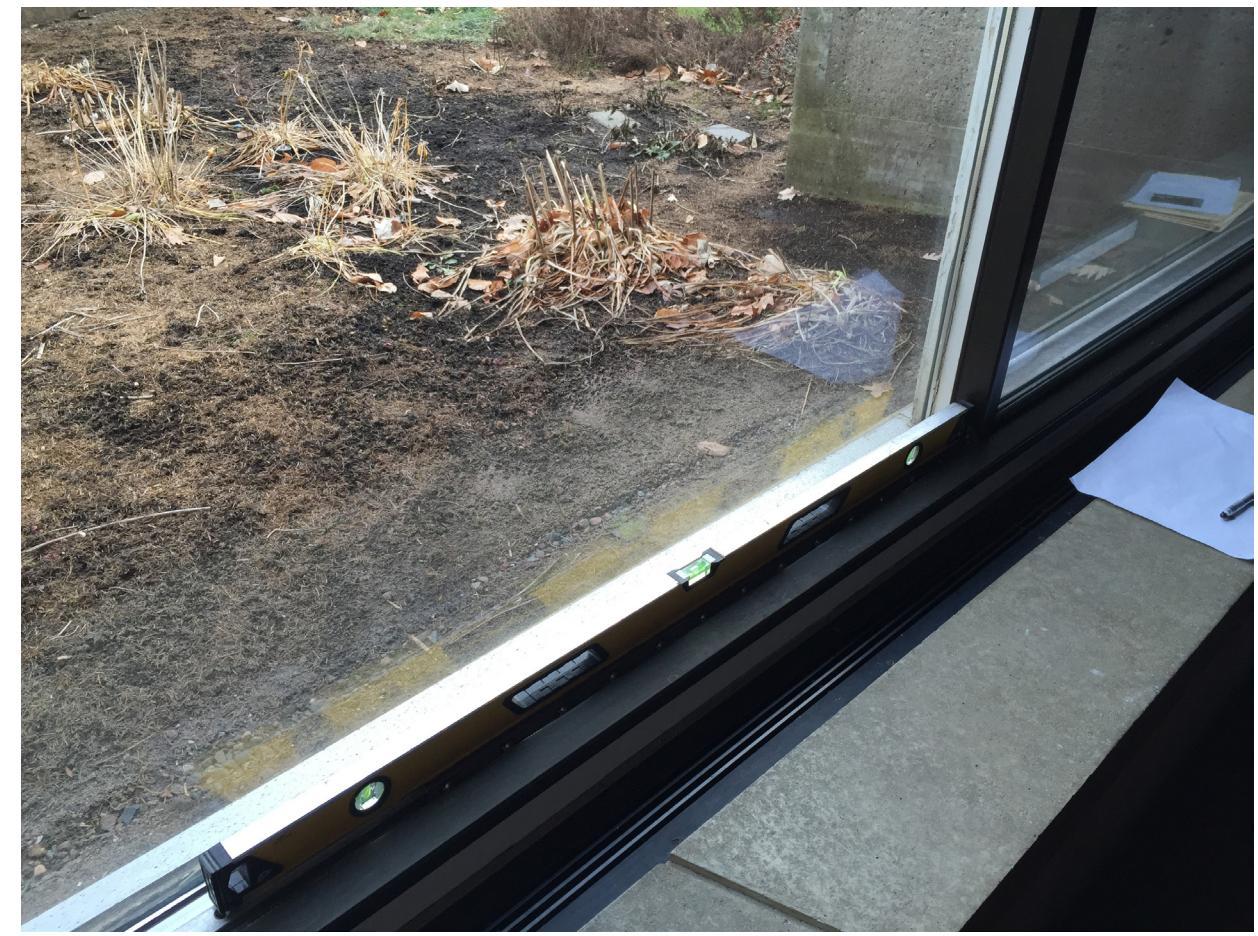
The sealant at the perimeter of the fixed glass has failed and allowing moisture penetration.

The wood under the sliding panels shows minimal signs of compression from the weight of the glass; most are level indicating a solid base at that location.

The existing insulated glass should be replaced if restoration is undertaken because of the age (31 years) and the stress to the perimeter insulated glass seal from handling.

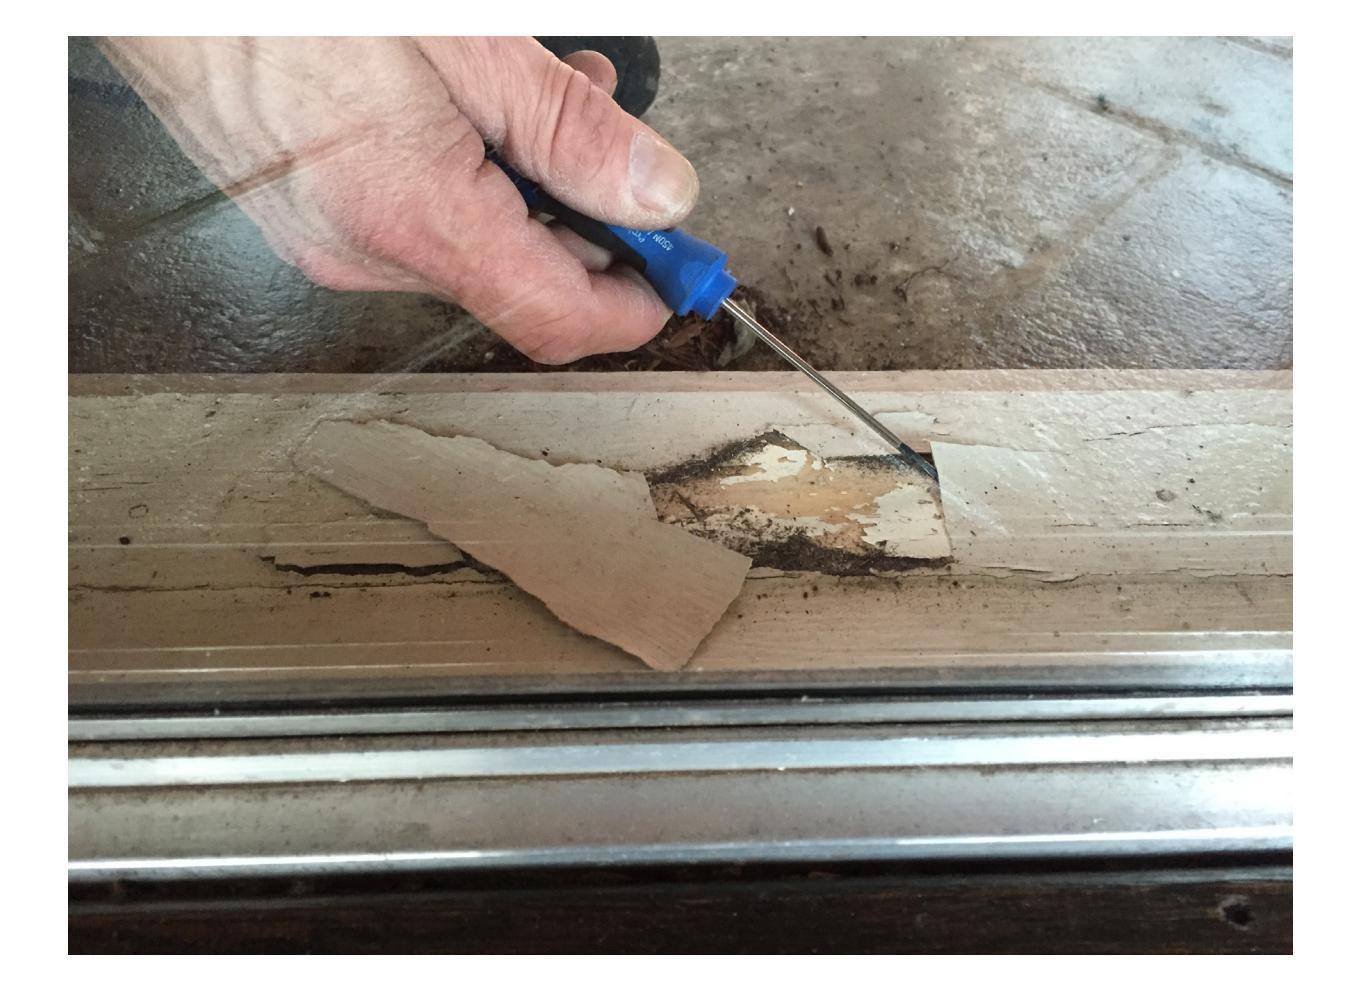
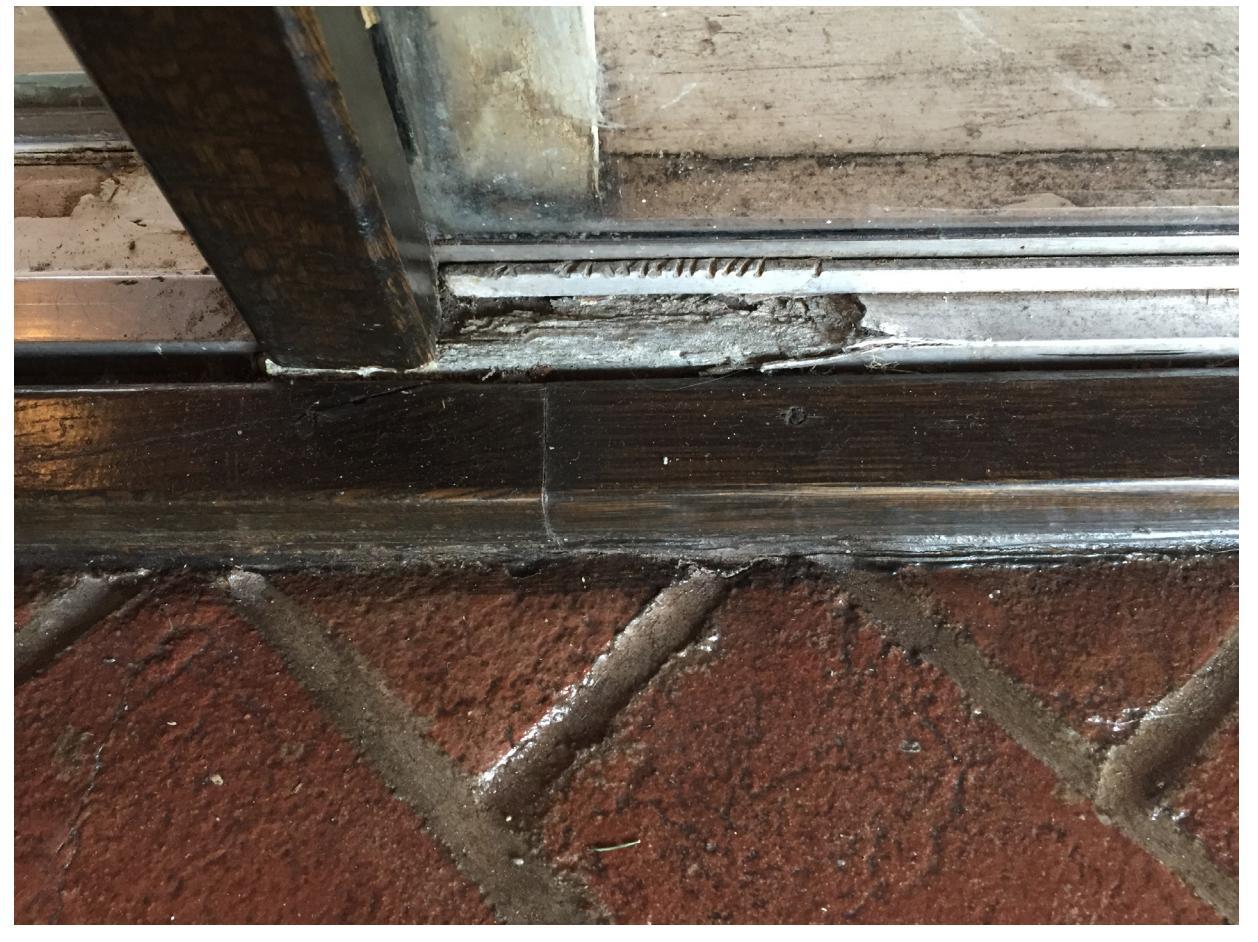
East and West Cloister Walk

The windows on the walk ways are generally in good condition. The large fixed glass panels have been converted to insulated glass and this existing glass could easily be replaced with better performance glass. (See insulated glass product comparison chart) Stripping and refinishing of the wood frames should be undertaken to preserve their original condition.
