FINAL REPORT July 2016

SAINT JOHN'S ABBEY CHURCH

CONSERVATION RESTORATION PRESERVATION

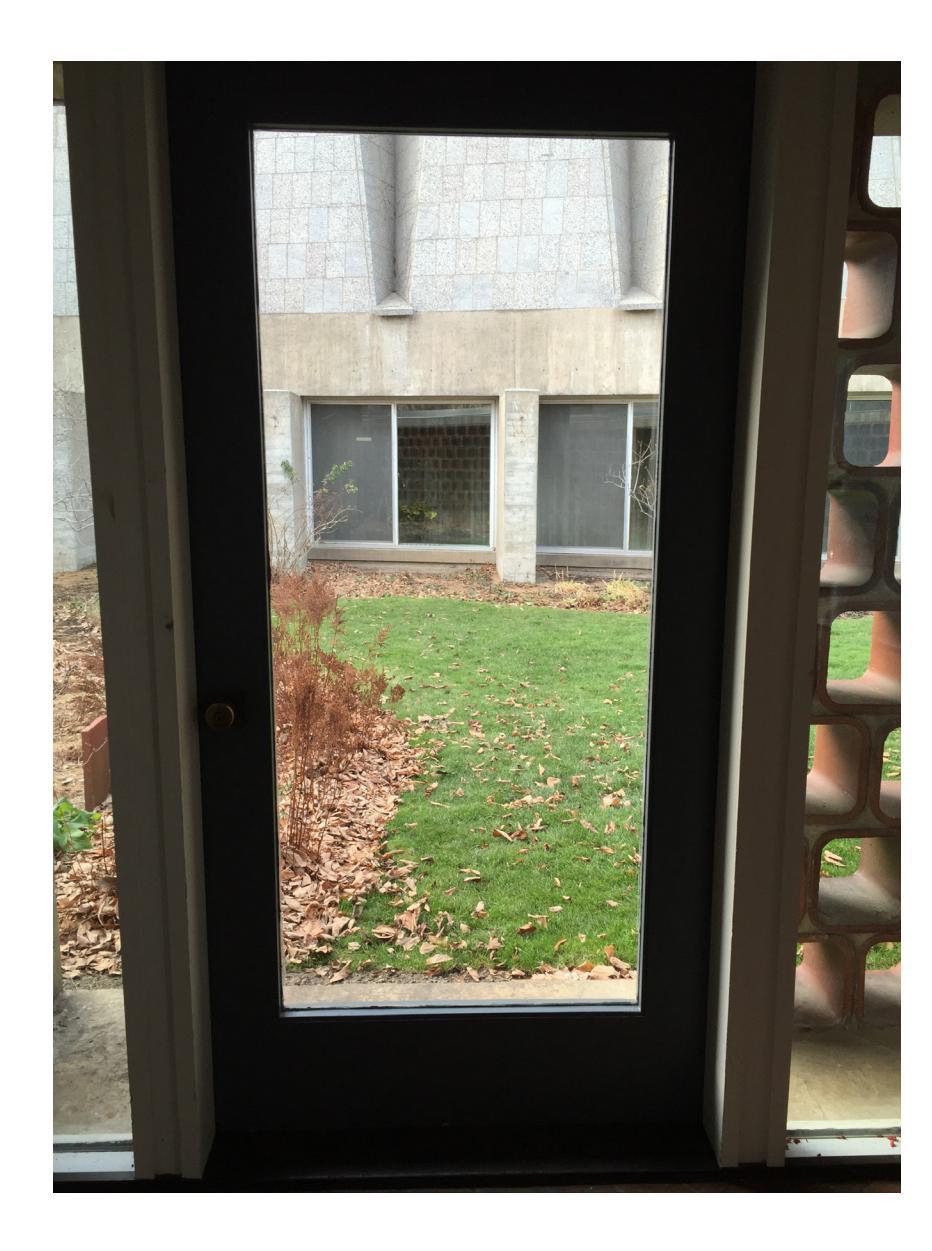
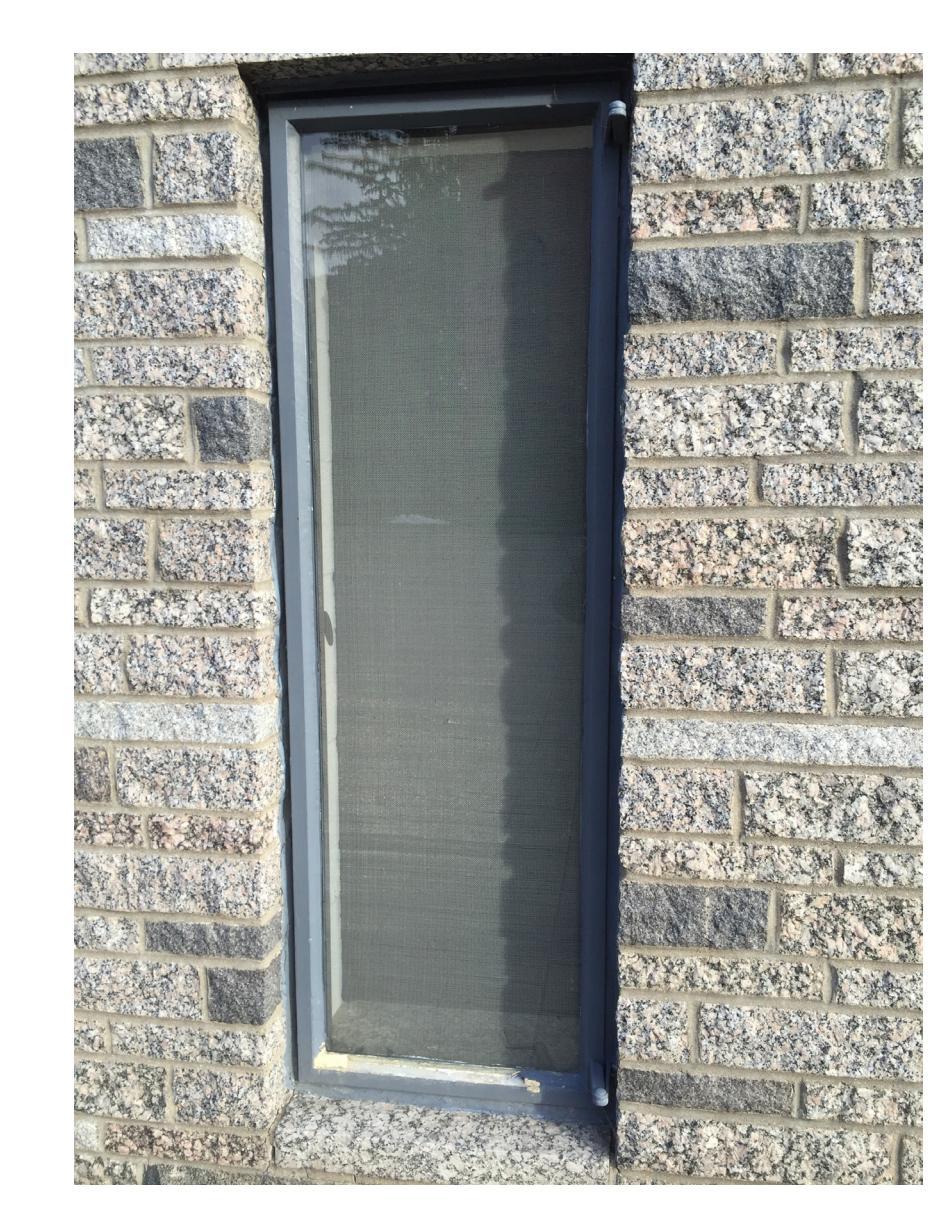
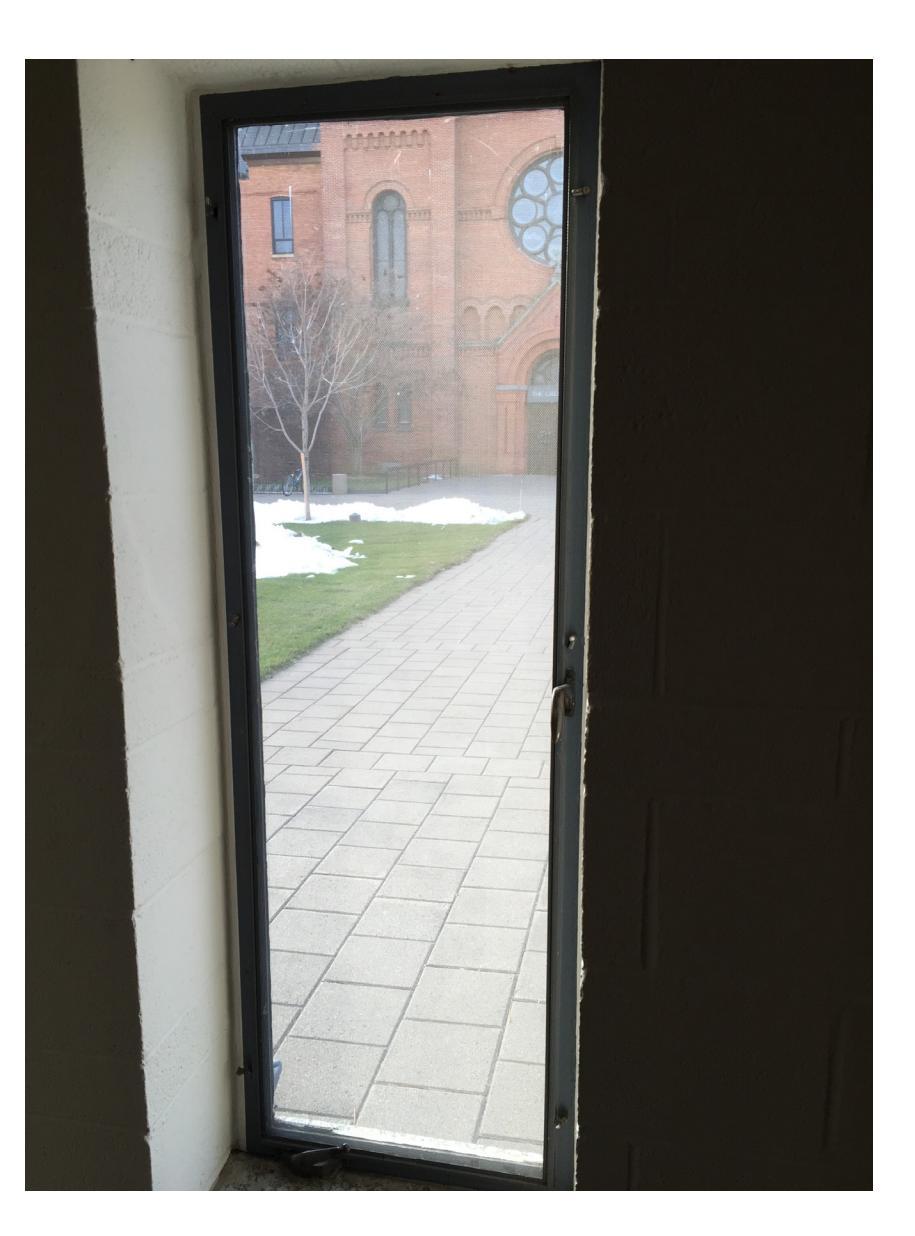
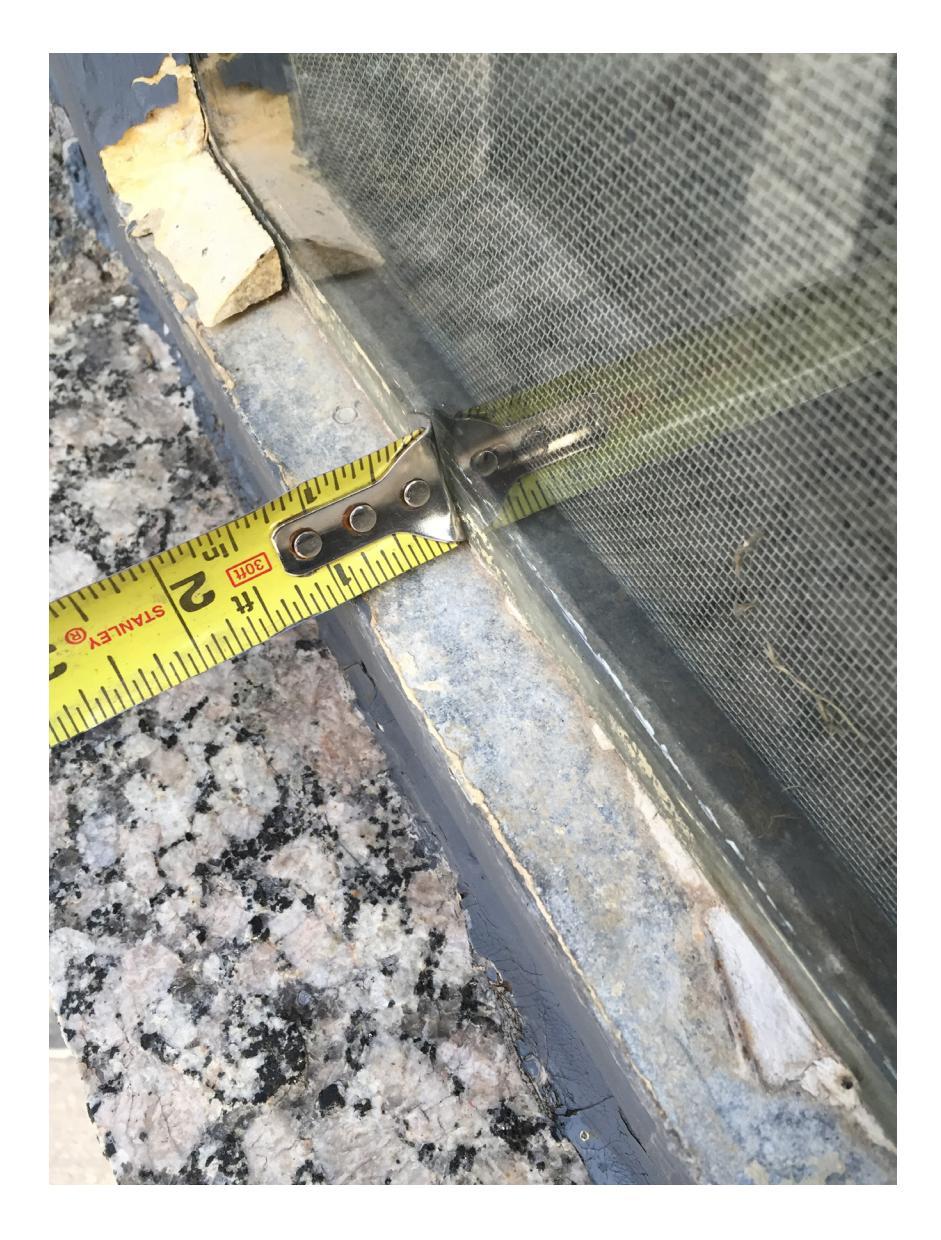
There are four original sliding door assemblies in each walkway similar to the twenty original panels in the Sanctuary that are glazed with single 1/4" non insulated glass. These doors could be modified to receive high performance glass (see performance chart) utilizing the methods used to convert the sanctuary windows. There is one door showing signs of metal deterioration.

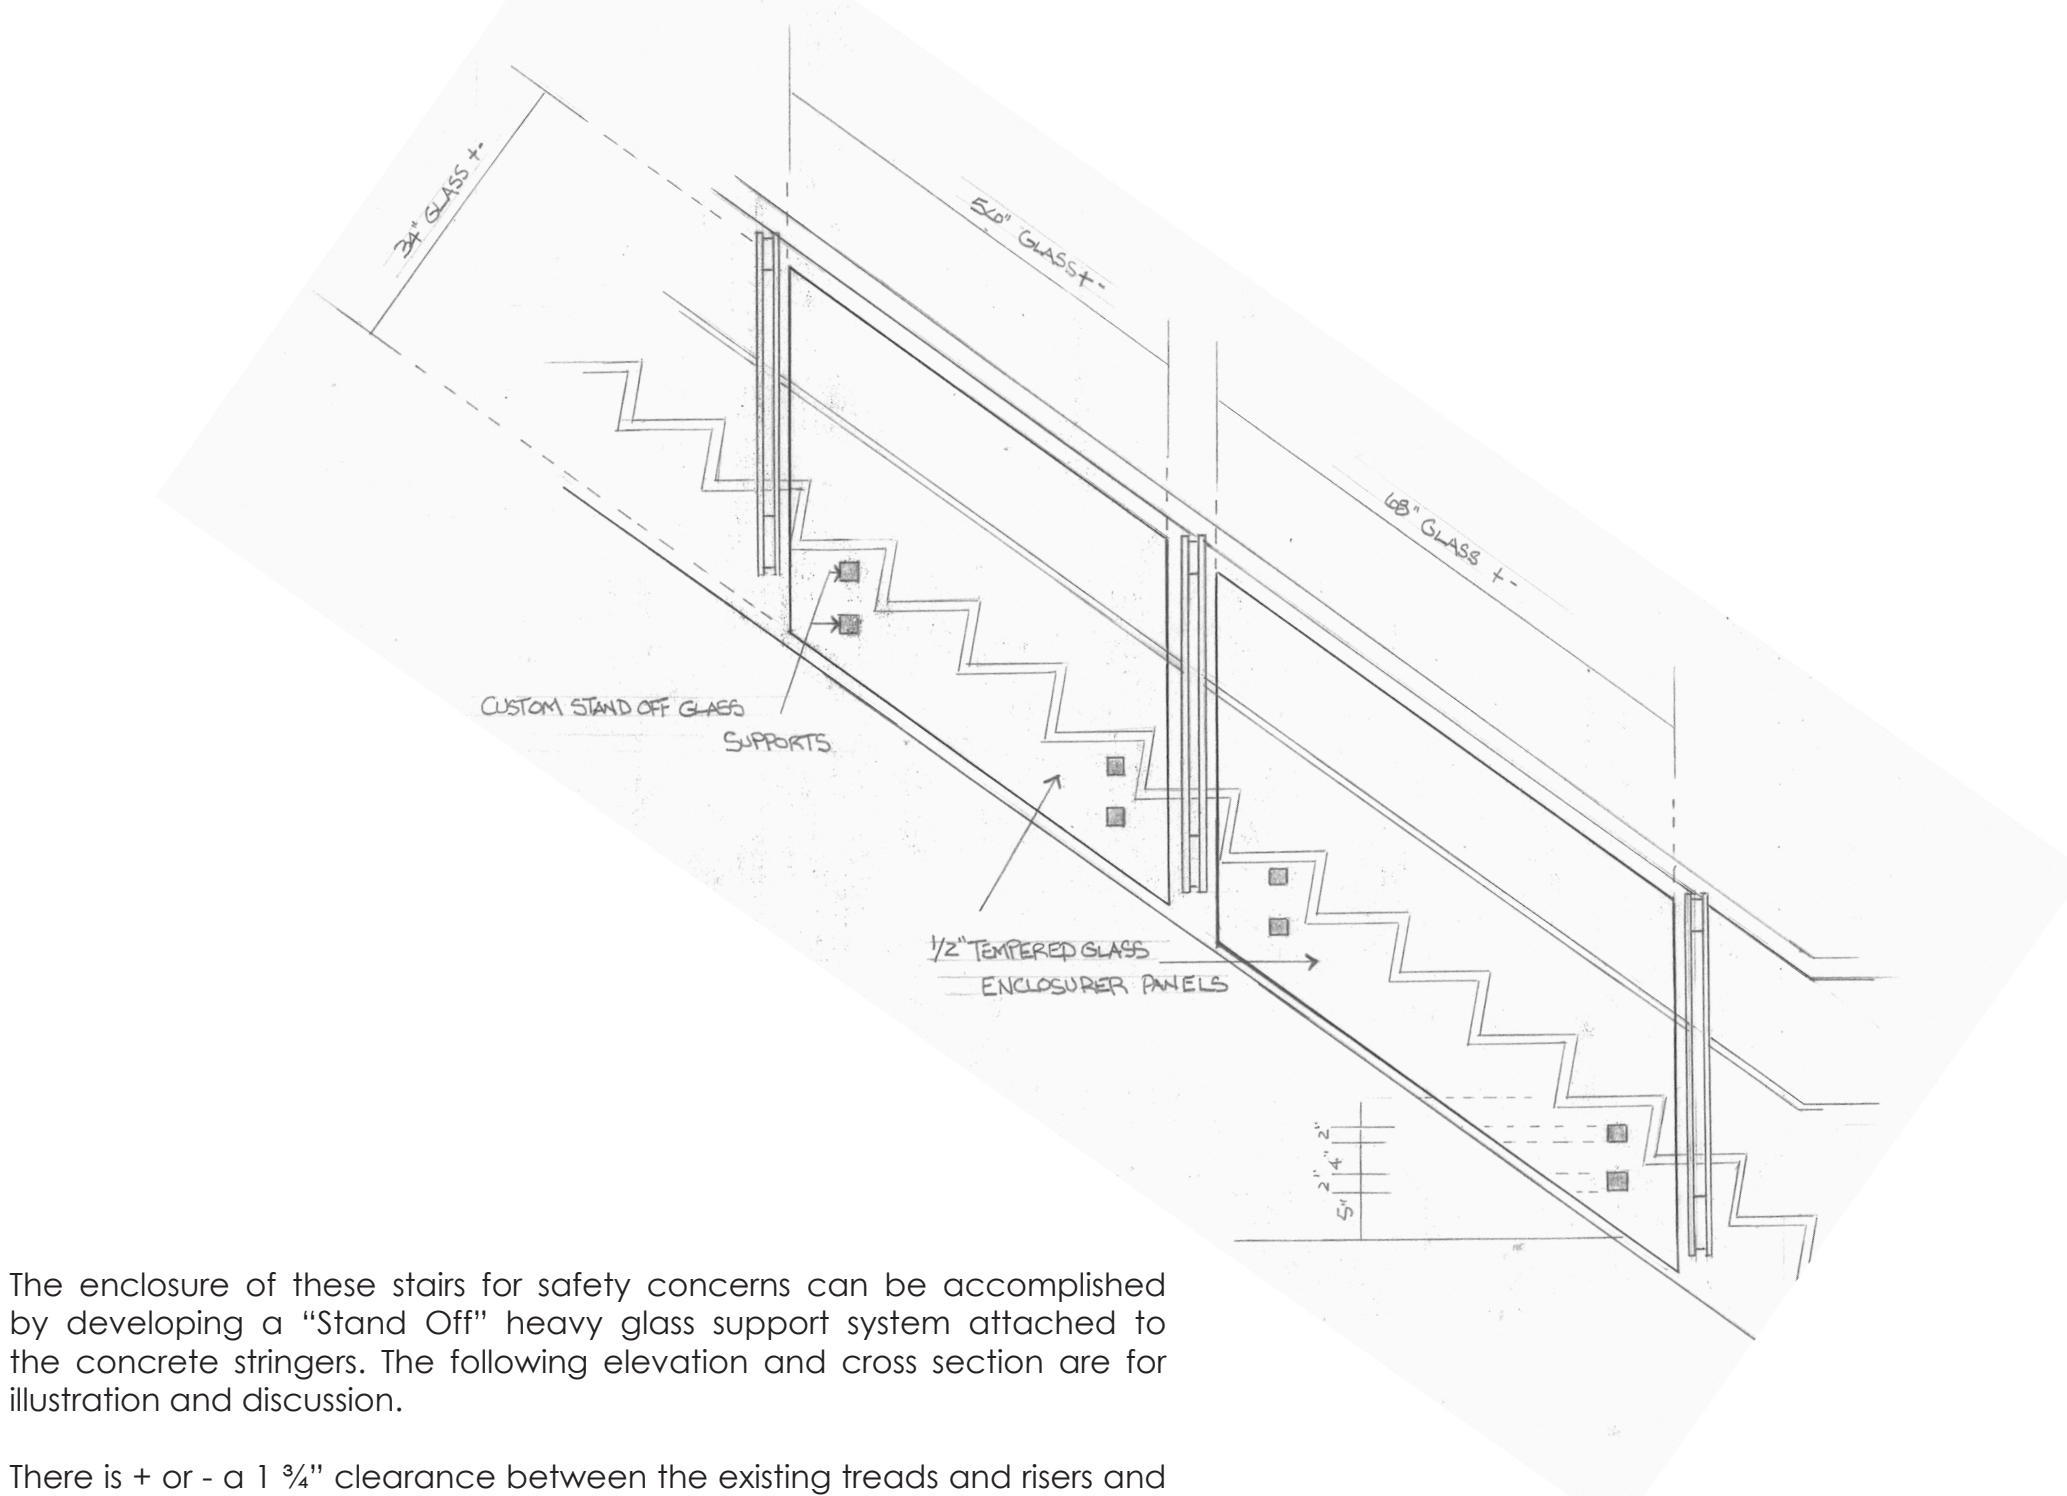
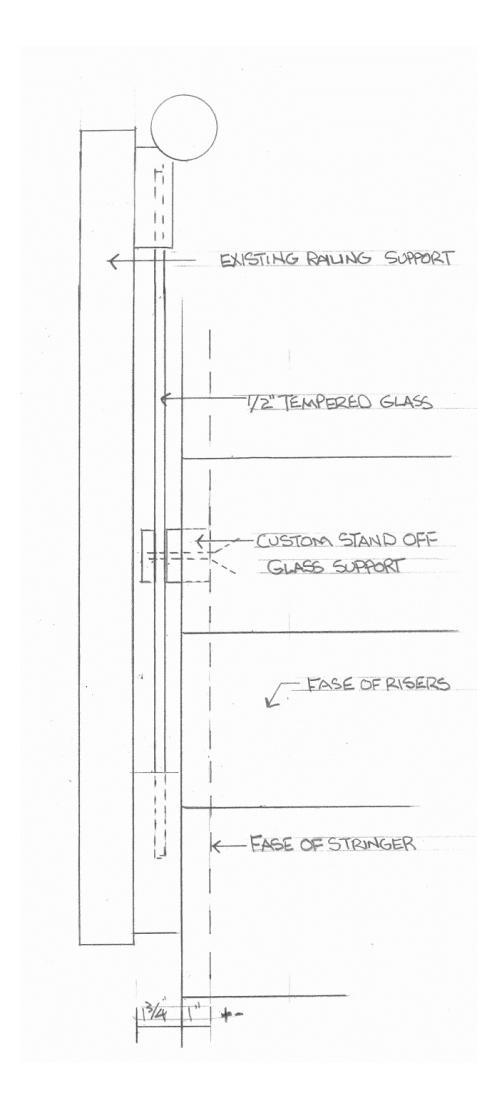
East Stairway to the Lower Restrooms

There is + or - a 1 ³/₄" clearance between the existing treads and risers and railing system allowing the placement of enclosure safety tempered glass. Custom standoff glass supports can be made and finished to compliment the original architectural design. A possible concern is the anchoring used to attach the stand offs to the concrete formed stringer. The original concrete stringer drawings should be reviewed for location of steel reinforcing.

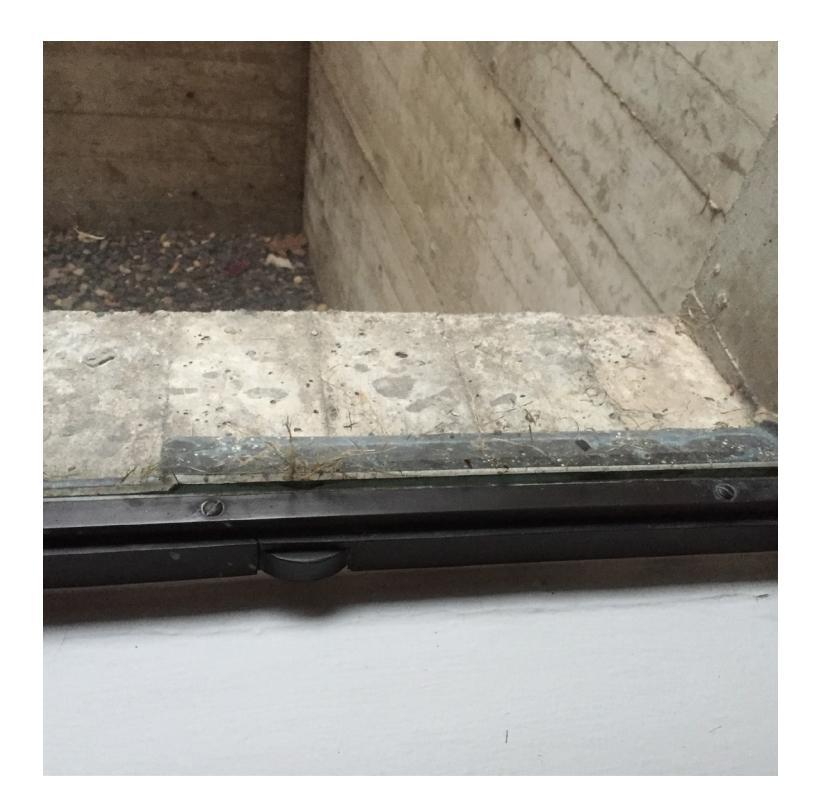
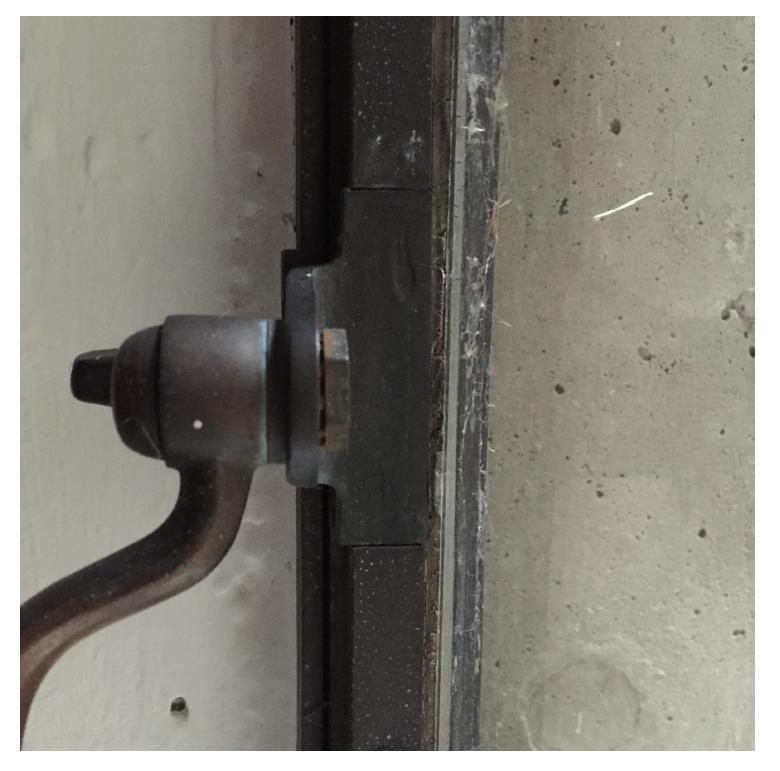
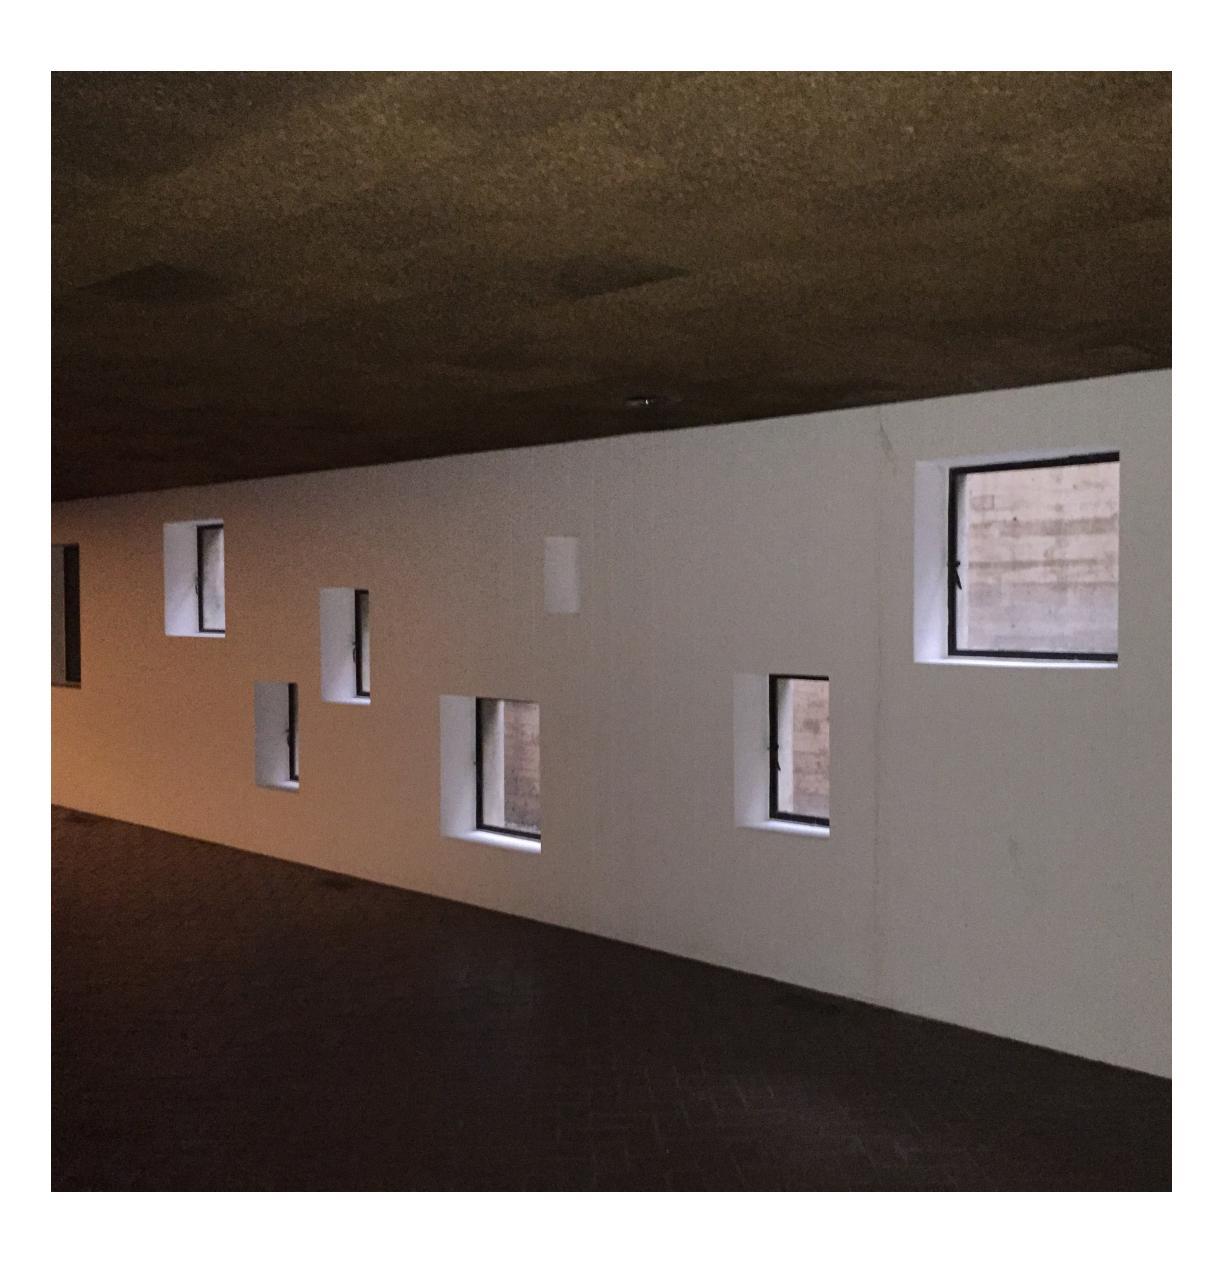
Basement Windows

These windows are quite unique; they are constructed of brass/ bronze and glazed with 1/8" monolithic single pane non-insulated glass

There are both fixed and center pivoted operable windows with latching handles. The screw applied glazing stops and the latching handles will prevent replacing the single glass with thicker insulated glass.

Handle is pressed against the glass allowing no room for thicker glass

The glass can be replaced with higher performing Low- E #2 monolithic glass by removing the existing glass and re-glazing into the existing stop system. See below data sheets for improved performance. The windows performance can also be enhanced by the application of compatible weather-stripping.

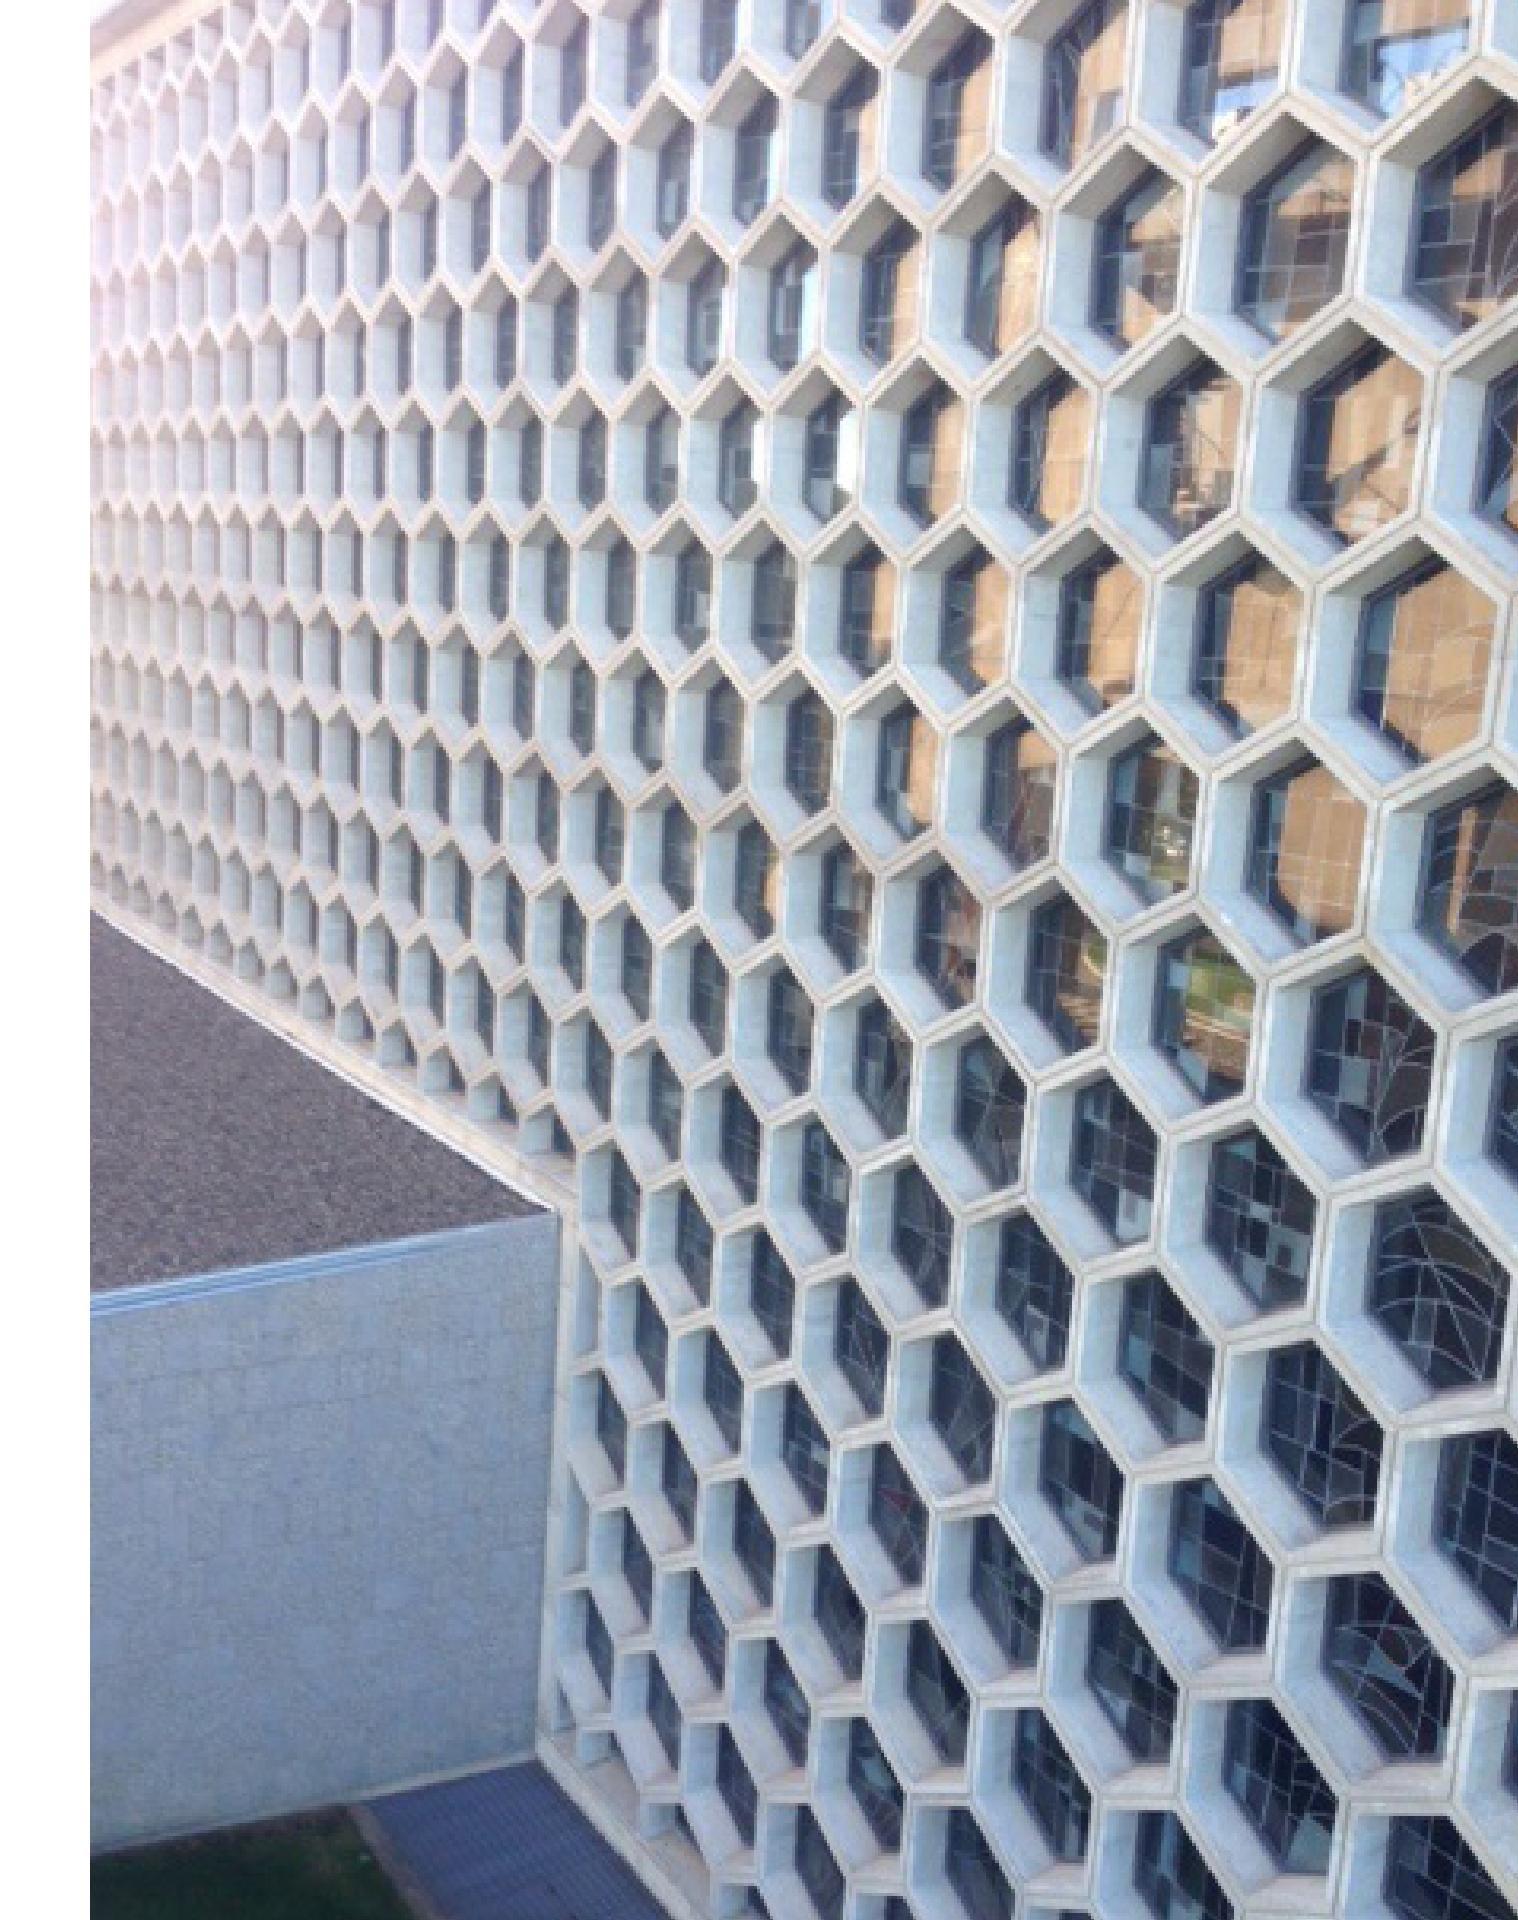
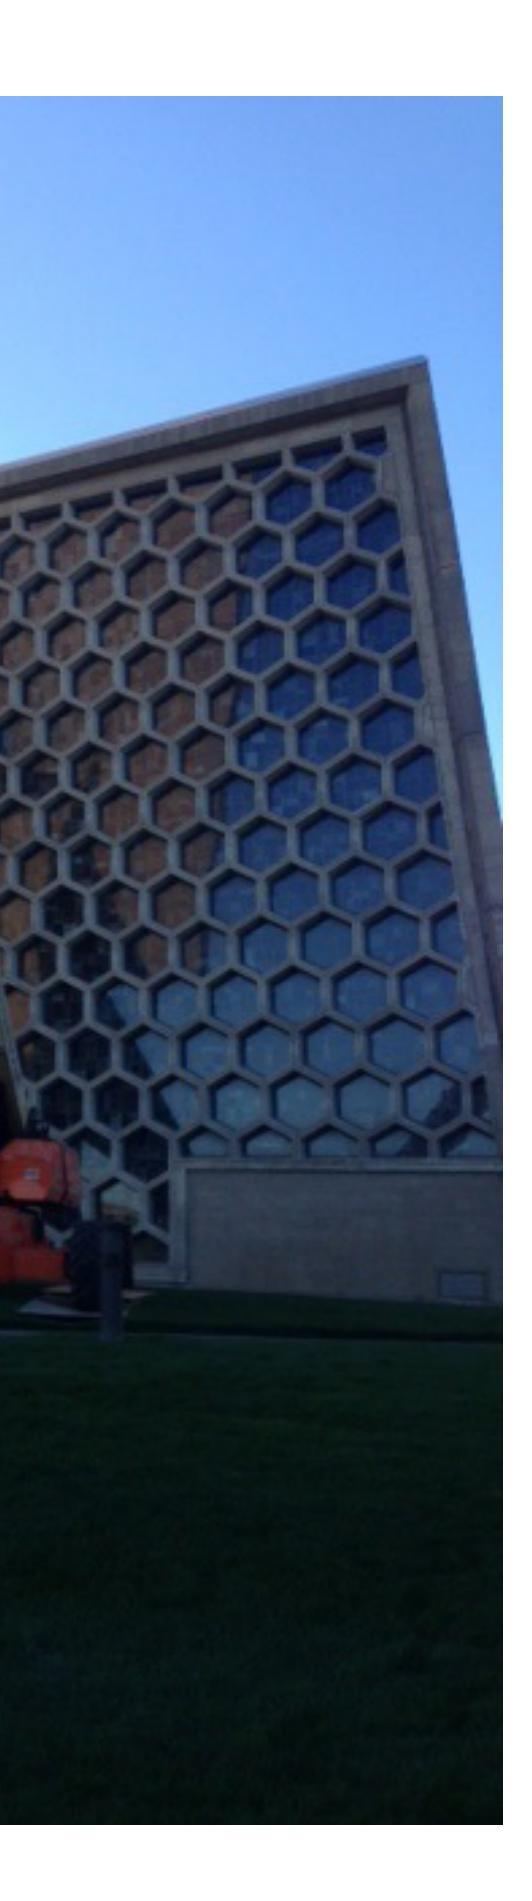
North facing stained glass wall of windows

On inspection of the interior and exterior, we found the integrity of the lead and solder joints in good condition. There are no noticeable cracks or breaks detected in either lead or solder joints. The reinforcing bars, with a few exceptions, are intact, still soldered to the lead and performing very well. No bowing or bulging of the panels was seen.

The stained glass window panels have dust and dirt and some spider webs on both the interior and exterior stained glass panels. The interior and exterior concrete portions of the windows openings are also quite dirty and dusty.

There are a few pieces of cracked stained glass on the north facing wall.

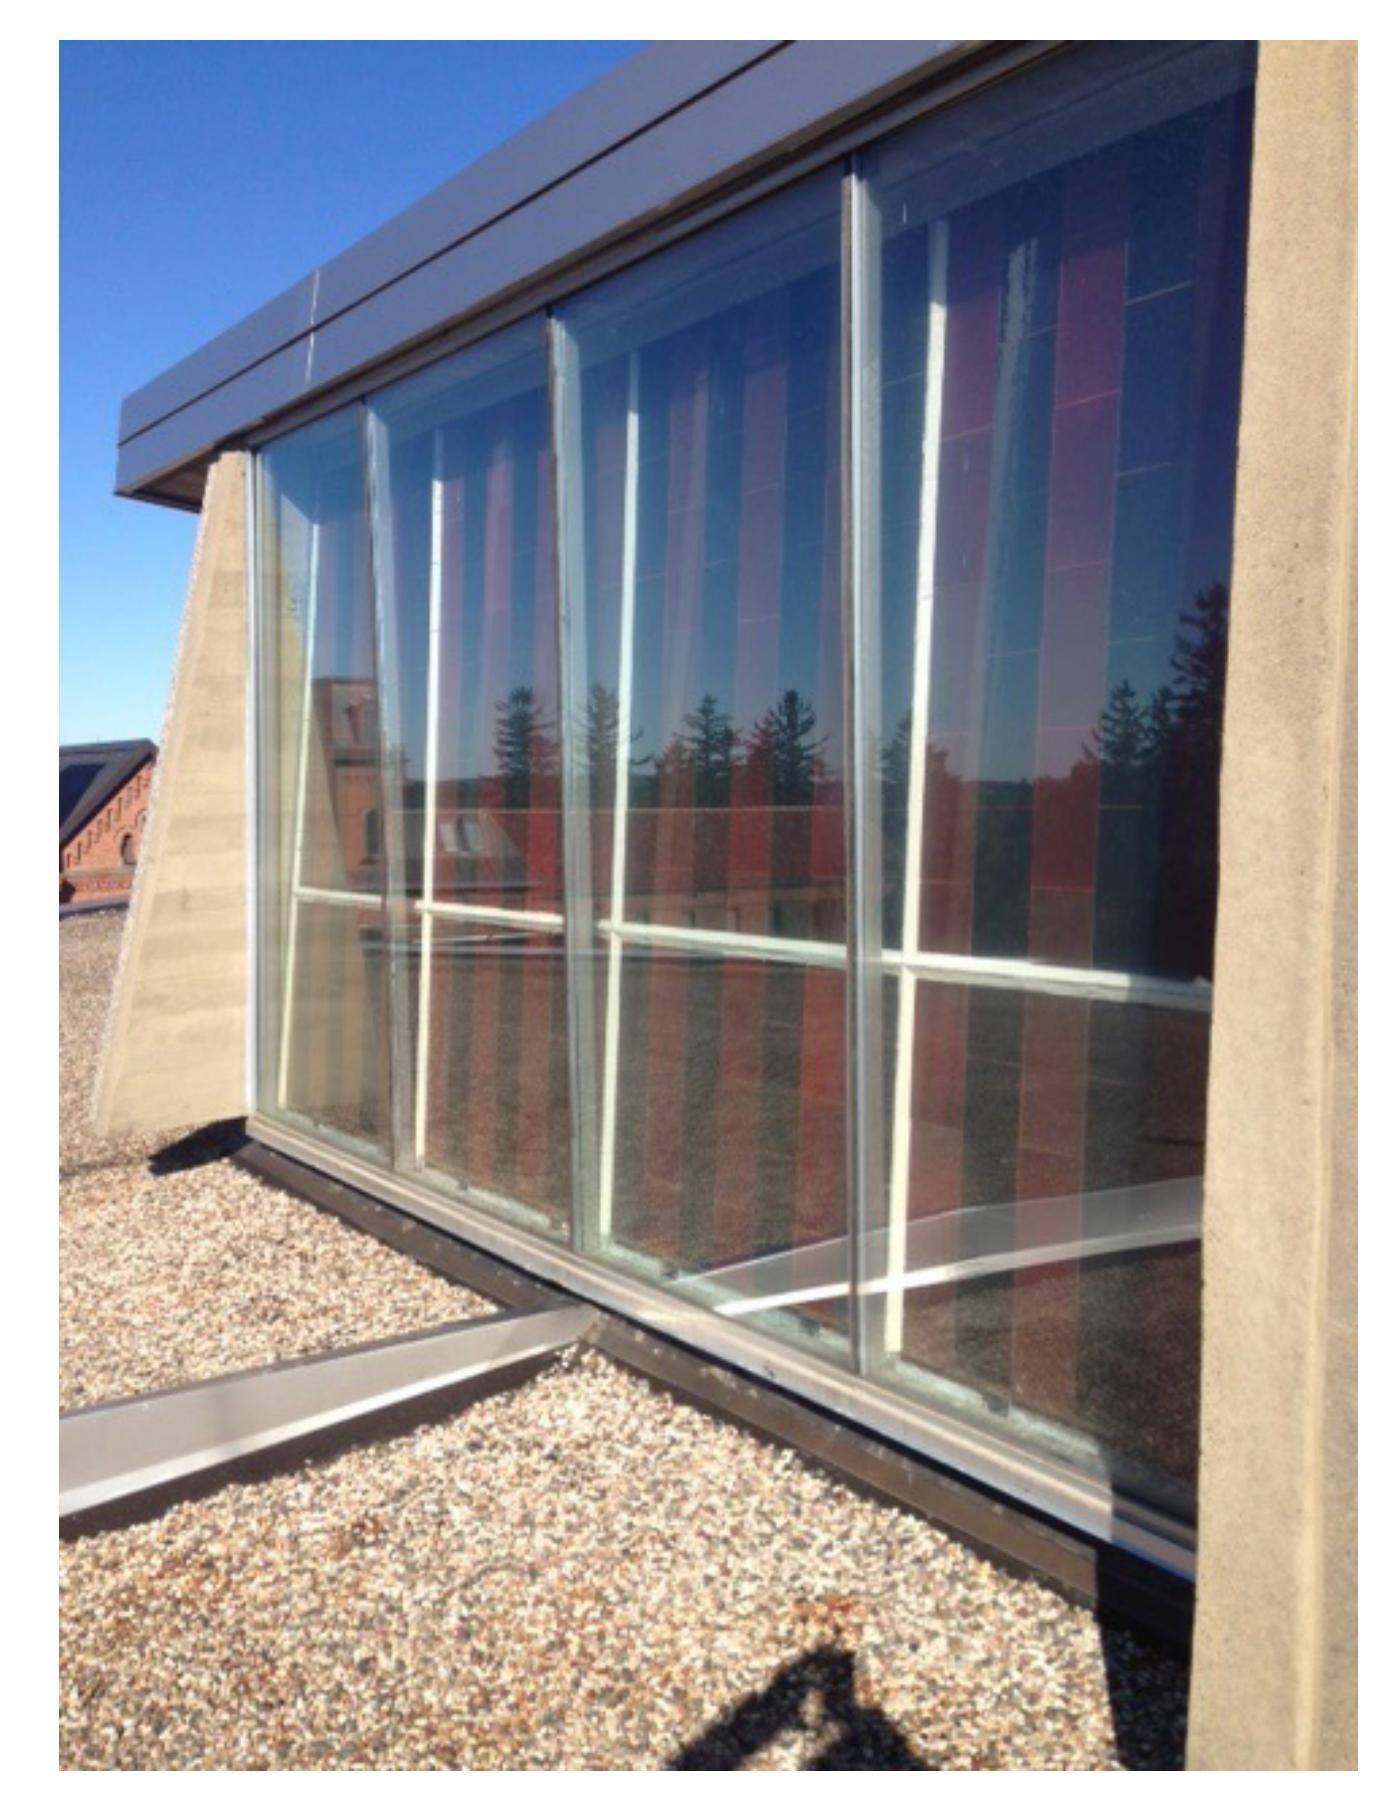
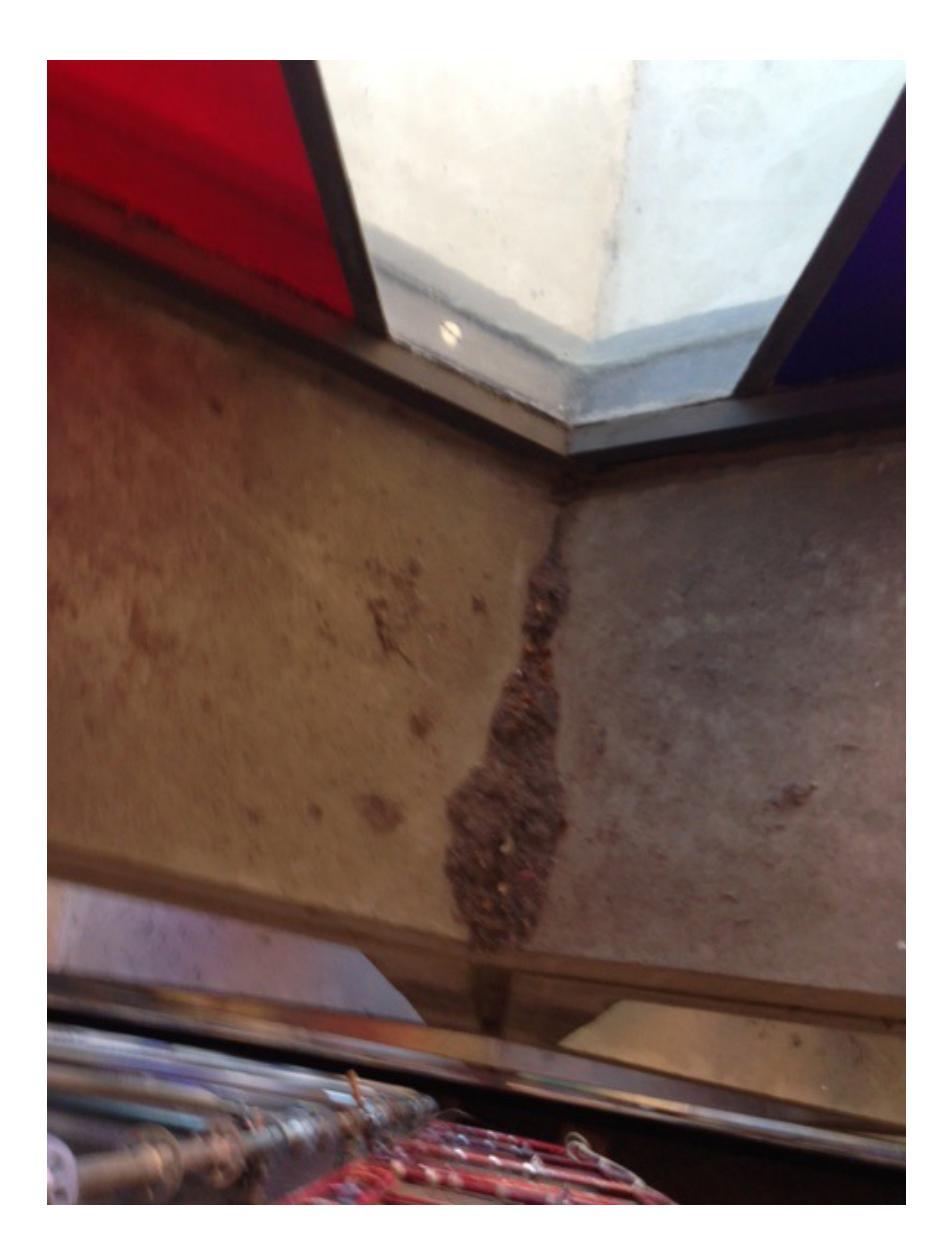
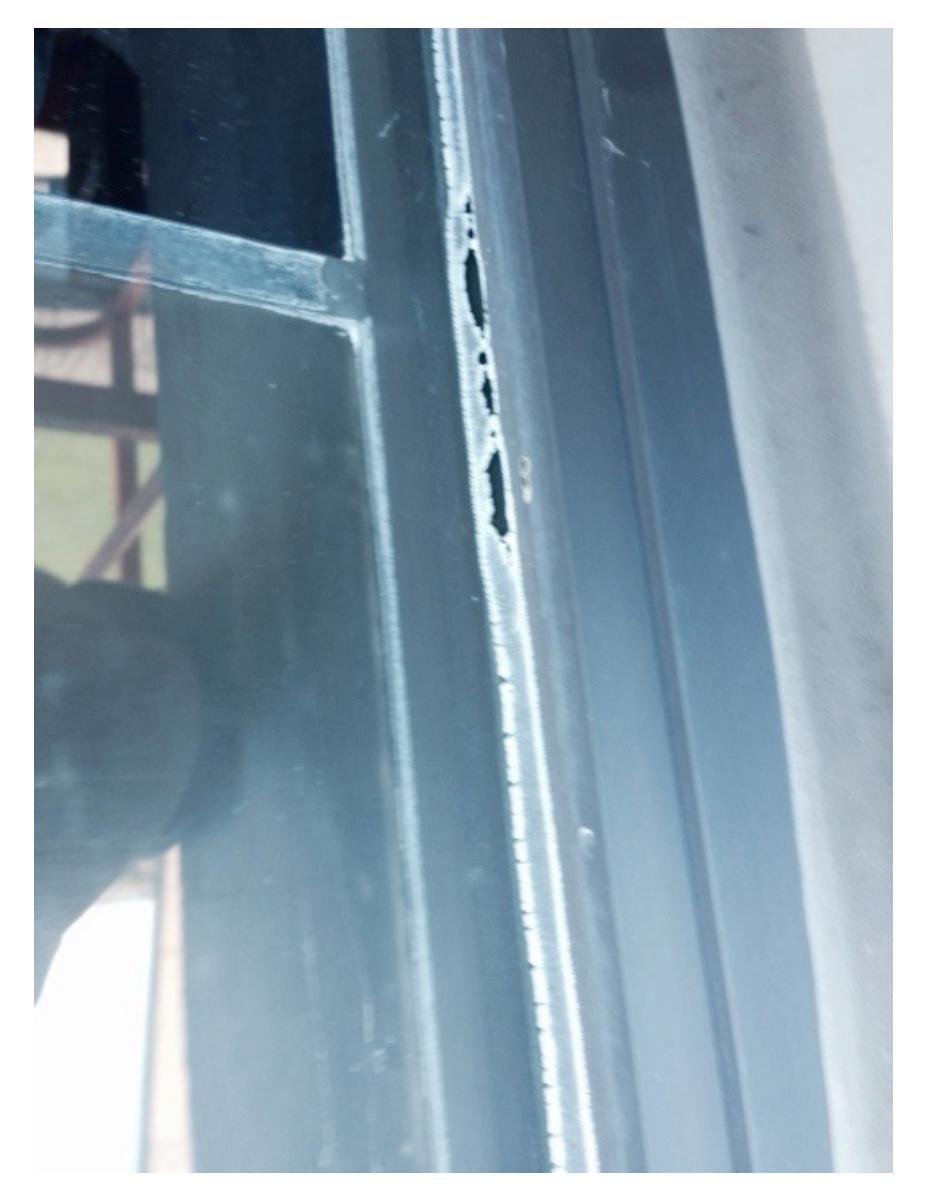
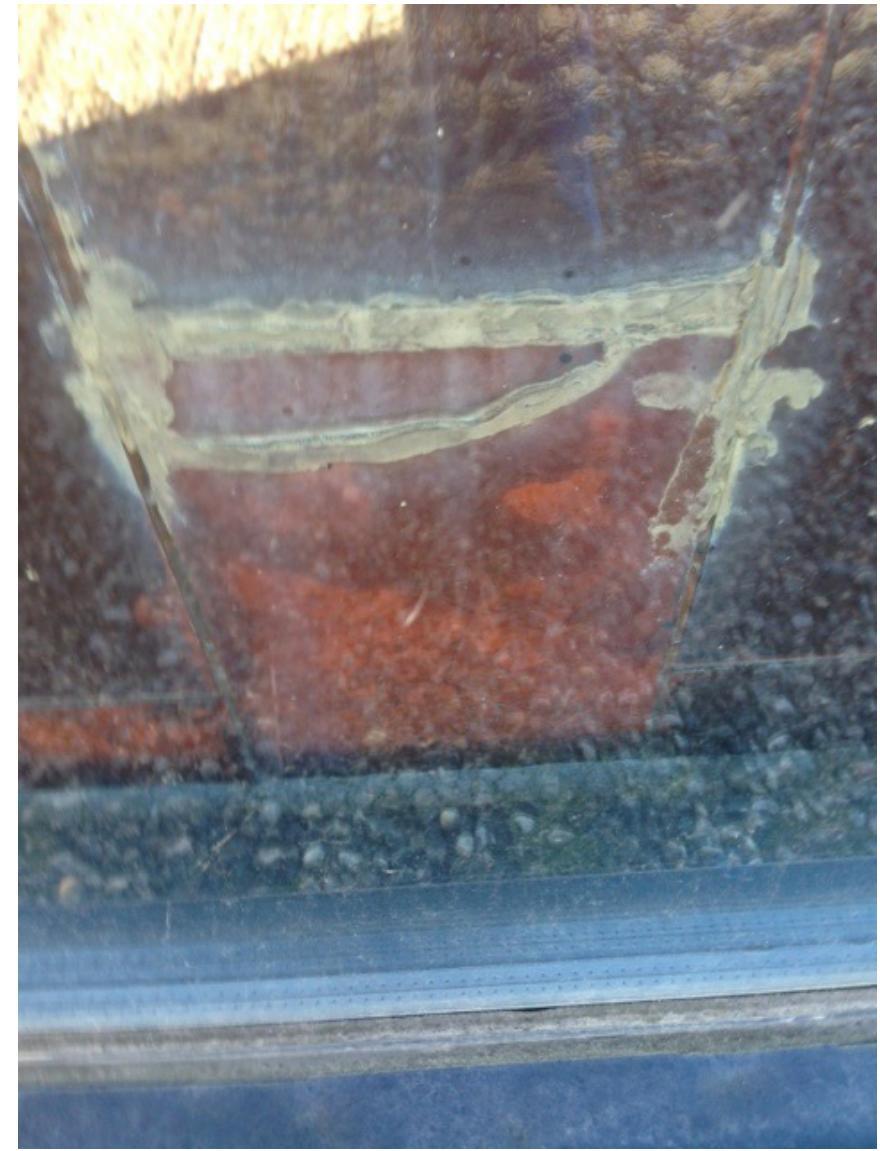
1. Some stained glass pieces are missing and cracked.

3. Dirt is getting between the stained glass and $^{1}\!\!/''$ clear glass.

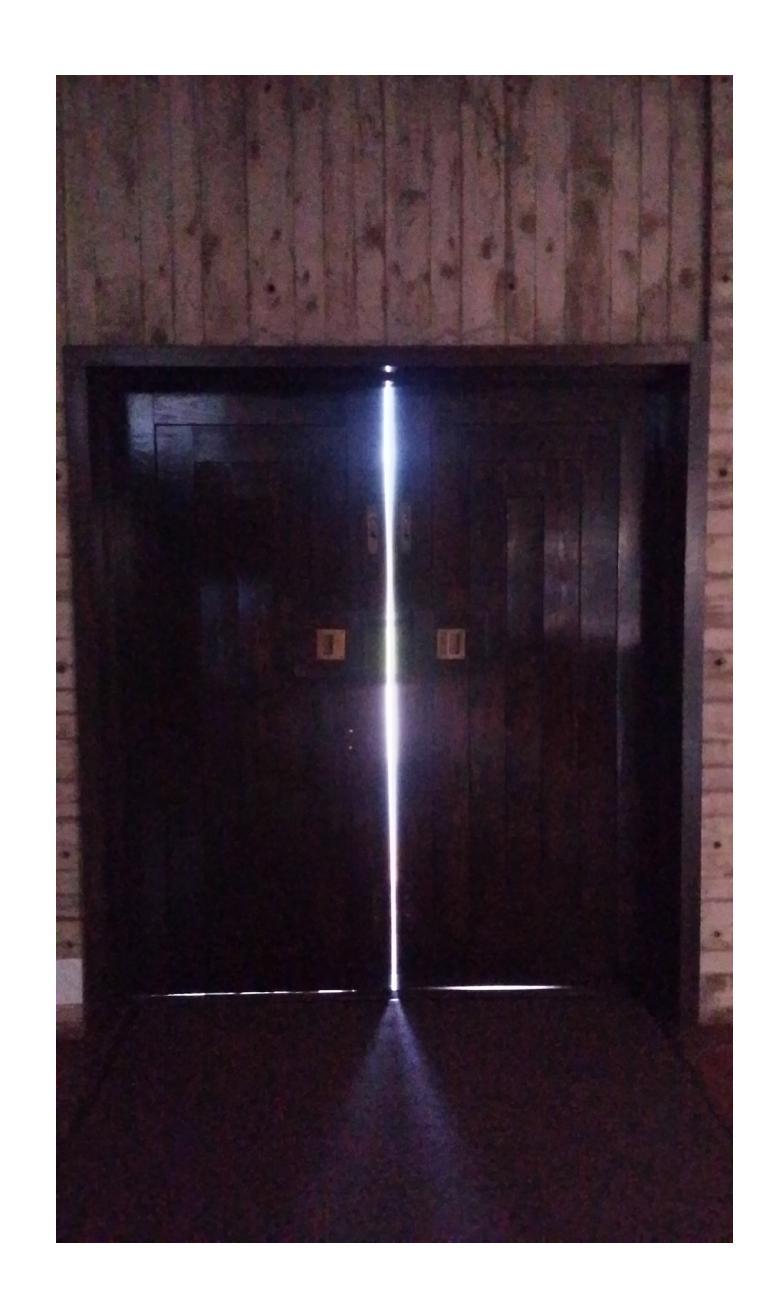
The main Abbey Church entry is north-facing, through the Baptistry. There is no air lock. Solid wood pairs of doors do not provide a weather seal. Light - and cold air in the winter - leaks through where the door leafs should join. Options for restoration and repair include fitting the existing door edges and bases with seals to provide a tight fit; or reconstruction of new, thicker doors with faces that are identical to the existing ones but which clad thermally-broken insulating cores.

times creates a whistle.

ABOVE A pair of entry doors from beneath the Bell Banner porch into the Baptistry. Light leak is a simile for air infiltration in the winter, which at
