FINAL REPORT July 2016

SAINT JOHN'S ABBEY CHURCH

CONSERVATION RESTORATION PRESERVATION

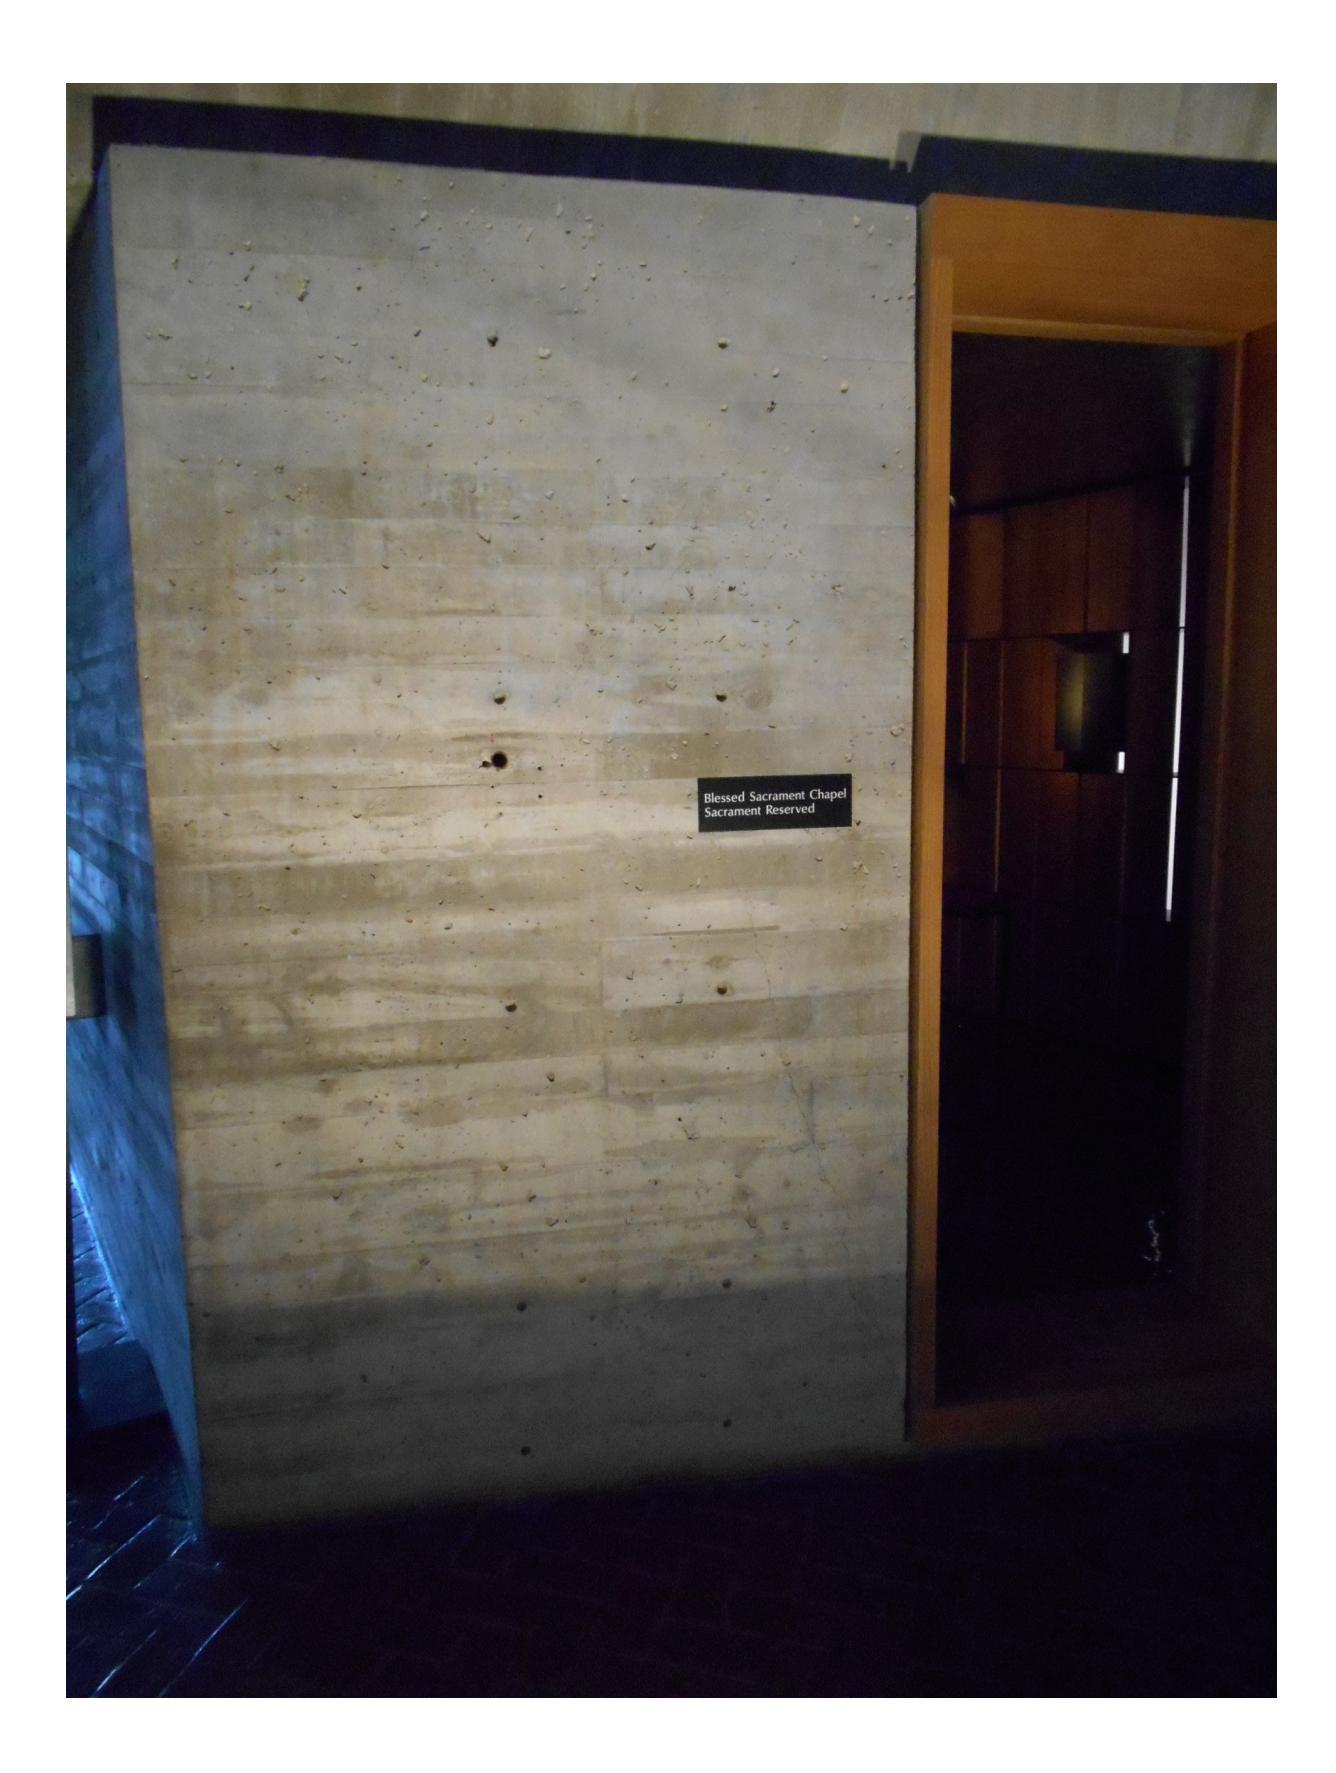
Sanctuary Interior Surface Survey

The sanctuary interior surfaces consist of the original exposed concrete folded plate structure. Minor cracking was observed near the base of the east and west elevation walls near the north end. The cracking was not judged a structural concern. Additional cracking was observed on the interior wall adjacent to each side of the doorway to the Blessed Sacrament Chapel on the east side of the sanctuary. The cracking was not judged a structural concern.

One location at the third roof rib from the north on the west wall elevation a short length of cold joint/crack was observed that exhibit a leached whitish material. The material is unknown but appears consistent with form oil or efflorescence. The location is at the bottom of the folded roof plate rib location. The cracking is not judged a structural concern.

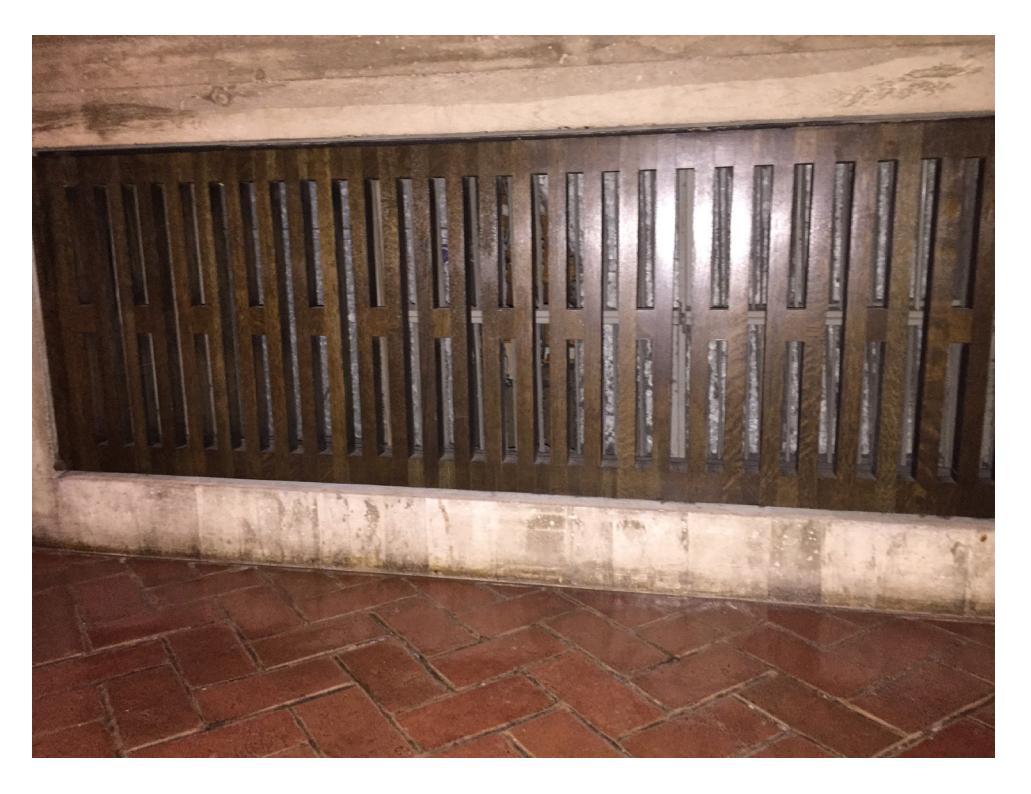
Figure 3: Return Grille at back of Church

The return air ductwork consists of a combination of ducted and plenum return. The return air ductwork is routed to the main church through ductwork located in the basement ceiling. Return air is then returned from the main church through wall grilles at the West side from the confessionals and at the back of the church, adjacent to the baptistry, as indicated in Figure 3: Return Grille at back of Church. Air is also returned from the choir areas from below seat grilles and plenums as shown in Figure 4: Return Grille under Seat at Choir. This method of returning air is efficient with the design of the church as there is limited return ductwork. One concern though is that the heated air can stratify in the large volume space and result in significant temperature differences at the balcony

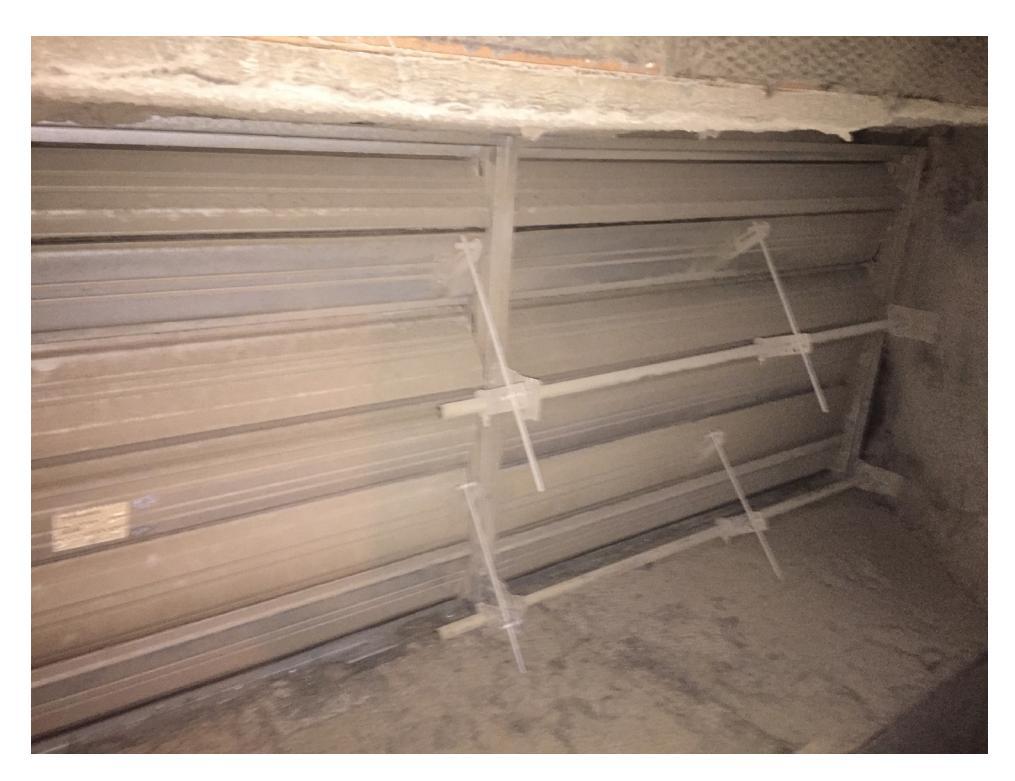
The dampers are original to the building construction and are therefore over 55 years old. The outside air dampers are worn and do not actuate and seal properly, refer to Figure 5: Outdoor Air Dampers (next page). On the day of the field review, the dampers were 100% closed, but significant cold air was observed penetrating the dampers. This has led to the steam coil freezing and resulting in significant repairs to the steam coil. The maintenance personnel have attempted to mitigate the infiltration by partially blocking off the intake located in the tunnel as indicated in Figure 6: AHU-1 Outside Air Inlet (next page). Consideration should be given to replacing the dampers in conjunction with an overall air handling unit replacement.

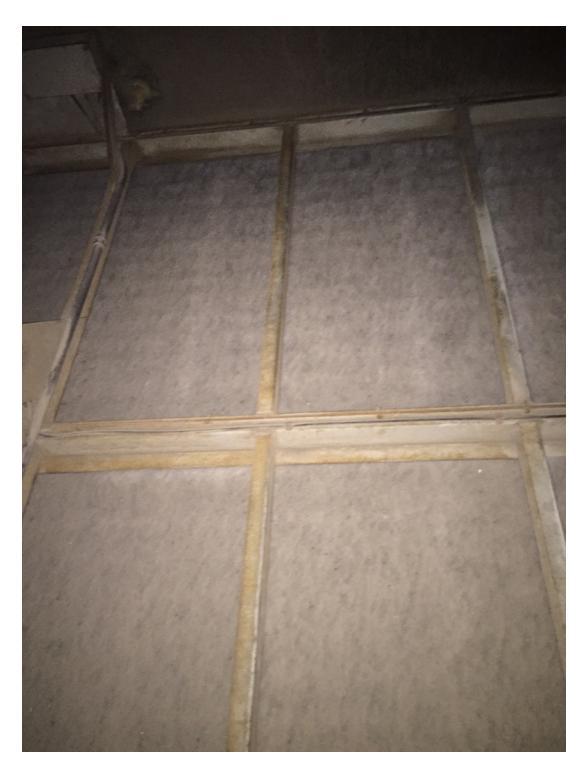
Figure 7: AHU-1 Filter Section

The original filtration system installed in the AHU was a roll filter. That filter has been removed and replaced with filters that consist of a fabric media filters, shown in Figure 7: AHU-1 Filter Section. The filters are located immediately downstream of the mixing plenum. Facilities personnel indicate that the filters are changed regularly and do not report any issues with the filters. The existing filtration level of the filter bank was reported to be MERV 8. Consideration should be given to replacing the filters in conjunction with an overall air handling unit replacement plan.

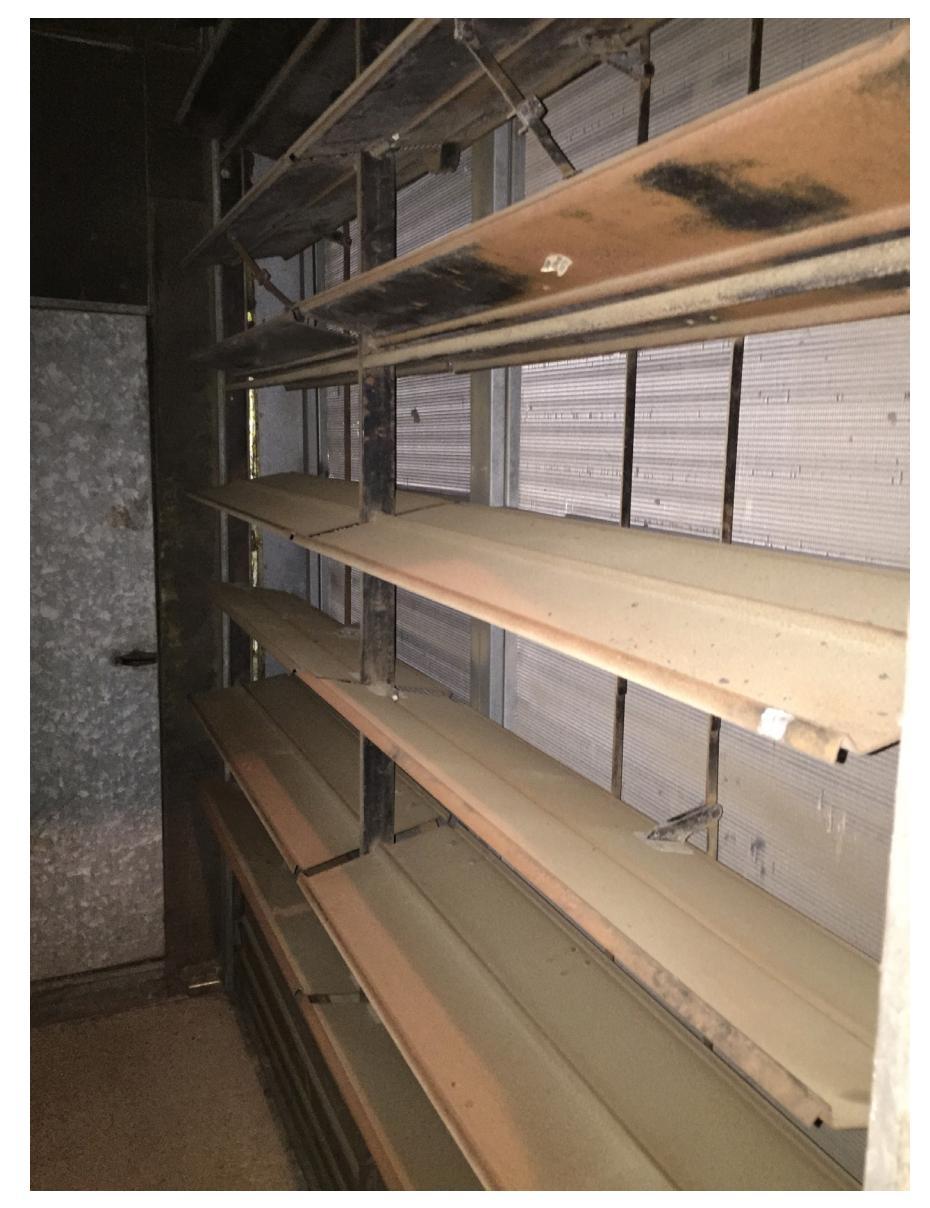
The preheat coil is original to the building construction. The stream preheat coil consists of multiple individual coils to make-up the larger complete coil. An integral face and bypass damper is installed on the coil. The dampers are controlled with pneumatic actuators. Operation of these dampers could not be verified. Facilities personnel noted that the coil has frozen due to the outside air damper issues and repairs have occurred to the coil. There was no access to the downstream coil section to perform a visual inspection. The condensate traps appear to be original to the coils. Due to their age, replacement parts are no longer available and are required to be completely replaced when they fail. Due to the repairs performed to the coil, the coil is operating on borrowed time and should be replaced. Refer to Figure 8: AHU-1 Steam Preheat Coil (next page) for the damper and coil.

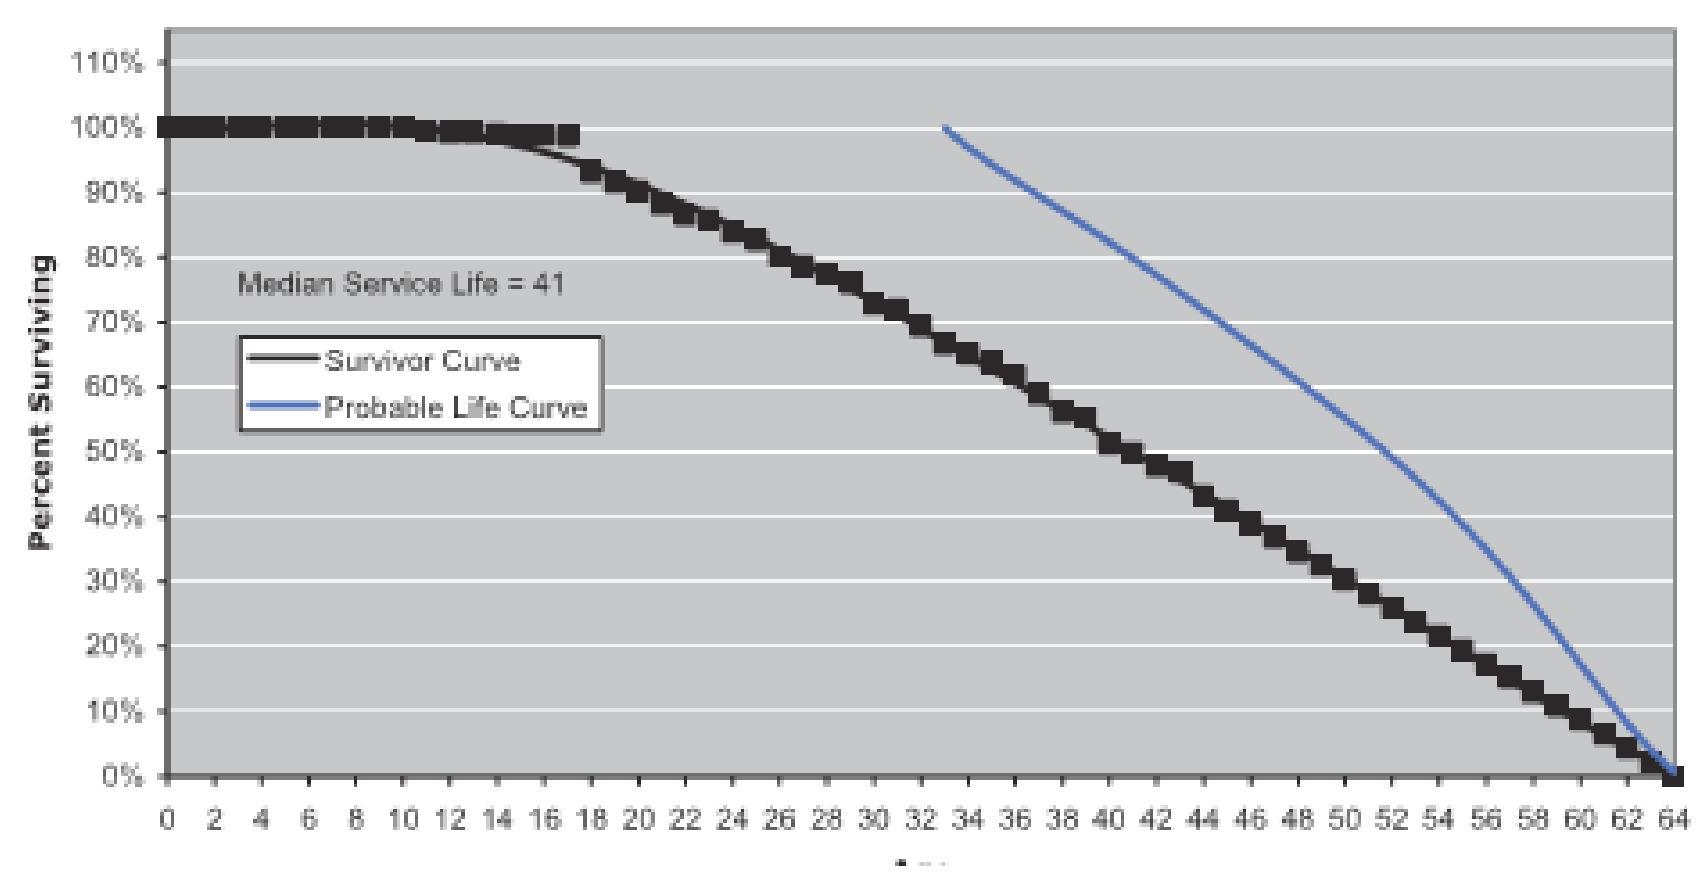
Figure 9: AHU Survivor Curve

Approach #3 is to compare the existing equipment life against the survivor curves from the NNSA benchmark data (Figure 9, next page). This graph indicates that the maximum probable life of the air handling unit is 64 years, with a mean life of 38 years.

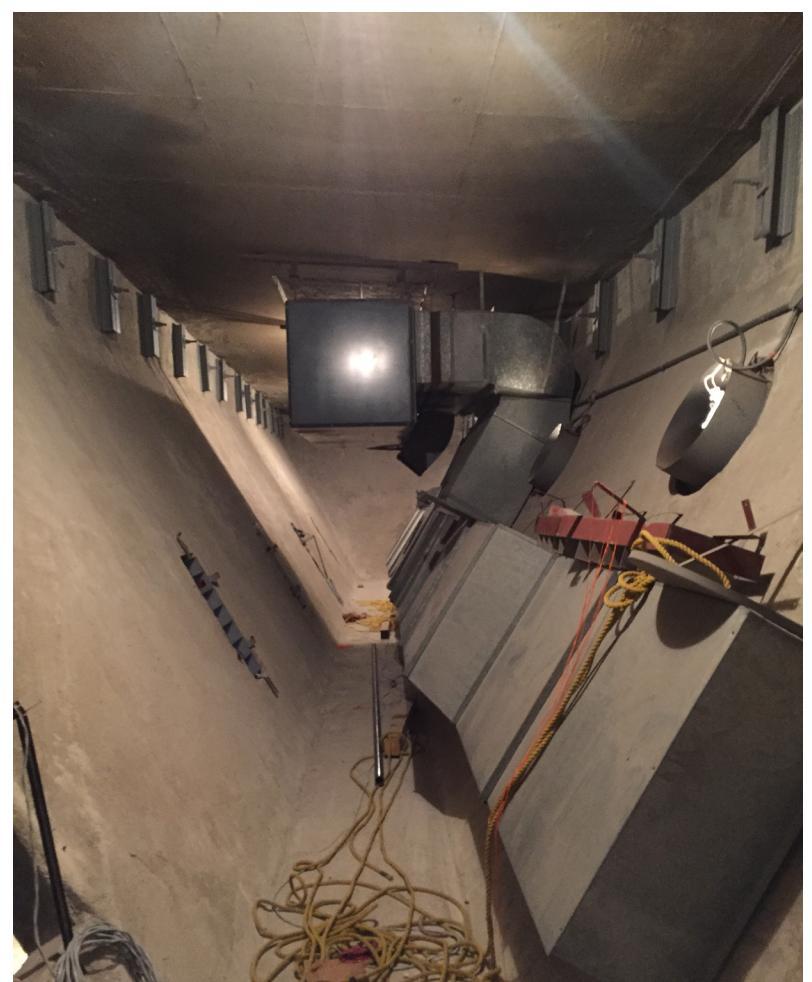
Figure 10: Recirculation Fan Installation

The recirculation fans are located in the upper saw tooth structure as shown in Figure 10: Recirculation Fan Installation. These fans draw in air from one side of the saw tooth and then blows it out the other side. Figure 11: Recirculation Fan Diffusers (next page) shows the supply diffuser locations. The system was reported to be noisy and therefore is not operated when the church is in use. The fans are in poor condition excessive bearing issue was observed and general unit casing was poor. The diffusers did not appear to have sufficient velocity to achieve a high vertical flow.

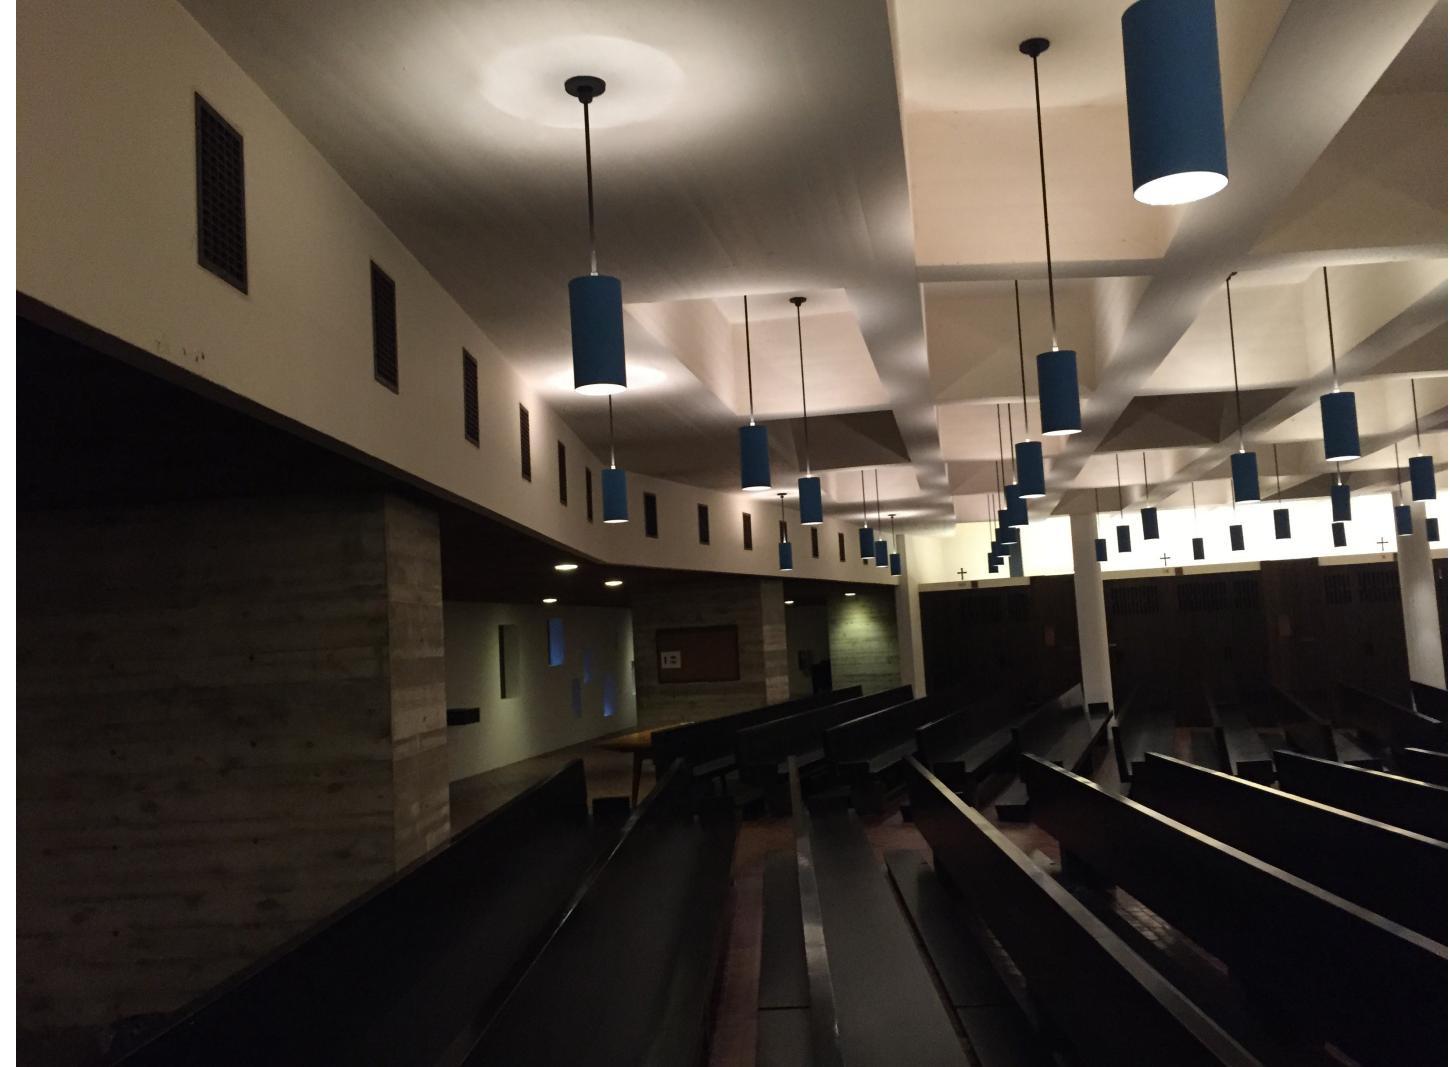
The supply air distribution system consists of ductwork with internal lining. All supply zones are fully ducted to the diffuser outlet. The supply air ductwork is routed to the Parish Church through ductwork located in the basement ceiling to overhead side wall grilles in the rear of the church. Refer to Figure 13: Parish Church Supply for the supply grille installation.

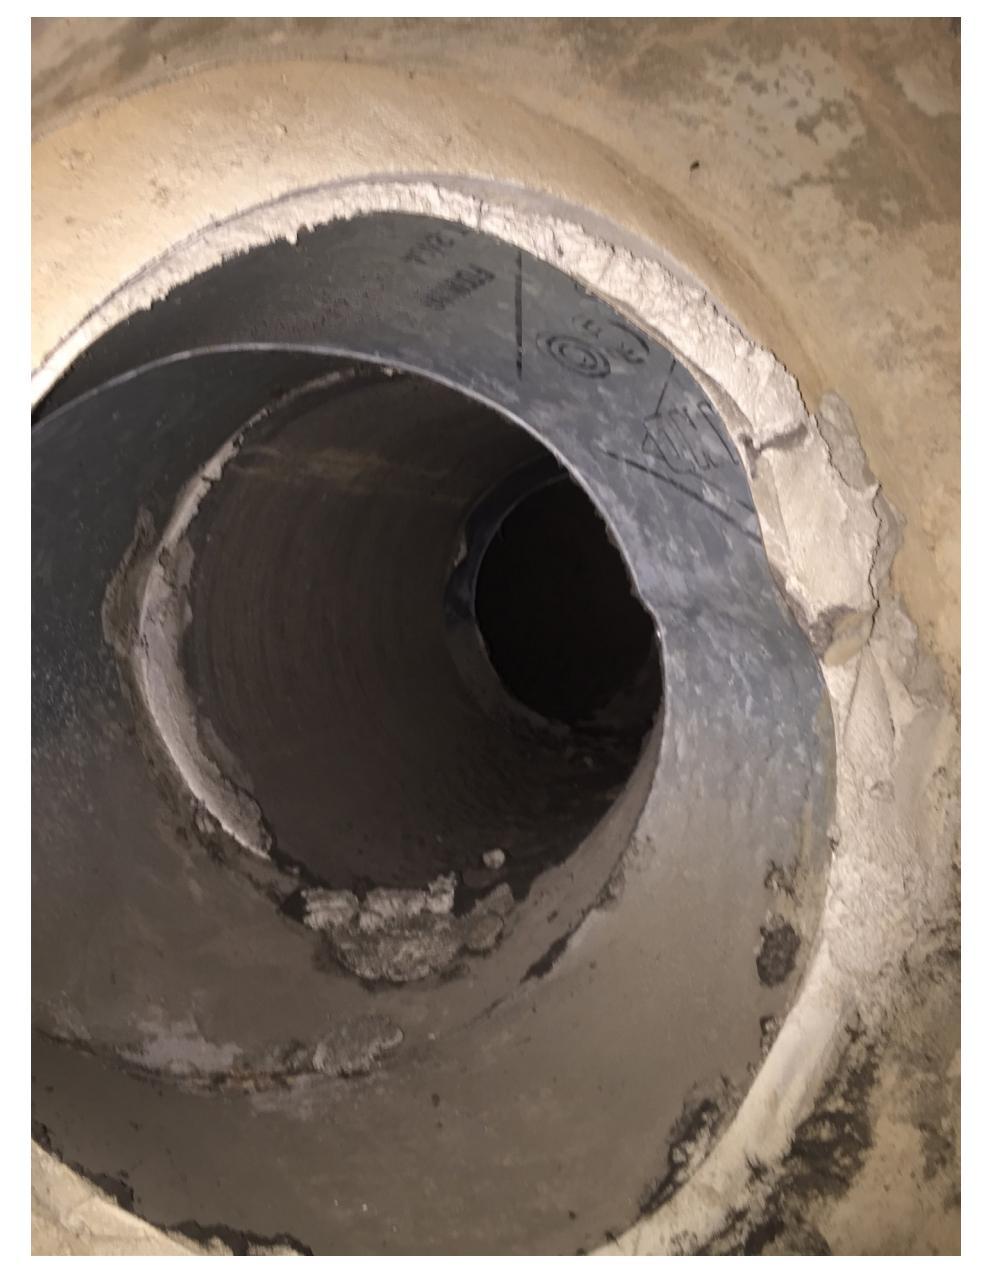
The return air ductwork consists of ducted and underground concrete tunnels for return. The underground return air tunnels are common to AHU-2, AHU-3 and AHU-4. The underground tunnels are comprised of concrete enclosures. Aside from being dirty, the enclosures appear to be in good condition. No moisture penetration was observed. Refer to Figure 14: Underground Return Conduit and Figure 15: Underground Return Tunnel for the representative photos. The underground return ducts are connected to return duct work and grilles located at the floor level of the parish church.

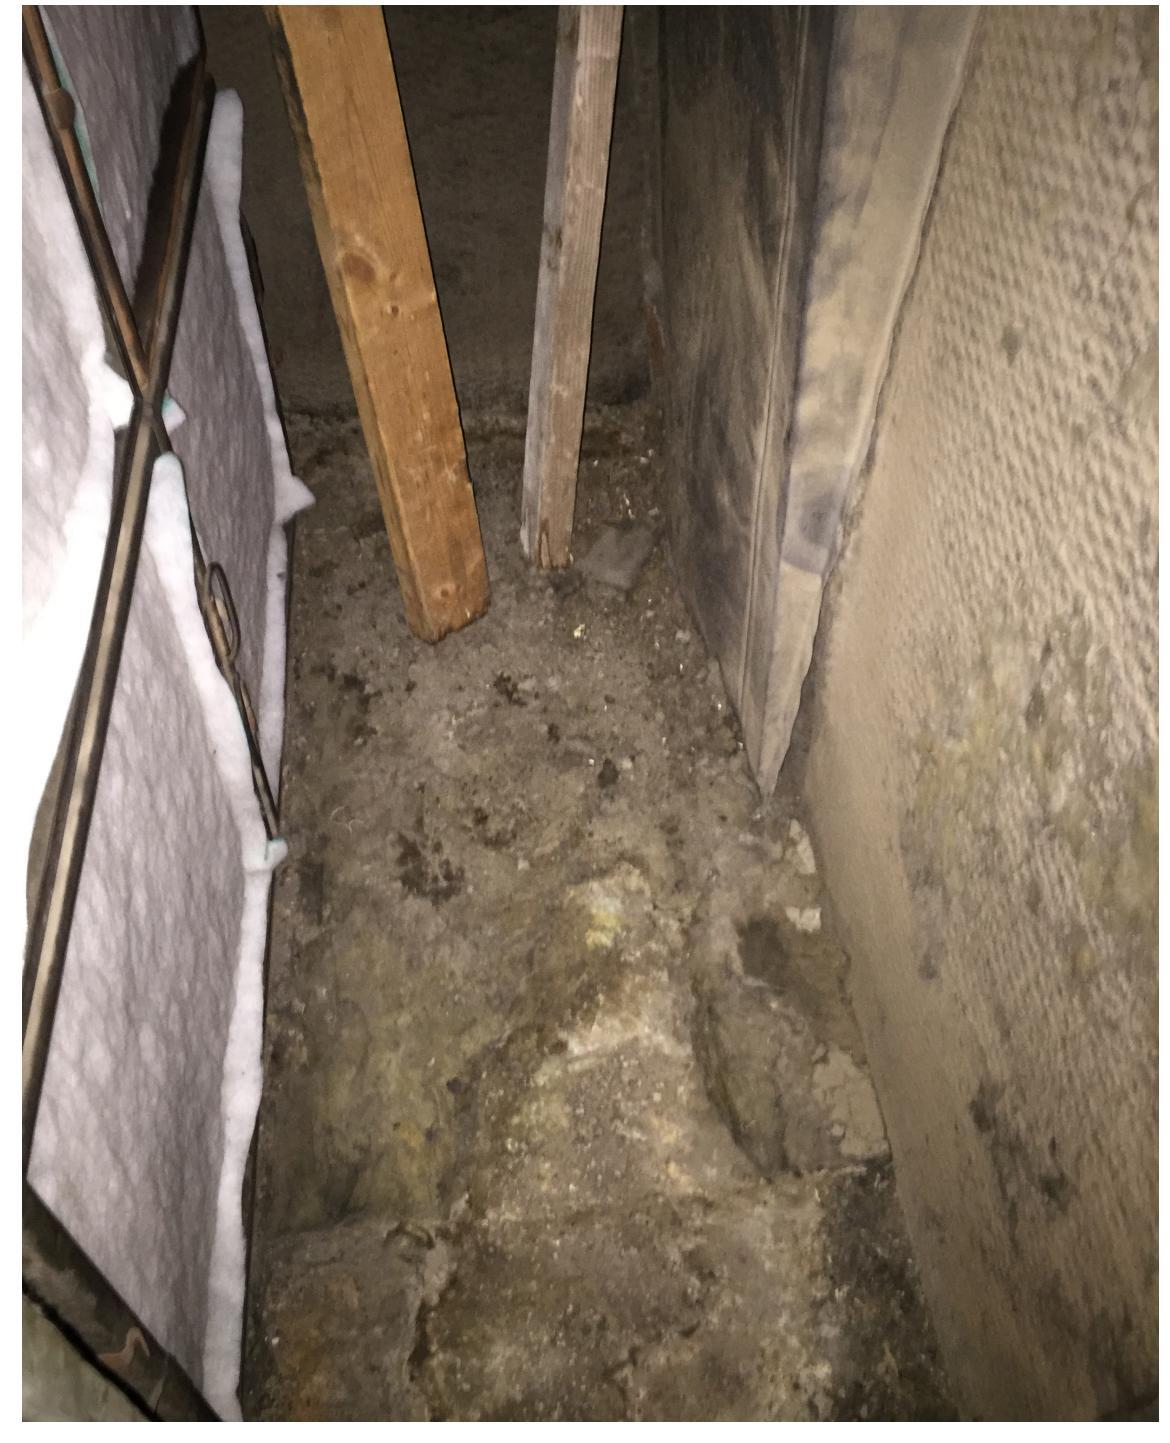
The air handling unit casing consists of a single wall sheet metal with internal fibrous insulation exposed in the air stream. The insulation has is soiled, deteriorating, failing, and beginning to separate from the sheet metal and be drawn into the air stream. Fibrous particles in the air stream can pose risk to both health of occupants and finishes in the building as these particles can be abrasive to adjacent air vents and be breathed in by individuals. The separation of the insulation from the casing is degrading the performance of the insulation. Refer to Figure 19: AHU-2 Insulation Condition (next page) for an example of the casing insulation condition. Consideration should be given to replacing the casing and insulation junction with an overall air handling unit replacement plan.

The condition the each air handling unit as a whole is near the end of its serviceable life. The casing, dampers and fan bearings are suspect. This is due to the conditions of the individual AHU components as well and the age of the air handling unit. The air handling unit and components are over 55 years old and beyond its expected life by utilizing the approaches described in the discussion of AHU-1. Due to its age, components could fail without notice. There are individual components of the air handling unit that may last longer than others, but consideration should be given to replacing the entire air handling unit as it will likely

not last an additional 50 years. Therefore, it is recommended to replace the air handling unit with a unit designed with both energy efficiency upgrades and performance enhancements to increase occupant comfort.

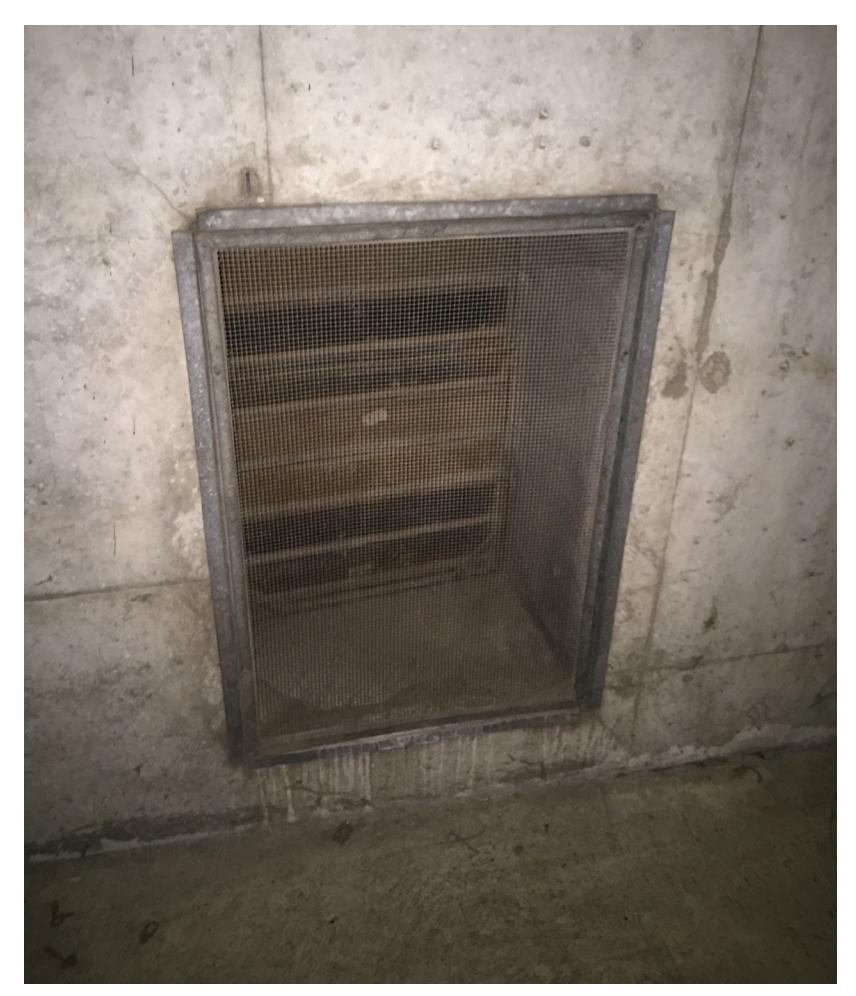
The dampers are original to the building construction and are therefore over 55 years old. The outside air dampers are worn and do not actuate and seal properly. Some of the linkages on the damper were disconnected or failed. The unit has as freeze sensor installed to prevent adverse effects of freezing air. The outside air is taken in from the air tunnel via a grille as indicated in Figure 23: AHU-3 Outside Air Inlet (next page). Consideration should be given to replacing the dampers in conjunction with an overall air handling unit replacement.

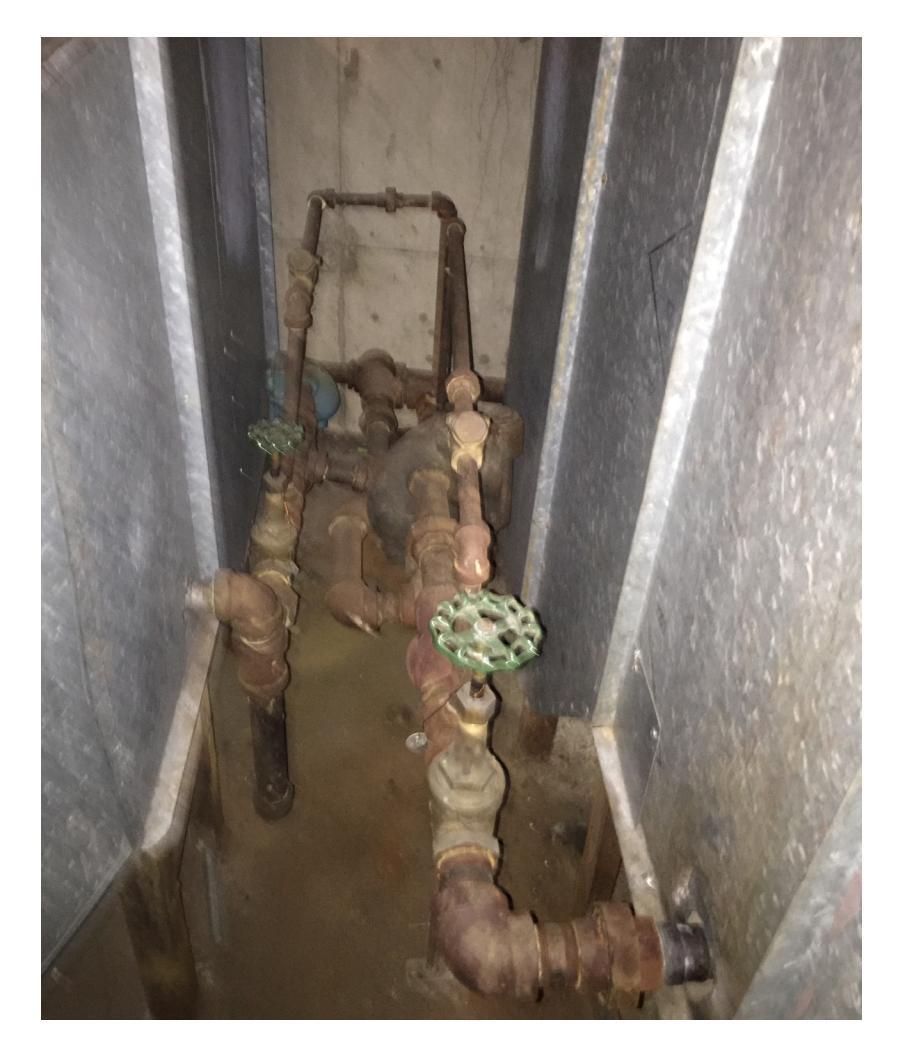
The heating coil is original to the building construction. The coil is controlled with a pneumatic operated control valve. Observation of the coil indicated not visible signs of wear. Although due to its age the coil tube ends are suspect. The condensate traps appear to be original to the coils, refer to Figure 25: AHU-3 Steam Trap (next page). Due to their age, replacement parts are no longer available and are required to be completely replaced when they fail.

The condition the each air handling unit as a whole is near the end of its serviceable life. The casing, dampers, steam coil and traps, and fan bearings are suspect. This is due to the conditions of the individual AHU components as well and the age of the air handling unit. The air handling unit and components are over 55 years old and beyond its expected life by utilizing the approaches described in the discussion of AHU-1. Due to its age, components could fail without notice. There are individual components of the air handling unit that may last longer than others, but consideration should be given to replacing the entire air handling unit as it will likely not last an additional 50 years. Therefore, it is recommended to replace the air handling unit with a unit designed with both energy efficiency upgrades and performance enhancements to increase occupant comfort.

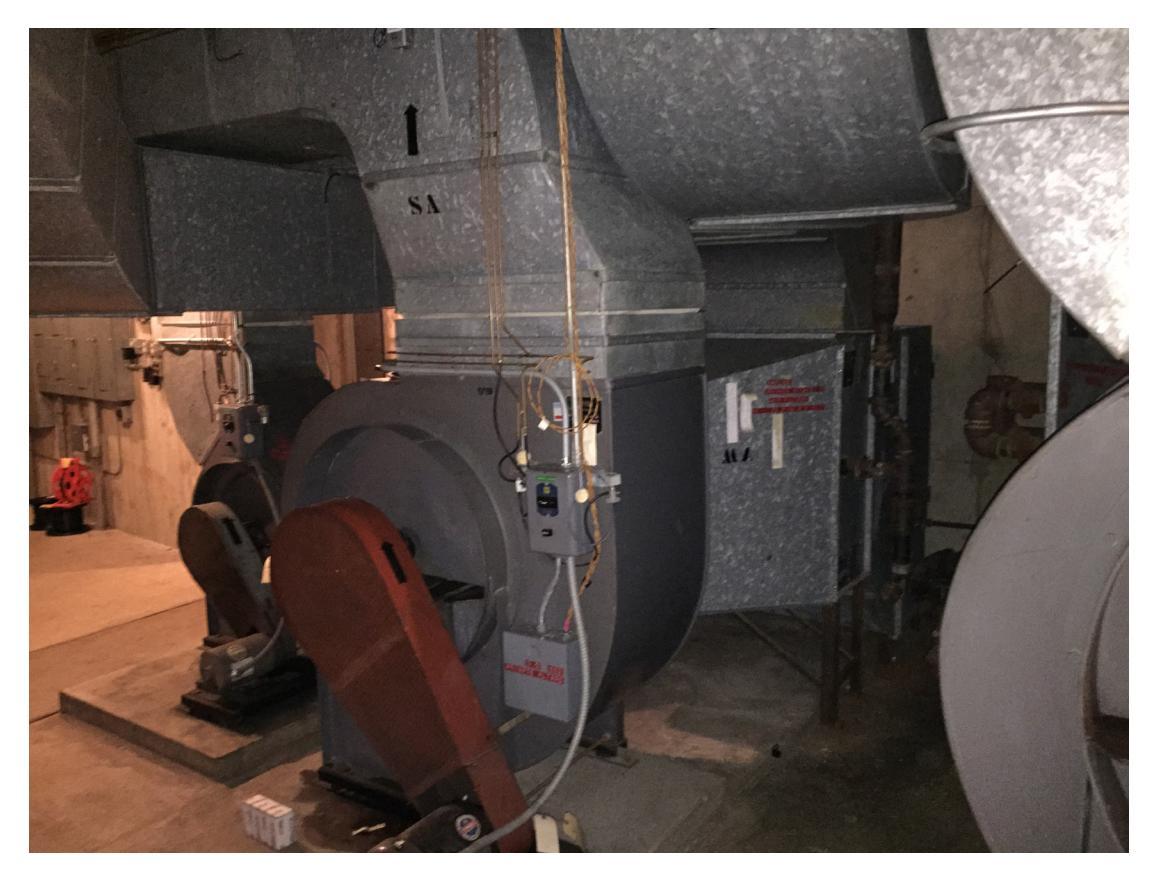
The fan is original to the building construction and is over 55 years old. Refer to Figure 26: AHU-3 Supply Fan and Enclosure. The existing supply fan is a constant flow fan with a starter. The fan is a single inlet backward inclined utility set return fan.

- The appears to be original.
- The fan casing appears to be sound.
- The flexible connector is showing signs of wear.
- There is a significant amount of oil / grease under the fan. The fan bearing condition may be suspect.
- Fan shaft and blade soundness (due to stress fatigue) is not attainable by visual observation.

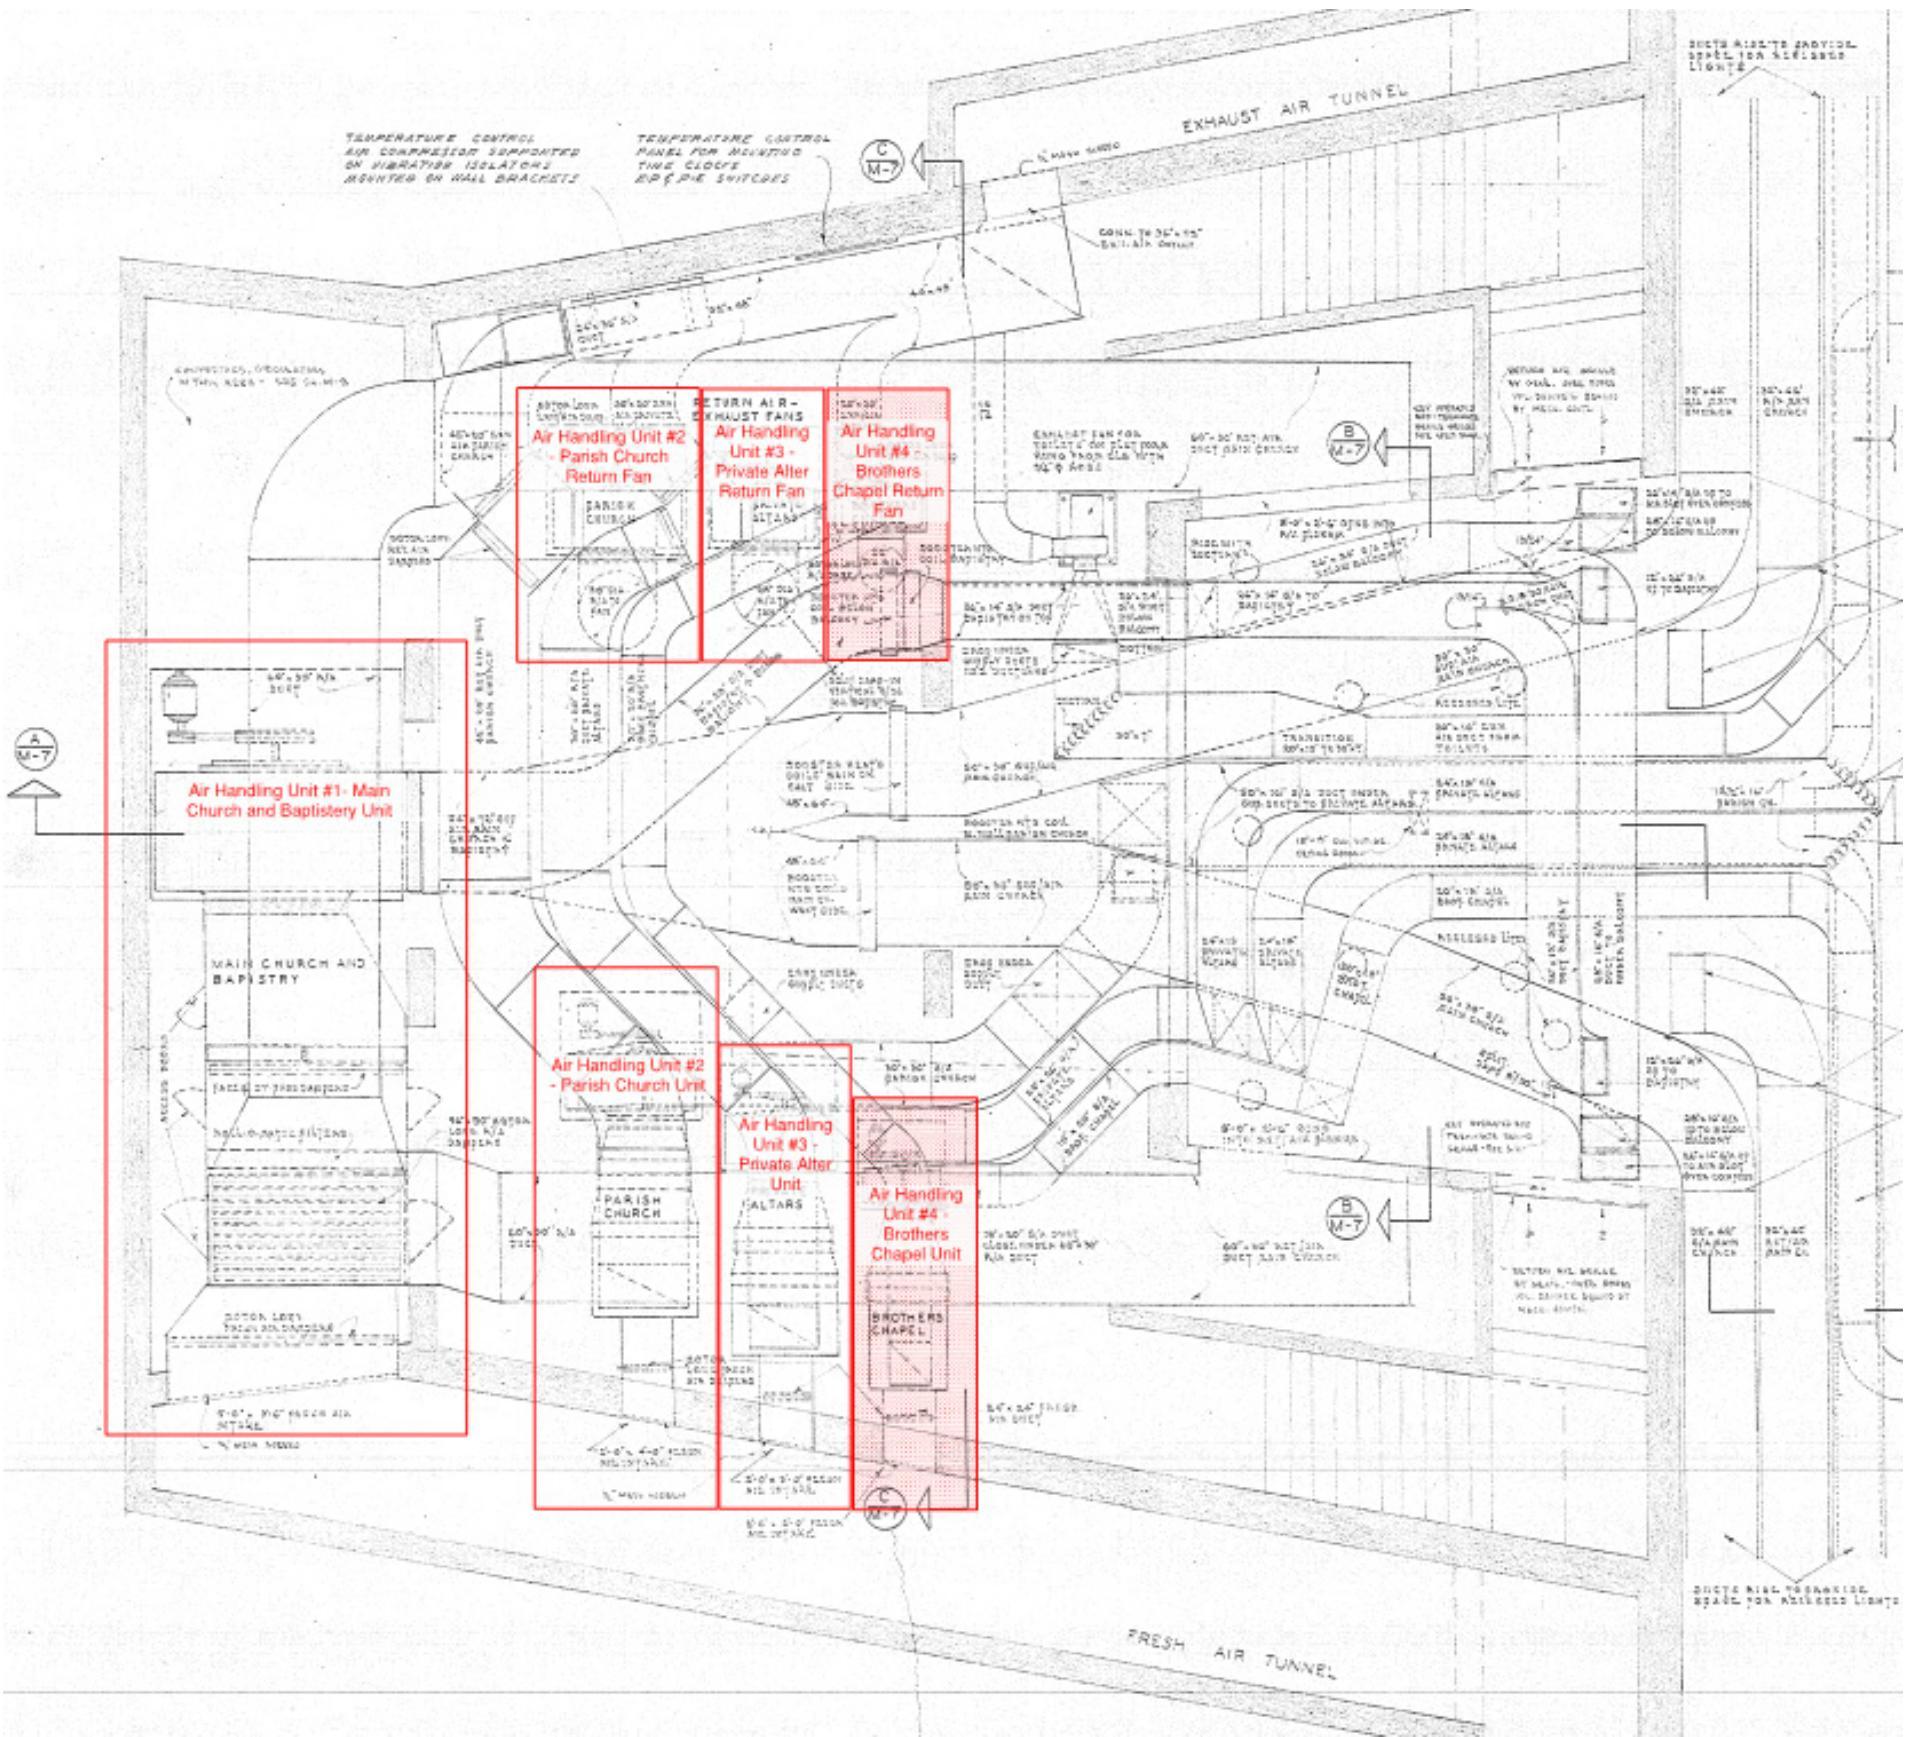
The air handling unit (AHU) is original to the 1957 building placing the unit and the components over 55 years old. This unit consists of a single inlet backward inclined utility set return fan, pneumatic operated return, relief and outdoor air dampers, fiber media filters, steam preheat coil, and single inlet backward inclined utility set supply fan. This unit does not have a cooling coil for dehumidification or a humidifier. This AHU is a built-up air handling with single wall construction and exposed fibrous insulation exposed in the air stream. The unit and associated return fan is located in the basement mechanical room as highlighted in Figure 27: Mechanical Plan Excerpt (next page).

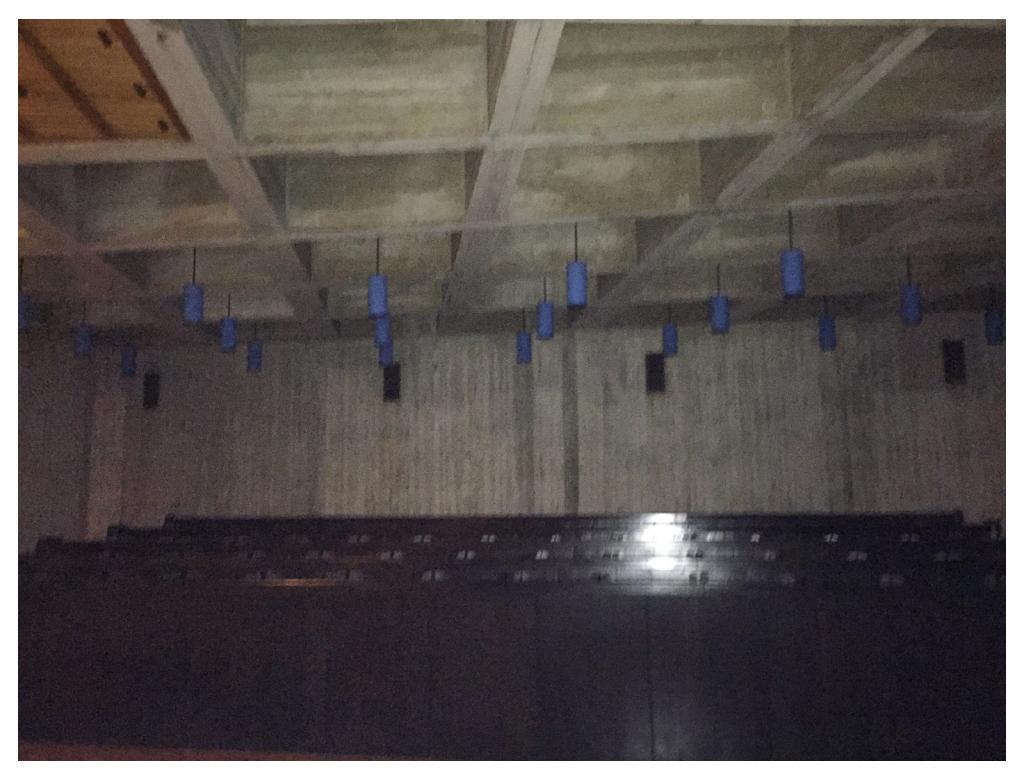
Figure 28: Brothers' Chapel Supply

The supply air distribution system consists of ductwork with internal lining. All supply zones are fully ducted to the diffuser outlet. The supply air ductwork is routed to the Brothers Chapel through ductwork located in the basement ceiling to overhead side wall grilles on the East and west sides of the chapel. Refer to Figure 28: Brothers Chapel Supply (page 281 upper left) and Figure 29: Brothers Chapel Return Grille (page 281 lower left) or the supply and return grille installation.
