FINAL REPORT July 2016

SAINT JOHN'S ABBEY CHURCH

CONSERVATION RESTORATION PRESERVATION

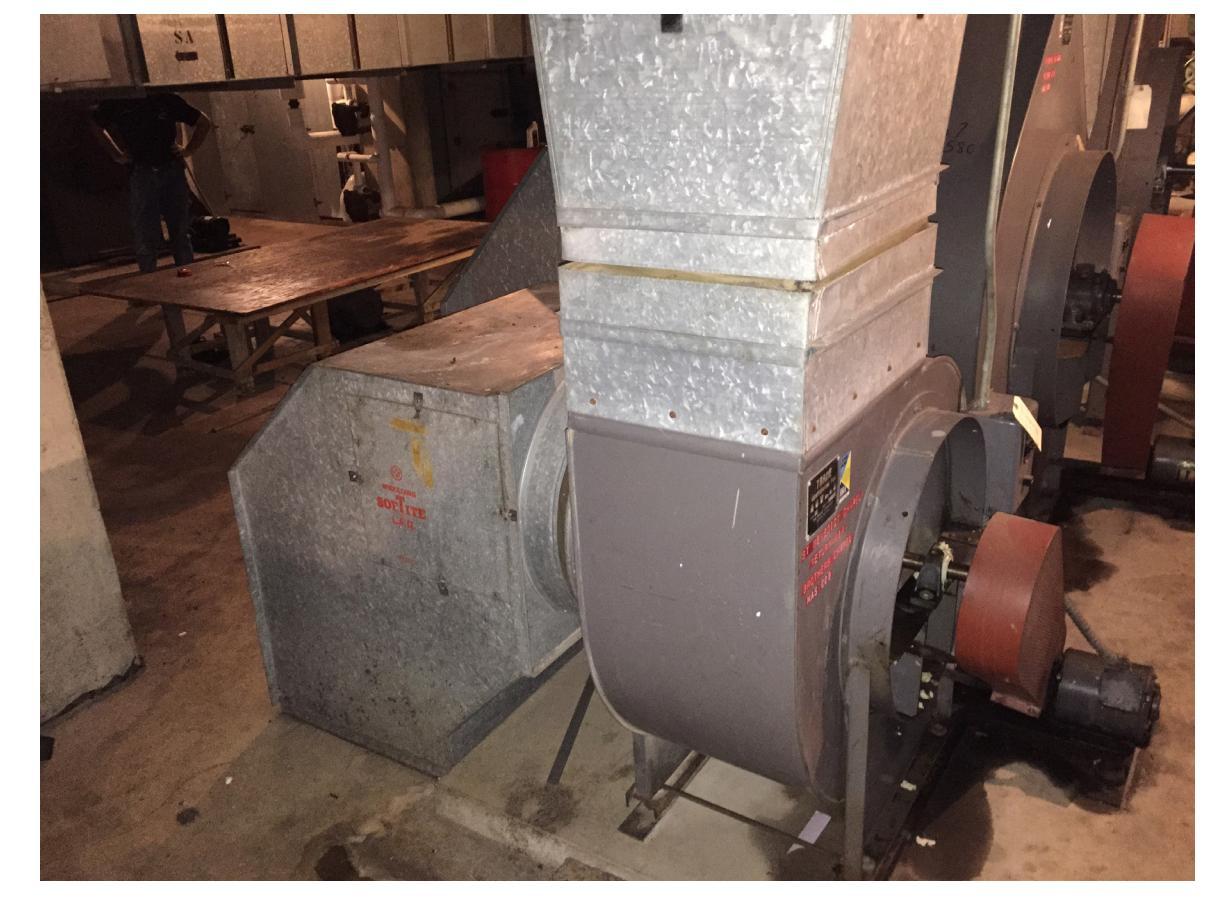
Figure 30: AHU-4 Return Fan

The return fan is original to the building construction and is therefore over 55 years old. The existing fan does not have inlet vanes or VFD to control fan speed. Fan condition is as follows:

- The appears to be original.
- The fan casing appears to be sound.
- The flexible connector is showing signs of wear. .
- There is a significant amount of oil / grease under the fan. The bearing block appears to have been repaired. The fan bearing condition may be suspect.
- Fan shaft and blade soundness (due to stress fatigue) is not attainable by visual observation.

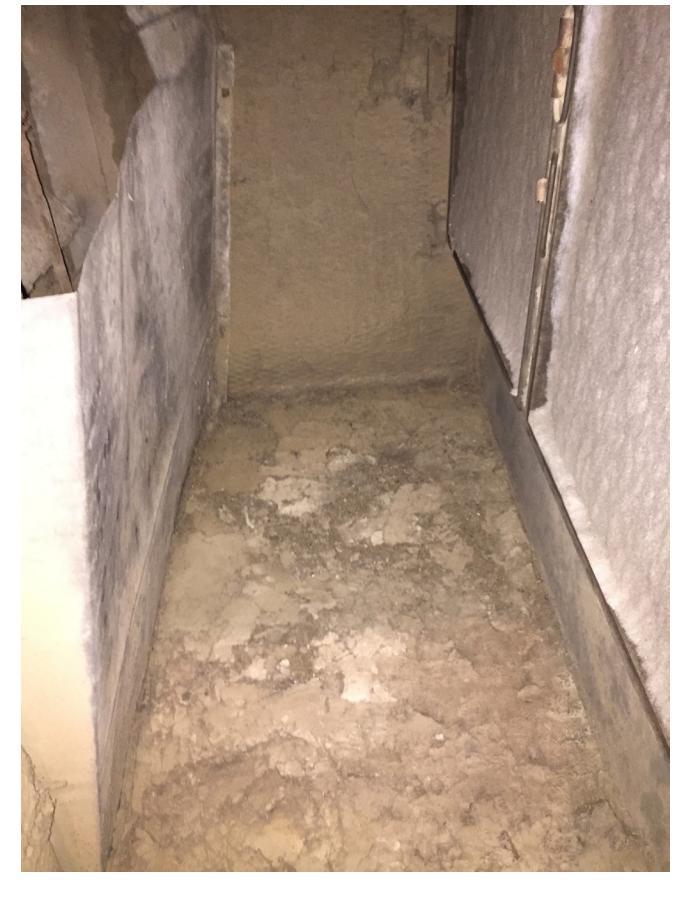
The air handling unit casing consists of a single wall sheet metal with internal fibrous insulation exposed in the air stream. The insulation has is soiled, deteriorating, failing, and beginning to separate from the sheet metal and be drawn into the air stream. Fibrous particles in the air stream can pose risk to both health of occupants and finishes in the building as these particles can be abrasive to adjacent air vents and be breathed in by individuals. The separation of the insulation from the casing is degrading the performance of the insulation. Refer to Figure 33: AHU-4 Insulation Condition (left) for an example of the casing insulation condition. Consideration should be given to replacing the casing and insulation junction with an overall air handling unit replacement plan. Refer to Figure 35:AHU-4 Supply Fan and Casing (next page).

The condition the each air handling unit as a whole is near the end of its serviceable life. The casing, dampers, steam coil, steam traps and fan bearings are suspect. This is due to the conditions of the individual AHU components as well and the age of the air handling unit. The air handling unit and components are over 55 years old and beyond its expected life by utilizing the approaches described in the discussion of AHU-1. Due to its age, components could fail without notice. There are individual components of the air handling unit that may last longer than others, but consideration should be given to replacing the entire air handling unit as it will likely not last an additional 50 years. Therefore, it is recommended to replace the air handling unit with a unit designed with both energy efficiency upgrades and performance enhancements to increase occupant comfort.

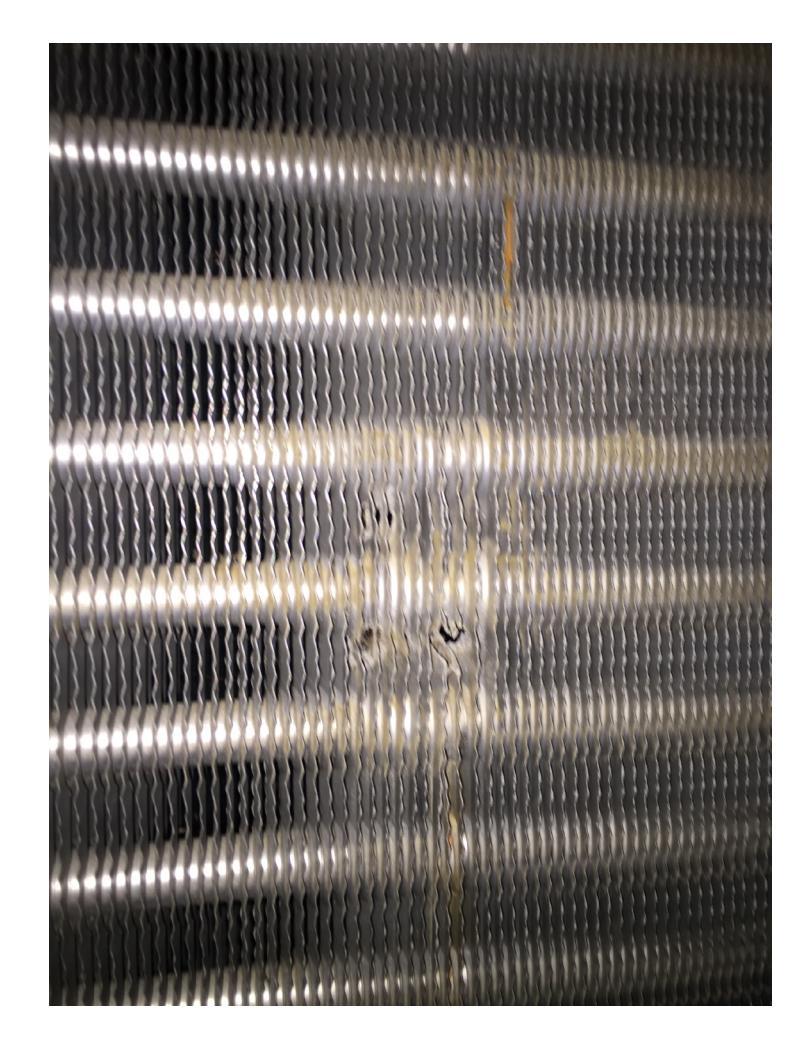
The heating coil is original to the building construction. The coil is controlled with a pneumatic operated control valve. The coil shows signs of damage as indicated in Figure 34: AHU-4 Steam Coil (next page, upper left). It is unknown if this coil is functioning or has been repaired. The condensate traps appear to be original to the coils. Due to their age, replacement parts are no longer available and are required to be completely replaced when they fail.

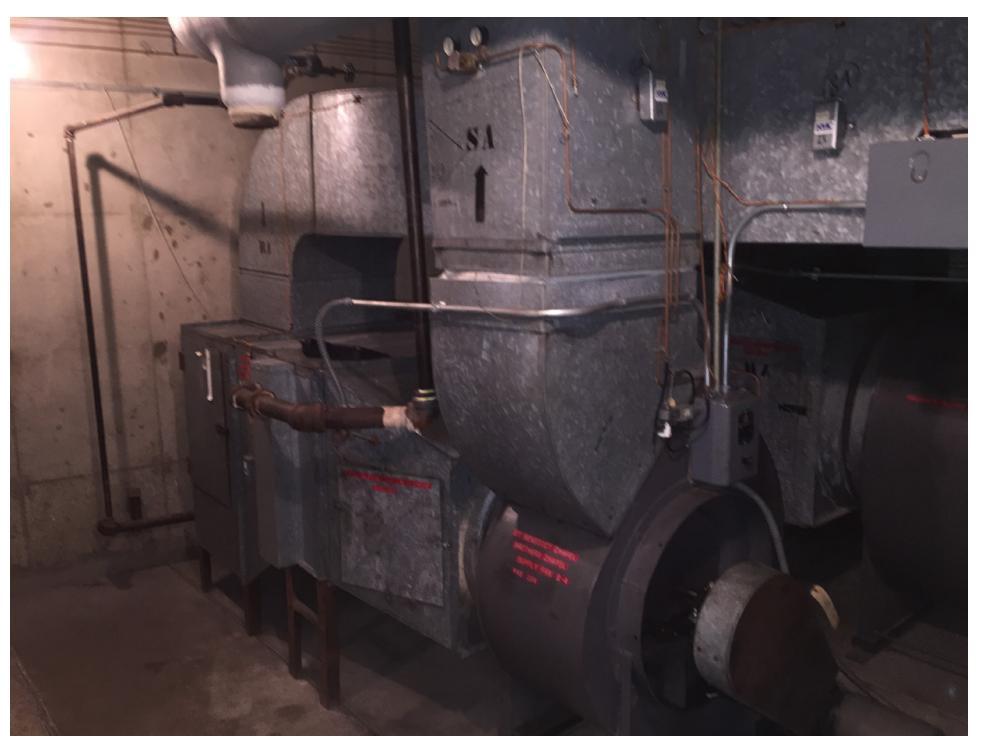
Figure 35: AHU-4 Supply Fan and Casing

- The motor appears to be original.
- The fan casing appears to be sound.
- The flexible connector is showing signs of wear.
- There is a significant amount of oil / grease under the fan. The fan bearing ٠ condition may be suspect.
- Fan shaft and blade soundness (due to stress fatigue) is not attainable by visual observation.

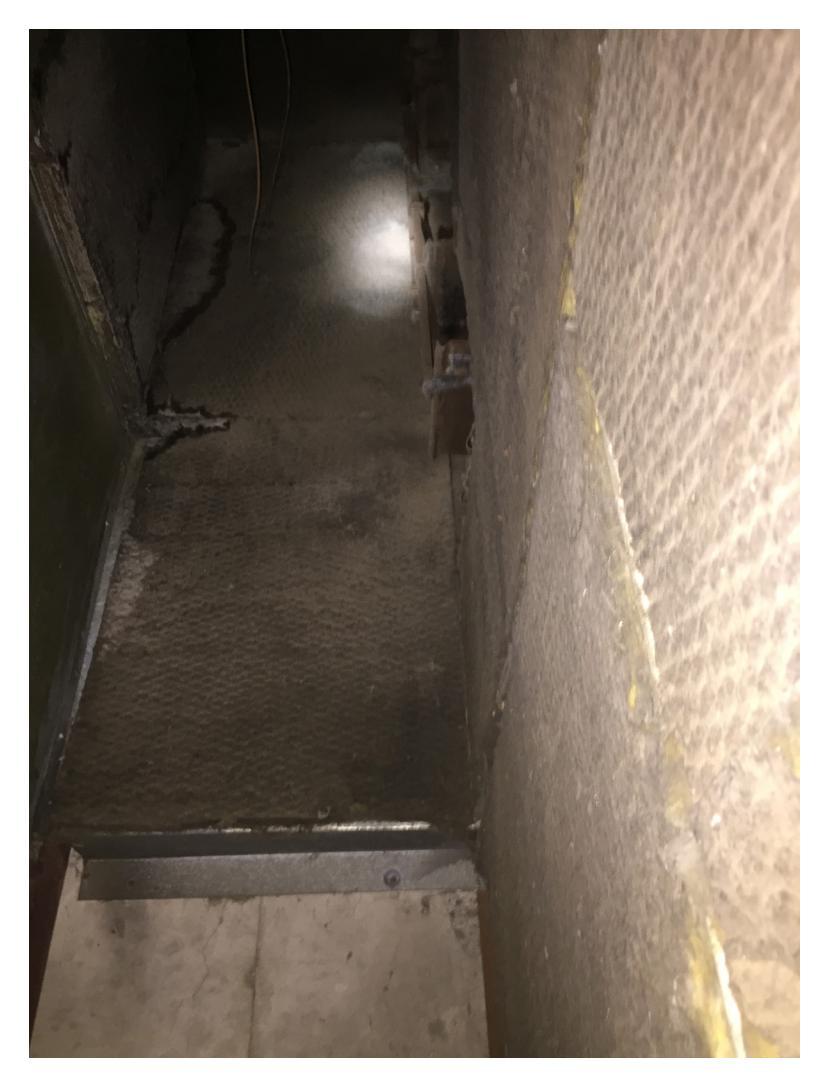
The air handling unit casing consists of a single wall sheet metal with internal fibrous insulation exposed in the air stream. The insulation has is soiled, deteriorating, failing, and beginning to separate from the sheet metal and be drawn into the air stream. Fibrous particles in the air stream can pose risk to both health of occupants and finishes in the building as these particles can be abrasive to adjacent air vents and be breathed in by individuals. The separation of the insulation from the casing is degrading the performance of the insulation. Refer to Figure 41: AHU-5 Insulation Condition (above, left) and Figure 42: AHU-5 Insulation Condition (above) for an example of the casing insulation condition. Consideration should be given to replacing the casing and insulation junction with an overall air handling unit replacement plan.
Filter Section Condition

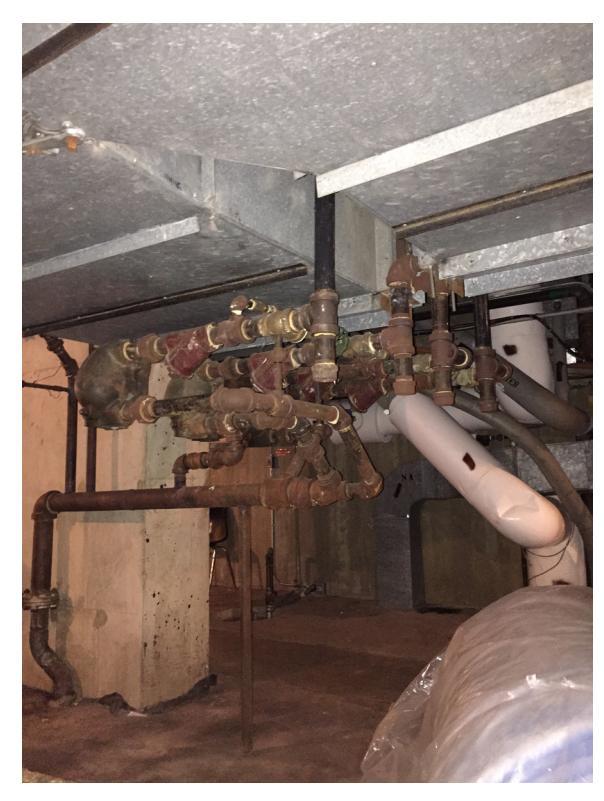
Figure 43: Steam Trap Assembly at Zone Coil

The steam traps are original to the building construction. Refer to Figure 43: Steam Trap Assembly at Zone Coil, above right). Facilities personnel have been maintaining these traps as they fail. Due to the age, the steam traps service parts are no longer available.

Due to the age the condensate piping smaller than 3 inch in size and all underground condensate piping is recommended to be replaced as it is near the end of its useful life. The steam traps should be replaced with new traps to allow for continued serviceability. Recommend that the owner survey and remove all ACM insulation.

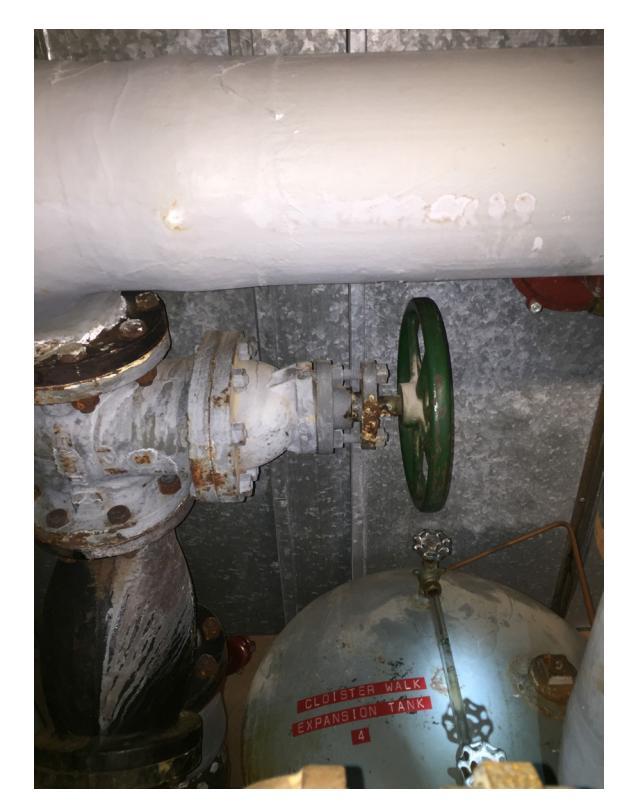
The Steam and condensate isolation valves appear original to the building construction. There are visible signs of wear, corrosion and leaks at the valves. The function and ability to operate as designed is in question. Refer to Figure 44: Steam Condensate Piping (right).

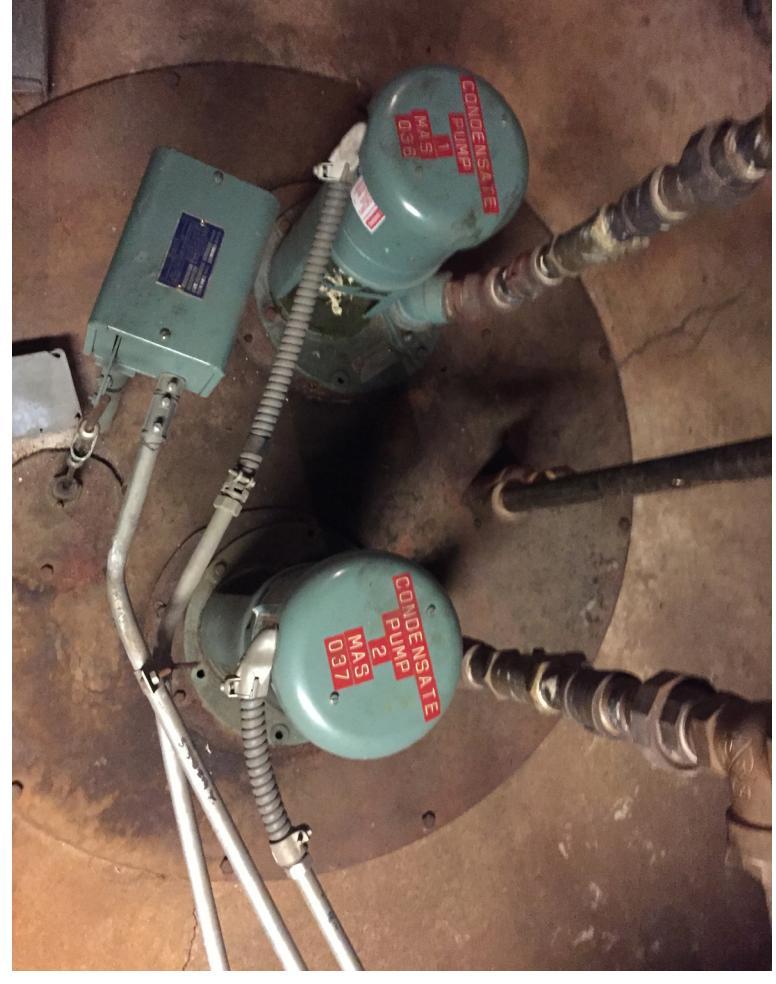
Condensate receiver pumps the building steam condensate to the central condensate receiver located in an adjacent building. This condensate receiver and pump is original to the building construction. The system appears to be average condition for its age. The tank condition and lining is unknown due to it being buried. Facilities personnel did not note any performance issues or leaks with this pump or tank. Refer to Figure 45: Building Condensate Receiver (below).

Recommendation/Comments: The condensate pump unit is past its estimated service life of 15 years per ASHRAE guidelines. Consideration should be given to establishing a scheduled replacement plan for this condensate pump.

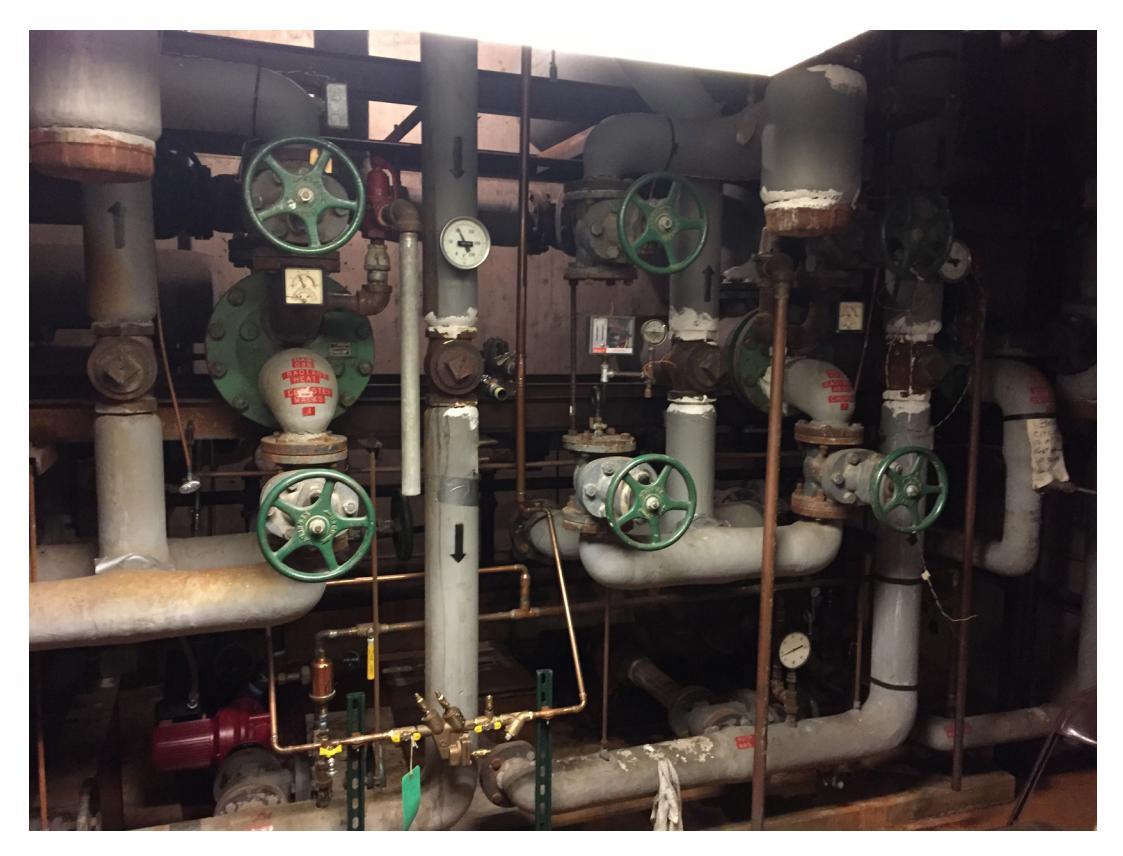
Figure 46: Steam to Water Heat Exchangers

The steam to water heating system consists of three steam to water heat exchangers. Refer to Figure 46: Steam to Water Heat Exchanger (above). The original plans show 5 heat exchangers, but due to failures 2 have been removed. Of the remaining heat exchangers, only one functions. This heat exchanger serves low temperature heating water to the remaining cloister passage in floor and finned tube radiation. The pump on the new zone was recently replaced.

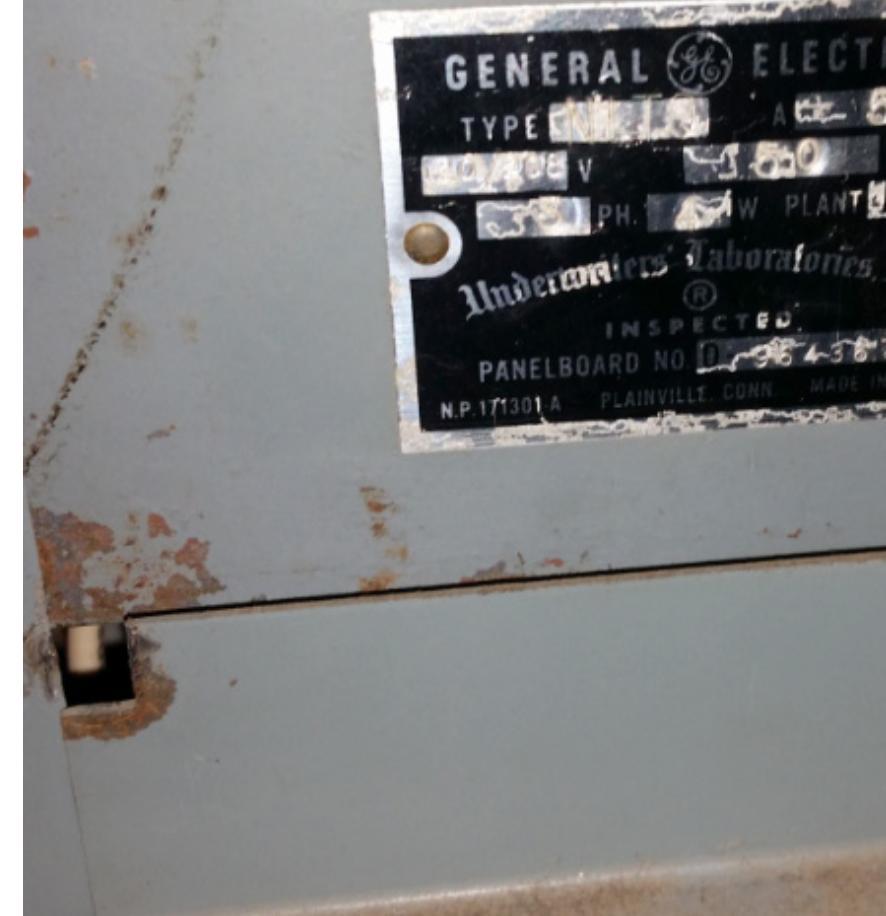
The vast majority of electrical equipment including panelboards, contactor cabinets, and distribution panels installed in Abbey Church are original to the 1957 construction. The majority of panelboards were manufactured by GE as shown in the nameplate shown in Figure 48 - Typical Panelboard Nameplate (preceding page, left).

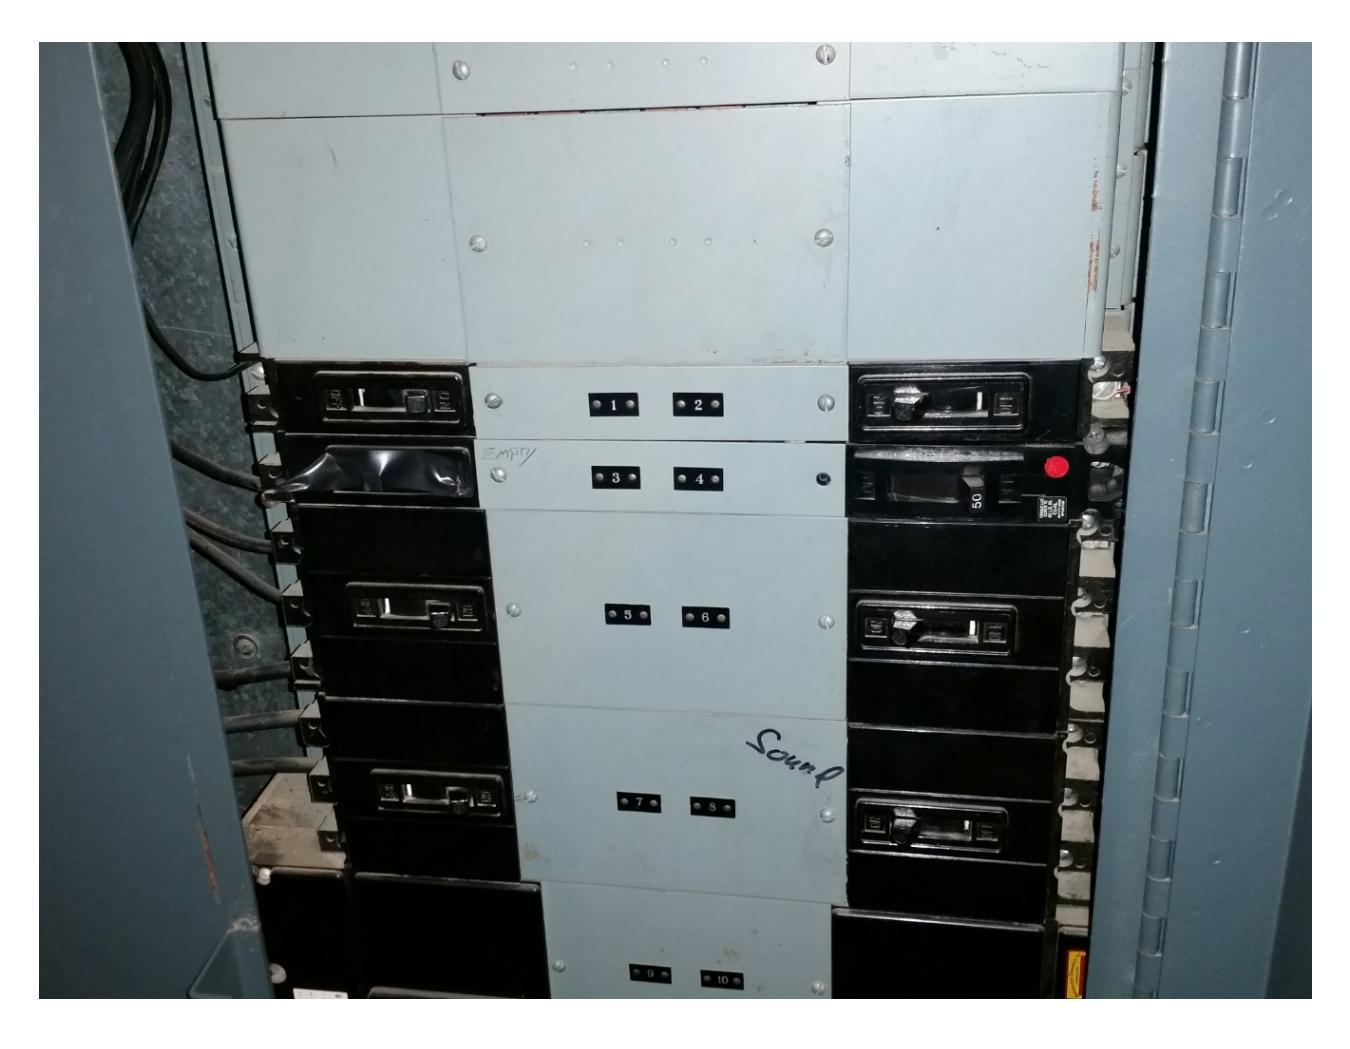
Main distribution panel has exposed live part and lugs of circuit breaker are exposed were conductors are landed on the circuit breakers. This is accessible by simply opening the panelboard cover. The room that this equipment is located in is accessible to many of the building users, because the camera equipment is located in this space; refer to Figure 49 - Distribution Cabinet (right).

As shown in the photo, there are covers missing from the panelboard enclosure. This panelboard was not locked at the time of our site visit. During discussions with the facility staff it was noted that this also occurs elsewhere on campus.

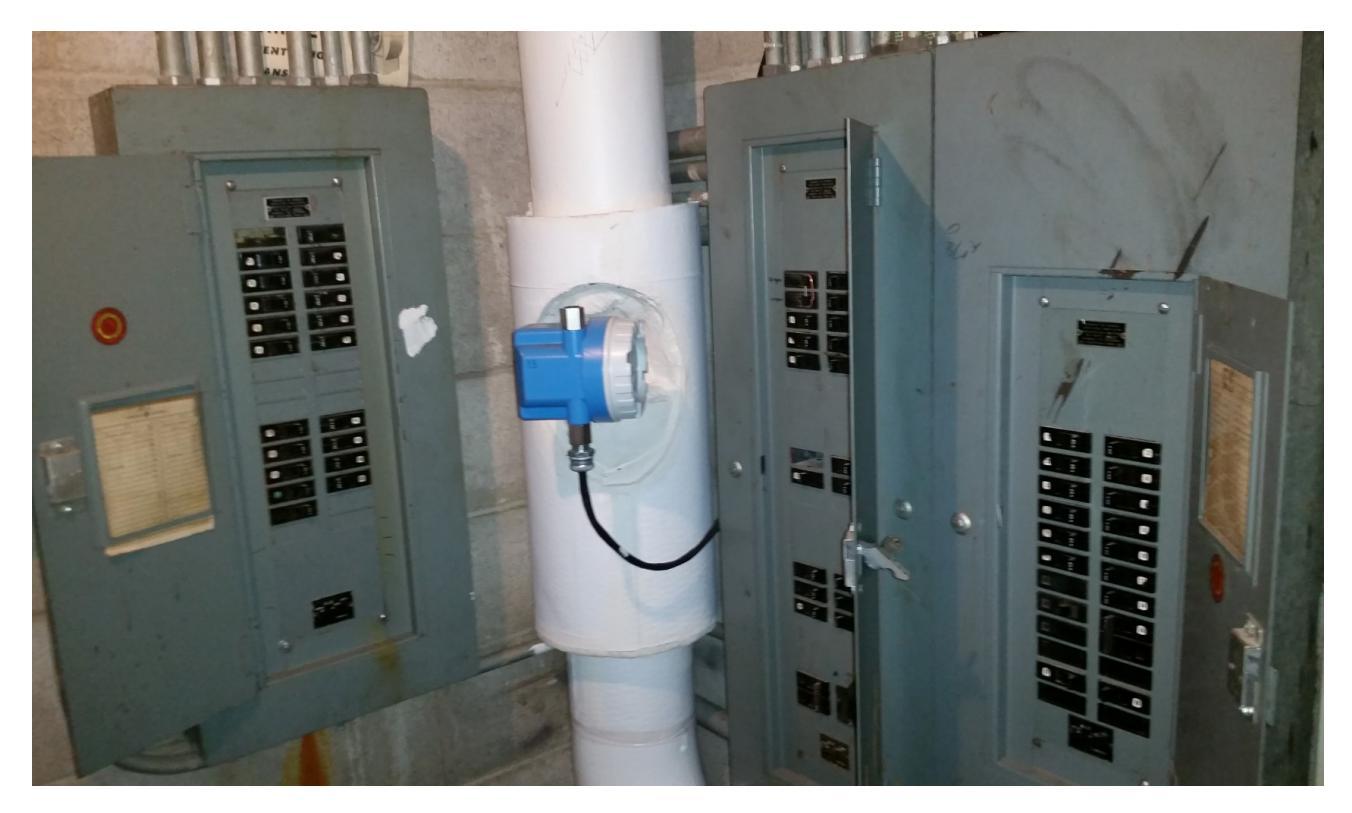
Another code related issue is the working clearance in front of electrical equipment. The required working clearance is 3 feet minimum required per NEC 110.26(A)(1). The working clearance is infringed on by mechanical piping that creates the capacitor bank that is installed on the ground at this location. Refer to Figure 50 - Working Clearance Violation and Figure 51 - Working Clearance Violation for illustration (right).

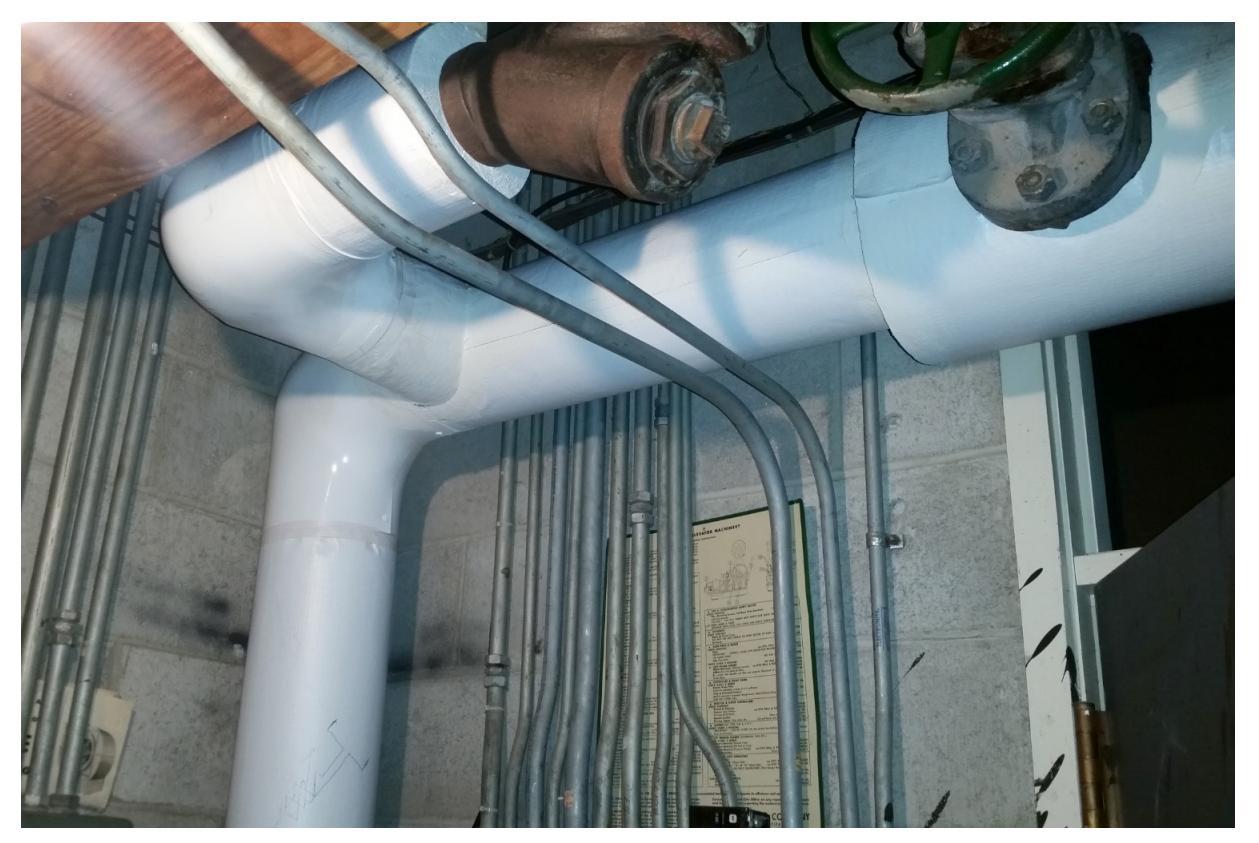
In addition to the working clearance in front of the equipment, there • is a condition where the dedicated electrical space requirements above and below panelboards, per NEC 110.26(E), is not being met. Refer to Figure 52 - Dedicated Electrical Space Above (net page, top left)and Figure 53 -Dedicated Electrical Space Below (next page, lower left).

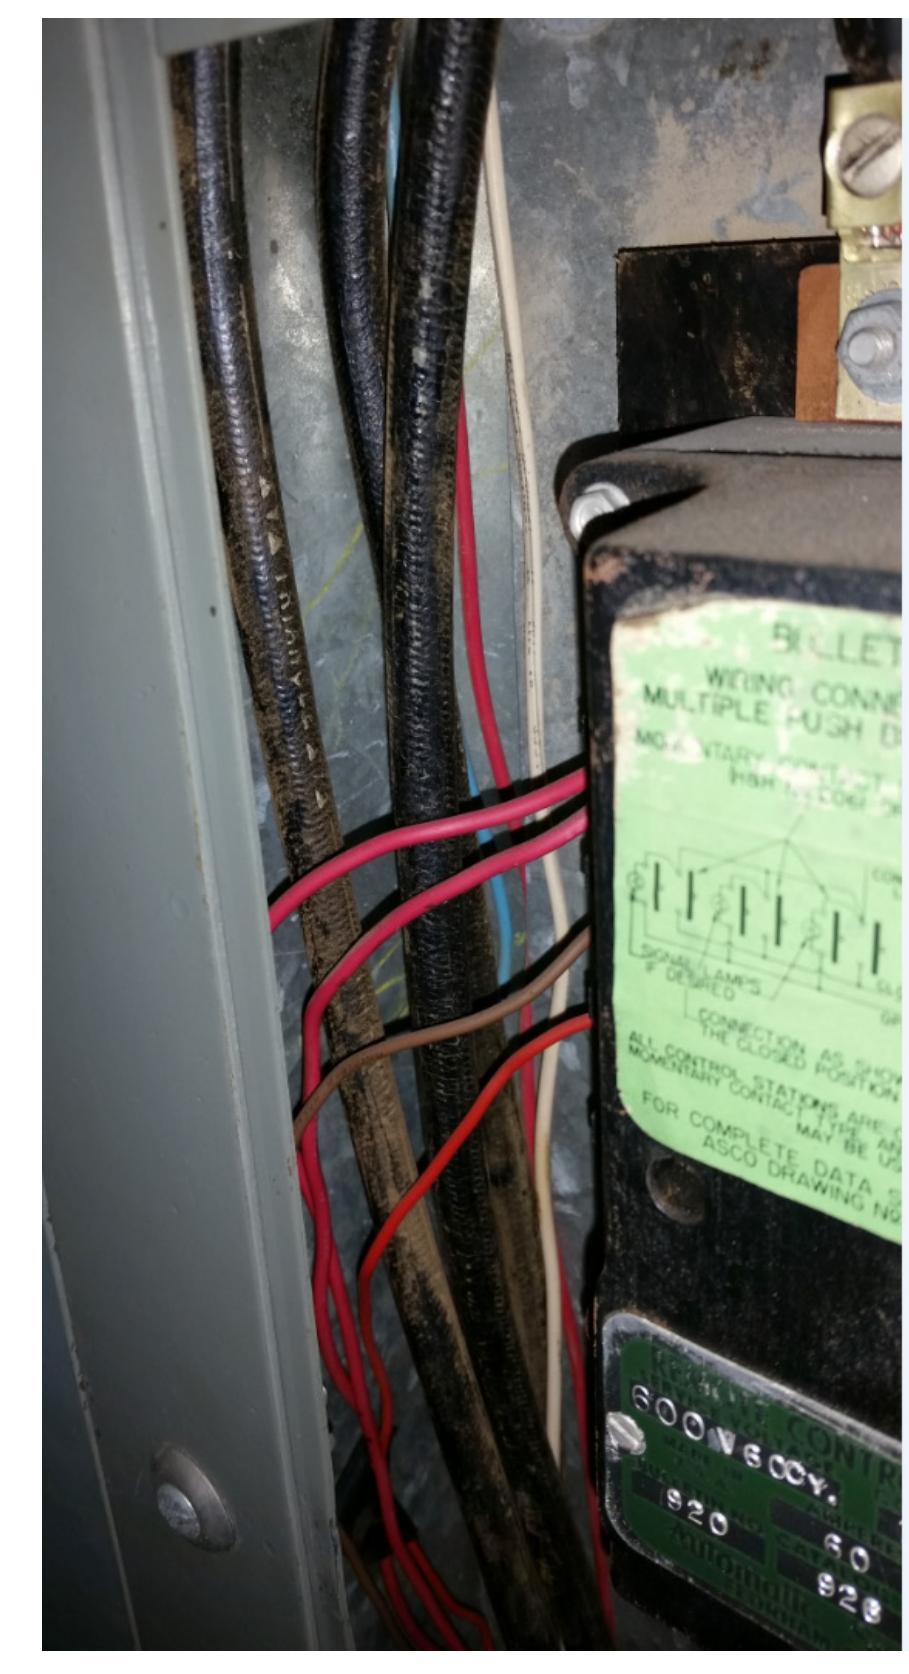
Figure 54 - Conductors within Panel Enclosure

In areas were panel covers were not fully intact or conductors were able to be observed it appeared that the conductor insulation on the feeders conductors was starting to deteriorate as the conductors are 50 plus years old. If insulation deterioration continues this could become a safety concern. Refer to Figure 54: Conductors within Panel Enclosure, preceding page).

General industry practice is that switches, panelboards, circuit breakers, and feeder conductors have a useful service life of 30 to 40 years. Service life depends on the performance of routine maintenance. Dunham Associates recommends maintaining electrical equipment in accordance with manufacturer recommendation and the InterNational Electrical Testing Association (NETA) Maintenance Testing Specification (MTS). Due to the quantity of items required for the facilities department to maintain on a regular basis, typically maintenance is not performed per the NETA specifications over the life of the equipment. Therefore, equipment manufactured in 1957 may need replacing.

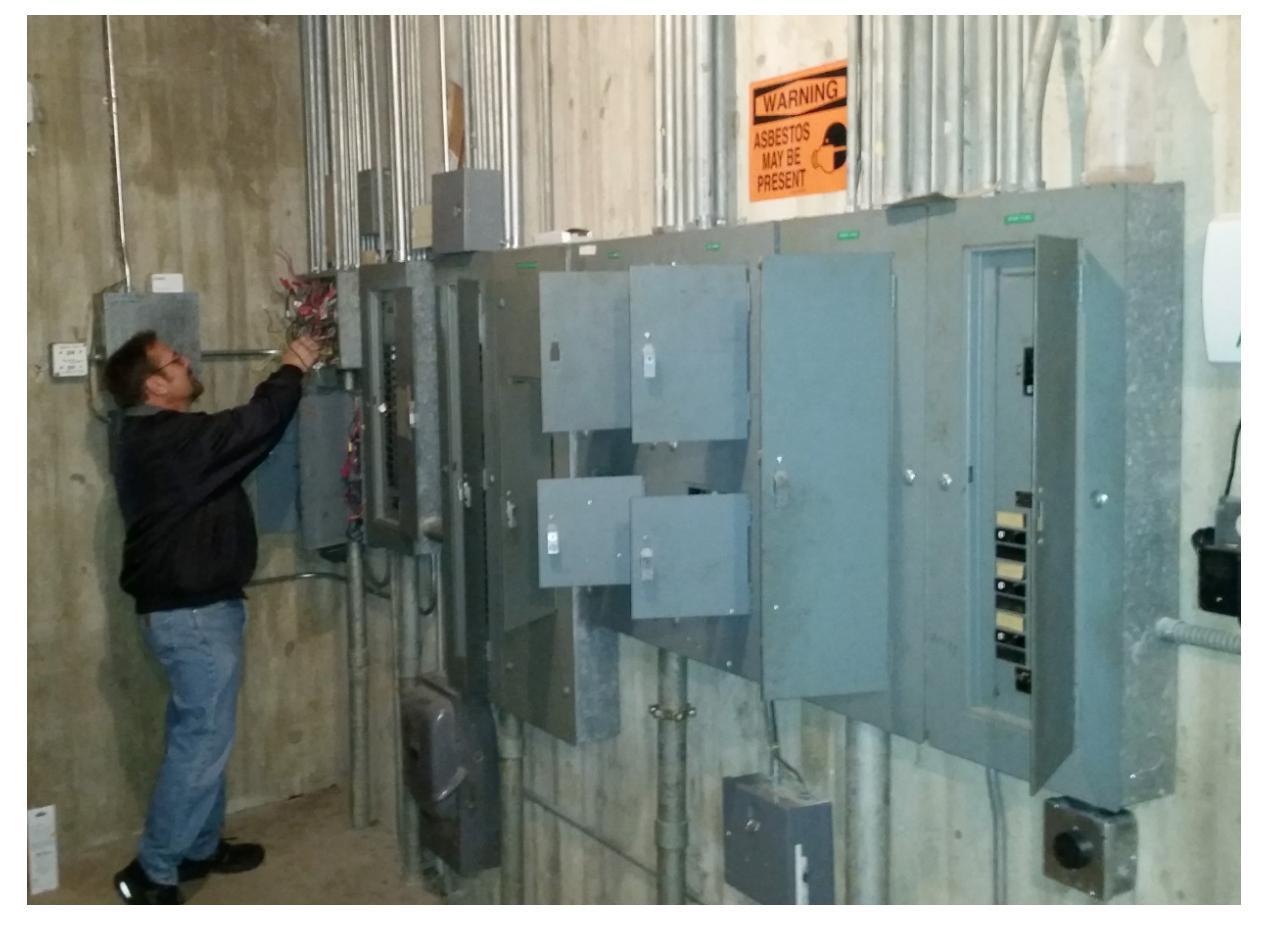
There were electrical boxes overserved in the building that do not have adequate free space within the box per NED 314. It was also observed that much of the electrical system is not sufficiently label which makes trouble shooting or rewiring very difficult; refer to Figure 55 - Trouble Shooting Existing Electrical System (below, left) and Figure 56 - Open Junction Boxes (below, center).

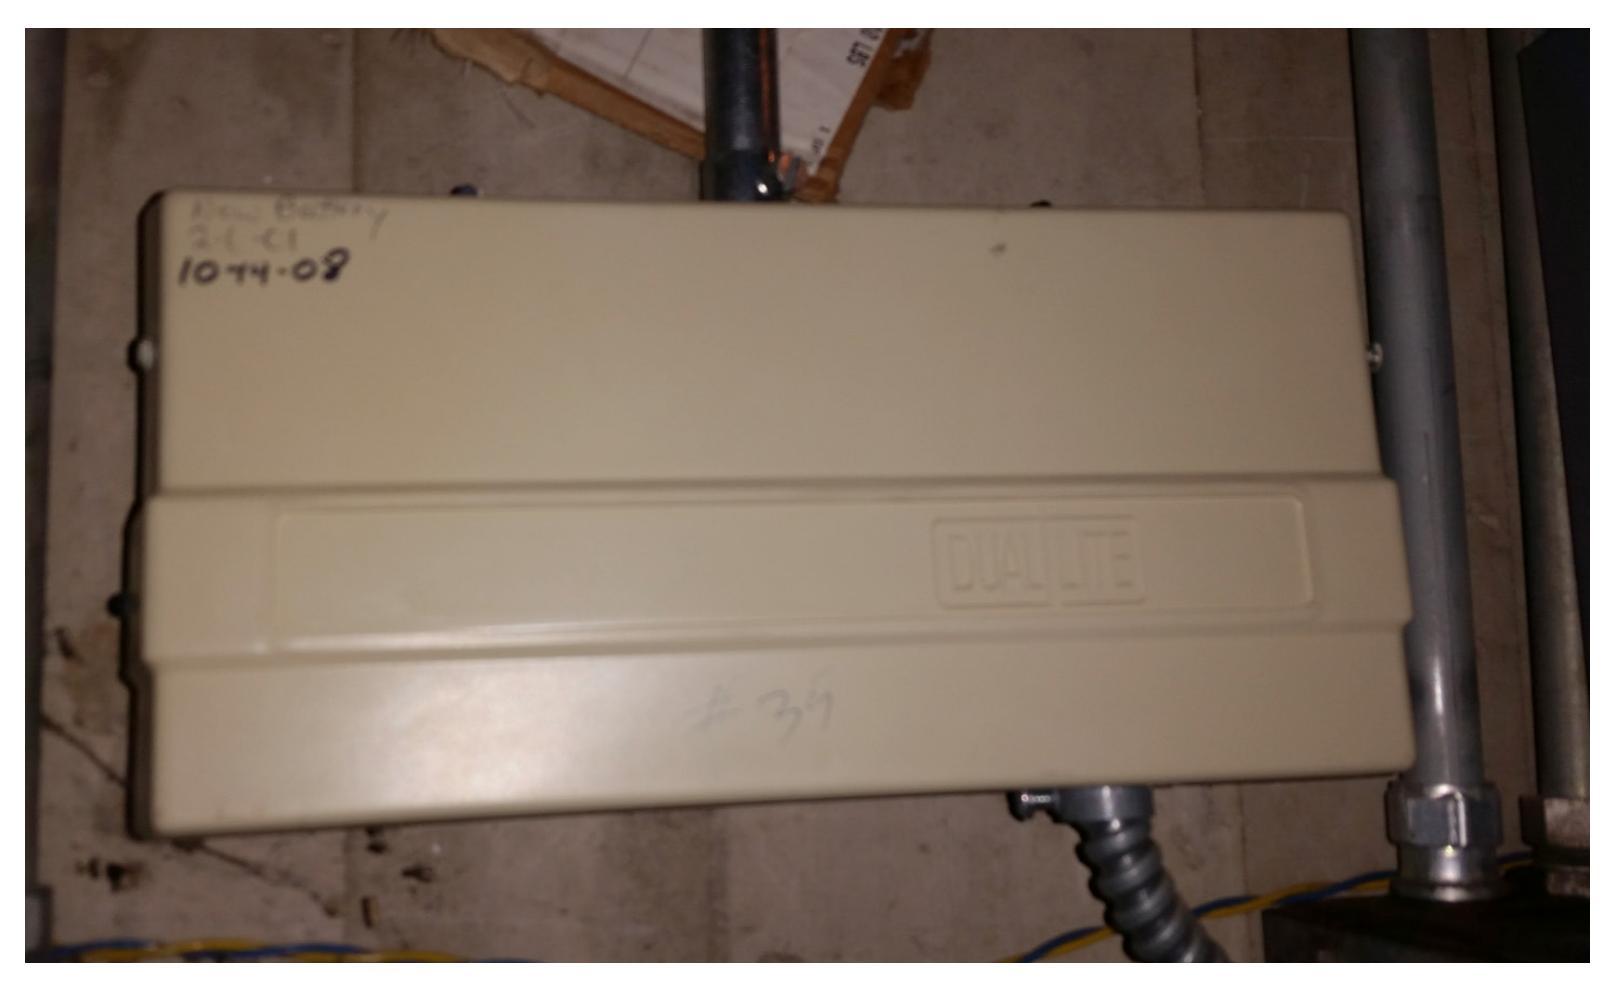
There were limited emergency systems observed. There appeared to be limited to no emergency egress lighting in the main Church. A small lighting battery inverter was observed in the south mechanical room on the Crypt Level as shown in Figure 59 - Lighting Battery Pack (next page, upper left).

Note: the batteries in this device were changed in 2008, and likely not able to maintain required output due to the age of the batteries. This condition has been observed on other universities were general maintenance on battery inverters is difficult for facility staff when managing multiple buildings.

As previously described; the emergency systems within the Church are limited and the lack of emergency egress lighting is a major concern. The battery inverter system does not appear to be maintained based on the labeled dates that batteries were changed in the unit. There was no fire alarm system observed in the building.

Install an emergency distribution system from the generator system that feeds into the Lower Level of Alcuin Library. A new 4-pole open transition automatic transfer switch with associated 100A – 208/120V emergency panelboard and a 480V primary to 208/120V secondary 30kVA transformer is recommended for the Church. The existing generator that feeds into Alcuin Library is a diesel unit rated at 150kW – 277/480V. This generator serves as the emergency source for Alcuin Library and the Guest House.

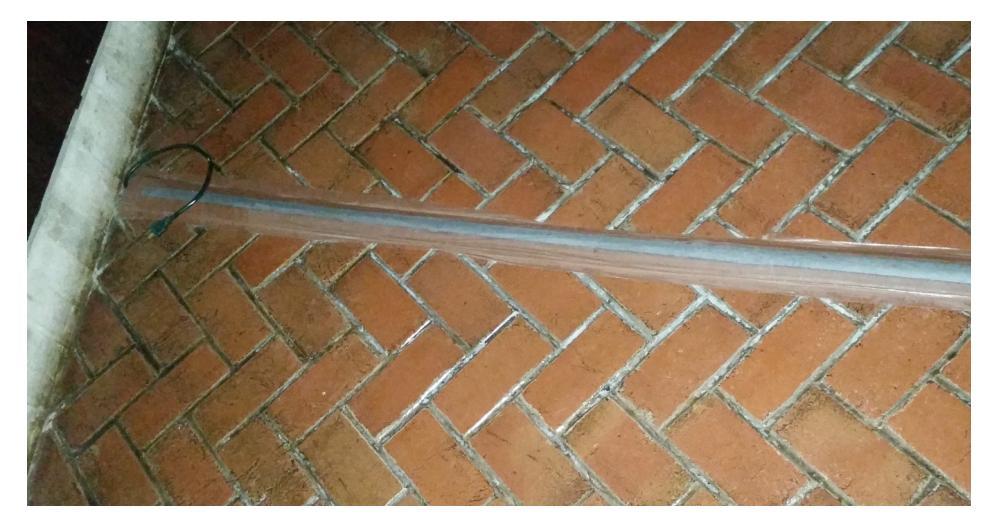
The limitation to the wiring devices in the Church is the limited locations. At the time the Church was constructed there was not a need for the amount of receptacles that would be installed in this building if were constructed today. Examples of temporary fixes that the University has installed to remedy this situation are shown in Figure 72 – Surface Raceway in Main Entry of Church (below) and Figure 73 – Receptacle near Private Chapels (above right). These solutions include surface raceways to conceal extension cords to taping extension cords at the floor transition to the wall.

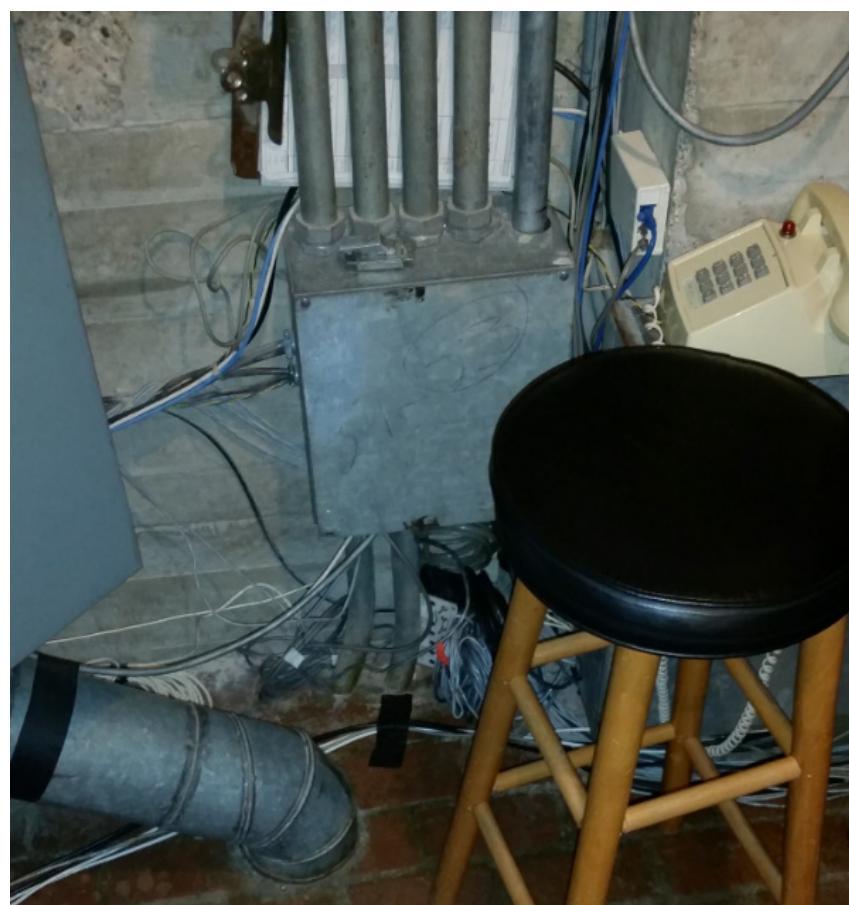
Where communication cabling was observed much of the cabling was exposed as shown in Figure 81 – Exposed Communication Cabling (above).

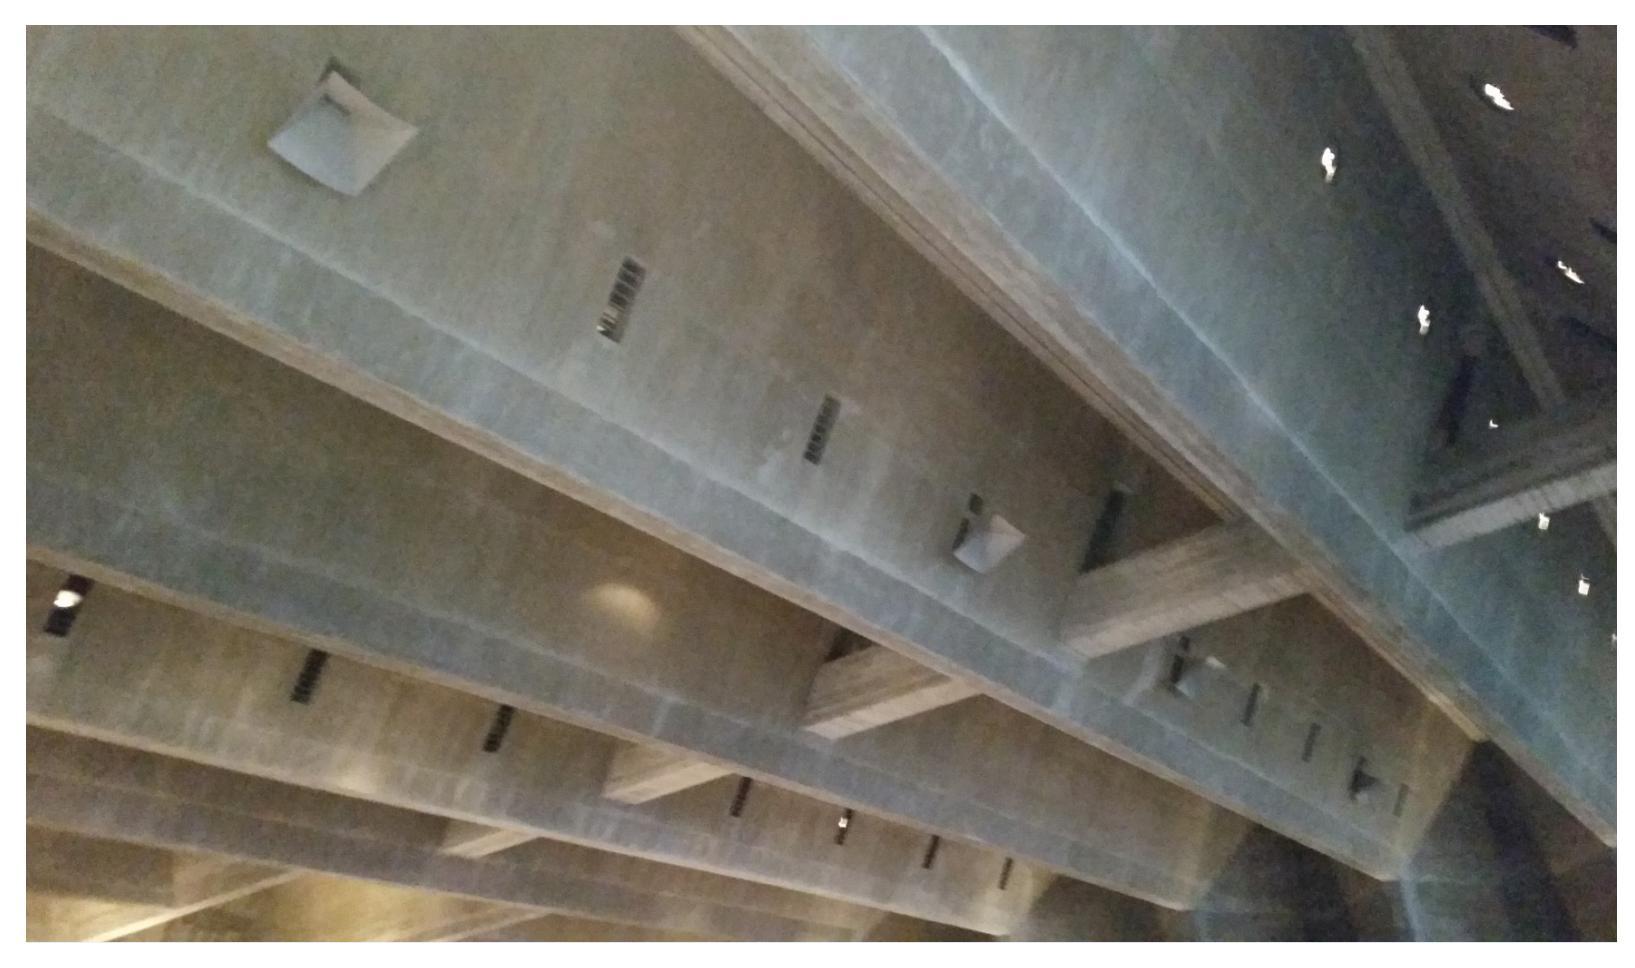
The balcony speakers have been turned off due to echoing as seen in Figure 86 – Sign Regarding Balcony Speakers (next page, upper left). The sound quality on the balcony is poor due to the surfaces in the building and the distance from the speakers as seen in Figure 87 – Speakers Located in Truss Space (next page, upper right).

The sound system in the building is marginal and showing its age. The issues with the balcony system were previously discuss, and it should be noted that the sound system in the Parish Church is very loud and there is limited adjustments that users can make on the system.

It is recommended that all speakers and associated cabling and equipment be removed during the renovation. The quality requirements that you would expect for a Church of this nature require a modern sound system.

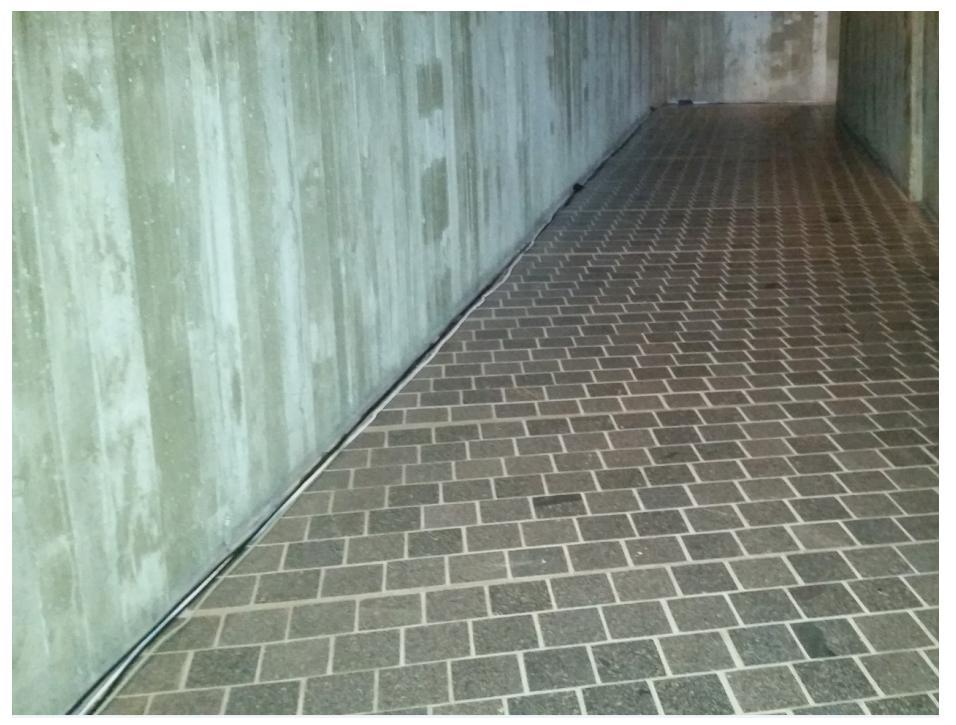
The camera system is in great condition, and this system gives the University the capabilities to broadcast any events that occur in the Main Church. The only modifications recommended for this system is to conceal exposed cabling to the camera on the Balcony Level. Cables were not able to be pulled through the existing pipe that was recessed in concrete to the camera location, refer to Figure 92 – Exposed Camera Cabling (above) for exposed cabling image.
