**SEISMIC RETROFITTING PROJECT**  
The Earthen Architecture Initiative

Building: **KUÑO TAMBO CHURCH**  
Cusco, Perú

Sheet Title: **Structural Prospection**  
IS-1

**KT-P-1**

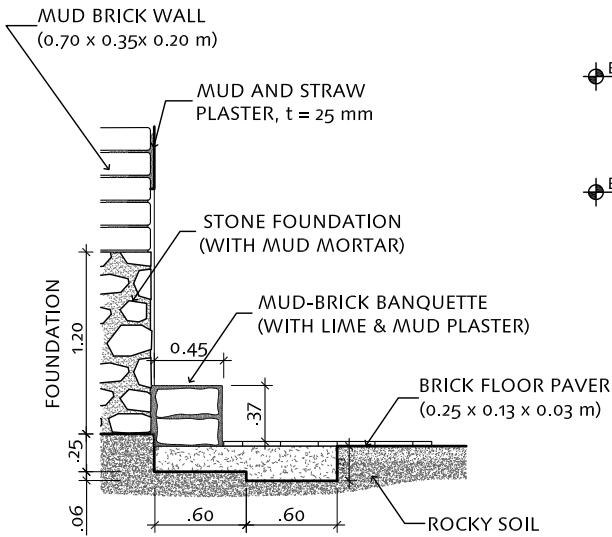
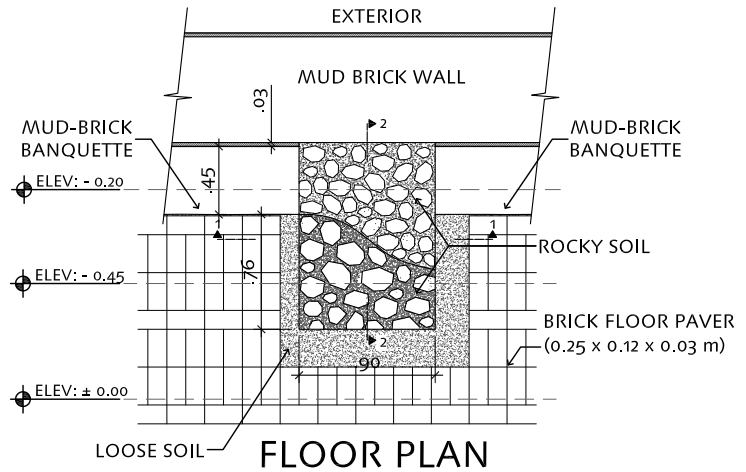
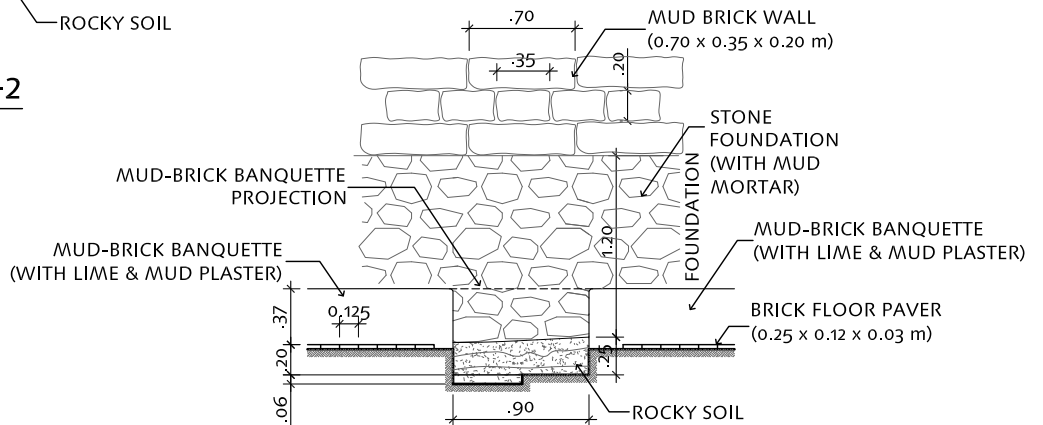
THE OBJETIVE OF OPENNING IS-1 IS TO IDENTIFY THE CHARACTERISTICS OF THE FOUNDATION. AFTER REMOVING THE BRICK FLOOR AND SOME COMPATED SOIL, AT A DEPTH OF 0.25 m WE FOUND ROCKY SOIL CORRESPONDING TO THE SLOPE OF THE HILL WHERE THE CHURCH IS SITUATED. TAKING ADVANTAGE OF THE PARTIAL LOSS OF THE BANQUETTE, WE WERE ABLE TO EXTEND THE OPENNING TO THE LATERAL WALL OF THE CHURCH AND SEE THAT ON TOP OF THE ROCKY BASE RESTS A "SOBRECIMIENTO" CONSISTING OF ANGLED STONES WITH A CLAY-RICH MORTAR TO A HEIGHT OF 1.20 m. ON TOP OF THIS "SOBRECIMIENTO" THERE IS THE ADOBE WALL. THE MUD BRICK BANQUETTE IS CONSTRUCTED ADJACENT, BUT NOT CONNECTED, TO THE WALL.

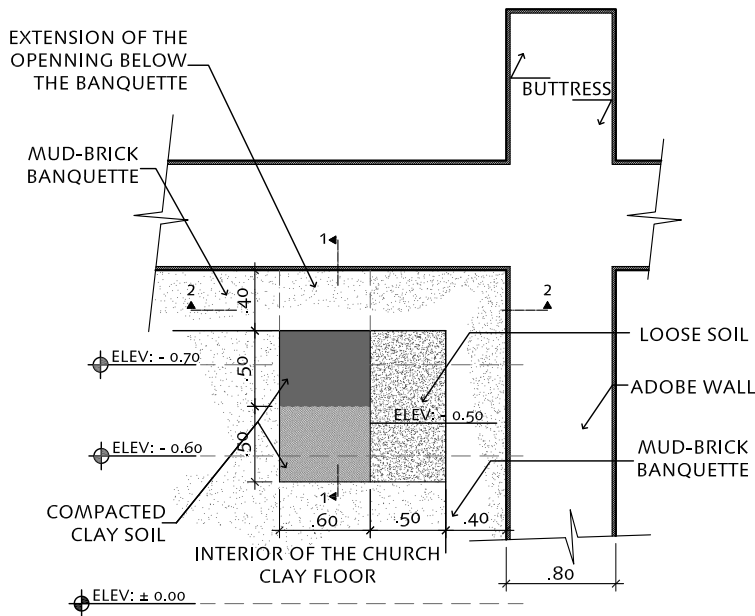
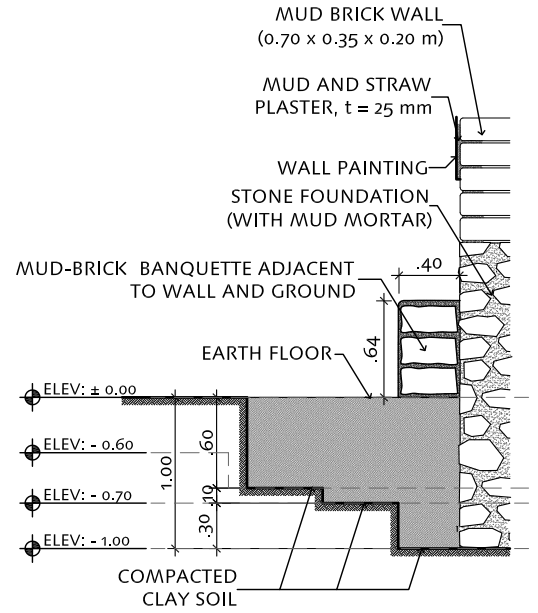
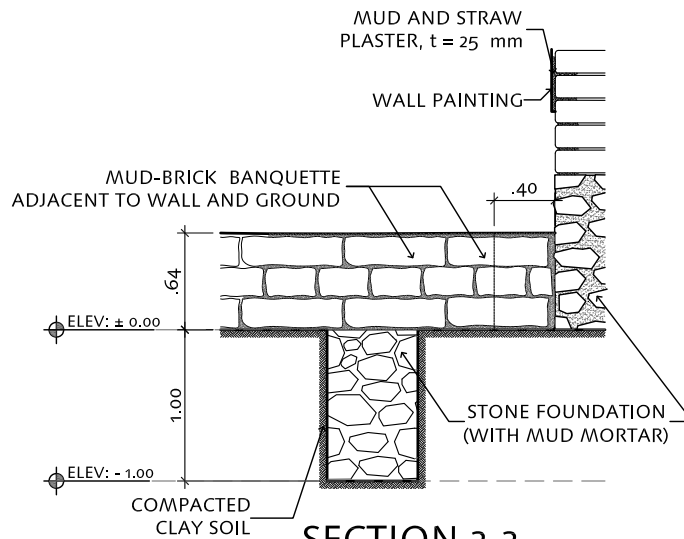
Sheet Title: **Structural Prospection**  
IS-3

THIS OPENING IS LOCATED AT THE FLOOR AT THE CORNER OF THE FRONT FAÇADE AND WEST LATERAL WALL, AND ITS OBJECTIVE IS TO IDENTIFY THE FOUNDATION CHARACTERISTICS IN THIS SECTOR. THERE IS AN "L"-SHAPED MUD BRICK BANQUETTE, 0.40 m HIGH BY 0.40 m WIDE, WHICH IS ADJACENT, BUT NOT CONNECTED, TO BOTH WALLS. UNLIKE PROSPECTION IS-1, THERE ARE NO BRICKS AT THE FLOOR, ONLY LOOSE EARTH. AT A DEPTH OF 0.50 m, HUMAN REMAINS WERE FOUND. BELOW THIS, THE SOIL IS MORE COMPACTED, AND THE COMPACTION INCREASED AS WE DESCENDED. BY EXTENDING THE OPENING UNDER THE MUD BRICK BANQUETTE ADJACENT TO THE MAIN FAÇADE, WE WERE ABLE TO SEE THE FOUNDATION. IT IS COMPOSED OF ANGLED STONES AND A CLAY MUD MORTAR, AND IT HAS A DEPTH OF 1.00 m AS MEASURED FROM THE FLOOR LEVEL IN THE CHURCH. UNDER THIS FOUNDATION THERE IS COMPACTED SOIL.

AS COMPARED TO PROSPECTION IS-1, THIS FOUNDATION IS DEEPER AND HAS A HIGHER LEVEL OF SOIL COMPACTION, WHICH WAS DIFFICULT TO EXCAVATE WITH THE TOOLS USED FOR THE INVESTIGATIONS. THEREFORE, WE CAN DEDUCE THAT THE CHURCH SITS ON A HILL, WITH THE HIGHEST PART IN THE ZONE OF THE ALTAR, WHICH HAS A ROCKY BASE (AS SEEN IN PROSPECTION IS-1); AND AT THE LOWER SLOPE OF THE HILL IS THE FACADE WALL, WHICH HAS A DEEPER FOUNDATION. THE LEVEL FLOOR INSIDE THE CHURCH WAS CREATED WITH A HIGHLY COMPACTED, CLAY-RICH SOIL.

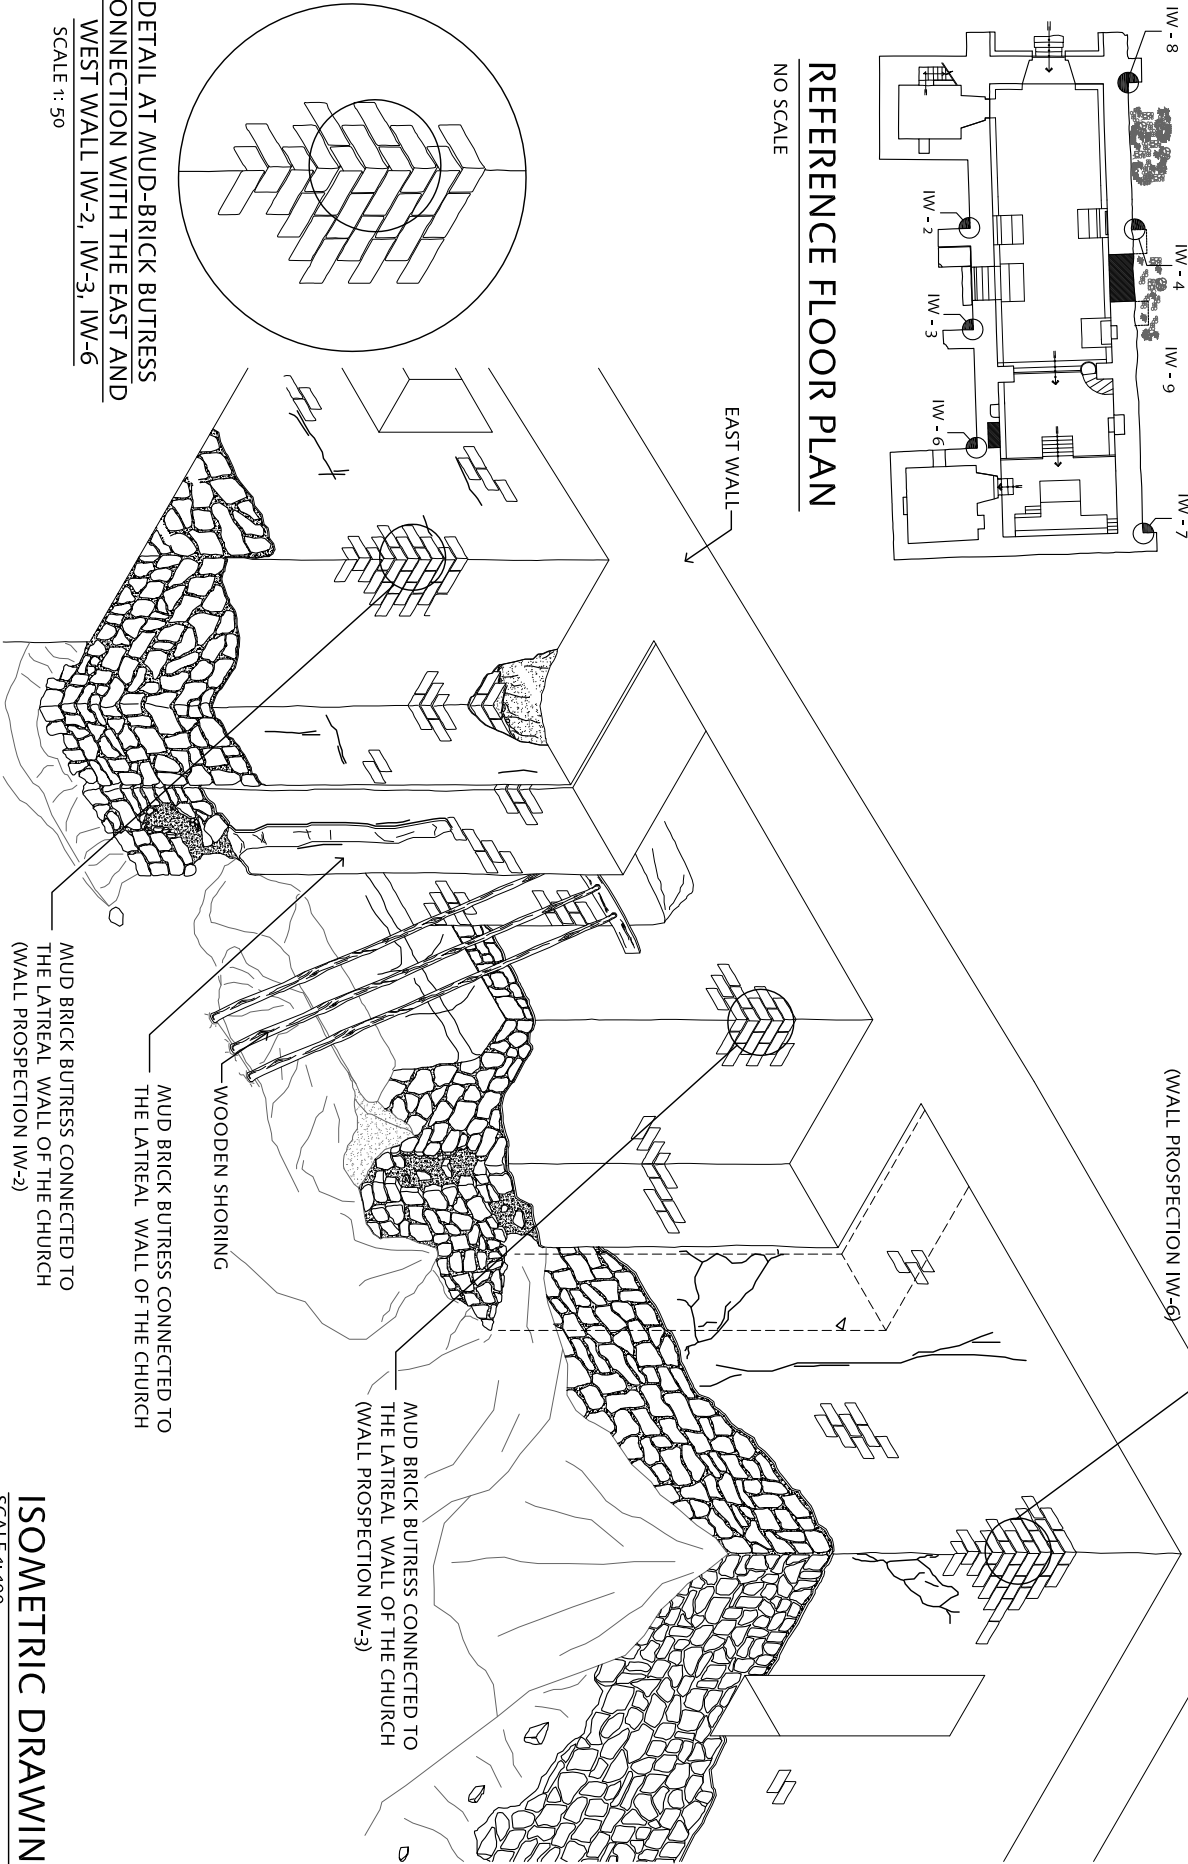
**DETAIL AT MUD-BRICK BUTRESS CONNECTION WITH THE EAST AND WEST WALL IW-2, IW-3, IW-6**  
SCALE 1: 50

THE SACRISTY IS CONNECTED TO THE LATERAL WALL OF THE CHURCH (WALL PROSPECTION IW-6)

MUD BRICK BUTRESS CONNECTED TO THE LATERAL WALL OF THE CHURCH (WALL PROSPECTION IW-2)

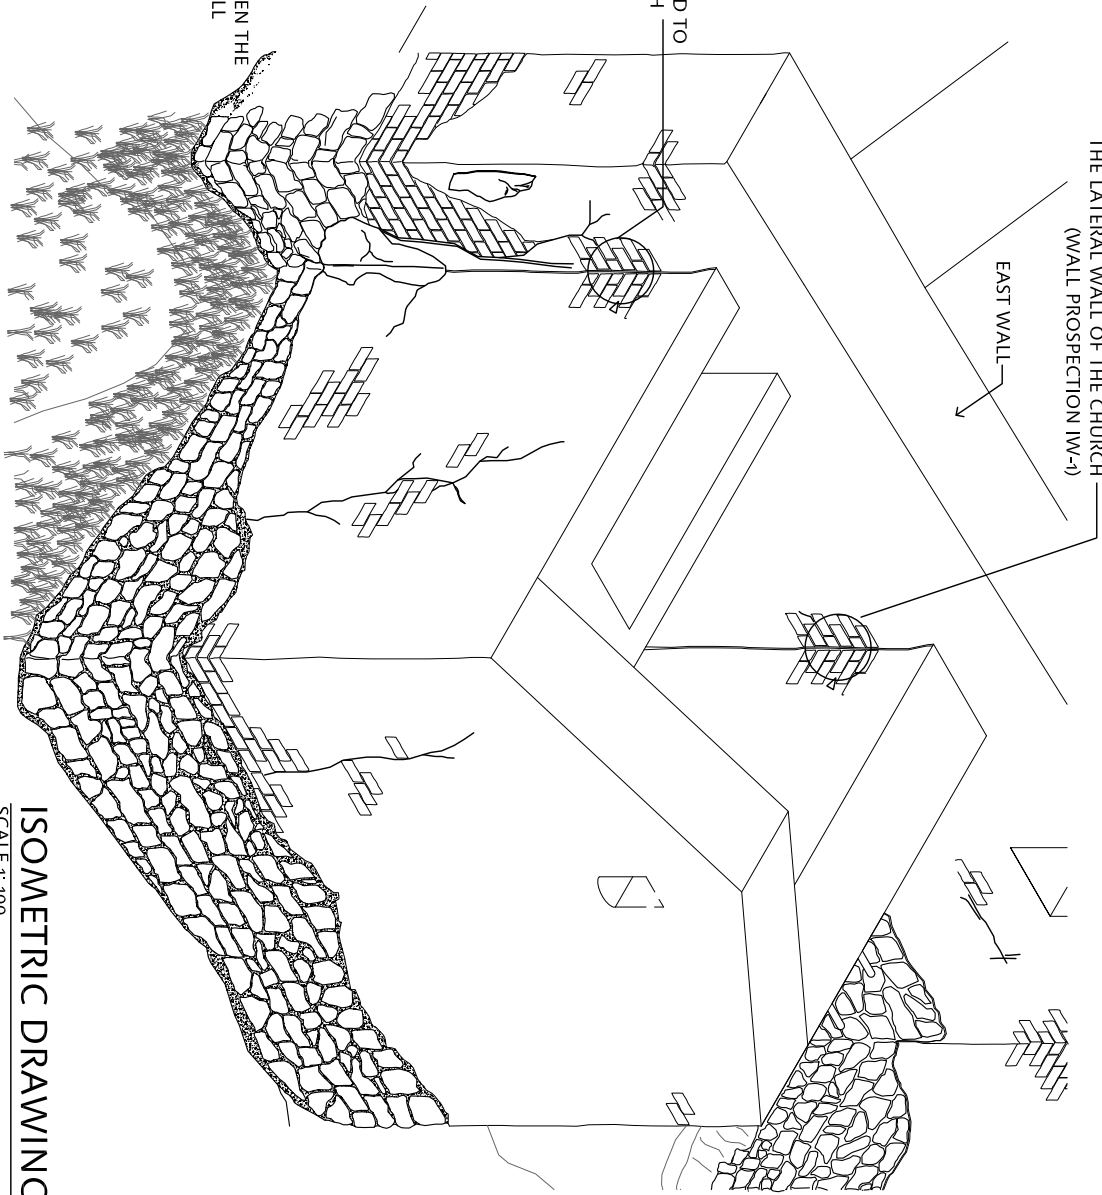
**CONNECTION DETAIL OF THE BAPTISTERY AND THE EAST CHURCH WALL**  
SCALE 1: 50

THERE IS NO CONNECTION BETWEEN THE BAPTISTERY AND THE CHURCH WALL
