Proposals for Future Conservation Actions

Testing of Stone and Masonry Conservation Techniques and Materials

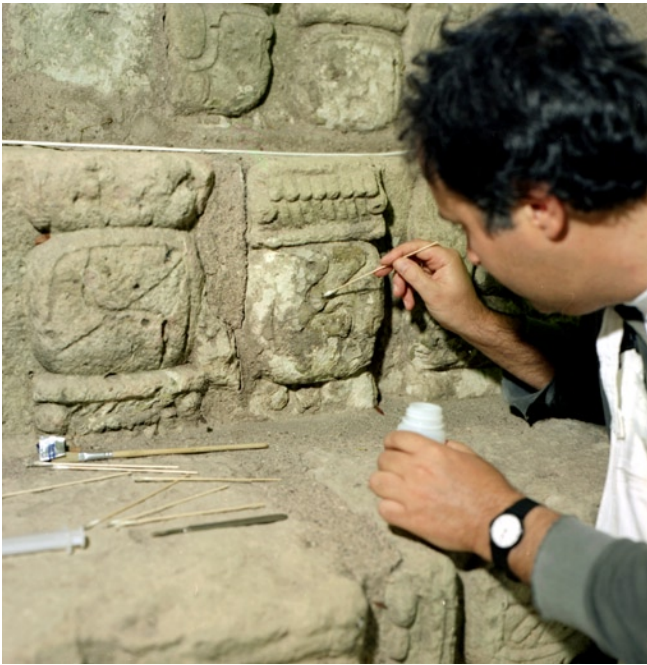
Figure 109 Reduction of previous treatments from a stone surface with acetone applied by a cotton swab.

The preferred method, which affords greater control, is swabbing. After attempts at cotton swab reduction of previous treatments (**Fig. 109**), various types and sizes of synthetic foam swabs were used. These proved to be far more effective because of their capacity to hold the solvent in greater quantity and over a longer period of time. Unfortunately, these types of swabs were not found to be available in Honduras, but they were considered essential to realistic treatment times and could be easily imported or ordered from Web sites at a modest cost.

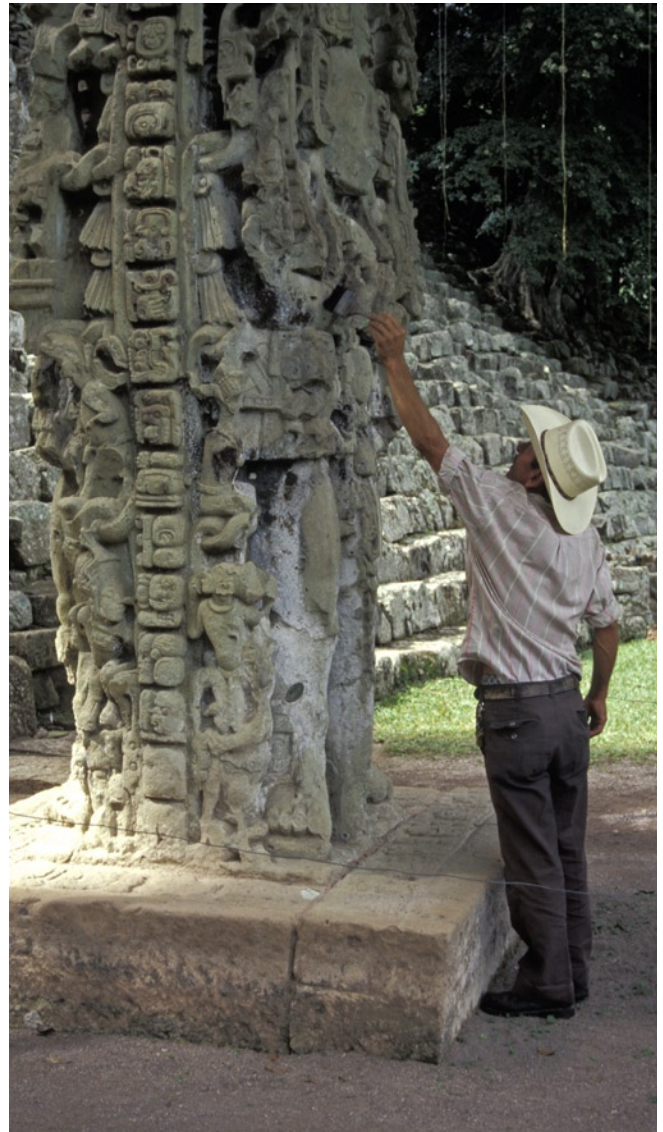
Another aspect of ordinary cleaning maintenance that was temporarily suspended on the Stairway during the project was the removal of cobwebs, which accumulate on stone surfaces throughout the site (**Figs. 122, 123**). While there is no way to prevent the formation of cobwebs, their periodic removal on the Stairway should be carried out only by trained personnel and performed together with leaf removal a few times a year.

Figure 125 IHAH staff member using a brush to remove spiderwebs from a stela.

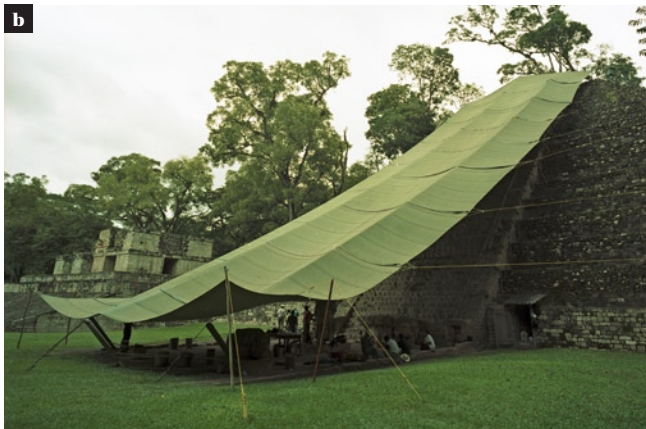
Since the shelter was first installed in 1985, modifications to it have been made to improve its protective function. Primarily, the length of the tarpaulin has been extended so that it covers more of the upper part of the pyramid (**Figs. 126, 127a, b**), and as a consequence, rainwater no longer collects above the Stairway. During this project, modifications to the shelter have already been proposed informally, and some have been carried out, such as improvements to the lateral anchoring of the tarpaulin so that it remains more taut and less prone to tear in high winds (**Figs. 128, 129**). The following additional modifications could be employed to improve the current performance of the shelter:

Figures 127a and b The shelter of the Hieroglyphic Stairway in 1992, with coverage that stops short of the top of the pyramid (a); a replacement tarpaulin, in place in 2001, offers greater coverage of the top of the pyramid (b).

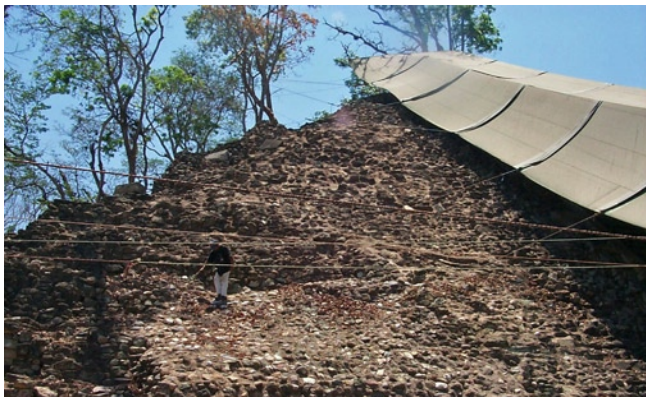
Figure 128 Shelter in 1998, with previous system of lateral supports.

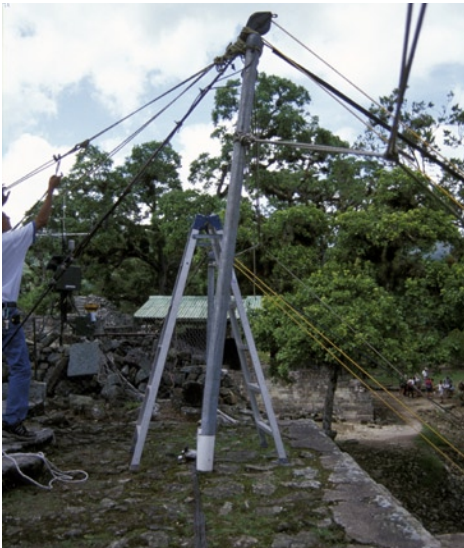
2. *Reinstall or replace the central cable support.* The increasing frequency of the removal and reinstallation of the tarpaulin has caused the existing center cable support at the top of the Stairway to deflect downward. As a result, the tarpaulin moves increasingly closer to the top of the Stairway (**Fig. 130**), and it touches stone surfaces during high winds. The proximity of the tarpaulin to the top of the Stairway reduces air circulation and increases air temperature in this part of the Stairway (see “Environmental Monitoring”); however, it increases stone surface temperatures only slightly, so it does not seem to be a significant factor in stone deterioration. As a temporary solution, a small metal cable has been attached to the top of the support in order to pull it back to vertical (**Fig. 131**). If the cable support is reinstalled or replaced, it should be done in such a way that the height of the tarpaulin above the top of the Stairway is increased.

Figure 131 The central shelter cable support. Additional cable on the left keeps the support vertical.

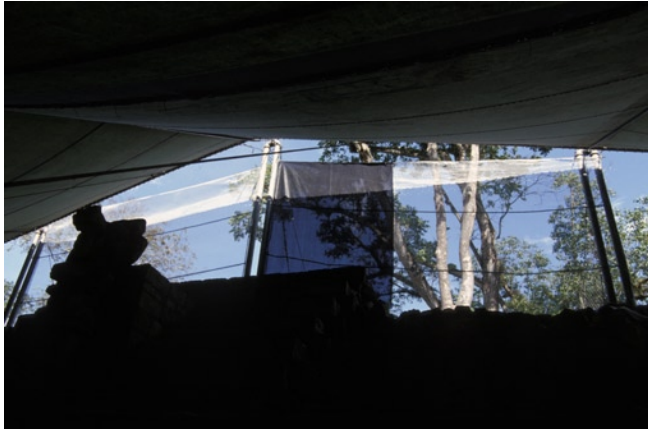
Figure 154 Trial placement of dark netting at the top of the Stairway in order to reduce visual contrast and improve the visibility of the Stairway from the Plaza.
