# 山门 状况评估

## Shanmen Condition Assessment

Shanmen, or the gatehouse, is a simple rectangular structure, three bays wide and one bay deep. The gatehouse has surviving painted polychrome decoration on both exterior and interior architectural wooden surfaces.

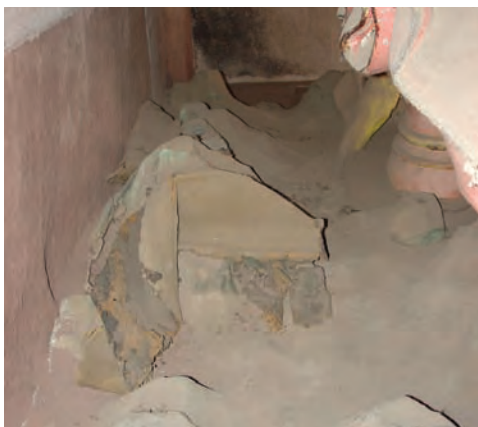
在哼哈二将中“哈”的塑像后可见的脱落彩画。  
Fallen piece of painting found on the ground behind the Temple Guardian *Ha*.

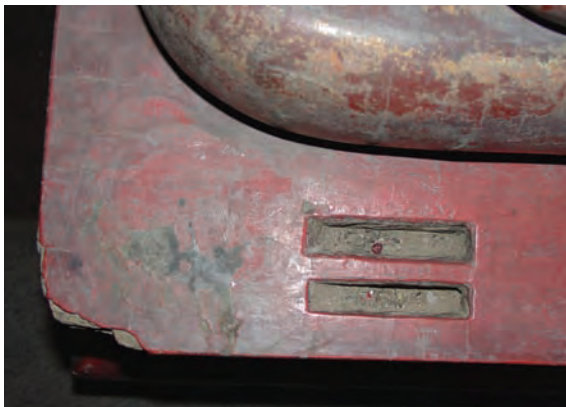
座椅底座东南角用以衔接现已遗失的座椅扶手的凹槽。  
Southeast corner of throne base showing grooves for insertion of missing throne arms.

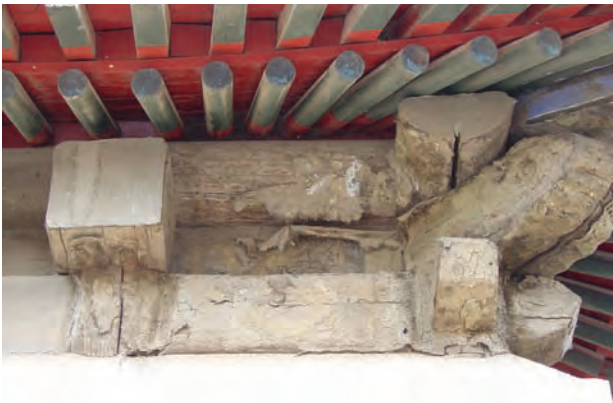
西南角，西墙  
Southwest corner, west wall

小片彩画虽然残损严重，但仍可见于下层西南及西北角。

Small patches of painting, though deteriorated, still survive on the southwest and northwest corners of the lower level of the Bell Tower.

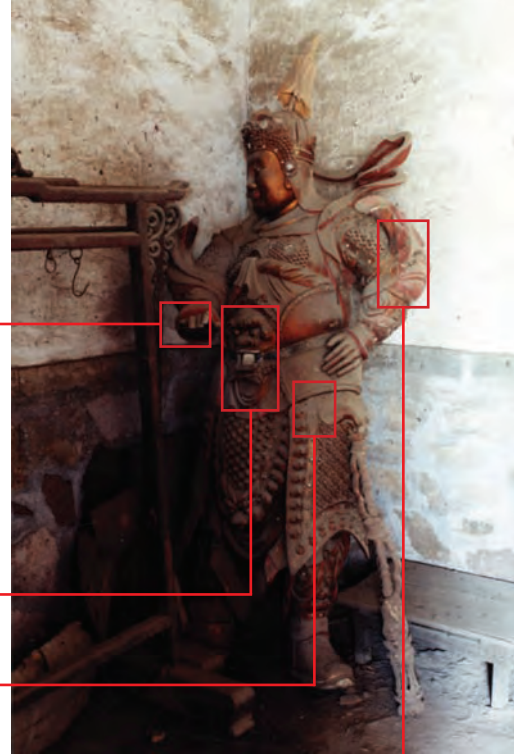
韦陀像右手的缺损。并注意堆积有厚重的尘土。

Loss on the right hand of *Weituo*. Note also heavy dust deposition.
