Eames House Conservation Project: Investigations 2011 to 2016

Research Report

Edited by Laura Matarese
with Chandler McCoy and Gail Ostergren

The Getty Conservation Institute

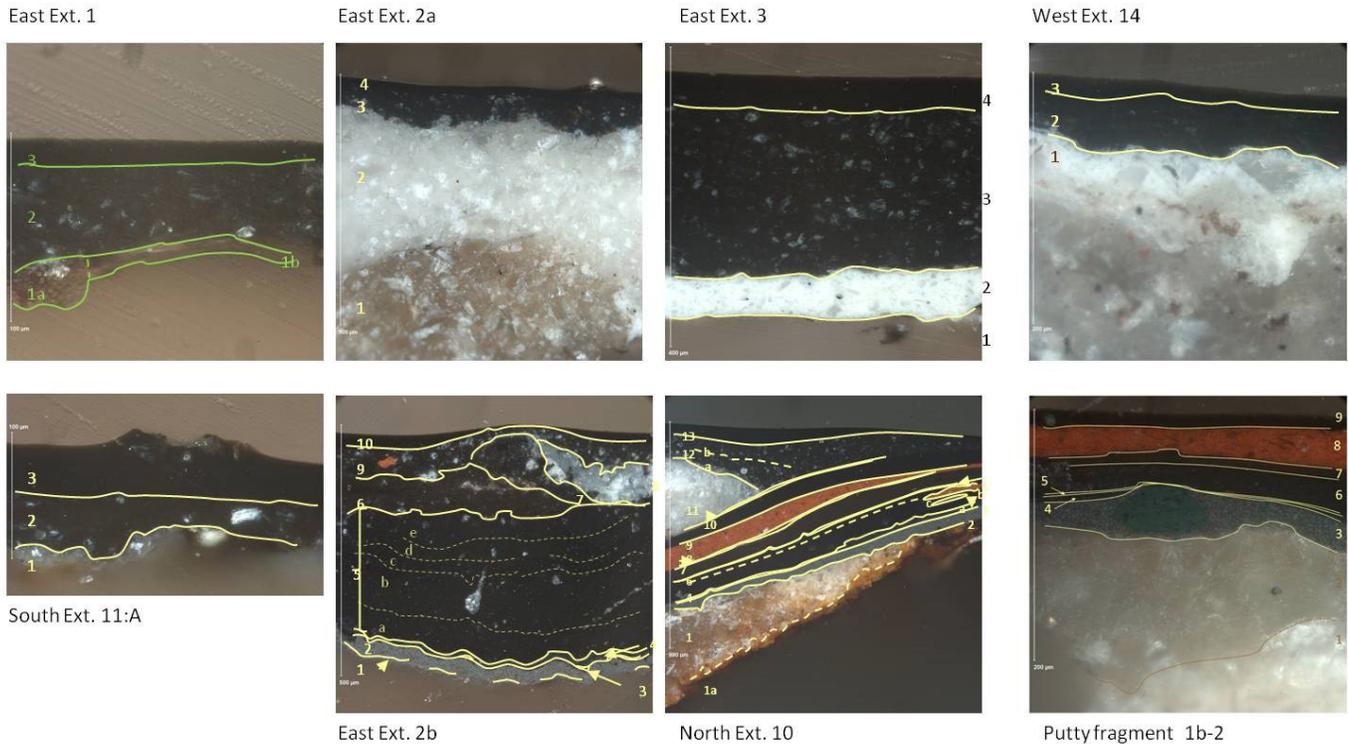
FIGURE 1.1

The cross section samples from the now-black metalwork are illustrated together in figure 1.1, with each sample annotated to show the layer structure. Of the samples from the building itself, only samples East Exterior_2b and North Exterior_10 show complex stratigraphies that include what could be interpreted as the earliest layers of paint applied to the structure. Samples of paint from selected fragments of putty detached in the 1994 Northridge earthquake also show complex stratigraphies that, while lacking the most recent strata, have definite correspondences to the samples taken from the building.

The uppermost two layers in sample Eames House_putty#1b-2 (black paint over red primer) have direct correspondences with layers in sample North Exterior_10; these strata represent the most recent coatings prior to the 1994 earthquake. Accordingly, given their position in the stratigraphy and their composition, these layers can be linked to the first repainting campaign by Clayton Coatings, commissioned in 1989 by the family after the death of Ray Eames. These paints are identified as Ameritone Alkyd Enamel Satin black over Dunn-Edwards Bloc-Rust #43-4. In 1989–90, therefore, the metal framework of the residence was black in color, with satin finish. Alkyd was identified as the binder for uppermost black paint layer by Py-GCMS (fig. 1.1).

In samples East Exterior_2b, North Exterior_10, and Eames House_putty#1b-2, immediately beneath the 1989 paint and primer layers lies a dark brown, chlorine-rich coating, the status and dating of which are relatively uncertain. This layer is interpreted as possibly a mastic or sealant layer, or a similar coating applied for protective, water-repellant purposes. In each of these samples, lying directly beneath the dark brown mastic/sealant is a sequence of black paint layers, seemingly representing two different campaigns; the earlier campaign appears to have involved repeat applications of similarly-composed paint. The dates of these two painting campaigns cannot be deduced with any certainty from the evidence, nor can they be dated in relation to Charles Eames's death in 1978, when a repair campaign is recorded. It seems probable, however, that the exterior metalwork was painted black at the time of Ray Eames's death in 1988. If, however, the upper stratum of

Set of cross section samples from the exterior black metalwork and putty fragment detached during the 1994 Northridge earthquake.

this early black sequence is tentatively linked to the 1978 repair campaign, then the lower stratum, which consists of multiple substrata, must be earlier, predating Charles Eames's death, leading to the conclusion that the exterior metalwork was painted black during Charles Eames's lifetime.

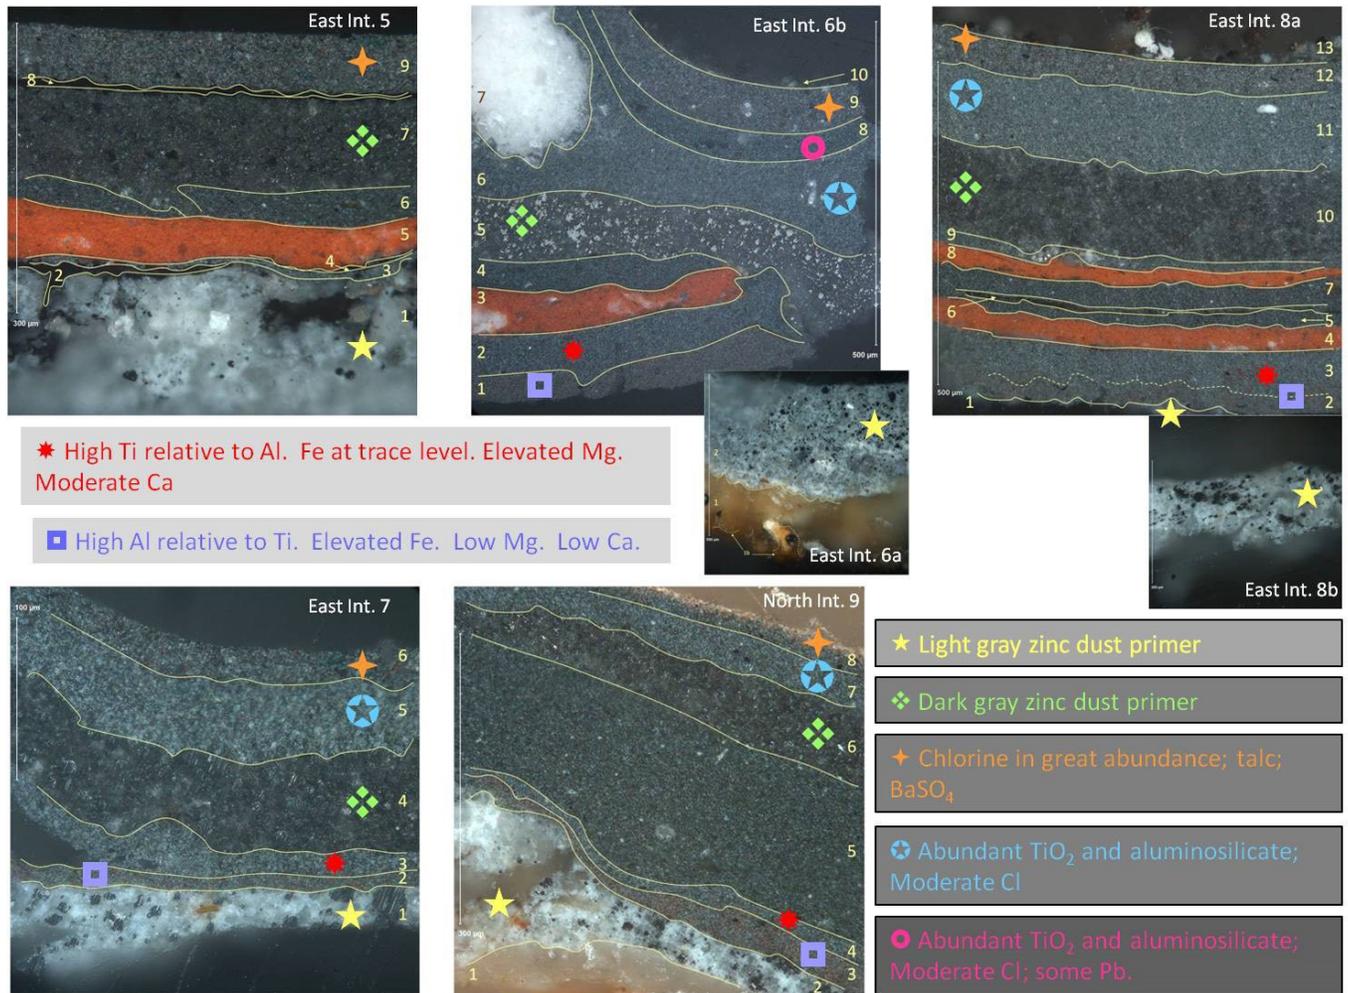
The samples of paint from the interior metalwork all have quite complex stratigraphies that illustrate repeated cycles of priming and painting (fig. 1.2). The stratigraphies are somewhat variable across the sample set. Although no two samples have exactly the same layer structure, some correspondences and commonalities do occur. The differences in the stratigraphies across the group suggest a degree of specific local variation in the paint treatments. There are few, if any, temporal reference points to allow reliable dating of any of the layers in the interior metalwork samples, with the exception, perhaps, of the uppermost, most recent one in each.

All the interior samples share a common uppermost paint layer. A distinctive feature of this layer is the super-abundance of chlorine, associated with the presence, probably, of a chlorinated rubber paint binder. It is reasonable to connect this paint layer to the 2003 painting campaign by Dan Elliott.

FIGURE 1.2
Samples from interior metalwork showing commonalities across the sample set.

As already noted, the upper dark gray zinc-based primer can be confidently identified as non-original, as can the paint layers above. The paint layers beneath the 2013 dark gray zinc-based primer are obviously more significant in terms of the early history of the interior paint scheme. Most of the interior metalwork samples show commonalities in the lowest two paint layers that lie directly above the pale gray zinc-based primer. These paints are both mixed, or subtractive, grays of the type described above; the upper one is cooler (i.e., less red) than the lower, which can be seen to be more abundant in red (iron oxide) particles. The composition of these two early paint layers is quite similar, but there are some distinctive differences that allow them to be positively correlated across the sample set.

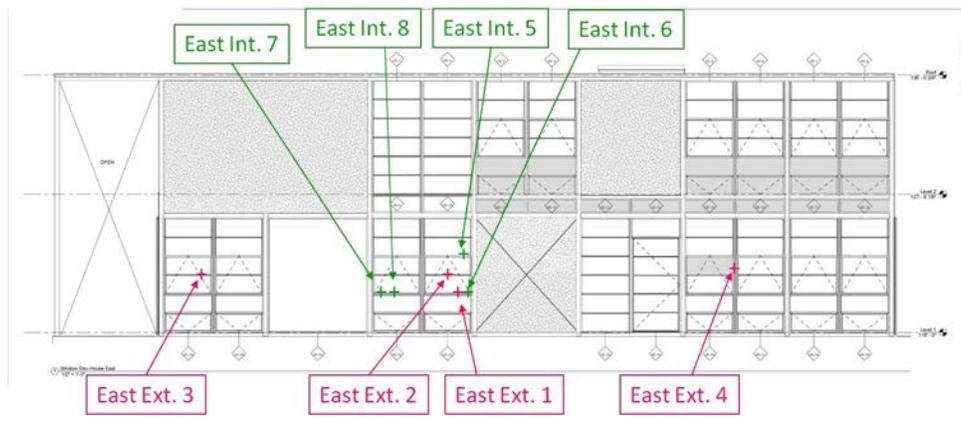
FIGURE 1.5

The locations of the samples taken from the structure are shown on the drawings of the respective elevations given in figures 1.5–1.8. Samples from the exterior are indicated by magenta font; samples from the interior by green font. The samples were all taken from areas of existing damage (cracking, flaking, etc.) in the paintwork. It should be stressed that the sample material taken at any specific location may not be wholly representative of the general surrounding area and that the local stratigraphy may be influenced by the

Eames House, Pacific Palisades. Drawing of east elevation showing locations of sample sites East Exterior #1–4 and East Interior #5–8. Drawing: Adapted from drawing by Escher GuneWardena Architecture, © Eames Office.

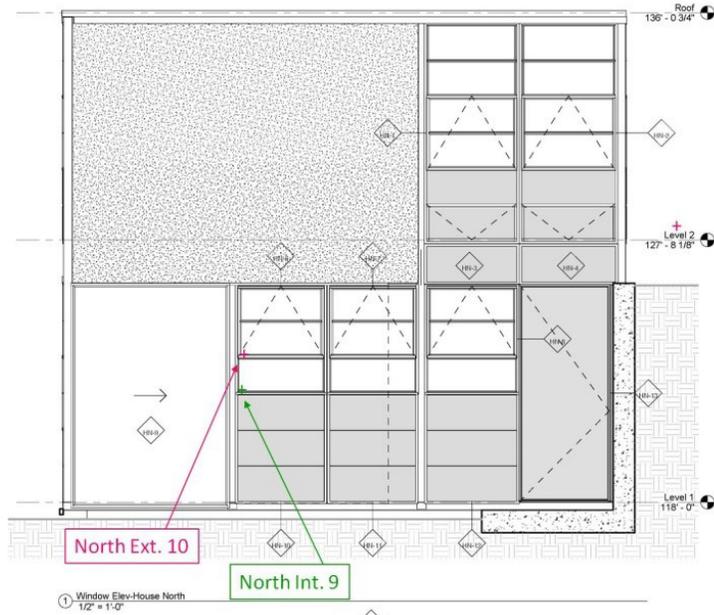
FIGURE 1.6

Eames House, Pacific Palisades. Drawing of north elevation showing locations of sample sites North Interior #9 and North Exterior #10. Drawing: Adapted from drawing by Escher GuneWardena Architecture, © Eames Office.

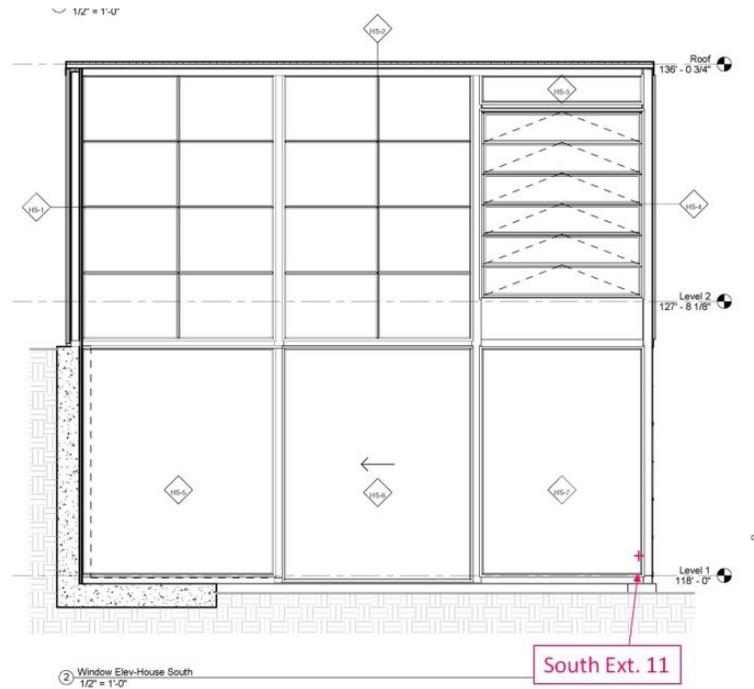
FIGURE 1.7

Eames House, Pacific Palisades.
Drawing of south elevation showing
locations of sample site
South Exterior #11. Drawing:
Adapted from drawing by Escher
GuneWardena Architecture,
© Eames Office.

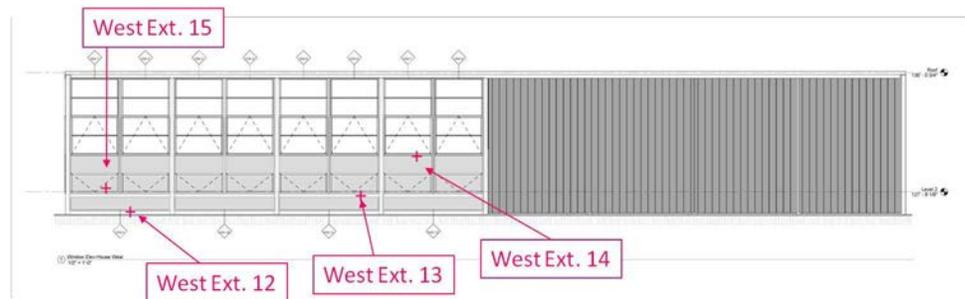
FIGURE 1.8

Eames House, Pacific Palisades.
Drawing of west elevation showing
locations of exterior sample sites
West Exterior #12–#15. Drawing:
Adapted from drawing by Escher
GuneWardena Architecture,
© Eames Office.

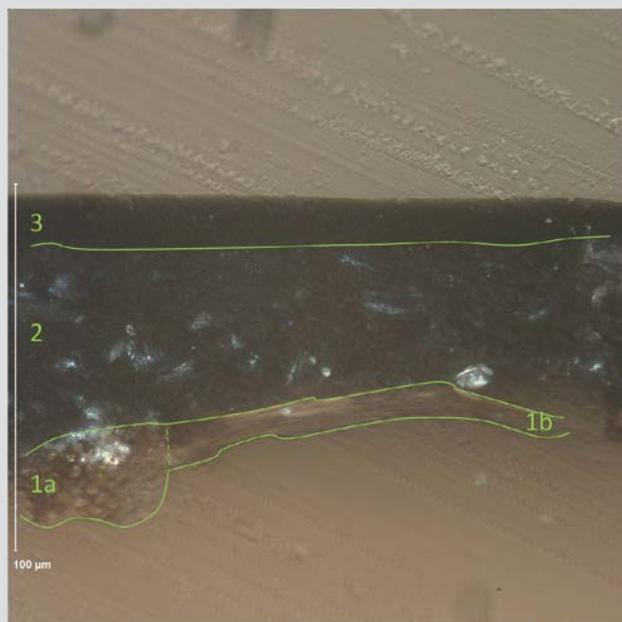
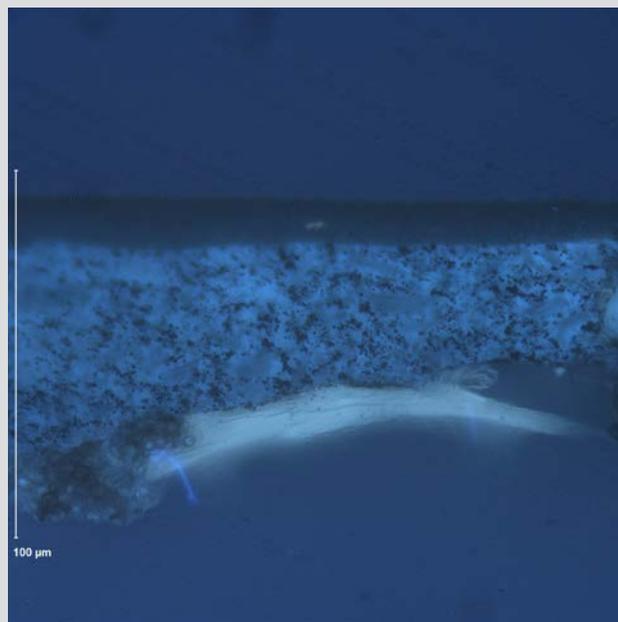
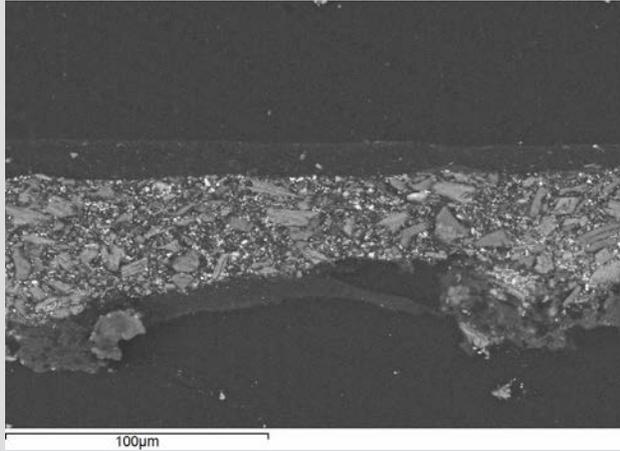
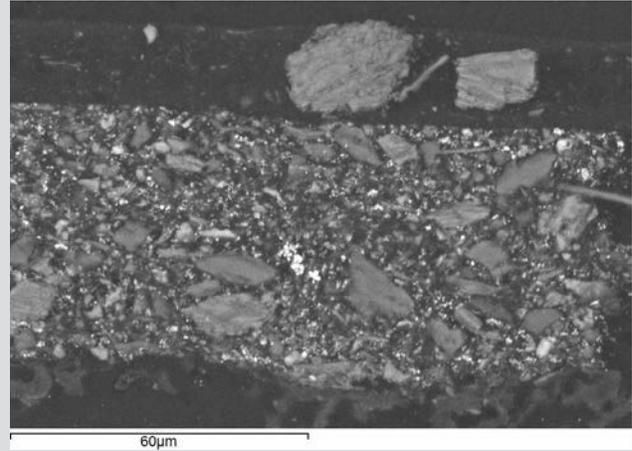
1.6.1 Sample East Exterior_1

Sample is a flake from window frame taken from a location where new glass has been fitted.

FIGURE 1.9A
Cross section of sample East Exterior_1. Crossed polarizing filters with added sidelight. 50× objective + 1.5× magnifier (= 75×). Annotated to show layer structure.

FIGURE 1.9B
Cross section East Exterior_1. UV fluorescence. 50× objective + 1.5× magnifier (= 75×).

FIGURE 1.9C
Cross section East Exterior_1. Backscattered electron image.

FIGURE 1.9D
Cross section East Exterior_1. Backscattered electron image.

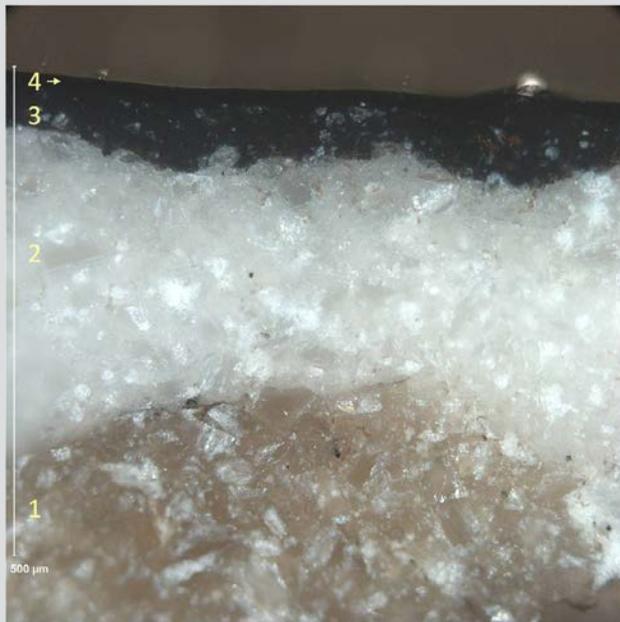
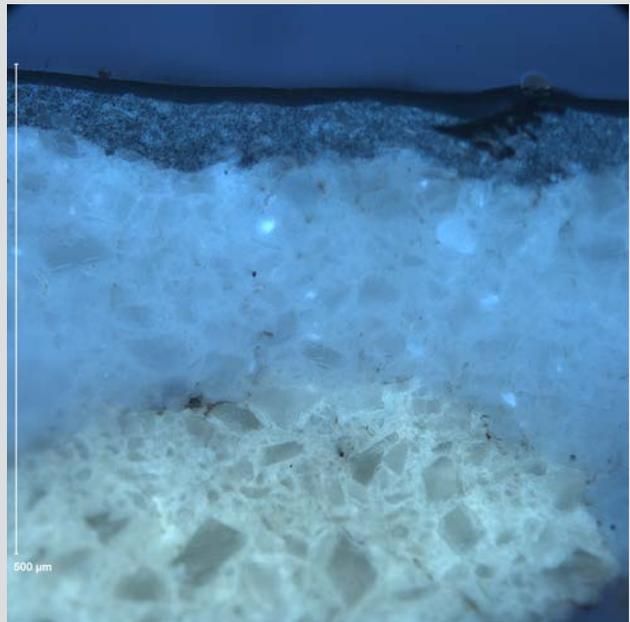
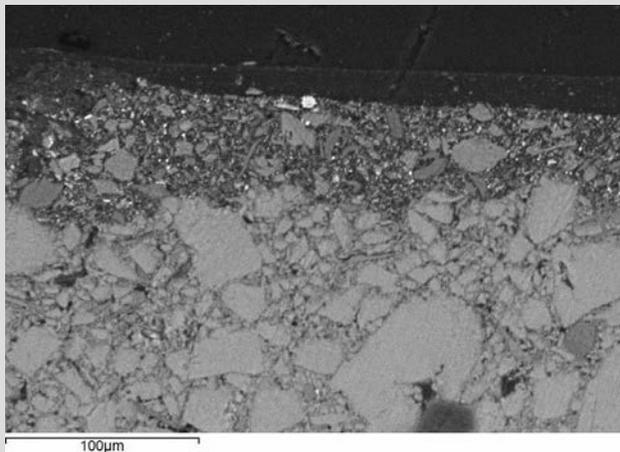
1.6.3 East Exterior_2a

Cross section sample East Exterior_2a has a simple stratigraphy similar to that observed in several other samples from the exterior metalwork, in particular East Exterior_1, East Exterior_3, South Exterior_11, and West Exterior_14. In this, as in the other samples, the paint consists of just

FIGURE 1.10A
Cross section East Exterior_2a. Crossed polarizing filters. 20x objective. Annotated to show layer structure.

FIGURE 1.10B
Cross section East Exterior_2a. UV fluorescence. 20x objective.

FIGURE 1.10C
Cross section East Exterior_2a. Backscattered electron image.

two layers: an upper layer of dense black (here, layer #4), which is carbon-rich, probably carbon black, is largely devoid of inorganic particulates, and which lies over a gray paint composed of carbon black extended with a magnesium- and silicon-rich colorless pigment, probably talc.

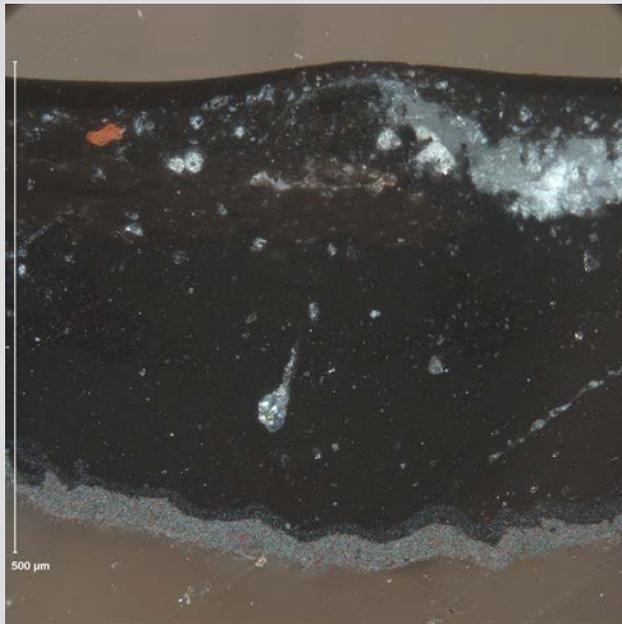
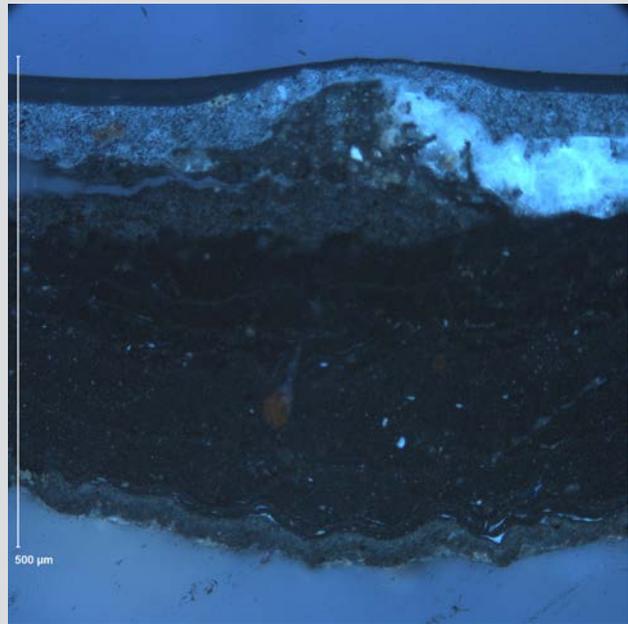
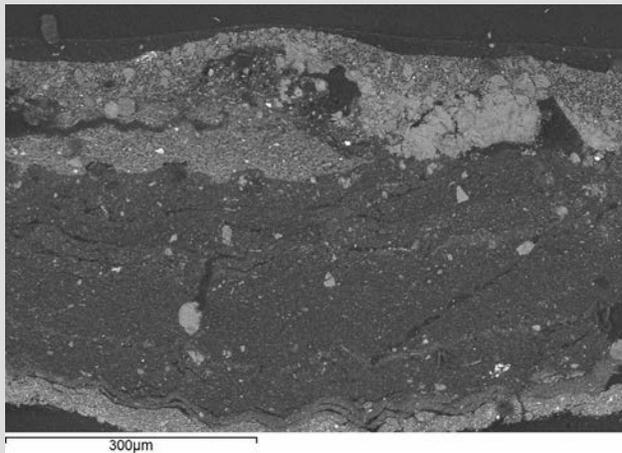
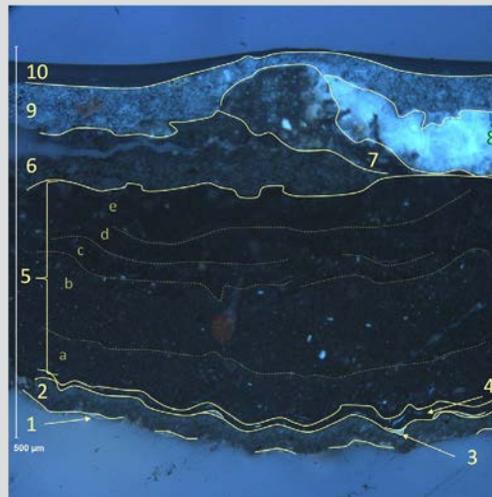
Layer #5 is a thick black paint in which several substrata (a–e) are visible, both by optical and electron microscopy. The boundaries between the substrata are somewhat uneven and indistinct. In terms of elemental composition, all the substrata of layer #5 appear similar—aluminum and silicon are by far the most abundant elements besides carbon—and an aluminosilicate extender is indicated as being present throughout, possibly also with some alumina. Layer #5 in sample East Exterior_2b is comparable with layer #4 in sample North Exterior_10.

Beneath thick black paint layer #5 is a dark gray paint (#4) with an uneven surface. This layer was not analyzed specifically for elemental composition, but elemental mapping indicates the presence of titanium, probably in the

FIGURE 1.11A
Cross section East Exterior_2b. Crossed polarizing filters with added sidelight. 20x objective.

FIGURE 1.11B
Cross section East Exterior_2b. UV fluorescence. 20x objective.

FIGURE 1.11C
Cross section East Exterior_2b. Backscattered electron image.

FIGURE 1.11D
Cross section East Exterior_2b. UV fluorescence. 20x objective. Annotated to show layer structure.

form of titanium white pigment, with aluminosilicates and a trace of iron oxide red. Unidentified discontinuous deposits of organic material (#3), which is strongly fluorescent under UV, underlie dark gray paint layer #4.

At the base of sample East Exterior_2b are discontinuous deposits (#1) of material that is weakly fluorescent under UV. Elemental mapping shows this material to be rich in calcium, and it is probably residue of putty (figs. 1.12a–1.12i and figs. 1.13a–1.13i).

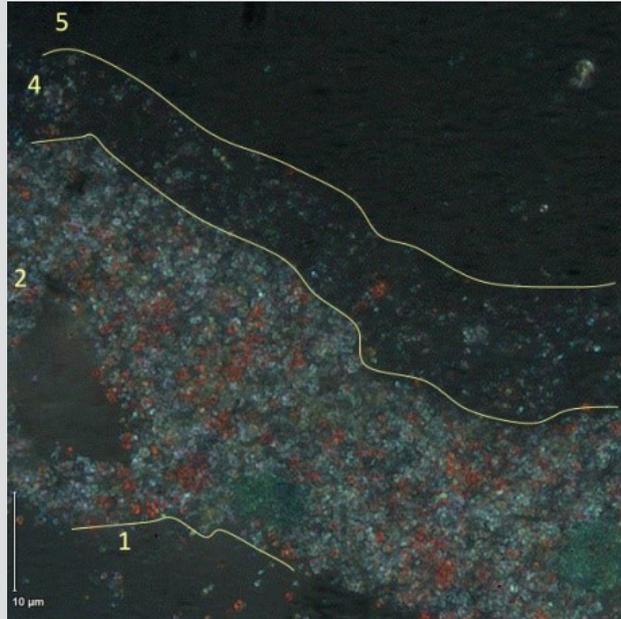
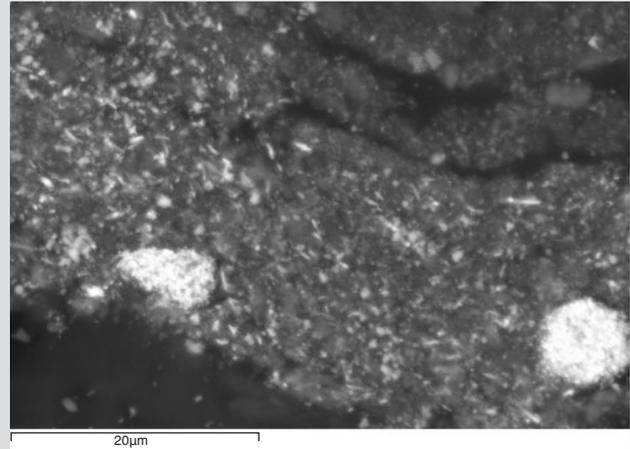
FIGURE 1.13A
Cross section East Exterior_2b at high magnification. Crossed polarizing filters. 100× objective + 2× magnifier (= 200×).

FIGURE 1.13B
Cross section East Exterior_2b at high magnification. Backscattered electron image.

High magnification optical and electron microscopy was performed on the lower strata of sample North Exterior_10 with a view to looking more closely at the correspondence with the lower layers of East Exterior_2b. A high magnification detail (100× objective) of sample North Exterior_10 is given in figure 1.24, which should be compared with figure 1.13a.

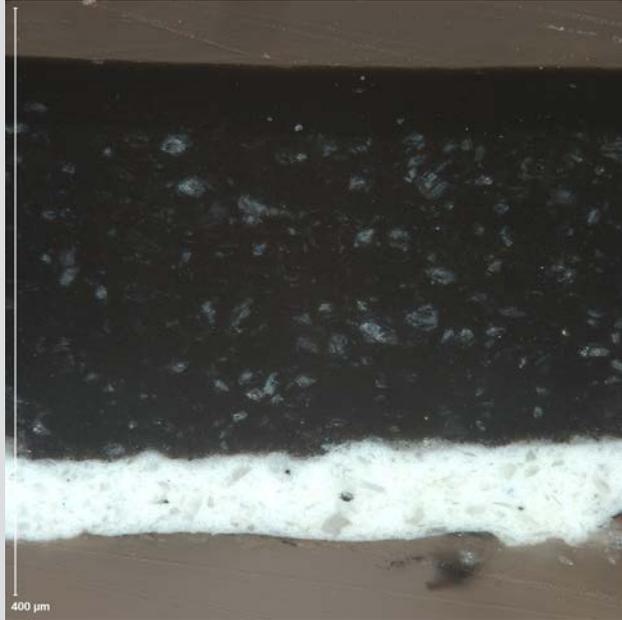
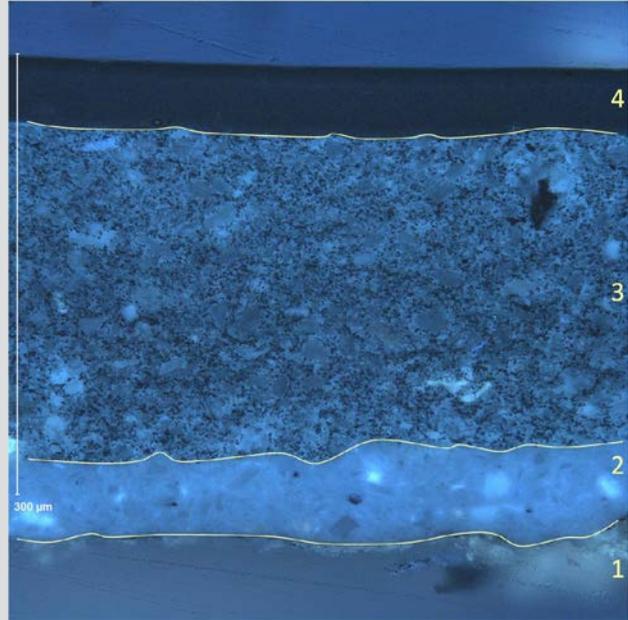
1.6.5 Sample East Exterior_3

Sample taken from edge of loss on window frame at location of historic glass; white layer visible beneath the black paint.

Cross section East Exterior_3. Crossed polarizing filters with added sidelight. 20× objective + 1.5× magnifier (= 30×).

Cross section East Exterior_3. UV fluorescence. 20× objective + 1.5× magnifier (= 30×). Annotated to show layer structure.

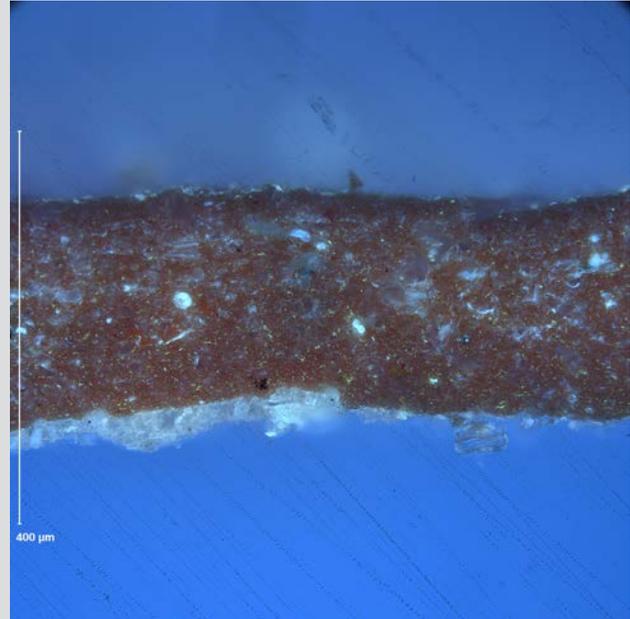
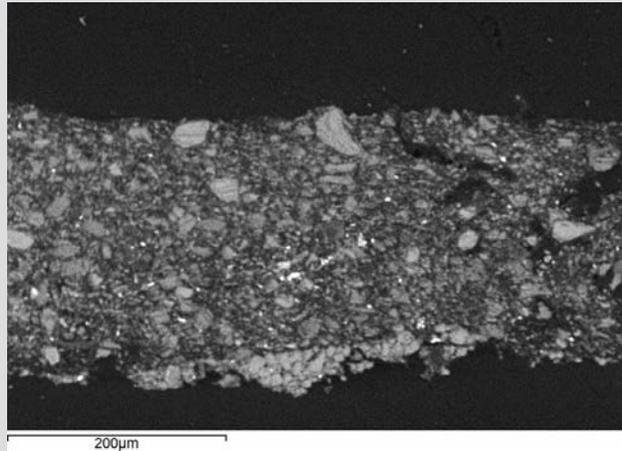
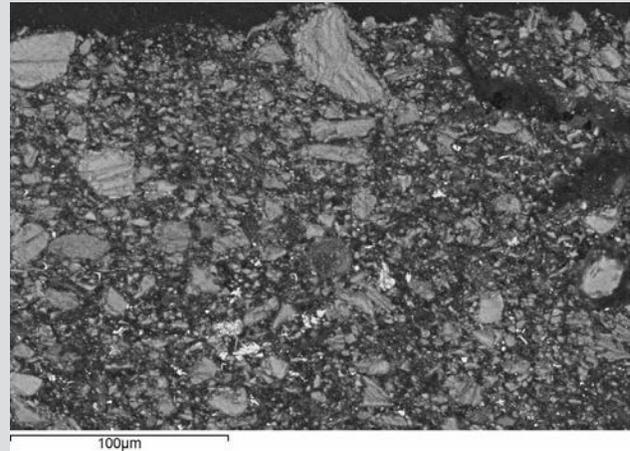
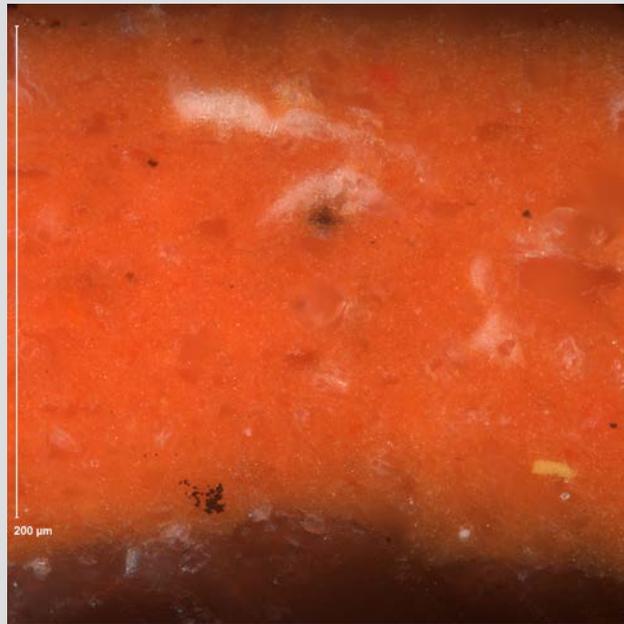
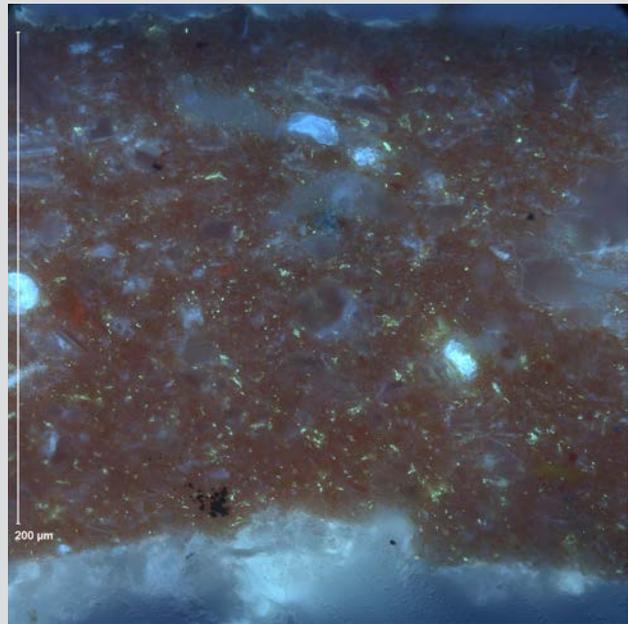
No complex stratigraphy is observed in the sample from the orange-red panel (East Exterior_4), which comprises a single paint layer directly on the panel support. This paint was found to contain probably two different orange-red colorants: lead chromate and an organic pigment, the identity of which has not been determined.

Sample taken from a crack near the edge of the orange panel where it meets the black frame; white layer visible beneath; possibly some panel fibers included in the sample.

FIGURE 1.15A
Cross section East Exterior_4. Crossed polarizing filters. 20× objective. Annotated to show layer structure.

FIGURE 1.15B
Cross section East Exterior_4. UV fluorescence. 20× objective.

FIGURE 1.15C
Cross section East Exterior_4. Backscattered electron image.

FIGURE 1.15D
Cross section East Exterior_4. Backscattered electron image.

FIGURE 1.15E
Cross section East Exterior_4. Crossed polarizing filters. 50x objective.

FIGURE 1.15F
Cross section East Exterior_4. UV fluorescence. 50x objective.

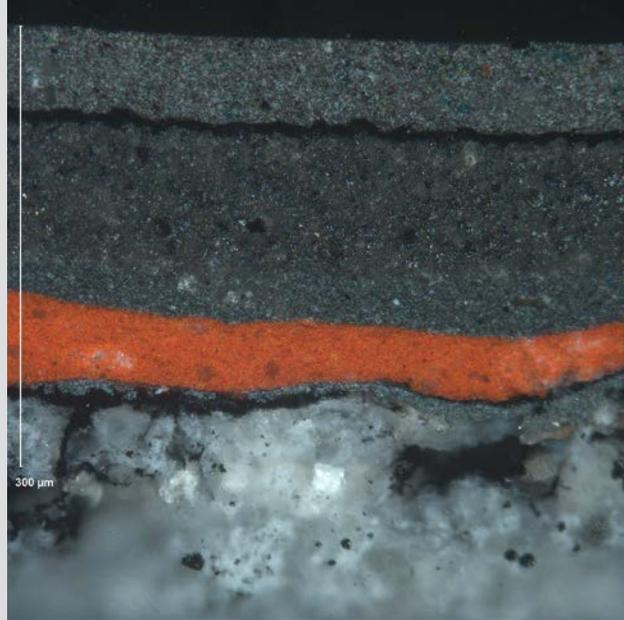
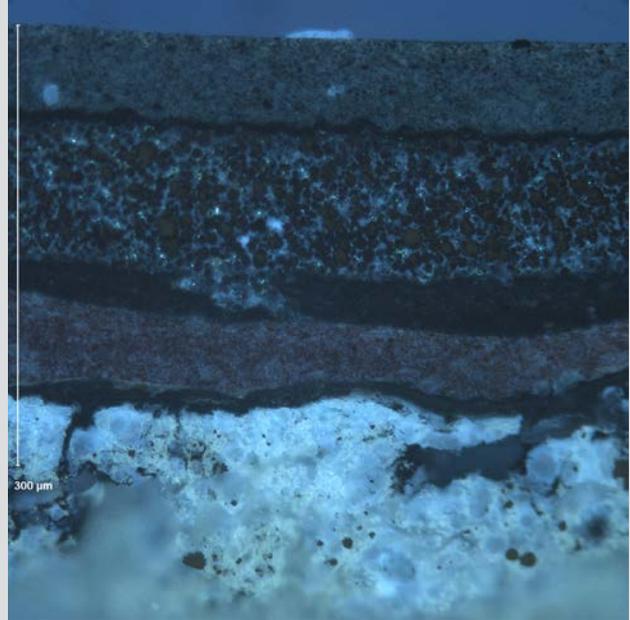
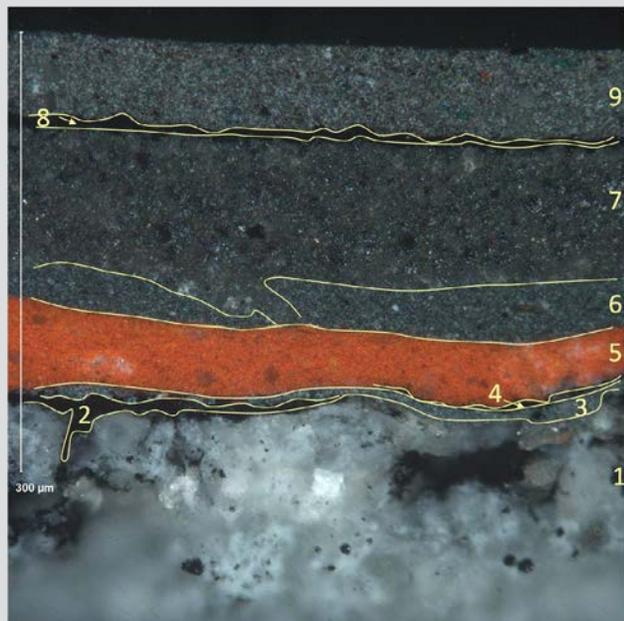
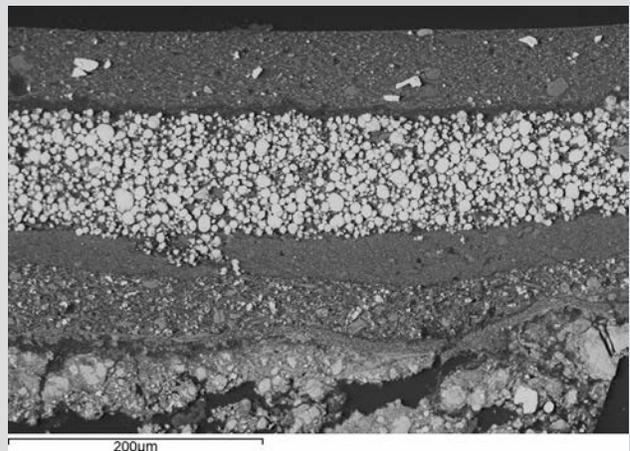
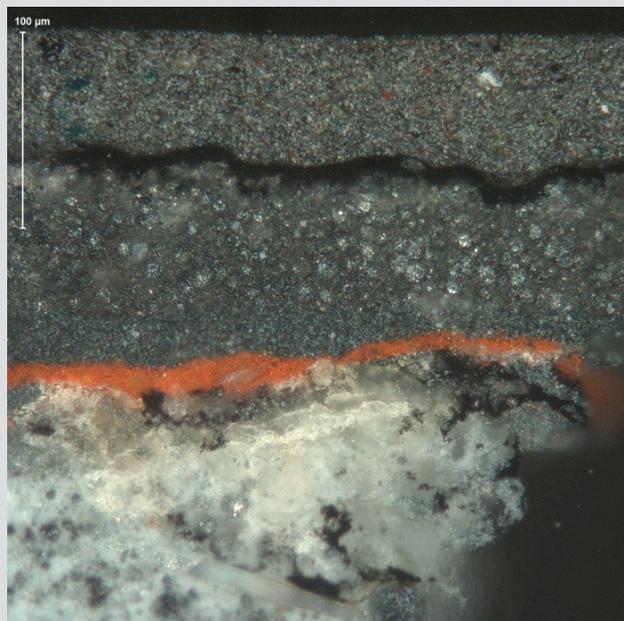
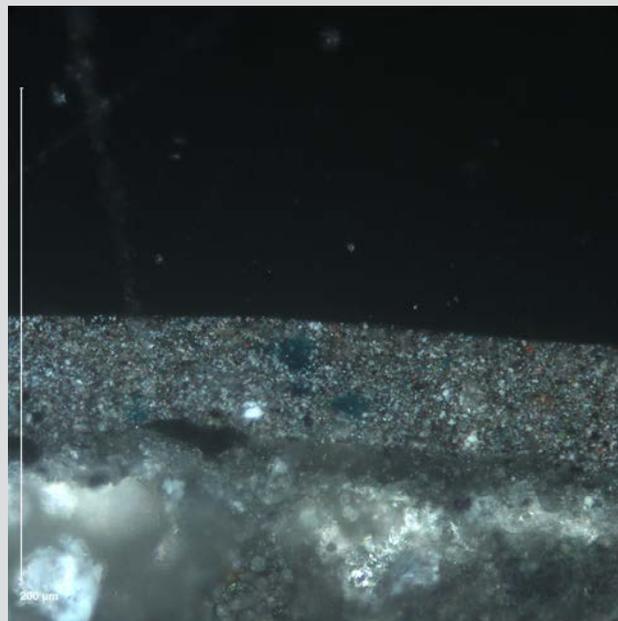
Sample taken from the edge of the frame, from an area with a thick buildup of paint.

Cross section East Interior_5. Crossed polarizing filters. 20× objective + 1.5× magnifier (= 30×).

Cross section East Interior_5. UV fluorescence. 20× objective + 1.5× magnifier (= 30×).

Cross section East Interior_5. Crossed polarizing filters. 20× objective + 1.5× magnifier (= 30×). Annotated to show layer structure.

Cross section East Interior_5. Backscattered electron image.

FIGURE 1.16E
Cross section East Interior_5. Crossed polarizing filters. 20x objective + 2 magnifier (= 40x).

FIGURE 1.16F
Cross section East Interior_5. Crossed polarizing filters. 50x objective. Detail showing transparent blue-green pigment in uppermost layer #9.

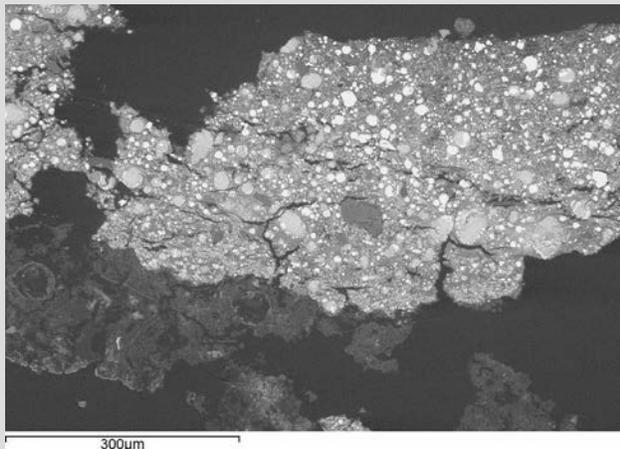
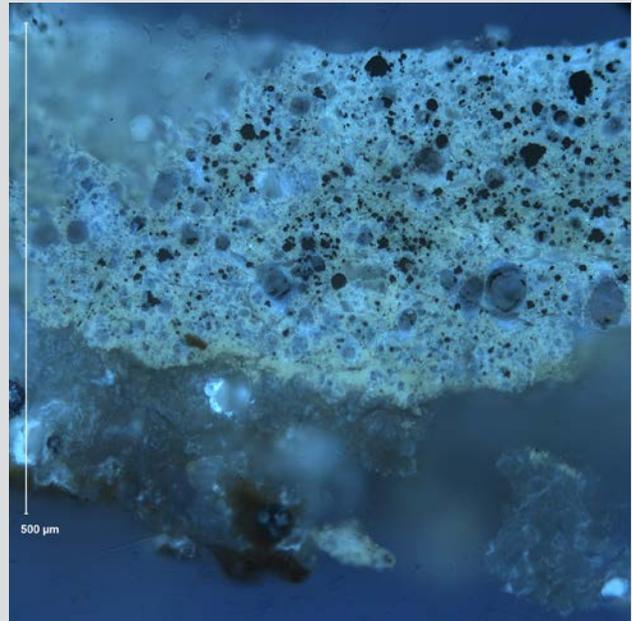
FIGURE 1.17A
Cross section East Interior_6a. Crossed polarizing filters. 20× objective. Annotated to show layer structure.

FIGURE 1.17C
Cross section East Interior_6a. Backscattered electron image.

Pale gray primer layer #2 appears quite brittle, possibly

FIGURE 1.17B
Cross section East Interior_6a. UV fluorescence. 20× objective.

degraded. It is clear that the paint layers above adhere only weakly to the primer, which is reflected in the separation at this interface of the sequence of paint layers that make up cross section sample East Exterior_6b. Very slight traces of the pale gray primer can be seen on the underside of paint fragments in the stock of sample material obtained at this location.

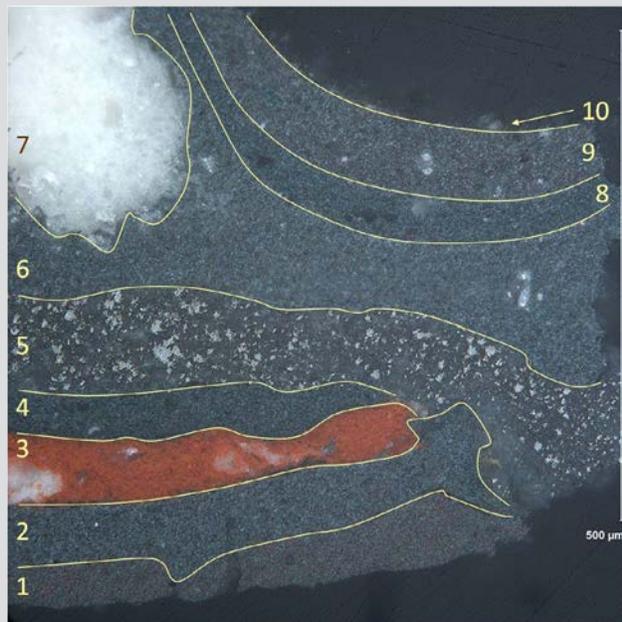
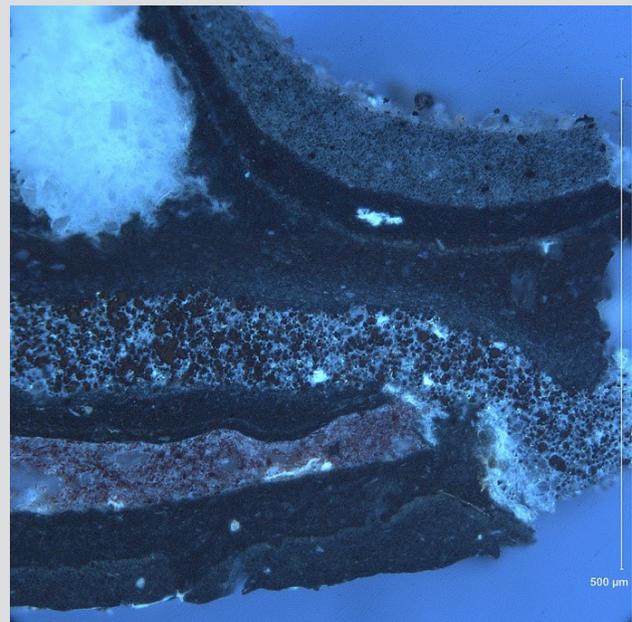
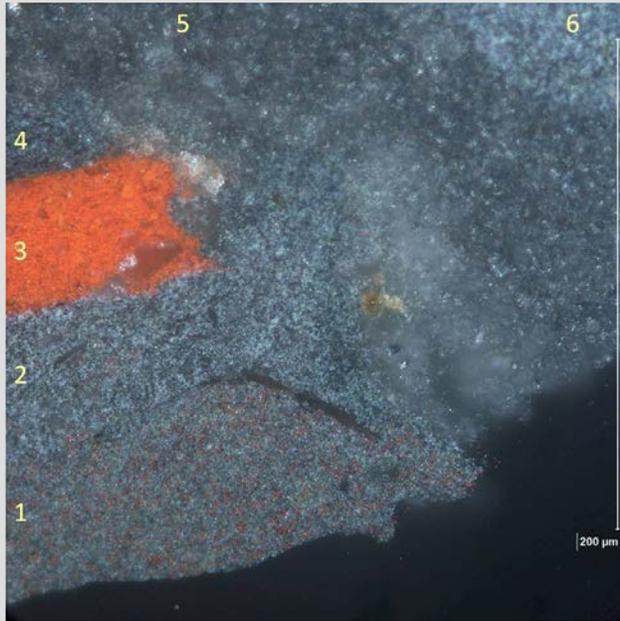
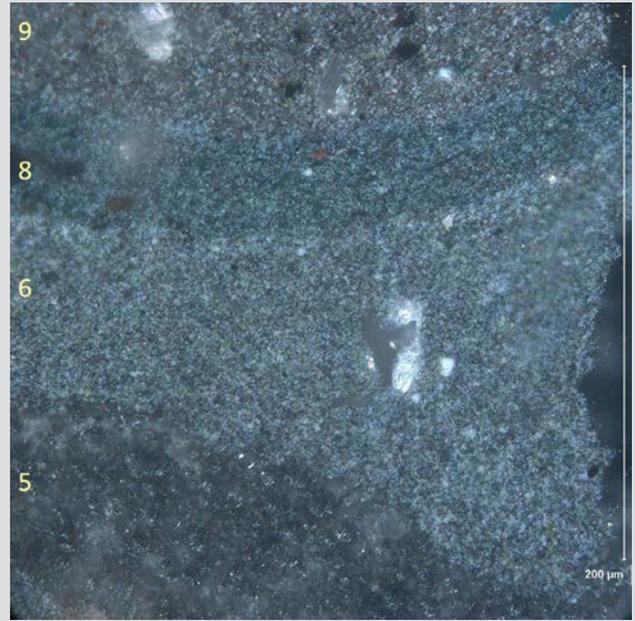
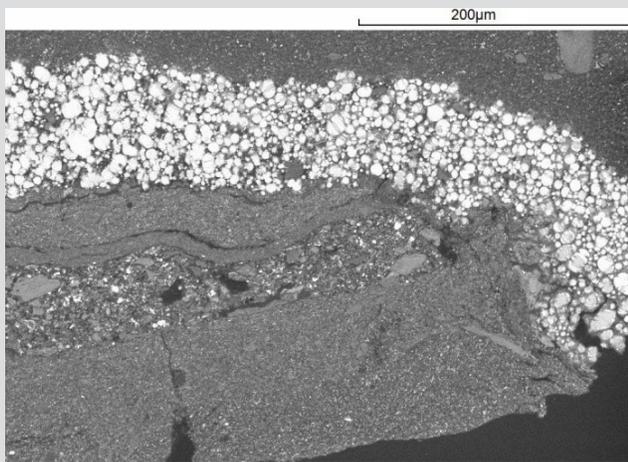
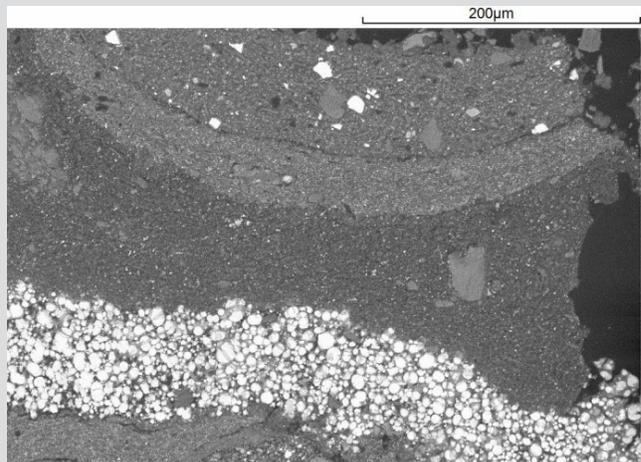
Cross section East Interior_6b. Partially uncrossed polarizing filters. 20x objective. Annotated to show layer structure.

Cross section East Interior_6b. UV fluorescence. 20x objective.

FIGURE 1.18C
Cross section East Interior_6b. Lower right of sample. Crossed polarizing filters. 50x objective. Annotated to show layers.

FIGURE 1.18D
Cross section East Interior_6b. Upper right of sample. Crossed polarizing filters. 50x objective. (Layer #7 out of view.) Annotated to show layers.

FIGURE 1.18E
Cross section East Interior_6b. Lower right of sample. Backscattered electron image.

FIGURE 1.18F
Cross section East Interior_6b. Upper right of sample. Backscattered electron image.

Interior_6a. The various layers in sample East Interior_6b are summarized in the tables below. It can be noted that lower layers #1–4 are not continuous across the sample, but are truncated. The truncated edge of these layers at the right of the sample is overlaid by layer #5. The interface between layers #4 and #5, therefore, represents a distinct boundary in the history of the paint layers at this location.

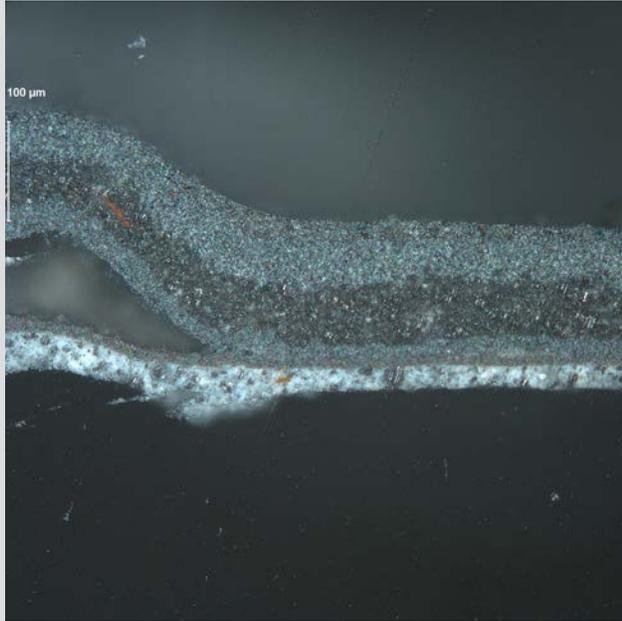
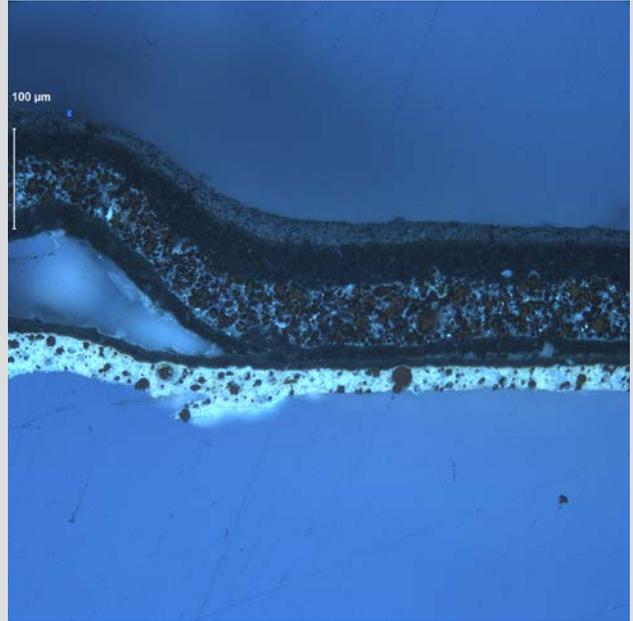
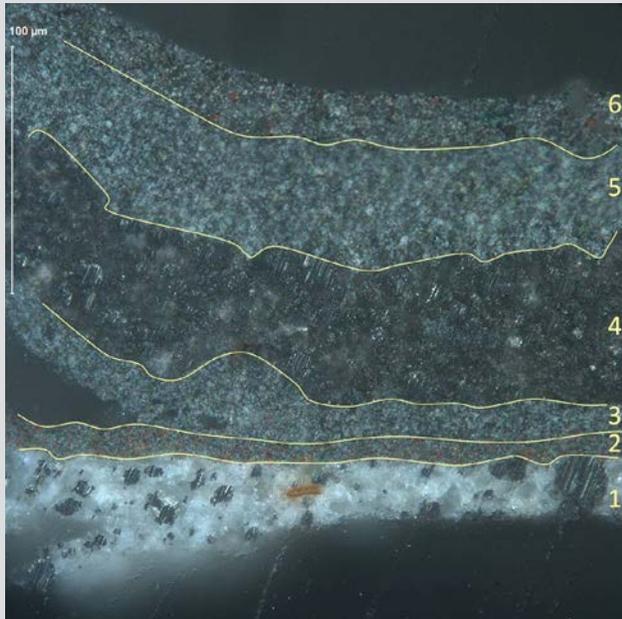
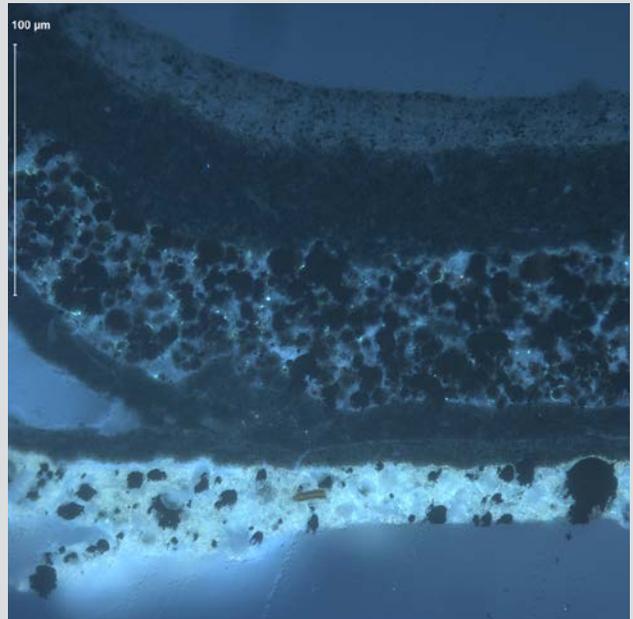
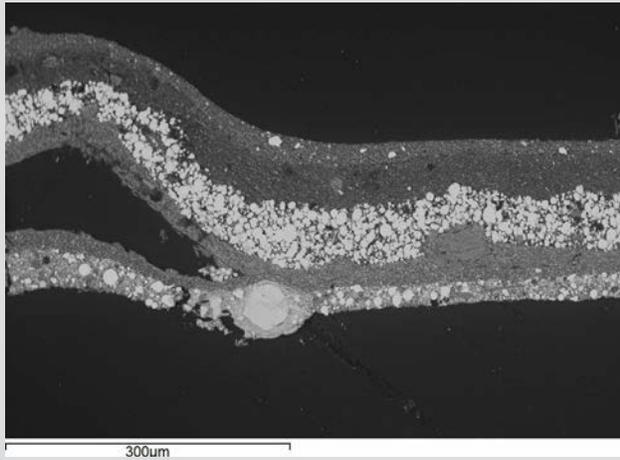
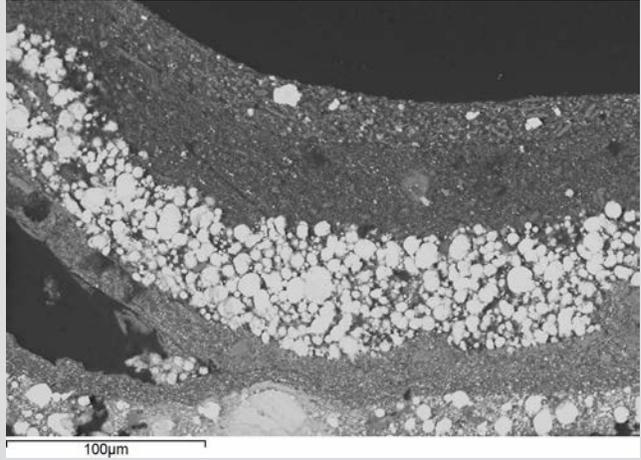
FIGURE 1.19A
Cross section East Interior_7. Crossed polarizing filters. 20x objective.

FIGURE 1.19B
Cross section East Interior_7. UV fluorescence. 20x objective.

FIGURE 1.19C
Cross section East Interior_7. Crossed polarizing filters. 50x objective. Annotated to show layer structure.

FIGURE 1.19D
Cross section East Interior_7. UV fluorescence. 50x objective.

FIGURE 1.19E
Cross section East Interior_7. Backscattered electron image.

FIGURE 1.19F
Cross section East Interior_7. Backscattered electron image.

It appears that cool gray paint layer #3 is not strongly adhering to the underlying warm gray layer #2, and this defect may be responsible for the delamination of the upper paint layers from the priming that was noted during sample
