Eames House Conservation Project: Investigations 2011 to 2016

Research Report

Edited by Laura Matarese
with Chandler McCoy and Gail Ostergren

The Getty Conservation Institute

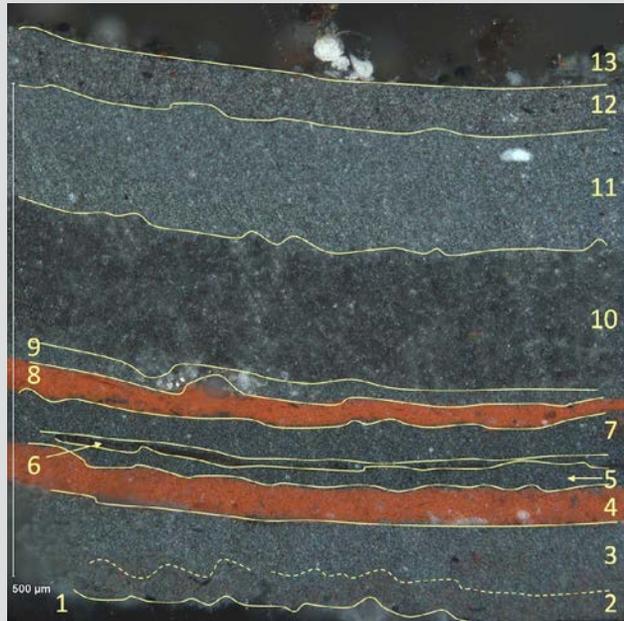
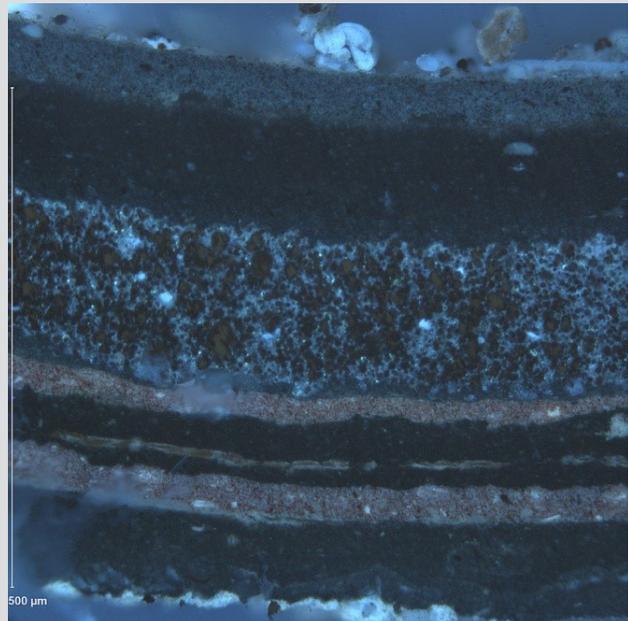
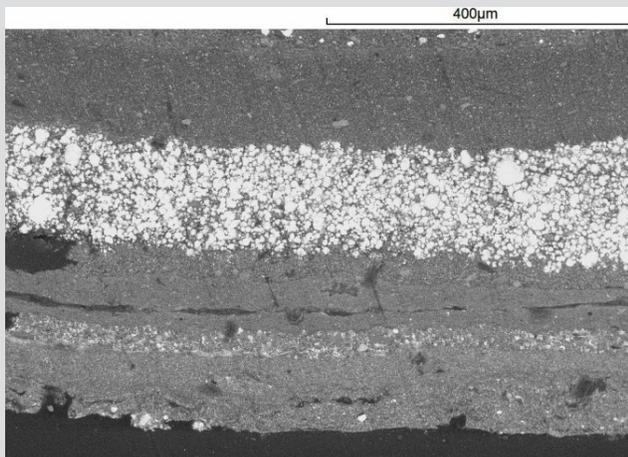
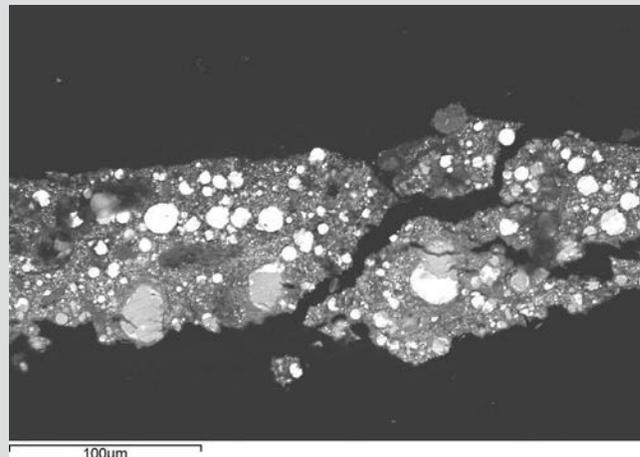
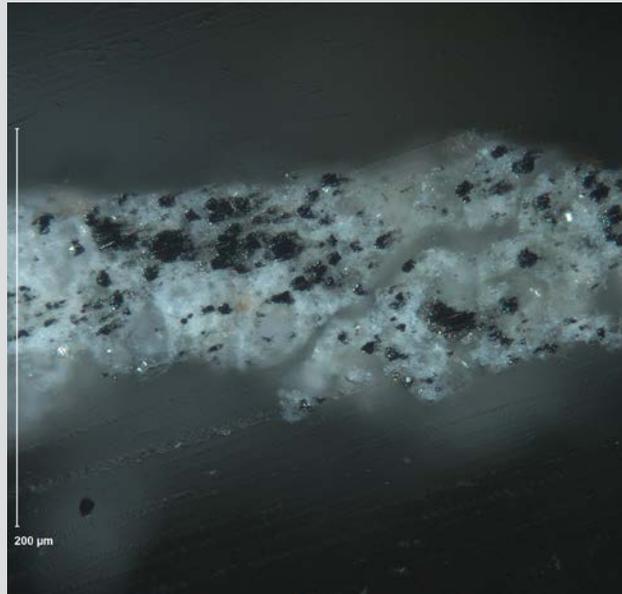
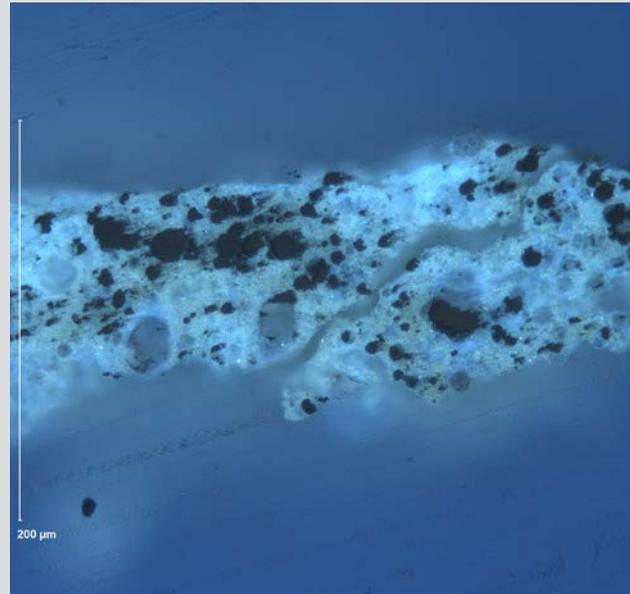
Sample taken from a thick buildup of paint next to the windowpane. Sample broke into two fragments during mounting; each fragment was embedded separately. Cross section East Interior_8a consists of the upper paint layers of dark gray and red primer. Cross section East Interior_8b is the lower fragment that consists of gray primer only. The

FIGURE 1.20A
Cross section East Interior_8a. Crossed polarizing filters. 20x objective. Annotated to show layer structure.

FIGURE 1.20B
Cross section East Interior_8a. UV fluorescence. 20x objective.

FIGURE 1.20C
Cross section East Interior_8a. Backscattered electron image.

FIGURE 1.20D
Cross section East Interior_8b. Backscattered electron image.

FIGURE 1.20E
Cross section East Interior_8b. Crossed polarizing filters. 20× objective + 2× magnifier (= 40×).

FIGURE 1.20F
Cross section East Interior_8b. UV fluorescence. 20× objective + 2× magnifier (= 40×).

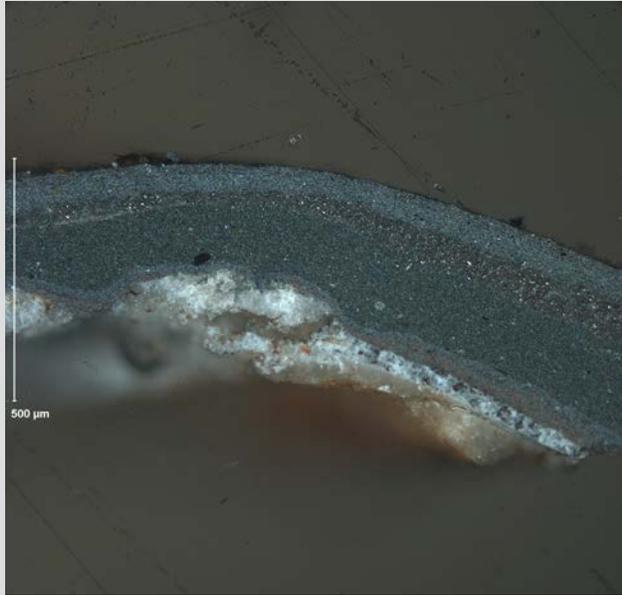
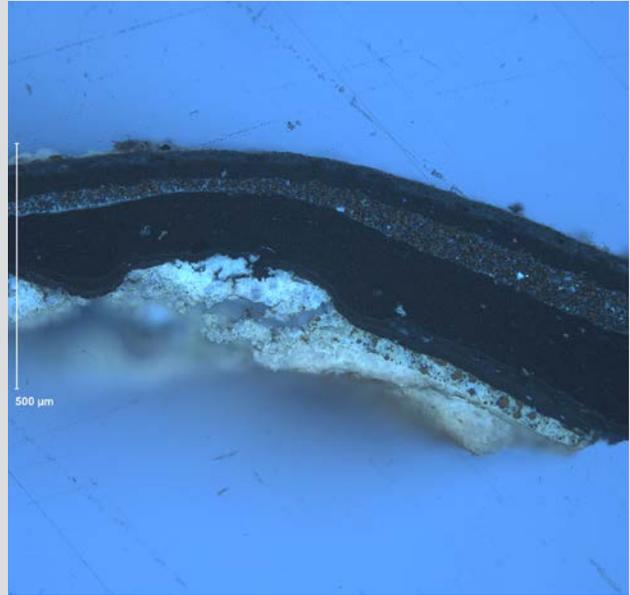
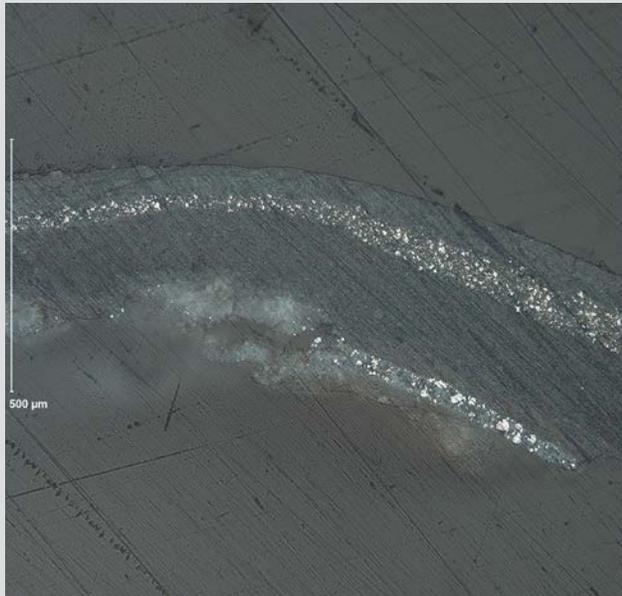
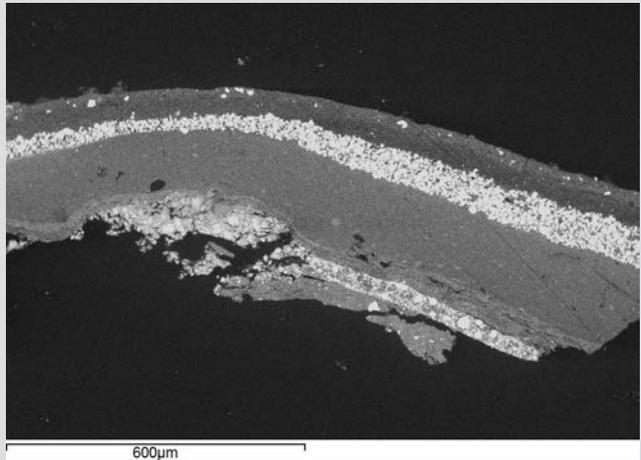
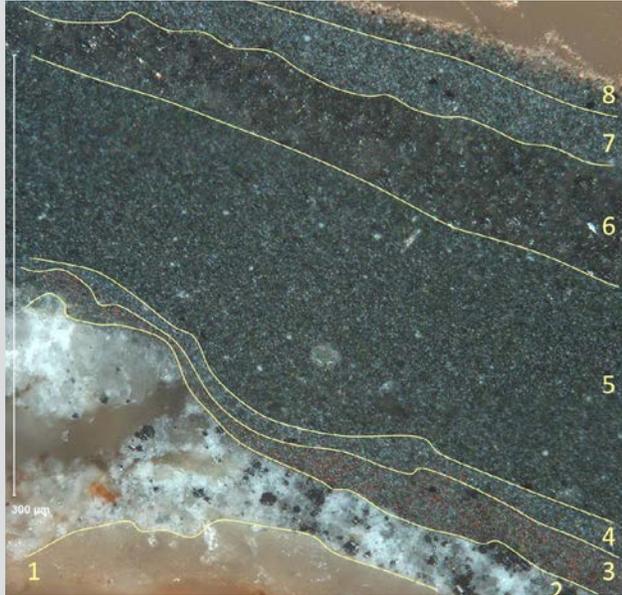
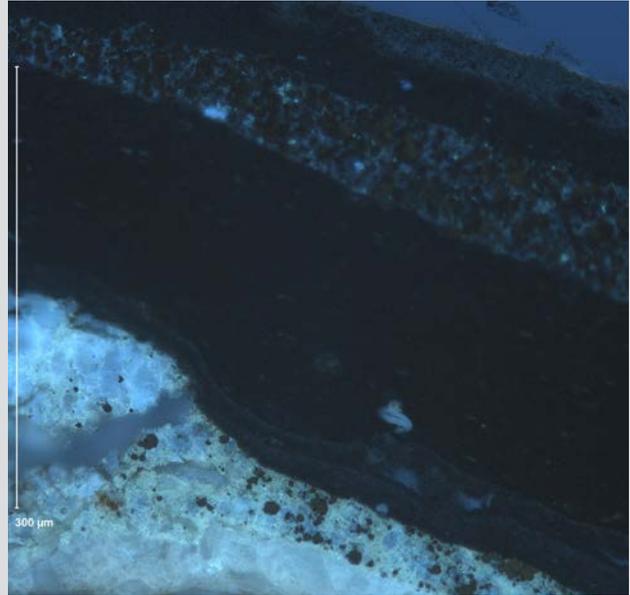
FIGURE 1.21A
Cross section North Interior_9. Crossed polarizing filters. 10x objective.

FIGURE 1.21B
Cross section North Interior_9. UV fluorescence. 10x objective.

FIGURE 1.21C
Cross section North Interior_9. Partially uncrossed polarizing filters. 10x objective. Reflective metallic (zinc) particles are clearly indicated.

FIGURE 1.21D
Cross section North Interior_9. Backscattered electron image.

Cool, greenish gray paint layer #5, which is distinctively rich in iron, does not have any analogues in other samples

from the interior metalwork. It may represent a unique repainting treatment of the north (kitchen) interior trim. Chlorine-rich uppermost layer #8 was shown by Py-GCMS to be based on an organic binder of chlorinated rubber.

Cross section North Interior_9. Crossed polarizing filters with additional sidelight. 20x objective + 1.5x magnifier (= 30x). Annotated to show layer structure.

Cross section North Interior_9. UV fluorescence. 20x objective + 1.5x magnifier (= 30x).

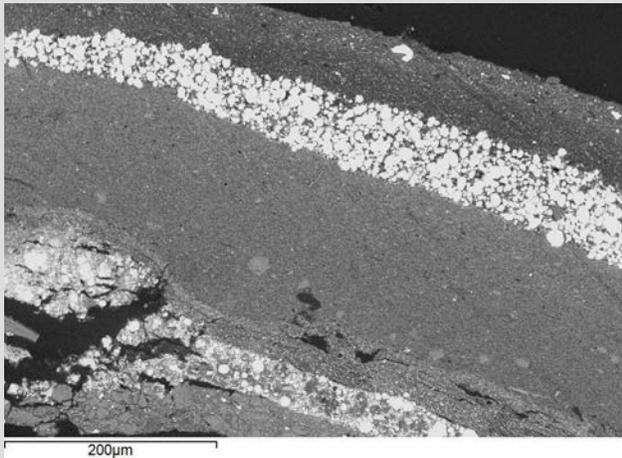
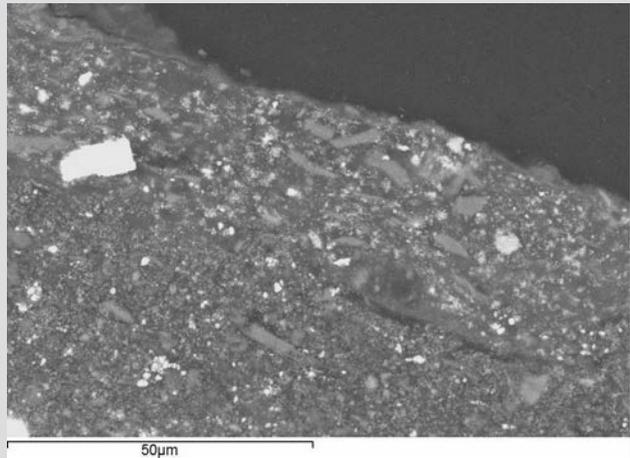
Cross section North Interior_9. Backscattered electron image.

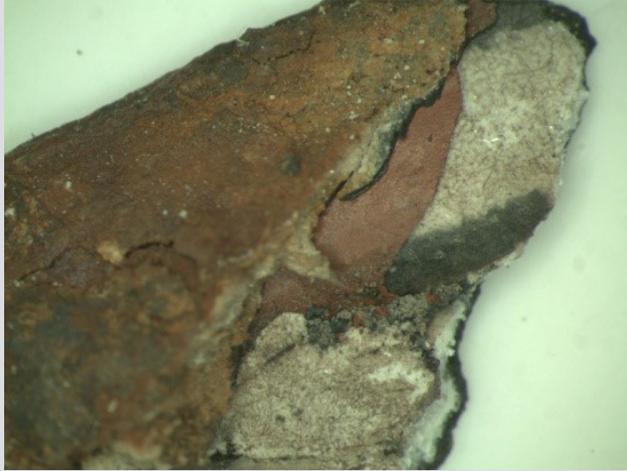
FIGURE 1.22A
Sample North Exterior_10; underside, unmounted.

From corner of window frame, black paint bubbled up from failed putty/corrosion; sample may include a red primer and putty.

Cross section North Exterior_10 contains a complex stratigraphy, with several layers in common with sample East Exterior_2b, as noted earlier. The layer structure of sample North Exterior_10 is summarized in table 1.21.

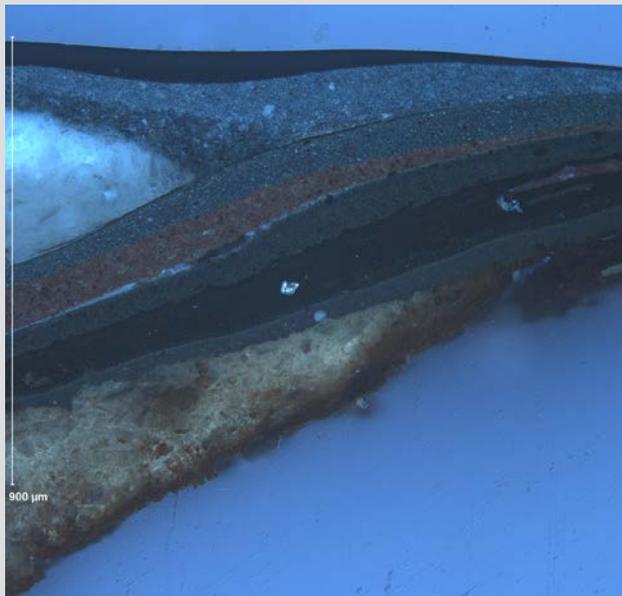
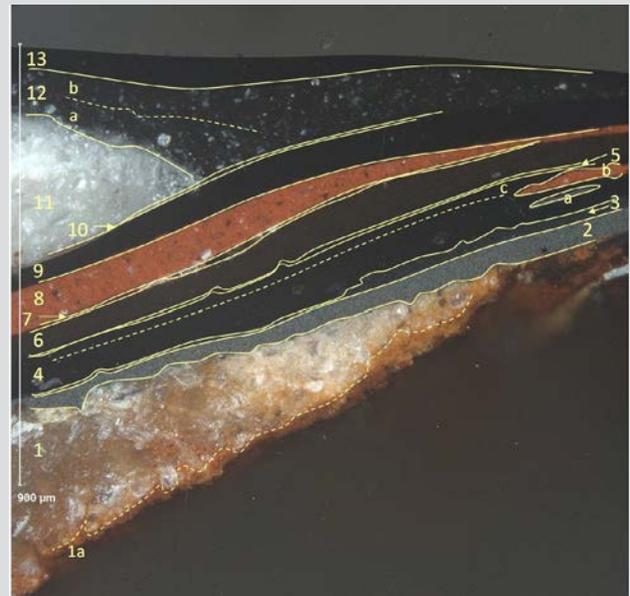
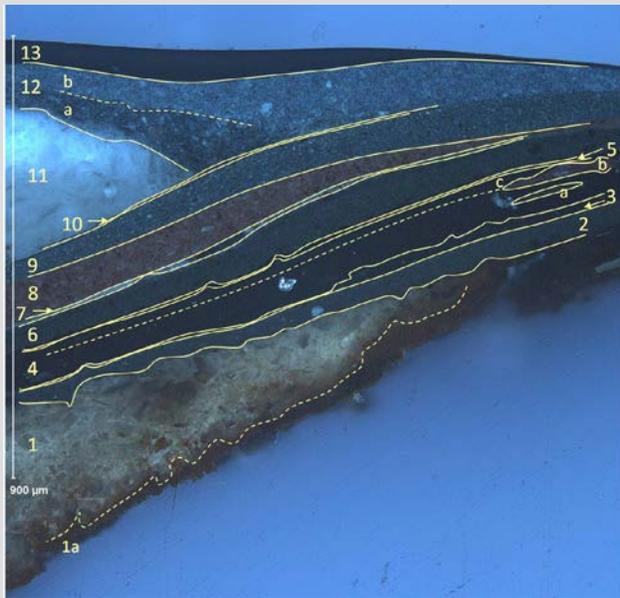
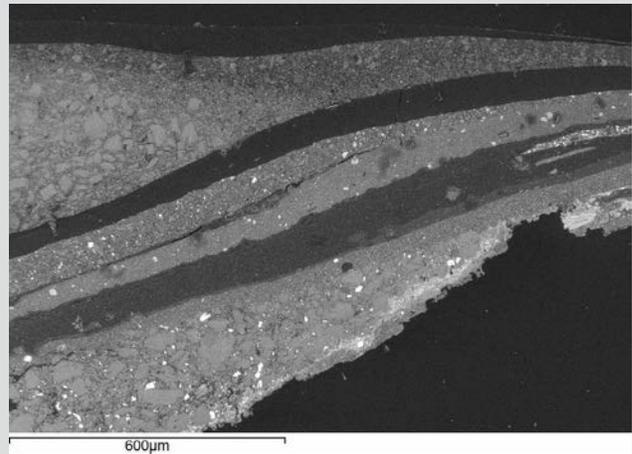
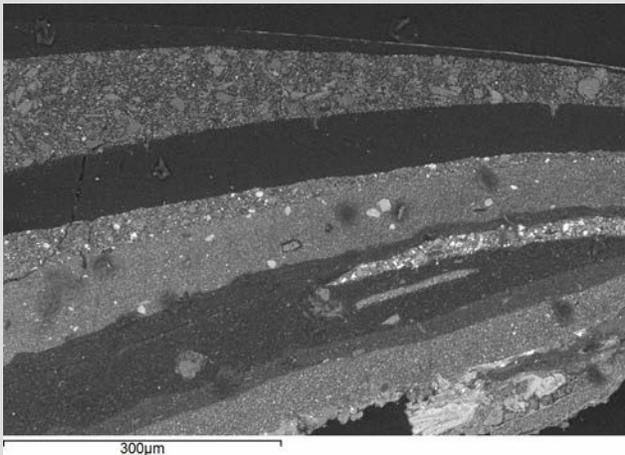
1.6.12 Sample North Exterior_10

FIGURE 1.22C
Cross section North Exterior_10. UV fluorescence. 10x objective.

FIGURE 1.22D
Cross section North Exterior_10. Crossed polarizing filters. 10x objective. Annotated to show layer structure.

FIGURE 1.22E
Cross section North Exterior_10. UV fluorescence. 10× objective.
Annotated to show layer structure.

The two uppermost paint layers #12 and #13 of sample North Exterior_10, as already noted, appear quite recent and are almost certainly connected with the most recent repainting of the residence metalwork in 2003. The same status probably also applies to bright white putty layer #11 which appears to be preparation for the most recent campaign of painting. Putty layer #11 marks a discontinuity with the underlying strata, which are almost certainly from earlier interventions.

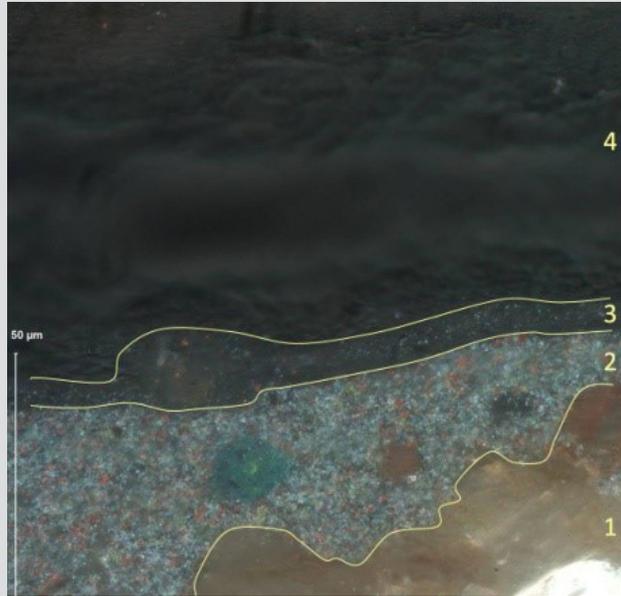
FIGURE 1.24
Cross section North Exterior_10 at high magnification. 100× objective

High magnification optical and electron microscopy was performed on the lower strata of sample North Exterior_10 with a view to looking more closely at the correspondence with the lower layers of East Exterior_2b. A high magnification detail (100× objective) of sample North Exterior_10 is given in figure 1.24, which should be compared with figure 1.13a.

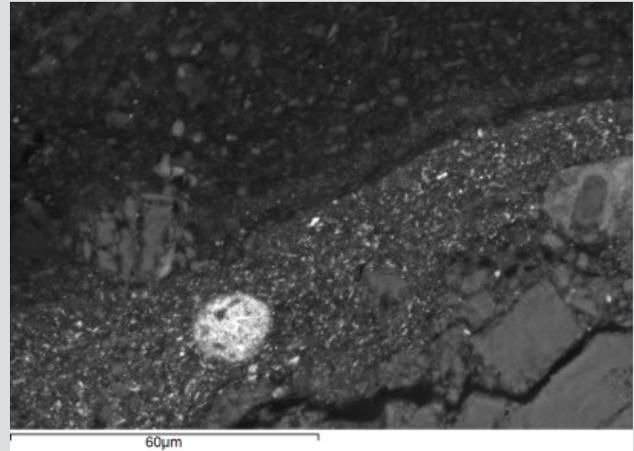
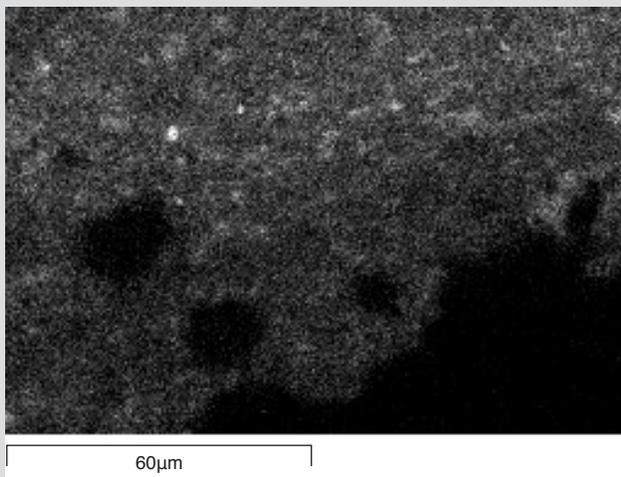
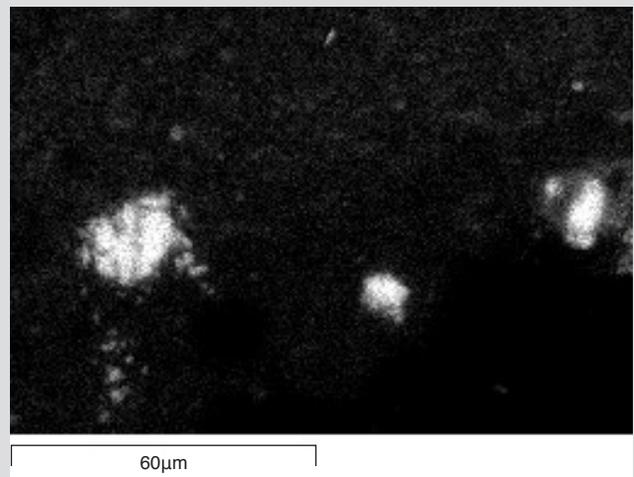
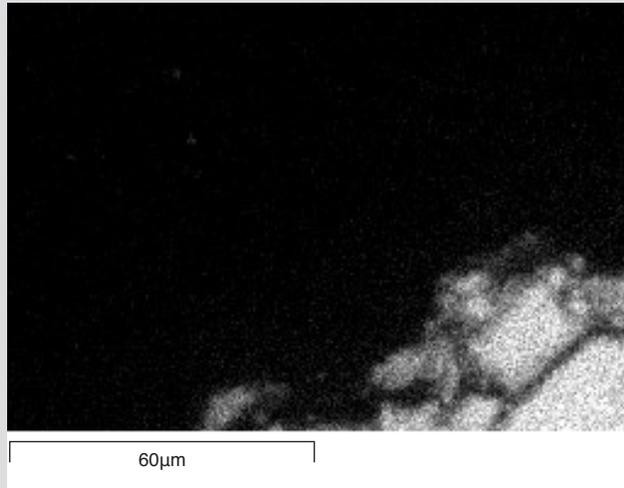
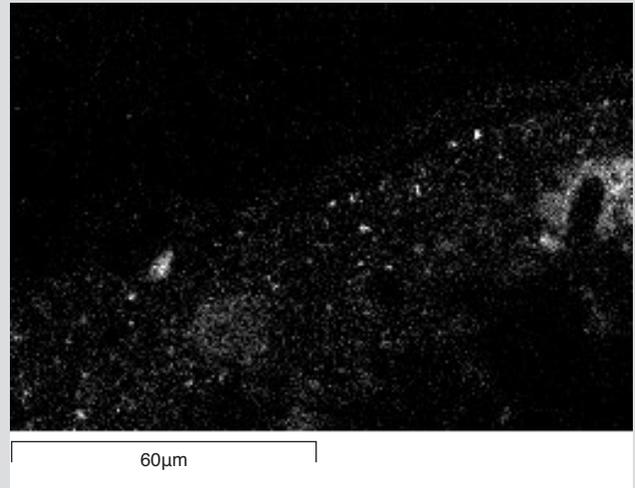
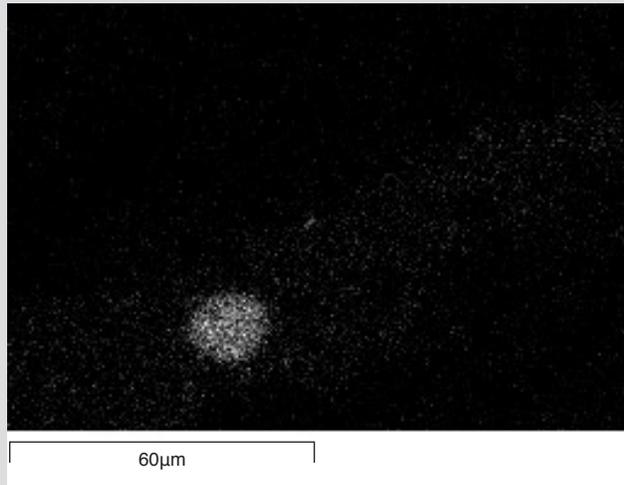
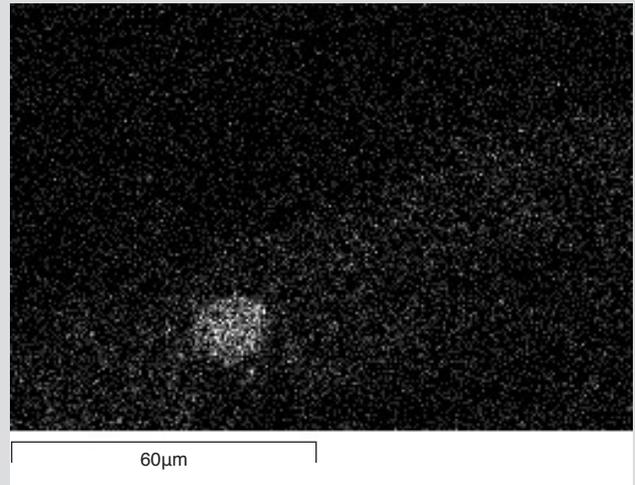
FIGURE 1.25A
Cross section North Exterior_10. Backscattered electron image.

Medium gray paint layer #2 is composed of a mixture of white, red, blue-green, and yellow particles. The white particles are rich in titanium, indicative of titanium dioxide; the red particles are rich in iron (without Al or Si), indicative of synthetic iron oxide red; and the blue-green particles show coincident abundance of chromium and lead with some iron, which is indicative of chrome green (i.e., yellow

lead chromate with Prussian blue). Isolated particles of yellow, which are rich in lead and chromium, are probably yellow lead chromate as an independent pigment. The composition of paint layer #2 in sample North Exterior_10

is effectively the same as the corresponding layer in sample East Exterior_2b; they probably derive from the same campaign of painting. The same applies to the layer #3 above.

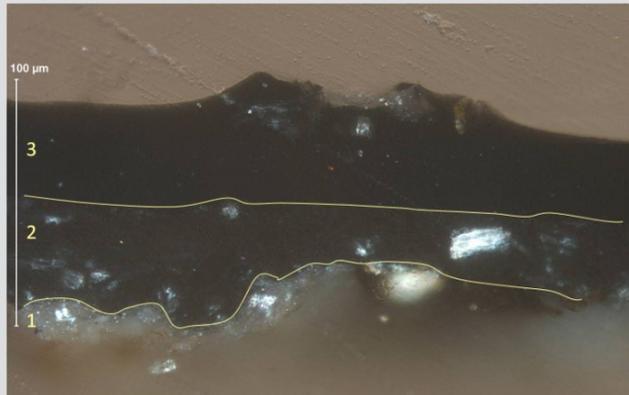
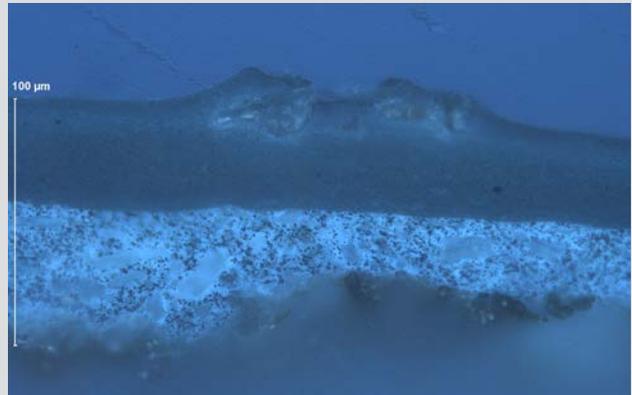
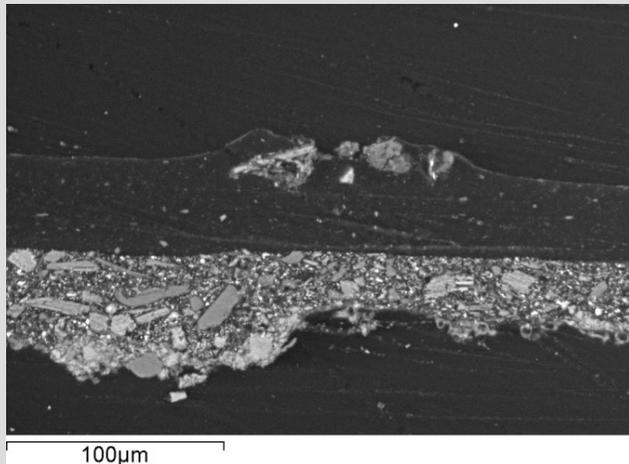
FIGURE 1.26A
Cross section South Exterior_11 Fragment A. Crossed polarizing filters. 50× objective. Annotated to show layer structure.

Sample of black paint taken from edge of loss on window frame shows the putty is failing. Three separate subfrag-

ments from the fragment selected as cross section. Uppermost Fragment A includes the paint layer(s); lower Fragments B and C are essentially putty material.

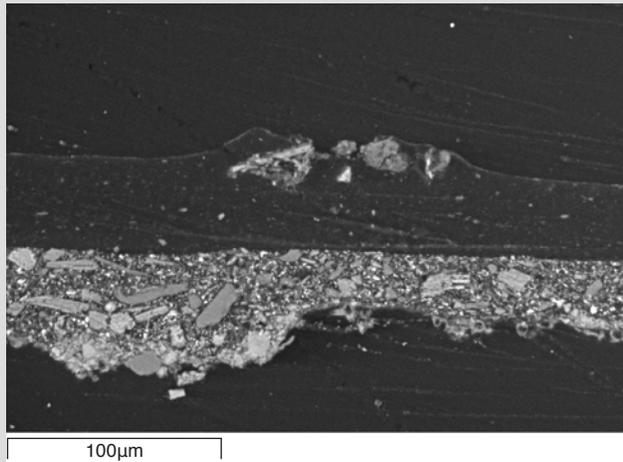
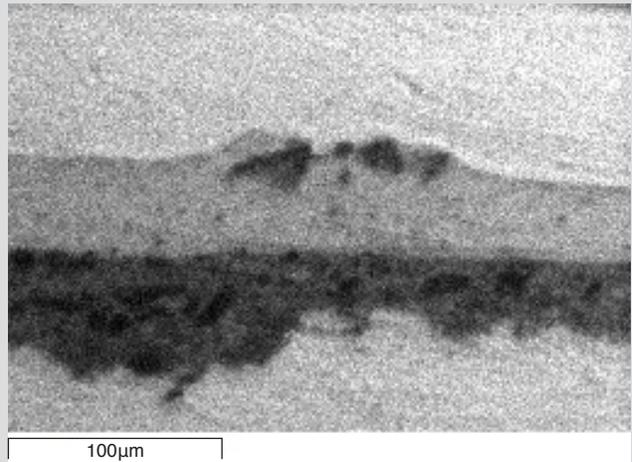
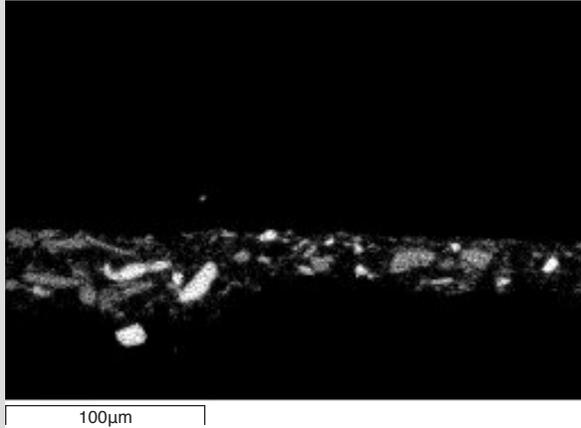
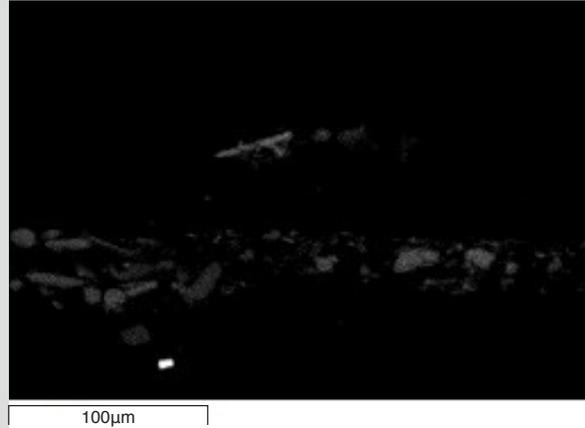
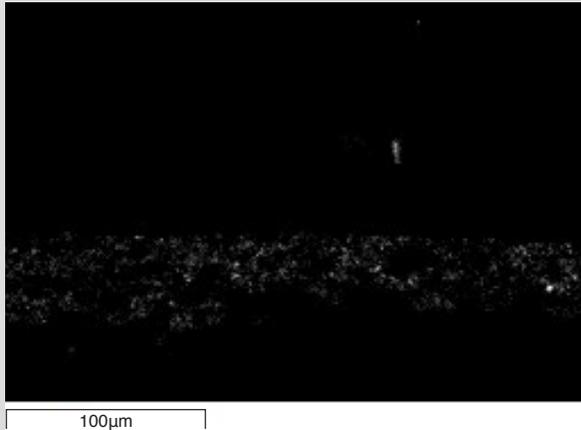
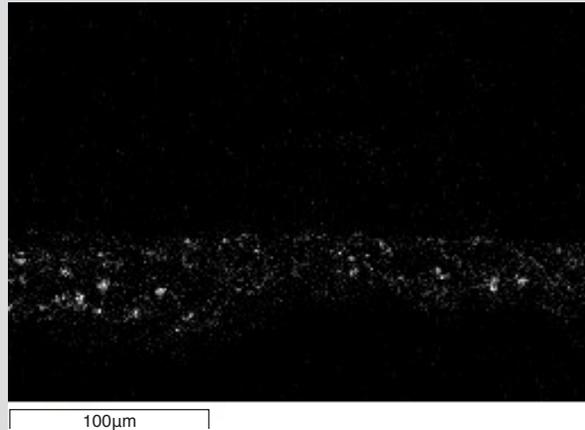
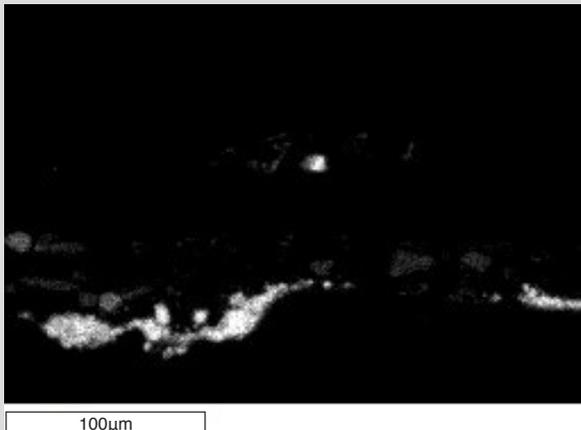
FIGURE 1.27A
ESEM-EDS of cross section South Exterior_11 Fragment A.
Backscattered electron image.

The elemental distributions suggest the uppermost black paint layer #3 is mostly organic in composition, probably as carbon black. Gray paint layer #2 contains magnesium, silicon, iron and zinc, with the magnesium and silicon

showing the kind of coincident abundance that is usually associated with talc. The iron may present as (possibly black) iron oxide, and the minor amount of zinc might suggest zinc oxide. Lowest putty layer #1 is abundant in calcium, probably in the form of calcium carbonate.

This stratigraphy is analogous to those observed in other samples of the exterior black paint, particularly East Exterior_1, East Exterior_2a, and East Exterior_3.

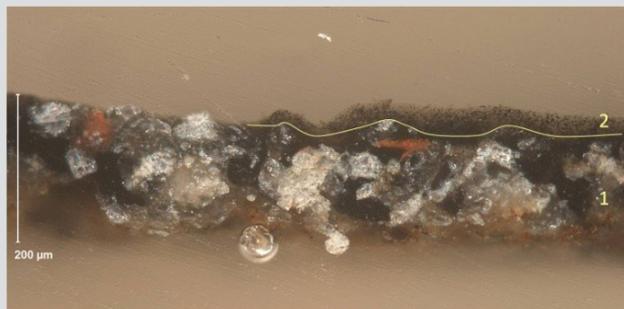
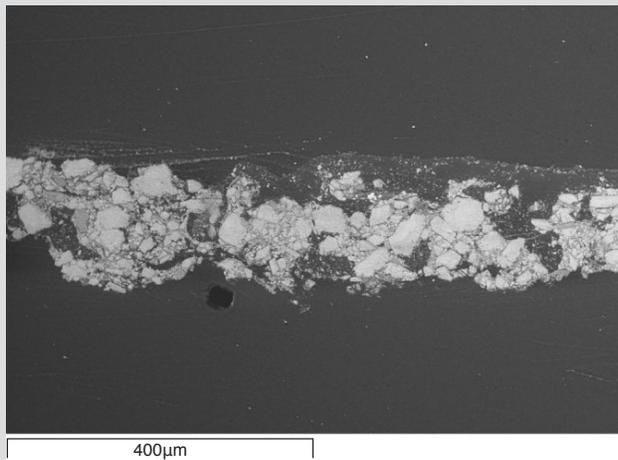
FIGURE 1.28A
Cross section South Exterior_11 Fragment B. Crossed polarizing filters. 10x objective + 1.5x magnifier (= 15x).

Fragment B of cross section sample South Exterior_11 comprises a detached fragment of putty (layer #1) that has isolated inclusions of red and black paint and corrosion products on its underside, and a thin surface layer (#2) of black or dark gray paint composed mostly of fine black organic particles, probably carbon black.

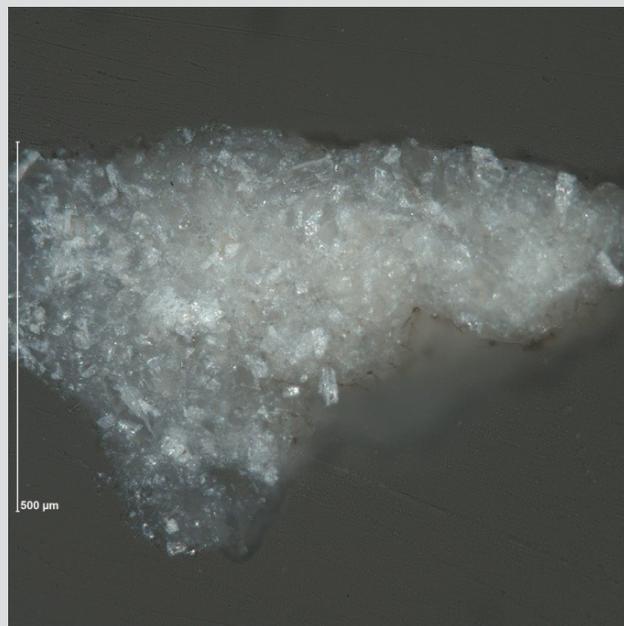
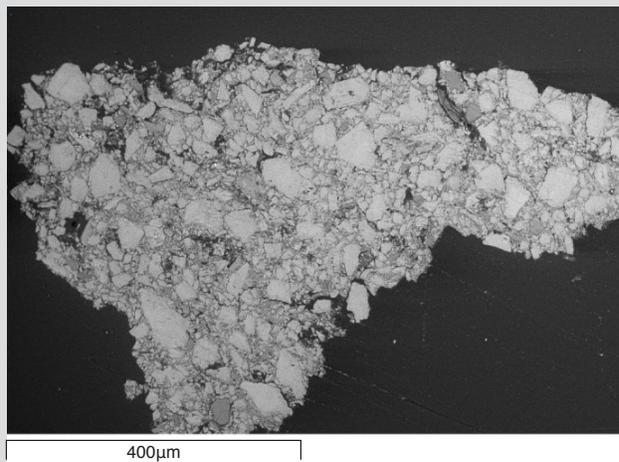
FIGURE 1.29A
Cross section South Exterior_11 Fragment C. Crossed polarizing filters. 10x objective + 1.5x magnifier (= 15x).

Fragment C of cross section sample South Exterior_11 consists solely of white putty material composed of mostly of calcium carbonate, plus a minor proportion of calcium magnesium silicate.

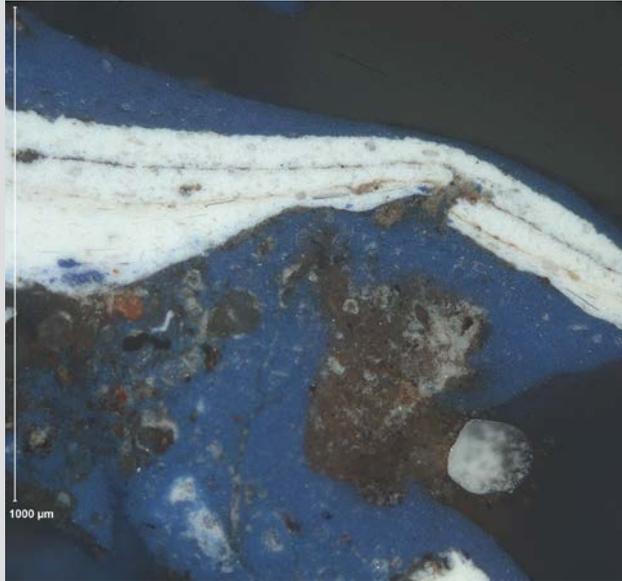
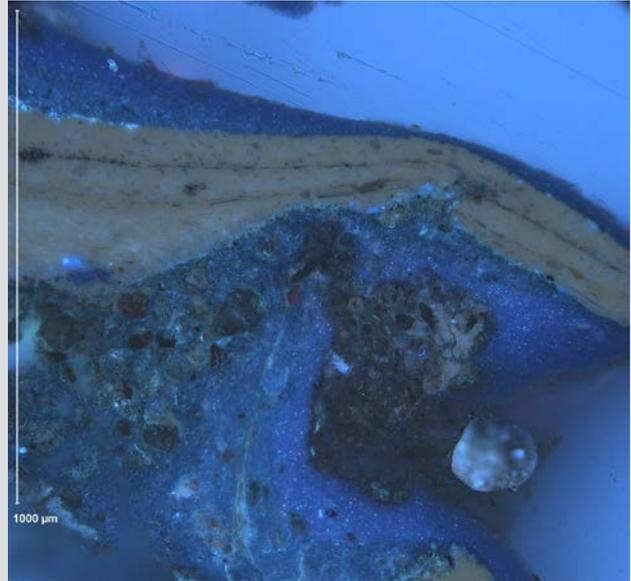
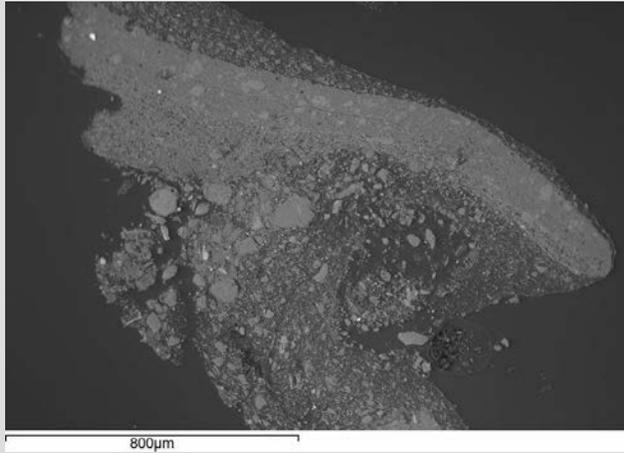
FIGURE 1.30A

Sample West Exterior_12 is difficult to interpret, in part due to the lack of a distinct layer sequence, discontinuous

layers, and the presence of isolated domains of one material within another. These features are probably related to the particular location from where the sample originates, at the very edge of a painted blue panel at the boundary with the metal frame. A thick buildup of white material, pre-

sumed to be caulk, was noted at this location when the sample was taken. These considerations should be taken into account when reading the description of the sample that is outlined in table 1.24 (see fig. 1.30d).

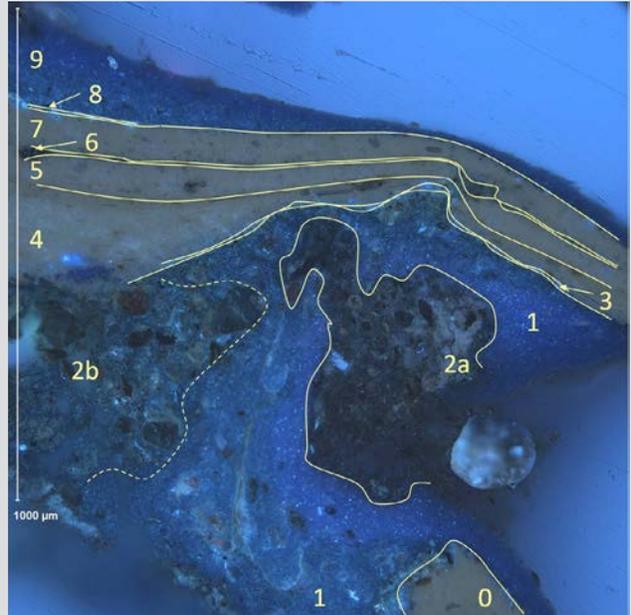
FIGURE 1.30D

Cross section West Exterior_12. UV fluorescence. 10x objective. Annotated to show layer structure.

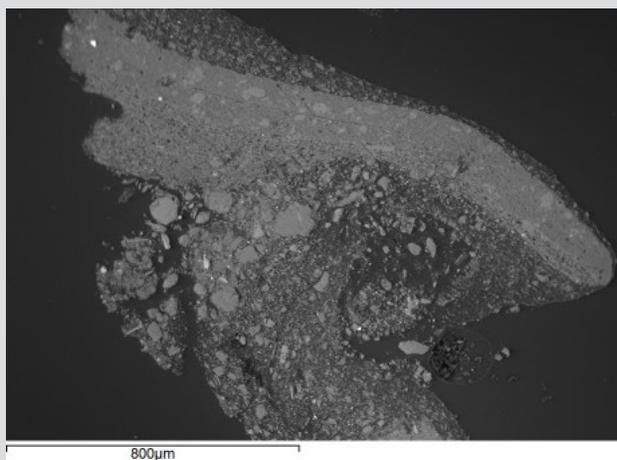
Cross section West Exterior_12 was analyzed by ESEM-EDS only using the elemental mapping function of the INCA analysis system. The main elemental maps are presented in figures 1.31a–1.31i.

In addition to the observations on pigment composition made in the preceding section, the main finding of the ESEM-EDS analysis is the lack of any elements that are indicative of any inorganic (mineral) blue pigments. Accordingly, an organic blue pigment is suspected as the colorant in layers #1 and #9.

FIGURE 1.31A
Cross section West Exterior_12. Backscattered electron image.

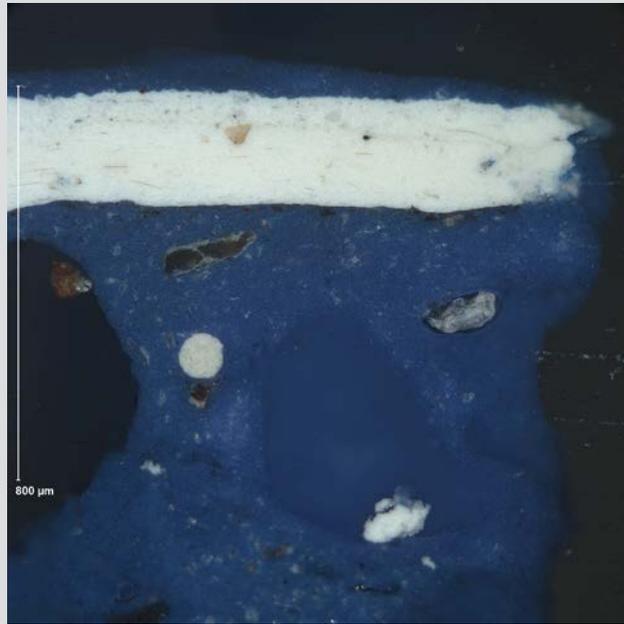
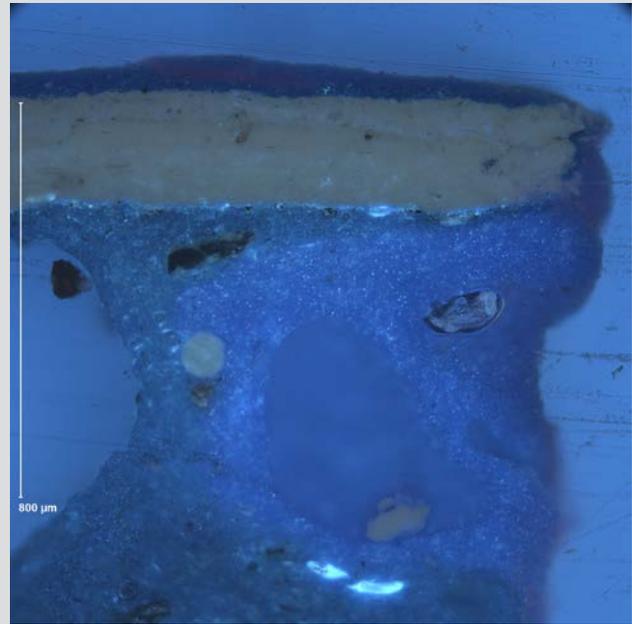
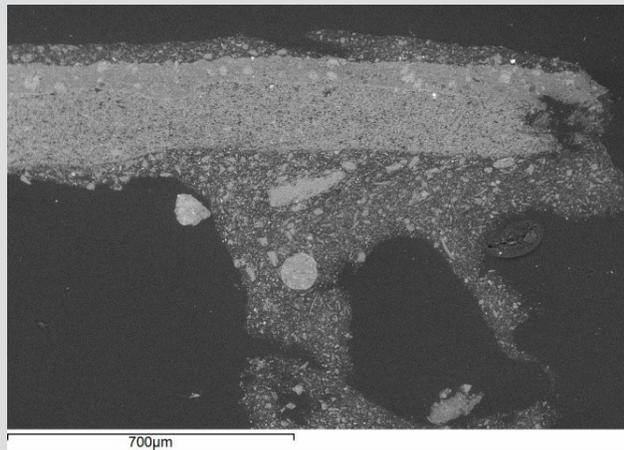
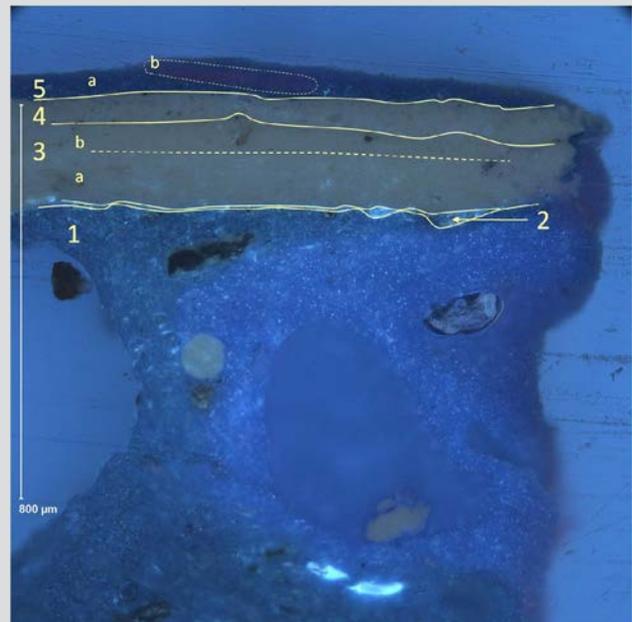
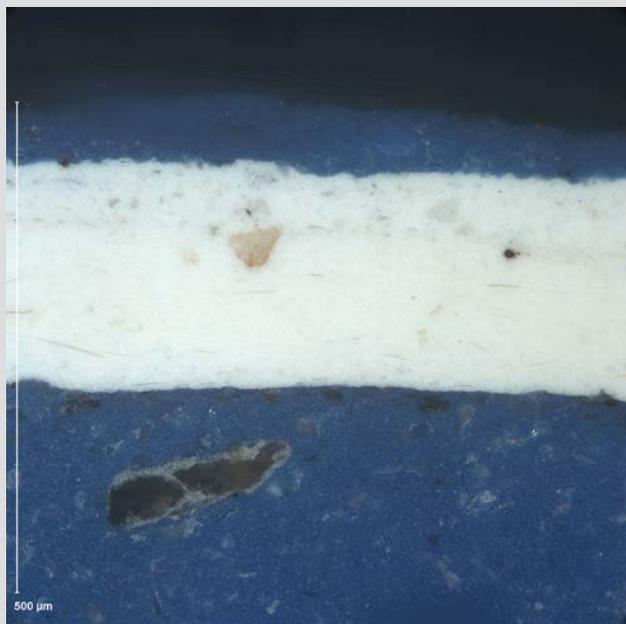
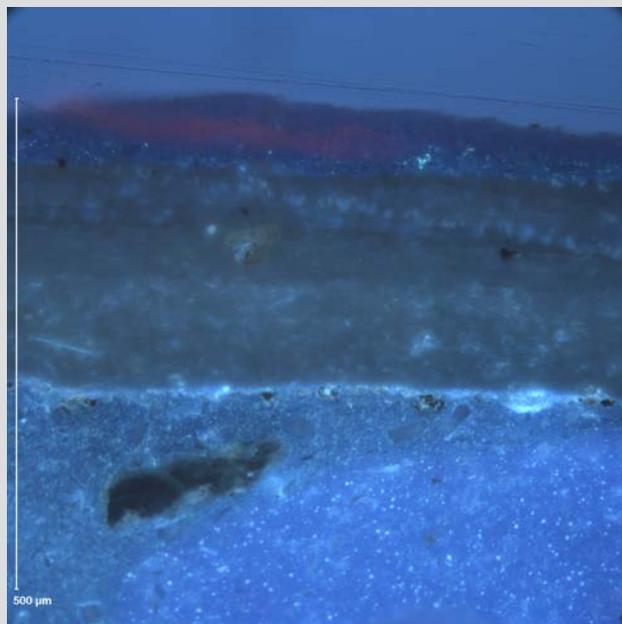
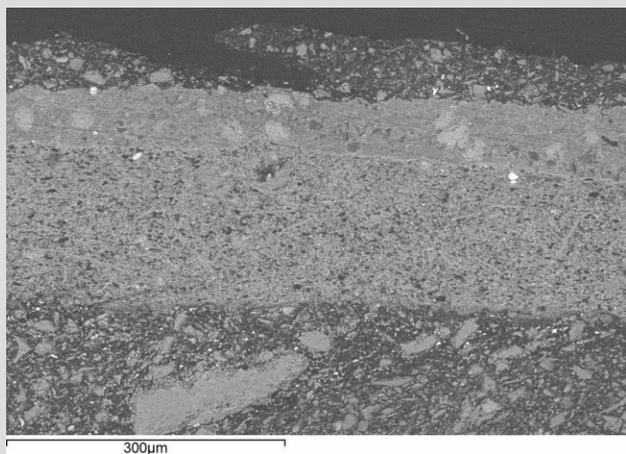
Blue paint from edge of repainted area, possibly includes caulk.

Cross section sample West Exterior_13 shares several common features with sample West Exterior_12. As in the preceding sample, West Exterior_13 shows two layers of blue paint (#1 and #5) that have essentially the same elemental composition. In both cases, no elements are

fluorescent under UV, the status of which is uncertain. Two dense white layers #3 and #4, follow, both of which may be caulk. These differ slightly in conformation: the upper layer #4 includes large transparent colorless particles in addition to fine opaque white; lower layer #3 appears to correspond with the lowest caulk layer #4 in sample West Exterior_12, while upper caulk layer #4 of West Exterior_13 corresponds with one or other of layers #5 and #7 of the preceding sample. The unidentified, unusual red-fluorescent feature (#5b) in upper blue paint layer #5 is carbon-rich (i.e., organic) and may represent an aggregate of organic colorant.

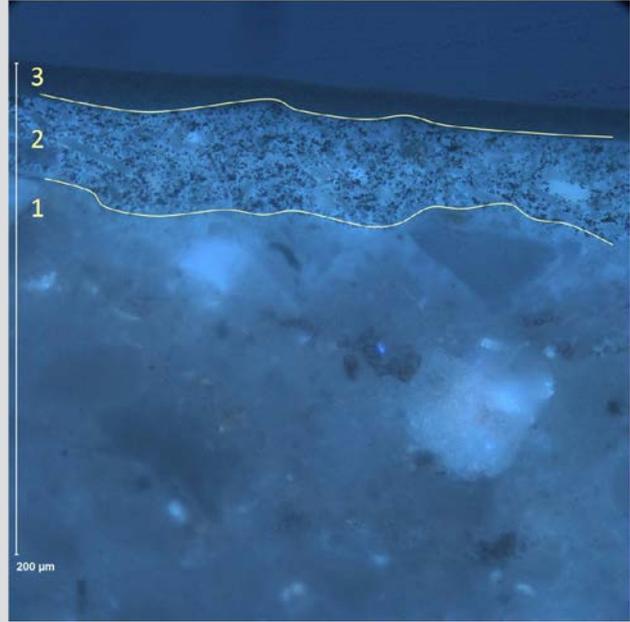
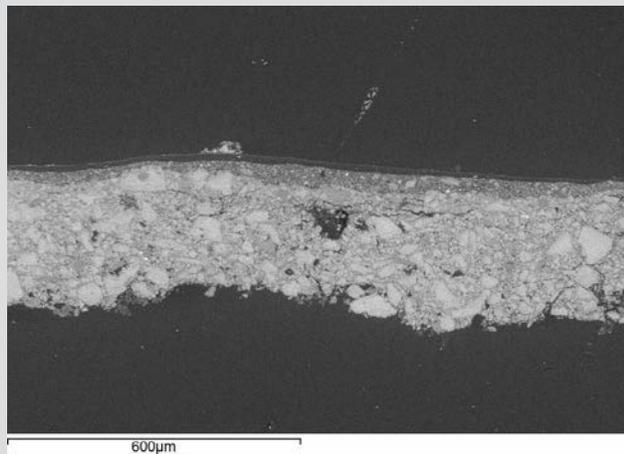
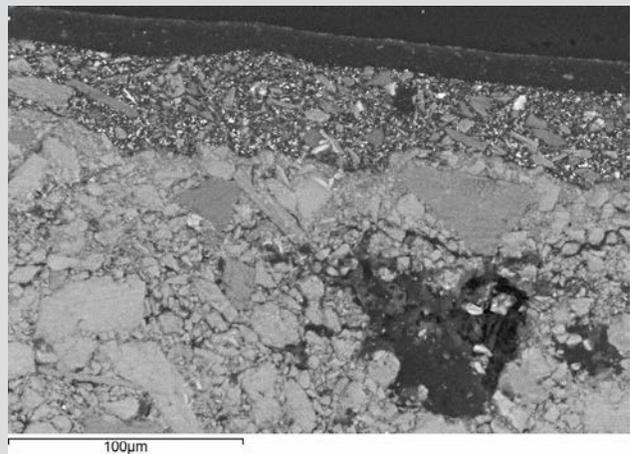
Loose fragment from edge of loss in black paint on metal frame.

Cross section sample West Exterior_14 has a simple stratigraphy that is essentially the same as East Exterior_2a, East Exterior_3, and South Exterior_11 Fragment A, with similarities also to sample East

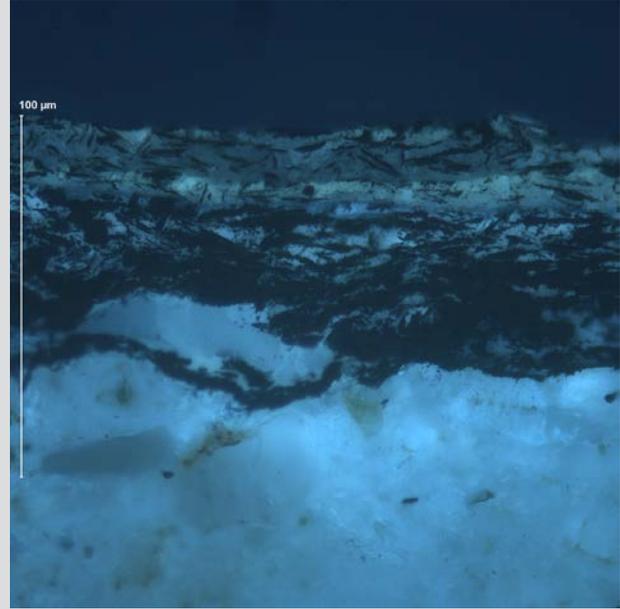
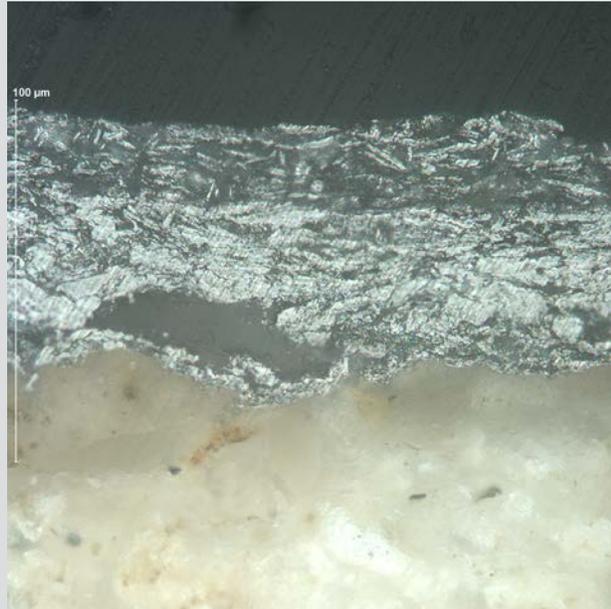
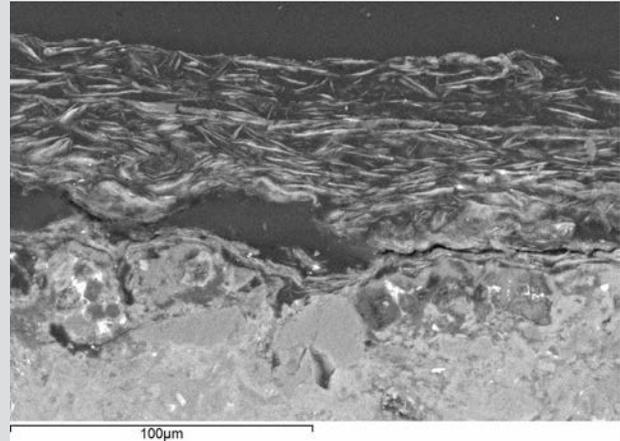
Metallic paint at location of impact damage site on silver-painted panel. Sample also includes some of the underlying panel material.

Cross section sample West Exterior_15 shows a relatively simple stratigraphy as follows:

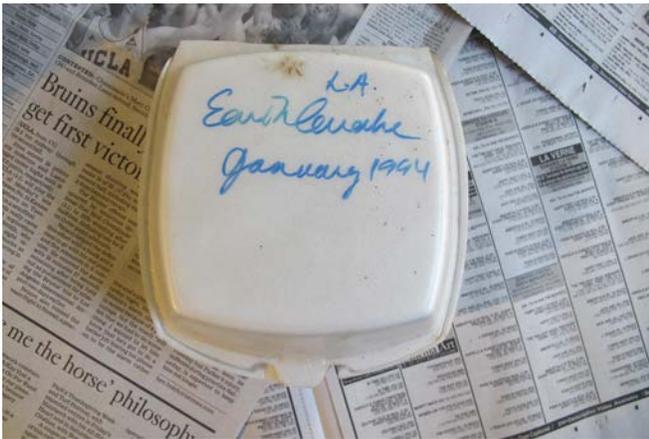
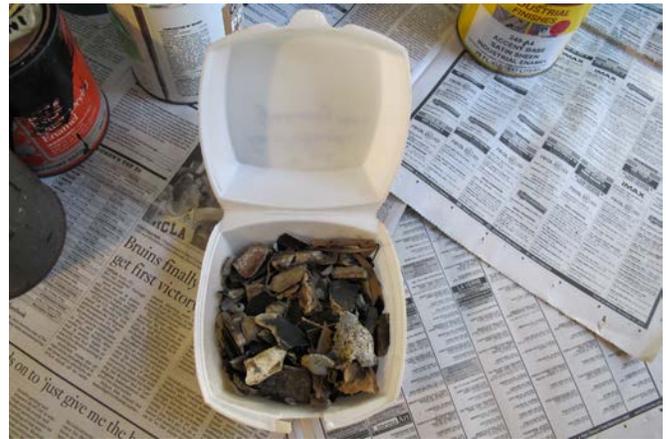
The large samples taken from a container filled with putty fragments have a slightly different appearance—lighter and darker putty colors—probably from different putty campaigns. Two large putty fragments, respectively Eames House_putty#1a and Eames House_putty#1b, were collected, and samples from each were mounted as cross sections. Whether the samples of painted putty derive from the interior or exterior of the building is not indicated in any way on the box of material. Of these two main fragments, Eames House_putty#1b is the more informative in terms of stratigraphy, and the observations on that fragment only are reported here.

FIGURE 1.35A
Container of putty fragments from the Eames House residence or studio dated detached during the Northridge earthquake, 1994.

FIGURE 1.35B
Putty fragments detail.
