Eames House Conservation Project: Investigations 2011 to 2016

Research Report

Edited by Laura Matarese
with Chandler McCoy and Gail Ostergren

The Getty Conservation Institute

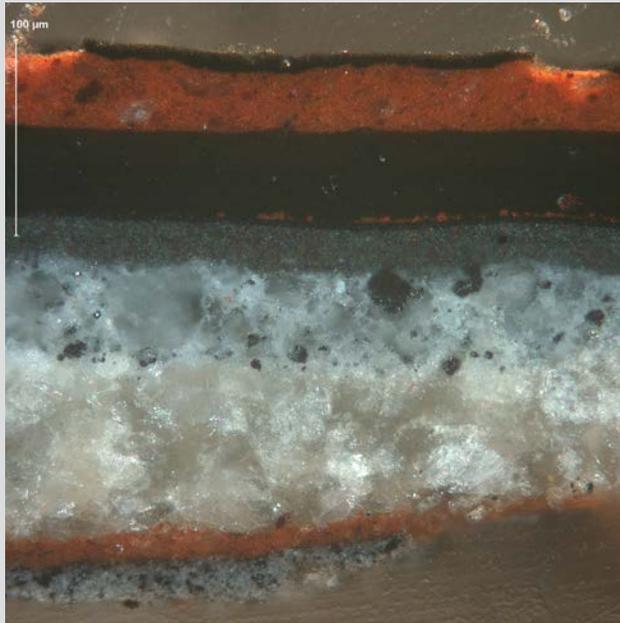
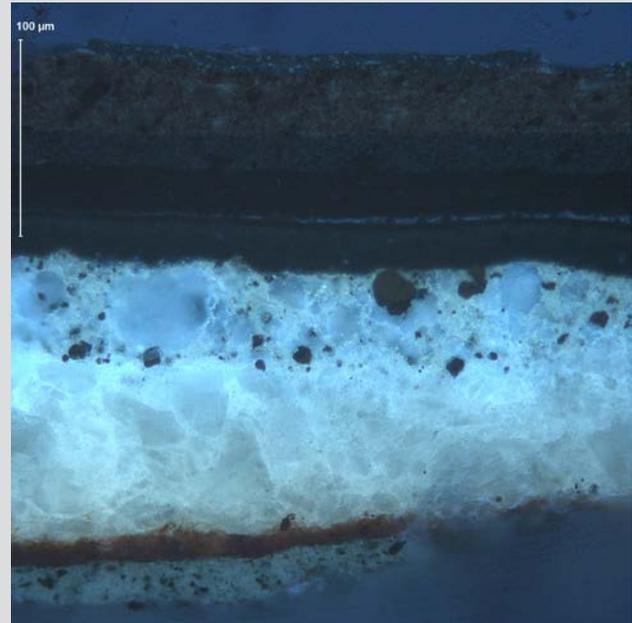
1.7.1 Sample Eames House_putty#1b-1

Some variability within fragment Eames House_putty#1b was evident. Accordingly, two separate subfragments—Eames House_putty#1b-1 and Eames House_putty#1b-2—were prepared as cross sections in order to accommodate the internal variability of the larger stock fragment. Of the two subfragments, sample Eames House_putty#1b-1 has the fuller stratigraphy, and includes two light gray primers. There is sufficiently good correspondence between the paint layer structures of the two detached putty fragments, and also with sample North Exterior_10 (see fig. 1.51 in sect. 1.10.1 below), to indicate that the fragments come from the exterior metalwork of the house.

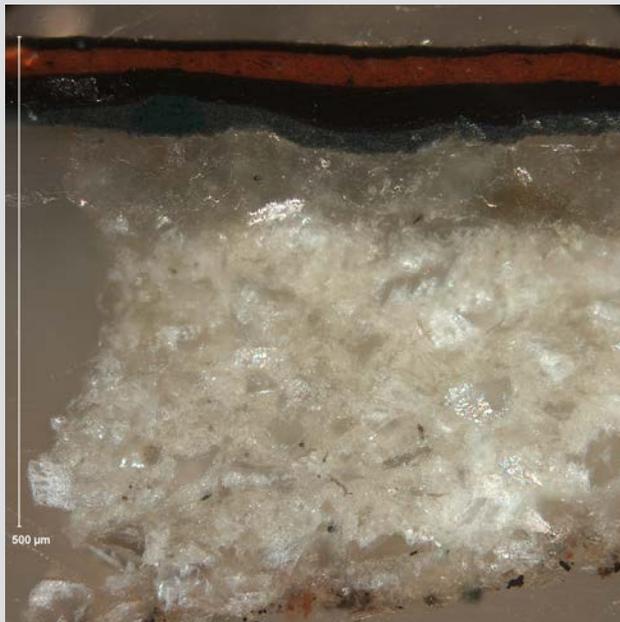
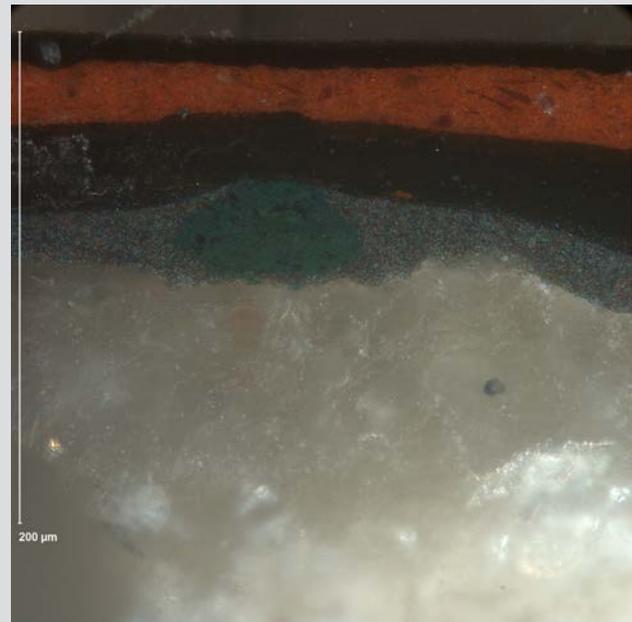
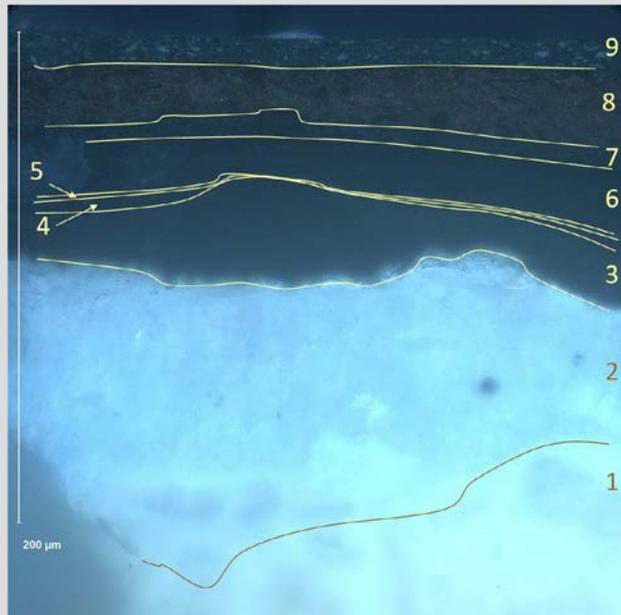
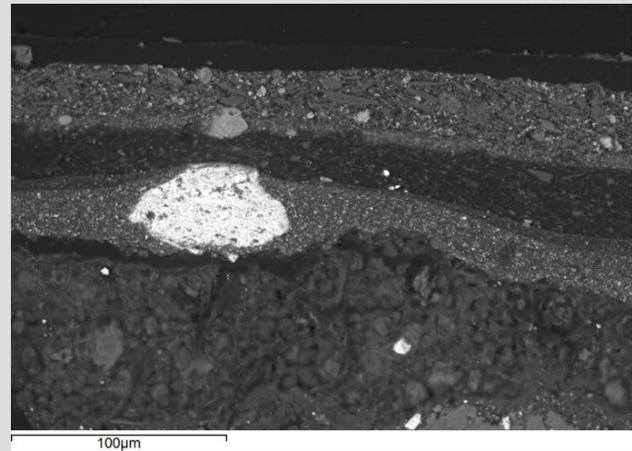
1.7.2 Sample: Eames House_putty#1b-2

3	Mixed gray paint with large aggregate of blue green pigment. Particulates: opaque white; transparent colorless; red; blue-green; possibly yellow.	Al , Si , <i>Cl</i> <i>Ca</i> , <i>Ti</i> , <i>Cr</i> , <i>Fe</i> , <i>Zn</i> , <i>Pb</i>	Aluminosilicates Titanium dioxide Red iron oxide Chrome green (lead chromate + Prussian blue)❖
2	Putty or primer	Zn , <i>Ca</i> (slight traces of <i>Mg</i> , <i>Al</i> , <i>Si</i> , <i>S</i> , <i>Cl</i> , <i>Ti</i> , <i>Cr</i> and <i>Fe</i>)	Deteriorated zinc primer?
1	Putty	Calcium-rich	Probably calcium carbonate

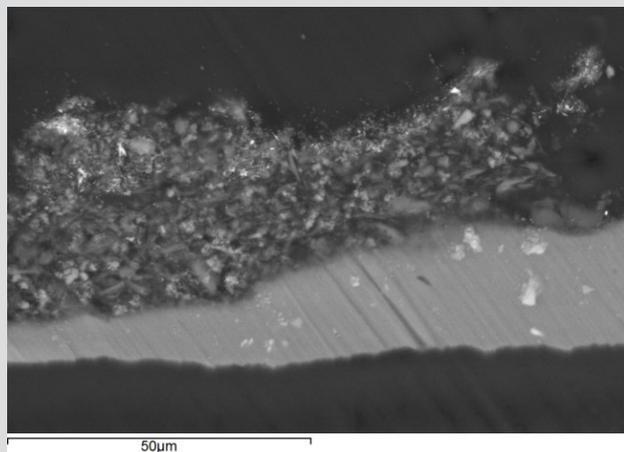
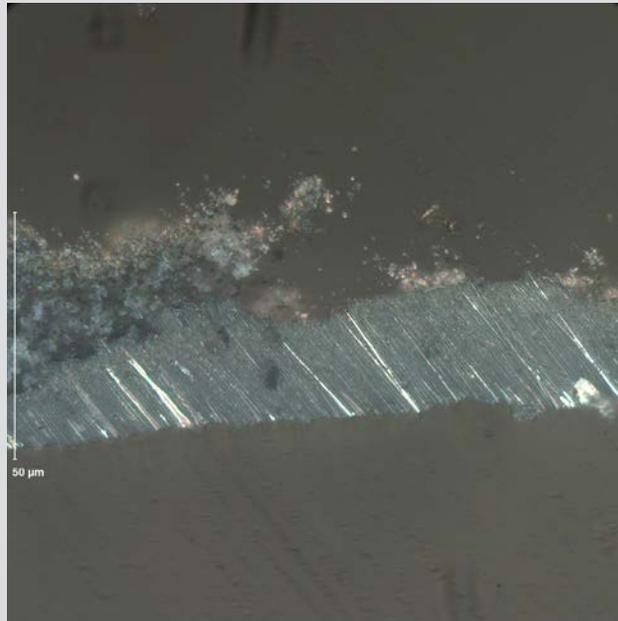
Eames House_ Plate #4 appears to consist of separate applications of slightly different paints, which give the internal substructure that is evident both by optical and electron microscopy. Towards the upper surface, the paint is finer grained, with some red and yellow particles visible, possibly together with black. ESEM-EDS analysis of the upper substratum points to a composition that includes abundant aluminosilicate extender and titanium dioxide, possibly with traces of iron oxide and lead chromate. Some calcium carbonate may also be present; carbon black cannot be excluded.

The coarser, more transparent lower substratum is seemingly composed mostly of aluminosilicate extender and titanium dioxide, with calcium carbonate also present in greater abundance than in the upper substratum. As in the upper sublayer, carbon black cannot be excluded.

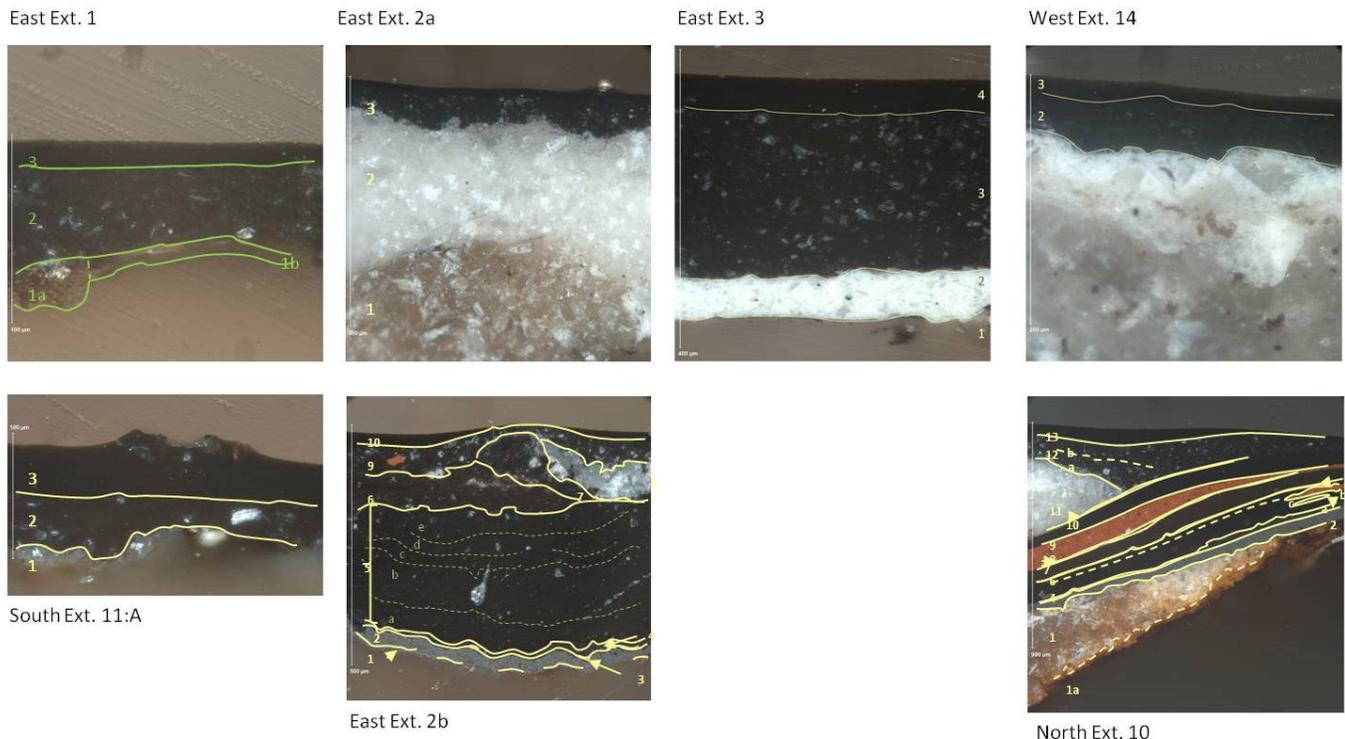
FIGURE 1.49
Set of cross section samples from the exterior black metalwork.

It can be seen immediately that both East Exterior_2b and North Exterior_10 have far more complex stratigraphies than the other samples, regardless of whether they come from areas of historic or replaced glass. The two samples appear to illustrate relatively complete histories of the painting interventions at those locations, while the other samples only offer evidence of recent repainting. “Old” paint layers are missing from all of the samples East Exterior_1, East Exterior_2a, East Exterior_3, South Exterior_11, and West Exterior_14.

The same pattern of two adjacent paint layers—dense black over dark gray—at the uppermost level appears in all of the samples from the exterior metalwork, and it seems probable that these layers derive from a recent repainting intervention, or, possibly, two separate interventions. According to information from the Eames Foundation, the most recent painting campaign was performed in 2003 by Dan Elliot. Comparison of sample North Exterior_10 with sample Eames House_putty#1b-2 (see fig. 1.50) shows good correspondence between the lower strata of the samples, up to a black paint, layer #9 in both samples, that is composed essentially just of carbon black, but the upper layers of gray paint (#12) and black paint (#13) that occur in North Exterior_10 are missing from the putty fragment, reportedly detached in 1994. This observation leads to the conclusion that gray paint (#12) and black paint (#13) in sample North Exterior_10, and the corresponding layers in the other samples from the exterior metalwork, were applied after 1994 (i.e., as part of Dan Elliot’s painting campaign). The lower dark gray paint (#12), which is characterized by

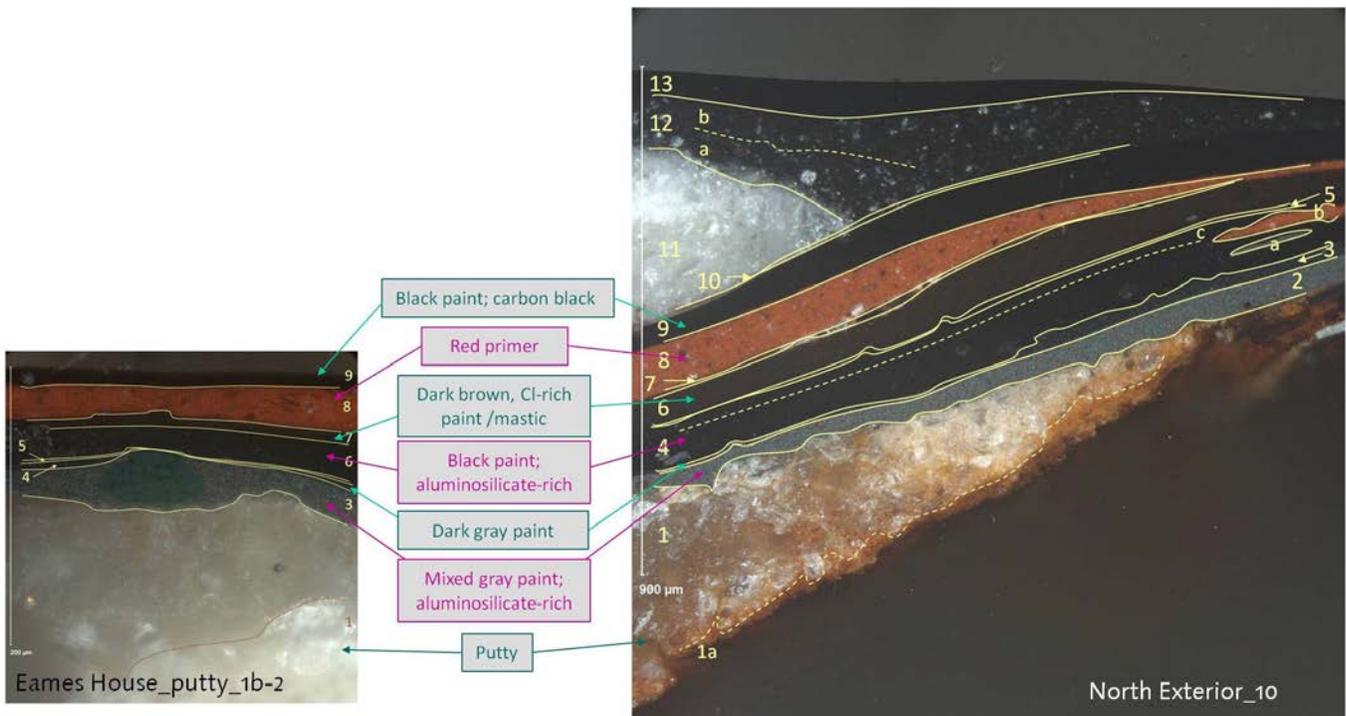
FIGURE 1.50
Correspondences of layers
between sample North Exterior_10
and sample Eames House_
putty#1b-2.

The two uppermost paint layers #12 and #13 of sample North Exterior_10, as already noted, appear quite recent and are almost certainly connected with the most recent repainting of the residence metalwork in 2003. The same status probably also applies to bright white putty layer #11 which appears to be preparation for the most recent campaign of painting. Putty layer #11 marks a discontinuity with the underlying strata, which are almost certainly from earlier interventions.

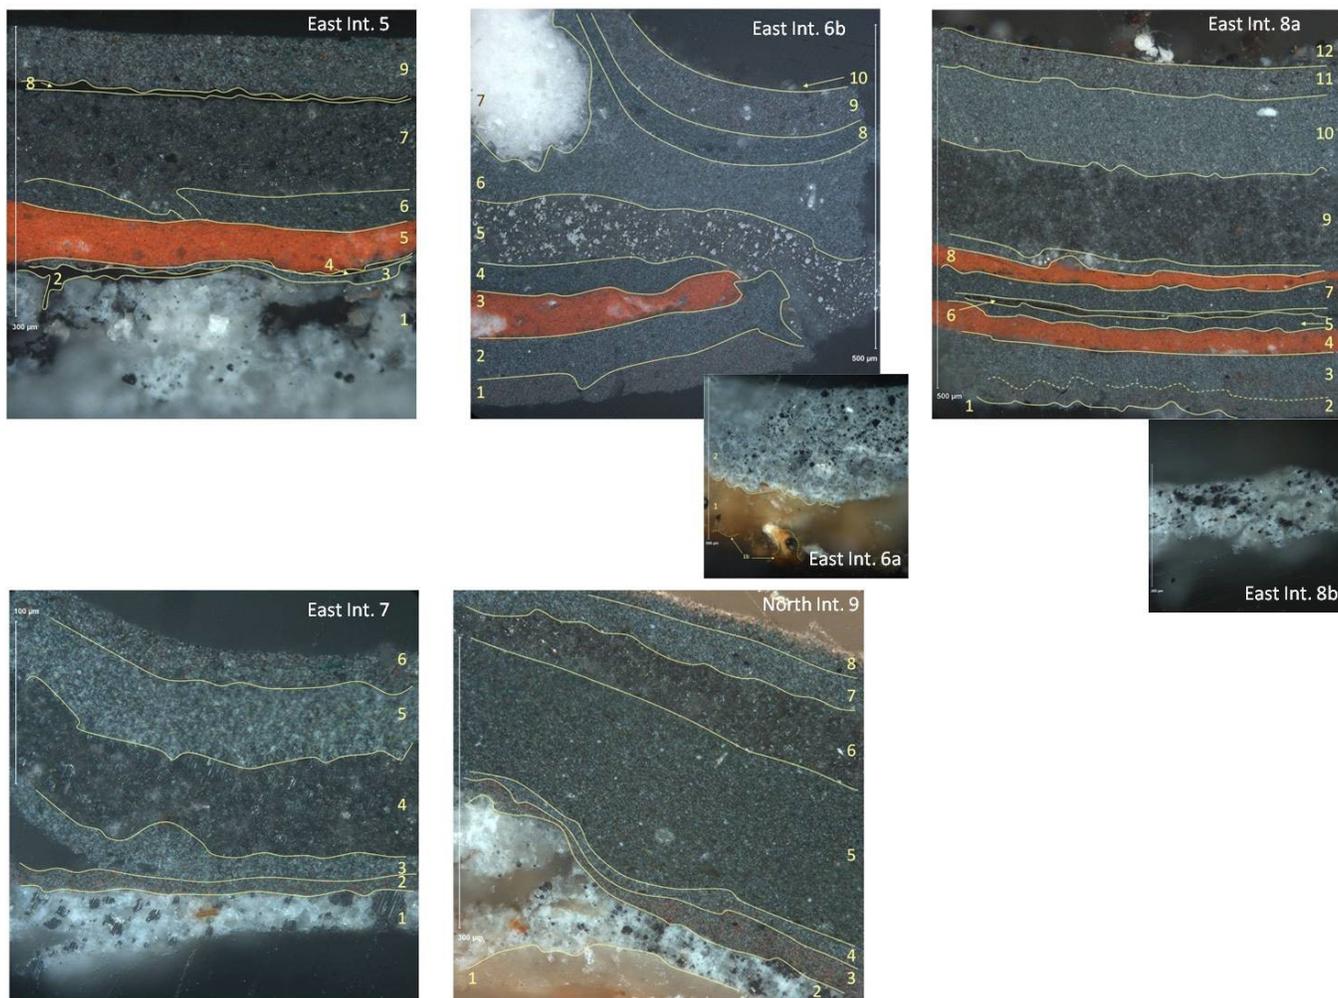
Compared alongside each other (fig. 1.51), it can be seen that there is considerable variability in the stratigraphies of the cross section samples from the interior: no two samples have the same layer structure. Nonetheless, some similarities and correspondences do occur within the sample set.

- East Interior_5: two layers, a thin black paint superposed on a mixed gray
- East Interior_6b: three layers of fine-grained gray paint that differ slightly in shade.
- East Interior_7, East Interior_8a, and North Interior_9: two layers of fine-grained gray paint, the lower one lighter and cooler, more blue-green, than the upper.

FIGURE 1.51
Cross section samples from the interior metalwork of the Eames House.

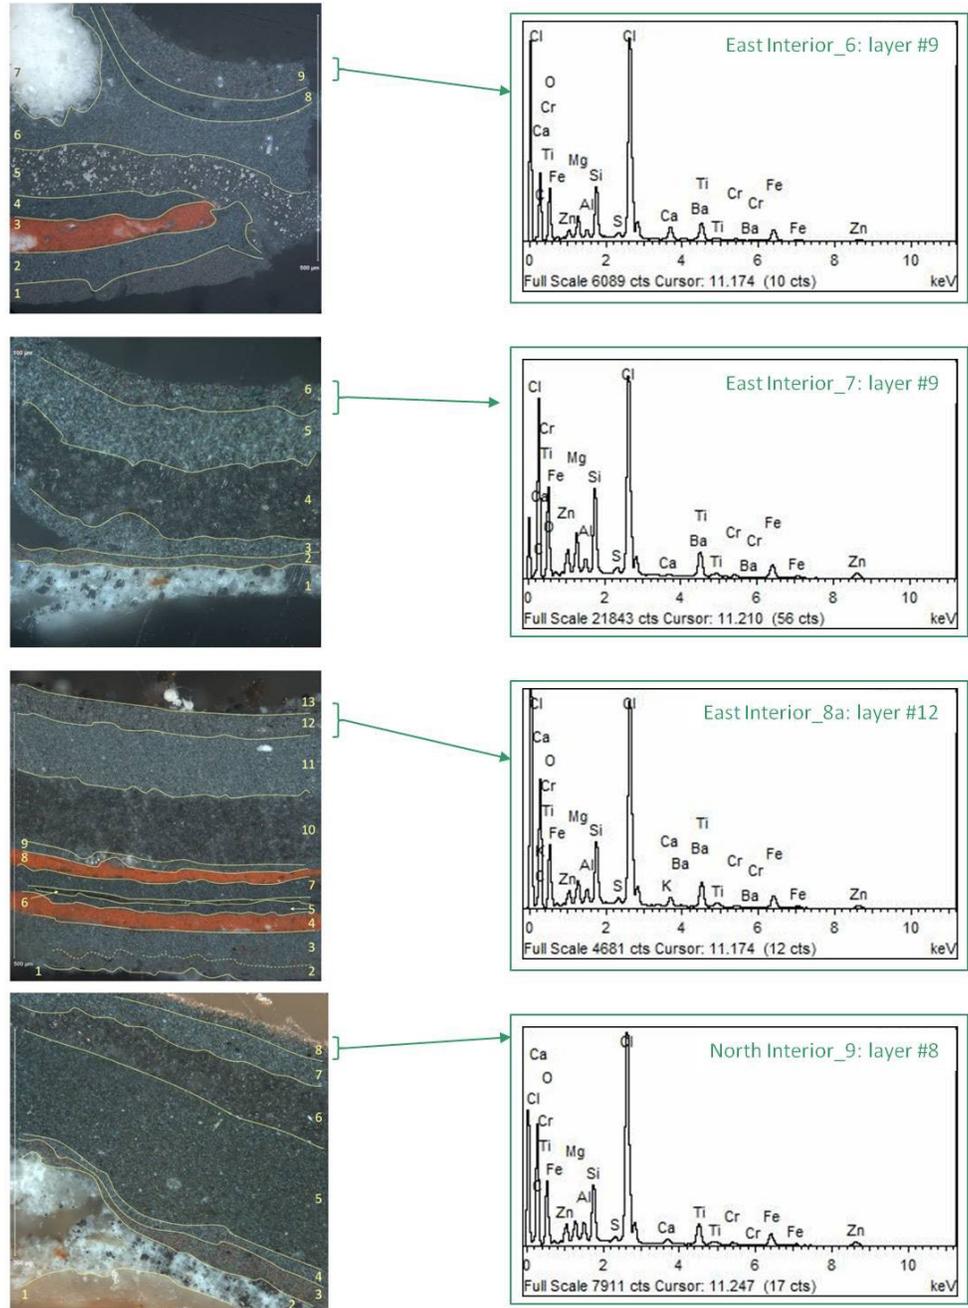
FIGURE 1.52

The similarity of these layers can be seen by comparing the ESEM-EDS spectra obtained from them (fig. 1.52). The distinctive chlorine-rich paint must derive from the most recent painting campaign on the interior metalwork.

Comparison of topmost paint layers in samples from the interior metalwork. A similar elemental profile is observed also in sample East Interior_5.

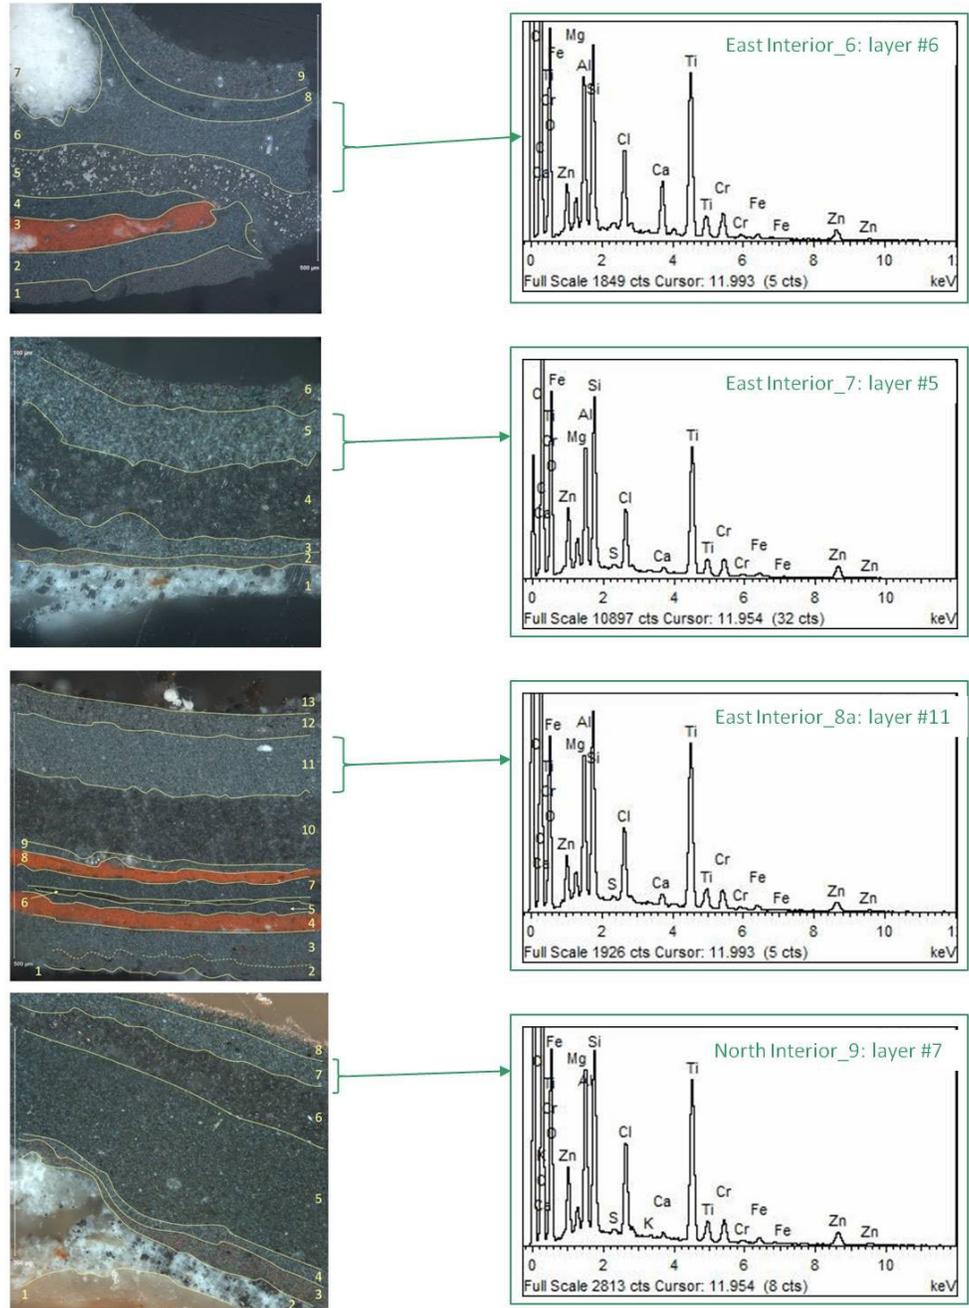
FIGURE 1.53

This layer is missing from sample East Interior_5, but features in all other samples in this group. It is characterized by an elemental profile in which Si predominates, with abundant Al and Ti, and some chlorine, but at much lower levels than in the uppermost paints (fig. 1.53).

Comparison of next-to-topmost paint layers in samples from the interior metalwork. A corresponding layer is missing from sample East Interior_5.

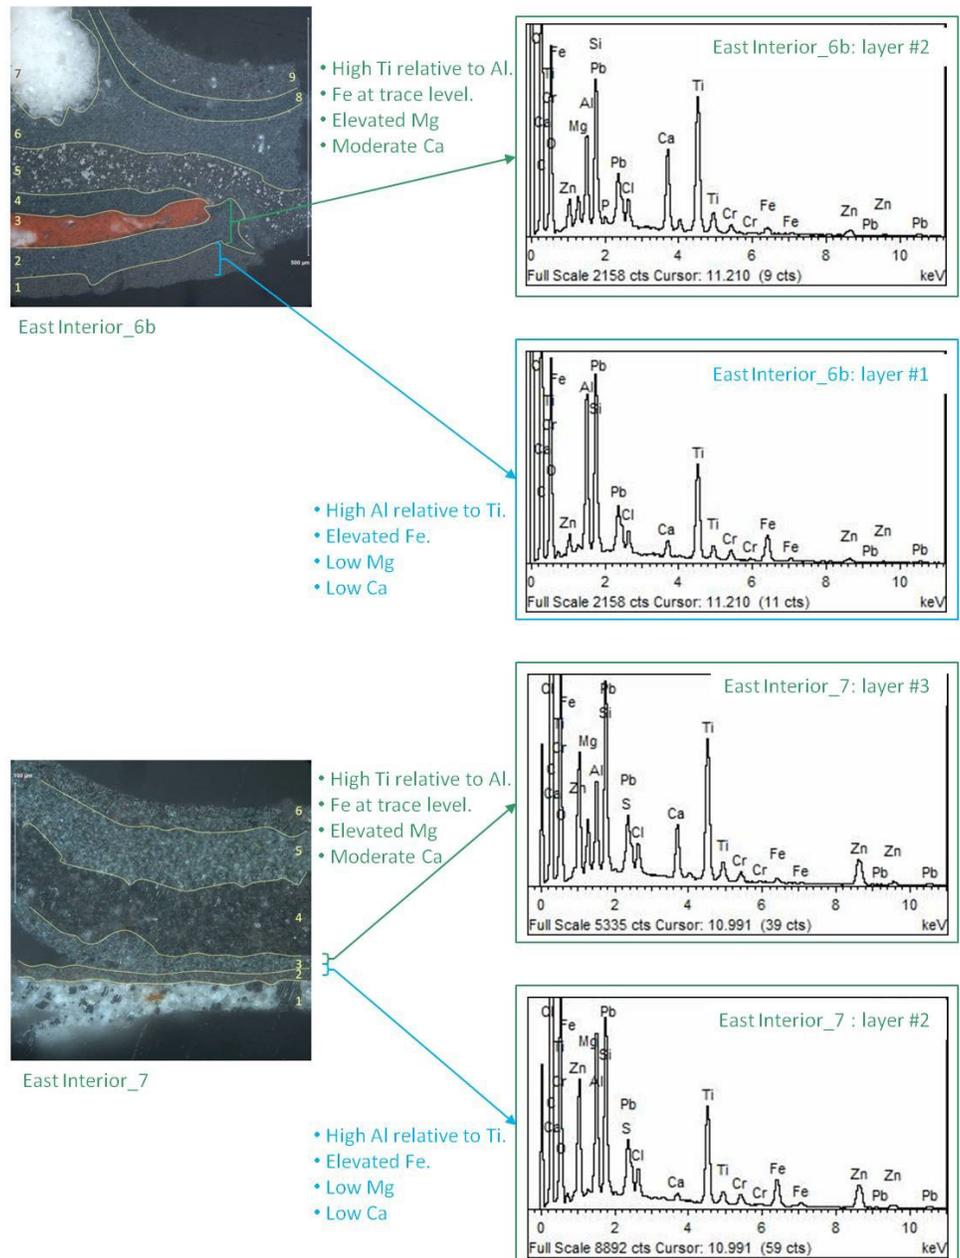
FIGURE 1.54

Comparison of lowest two paint layers in samples East Interior_6b and East Interior_7 from the interior metalwork.

is warmer, redder in color due to greater abundance of red particles (i.e., iron oxide). Despite the general similarity of elemental compositions of the first and second paint layers, there are subtle differences between them, the pattern of which is repeated across the group. This pattern is best illustrated by comparison of the corresponding layers in samples East Interior_6b and East Interior_7 (fig. 1.54). The same pattern is observed also in samples East Interior_8a and North Interior_9. It is not unreasonable to conclude that the first two paint layers in each of these samples correspond directly. If the pale gray priming corresponds with the original Galvanide primer, which is a reasonable hypothesis, although it cannot be proved from the available information, then the two paint layers just discussed appear to represent the first and second paint coatings applied to the interior metalwork. Whether these two paint applications are from the same painting campaign (i.e., multiple coats of slightly different color) or are separated temporally cannot be ascertained from the evidence provided by the samples. The elemental profile of the lowest paint layer in each of the samples under consideration here—East Interior_6b, East Interior_7, East Interior_8a, and North Interior_9—is very similar to that found for the first, warm gray paint layer in sample East Exterior_10. Curiously, the elemental profiles that are characteristic of the first two paint layers in this group of samples do not correspond perfectly with the paints on any of the reference plates associated with the interior metalwork/trim that are archived at the Eames House. Reference Plate #3 labeled “1948 Original Trim Color” shows some similarities with the second paint application: it has high proportion of Ti compared to Al, moderate Ca, and elevated Mg, with Cr and Pb present, but Fe is nearly completely absent. Reference Plate #1, labeled “Int. Color 4-15-69,” also has an elemental composition similar to that of the second paint application, but the abundance of Ca is lower, and the Fe is elevated relative to Cr. None of the paints on the reference plates have the moderately elevated levels of iron (as red oxide) that are seen in the first paint layer in the interior metalwork samples.

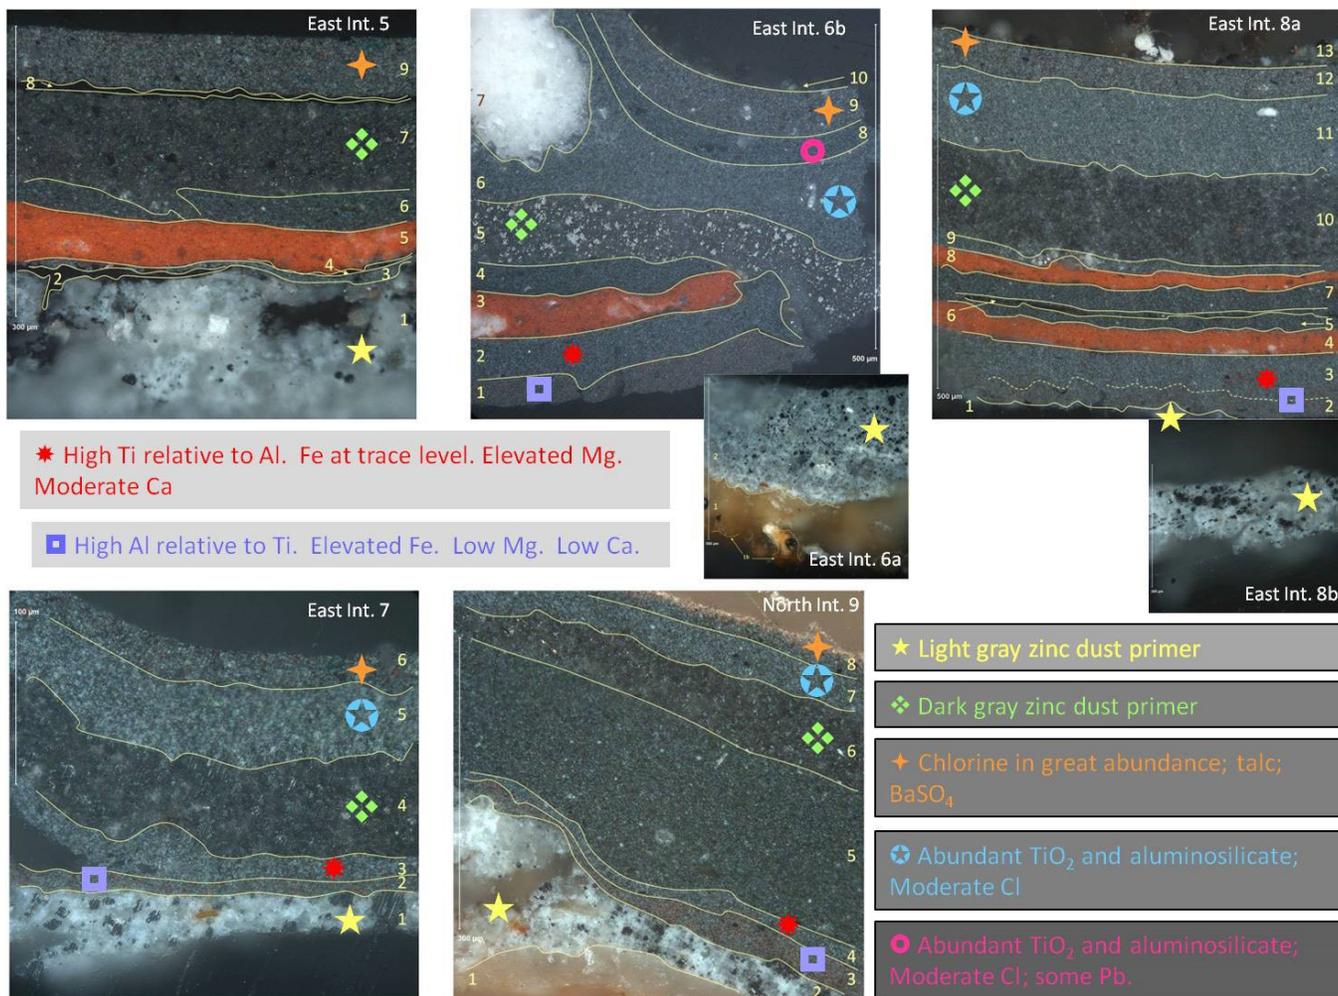
Apart from occurrences of red primer and two isolated instances of black paint, all the paint and primer layers in the samples are gray. Two different gray primers occur that are based on metallic zinc: a lower pale gray primer that may be original, and an upper dark gray zinc primer that must derive from a later repainting intervention. Although it cannot be said definitively, the lower gray zinc-based primer may be the A.C. Horn product Galvanide that was reportedly used originally to prime the metalwork (Eames and Entenza 1949b).

The paint layers, as opposed to primer layers, in the samples are dark grays, not black, that vary somewhat in tonality and hue. There is a considerable degree of compositional overlap between the different layers. They generally share quite similar elemental profiles featuring most of the elements, Mg, Al, Si, S, Cl, Ca, Ti, Cr, Fe, Zn, and Pb, with occasional specific omissions, mainly Fe or Pb, or distinctive high abundances, such as Ba, Cl, and Fe. The general similarity of the composition of the various paint layers might point to a common formulation concept, with some variation over time with regard to specific ingredients. The basis for dark gray interior paints is essentially titanium white (TiO₂) and carbon black, which is presumed by observation, though not positively identified chemically, plus colorless extenders of different types, and minor, variable amounts of colored pigments: red (iron oxide), yellow (chromate), and possibly blue-green (chromium-containing).

FIGURE 1.56
Samples from interior metalwork:
commonalities across the sam-
ple set.

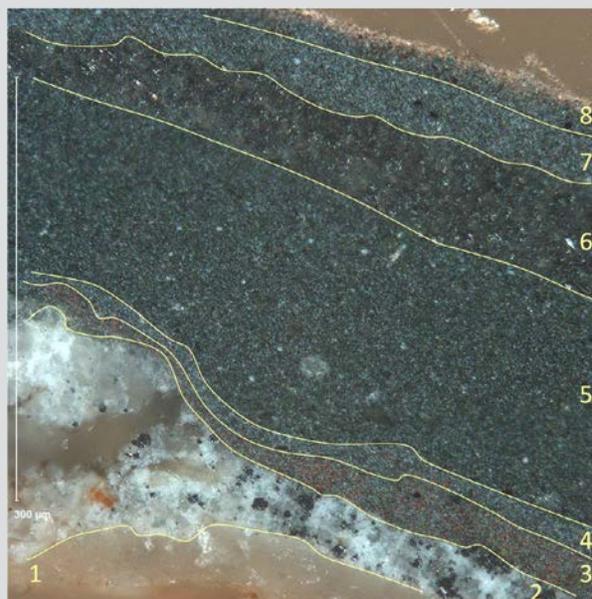
FIGURE A1.2

Py-GCMS analysis confirmed that the uppermost paint layer #8 is based on a chlorinated rubber binder, as had been suspected from the findings of elemental analysis by ESEM-EDS, which indicated abundant chlorine not associated with pigments/extendere.

Cross section of sample North Interior_9; visible light. Annotated to show layer structure.

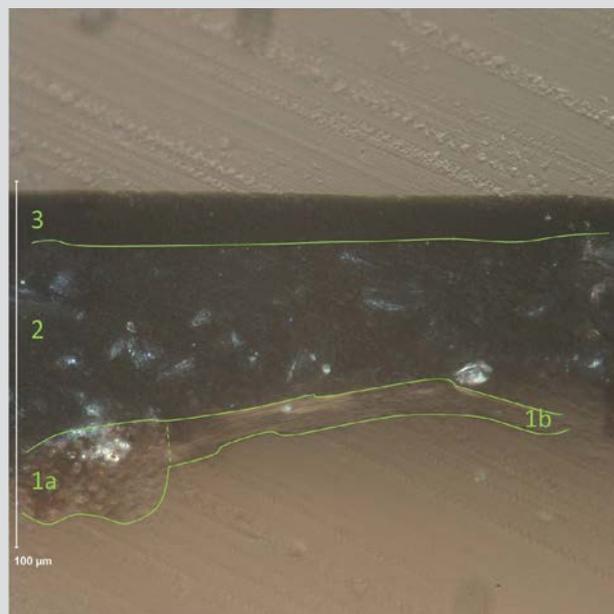
Uppermost black paint layer #3, which has parallels to all other samples from the exterior metalwork, is understood as being associated with the most recent repainting campaign at the residence in 2003. The organic binder is identified as an alkyd resin.

FIGURE A1.3
Cross section of sample East Exterior_1; visible light. Annotated to show layer structure.

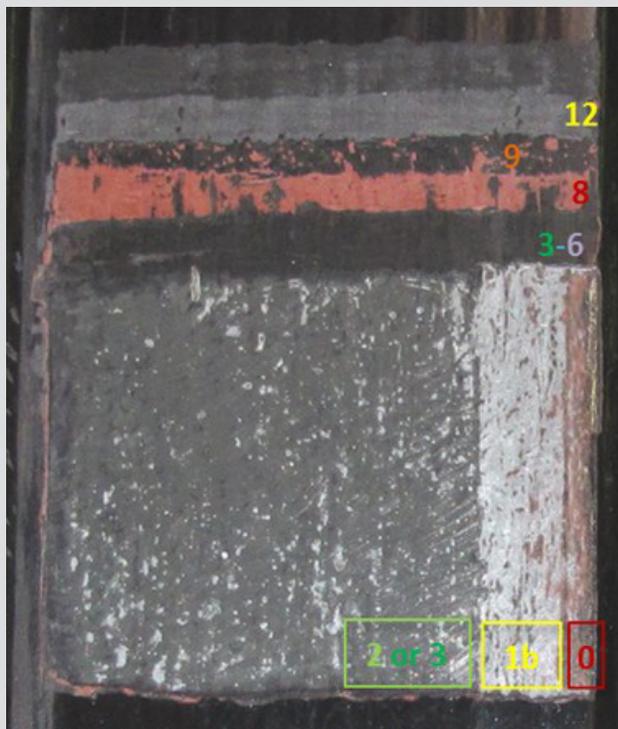
FIGURE A1.7
Paint excavation site on the exterior of the east wall.

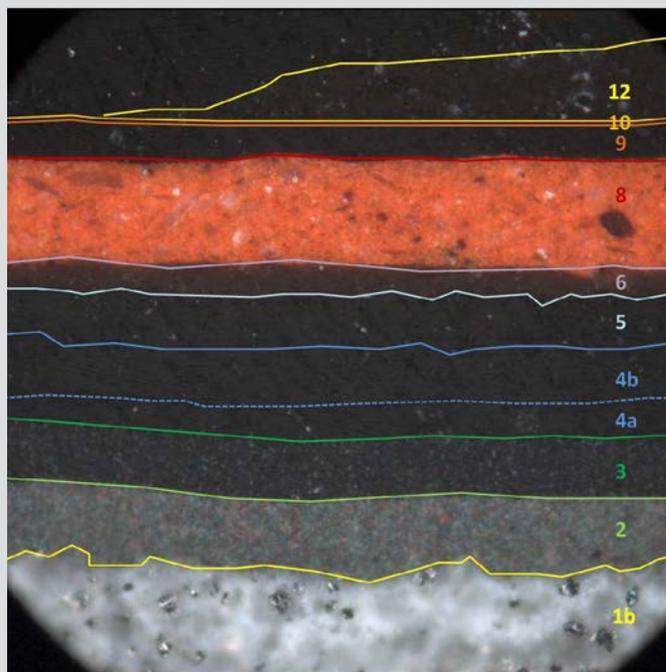
FIGURE A1.8
Stratigraphic diagram of a cross section paint sample from the exterior of the east wall, next to the excavation site (50x objective).

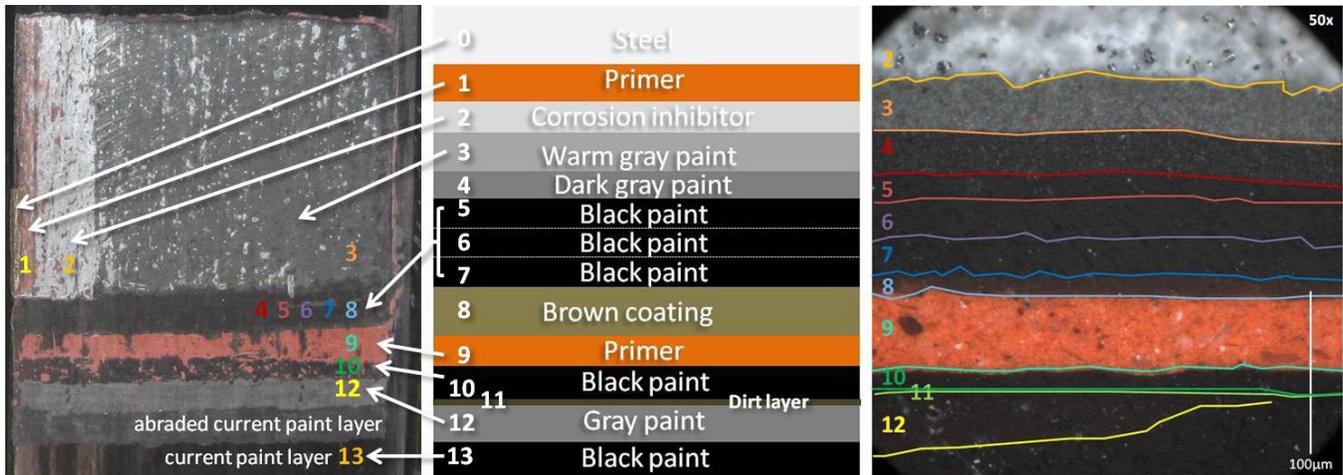
FIGURE 2.5
In situ paint excavation exposure window after completion (H_E), with layers numbered chronologically from lowest (earliest, number 0) to uppermost (most recent, number 13), and annotations where necessary.

From the results of the in situ investigation, a general paint stratigraphy for the exterior steelwork of the residence and studio can be summarized as follows. The steel substrate shows one to three layers of primer and a corrosion inhibitor, followed by a warm gray paint. A dark gray paint was applied at some time, followed by a series of one to three black paints. The black paint was then coated with a shiny brown material, followed by a black paint and then a gray paint, before the current black paint was applied (figs. 2.5–2.7).

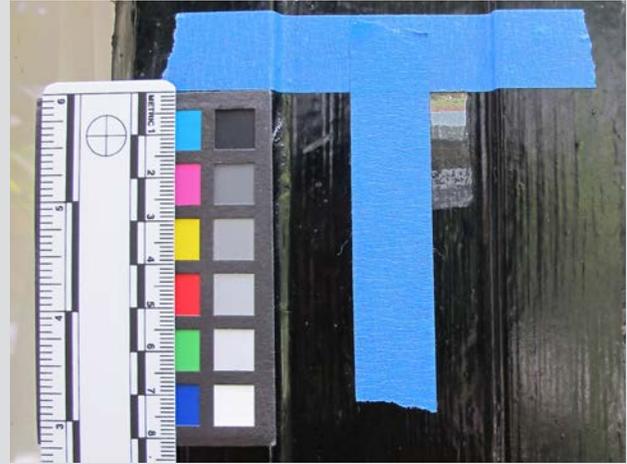
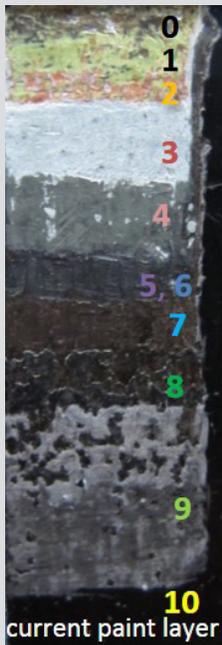
FIGURE 2.8B
House_north, in situ paint excavation exposure window.

FIGURE 2.8C
House_north, in situ paint excavation exposure window.

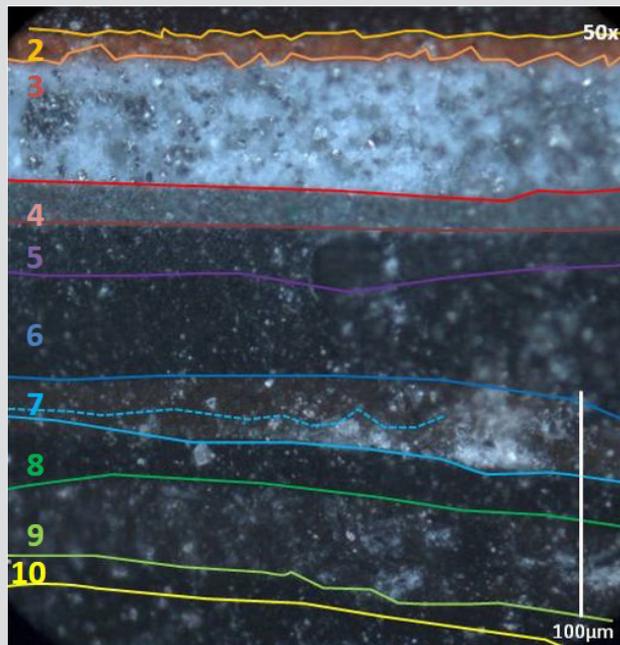
FIGURE 2.8D
House_north cross section microphotograph, with stratigraphic layers numbered (reflected visible light, 50x).

0. Steel, (not included in cross section)
1. Primer, yellow-green (not included in cross section)
2. Primer, orange
3. Corrosion inhibitor
4. Warm gray paint (white, black, red, yellow, blue-green particles), the first exterior paint layer
5. Dark gray paint (black, white, and red particles)
6. Black paint (uniform black particle content)
7. Brown layer, possibly a coating
8. Black paint (uniform black particle content)
9. Dark gray paint (black and white particles)
10. Current paint layer, black paint

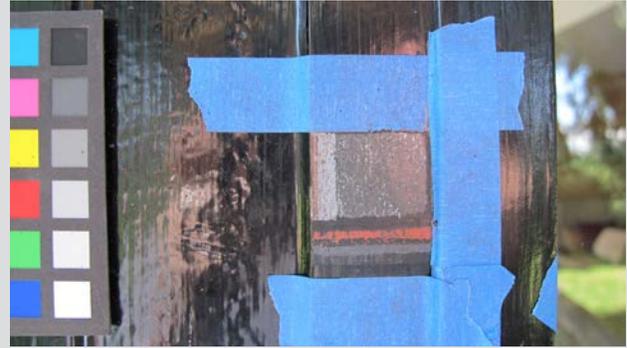
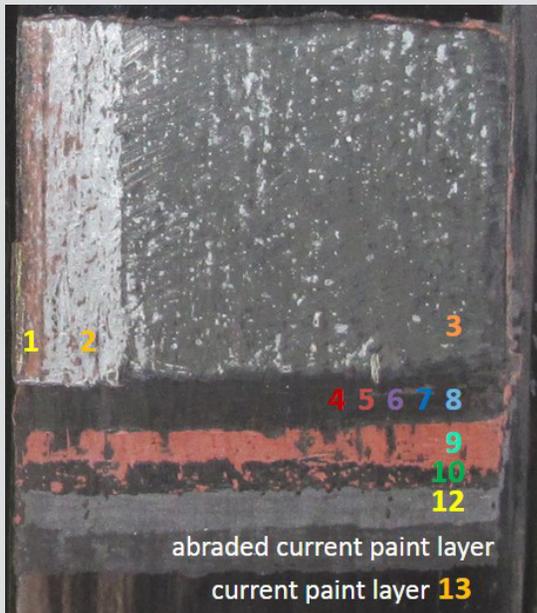
House_east, in situ paint excavation exposure window.

House_east, in situ excavation exposure window with numbered layers.

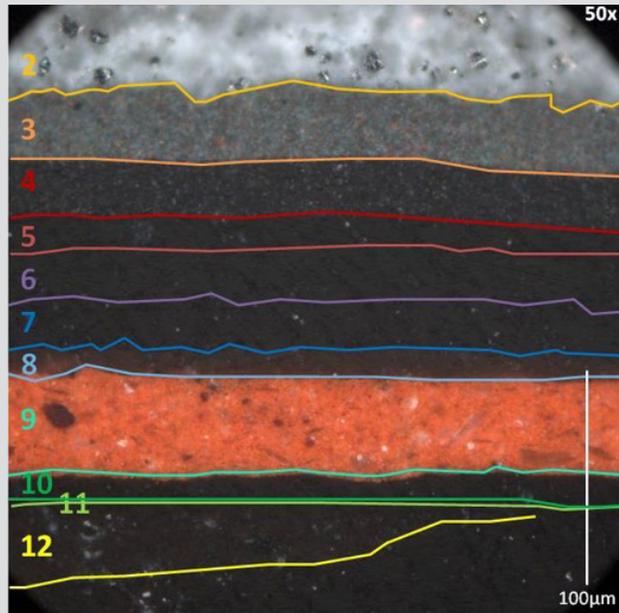
House_east cross section microphotograph with stratigraphic layers numbered (reflected visible light, 50x).

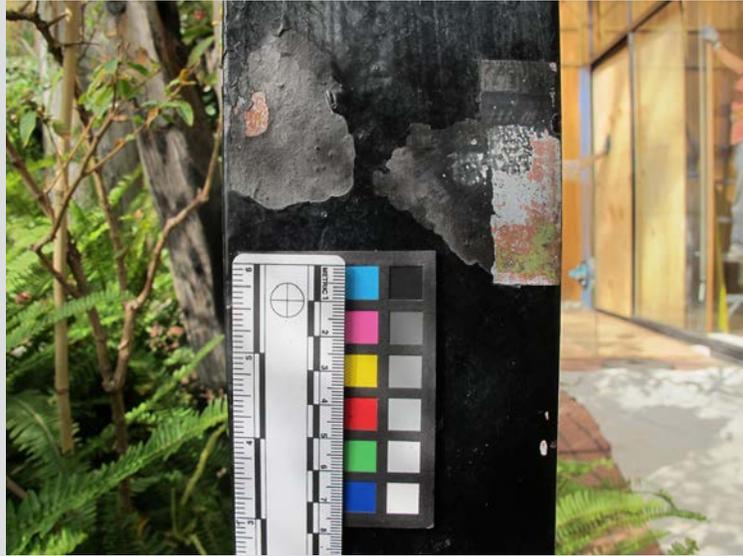
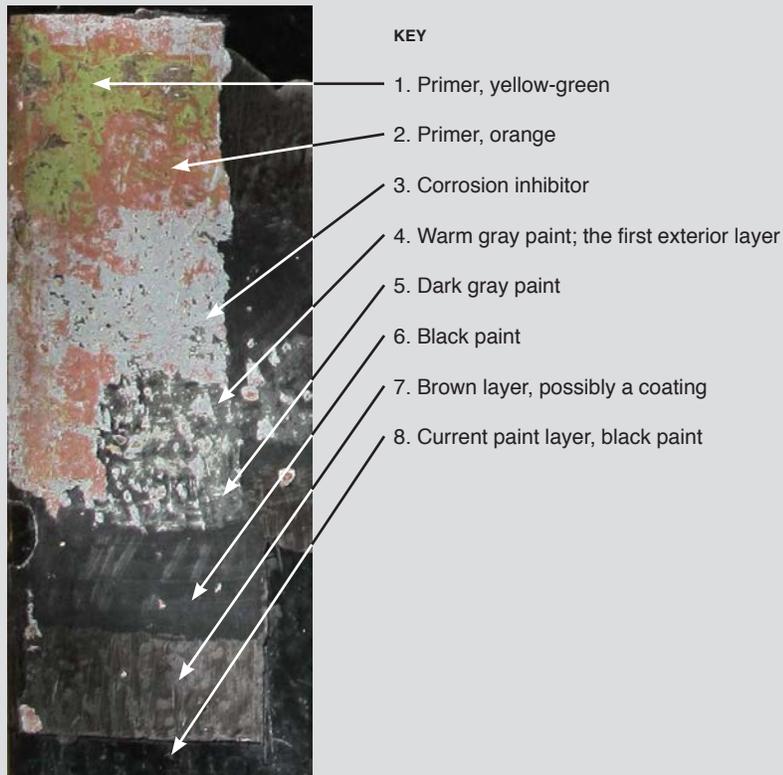
FIGURE 2.10B
An additional excavation was performed on beam 4D. A cross section sample was taken but was not imaged in 2013, at the time this report was prepared.

FIGURE 2.10C
House_east_2, in situ paint excavation exposure window with numbered layers.

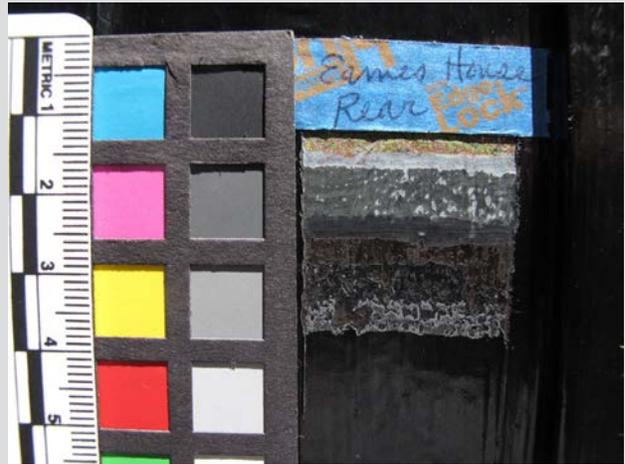
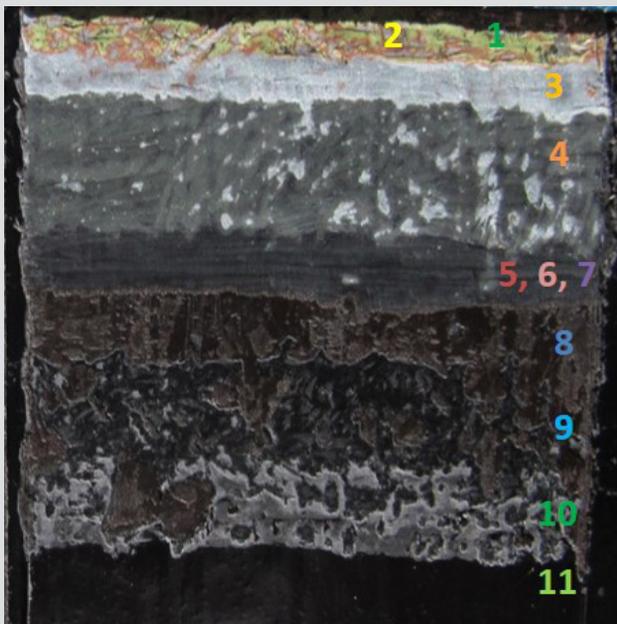
FIGURE 2.11B
House_north, in situ paint excavation exposure window.

FIGURE 2.11C
House_west, in situ paint excavation exposure window.

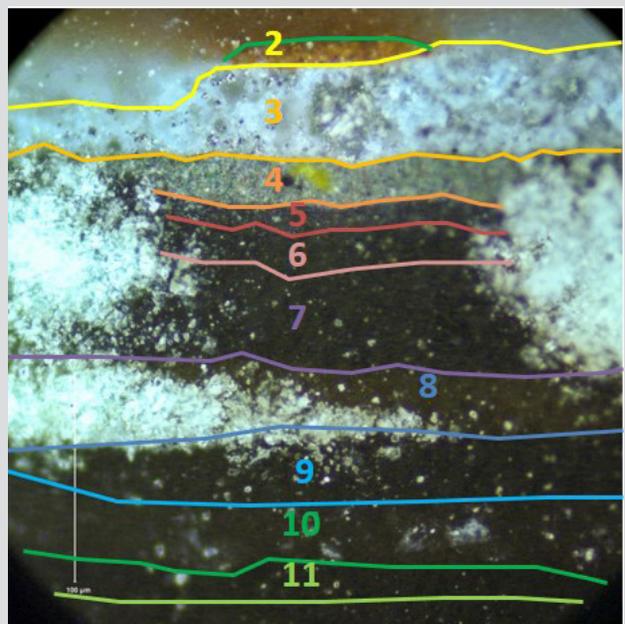
FIGURE 2.11D
House_west, cross section microphotograph, with stratigraphic layers numbered (reflected visible light, 50x).

- 0. Steel, (not included in cross section)
- 1. Primer, yellow-green (not included in cross section)
- 2. Primer, orange
- 3. Corrosion inhibitor
- 4. Warm gray paint (white, black, red, yellow, blue-green particles), the first exterior paint layer
- 5. Dark gray paint (black, white, and red particles)

- 6. Black paint (uniform black particle content)
- 7. Black paint (uniform black particle content)
- 8. Brown layer, possibly a waterproofing layer
- 9. Black paint (uniform black particle content)
- 10. Dark gray paint (black and white particles)
- 11. Current paint layer, black paint

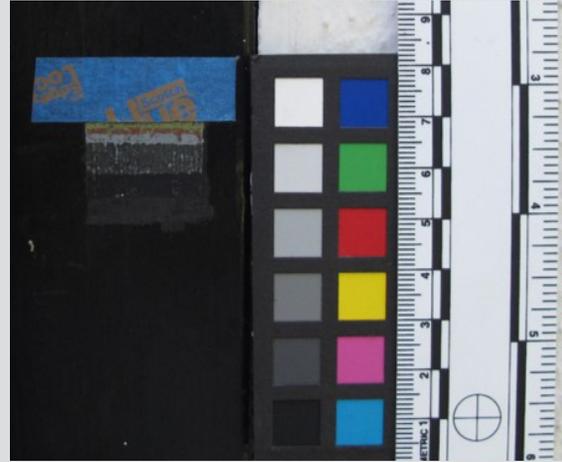
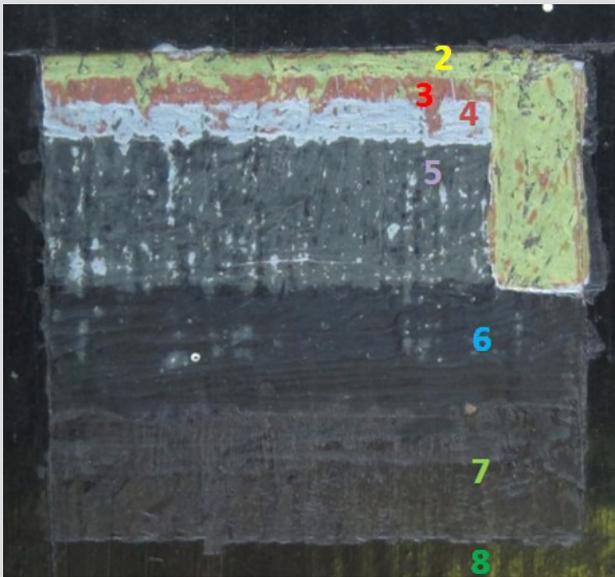
FIGURE 2.12B
Studio_north, in situ paint excavation exposure window.

FIGURE 2.12C
Studio_north, in situ paint excavation exposure window.

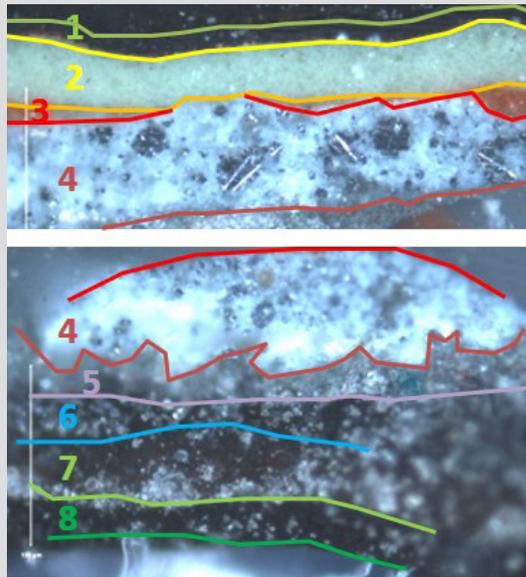
FIGURE 2.12D
Studio_north, cross section photomicrographs of one sample in two fragments with stratigraphic layers numbered (reflected visible light, 50x), the sample fractured during mounting.

- 0. Steel, (not included in cross section)
- 1. Black primer
- 2. Yellow-green primer
- 3. Orange primer
- 4. Light gray corrosion inhibitor (contains Zn particles)
- 5. Warm gray paint (white, black, red, yellow, blue-green particles), the first exterior paint layer
- 6. Dark gray paint (black, white, and red particles)
