Eames House Conservation Project: Investigations 2011 to 2016

Research Report

Edited by Laura Matarese
with Chandler McCoy and Gail Ostergren

The Getty Conservation Institute

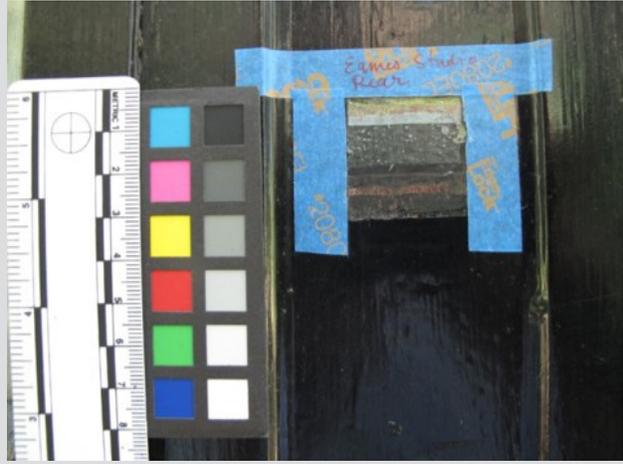
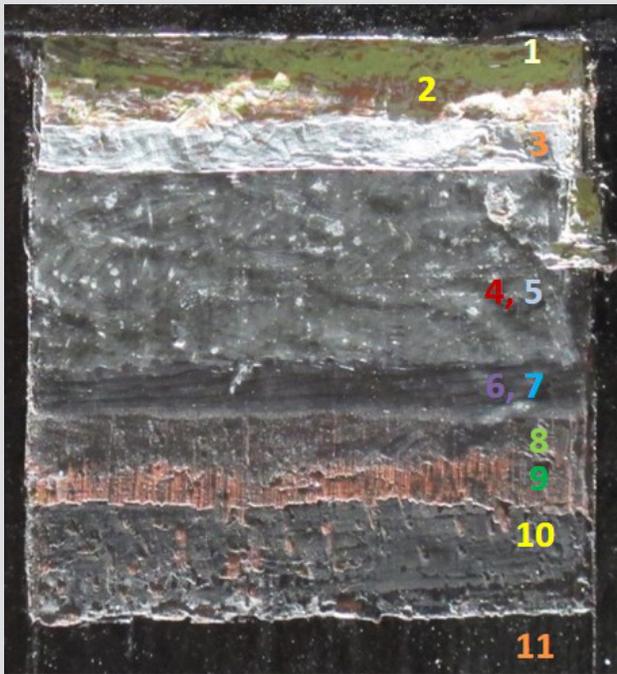
FIGURE 2.13B
Studio_west, in situ paint excavation exposure window.

FIGURE 2.13C
Studio_west, in situ paint excavation exposure window.

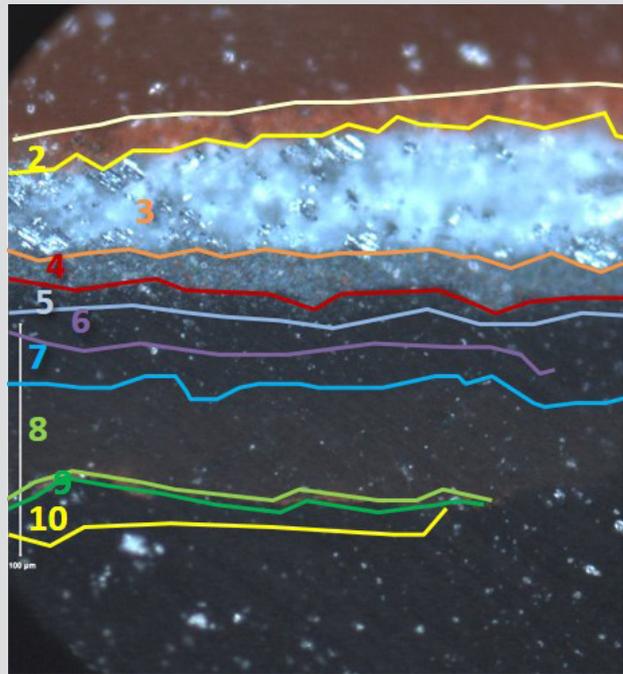
FIGURE 2.13D
Studio_west, cross section photomicrograph, with numbered layers (reflected visible light, 50x).

| <ul style="list-style-type: none"> 0. Steel, (not included in cross section) 1. Primer, yellow-green (not included in cross section) 2. Primer, orange 3. Corrosion inhibitor 4. Warm gray paint (white, black, red, yellow, blue-green particles), the first exterior paint layer 5. Dark gray paint (black, white, and red particles) | <ul style="list-style-type: none"> 6. Black paint (uniform black particle content) 7. Black paint (uniform black particle content) 8. Brown layer, possibly a waterproofing layer 9. Primer, orange 10. Dark gray paint (black and white particles) 11. Current paint layer, black paint (not included in cross section) |

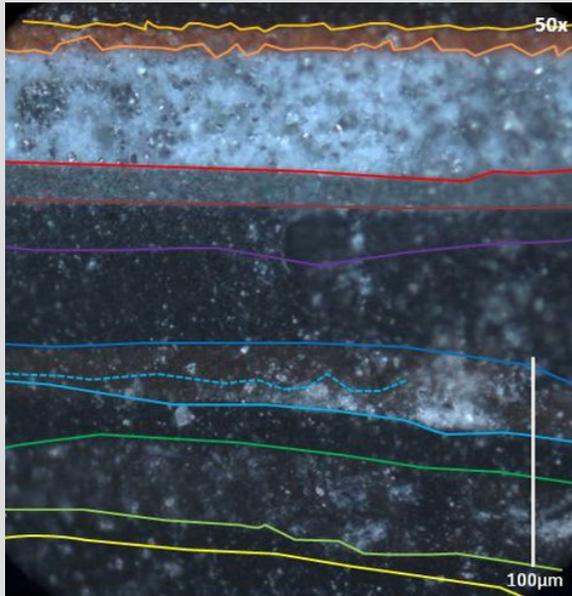
House_north

FIGURE 2.14A
House_north, cross section photomicrograph, with stratigraphic layers numbered (reflected visible light, 50x).

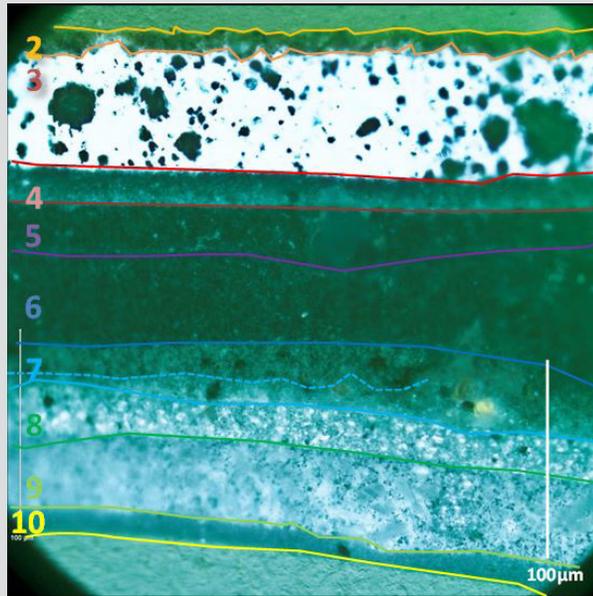
FIGURE 2.14B
House_north, cross section photomicrograph, with stratigraphic layers numbered (reflected ultraviolet light, 50x).

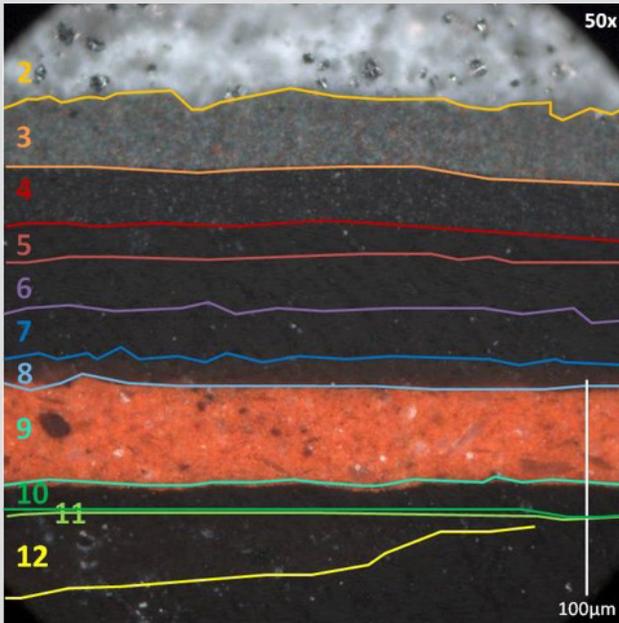
House_east

FIGURE 2.15A
House_east, cross section photomicrograph, with stratigraphic layers numbered (reflected visible light, 50x).

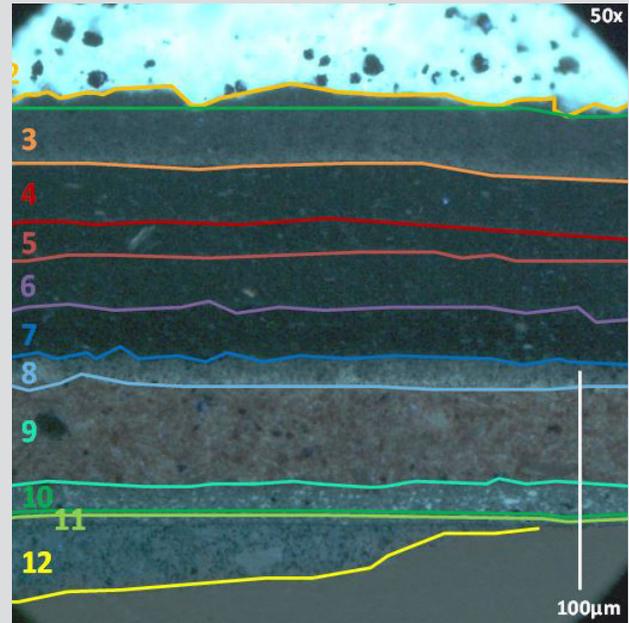
FIGURE 2.15B
House_east, cross section photomicrograph, with stratigraphic layers numbered (reflected ultraviolet light, 50x).

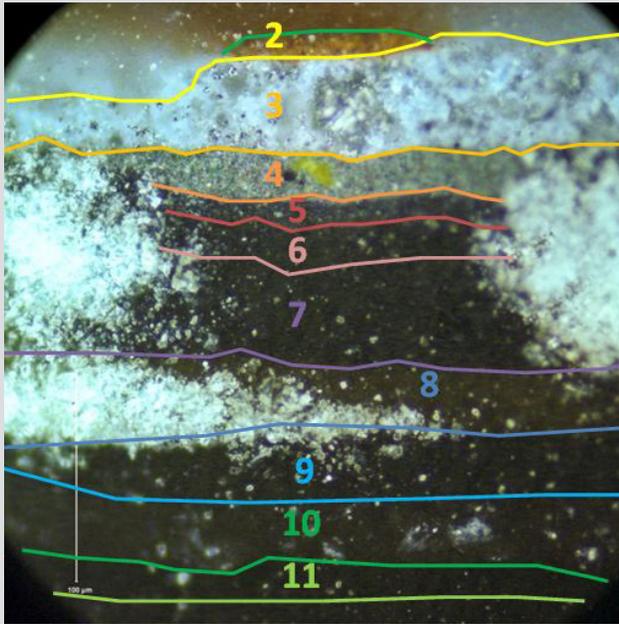
FIGURE 2.16A

House_west, cross section photomicrograph, with stratigraphic layers numbered (reflected visible light, 50x).

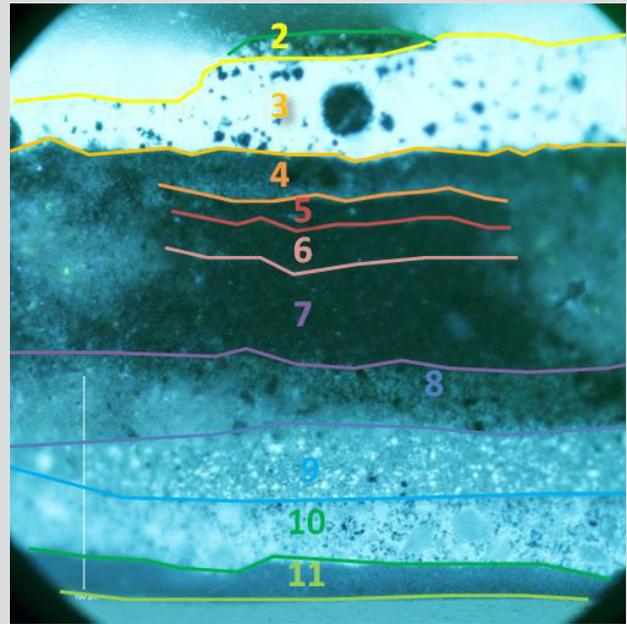
FIGURE 2.16B

House_west cross section photomicrograph, with stratigraphic layers numbered (reflected ultraviolet light, 50x).

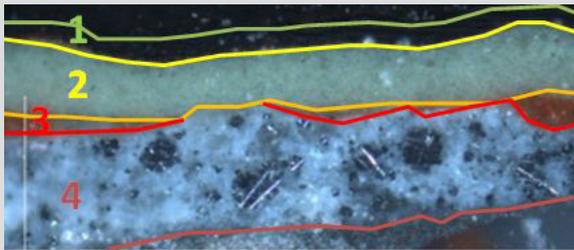
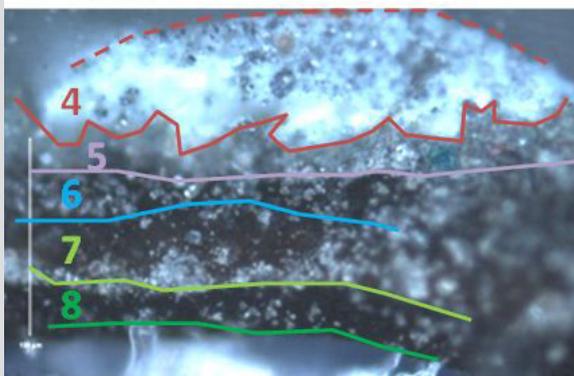
FIGURE 2.17A

Studio_north, cross section photomicrograph, with stratigraphic layers numbered (reflected visible light, 50x).

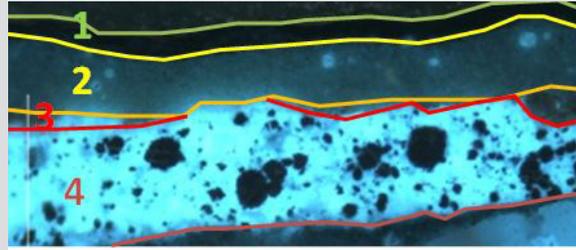
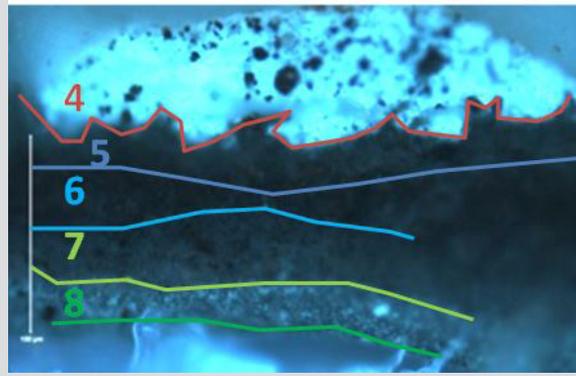
FIGURE 2.17B

Studio_north cross section photomicrograph, with stratigraphic layers numbered (reflected ultraviolet light, 50x).

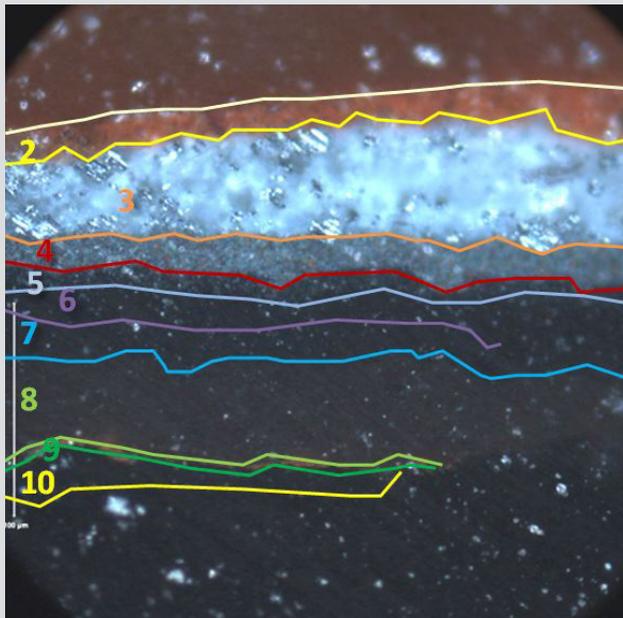
FIGURE 2.18A

Studio_west, cross section photomicrograph, with stratigraphic layers numbered (reflected visible light, 50×).

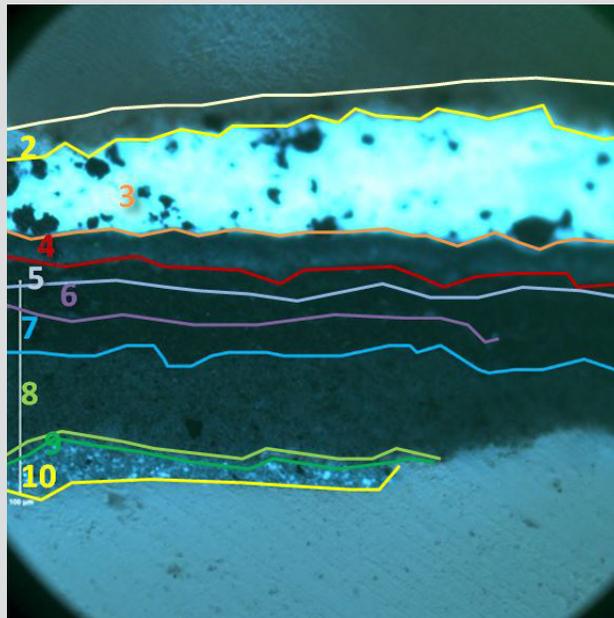
FIGURE 2.18B

Studio_west cross section photomicrograph, with stratigraphic layers numbered (reflected ultraviolet light, 50×).

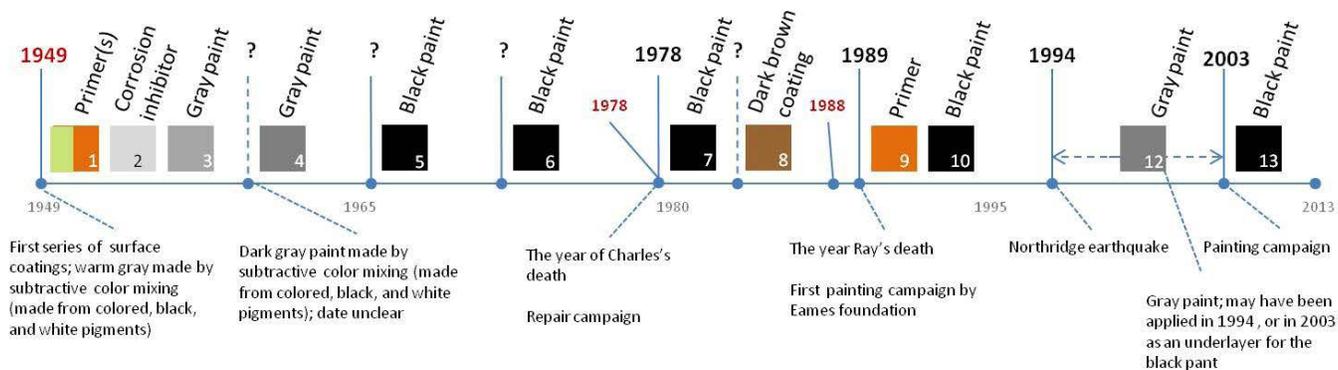
FIGURE 2.19

The results of the paint investigations at the Eames House residence and studio show between eight and thirteen layers, organized in six to eight painting campaigns between 1949 and 2013 (fig. 2.19). The samples from the exterior metalwork give evidence for repeated campaigns of priming and painting, and the residence and studio show nearly the same painting history.

Estimated timeline of the Eames House exterior paint history. The timeline shows estimated dates for each painting campaign and notes regarding each date or approximate date. Each layer is numbered and each generation is separated with a vertical line that signifies a specific date. The three significant dates are indicated in red. Known dates for paint generations are identified wherever possible and approximate dates are noted with a question mark (e.g. 1978?). Dotted vertical lines and horizontal arrows represent unknown temporal differences between the paint layers on both sides.

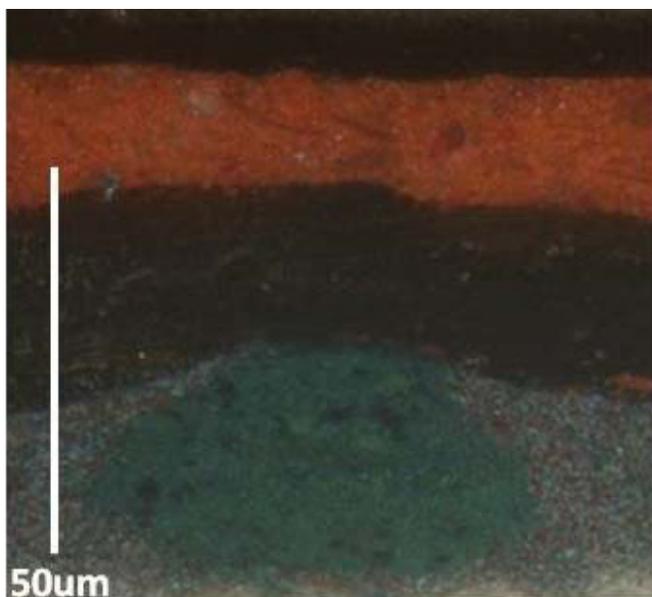
Both gray paints are made by subtractive color mixing (see chapter 1). The dark gray paint is comprised of black, white, and red particles; similarly, the warm gray is comprised of white, black, green, red, and yellow particles, but is more abundant in red particles (figs. 2.20–2.21). The subsequent paint layers, several blacks and another gray, do not exhibit subtractive color mixing, but are instead made of exclusively black or black and white pigments. Because the two lowest gray paints are made by a painterly method of subtractive color mixing, and are mixed from similar materials in different quantities, it suggests both the dark gray and warm gray paints were made and applied when Charles and Ray Eames were living at the Eames House.

FIGURE 2.20
Cross-sectional photomicrograph of sample taken from putty fragment, showing a large blue-green pigment aggregate and very fine red particles in the gray layer.

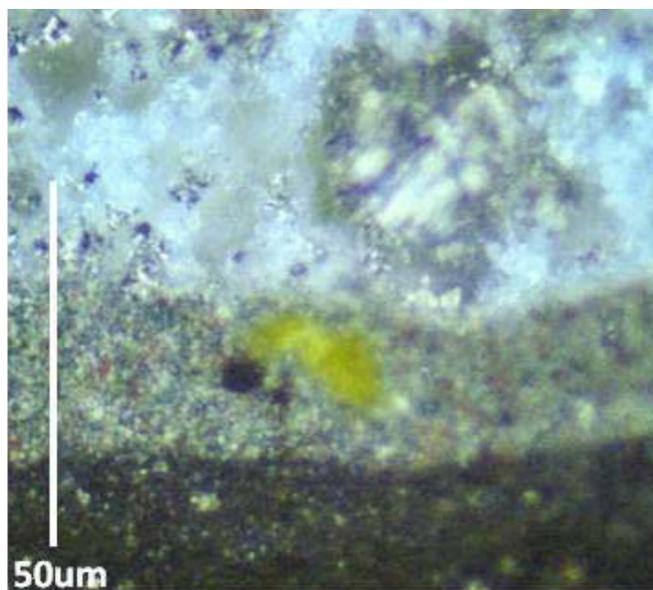
FIGURE 2.21
Cross-sectional photomicrograph of sample taken from exterior paint, showing a large yellow pigment aggregate and very fine red particles in the gray layer. Note the metallic zinc particles in the adjacent layer.

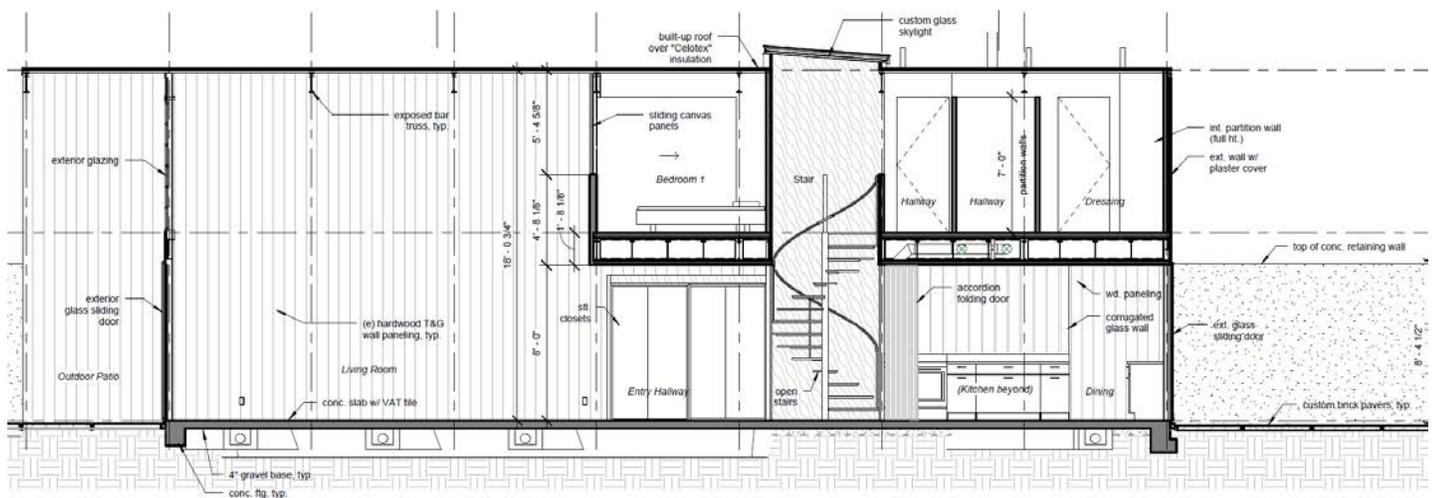
FIGURE 3.2

The wood paneling is located along the west wall of the Eames House residence (fig. 3.1). In the living room, the double-height west wall is clad entirely in vertical wood boards. This wood paneling extends along the covered section of the external west wall of the south courtyard, giving continuity to the length of the living room wall (fig. 3.2). A gold-painted

The wood paneling extends along the covered section of the external west wall of the south courtyard, giving a continuity to the length of the living room wall, 2011.

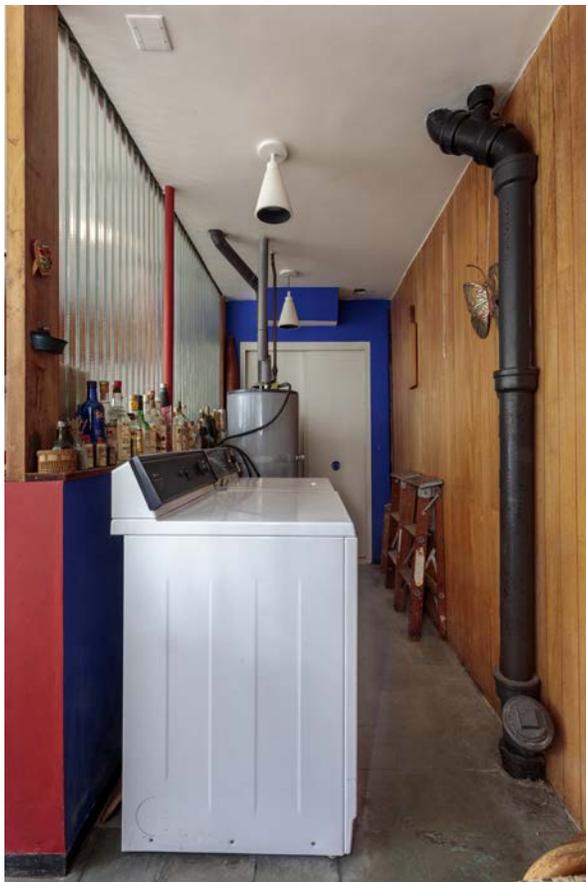
The wood paneling extends into the utility room behind the kitchen of the residence, 2016.

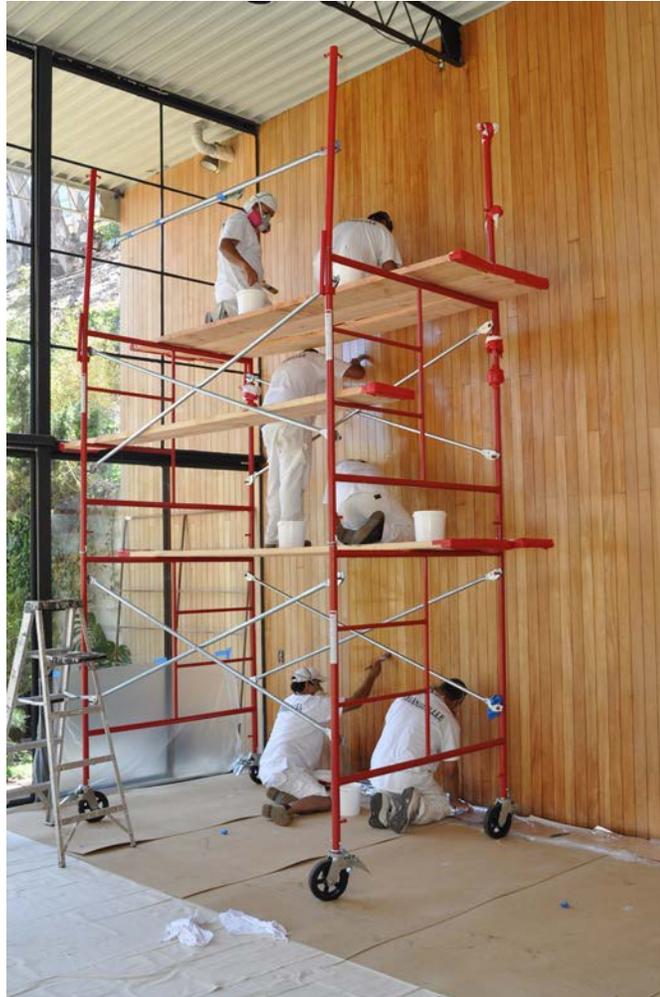
Contractors undertaking conservation treatment on the wood paneling in the living room, 2012.

solution, using a spray gun. He tinted the resin solution with TransTint dyes produced by J. B. Jewitt Co of Cleveland, Ohio, which are very light stable colorants reportedly based on Orasol dyes made by Ciba-Geigy.

4. Some small areas of particularly heavy staining that were not entirely removed by cleaning were in-painted using powdered pigments mixed into the resaturating varnish.

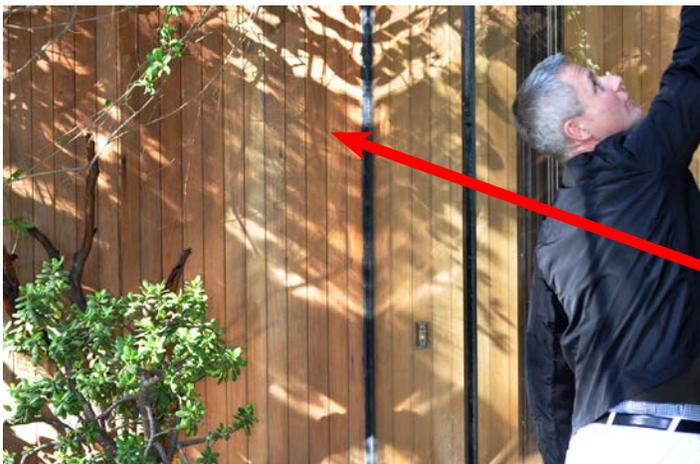
Sample PNL-5 Full thickness cuttings with all layers. Suitable for cross section analysis and/or layer by layer unpacking. Relatively well preserved area of varnish.

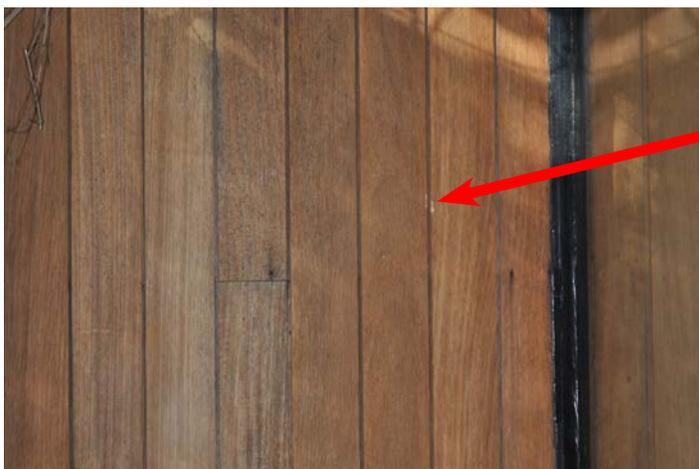
PNL-5a Scrapings of varnish adjacent to PNL-5. I tried to scrape all layers down to the wood. I did not detect any kind of waxy surface coating here.

Sample PNL-5a collected from an exterior wood panel showed the presence of calcium oxalate in the white area observed under the polarizing filters (see spectrum 8). The analysis result from the slight beige area showed the presence of wood fibers, oil and possible calcium oxalate (see spectrum 9). The presence of oil may indicate additional applications of coatings to the exterior panels.

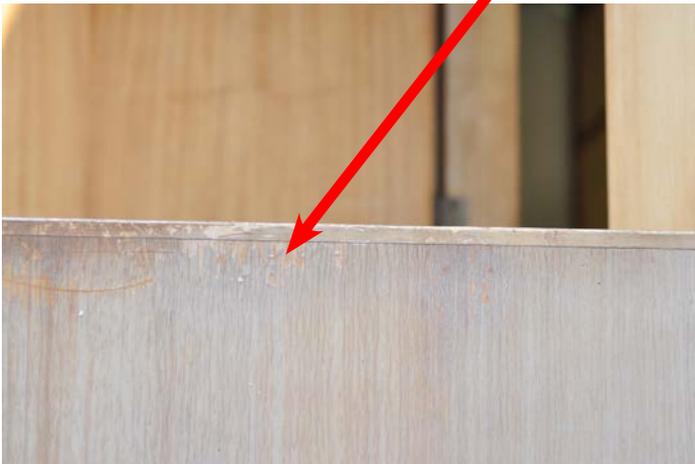
One sample (PNL-6) was also taken of the deteriorating coating on the wood paneling at the top of the stairwell. This sample is a fragment of flaking varnish (removes with tweezers) that represents the full thickness of the coating.

Sample PNL-6 Full thickness flake of deteriorated varnish.

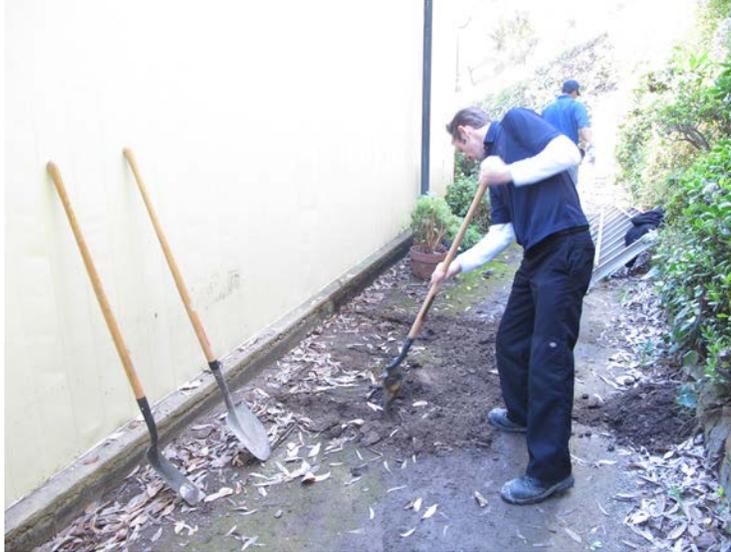
**FIGURE 4.19**

Pit during excavations, 2012.

The excavation ceased at the depth of approximately 5 ft. (1.52 m) due to soil compaction. In order to characterize the soil and analyze its water content, 50–80 mL of soil samples were collected in sealed containers starting at the 18 in. (45.72 cm) depth at approximately 1-foot intervals. The analysis was carried out by the GCI Science Department and included grain size, soil type, water content, and humidity. Two methods were used to determine water content in the soil samples. First, several 10-gram samples of the soil samples were analyzed using the gravimetric method, which determines the soil moisture by weighing the difference of the soil before and after oven drying (at 212°F for forty-eight hours). Second, the volumetric water content (VWC) was measured by placing sensors in the excavated pit. The VWC differs from the gravimetric water content (moisture content by weight); it is the product of the gravimetric water content and the bulk density of soil. The bulk density normally ranges from 0.5 for an aggregated clayey soil to 1.2 for a sandy soil. However, the bulk density changes with the compaction for the same soil. Volumetric water contents of the soil behind the retaining wall were monitored at depths of ¼ in. (8 cm), ½ in. (15 cm), 1 in. (30 cm), 2 in. (61 cm), 3 in. (91 cm), and 4 in. (122 cm).

During the excavation, the surface of the retaining wall was inspected for cracks and to verify the presence of the waterproofing membrane that was noted in the original architectural drawings. Due to the depth of the excavation, the presence of a French drain could not be confirmed, nor the extent or condition of the waterproofing membrane to the base of the retaining wall.

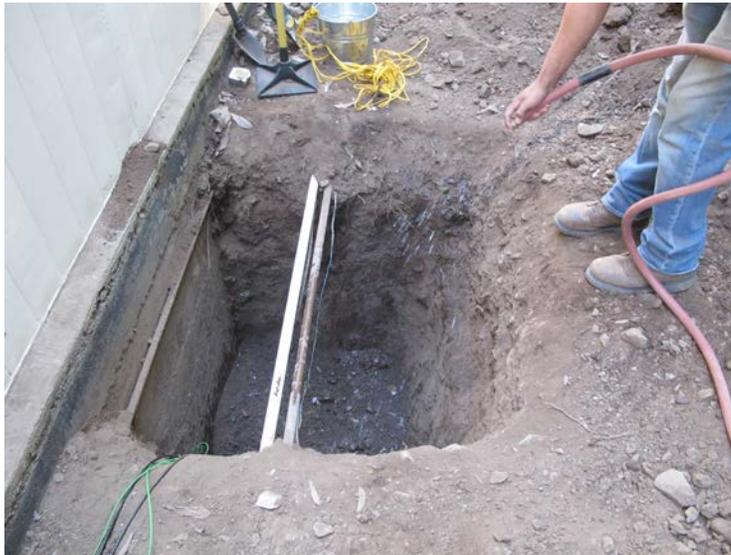
**FIGURE 4.20**

Backfilling the pit and installing sensors, 2012. Photo: Shin Maekawa

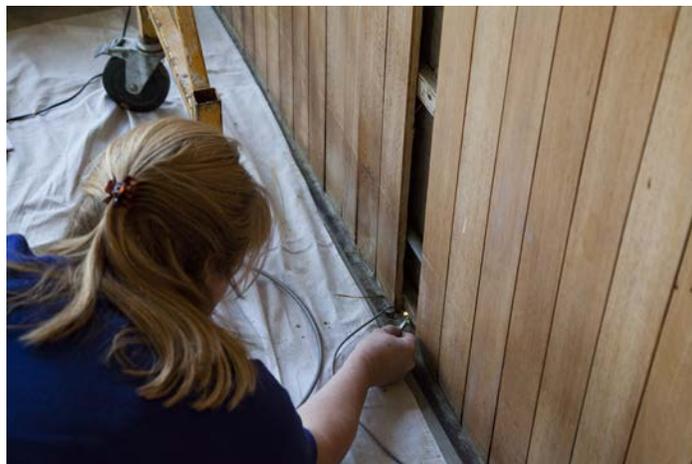
FIGURE 4.21

The condition of the interior surface of the retaining wall was assessed through observation using a borescope (endoscope with light source). On March 26, 2012, one of the vertical wooden planks was removed from the wall panel of the living room and a borescope was used to search for evidence of humidity within the wall cavity (fig. 4.21).

Joy Mazurek (GCI scientist) examines the structure of wooden panel and furring strips using a borescope, 2012. Photo: Holly Brobst

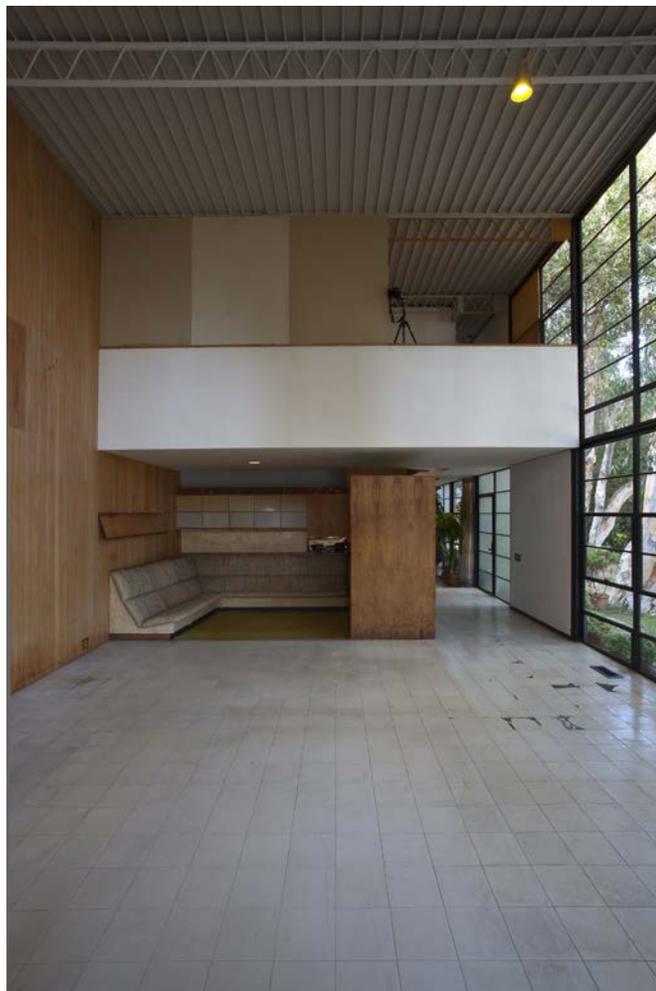
In 2011, while the collections of the living room were temporarily on display at the Los Angeles County Museum of Art, the original asbestos-containing vinyl composite floor tiles of the living room and part of the hallway (fig. 4.22) were removed due to their poor condition and hazardous composition, exposing the concrete floor slab and allowing access to the slab for scientific investigations.

A 2011 consultant's report identified high permeation of water vapor through the floor slab of the residence as the main cause of the deterioration of living room and kitchen floor tiles. The report also suggested that the water vapor permeating the floor slab could be contributing to increased moisture in the residence (D7 Consulting 2011). To further investigate these findings, the GCI conducted temperature and humidity investigations of the floor slab in the living room to determine if these factors contribute to the humidity in the residence and to confirm the need for a moisture vapor barrier as part of the replacement flooring system.

FIGURE 4.22
Picture of the living room in 2011,
with original floor tiles before
removal.

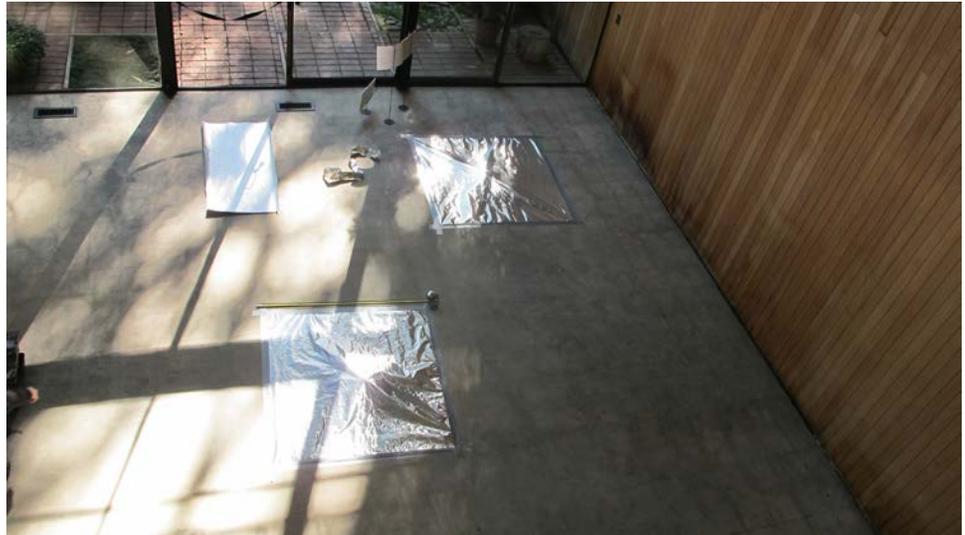
The concrete slab's temperature and humidity were monitored to confirm results by D7 Consulting, who had performed a calcium chloride test (ASTM 1869-04 Standard Test Method) to measure water vapor emission from the slab. On October 27, 2011, three temperature and humidity data loggers were placed in the concrete slab floor of the living room for a week (fig. 4.23). Two were placed directly on different areas of the floor surface and covered with a moisture barrier film with edges taped to the floor with duct tape to isolate the measurement environment from the room; one data logger was placed 5 ft. (152 cm) away from the wood-paneled wall and the other at the center of the living room. The third data logger was placed over the barrier film to measure the ambient temperature and humidity. On November 3, 2011, another two-sensor unit was placed on the floor of the living room—one sensor measured the room environment and the other was located in an existing 8 in. (20 cm) deep hole in the slab floor near the alcove/retaining wall (fig. 4.24). These data loggers continuously recorded temperature and humidity data until November 23, 2011, when the data were downloaded.

FIGURE 4.23
Location of temperature and humidity sensors on floor slab, 2011. Photo: Ana Paula Arato Gonçalves

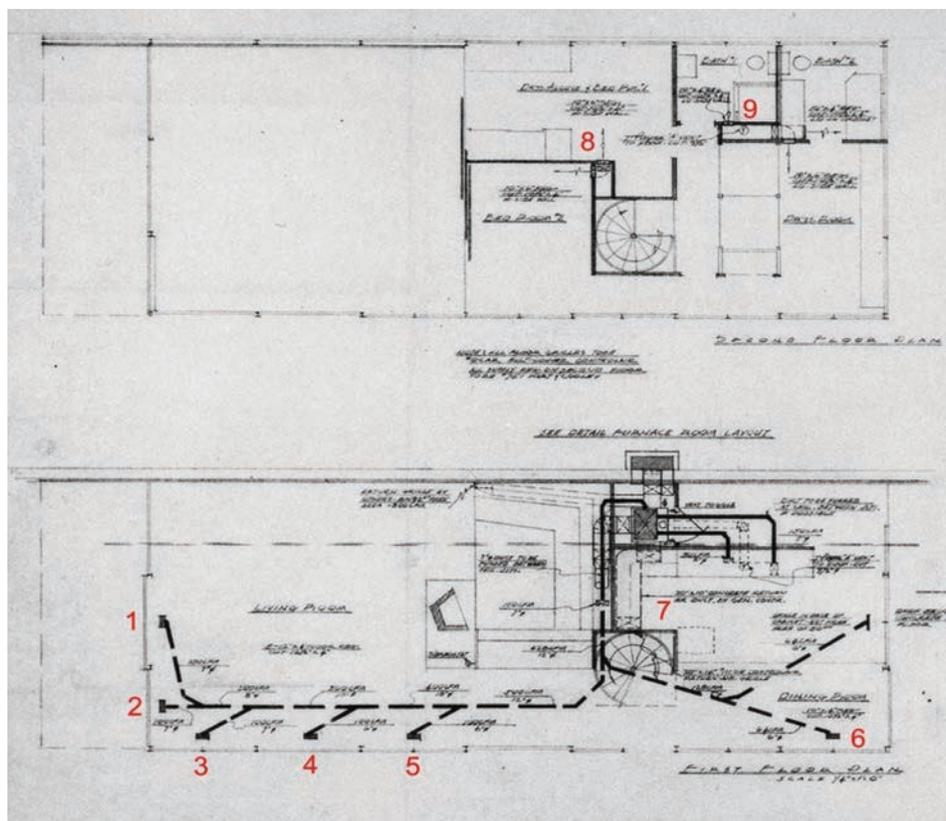
FIGURE 4.26

Eight segments of ductwork were inspected (fig. 4.26). Each length of duct started at a grille vent, which provided an entry point for the camera, and stretched in the direction of the furnace until it encountered an obstacle or reached the main line. Each length of duct was given a number according to the location of the entry point, or grille vent, starting in the living room and moving counterclockwise toward the kitchen and upper floor:

Numbers (1), (3), (4), and (5) identify lengths of duct that started at a grille vent and ended at the junction with the main line. Video recording went further into the main line when possible. Numbers (2) and (6) started at a grille vent and went as far as possible into the main line. Number (7) identifies the inspection of the return duct. Numbers (8) and (9) were located on the second floor and were built into the walls, as opposed to the other

Location and number of inspected duct paths. Drawing: Adapted from Eames House Detail Drawing Sheet 3, dated October 14, 1948, © Eames Office

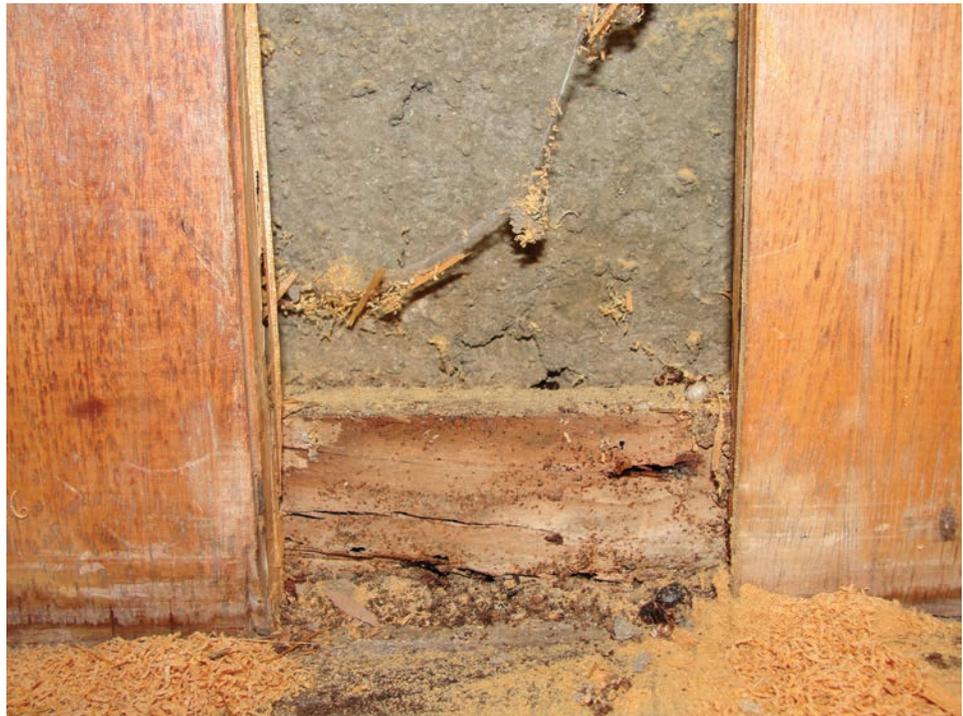
FIGURE 4.47

In the visual inspection performed on March 26, 2012, both the nailing and furring strips were found to be in good condition and are providing adequate support for the wall panel. Only the nailing and furring strips closest to the floor (fig. 4.47) show advanced deterioration. Nails used in the furring strips are lightly rusted and show tidemarks of rust on the wood around them indicating past condensation. Dark stains found on the bottom surface of the wood panel were tested at the GCI laboratories and were found not to contain fungi

Deteriorated condition of the nailing and furring strips closest to the floor, 2012. Photo: Ana Paula Arato Gonçalves

At the base of the retaining wall, the water vapor may have migrated from both the wall, as the condition of the waterproof membrane in this location is not known, and the slab floor (see next section), and remained cooler than exposed areas. Exposure allows heat transfer with the air, warming the surface. There is no natural convection in such a small and limited space, however, resulting in a cool and humid environment and causing the bottom wooden strips to rot.

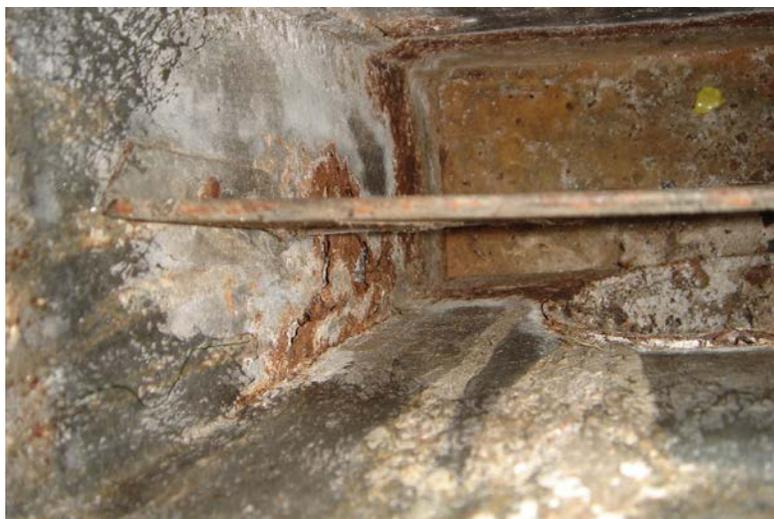
FIGURE 4.48

The inspection identified that more than half of the ducts have various levels of corrosion and disintegration (figs. 4.48–4.49). A summary of observations of each duct that was inspected is outlined in table 4.9. The thin metal heating ducts likely corroded as a result of the moisture content of the concrete floor slab. Condensation of moisture vapor on the

Deteriorated condition of the metal lined heating duct at a floor vent in the living room, 2011. Photo: David Carson

The investigation indicated that the ducts could possibly be thoroughly cleaned and relined for use, since the surrounding concrete appears to be in good condition.

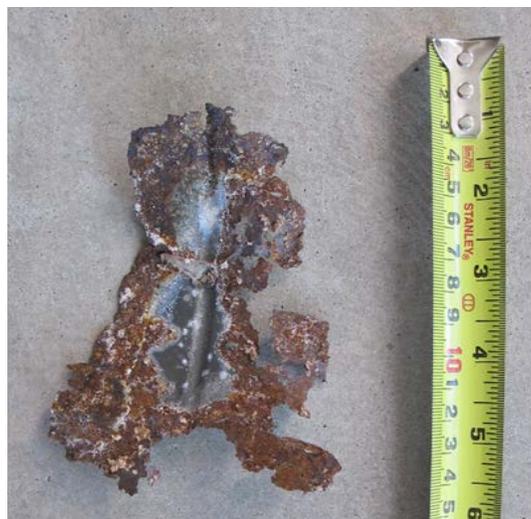
FIGURE 4.49

Debris sample of the deteriorated metal lining from a heating duct, 2011. Photo: Ana Paula Arato Gonçalves

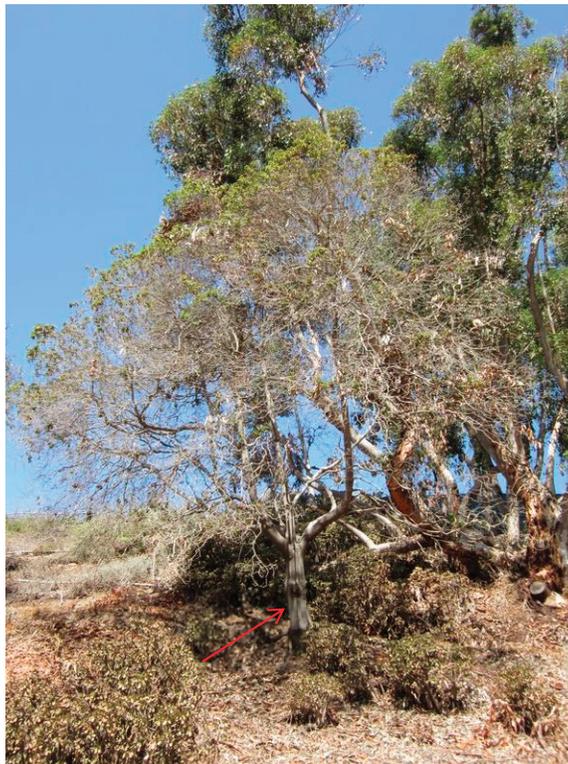
Tree Number: 2		Common Name: Victorian box	
		Botanical Name: <i>Pittosporum undulatum</i>	
Trunk Diameter: 9.5 (in inches)		Approximate Height Range: 0 - 20 (in feet)	
		S.U.L.E. Rating: Short	
Physiological Condition: C-	Structural Condition: B+	Volunteer: No (Y/N)	Pre-1949: No (Y/N)
Comments: In irreversible decline; likely drought, disease			
Recommendations: Remove

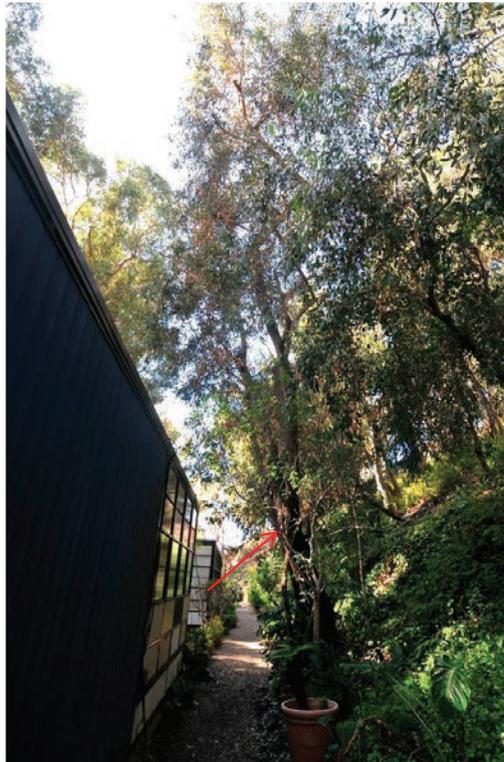
Tree Number: 71		Common Name: Red ironbark	
		Botanical Name: <i>Eucalyptus sideroxylon</i>	
Trunk Diameter: 10.5, 14 (in inches)		Approximate Height Range: 60+ (in feet)	
		S.U.L.E. Rating: Short	
Physiological Condition: B+	Structural Condition: C+	Volunteer: No (Y/N)	Pre-1949: Confirmed from historical photos (Y/N)
Comments: Next to building; heavily topped			
Recommendations: Phased removal

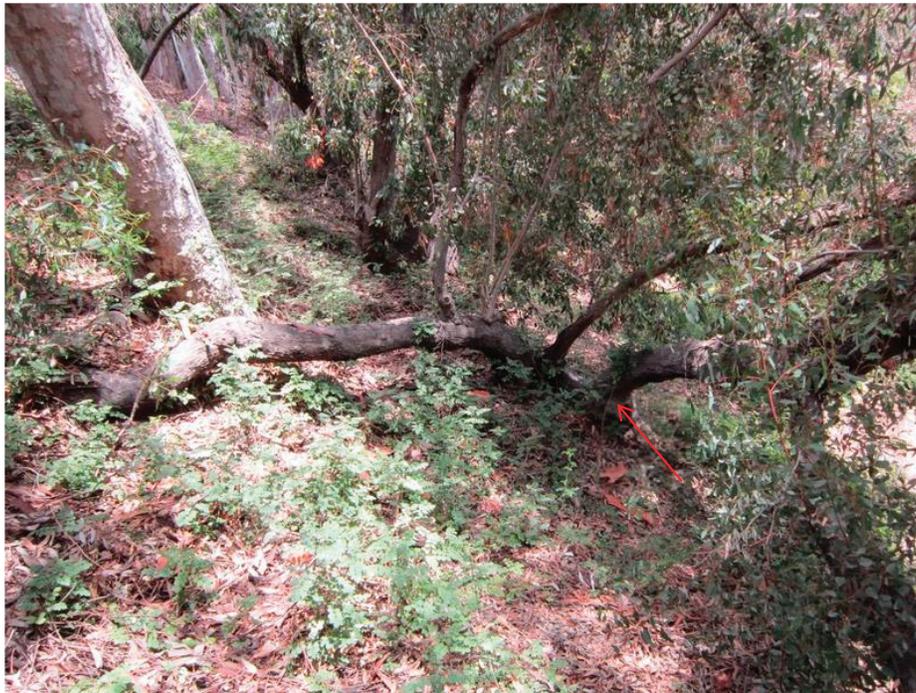
Tree Number: 82		Common Name: Flooded gum	
		Botanical Name: <i>Eucalyptus rudus</i>	
Trunk Diameter: 4, 8, 10.5 (in inches)		Approximate Height Range: 20 - 40 (in feet)	
		S.U.L.E. Rating: Medium	
Physiological Condition: B	Structural Condition: B-	Volunteer: No (Y/N)	Pre-1949: Unconfirmed; not likely (Y/N)
Comments: Bees in trunk; may indicate large pocket of decay; wouldn't damage much if this section failed. (no target)			
Recommendations:

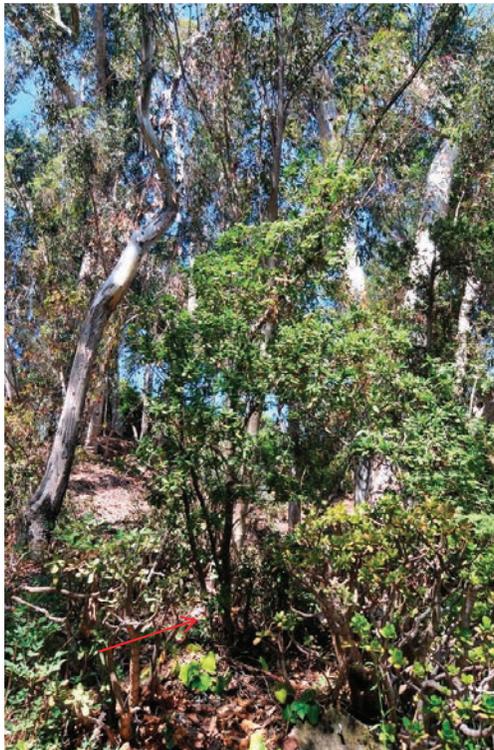
Tree Number: 102		Common Name: Mock orange	
		Botanical Name: <i>Pittosporum tobira</i>	
Trunk Diameter: 3, 3.5 (in inches)		Approximate Height Range: 0 - 20 (in feet)	
		S.U.L.E. Rating: Long	
Physiological Condition: A-	Structural Condition: B-	Volunteer: No (Y/N)	Pre-1949: No (Y/N)

Comments: Topped**Recommendations:**

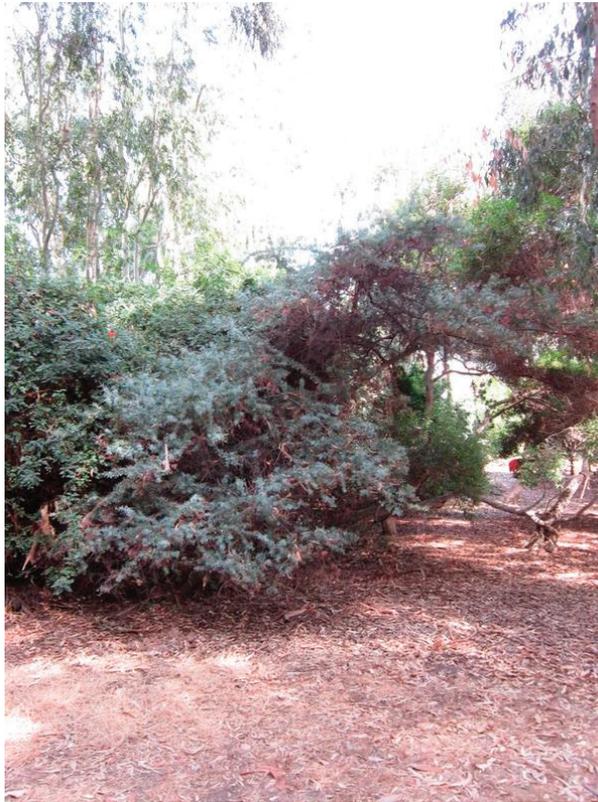
Tree Number: 160		Common Name: Silver acacia	
		Botanical Name: <i>Acacia dealbata</i>	
Trunk Diameter: 4 (in inches)		Approximate Height Range: 0 - 20 (in feet)	
		S.U.L.E. Rating: Medium	
Physiological Condition: A-	Structural Condition: B	Volunteer: No (Y/N)	Pre-1949: No (Y/N)

Comments: Leans to the south

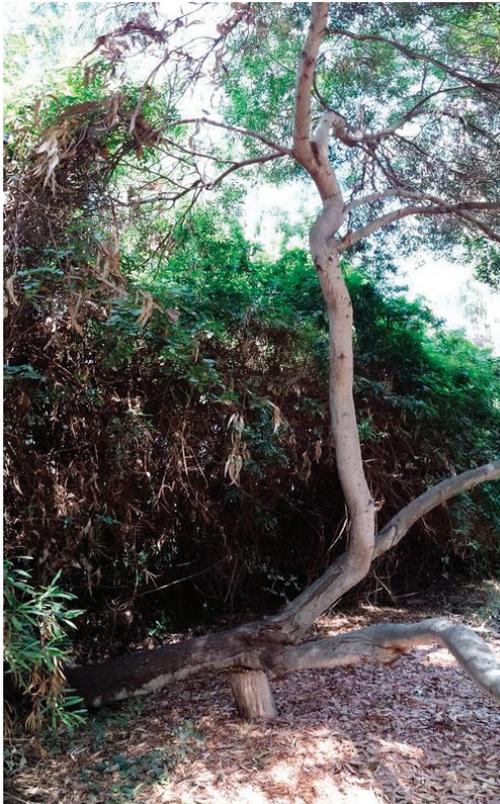
Tree Number: 164		Common Name: Sydney golden wattle	
		Botanical Name: <i>Acacia longifolia</i>	
Trunk Diameter: 11 (in inches)		Approximate Height Range: 20 - 40 (in feet)	
		S.U.L.E. Rating: Medium	
Physiological Condition: A-	Structural Condition: B-	Volunteer: No (Y/N)	Pre-1949: No (Y/N)

Comments: Lying on side; still "healthy"

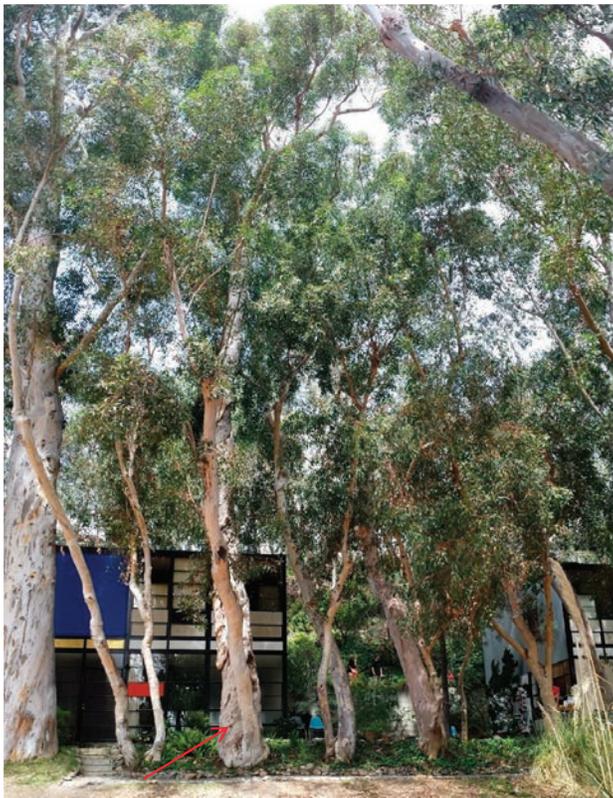
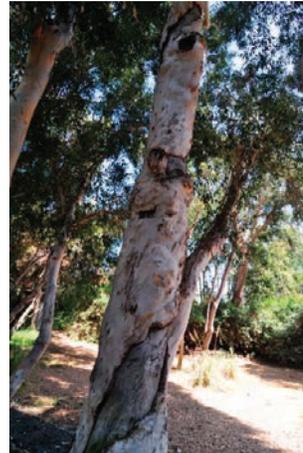
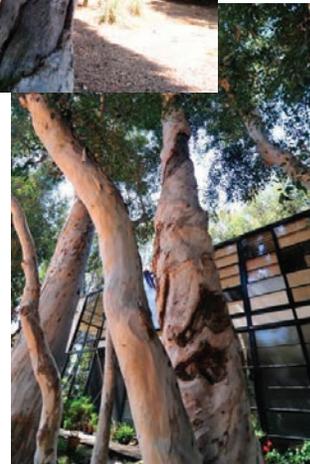
TREE EVALUATION FORM – EAMES House 203 Chautauqua Boulevard, Los Angeles, California Date of Inspection: July 2014			
Tree Number: 224		Common Name: Red gum Botanical Name: <i>Eucalyptus camaldulensis</i>	
Trunk Diameter: 12, 32.5 (in inches)		Approximate Height Range: 60+ (in feet)	S.U.L.E. Rating: Short
Physiological Condition: B+	Structural Condition: C-	Volunteer: No (Y/N)	Pre-1949: Confirmed from historical photos (Y/N)
Comments: Dead wood tissue within spiral (barber pole); better pruning than most			
Recommendations: 1 st removal of this row

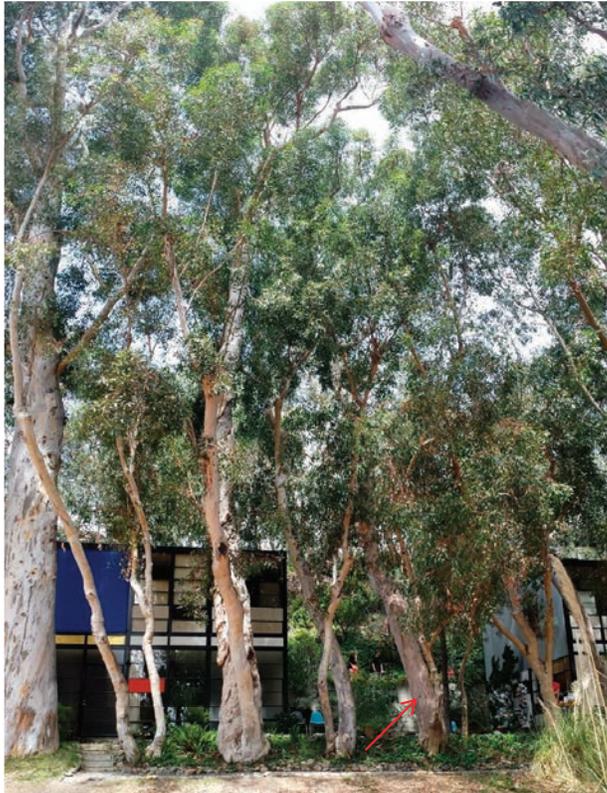
Tree Number: 226		Common Name: Red gum	
		Botanical Name: <i>Eucalyptus camaldulensis</i>	
Trunk Diameter: 5, 22 (in inches)		Approximate Height Range: 60+ (in feet)	
		S.U.L.E. Rating: Medium	
Physiological Condition: B+	Structural Condition: B	Volunteer: No (Y/N)	Pre-1949: Confirmed from historical photos (Y/N)

Comments: Better pruning than most

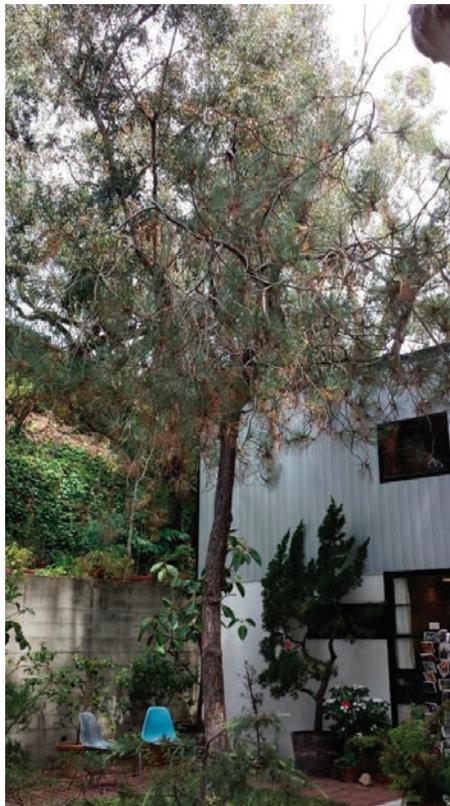
Tree Number: 228		Common Name: Torrey pine	
		Botanical Name: <i>Pinus torreyana</i>	
Trunk Diameter: 8 (in inches)		Approximate Height Range: 20 - 40 (in feet)	
		S.U.L.E. Rating: Medium	
Physiological Condition: B-	Structural Condition: B	Volunteer: No (Y/N)	Pre-1949: No (Y/N)
Comments: Misshapen from prior pruning; could be restoratively pruned			
Recommendations: Restoratively prune
