Eames House Conservation Project: Investigations 2011 to 2016

Research Report

Edited by Laura Matarese
with Chandler McCoy and Gail Ostergren

The Getty Conservation Institute

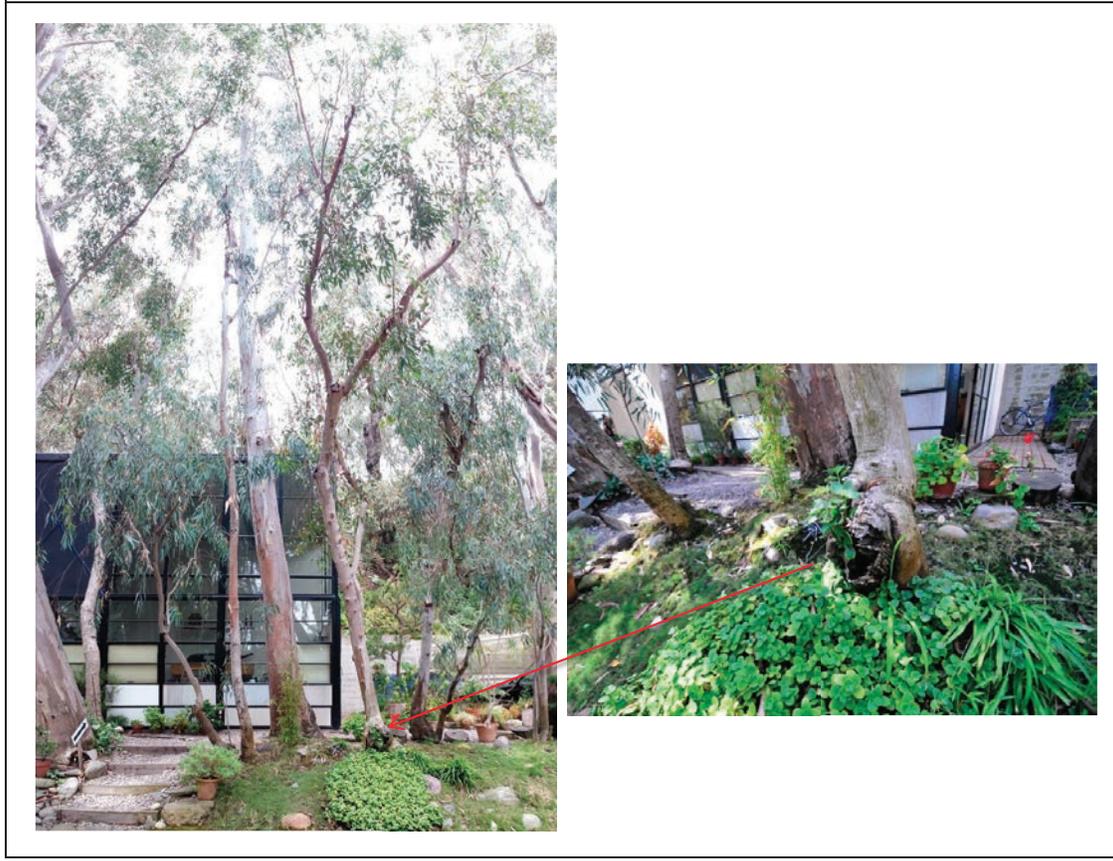
Tree Number: 240		Common Name: Red gum	
		Botanical Name: <i>Eucalyptus camaldulensis</i>	
Trunk Diameter: (in inches)	7	Approximate Height Range: (in feet)	20 - 40
		S.U.L.E. Rating:	Medium
Physiological Condition:	B	Structural Condition:	C-
		Volunteer: (Y/N)	Yes
		Pre-1949: (Y/N)	No

Comments: Large basal trunk wound with associated wood decay; leans to east; topped
