3.4 Geological and Environmental Description

3.5 Structural Description

3.6 Irregularities, Alterations, Damages, and Decay

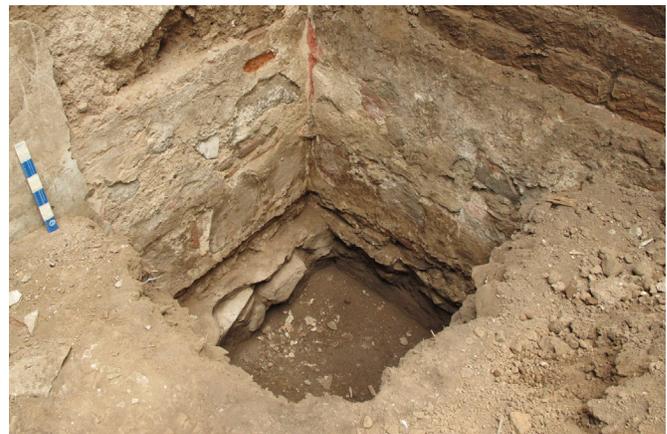
FIGURES 3.22 (TOP) AND 3.23 (BOTTOM)
Prospection IS-2, showing the foundation and base course at the northeast side of room 118 (the collapsed area).
Drawing: Mirna Soto, for the GCI.

The foundation and base course appear to be in fair condition overall, and the masonry is generally cohesive. In those areas that were opened up for the structural inspections, humidity was observed in the soil. This humidity is likely the result of improper site drainage in the patios of Hotel El Comercio and the adjacent casona. As a result of this humidity, disaggregation was noticeable at the soil layer above the rocky soil, particularly in the collapsed area of room 118.

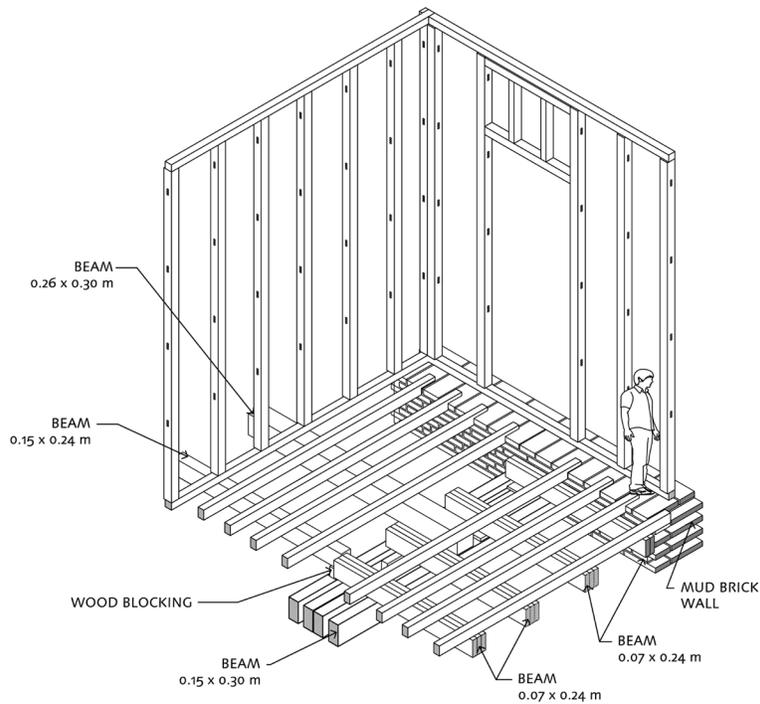
FIGURE 3.37 (TOP)

boards which serve as the finish floor. The space between the sleepers is filled with a mud and lime-based mixture. The third story floor construction is similar, but without overlapping beam ends. It is important to mention that the quincha partition wall between rooms 243 and 244 does not align with the floor beams which would have originally been embedded at the top of the now removed mud brick wall below. This suggests inadequate construction or later alteration of the second floor walls.

Prospections IIS-1 (room 243), showing the second floor construction above El Cordano bar with overlapping beams.
Drawing: Mirna Soto, for the GCI.

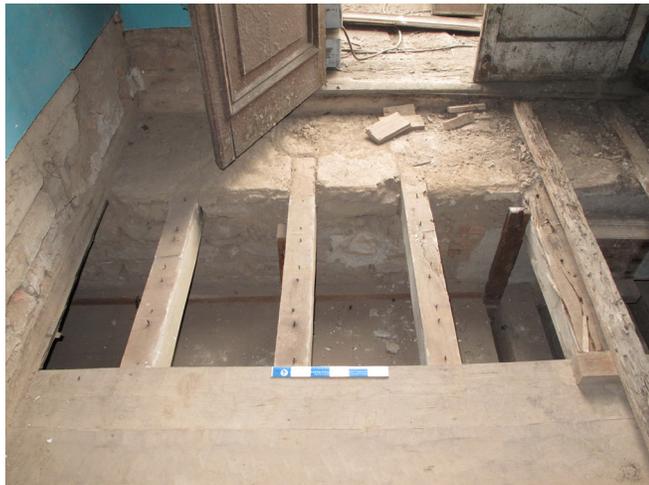
FIGURES 3.39 AND 3.40 (TOP AND BOTTOM)

Prospection IIS-1, showing the overlapping beam ends, which presumably relate to the removal of a wall in the bar below.
Image: Mirna Soto, for the GCI.

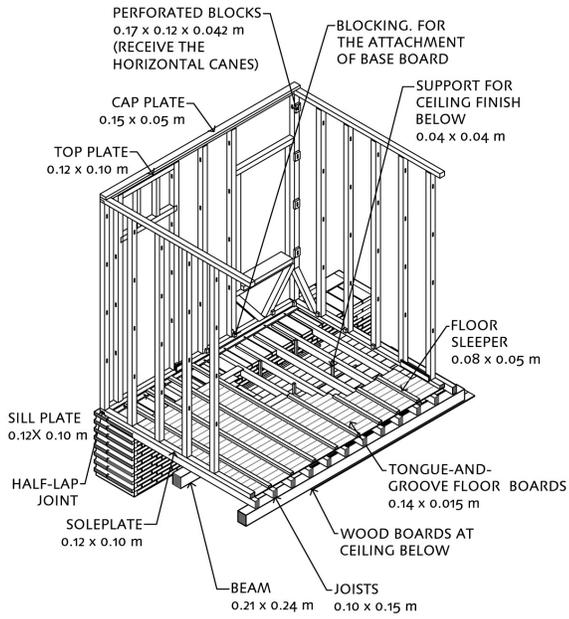
A slightly different configuration was observed at the floor structure in rooms 204 and 306 through prospections IIW-3 and IIIS-2 (Figs. 3.41, 3.43). In this area, the wood beams run parallel to the long façade at Jirón Carabaya with perpendicular joists above. The second floor joist ends are pocketed into the mud brick walls, and the third floor joist ends rest on a sole plate tie over the second floor quincha frames. Over the joists there is another layer of wood framing, wood boards, and sleepers with a mud and lime-based soil infill between them. As with the earlier prospection, the sleepers run in the same direction as the joists. Finally, there is a tongue-and-groove wood plank finish floor.

FIGURE 3.41
Prospection IIW-3, showing the second floor construction at the northwest façade (room 204).
Drawing: Mirna Soto, for the GCI.
