Eames House Conservation Project Cemesto Panel Investigations Phase I

Research Report

Getty
Conservation
Institute

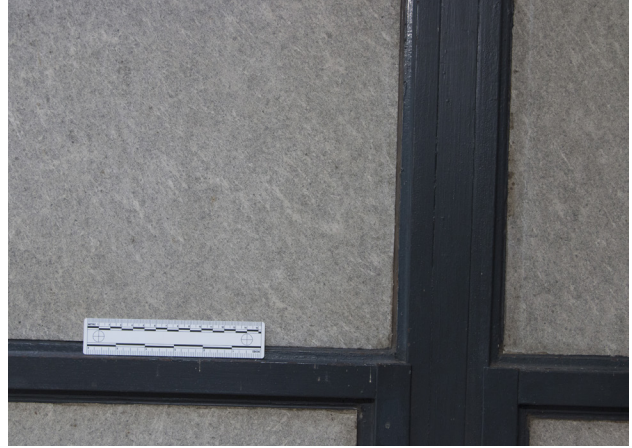
FIGURE 3.4 Photo of Eames House studio interior, east elevation, showing no soiling and the natural mottled gray color of the asbestos-cement board. Photo: Laura Matarese and Chandler McCoy, 2015. ©J. Paul Getty Trust.

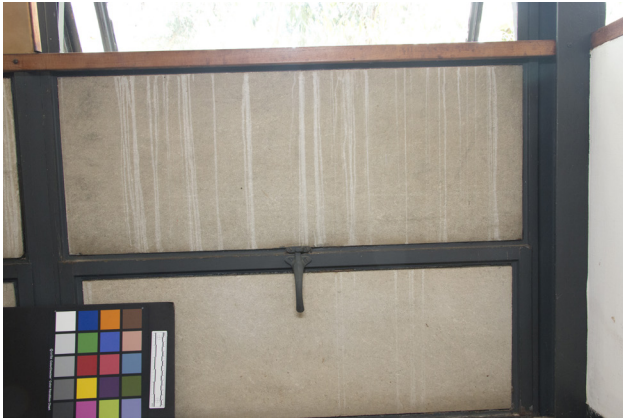
FIGURE 3.5 Photo showing white streaks on panel HE-3-5. Photo: Laura Matarese and Chandler McCoy, 2015. ©J. Paul Getty Trust.

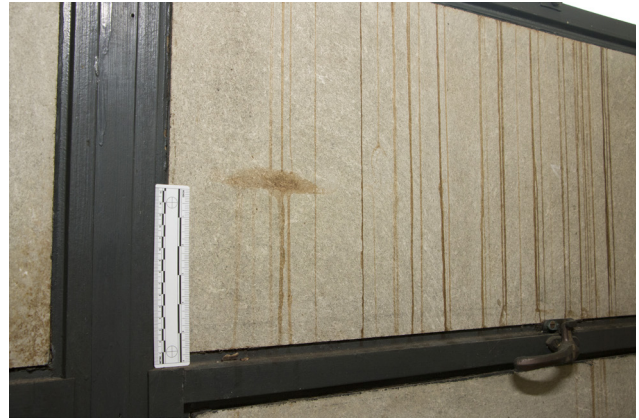
FIGURE 3.6 Photo showing brown marks on panel SW-1-5. Photo: Laura Matarese and Chandler McCoy, 2015. ©J. Paul Getty Trust.

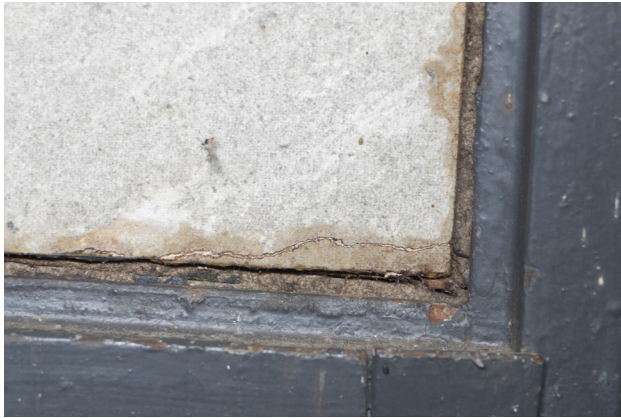
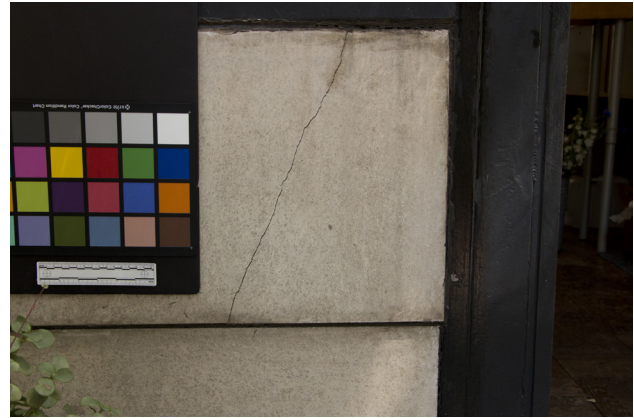
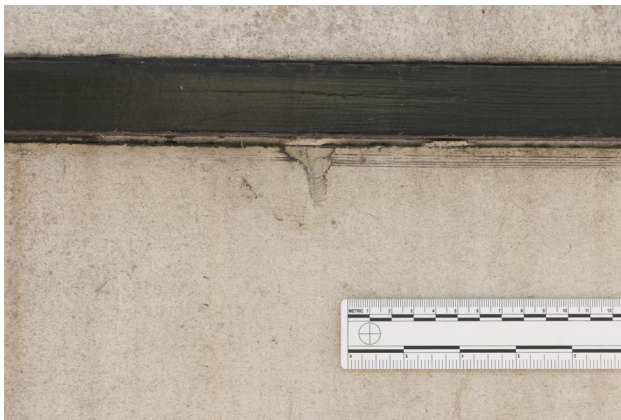
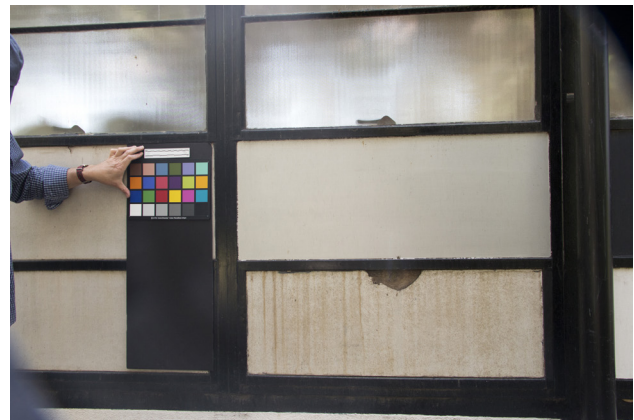
A few panels showed damage such as cracks, dents, and missing pieces (figs. 3.8a–d). On the exterior of the buildings, six of the eighty-seven panel faces had small to large cracks in the asbestos-cement facing, three had small dents in the facing, and ten had small to large missing pieces where part of the facing and fiberboard core had broken off. The interior panel faces of both structures had no cracks, four panels had dents, and four panels had missing pieces.

FIGURES 3.8A–D Examples of damage to panels at the Eames residence and studio: (a) a small crack in the asbestos-cement facing on the studio interior, east elevation; (b) a large crack in the asbestos-cement facing on the studio exterior, south elevation; (c) a small dent in the asbestos-cement facing on the studio exterior, west elevation; and (d) a panel with a large piece missing, exposing the Celotex fiberboard core, on the studio exterior, west elevation. Photos: Laura Matarese and Chandler McCoy, 2015. ©J. Paul Getty Trust.

Cracks, dents, and missing pieces on the exterior panel facings of the residence and studio appear to be caused primarily by physical impacts and other wear and tear. On the west elevation of the residence, dents are located adjacent to a gas meter and to plants in large terra-cotta pots. Impacts to the panels may have been caused by the installation of the gas meter or by moving the terra-cotta pots. The exterior face of one of the panels on the west elevation of the studio exhibits an area that broke away, possibly during the installation of telecommunications and internet wires (see fig. 3.7).

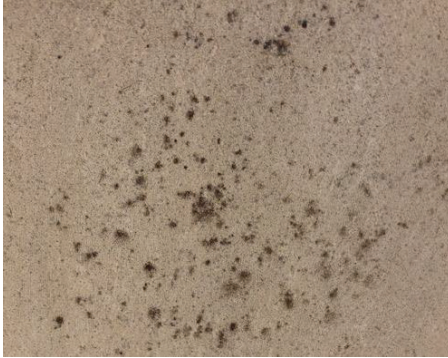
Image 1. Black fungus-like surface deposit on outdoor Cemesto panel. Sample 4.

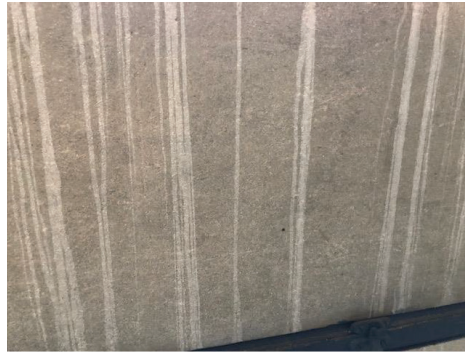
Image 2. White stripes on surface of indoor Cemesto panel (HE-35). Sample 1.

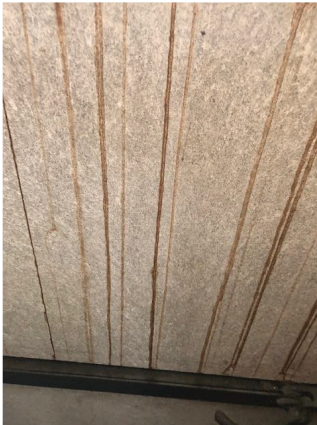
Image 3. Brown drip-like stripes from indoor Cemesto, top office. Sample 8.

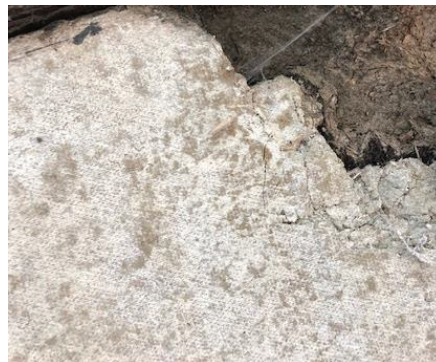
Sample 7 appears to have a speckle like pattern all over the Cemesto (image 4), however microscopic examination did not show evidence of fungal spores. This indicates that the dark speckle-like pattern is not from microbiological activity, and is likely the result of an unknown material used in the manufacturing process

Image 4. Dark speckle-like pattern on outdoor Cemesto panel. Sample 7.

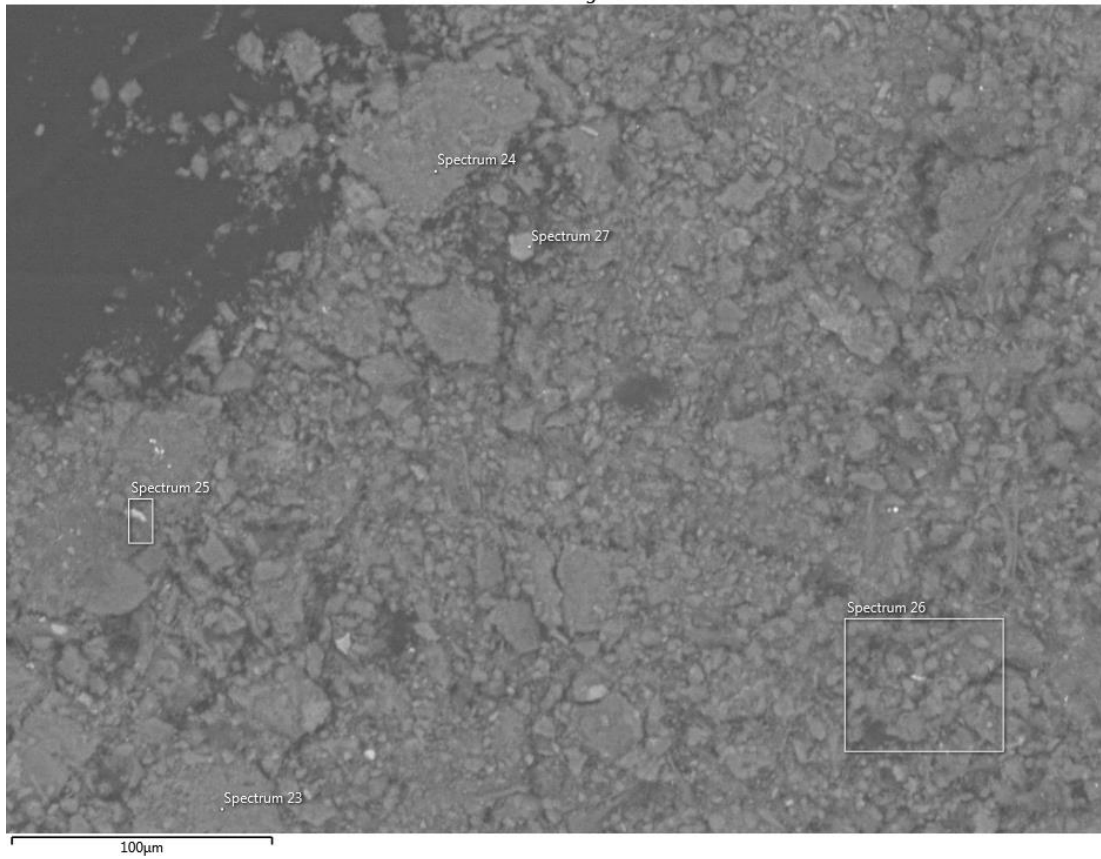
Sample 1. White stripe on Cemesto

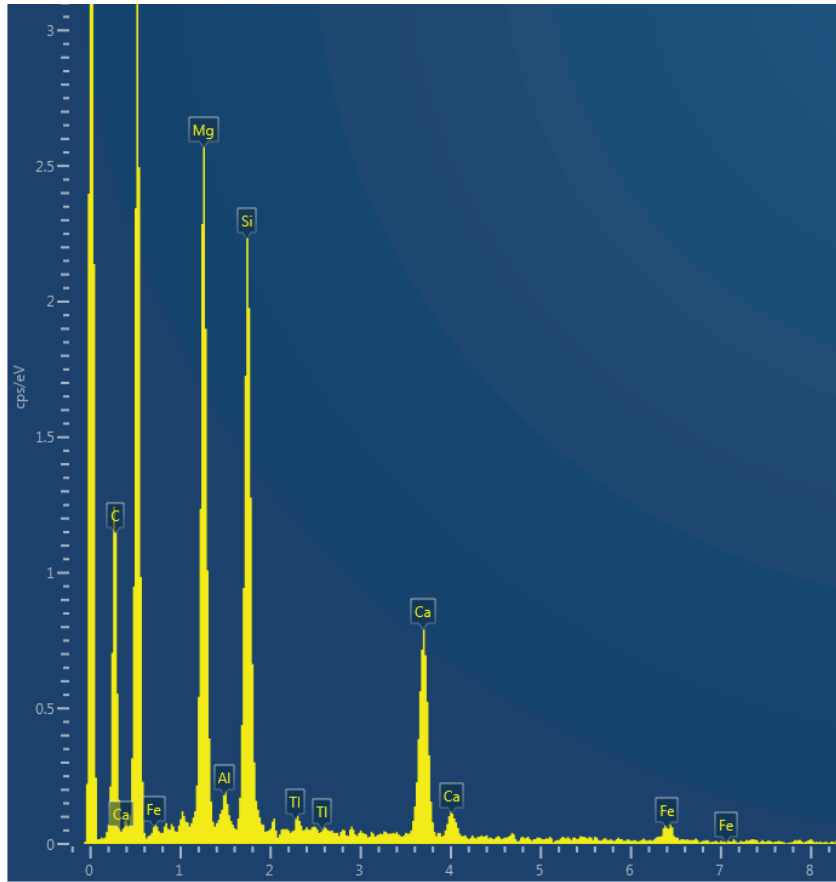
Sample 1. White stripe spectrum 23. Mg, Si, Ca, Fe, Al

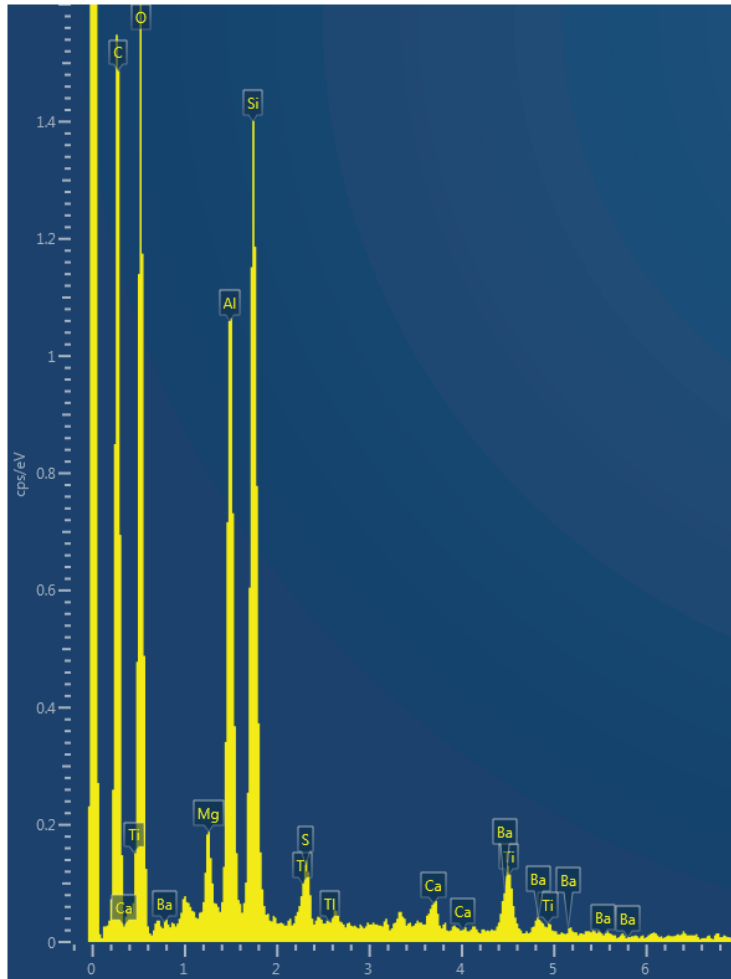
Sample 2. White powder on floor beneath sample 1 Cemesto. Spectrum 19. Al, Si, Mg, Ba

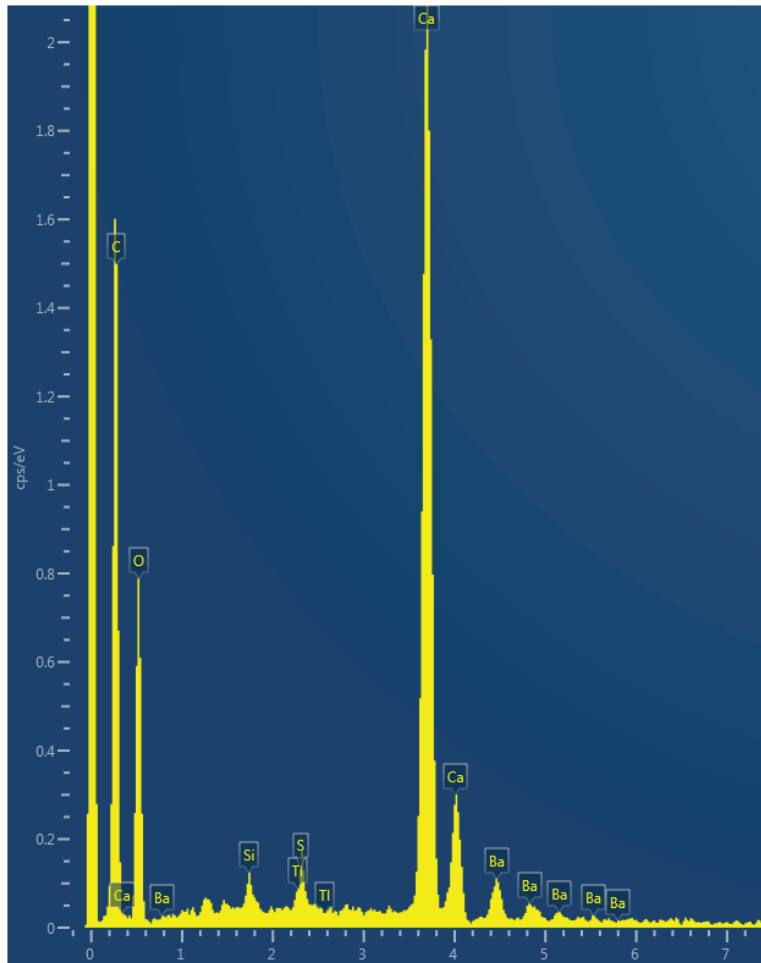
Sample 3 wood putty. Spectrum 20. Ca, Ba, Si

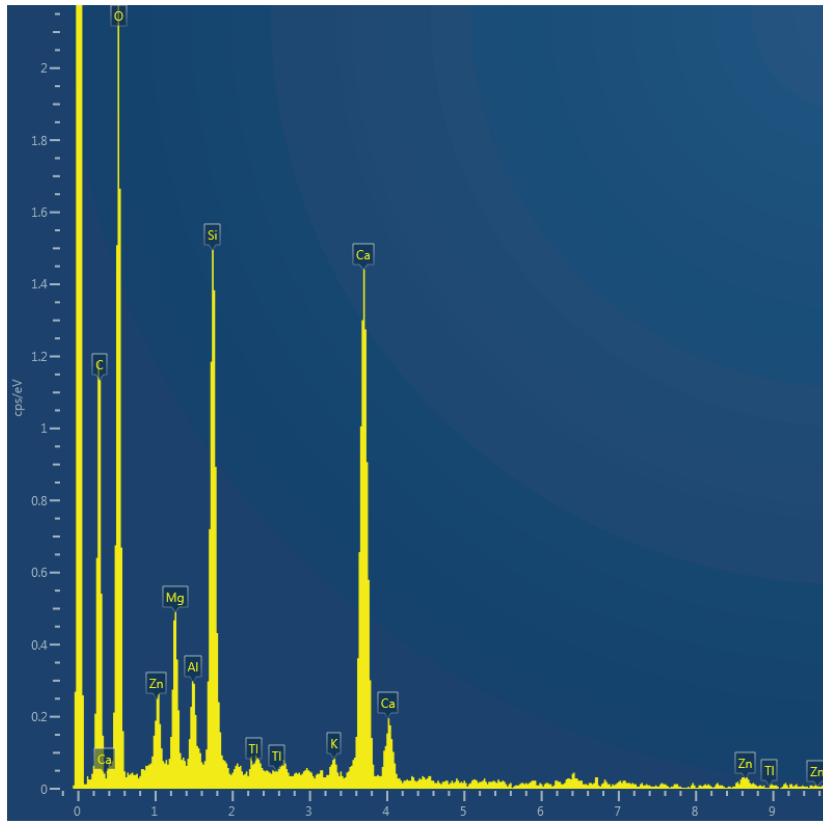
Sample 7 Cemesto. Spectrum 21. Ca, Si, Mg, Al, Zn

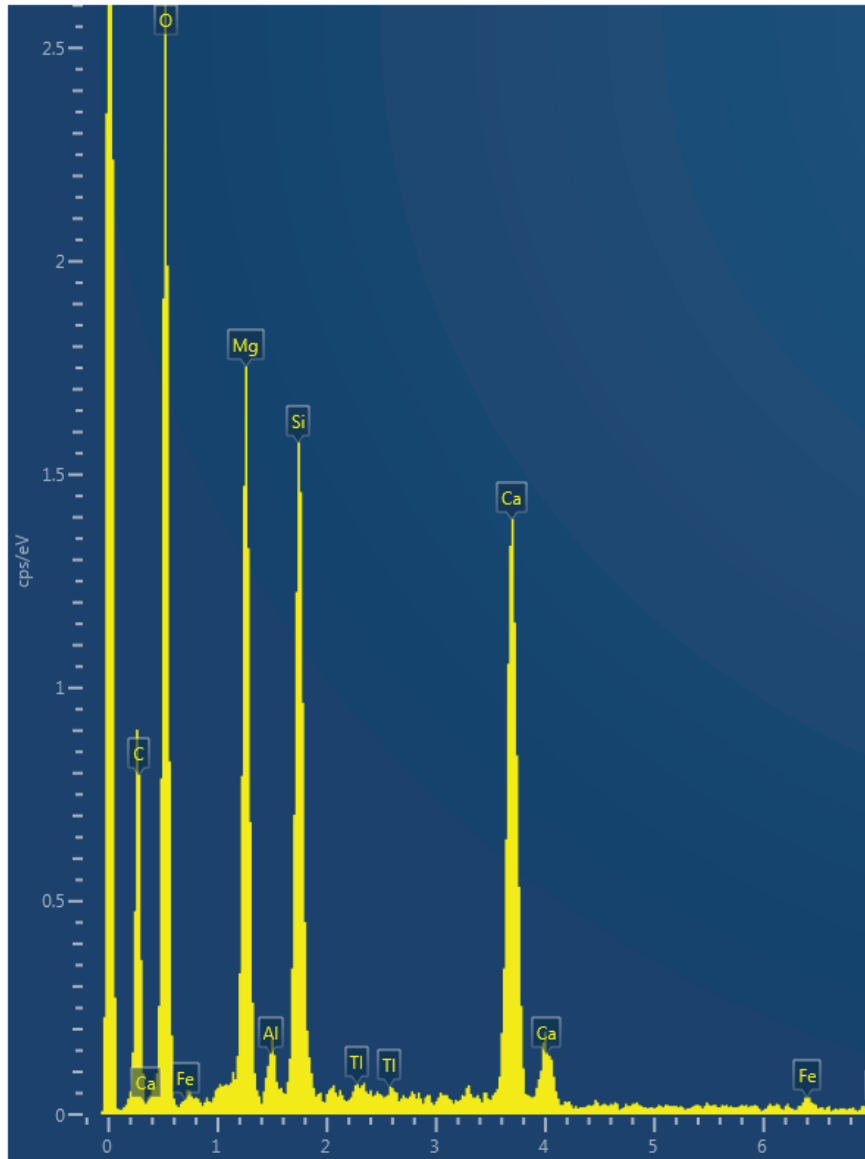
Sample 7 Cemesto. Spectrum 22. Ca, Si, Mg, Al

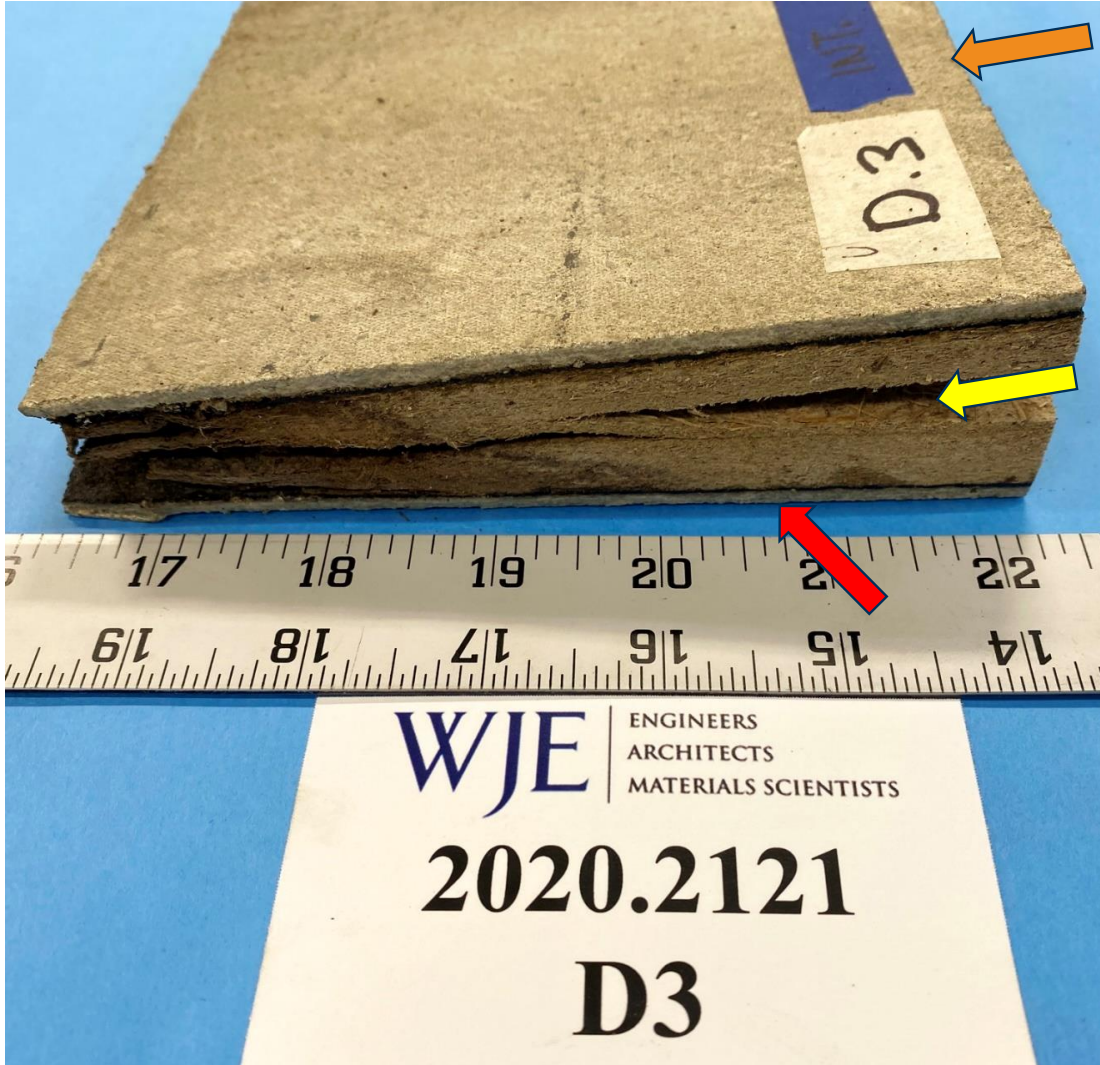
Figure 1. Sample D3. View of the interior surface (orange arrow), exterior surface (red arrow), and cross sectional surface (yellow arrow), as received. The sandwiched central strand core/board was disrupted. The exterior and interior surfaces are further shown below.

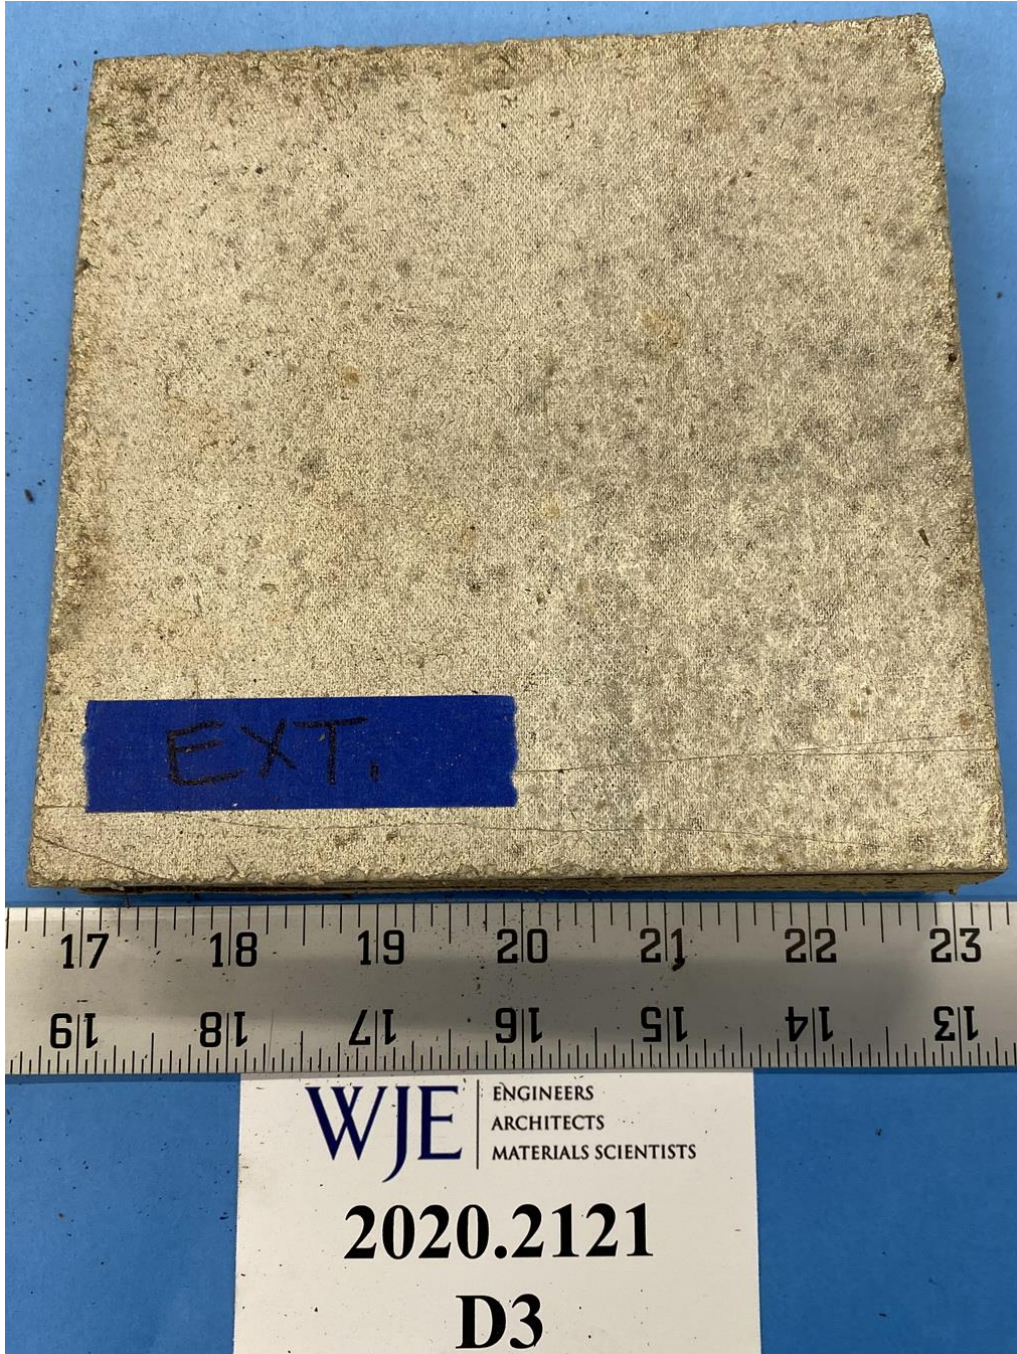
Figure 2. Sample D3. Exterior surface, as received.

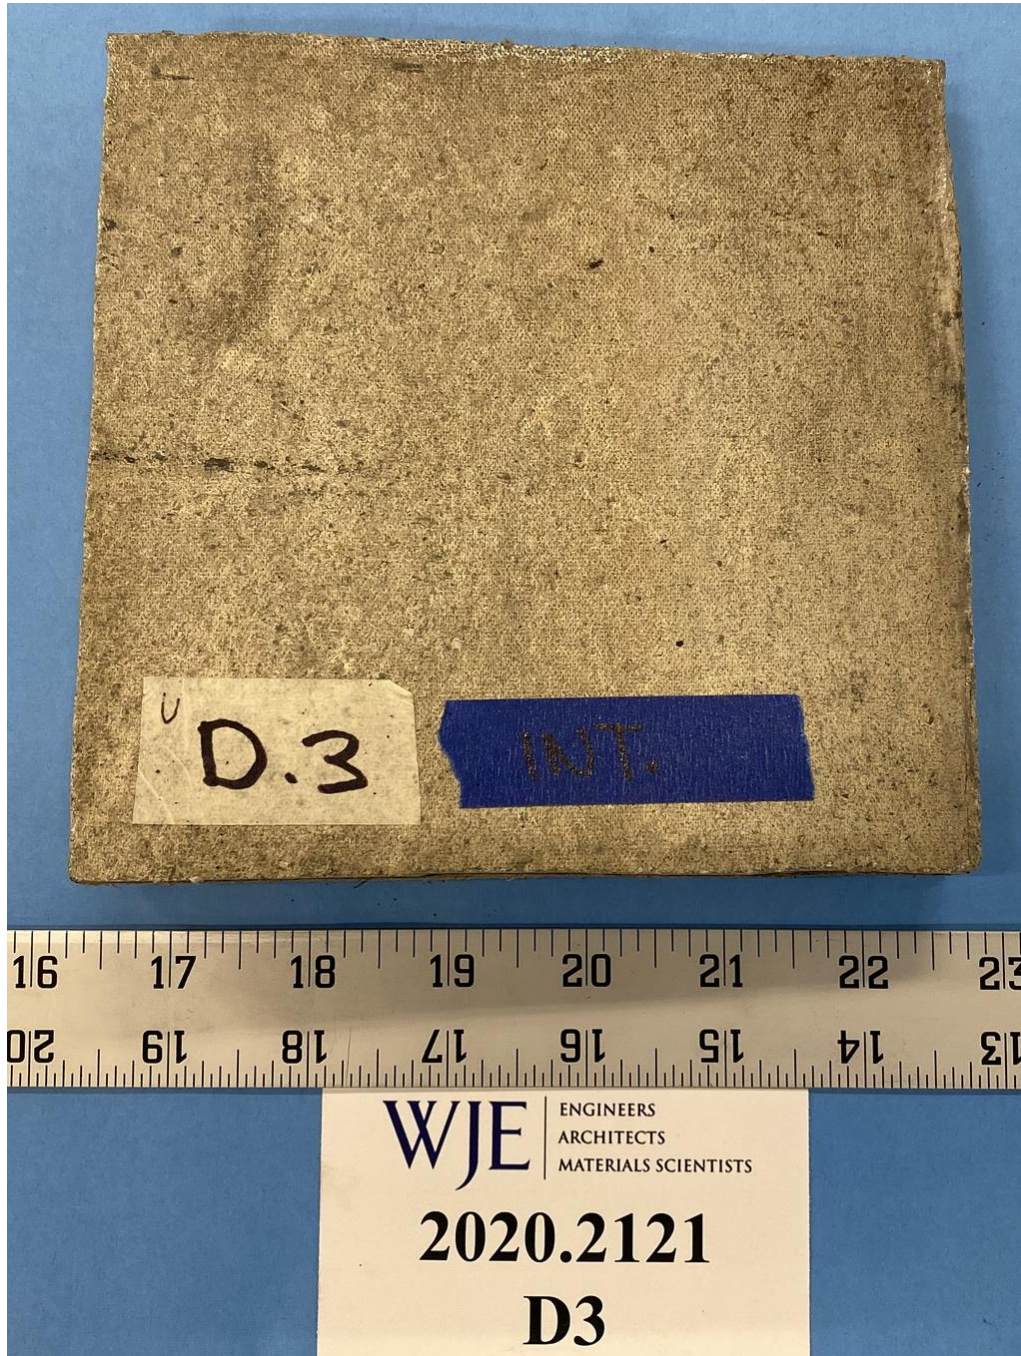
- Large cement particles that contained abundant ferrite and exhibited a brown to orange color (Figure 9), more abundant on the exterior surface.
- Iron oxides or iron hydroxides of unknown origin that were observed on the exposed surfaces, appearing to be more abundant on the interior surface (Figure 12).

Figure 3. Sample D3. Interior surface, as received.

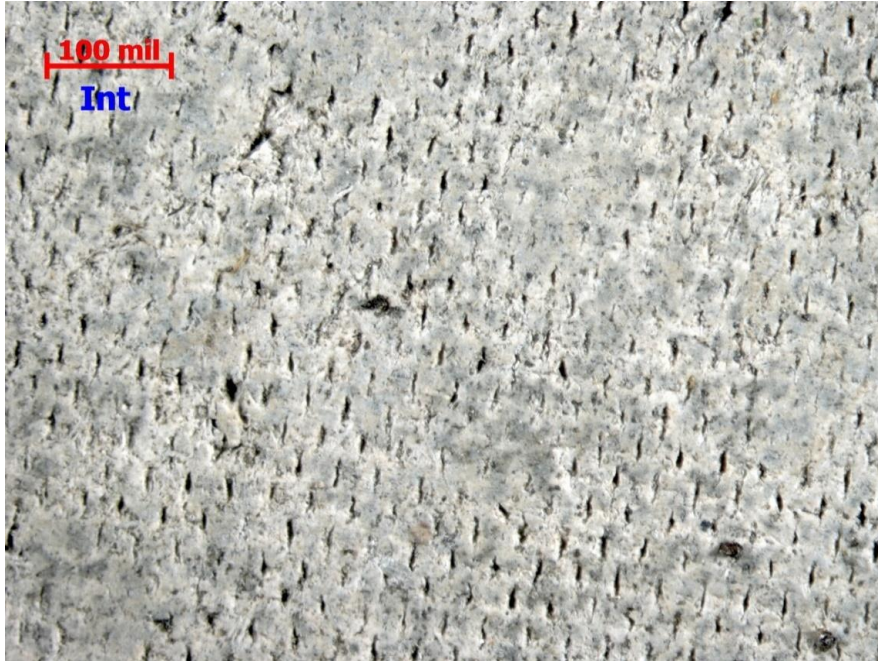
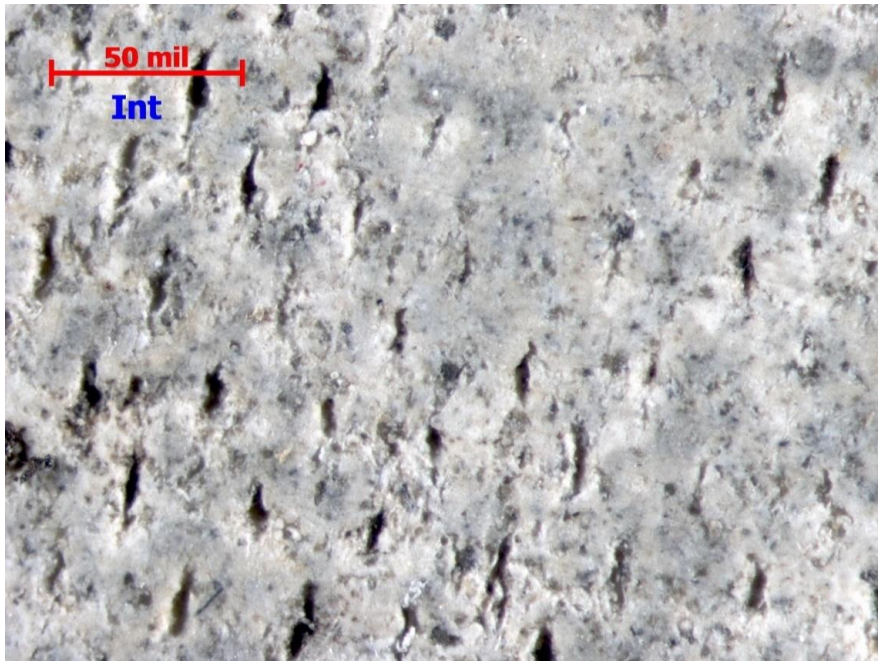
Bond between the fiber strands and the cement paste appeared to be tight overall. No gap or separation was observed except on the exposed surfaces (as described in the next section). Each sheet exhibited small directional or aligned indentations that likely represented imprints from the casting manufacture process (Figure 4 and Figure 5).

Figure 5. Sample D3. Close-up views of the interior surface, as received.

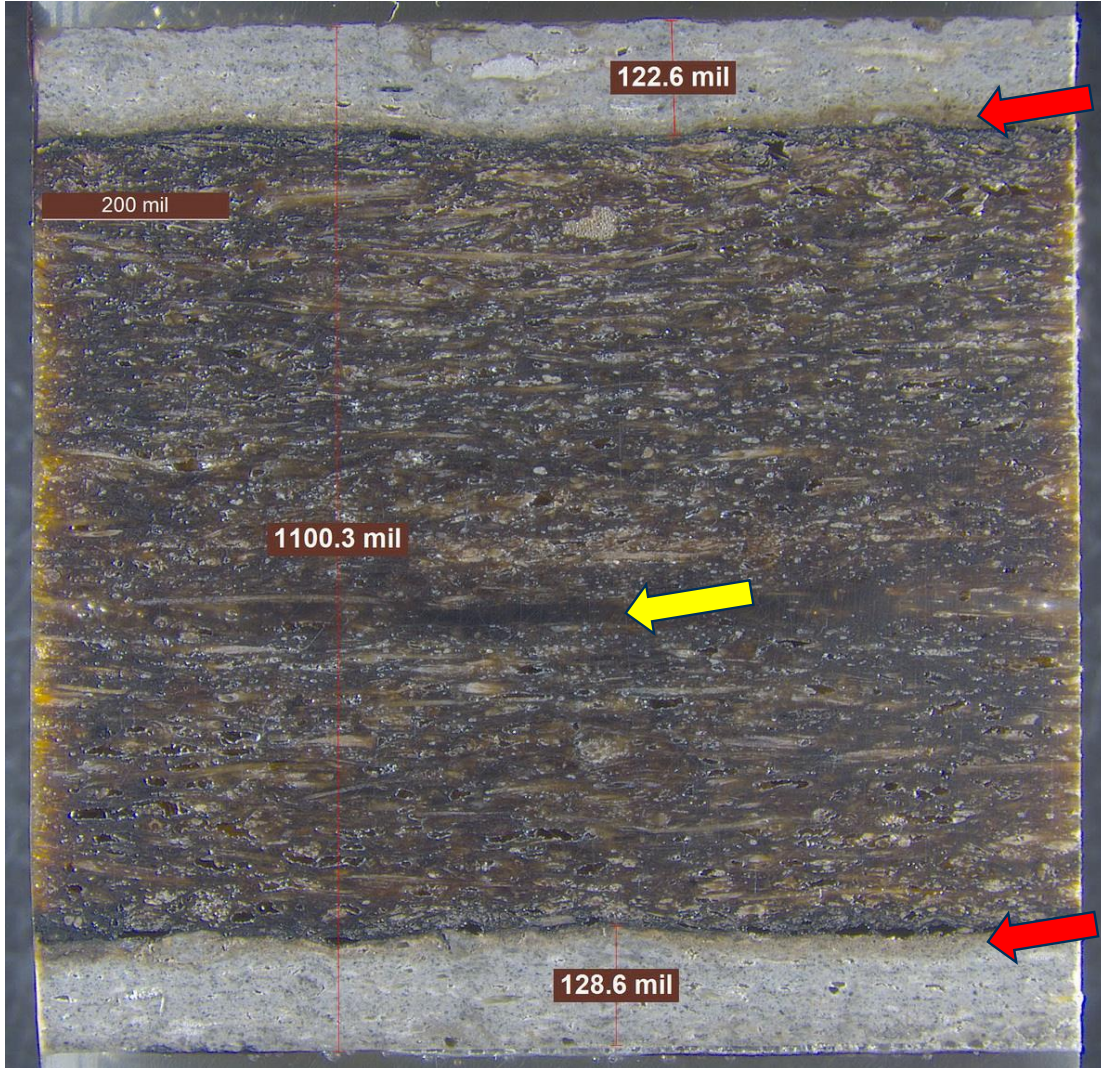
- Localized staining by the asphalt-like binder was also observed, mainly in the asbestos-cement sheets near the insulation (Figure 6, Figure 7). Potential degradation of the binder along a crack could cause staining/discoloration of the exposed surfaces.

Figure 6. Lapped cross section of the panel embedded in epoxy shows the overall appearance and thicknesses of the asbestos sheets (exterior on the top and interior on the bottom) and the insulation core. Red arrows indicate minor staining of the asbestos sheets by a black asphalt-like binder shown below. Yellow arrow shows mainly epoxy used in sample preparation.

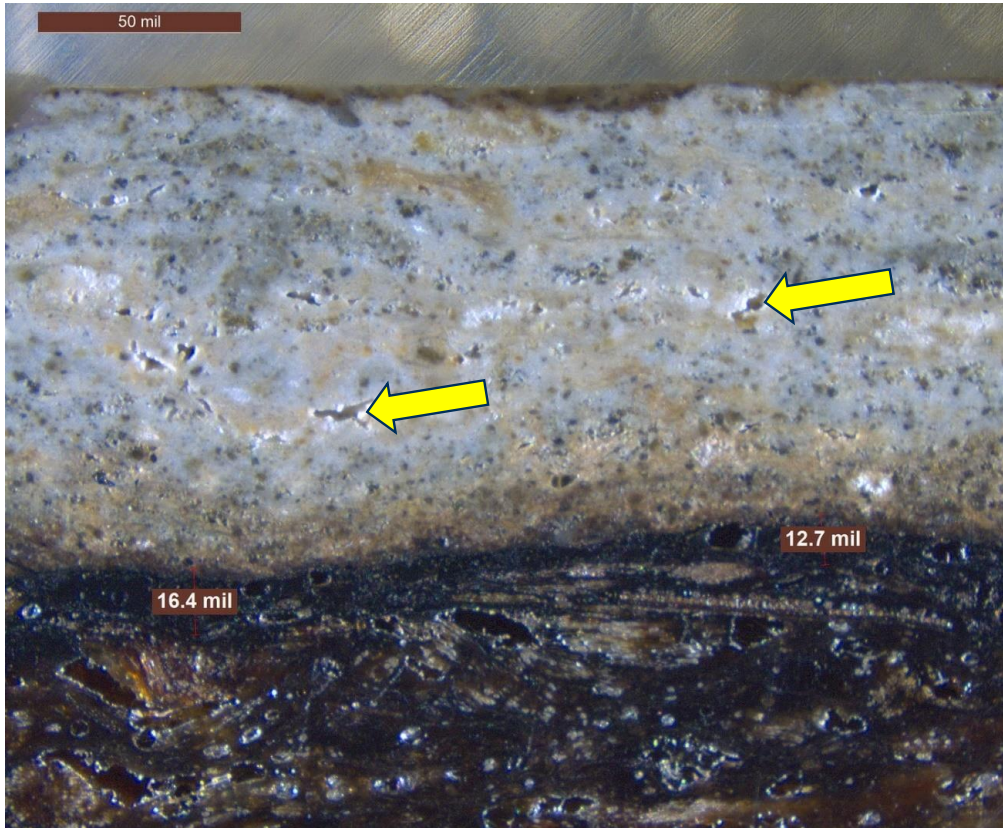
- No sand was observed in the asbestos-cement sheets (Figure 6 through Figure 10).
- No asbestos fibers were observed in the insulation core.
- A layer of black, asphalt-like (carbon-rich) binder or adhesive was present between the sheet and the insulation core (Figure 7). The layer was tested hydrophobic. Water droplets beaded on the black material. It likely served as a waterproof membrane. The insulation bagasse appeared to contain a minimal amount of the same asphalt-like binder (Figure 14).

- Elongated, irregularly-shaped air voids were observed. The elongation direction was parallel to the planar surface, consistent with a pressing and dewatering of the sheets during manufacture process. Estimated air content was 5 to 8 percent (Figure 7). The voids within the asbestos-cement sheets were generally empty and free of significant amounts of secondary deposits.

Figure 7. Close-up view of the exterior sheet and a portion of the insulation core. A layer of asphalt-like binder or adhesive was present between the sheet and the insulation core, measuring 10 to 20 mils thick. SEM/EDX analysis revealed the layer consists of mainly carbon and oxygen. Small amounts of the binder are also present in the insulation core. Arrows indicate voids that probably represented concentrations of water at time of manufacture and aligned by pressing/dewatering.

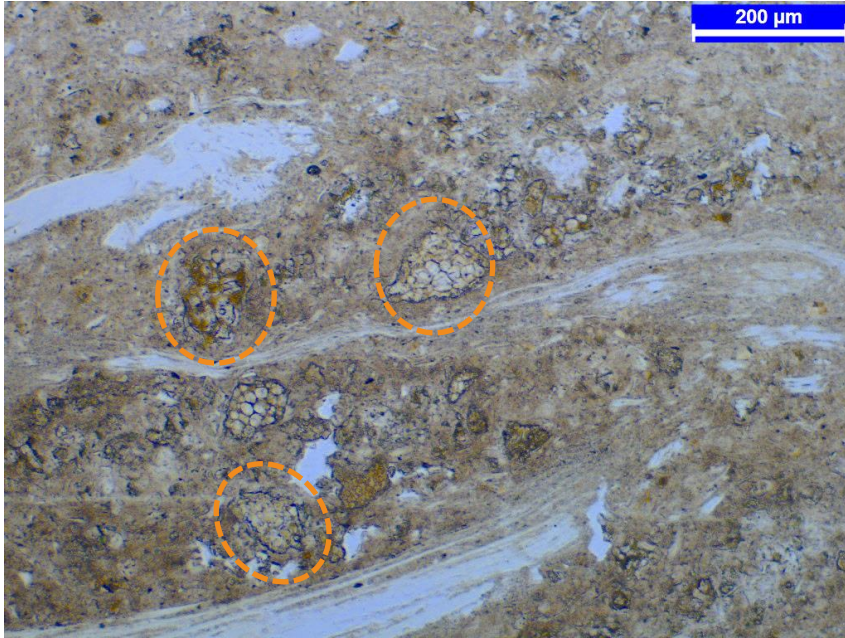
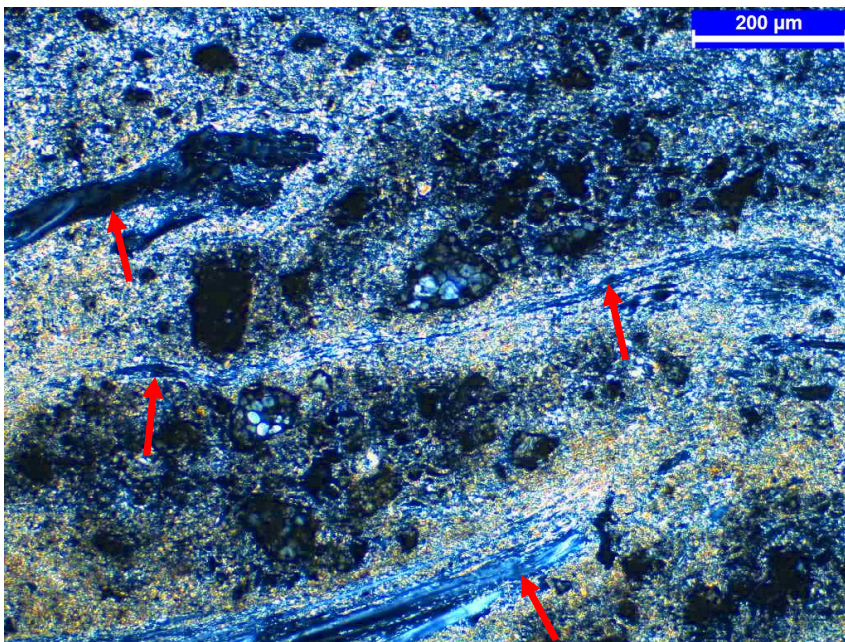
Figure 9. Thin-section photographs of the exterior sheet show large residual portland cement particles (circles) and asbestos strands (arrows). Note the patched or non-uniform carbonation along the fiber strands (golden bright specks in bottom photo). Top photo: plane-polarized light. Bottom photo: cross-polarized light.

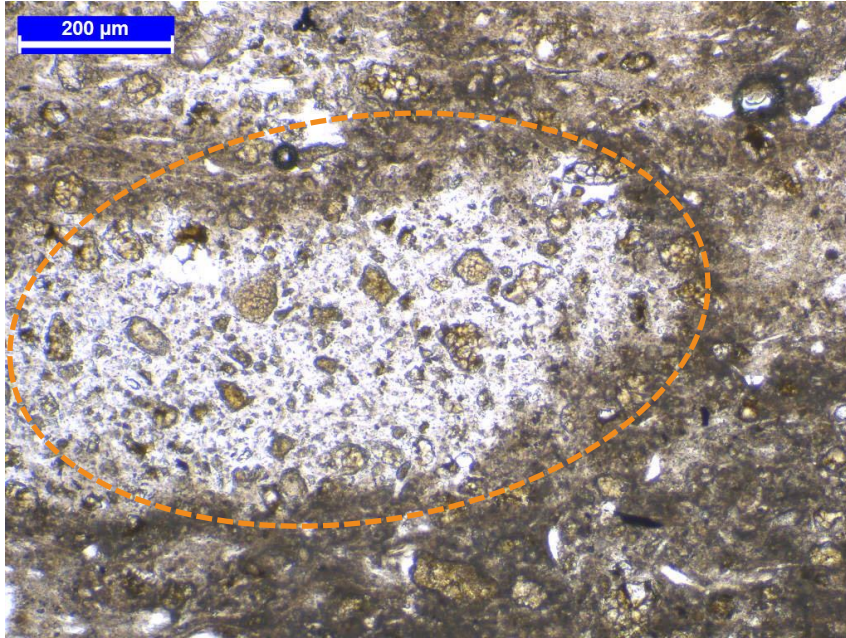
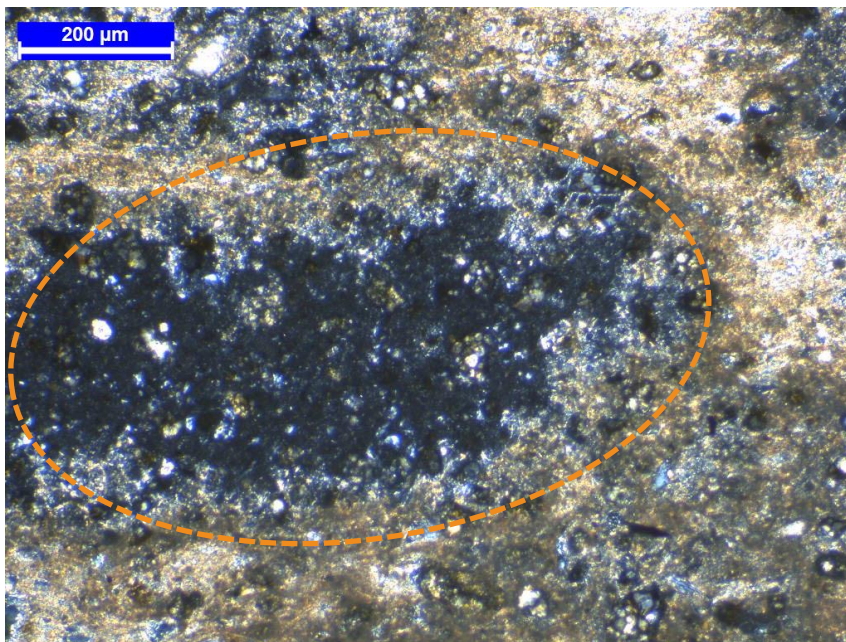
- The cement sheets were partially carbonated throughout the cross sections of the sheets, more frequently along voids and asbestos fibers. Many uncarbonated patches were observed (Figure 8, Figure 9, Figure 10), generally consistent with localized low w/c regions. The exposed surfaces were generally carbonated, as indicated by a phenolphthalein solution test. The surfaces remained the same color as prior to the application of the phenolphthalein and no pink staining was observed.

Figure 10. Thin-section photographs of the interior sheet show a portland cement lump (circled). Top photo: plane-polarized light. Bottom photo: cross-polarized light.

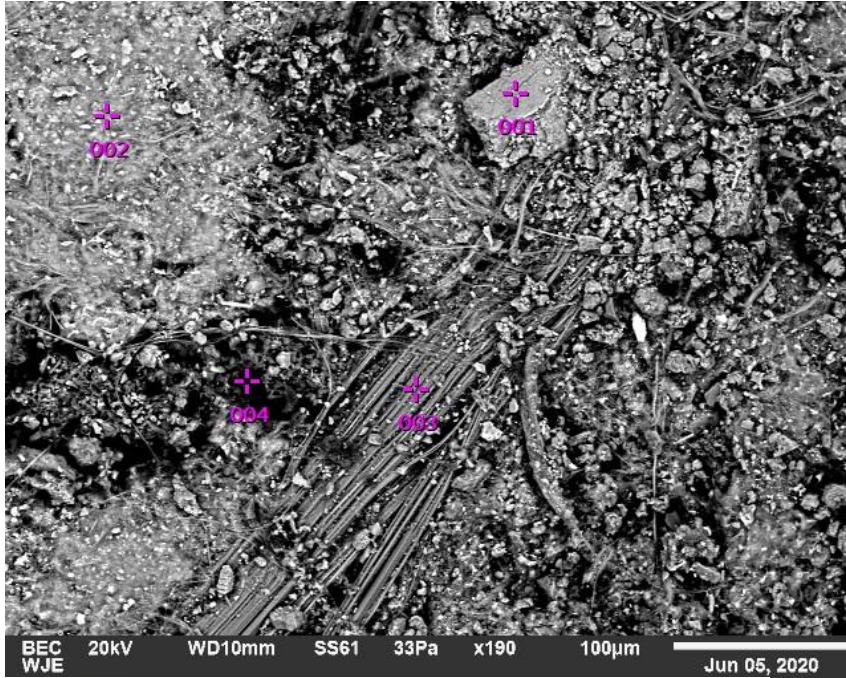
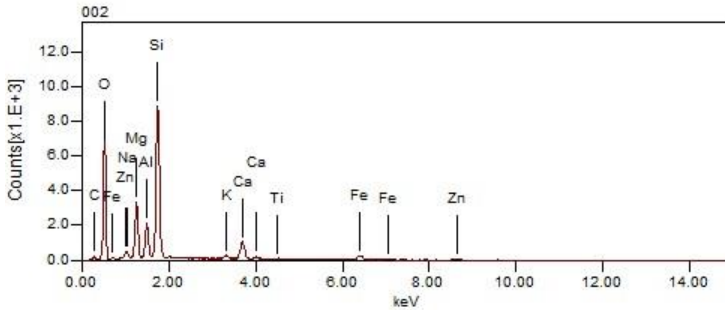
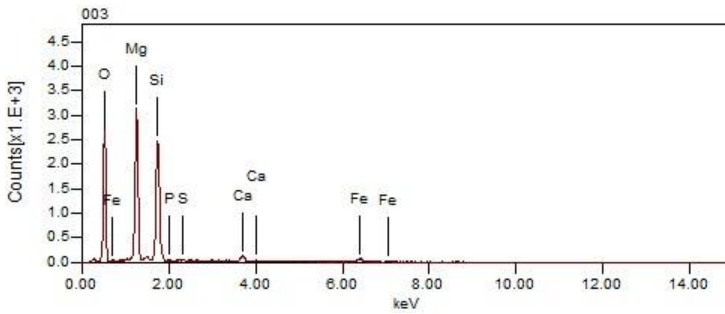
Detection of increased magnesium in the near-surface paste and the leaching might be consistent with acid dissolution (Figure 11, Figure 12). The small amounts of gypsum detected by XRD (Figure 13) possibly represents a reaction product of acid rain and the portland cement paste. However, gypsum appeared to be marginally greater in content on the interior surface. It therefore could have originated from other sources.

Figure 11. Backscattered electron image (top) of the exposed surface of the exterior sheet and representative EDS spectra for marked Spot 002 (middle, decalcified silicate gel) and for 003 (bottom, asbestos). Spot 001 was a hydrated cement particle. Spot 004 was a void.

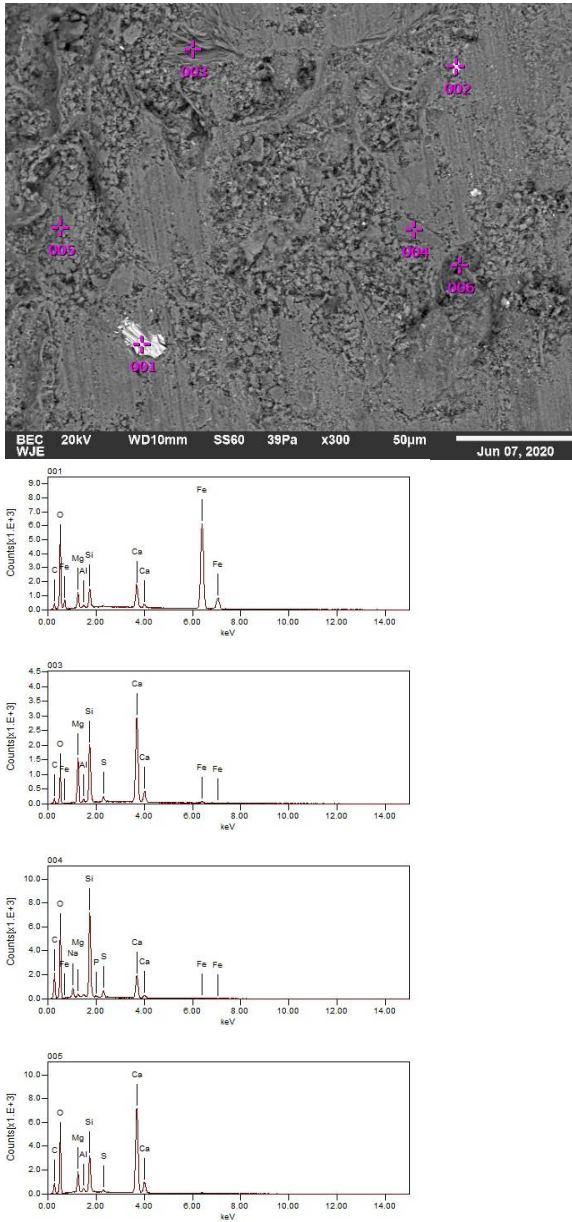
Figure 12. BE micrograph and point EDS spectra of the interior surface. Each EDS spectrum has a number in the upper left that corresponds with the location marked by cross-hairs with the same number in the micrograph. Spots 001 and 002 (spectrum not shown) were iron oxides/hydroxides. Spots 003 and 004 were mainly asbestos with minor calcite. Spot 005 was decalcified gel and Spot 006 was mainly calcite. The interior surface exhibited less amounts of asbestos strands and was in overall better condition than the exterior, consistent with the XRD observations shown below.

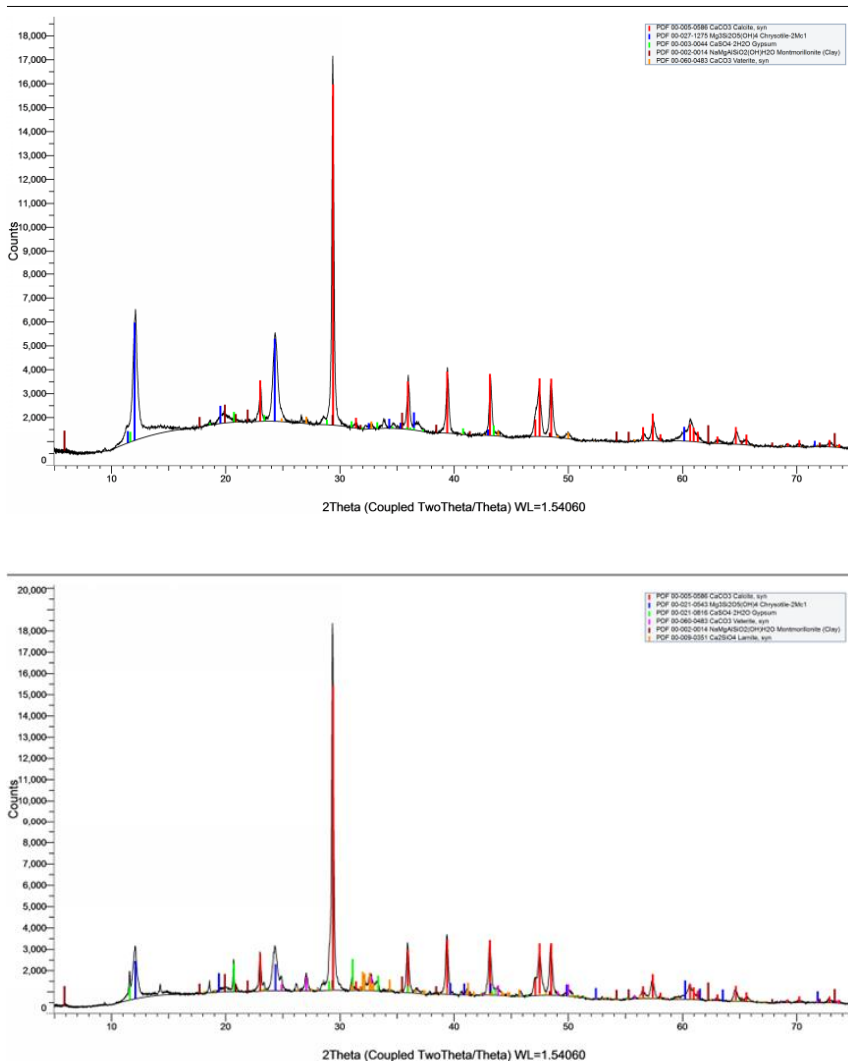
- Dirt or soil of varying amounts on the surfaces. Trace amounts of clay were detected on both surfaces based on the XRD patterns (Figure 13).
- Biological growth that directly caused the black spots or small areas of discoloration, more abundant on the exterior surface (Figure 4).

Figure 13. XRD patterns of the exterior surface (top) and the interior surface (bottom) of the panel. The patterns were collected directly on the exposed surfaces. Greater amounts of chrysotile were observed on the exterior surface than the interior surface (relative to calcite), consistent with more leaching and erosion on the exterior sheet. The greater hump with a peak position near 20 degrees two theta may represent the decalcified high-silica gel that is more abundant on the exterior surface than the interior surface. Trace to minor amounts of gypsum were detected, more on the interior surface.

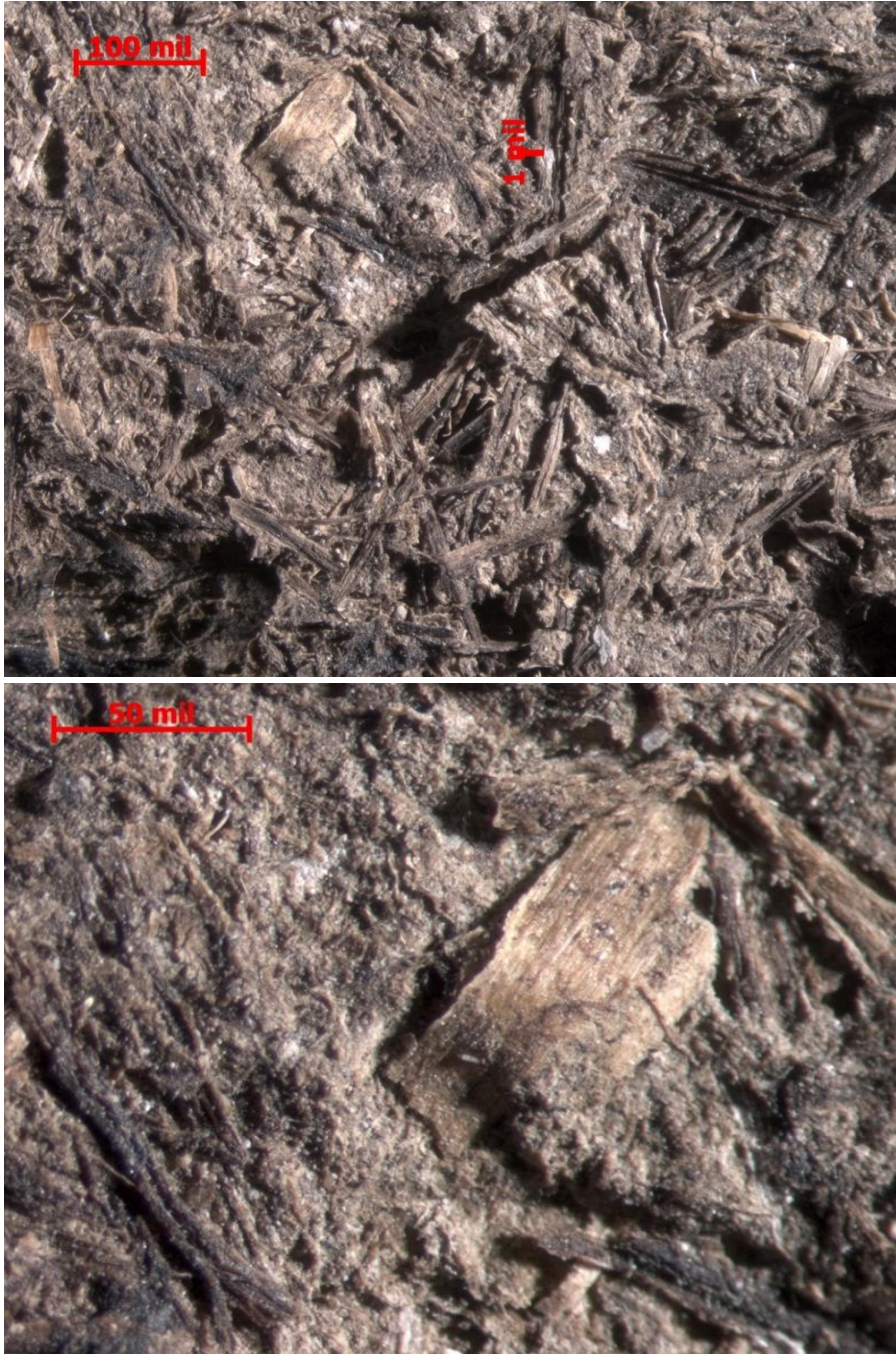
The bagasse insulation core exhibited material loss and moisture-related staining or discoloration as received. The staining and discoloration appeared to be overall more severe near the exterior sheet side.

Figure 14. Close-up views of the insulation core. It appeared to contain small amounts of black asphalt-like binder
