Eames House Conservation Project Cemesto Panel Investigations Phase I

Research Report

Getty
Conservation
Institute

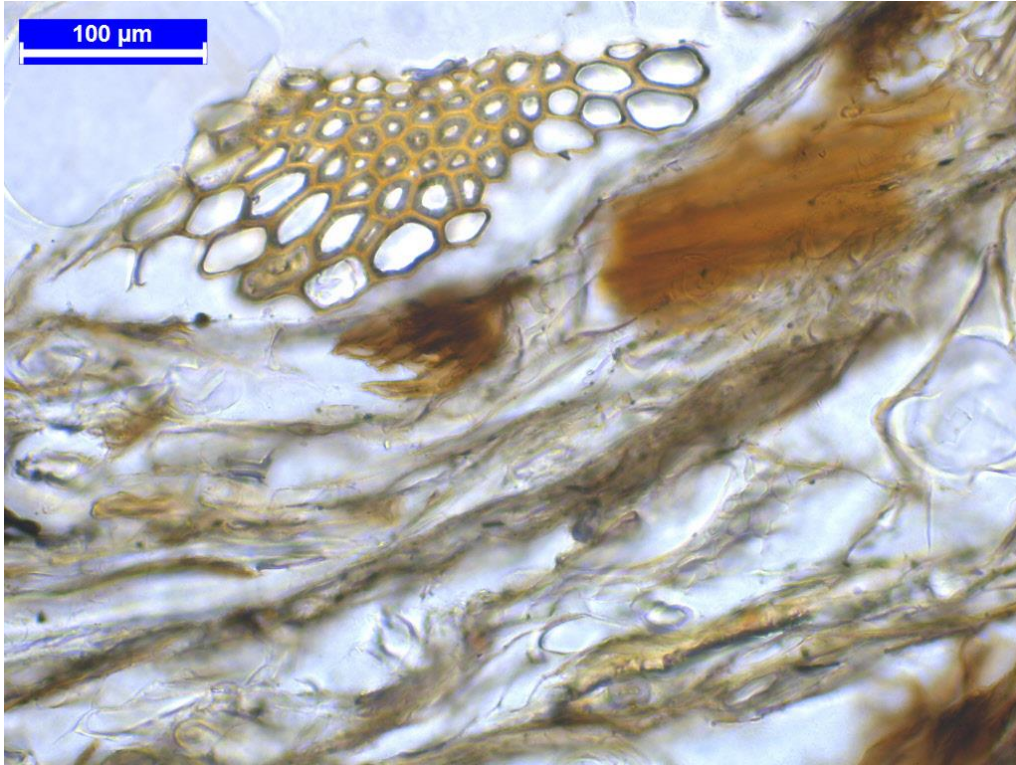
The insulation core fiber was plant-based and distinct cellulose texture was visible (Figure 14 and Figure 15). It is likely a bagasse. A bagasse refers to the dry pulpy fibrous residue that remains after sugarcane or sorghum stalks are crushed to extract their juice. Other major findings are summarized below and illustrated in attached figures.

Figure 15. Thin section photo of the insulation core shows cellulose texture of plant. Plane-polarized light.
