# Seismic Retrofitting Guidelines for the Conservation of Doctrinal Chapels on the Oyón Highlands in Peru

Patricia Navarro Grau, Julio Vargas Neumann, and Maribel Beas

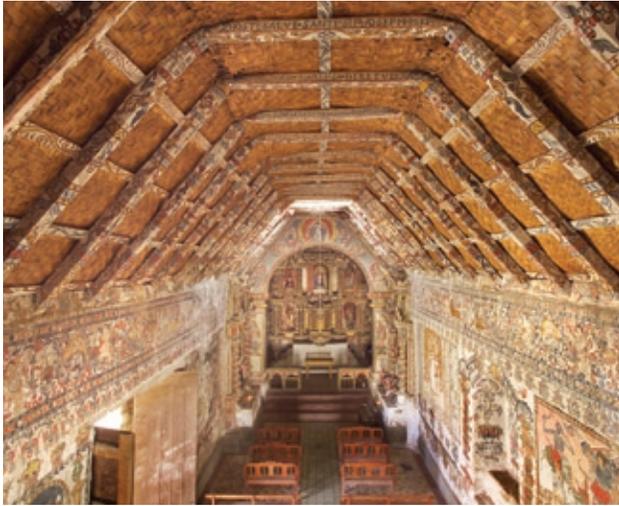
The interior wooden roof trusses are the pair and knot type, spaced 80 cm (31.2 in.) from each other and laid over a bond beam on top of the walls (fig. 2). Secondary wooden rafters resting over the upper wall beams support exterior metallic corrugated sheets. The condition of these wooden elements is structurally acceptable because of the dryness and the altitude of the Andes. Areas exposed directly to the weather and moist walls have mold and show deterioration.

FIGURE 2 Interior of the Rapaz Missionary Chapel showing roof construction. Photo: Daniel Giannoni.
