Application of Stability-Based Retrofit Measures on Some Historic and Older Adobe Buildings in California

Frederick A. Webster

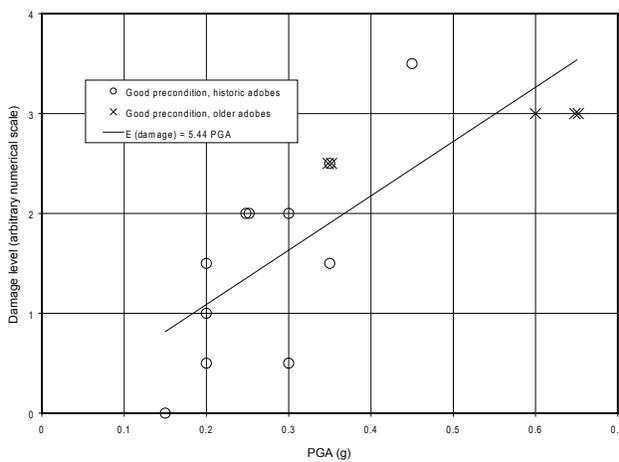
Figure 1 is a plot of damage versus peak ground acceleration for unreinforced, well-maintained historic and older adobes (sixteen out of the twenty-nine surveyed). These buildings had insignificant preexisting conditions; thus, adobes were excluded that had unrepaired or poorly repaired preexisting crack damage, severe water intrusion damage, or previous retrofits or upgrades. Figure 1 also includes a linear least-squares relationship ("best estimate") of damage as a function of PGA, which serves as a baseline for judging the performance of adobes that either suffered from or were enhanced by preexisting conditions. Even though con-

siderable scatter is evident, some trends are reasonably clear. It appears that PGA in the range of 0.1–0.2 g is needed to initiate damage in the well-maintained adobe buildings. At this level of shaking, cracks will begin to form at door and window openings and at the intersec-

tions of perpendicular walls. At a PGA of about 0.4 g, the damage is moderate to extensive and includes more general crack damage throughout the structure.

FIGURE 1 Northridge earthquake damage versus peak ground acceleration (PGA) for historic and older unreinforced and well-maintained adobes.

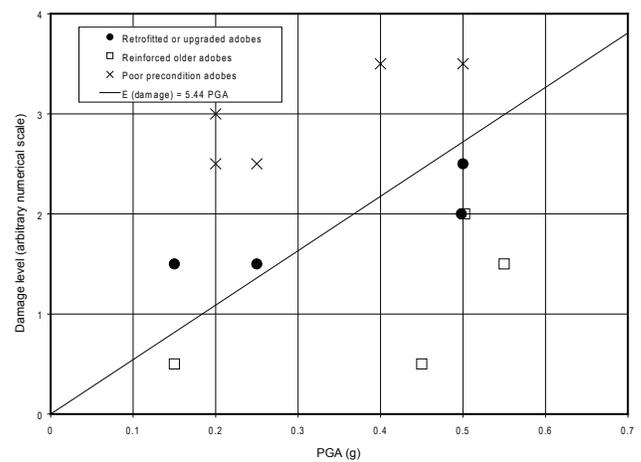
Figure 2 is a plot of damage level versus PGA for those adobes with the preexisting conditions (thirteen

FIGURE 2 Northridge earthquake damage versus peak ground acceleration (PGA) for adobes other than unreinforced and well-maintained.

out of twenty-nine surveyed). Relative to the “best estimate” for unreinforced, well-maintained adobes, pre-existing conditions have definite effects on the resulting damage states. Obviously, adobes in a poor precondition state fared worse than those that were well maintained. Even at moderately intense ground shaking (0.1–0.2 g), poorly maintained adobes suffered substantial damage. Another trend observed is that reinforced older adobe buildings show greater resistance to damage than the unreinforced, well-maintained adobes at all levels of ground shaking.

Not so obvious, because of the sparse data, is the effect that seismic retrofits or upgrades have on the performance of historic and older adobes. A preliminary conclusion from figure 2 might be that the value of seismic retrofitting or upgrading is not realized until relatively high levels of ground shaking (i.e., above 0.3 g). At lower levels of ground shaking, the retrofit measures do not appear to affect performance. At these lower levels, the retrofitted buildings behave much the same as unreinforced, well-maintained adobes. Similar performance
