Salk Institute for Biological Studies Conservation Project: Teak Window Wall Assemblies

Phase 1: Research and Investigation Results
and Preliminary Conservation Proposals

Sara Lardinois

The Getty Conservation Institute

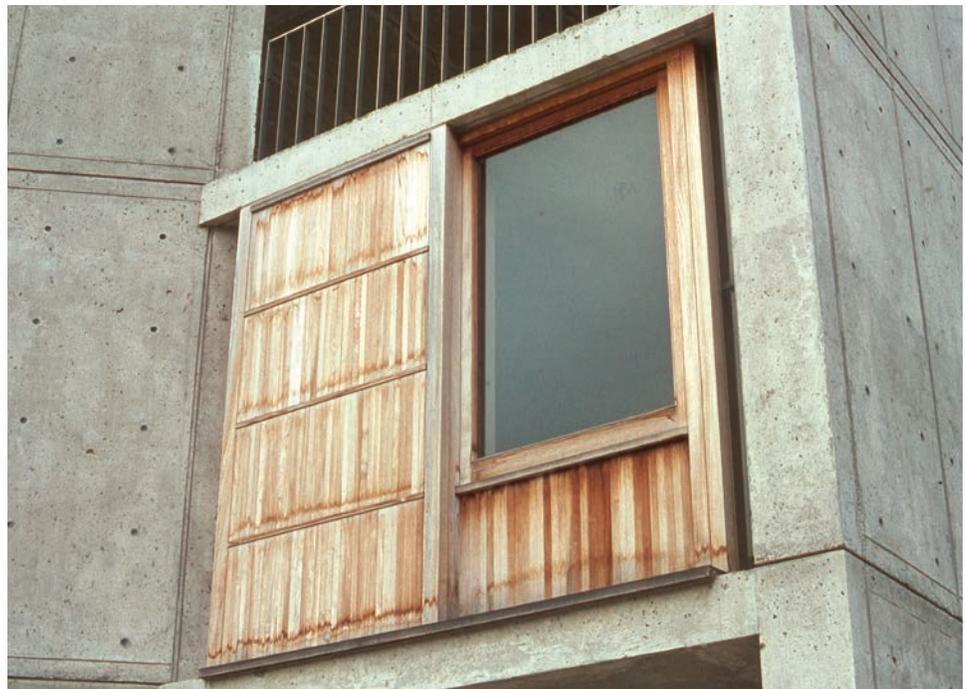
Photograph of a window wall assembly in the lower study of the north wing, taken in October 1967. Note the moisture staining above the sloped teak sill, teak drips, teak T&G boards, and the teak jambs, and below the teak drip cap.

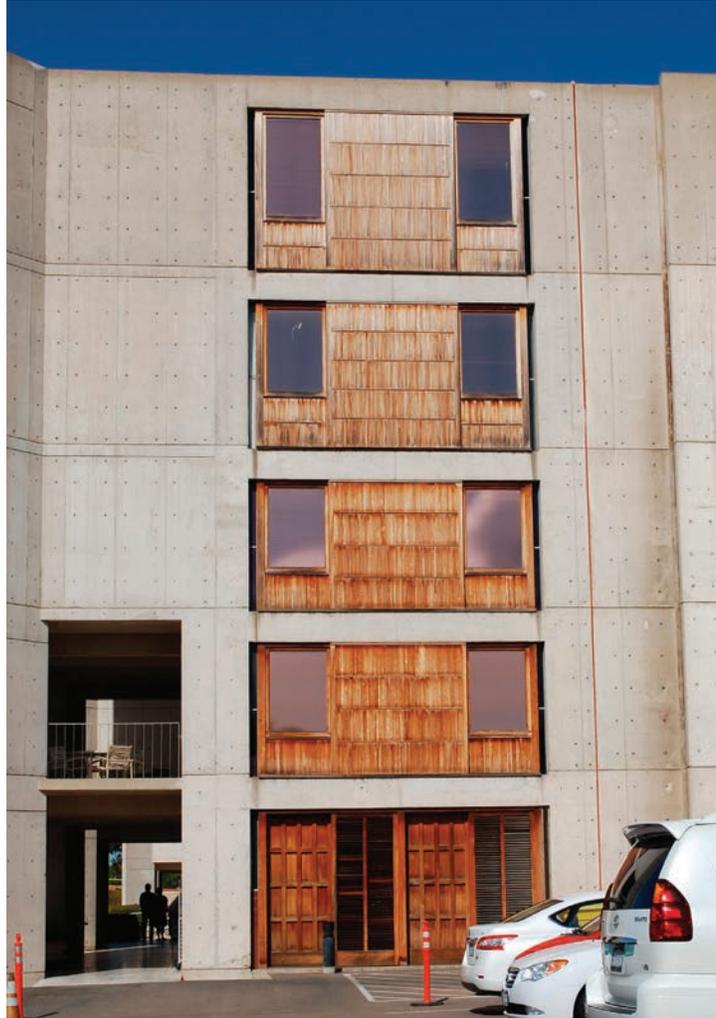
The degree of bleaching and gray patina increases from lower levels to upper levels at south-facing elevations, such as this one at the southern west office wing.

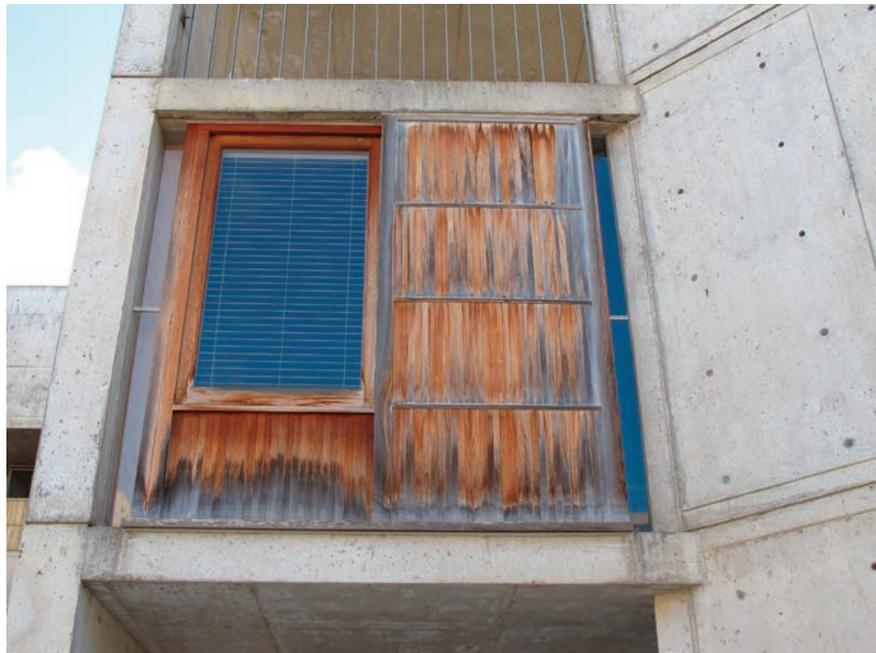
FIGURE 4.2

South study tower, lower level, north-facing window (SL4C). The gray patina is most prevalent on the horizontal sills, drips, and vertical trim boards. It also appears in those areas that exhibit moisture staining.

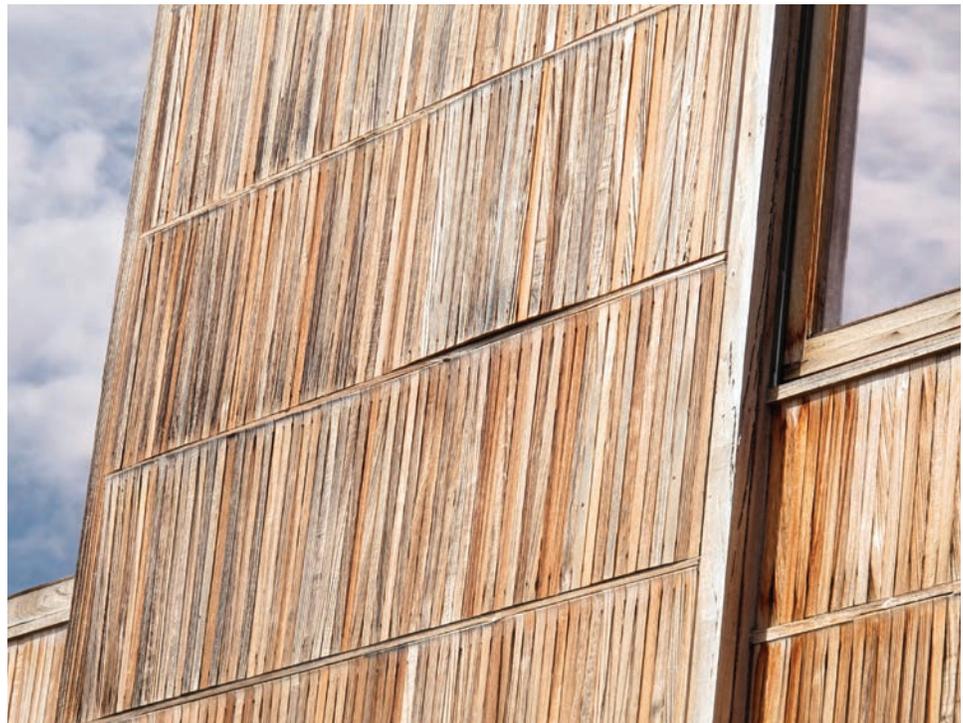
- Severe erosion (loss of approximately 20% or more of surface depth) was observed at south-facing elevations of both the office wings and the north study towers (figs. 4.3, 4.4); these conditions increase from the lower levels to the upper levels. In these areas of significant erosion, the following was noted:

Northern west office wing, south-facing window, sixth floor (NO6K). The vertical siding and horizontal drips exhibit severe erosion.

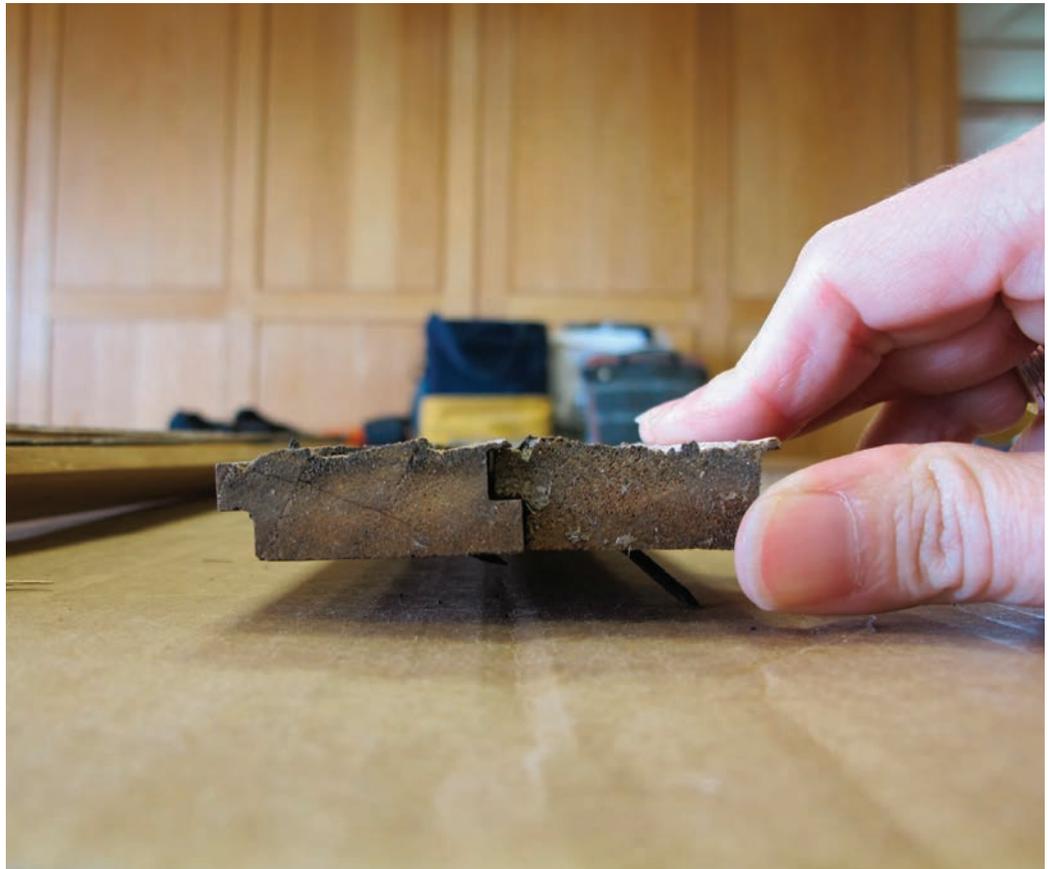
- The outer portion of the groove of the vertical T&G boards has completely weathered away, giving the appearance of shiplap rather than T&G joint and leaving nail heads of the fasteners exposed (fig. 4.5).

FIGURE 4.5
Vertical T&G boards from window wall assembly NO6K. The outer edge of the grooved piece has weathered away, giving the appearance of a shiplap rather than T&G joint. Image: J. Paul Getty Trust.

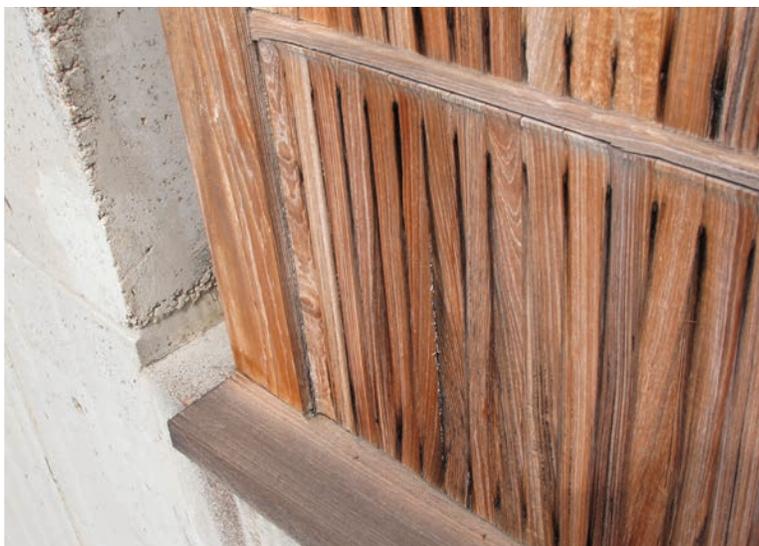
- The outer face of the horizontal drip, which was designed to lap over the tops of the vertical boards, has eroded away, leaving the drip flush with the face of the boards and the end grains of these boards unprotected (fig. 4.6).

FIGURE 4.6
Northern west office wing, south-facing window, sixth floor (NO6K). The outer face of the horizontal drip (top of image) has eroded away, leaving the drip flush with the face of the boards and the end grains of these boards unprotected.

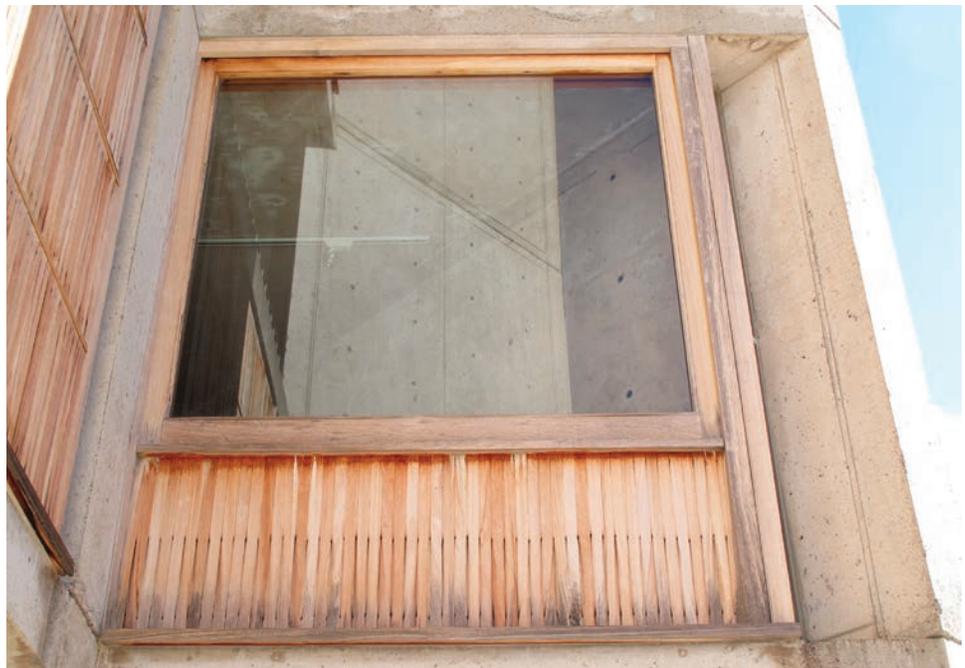
Black stains are present around and below the rows of nails used to fasten the T&G vertical siding boards to the underlying furring strips (fig. 4.9). These stains are most noticeable where the teak is eroded to a depth at which the nail heads are exposed.

Although galvanized nails were originally used to fasten the exterior teak cladding, the galvanic coating has deteriorated over time as surface erosion of the teak exposed the nail heads to atmospheric conditions such as airborne salts. The metal-oxide staining observed is a result of a chemical reaction between the exposed iron in the

North study tower (4N), west-facing lower study window (NL4B), showing iron stains around and below the rows of nails used to fasten the vertical T&G siding boards to the underlying furring strips.

nail core and the natural extractives in the wood. Staining of this nature often penetrates many cell layers into the wood surface and can be difficult to remove without aggressive sanding, which in turn reduces the overall remaining thickness of the wood.

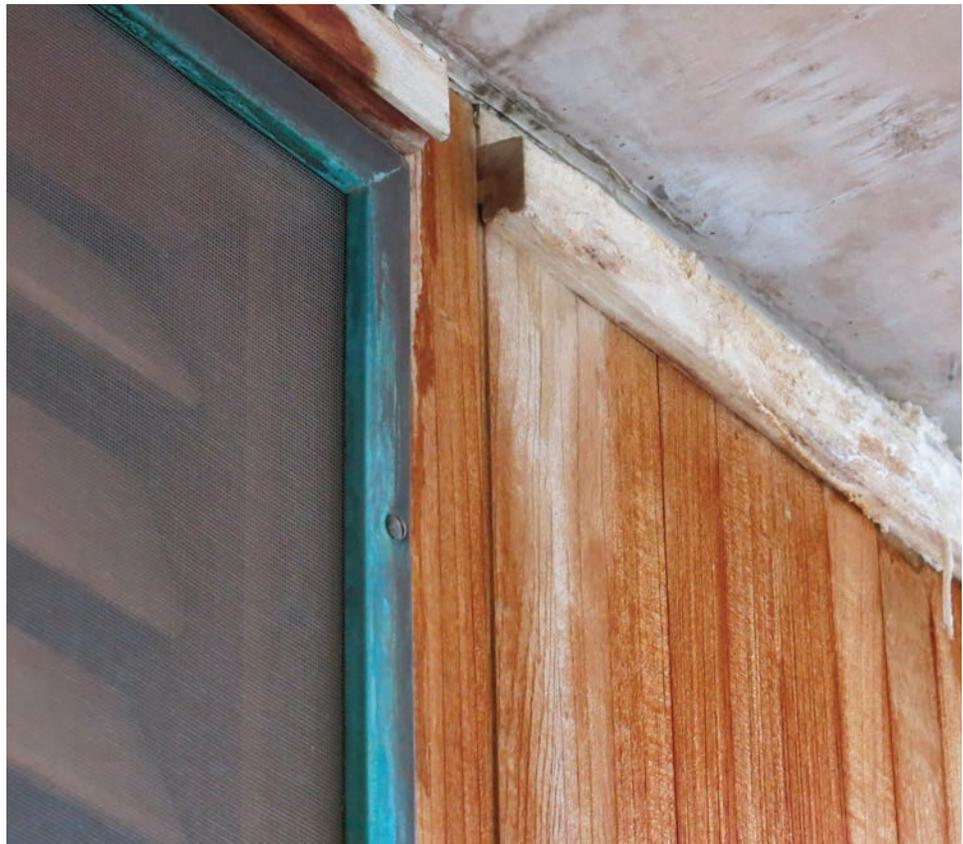
Calcite deposits were noted on some of the elevations of the study towers facing the sunken gardens (fig. 4.10), directly beneath those areas where concrete bridges interface with the study tower walls.

FIGURE 4.10
South study tower, south-facing lower study window, showing calcite deposits at the top of the window wall assembly.
Image: J. Paul Getty Trust.

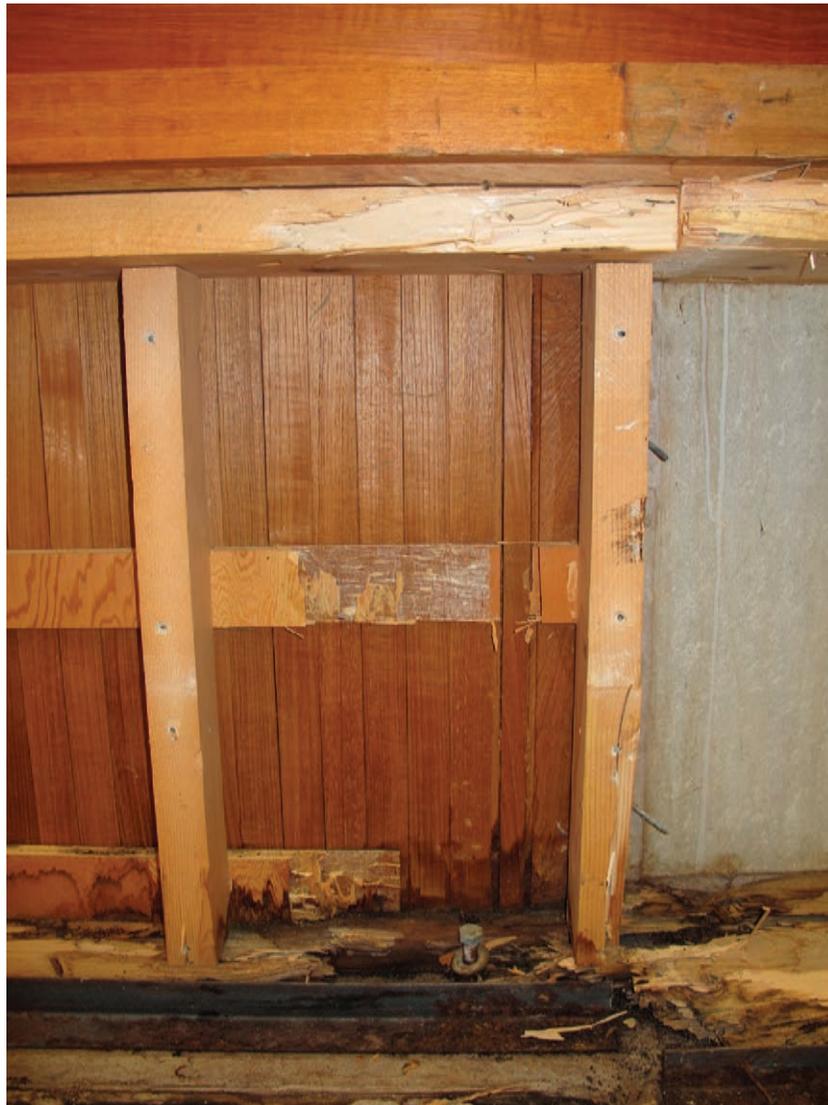
Probe 1, carried out at window wall number NL6C, a south-facing window on the lower level of the north study tower, revealed extensive insect damage in the sill plates, studs, window sill, and stops for the sliding windows and louvers (all white fir), as well as at the plywood furring strip for the vertical siding boards beneath the window opening (fig. 4.17). The damage was most significant in the sill plate, with a loss of approximately 50% of the area and two of the four anchor bolts no longer engaging with any wood, and in the lower portions of the studs. This is of great concern, as it impacts the overall structural stability

Probe 1, carried out at a south-facing window (NL6C) on the lower level of the north study tower, revealed extensive moisture infiltration and insect damage. Note the significant damage to the sill plate. The bolt in the bottom center of the image is no longer engaging with any wood.

of the units. Minor damage was noted in the upper portions of the framing, such as at the stops for the sliding windows and louvers. The area of damage also corresponds to an area exhibiting significant moisture staining along the base of the wall framing.

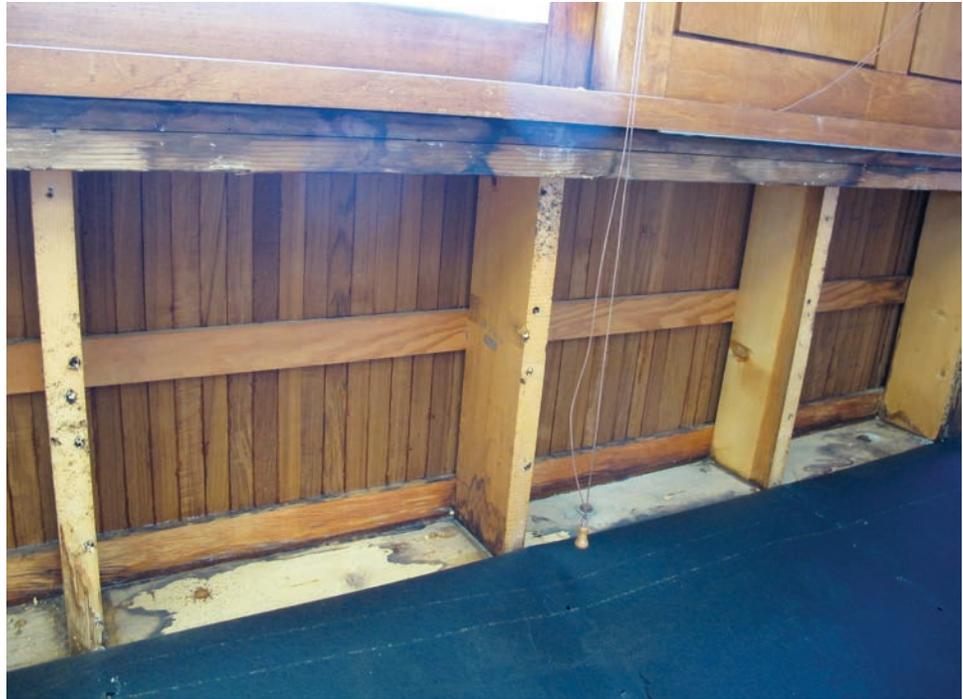
FIGURE 4.18

Probe 2, carried out at a west-facing window in the southern west office wing (SO4B), revealed water damage but no insect damage.

No insect damage was observed in Probe 2, carried out at window wall number SO4B, a west-facing, midlevel window in the southern west office wing (fig. 4.18). Water damage was noted; however, the presence of building paper and the possible application of a termite-resistant treatment in this area may partially explain the lack of damage in this location.

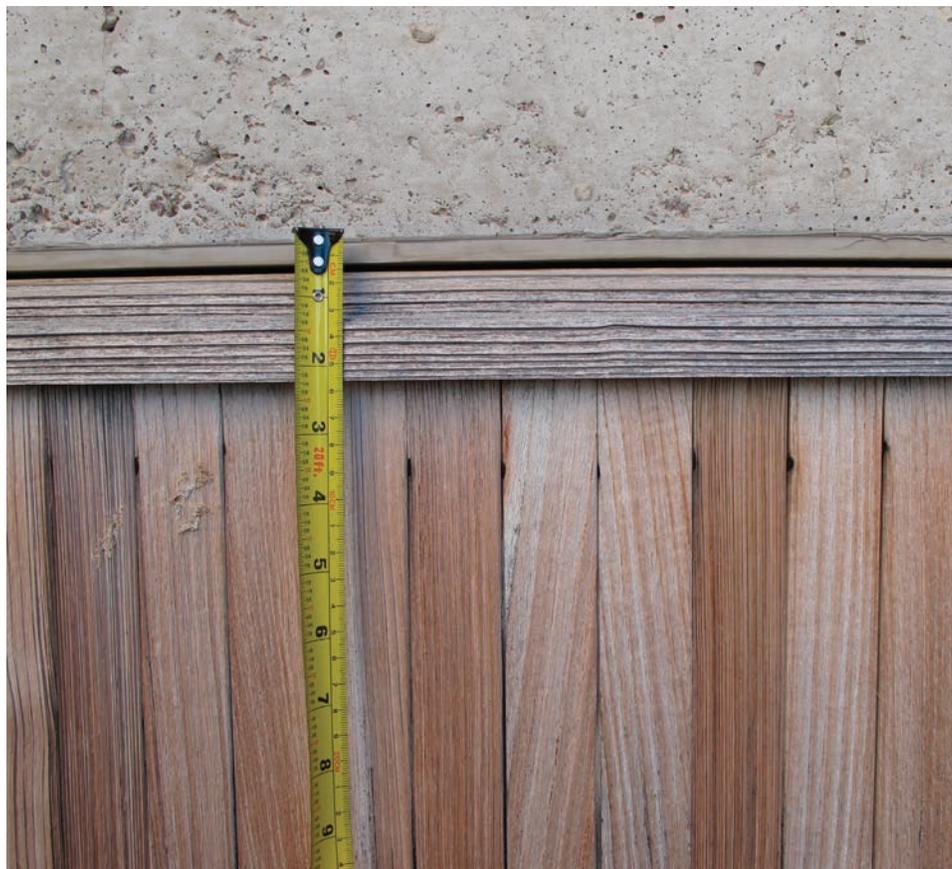
Failure of the sealant in the joint at both the top and bottom of the window walls was observed in many locations (fig. 4.22). This condition occurred most often in the joint below the sloped sill.

FIGURE 4.22
Northern west office wing, west-facing window (NO5G), showing sealant failure between the top of the teak window wall assembly and the adjacent concrete.
Image: J. Paul Getty Trust.

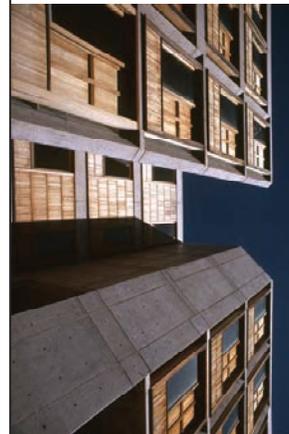
aaup.260.I.D.37.9_Oct 67

- October 1967**
- Moisture stains on lower portion of vertical siding panels
 - Dark gray appearance on steep leak sills
 - Dark gray appearance on leak windowsills
 - Dark red, varied appearance on shutters

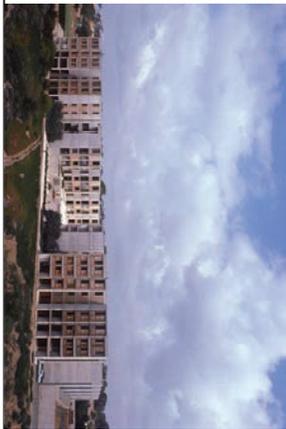
aaup.260.I.D.40.9_1972

- September 1972**
- Water marks on lower portion of vertical siding panels
 - Black fungus growth heavier on upper window wall assemblies
 - Gray appearance (weathering) on vertical siding panels and frames
 - Varied red appearance on shutters and frames

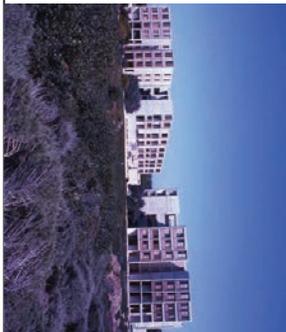
aaup.260.I.D.47.3_Mar 77

- March 1977**
- Fungus appear to be less dense than in previous years
 - Gray appearance (weathering) on window wall assemblies
 - Varied red appearance on window wall assemblies

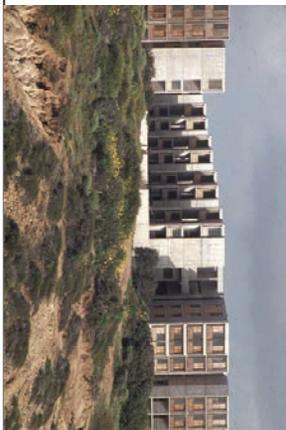
aaup.260.I.D.44.8_May 76

- May 1976**
- Fungus appear to be heavier at the south office building west-facing windows than at the north office building west-facing windows
 - Increase in black fungus growth
 - Moisture stains on window wall assemblies

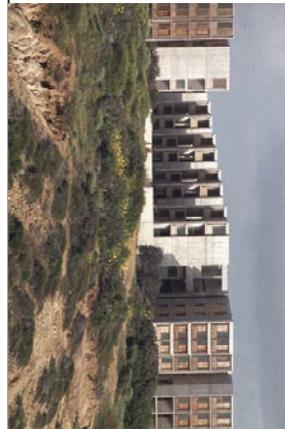
aaup.260.I.D.33.6b_July 65

- July 1965
- Gray appearance on sloped teak sills

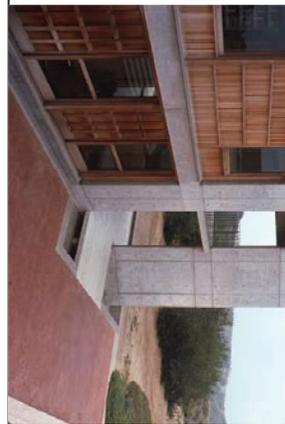
aaup.260.I.D.42.17_Mar 73

- March 1973
- Color of leak lightens

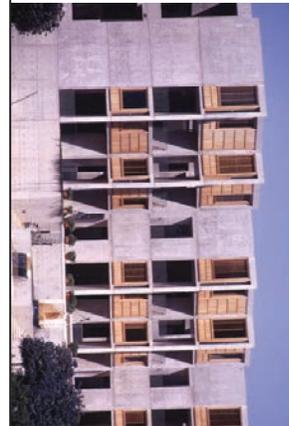
aaup.260.I.D.35.9_Oct 67

- October 1967**
- Moisture stains on lower portion of window walls
 - Black fungus growth on sloped teak sill, windowsill, sliding window sashes, and teak trim boards
 - Gray appearance on sloped teak sills and windowsills

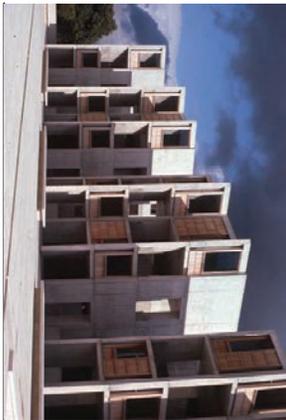
aaup.260.I.D.39.10_Apr 72

- April 1972**
- Moisture stains on lower portion of vertical sliding panels
 - Varied red appearance on teak drips with darker area above drips

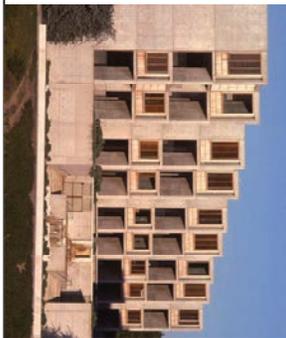
aaup.260.I.D.54.9_May 77

- May 1977**
- Black fungus growth on sloped teak sill and sliding window sashes
 - Weathering on window walls
 - Moisture stains on window walls

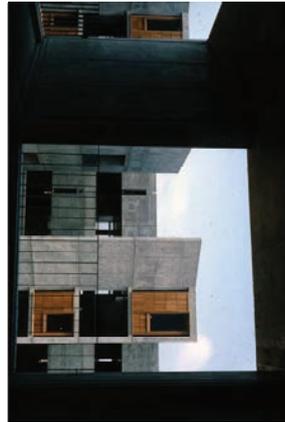
aaup.260.I.D.33.2_June 65

- June 1965**
- Installation of window wall assemblies complete; note that windows have not yet been installed
 - Color differences at adjacent vertical slidings
 - White appearance on sloped leak sill and teak drip cap; sunlight reflection or deposit?

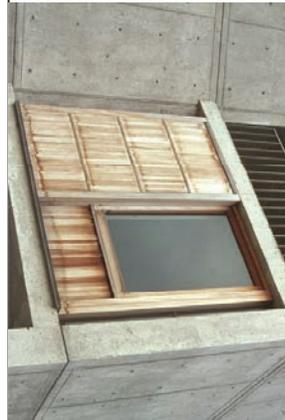
aaup.260.I.D.36.12_Oct 67

- October 1967**
- Moisture stains above sloped teak sill and teak drips and below drip cap
 - Black fungus growth on sloped leak sill and windowsill
 - Gray appearance on sloped teak sills and teak trim board

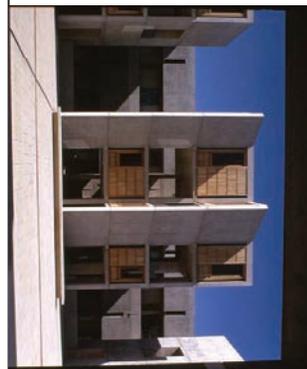
aaup.260.I.D.38.10_Apr 72

- April 1972**
- Dark red appearance below drips and windowsill

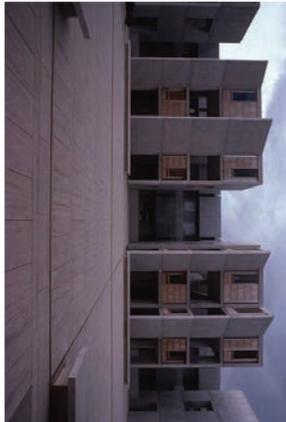
aaup.260.I.D.53.5_May 77

- May 1977**
- Black fungus growth on sloped teak sill and teak trim board
 - Moisture stains above sloped leak sill
 - Varied red appearance on teak, with dark red areas below drips and windowsills

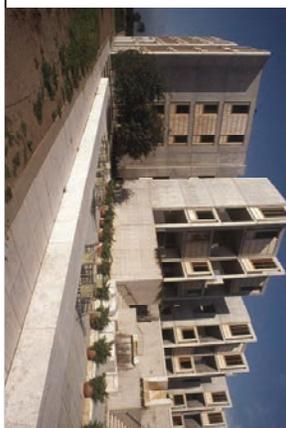
aaup.260.I.D.43.5_Mar 73

- March 1973**
- Teak has sunbleached appearance

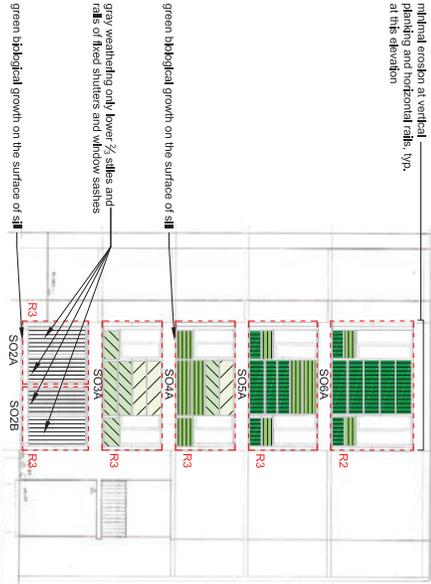
Additionally, early photographs of the site show moisture staining at the top and bottom of the vertical siding on many of the window walls (fig 3.7).

In the mid-1990s, a two-part cleaner and brightener (TE-KA brand Scrubless Cleaner), along with a wood oil sealer (Tip Top Teak) was applied to the teak in an attempt to improve its appearance and retard further deterioration. The wood oil sealer gave the wood its red appearance, which is still visible in parts of the building today.

The teak continued to be cleaned and sealed on a four- to five-year cycle, with more focus given to the highly visible plaza-facing elevations than to other areas of the building. Around 2009, as the Salk Institute considered a more serious repair project for the window walls, this cleaning process was halted. As of 2014, the only cleaning being undertaken is the washing of the window glass several times a year. Salk maintenance staff report that the windows are regularly maintained, with the interior faces of the sashes sanded and sealed and the operating hardware cleaned and waxed to maintain functionality.

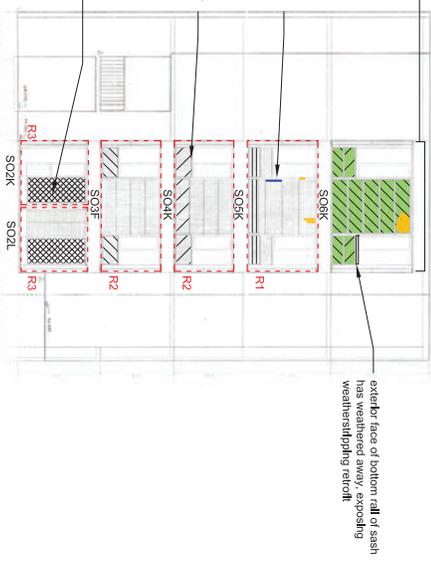
black fungus deposits on fixed louvers

exterior face of bottom rail of sash has weathered away, exposing weatherstripping retrofit

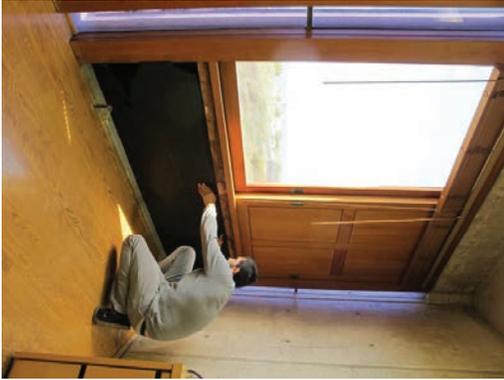
SO4B, AFTER REMOVAL OF OAK PANELING, SHOWING BUILDING PAPER AT INSIDE FACE OF FRAMING

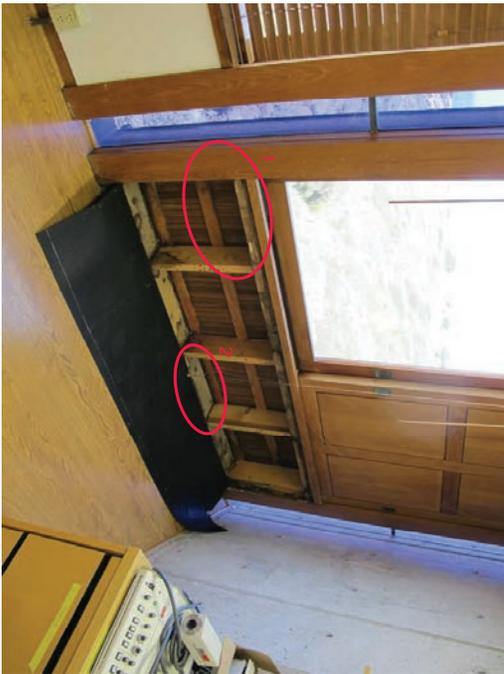
SO4B, AFTER REMOVAL OF BUILDING PAPER

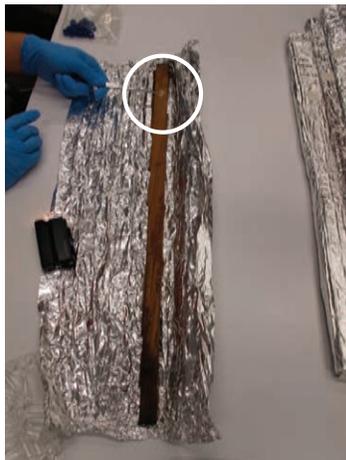
Sample C.1.
white glue-like
material

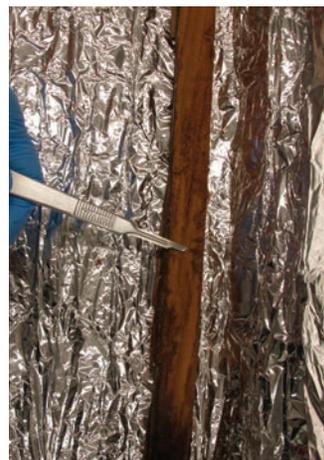
Sample C.2.
glue

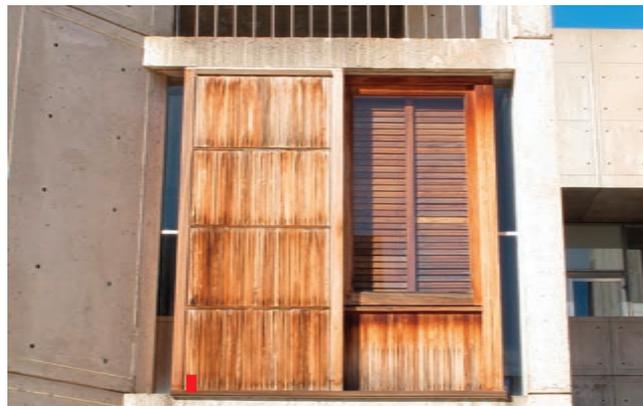
SAMPLE D

furring strip: assumed 2 x 4 bottom furring strip, west panel, slat row 1, in area where slat was removed

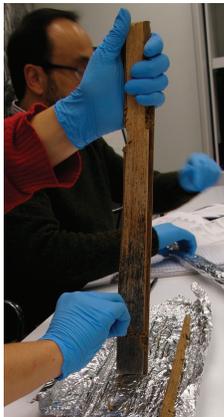
Sample H.1.
thin section to investigate depth of biological deterioration

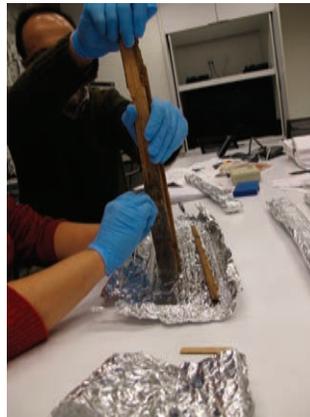
Sample H.2.
thin section to investigate depth of biological deterioration

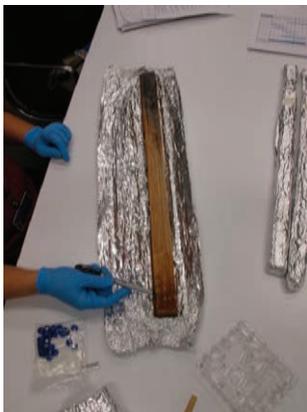
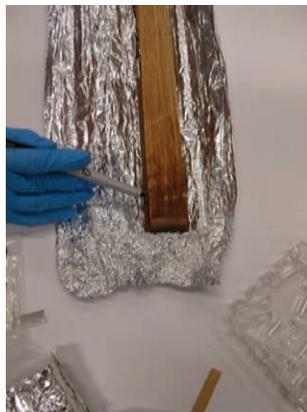
Sample J.1.
red coating

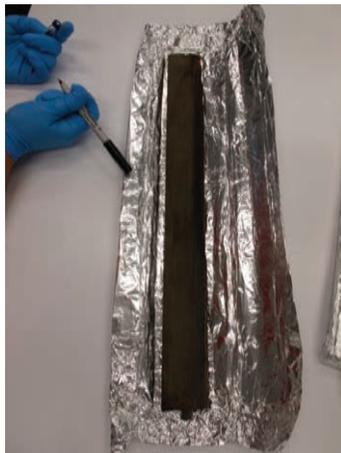
Sample K.1.
black spore

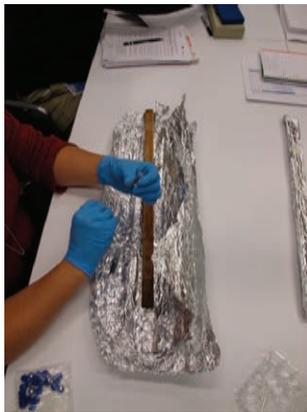
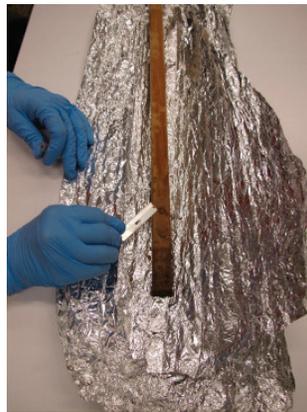
Sample L.1.
glue

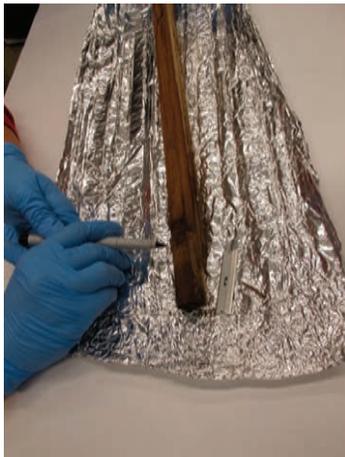
Sample M.1.
loose black deposit

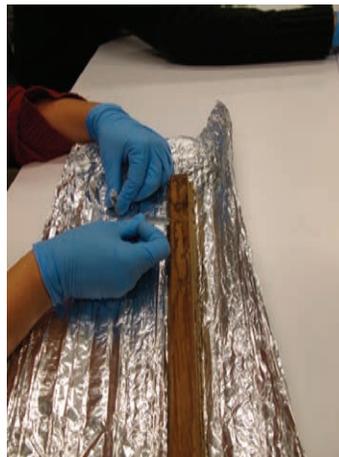
Sample M.2.
glue

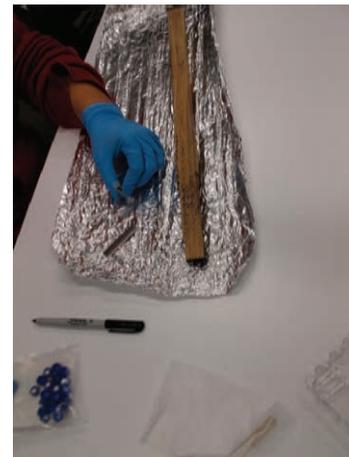
Sample M.3.
deteriorated wood

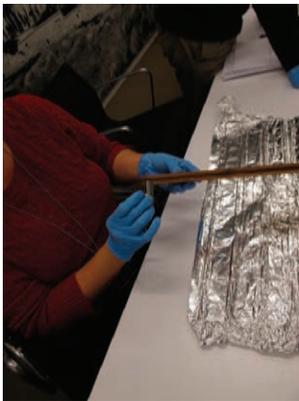
P.1.	Sample of wood in good condition

Sample P.1.
sample of wood in good
condition

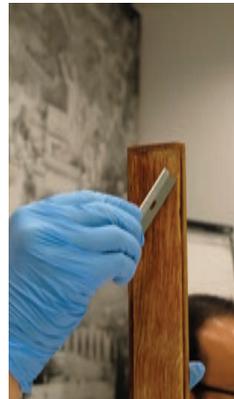
Sample P.1.
shiplap sample of
wood in good condition

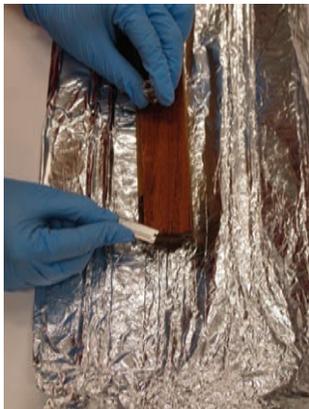
Sample Q.1.
red coating

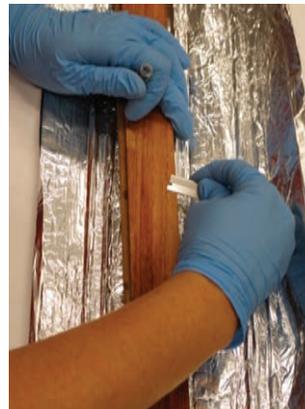
Sample Q.2.
seemingly non-coated

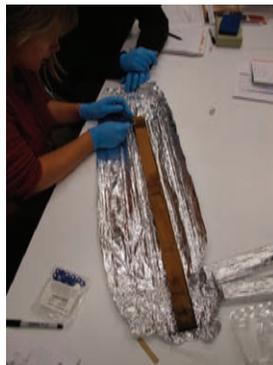
Sample S.1.
coating

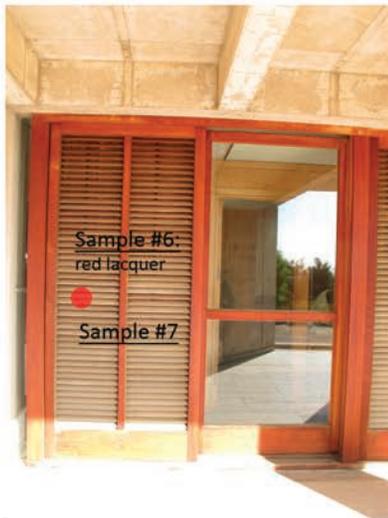
NO2C
samples #6 and #7 are taken from the panel behind the louver

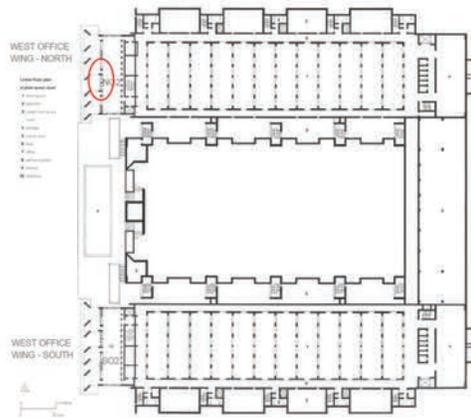
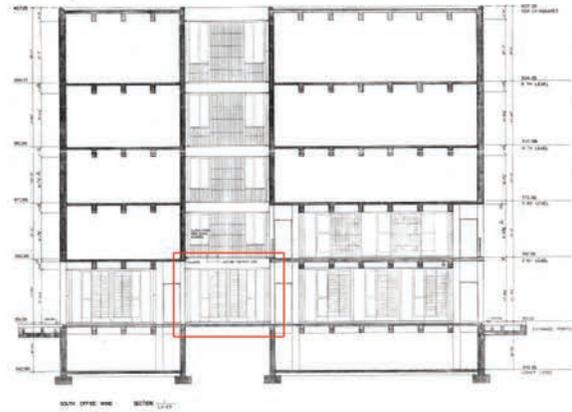
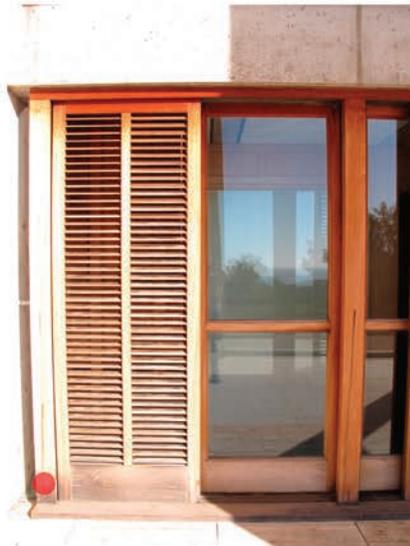
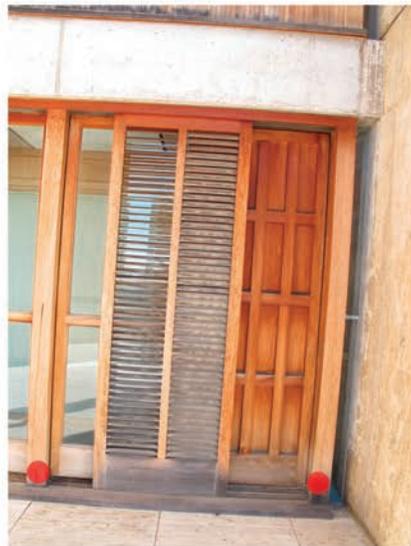
North Office Building | NO2F & NO2G | Sample 8

Sample #8:
black spore

A sample of the black biofilm (sample #8, windows NO2F and NO2G¹) was collected and placed in sterile water. Fungal hyphae grew in two days, strongly indicating that the fungus is actively growing (fig. 5). The hyphae were stained with lactophen cotton blue (see arrows).

DNA analysis showed that the dominant organism in the biofilm from sample #8 (windows NO2F and NO2G) is *Phaeothecoidea* spp.; it is a fungus commonly found on dead and decaying fauna and is the causal agent for leaf spot disease in eucalyptus and other trees. *Phaeothecoidea* spp growing on leaf matter is similar in appearance to the black material on the Salk wood because it is also encased in a black shiny exudate. The biofilm from sample #24 matched *Toxicocladosporium* spp.; these type of fungi are able to degrade cellulose and are visually similar to *Phaeothecoidea* spp. (black shiny exudate growing on leaf matter). As samples #J, #H, and #S are microscopically similar to each other, they were analyzed as a mixture. DNA analysis showed they belong to the order Capnodiales (fig. 6). Most importantly, DNA analysis of the fungi from Salk wood showed all to be within Capnodiales, an order that is also known as “sooty mold fungi” and is responsible for important crop and tree diseases.

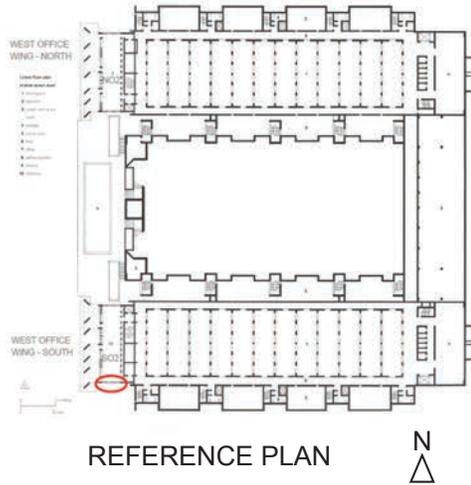
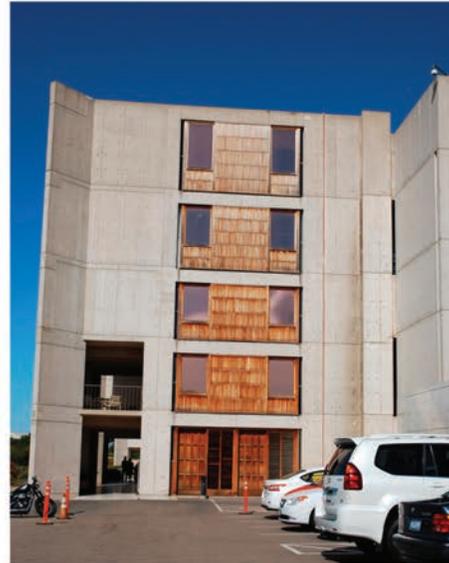
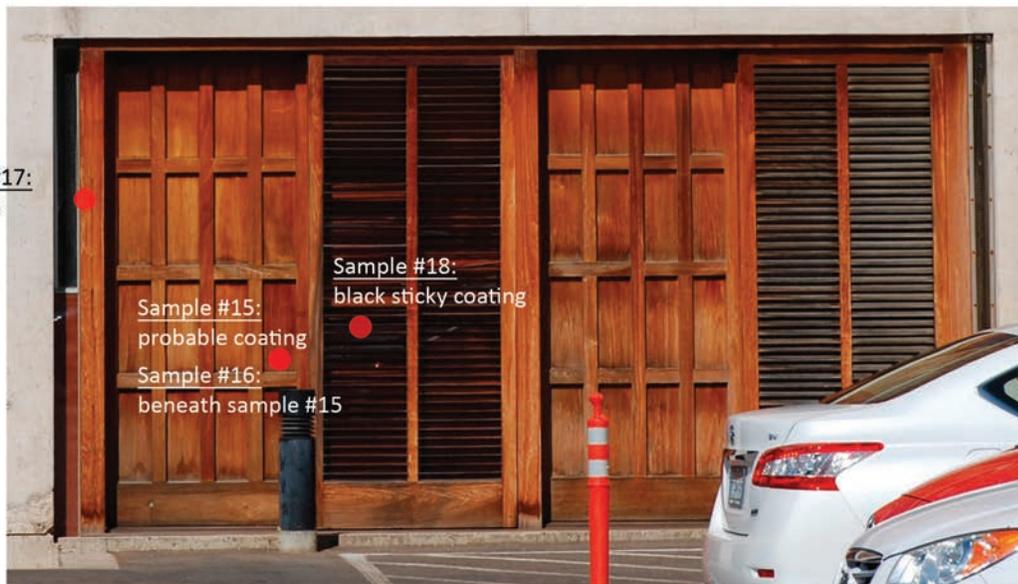
North Office Building | SO2K | Sample 15, 16, 17, 18

Sample #17:
rust stain

Sample #15:
probable coating

Sample #16:
beneath sample #15

Sample #18:
black sticky coating

Deposits such as calcite stalagmites were found in sample #26 SL4A, and sample #29 SL4A contains a blue copper corrosion product identified as copper chloride. Sample #18 SO2K contains a sticky (and fishy-smelling) black coating that is not a drying oil but rather a fatty acid, probably animal or vegetable lipids.

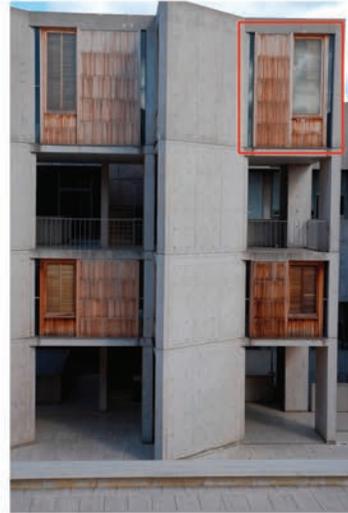
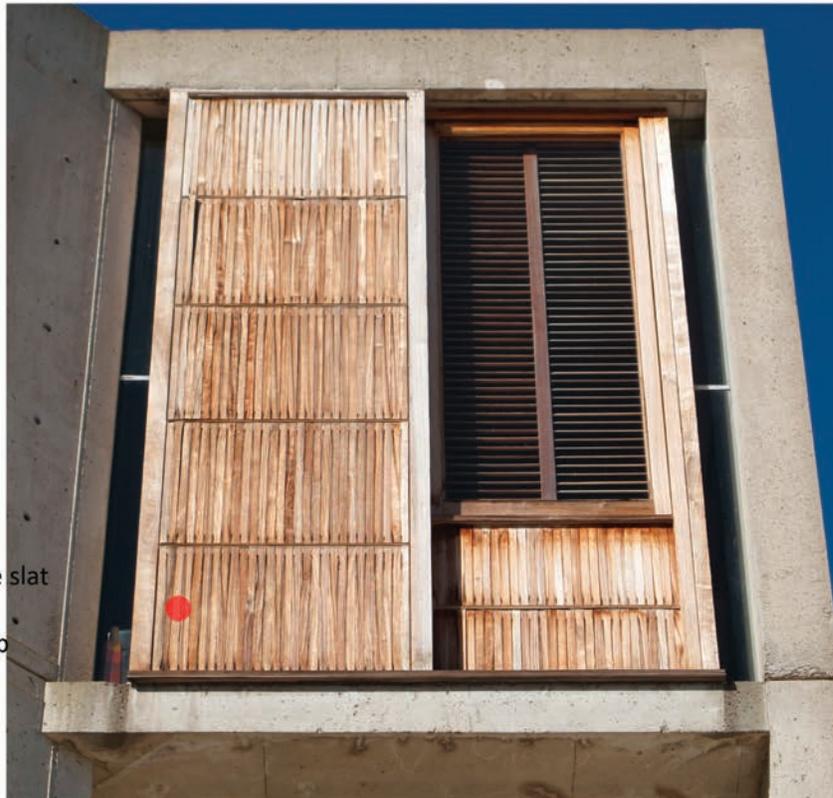
- Sample #21:
Debris behind the slat
- Sample #22:
Interior wood chip
- Sample #23:
Glue on the slat

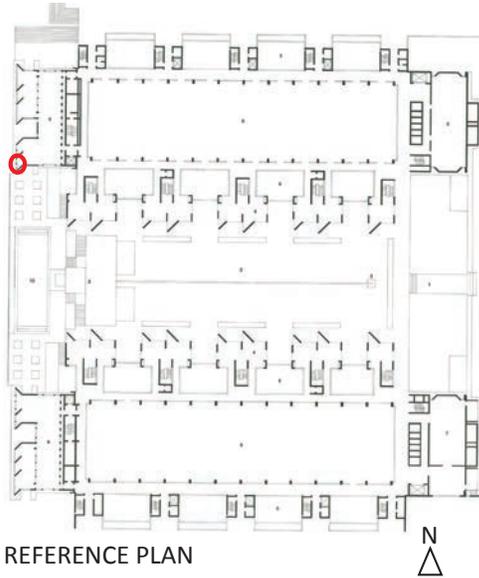
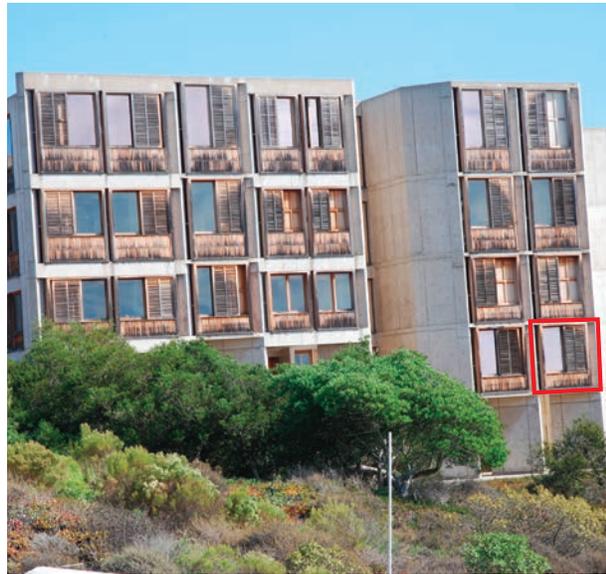
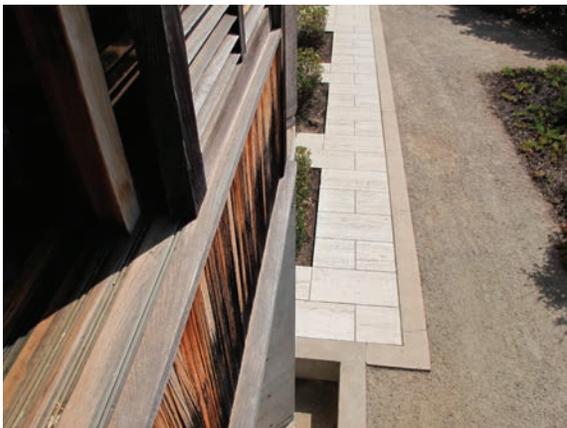
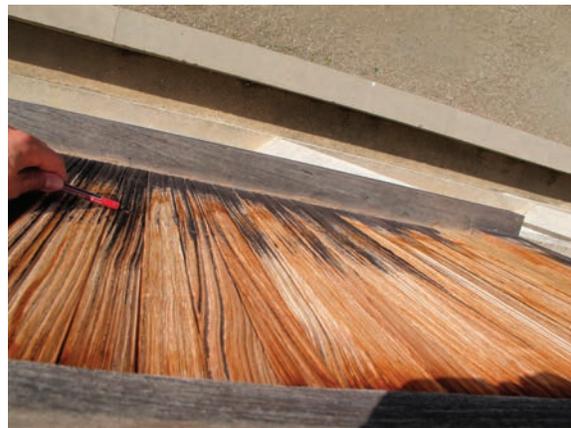
North Office Building | NO3E | Sample 31, 32

Sample #31 & 32: 7th slat from north;
area with black fungal growth

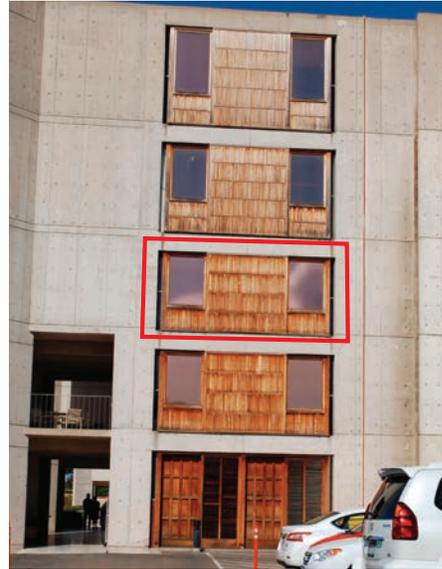
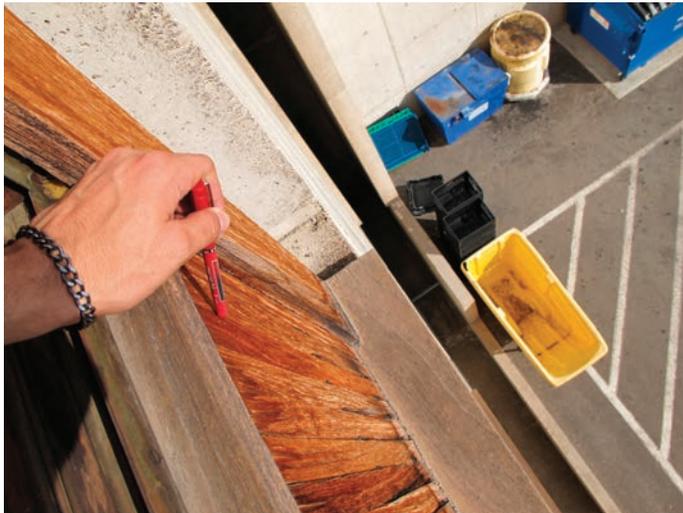
South Office Building | SO4K | Sample 33

Sample #33:

2 samples from 3rd slat from east.
To determine if treatment/coating
stratigraphy at upper levels is differ-
ent from that at lower levels.

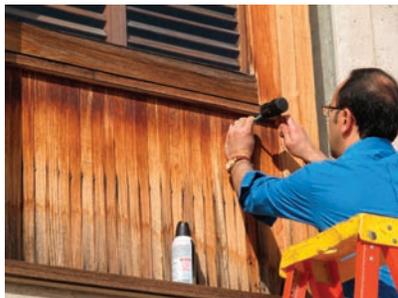
Sample #34:
top of 4th slat from east;
coating sample

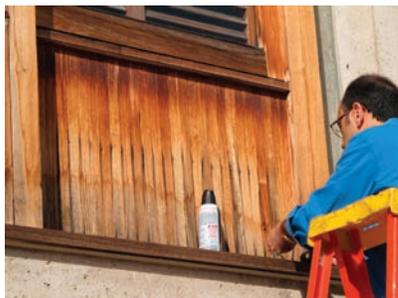
Sample #35:
bottom of 4th slat from east;
to compare coating with Sample #34

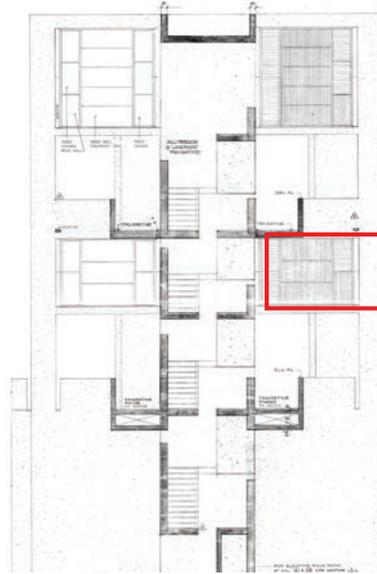
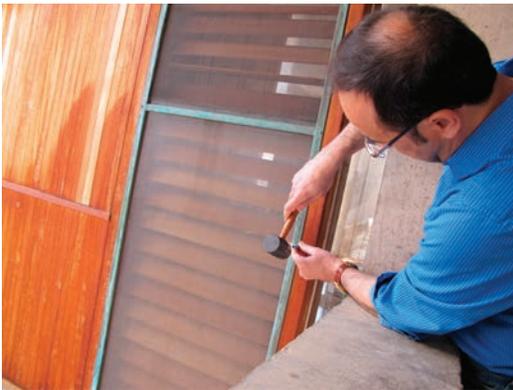
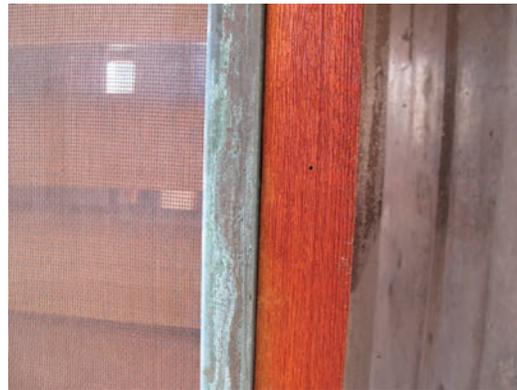
Sample #36:
taken from post; coating

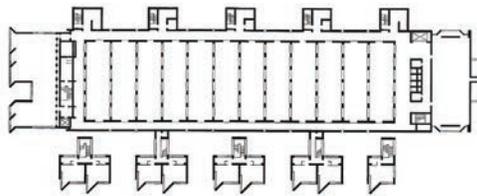
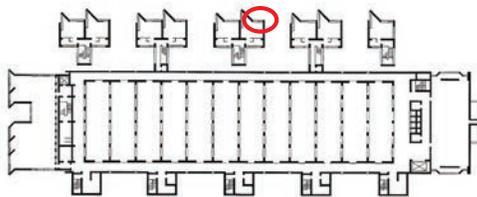
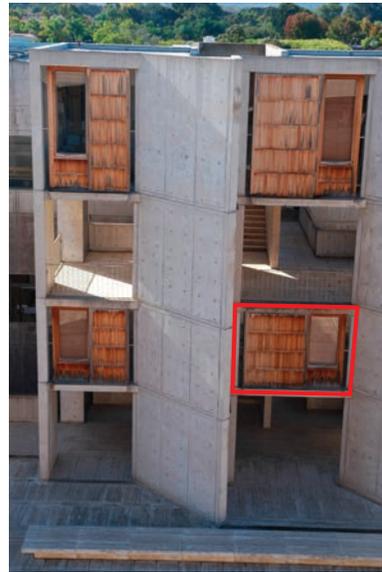
South Study Tower 7S | SL6C | Sample 37, 38, 39

Sample #37:
taken from top of 9th slat from left
