Salk Institute for Biological Studies Conservation Project: Teak Window Wall Assemblies

Phase 1: Research and Investigation Results
and Preliminary Conservation Proposals

Sara Lardinois

The Getty Conservation Institute

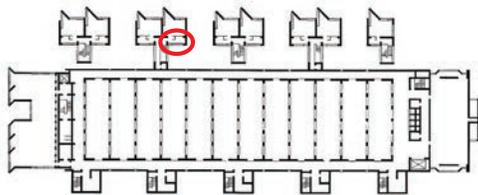
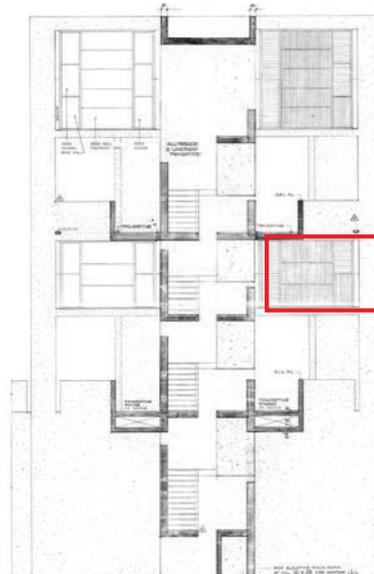
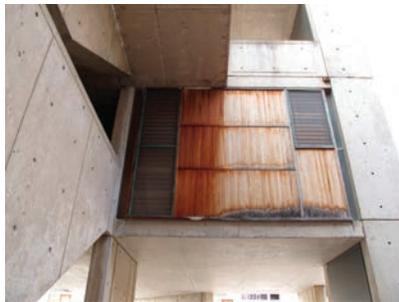
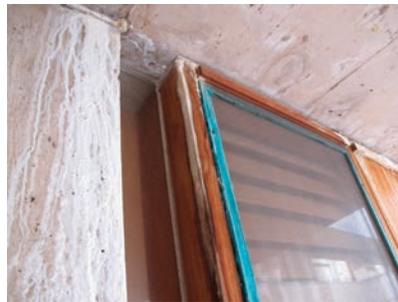
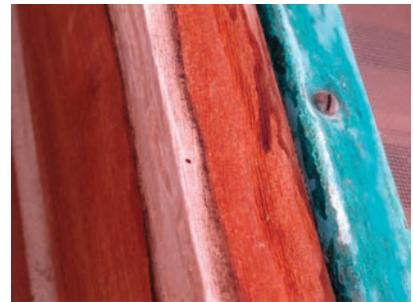
South Study Tower 4S | SL4A | Sample 40

Sample #40: taken from post by walkway;
sample included salt as well as coating

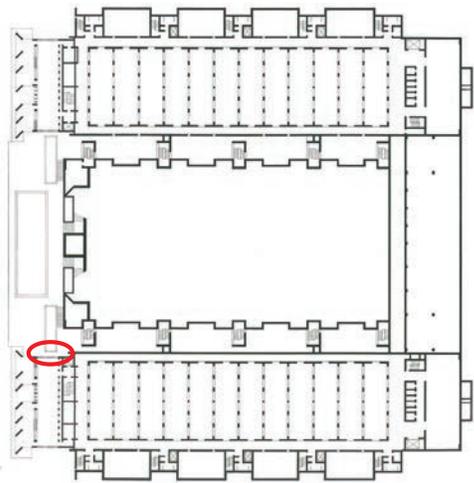
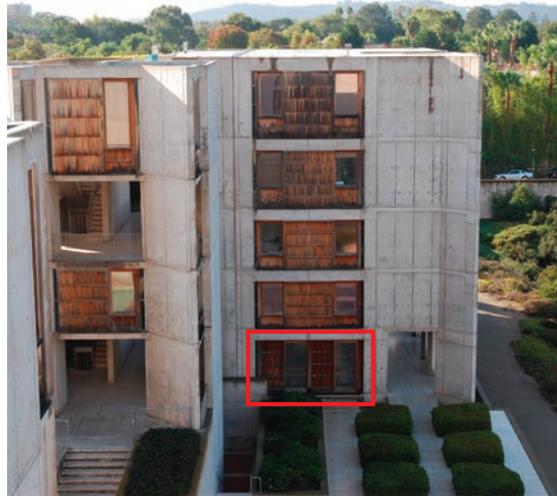
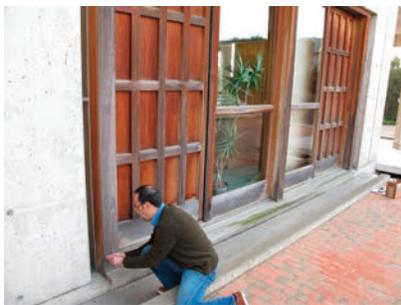
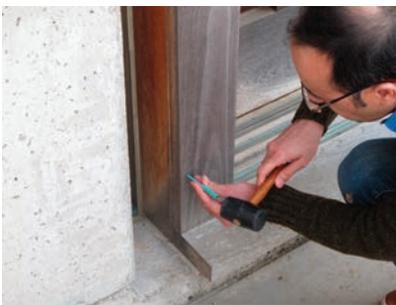
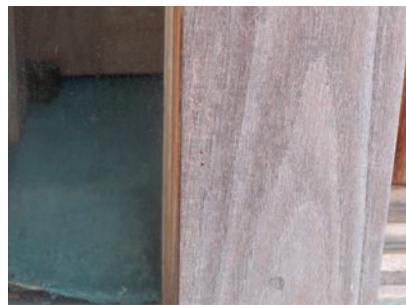
South Office Building | SO2A | Sample 41

Sample #41:
resampling of original Sample #3, as it was lost in mounting/preparation process

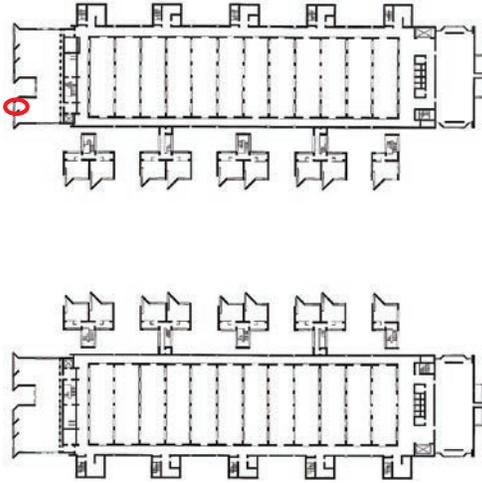
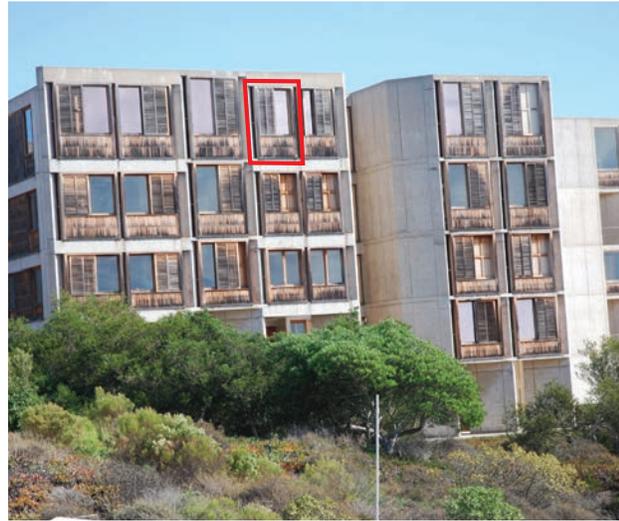
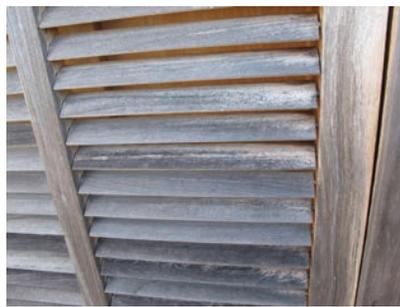
North Office Building | NO6H

Sample #42:
vertical trim (face); black crust

Sample #43:
vertical trim (side/return);
white efflorescence

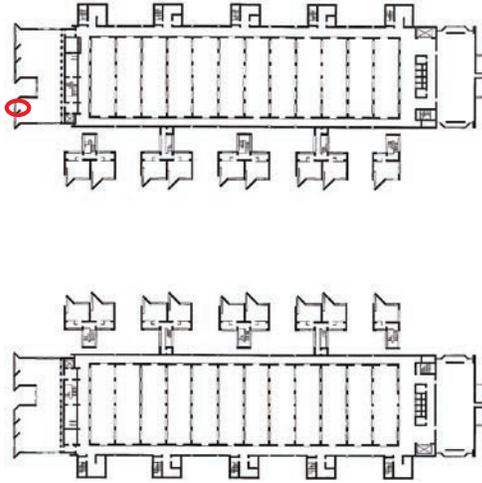
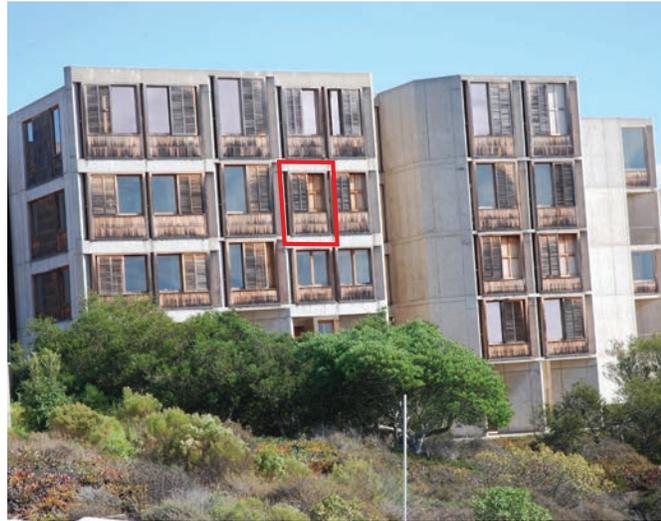
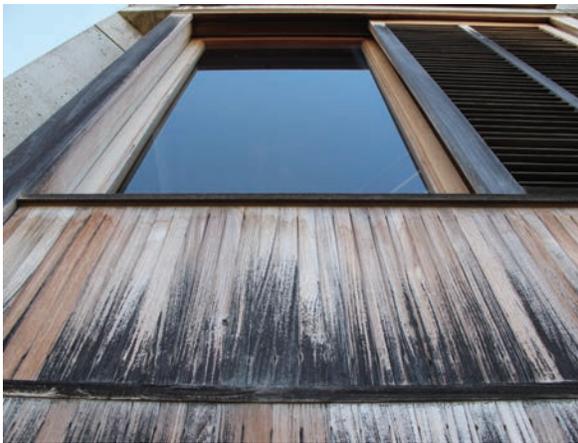
North Office Building | NO5H

Sample #44:
vertical trim; black crust

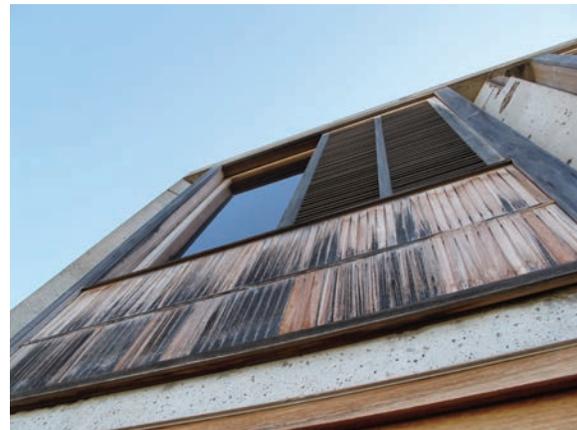
Sample #45:
loose piece of rail (center of span) between slat rows 1 and 2

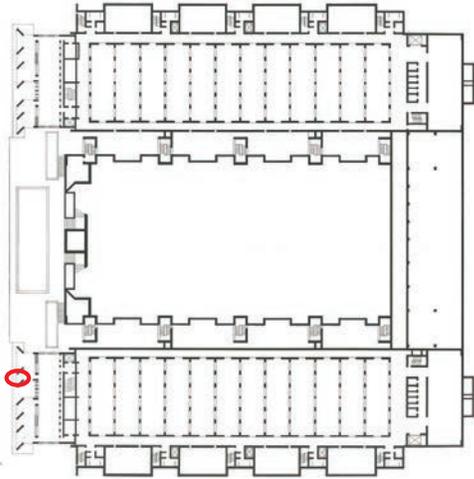
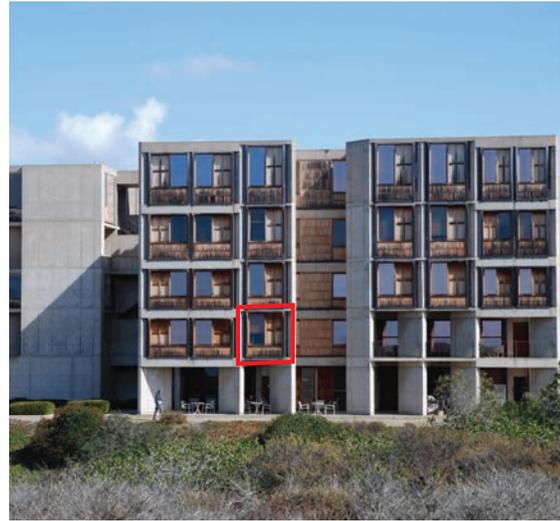
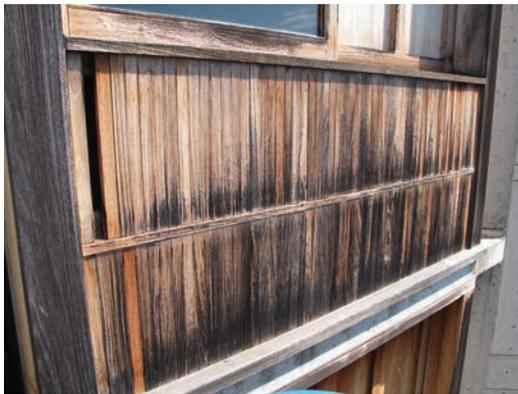
South Office Building | SO5D | Sample 46, 47

Sample #46:
slat; bottom of 4th slat from left (north), slat row 1

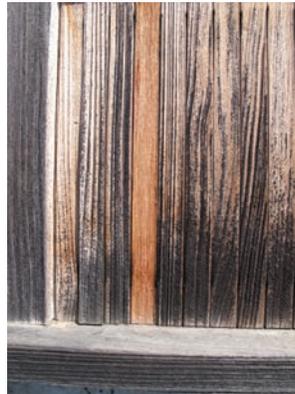
Sample# 47:
slat; bottom of 5th slat from left (north), slat row 1

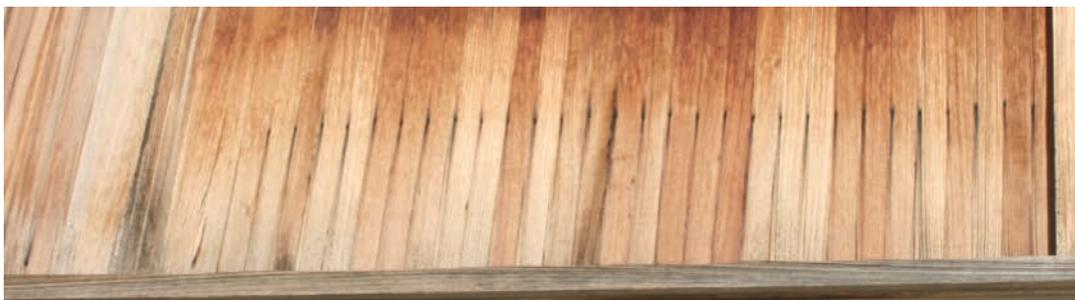
Figure 1

We observed several different types of black material on the wood at the Salk Institute. The simplest to identify by eye are the black deposits shown in figure 1 (Salk, undocumented location). These are iron and tannin reactions that occur when iron comes into contact with wood. The deposits are easily distinguished by the long trail of black below the nails. Other black deposits were found in some areas that were primarily composed of dust and dirt.

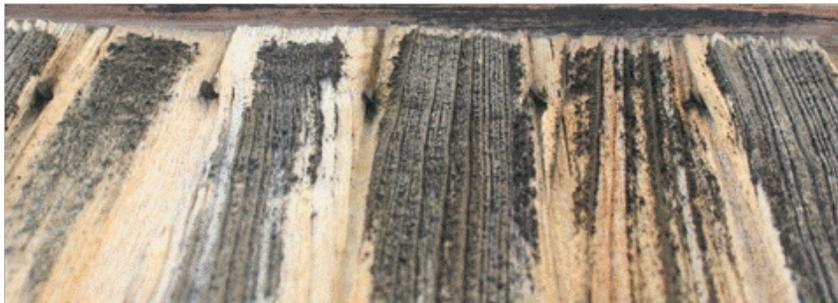
Figure 2

The photo below was taken outside windows NO4E and NO4F in Francis Crick's former office in the northern west office wing (fig. 2). It is representative of the ubiquitous black color found on the wood throughout the Salk Institute. It is a sooty material deposited on the surface or in the deep longitudinal grooves of the wood.

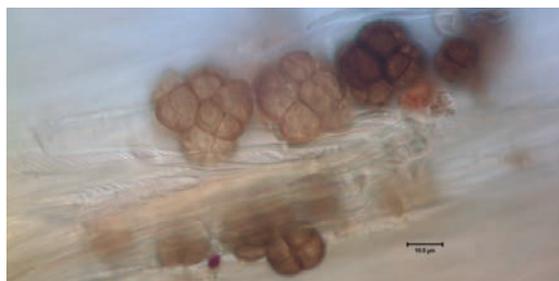
Figure 3 shows a microscopic image (100x oil immersion) of the sooty black material. It was positively identified as a microorganism (probably yeast) that was actively budding, dividing, and growing. It is highly pigmented with melanin, cells are between 5 and 10 micrometers in diameter, and groups of clusters or chains are clearly visible.

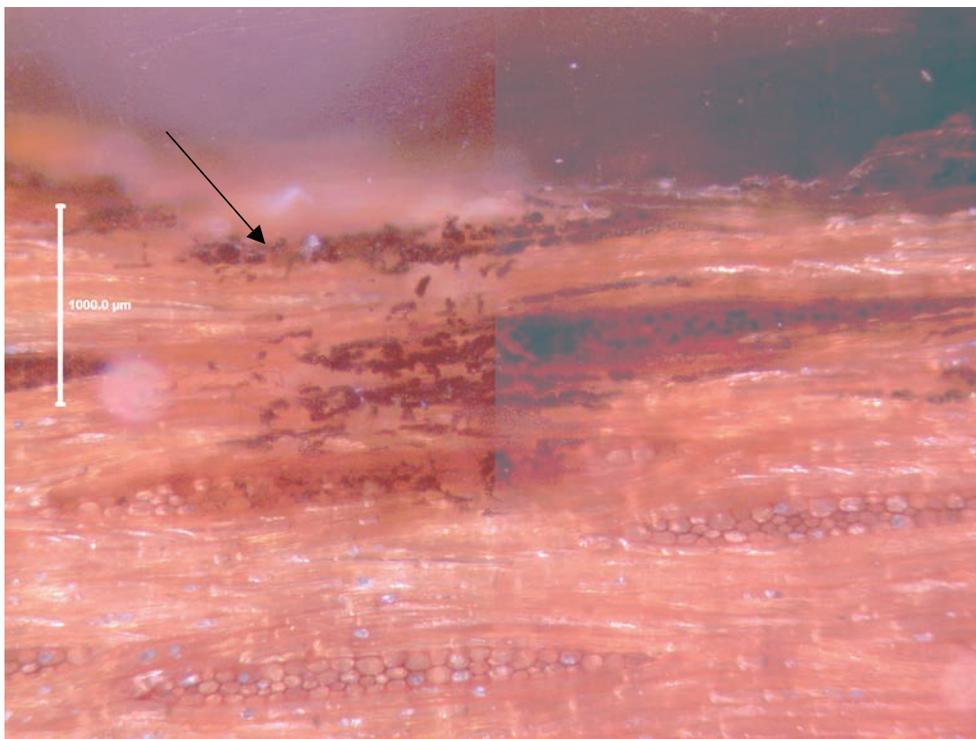
Figure 4

A cross section of wood with the black sooty microorganism on its surface is shown below (100x oil immersion). The microorganisms are the dark-brown specks or brown rice grains (see arrow, fig. 4). The growth of microorganisms on the surface of an object or substrate is defined as a biofilm and is often encapsulated in an extracellular matrix, most often a polysaccharide (long chain of sugars), in order to adhere to the substrate. The biofilm on the Salk wood is seen in figure 4 as brown clusters and penetrates to about 1000 μm or less.

The ubiquitous black sooty biofilm on the Salk wood is composed of fungi from order Capnodiales and penetrates the wood to a depth of about 1 mm. These fungi can degrade cellulose but cannot degrade lignin; thus they are not degrading the structural support of the wood. Most importantly, DNA analysis did not identify the type of fungus that can degrade lignin. The black sooty mold found on the Salk wood likely originates from the nearby leaves of the eucalyptus trees, spreading by wind or water droplets.

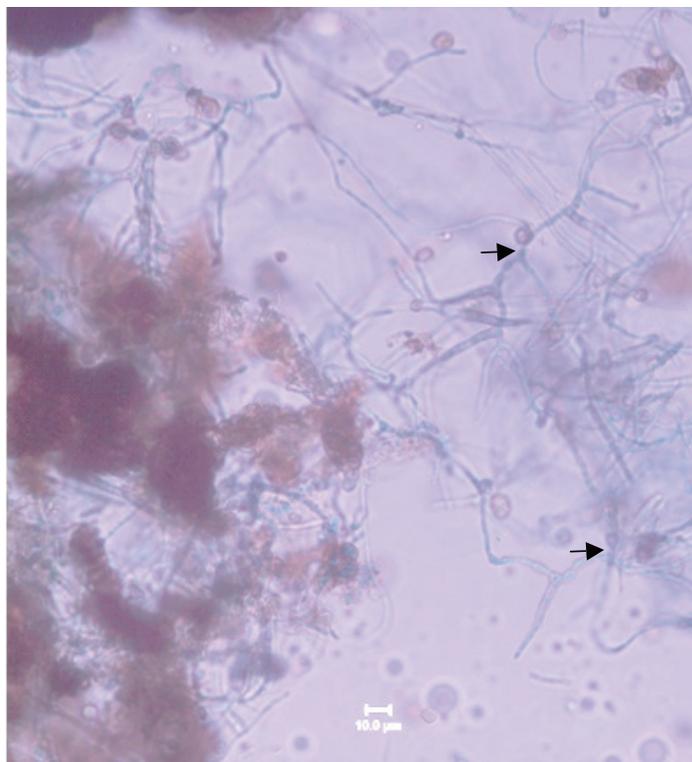
Figure 5

A sample of the black biofilm (sample #8, windows NO2F and NO2G¹) was collected and placed in sterile water. Fungal hyphae grew in two days, strongly indicating that the fungus is actively growing (fig. 5). The hyphae were stained with lactophen cotton blue (see arrows).

DNA analysis showed that the dominant organism in the biofilm from sample #8 (windows NO2F and NO2G) is *Phaeothecoidea* spp.; it is a fungus commonly found on dead and decaying fauna and is the causal agent for leaf spot disease in eucalyptus and other trees. *Phaeothecoidea* spp growing on leaf matter is similar in appearance to the black material on the Salk wood because it is also encased in a black shiny exudate. The biofilm from sample #24 matched *Toxicocladosporium* spp.; these type of fungi are able to degrade cellulose and are visually similar to *Phaeothecoidea* spp. (black shiny exudate growing on leaf matter). As samples #J, #H, and #S are microscopically similar to each other, they were analyzed as a mixture. DNA analysis showed they belong to the order Capnodiales (fig. 6). Most importantly, DNA analysis of the fungi from Salk wood showed all to be within Capnodiales, an order that is also known as “sooty mold fungi” and is responsible for important crop and tree diseases.

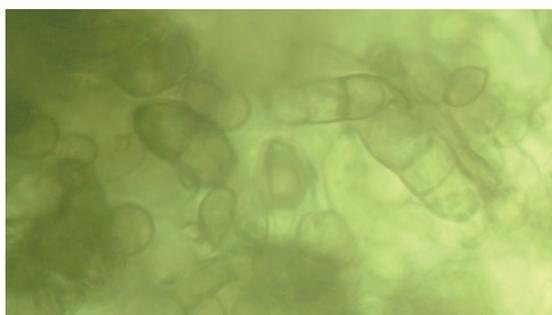
Figure 7. Eucalyptus leaf fungus growing on-site.

Lastly, black material found on the eucalyptus leaves from trees found on the Salk property were also sent for DNA analysis. The black sooty mold samples were scraped from leaves that had black raised areas. The microorganism is similar under the microscope to the black deposits on the Salk wood (fig. 7). The DNA analysis identified two matching markers, order Dothideales and phylum Ascomycota. Dothideales contains fungi that are plant pathogens and Ascomycota is the larger group of fungi that includes Dothideales and Capnodiales. Even though DNA analysis did not identify the fungi to species level, phylum Ascomycota is probable because it contains many fungal plant pathogens.

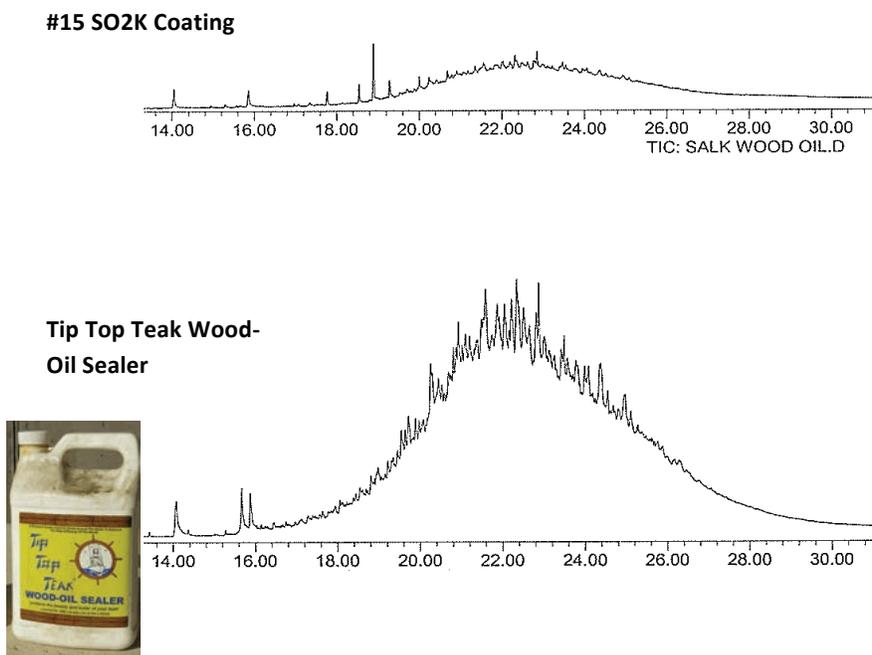
Figure 8

Two GC/MS chromatograms are shown in figure 8. The chromatogram on bottom is from a wood treatment material called Tip Top Teak Wood-Oil Sealer that was found on-site at the Salk Institute and analyzed as a reference material. The chromatogram on top is from sample #15 SO2K coating. Tip Top Teak was identified in several samples due to this wide set of peaks; it displays a variety of high-molecular-weight hydrocarbons (perhaps a hydrocarbon-based wax) and fatty acids from a drying oil (results not shown). Figure 9 summarizes all of the samples tested using GC/MS that match Tip Top Teak.

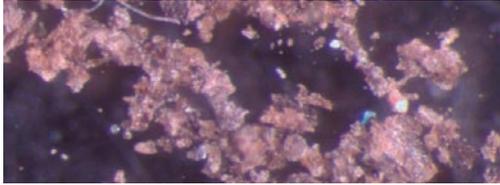
Tip Top Teak Wood-Oil Sealer Sample and Description	Image of Sample
#4 NO2A red stain/varnish and (right) #5 NO2A black biofilm on vertical framing

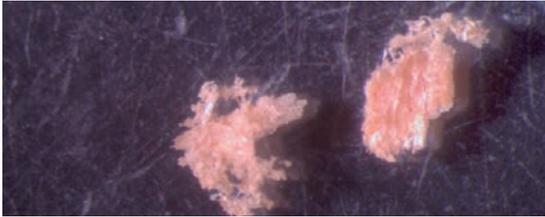
Figure 9

#Q1 NL8A slat red coating and (right) #Q2 NL8A slat seemingly non-coated

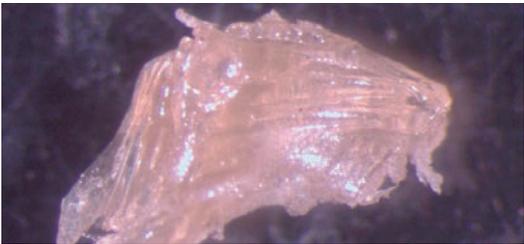
Acrylic polymers were also identified in several samples by pyrolysis GC/MS, based on the presence of ethyl acrylate, methyl methacrylate, ethyl methacrylate, and butyl methacrylate (fig. 10). This indicates a modern formulation, as it is a complex mixture of acrylic monomers. Diisooctyl phthalate was present in the GC/MS chloroform extracts as well as phenol, pentachloro- (an herbicide, fungicide, and insecticide), and oxybenzone (a UV inhibitor).

Acrylic Polymer	Image of Sample
#6 NO2C panel red stain lacquer

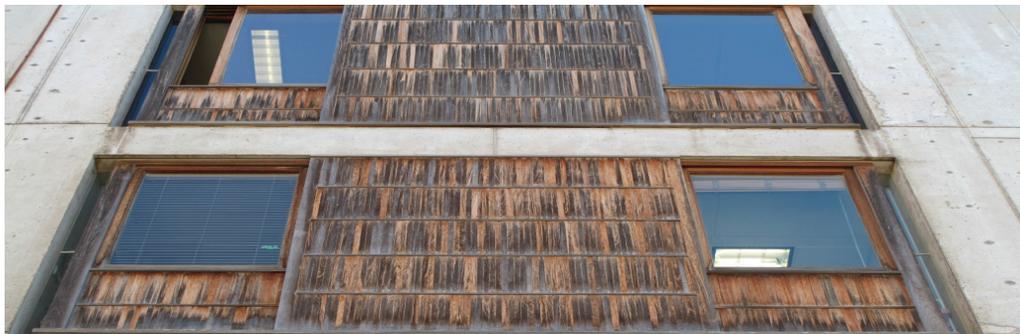
Figure 1

The ubiquitous black accumulations found on the teak wood surface ranged in color from light gray to very thick black sooty deposit (fig. 1). The buildup was more evident on the north- and west-facing elevations. The light-gray patinas were mainly observed on the lower parts of the vertical slats in contact with the windowsills and various horizontal dividing pieces. The deposits were likely the result of capillary movement of water containing dissolved salts and various organic matter.

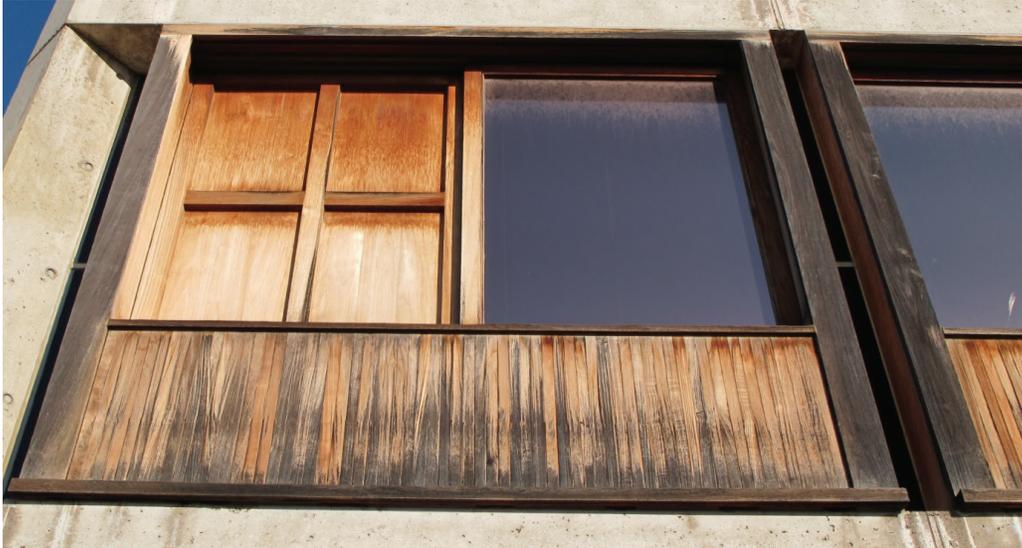
Other areas showed a wide spectrum of surface deposits ranging from white powdery layers on vertical slats and trims to red coatings resulting from previous treatment applications. Figure 2 illustrates the reddish coatings seen frequently on the upper and more protected areas of the windows. Figures 3 and 4 show the gray patina that usually forms on the lower part of the slats

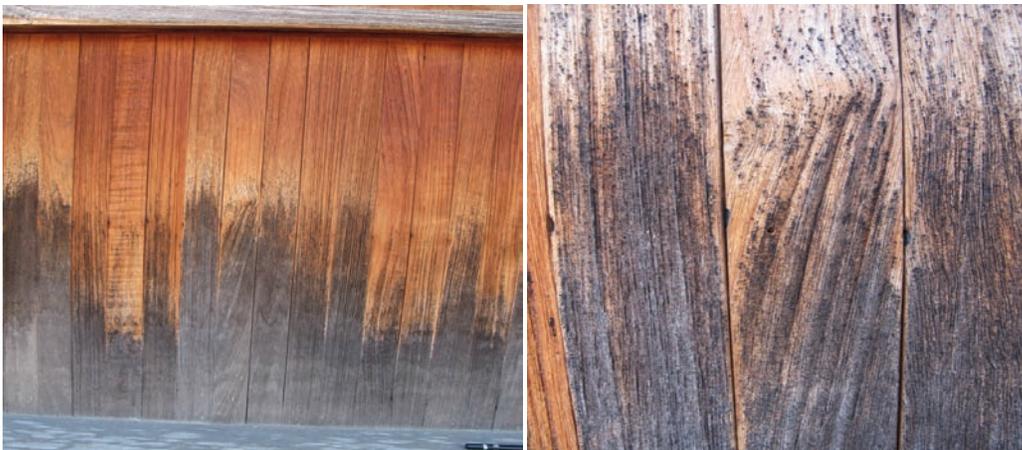
Figures 3 and 4

due to the aforementioned capillary migration of water-soluble salts and other components that may promote the growth of the fungal biofilms. White and black deposits were also observed on vertical window trims.

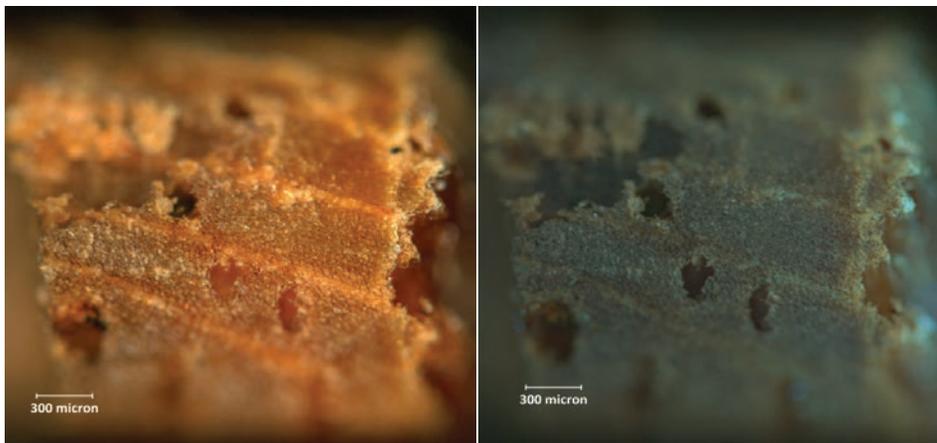
Figures 9 and 10 show core samples removed from the top part of the single slat discussed in section 3.1. Both visible and UV illuminated images show the top deposits concentrated on the surface. FTIR analysis of the surface composition indicated the presence of oil, acrylic, and oxalate material. The presence of the first two components was likely the result of previous surface applications, while the occurrence of oxalate is a likely the result of biological and environmental interactions.

Figure 9. Sample 37 from SL6C, cross sectional view under visible (left) and UV illumination.

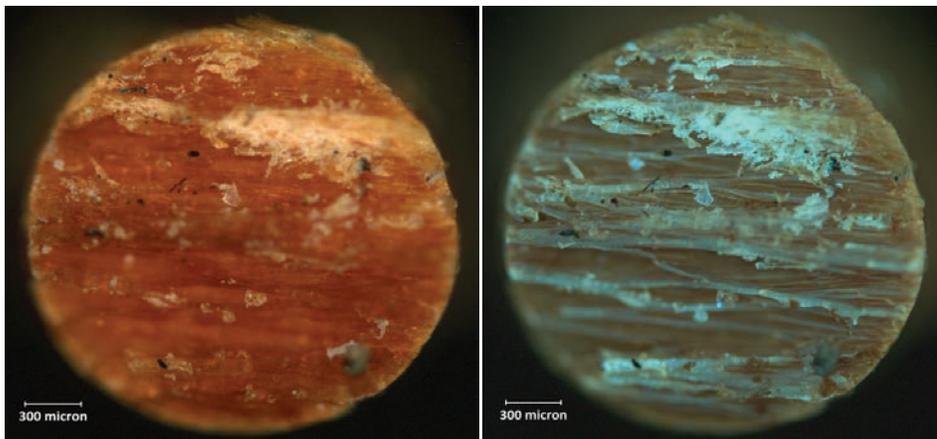
Figure 10. Sample 37 from SL6C, surface area under visible (left) and UV illumination.

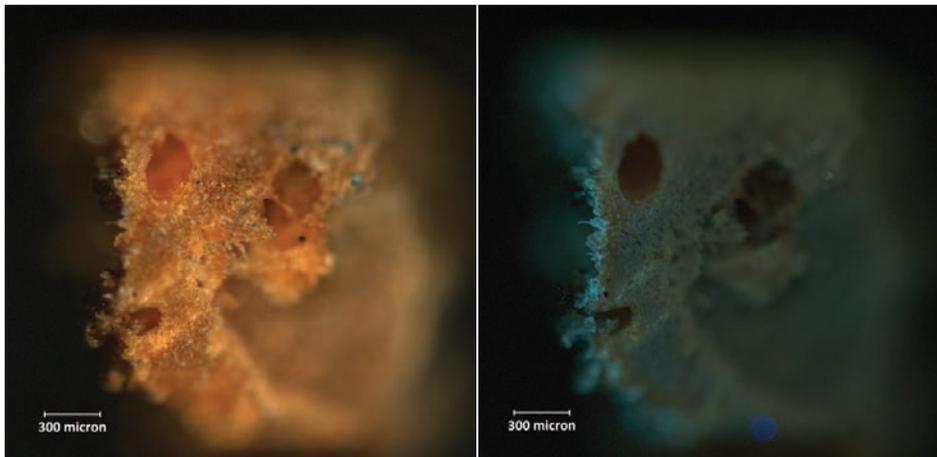
Figures 11 and 12 show core samples removed from the middle area of the slat. Both visible and UV illuminated images again show the top fungal layer to be concentrated on the surface. The presence of acrylic from artificial surface treatments and protein originating from the fungal layer was confirmed.

Figure 11. Sample 38 from SL6C, cross sectional view under visible (left) and UV illumination.

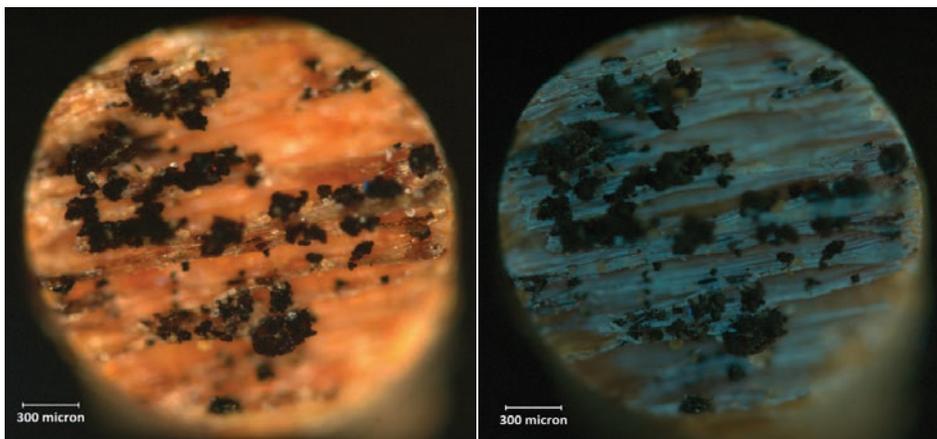
Figure 12. Sample 38 from SL6C, surface area under visible (left) and UV illumination.

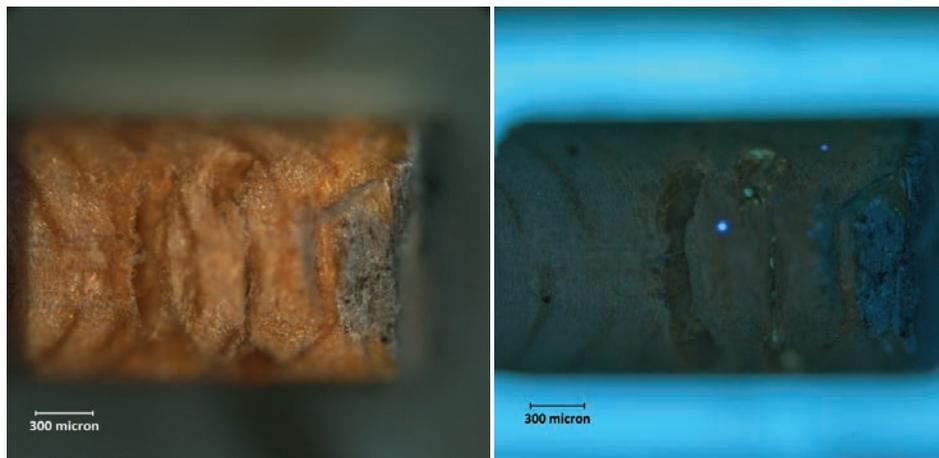
Figures 13 and 14 show core samples removed from the lower part of the slat. Both visible and UV illuminated images show the top gray layer to be concentrated on the surface but different in color and texture when compared with the middle layer. This is likely due to the presence of water-soluble material wicking up the wood. FTIR analysis of the top layer show the presence of oil and oxalate.

Figure 13. Sample 39 from SL6C, cross sectional view under visible (left) and UV illumination.

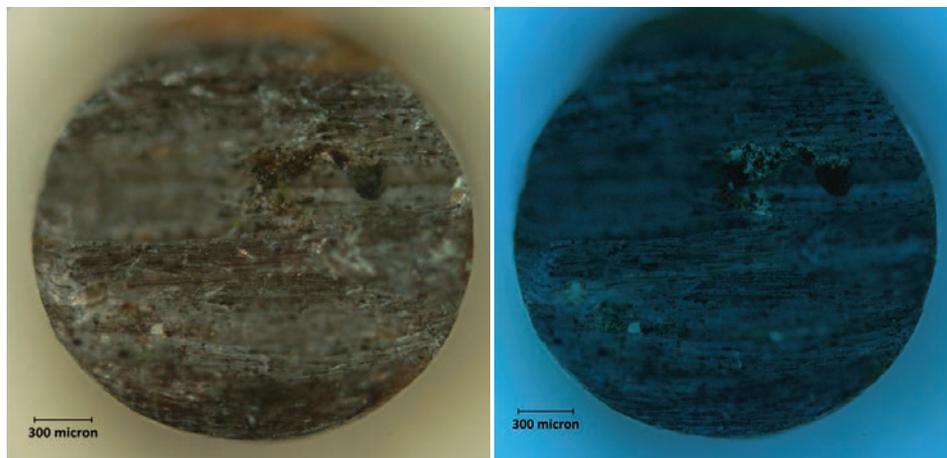
Figure 14. Sample 39 from SL6C, surface area under visible (left) and UV illumination.

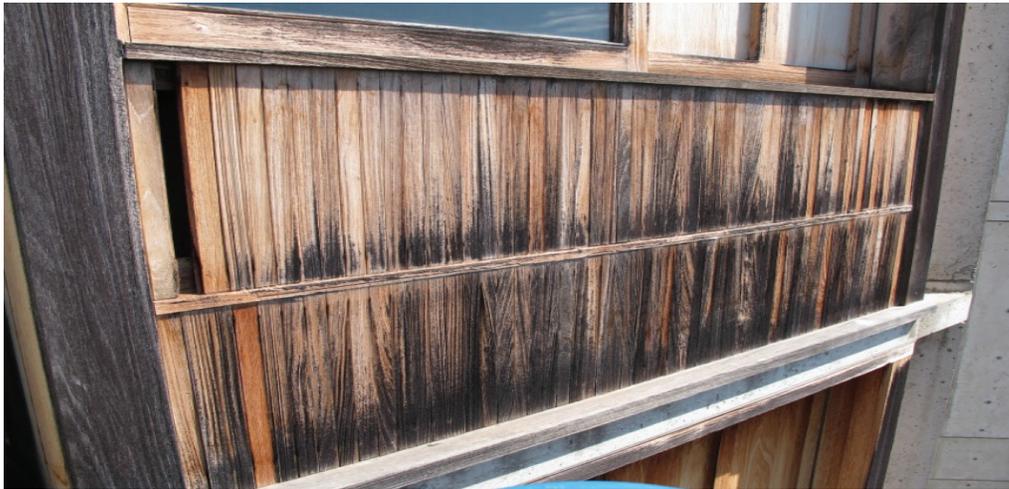
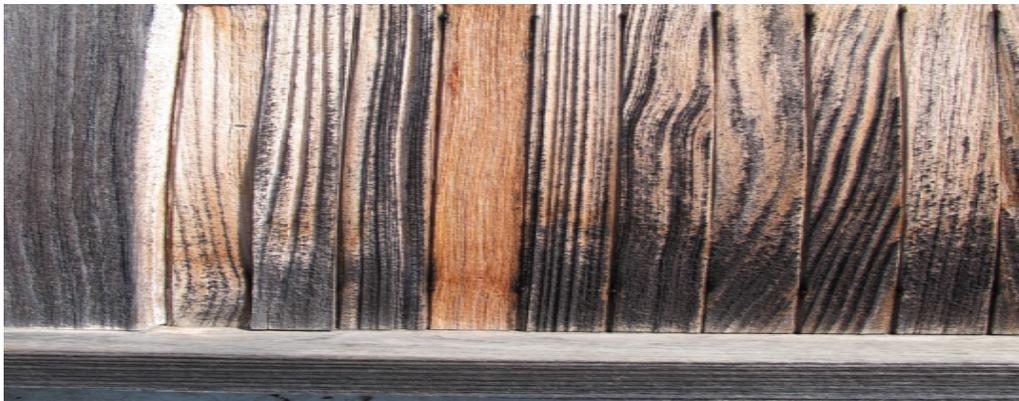
Adjacent divergent slats were present in different areas of the Salk Institute. Photographs taken from the west elevation of the south office building show large areas of biological growth, with few slats showing lack of infestation (figs. 15 and 16).

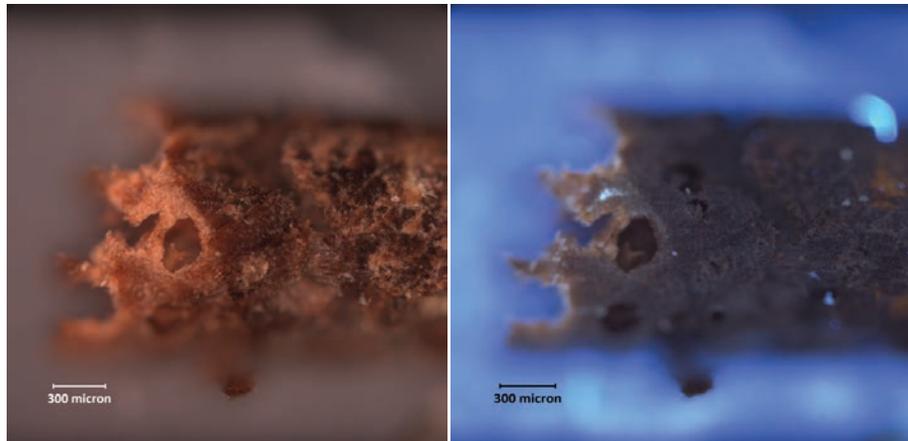
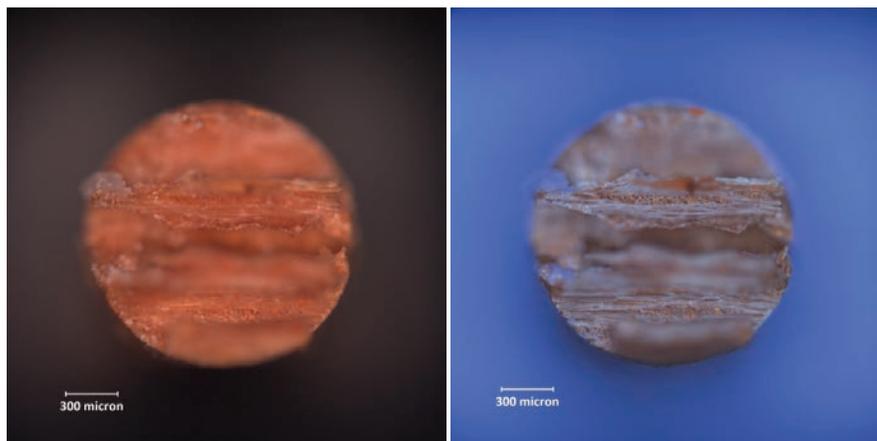
The photomicrographs in figures 17 and 18 clearly show the lack of fungal infestation on the red-coated slat. However, the teak wood exhibited weathering patterns on the uneven surface. Analysis results indicated the presence of resinous material, likely applied as a surface coating.

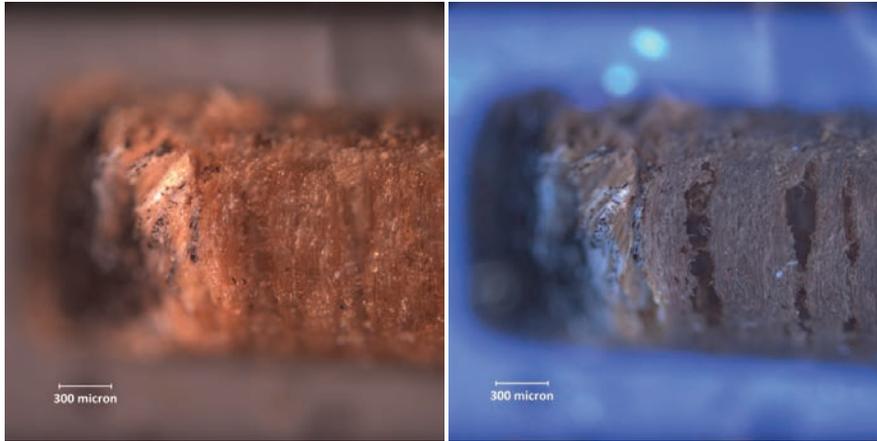
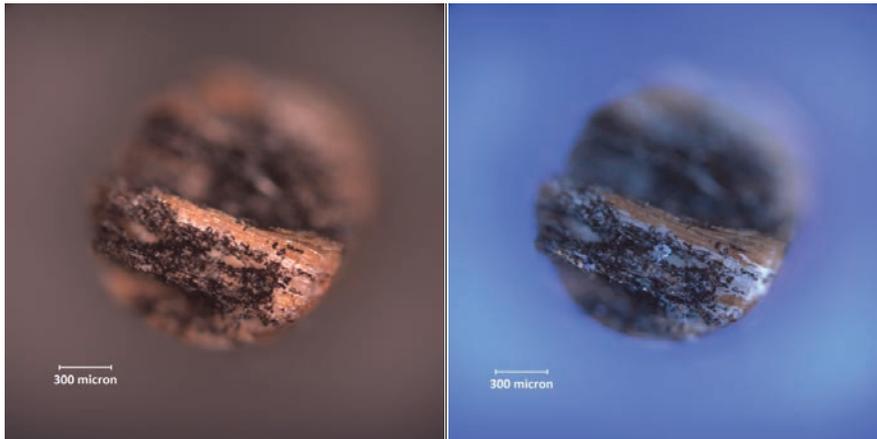
The photomicrographs in figures 19 and 20 show a black crust on the surface of the core sample. Analysis results indicated the presence of inorganic carbonates and wax.

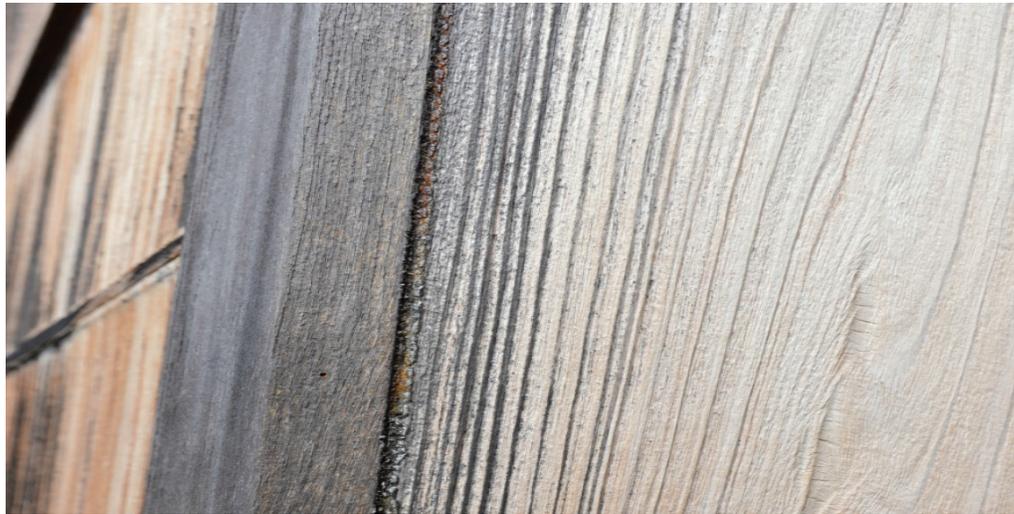
The west elevation of the north building showed different coatings on the same vertical trim. The west-facing trim contained a black crust, while the adjacent south-facing trim exhibited white efflorescence. Figure 21 illustrates the visual differences between the west and south sides. Figure 22 shows tiny holes created by the sampling biopsy punches on the south side.

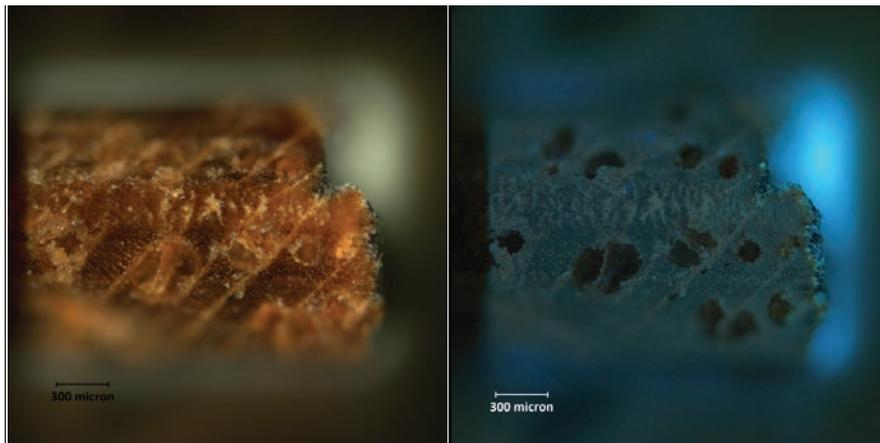
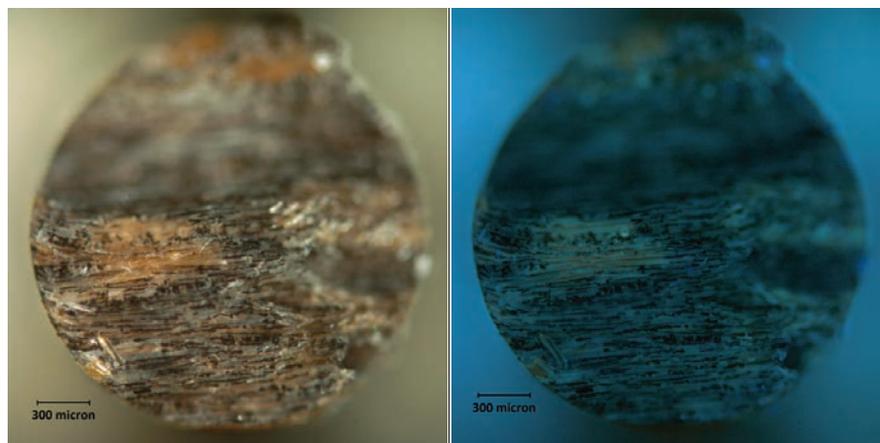
A black crust layer appears to be concentrated on the top thin surface of the wood (figs. 23 and 24). The core sample contains a larger number of vacuoles, or holes, when compared with the core taken from the adjacent south-facing trim. This variation may be attributed to the inherent differences in the source of the teak wood (plantation vs. old growth) or the cut angle of the wood lumber. The layer of black crust contained proteinaceous material, likely produced by the fungal material, as well as other minor components that were difficult to identify.

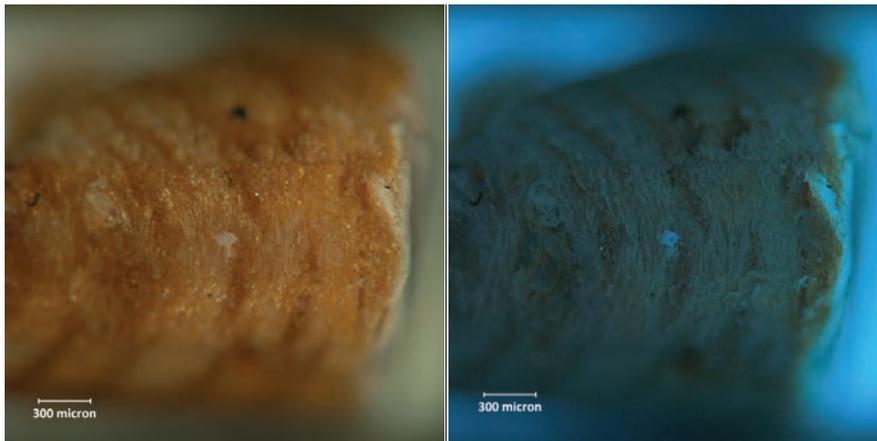
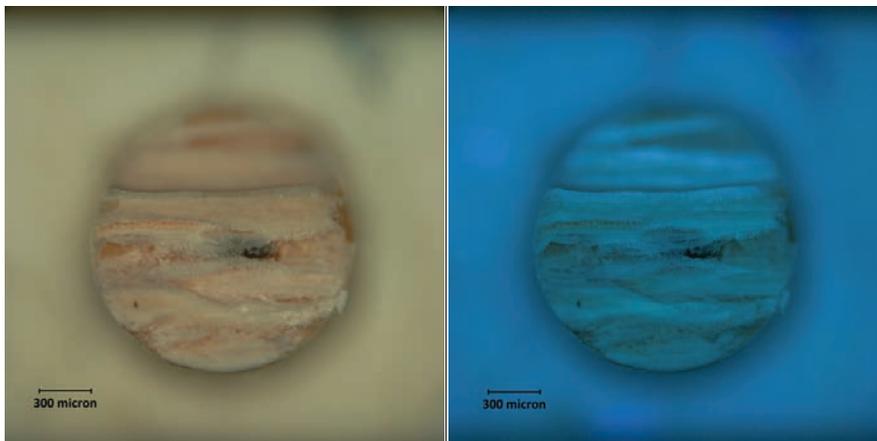
The white coating appears very thin but is layered on the surface of the core sample (figs. 25 and 26). In comparison with the wood in the west-facing sample, the wood in the core sample contains a smaller number of holes. The white efflorescence showed the presence of oxalate, a product that may be the result of various environmental influences.

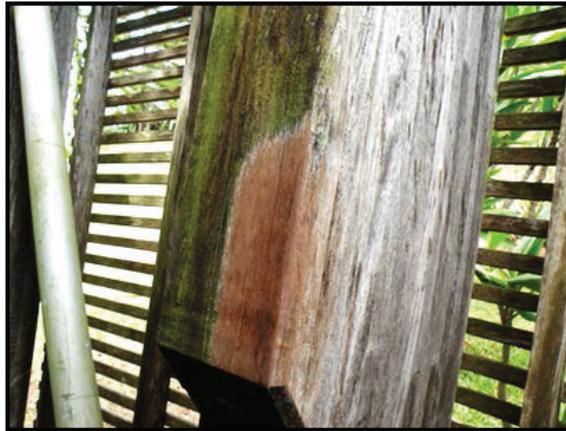
Figure 2.4. Example of biological growth and weathered patina, both of which can be removed through careful cleaning.

Biological growth other than decay can be removed with careful cleaning (fig. 2.4), but unless the favorable underlying conditions are altered, the growth will return. Biological growth can be controlled in a number of ways, including chemical treatments, cleaning, and altering construction details and/or microclimatic conditions. The simplest means of controlling biological growth includes reducing the amount of available moisture and trimming trees and vegetation to increase sunlight exposure to enhance drying.

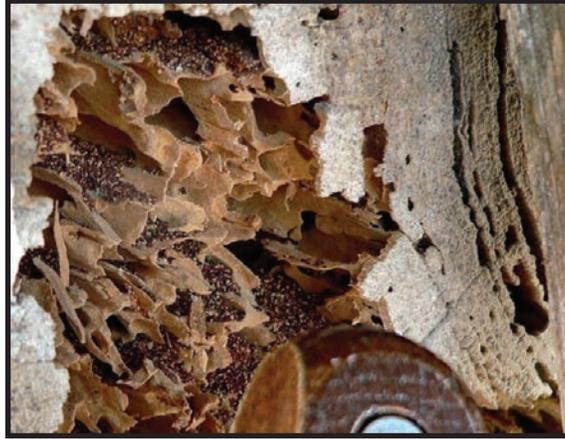
The termite species identified at the Salk are drywood termites (*Incisitermes* spp., likely *I. minor*). Drywood termites do not require contact with soil or sources of moisture within the wood. Colonies can reside in non-decayed wood with low moisture contents. Drywood termites live in small social colonies, with as few as fifty insects, to more than three thousand insects in a mature colony. They remain entirely above ground and do not connect their nests to the ground with mud tubes or galleries. Typically, the first sign of a drywood termite infestation is fecal pellets collecting at or near the base of wood members. The fecal pellets are hard, angular, and less than 1 mm in length, and vary in color from light gray or tan to very dark brown (figs. 2.5 and 2.6). Interior galleries tend to be broad pockets or chambers connected by smaller tunnels that cut across latewood. Irreparable damage to wooden elements can be caused by drywood termites in two to four years, depending on the size of the element and the size of the infestation.

Figure 2.5. Example of typical drywood termite galleries discovered after breaking through a thin shell of sound-looking wood. Note the collection of frass. Awl handle in foreground is shown for scale.

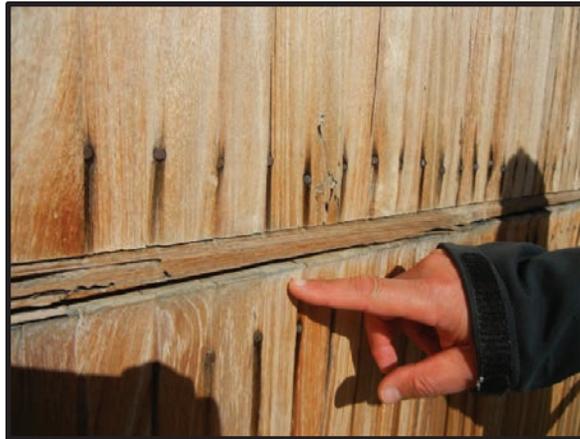
Figure 3.3. Visual inspection of a panel with significant weathering and erosion.

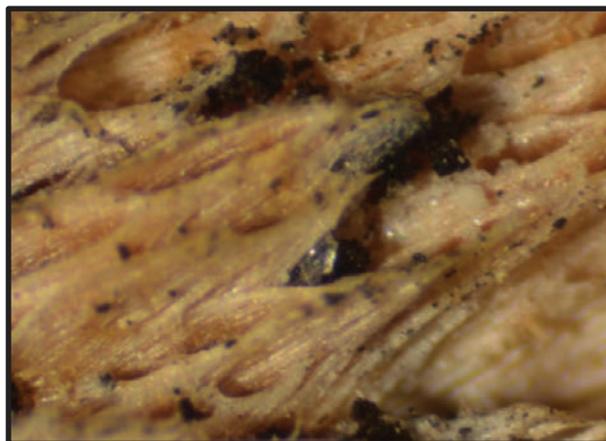
Figure 4.1. Specimen F, viewed under the stereomicroscope, showing weathered wood surface, open cellular structure, and weak cellular bonds. Note biological growth (center).

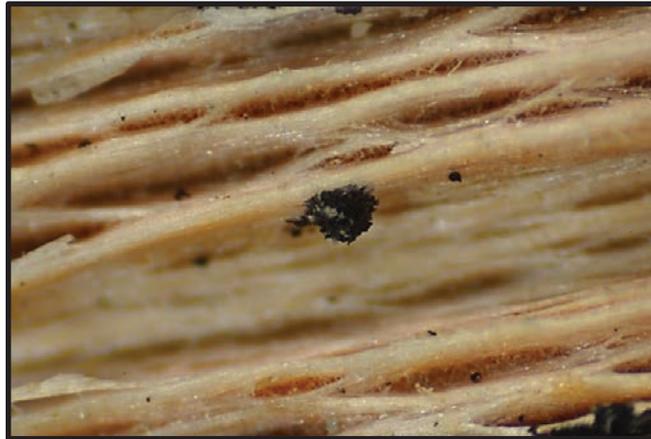
Figure 4.2. Specimen F showing a particle of sand and biological growth on the weathered surface.

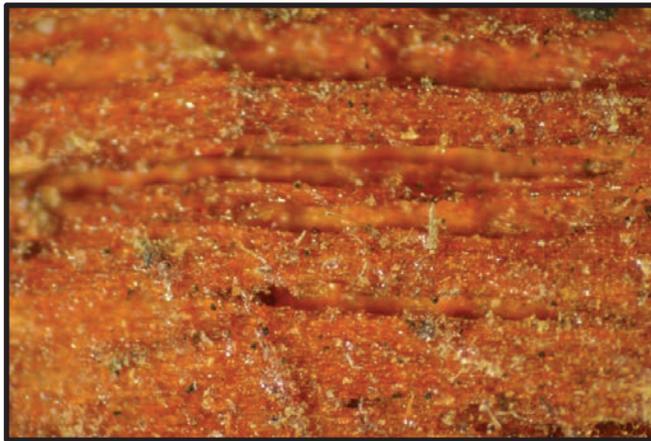
Figure 4.3. Specimen I showing a weathered wood surface and biological growth that appears to be clustered around a debris particle.

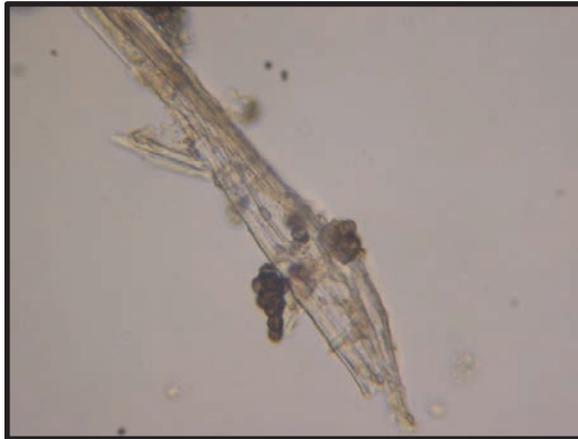
Figure 4.6. Biological growth on a wood fiber, 400x magnification.

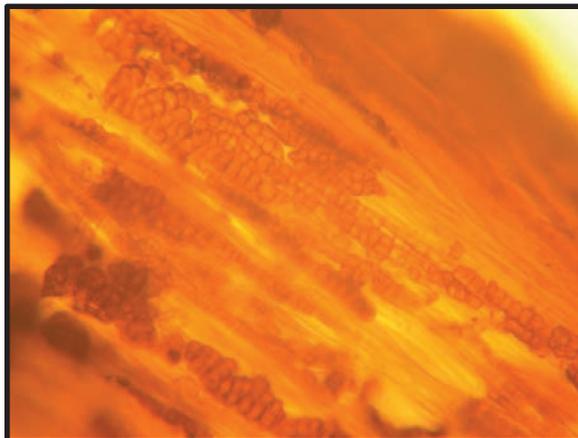
Figure 4.7. Biological growth on or in the wood cells, 400x magnification.

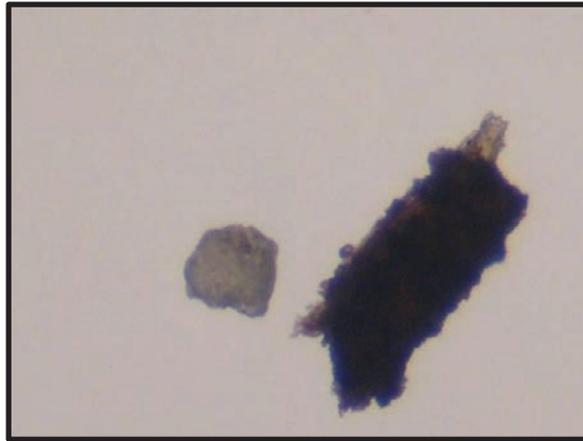
Figure 4.8. Grain of sand next to a small wood fragment covered in biological growth, 400x magnification.

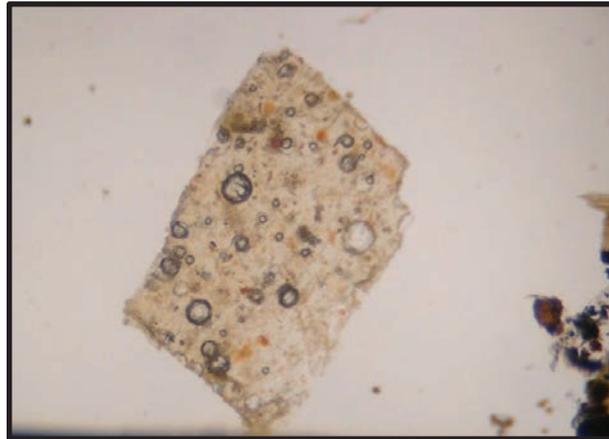
Figure 4.9. Small fragment of adhesive, 400x magnification.

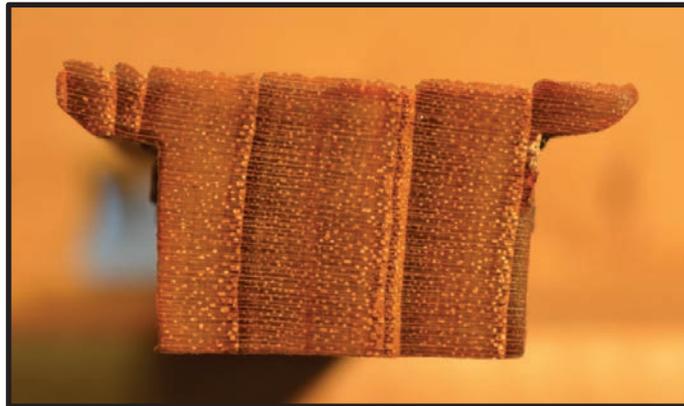
Specimens C and S are vertical-sawn slats (figs. 4.22 through 4.25). Both specimens have significant surface texture, but specimen C is significantly eroded while specimen S exhibits minor erosion. This difference may possibly have to do with the number of growth rings per inch (specimen C has three growth rings per inch; specimen S has seven growth rings per inch) or the location of the specimen on the building (specimen C was originally located on the south elevation of NL6C, facing the courtyard; specimen S was located on NO3E, facing the ocean), or a combination of these factors.

Figure 4.22. Specimen C, top end grain, showing vertical grain orientation and erosion of the earlywood.
