Salk Institute for Biological Studies Conservation Project: Teak Window Wall Assemblies

Phase 1: Research and Investigation Results
and Preliminary Conservation Proposals

Sara Lardinois

The Getty Conservation Institute

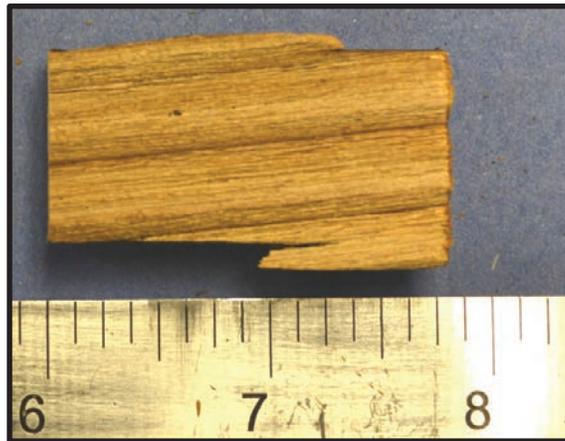
Specimens C and S are vertical-sawn slats (figs. 4.22 through 4.25). Both specimens have significant surface texture, but specimen C is significantly eroded while specimen S exhibits minor erosion. This difference may possibly have to do with the number of growth rings per inch (specimen C has three growth rings per inch; specimen S has seven growth rings per inch) or the location of the specimen on the building (specimen C was originally located on the south elevation of NL6C, facing the courtyard; specimen S was located on NO3E, facing the ocean), or a combination of these factors.

Figure 4.23. Small portion of specimen C showing extensive erosion of the earlywood on the exposed face.

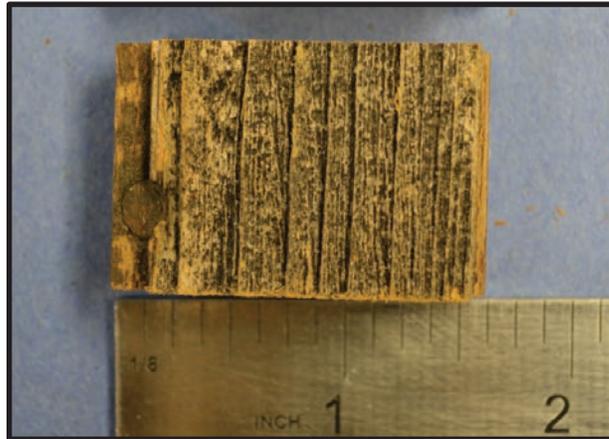
Figure 4.25. Small sample from the bottom of the exposed face of specimen S showing typical grooved weathering pattern of vertical grain elements.

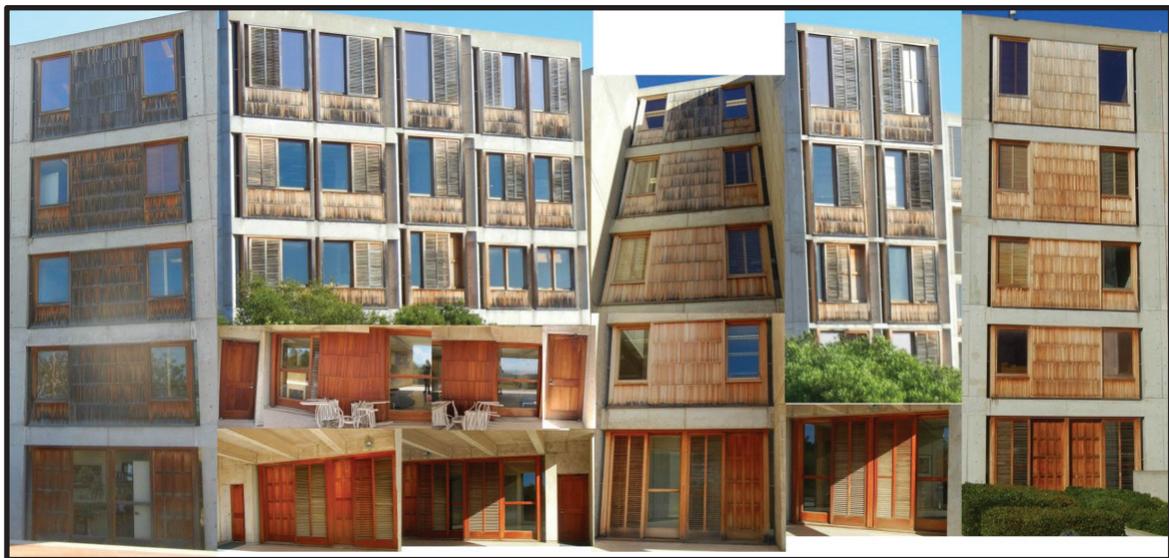
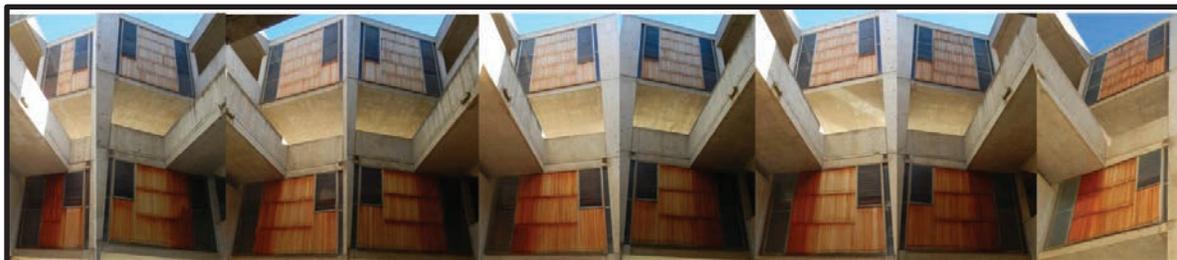
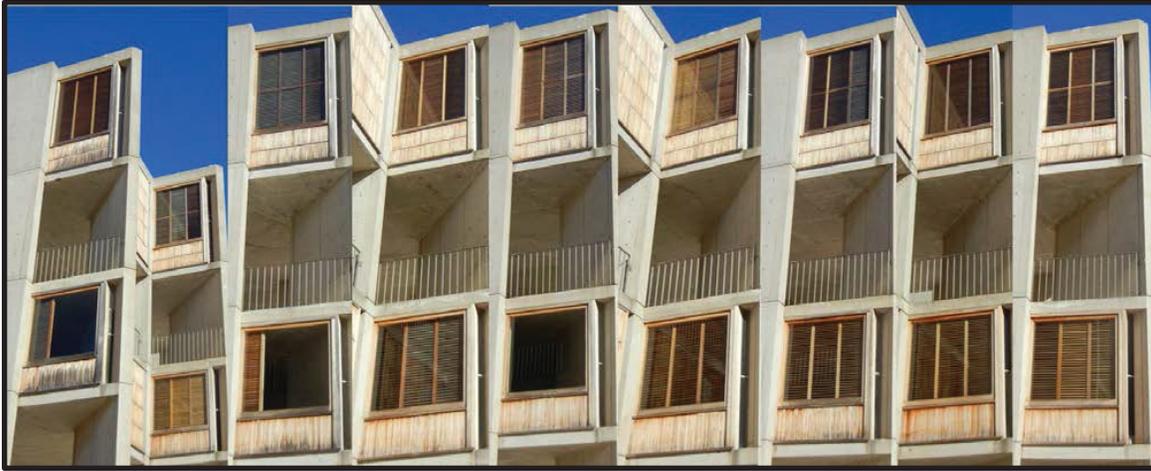
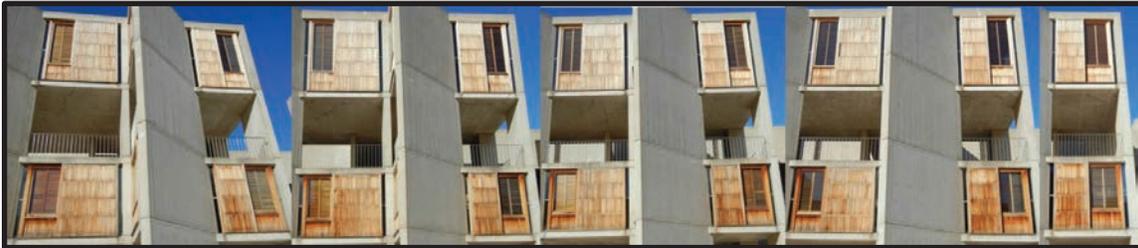
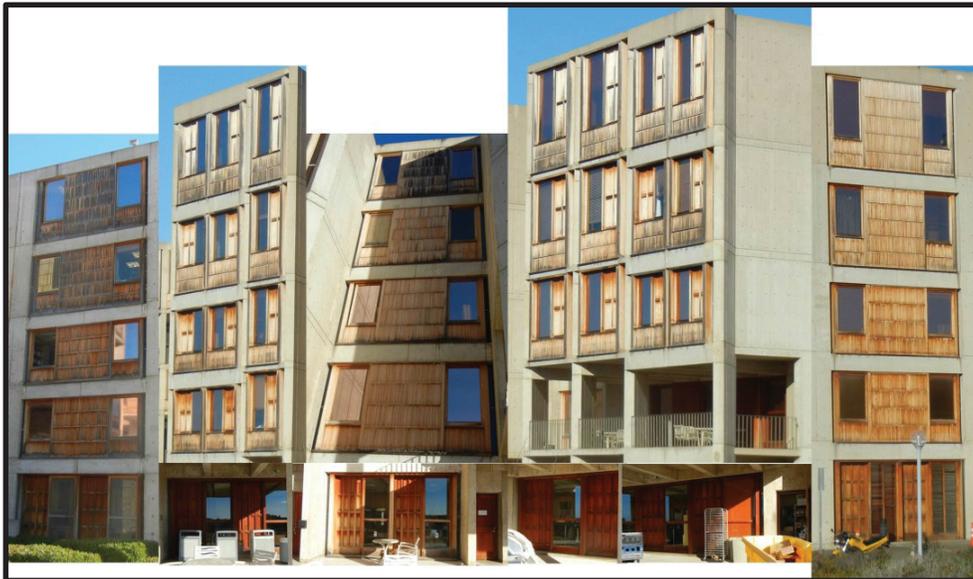
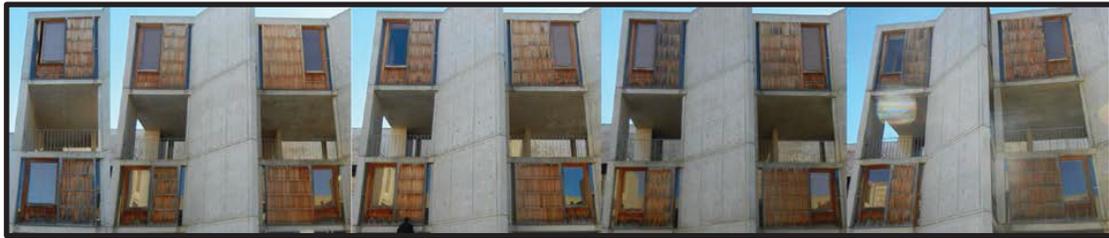
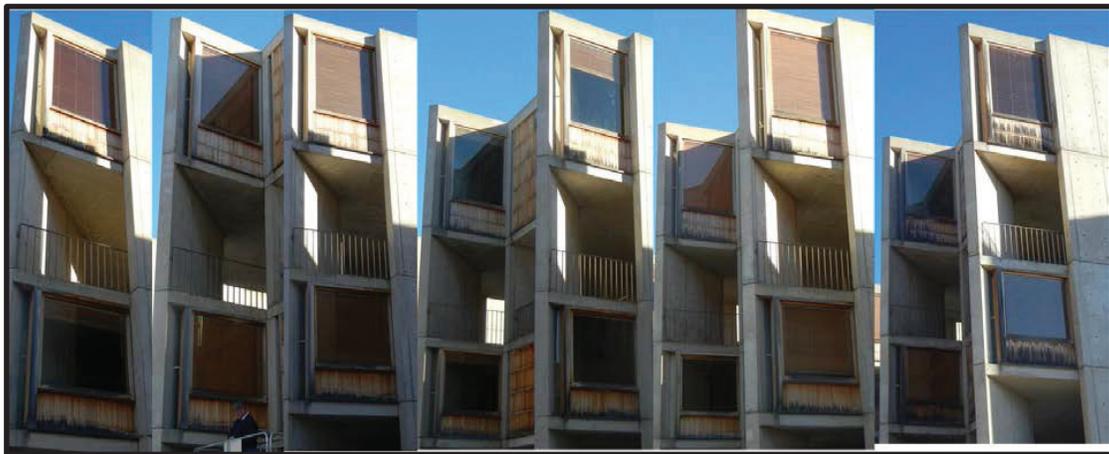
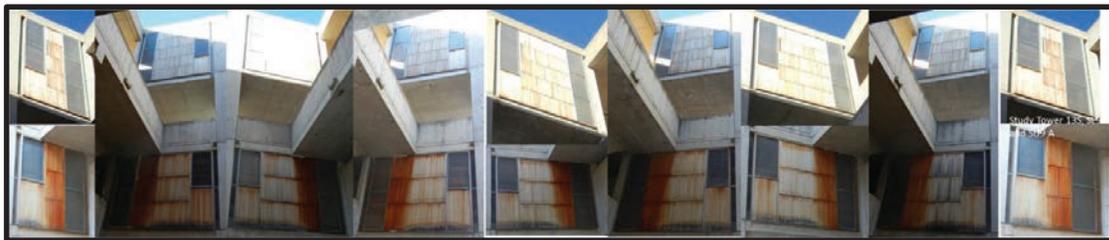
It is helpful to examine the teak fenestration panels as a whole to gain perspective on general patterns of weathering and discoloration that can be identified. Figures 5.1 through 5.8 are composite images of the various elevations that show general trends of black spore growth, bleaching, and weathering.

South, unprotected elevations (north study towers, C elevations facing the courtyard, unprotected south study towers facing the laboratories, the south elevation of the north office tower, and the south elevation of the south office tower) show significant bleaching that increases with elevation (height). Areas protected by overhangs retain more of the orange color associated with past surface treatments (see fig. 5.8).

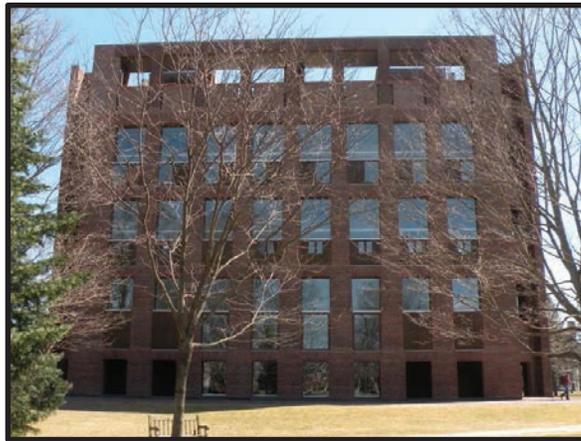
Figure 7.2. North elevation, Library at Phillips Exeter Academy.

In April 2014 Ron Anthony from A&A visited the Library and met with facilities staff and the library archivist to review the effectiveness of the periodic cleaning, brightening, and oiling procedure used by the Academy. Figure 7.2 shows the north elevation, which was treated during the summer of 2013 (approximately nine months before to the photograph was taken). Figures 7.3 through 7.5 show the condition of teak fenestrations on the first, second, and third floors, respectively, of the north elevation. Note that from a distance the overall appearance of the treated teak panels and trim is uniform in color and texture. However, in areas where the teak is protected from direct exposure to UV and precipitation, the color change is more pronounced as a function of the degree of exposure, as is shown just below the flashing in figure 7.6. Additionally, close examination revealed that some of the treatment has already begun to weather despite being applied less than a year earlier (fig. 7.7).

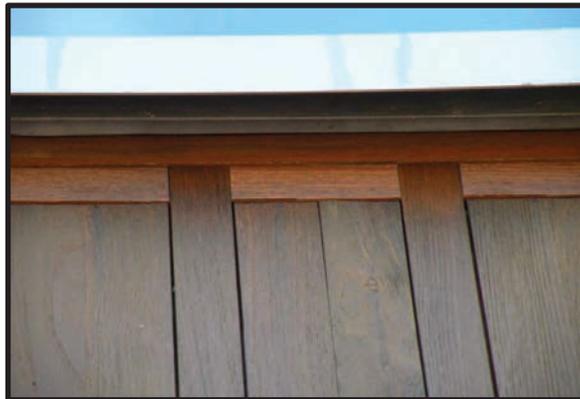
Figure 7.6. The relatively protected teak just below the flashing has retained a much lighter color after treatment than the more exposed teak.

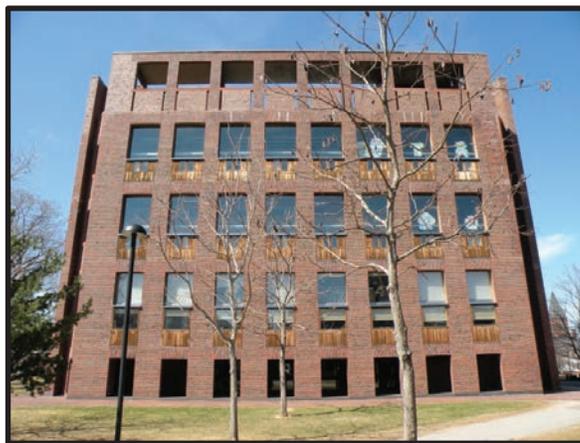
Figure 7.8. South elevation, the Library at Phillips Exeter Academy.

The south elevation, which was treated in 2011, is shown in figure 7.8. Figures 7.9 through 7.11 show the condition of teak fenestration units on the first, second, and third floors, respectively, of the south elevation. Note that from a distance the overall appearance of the treated teak panels and trim is weathered and less uniform in color and texture than the more recently treated north elevation. The fenestration units have also differentially weathered with height (i.e., the teak on the first floor has weathered less than the teak on the second floor, which has weathered less than the teak on the third floor). Close examination revealed that some of the treatment has weathered severely and that the treatment has been largely ineffective (fig. 7.12).

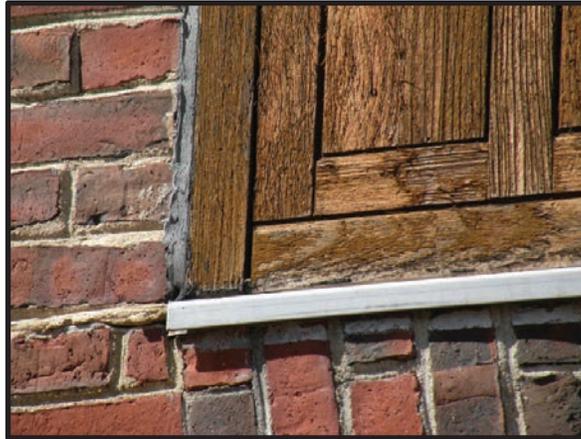
Figure 7.12. Close-up of teak fenestration unit on south elevation showing that the treatment has weathered severely and has been largely ineffective in maintaining the appearance or protecting the wood.

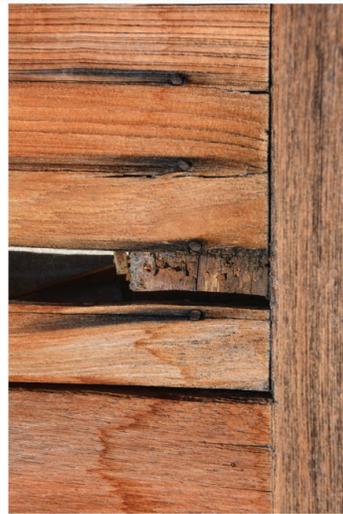
010. Specimen D panel NL6C.JPG

D	furring strip	NL6C	assumed 2 x 4 bottom furring strip, west panel, slat row 1, in area where slat was removed				
E	furring strip	NU7C	east panel, slat row 3, lower strip behind 2nd-4th slat from west	drywood termite damage

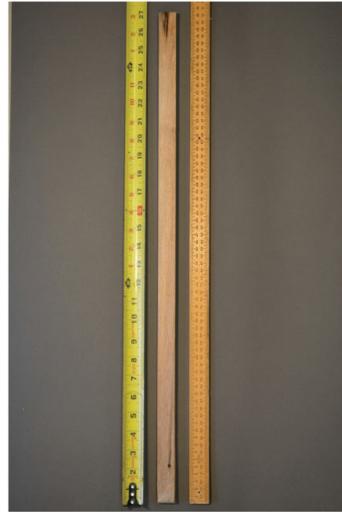
016. Specimen F exposed face.JPG

Specimen	Element	Location	Description	Comments	Rough Dimensions	Metal Fasteners	Weight (grams)
F	vertical ship-lap slat	NU7C	east panel, slat row 3, 2nd slat from west	iron oxide staining from metal fasteners in two locations on exposed face, has small lip of protected wood on one end	15/16" x 26-27/32"; 5/8" at smallest thickness, 7/16" at largest thickness	none	140.57
G	vertical ship-lap slat	NU7C	east panel, slat row 3, 3rd slat from west	ship-lap/half-lap slat, small knot 1/4" wide visible front and back face, 1 nail in place, 1 other nail hole, slight lip of protected wood one end only	1-5/8" x 26-7/8" x 11/16" at thickest; 9/16" at thinnest, opposite end from lip	finish nail approximately 2-1/2" long	226.92
H	tongue-and-groove vertical slat	SL8B	slat row 1 under window, 5th from north, multiple pieces	cut and/or broken into 5 pieces during removal, tongue-and-groove slat, grayed and black spores near bottom, top still has some red color; surface protected under horizontal slat has virtually no weathering at all	largest piece: 1-5/8" x 17-3/8" long, 3/4" at widest (bottom) and 11/32" at thinnest; tongue is 1/4" x 1/4"; groove is 1/8" thick x 1/4" deep	two nails, common (not finish nails), approximately 1-1/2" long	243.18

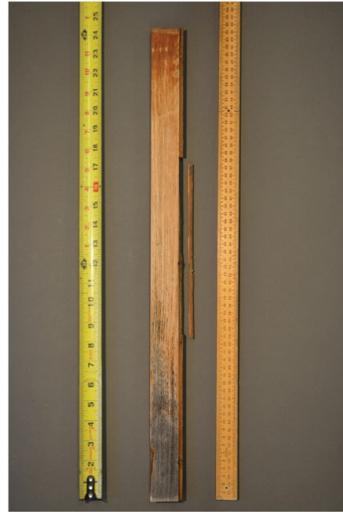
028. Specimen J exposed face.JPG

Specimen	Element	Location	Description	Comments	Rough Dimensions	Metal Fasteners	Weight (grams)
J	tongue-and-groove vertical slat	SL8B	slat row 1 under window, 4th from north	tongue-and-groove slat from south study, small piece of tongue broken off; virtually no weathering at top where slat was protected by horizontal slat, has original color there; possible Teka remnants that fade/bleach down the length, with black spores and gray weathering appearing near the bottom	1-11/16" x 24-1/8" x 3/4" at thickest; 11/16" at bottom, assumed thinnest	3 nails with heads approximately 1-1/2" long	256.88
K	large louver (exterior)	SO2K	21st louver from bottom, western-most row of louvers	blind louver same as specimen A, specimen is dirty and fragile, weathered paper-thin on one edge; some fading of color and black spores on one face, dirt and black spores on the other face	2-1/16" x 19-1/32"; 5/16" at thickest, 1/64" at thinnest	possible copper ring 3/8" long, 7/16" diameter, walls 1/32" thick	75.23

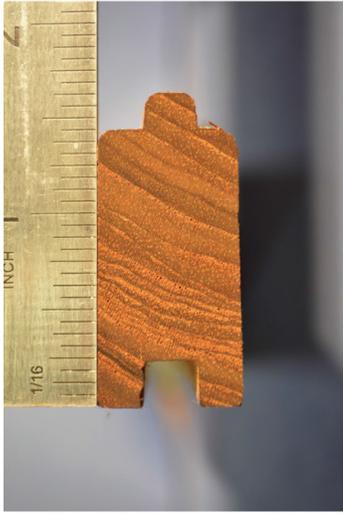
051. Specimen Q end grain.JPG

Specimen	Element	Location	Description	Comments	Rough Dimensions	Metal Fasteners	Weight (grams)
Q	tongue-and-groove vertical slat	NL8A	#4 (get additional info)	tongue-and-groove slat, orange color on exposed face, small knot visible, small area at top with virtually no weathering where protected. Some surface texture following grain, no visible spores or graying, just some fading; groove broken at bottom from extraction. Very minimal surface texture on top 2/3s of exposed face.	1-5/8" x 31-1/2" x 3/4" top and bottom thickness	none	312.72
S	tongue-and-groove vertical slat	WOW N3	west face	tongue-and-groove slat same as others with area of unweathered near top, three nails, heavily textured along length, black spores at top and heavier concentration at bottom; middle nail split tongue at entry point	1-5/8" x 26" x 3/4" top and bottom thickness	3 metal nails estimated 1-1/2" long with heads, oxidized	275.48

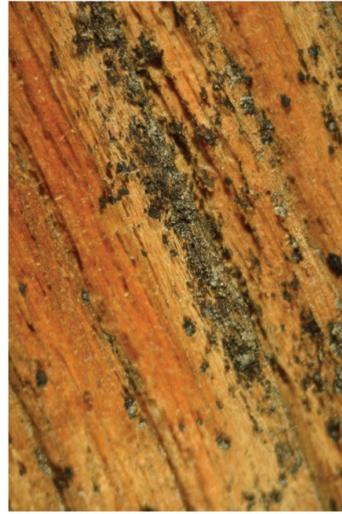
054. Specimen S spore growth.JPG

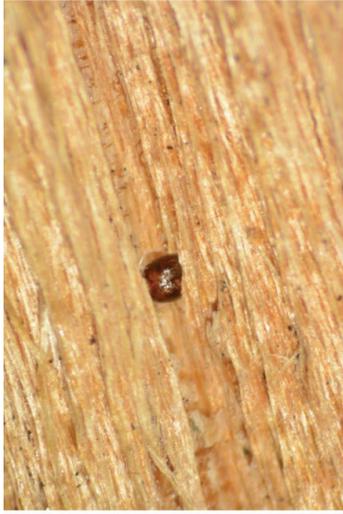
063. Specimen V unknown deposit.JPG
