BEIRA CENTRAL STATION

CONSERVATION MANAGEMENT PLAN

Elisiário Miranda and Paulo B. Lourenço (coords.)

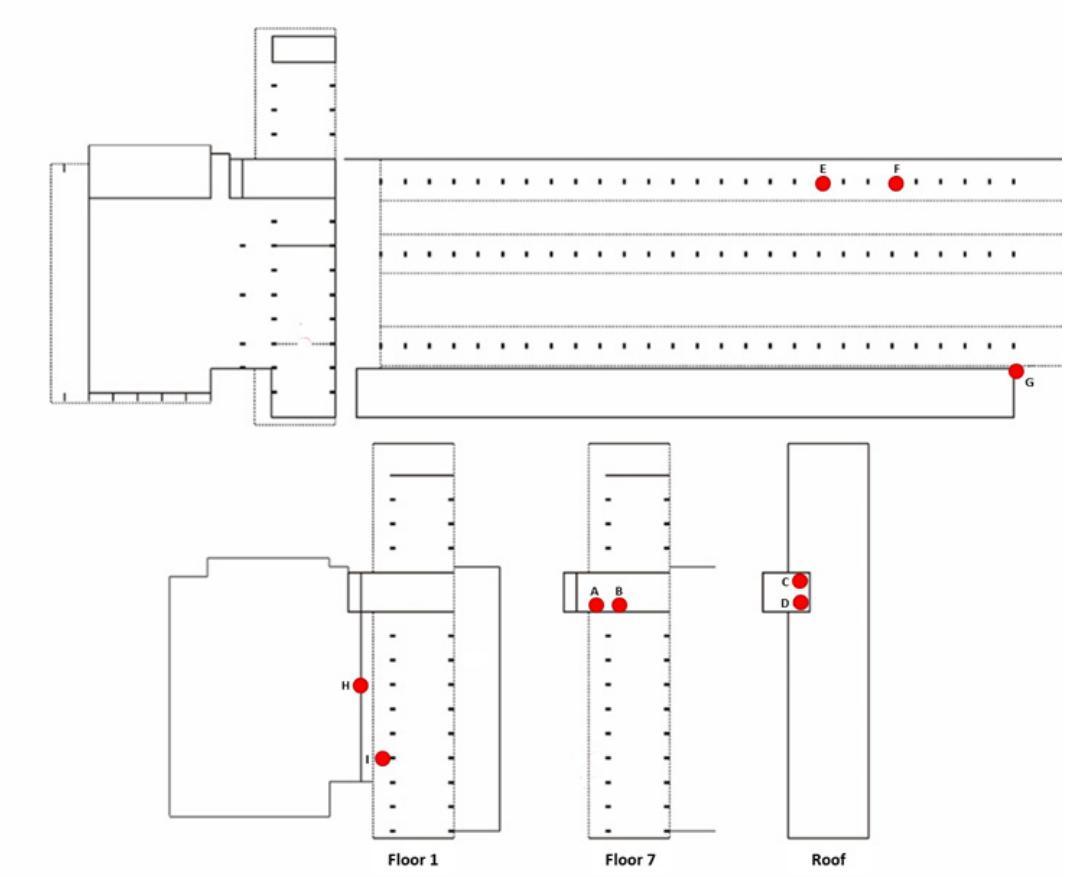
between January 31 and February 4, 2022, from nine locations (Figure 4.37). A single core was extracted from locations A, B and F, while two cores were extracted from locations C, D, E, G, H and I.^{4.17} The cores were subjected to compression test. On ten cores, carbonation depth tests were also carried out. Additionally, samples of the concrete paste were taken on-site and tested in order to determine the chloride and sulphate contents. Due to a lack of locally accessible equipment, petrographic investigation and secondary electron microscopy (SEM) to identify potential Alkali-Silica Reaction (ASR) at the concrete could not be performed. Figure 4.37 shows the location of core sampling areas and Figures 4.38 to 4.43 show photographs of the locations.

Figure 4.37 Location of core sampling.

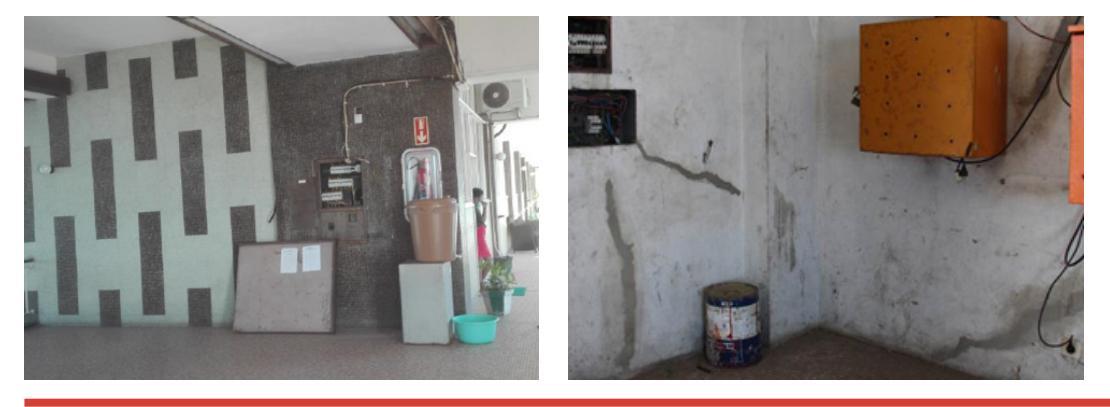
Figure 4.38 Locations selected for coring: walls at the seventh floor (locations A and B).

Figure 4.39 Locations selected for coring: columns at rooffloor (loca-tions C and D).

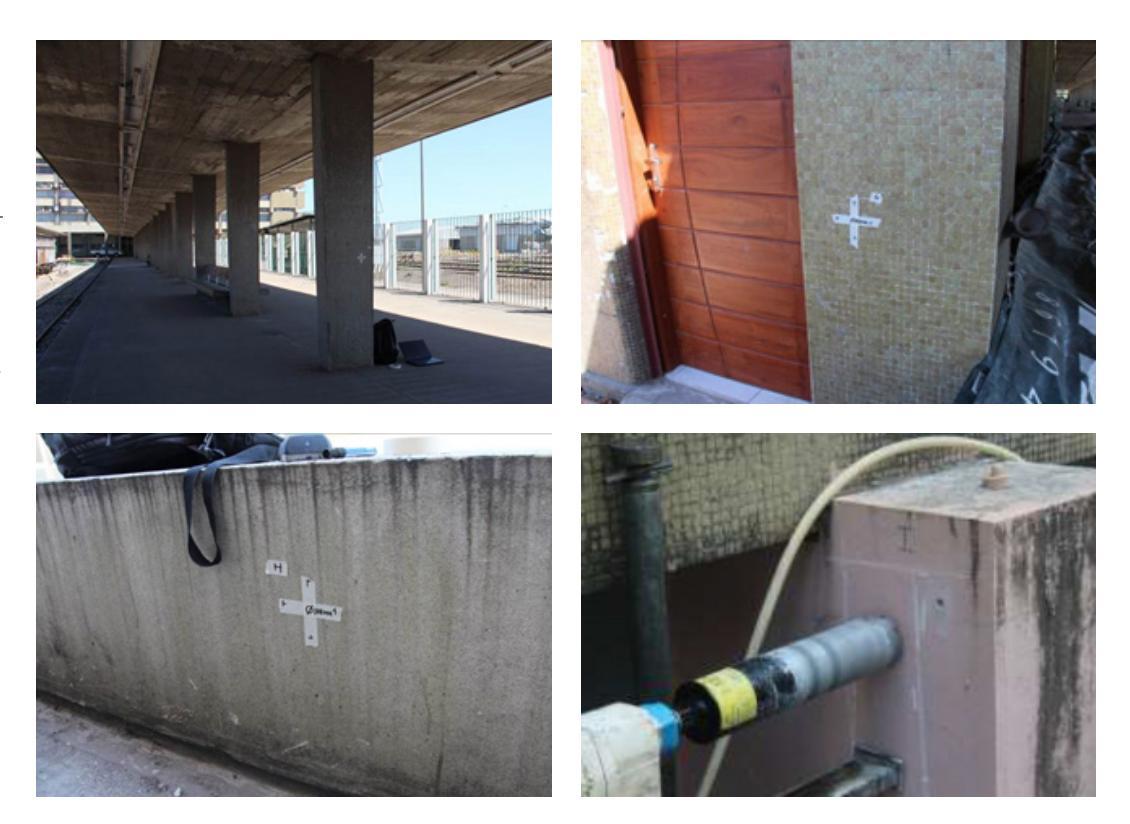
Figure 4.40 Locations selected for coring: columns at platforms' area (locations E and F).

Figure 4.41 Locations selected for coring: column at the command building (location G).

Figure 4.42 Locations selected for coring: beam over the slab of the atrium transition space (location H).

Figure 4.43 Locations selected for coring: beam protruding from the slab over the transition space (location I).

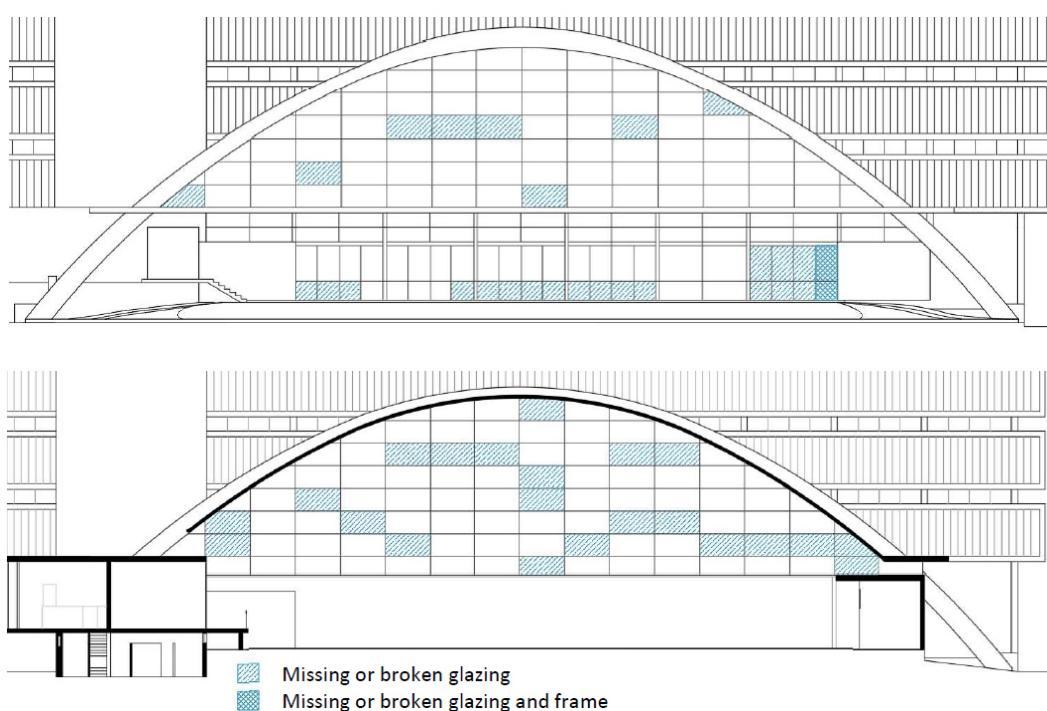
Missing or broken glazing and frame

Material loss. The current condition of the glazing and the roof cover is strongly affected by the lack of maintenance and the effects of the natural disasters as the recent Idai cyclone. From the front and rear façades of the atrium, the windows and entrance doors glazing is either broken or missing (Figures 4.46-4.47). Similarly, in the administration building, loss of glazing is evident on the rear façade (Figure 4.48).

Figure 4.46 Broken glazing on the front façade of the public atrium.

Figure 4.47 Broken glazing on the rear façade of the public atrium.

Figure 4.48 Broken glazing on the rear façade of the staircase of the administration block.

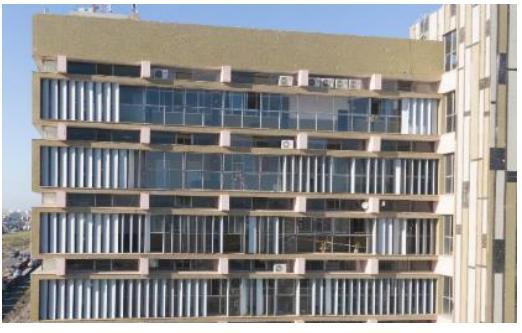
Cracks. The masonry walls present diagonal cracks on the rear façade of the atrium (Figure 4.53) and horizontal cracks on the front and rear façades of the administration building (Figure 4.54). The main transversal beams of the first floor of the administration building are affected by vertical cracks (Figure 4.55), whereas map cracks are diffused on the interior beams of the administration building (Figure 4.56) and on the exterior concrete elements of both the platforms and of the transitional space between the administration building and the

Figure 4.53 Diagonal cracks on the rear façade of the public atrium.

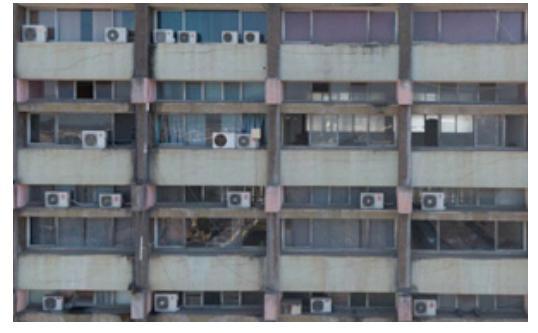
Figure 4.54 Horizontal and diagonal cracks at the rear façade of the administration block.

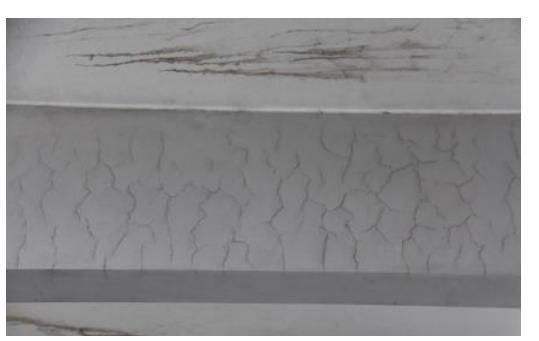
Figure 4.55 Vertical crack on a beam of the first floor of the administration block.

Figure 4.56 Map crack on an interior beam of the first floor of the administration block.

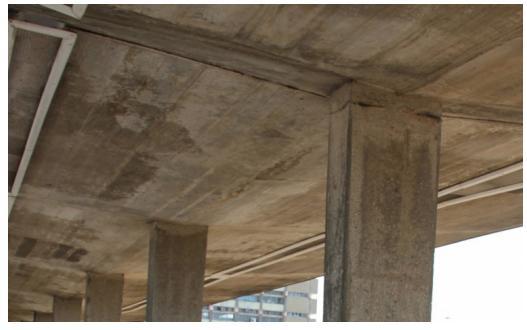
Figure 4.57 Deformation and cracks of the columns of the platform's area.

Figure 4.58 Deformation and cracks of the columns of the platform's area.

Deformation. The columns supporting the platform's area slab that is connected to the command building show deformation in a form of swaying towards the command building (Figures 4.57-4.58).

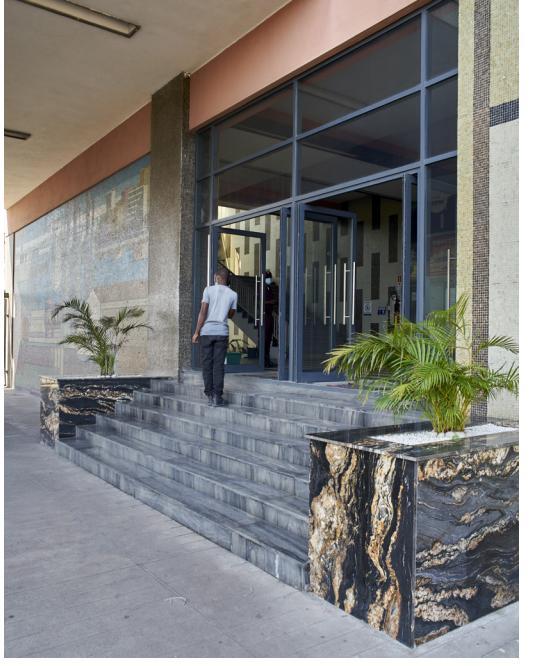
- overlapping of the *Triage* glass mosaic mural with illuminated advertisements, air conditioners and miscellaneous cabling (Figure 4.62);
- alteration of the private entrance to the administration block (from the outside and from the public atrium), by replacing the glazing, cladding of the steps and flower boxes (Figures 4.63-4.64);

Figure 4.63 Entrance to the administration block showing replaced glazing, cladding of the steps and flower boxes (EM, 2022).

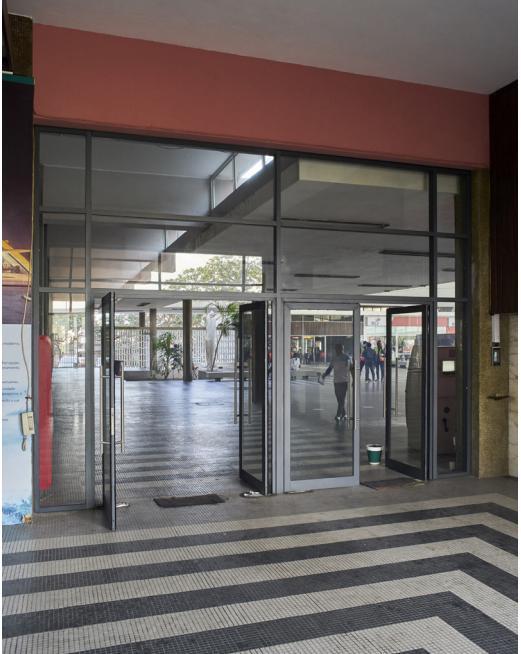
Figure 4.64 Entrance to the administration block from the public atrium showing replaced glazing (EM, 2022).

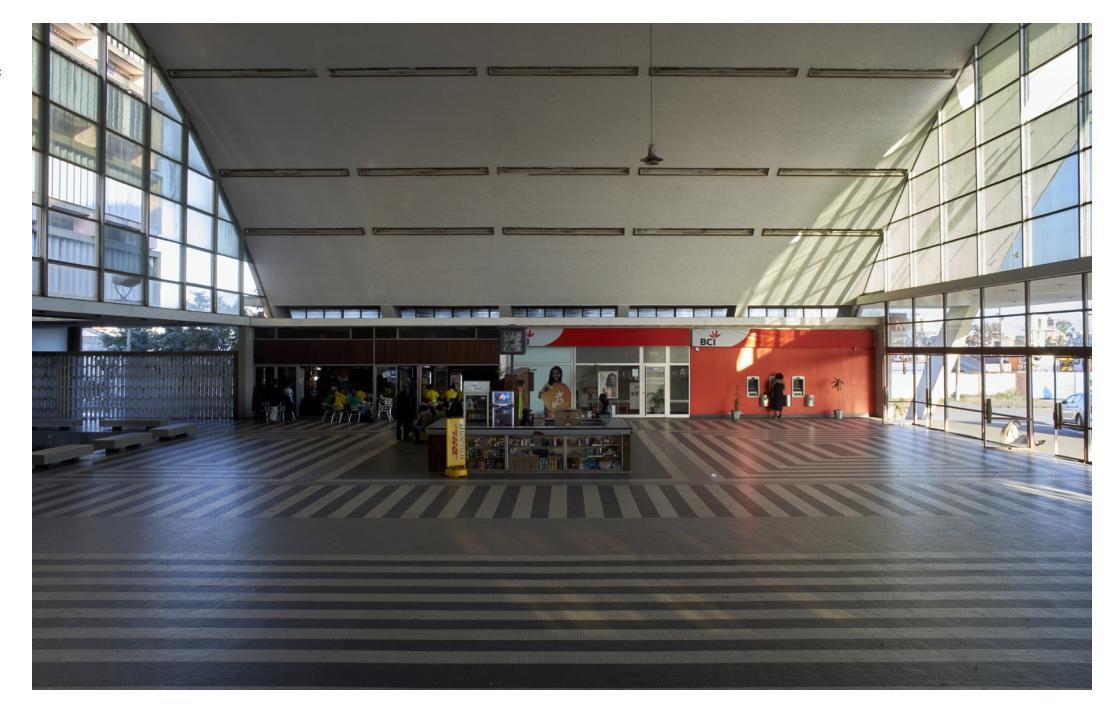
- remodeling of the façade of two first stores in the public atrium (Figure 4.65);
- replacement of the main elevators and the widening of its access doors in the upper floor of the administration block (Figure 4.66);

Figure 4.65 Façade of the shops of the public atrium after remodeling of the two on the right side (EM, 2019).

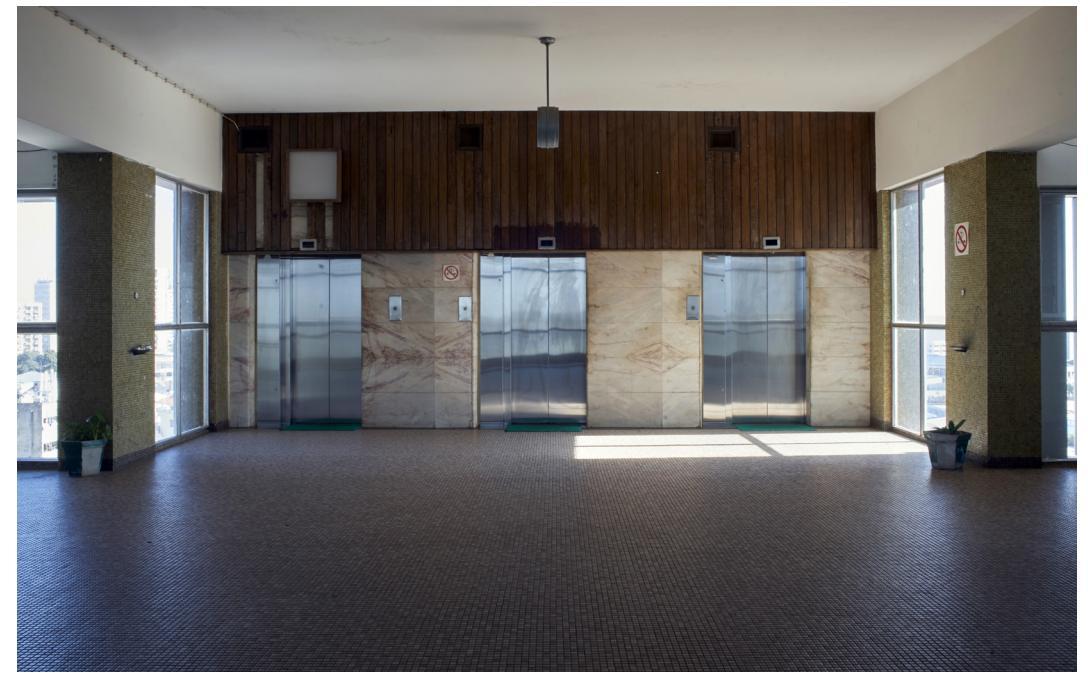
Figure 4.66 Widening of the elevator doors in the upper floor of the administration block (EM, 2019)

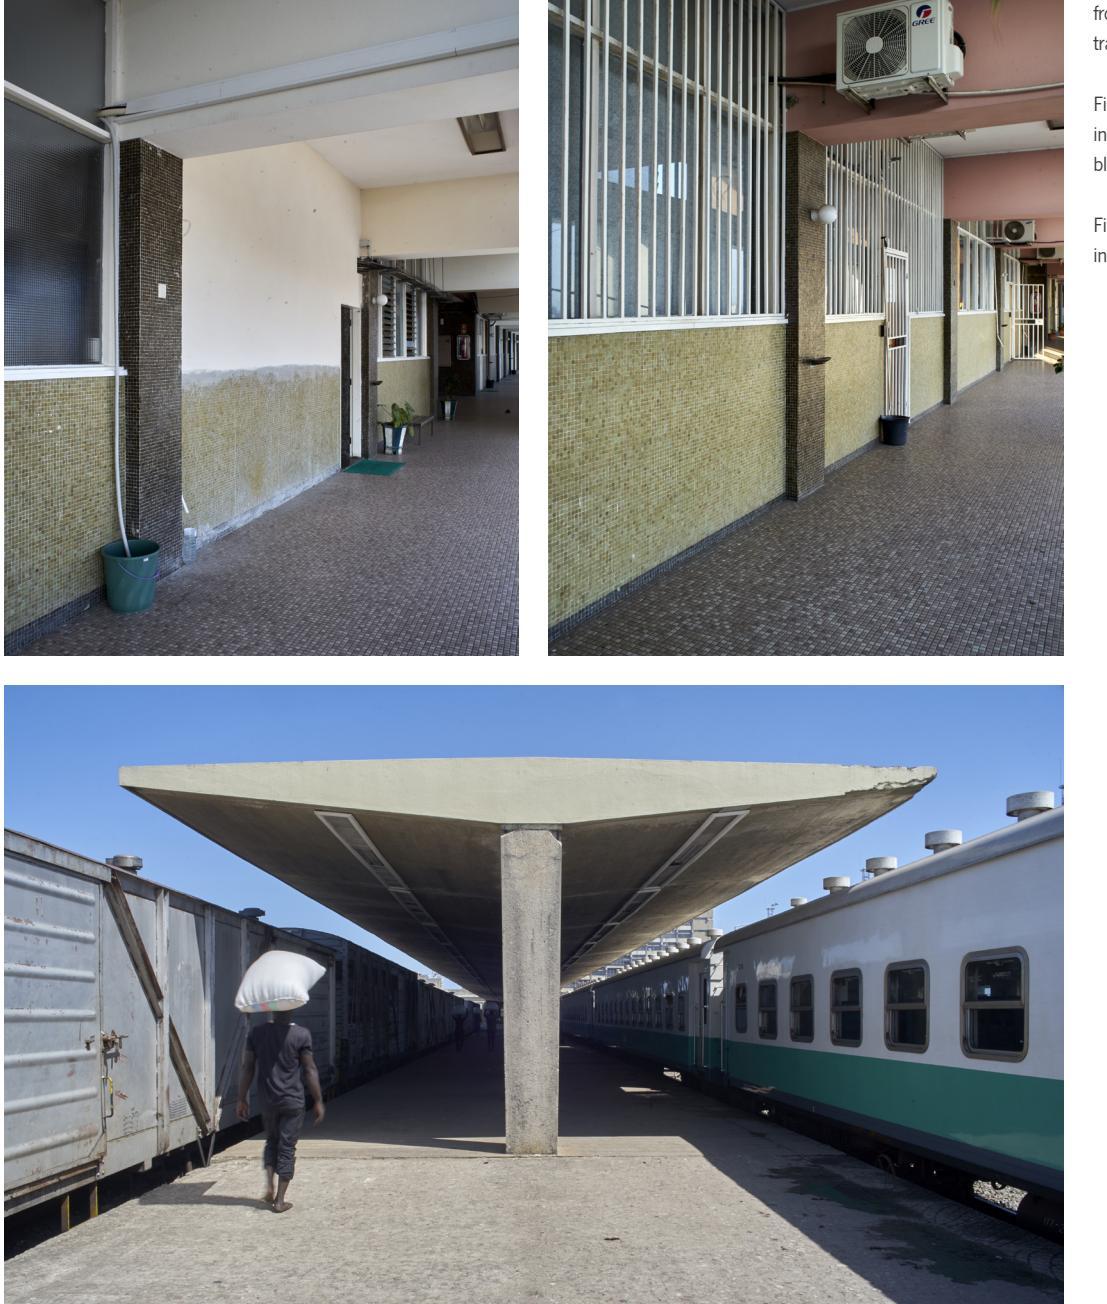
- closing of the glass fronts to the galleries of some offices in the administration block as well as changing the galleries' original colors (Figure 4.67); and

- grid placement in frames separating galleries and workspaces, casual placement of air conditioning units along these galleries (Figure 4.68) and in the northeast façade of the administration block.

Figure 4.67 Closing of the glass fronts to the galleries of the administration block (EM, 2019).

Figure 4.68 Air conditioning units in the galleries of the administration block (EM, 2019).

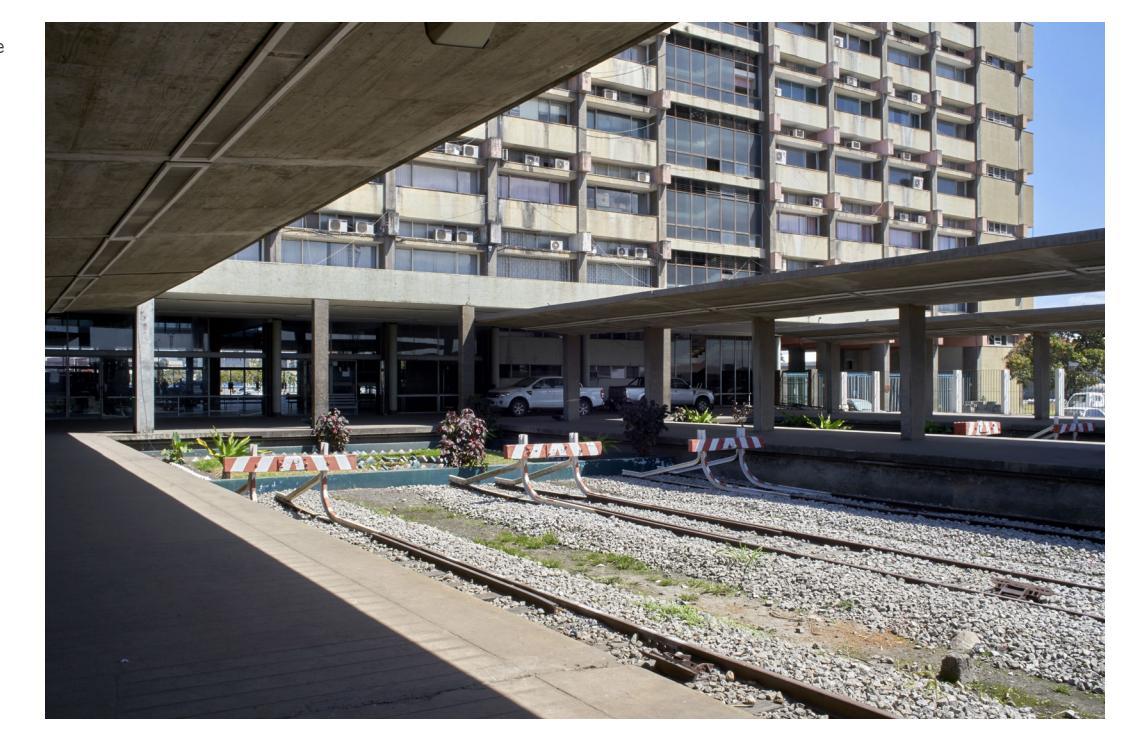
HVAC systems and other infrastructures (e.g. air-conditioning equipment, electrical appliances, fixtures, miscellaneous cabling, open and uncovered shafts, etc.) have been installed over time in the station and currently affect the original aspect of the building. Moreover, the use of some of the original or added systems have been suspended due to their obsolescence, although they have not been removed. A detailed survey and mapping of such installations should be carried out and alternative solutions should be designed to ensure the comfort of the users and the functionality of the spaces but re-establishing the original aesthetic of the building. To this end, the possible need for the creation of new infrastructures in the building is admitted and it is recommended that the obsolete elements, that cannot

Figure 5.11 Air conditioners on the back elevation of the Beira Central Station (EM, 2019)

In the case of the air conditioners on the rear façade of the Beira Central Station (Figure 5.11), their placement should be modified according to the original layout. This was, indeed, driven by a well-thought and clear relationship with the façade.
