Boston City Hall

Conservation Management Plan

January 2021

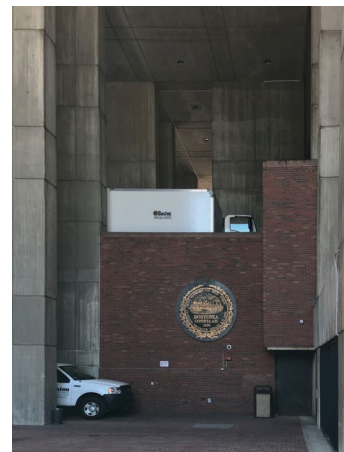
Vehicles parked in the Congress Street porch and under the building overhangs.

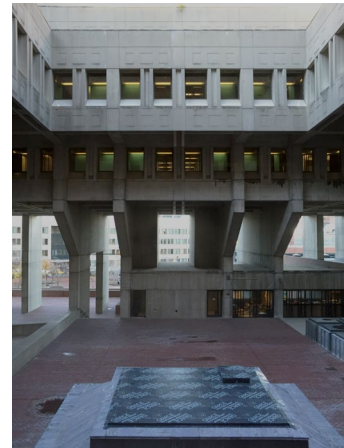
The central skylight is currently covered with a temporary membrane of waterproofing material to address a leak.

Metal panels have been added under many of the windows facing the courtyard as bird deterrent. The concrete under many of these windows is stained.

Waterproofing membrane covering central skylight and metal panels under upper-floor windows.

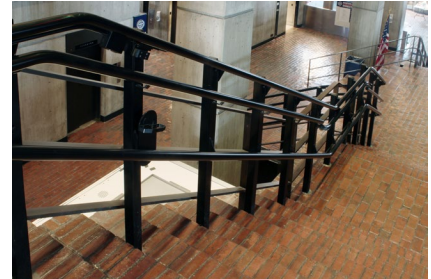
Rail-mounted lift on the monumental stair.

E19 Remove stair lift if adequate alternative access method is implemented. Repair all attachment locations after removal.

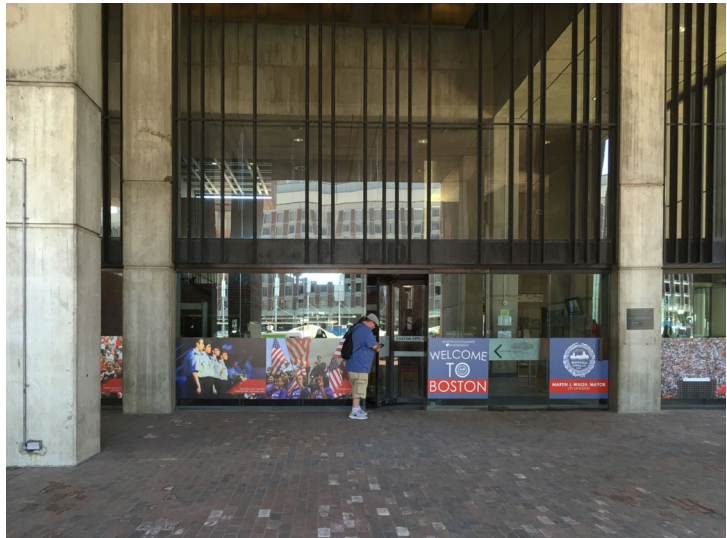
Vinyl window graphics at the plaza lobby entrance.

Vinyl on the glass at the plaza lobby entrance impair views into the space.

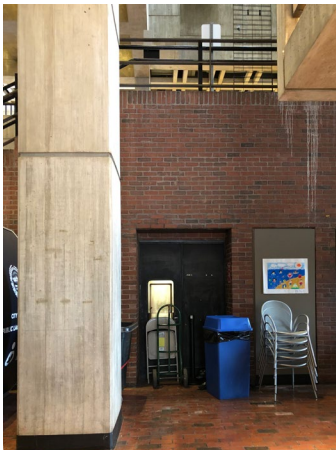
Technological vestiges like phone booths and water fountains are no longer in use. The phone booths in this space have been replaced with solid panels. The water fountains are no longer functional.

Items such as moveable furniture and equipment for cleaning and events are often stored near the bottom of the mayor's stair.

Furniture and equipment stored in the lobby. Non-functional water fountain and new panels at former phone booth locations.

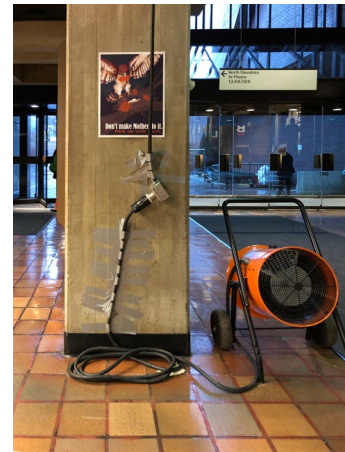
Supplementary heating with cords taped to the concrete.

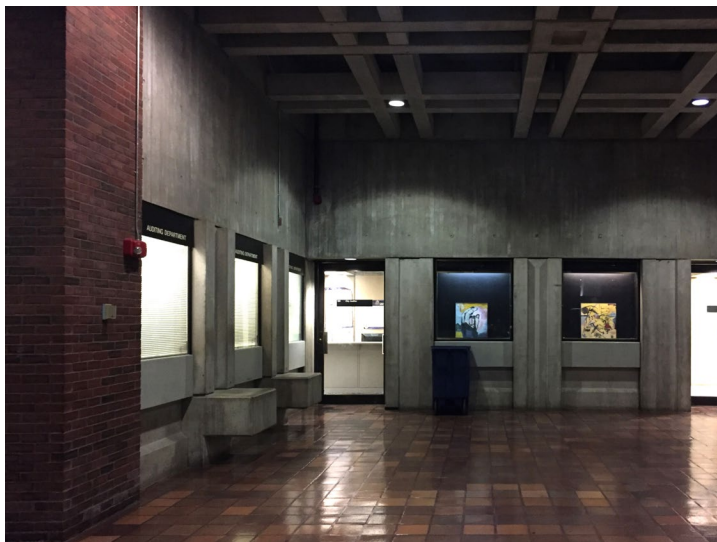
Though this is still the main location for public transactions, there are substantially fewer in-person transactions compared to the original planning. As a result, a profusion of closed windows makes the space feel unwelcoming.

Closed transaction windows on level M.

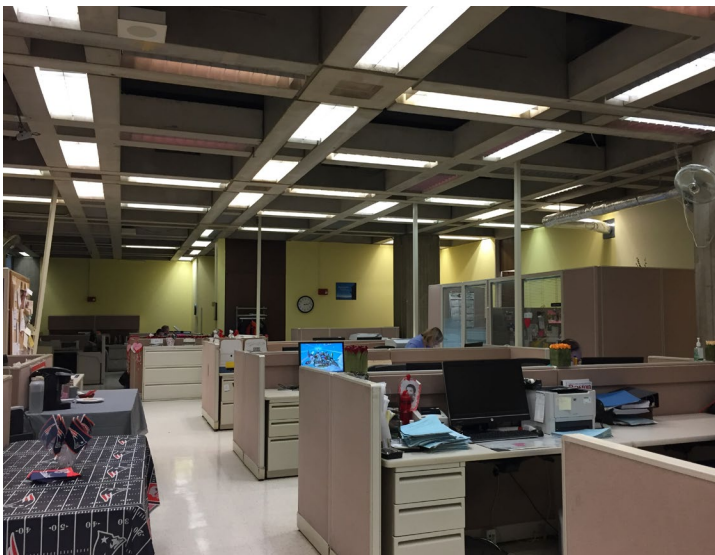
Second-floor office space showing power drops from the ceiling.

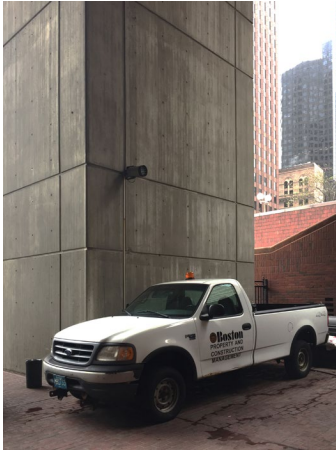
Vehicle parked on the Congress Street porch.

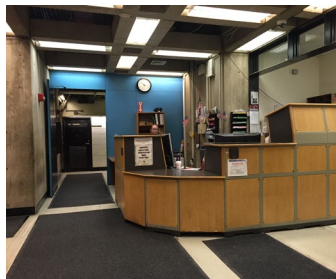
Security desk in the inner lobby.

The Congress Street entrance is undersized for the daily capacity it handles. Its location provides a crucial entry to the building, as it is the only entrance that is visible from and located on a street. It is currently the only after-hours entrance and exit.

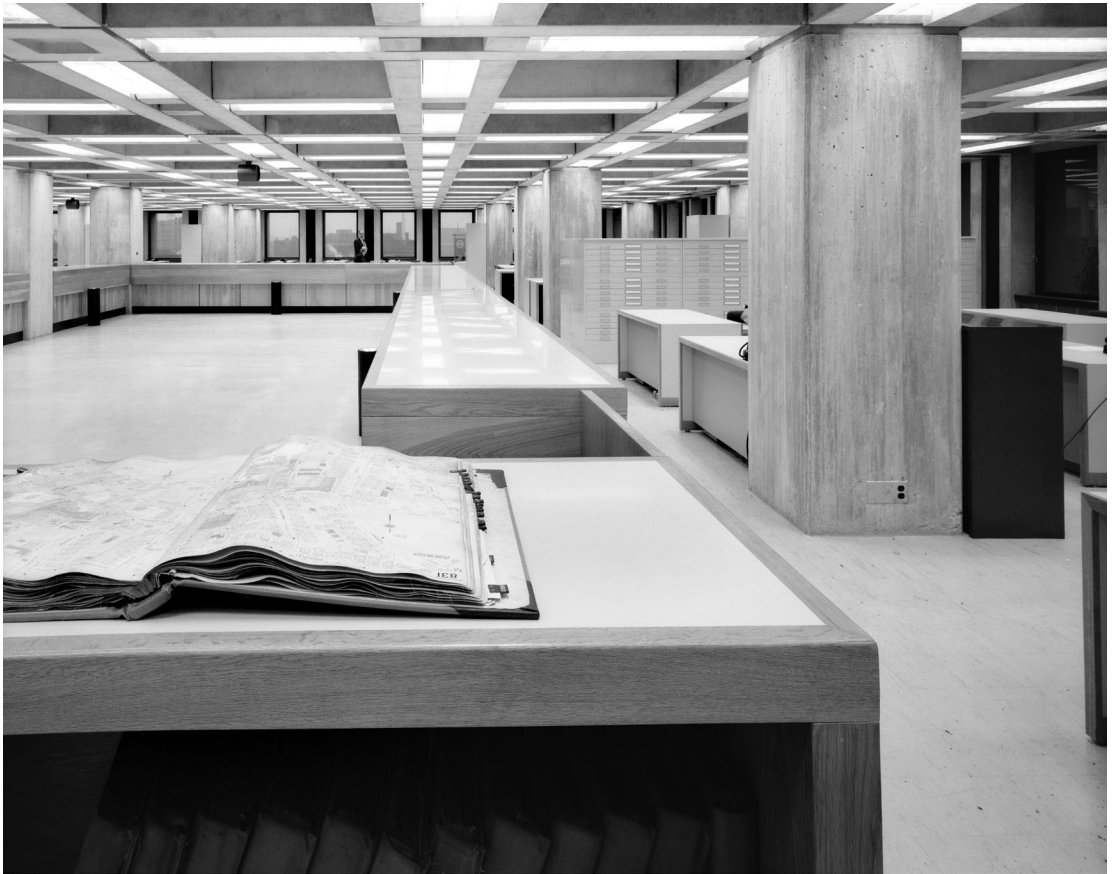
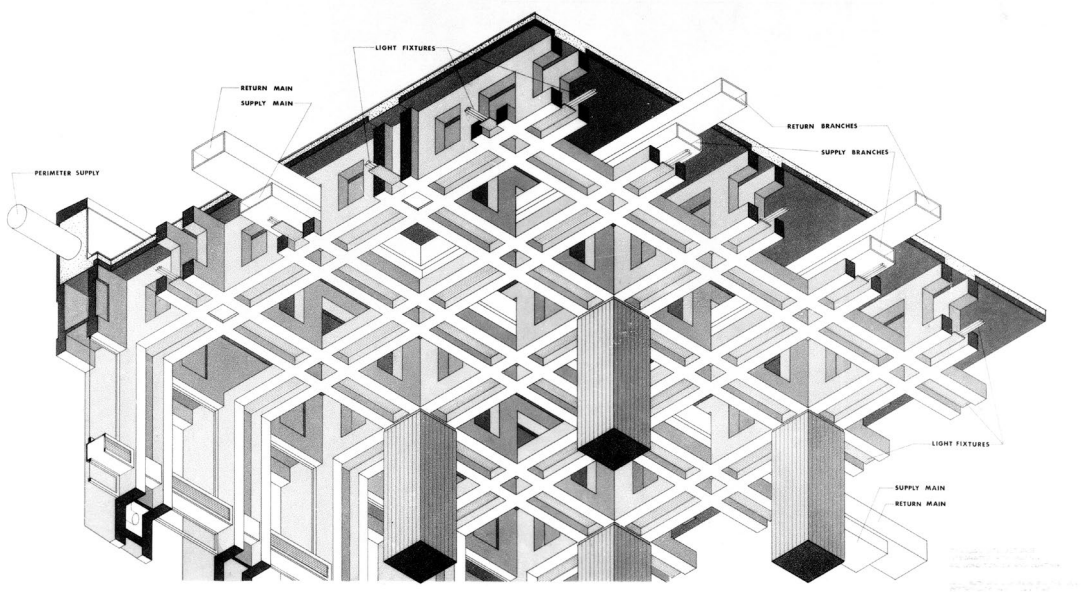
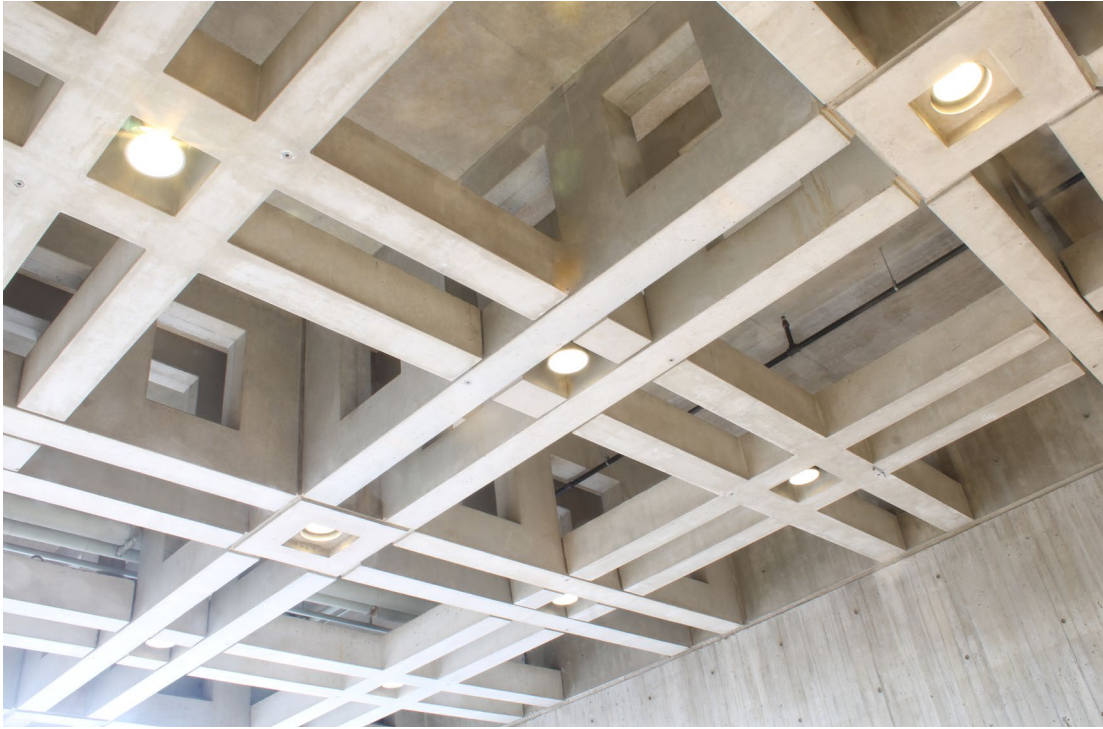
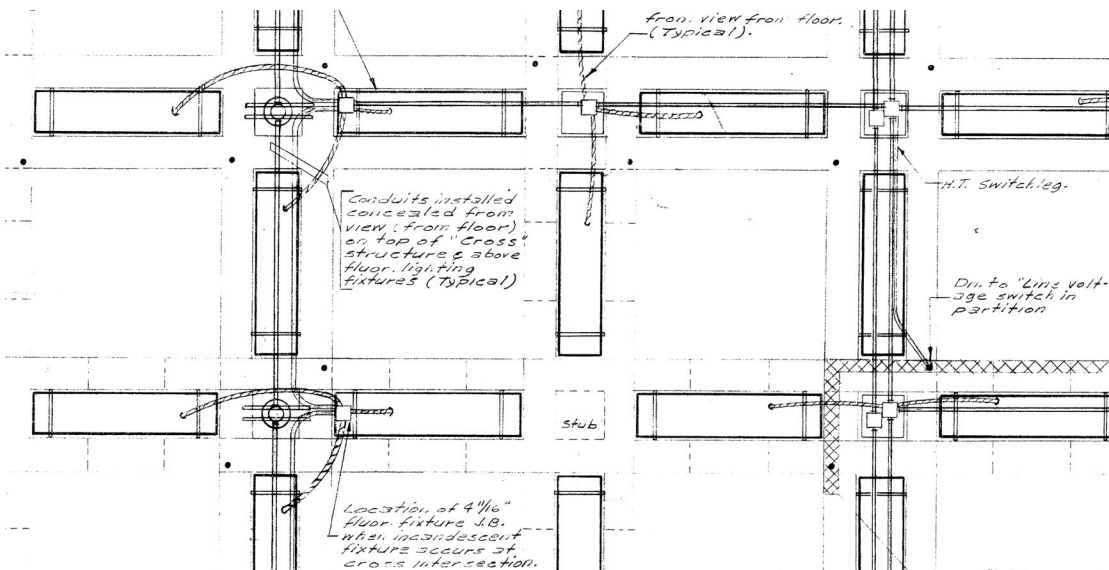
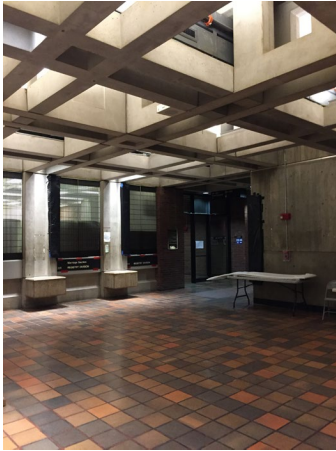
Vierendeel trusses and ceiling grid in the second-floor transaction area.

The precast concrete Vierendeel truss and associated cross beams are in good condition. There are some areas of small spalling and staining, consistent with the exposed concrete surfaces throughout the building.

At the transaction level, there is at least one example of inspired graffiti. The original intent of using the grid to mask the various runs of mechanical infrastructure and facilitate access to these systems for repair and upgrades has been lost. New cables are run haphazardly above the grid and blight the otherwise neat appearance originally intended. In some cases, the installation of new services has resulted in physical installation along the precast ceiling grid.

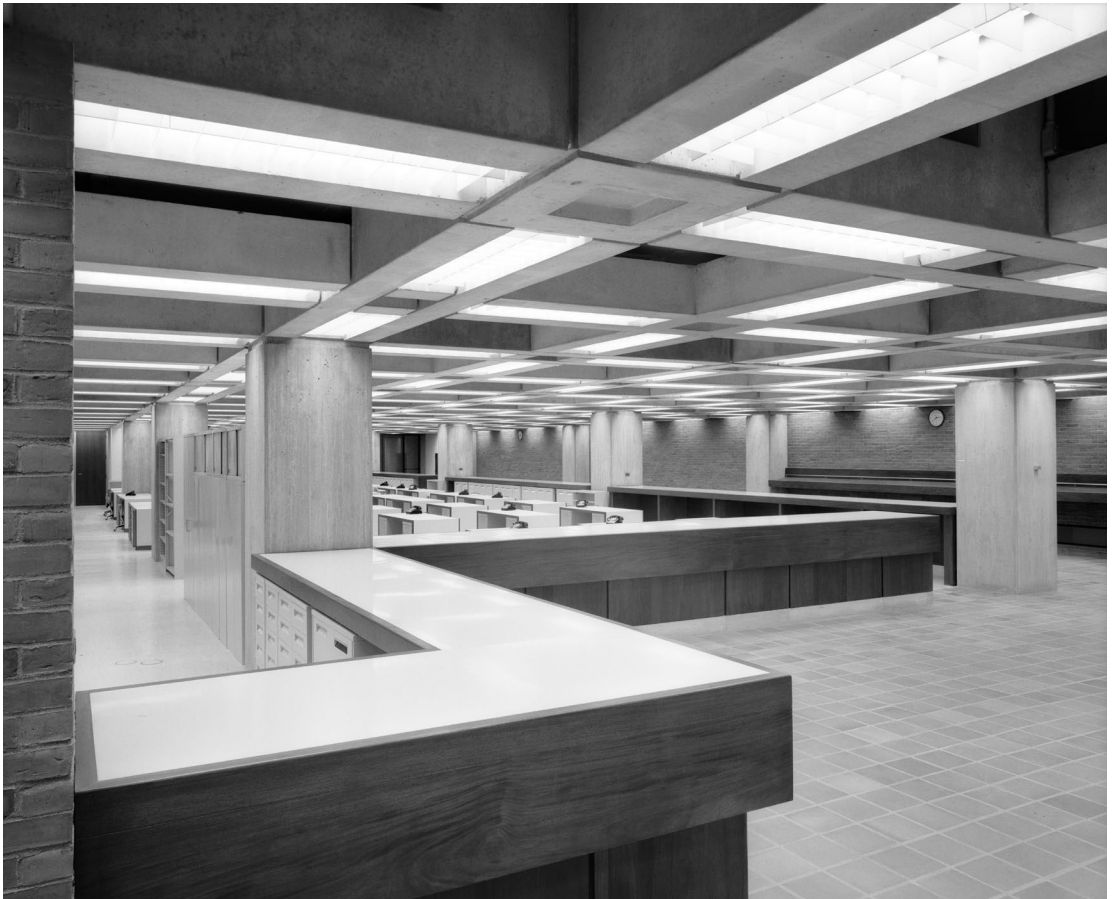
Linear fluorescent fixtures in a second-floor office space.

Most of the original linear fluorescent fixtures on the interior are still in place. The lamps are in need of frequent replacement, and they are not always replaced with consistent color temperature lamps—many fixtures are located in extremely high locations that require costly lifts and other specialized equipment to reach. Fixtures have been replaced in some locations as part of recent office renovation projects.² Replacement LED lamps have been installed in other locations.

M3 All fixtures and lamp or bulb replacements should be 3000K color temperature.

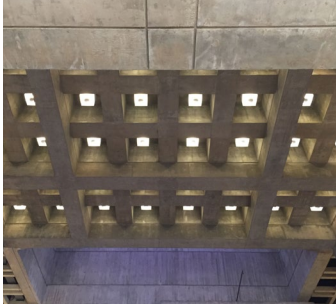
New LED fixtures in the plaza lobby.

All of the original can downlights in the plaza lobby, city council chamber, and anteroom outside of the Curley Room, as well as a number of the cans on the second floor transaction level have been replaced with LED fixtures as part of recent renovation projects.³ LED relamping has resulted in maintaining design intent, cost effective and energy savings.

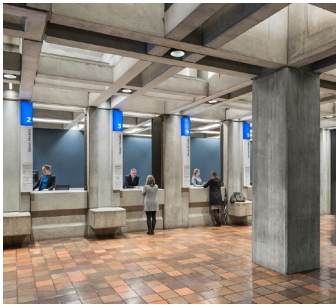
New LED lighting in part of the second-floor transaction level.

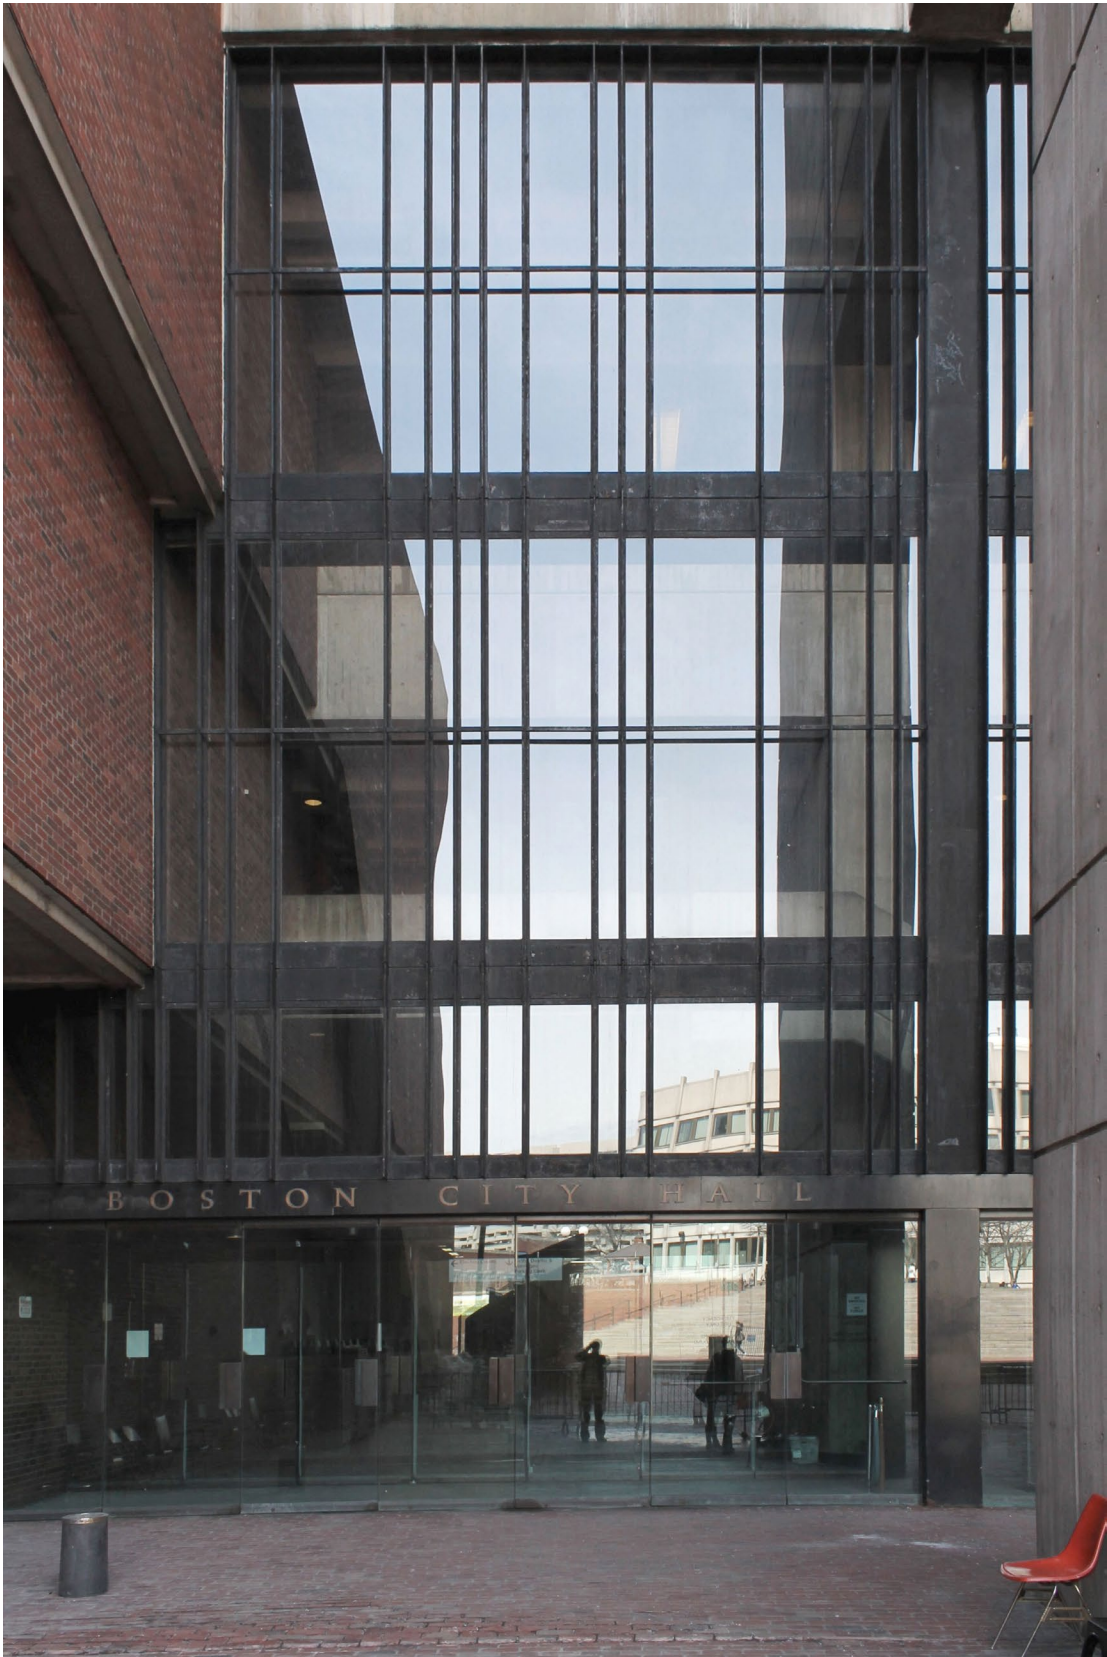
The steel mullions all show significant signs of coating failure on the exterior. As the coating has failed, rust has developed on these surfaces. There is no obvious evidence of structural failure in these mullions. Also the system is not energy efficient.

Right: Example of coating failure and subsequent rusting of mullions at exterior curtain wall. This location is at the Congress Street entrance, but the condition is typical.

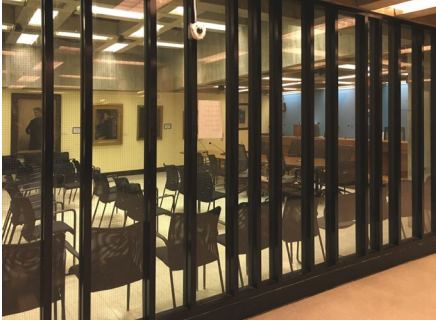
Meeting room 801, showing the storefront system that does not match the original.

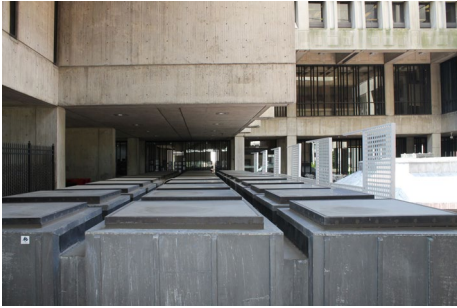
Bank of thirty-three skylights as seen in courtyard.

The acrylic covering for the bank of thirty-three skylights on the courtyard is dark, dirty, and provides little natural light to the transaction space below. Several of the coverings are cracked or broken. Due to various failures of the fixtures or bulbs, the supplementary lighting installed within the shafts is often not functional. Given that these skylights are partially located under the overhanging hood above, there is some question as to the effectiveness of this natural lighting strategy. Writing in the *Hudson Review* in 1970, art scholar Charles W. Millard observed that:

- M4 Restore the central skylight to provide daylight to spaces below.
- M5 Replace acrylic cover panels on the bank of thirty-three skylights to increase the amount of light that penetrates to the transaction area below.

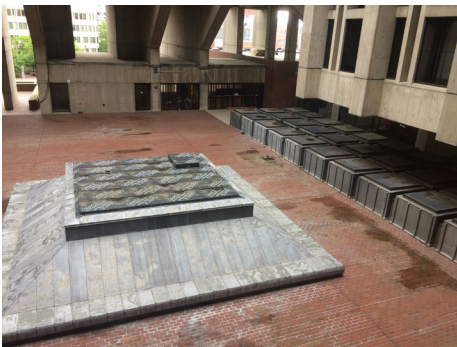
View of central skylight showing metal cladding and Grace I&W covering the top opening.

The oculus has suffered from extensive leaking, which results in mechanical failure of the escalators below. In response to these ongoing leaks, the top of the oculus has been sealed with W.R. Grace Ice & Water Shield.

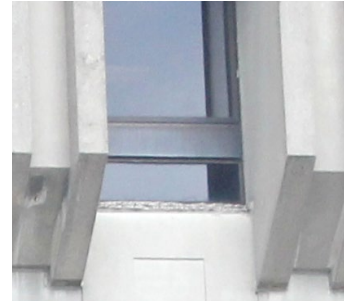
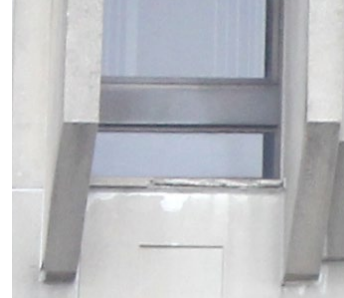
Conditions on the east elevation (along Congress Street) are significantly worse than conditions on other elevations. This is likely the result of prevailing harsh weather coming from the east.

East elevation at south corner (nominally above mayor's office suite); note multiple instances of spalled concrete on fins and window sills (June 21, 2018).

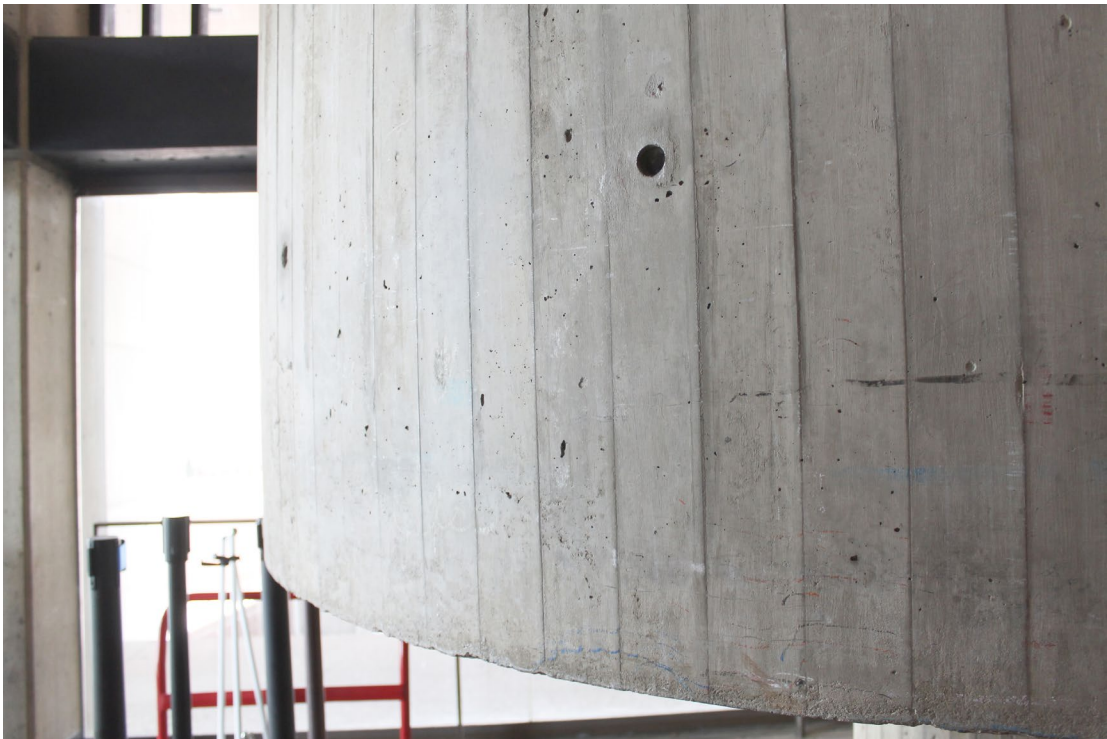
On the interior, the concrete remains exposed as the finish material. While not exposed to weather over the last fifty years, the appearance of the concrete inside has also evolved. There is overall atmospheric staining (likely due to decades of cigarette smoke), general staining at high traffic areas (likely due to hand oils), chips and dings in the concrete surface, and residue associated with various adhesives.

General conditions of interior concrete, shown at the mayor's stair (June 21, 2018).

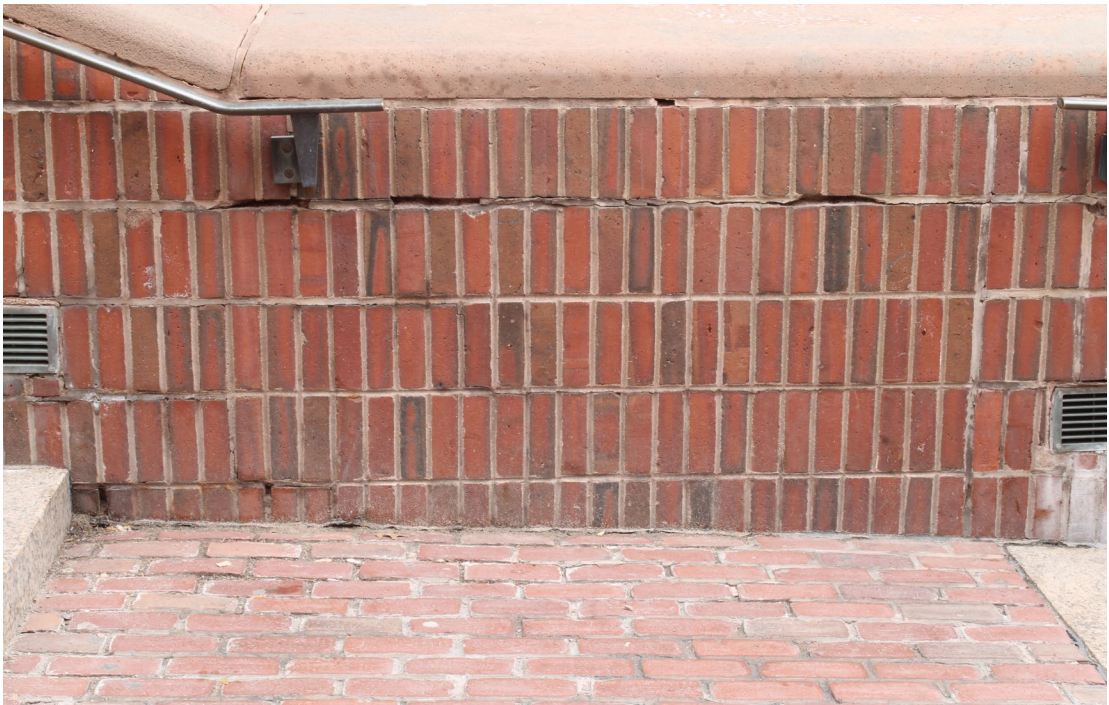
Failed mortar joints (January 11, 2021).

- Mortar should be Type N
- Color should match adjacent mortar. Mockups should be required to confirm color match; allow mockups to cure a minimum of 7 days.
- Failed mortar joints should be cleaned out of loose material to a depth at least twice the width of the joint.
- Existing stable mortar should be damp prior to installation of new mortar.
- New mortar should be mixed to a moist, but firm consistency.
- New mortar should be pressed into joint firmly.
- Joint should be tooled to match adjacent joint detail.
- Clean area using gentlest means possible to remove residue after new mortar sets.

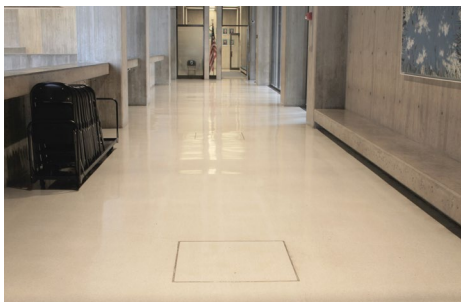
By July of 1968 there were several instances of delamination of the flooring on the fifth through ninth floors. These areas were described as “large blisters of approximately 2 to 3 feet in diameter.”³ Synterra Corporation of California (no longer in business) hypothesized three potential causes of the failure:

Polyester terrazzo floor on the fifth floor's known delamination area (June 21, 2018).

- The use of localized space heaters after the floor work could cause thermal stress that could result in bond failure and warping in specific locations.
- Spillage of materials after priming and before application of the topping—this includes water. Apparently “a half ounce of water spilled just prior to pouring of the topping can cause a 3 foot diameter bond failure.”⁴
- The use of special additives such as calcium chloride, accelerators, retarders, or curing compounds.

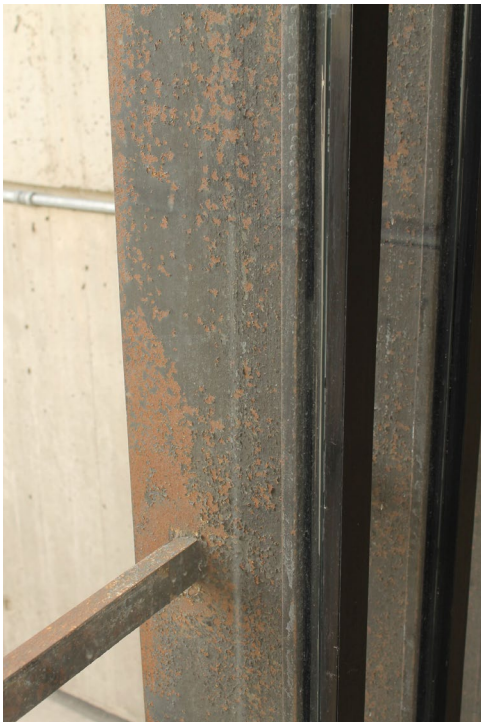
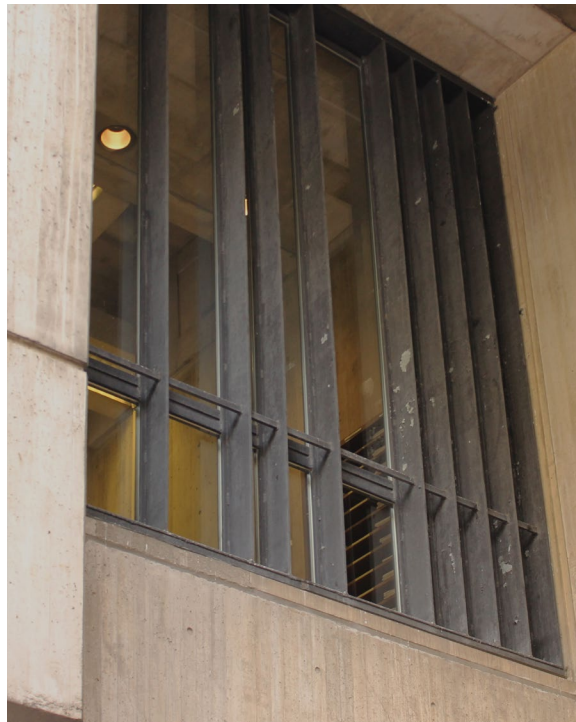
Typical window mullion conditions (March 29, 2018).

The steel window mullions located at levels five and lower are all showing significant paint loss with resulting rust development. Based on inspection of the mullions at various levels, it appears that the specified color (Dark Amber or Dark Bronze) was never implemented. All mullions (interior and exterior) are black. There is a small section of bronze colored mullions at the Congress Street entrance, but this appears to be a post construction replacement of a storefront unit at this sole location.

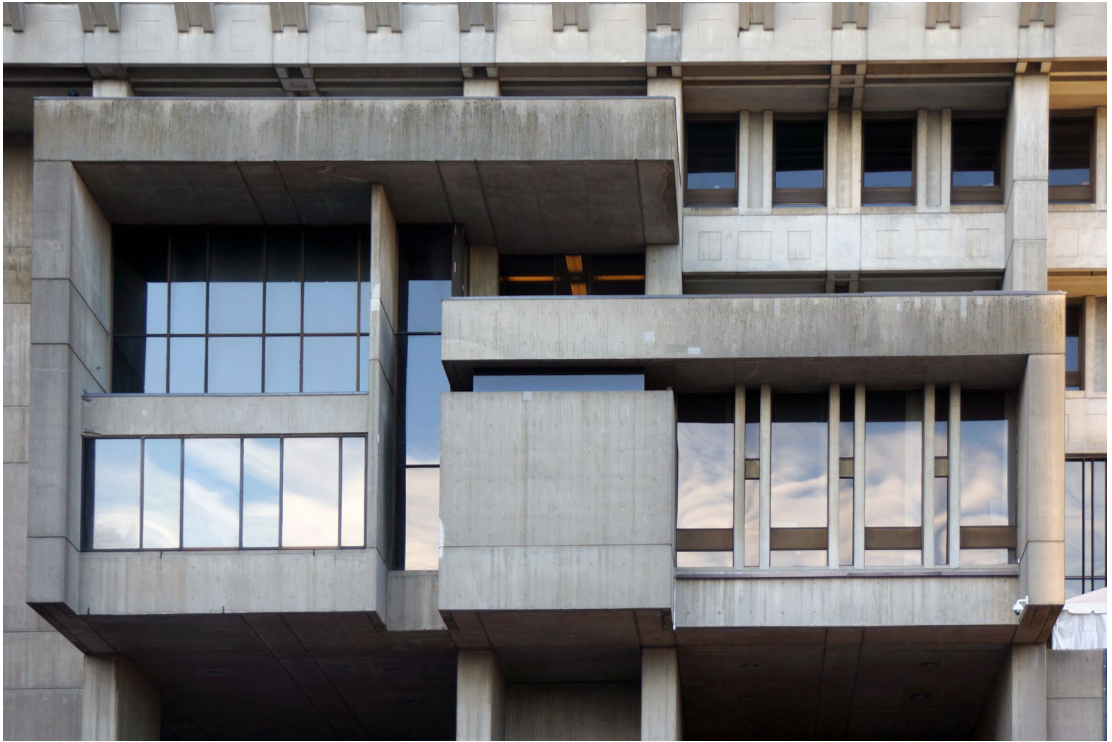
Glass in the ceremonial hood along the south facade (January 26, 2021).

M49 Identify feasibility of replacement of single-pane window units on the ceremonial levels with insulated glass units. Units must matching originals in glazing color, reflectance, and transparency, while replicating the original design details.
