TBILISI CHESS PALACE AND ALPINE CLUB

CONSERVATION MANAGEMENT PLAN

TBILISI 2021

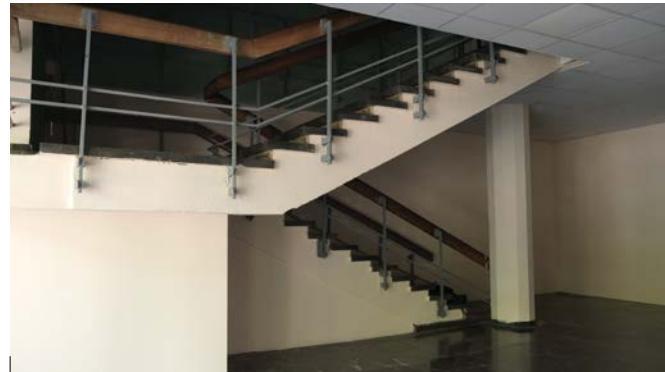
Staircase in the northwest of the interior. 2020

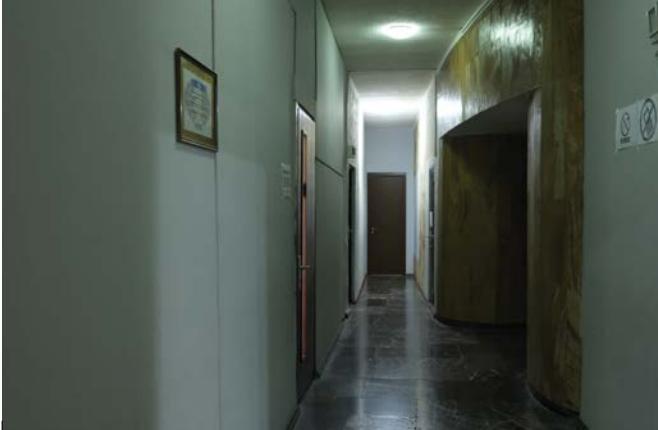
Vestibule on the eastern side of the first floor. 2020

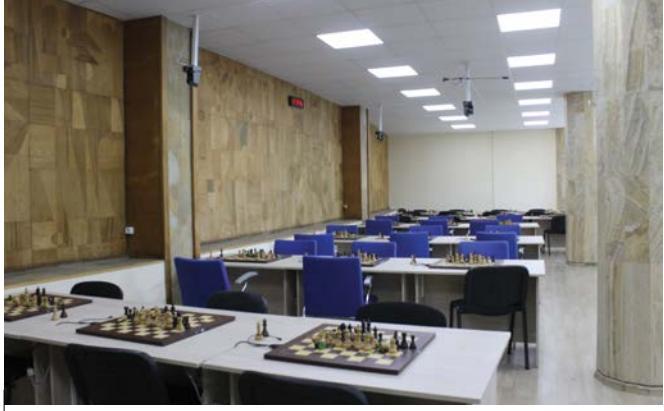
Due to the installation of offices onto the balconies surrounding the building, many of the original aluminum windows and doors were altered or removed. Inappropriate and incompatible actions were also performed with regards to the architectural details, existing in the interior. Inadequate interventions caused substantial physical and mechanical damage to the architectural and artistic details, such as the cladding of the columns in the present billiard hall, which were painted numerous times (with different types of paints of various colors).

On the monumental woodcut panel in the billiard hall brackets for holding billiard cues, large pipes for heating, ventilation and airconditioning, and various types of hooks were installed.

Eastern Gallery on the second floor. 2020

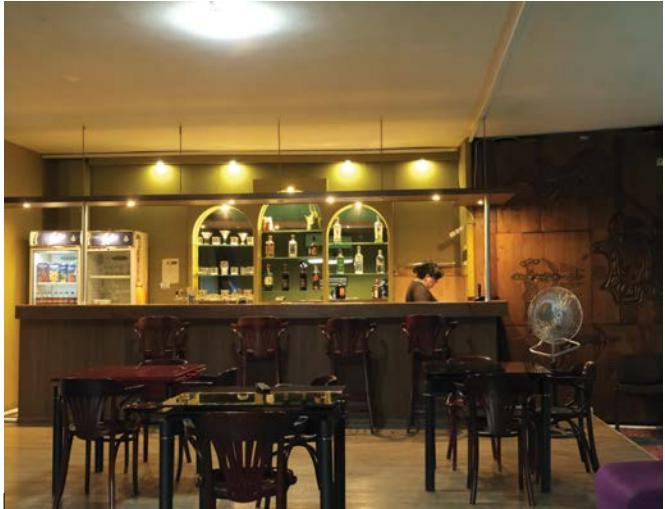
North-east part of the building where the staircase was located. 2020

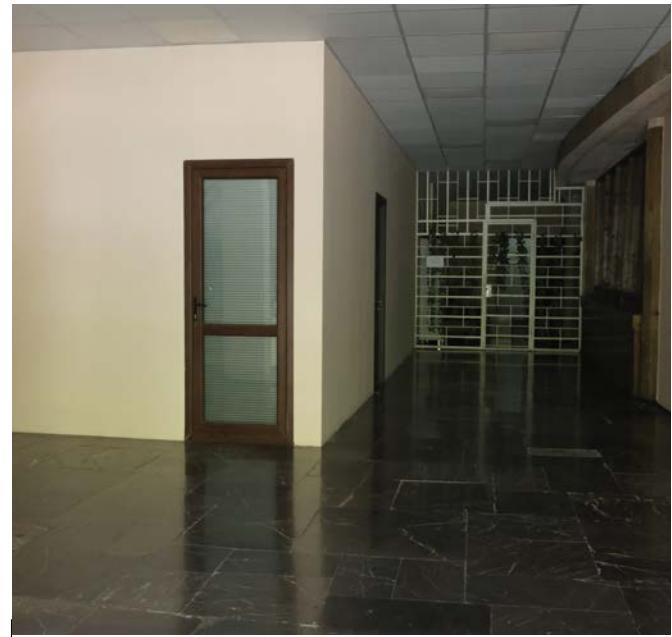
Northern Gallery of the first floor. 2020

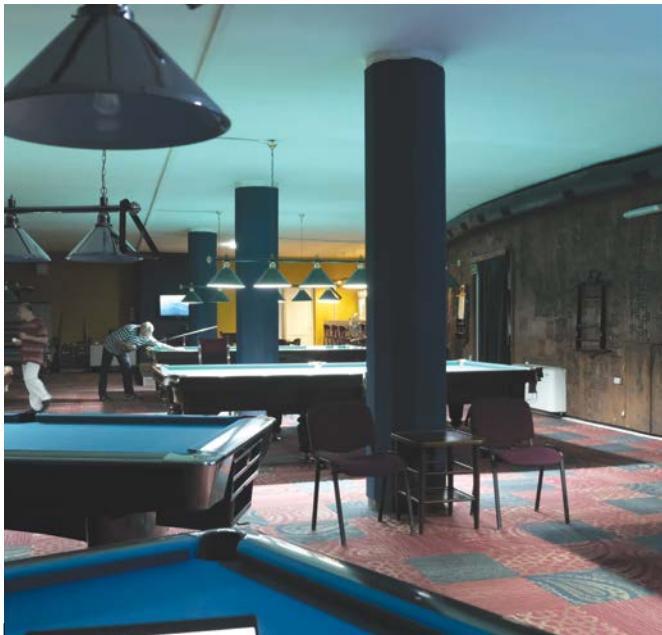
Northern Gallery of the second floor. 2020

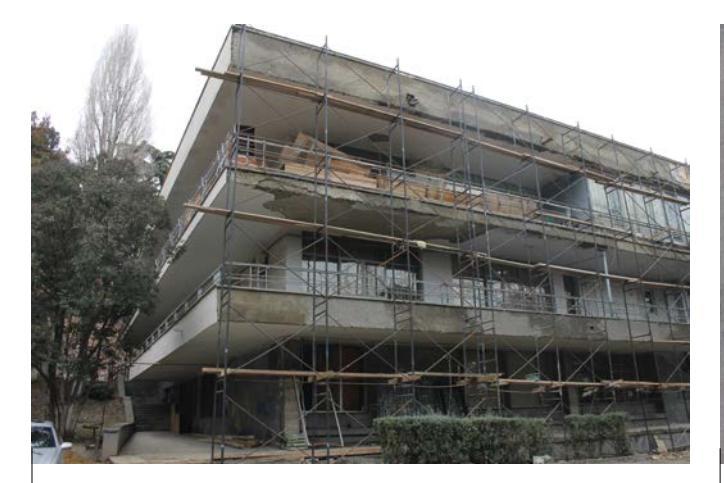
In the process of rehabilitation, the original technique of cladding and pattern of laying the tiles on the façade was neglected. The tiles were attached to the support using cement mortar and small screws. The joints between the tiles

Process of replacing stone cladding on east façade. 2018

were filled with inappropriate filler and processed with a multifunctional electric cutter, causing mechanical damage to the stone surface.

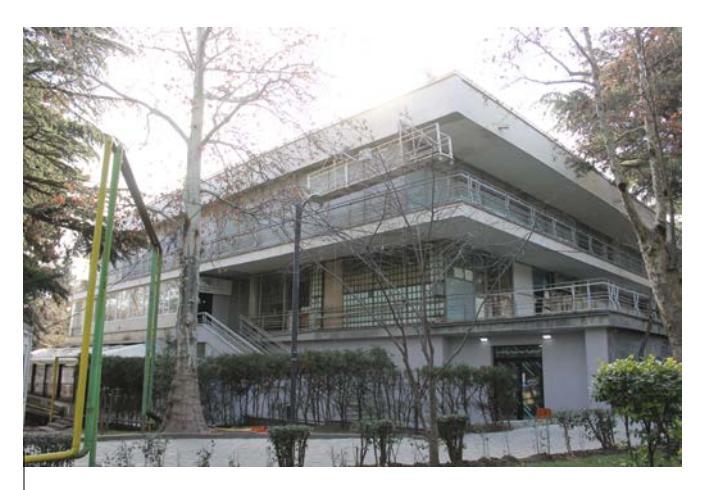
Northern Façade. 2019

As mentioned before, the artistic appearance of the building's façade, which was formed by rhythmically distributed large aluminum vitrage and wide balconies, is presently defaced by improper and visually disturbing additions.

Basalt Stonework - The damage of the basalt stonework, existing on the Basement Floor, is expressed in small lacunas of the stone, chipping, and superficial disintegration. The damaged areas are spread all over the perimeter of the cladding, however, they are more concentrated on the façade of the Alpine Club;

Eklari Stone - surviving finishing of *Eklari* stone displays deterioration patterns: the surfaces of stone slabs are weathered, delaminated, and scaled. In certain sections, there are separations of superficial layers and salt crystallization. Besides, the surface of the decorative stone wall is covered with exogenetic deposits.

Damages of the façade cladding and other architectural elements are mainly caused by the lack of maintenance, improper use, and mechanical impact. Besides, due to incorrect installation of the water diversion system on the upper terrace, atmospheric precipitation caused damage to cladding stone. Improper functioning of the water diversions system contributed to continuous infiltration of water from the terrace into the walls, finally leading to severe damage of the slabs.

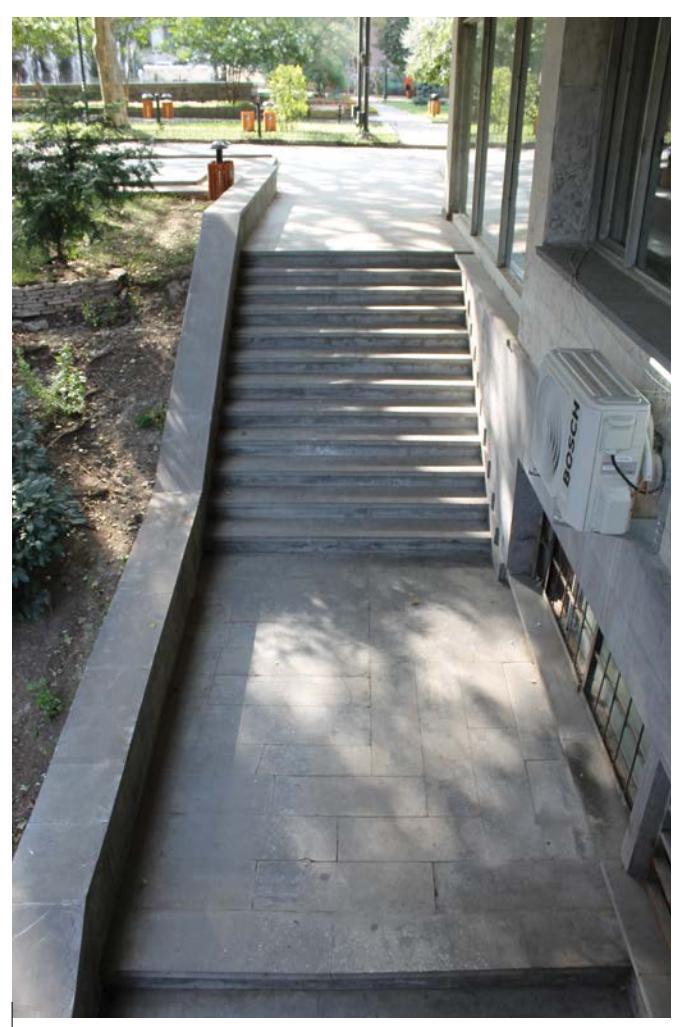
In the middle part of the northeastern and northern façades of the terrace the paving is lowered (the ground is settled). Cracking and breaking of individual stones are also observed.

The damage is linked to the infiltration of atmospheric precipitation, caused by the wrong location of water diversion pipes on the roof and balconies, as well as the absence of drainage and runoff water channels.

A Terrace on the Basement Floor. South of the Building. 2018

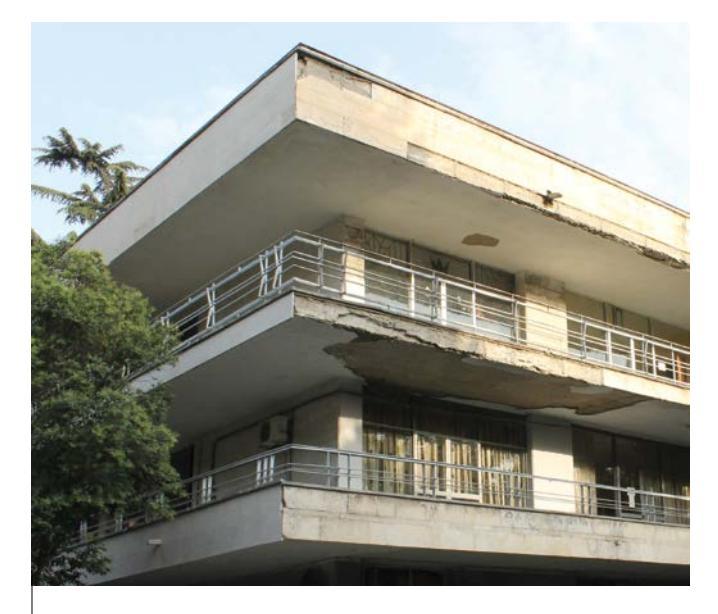
Renewed Stone Cladding on the East Façade.

Cladding - In some places, stones are coming loose; the original laying of the stone cladding was altered (thinner stone slabs were used, and the technique of attaching them to the support is unauthentic and wrongful). The three-row stone cladding pattern on the balcony parapet shield, on the

first floor, is replaced by new, two-row cladding. Their height is also increased at the expense of their alignment on one line. The surfaces of the majority of old tiles are scaled and delaminated.

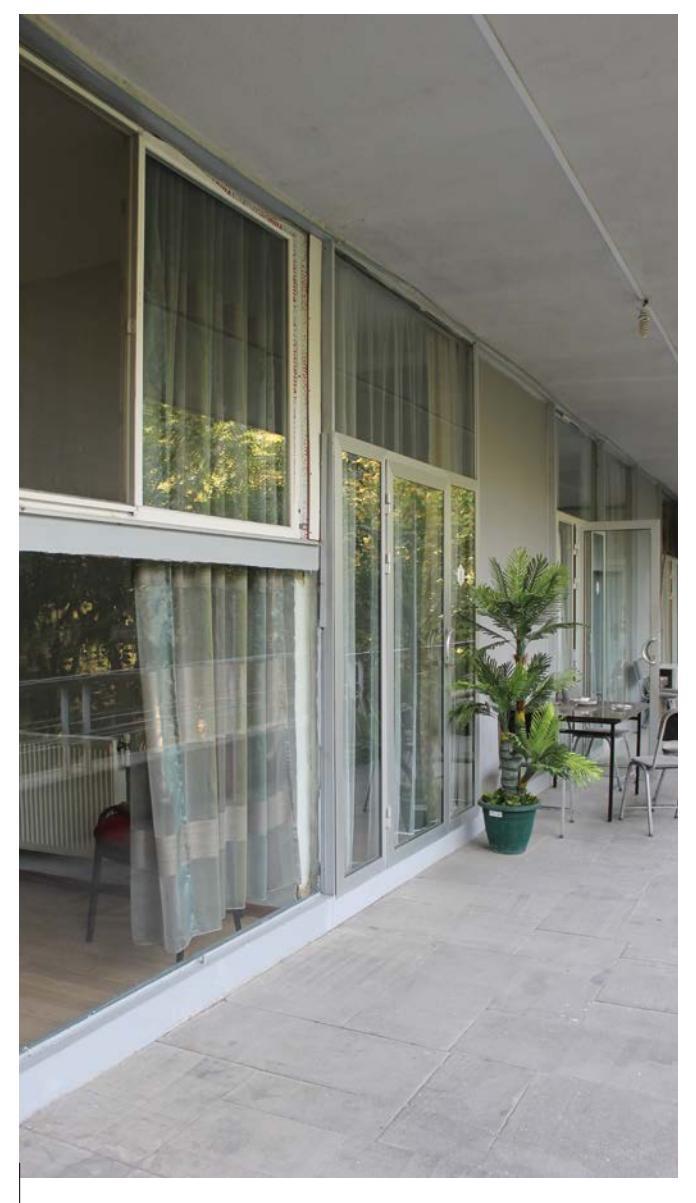
Aluminum Vitrages. 2019

The majority of the preserved original profiles have only minor damages, expressed in localized (spot) deformation-buckling. Part of the profile is lost, part is painted or altered.

Lack of maintenance, improper use, and mechanical impact. Improper installation of individual elements also occurs, which could be leading to the penetration of atmospheric precipitation or wind into the interior.

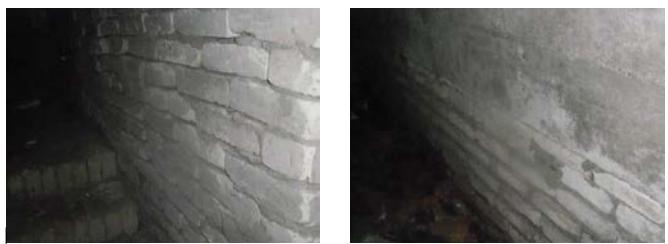
Figs. 19 and 20 Silica bricks used in the building

- The ground near the stairs of the Alpine Club is lowered and the gutter is deformed;
- The quality of attachment of slabs to the façade of the second floor adjacent to the Alpine Club is poor;
- Calcium-silicate bricks are used;
- Cracks are noticeable in the walls of the Main Hall (520 seats);
- There are bulges and cracks in the plastering in the section where water diversion systems are located;
- Most of the roofing tiles are badly damaged due to humidity; leaching of tiles has begun, affecting concrete and leading to concrete grade depreciation. Protecting concrete layers of some of the tiles are damaged and corrosion of the bar mat reinforcement has started.

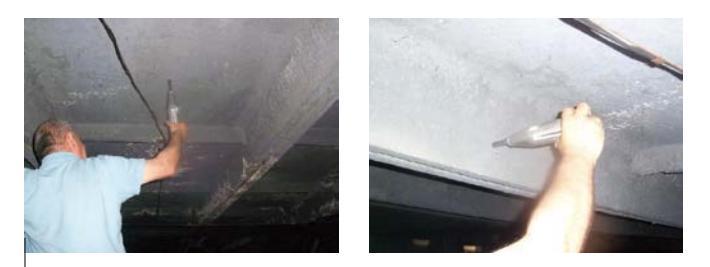
Fig. 22,23. Identification of concrete grade in ribbed slabs of roofing

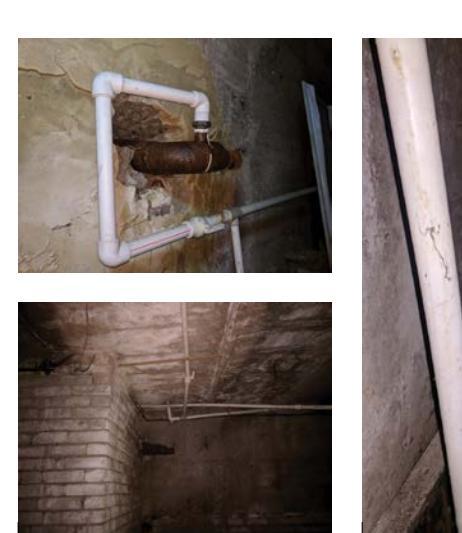
fig. 1-2

Water is supplied to the building through a DN100 mm steel pipe, running from the side of the front façade (Vera Park fountain). The pipe reaches the section of the building occupied by the Chess Federation, on a basement level. It was installed at the time of construction of the building. It appears that the original pipe has not been replaced in recent years. To allow separate water supply and metering facilities for the Chess Palace and the Alpine Club, the steel pipe was cut, and separate, branched polypropylene (PP) 32 mm pipes were placed. (See figures 1 and 2). At the same place, is located the Chess Federation's water meter.

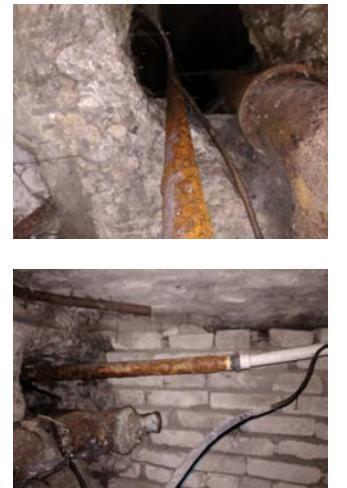
fig. 4-5

The basement itself consists of several individual halls, which are not connected with doorways. There is only one small opening, a hole made in the wall of ground and concrete, in which only a thin, flexible person may fit through. There are several smaller holes for pipes and cables (see fig. 4, 5, and 6).

As it was impossible to arrange new polypropylene pipes in the halls next to the basement, plastic pipes were joined again to old distribution pipes of steel. It was thus only a partial improvement. (See fig. 5 and 6).

The basement-level sewerage system, made up of DN100 mm cross-section cast iron pipes, has never been replaced. Sealing has been damaged at many points of connection (nipples) and became wet in certain sections. It is likely that water leaks in these areas when flushing the toilets (See fig. 4 and 5).

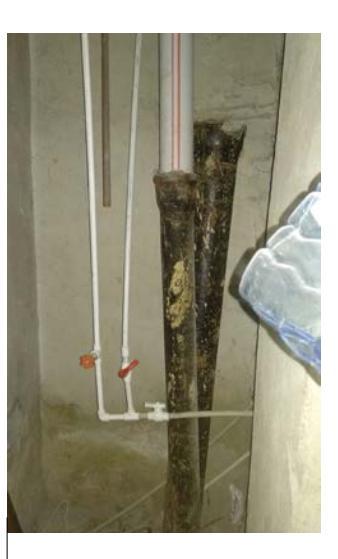
fig. 7

In the basement, all pipes, except for the one in the main collector, are made of cast iron. The cast-iron pipes pass through and above the first-floor flooring. Some of them running at the height of 1-1,2m and connecting to PVC (sewer plastic) pipes, while the majority of cast iron pipes have been left untouched (see fig. 7).

Apart from that, next to 100 mm sewer pipes, there are 150 mm diameter rainwater pipes, which are not functioning. Most of these pipes on the upper floors have been dismantled; only the ones on the first-floor level, going down to the basement level, remain (see fig. 7).

iron pipes are connected to a rainwater pipe, instead of sewer, and sewage waters likely discharge into the central rainwater system, instead of sewers (see fig. 7).

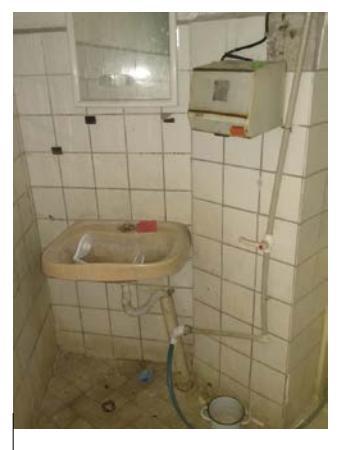
fig. 10

Toilet facilities on the first and upper floors in the section used by the Chess Federation are made of new materials, according to modern designs using, but the toilet on the backstage of the Main Hall is in a bad shape. It is most probably out of use now (fig. 10). In addition to that, several sewer pipes go down the backstage of the Main Hall and are done without proper designs. Other pipes pass through narrow service openings in the walls, which are full of garbage. Some of the pipes are new, while some are old and need to be replaced.

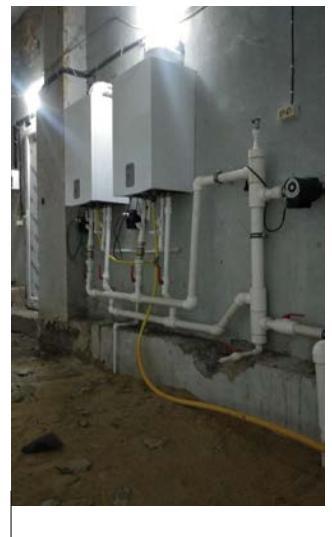
fig. 14

In the pool halls and the café, the sanitary conveniences appear to be in satisfactory condition (fig. 14), however, it was impossible to access the basement, as the access to it was blocked.

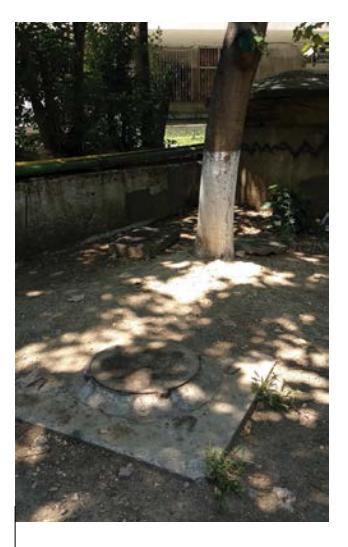
fig. 18

From the sewer pipe outside the building, water is discharged into sewage wells next to the parking lot in the backyard. One of the wells serves the facilities of the Chess Federation (fig. 18), and the other – those of the Alpine Club.

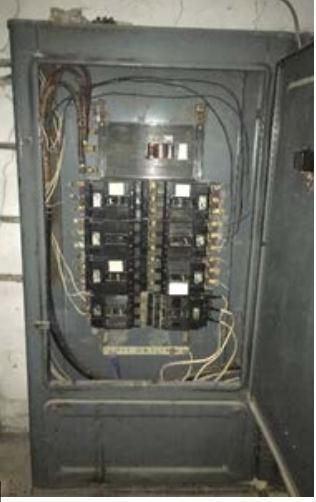
fig. 1-2

The electricity metering unit is located on the wall of an electrical substation. From this point, power is supplied to the building through a low voltage cable, which is placed in the ditch. It shall be mentioned that the service power cable was replaced several years ago and its condition is satisfactory. There are no power supply problems due to this low voltage cable (there is no need for replacement or repair).

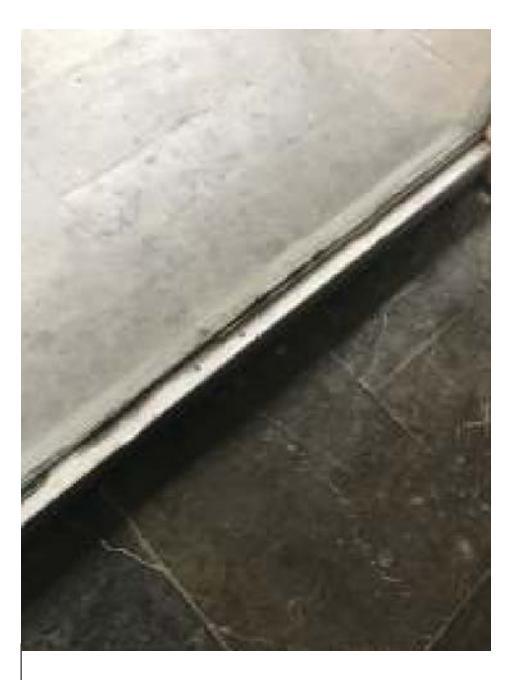
It should be noted that the vitrage is of low quality, and incorrectly installed. Single glazing with glass with a thickness of 6 mm is used, the frames are metal in some places, the rest is an aluminum profile, steel angles are used to fix the glass (photo # 1), which are attached to the frame with self-tapping screws. Isolation is practically not used. Such a construction is characterized by low energy efficiency due to high heat losses and intense infiltration.

The heat loss of the building is comparable if modern structures and materials are used in the Aluminum Vitrage windows. The comparison shows that heat losses are reduced by 3 times. This is the most important issue for improving energy efficiency.
