# The Gateway Arch

GATEWAY ARCH NATIONAL PARK  
ST. LOUIS, MO

CONSERVATION  
MANAGEMENT PLAN

AUGUST 2020

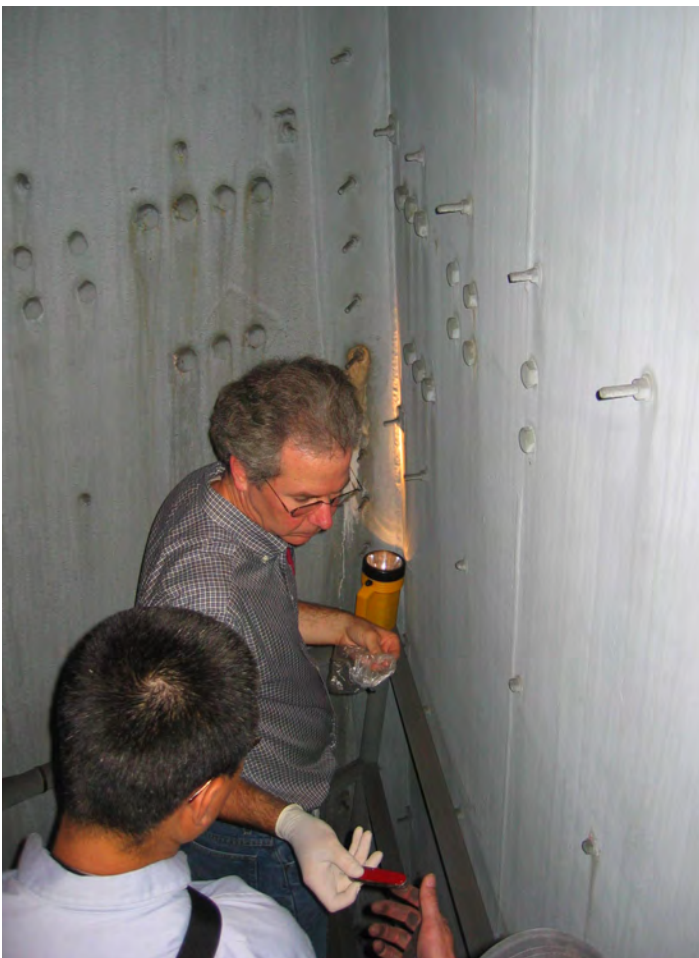
*Figure 2-23—Close up inspection of the interior carbon steel skin from the interior stairs. Source: S. Kelley*

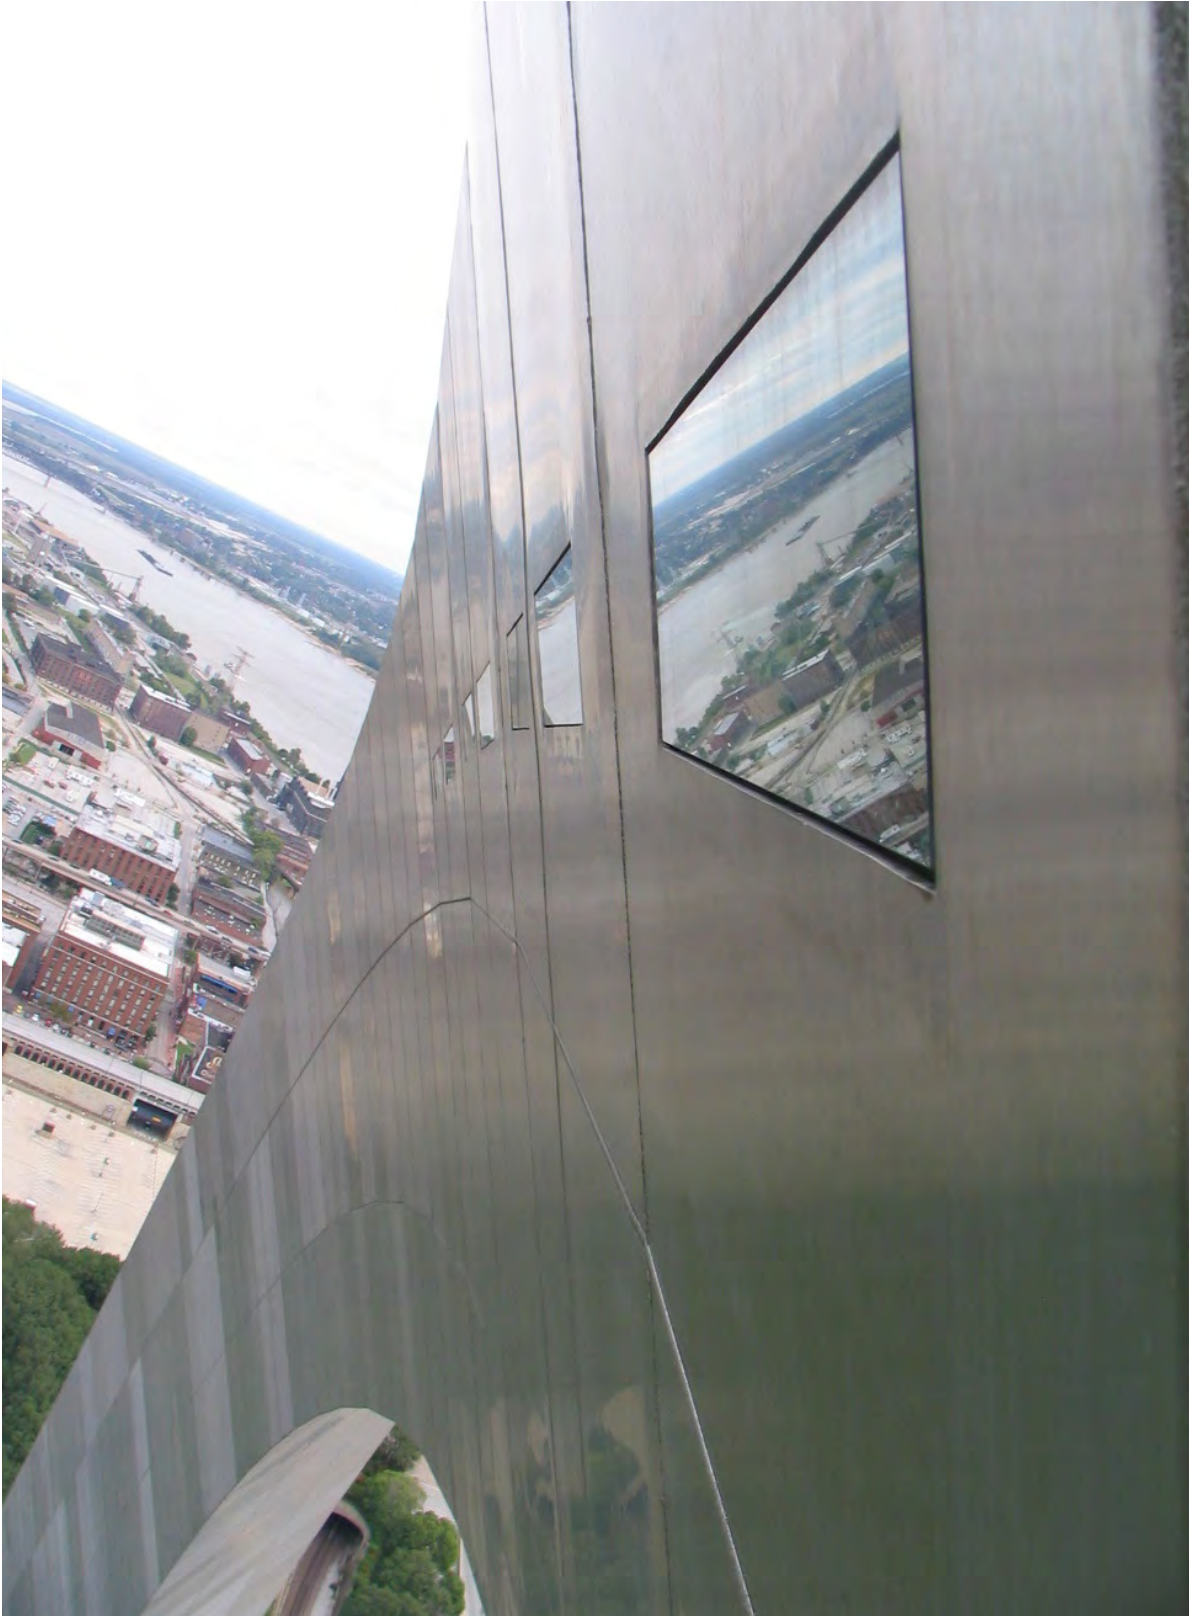
*Figure 2-25—  
Inspection of  
the skin from a  
window of the  
visitors' viewing  
area.*

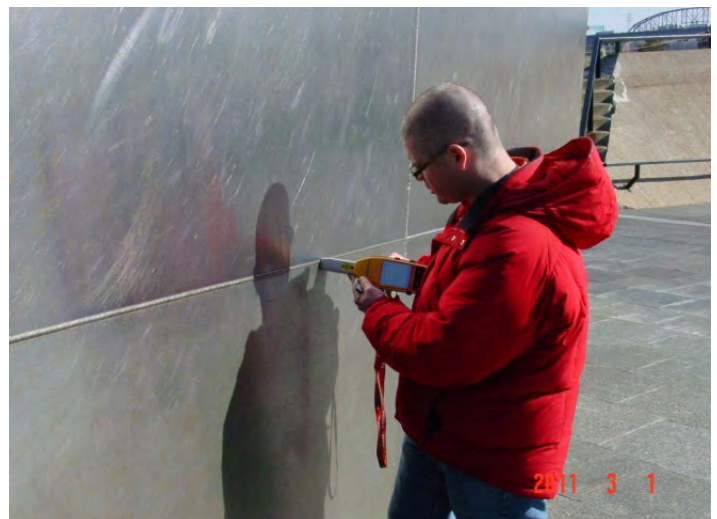
The exterior surfaces of the Arch intrados were visually inspected using telephoto photography, field microscopes, and a hand-held XRF device (Figure 2-28). Many of the discolorations of concern are caused by atmospheric pollutants or inadequate cleaning and polishing of the Arch after erection. Chromium depletion has been detected at some of the welds which can lead to intergranular corrosion. In addition, some carbon steel from the back-up plate may have been incorporated into the weld. If this material is exposed to water and air, corrosion can occur and stain the surface of the stainless steel. Near grade, crevice corrosion is the result of removal of the chromium oxide layer from the tools used to create incised graffiti, a result of surface metal deposits left from those tools, or a combination of the two.

*Figure 2-28—The surface of the steel was evaluated using a handheld XRF in March 2011. Source: P. Krauss*

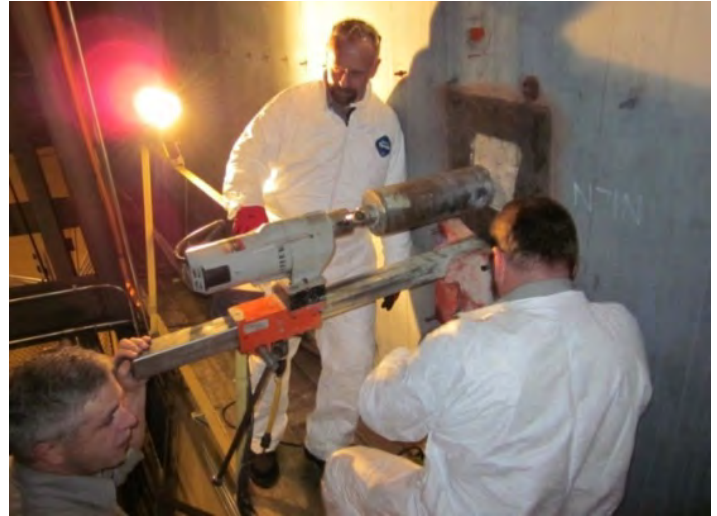
Samples of carbon steel and concrete were removed from the legs of the Arch (Figure 2-29) for testing in the laboratory. Stainless steel from the archives was laboratory tested as well. The steels were found to meet requirements specified during construction. Review of the concrete mixture characteristics indicated that the concrete is not of concern.

*Figure 2-29—Coring extraction of 5 inch diameter concrete sample using a coring rig attached to the wall at North Station 71. Source: S. Kelley*

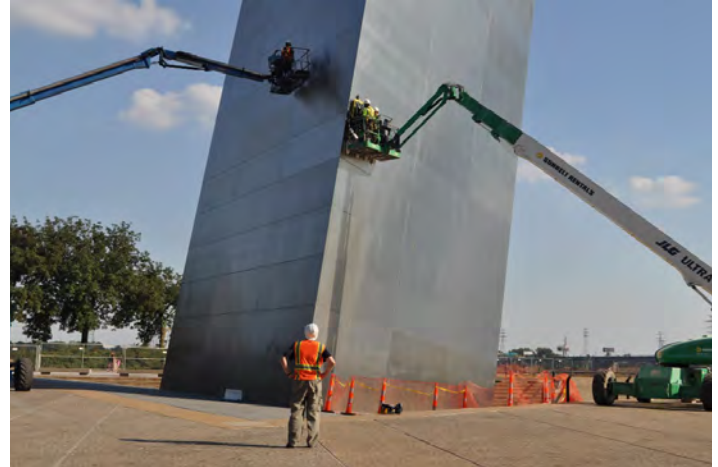
*Figure 2-33—Inspection of the lower reaches of the north leg with personnel lifts. Source: S. Kelley*

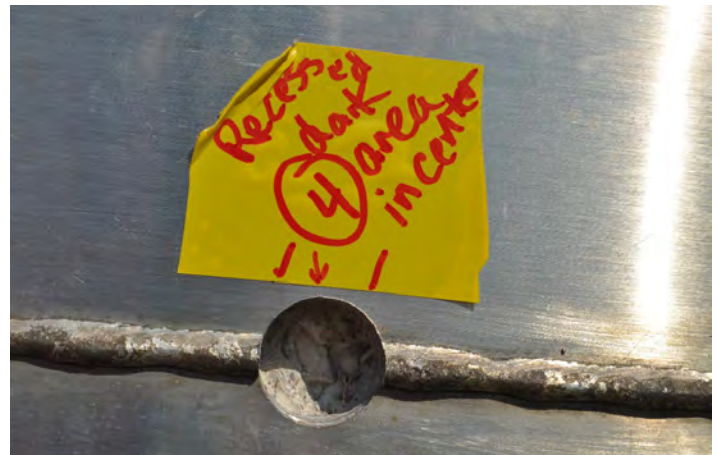
*Figure 2-34—Removal of a field weld sample from the exterior skin of the arch. Source: S. Kelley*

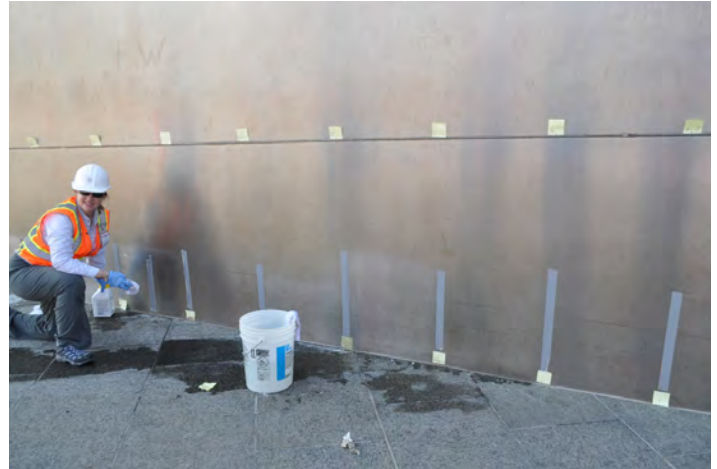
The cleaning trials were successful at reducing some of the discoloration and provided a wide range of passivation and refinishing options for the stainless steel. Based on the nature of refinishing stainless steel, it is likely that

*Figure 2-35—Cleaning samples performed by Catherin Houska. Source: S. Kelley*

any attempt to globally refinish the stainless steel panels could result in a more noticeable uneven appearance in the finish. At the base of the Arch at locations of incised graffiti, a cleaning treatment could be implemented with a more precise method of refinishing the stainless steel and an acceptable treatment could be applied. To develop a cleaning treatment at the base, consideration should be given to the anticipated refinish appearance of the stainless steel, including graffiti, and long-term maintenance of the stainless steel at the base.

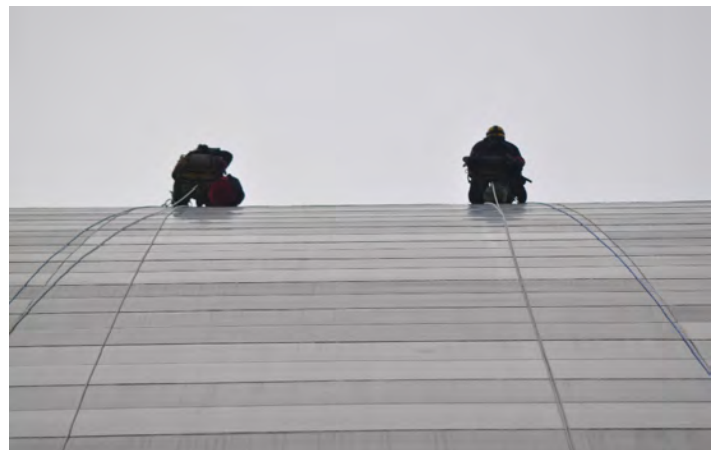
*Figure 2-36—Inspection of the welds on the extrados of the north leg using DAT. Source: S. Kelley*

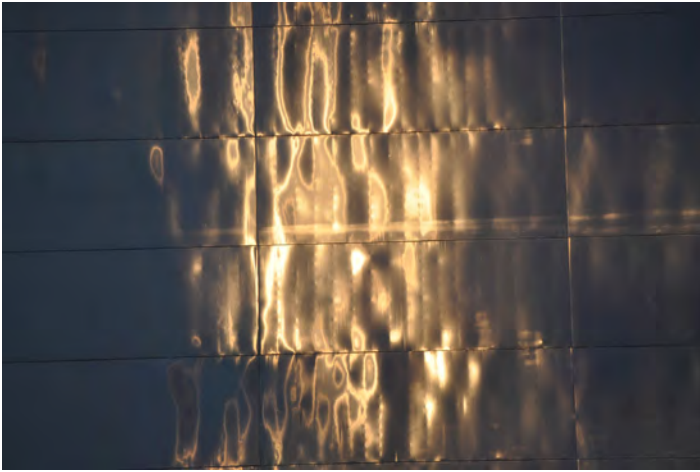
*Figure 5-9—Oil canning of the stainless steel surface at the upper reaches of the Monument can easily be seen during some lighting conditions. Source: S. Kelley*

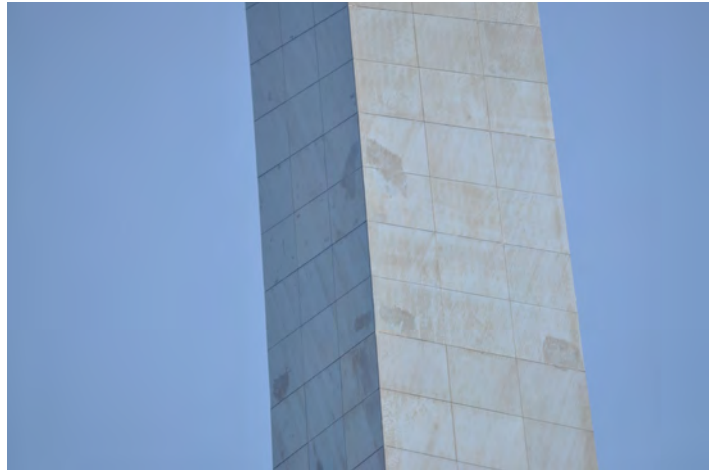
*Figure 5-10—Blemishes on the intrados of the south leg where the trussed strut was temporarily installed to stabilize the two legs during construction. Source: S. Kelley*

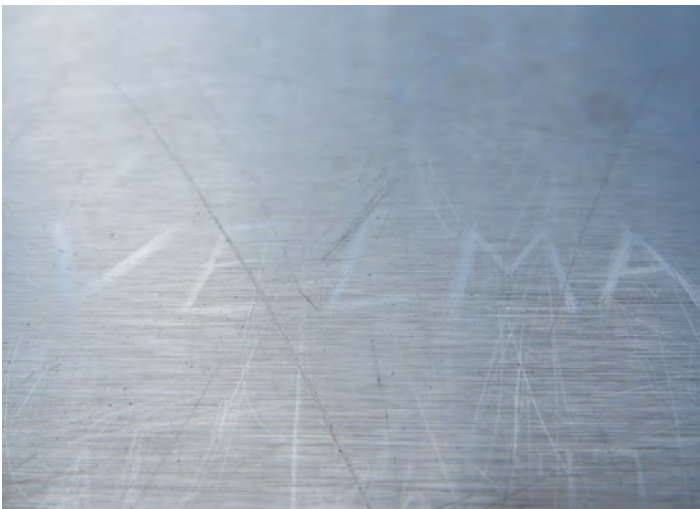
*Figure 5-11—Incised graffiti at the base of the Monument. Source: S. Kelley*

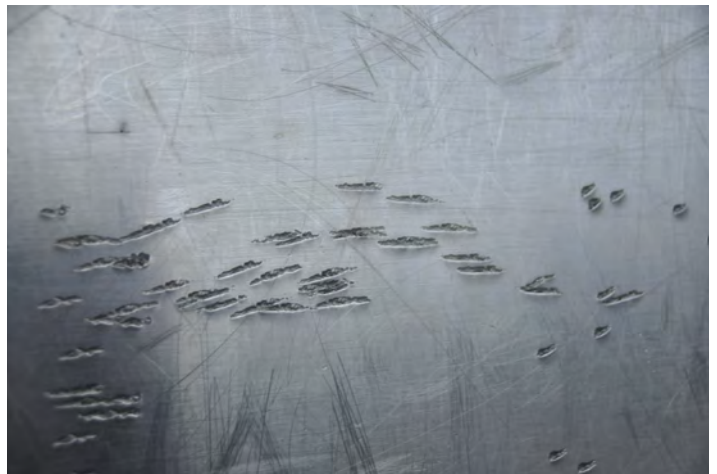
*Figure 5-12—Damage to the surface of the Monument caused by striking with the claw of a hammer. Source: S. Kelley*

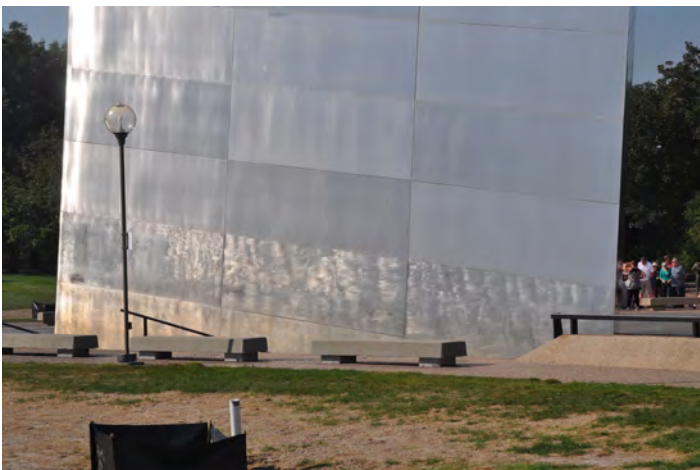
*Figure 5-13—Unsuccessful refinishing of the east face of the south leg, date of refinishing unknown.*

There has been discussion regarding whether the incised graffiti should also be removed by refinishing the plates on the base segment of each leg. It was noted that the east face of the south leg had been refinished in the past using the circular grinder and unsuccessful attempt to mitigate the graffiti. This treatment has strikingly changed the appearance of the east face of the leg and is arguably more unsightly than the incised graffiti when viewed from a distance. Consequently, we also performed a cursory study on refinishing as removal of the graffiti is not possible using any of the cleaning methods that were tested.

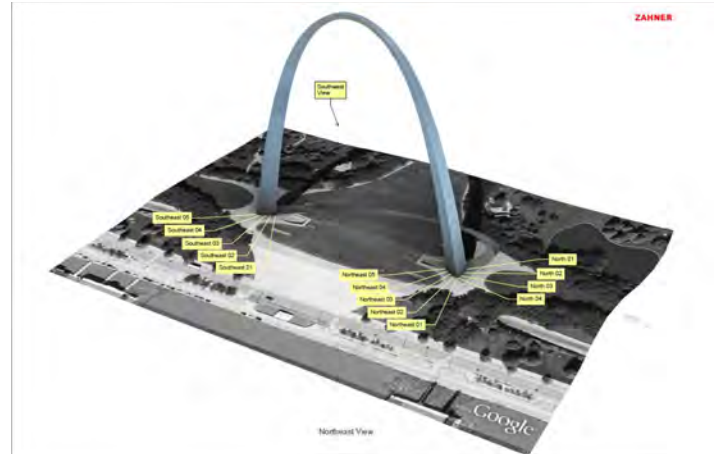
A visual inspection was performed of the stainless steel surfaces of the north and south legs from grade to the second horizontal weld line (Figures 5-14 and 5-15). This inspection took place on August 3, 2018 by Al O'Bright representing the National Park Service; Paul Kuensner of the Association for Preservation Technology; Dan Gierer and William Zahner of Metalabs; and Dan Worth, Julie Cawby, and Steve Kelley of BVH Architecture. The purpose of this study was to determine parameters for potentially refinishing the base of the Monument where there are extensive blemishes from incised graffiti. A detailed record of the visit is found in Appendix B.

*Figure 5-14—Schematic view of the areas tested during the initial skin analysis, view from the northeast. Source: Zahner Metalab report*

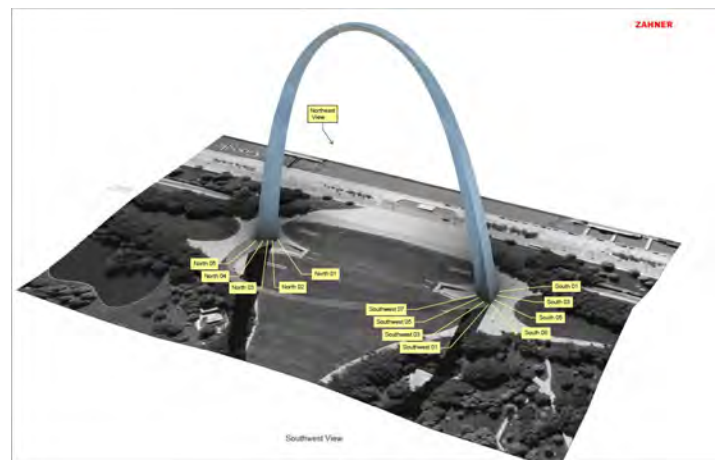
*Figure 5-15—Schematic view of the areas tested during the initial skin analysis, view from the southwest. Source: Zahner Metalab report*

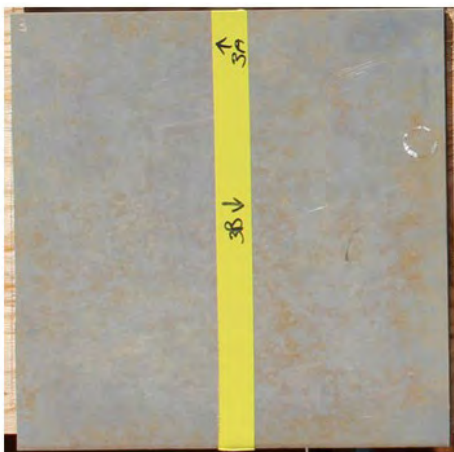
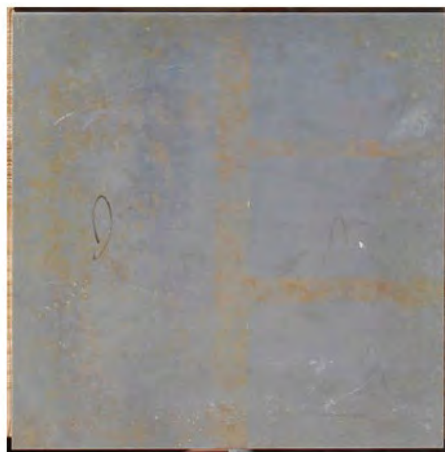
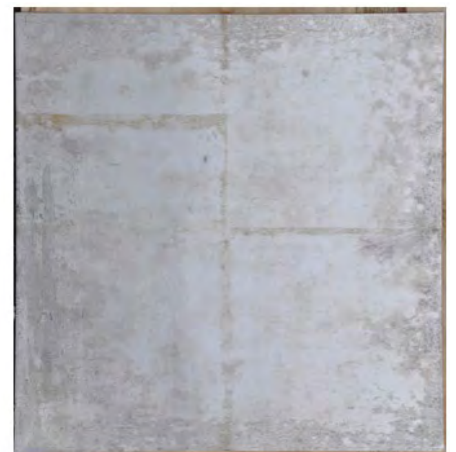
The results of the cleaning of these three panels using water techniques shown in Figure 5-33.

Figure 5-33—Result from testing, shown from left to right, on panels 3, 4 and 6. Source: S. Kelley

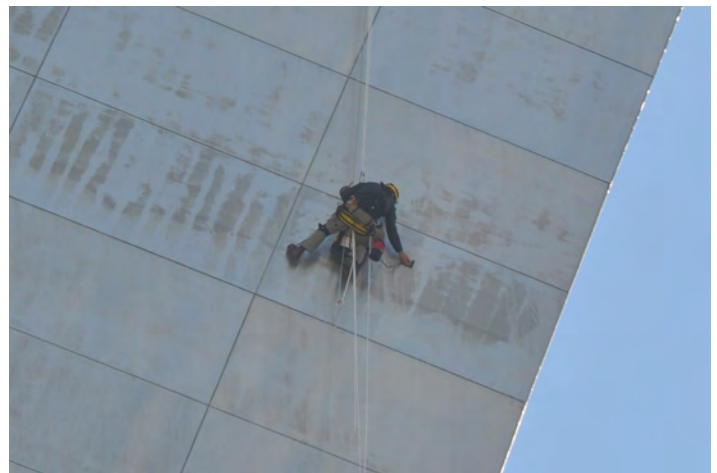
*Figure 5-48—Testing being performed at approximately 425 feet above grade on atmospheric pollutant deposits. This is the only cleaning testing done only on deposits. Source: S. Kelley*

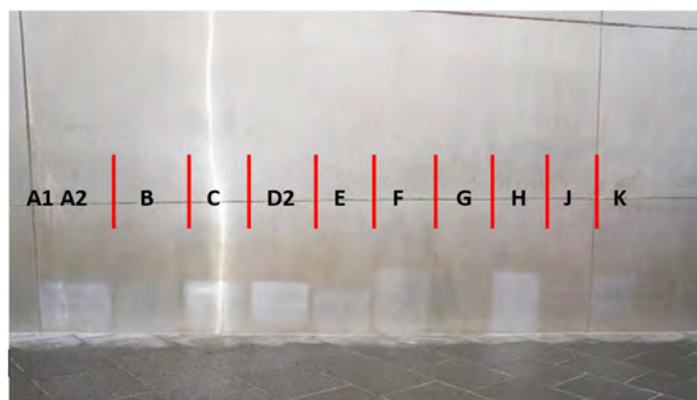
*Figure 5-49—The labeled areas of the testing on the east face of the north leg of the monument in 2014. The successful tests were found to be A, C, F and H. Source: 2015 Gateway Arch Corrosion Investigation Part III, WJE*

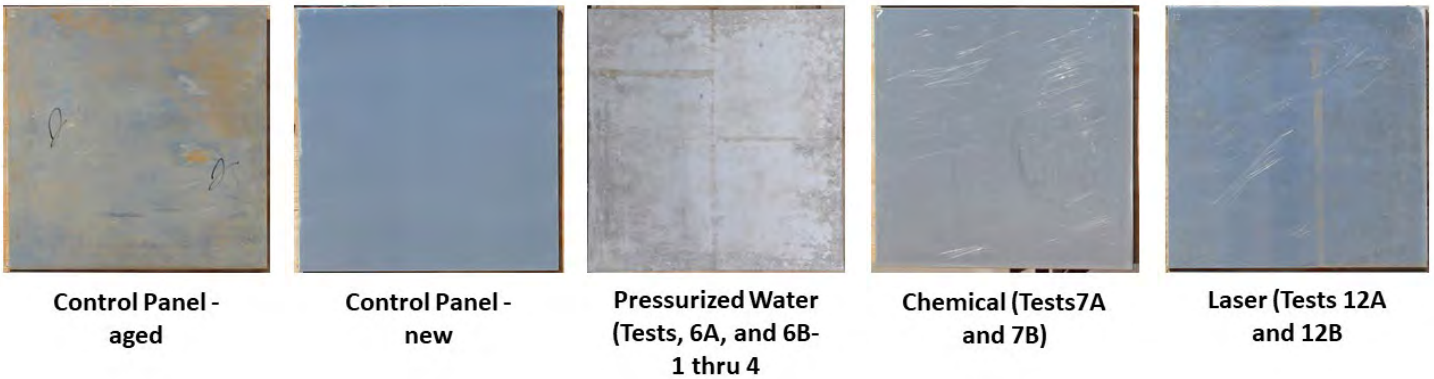
The techniques tested by Kärcher—which included pressurized water, steam and dry ice—may be acceptable to remove surface deposits on the upper reaches of the Monument. However, they left discolorations on the surface and were not found to be suitable for the removal of surface

Figure 5-51—The most successful cleaning samples using water, chemical and laser are shown on the right with the control panels shown on the left. Source: S. Kelley

corrosion or the corrosion from iron deposits within the graffiti.

The AstroPak chemical cleaning was found to be successful in removing surface corrosion and embedded metal oxides within the graffiti. The chemical techniques that they utilized produced the appearance of the test panels closest to the control panel.

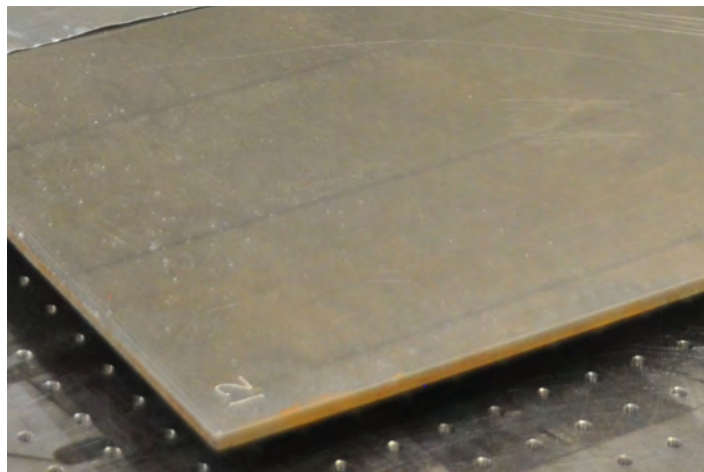
Overlap lines were visible on the sample panels (Figure 5-52).

*Figure 5-52—Close up view of panel 12 after laser cleaning showing lines where the passes with the laser overlapped.  
Source: S. Kelley*

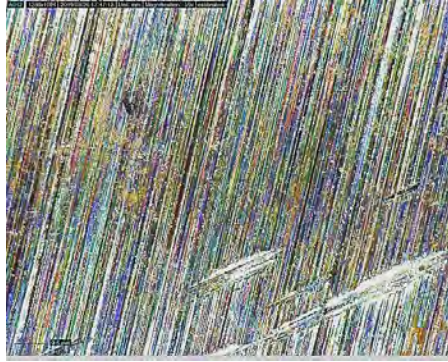
be seen indicating that the embedded iron had not been removed (Figure 5-58). This cleaning method was not considered effective.

Figure 5-58—Water cleaning Sample 4A shows significant remaining staining associated with deicing salts pitting. 58.9x. Source: C. Houska

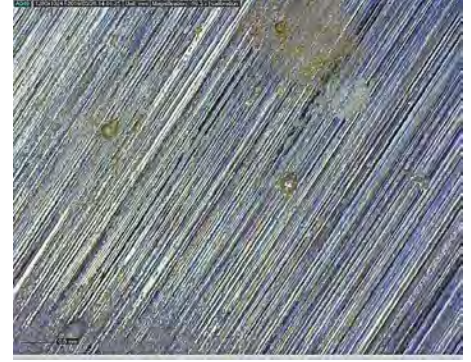
The chemical cleaning Sample 9 met with the greatest success (Figure 5-59). Deicing salts staining was removed. No embedded iron particles were observed but some residual staining was still present on the surface. This method was considered effective.

Figure 5-59—Chemical cleaning Sample 9. No embedded iron particles were observed but some residual staining was still present on the surface. 59.3x. Source: C. Houska

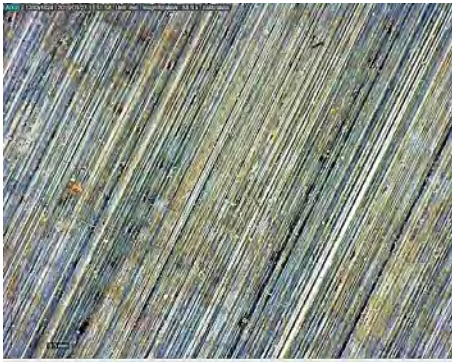
Laser cleaning provided varying results, many of them unsatisfactory. The most successful Sample was 12A. The embedded carbon steel and corrosion staining were removed other than very small particles (Figure 5-60). However, on this same sample there was what is hypothesized as heat-related surface damage which appeared as darkened areas that were not visible to the naked eye (Figure 5-61). On Sample 13 the brushed finish of the stainless steel appeared to be melted by the laser (Figure 5-62). There was significant heat related surface damage (dark areas) over the entire surface. Of the cleaning methods evaluated, the one with the most flexibility in the least amount of research is lasers. The gentleness evaluation of lasers reveals that more research is required to determine those parameters will not cause damage to the surface of the monument.

Figure 5-60—Laser cleaning Sample 12A. There is residual surface contamination from corrosion staining and embedded iron. 50.9x. Source: C. Houska

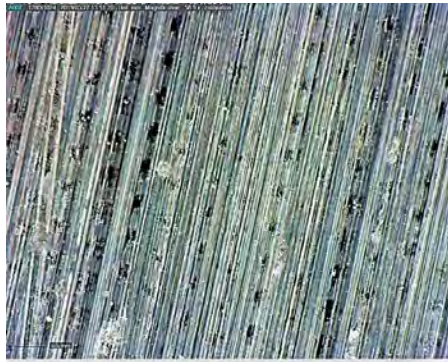
Figure 5-61—Laser cleaning Sample 12A. In this area there are what is believed to be significant heat-related surface damage (dark spots). 58.9x. Source: C. Houska

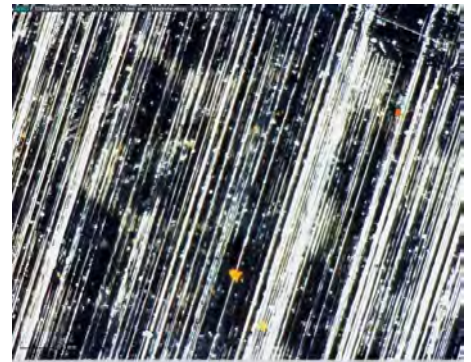
Figure 5-62—Laser cleaning Sample 13. There is significant heat-related surface damage (dark areas) over the entire surface and some areas had melted (polished grain line was gone). 59.3x. Source: C. Houska

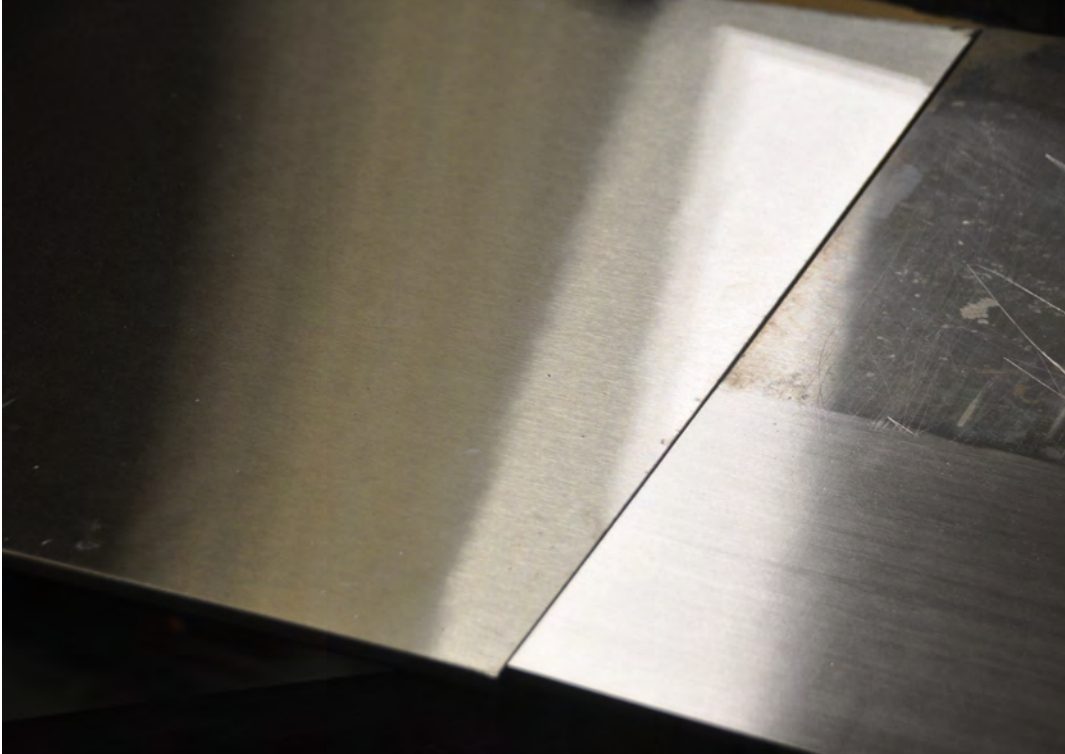
The results can be seen in Figures 5-66 and 5-67. Results of the refinishing were not perfect but show promise. The refinishing technique but must be further developed in trials to achieve a specular gloss that is closer to the original on the Monument.

*Figure 5-66: A comparison of the control panel (left) and refinished panel (right) showing similar reflectance characteristics.*

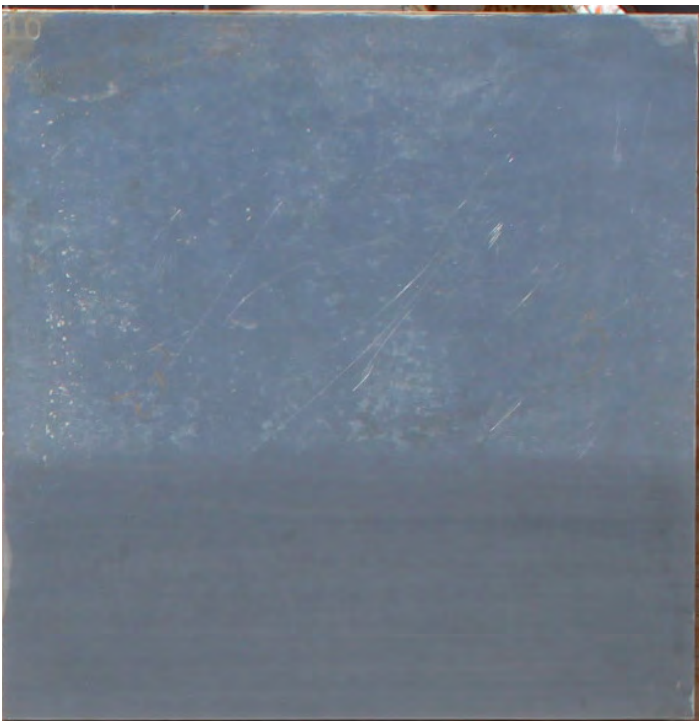
*Figure 5-67: Partially refinished panel as viewed outside on a sunny day.*

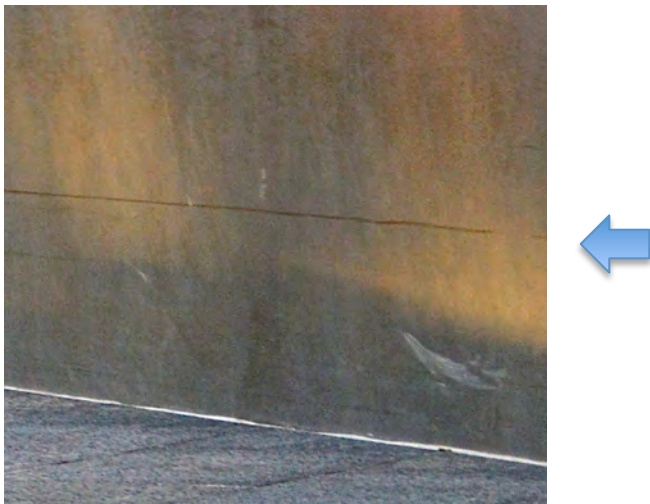
This iron surface contamination should be removed, particularly from the long deep scratches, because the corrosion product from this deposit creates a crevice and does not allow oxygen to reach the surface. Corrosion of the stainless steel under the carbon steel corrosion product deposit will continue. Crevice corrosion can occur when the surrounding exposed stainless does not corrode and the rate of corrosion is higher. The exposure of these areas to deicing salt will increase the corrosion rate.

Figure 1: Embedded carbon steel, probably from a snow plow blade (Photo taken by authors in 2014)

Over time, this linear, concentrated increased thickness loss due to corrosion could lead to thickness loss that presents a concern and weld repair might then become necessary. That is easily avoided. Removal of the contamination should be with stainless steel pickling paste painted on to these localized areas with a small artists brush in accordance with ASTM A380 followed by chemical passivation to improve the corrosion resistance within the scratch. Pickling will dull the finish locally but careful limited application should not make it noticeable since it is so close to the ground. These strong acids should only be used in compliance with manufacturers recommendations to ensure operator safety and to prevent damage to surrounding materials.

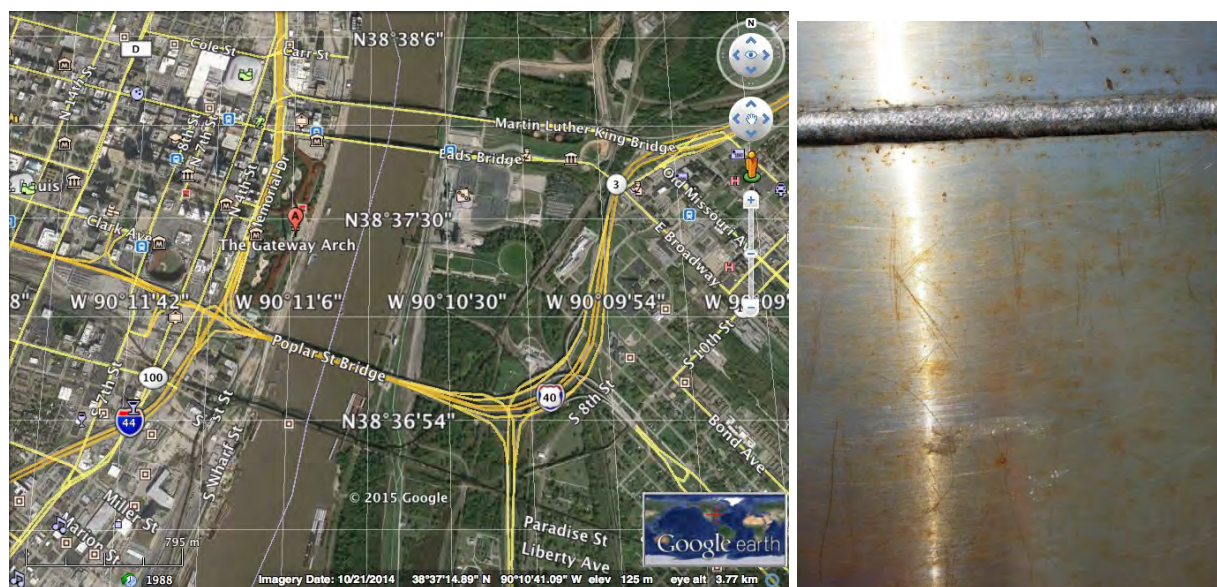
Other than very small, localized areas, such as the elevated areas where iron and ferrochrome particles were found, the only corrosion observed on the surface was at the base. This area would not be as effectively washed by rain as elevated areas with higher wind levels. Light staining caused by microscopic deicing salt related pitting was observed at the base. Very little residue was found on the surface when a Chlor-Test was done, but that would not be unusual in the fall. This corrosion is superficial and could easily be removed.

Figures 2 and 3: Google Earth image (Left) showing the highways and bridges immediately around the site which are adding deicing salts (chlorides) to the environment and the superficial corrosion staining at the base caused by deicing salt exposure. (Right photo taken by authors in 2014)

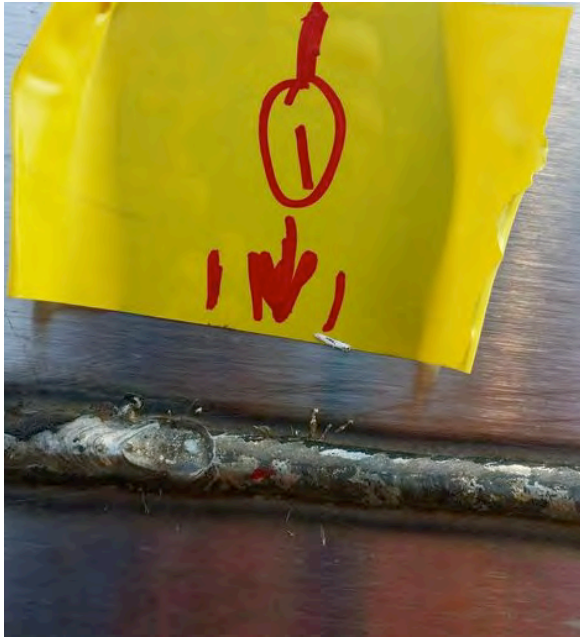
Sample No.	Face	Row	Panel	Location	Observations during sample selection	Imperfections
W1	West	9	North	12 ft. from north edge of panel	Very wide rounded weld bead with possible weld slag on the surface. Identified as a field weld.	Plate: Sensitized (A4, A5), small inclusions (A6), manganese sulfide stringers (A7, A8) Weld: Surface weld slag confirmed (A9)
W2	West	10	Center	4 ft. from south edge of panel	Somewhat larger section of an otherwise smaller shop weld	Plate: Sensitized (A14, A15), a small surface void that may either be pitting corrosion or an inclusion pulled from the surface during polishing (A16) Weld: Weld porosity (A13)
W3	West	6	North	2 ft. from north edge of panel	Weld repair area, shop weld	Plate: sensitized (A20, A21, plate inclusion (A24) Weld: Outside notch on weld surface (A22), undercut (A23), weld void (A25)
W4	West	6	North	6 ft. from north edge of panel	Somewhat recessed area shop weld with possible weld slag	Plate: sensitized (A29) Weld: Numerous small voids (A28)

Figure A1: W1, prior to removal (Photo taken by authors in 2014)

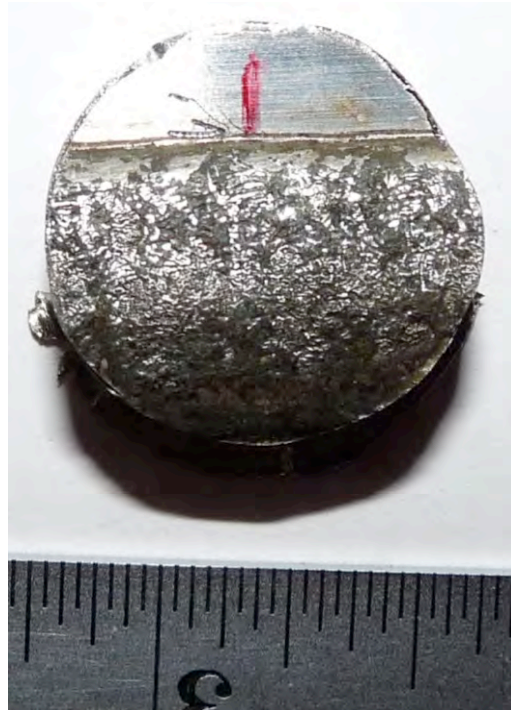
Figure A2: W 1 as-received condition.  
(Scale=1/32") (Photo taken by authors in 2014)

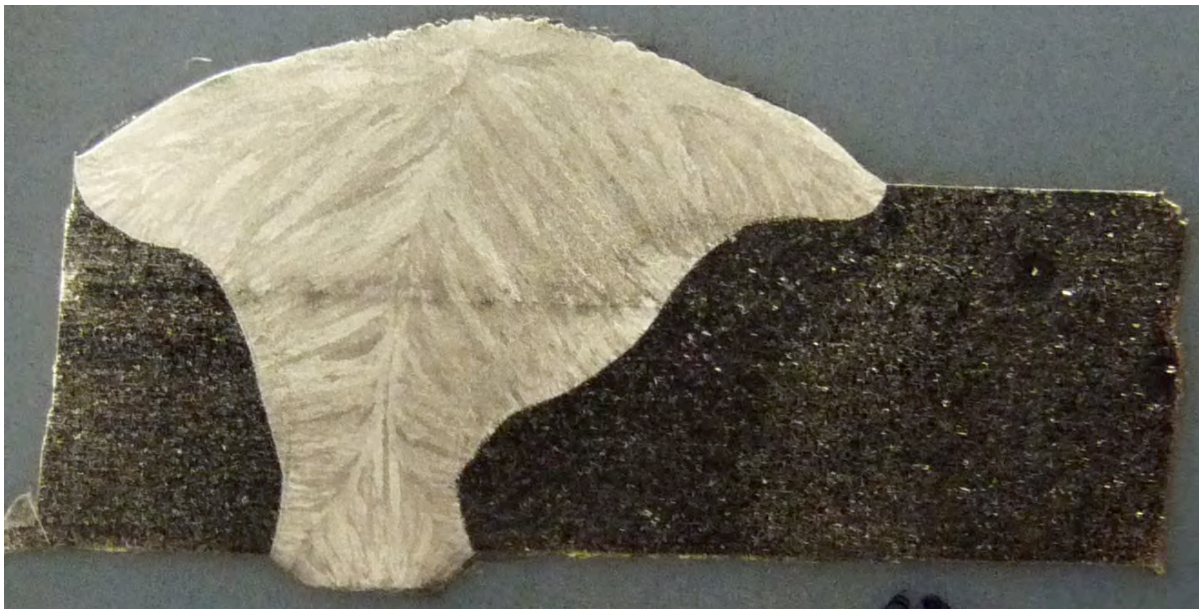
Figure A3: Macrograph cross of section W1 in the etched condition (Photo taken by authors in 2014)

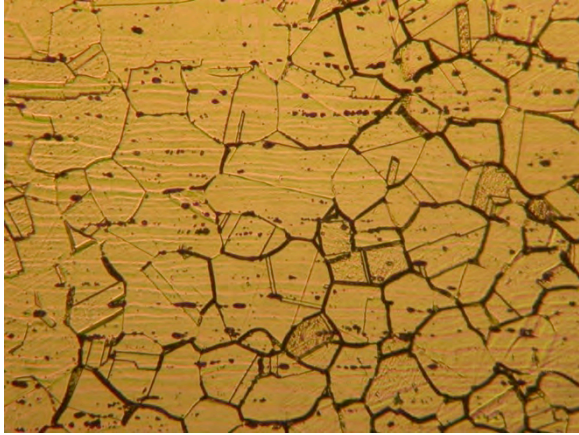
Figure A4: Micrograph of W1 in the etched condition showing sensitized grains (right) and grains that are not sensitized (left). (256x)  
(Photo taken by authors in 2014)

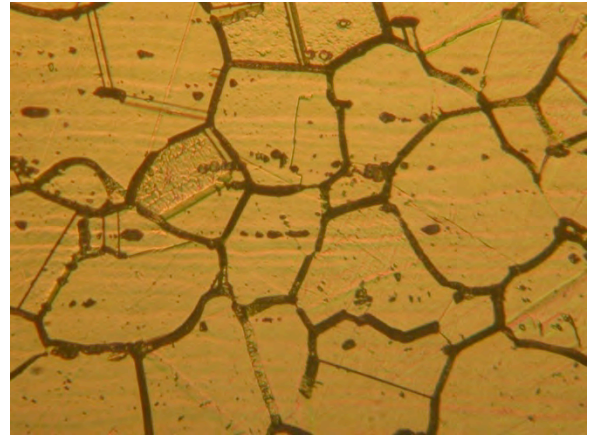
Figure A5: Micrograph of W1 in the etched condition showing sensitized grains in the plate. (517x)  
(Photo taken by authors in 2014)

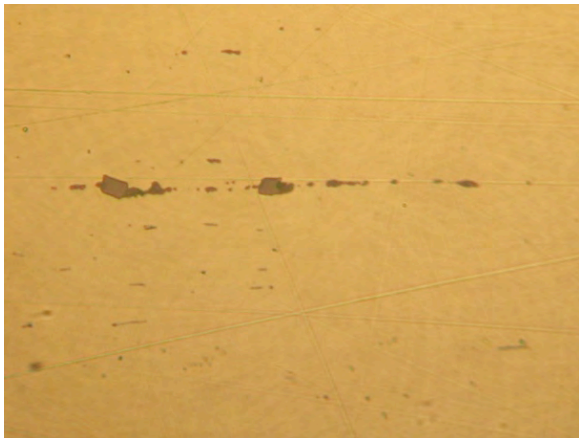
Figure A6: Micrograph of a plate inclusion, W1, as-polished condition. (517x) (Photo taken by authors in 2014)

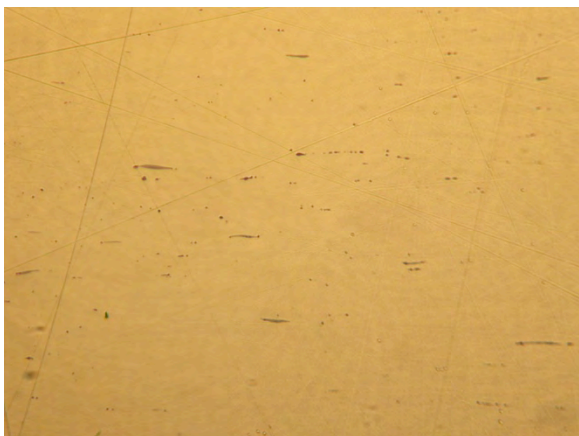
Figure A7: Micrograph of manganese sulfide stringers in the plate, W1, as-polished condition. (256x)  
(Photo taken by authors in 2014)

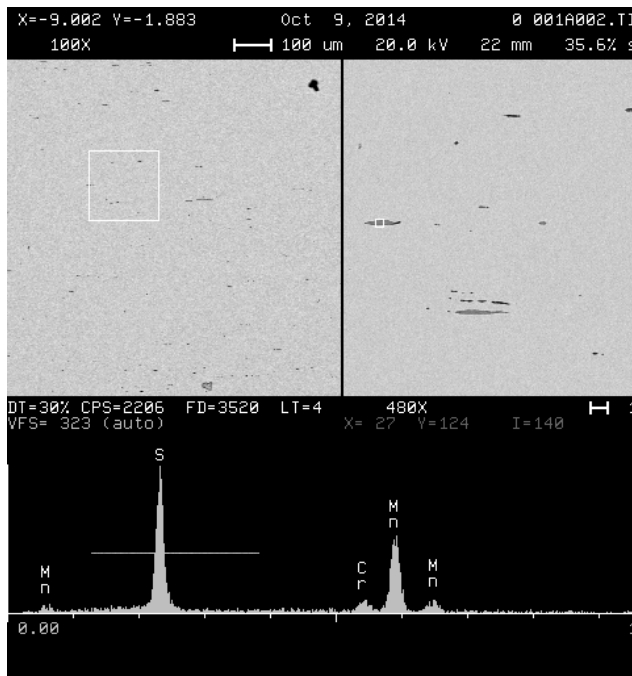
Figure A8: SEM/EDS confirming the presence of manganese sulfide stringers (RJ Lee SEM sample scan 2014)

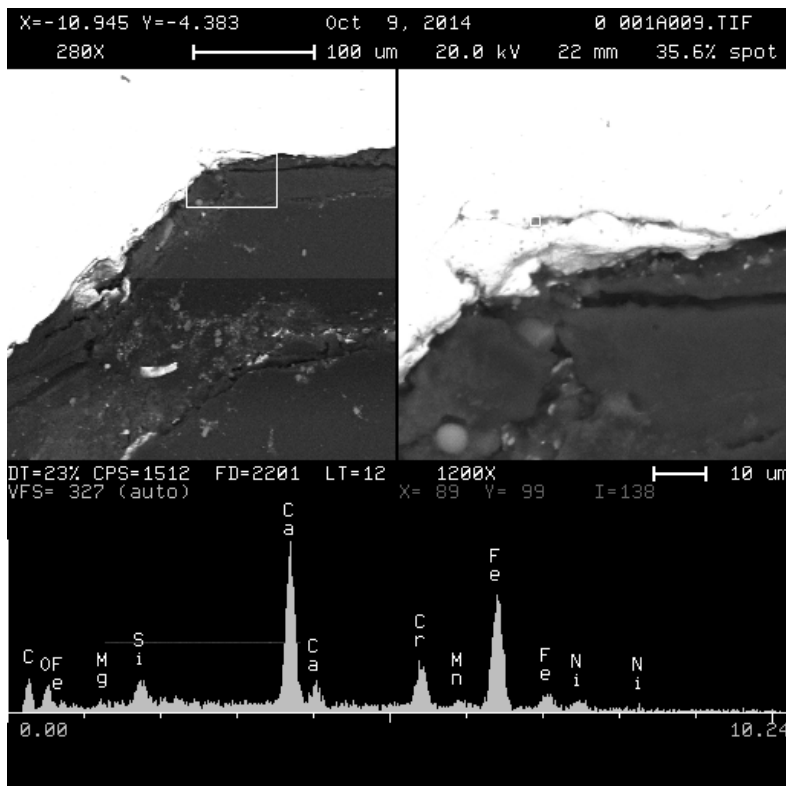
Figure A9: SEM/EDS showing some W1 surface weld slag (Ca and Si) (RJ Lee SEM sample scan 2014)

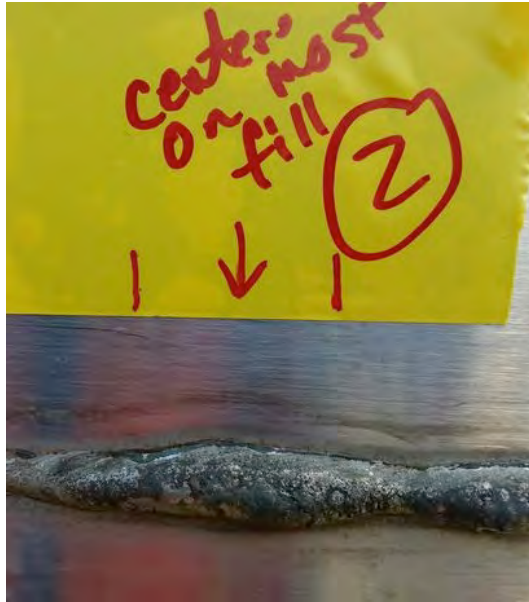
Figure A10: W2 prior to removal (Photo taken by authors in 2014)

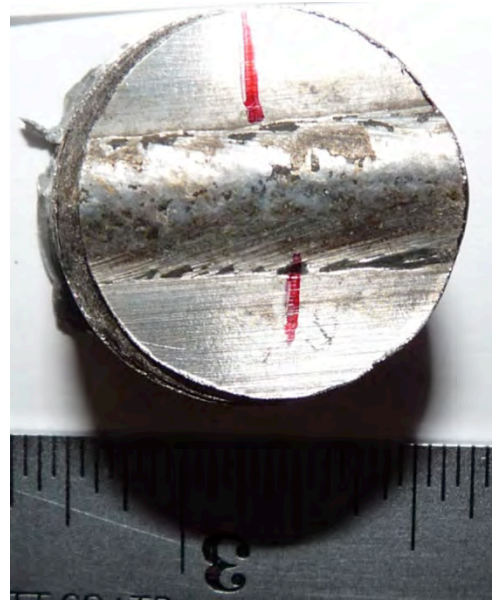
Figure A11: W2 as-received condition. (Scale=1/32") (Photo taken by authors in 2014)

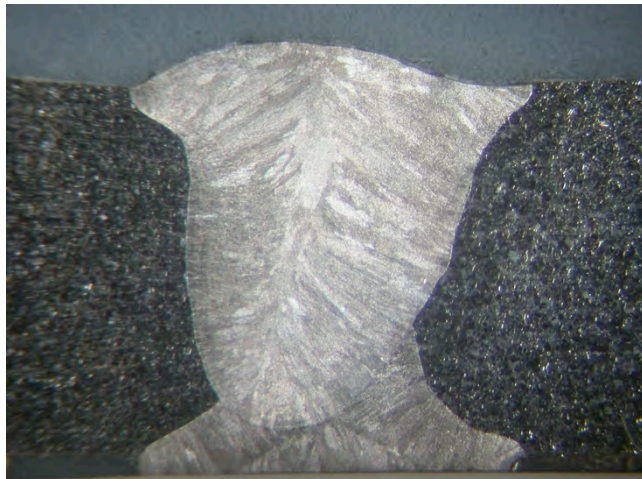
Figure A12: Macrograph of W2, etched condition (Photo taken by authors in 2014)

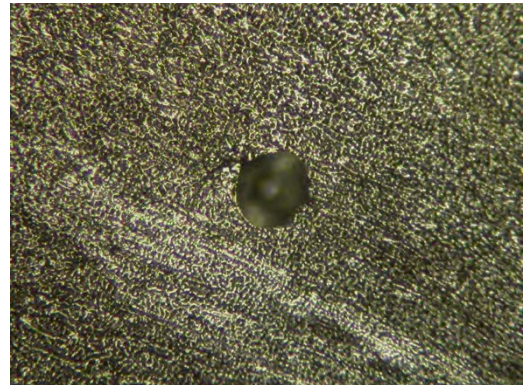
Figure A13: Micrograph of W2, etched condition, weld porosity, approximate diameter 0.004" (Photo taken by authors in 2014)

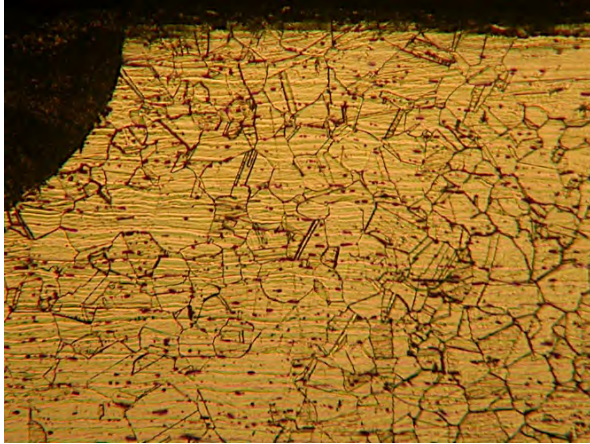
Figure A14: Micrograph W2 etched condition showing weld metal (top left corner), a band of grains that are not sensitized (center) and a band of sensitized grains (right). (122x) (Photo taken by authors in 2014)

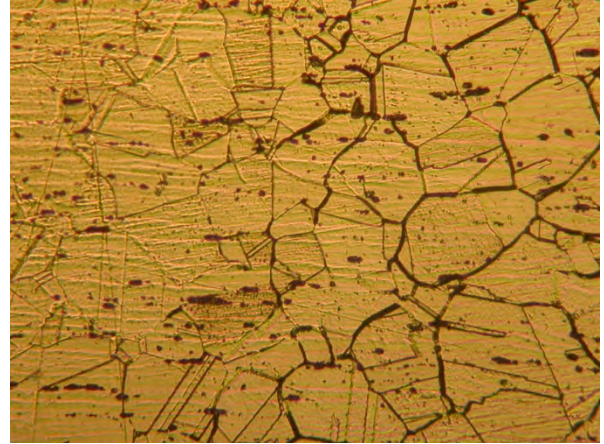
Figure A15: Micrograph W2, etched condition showing sensitized grains (right) and grains that are not sensitized (left). (256x) (Photo taken by authors in 2014)

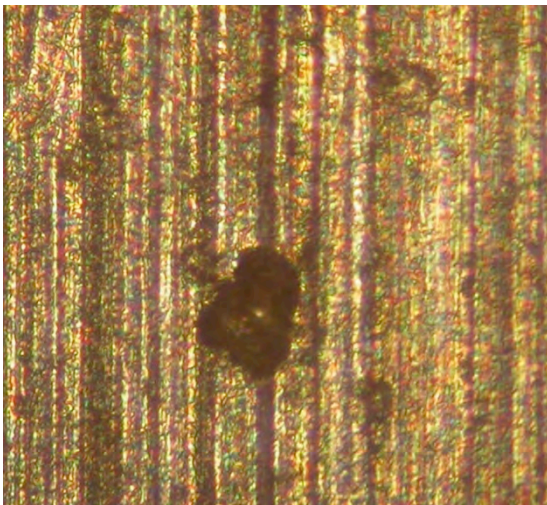
Figure A16: Cut, un-mounted section of the surface of the W2 sample with a small void of approximately 0.002" diameter located approximately 0.045" from the edge of the weld. This may have been very minor corrosion pitting of the surface since there are similar very small pit like shapes on the surface around it, but there was no visible staining when we examined it. Alternatively, an inclusion could have been pulled out of the surface during polishing. (Photo taken by authors in 2014)

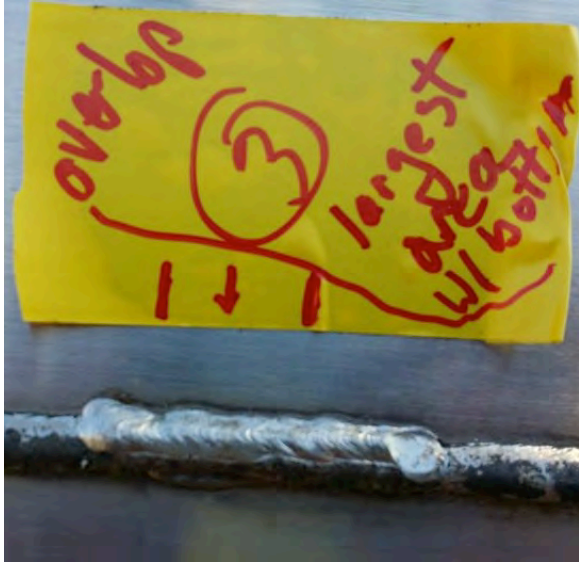
Figure A17: W3 prior to removal (Photo taken by authors in 2014)

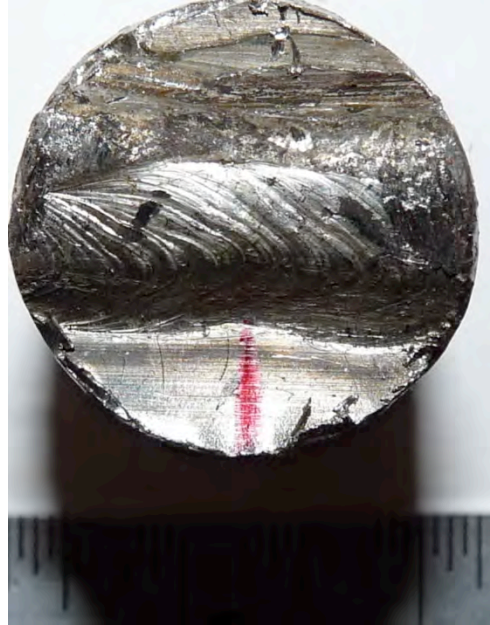
Figure A18: W3 as-received condition. (Scale=1/32") (Photo taken by authors in 2014)
