# The Gateway Arch

GATEWAY ARCH NATIONAL PARK  
ST. LOUIS, MO

CONSERVATION  
MANAGEMENT PLAN

AUGUST 2020

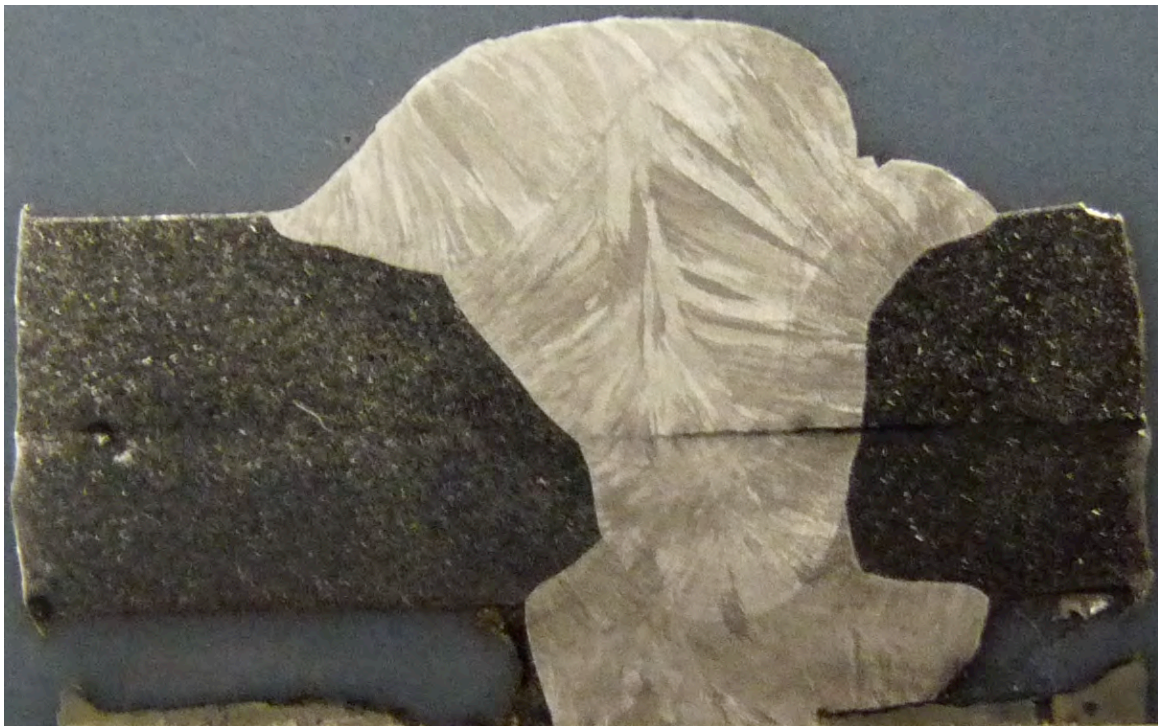
Figure A19: Macrograph of W3, etched condition. (Photo taken by authors in 2014)

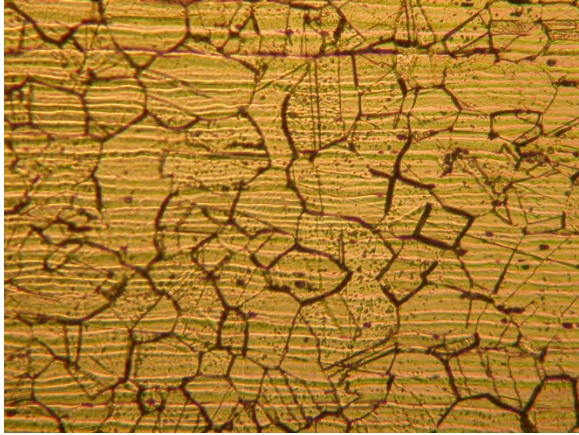
Figure A20: Micrograph W3, etched condition showing sensitized grains in the plate. (256x) (Photo taken by authors in 2014)

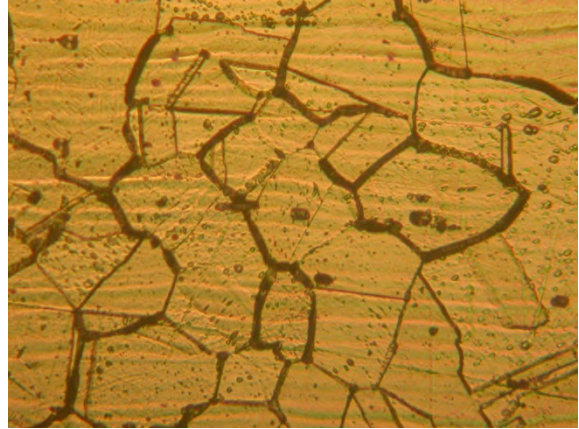
Figure A21: Micrograph W3, etched condition close up of sensitized grains in the plate. (517x) (Photo taken by authors in 2014)

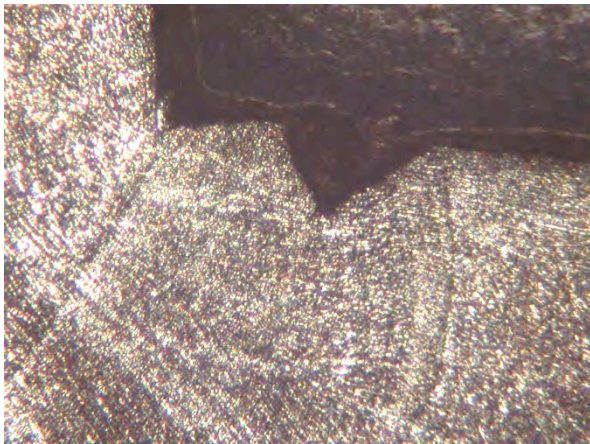
Figure A22: Micrograph W3, etched condition showing a notch in the outside weld surface. (122x) (Photo taken by authors in 2014)

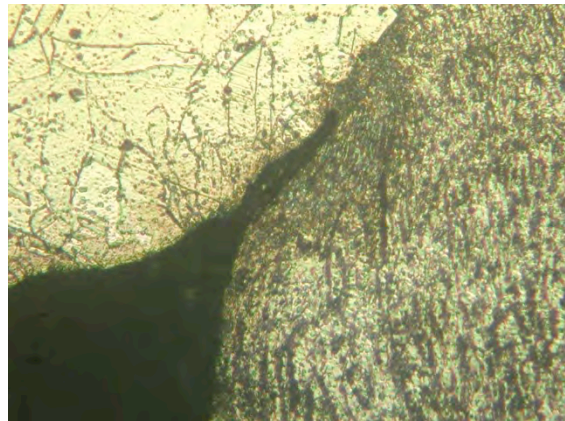
Figure A23: Micrograph W3, etched condition showing shallow undercut where the weld metal and base metal meet, inside surface of the plate. (517x) (Photo taken by authors in 2014)

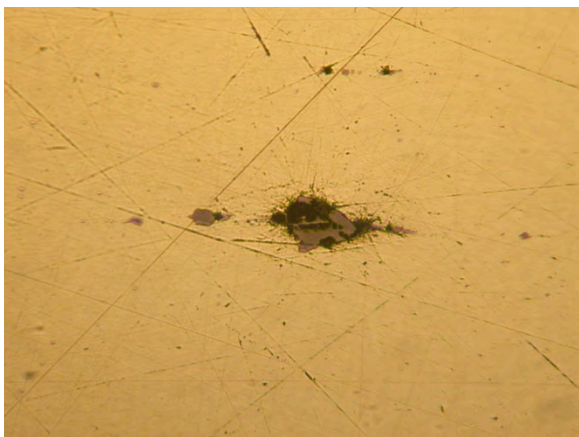
Figure A24: Micrograph, W3, plate inclusion, as-polished condition. (256x) (Photo taken by authors in 2014)

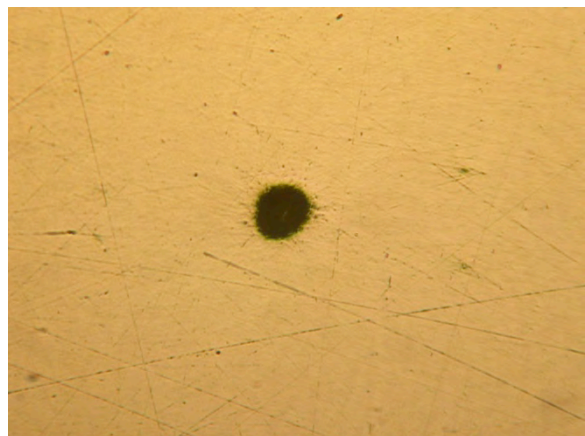
Figure A25: Micrograph, W3, weld void, approximate diameter 0.004", shown as-

polished condition. (Photo taken by authors in

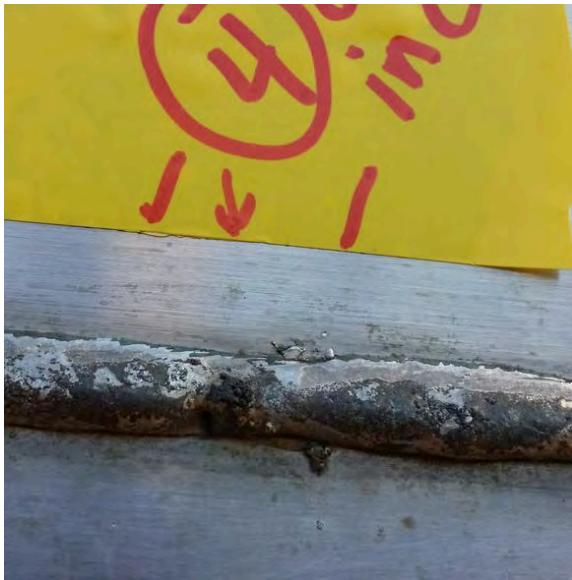
Figure A26: W4 prior to removal (Photo taken by authors in 2014)

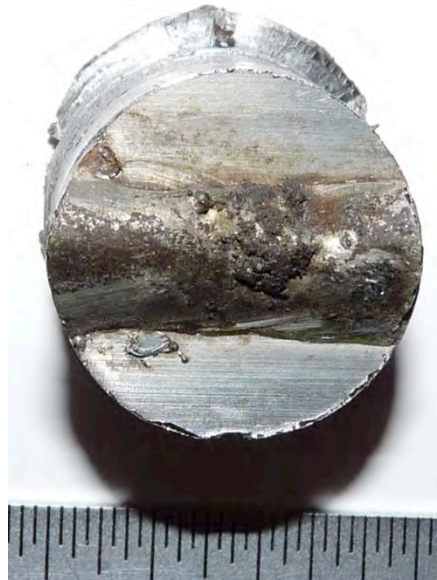
Figure A27: W4 as-received condition. (Scale=1/32") (Photo taken by authors in 2014)

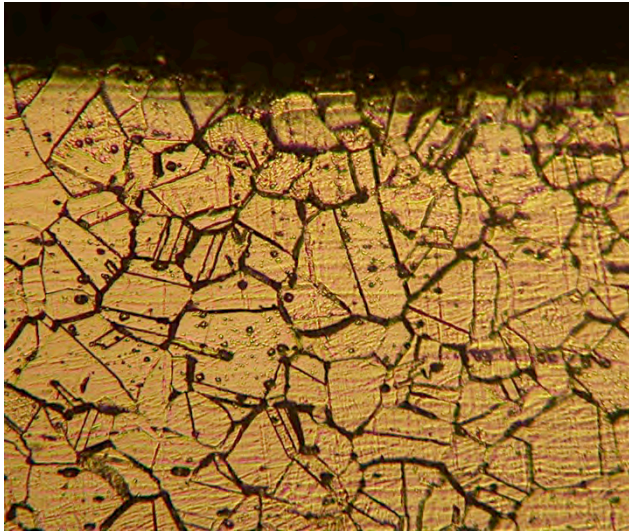
Figure A29: Micrograph, W4, etched condition showing sensitized grains near the outside surface of the plate. (256x)  
(Photo taken by authors in 2014)

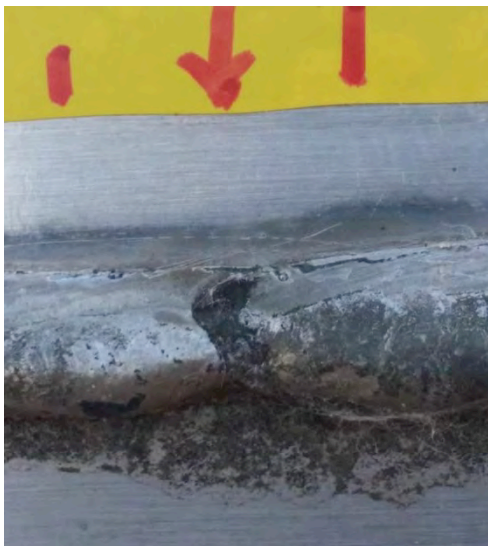
Figure A30: W5 prior to removal (Photo taken by authors in 2014)

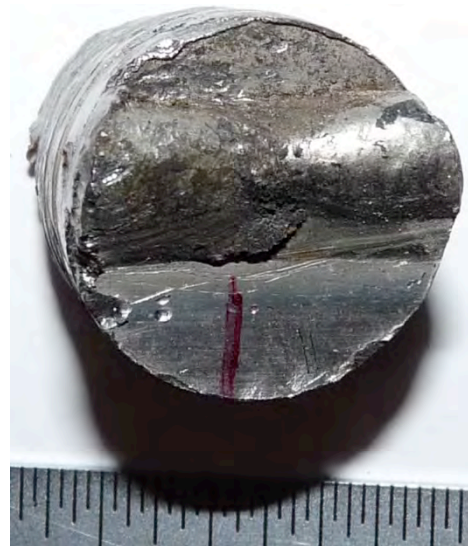
Figure A31: W5 as-received condition.  
(Scale=1/32") (Photo taken by authors in 2014)

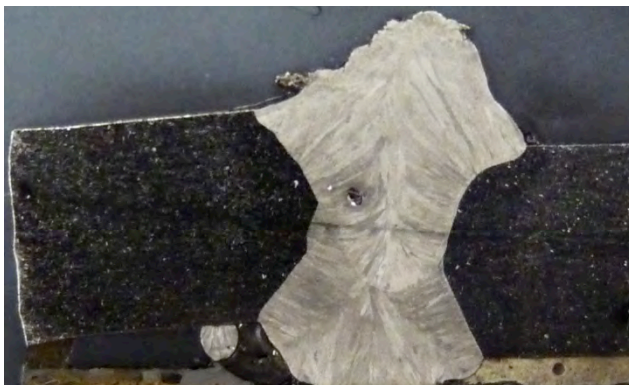
Figure A32: Macrograph W5 etched condition with a visible void. The minor plate misalignment

is not a structural concern. (Photo taken by authors in 2014)

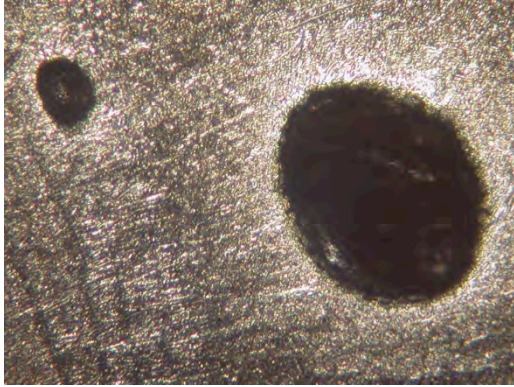
Figure A33: Micrograph W5 etched condition showing porosity in the weld metal with approximate diameter of 0.024". (Photo taken by authors in 2014)

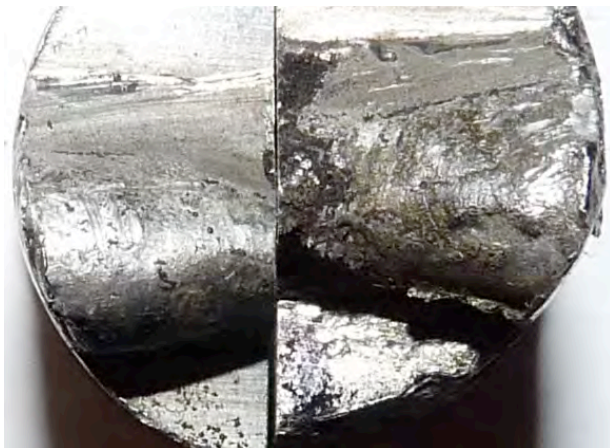
Figure A35: W5 after sectioning through weld slag contamination that was visible on the weld surface. (Photo taken by authors in 2014)

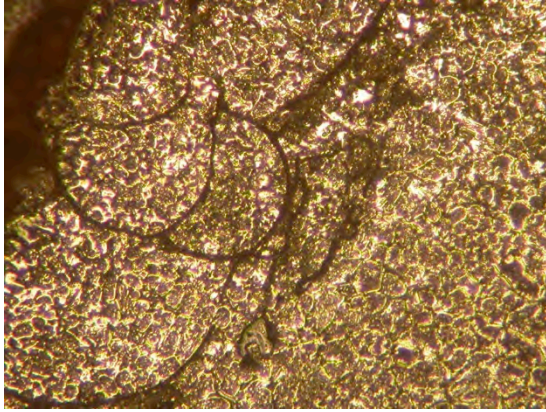
Figure A36: Micrograph of W5 same area, weld crown in the etched condition with sub surface weld slag. (256x) (Photo taken by authors in 2014)

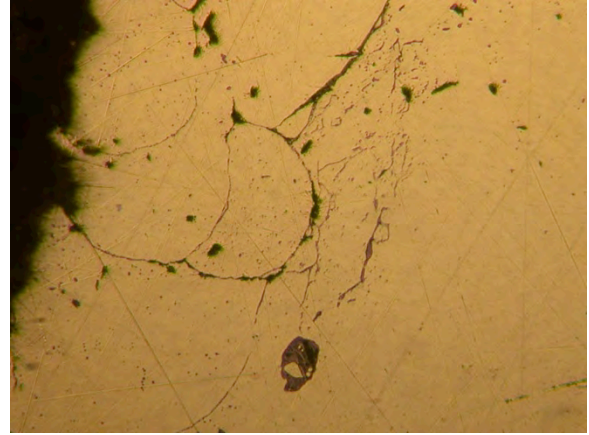
Figure A37: Micrograph W5 at the weld crown shown in the as-polished condition showing the sub surface weld slag. (256x) (Photo taken by authors in 2014)

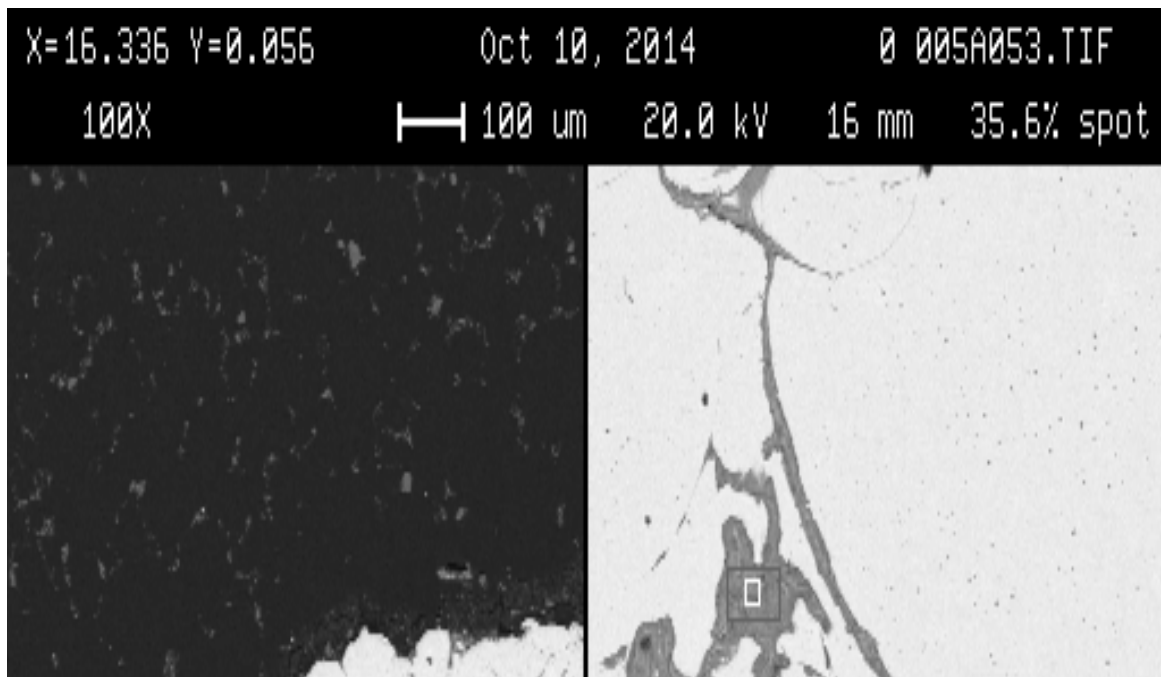
Figures A38: SEM, same weld slag inclusion area with different magnifications (RJ Lee SEM sample scans 2014)

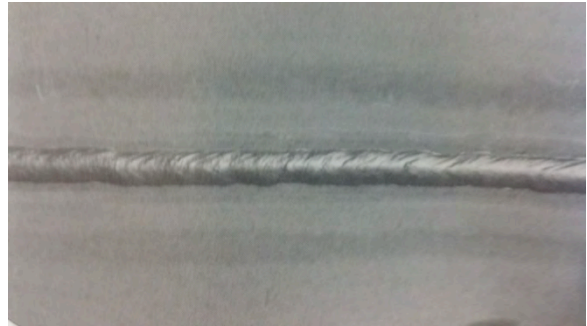
This image is representative of the ideal appearance of a stainless steel weld: uniform with a relatively smooth, consistent, not overly large weld bead. There were many welds with this overall appearance on

the Arch, particularly at elevated levels, although many had some weld spatter.

Figure B1: Ideal stainless steel weld appearance (Photo taken by authors, archive)

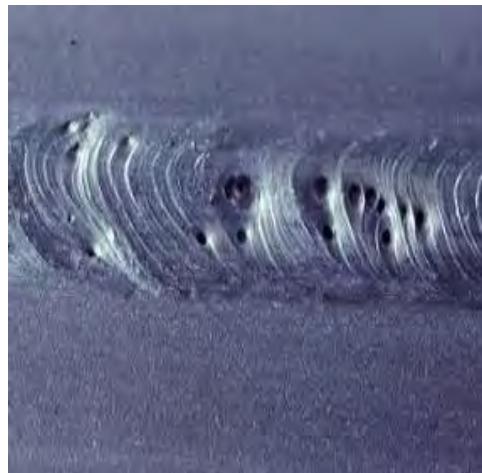
Only small isolated small areas of porosity were found within the Gateway Arch weld samples and they were not considered a problem.

Figure B2: This image is representative of clusters of porosity breaking the surface. Nothing this severe was documented on the Arch. (Photo Avesta Welding Manual)

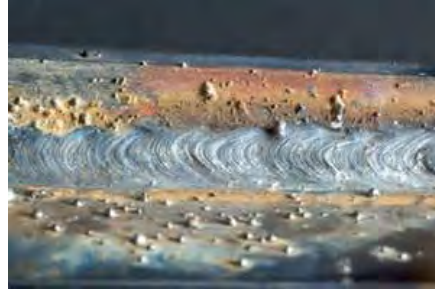
Weld spatter can be an initiation point for corrosion and can increase surface deposit build up. Surface deposits can also cause corrosion or surface discoloration. Generally, it should be removed.

Weld spatter was documented on many of the Arch's welds although there was a great deal of variation seen. In some areas, it was obviously associated with increased surface deposit accumulation and discoloration. The image shows the typical appearance of this imperfection.

Figure B3: Weld spatter. (Photo Avesta Welding Manual)

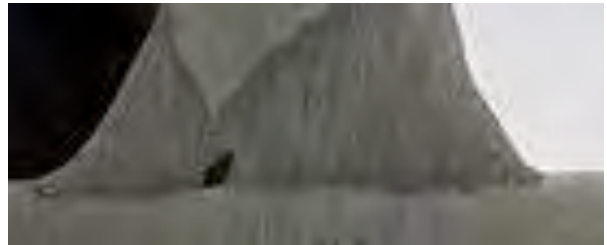
Weld slag can be found on all weld types. Carbon and silicon are associated with these inclusions when analyzed using SEM/EDS. Small, spherical inclusions within the weld cross section are generally acceptable. The size and length of the inclusions is another factor in acceptability and potential impact on structural integrity.

Figure B3: Weld slag inclusion (Photo Avesta Welding Manual)

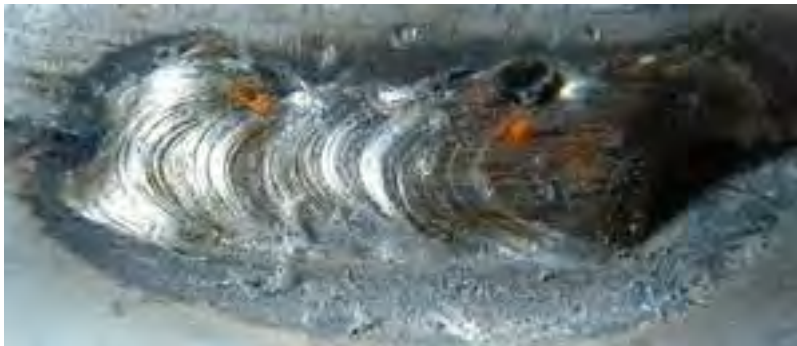
Slag “islands” occur in the surface of the weld and can be a location where corrosion can initiate. Slag “islands” generally cannot be removed by brushing but light grinding is typically sufficient. Both types of

Figure B4: Weld slag on the surface (Photo Avesta Welding Manual)

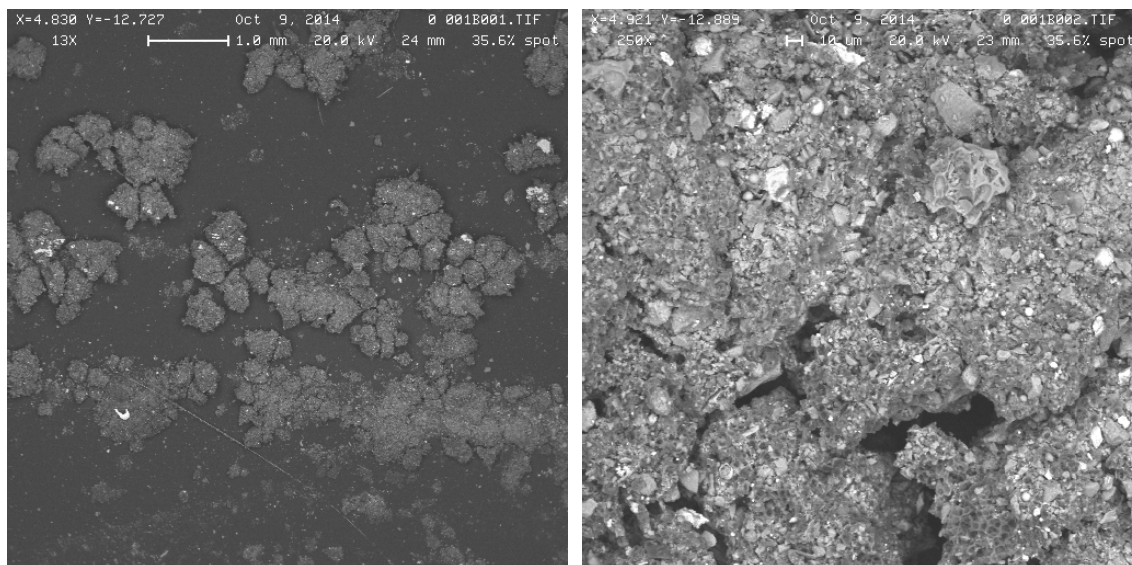
Both samples were dark in color and nearly identical in appearance and analysis. The only variation was the size of the deposit. The deposit appeared to mainly consist of particle agglomerations (Figure C1) and was largely removable with a wet cloth (Figure C2). This was representative of the appearance of the dark deposits found around welds.

Figures C3 and C4: SEM images of the deposits at different magnifications. (RJ Lee SEM sample scans 2014)

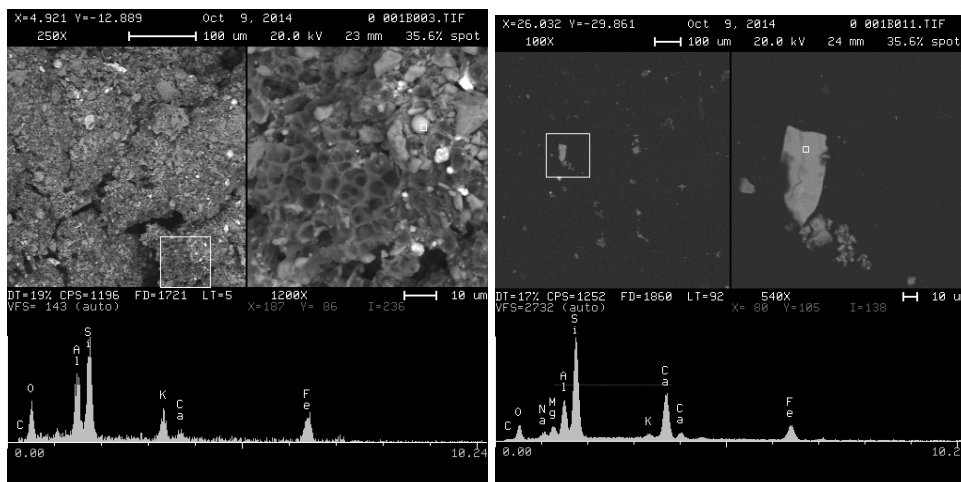
Figures C5 and C6: Representative particles of what appears to be electric arc furnace slag from steel production or fly ash with some iron particles trapped in it. (RJ Lee SEM sample scan 2014)

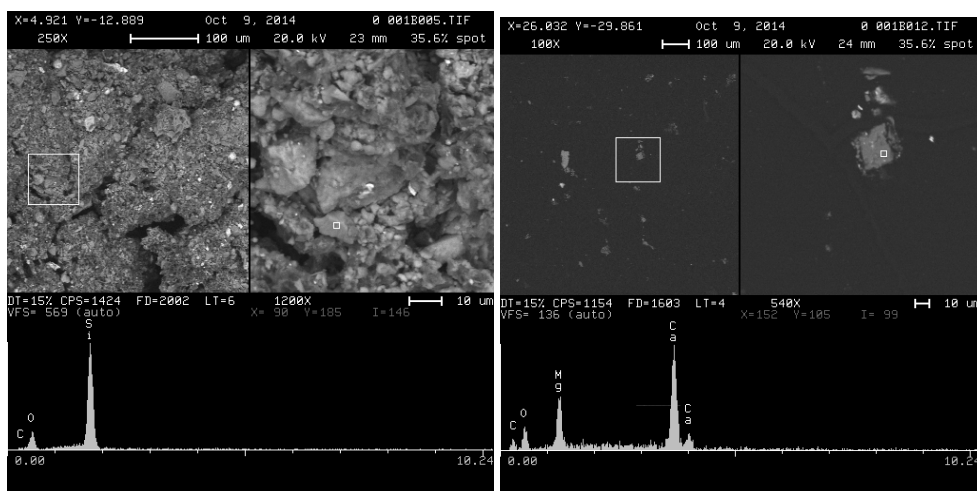
Figures C7 and C8: Representative scans of silica (sand) and soil (C8). (RJ Lee SEM sample scans 2014)

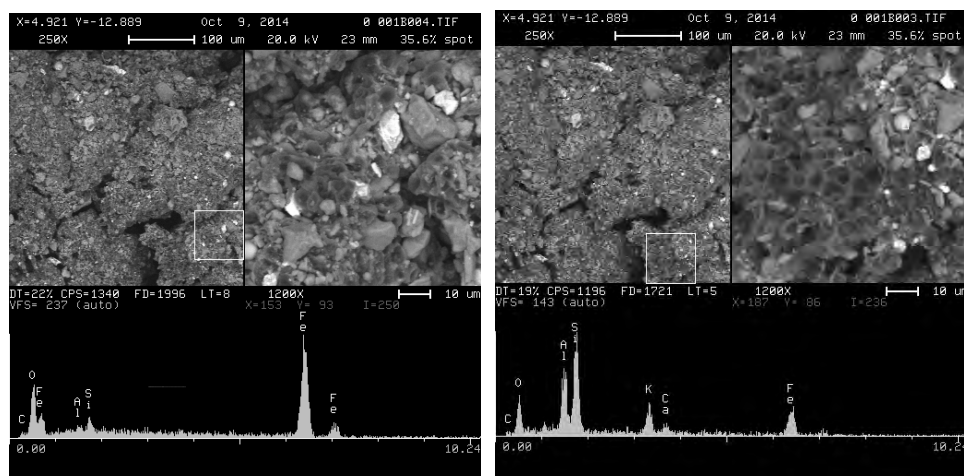
Figures C9 and C10: (C9) Iron particle from carbon or steel manufacturing or fabrication combined with oxygen (corrosion) and (C10) soil combined with iron. (RJ Lee SEM sample scans 2014)

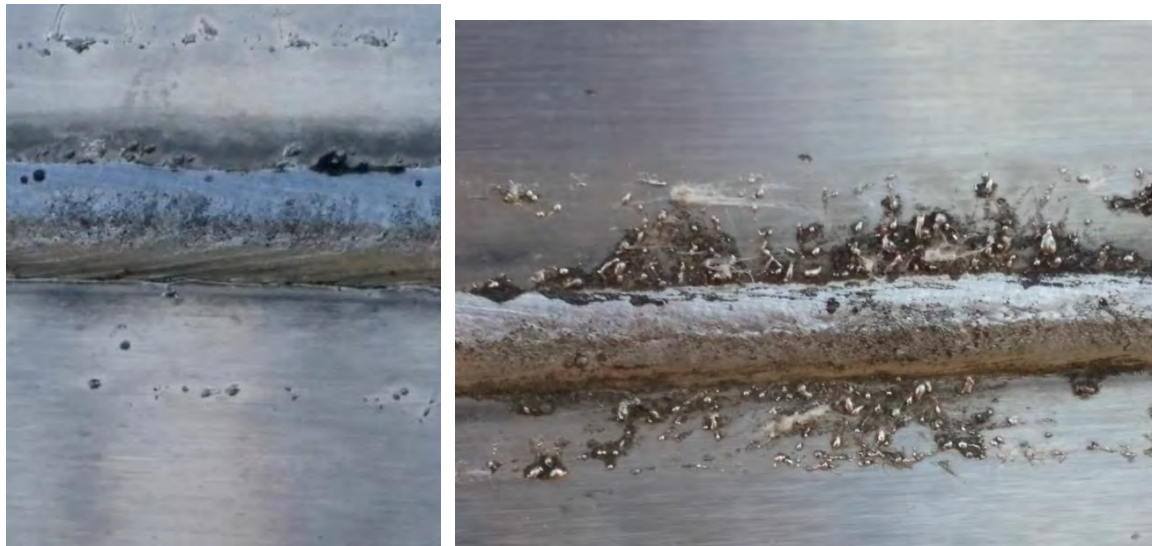
Figure C11 and C12: Weld spatter differences in areas with minimal versus significant surface deposits. (Photos taken by authors in 2014)

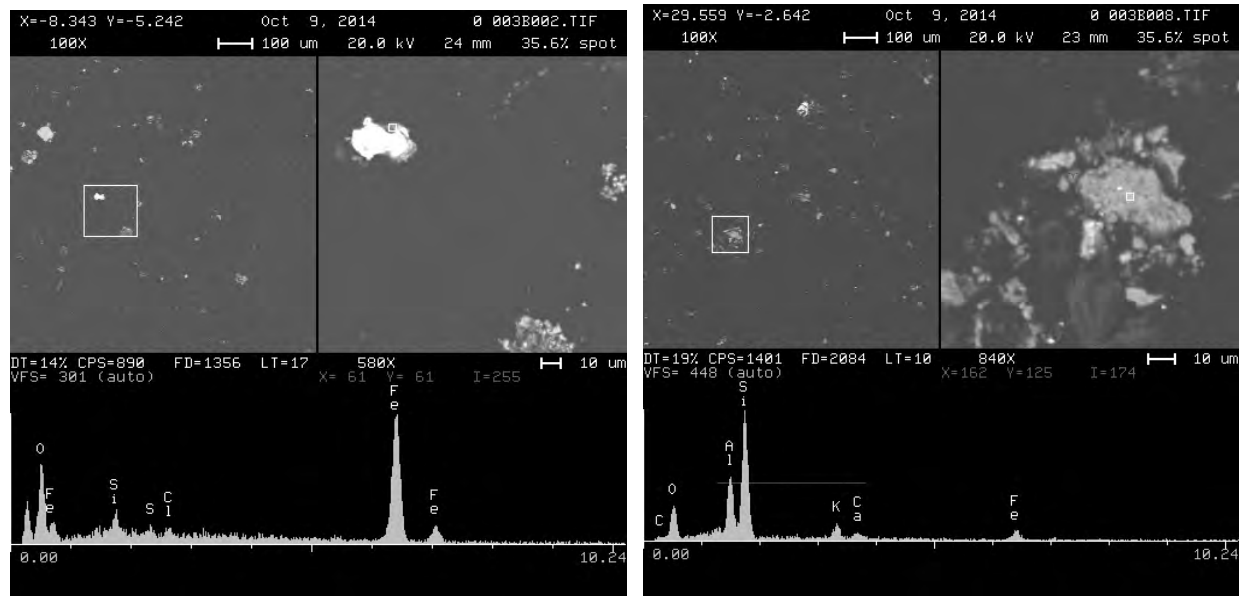
Figure C13 and C14: Iron with small amounts of silica and chlorides (left, C13) and soil with a small amount of iron (right, C14). (RJ Lee SEM sample scans 2014)

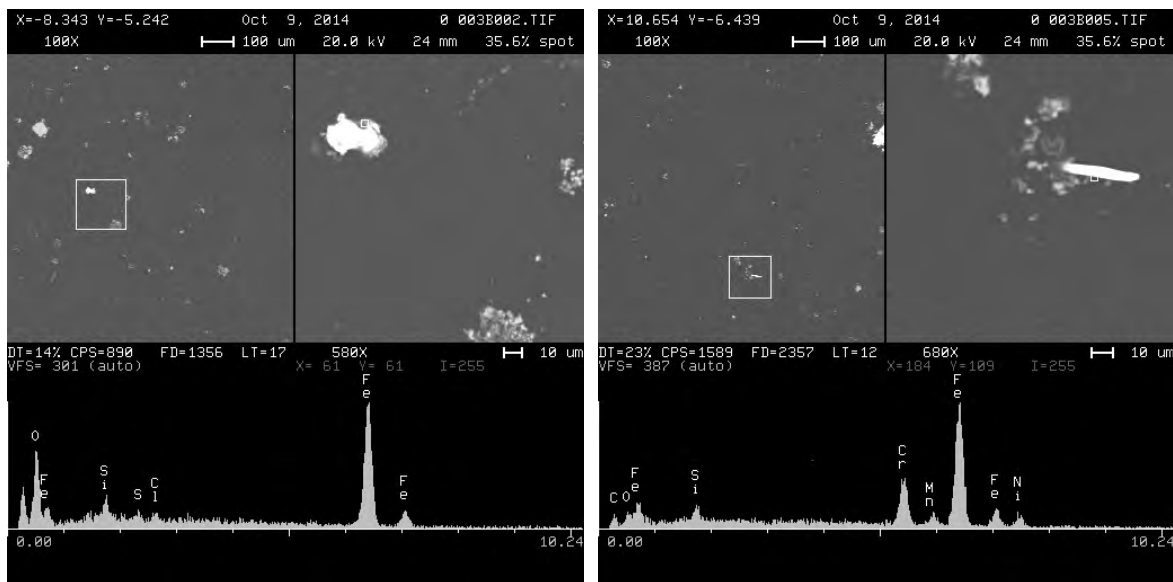
Figure C15 and C16: Iron with small amounts of soil (left, C15) and a stainless steel particle (no oxygen so it is not corrosion product) (right, C16). (RJ Lee SEM sample scans 2014)

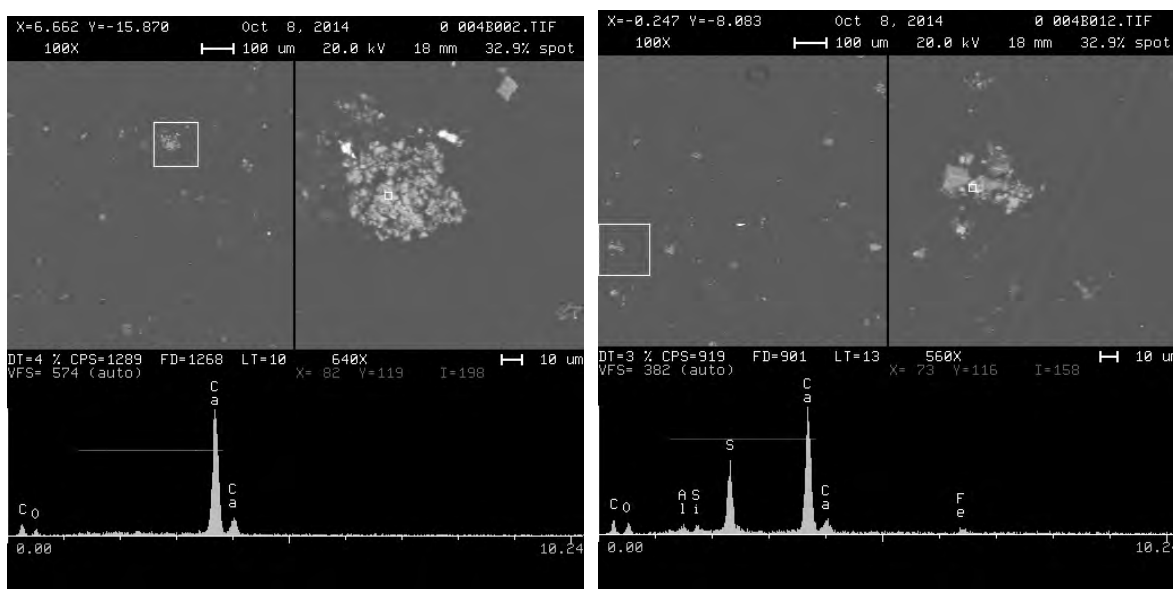
Figure C17 and C18: Calcium (left, C17) and fly ash (right, C18). (RJ Lee SEM sample scans 2014)

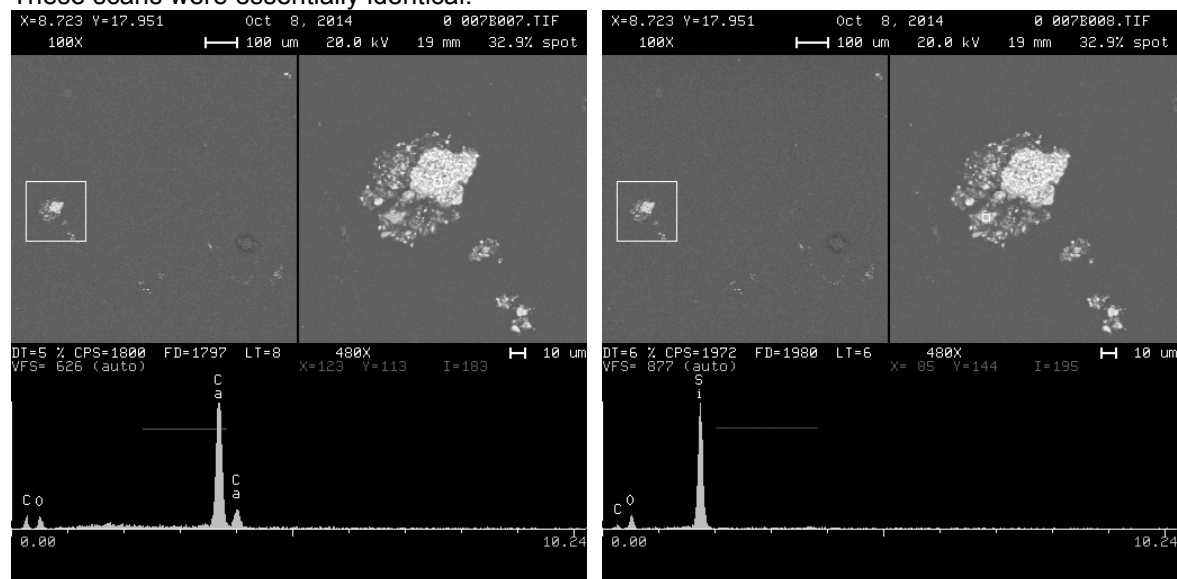
Figure C23 and C24: Calcium particle (left, C23) and silica (right, C24) (RJ Lee SEM sample scan 2014)

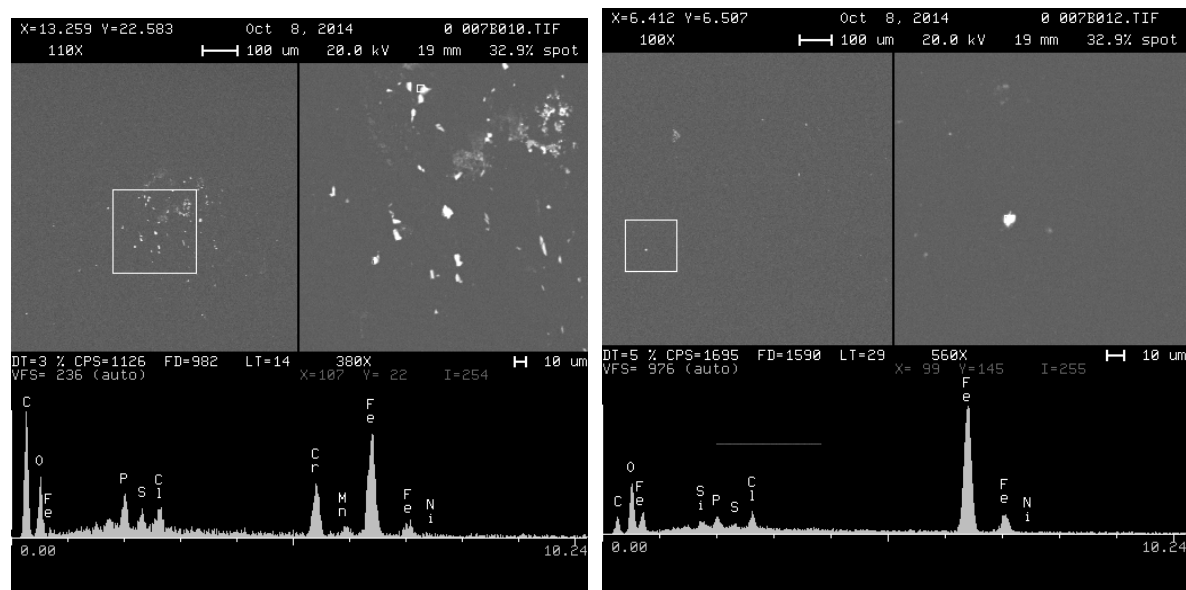
Figure C25 and C26: Probably ferrochrome with chlorides with carbon rich organics (left, C25) and iron with small amounts of chlorides and soil (right, C26). (RJ Lee SEM sample scan 2014)

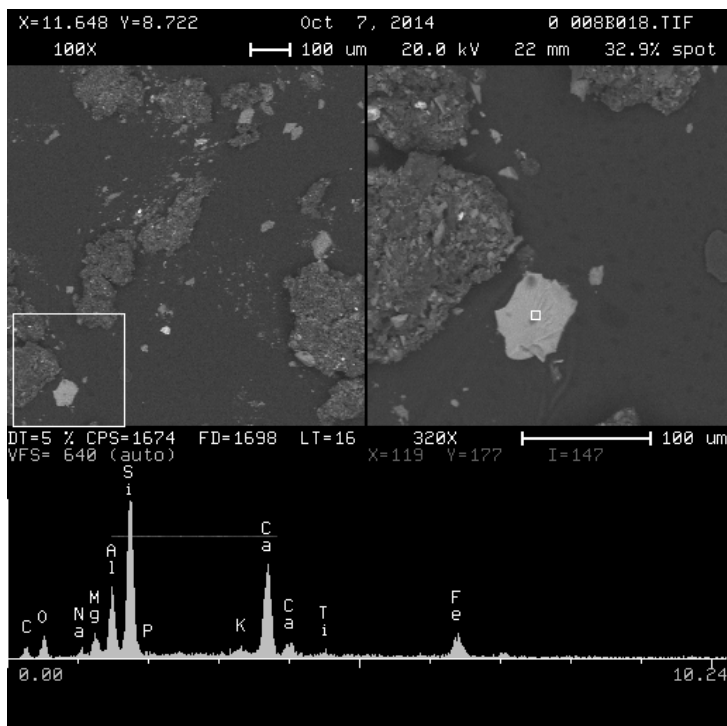
Figure C27: Fly ash, soil and a small amount of iron. (RJ Lee SEM sample scan 2014)

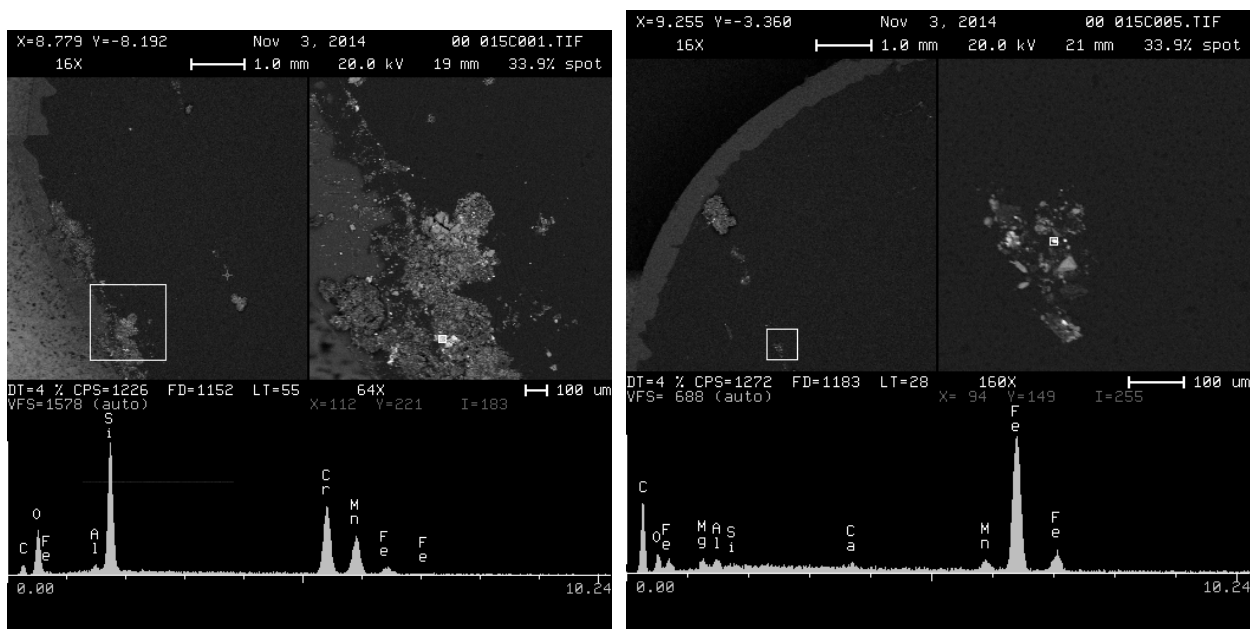
Figure C28 and C29: (left, C28) Slag from iron or steel production and (right, C29) iron with small amounts of soil and iron with soil. (RJ Lee SEM sample scans 2014)

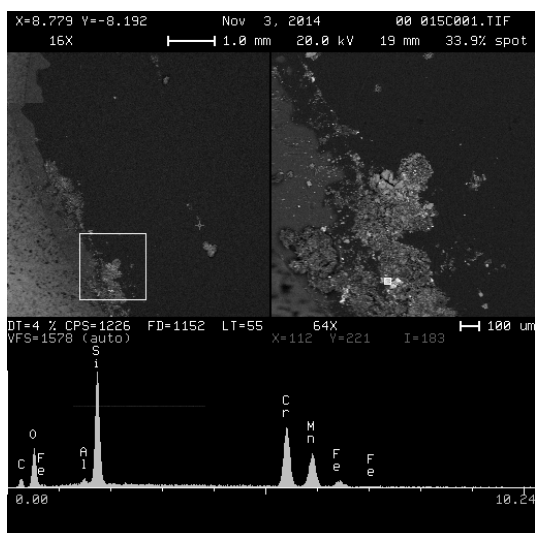
Figure C30: Soil and ferrochrome particles. (RJ Lee SEM sample scan 2014)

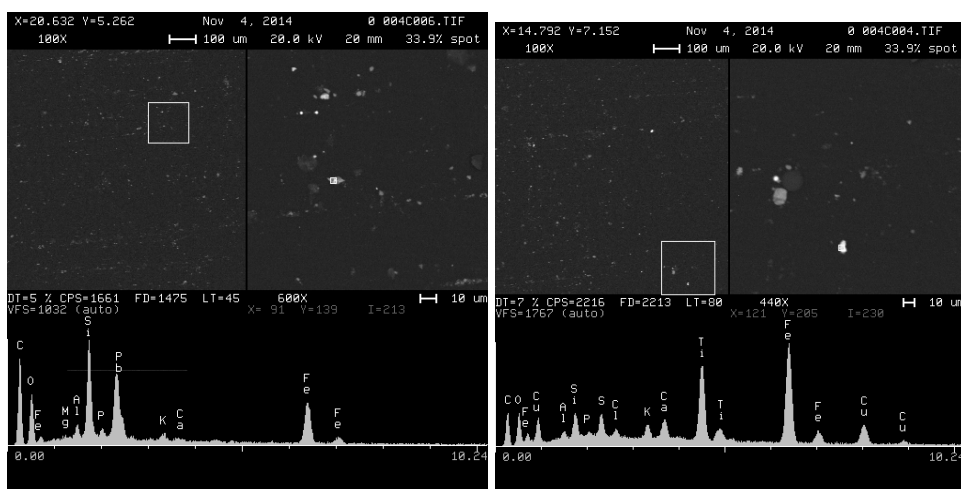
Figure C31 and C32: These particles are representative of the unusual metal particle combinations found on this sample including lead, iron, soil and carbon organics (left) and titanium with iron and smaller amounts of copper, chlorides, and soil (right). (RJ Lee SEM sample scan 2014)

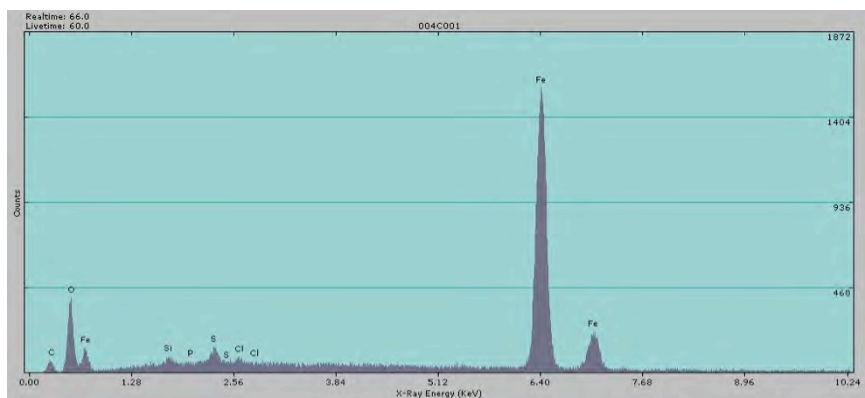
Figure C33: Iron particle with oxygen (corrosion). (RJ Lee SEM sample scan 2014)

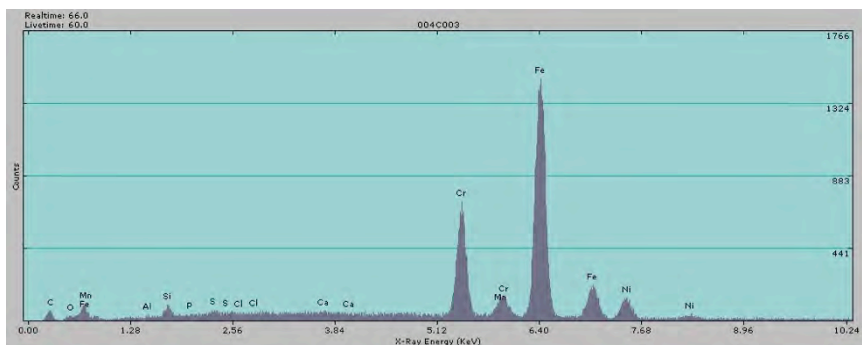
Figure C34: Stainless steel particle with no oxygen (corrosion) with minor amounts of chlorides (salt) and soil. (RJ Lee SEM sample scan 2014)

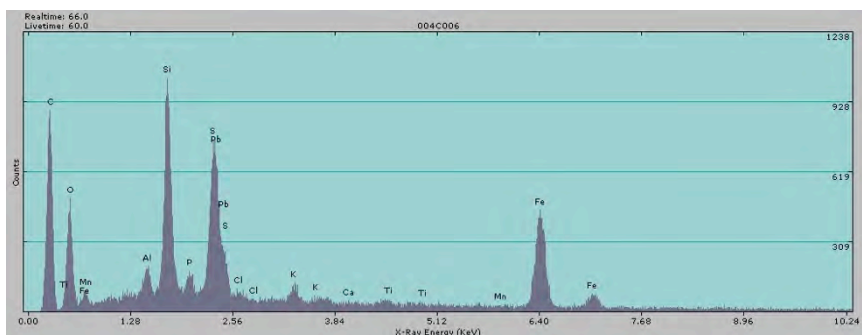
Figure C35: Soil combined with iron and steel slag and some lead. (RJ Lee SEM sample scan 2014)

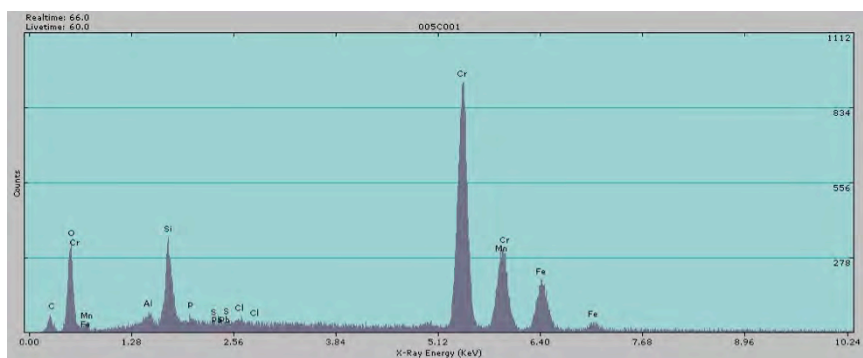
Figure C38: Ferrochrome and fly ash. (RJ Lee SEM sample scan 2014)

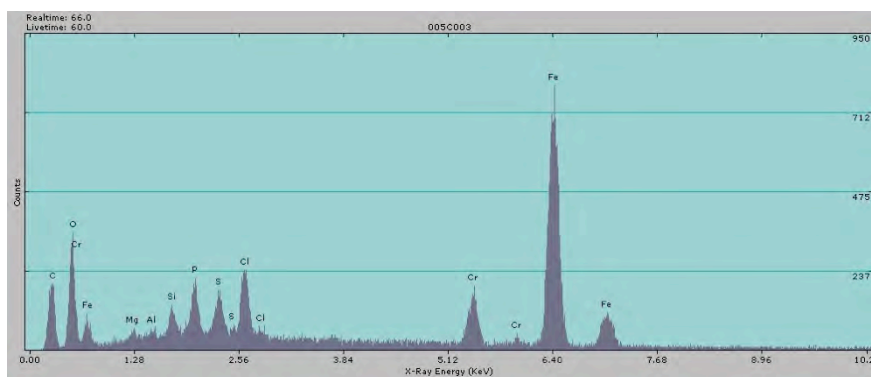
Figure C39: Ferrochrome, chlorides (salt), and soil. (RJ Lee SEM sample scan 2014)

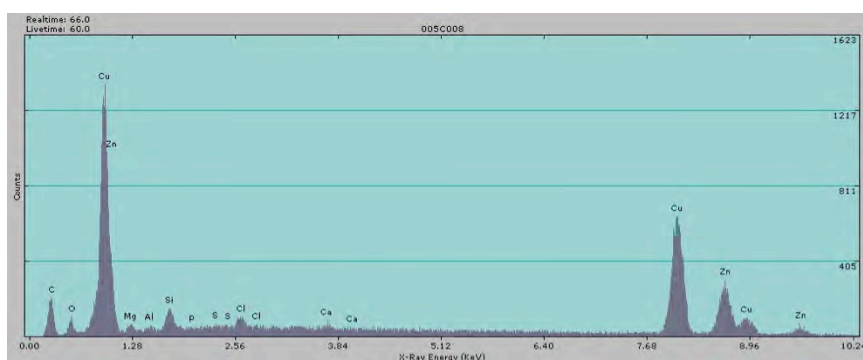
Figure C40: Copper zinc alloy particle with minor amounts of chlorides (salt) and soil. (RJ Lee SEM sample scan 2014)

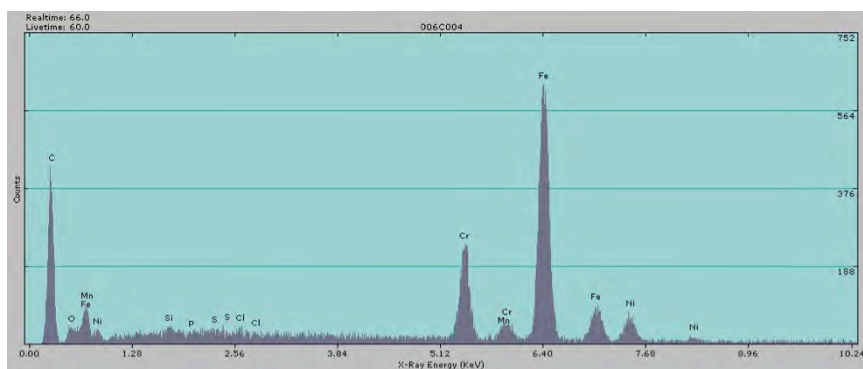
Figure C41: Most of the particles were ferrochrome combines with carbon rich organics (i.e. spores and pollen) with very small amounts of soil and chlorides (salt). (RJ Lee SEM sample scan 2014)

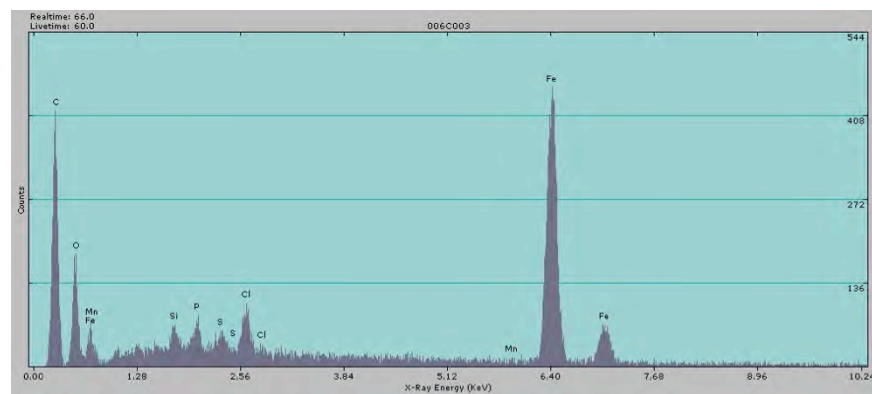
Figure C43: Iron particle combined with carbon rich organics (i.e. pollen and spores) and smaller amounts of chlorides (salt) and soil. (RJ Lee SEM sample scan 2014)

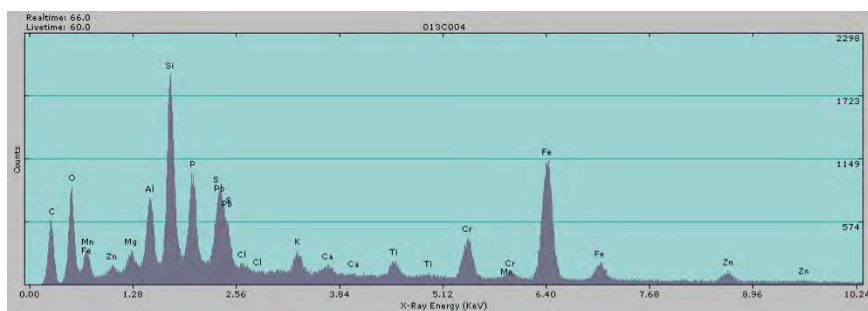
Figure C48: Ferrochrome, soil, potassium, zinc, and soil. (RJ Lee SEM sample scan 2014)

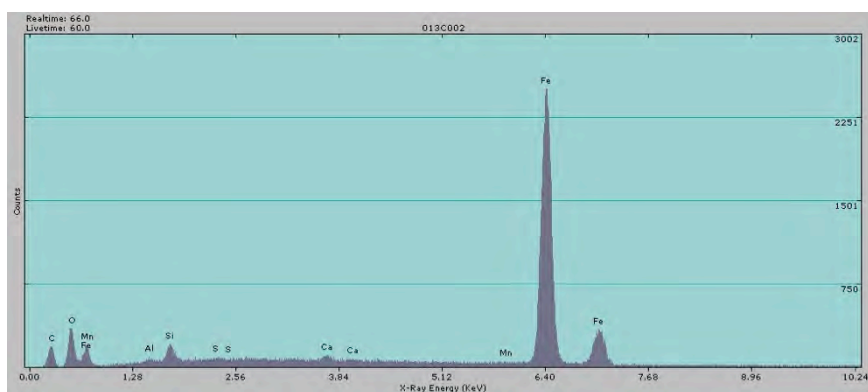
Figure C49: Iron particle with small amounts of soil. (RJ Lee SEM sample scan 2014)

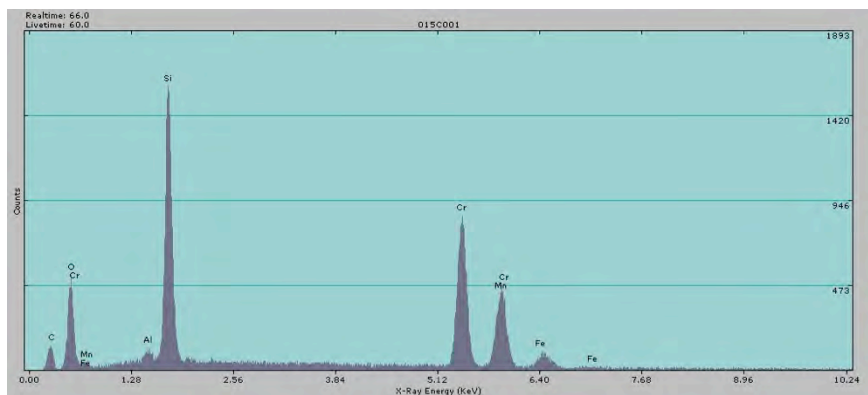
Figure C50: Ferrochrome combined with soil. (RJ Lee SEM sample scan 2014)

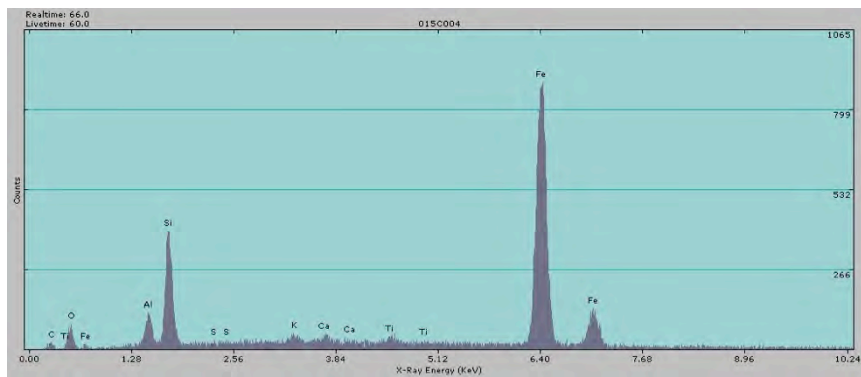
Figure C51: Most of the particles were iron combined with soil and some fly ash. (RJ Lee SEM sample scan 2014)

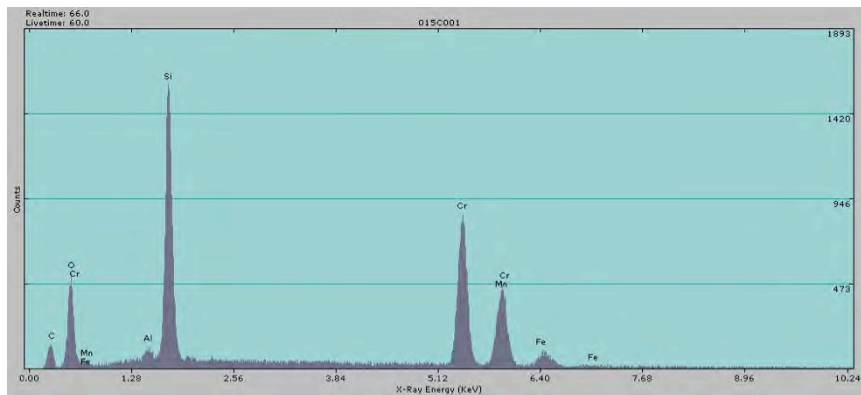
Figure C52: Ferrochrome combined with soil. (RJ Lee SEM sample scan 2014)

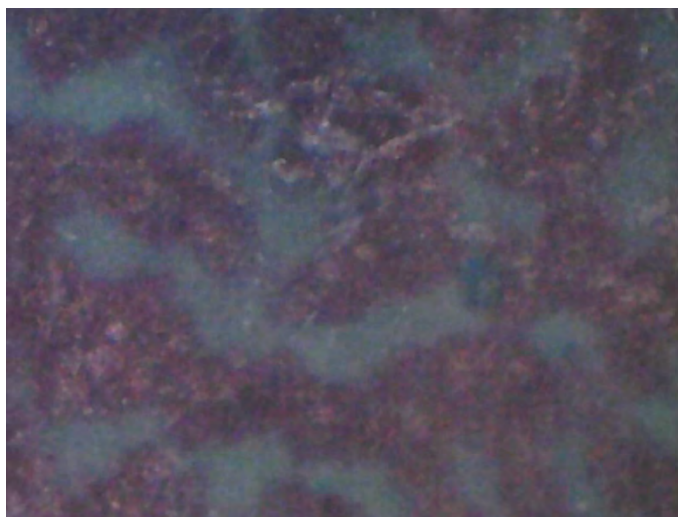
Image 1: Green color with reddish back ground at horizontal weld. North leg, West side.

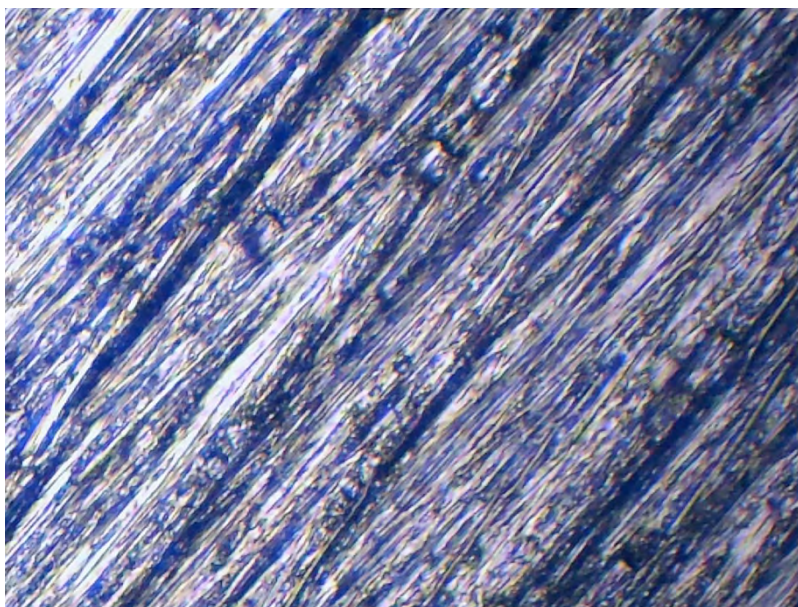
Image 2: Close up of stainless steel surface above scratch

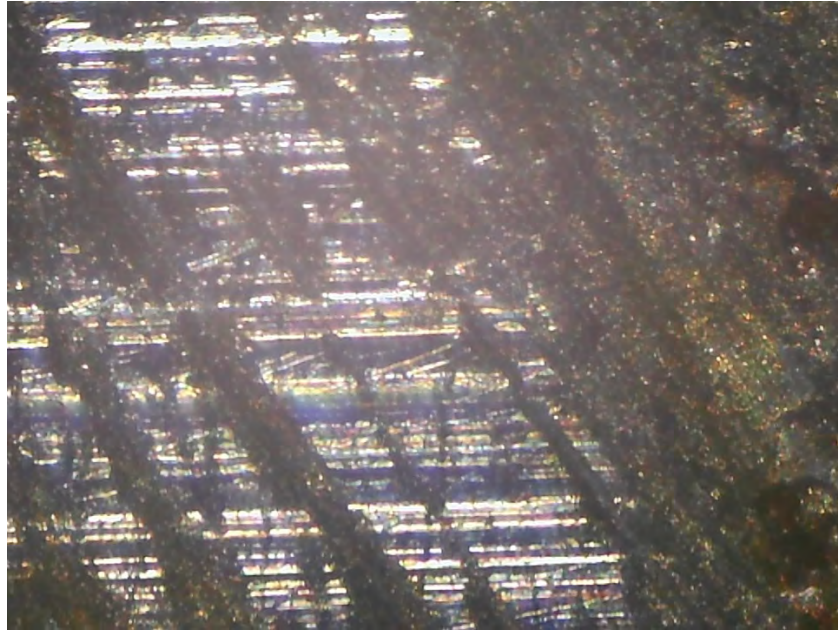
Image 3: Cross grain scratches on surface
