# The Gateway Arch

GATEWAY ARCH NATIONAL PARK  
ST. LOUIS, MO

CONSERVATION  
MANAGEMENT PLAN

AUGUST 2020

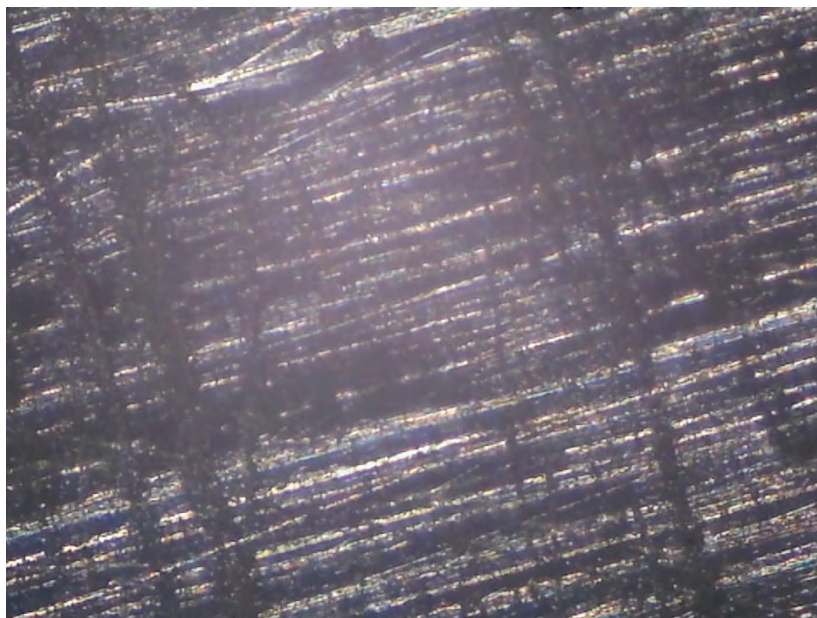
Image 4: Cross grain scratch on stainless steel surface

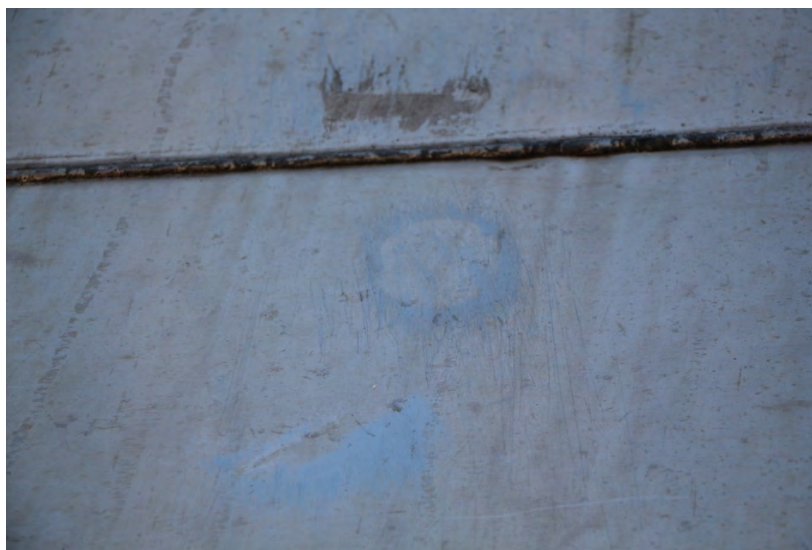
Image 5: Weld and marks on surface

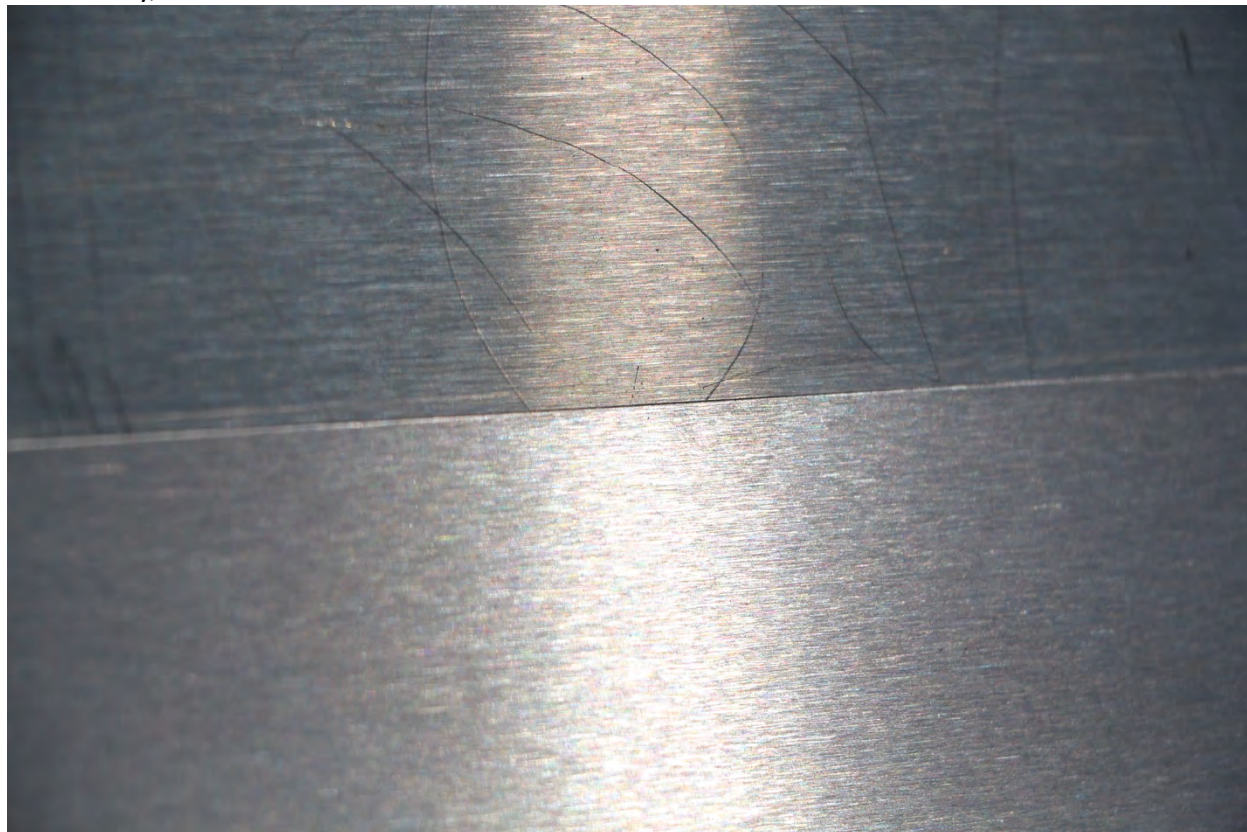
Image 6: 180 grit aluminum oxide comparison. Note color of arch is darker

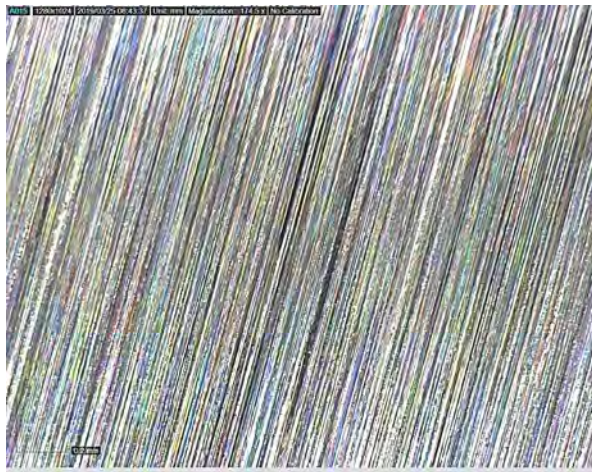
Figure E.4A: Representative photomicrograph of the control sample finish, 175X

A representative photomicrograph of the control sample finish is provided in Figure E.4A. The finish was cleanly cut with minimal areas of surface overlap (smearing) or visible tearing. A cleanly cut surface provides better corrosion performance than a finish of equivalent surface roughness which has these defects. This image is provided for comparison with the later images illustrating the effectiveness of cleaning trials.

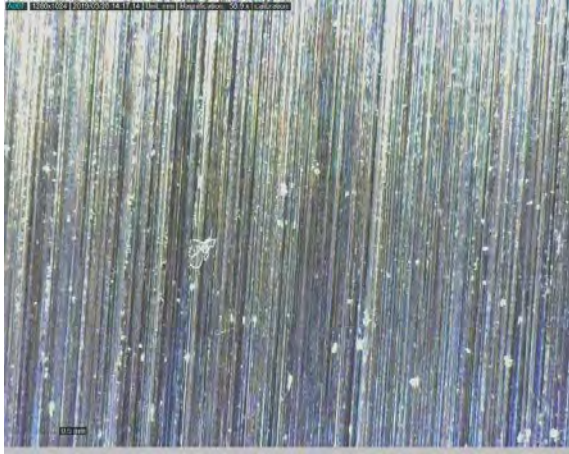
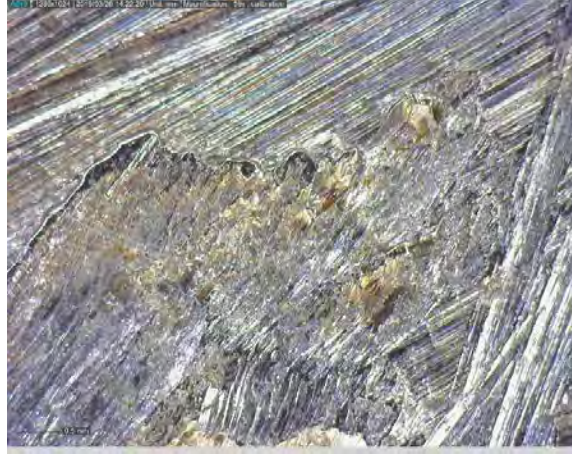
H.1 Sample Astropak #7 401 buffer 59.1x images: (L) Deicing salts staining was completely removed with some minor surface pitting observed, (R) Some embedded iron particles and resultant staining were still present on the surface but only clearly visible under microscopic examination.

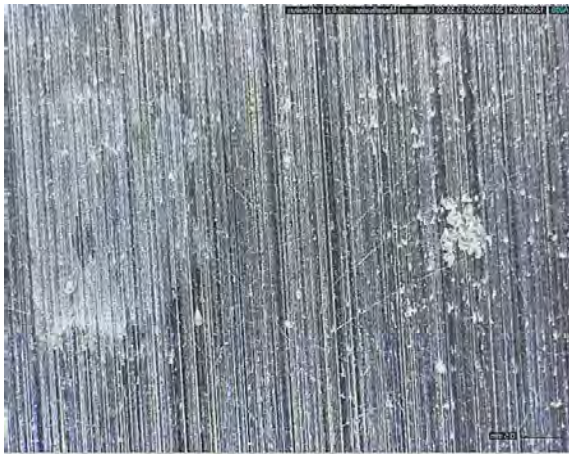
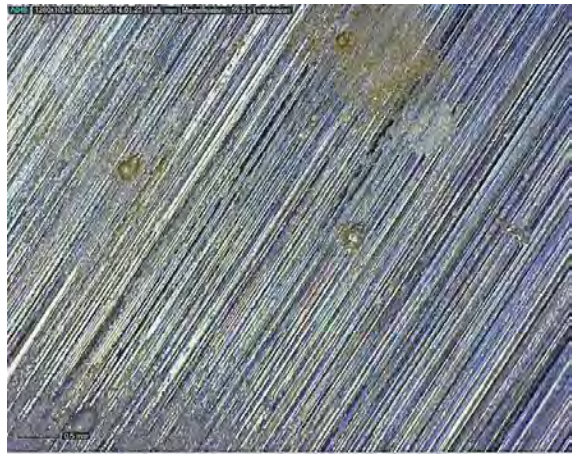
H.2 Sample Astropak #7 hand buffed images: (L) Deicing salts staining was completely removed with some minor surface pitting observed 58.9x, (R) This area was particularly aggressively scratched. Some very small embedded iron particles and resultant staining were still present on the surface but only visible under microscopic examination 59x.

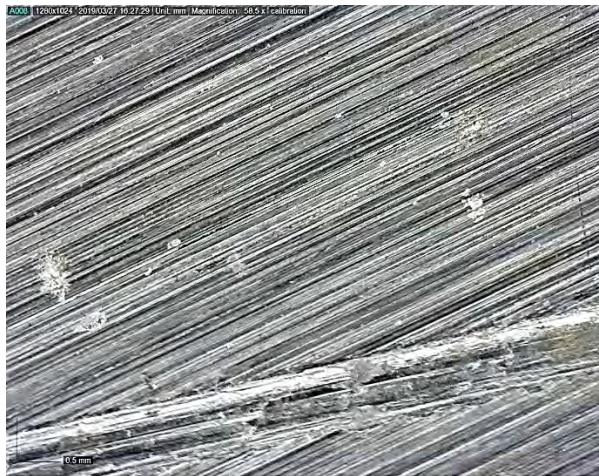
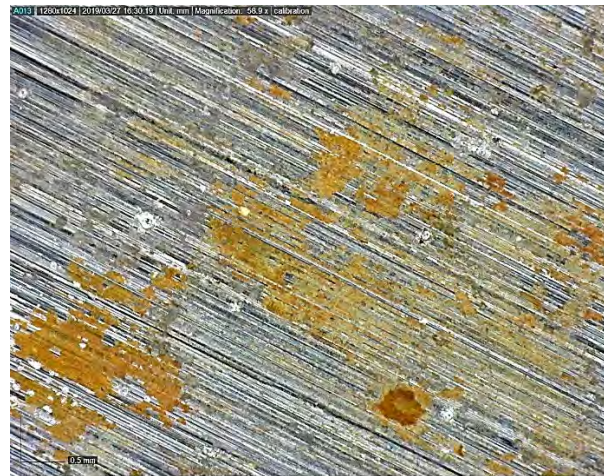
H.3 Sample Astropak #9 hand buffed bottom images: (L) Deicing salts staining was completely removed. This sample had numerous areas with the unidentified surface deposit, which is also shown in this image. 58.8x, (R) No embedded iron particles were observed but some residual staining was still present on the surface. The unidentified deposit appeared to be holding these remaining particles onto the surface, so the cleaning method was considered effective in meeting the goals of the project. The effect of the deposit was only clearly visible under microscopic examination. 59.3x.

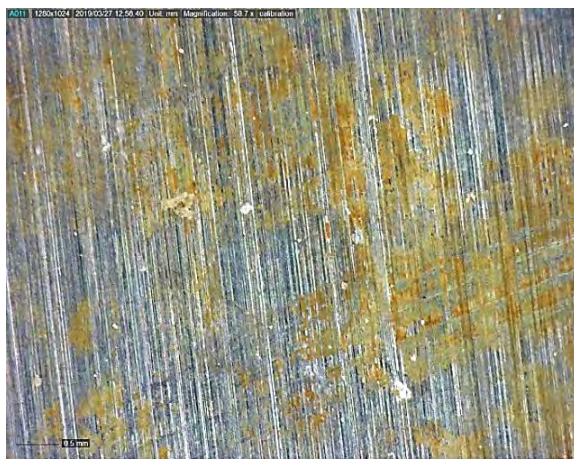
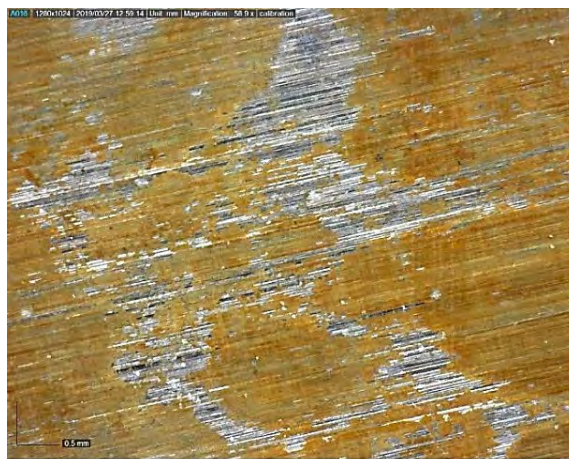
H.5 Sample Karcher sample 3A images: (L) Neither the deicing salts nor the embedded carbon steel staining had been completely removed from the surface. 58.7x, (R) Staining around visible areas of deicing salts pitting was visible. The cleaning method was not considered effective. 58.9x

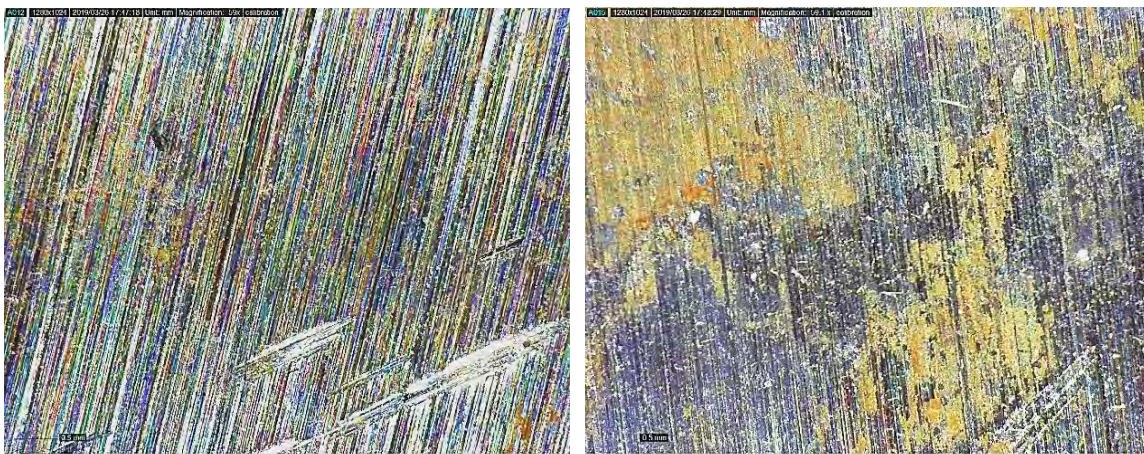
H.8 Sample Karcher sample 4B1 dry ice 1 cleaning images: The effectiveness of this cleaning method varied by area. (L) The deicing salts staining and carbon steel contamination related

corrosion were reduced but not eliminated in some areas. 59x, (R) There was significant residual deicing salts and embedded iron corrosion visible in many areas indicating that it had not been removed. The cleaning method was not considered effective. 59x.

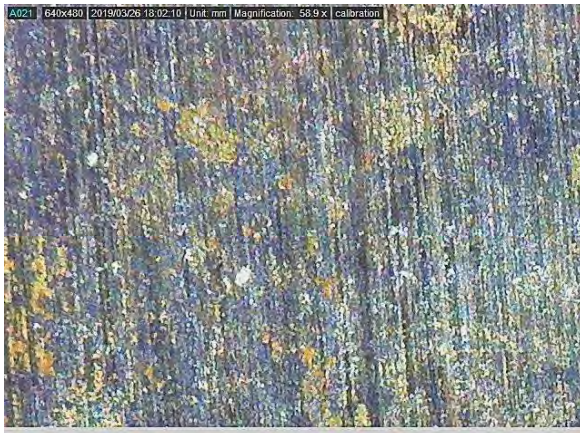
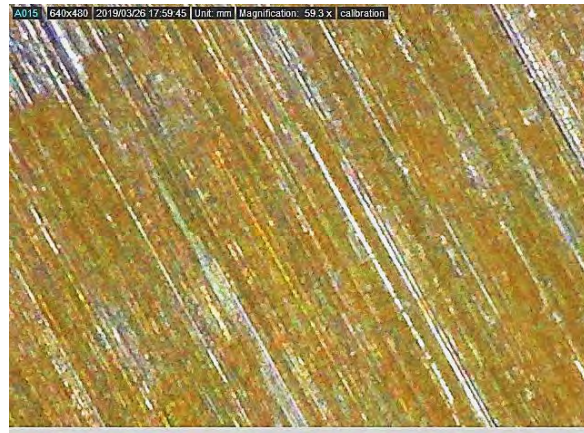
H.9 Sample Karcher sample 4B2 dry ice 2 cleaning images: The effectiveness of this cleaning method varied by area. (L) The deicing salts staining and carbon steel contamination related corrosion on the surface were reduced but not eliminated in some areas. 58.9x, (R) Other areas were still substantially stained. The cleaning method was not considered effective. 59.3x.

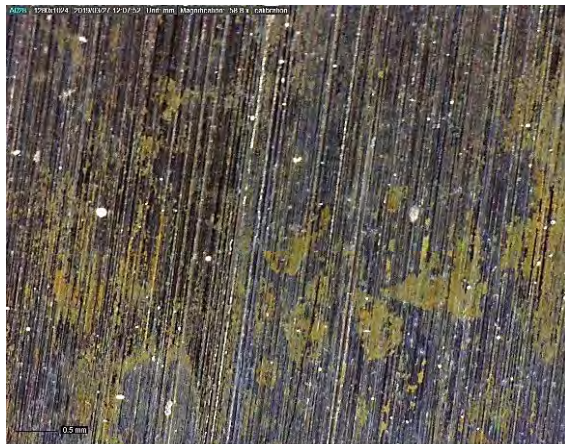
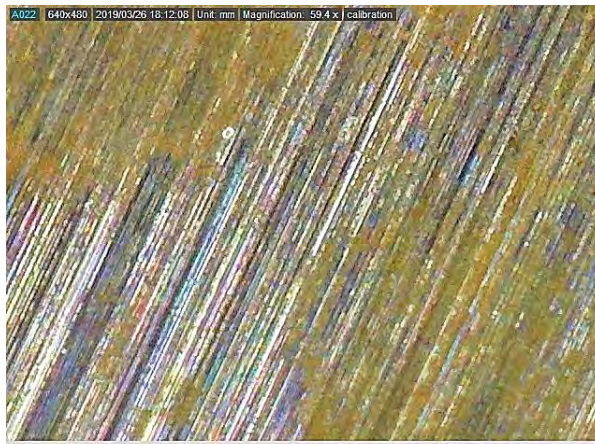
H.10 Sample Karcher sample 4B3 dry ice 3 cleaning images: The effectiveness of this cleaning method varied by area. It was not considered effective. (L) The deicing salts staining and carbon steel contamination related corrosion on the surface were reduced but not eliminated in some areas. 58.8x, (R) Other areas were still substantially stained. 59.4x.

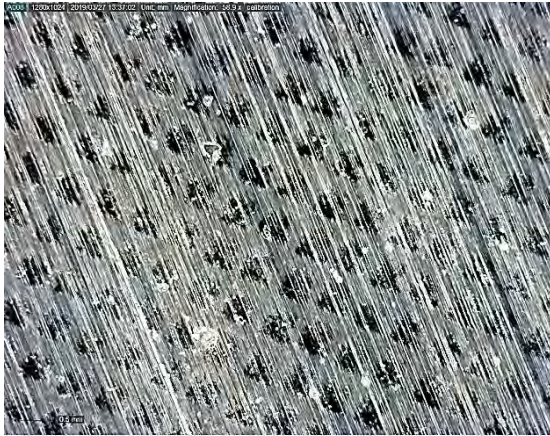
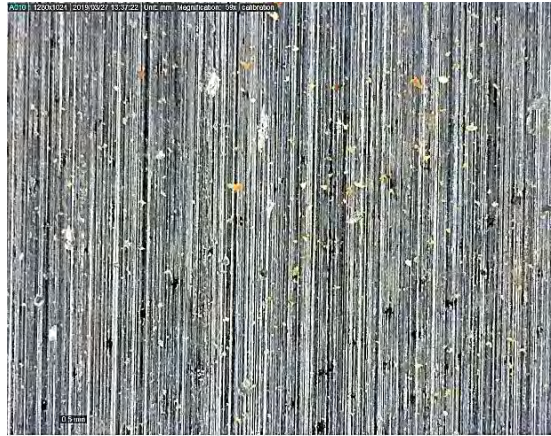
H.11 Sample Adapt laser cleaning sample 11A cleaning images: The embedded carbon steel and corrosion staining were substantially reduced but still visible but significant heat related surface damage (dark areas) was observed. (L) Heat related damage was visible. 58.9x, (R) Other areas had less heat damage but still had visible surface contamination. 59x. See Section G.3 for commentary about laser cleaning heat damage.

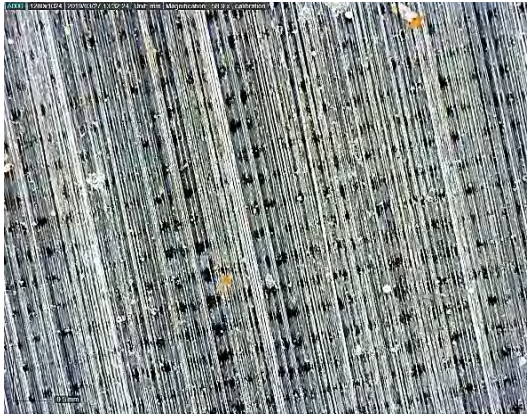
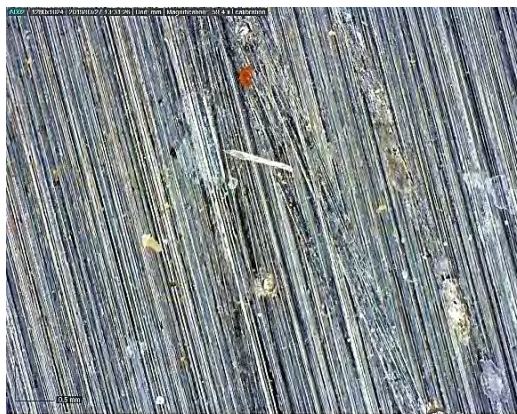
H.12 Sample Adapt laser cleaning sample 11B cleaning images: Most of the embedded carbon steel and corrosion staining were removed with only a few scattered remaining spots but heat related surface damage (dark areas) was observed. (L) Heat related surface damage was clearly visible on the surface along with some embedded iron. 58.9x, (R) Other areas had less heat damage but still had visible surface contamination. 59x. See Section G.3 for commentary about laser cleaning heat damage.

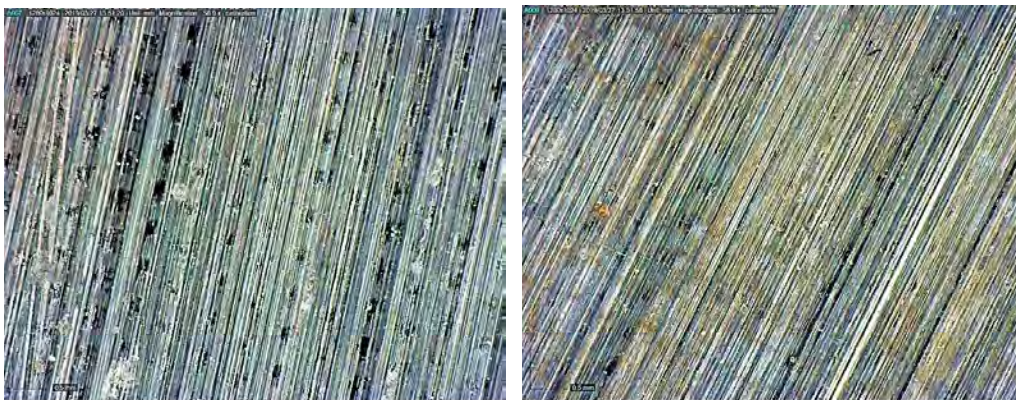
H.15 Sample Adapt laser cleaning sample 12A cleaning images: (L) The embedded carbon steel and corrosion staining were removed other than very small particles from the areas with

more significant heat related surface damage (dark areas). 58.9x, (R) Other areas had less heat damage but still had visible surface contamination from corrosion staining and embedded iron. 50.9x. See Section G.3 for commentary about laser cleaning heat damage.

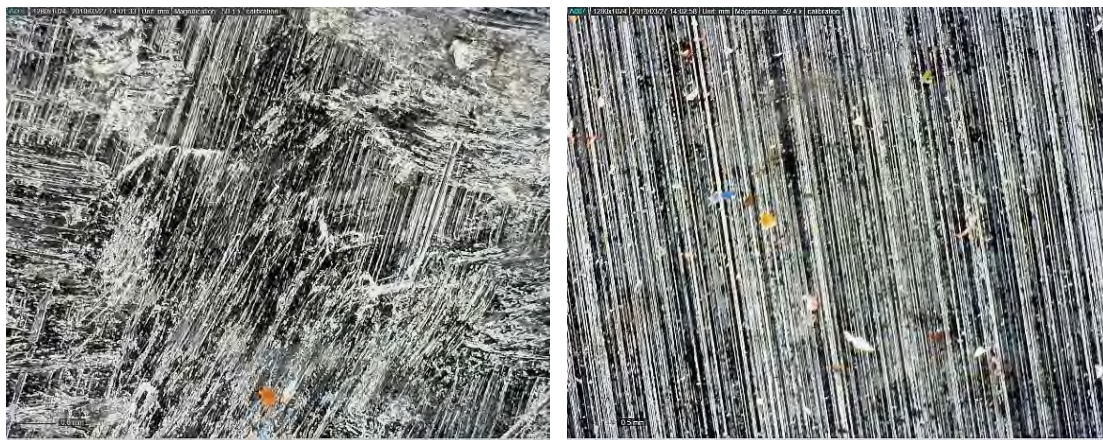
H.18 Sample Adapt laser cleaning sample 13B cleaning images: (L, 59.1x and R, 59.4x) The sample was consistent in appearance. Some scattered embedded carbon steel particles were visible. There was significant heat related surface damage (dark areas) over the entire surface. See Section G.3 for commentary about laser cleaning heat damage.

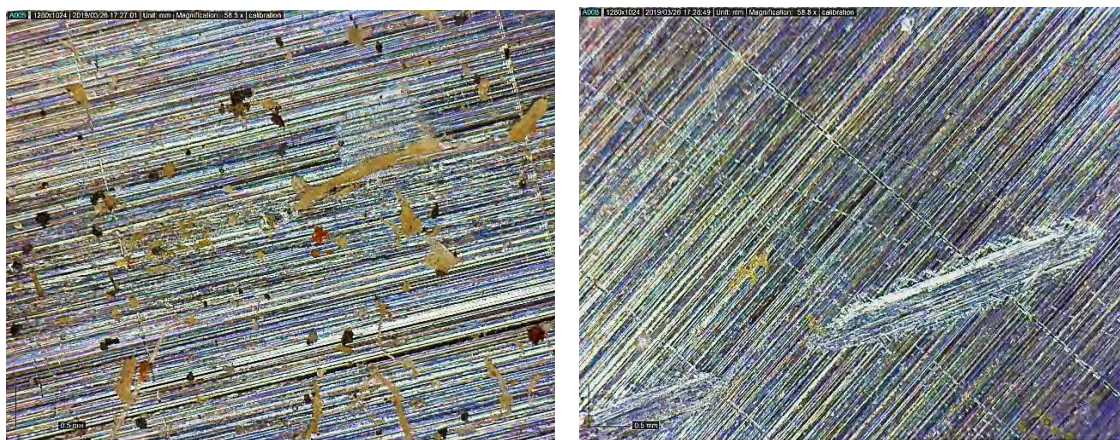
H.19 Zahner electropolished sample (L, 59.5x and R, 59.8x) The surface was visibly smoother with much shallower polishing lines as occurs with electropolishing, which also increases reflectivity and gloss. The level of residual embedded carbon steel particles visible on the surface varied with the area as is shown in these images.
