CONSERVATION AND  
MANAGEMENT PLAN

THE NATIONAL  
LIBRARY OF KOSOVO  
PJETËR BOGDANI  
BIBLIOTEKA KOMBËTARE  
E KOSOVËS

OCT. 2017 PRISHTINA, KOSOVO  
KOSOVO ARCHITECTURE FOUNDATION

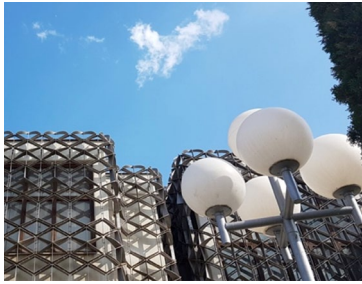
**FIGURE 117**

the illumination levels soon after the library was completed in 1981

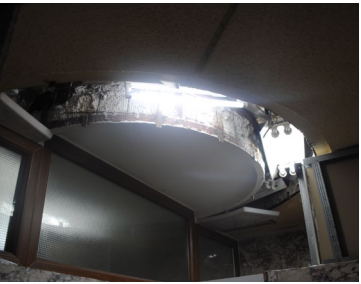
**FIGURE 119**  
LIGHT TYPE #1 - Circular lights over open areas repeat the dome motif in many spaces. The light levels in many spaces and circulation routes is inadequate.

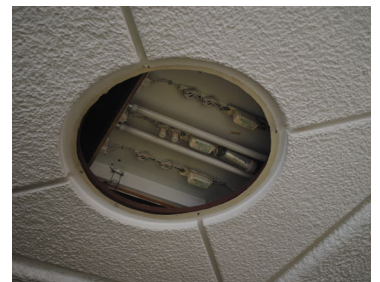
**FIGURE 125**  
LIGHT TYPE #2 - Single circular panel set inside a square. Installed in corridors and office. Most of these fixtures are intact but require maintenance, upgrades and replacement panels.

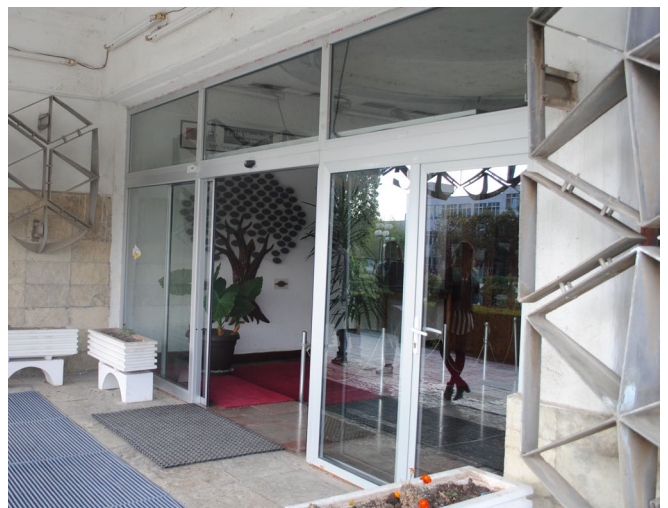
127

**FIGURE 127**  
replaced original doors with aluminum frame doors at the administrative entrance

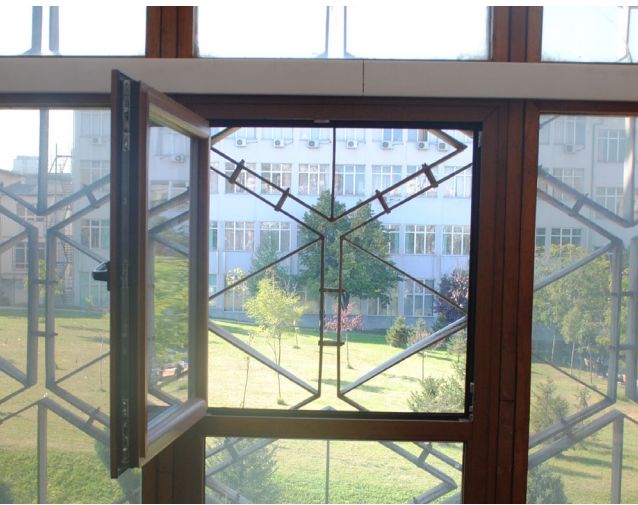
131

**FIGURE 129**  
detail of the wood cladding in an original window – largely in good condition but requires maintenance and a new finish
