Leibniz Institute for
Astrophysics Potsdam

The Einstein Tower in Potsdam

Final Report 2018

The Einstein Tower

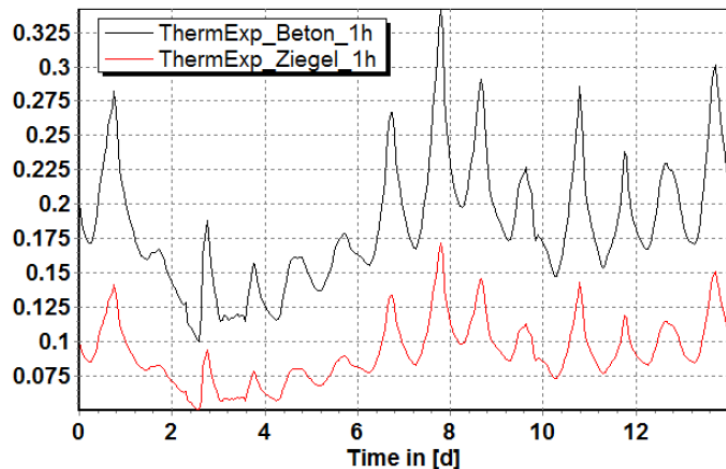
At the tower, a horizontal crack is visible in the west wall at the window level above the first platform, both inside and outside. If it passes through the entire wall is not certain but likely. It had to be determined why this crack is present on the west side only but not on the east side at the analogue place. A one-dimensional simulation was carried out assuming a non-stationary interior and exterior climate. Air temperatures on the outside are the same, but the radiation and the impact by driving rain are different. On the west wall about 6 K higher maximum temperatures occur, since here the solar radiation is superimposed upon the higher outside air temperature in the afternoon. Since the

On days with direct radiation, the temperature gradient in the west wall is significantly higher. In the middle of the plotted period, two cloudy days are visible where the gradients are approximately equal. The irradiation and therefore the temperature load on the outer wall is thus significantly higher in the west than in the east. However, these temperature gradients per se are not so high that such severe damage – crack through the entire cross-section of the wall – would only point to this cause. More likely is a superposition of an unknown constructive weakness (impact of window linings, possibly corrosion of steel elements, which were not inspected during renovation, etc.) upon the influence of temperature.

Thermal expansion (millimeters) of concrete and bricks over a period of 14 days. (Credit: John Grunewald and Hans Petzold, TU Dresden)

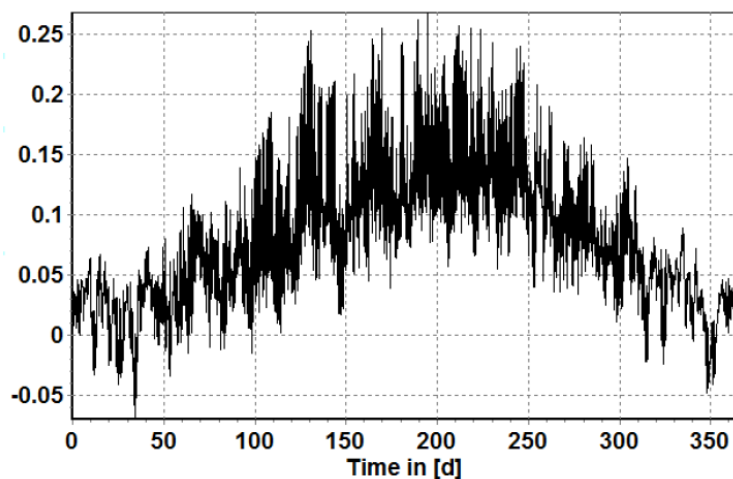
Temporal evolution of the thermal expansion (mm m^{-2}) of the bricks under the sheet metal roof during the course of the year. (Credit: John Grunewald and Hans Petzold, TU Dresden)

A simulation with real climate conditions shows that the design has some reserves in practice. At 20 °C and 40% humidity, the condensate volume would be a little less than 1 kg m^{-2} at a real outdoor climate. Since an adjacent layer is not absorbent, only 0.5 kg m^{-2} would be permissible according to the German standard DIN 4108. Due to the solar radiation impinging on the level roof during the warm seasons, the (calculated) moisture dries well and there is no continuous build up in the following years. With the more realistic 14°C and 40% mentioned above no condensate would occur.

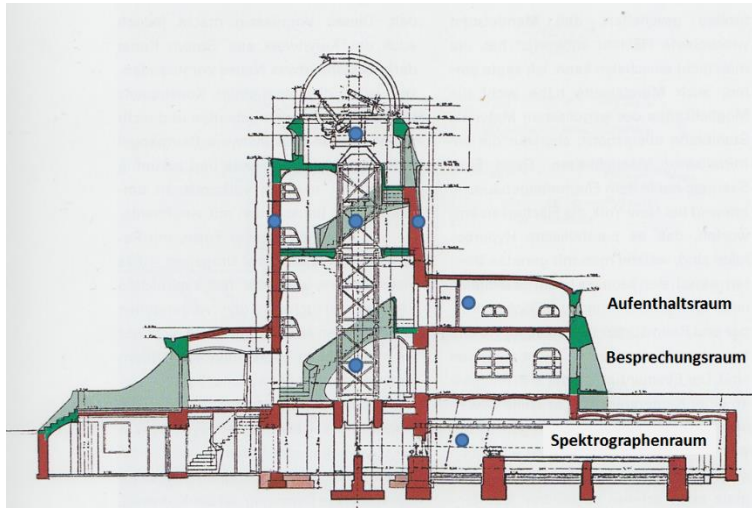
Measuring points for temperature and humidity are marked by blue circles. (Credit: John Grunewald and Hans Petzold, TU Dresden)

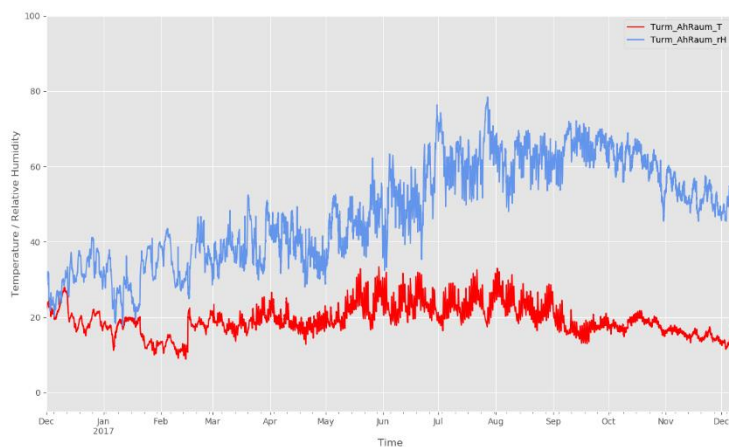
Room temperature (°C, red) and humidity (% , blues) measured in the office at the upper floor. (Credit: John Grunewald and Hans Petzold, TU Dresden)

During the course of the year, the air temperature is between 10 °C in mid-February and a maximum of approx. 33 °C in May to August. Therefore, the office at the upper floor does not only cool down moderately in winter; the jump from about 10°C to 20°C in mid-February is probably due to a corresponding temperature setting of the heating system by the users. The summer temperature is freely adjustable. The temperatures are not likely to be extreme for the building structure. However, for office work, the temperatures are clearly outside the comfort zone.

If one looks at the room temperatures with the outside air temperature in a heat period, here in June 2017, the room temperature during the day is about 3–5 °C above the outside air, which is plausible. At night, the outside air cools down considerably and is clearly below 20 °C. If night ventilation were possible, the room could cool down at night and a comfortable room climate would be possible, at least in the morning hours.

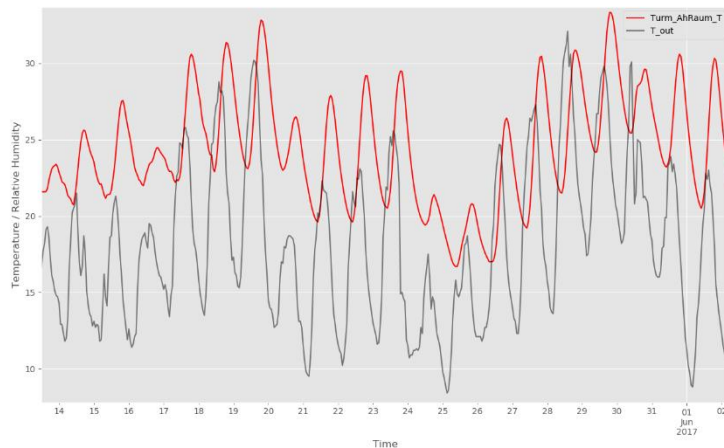
Room temperature (°C, red) measured in the meeting room at the ground floor level and outside air temperature (°C, gray). (Credit: John Grunewald and Hans Petzold, TU Dresden)

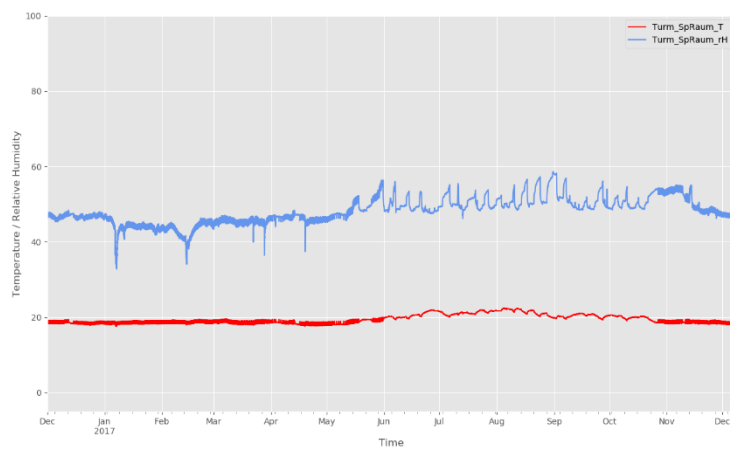
The temperature is almost constant throughout the year at about 20 °C. In winter, due to the temperature regulation, there are small short-term fluctuations, in summer the temperature settles freely, and it is only slightly above 20 °C. Even in the warm season, humidity typically does not exceed 60%, i.e., dehumidification obviously functions reliably. Only during extremely rainy periods, the relative humidity in the spectrograph room and the surrounding gallery may exceed 60% reaching up to 70%, even if all dehumidifiers are running. Of course, the variations of temperature and humidity are much lower in the spectrograph room itself.

Air temperature (°C, red) and humidity (% , black) measured in the spectrograph room. (Credit: John Grunewald and Hans Petzold, TU Dresden)
